Investigation of Failures of White-Coat Plaster

United States Department of Commerce
National Bureau of Standards
Building Materials and Structures Report 121

Lansing S. Wells, Walter F. Clarke, Edwin S. Newman, and Dana L. Bishop

Issued February 1, 1951

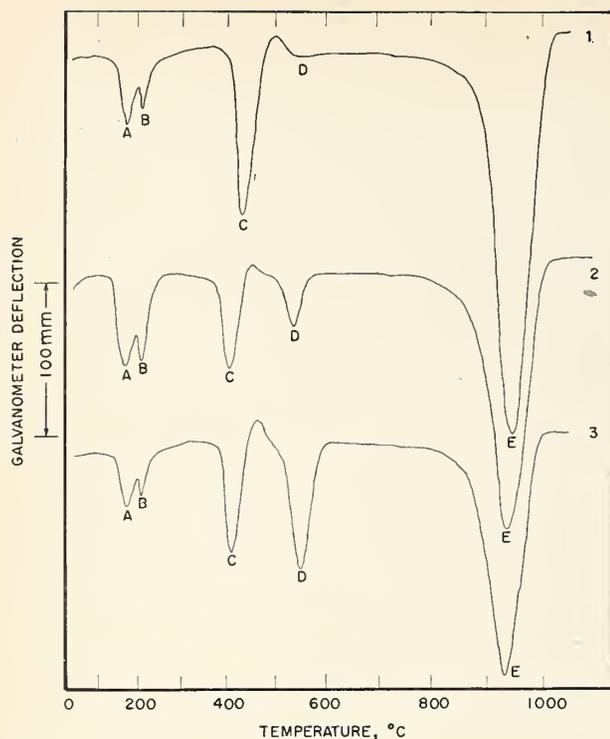
FIGURE 19. Differential heating curves of three samples of white-coat plaster that had failed by expansion.

The five major heat effects are shown on the heating curves of samples from three plaster failures, figure 19. Particularly to be noted is the almost complete absence in curve 1 of the deflection characteristic of the dehydration of $\text{Ca}(\text{OH})_2$. This sample, in which almost complete carbonation of $\text{Ca}(\text{OH})_2$ had occurred, contained no detectable magnesium carbonate. The composition of the plasters represented by the curves in figure 19 can be found in table 3, where samples numbered 42, 32, and 6 correspond to curves 1, 2, and 3, respectively. The areas of the magnesium-hydroxide deflections on the heating curves are roughly proportional to the calculated $\text{Mg}(\text{OH})_2$ in these plasters. It is apparent that the assumptions made in calculating the compound composition of the plasters must be approximately correct.

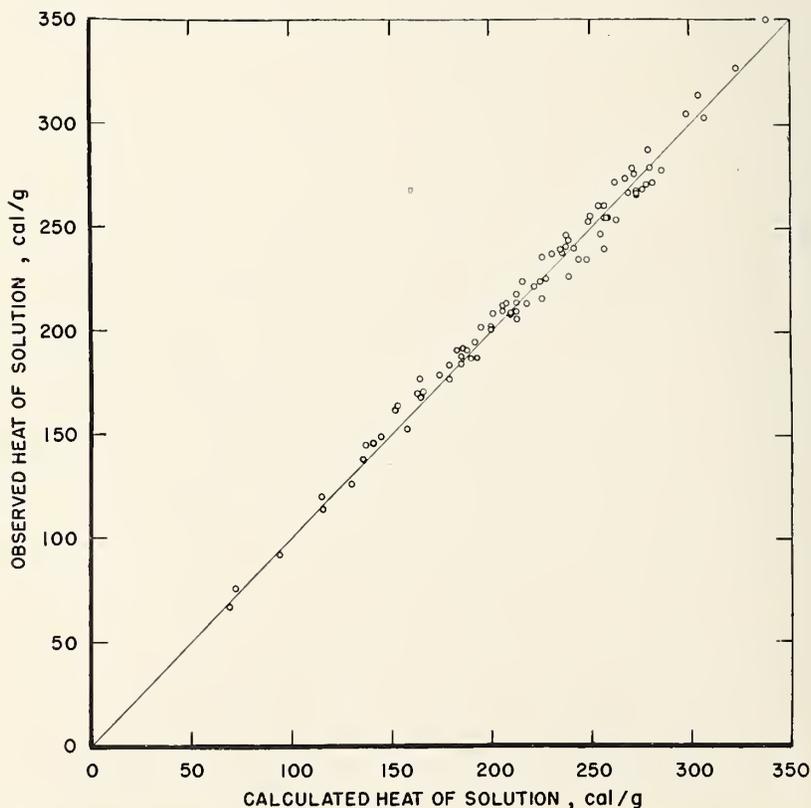
FIGURE 20. Scatter diagram of 88 pairs of calculated and observed heats of solution of samples of failed white-coat plaster.

Figure 20 is a scatter diagram of the 88 pairs of observed and calculated heats of solution. The line best representing these data, determined by the method of least squares, is $Ob = 5.4 + 0.980 C$, regarding the calculated values as the independent variable, and $Ob = 2.6 + 0.993 C$, regarding the observed heats of solution as the independent variable. In these equations Ob and C represent the observed and calculated values, respectively. In figure 20 is shown only the line representing equality of the calculated and observed values. The two lines representing the equations determined by the method of least squares are not shown in figure 20, because they would be so close to the line plotted that the paths of the three separate lines could scarcely be followed and the figure would be confusing.

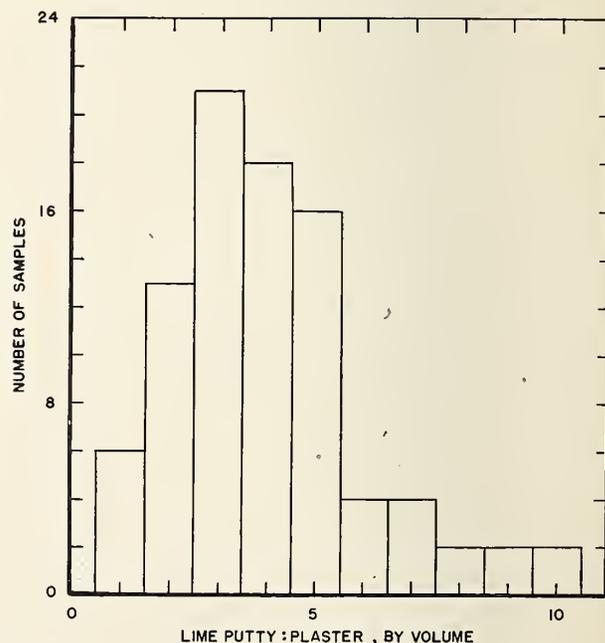
This formula was used in obtaining the values recorded in column 21 of table 3. Plaster failures from which these samples were taken occurred with ratios of lime putty to CaSO₄·½H₂O as low as 0.8 and as high as 9.8. Figure 21 is a distribution diagram of the ratios of lime putty to CaSO₄·½H₂O (by volume) for the 88 samples. The average ratio, taken from the grouped data, was 4.0, and 90 percent of the samples were scattered more or less symmetrically about that figure. Only the samples with ratios of 7.0 and higher (8 in all) appear to fall out of that distribution.

FIGURE 21. Distribution diagram of the ratios (by volume) of lime putty to gaging plaster (CaSO₄·½H₂O) for 88 (N) samples of white coat.

The average ratio (\bar{x}) is 4.0, and the standard deviation (σ) is 2.0.
