> Fire Tests of Wood-Framed Walls and Partitions With Asbestos-Cement Facings

United States Department of Commerce National Bureau of Standards Building Materials and Structures Report 123

Nolan D. Mitchell

Building Materials and Structures Report 123 Issued May 10, 1951

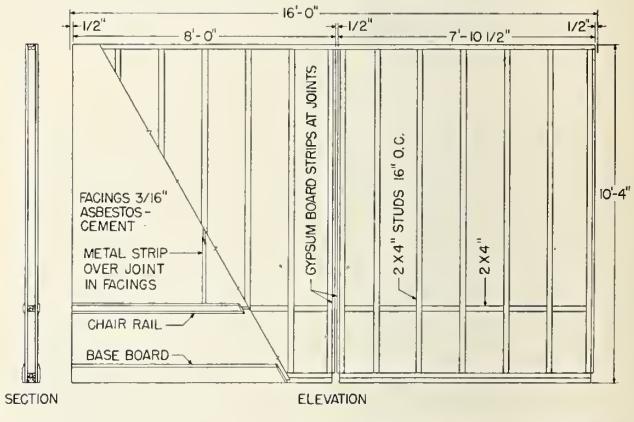
FIGURE 1. Details of a partition faced with asbestoscement sheets.

The end study of sections of walls and partitions that were to be tested under load were lined on the side facing the open joint through the framing with 3¹/₂- by ³/₈-in. gypsum-board strips, as shown in figure 1. To afford some degree of protection against early ignition, strips of gypsum board were applied along the edges of the wood studs of two partitions (tests 6 and 7) and three walls (tests 9, 10, and 11). These strips were 4 in. wide. For the partitions they were of $\frac{3}{8}$ in. thickness and for the interior facings of the walls of tests 10 and 11 of $\frac{1}{2}$ in. thickness. The wall in test 8 had insulated sheathing board for the interior facing. The partitions in tests 2 and 3 had sheathing of gypsum board over which the asbestos-cement sheets were applied, the gypsum board on section A being $\frac{3}{8}$ in. thick and on section B, $\frac{1}{2}$ in. thick.

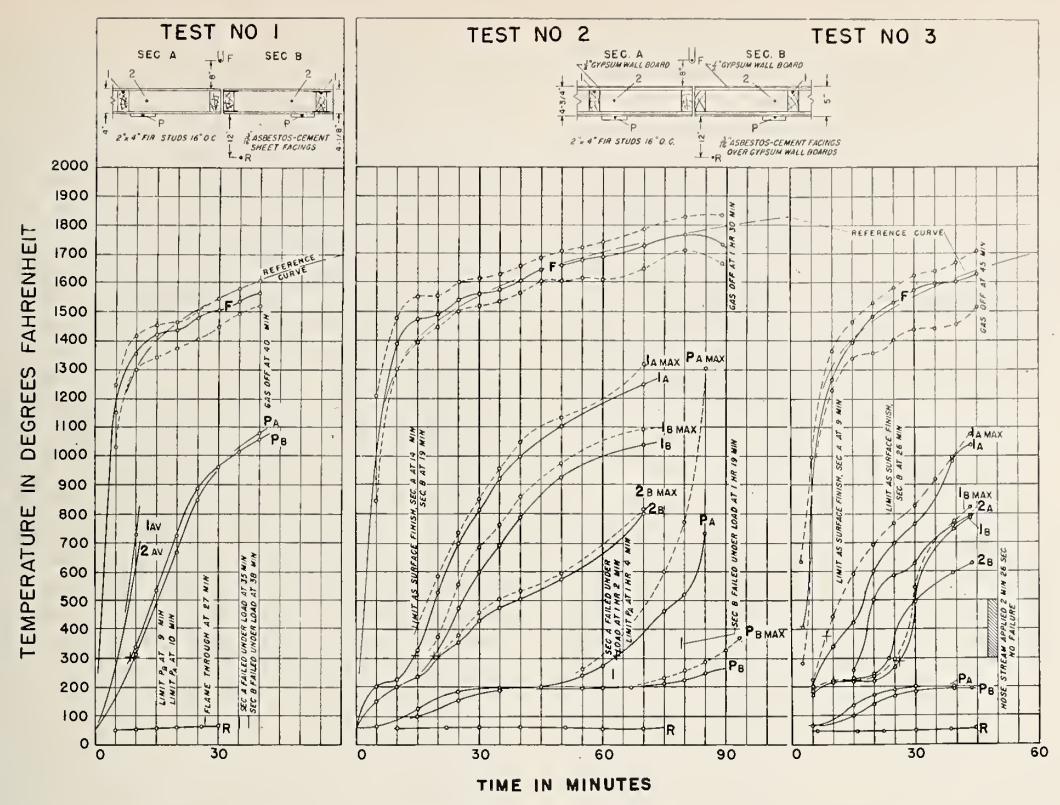
FIGURE 3. Furnace and partition temperatures for partitions with no insulation between studs. Tests 1, 2, and 3.

The limiting temperature rise of 250 deg F (139 deg C) on the unexposed face of this partition, test 1, was reached at 9 min for section B, and at 10 min for section A. The limiting rise of 325 deg F (181 deg C) at one point on the surface was reached at 10 min for both sections A and B. At a joint on the unexposed surface, where one sheet had bulged away from the stud, flames appeared at 27 min after the start of the fire. Glow, which was observed on the chair rail of section A at 36 min, developed into flame at 39 min. Other data for tests 1, 2, and 3 are shown in figure 3. Load failures of sections A and B occurred at 35 and 38 min, respectively.

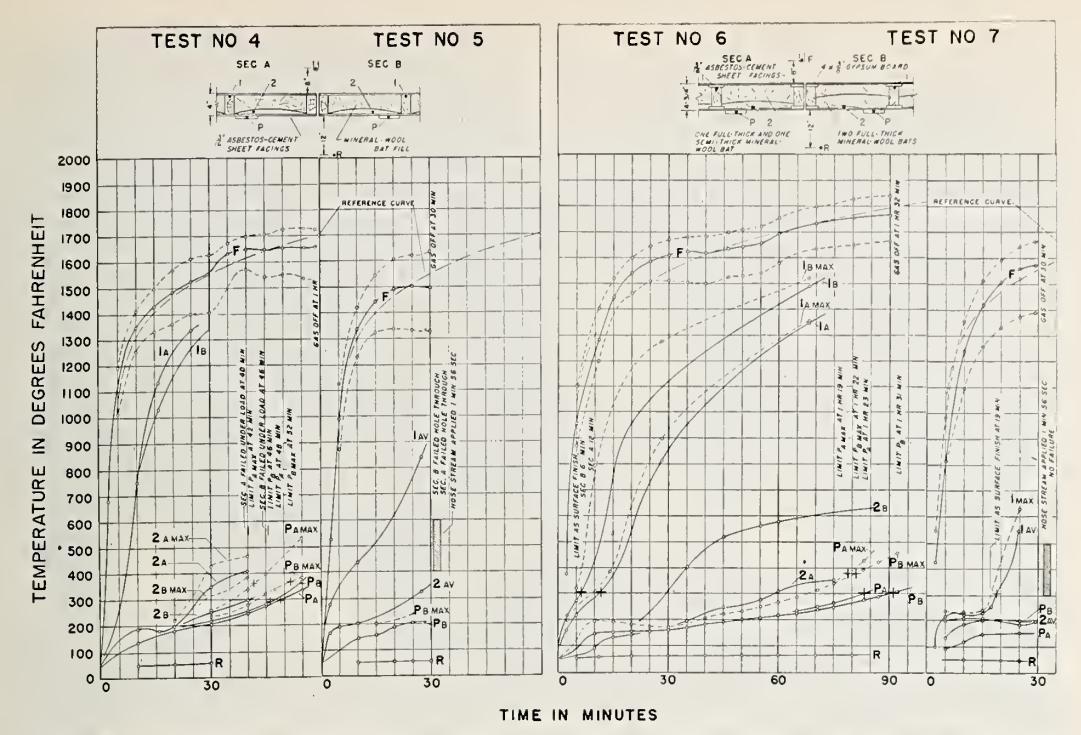
FIGURE 9. Furnace and partition temperatures for partition with mineral-wood fill between studs. Tests 4, 5, 6, and 7.

Failure by a temperature rise of 325 deg F (181 deg C) at one point of section A of the partition of test 6 occurred at 1 hr 19 min and on section B at 1 hr 22 min. The limiting rise of 250 deg F (139 deg C) as the average of five locations was reached at 1 hr 23 min on section A and at 1 hr 31 min on section B. Deflections of the midpoints of sections A and B toward the fire at 1 hr 25 min were 0.6 and 0.7 in., respectively. There was only minor cracking of the facing sheets on the unexposed surface. Figure 8 shows the face of the partition after 1-hr 32-min exposure to fire.

Data for the partitions with mineral-wool fill between the studs, tests 4, 5, 6, and 7, are shown in figure 9.

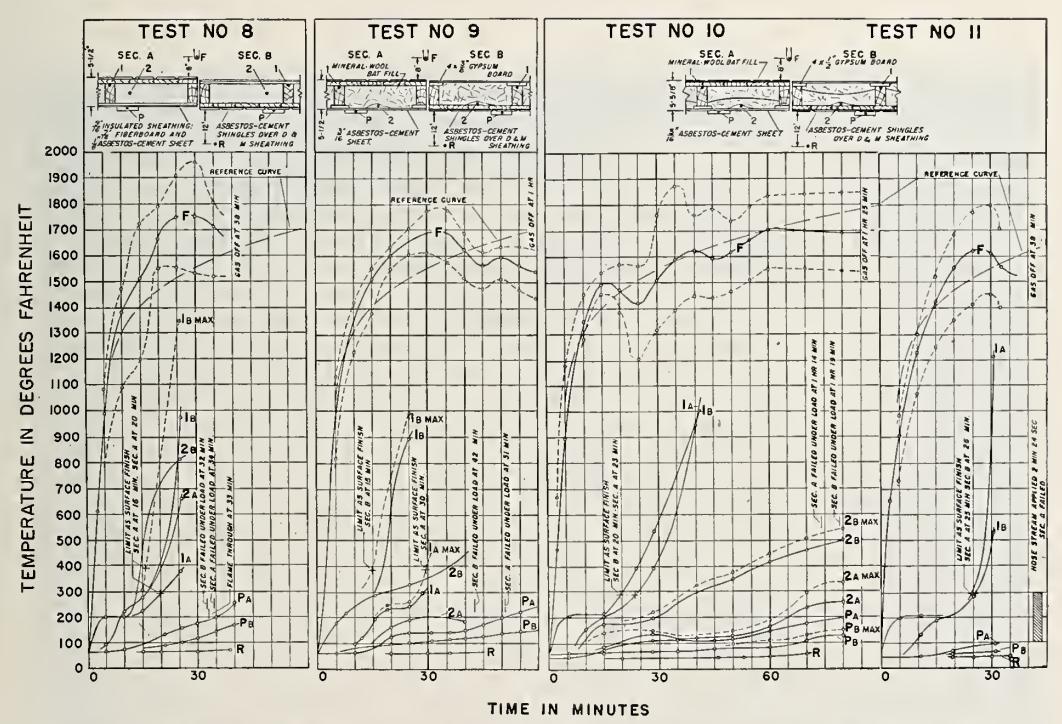
FIGURE 10. Furnace and wall temperatures for walls with asbestos-cement shingles. Tests 8, 9, 10, and 11.

Three walls with asbestos-cement shingles on one side and asbestos-cement sheets on the other were subjected to fire-endurance tests, and one wall to a fire and hose-stream test. Each wall was divided into two equal sections, section A having the shingled face exposed to the fire, and section B with the sheet-faced side so exposed. All three walls subjected to the fire-endurance test failed by buckling of the stude under load. The limiting rise of temperature as measured by thermocouples under asbestos pads on the unexposed surface was not attained during the fire exposure in any of the three tests, the fires of which were continued for periods of 38 min, 1 hr, and 1 hr 25 min for tests 8, 9, and 10, respectively. Data for the walls (tests 8, 9, 10, and 11) are shown in figure 10.
