Atmospheric Exposure Tests of Nailed Sheet-Metal Building Materials

Building Materials and Structures Report 128

Theodore H. Orem

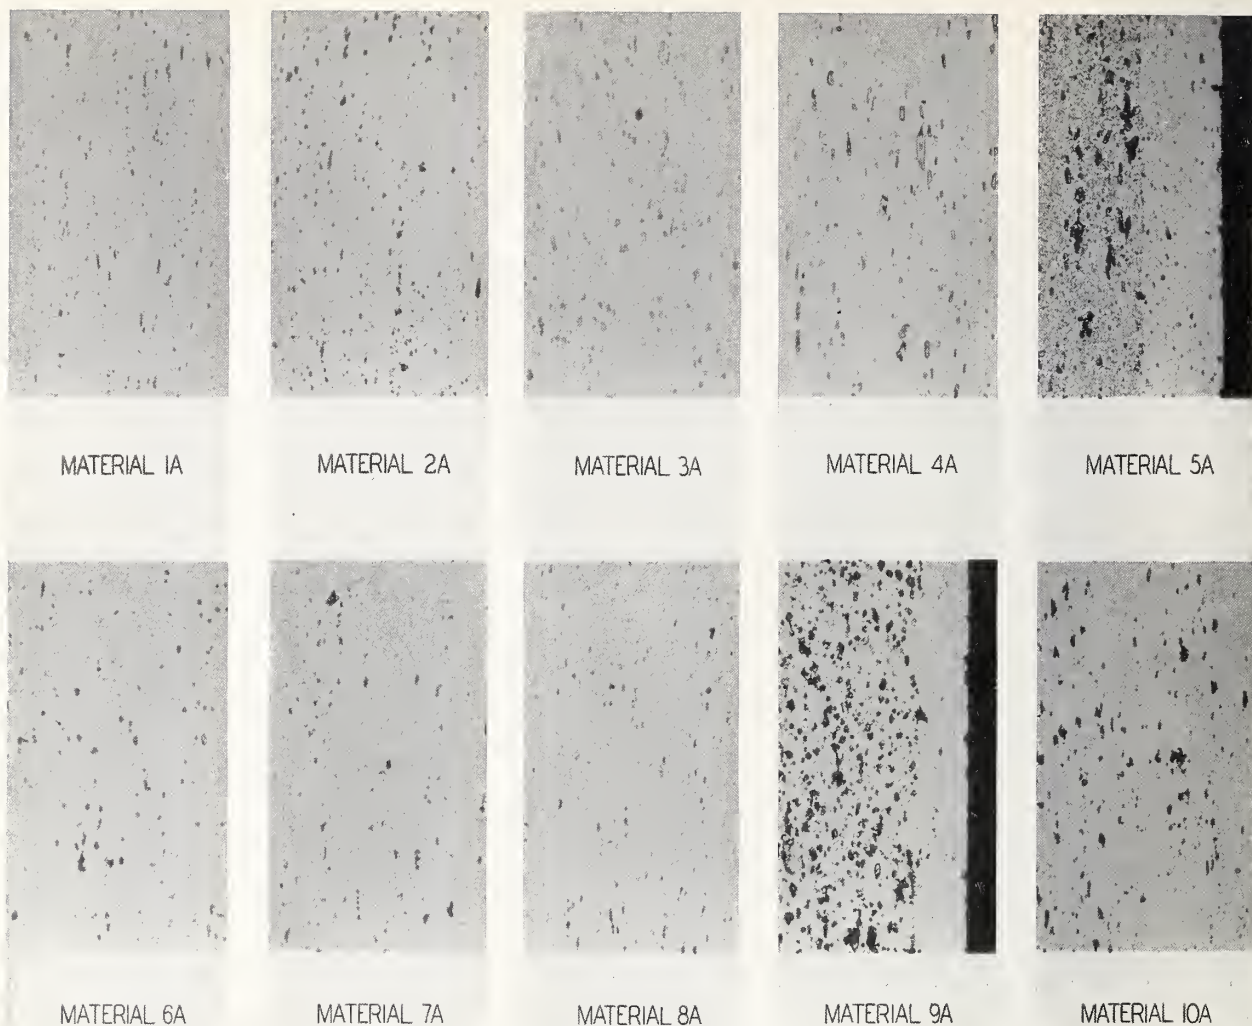
FIGURE 1. Microstructure of aluminum base alloys.

Materials 5A and 9A etched with Keller's etch; others unetched. Photomicrographs in rolling direction at $\times 250$.
