# Fire Resistance of Shutters for Moving-Stairway Openings

United States Department of Commerce  
National Bureau of Standards  
Building Materials and Structures Report 129

Issued March 1, 1952

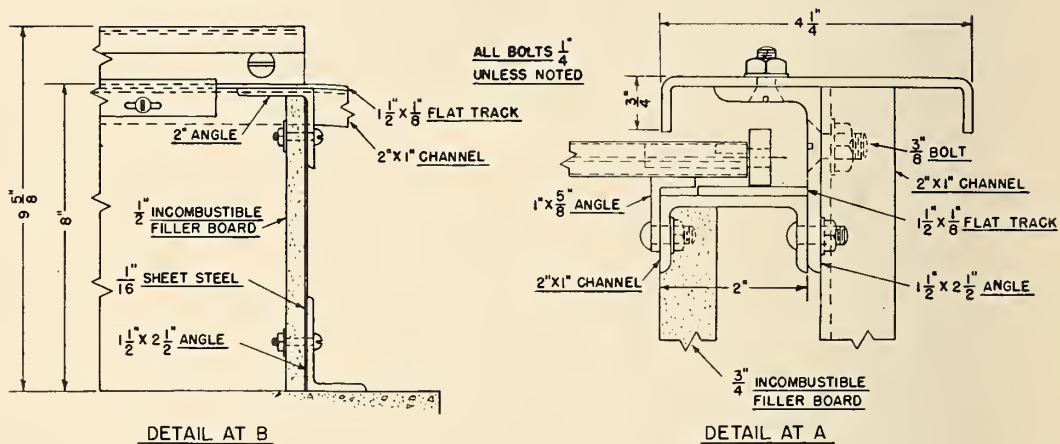
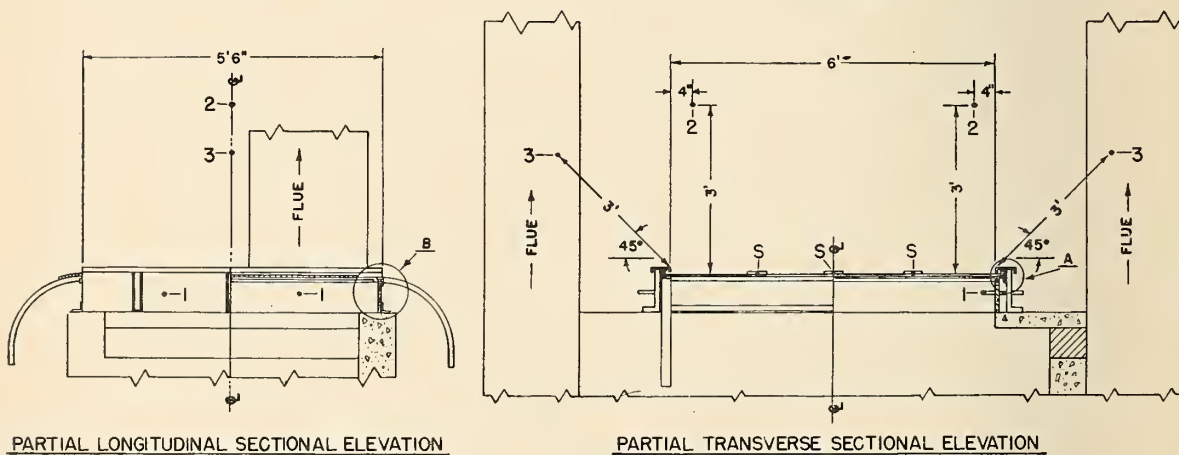
FIGURE 1. Constructions and thermocouples for exploratory test.

The exploratory test was made to determine the adequacy of the shutter and guides alone. Therefore, the construction of the mounting framework was relatively simple, as shown in figure 1.

In the smaller furnace six thermocouples were placed about 2 ft below the shutter. Two others, without pipes, were located with their junctions approximately 3 in. below the shutter and 4 in. from the track on each side. Four thermocouples protected by asbestos sleeving were placed on the top surface of the shutter, with about 6 in. of their leads coiled under felted asbestos pads. Other thermocouples were placed in the air above and near the shutter, as indicated in the sketches of figure 1.

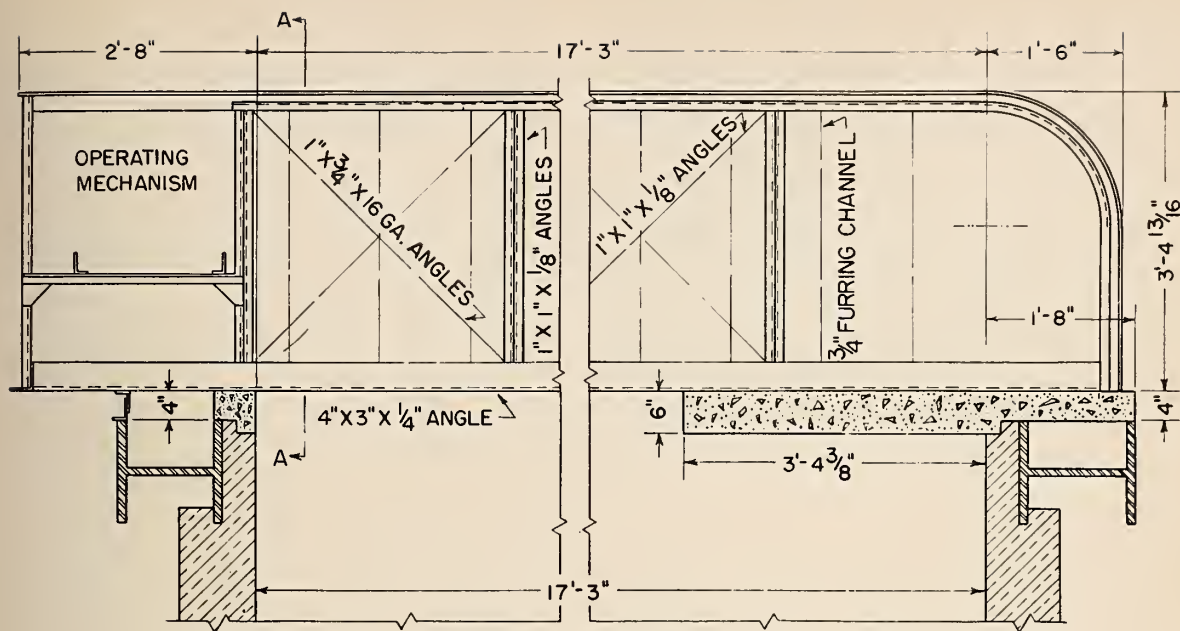
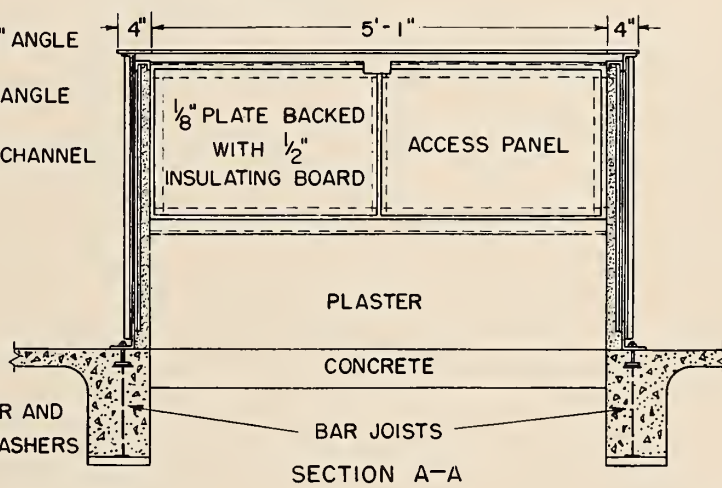
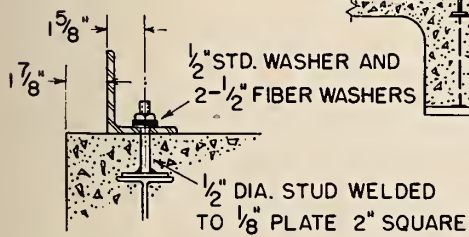
FIGURE 2. Construction details for test A.

The balustrade frames used in the full-scale tests were delivered assembled by the manufacturers and required only placement in the test furnace, plastering, and mounting of the shutters. Other details of the constructions are given in figures 2 and 3. The major differences between the two balustrade constructions were in mounting posts, slip joints, and other provisions added in the last installation to allow for thermal expansion of the members without undue distortion.

The primary source of trouble in test A was the spreading of the side rails, or balustrades. The shutter guide rail was rigidly attached as a part of the top chord of the truss, the inner portions being directly exposed to the furnace fire, whereas the outer portions were cooled by the air outside the furnace, a condition which resulted in a considerable difference in the thermal expansions along the inner and outer edges. This difference in expansion caused bowing of the chord members and consequent spreading of the guide rail, thus allowing the shutter rollers to drop out of the guide slots. The transverse members of the housing for the operating mechanism fixed the rear ends of the guides, and outside braces set at  $2\frac{1}{2}$  ft from the beginning point of curvature of the rail resulted in the spreading of the relatively free curved portion of the guides. In test B this effect was partly obviated by providing an expansion joint in the guide rail and placing the top chord of the balustrade framework below the guide rail, where it was somewhat protected from the fire by plaster. Another means of neutralizing unequal expansion was introduced by making saw cuts in the inner edges of the top chord and the guide rail. In spite of these provisions, some spreading of the guide rails was observed. This should be overcome by increased allowance for expansion. Any provisions that make adequate allowances for expansion effects might be substituted for those employed in test B.

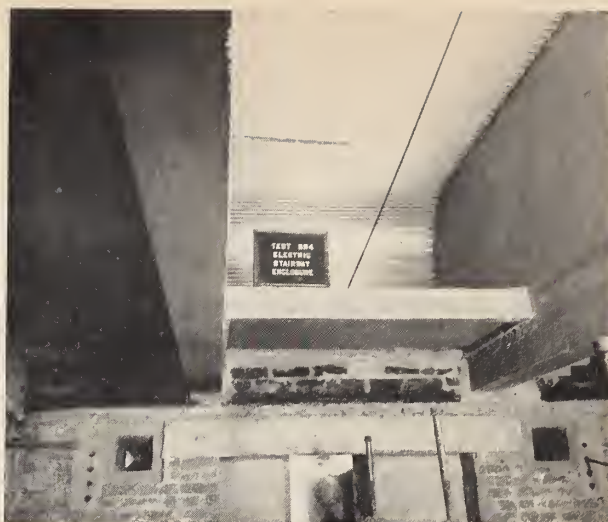
FIGURE 5. Interior of furnace and underside of shutter before test A.

For tests A and B, 12 of the pipe-encased thermocouples were placed in the furnace below the concrete slabs, and 4 of them were placed 2 to 3 in. below the steel shutter, along its center line (fig. 5). Four thermocouples, each in asbestos sleeving, were placed on the top surface of the shutter along its center line, with about 6 in. of their leads coiled under felted asbestos pads. Four others, also in asbestos sleeving, were suspended in the air about 3 ft above the edges of the shutter.

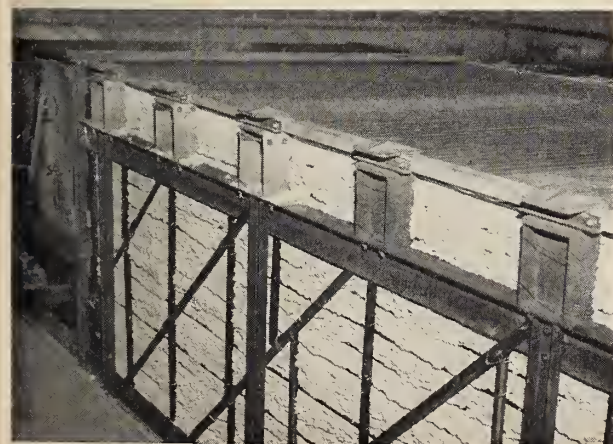
FIGURE 4. Specimen before test B.

The shutter for test A was actuated normally by push-button controls. Its closure could be arrested by a sensitive leading edge. Automatic closure was demonstrated by the use of three devices mounted in parallel and actuated independently, one by smoke, one by rate of rise of temperature, and one by heat (fusible link). The shutter for test B was equipped for operation by hand crank only (fig. 4).

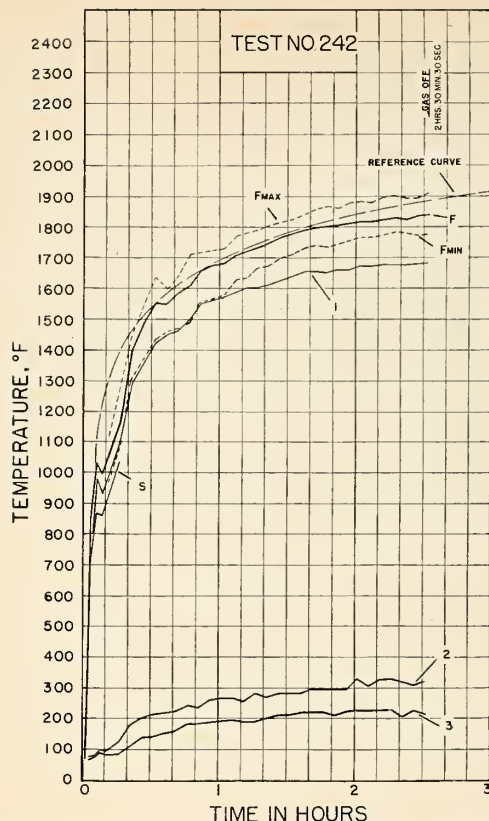
FIGURE 6. Time-temperature curves from exploratory test.

The lubricants in the shutter joints burned during the first 10 min of the test, producing considerable smoke. At 45 min the shutter had sagged approximately 4 in. at the center, and the side rails had bowed in about  $\frac{1}{4}$  in. By the end of the test, at  $2\frac{1}{2}$  hr, these distortions had increased to  $5\frac{3}{4}$  and  $\frac{3}{8}$  in., respectively, but were still not considered unduly large. During the test no flames passed through the shutter or around its edges.

After the test the shutter and side rails were intact, but the shutter could not be operated until the top covers had been removed from the guide rails. The temperatures are shown in figure 6.

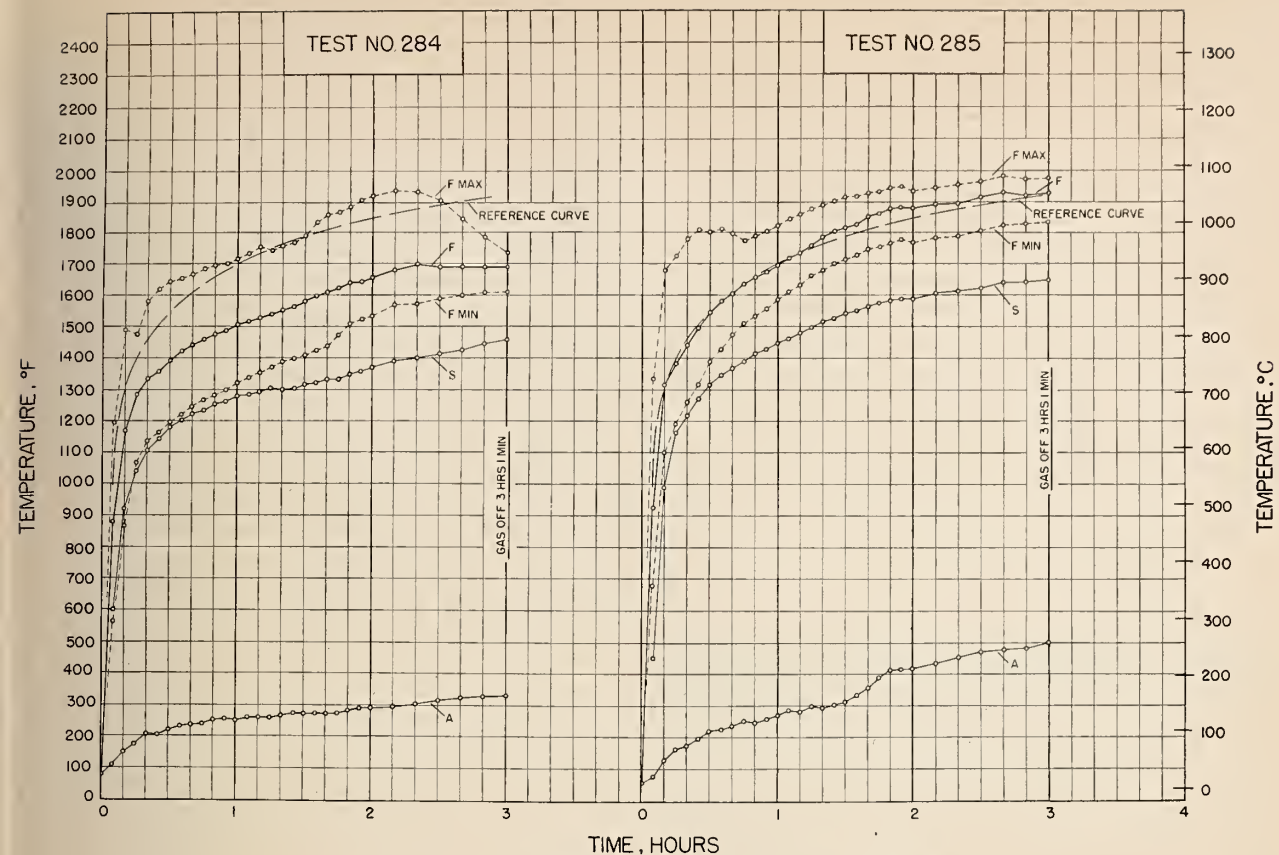
FIGURE 8. Time-temperature curves from tests A and B.

The severity of the fire exposure, as measured by the ratio of the area under the curve of average furnace temperatures to the area under the reference curve was 92.8 percent. These curves are shown in figure 8. The large openings that devel-
