NBS BUILDING SCIENCE SERIES 143

Investigation of the Kansas City Hyatt Regency Walkways Collapse

DEPARTMENT OF COMMERCE • NATIONAL BUREAU OF STANDARDS

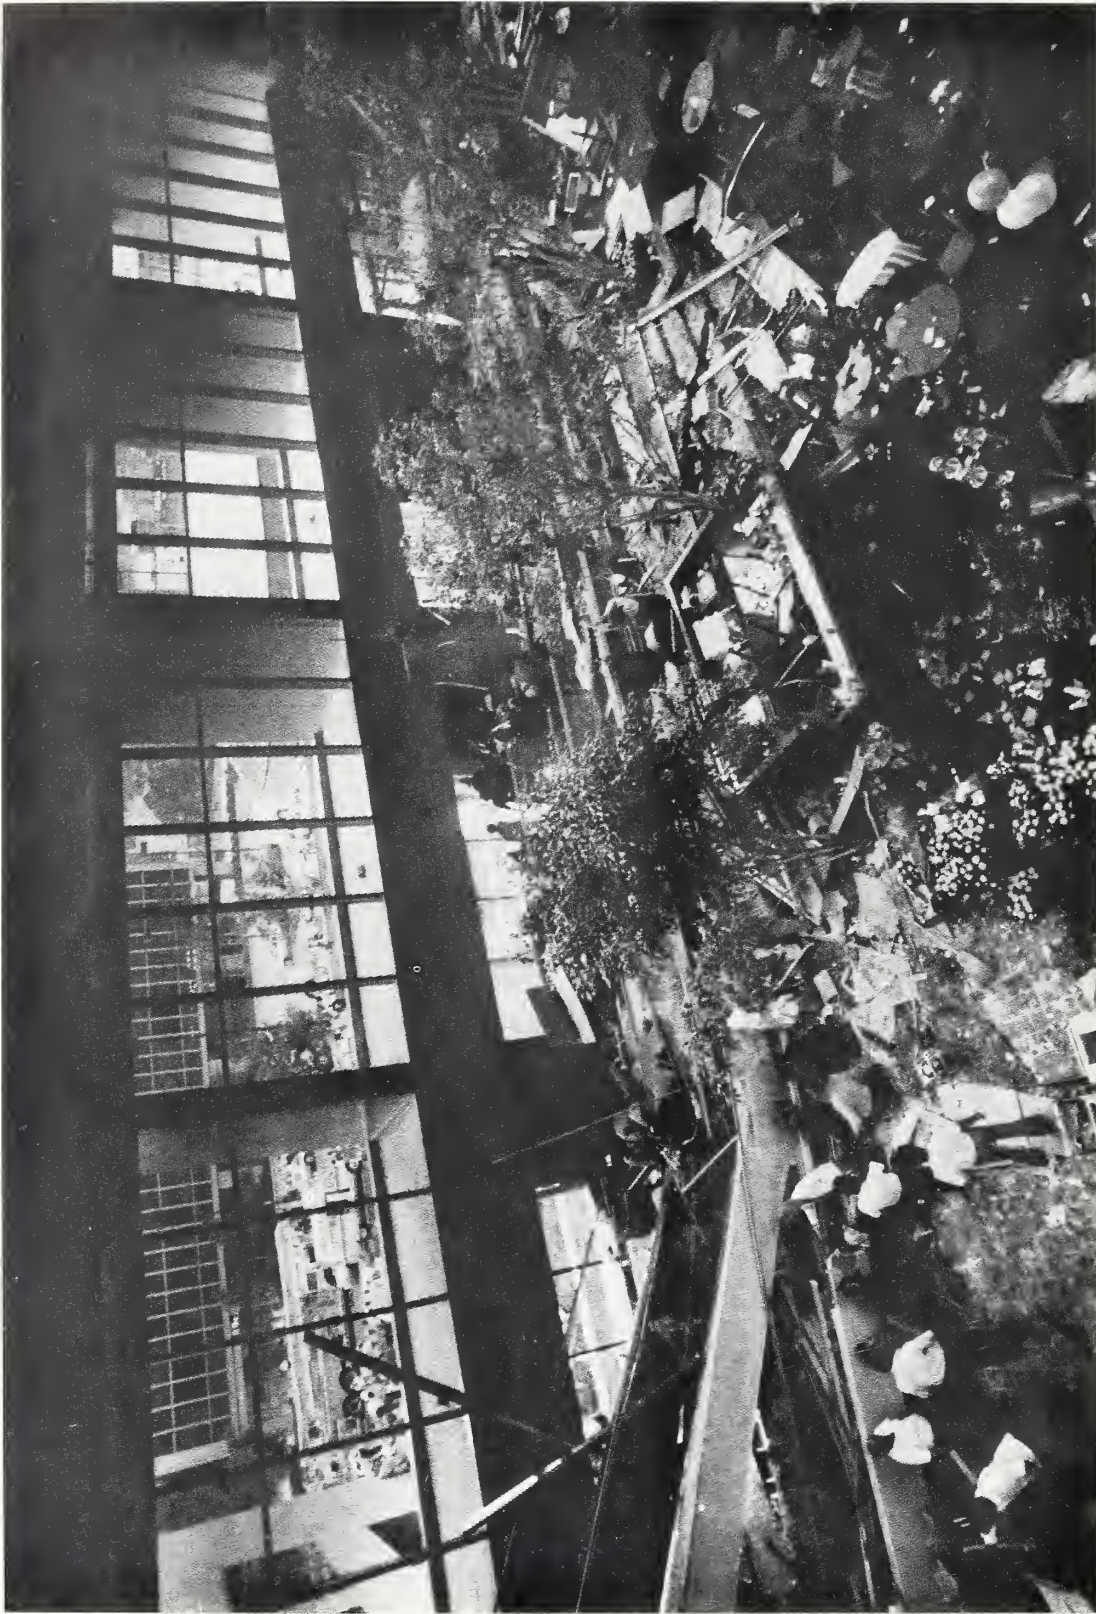
Figures 4.1 and 4.2 show the walkways shortly after the collapse, just as the rescue operation was getting under way. The photograph in figure 4.1 appears to have been taken from the stairway landing at the south side of the atrium between the second and third floors. The view is to the west-northwest and shows part of span U7-8 which lodged in the second-floor portal originally occupied by span L7-8. Spans U8-9 and U9-10 can be seen behind the trees in the middle of the picture. The photograph in figure 4.2 was taken from the third floor with the view directly to the north along the axis of the walkways. Span U7-8 is in the foreground and the third floor walkway can be seen to the upper right. Span U10-11 is visible at the far (north) side of the atrium. The north end of this span appears to have experienced an appreciable displacement to the west during the collapse. Water is coming from walkway sprinkler pipes severed when the north walkway spans were pulled off of their bearing seats.

Figure 4.1 Walkways shortly after the collapse. View is to the west-northwest with span U7-8 sloping down and to the right. Spans U8-9 and U9-10 are visible behind the trees. Photo by Greg Smith, reprinted by permission of The Kansas City Times, © 1981, The Kansas City Star Company.

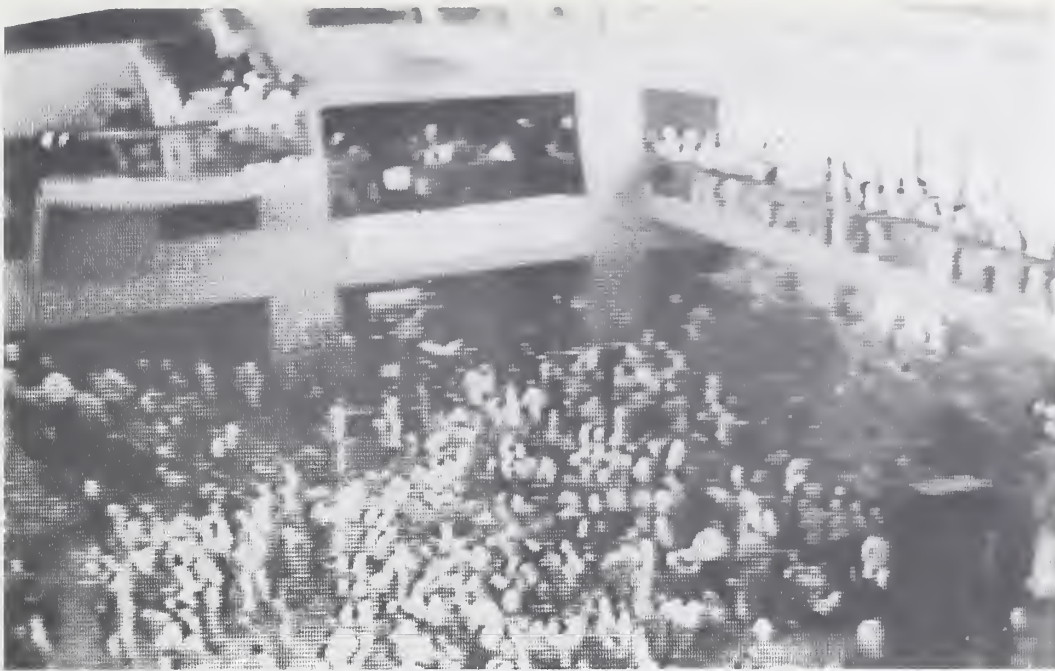
Three segments of the tape provided by KMBC TV were suitable for analysis. The scene in figure 4.4 is from the third floor balcony on the north side of the atrium with the view to the southwest. All of span L7-8 and most of span L8-9 of the second floor walkway are visible. A portion of the third floor walkway is visible at the upper right. The time bracket is believed to be 6:50 to 7:00 PM, based on the scheduled break of the band and their absence from the bandstand which is located directly below the banner on the south wall of the atrium. There appear to be 11 people on span L7-8 and 16 people on span L8-9. Of the 11 people on span L7-8, 10 appear to be standing at the handrail. Of the 16 people on span L8-9, 12 appear to be standing at the handrail.

Figure 4.4 Scene from third floor balcony on north side of atrium. View to the southwest showing spans L7-8 and L8-9 of second floor walkway. Videotape courtesy of KMBC TV.

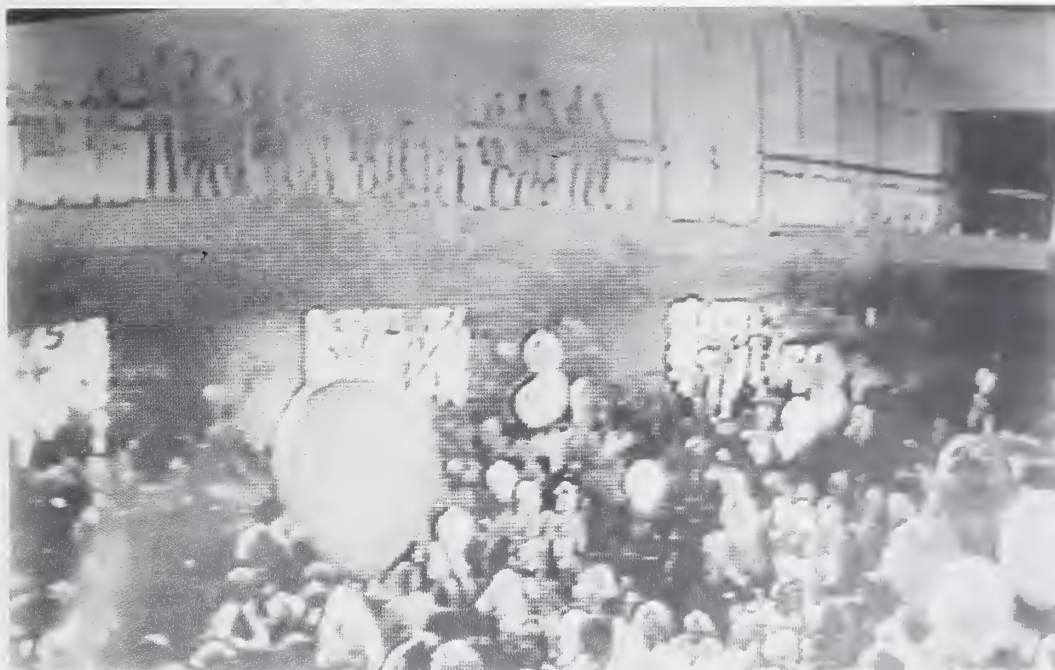
The scene in figure 4.5, believed to have been taken a few minutes after the frame shown in figure 4.4, appears to be from the landing of the main stairway in the southeast corner of the atrium, looking northwest. Part of span L8-9 and all of spans L9-10 and L10-11 of the second floor walkway are visible. Eight or nine people are occupying the south portion of span L9-10 along the handrail and span L10-11 is not occupied.

Figure 4.5 Scene from landing of main stairway in southeast corner of atrium. View to northwest shows part of span L8-9 and all of spans L9-10 and L10-11 of second floor walkway. Videotape courtesy of KMBC TV.

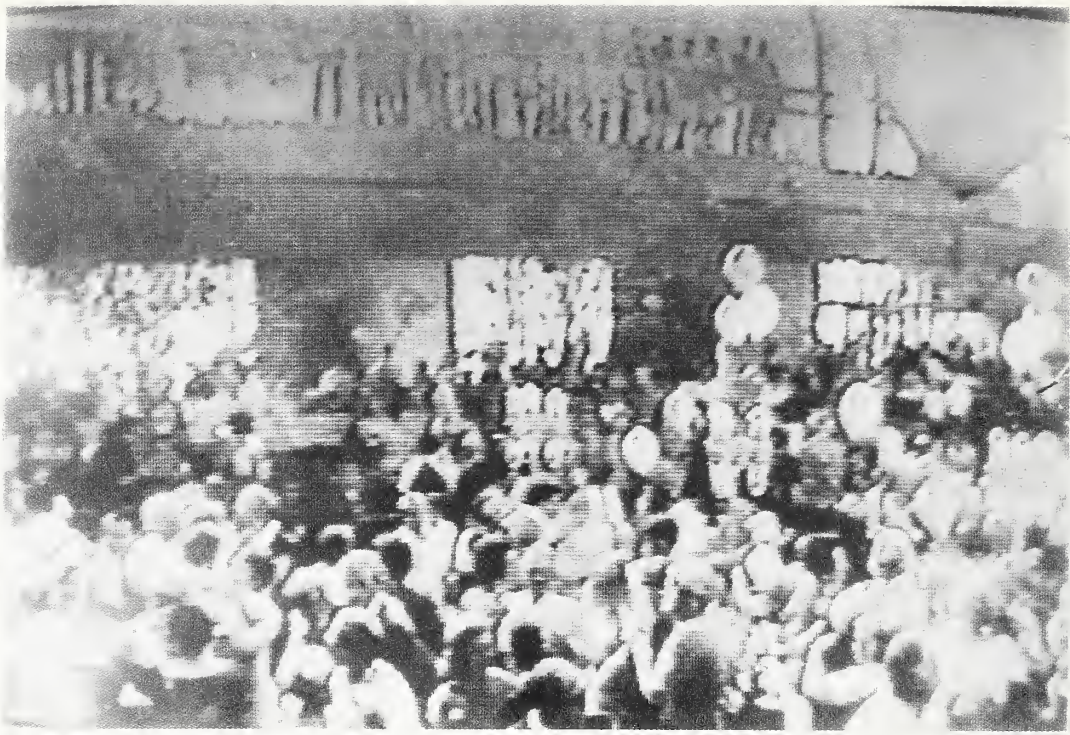
The scene in figure 4.6, taken a few frames later, appears to be from the same location as that in figure 4.5, but shows more of span L8-9. Judging from their relative heights, the people on span L9-10 have not moved from their positions shown in figure 4.5. It appears that the count on span L9-10 is now 11, but blurring makes an accurate count difficult.

Figure 4.6 Same view as figure 4.5, but a few frames later. Videotape courtesy of KMBC TV.

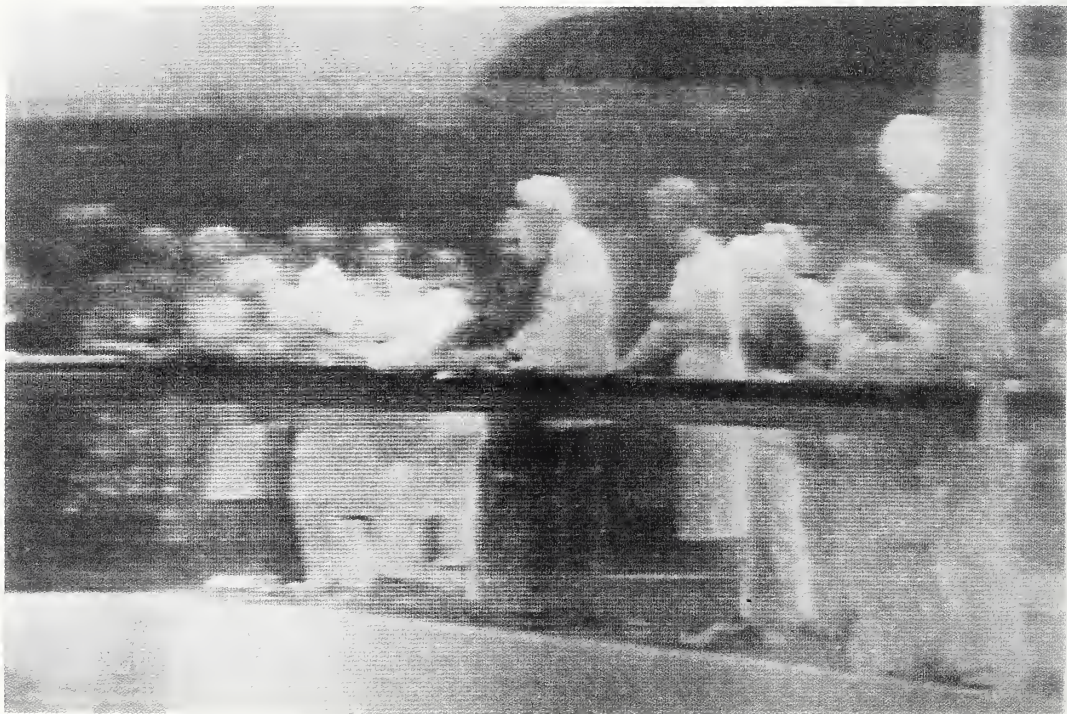
Figure 4.7 is a close-up of the southernmost span (span M7-8) in the third floor walkway. The view is from the same location as figure 4.4. Again, it is difficult to make an accurate count, but at least 11 persons can be observed.

Figure 4.7 View from third floor balcony on north side of atrium. View to southwest showing southernmost span (span M7-8) of third floor walkway. Videotape courtesy of KMBC TV.

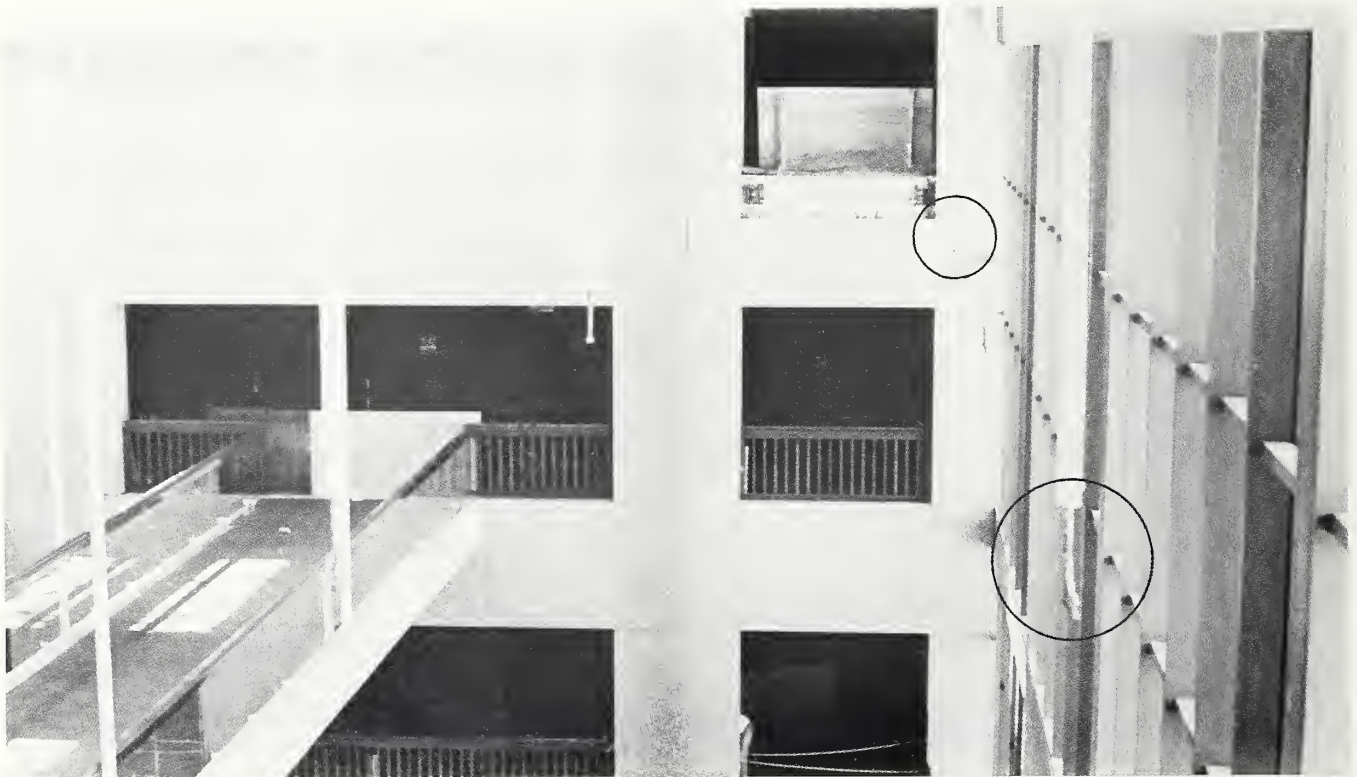
Figure 5.4 Fourth floor to ceiling hanger rods. View from fourth floor looking south.

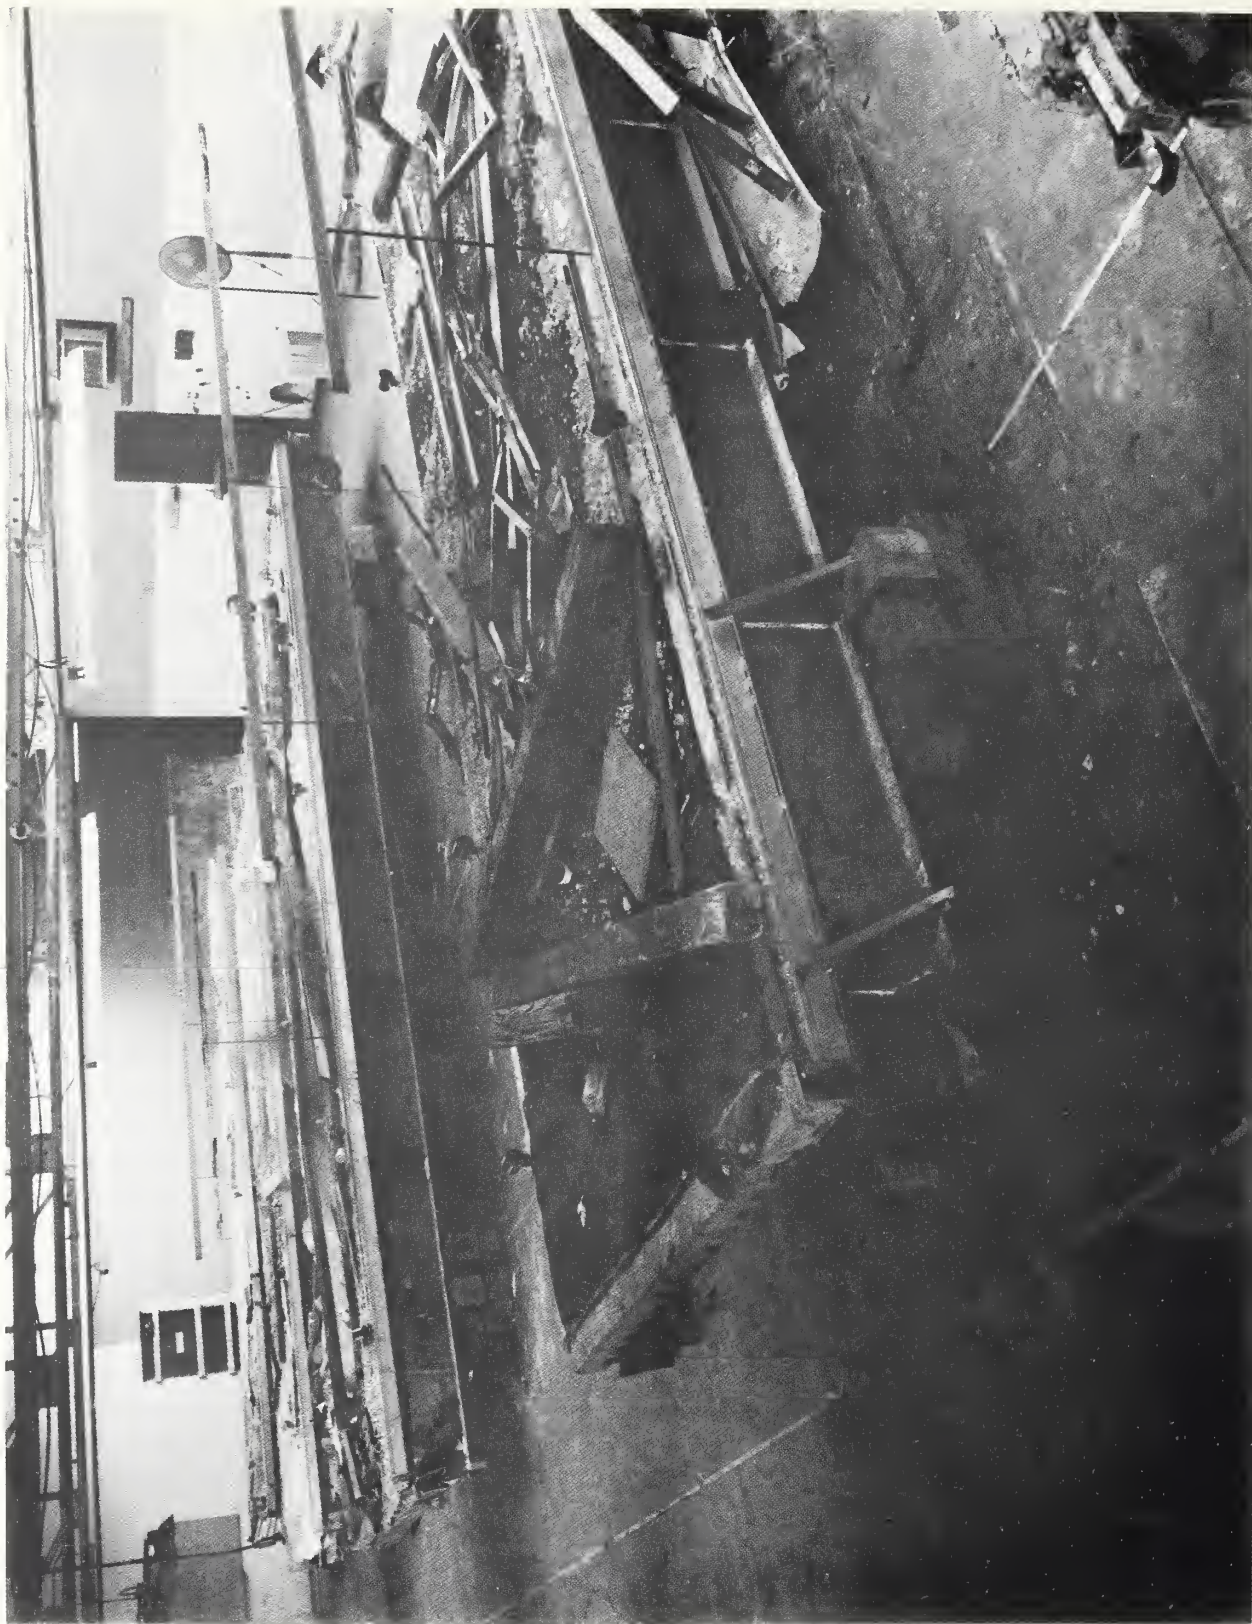
Figure 5.6 General view showing spans of fourth floor walkway.

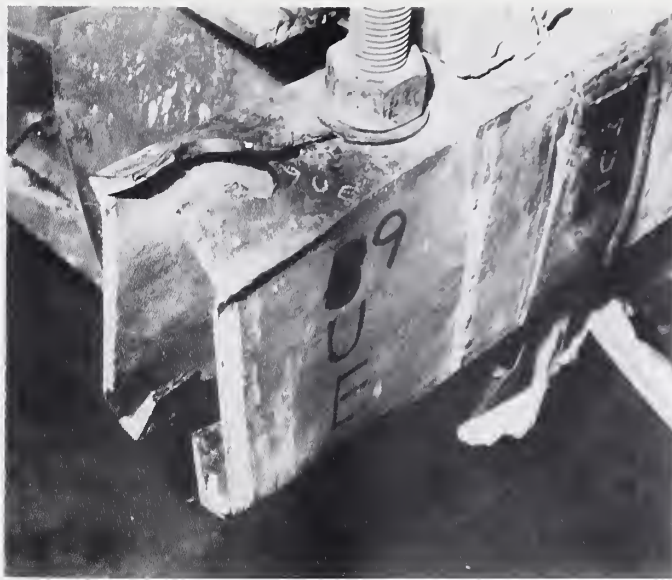
rods 8UE, 9UE, and 10UE strongly suggests that failure initiated along the east line of hanger rods.

Figure 5.7 Hanger rod pull-through at location 9UE.

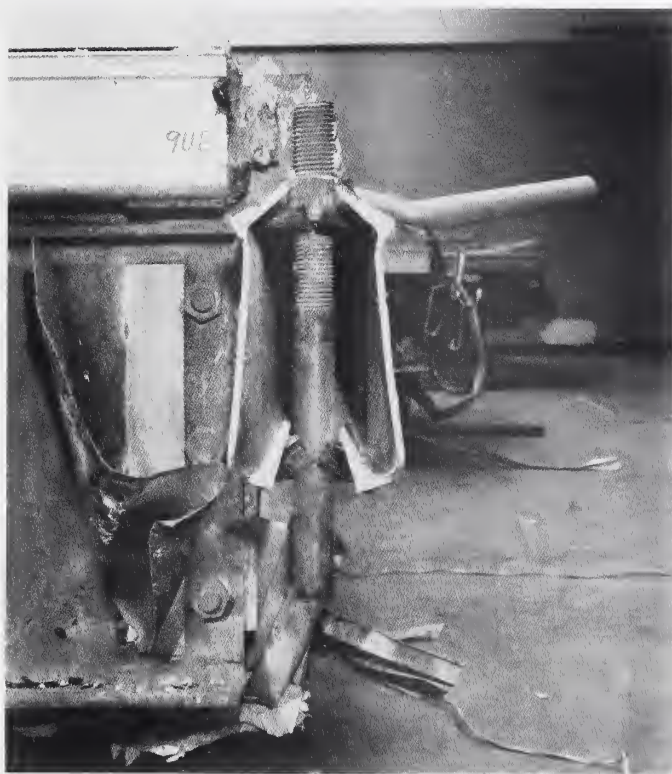
Figure 5.8 End view of box beam at location 9UE.

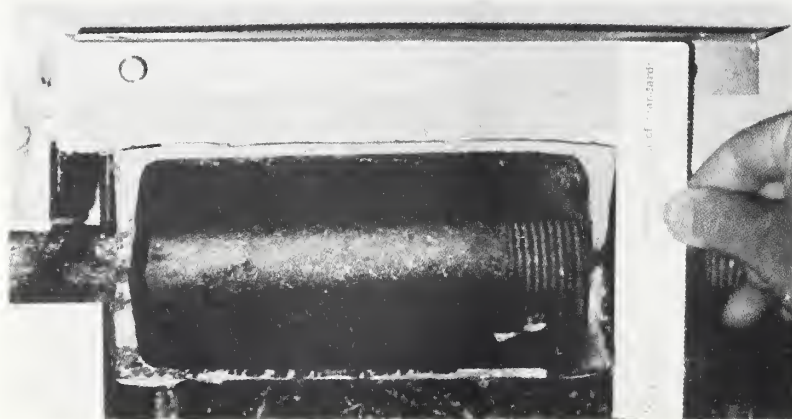
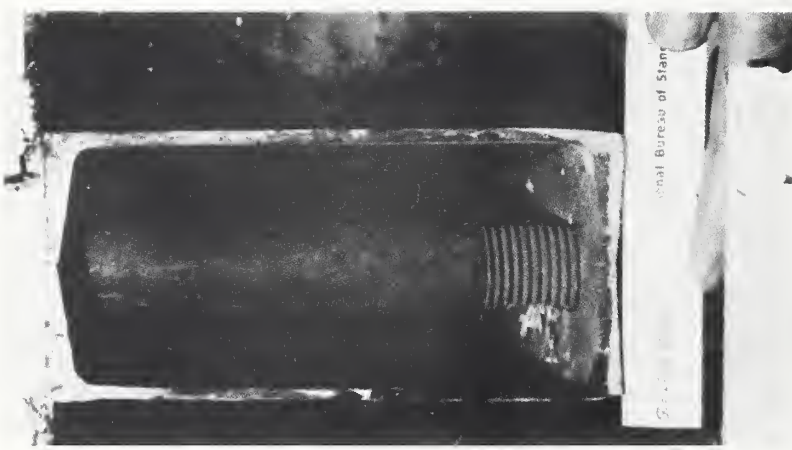
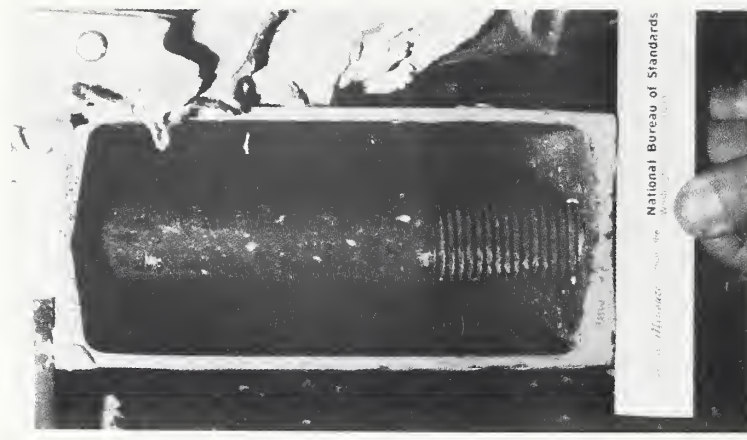
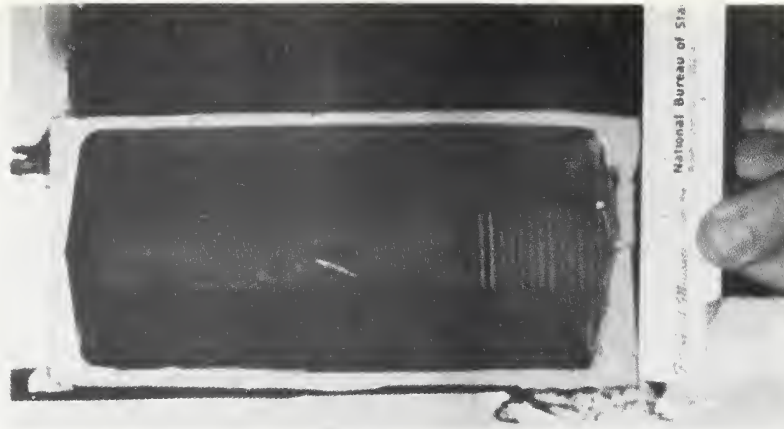
Figure 5.9 Evidence of permanent distortion in box beam ends of third floor walkway.

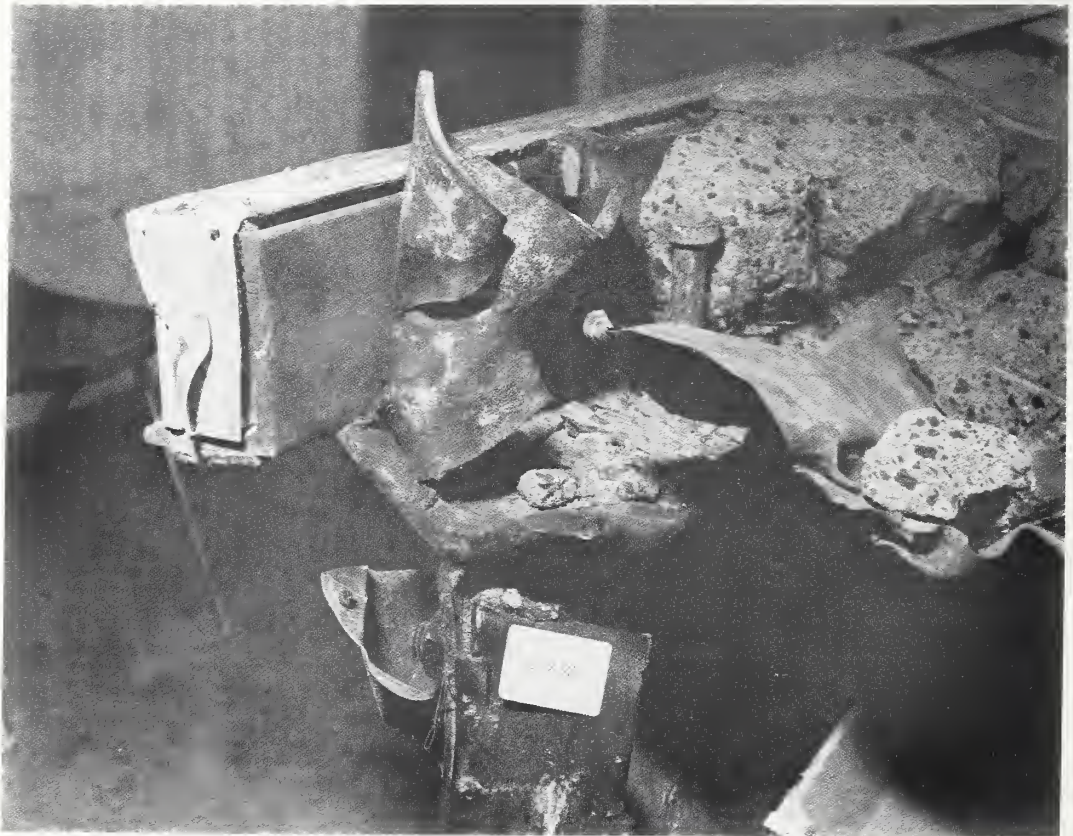
Figure 5.12 End view of 1/4" x 6" edging plate at location 10UW (Span U10-11).

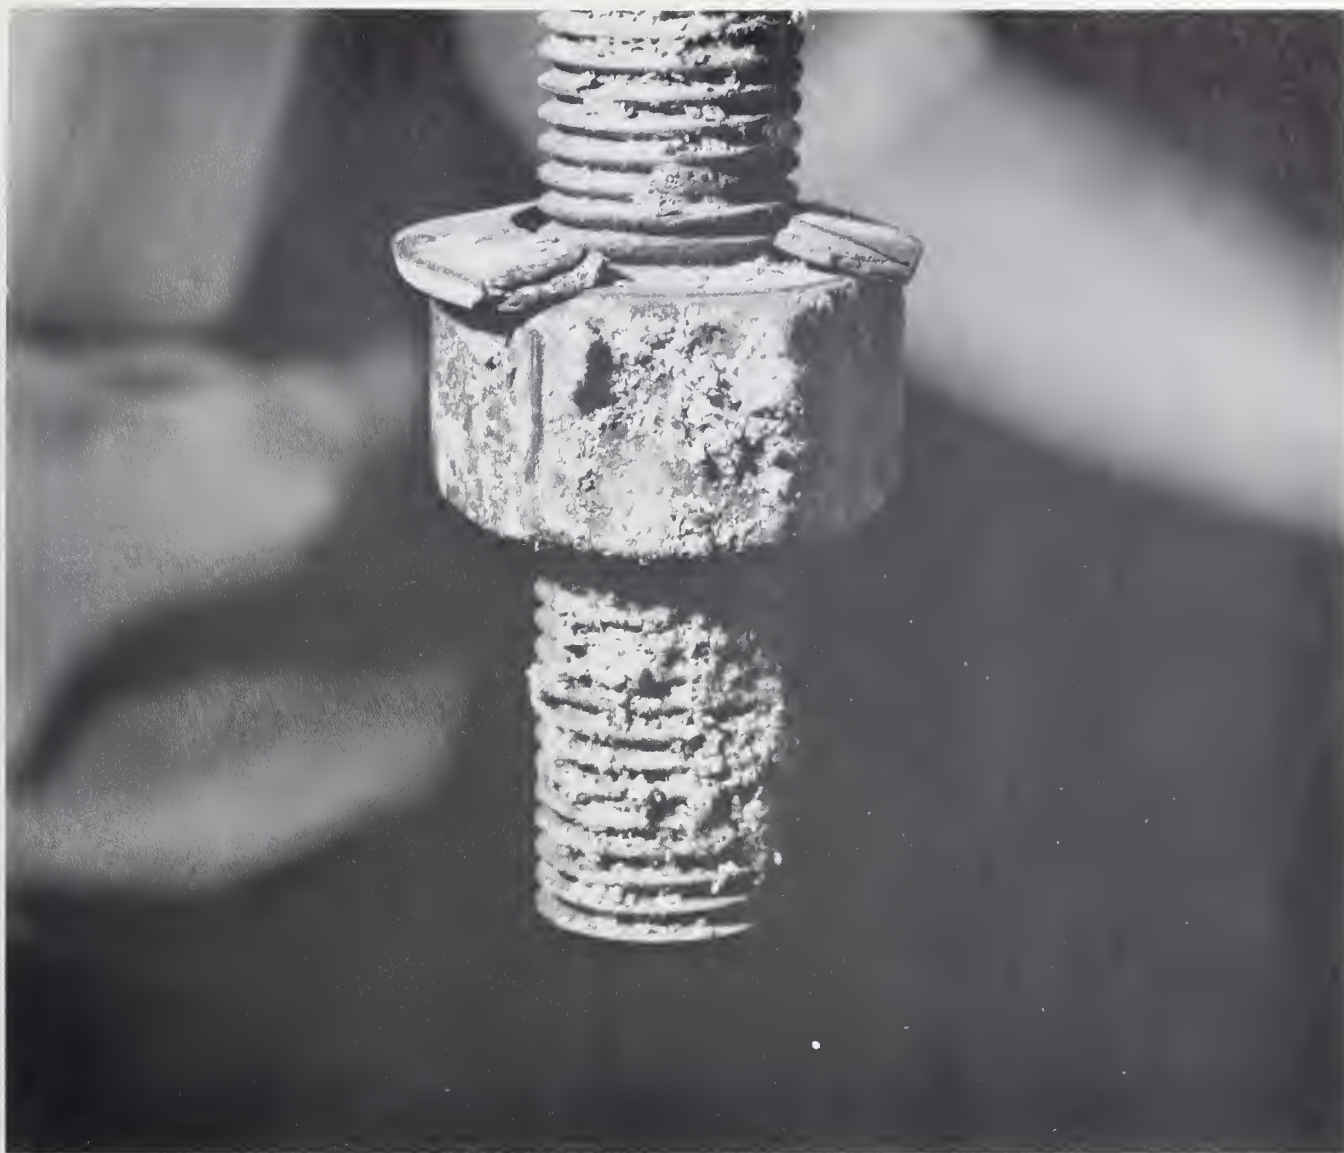
Figure 5.13 Washer at bottom end of fourth floor to ceiling hanger rod 9UW.

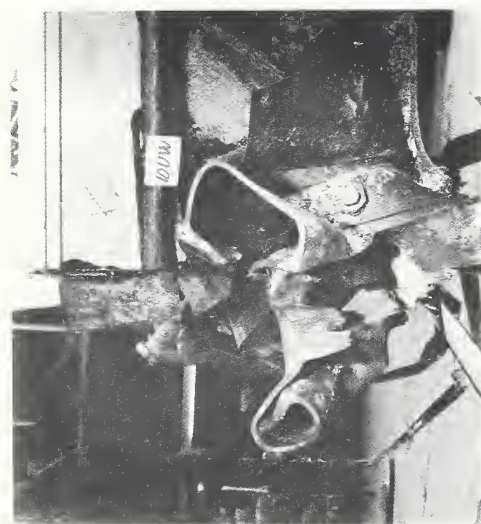
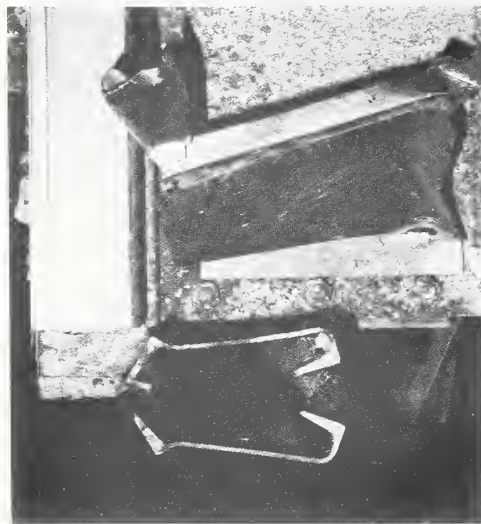
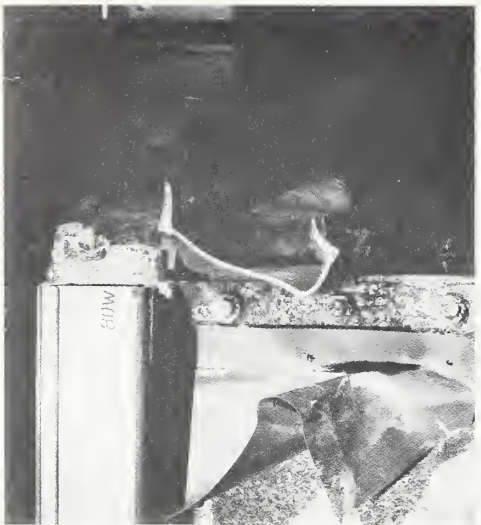
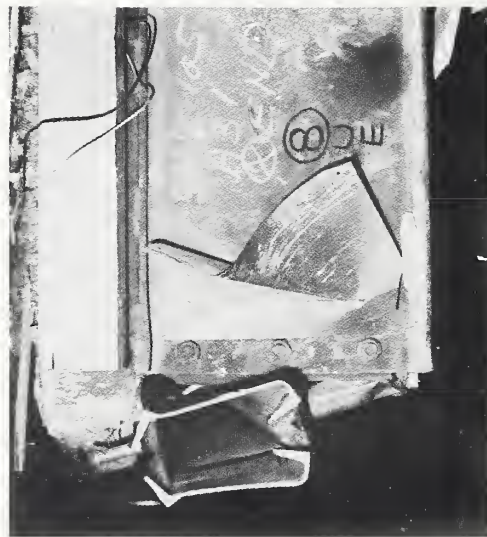
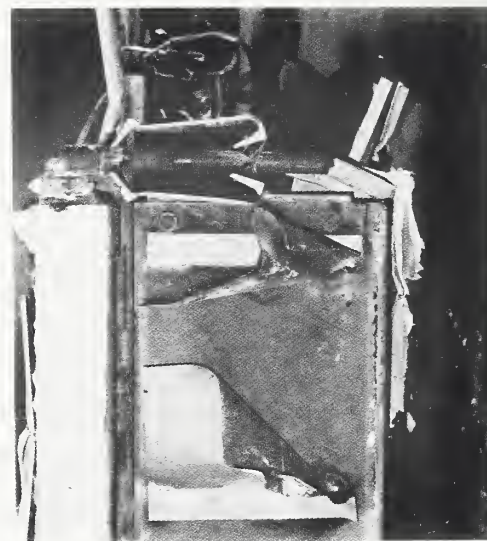
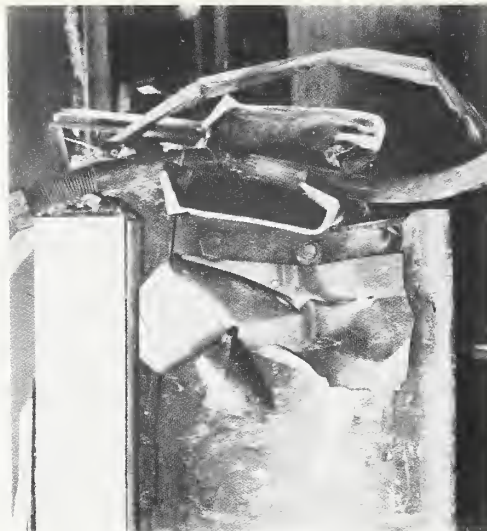
Figure 5.14 Observed symmetry of distortion of box beams at locations 8U and 10U relative to the box beam at location 9U.

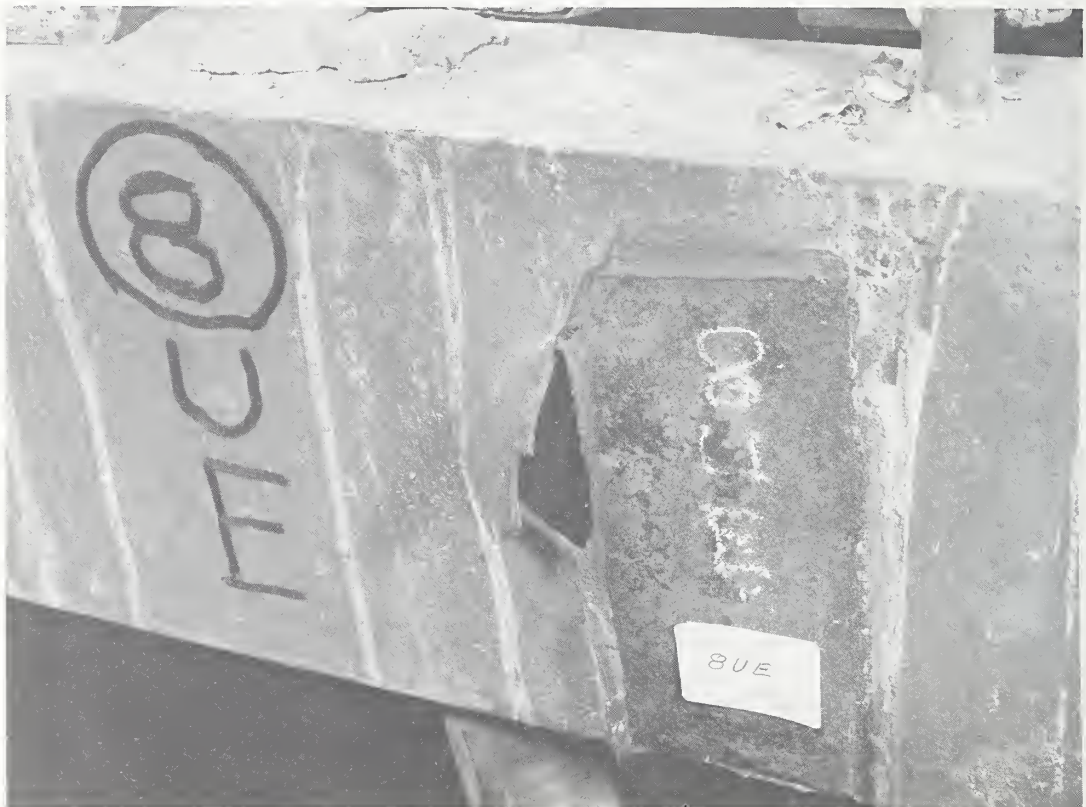
Figure 5.24 Tear in box beam web at location 8UE.

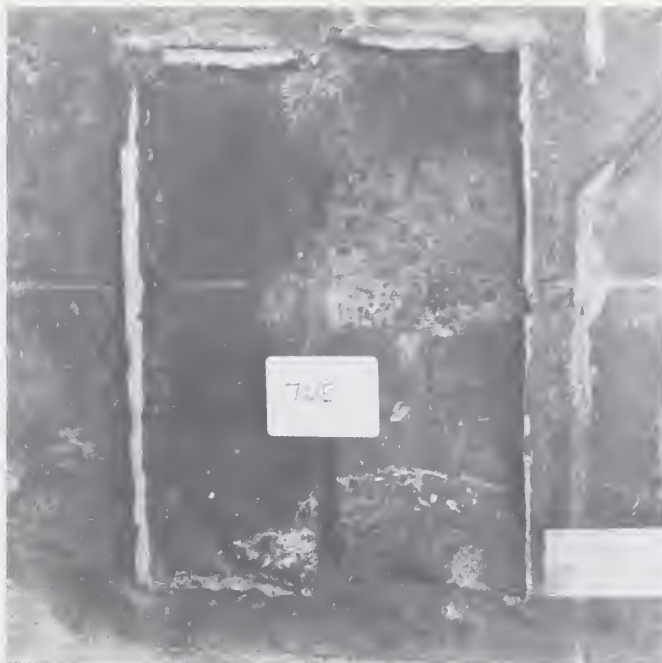
Figure 5.25 Embedded plate at connection 7UE.

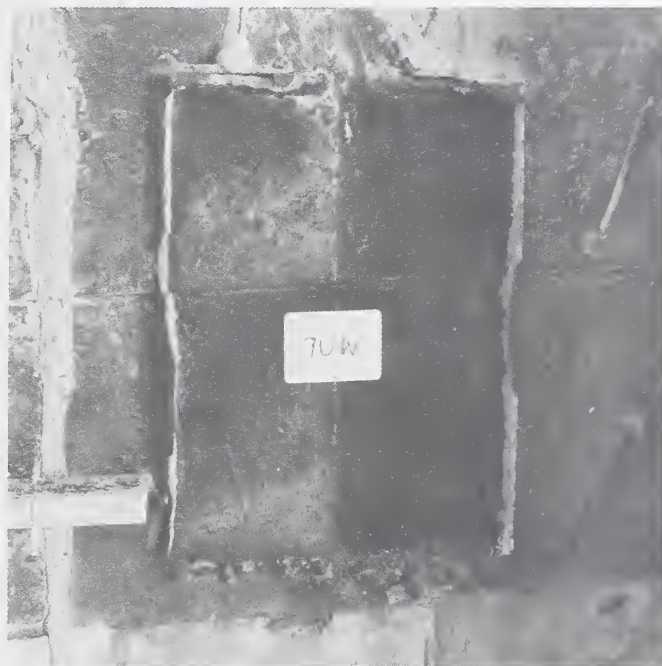
Figure 5.26 Embedded plate at connection 7UW.

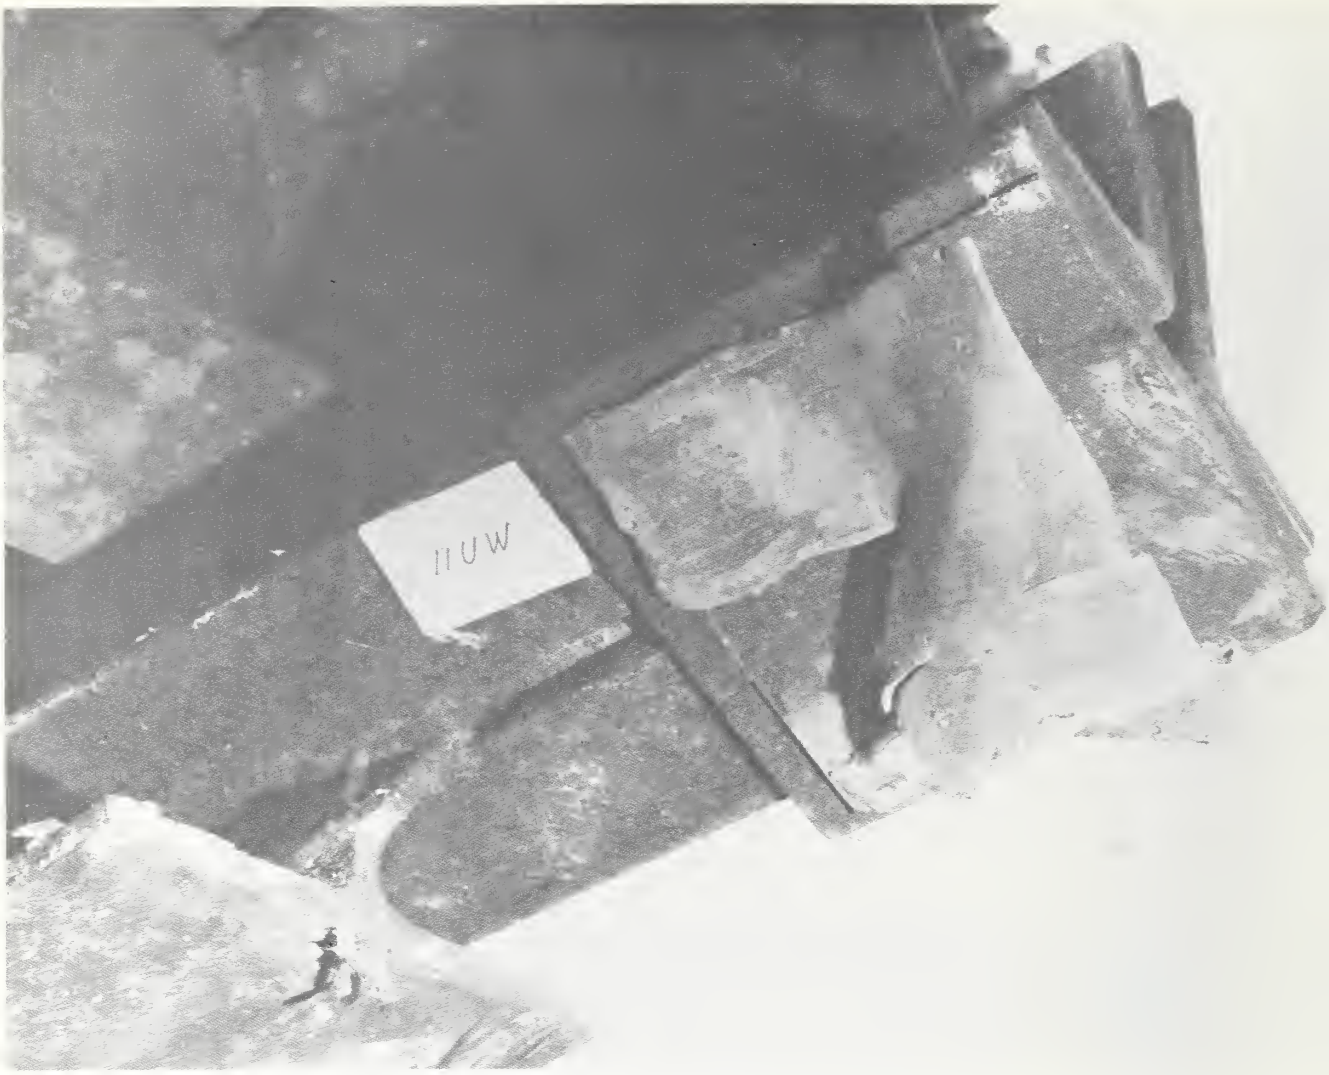
Figure 5.27 Modified bearing pad at location 11UW.

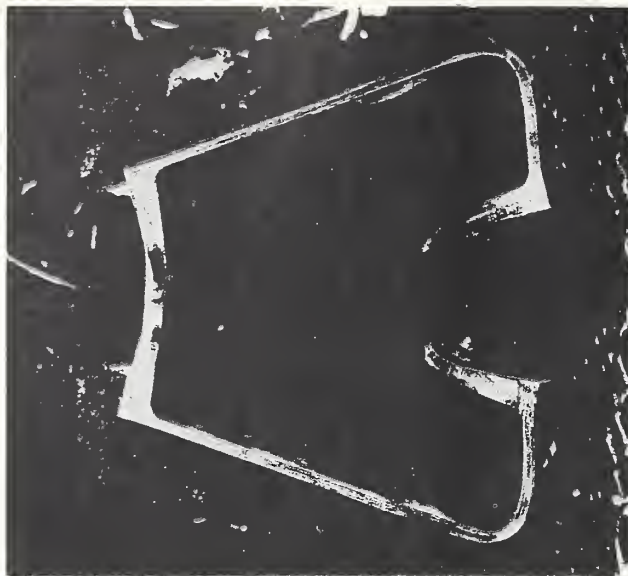
Figure 6.14 Deformed shapes.

Three different failure types, assigned the identifiers I, II, and III, were observed and are shown in figure 6.14. The bottom flanges of specimen K2, and others exhibiting type I behavior, fold back about a plastic hinge in the web and do not show any discernible bending. The flanges in type III behavior, illustrated by J1, fold back about the plastic hinge in the web but also show pronounced bending in the flange. Type II behavior exhibits slight bending in the flange tips as illustrated by specimen M1. None of the washers fractured in these tests.

Type III behavior is usually characterized by a load-deflection curve which has a relatively rounded shape (as compared to type I) at maximum load. Visual observation of a few specimens indicates that the exterior weld between the lower flange hanger rod holes also cracks between 6 to 8 kips (27 to 36 kN) of upper rod load. Cracking of the interior weld begins adjacent to the outer hanger rod hole at between 10 to 12 kips (44 to 53 kN) and progresses to the end of the beam by about 15 kips (67 kN). Shortly after this stage of cracking the deformations become visible. At the maximum load the interior weld has not yet fractured between the exterior hole and the beam end. The resistance to load decreases with increased deflection, but at a constant rate. The rate is quite similar to the load loss rate following the peak load in the type I behavior. The gradual loss in resistance to load continues with progressive cracking until the interior weld between the outer hole and the beam end fractures, at which point there is a sharp drop in load resistance. The bottom flanges exhibit pronounced bending as illustrated by specimen J1 in figure 6.14.

Type II behavior is between the two extremes (figure 6.15). Initially it exhibits the characteristics of type III behavior. However, the interior weld between the exterior hanger rod hole and beam end fractures at or just after the peak load, unlike the type III beams. The bottom flanges appear more like type I but show a small amount of bending as for specimen T3 in figure 6.14.

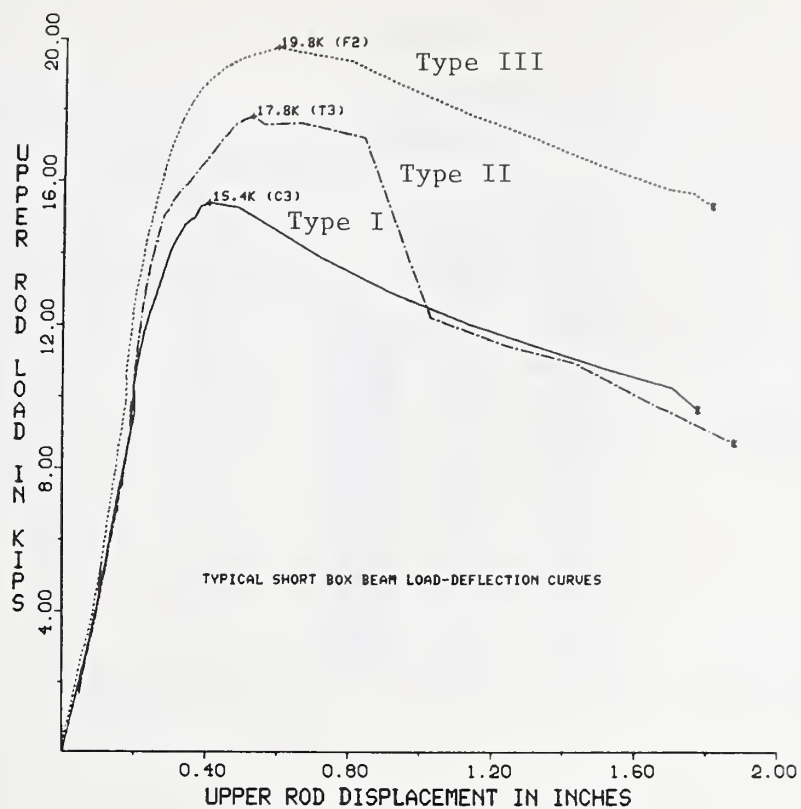
Figure 6.15 In-plane load deflection curves for specimens C-3, F-2, and T-3.

Three typical in-plane load-deflection curves for the short box beam specimens are shown in figure 6.15. (A complete set of load-deflection curves is presented in appendix A.6.10.) Each curve is a plot of the load measured by the upper rod load transducer versus the displacement of the rod measured by the LVDT at the box beam terminus of the upper loading rod (LVDT no. 2 in figure 6.13). The peak load achieved by each of the specimens is shown on their respective curves. The asterisk on each curve indicates the end of reliable measurement by the displacement device and does not necessarily denote final rod pull-through.

The in-plane load-deflection curves in figure 6.15 illustrate specimen behavior usually associated with failure types I, II, III and are again illustrated by specimen C3, specimen T3, and specimen F2, respectively.

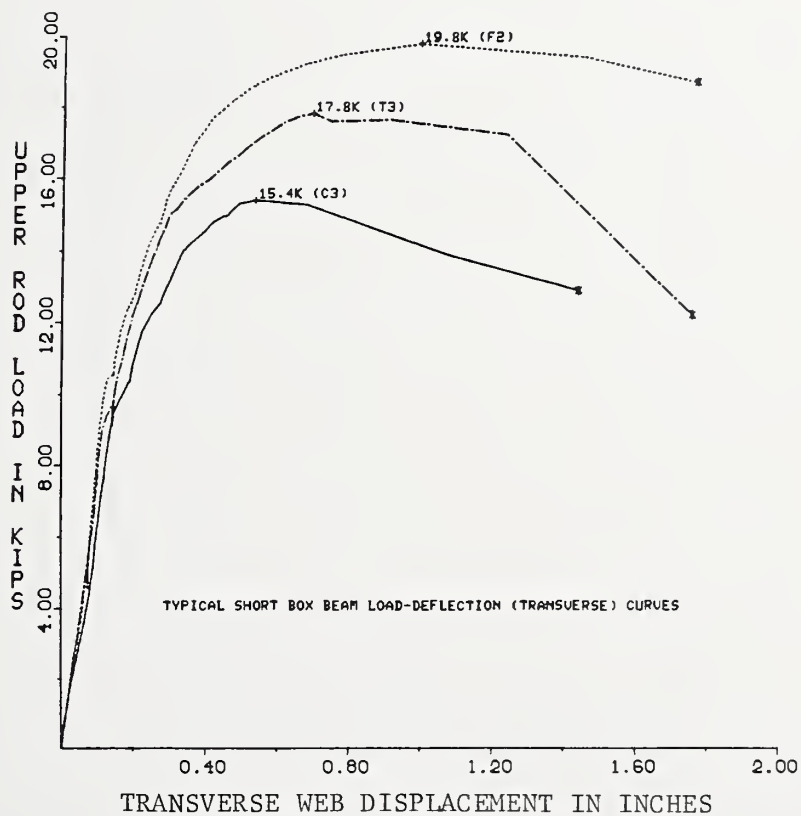
Figure 6.16 Out-of-plane web load displacement curves for specimens C-3, F-2, and T-3.

The out-of-plane load-deflection curves show the same trends as exhibited by the in-plane load-deflection curves. The out-of-plane load-deflection curves for the above described specimens are shown in figure 6.16. Each curve is a plot of the same load described for figure 6.15 versus the displacement measured by the middle transverse LVDT (figure 6.13). These data show that the web is beginning to deform outward shortly after the application of dead load from the second floor is started.

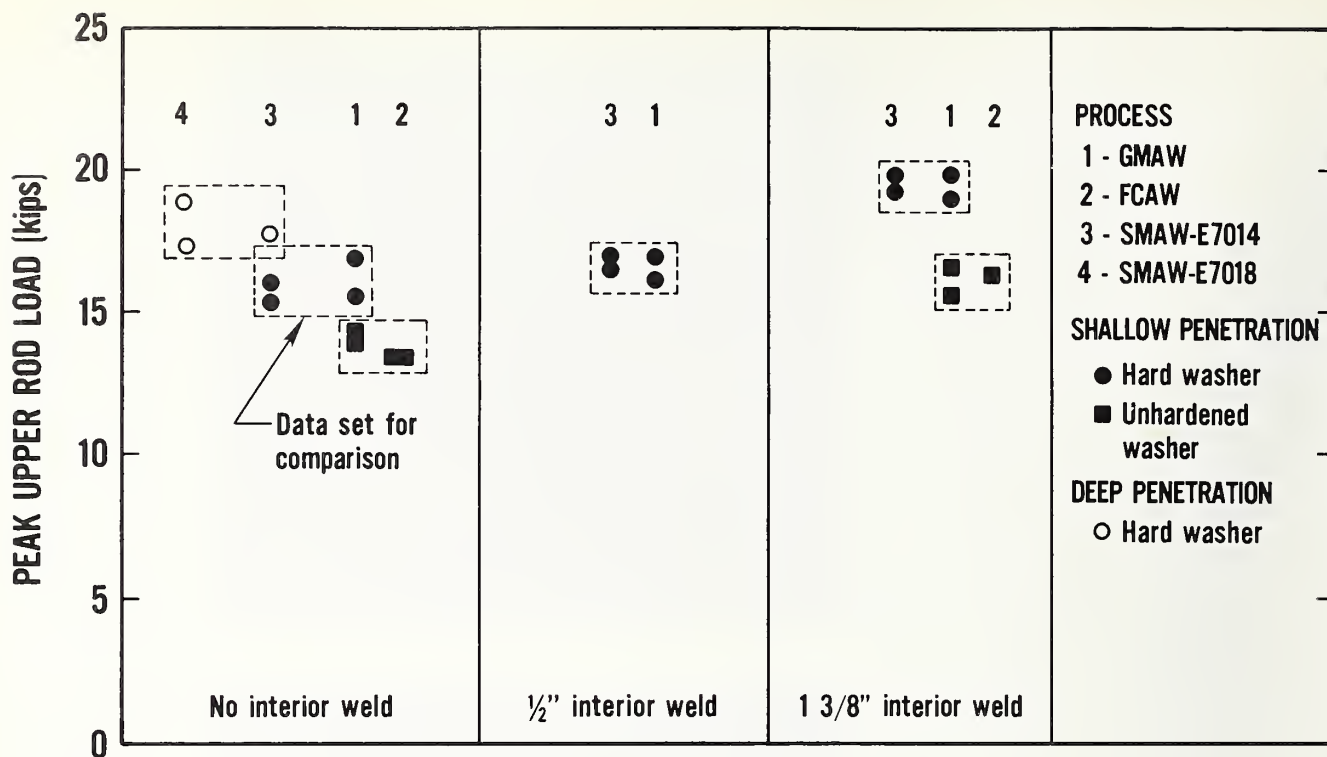
Figure 6.17 Effect of weld process.

Comparisons between specimens in which the only intentional difference is the welding process appear in figure 6.17. Six sets of data, each consisting of comparable specimens, are shown enclosed in the figure. Hardened washer data are used where possible since it was found (section 6.10.5) that hardened washers were used in the actual walkway construction. The specimens compared for a particular process were fabricated at the same time. This selection of data was done to maintain as much similarity as possible since there was variation in the amount of weld material deposited and, as discussed in

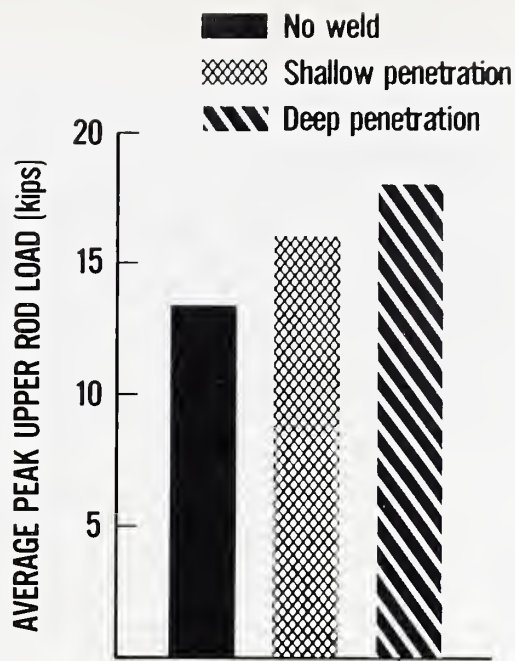
Figure 6.18 Effect of exterior weld penetration.

Exterior Weld Penetration. The exterior weld penetration depth for specimens without an interior weld has a significant effect on the peak upper rod load of the short box beams, as shown in figure 6.18. The average peak loads for specimens E1 and E2 having no weld (no penetration), C1 and C3 having a shallow penetration weld, and A1 and A2 having a deep penetration weld are shown in the figure to illustrate that there is significant difference in load resistance between the case of shallow penetration and deep penetration. The difference is about 2.5 kips (11.1 kN).
