NBS BUILDING SCIENCE SERIES 143

Investigation of the Kansas City Hyatt Regency Walkways Collapse

DEPARTMENT OF COMMERCE • NATIONAL BUREAU OF STANDARDS

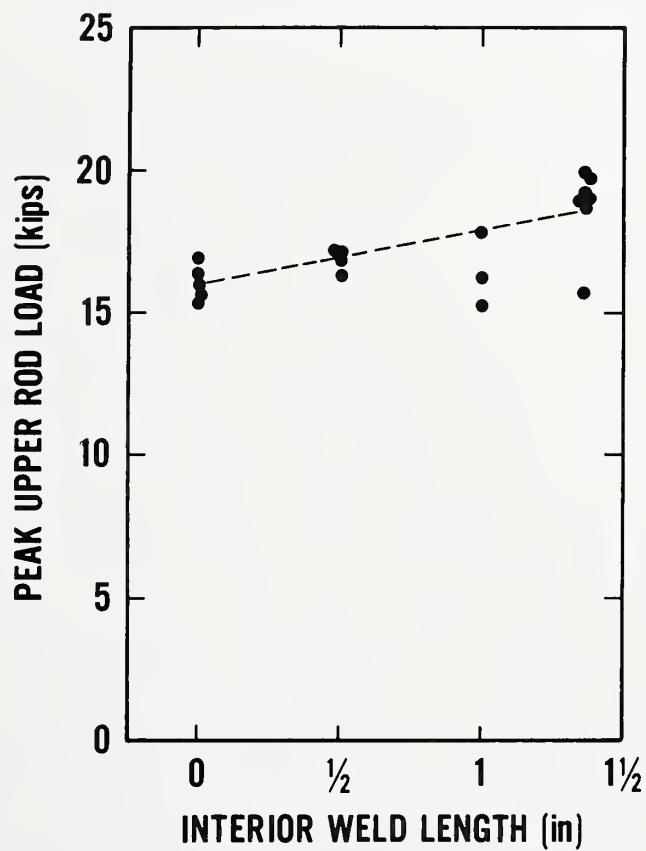
Figure 6.19 Effect of interior weld length on peak load.

Interior Weld Length. The length of interior weld has a significant effect on load resistance of the short box beams. A limited comparison of test results is shown in figure 6.19 to illustrate this point. Data shown include shallow penetration weld specimens shown in table 6.1 except for variations due to weld position, washer thickness, nut shape, nut orientation, clip angle presence, initial rod load, and number of rods. Although a regression analysis was not done it is apparent that increasing the interior weld length increases the load resistance. The increase in load resistance is roughly linearly proportional to the increase in interior weld length. However length of interior weld alone is insufficient to account for load variation since it does not consider penetration of either the interior or exterior welds.

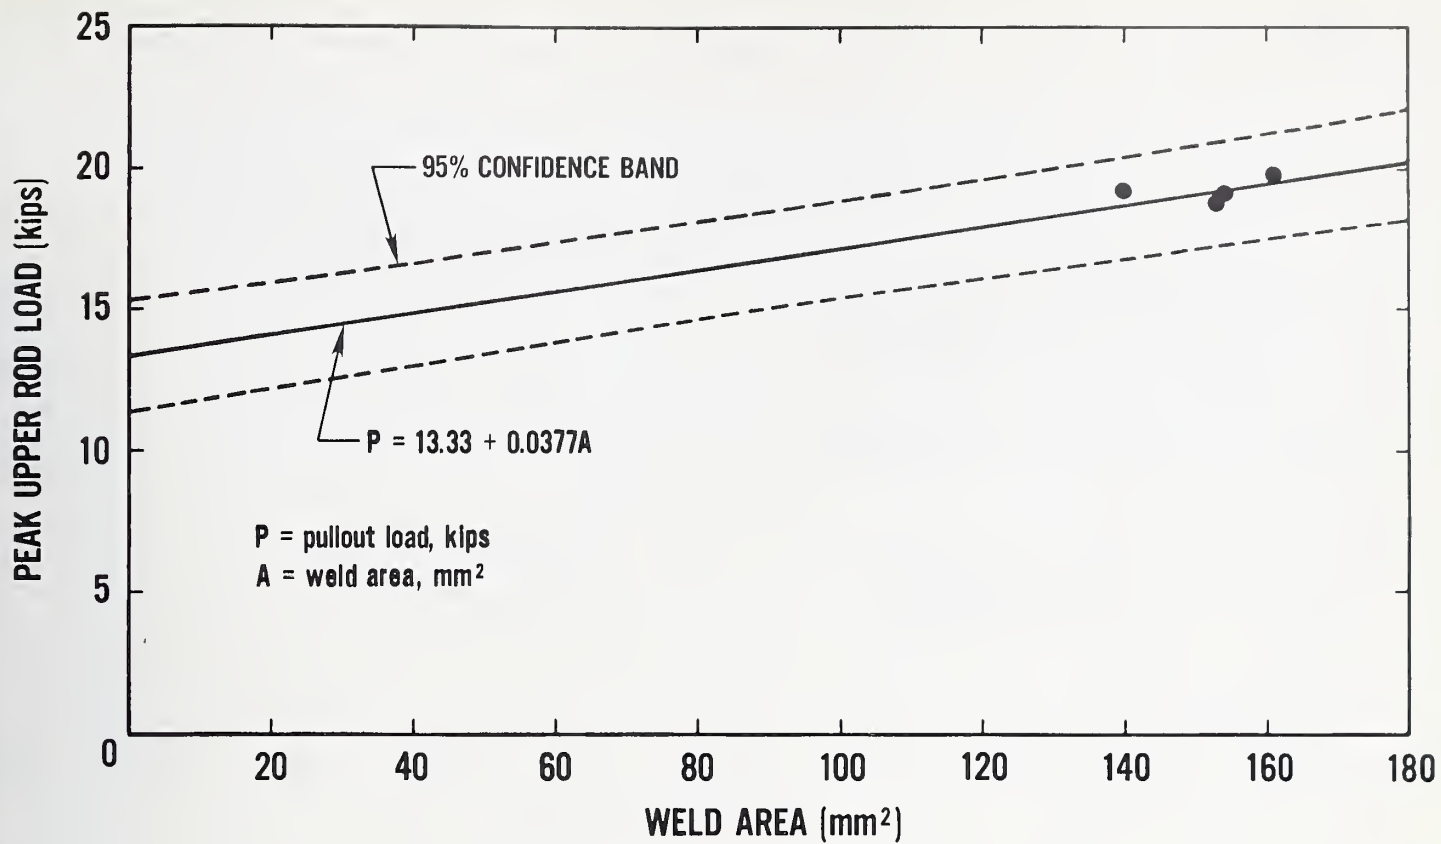
Figure 6.21 Effect of clip angles.

The presence of clip angles does not significantly affect the peak upper rod load capacities of the short box beams as is apparent from the data for specimens S1-S4 shown in figure 6.21 compared to the mean peak upper rod load and the 95 percent confidence band. This observation was expected based on the zone of distress observed on the white-washed box beams since the zone of distress did not extend to the location of the stringer-box beam clip angle.

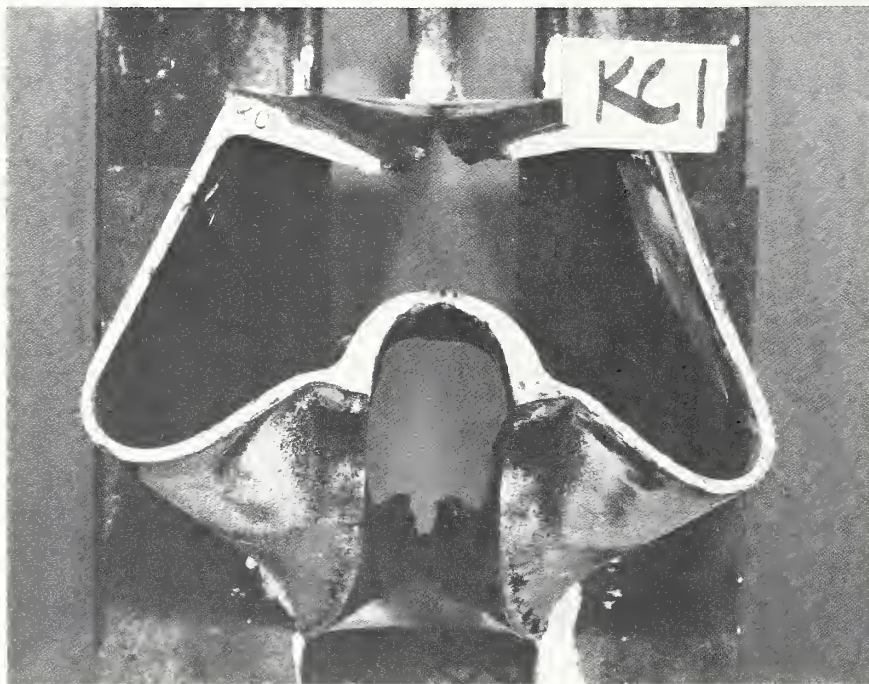
Figure 6.35 Deformed shape of walkway specimen KC1.

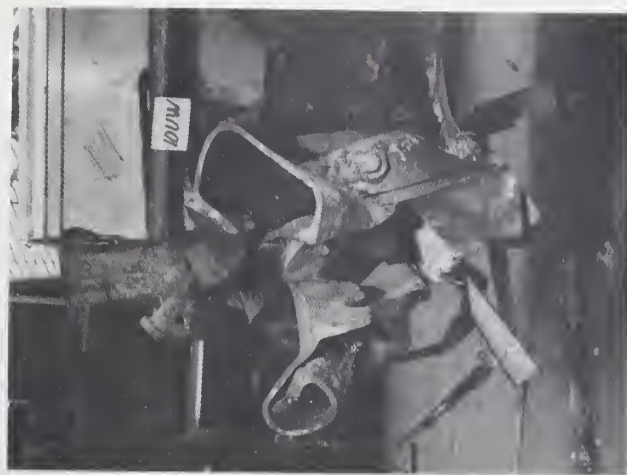
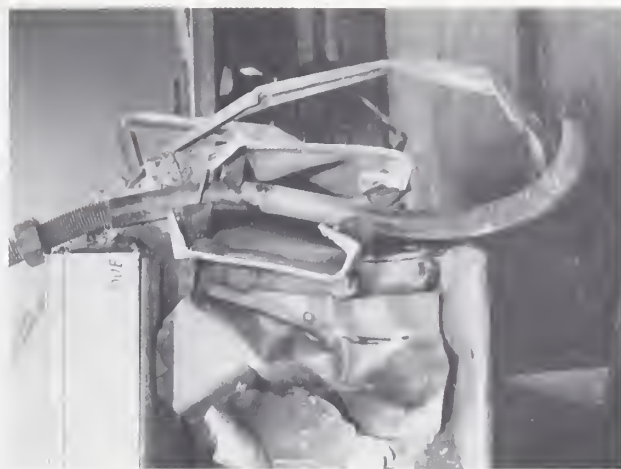
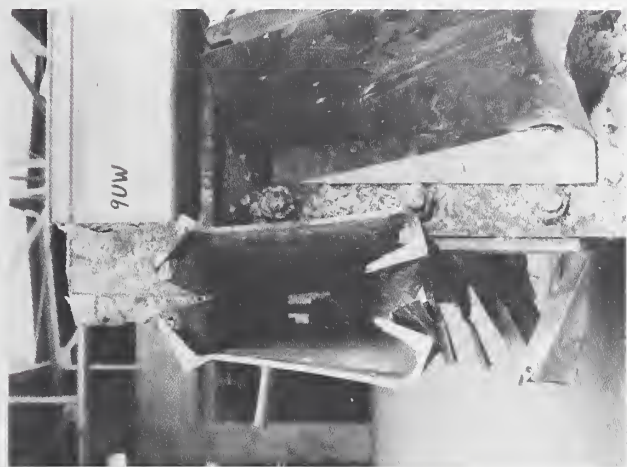
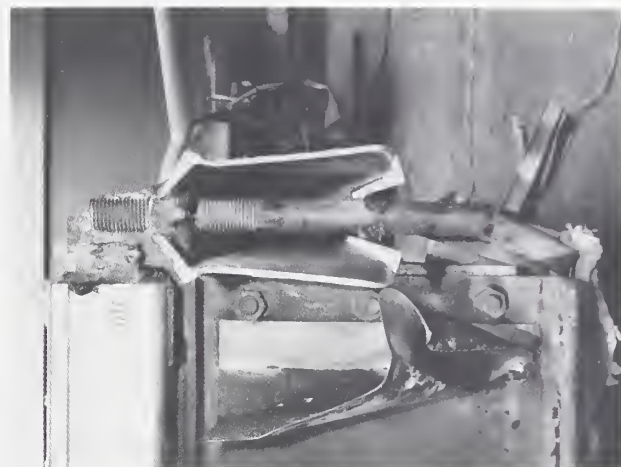
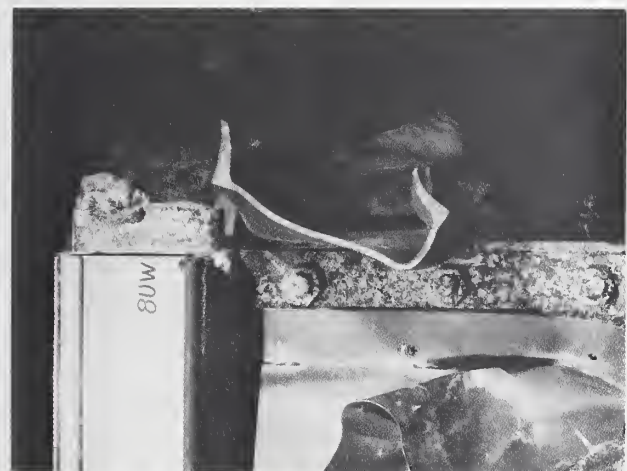
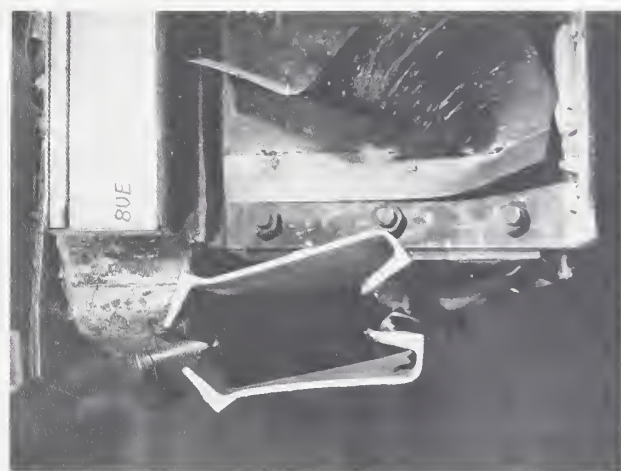
Figure 6.36 Walkway deformed shapes.

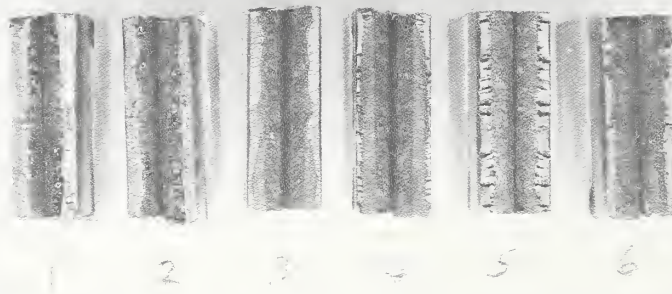
Variation in the transverse strength of the walkway box beam longitudinal welds was determined by testing 1.0 in (25.4 mm) wide tensile coupons to failure. Weld caps were machined flush to simulate conditions near the beam ends. The results, summarized in table 7.5, show a substantial variation in breaking load among specimens taken from the same beam. The observed variability is not unusual for the type of weldment tested considering the small weldment area sampled by each specimen. Figure 7.9 shows the variability in the amount of weld metal from specimen to specimen at the fracture. This variability correlates reasonably well with the specimen breaking loads (table 7.5). Differences in the amount of porosity found on the fracture surfaces of the specimens also contribute to the ultimate strength variation.

Figure 7.9 Fracture surfaces of walkway weldment tensile specimens. Both halves of each fracture are shown. The bright regions represent fracture and indicate the depth of weld penetration. Specimen key is as follows. X1

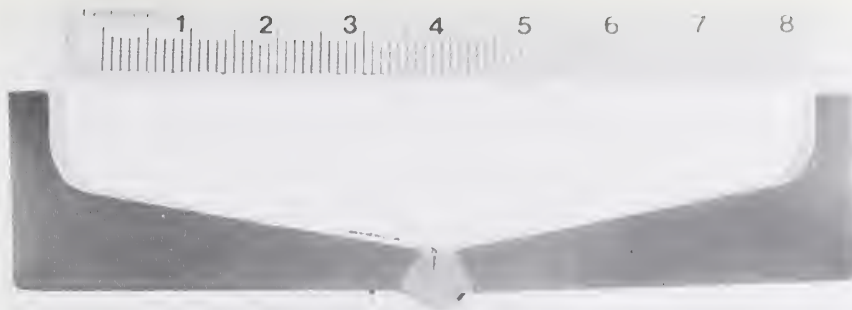
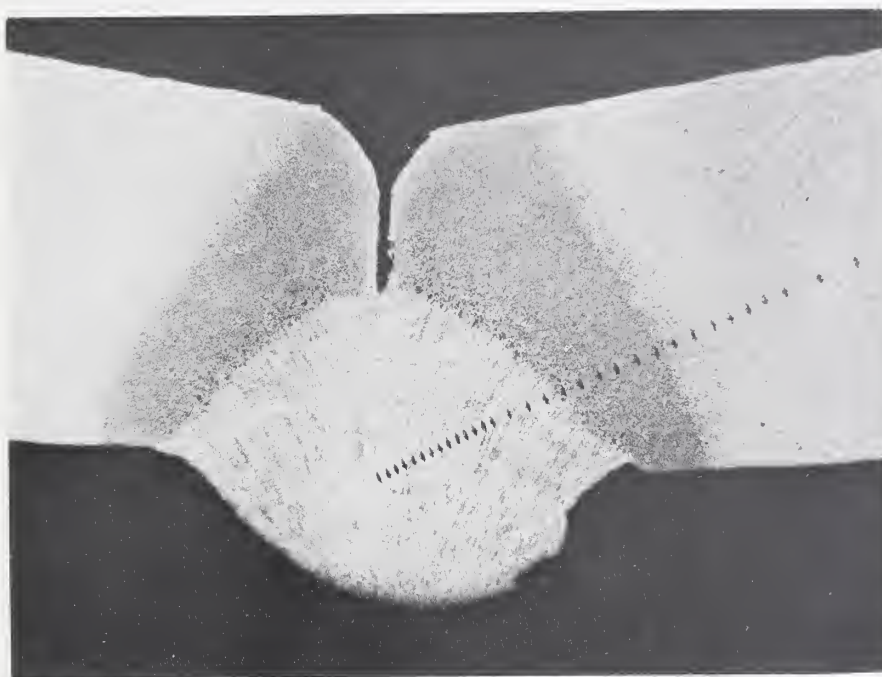
Figure 7.10 Transverse section through NBS weldment IC welded by the GMAW process. Dark regions separating weld metal from flange base metal are heat-affected portions of base metal. Aligned indentations are microhardness measurements. a, X1; b, X8 1/2

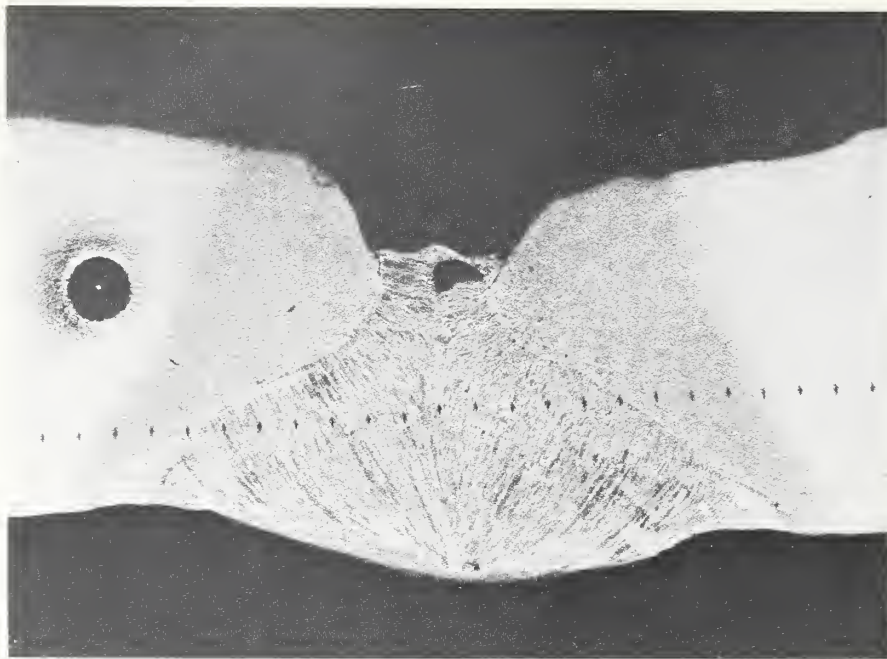
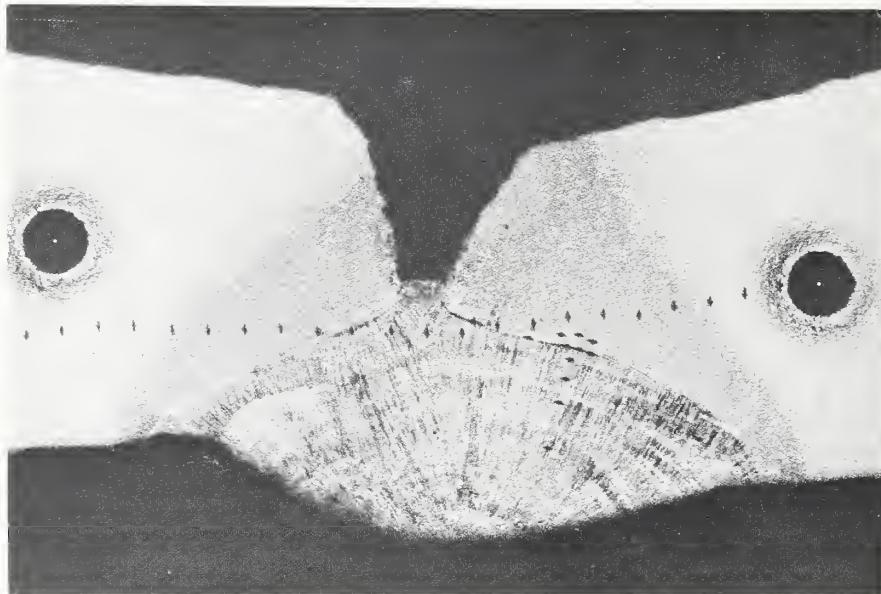
Figure 7.10 illustrates the appearance of an NBS weldment made by the GMAW process, while figures 7.11-7.13 illustrate the appearance of weld regions in box beams 9U, 8L and 9M, respectively. Basic walkway weldment hardnesses were normal. Maximum hardnesses were 92-95 Rockwell B (HRB) for the weld regions, 85-93 HRB for the heat-affected zones and 70-79 HRB for the unaffected parent metal. Small zones of increased hardness (28-33 HRC) were noted in the heat-affected zones of one section taken from location 9U and one section taken from location 8L. The structure of the hard zones appeared to be tempered martensite.

Figures 7.10 to 7.13 illustrate a substantial variability in the contour of the mating flange ends forming the faying surfaces for welding. The effect, coupled with differences in weld penetration, creates regions of varying notch acuity in the weld region. However, no cracks were observed to have initiated from such notches in any of the sections studied.

Figure 7.11 Cross sections through weld regions of box beam 9U (NBS 1). Sections were separated about 7 in (180 mm) along the beam length. Microhardness indentations traverse the surfaces.
X 8 1/2

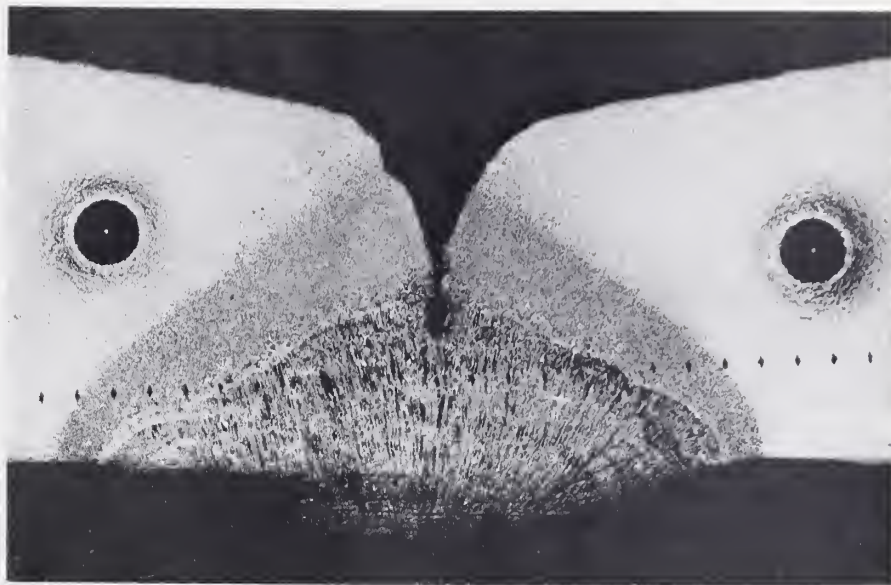
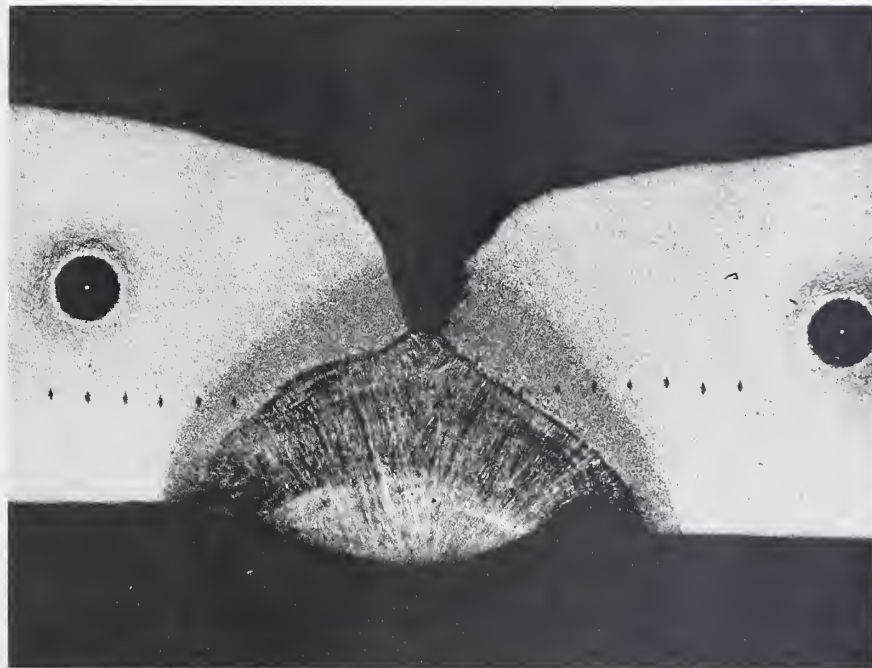
Figure 7.12 Cross sections through weld regions of box beam 8L. Sections were separated about 7.5 in (190 mm) along the beam length. Microhardness indentations traverse the surfaces. X8 1/2

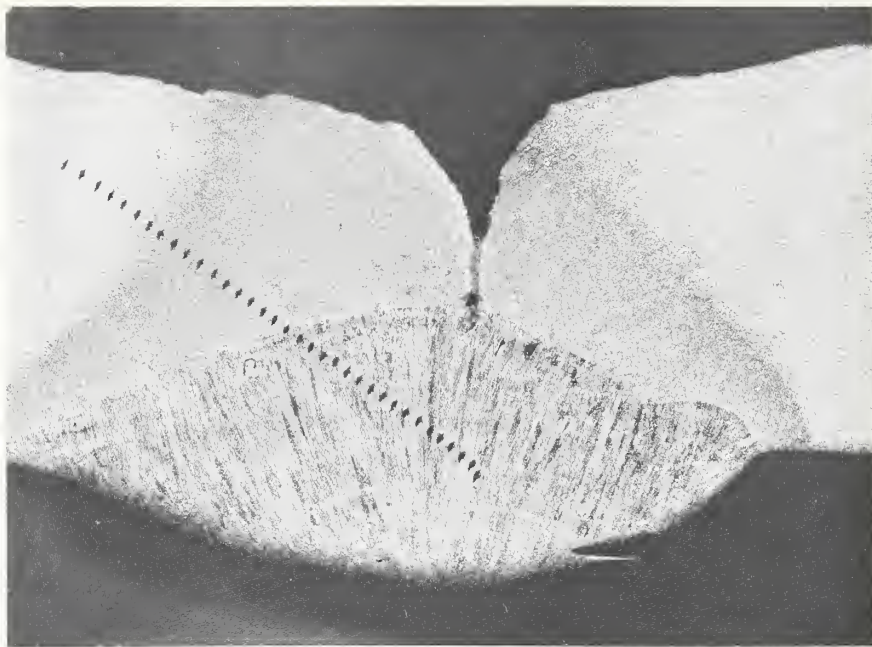
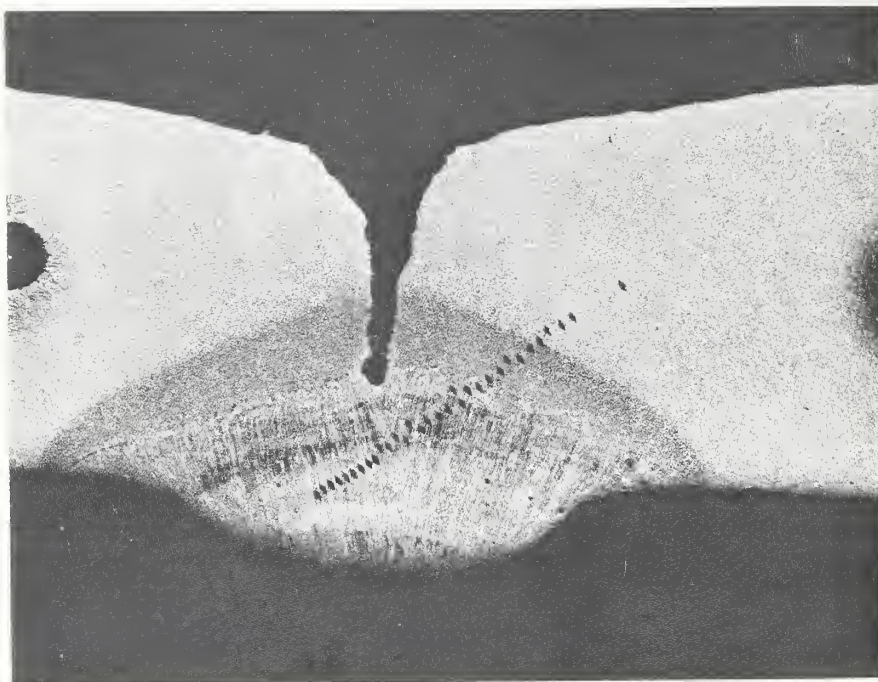
Figure 7.13 Cross sections through weld regions of box beam 9M. Sections were separated about 7.5 in (190 mm) along the beam length. Microhardness indentations traverse the surfaces. X8 1/2

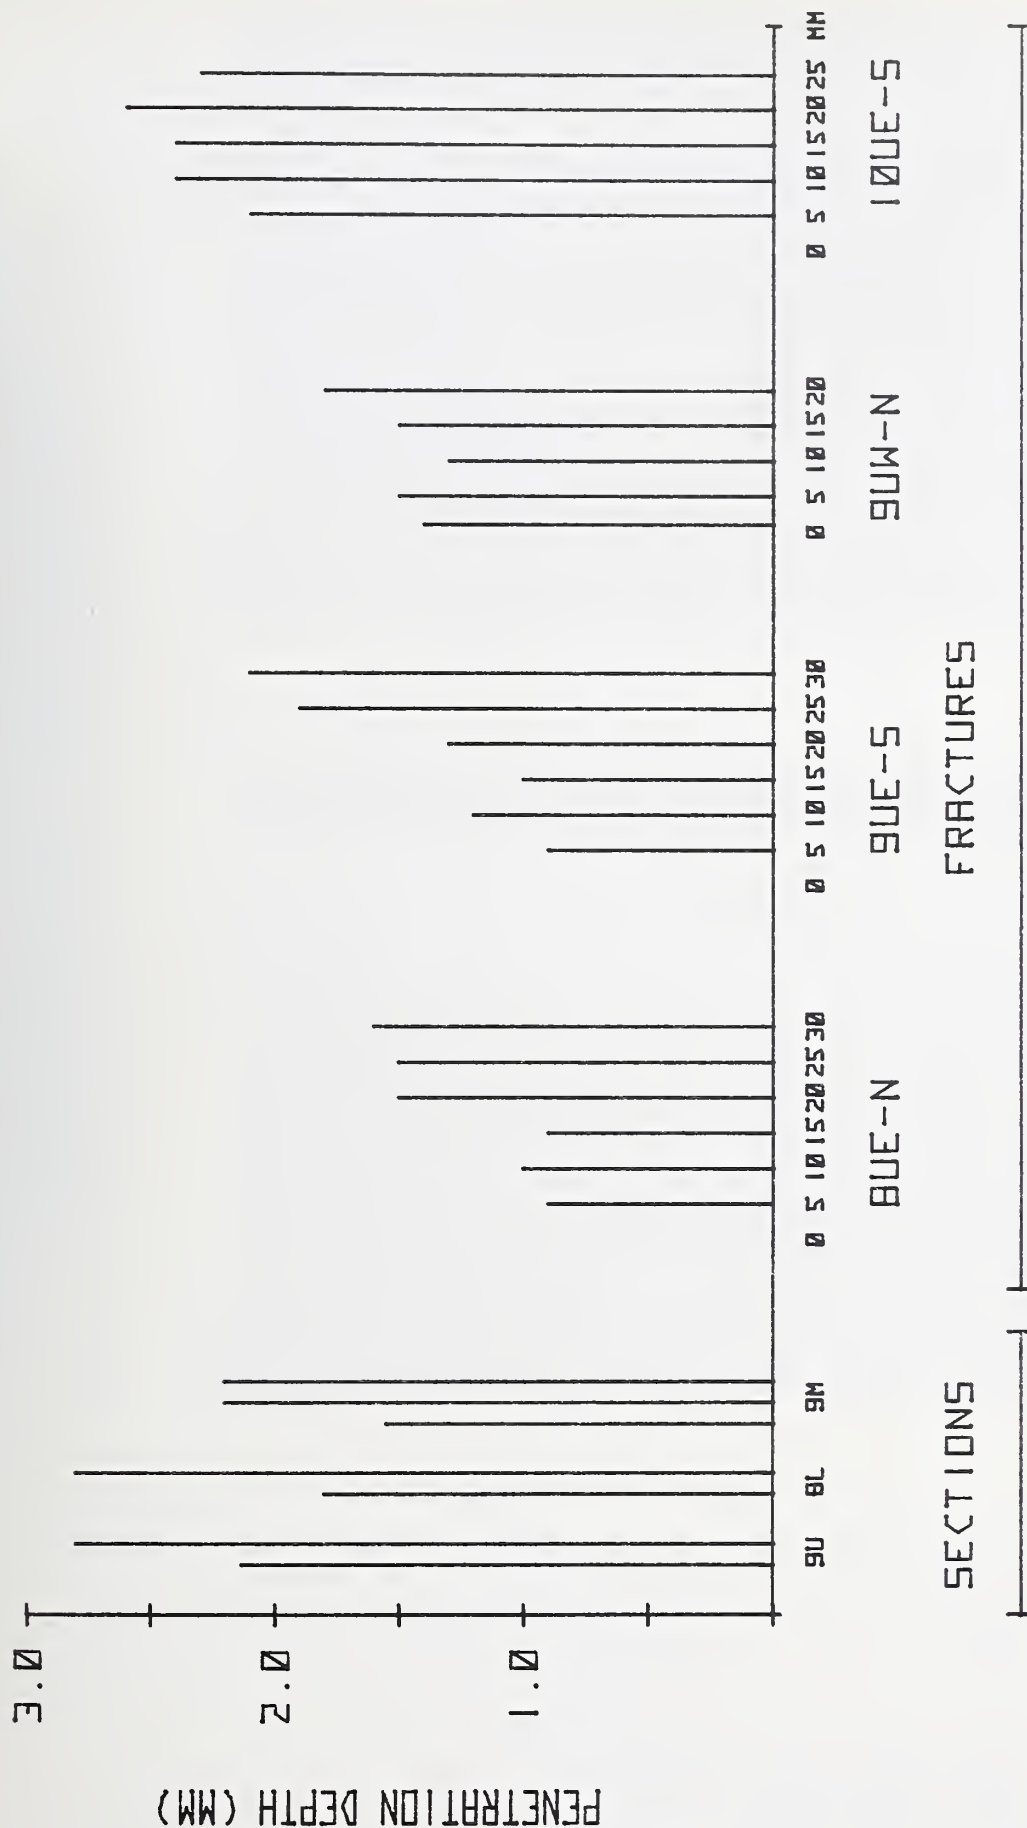
A series of optical and metallographic measurements of longitudinal weld penetration in the interiors of box beams 9U, 8L and 9M and at the ends of box beams at locations 8UE, 9UE, 9UW and 10UE are summarized in figure 7.14. The latter set was taken in the lower flange region between the beam end and the outer hanger rod hole following weldment fracture. From figure 7.14 the weld penetration data from the sectional specimens average about 2.2 mm. The data from the fracture surface at location 10UE average about 2.4 mm, while the average weld penetration at locations 8UE, 9UE, and 9UW is near 1.5 mm. All weld penetration data from fractures represent minimum values, considering that the surfaces examined represent final reductions in area at fracture.

rod holes at locations 8UE, 9UE and 9UW (figure 7.14) suggests that a "run-on" tab was not used in walkway beam fabrication. Weld penetration at location 10UE suggests that this beam was cut to length after the welding operation. Evidence of such an operation was also noted at location 8UW during the site investigation (section 5.3.3).

Figure 7.14 Penetration depth of walkway box beam longitudinal welds. Locations 9U, 8L, 9M measured on cross sections of beam interior. Locations 8UE, 9UE, 9UW and 10UE measured from fractures with data points reflecting indicated millimeter distances from beam ends.

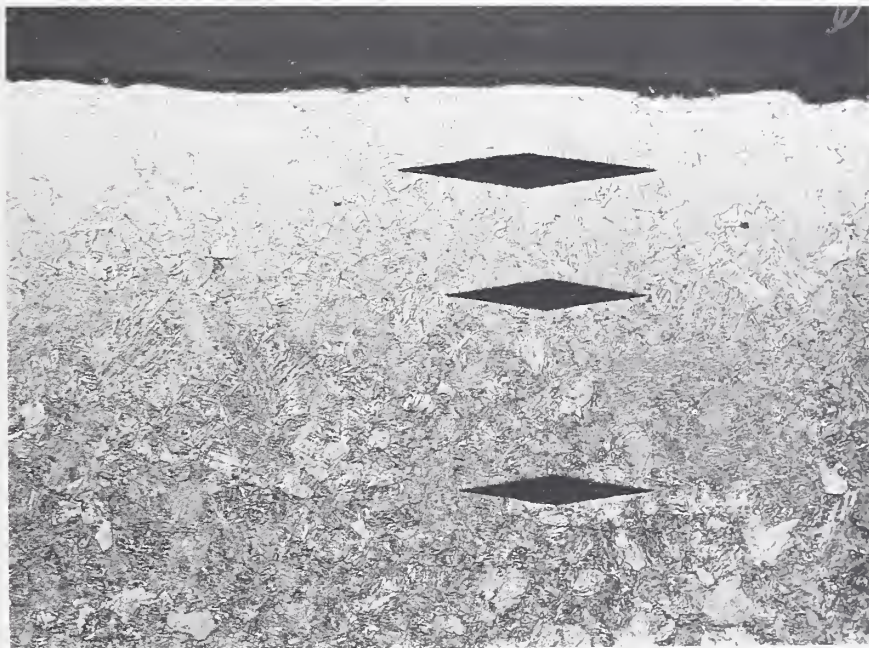
Figure 7.16 Microstructures of washers from 9MW (NBS specimen 3), (a), and of hardened washer used in NBS tests, (b). Whiter layer near surface (top of illustrations) is decarburized layer. Interior structure is tempered martensite. Etchant: Picral. X200

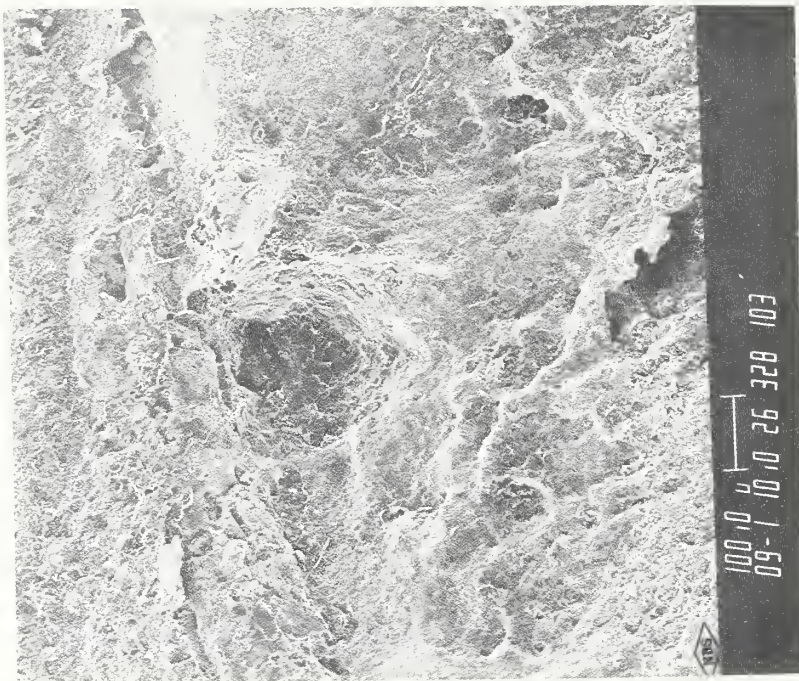
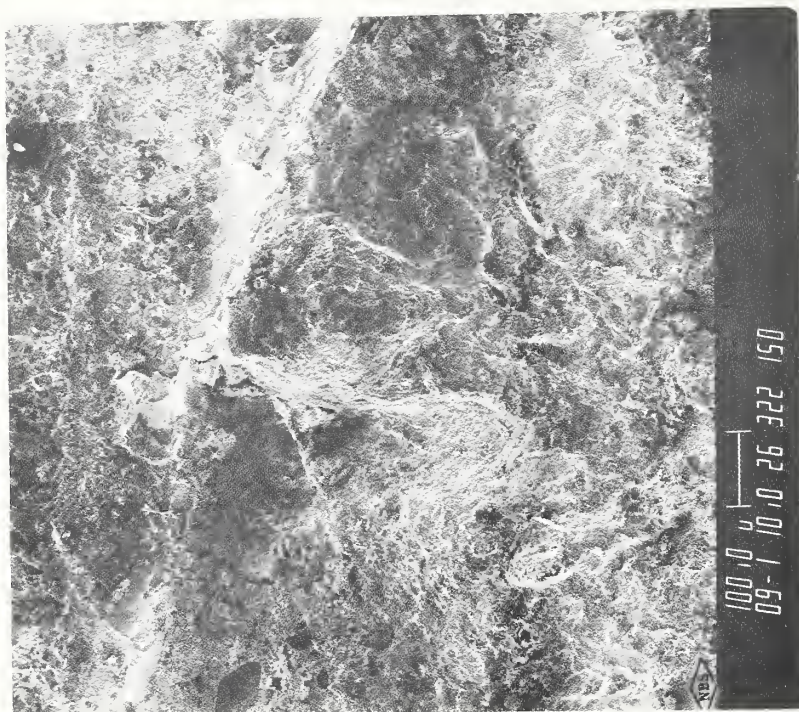
Procedures used to replicate the fracture surfaces have been described in section 5.5. The replication technique is capable of reproducing details of the fracture surface with reasonable fidelity, provided that intimate contact is achieved between the replication media and the surface (figure 8.1). Failure to achieve contact produces artifacts in the replica that must be discounted in the analysis. The replica is a mirror image of the original surface and may have a different sense of image contrast--in one case the image contrast is due to both topography and composition variation (8.1a) and in the other the image contrast is due to topography alone (8.1b). Selection of a specific replica from each surface for study was based on visual evaluation of the

Figure 8.1 Comparison of quality of image by direct SEM (a) and by replication (b) where replica contact is ideal. Fracture surface is located at root of upper exterior longitudinal weld of walkway box beam at location 8UW (north). Magnification X100.

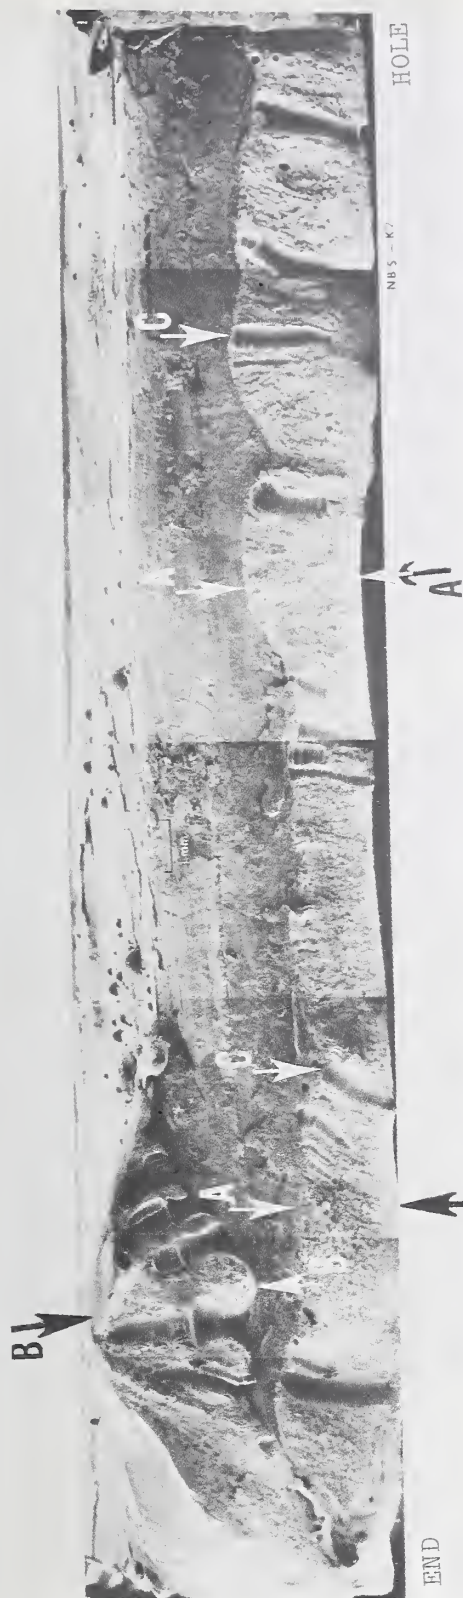
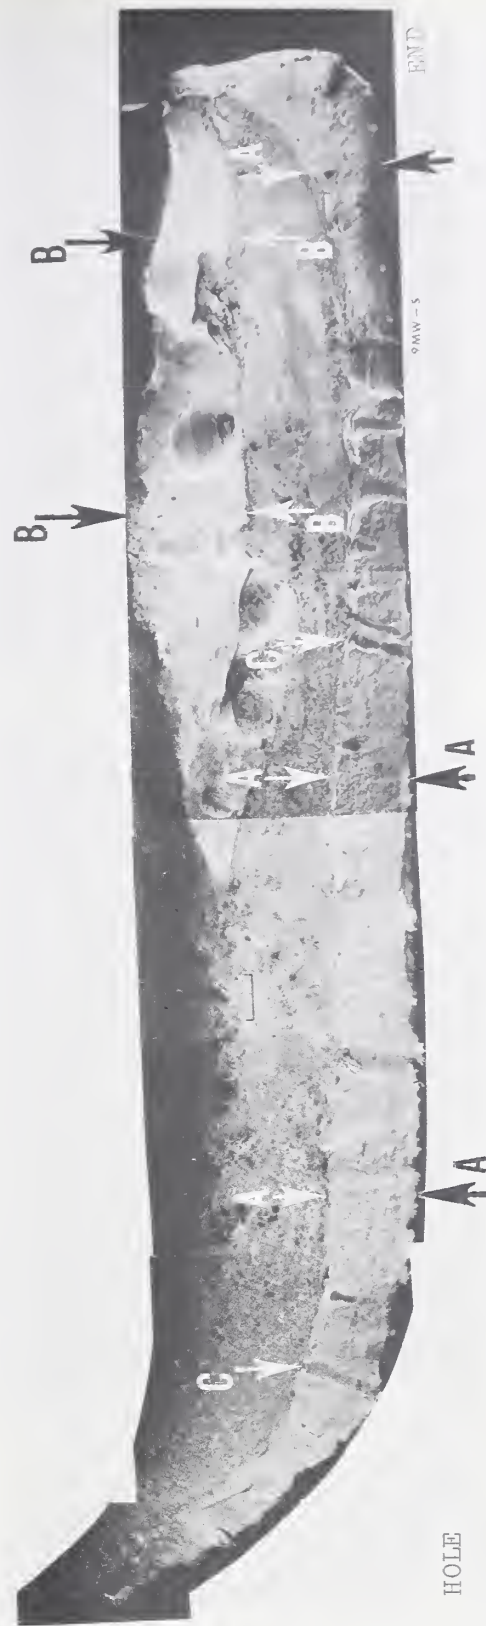
Figure 8.2 illustrates that the gross features of the fracture in the lower longitudinal weld between the outer hanger rod hole and beam end of box beams tested to failure were similar, regardless of whether the beam had been fabricated at NBS or had been obtained from the walkway debris. Rounded and piping porosity are evident in both fractures. The sharply delineated weld region in these figures indicates the absence of rust on the freshly fractured surfaces.

Figure 8.2 One half of box beam fracture surface between beam end and outer hanger rod hole for NBS fabricated box beam K2 (a) and for walkway box beam 9M tested at NBS (b). Exterior longitudinal weld indicated by arrows A, interior tack weld indicated by arrows B, examples of piping porosity indicated by arrows C. Magnification X6.

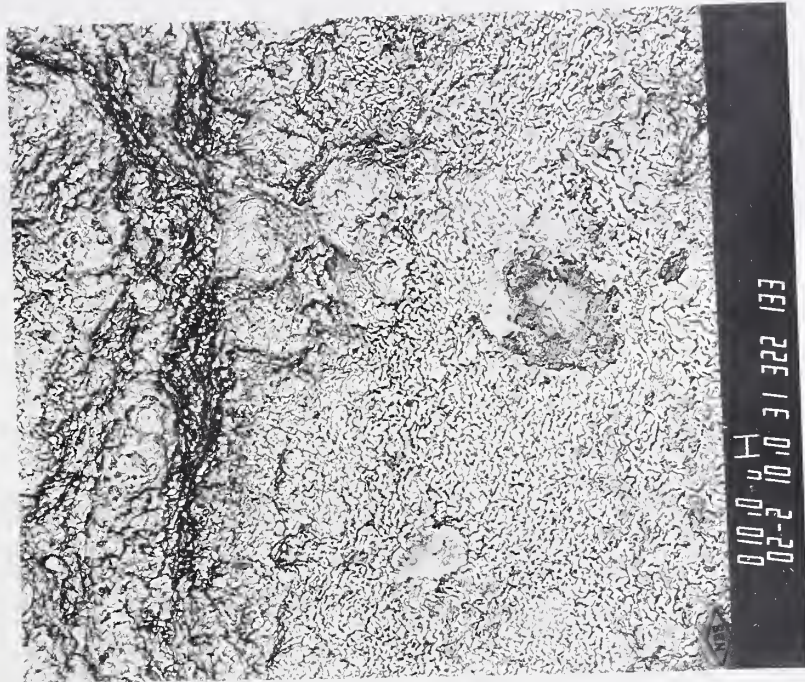
through the porosity (figure 8.3). While many of the replicated sections provided reasonable resolution of the fractographic features, figure 8.4 illustrates that in some cases a very tight oxide layer had modified the original fracture surface.

Figure 8.4 Photomicrograph of a replica from the shear lip region at location 8UE. The surface oxidation has removed the fine shear dimpled rupture features in this area. Magnification X250.

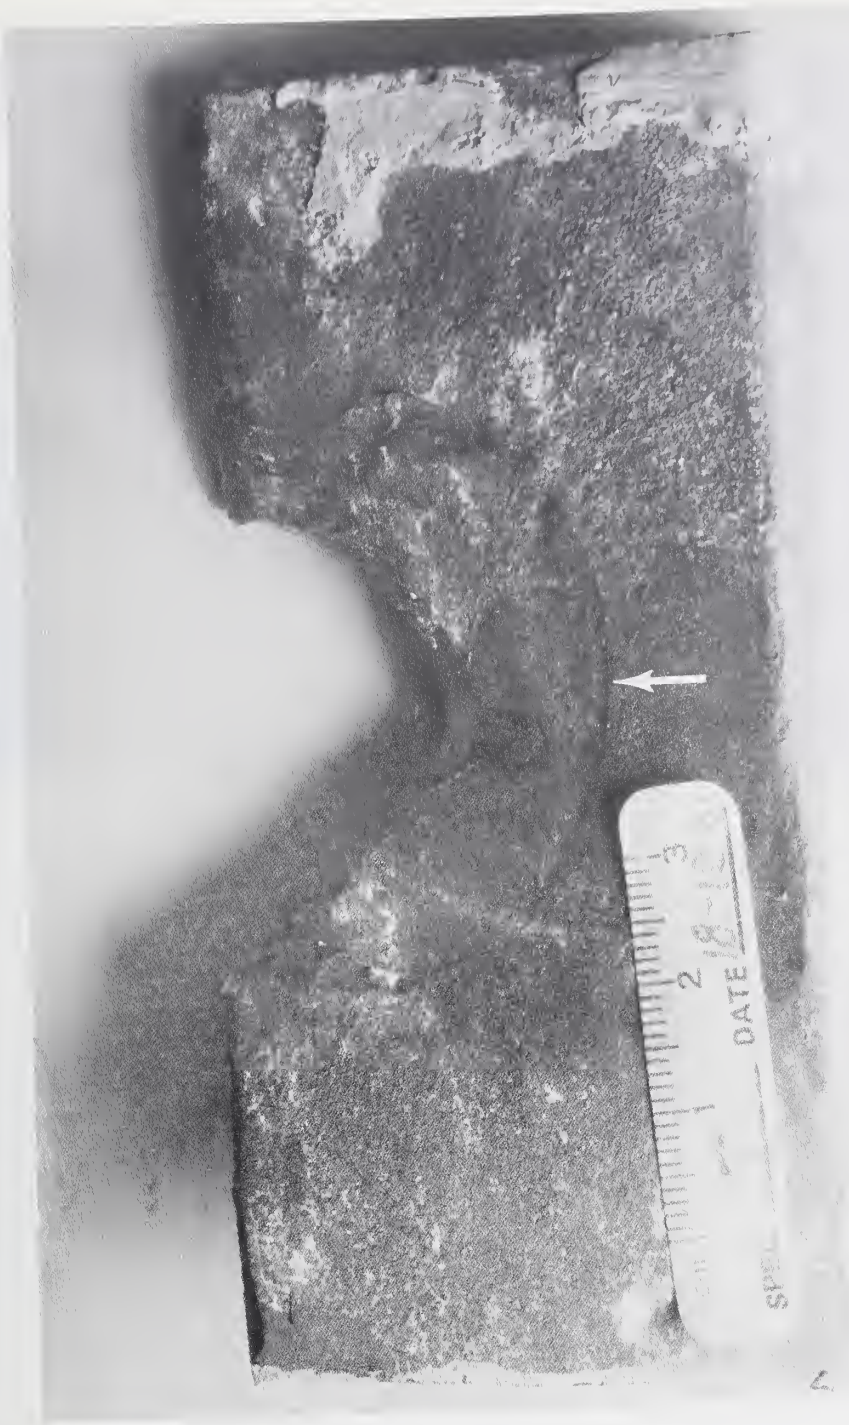
Washers at locations 9UE and 8UE were missing after the collapse. However, figures 8.8 and 8.10 provide clear evidence that washers had been installed at both locations.

Figure 8.10 Washer contact region on bottom flange at location SUE (north).
Arrow denotes initial washer position. Magnification X1.5.

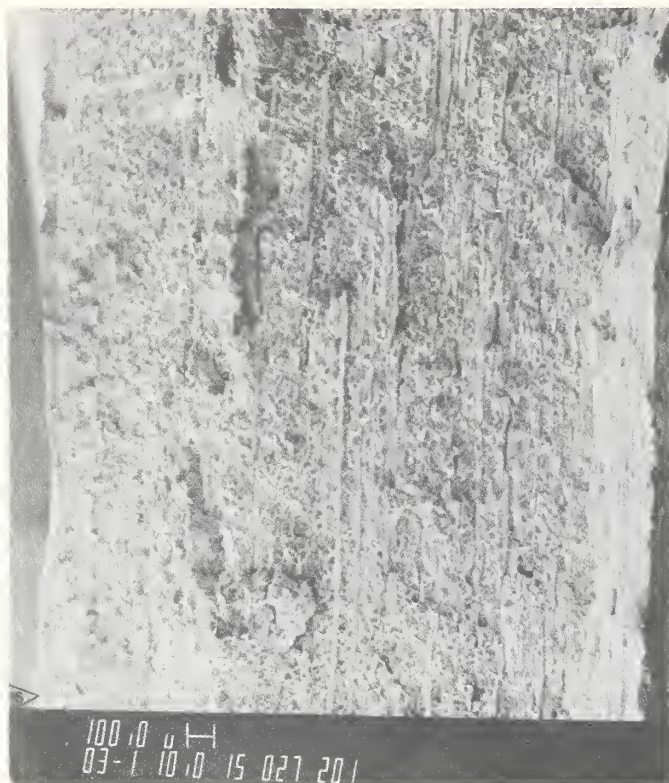
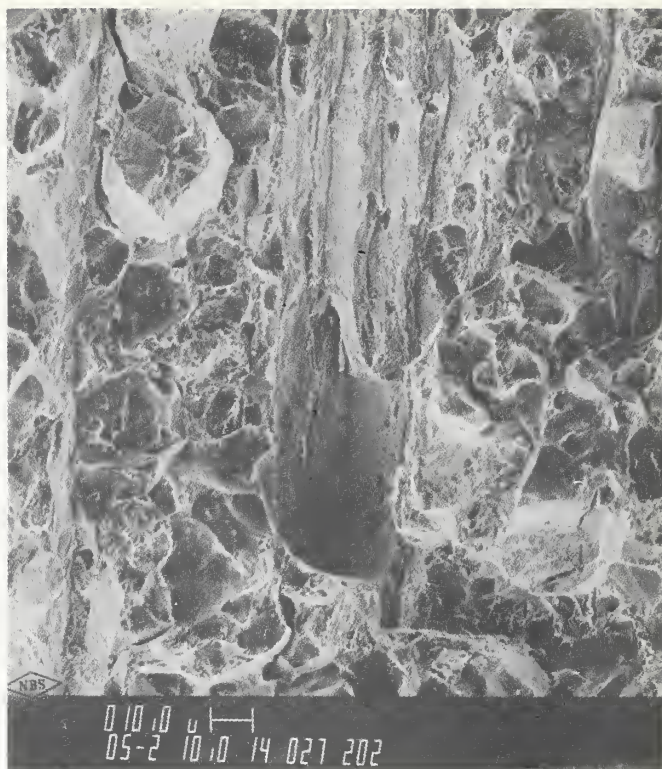
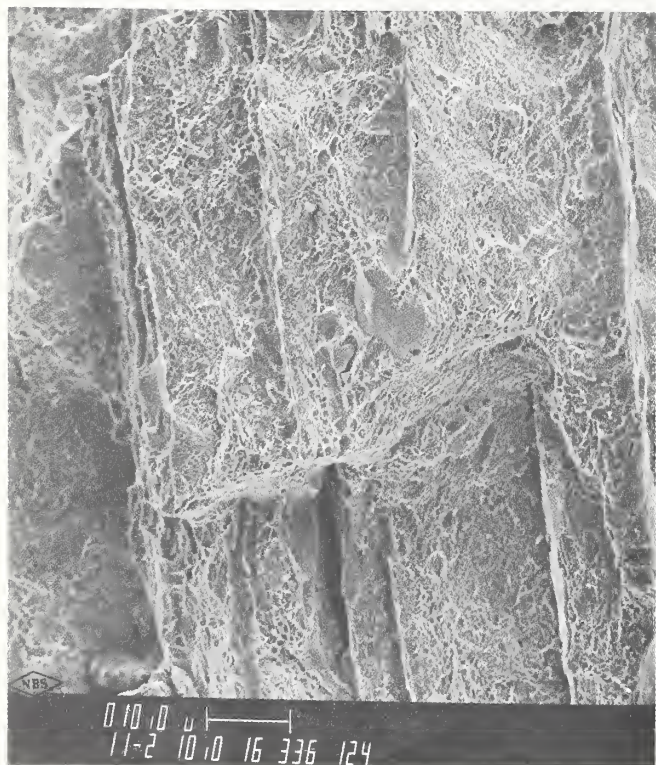
Prominent elongated MnS inclusions can be observed on the fracture surfaces in figures 8.11a and 8.11c. Hardened washers bent around a direction parallel to such inclusions could be expected to display low ductility.

Figure 8.11 Fractographic appearance of hardened washer fractured in NBS test of walkway box beam 9M, washer installed at location 9MW (a). Center portion, area (b), reveals a mixture of brittle (intergranular and cleavage) and ductile fracture. Area (c) reveals ductile rupture through a decarburized surface layer. Elongated features are indicative of MnS stringers. Magnifications (a) X35, (b) X550, (c) X1050.

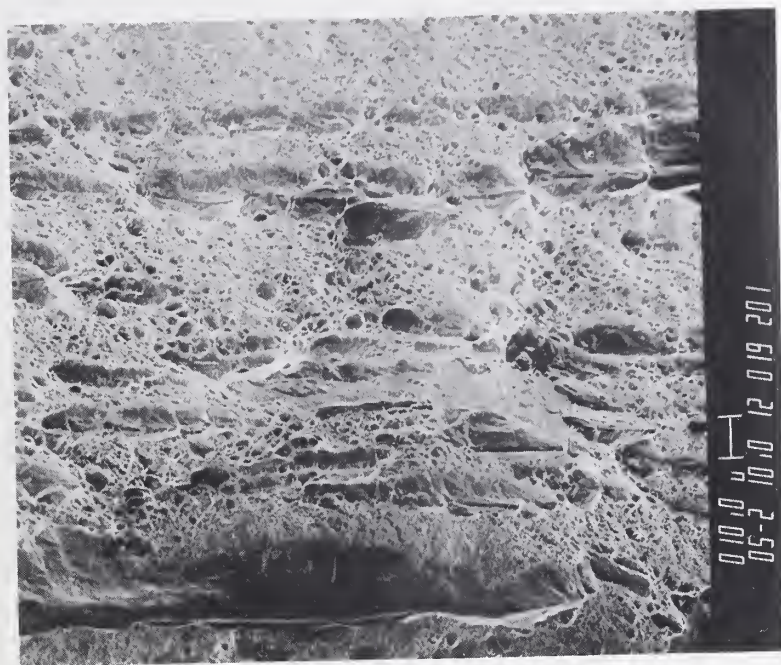
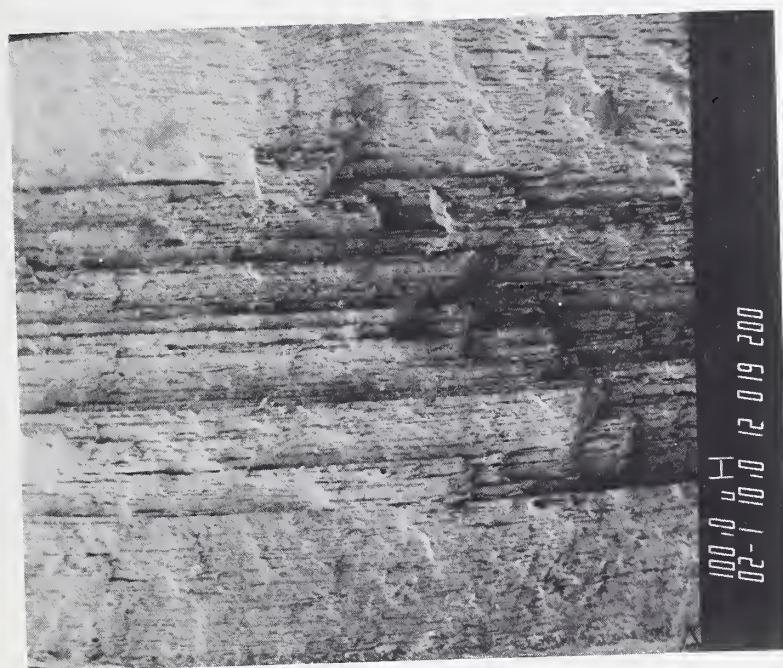
Figure 8.12 Fractographic appearance of walkway washer fractured in NBS test of box beam 9M (specimen KCl). Lower magnification view (a) shows high density of MnS stringers oriented parallel to the bend axis. Higher magnification view of center portion (b) shows mostly ductile rupture. Magnification (a) X25, (b) X550.

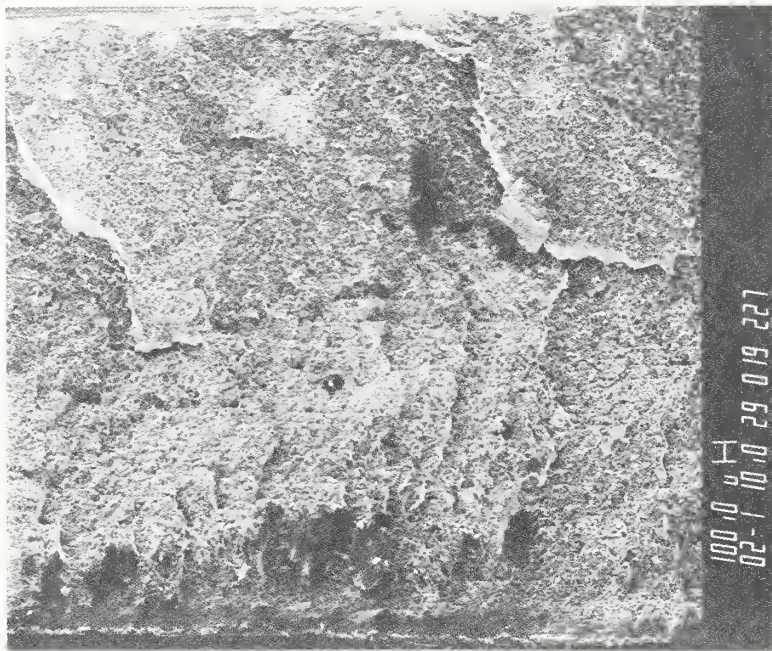
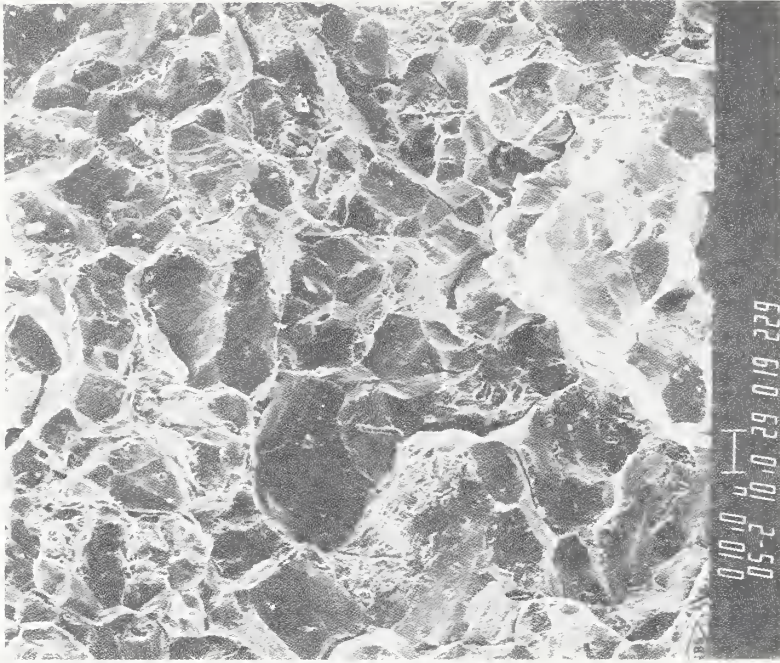
Figure 8.13 Fractographic appearance of walkway washer from upper end of hanger rod at location 9UE (NBS 11B) broken at NBS. Lower magnification view (a) shows no prominent MnS inclusions. Higher magnification view of center portion (b) shows essentially brittle intergranular fracture with a small amount of ductile rupture. Magnification (a) X25, (b) X550.

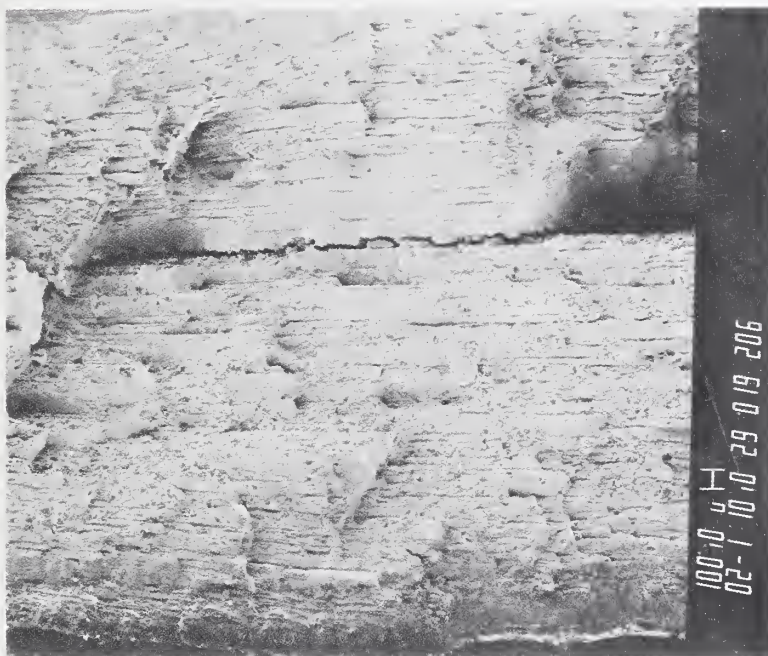
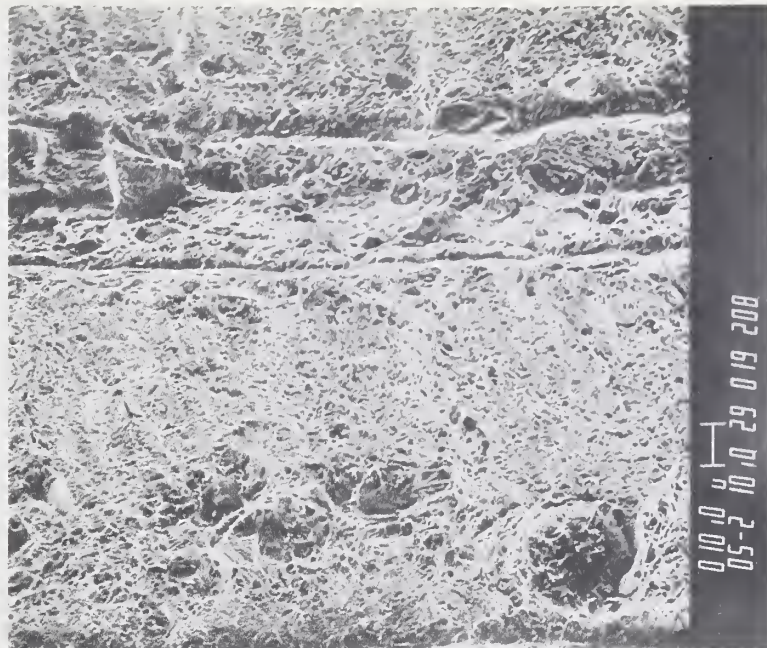
Figure 8.14 Fractographic appearance of NBS washer No. 3 broken at NBS. Low magnification view (a) shows elongated MnS inclusions. Higher magnification view of center portion (b) shows essentially ductile rupture. Magnification (a) X25, (b) X550.
