NBS BUILDING SCIENCE SERIES 143

Investigation of the Kansas City Hyatt Regency Walkways Collapse

DEPARTMENT OF COMMERCE • NATIONAL BUREAU OF STANDARDS

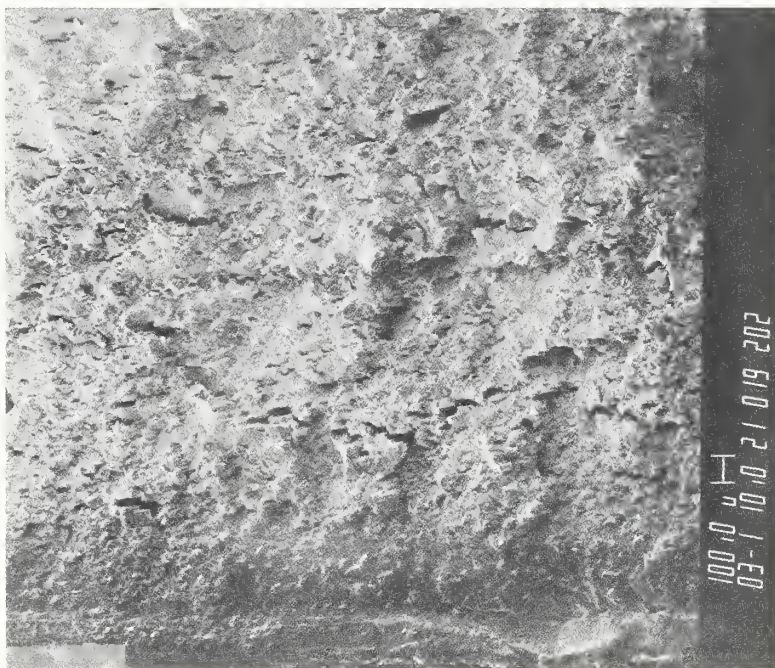
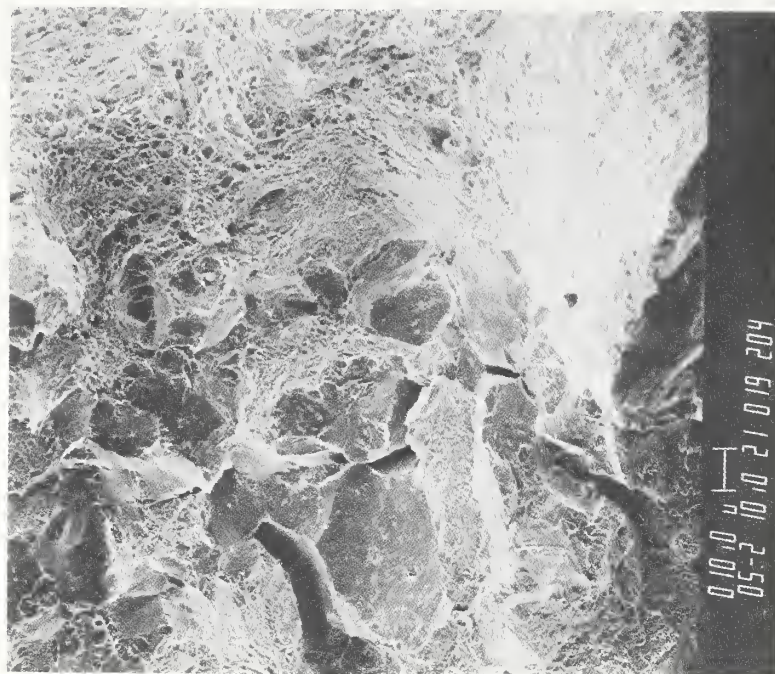
Figure 8.15 Fractographic appearance of NBS washer No. 2 broken at NBS. Low magnification view (a) shows no prominent MnS inclusions. Higher magnification view of center portion (b) shows 15-20 percent brittle intergranular fracture along with ductile rupture. Magnification (a) X35, (b) X550.

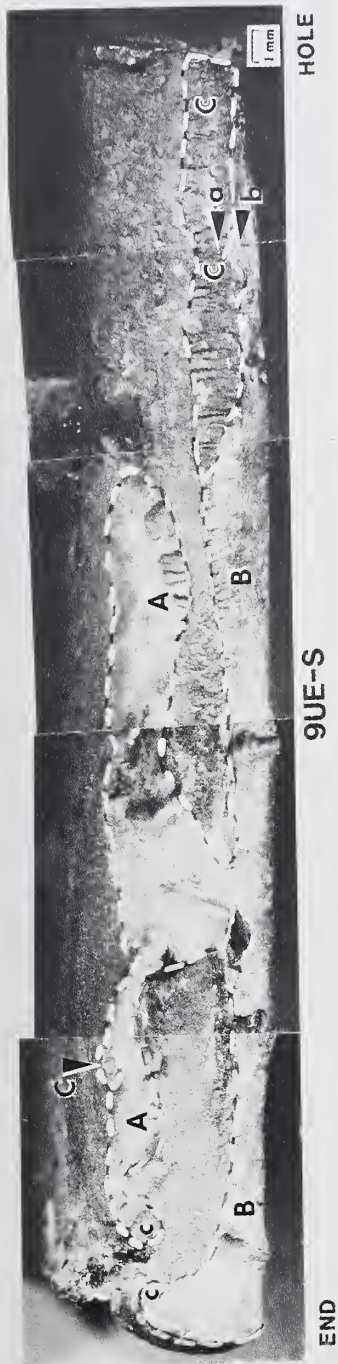
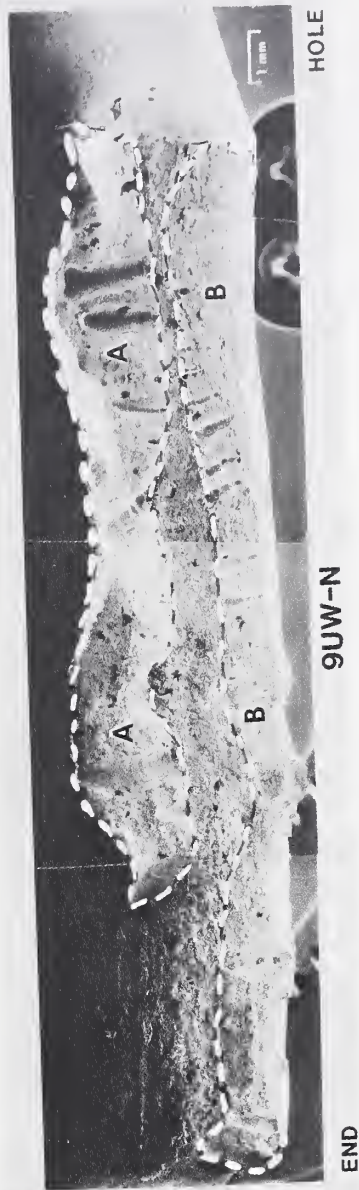
Figure 8.18 One half of box beam lower fracture surface between beam end and outer hanger rod hole.

(A) fracture area of the interior tack weld, (B) exterior longitudinal weld, (C) preexisting crack regions. This designation also is applicable to figures 8.19, 8.20, and 8.21. (a) and (b) noted by arrows on 9UE, indicate locations of figures 8.22 (a) and (b), respectively.

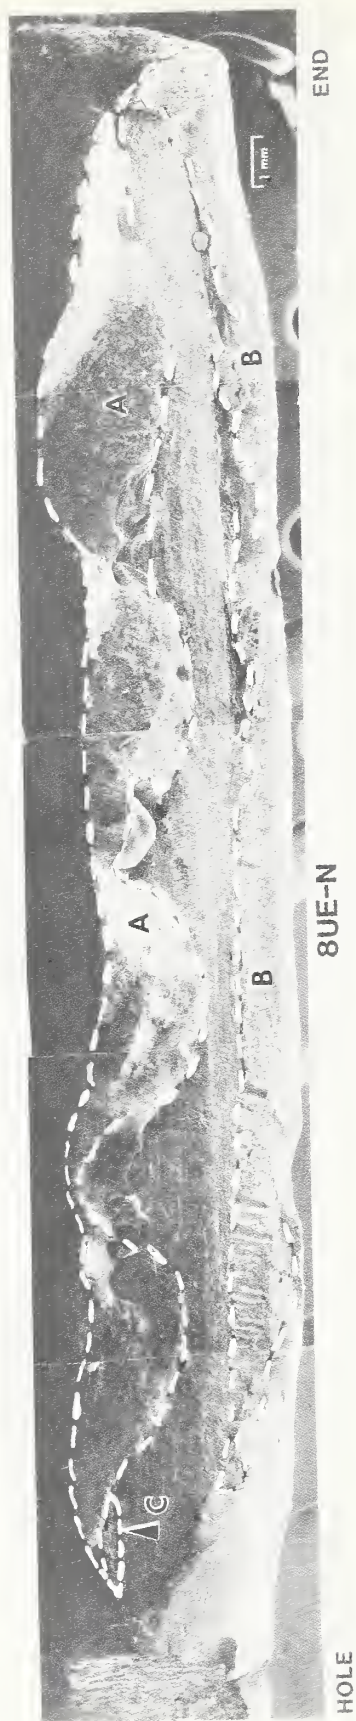
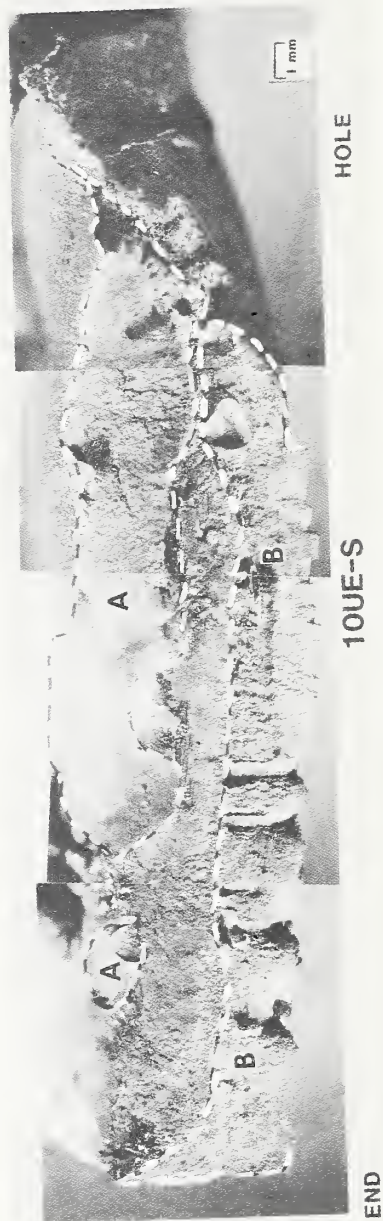
Figure 8.19 One half of box beam lower fracture surface between beam end and outer hanger rod hole.

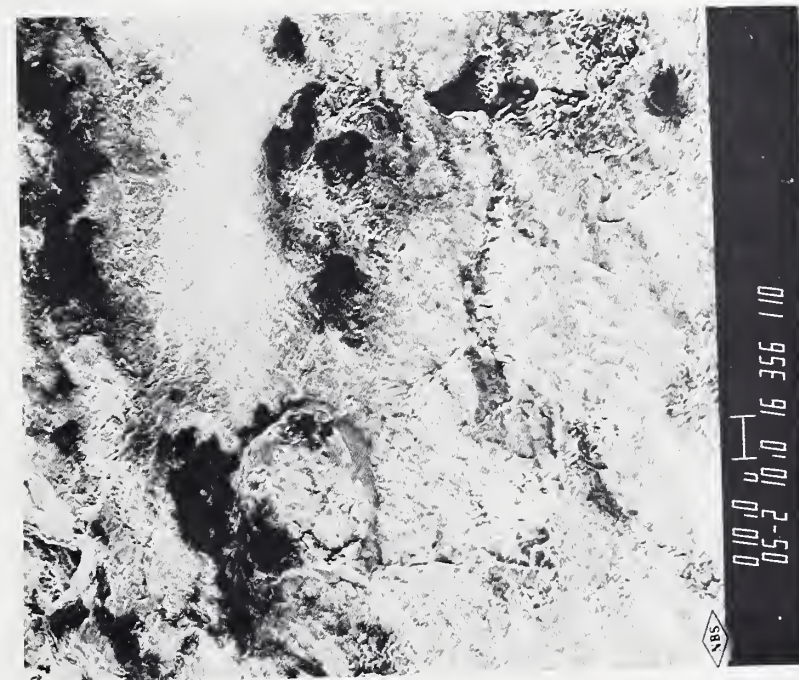
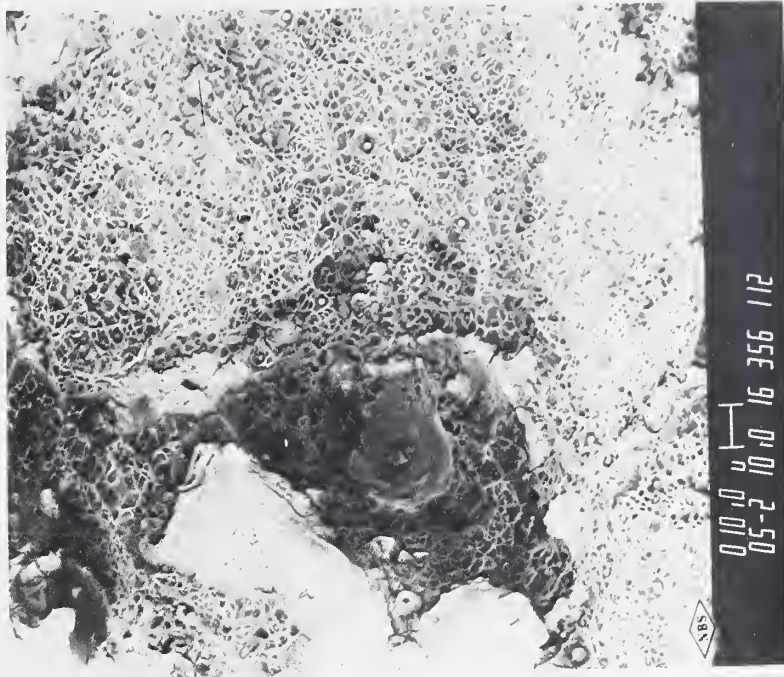
Different textures in the fracture topography provided evidence that cracks had existed in the weld roots in the regions between the hanger rod holes and in the regions between the outer hanger rod holes and beam ends prior to gross weld failure at the time of collapse. Figures 8.5 (a-c) illustrate the appearance of several such regions in the exterior longitudinal welds at locations 9UW, 9UE and 8UW.

Figure 8.22 Fracture appearance in the preexisting crack region (a) and in the region of final crack propagation (b) at location 9UE adjacent to the outer hanger rod hole. Magnification X550.

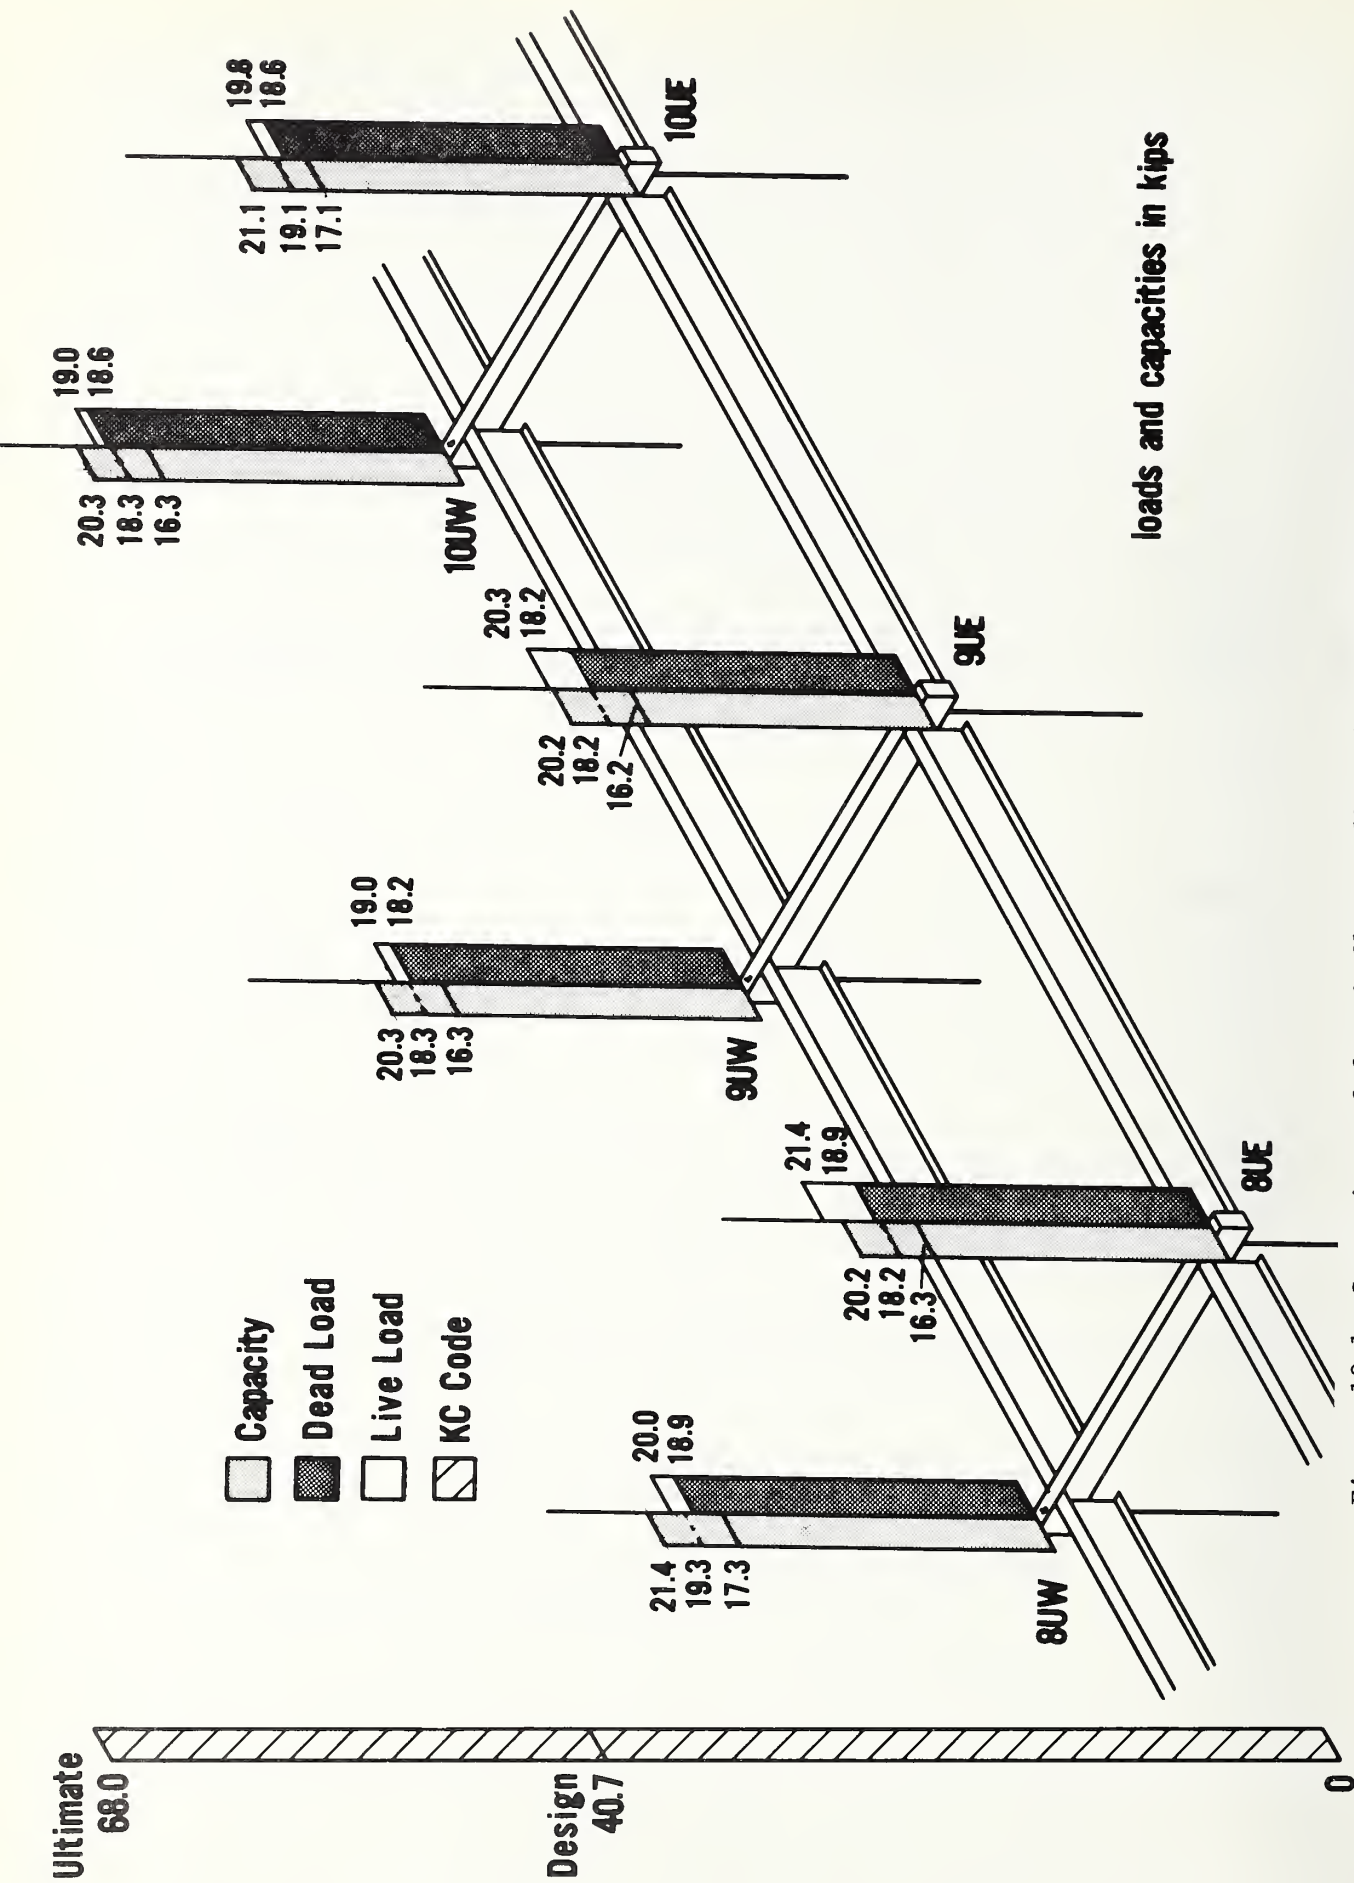
Figure 10.1 presents similar information for the other fourth floor box beam-hanger rod connections. This figure shows that, with the exception of locations 8UE and 10UW, the estimated mean ultimate capacity of each fourth floor box beam-hanger rod connection either equals or slightly exceeds the estimated dead load effect. However, the estimated mean ultimate capacity is exceeded by the sum of the estimated dead load and upper-bound live load in every case.

It is important to point out that the load capacities described in figure 10.1 are ultimate values. As noted in section 9.3.3, the design load (estimated nominal dead load plus code-specified design live load) for a fourth floor to

Because of the safety factor, the resulting connection would be expected to have an ultimate load capacity substantially higher than the working stress value of 40.7 kips (181 kN). Using a factor of safety of 1.67, which is the lowest value that would govern any part of the design of the box beam-hanger rod connections under the applicable provisions of the AISC Specification, it would be expected that the ultimate load capacity of the resulting connection would be at least 1.67 times 40.7, or 68 kips (302 kN). Thus any given box beam-hanger rod connection in the fourth floor walkway should have been able to support an ultimate load of at least 68 kips (302 kN) instead of the average ultimate capacity of 18.6 kips (83 kN) estimated for the 6 fourth floor walkway connections. Since the AISC Specification is the basis for the steel design provisions of the Kansas City Building Code, this same ultimate load capacity would be expected of a connection designed under the Kansas City Building Code. The hanger rod load to be applied in working stress design under the Kansas City Building Code and the expected ultimate load capacity are shown in the bar diagram on the left in figure 10.1.

Figure 10.1 Comparison of fourth floor walkway box beam-hanger rod connection capacities with loads believed to have been acting at time of collapse.

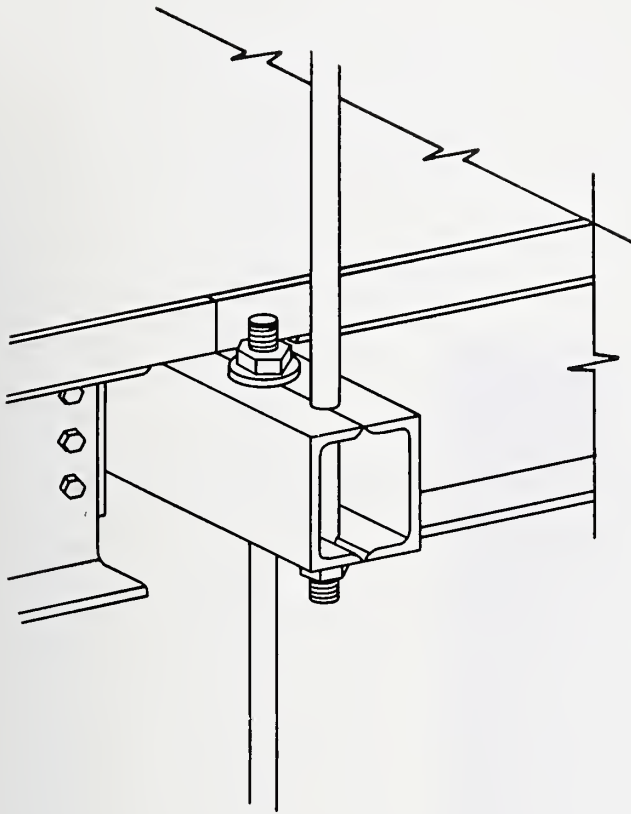
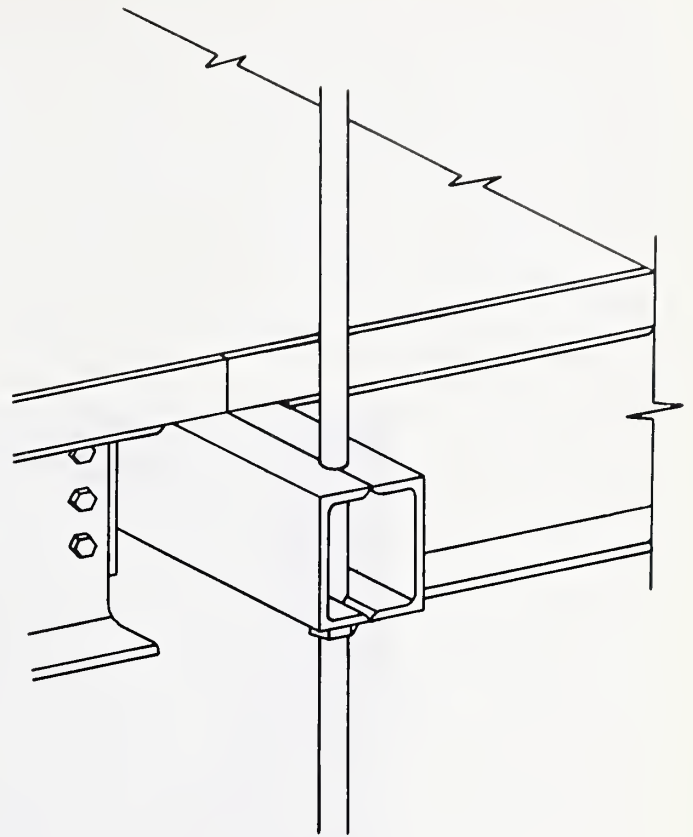
Figure 10.2 Comparison of interrupted and continuous hanger rod details.

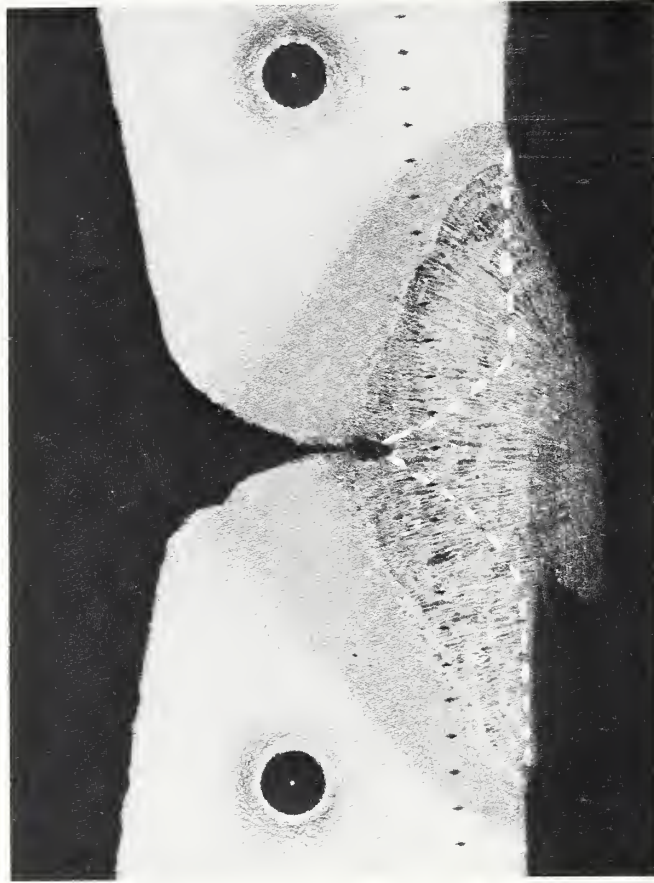
11. Average joint penetration for the box beam longitudinal welds was less than that required by AWS D1.1-79 for a prequalified partial joint penetration groove weld. However, it is concluded that due to the presence of tack welds the actual ultimate capacities of the box beam-hanger rod connections probably were higher than would be expected for a partial joint penetration groove weld with the prescribed minimum effective throat acting alone.

Figure 10.3 Cross section through weld region of walkway box beam 8L showing the exterior longitudinal weld joint at the bottom flange. Dotted lines indicate approximate original geometry of the flange toes. X8 1/2

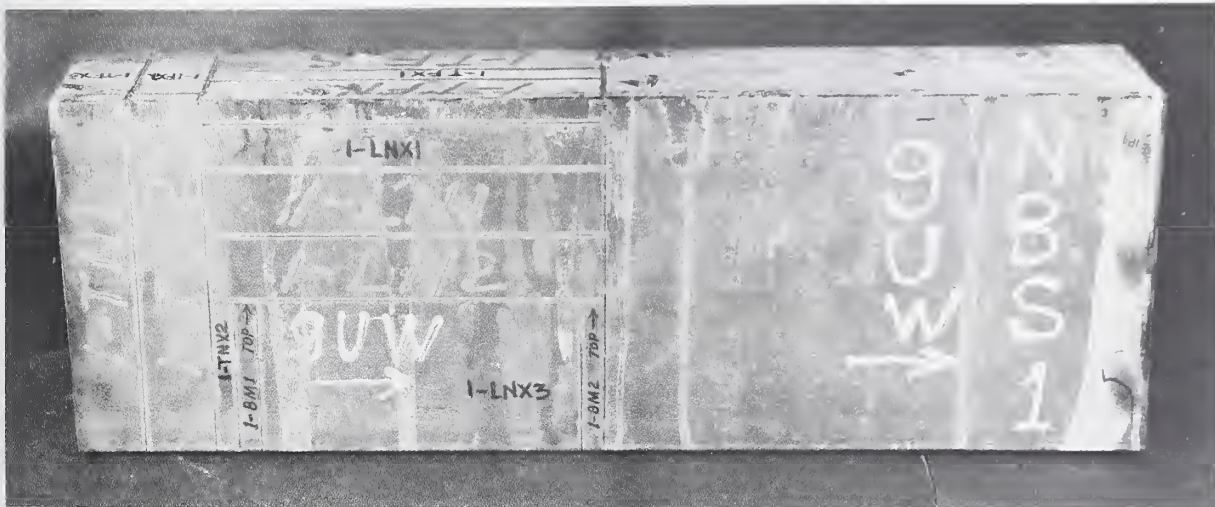
a. North face of box beam segment 9U (NBS 1).

Figure A7.3.2-1 Location of test specimens from box beam segment 9U obtained from the walkway debris.

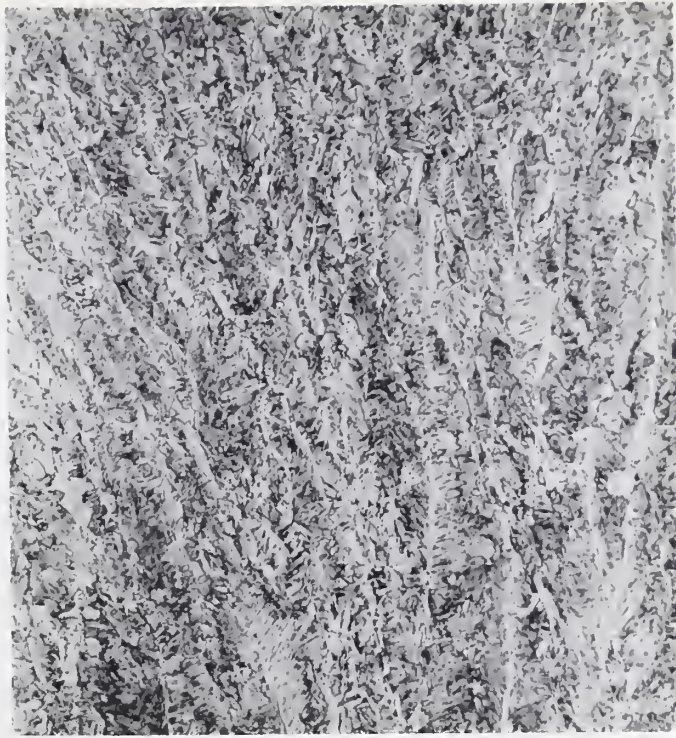
Figure A7.4.1-3 Microstructure representative of the weld metal in transverse section through NBS weldment IC. The microstructure appears to consist primarily of bainite. Etchant: two percent nital. X200

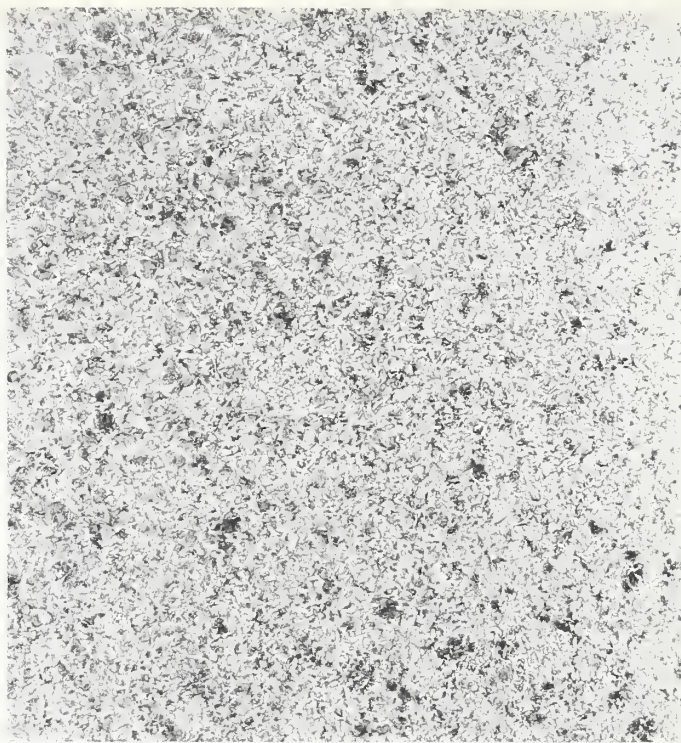
Figure A7.4.1-5 Representative microstructure of the heat affected zone in transverse section through NBS weldment IC. The microstructure consists of ferrite, primarily as a network in prior austenite grain boundaries, bainite, partially spheroidized carbides, and tempered martensite. Etchant: two percent nital. X200

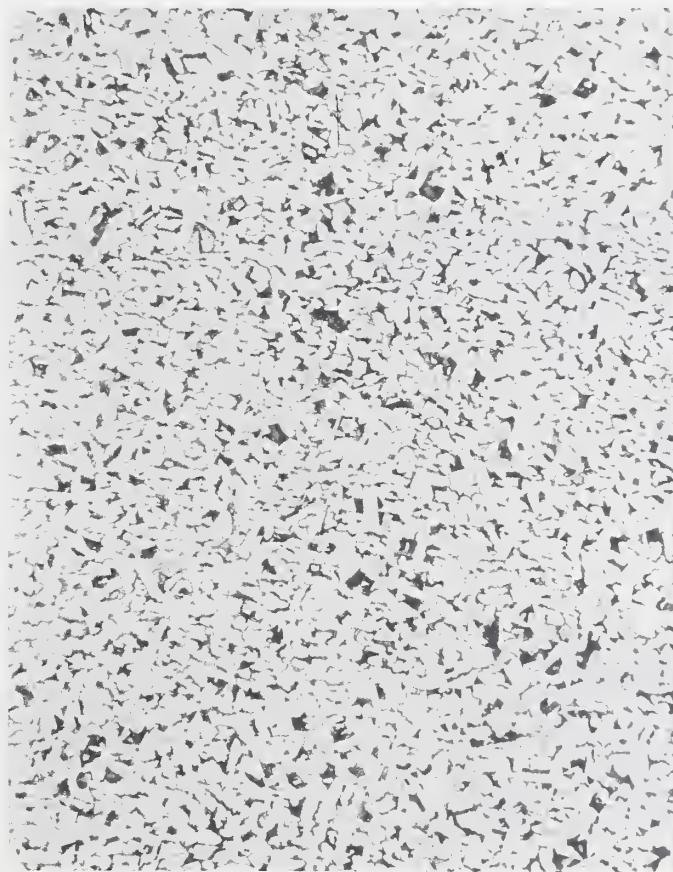
Figure A7.4.1-7 Microstructure representative of the base channel material from NBS weldment IC. The microstructure consists of relatively fine grained ferrite (light) and pearlite (dark) in a normalized condition. Etchant: two percent nital. X200

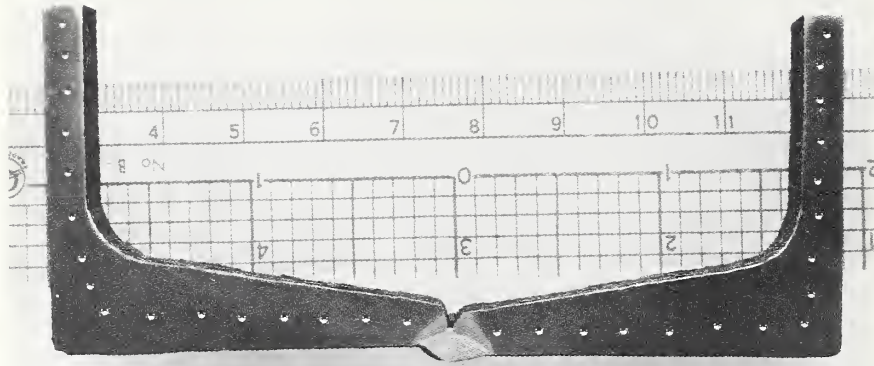
Figure A7.4.1-8 Transverse section 1BM1 through the bottom of walkway box beam 9U (NBS 1). The north channel of the box beam is to the left and the south channel is to the right. The weld connecting the flanges of the two channels used to fabricate the box beam is in the center. Parts of the web regions of each channel had been removed before this photograph was taken. The indentations appearing on the surface of the section are the result of hardness measurements. Etchant: two percent nital. ~X1

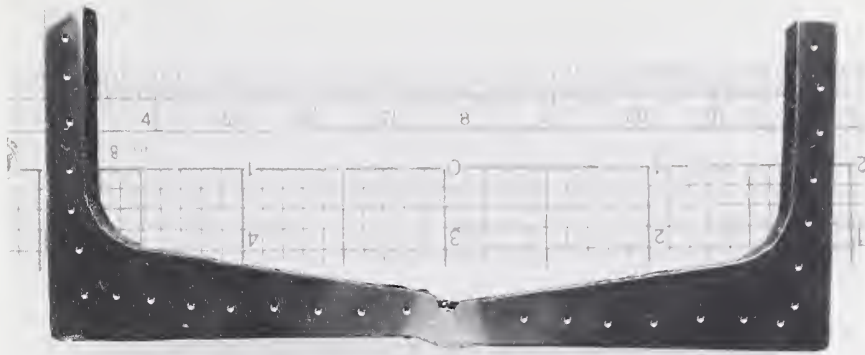
Figure A7.4.1-10 Transverse section 1BM2 through the bottom of walkway box beam 9U (NBS 1). The north channel of the box beam is to the left and the south channel is to the right. The weld connecting the flanges of the two channels used to fabricate the box beam is in the center. Parts of the web regions of each channel had been removed before this photograph was taken. The indentations appearing on the surface of the section are the result of hardness measurements. Etchant: two percent nital. ~X1

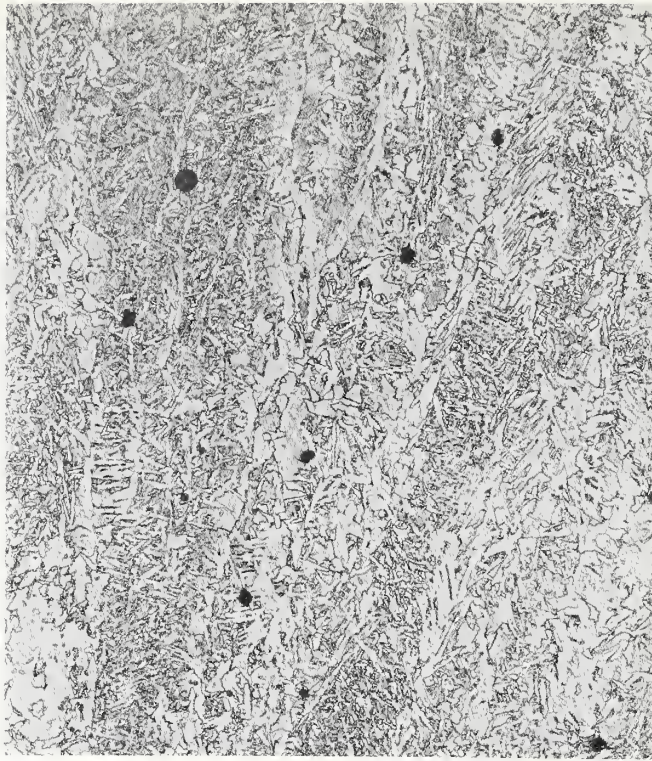
Figure A7.4.1-12 Representative microstructure of the weld metal in transverse section 1BM1 through box beam 9U (NBS 1). The microstructure consists primarily of bainite. Some inclusions are evident. Etchant: two percent nital. X200

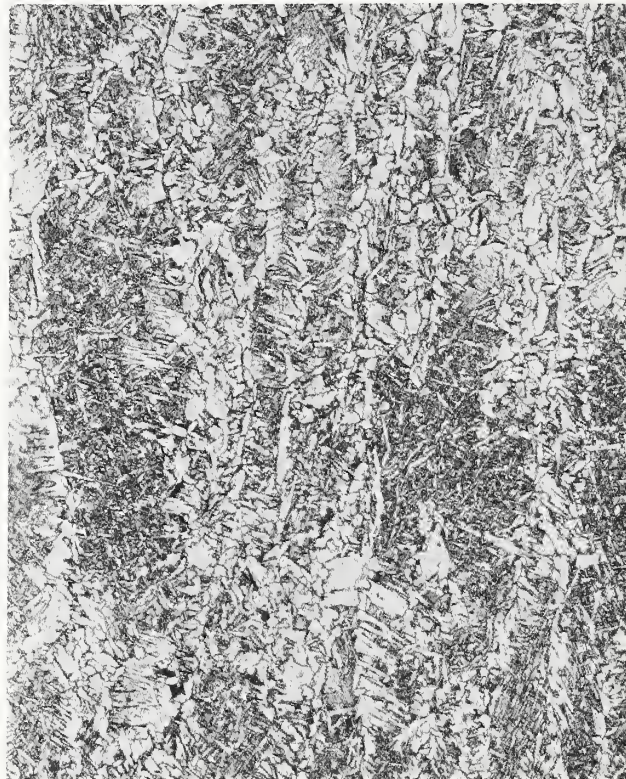
Figure A7.4.1-13 Representative microstructure of the weld metal in transverse section 1BM2 through box beam 9U (NBS 1). The microstructure consists primarily of bainite. Etchant: two percent nital. X200

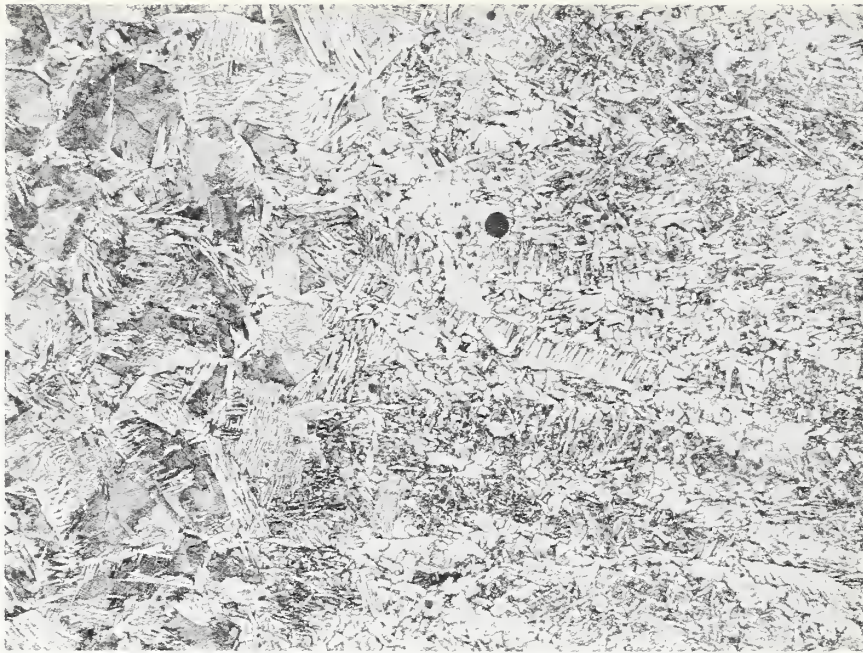
Hard patches were not observed in the transition region from weld to heat affected zone in section 1BM2. An area representative of this region in section 1BM2 is shown in figure A7.4.1-16.

Figure 7.4.1-16 Transition zone from weld metal (right) to heat affected zone (left) in section 1BM2. Some inclusions can be seen. Etchant: two percent nital. X200

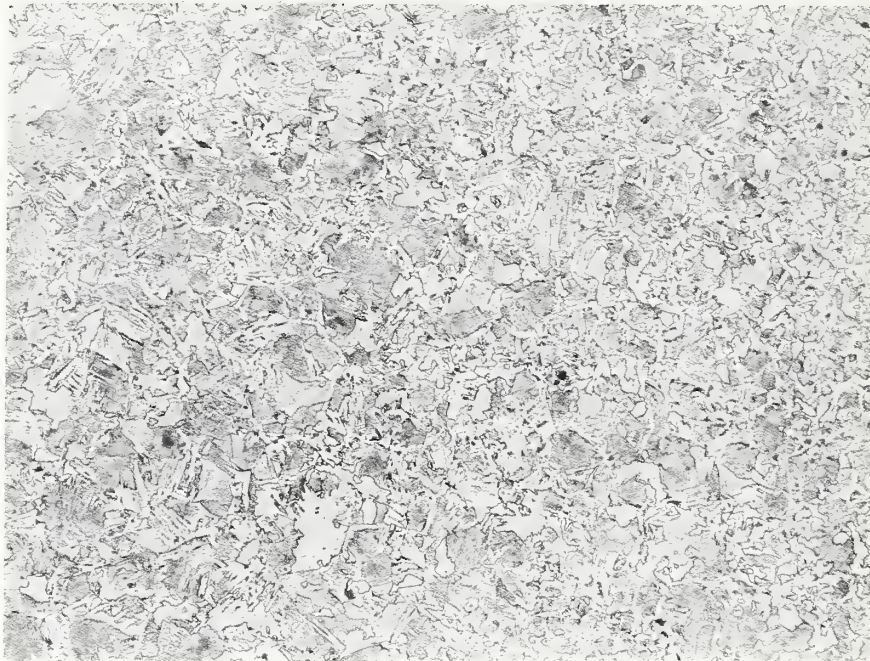
Figure A7.4.1-17 Region representative of the heat affected zone in section 1BM1. The microstructure appears to consist of ferrite, both as a network in prior austenite grains and as needles, bainite, partially spheroidized carbides, and tempered martensite. Etchant: two percent nital. X200

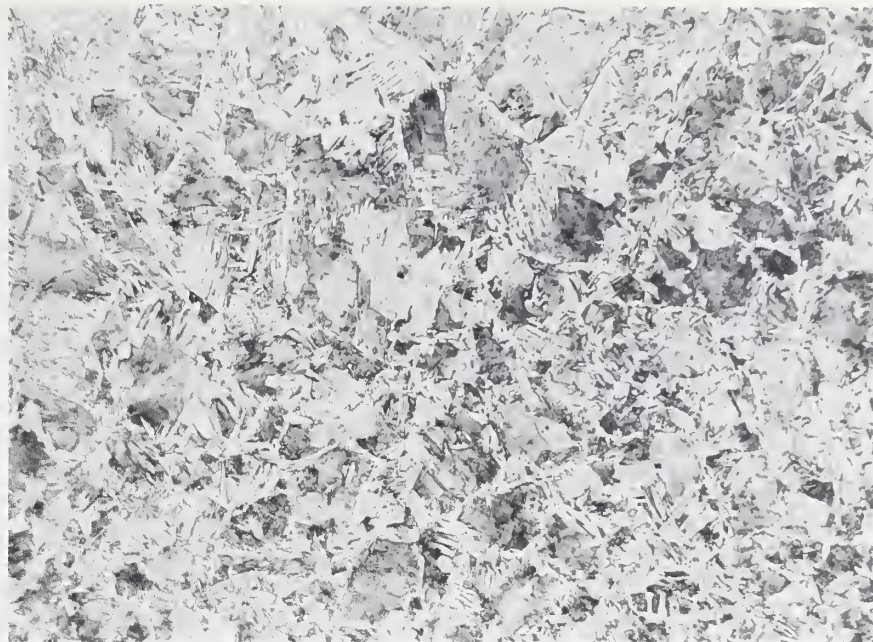
Figure 7.4.1-18 Region representative of the heat affected zone in section 1BM2. The microstructure appears to consist of ferrite, both as a network in prior austenite grains and as needles, bainite, partially spheroidized carbides, and tempered martensite. Etchant: two percent nital. X200

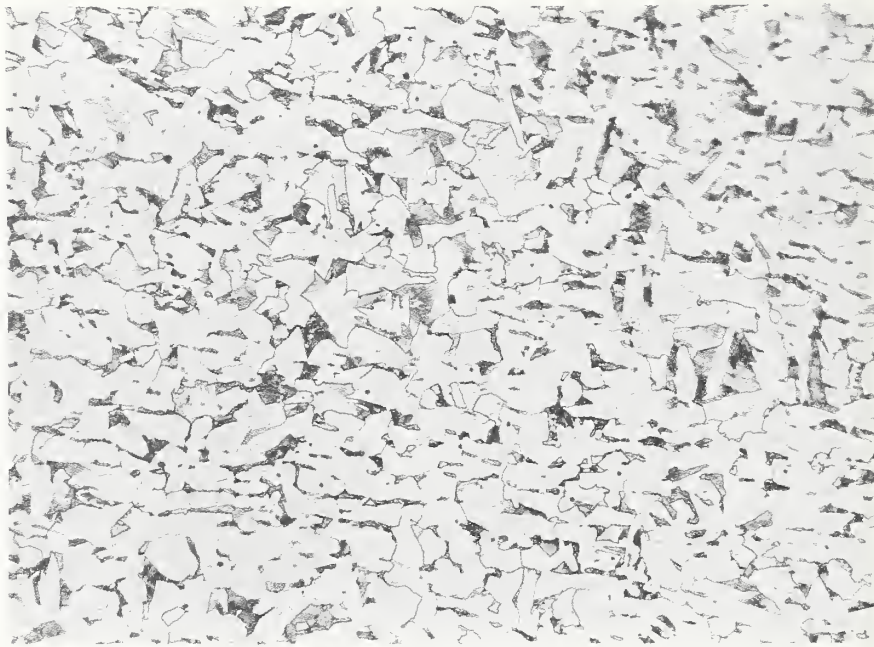
Figure A7.4.1-20 Region representative of base channel material in section 1BM1. The microstructure consists primarily of ferrite (light) and pearlite (dark) in the normalized condition. Etchant: two percent nital. X200

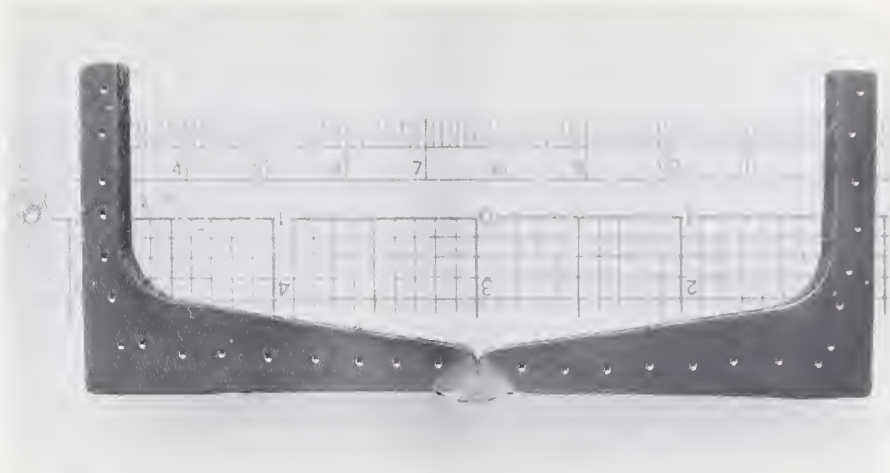
Figure A7.4.1-21 Transverse section 2BM1 through bottom of walkway box beam 8L (NBS 2). The north channel of the box beam is to the left and the south channel is to the right. The weld connecting the flanges of the two channels used to fabricate the box beam is in the center. Parts of the web regions of each channel had been removed before this photograph was taken. The indentations appearing on the surface of the section are the result of hardness measurements.
Etchant: two percent nital. ~X1

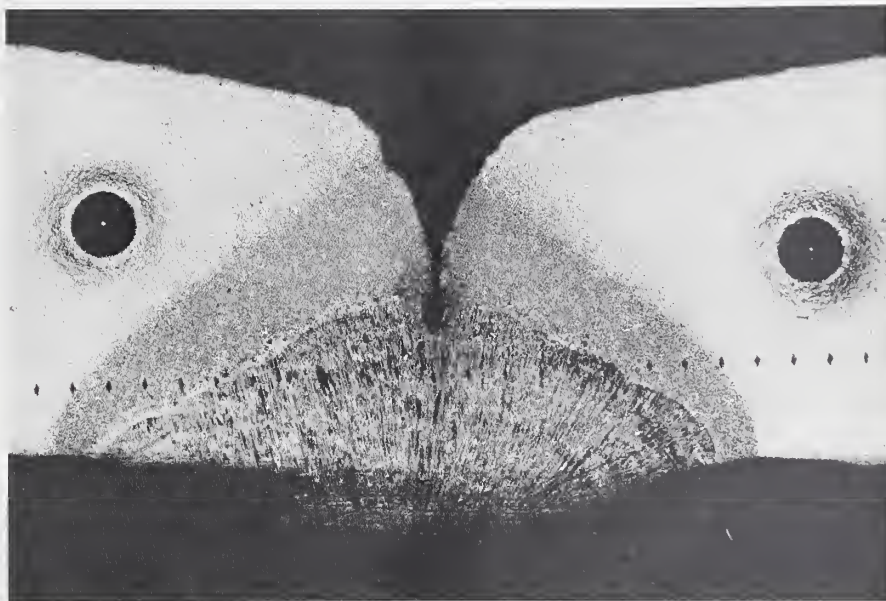
Figure A7.4.1-22 Part of the transverse section shown in figure A7.4.1-21, but at higher magnification. The region at the bottom center is weld metal. The dark gray regions on either side of the weld metal are the heat affected zones associated with the weld. The lighter regions on either side of the figure beyond the heat affected zones are base channel material.
Etchant: two percent nital. X8.5

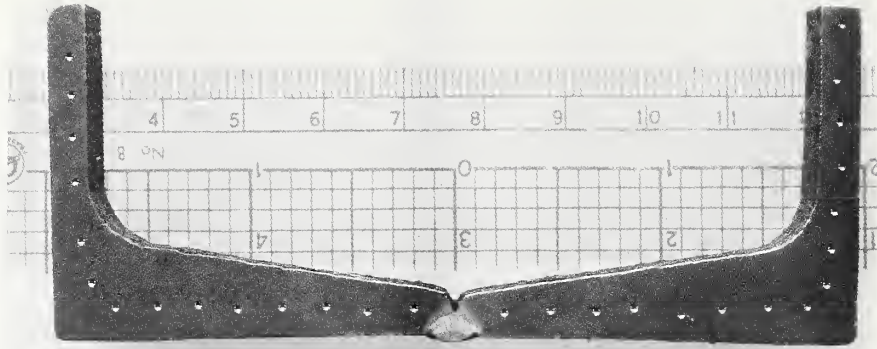
Figure A7.4.1-23 Transverse section 2BM2 through bottom of walkway box beam 8L (NBS 2). The north channel of the box beam is to the left and the south channel is to the right. The weld connecting the flanges of the two channels used to fabricate the box beam is in the center. Parts of the web regions of each channel had been removed before this photograph was taken. The indentations appearing on the surface of the section are the result of hardness measurements. Etchant: two percent nital. X1

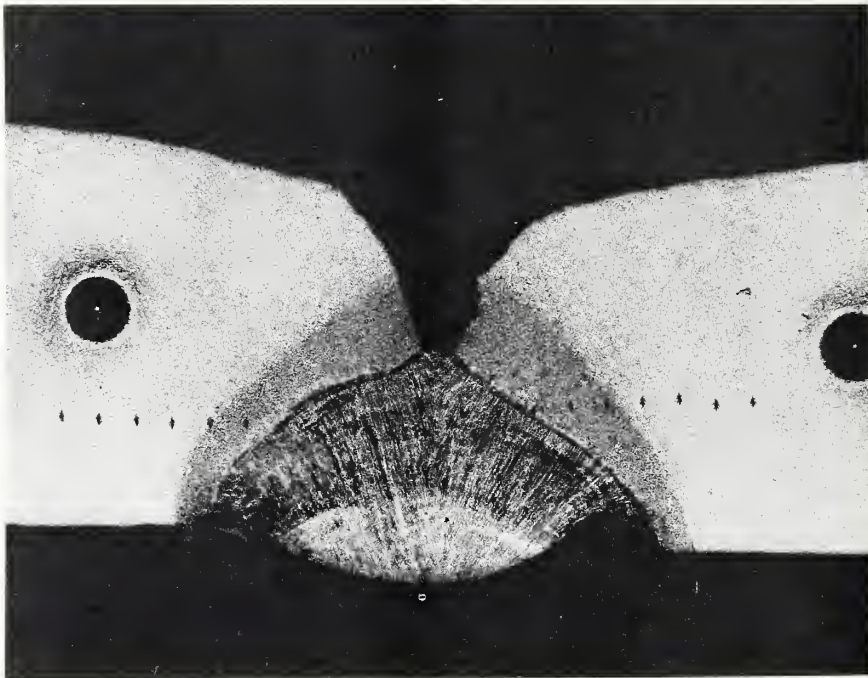
Figure A7.4.1-24 Part of the transverse section shown in figure A7.4.1-23, but at higher magnification. The region at the bottom center is weld metal. The gray regions on either side of the weld metal are the heat affected zones associated with the weld. The lighter regions on either side of the figure beyond the heat affected zones are base channel material. Etchant: two percent nital. X8.5

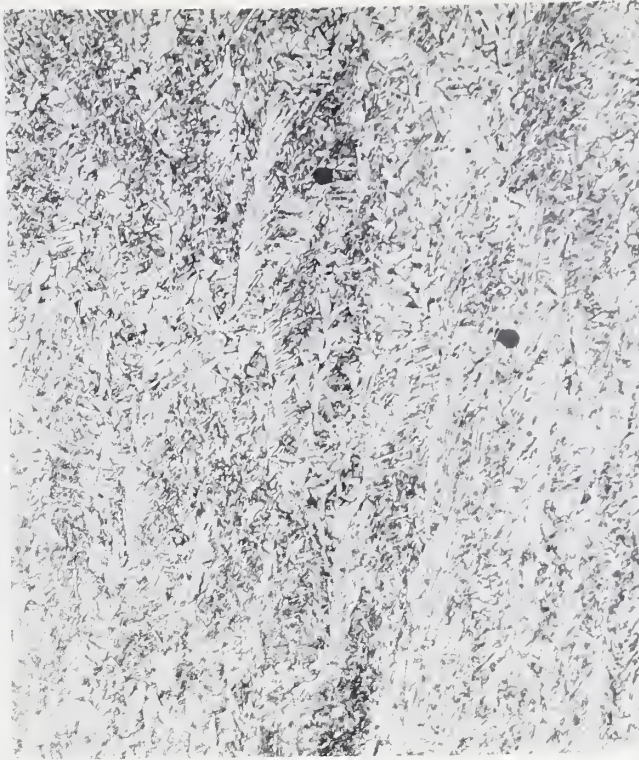
Figure A7.4.1-25 Representative microstructure of the weld metal in transverse section 2BM1 through box beam 8L (NBS 2). The microstructure appears to consist primarily of bainite. Some inclusions are evident. Etchant: two percent nital. X200

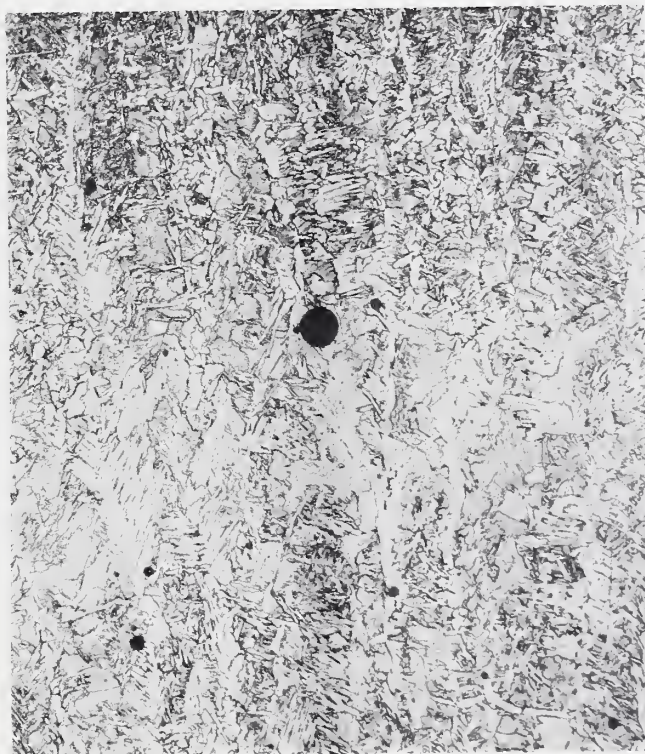
Figure A7.4.1-26 Representative microstructure of the weld metal in transverse section 2BM2 through box beam 8L (NBS 2). The microstructure appears to consist primarily of bainite. Some inclusions are evident. Etchant: two percent nital. X200

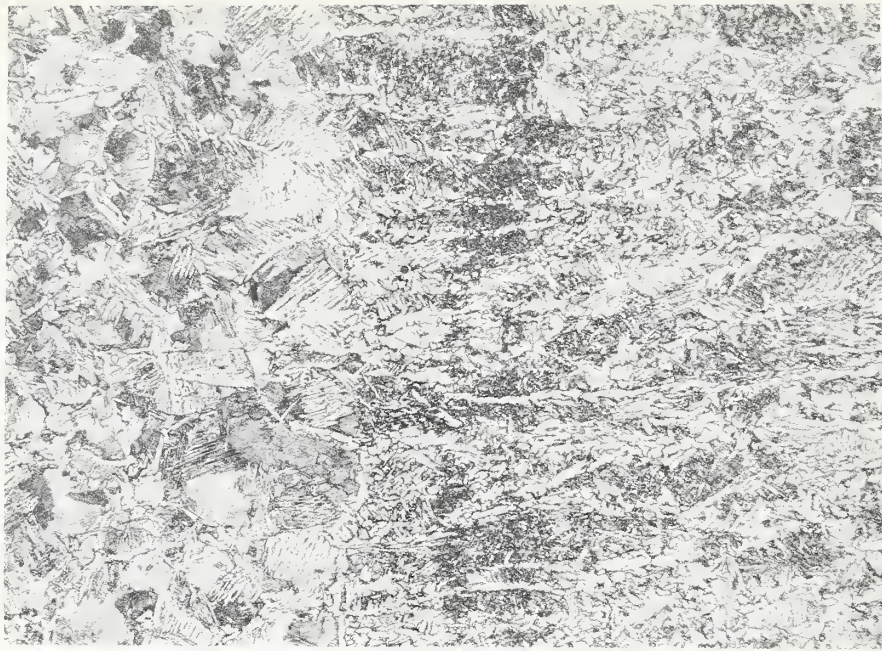
Figure A7.4.1-27 Transition zone from weld metal (right) to heat affected zone (left) in section 2BM1. Etchant: two percent nital. X200

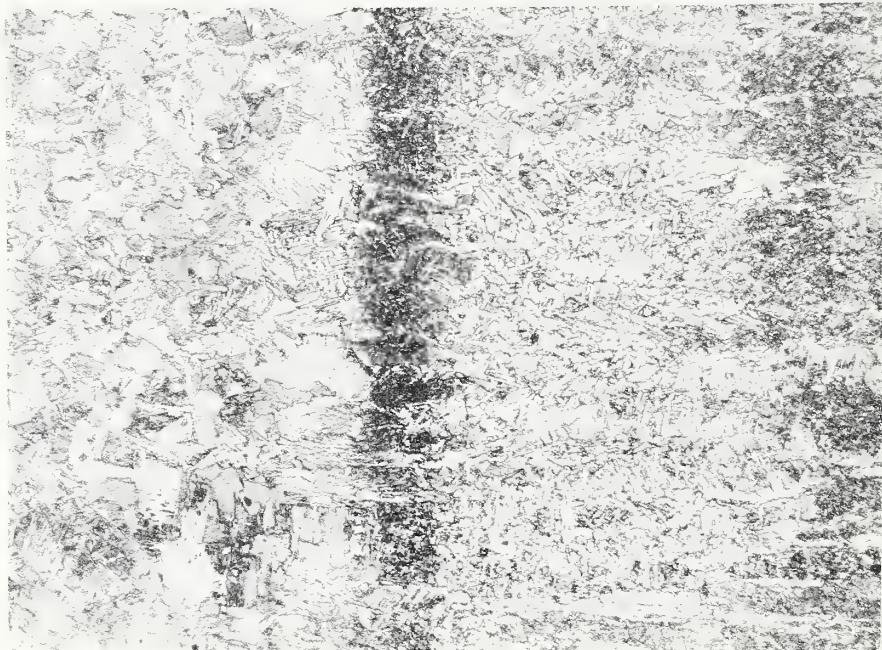
Figure A7.4.1-28 Transition zone from weld metal (right) to heat affected zone (left) in section 2BM2. Etchant: two percent nital. X200

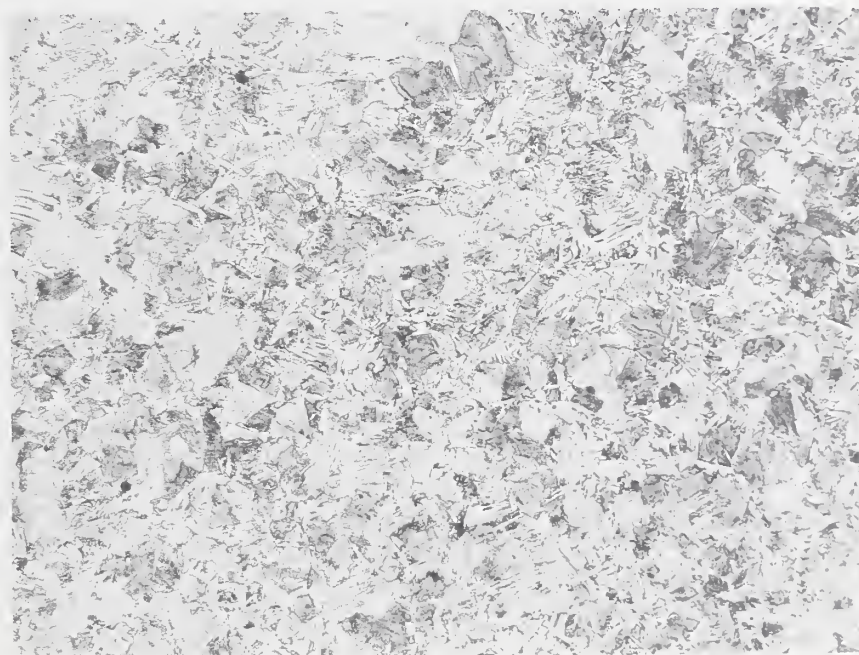
Figure A7.4.1-30 Representative microstructure of the heat affected zone in section 2BM1. The microstructure appears to consist of ferrite, both as a network in prior austenite grain boundaries and as needles, bainite, partially spheroidized carbides, and tempered martensite. Etchant: two percent nital. X200

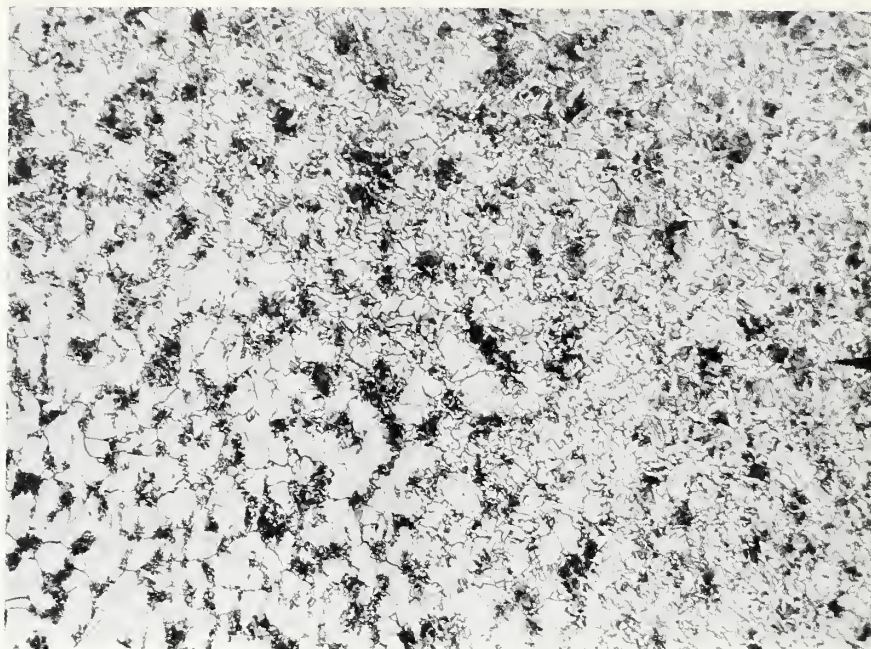
Figure A7.4.1-31 Transition region from heat affected zone (right) to base channel material (left) in section 2BM1. Etchant: two percent nital. X200
