NBS BUILDING SCIENCE SERIES 143

Investigation of the Kansas City Hyatt Regency Walkways Collapse

DEPARTMENT OF COMMERCE • NATIONAL BUREAU OF STANDARDS

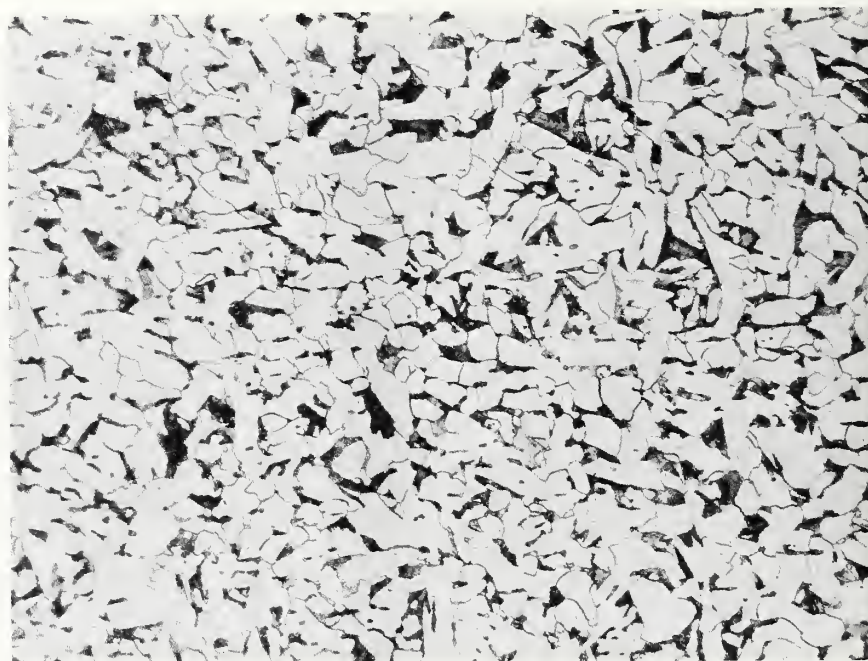
Figure A7.4.1-32 Region of section 2BM1 representative of the base channel material in both sections through box beam 8L. The microstructure consists primarily of ferrite (light) and pearlite (dark) in the normalized condition. Etchant: two percent nital. X200

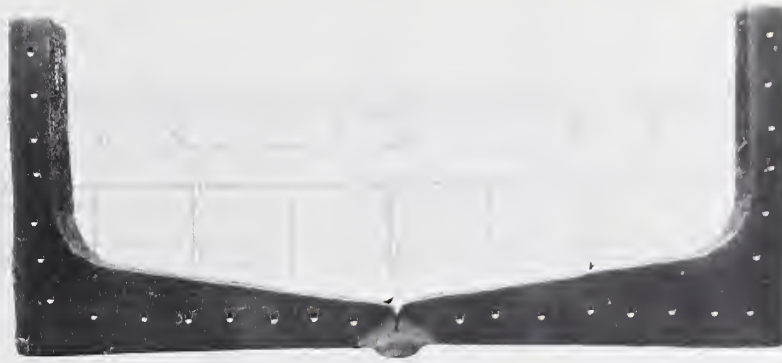
Figure A7.4.1-33 Transverse section 3BM1 through the bottom of walkway box beam 9M (NBS 3). The south channel of the box beam is to the left and the north channel is to the right. The weld connecting the flanges of the two channels used to fabricate the box beam is in the center. Parts of the web regions of each channel had been removed before this photograph was taken. The indentations appearing on the surface of the section are the result of hardness measurements. Etchant: two percent nital. ~X1

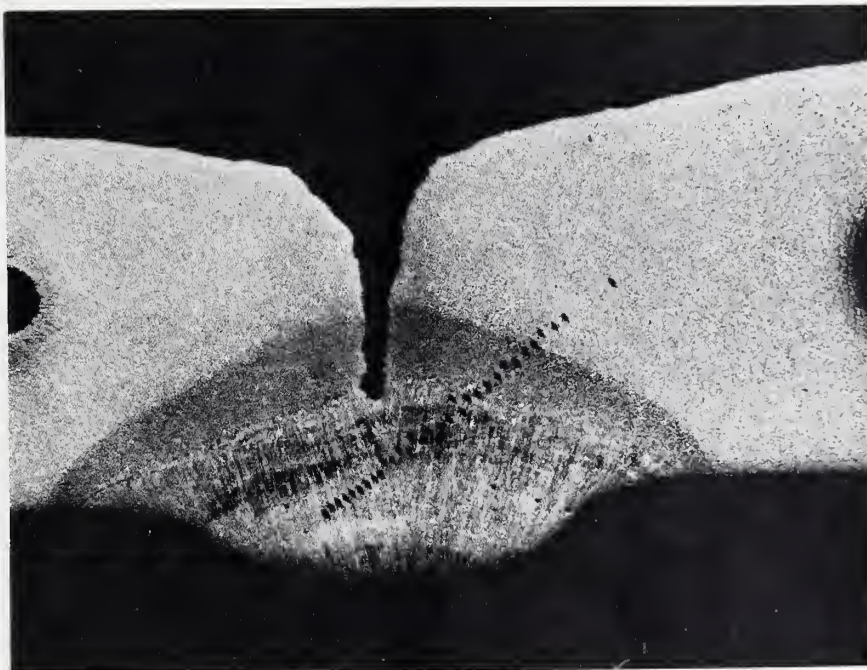
Figure A7.4.1-34 Part of the transverse section shown in figure A7.4.1-33, but at higher magnification. The region at the bottom center is weld metal. The gray regions on either side of the weld metal are the heat affected zones associated with the weld. The lighter regions at either side of the figure beyond the heat affected zone are base channel material. Etchant: two percent nital. X8.5

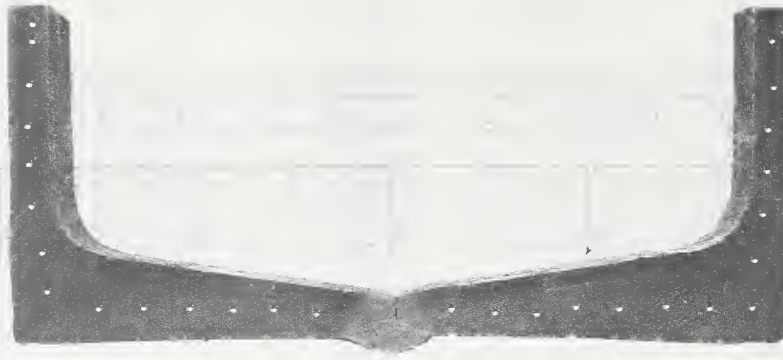
Figure A7.4.1-35 Transverse section 3BM2 through the bottom of walkway box beam 9M (NBS 3). The south channel of the box beam is to the left and the north channel is to the right. The weld connecting the flanges of the two channels used to fabricate the box beam is in the center. Parts of the web regions of each channel had been removed before this photograph was taken. The indentations appearing on the surface of the section are the result of hardness measurements. Etchant: two percent nital. ~X1

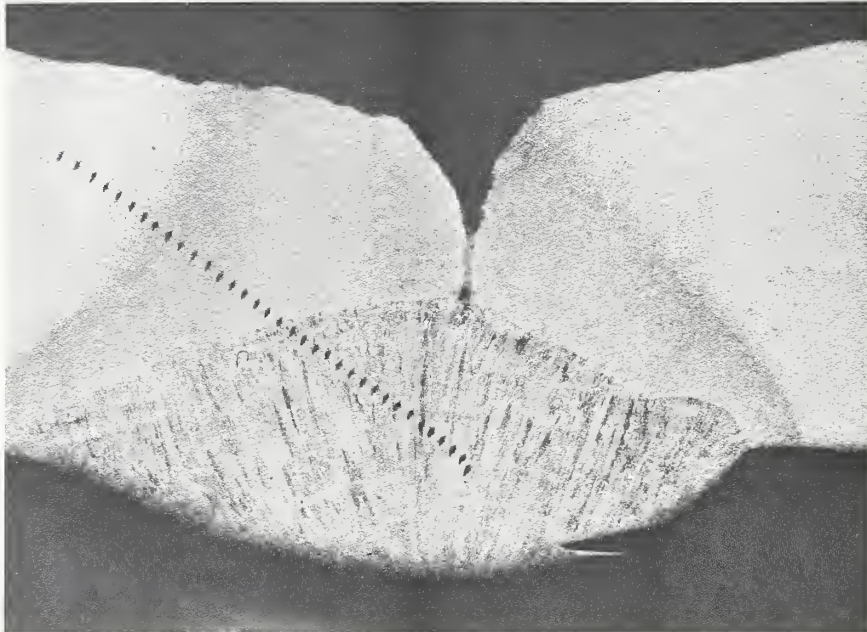
Figure A7.4.1-36 Part of the transverse section shown in figure A7.4.1-35, but at higher magnification. The region at the bottom center is weld metal. The gray regions on either side of the weld metal are the heat affected zones associated with the weld. The lighter regions at either side of the figure beyond the heat affected zones are base channel material. Etchant: two percent nital. X8.5

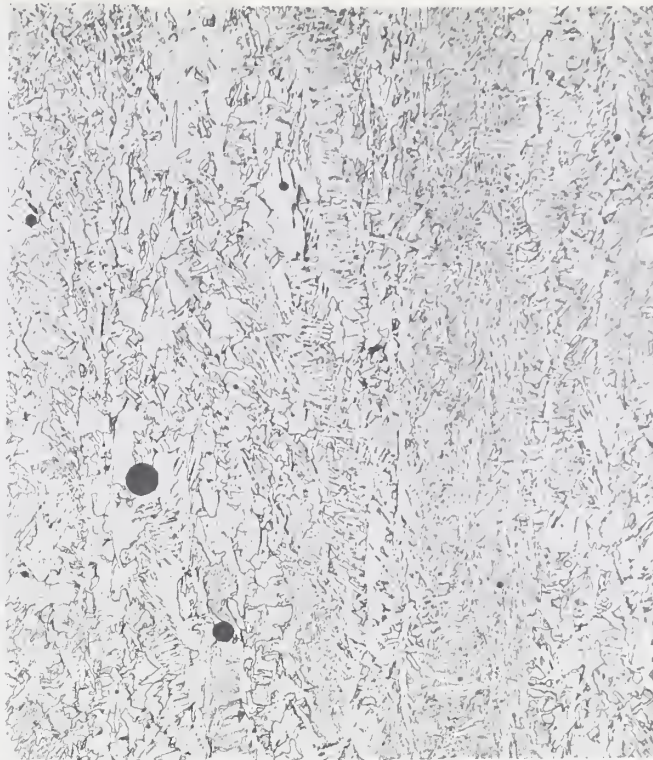
Representative regions of the weld from sections 3BM1 and 3BM2 are shown in figures A7.4.1-37 and A7.4.1-38, respectively. In both cases, the microstructure appears to consist primarily of bainite. More inclusions are evident in section 3BM1 than in section 3BM2. The average hardness of the weld was essentially the same for both sections, being somewhat lower than that of the welds at the sections from the other two walkway box beams.

Figure A7.4.1-37 Representative microstructure of the weld metal in transverse section 3BM1 through box beam 9M (NBS 3). The microstructure consists primarily of bainite. Several inclusions are evident. Etchant: two percent nital. X200

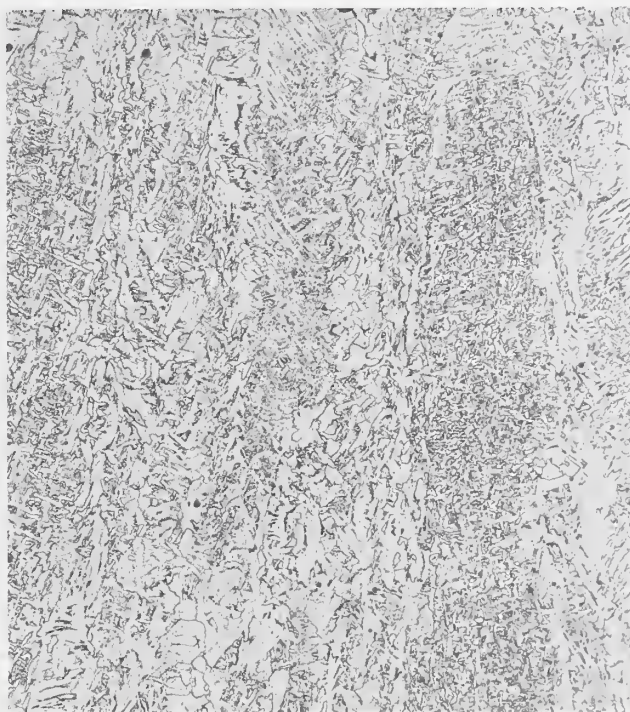
Figure A7.4.1-38 Representative microstructure of the weld metal in transverse section 3BM2 through box beam 9M (NBS 3). The microstructure consists primarily of bainite. Etchant: two percent nital. X200

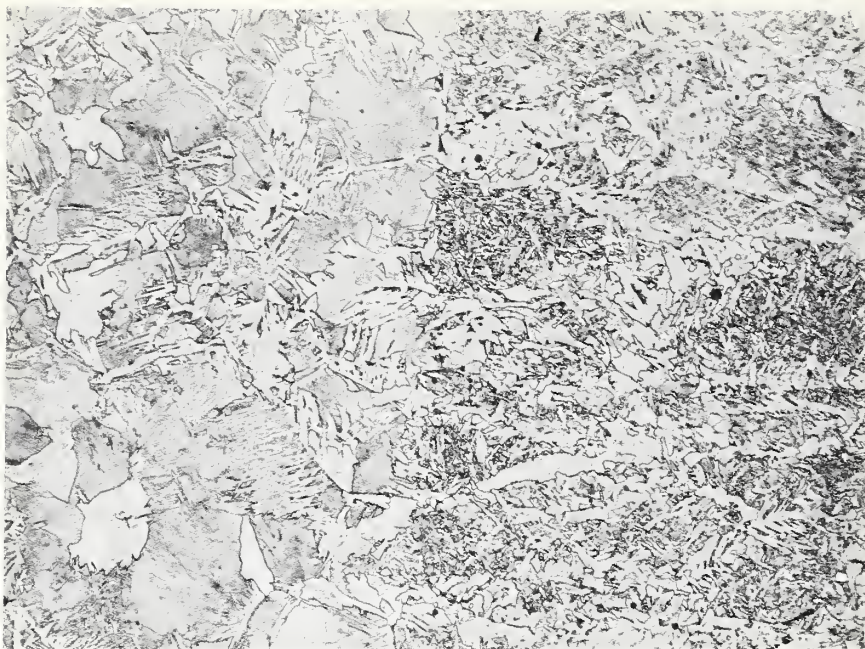
Nothing unusual was observed at the transition from the weld to the heat affected zones in either section. None of the harder regions found in the transition regions of sections 1BM1 and 2BM2 were in evidence. A region representative of these transition regions in section 3BM2 is shown in figure A7.4.1-39.

Figure A7.4.1-39 Transition zone from weld metal (right) to heat affected zone (left) in section 3BM2. Some inclusions can be seen primarily in the weld metal. Etchant: two percent nital. X200

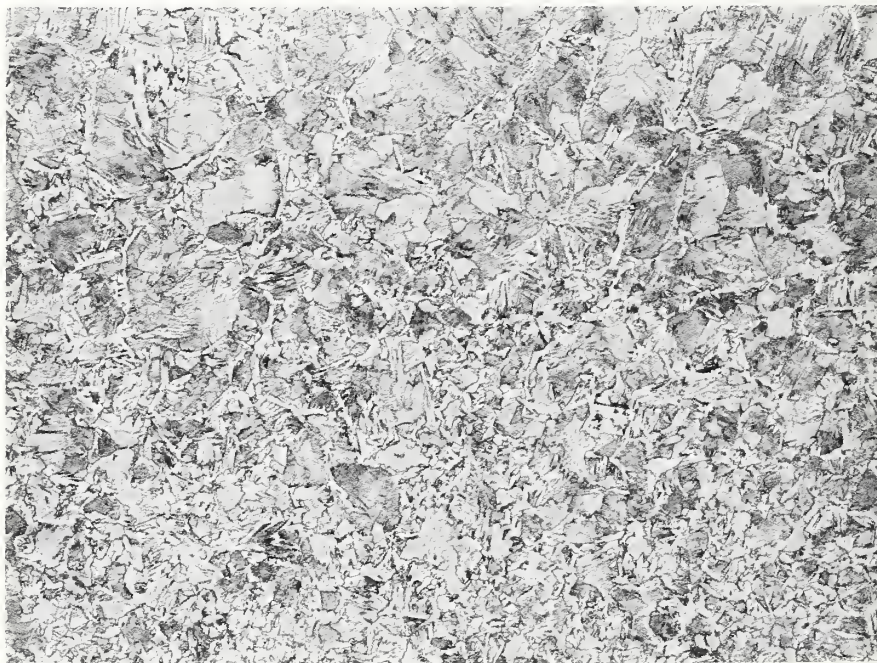
The microstructure and hardness of the heat affected zones in both section 3BM1 and 3BM2 were similar. In both cases, the microstructure consists of ferrite both as a network in prior austenite grain boundaries and as needles, bainite, partially spheroidized carbides and some tempered martensite. Hardness in the heat affected zones was similar to that of the weld. A region representative of the heat affected zone in section 3BM1 is shown in figure A7.4.1-40.

Figure A7.4.1-40 Region representative of the heat affected zone in section 3BM1. The microstructure appears to consist of ferrite both as a network in prior austenite grain boundaries and as needles, bainite, partially spheroidized carbides, and tempered martensite. Etchant: two percent nital. X200

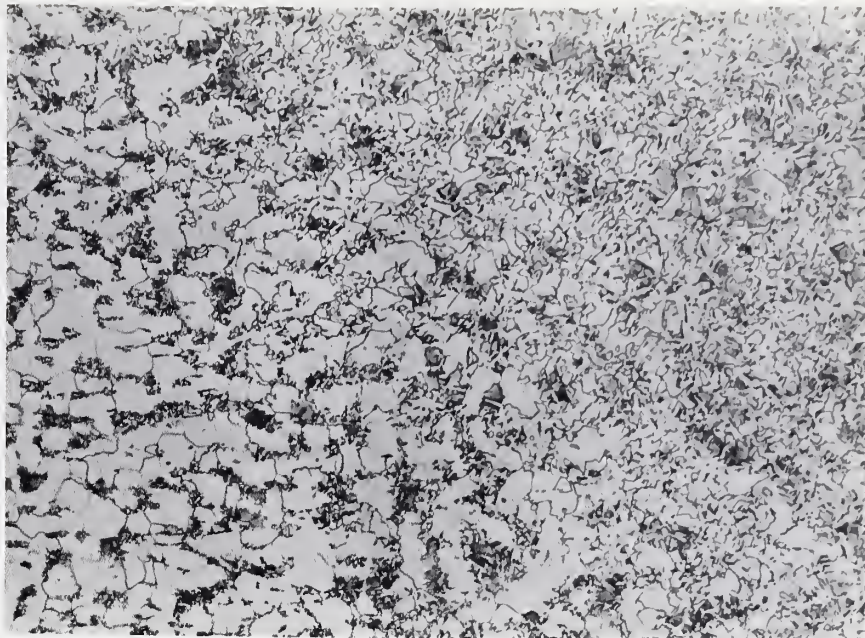
Figure A7.4.1-41 Transition zone from heat affected zone (right) to base channel material (left) in section 3BM2.
Etchant: two percent nital. X200

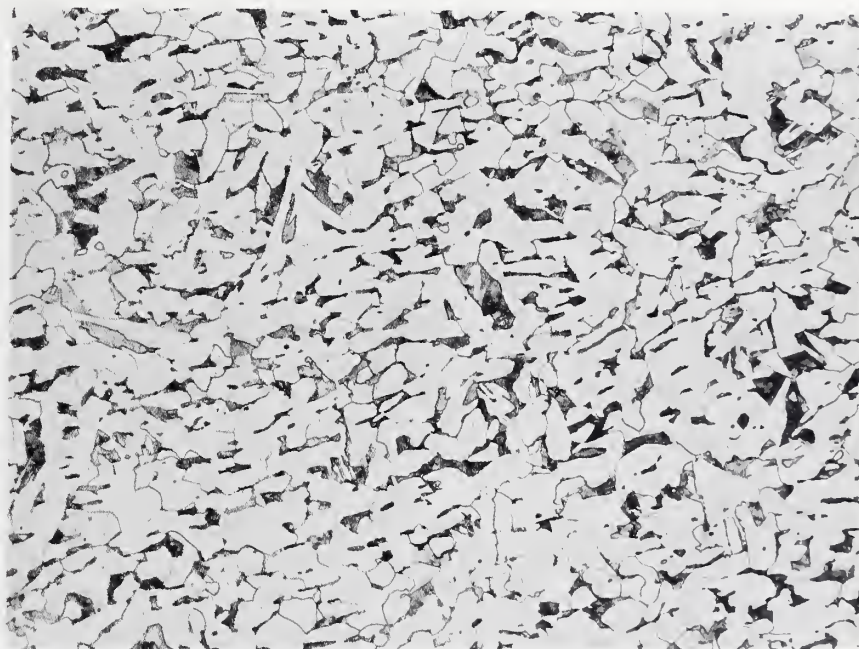
The base material of both channel pieces of the box beam appeared similar in microstructure in both sections 3BM1 and 3BM2. In both cases, the microstructure consists of ferrite and pearlite in a normalized condition. A region representative of the channel material is shown in figure A7.4.1-42. Hardness of both channels was also similar.

Figure A7.4.1-42 Representative region of base channel material in section 3BM1. The microstructure consists of ferrite (light) and pearlite (dark) in the normalized condition.
Etchant: two percent nital. X200

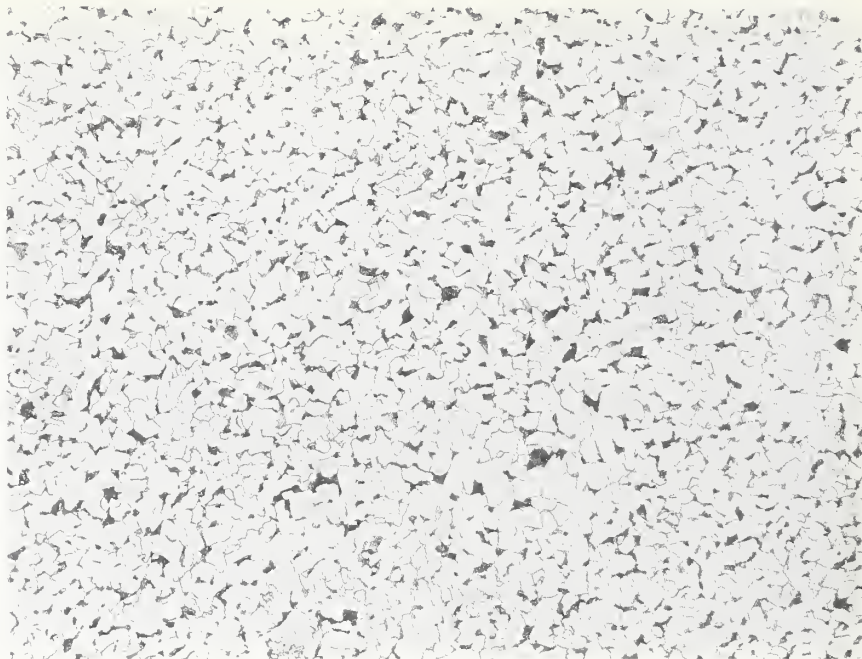
Transverse and longitudinal sections from each of the walkway hanger rod segments obtained from the debris (NBS 5A and 5B) were examined metallographically. The locations of these sections in the hanger rods are shown in figure A7.3.3-1. A representative region showing the etched microstructure of the transverse section from hanger rod NBS 5A is shown in figure A7.4.2-1. The

microstructure consists of ferrite (light) and pearlite (dark) in a reasonably fine grained (ASTM grain size 9) normalized structure.

Figure A7.4.2-1 Transverse section through hanger rod NBS 5A showing the representative microstructure. The microstructure consists of relatively fine grained ferrite (light) and pearlite (dark) in a normalized condition. Etchant: two percent nital. X100

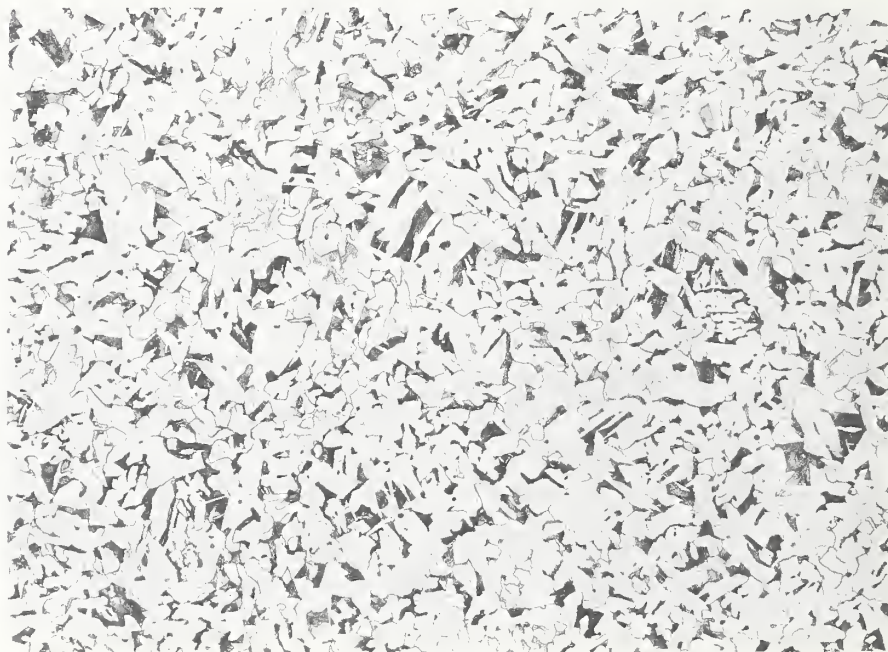
The representative microstructure of the transverse section from hanger rod NBS 5B is shown in figure A7.4.2-2. The microstructure again consists of ferrite (light) and pearlite (dark) in the normalized condition. This microstructure is coarser (ASTM grain size 7-1/2 to 8) than that of hanger rod NBS 5A, and there appears to be more pearlite present than in hanger rod NBS 5A.

Figure A7.4.2-2 Transverse section through hanger rod NBS 5B showing the representative microstructure. The microstructure consists of ferrite (light) and pearlite (dark) in a normalized condition. Etchant: two percent nital. X100

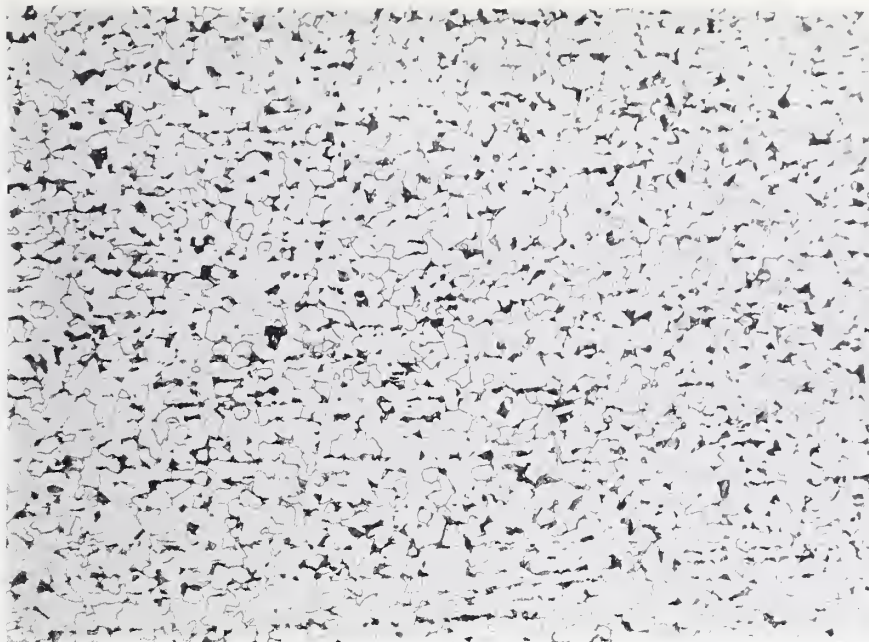
Longitudinal sections through each hanger rod segment revealed the material of both to be fully normalized with equiaxed grains. Regions representative of the longitudinal microstructures are shown in figure A7.4.2-3 for rod segment NBS 5A and in figure A7.4.2-4 for rod segment NBS 5B.

Figure A7.4.2-3 Longitudinal section through hanger rod NBS 5A showing the normalized microstructure consisting of ferrite and pearlite. Etchant: two percent nital. X100

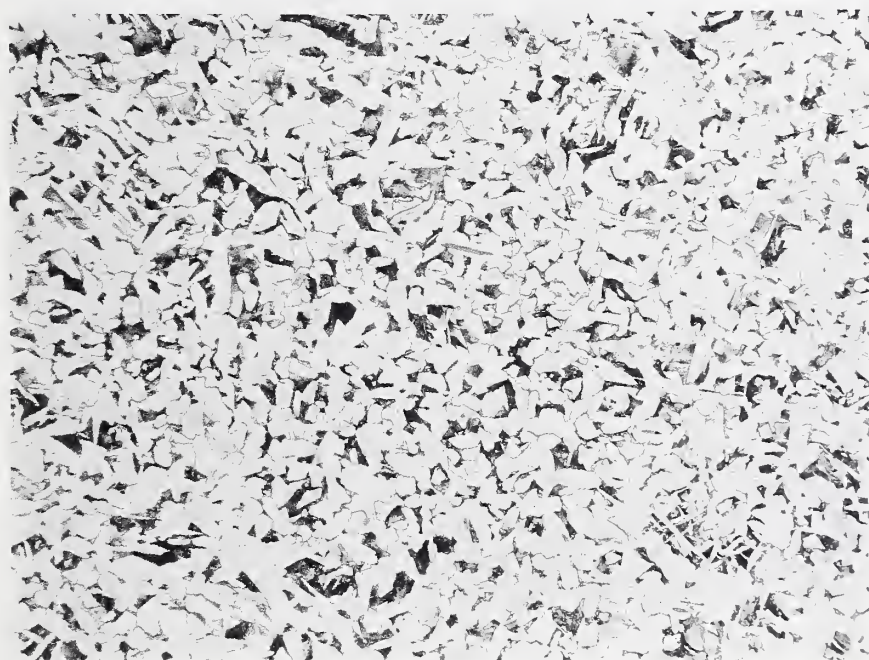
Figure A7.4.2-4 Longitudinal section through hanger rod NBS 5B showing the normalized microstructure consisting of ferrite and pearlite. Etchant: two percent nital. X100

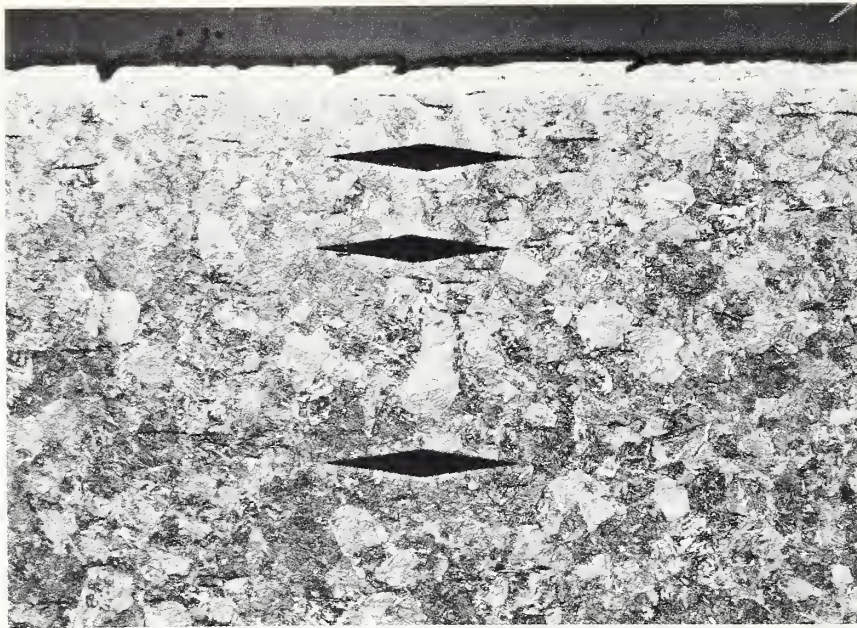
Knoop microhardness measurements at a load of 500 grams force (HK₅₀₀) were made on a cross section through a washer from the walkway debris at location 9MW after it had been used in an NBS full length test on box beam 9M. During the test, the washer fractured into five pieces. A microhardness traverse was made through the thickness of the washer on the section examined. The washer thickness was approximately 0.075 in (1.80 mm). Average hardness from 16 measurements across the section was 459 HK₅₀₀ which is approximately equivalent to 44.3 HRC and the hardness range was 422 to 514 HK₅₀₀ (41.5 to 48.5 HRC). The highest values were near the center of the section and the lowest values were near the surface of the washer. The microstructure of the washer from location 9MW is shown in figure A7.4.3-1. There is a very small apparent decarburized

layer at the surface (light area at the top in the figure). Tempered martensite is the primary constituent of the microstructure.

Figure A7.4.3-1 Microstructure of washer from location 9MW in the walkway debris. The thin, light layer at the surface (horizontal near the top in the figure) is the decarburized layer at the washer surface. The microstructure consists primarily of tempered martensite. Etchant: Picral. X200

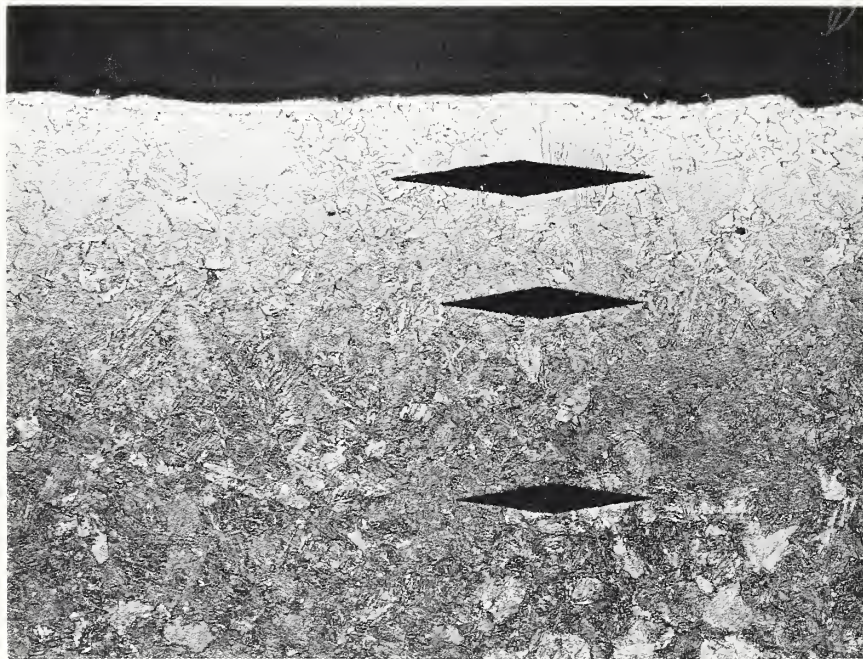
A similar microhardness traverse on a section through one of the NBS hard washers was made. Hardness values in this section, excluding the decarburized layer at the surface, averaged 431 HK₅₀₀ (42.5 HRC) and ranged from 401 to 422 HK₅₀₀ (40 to 43.5 HRC). Measured hardness in the decarburized layer was as low as 247 HK₅₀₀ (99 HRB). The microstructure of the NBS hard washer is shown in figure A7.4.3-2. The decarburized layer at the surface appears light in the figure. Tempered martensite is the primary constituent in the microstructure.

Figure A7.4.3-2 Microstructure of NBS hard washer. The light layer at the surface (horizontal near the top in the figure) is decarburized. The microstructure consists primarily of tempered martensite. Etchant: Picral. X200
