NBS BUILDING SCIENCE SERIES 145

# Investigation of Construction Failure of Harbour Cay Condominium in Cocoa Beach, Florida

H. S. Lew  
N. J. Carino  
S. G. Fattal  
M. E. Batts

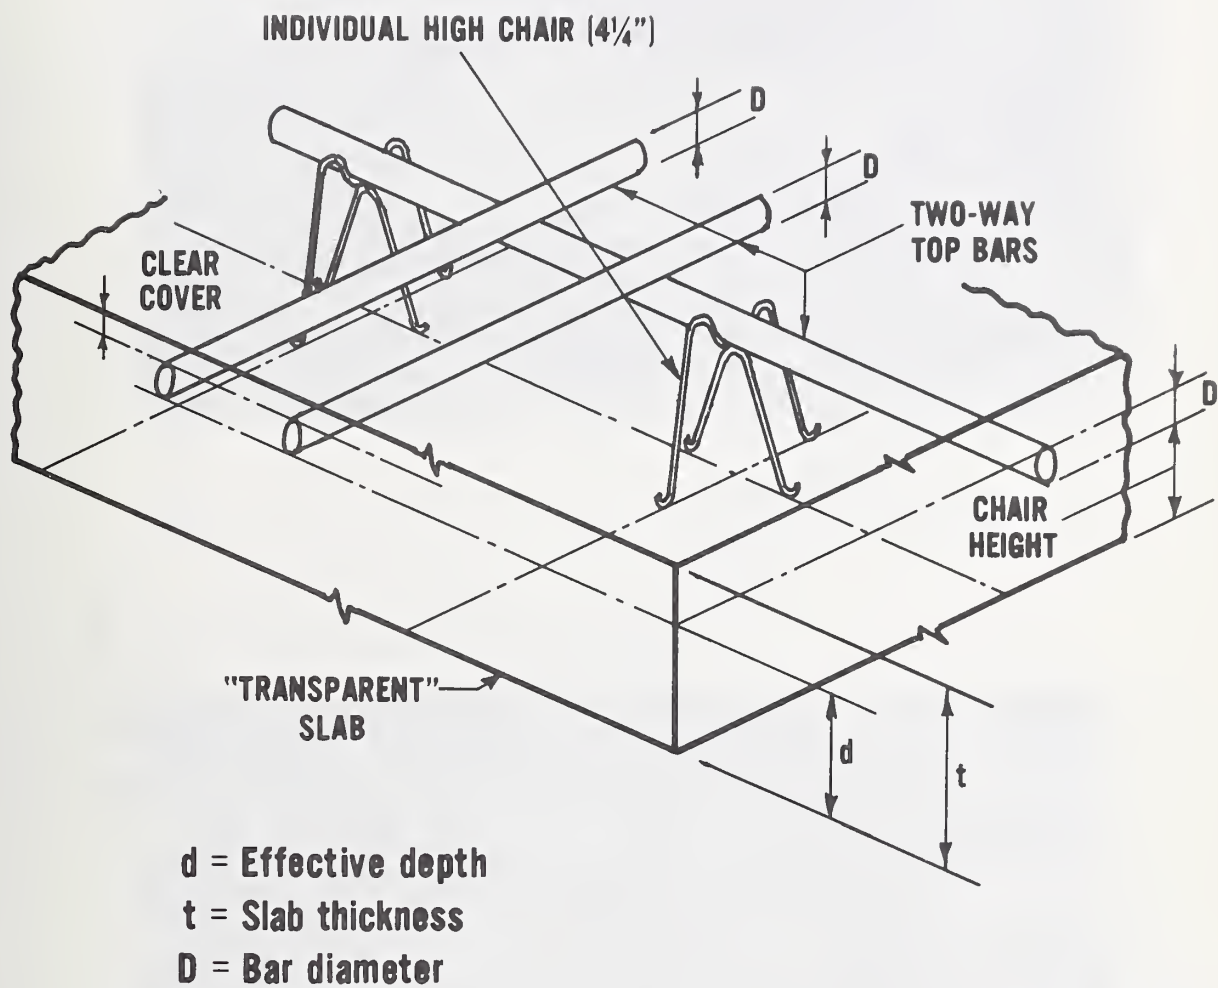
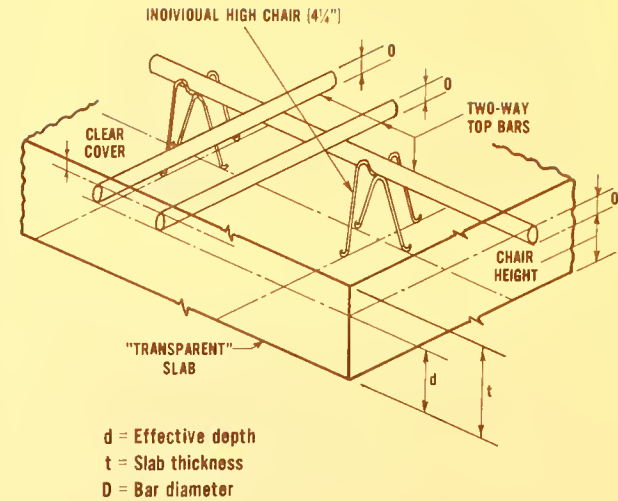
Figure 2.3 Configuration of chairs and top reinforcement in column strip

From the same sources, the quantities and sizes of individual high chairs (IHC) supplied for the top steel in a floor slab were identified as follows: 500 - 5-3/4" IHC, 470 - 4-1/4" IHC, 70 - 5" IHC, 50 - 4" IHC and 70 - 3-1/4" IHC. In addition, #5 support bars were supplied for use with the high chairs in the middle strip to support the one-way top reinforcement in these strips (fig. 2.1). The specified spacing of high chairs was 4 ft (1.2 m) on center. With the aid of the framing plan for top bars in the slab (fig. 2.1), and quantities of chairs of various specified sizes supplied, it was determined that the 5-3/4-in (146-mm) high chairs were used for the one-way top reinforcement in the middle strips and the 4-1/4-in (108-mm) high chairs were used for the two-way top reinforcement in the column strips. Figure 2.3 shows the top reinforcement layout in a column strip assuming bars in both directions have the same diameter D. The relationship between chair height, bar diameter, effective depth, cover, and slab thickness are illustrated in the same figure. Chairs having specified sizes other than these two were supplied in much smaller quantities for use with the top reinforcement of the thinner slabs in the balcony and walkway, and those in the elevator tower and stairwells.

The importance placed on actual chair heights and their location is due to the fact that the effective depth of the slab is a critical parameter governing its punching shear and bending capacity. Figure 2.6 defines the critical shear area used in calculations of punching shear stresses in the slab at the periphery of a column. The punching shear area depends on the sectional dimensions  $c_1$  and  $c_2$  of the column and the effective depth,  $d$ , which appears in all three dimensions defining this area.

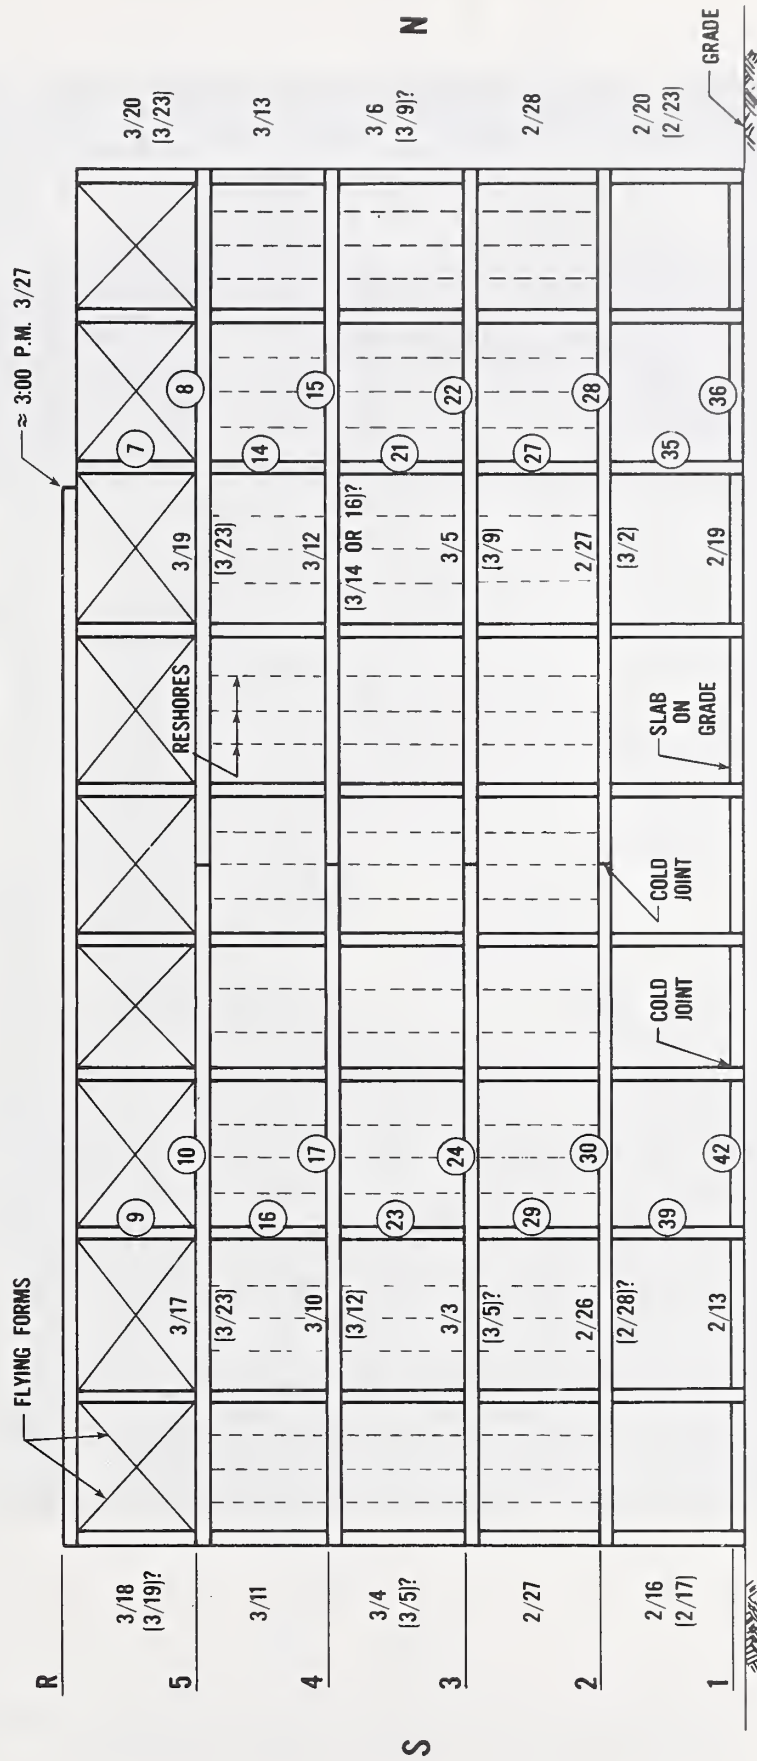
Figure 2.11 Assumed state of construction at time of the collapse

Figure 2.11 shows the various casting and stripping dates and the ages of the columns and floor slabs relative to the time of the collapse. In the case of incomplete information or conflicting witness statements regarding the date of a particular event, a question mark appears next to the specified date in the figure. Note that, unlike the lower story slabs, the roof slab was scheduled to be cast in one day. At the time of the collapse, all but the two north bays of the roof slab had been cast.

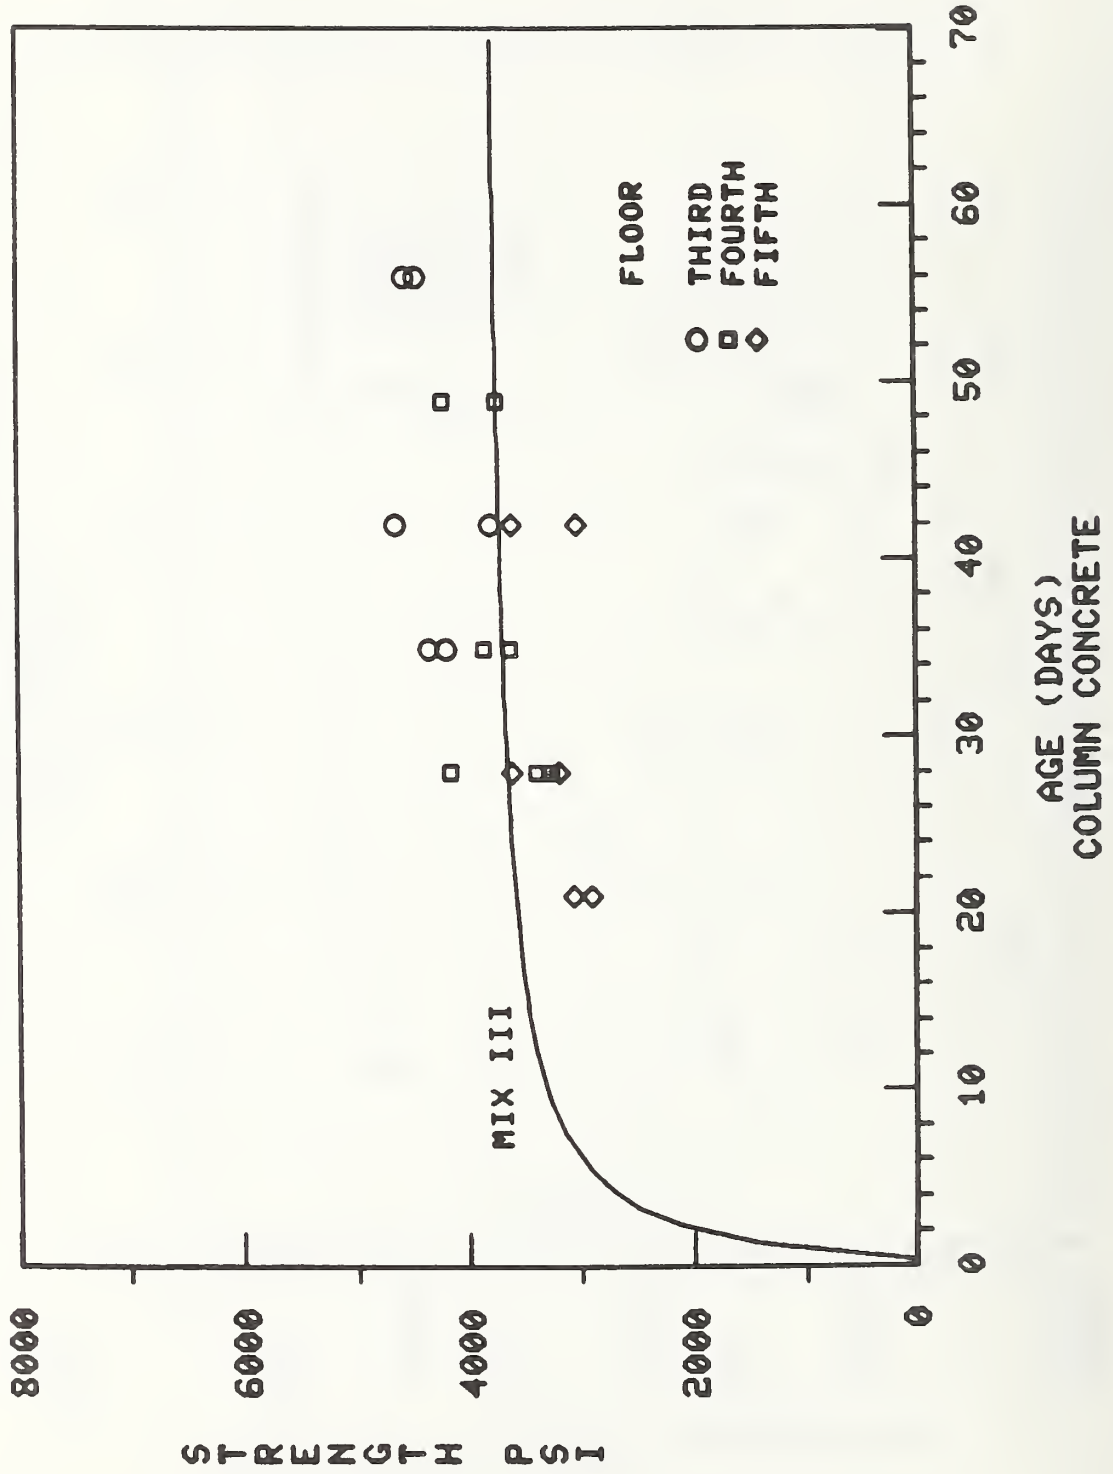
Figure 4.7 Comparison of strength of cores from columns with the laboratory mix

Figure 4.7 compares Mix III with the column core strengths. The laboratory mix is consistent with these core tests.

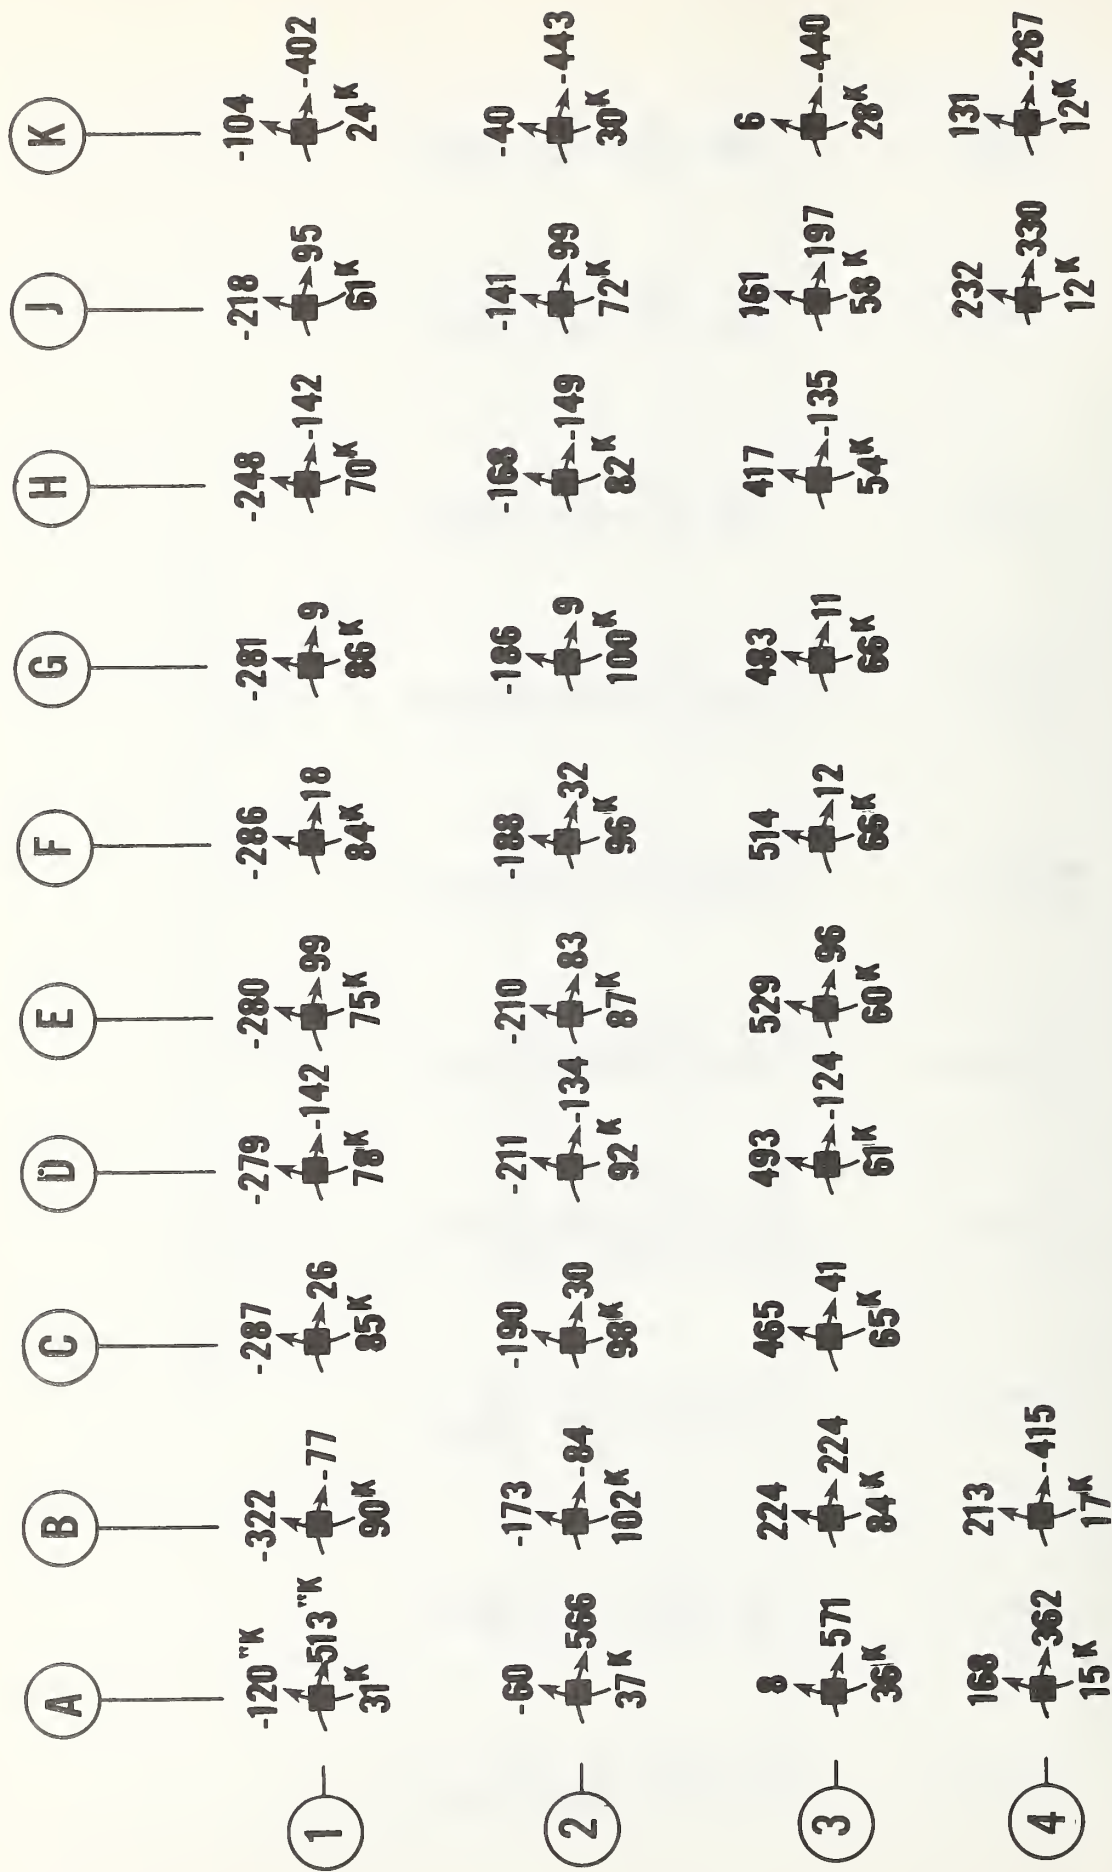
Figure 5.13 Fifth floor punching shear and column moments

- 4) In order to account for the three-dimensional response of the shored structure, the finite element method was used for the final analysis.
- 5) The results of the analysis indicate that the most heavily loaded slab-column connections are in the fifth floor at columns B-2 and G-2.

To verify that such a failure had occurred, punching shear stresses resulting from direct shear forces and unbalanced moments were computed at slab-column connections using the shear and moment values for construction loads given in figure 5.13. These shear stress values were compared with the shear capacity of the slab based on the predicted in-place strength of concrete at the time of collapse. Because the punching shear stress values are maximum at the fifth floor level (see figures 5.12 and 5.13), the shear stresses are evaluated only for this level. The guidelines given in the ACI Code [2.1] are followed in computing the punching shear stress. Figure 6.1(a) shows the critical section in the slab around an interior column. The critical section where shear stresses are evaluated is taken perpendicular to the plane of the slab and a distance a half of the effective depth away from the periphery of the column.

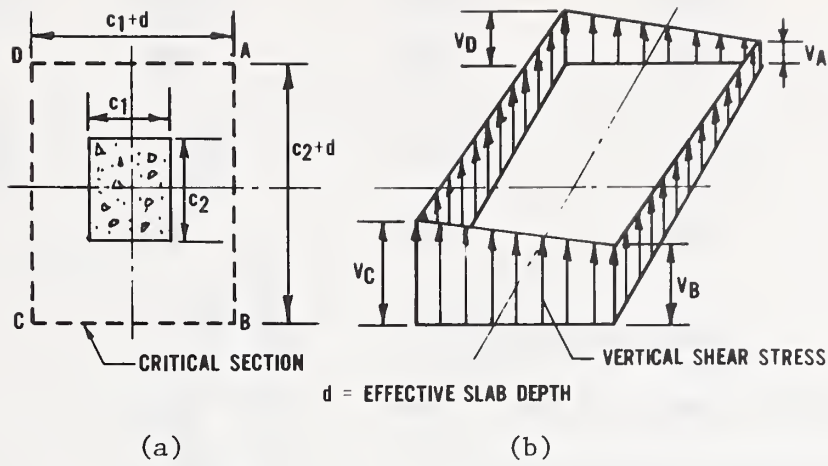
Figure 6.1 Shear stress distribution at interior column

The assumed distribution of shear stresses at the critical section is shown in figure 6.1(b). The critical sections for edge and corner columns and corresponding assumed shear stress distributions at these critical sections are shown in figure 6.2(a) and (b) and figure 6.3(a) and (b), respectively.

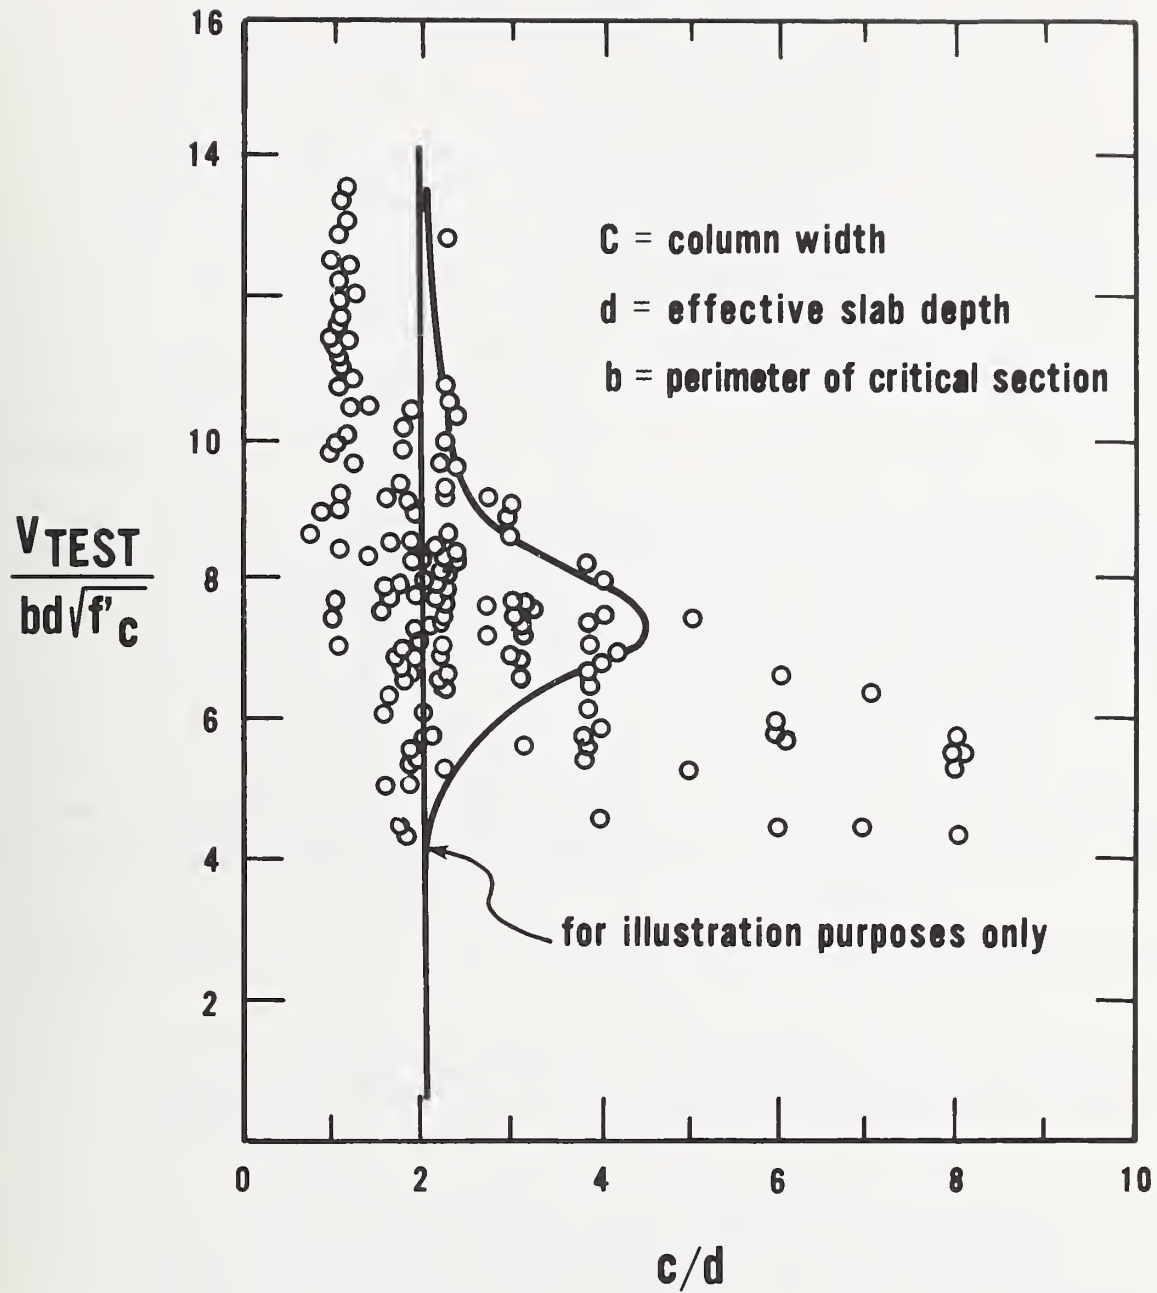
Figure 6.5 Results of punching shear tests of slab-column connections (ref. 6.1)

the fifth floor exceeded the nominal punching shear capacity of the slab. This would suggest that failure should have occurred prior to the placement of concrete to column line H. To examine why failure did not occur earlier requires a review of the ACI provision of  $4\sqrt{f'_c}$ . Figure 6.5 shows experimental punching shear strengths, normalized by  $bd\sqrt{f'_c}$ , versus  $c/d$  where  $b$  is the perimeter of critical section,  $c$  is the side length of column and  $d$  is the effective depth of the slab [6.1]. It is clearly seen in this figure that the punching shear strength is a probabilistic parameter which exhibits a high degree of variability. It is evident that  $4\sqrt{f'_c}$  as used in the ACI Code is a lower bound strength, that would be justified for the purpose of design. For failure analysis, however, the actual shear strength should be used, and it would be greater than  $4\sqrt{f'_c}$ . According to the data shown in figure 6.5, the mean punching shear strength could be as high as  $7\sqrt{f'_c}$  and the probability of a punching shear strength of  $4\sqrt{f'_c}$  occurring at any given location in the structure is relatively low. However, the probability of failure initiating at some location in the entire structure increases rapidly with the number of locations where the shear stresses are in the neighborhood of  $4\sqrt{f'_c}$ . According to figure 6.4, there are at least 30 such locations in the fifth floor slab.

If, for the sake of illustration, the probability of failure at any given location where a stress of  $4\sqrt{f'_c}$  occurs is assumed to be two percent ( $P_1 = .02$ ), which is quite plausible in light of the data shown in figure 6.5, the probability of failure,  $P_2$ , of an element in a system consisting of 30 such locations would be (assuming independence)

It should be pointed out that the data shown in figure 6.5 was obtained from laboratory experiments where, in general, much better quality control can be exercised than in the field. Therefore, it is reasonable to expect that if actual field conditions were simulated, the data would have shown greater scatter and a lower expected value than indicated in figure 6.5. Both factors imply a greater probability of strength below  $4\sqrt{f'_c}$ . There is evidence,
