NBS BUILDING SCIENCE SERIES 165

Engineering Aspects of the September 19, 1985 Mexico Earthquake

Following the September 19, 1985 Mexico earthquake, a team consisting of four engineers and one seismologist from the National Bureau of Standards (NBS) and the United States Geological Survey (USGS) was dispatched to Mexico City to provide technical advice to the US rescue effort and to assess structural damage. This report is primarily based on data gathered by the team, but it also contains a compilation of other available information. The report addresses the origin and characteristics of the observed ground motion, the ability of buildings designed in accordance with present and proposed seismic design provisions to resist this type of ground motion, and observed data on structural and foundation failures.

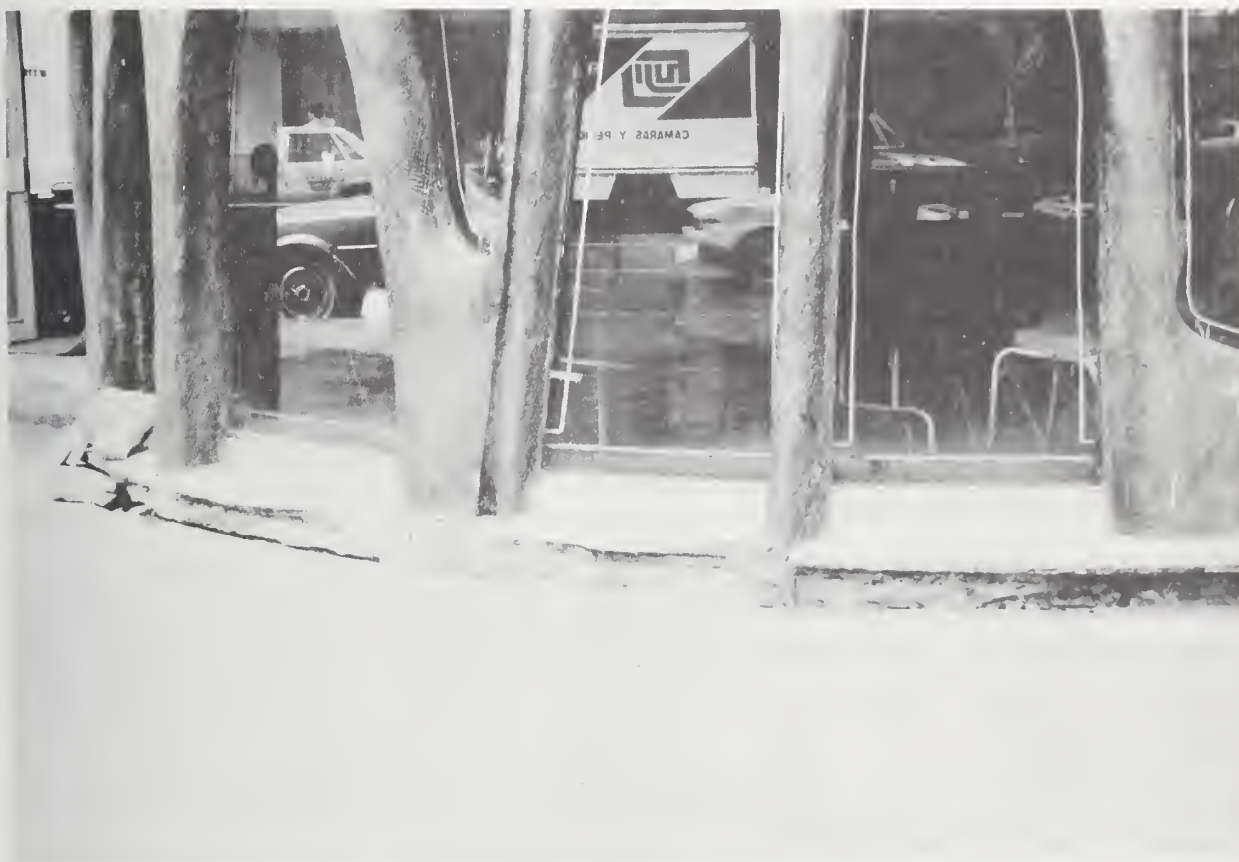
Figure 4.4. Differential displacement between sidewalk and building at the west corner of Versailles and Reforma.

Thus, it is reasoned that the phenomena observed in figures 4.1 through 4.4 are the result of a relaxation in the negative friction forces acting on the piles. This relaxation is the result of loss of shear strength. The loss of shear strength occurred because the clays are sensitive (refer to figure 3.9) and was caused by shear deformations associated with the relative motion between the piles and the surrounding soil. From available data [8] it is estimated that between 85 and 88 percent of the shear strength can be lost. This loss of shear strength does not necessarily lead to an overall foundation failure (it did not cause such a failure in the buildings shown in figures 20 to 23), particularly, since it also results in the relaxation of negative friction forces which the pile had to resist, but it is an important limit state, which should be considered in the design of earthquake-resistant structures founded on sensitive clays.

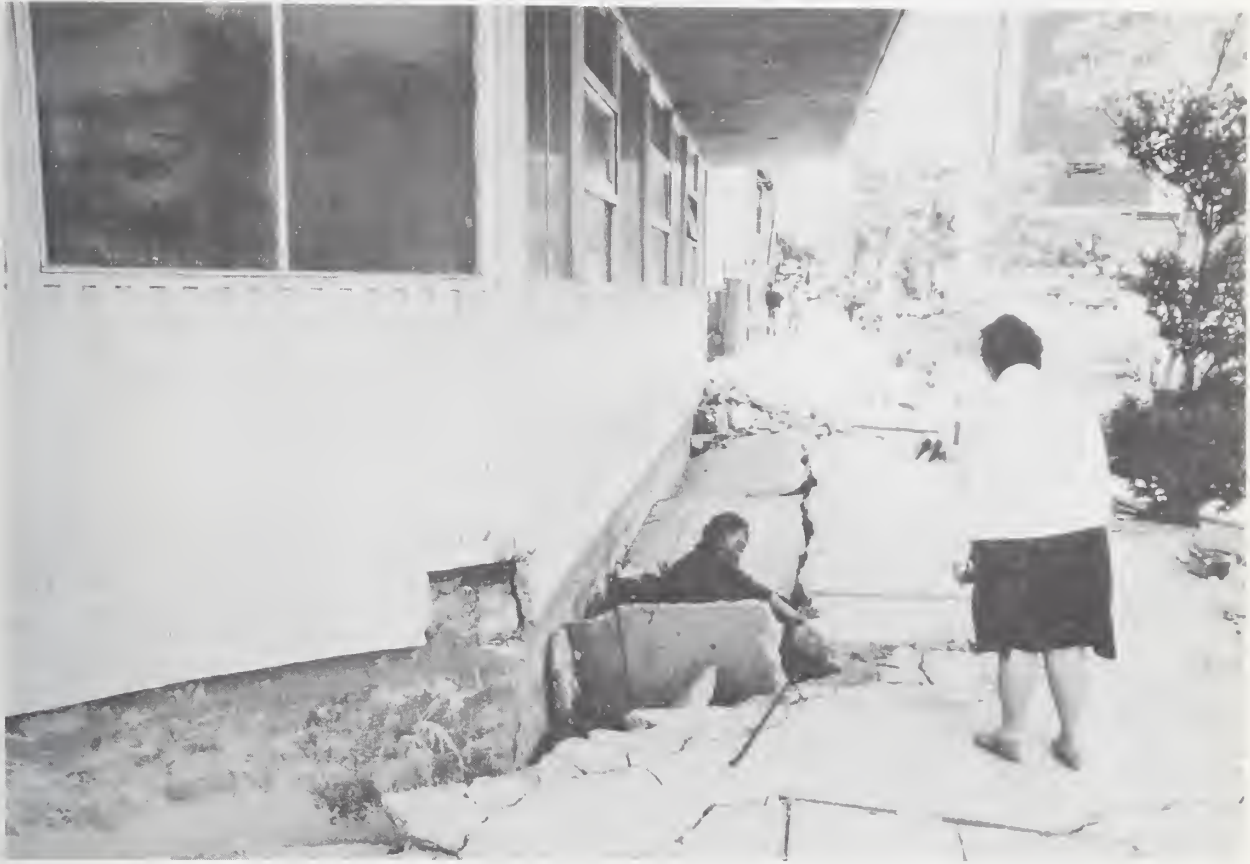
Figure 4.5 shows a tilted ten-story building in the southwest corner of the intersection of Lazaro Cardenas and Fernando. Relative displacements between the building and the sidewalk to the north are shown in figure 4.6, and figure 4.7 shows damage caused to adjacent two-story buildings by the tilting structure. This building is in the vicinity of the severely damaged Communications Center (SCT) where several buildings collapsed. Figure 4.8 shows another tilted building in the same general area in the northwest corner of the intersection of Xola and University. This ten-story building also suffered severe structural and cladding damage. Figure 4.9 shows two- and three-story buildings a short distance to the south on University and opposite the severely damaged Communications Center which apparently did not suffer damage. Likewise, many two-story residential buildings on University to the north of Xola, where two multi-story reinforced concrete buildings (one of them post-tensioned) collapsed, also appeared undamaged.

Figure 4.6. Relative displacement between sidewalk and tilted building at Lazaro Cardenas and Fernando.

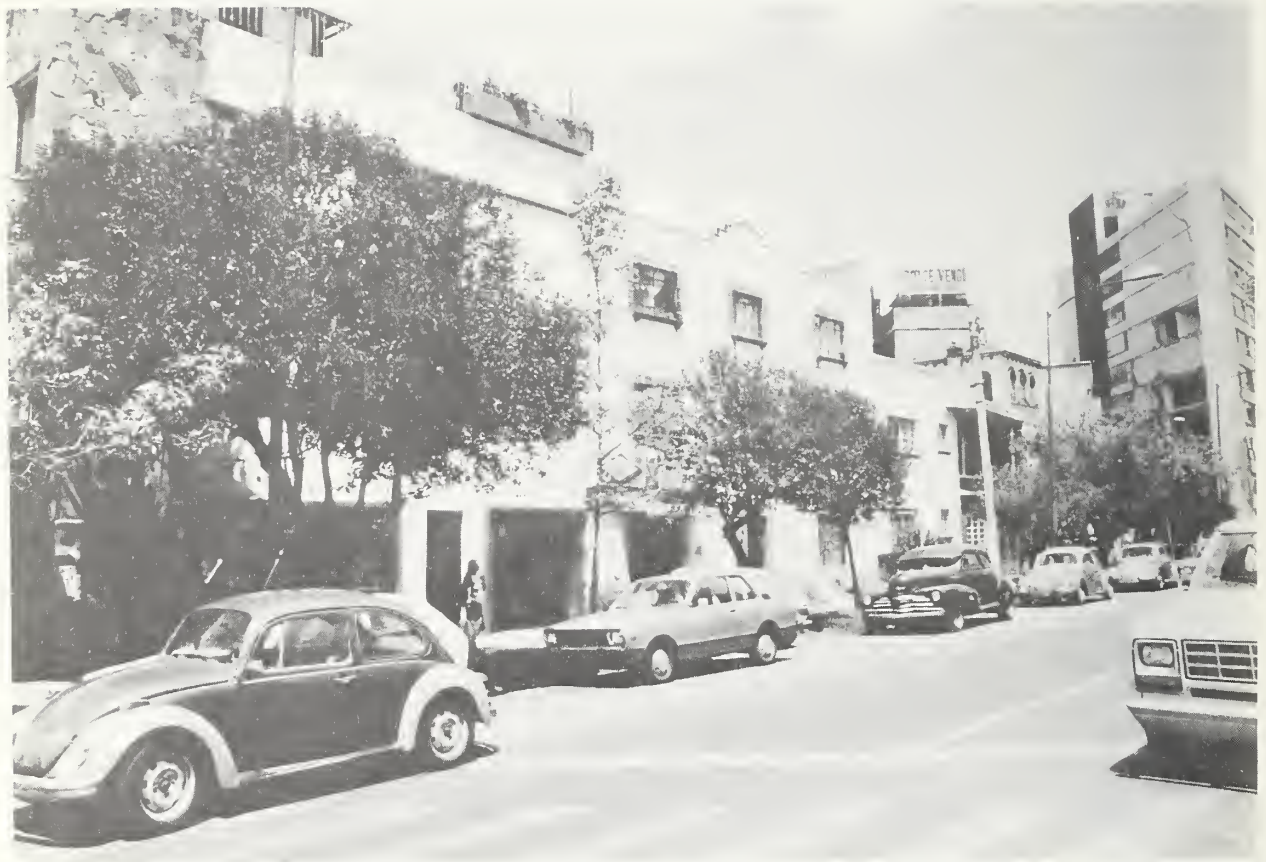
Figure 4.9. Undamaged two and three story buildings on University Boulevard opposite the severely damaged Communications Center.

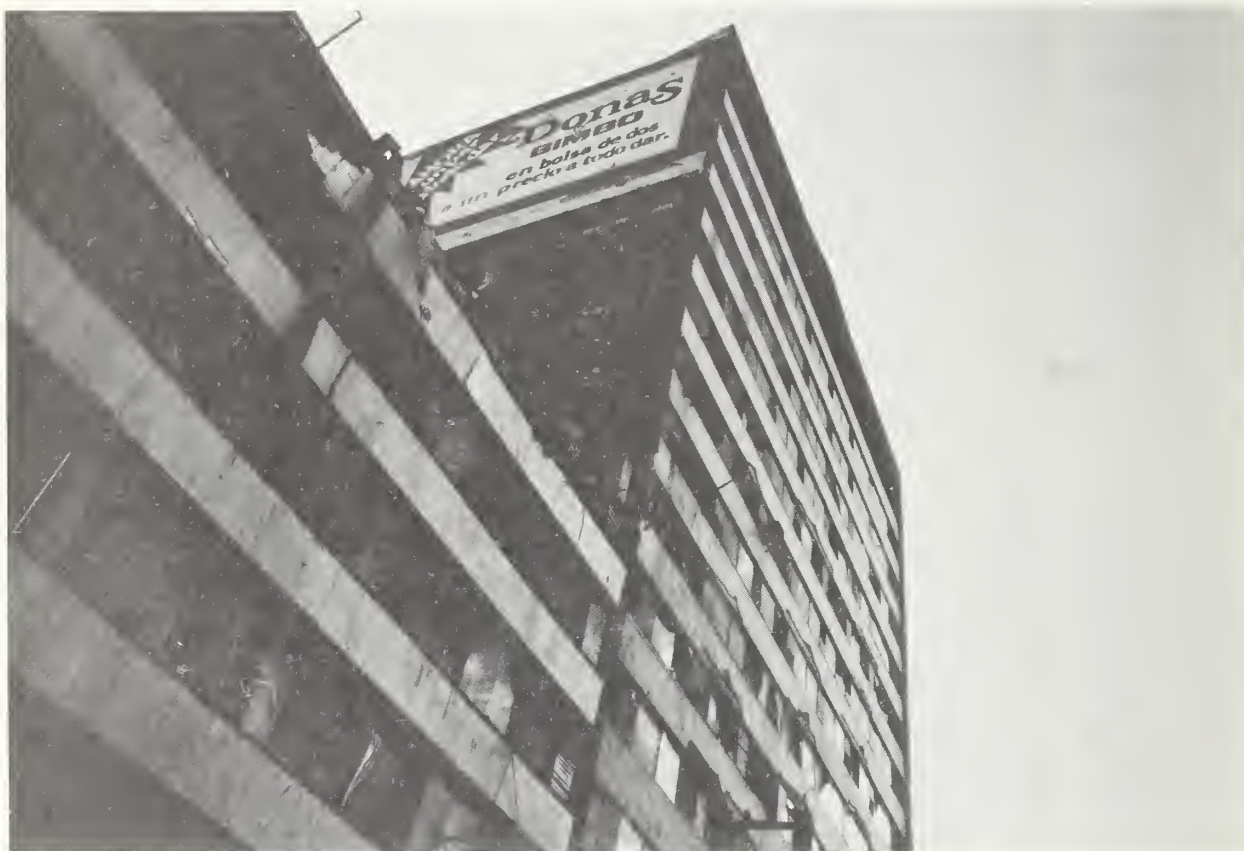
Many buildings were damaged as a result of distortions caused by differential foundation settlements. An example is shown in figures 4.14 and 4.15. The far corner (SW) of the building shown in figure 4.14 which is located on the south side of Teresa De Mier just to the east of Medico Militar settled more than the other corners. This differential settlement resulted in a warping distortion which can be seen in the wall shown in figure 4.15.

Figure 4.15. Warped wall on the north side of building on Teresa de Mier.

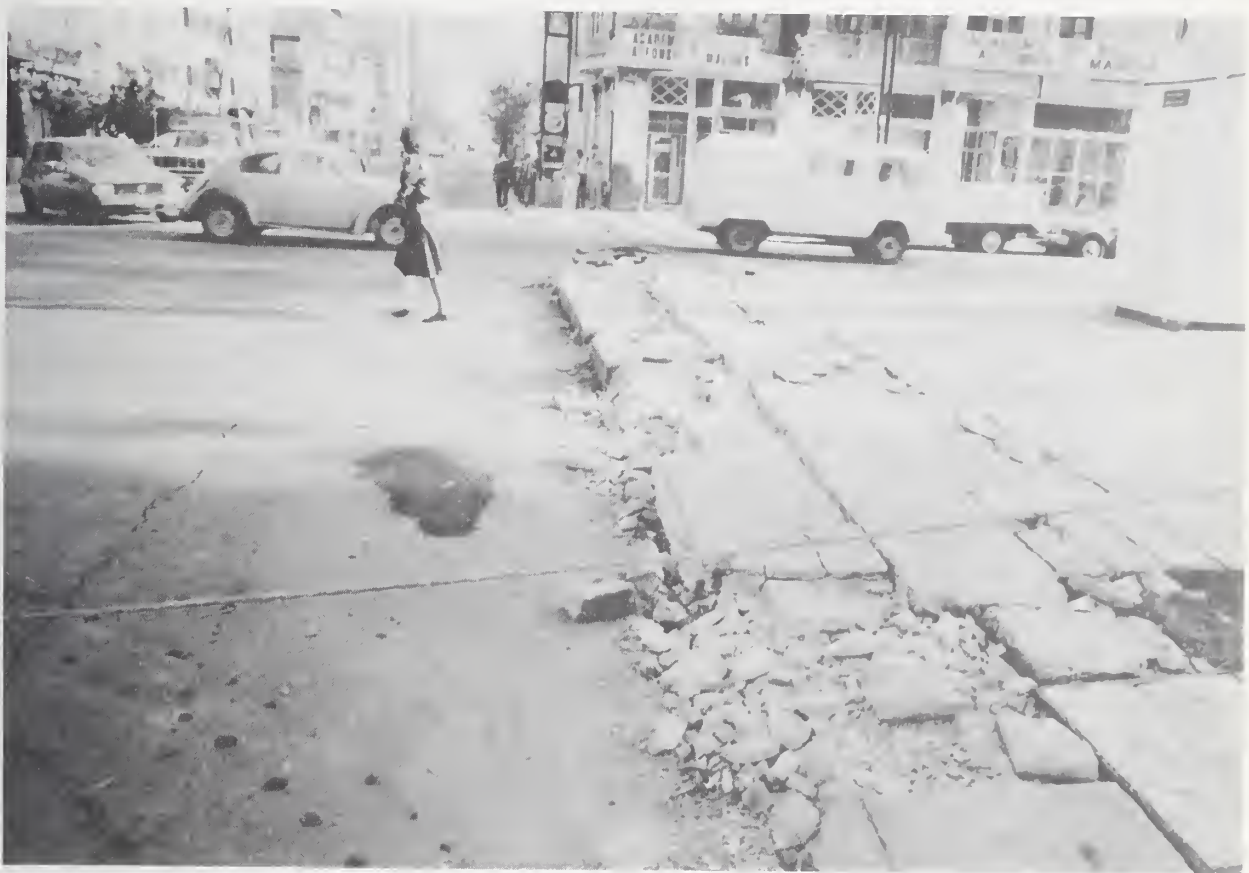
Figure 4.16. Soil disturbance over utility line at the intersection of Monterrey and Obregon.

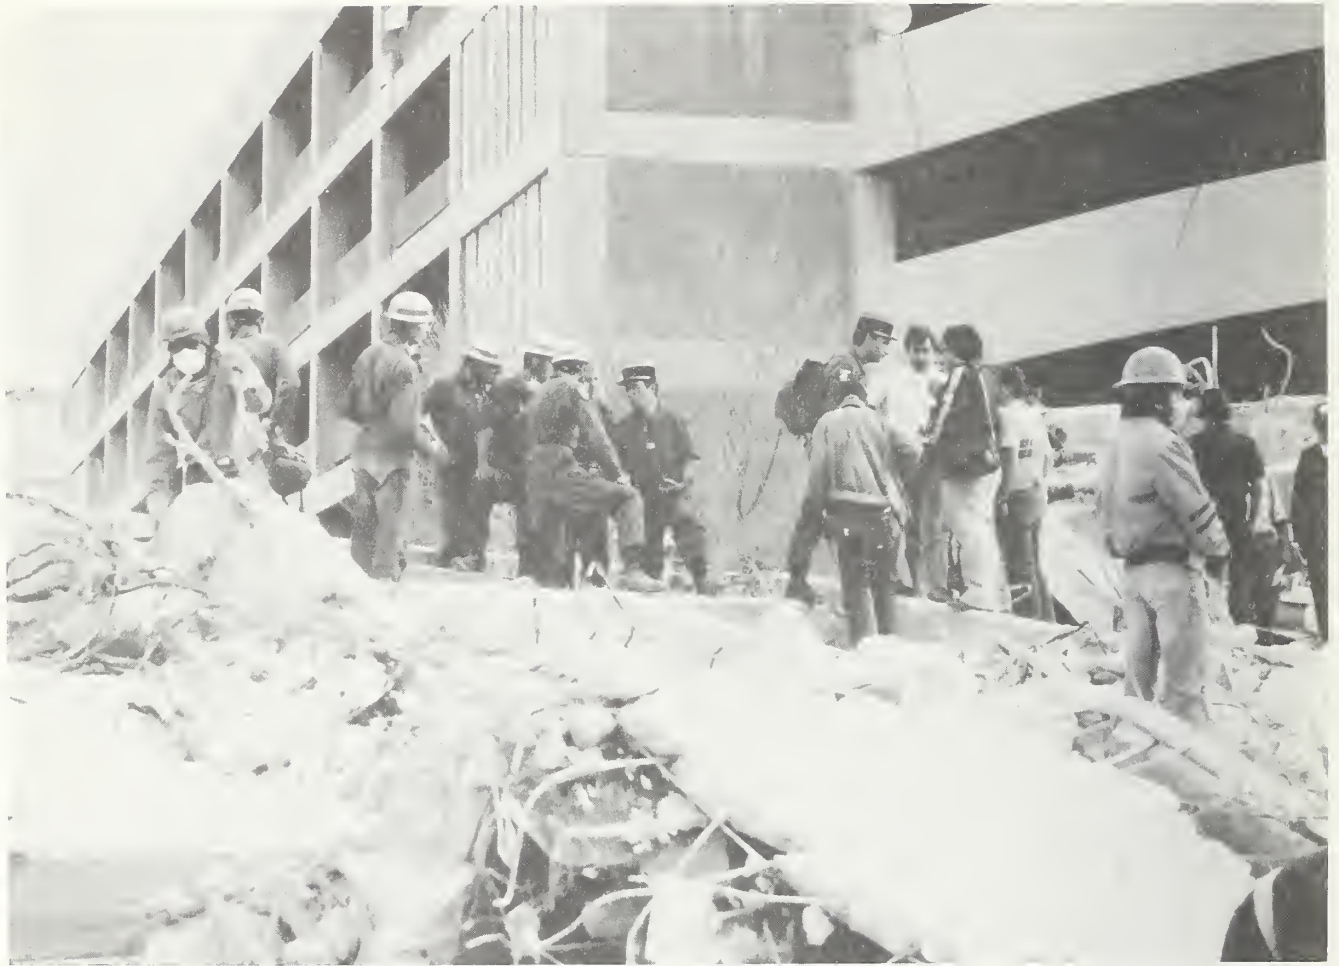
Figure 5.7. Reinforced concrete shearwalls in the corners of the parking garage of the Mexico General Hospital. The group standing in the foreground was part of the dog-rescue team from France. These teams successfully tracked down several survivors trapped in rubble of the buildings that collapsed.

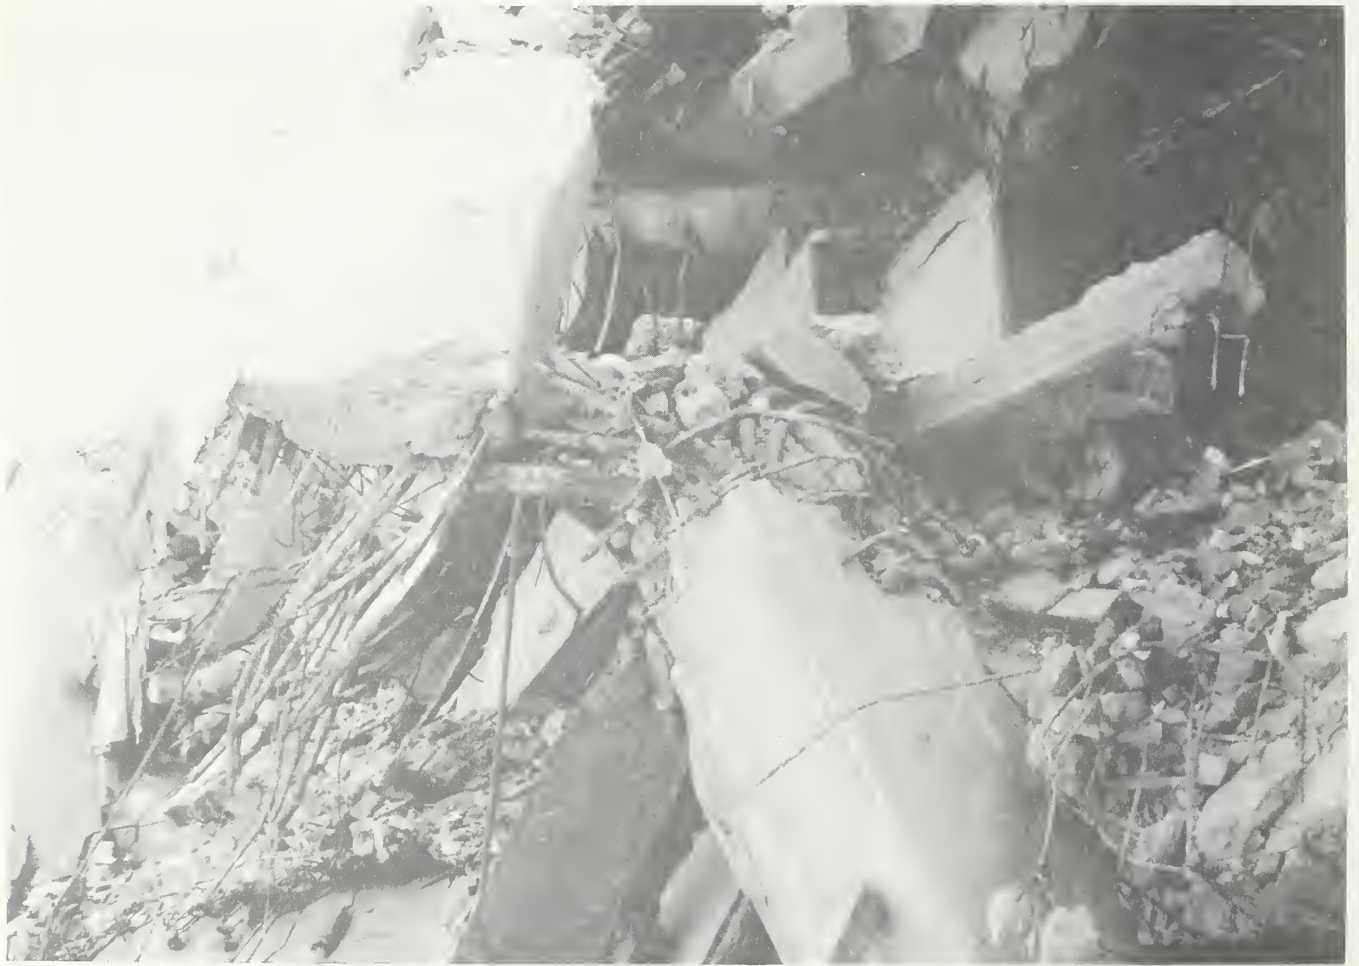
The lack of such confinement, and the presence of splices in such critically underconfined joints -- which could lead to a loss of vertical load bearing continuity as soon as the bond strength is lost following core breakup -- directly contributed to the failure of the Juarez Hospital. This particular structure received considerable media attention as rescue personnel

Figure 5.11. Close up joint details of collapsed Juarez Hospital indicating lack of sufficient confining reinforcement in the vicinity of the joint.

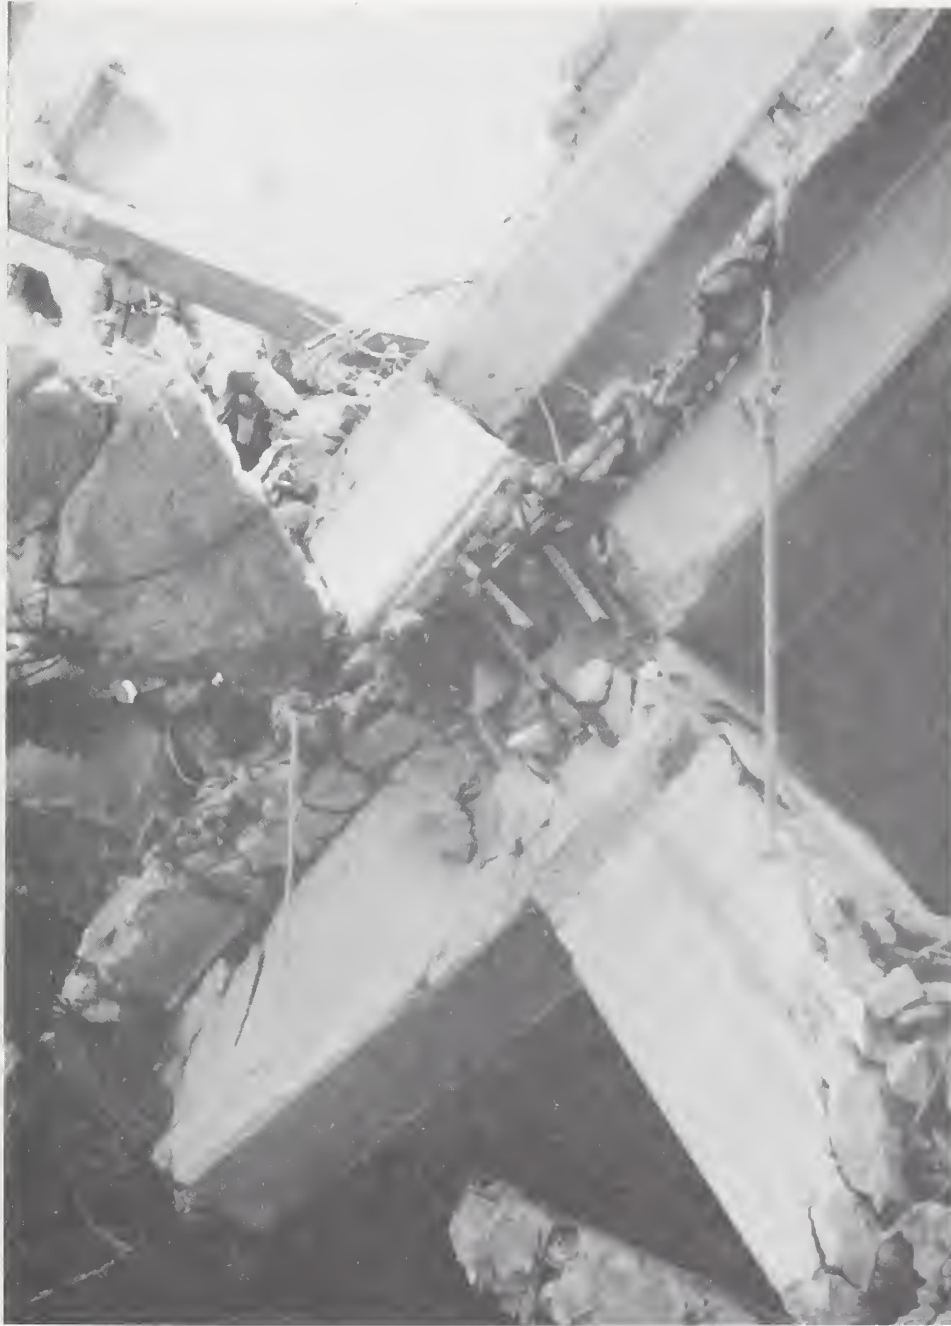
Figure 5.12. Joint details of collapsed Juarez Hospital indicating adverse effect of a splice.

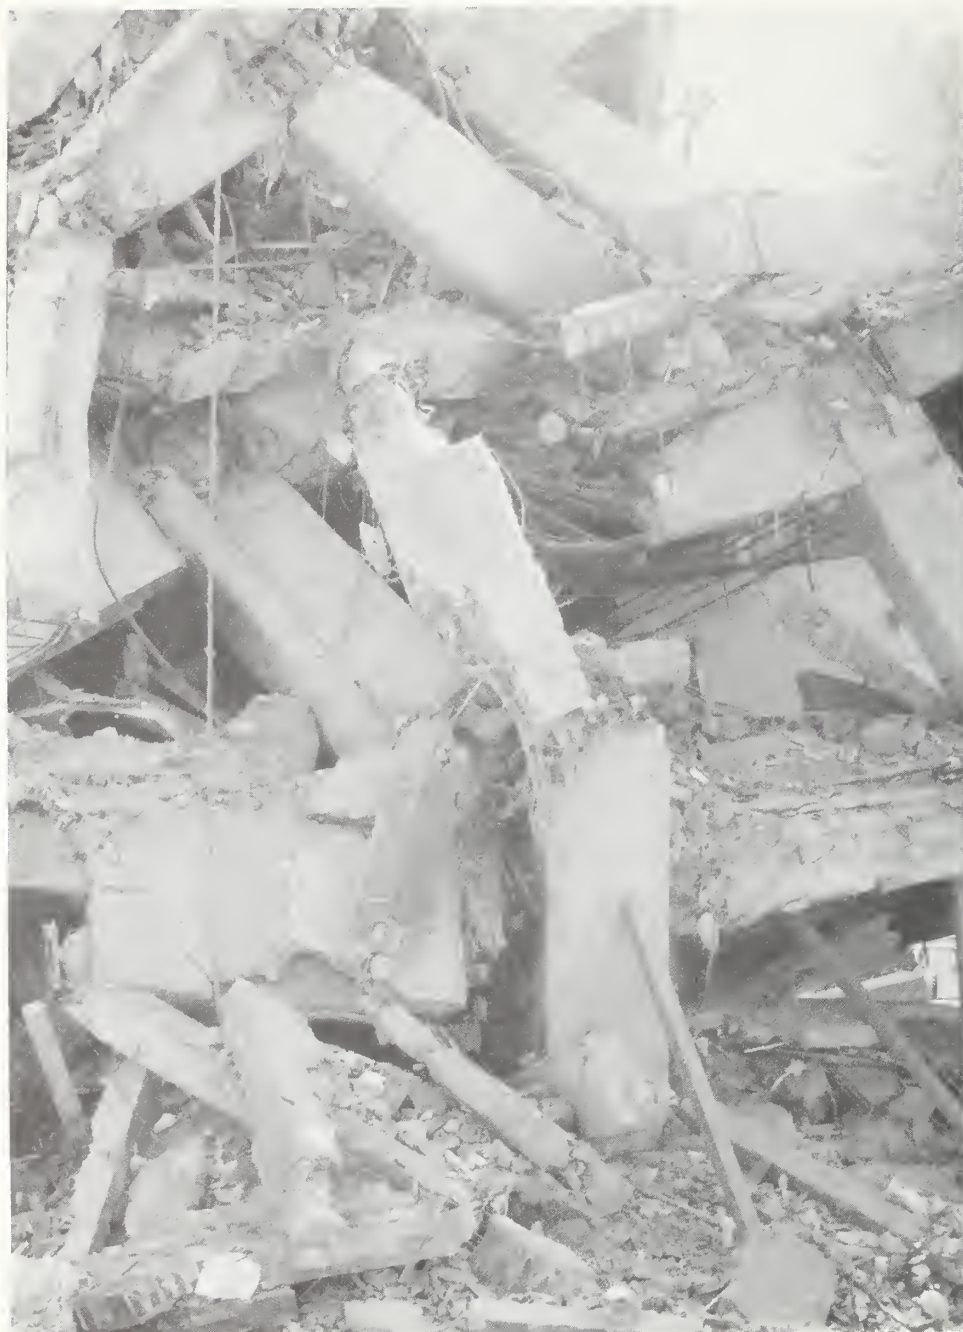
Figure 5.13. View looking south at Juarez Hospital showing how column hinging permitted rotation of successive floors toward the east.

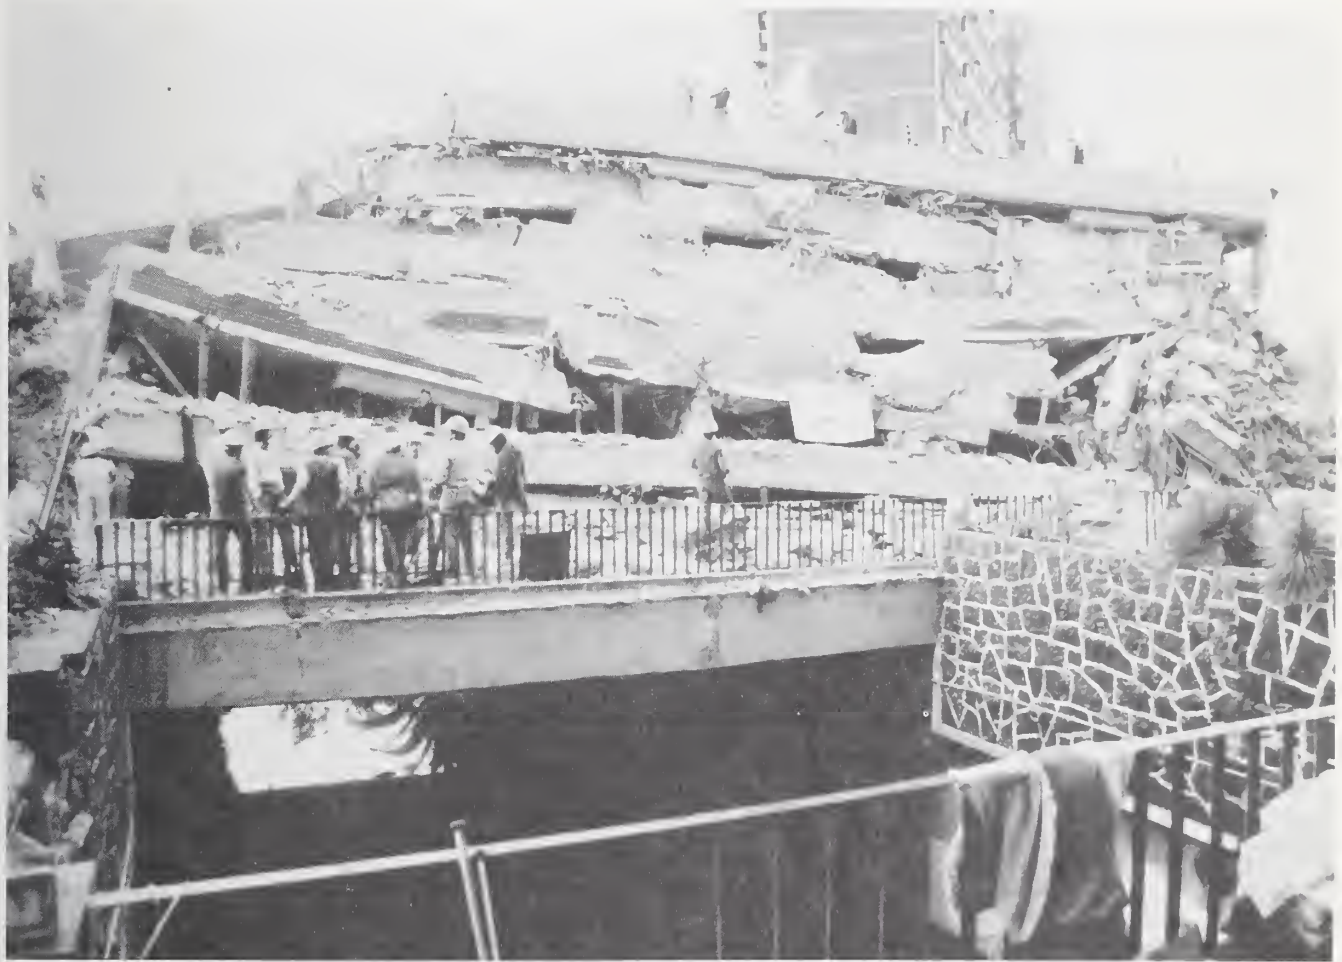
Figure 5.18. Pancake type collapse of eight story apartment.

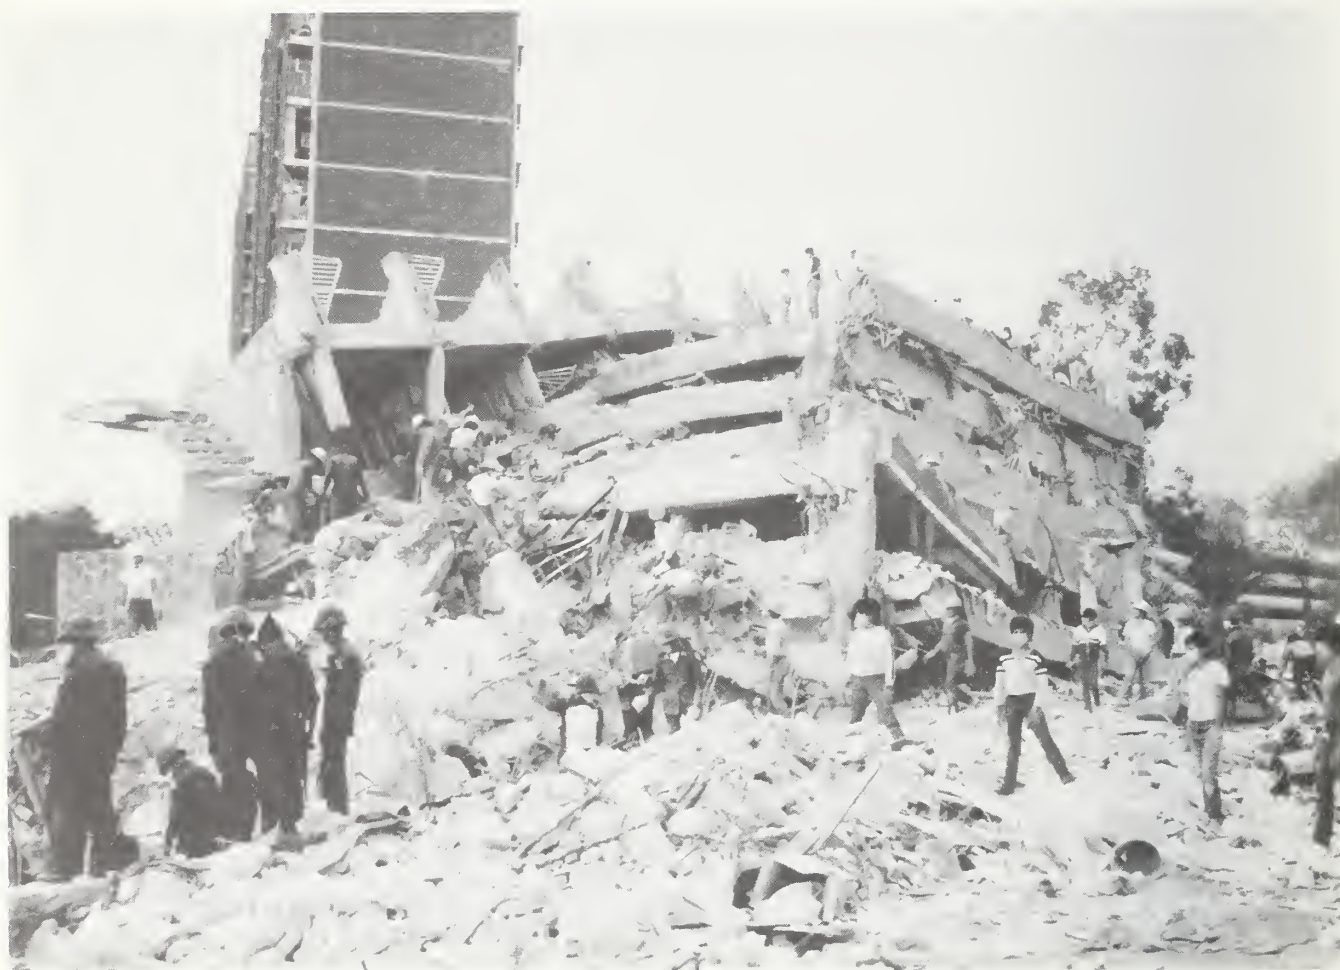
Figure 5.19. View of collapsed apartment looking northeast.

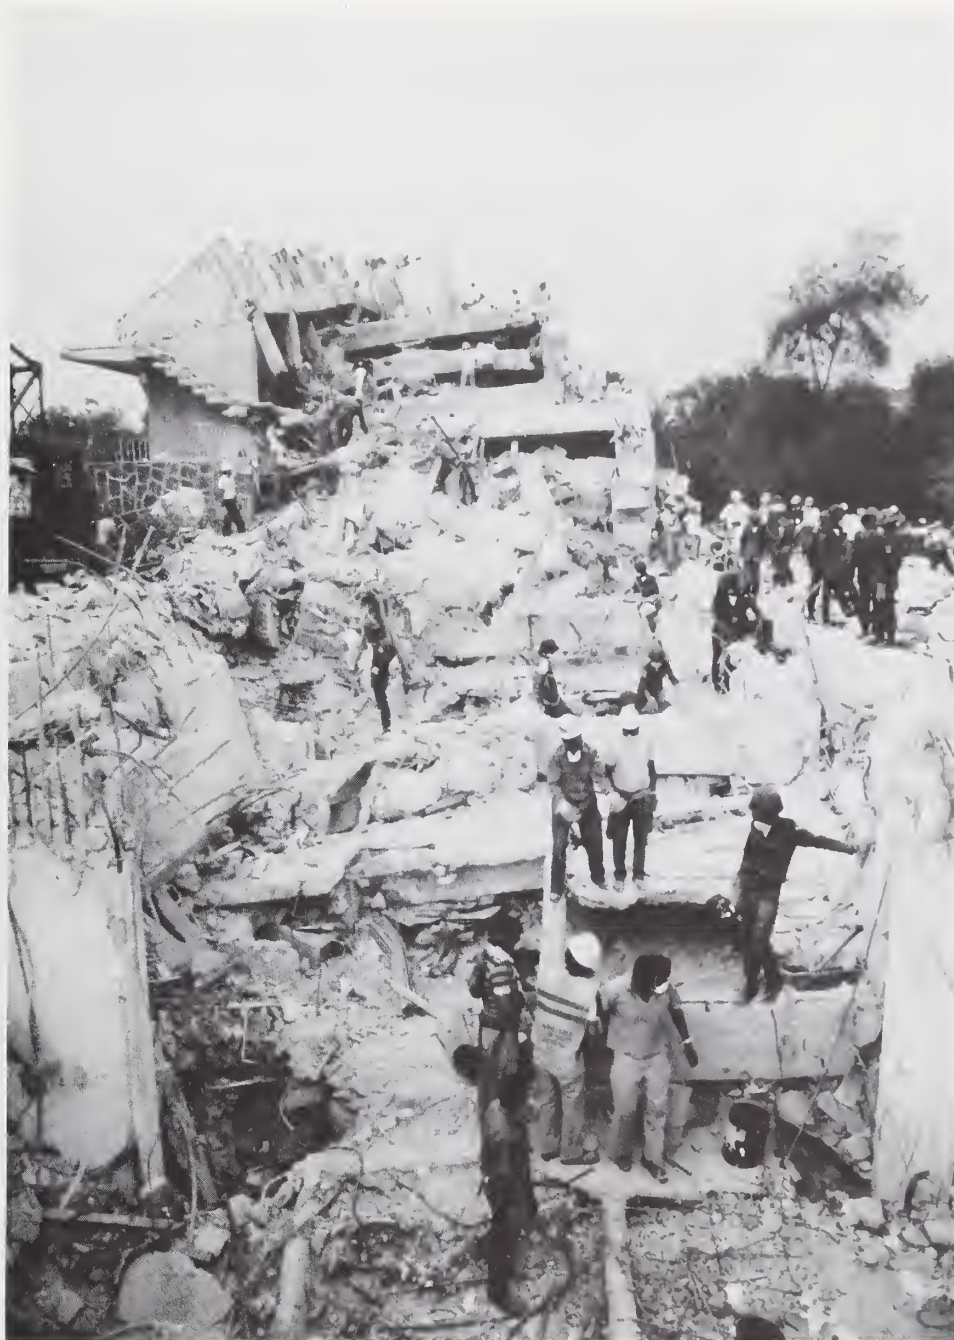
Figure 5.20. View of collapsed apartment structure looking east.

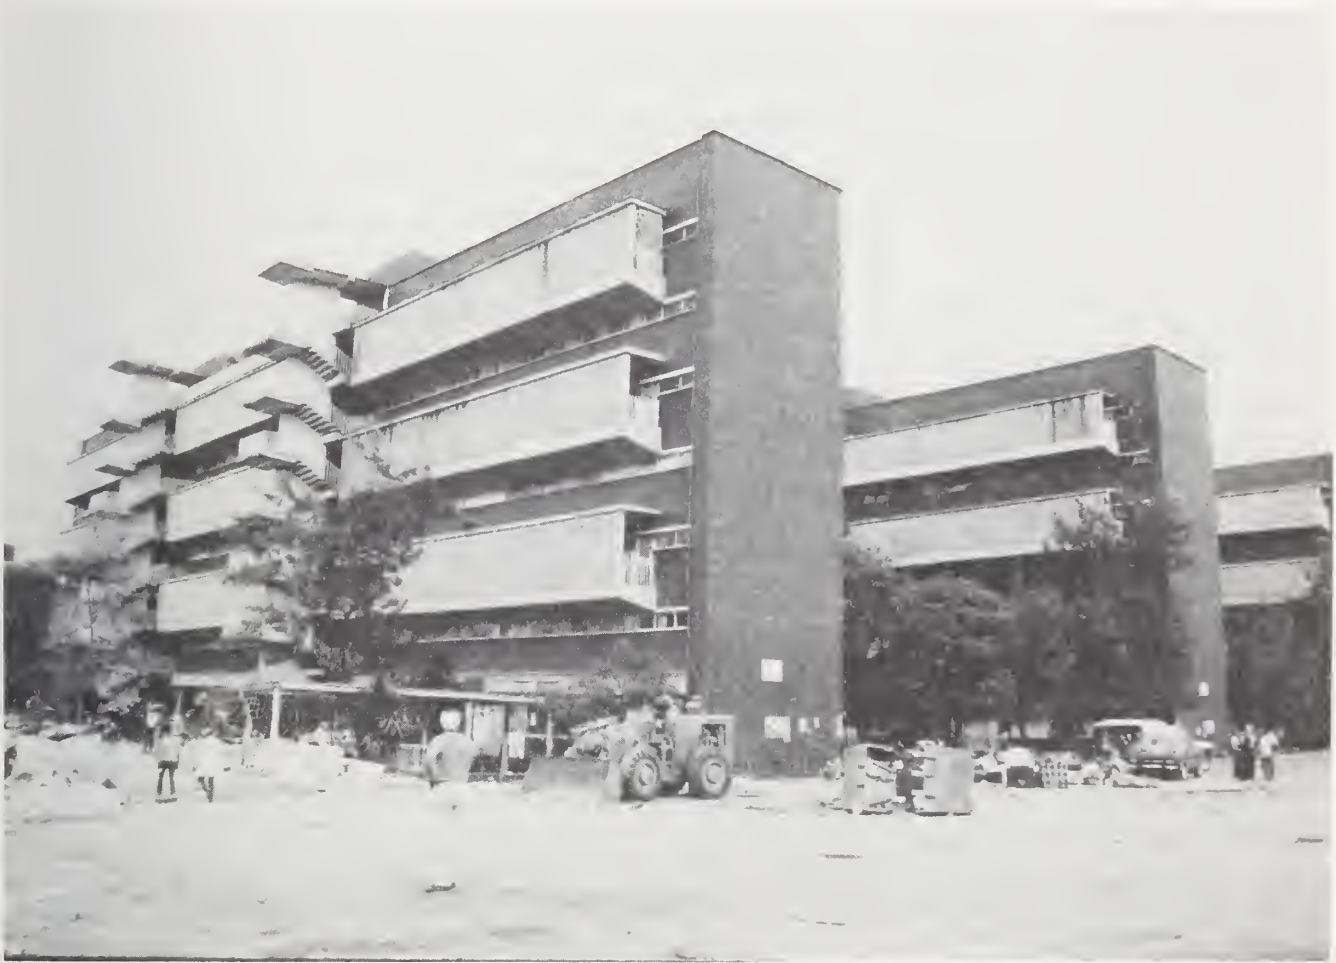
It is of particular interest to know why this particular building collapsed, while its three sister structures (figure 5.21) immediately to the south, did not. Part of the reason may be local variations in the soil consolidation, or perhaps differential-settlement induced stresses, as mentioned in Section 5.2.

Figure 5.21. Undamaged apartment building near identical structure which collapsed.

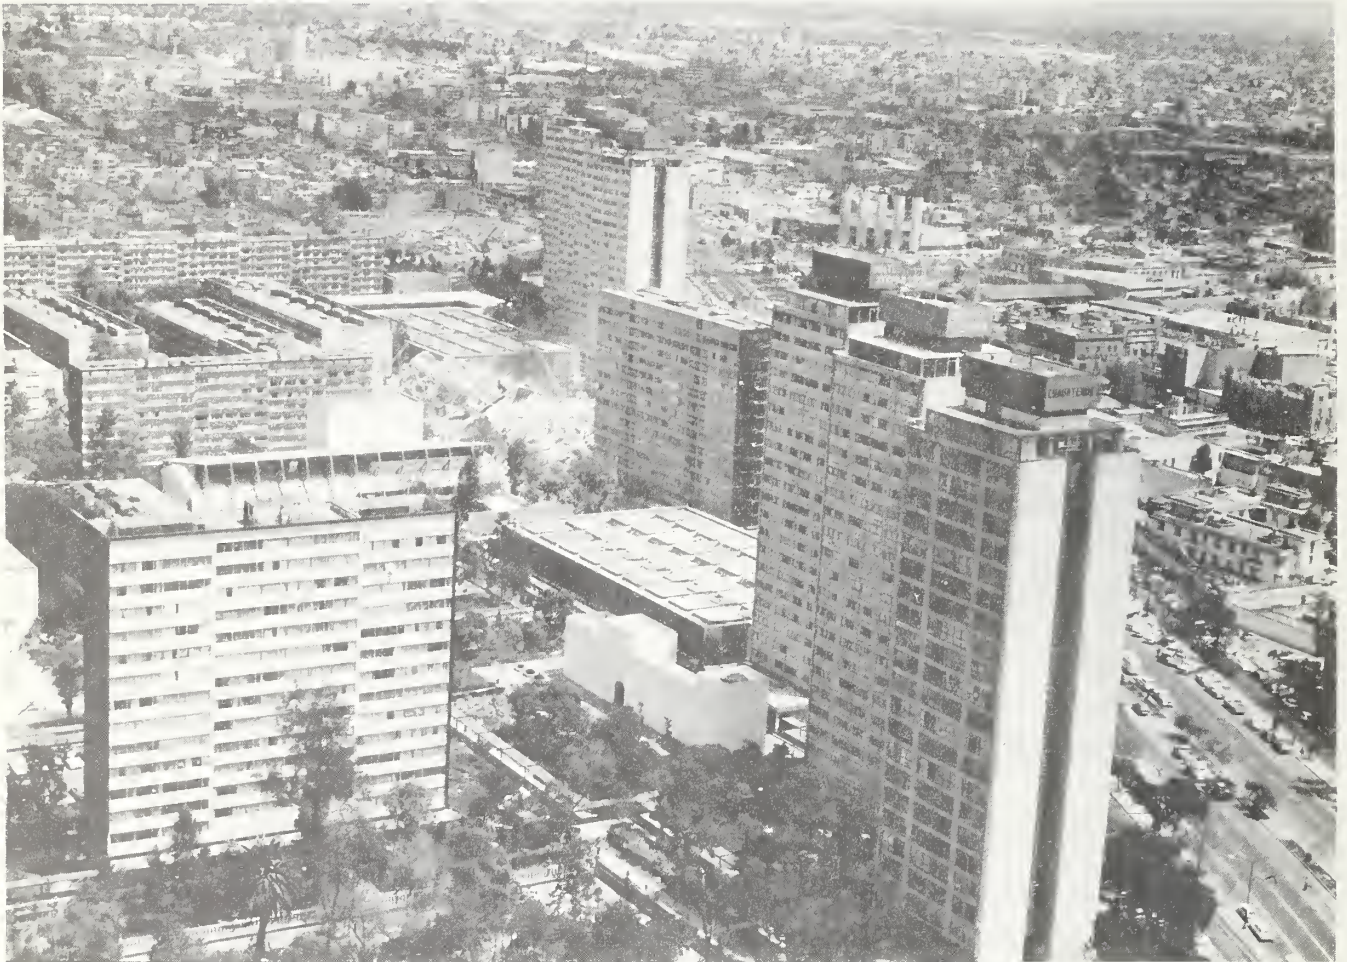
Figure 5.27. The Tlaltelalco Apartment Complex. Nuevo Leon building is located at center of photo. Aerial view looking northeast.

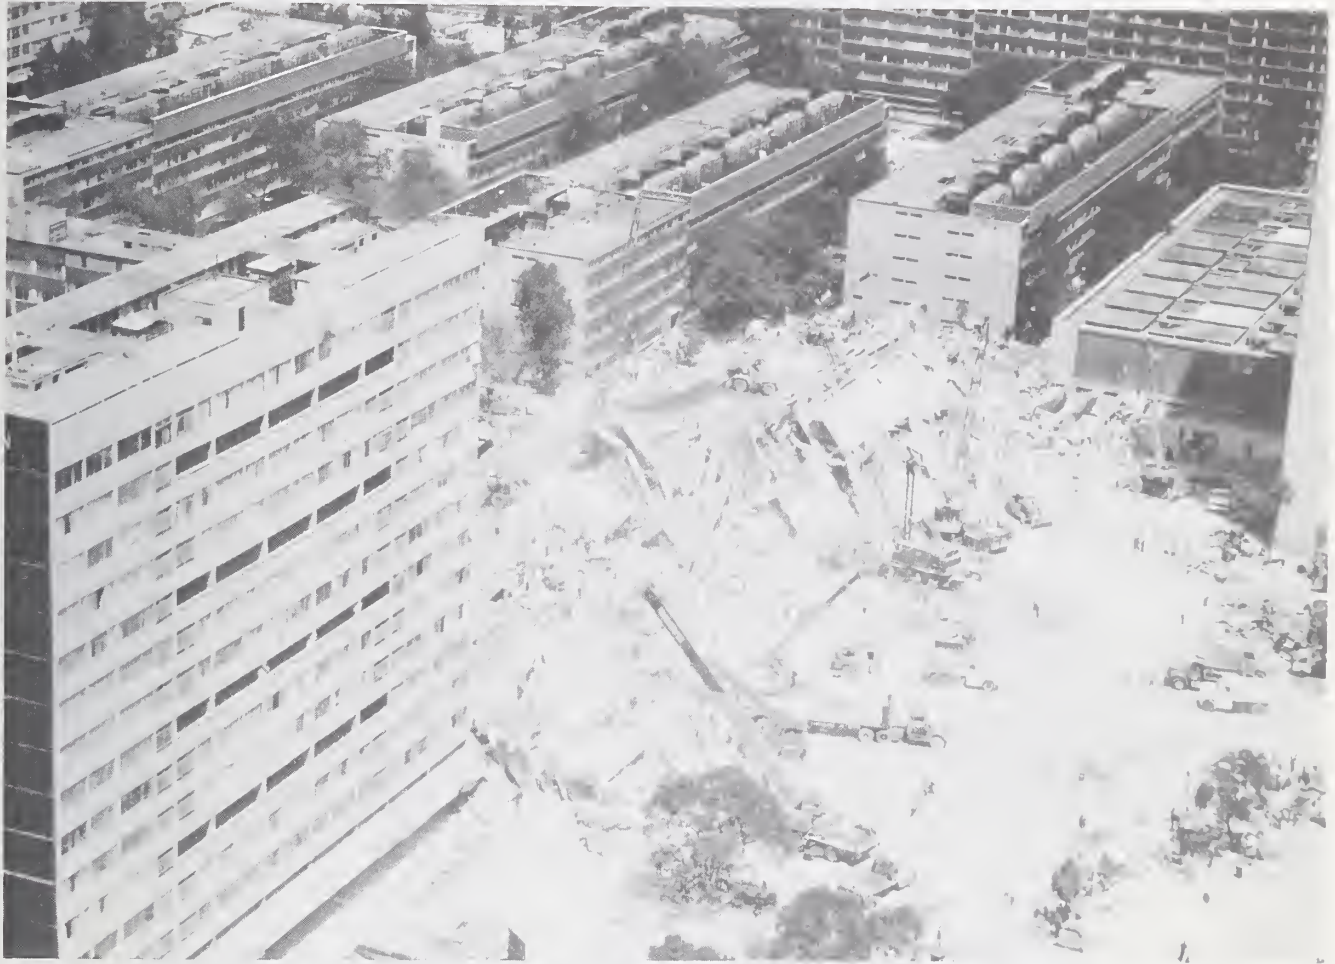
Figure 5.28. Aerial view looking northwest of the Nuevo Leon Apartment Complex.

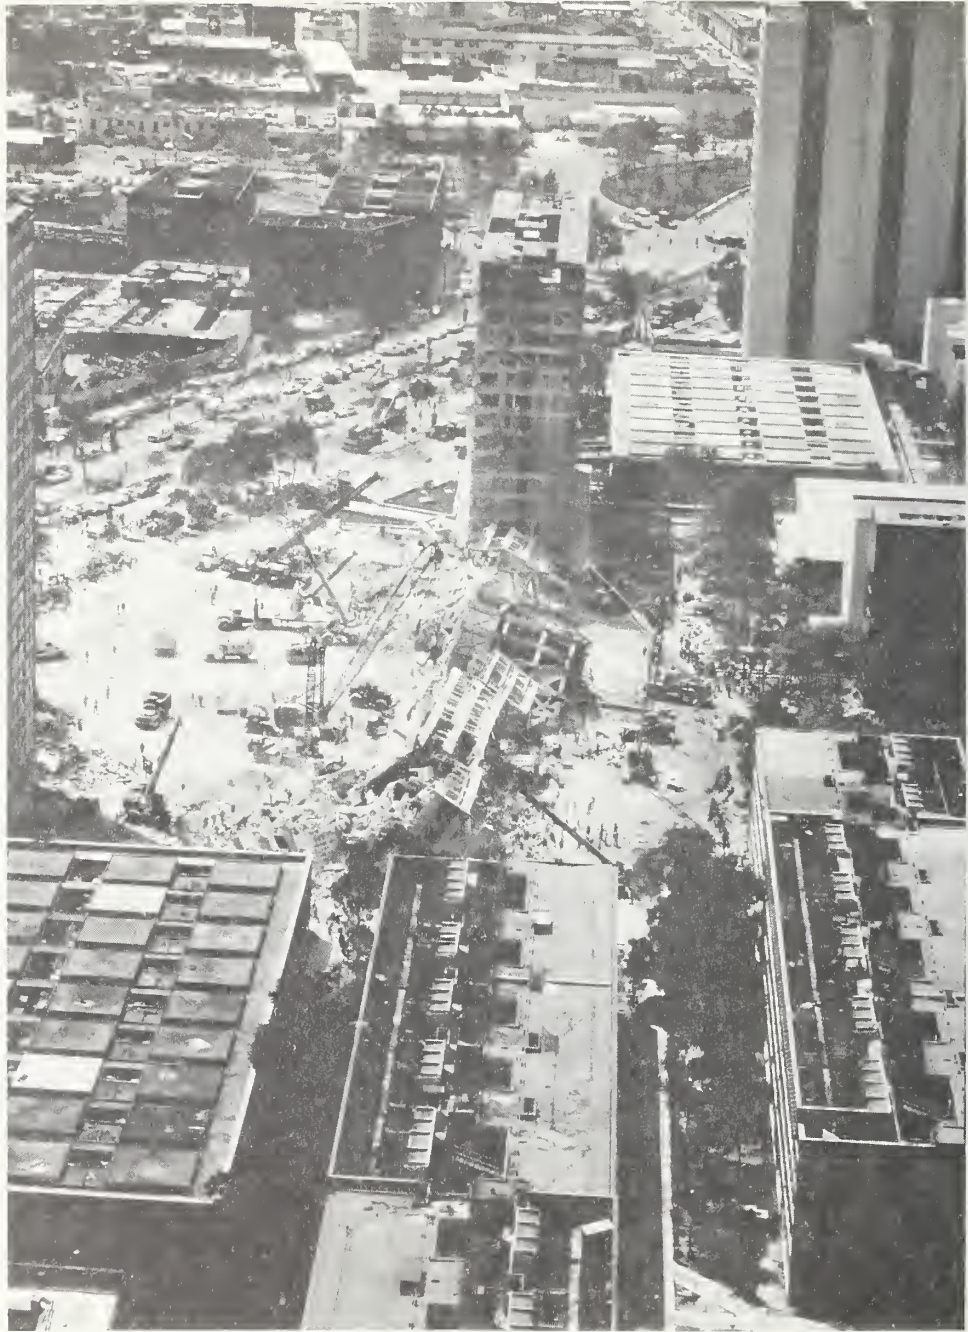
Figure 5.29. Aerial view looking south of the Nuevo Leon Apartment Complex.

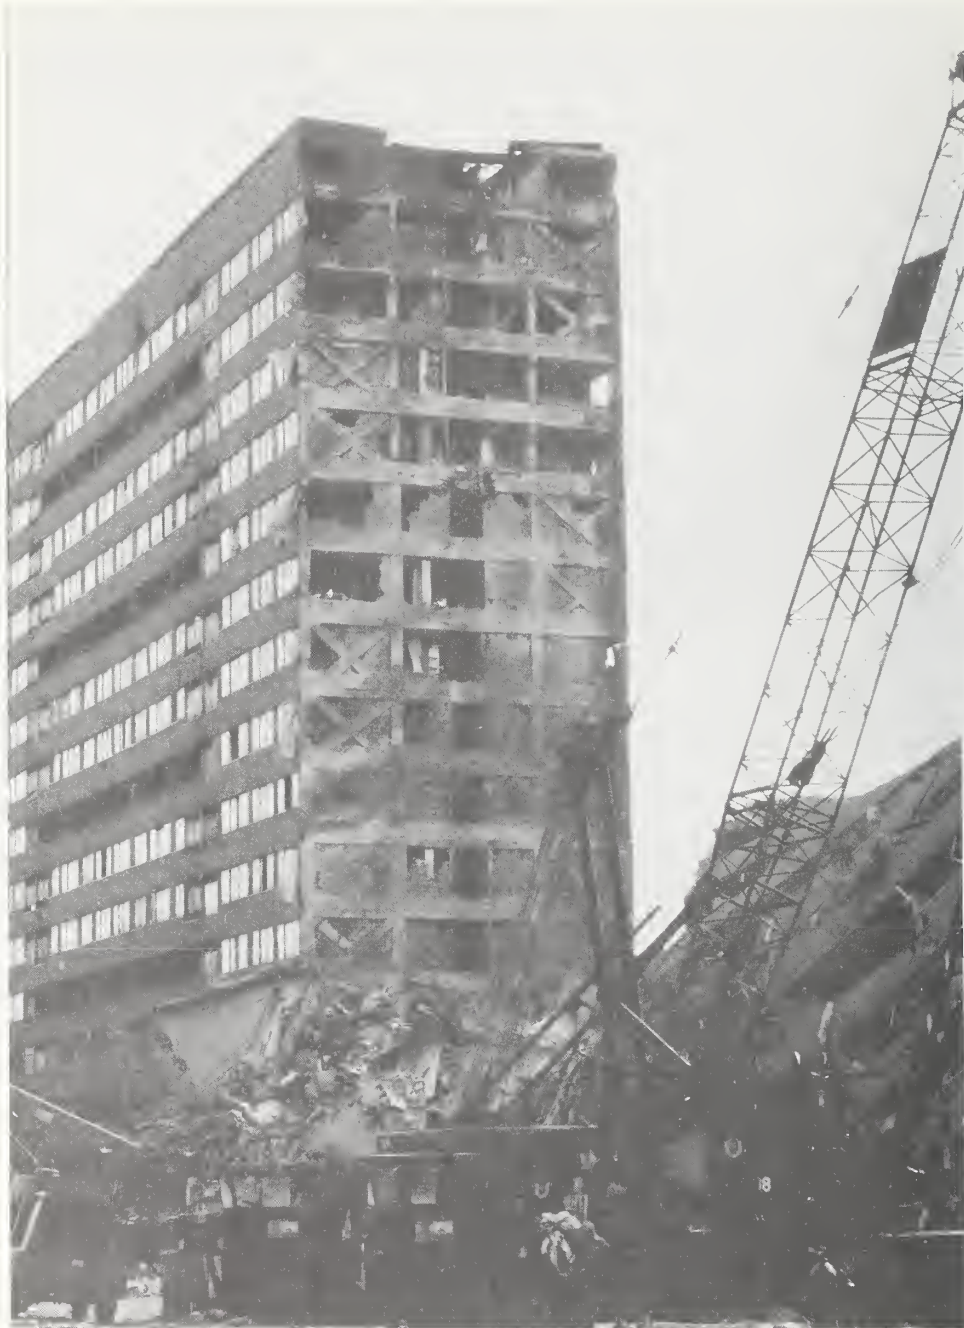
Figure 5.31. Concrete X-braces in remaining tower of Nuevo Leon Apartment Complex.
