NBS BUILDING SCIENCE SERIES 165

Engineering Aspects of the September 19, 1985 Mexico Earthquake

Following the September 19, 1985 Mexico earthquake, a team consisting of four engineers and one seismologist from the National Bureau of Standards (NBS) and the United States Geological Survey (USGS) was dispatched to Mexico City to provide technical advice to the US rescue effort and to assess structural damage. This report is primarily based on data gathered by the team, but it also contains a compilation of other available information. The report addresses the origin and characteristics of the observed ground motion, the ability of buildings designed in accordance with present and proposed seismic design provisions to resist this type of ground motion, and observed data on structural and foundation failures.

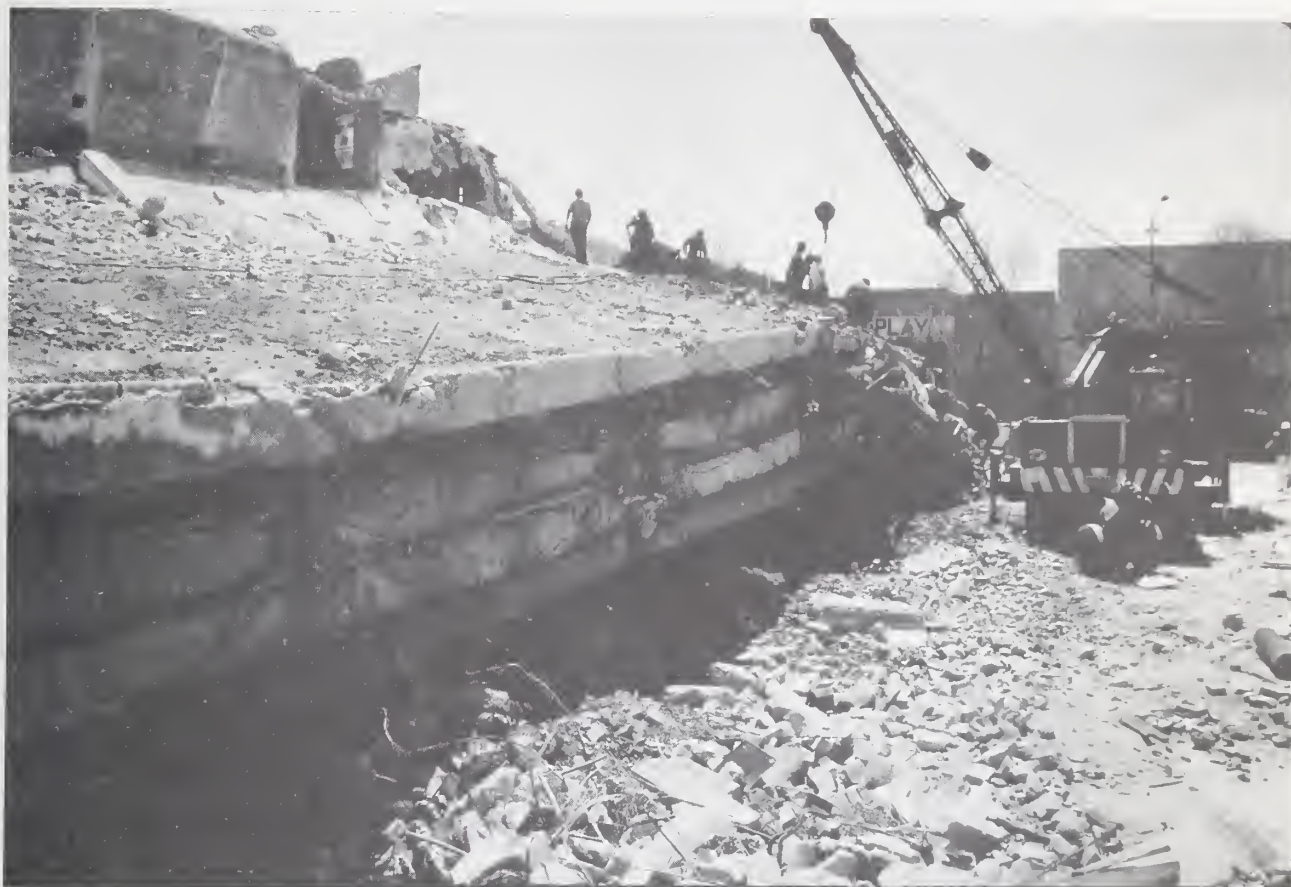
Figure 5.35. Collapsed office building near the corner of Neva and Barragan Streets.

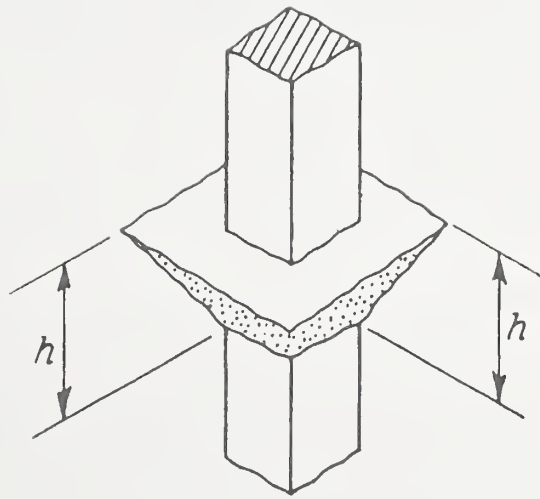
Figure 5.37. Shear cone resulting from punching shear failure.
Ref. [24].

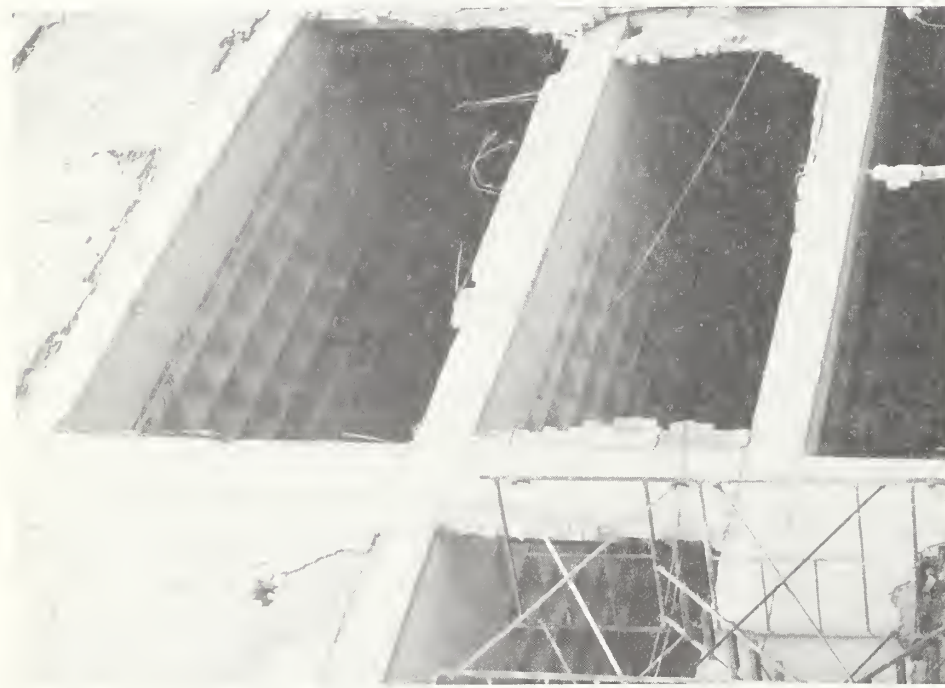
In many cases, the extent of damage to this type of structure was determined by the presence or absence of masonry exterior infill shear walls, as demonstrated in figures 5.38 a and b. The infill walls shown in figure 5.38a failed, and in the process absorbed a

(a) Waffle slab building in which masonry infill walls absorbed much of the earthquake energy.

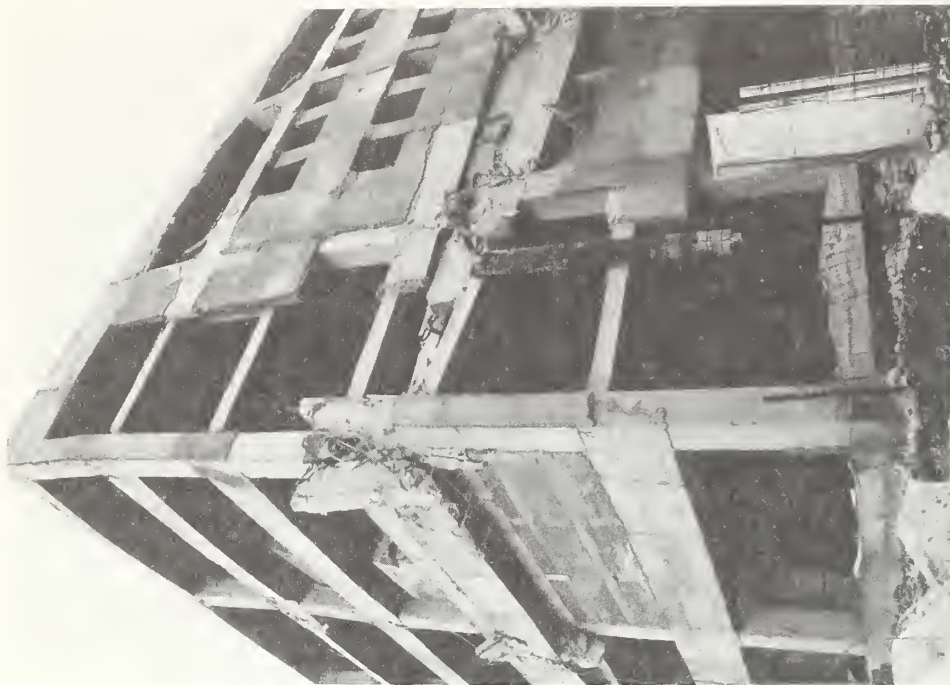
substantial amount of energy prior to buckling outward. On the other hand, the Banco Vencen building near the corner of Ave. Trujano and Hidalgo (figure 5.38 b) was under construction and masonry walls were in the process of being added to some of the upper floors, but were not complete enough to prevent column shear failures from occurring along the entire eastern side of the frame at the third story. Those portions of the building where the infill walls had been completed remained standing. A typical example of a failure of a waffle-slab structure with flexible columns was the 10-story apartment building at the corner of Ave. Dinamarca and Chapultepec shown in figures 5.39 a and b.

(b) Collapsed waffle slab building which was under construction.

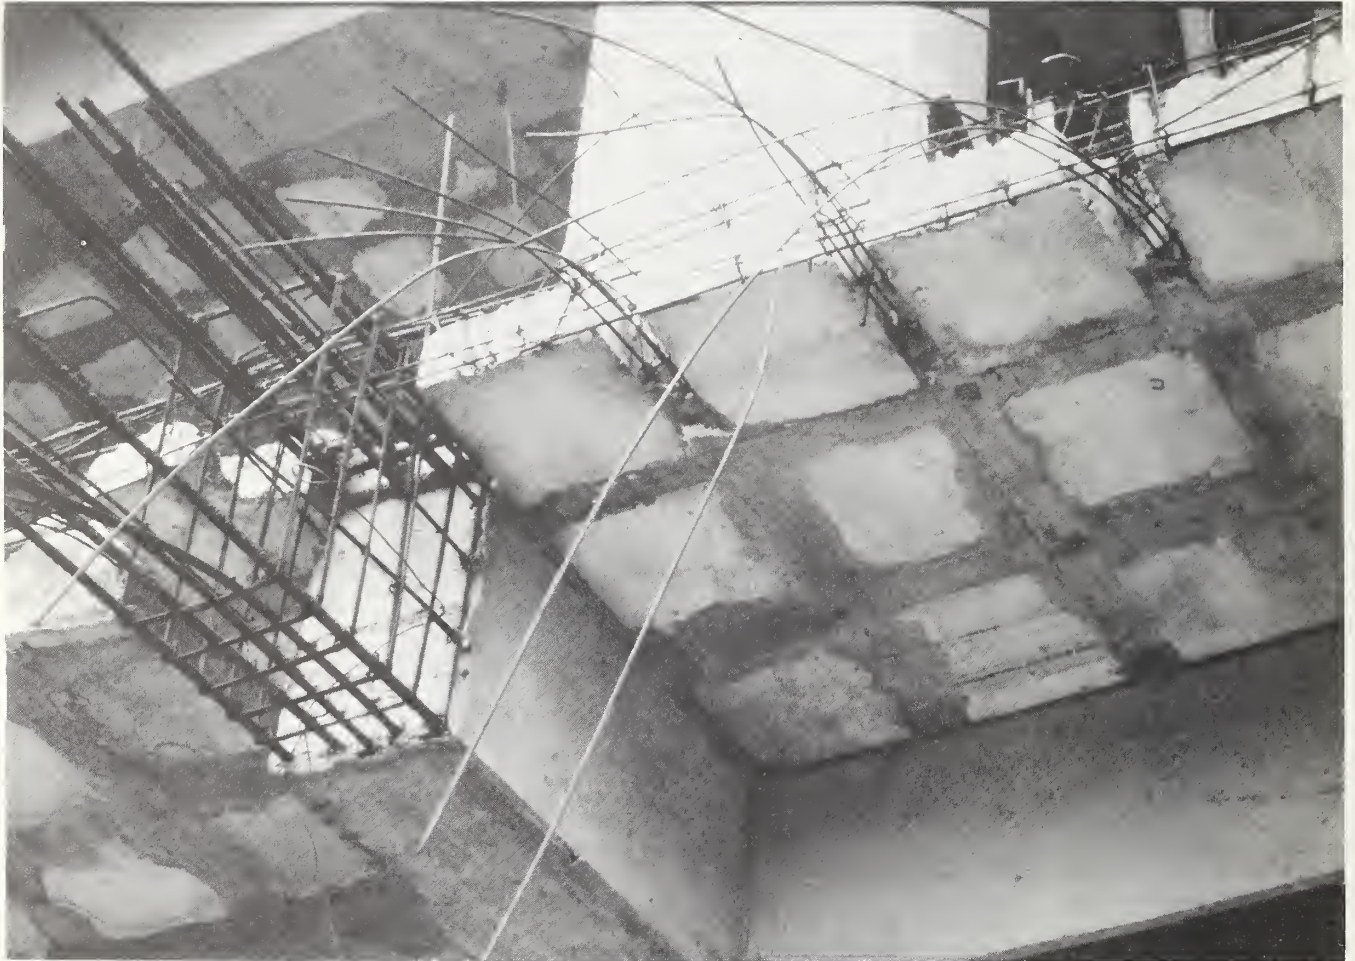
Two unusual variations in waffle slab construction bear mentioning, as they proved to be particularly poor performers during this earthquake. Figure 5.40 shows a new parking garage north of the U.S. Embassy on Ave. Reforma under construction, using rectangular cinder blocks in place of the traditional metal pan forms. The rationale behind this technique was to use readily available, inexpensive cinder block to form the blockout, thereby avoiding the expense of an inventory of metal pan forms while also leaving a smooth ceiling surface for finishing. These cinder blocks are spaced similarly to their metal counterparts, but are left in the structure permanently. Because they are cast into the slab the cinder blocks add to the mass of each floor level.

Figure 5.40. Parking garage under construction on Reforma, north of the U.S. Embassy.

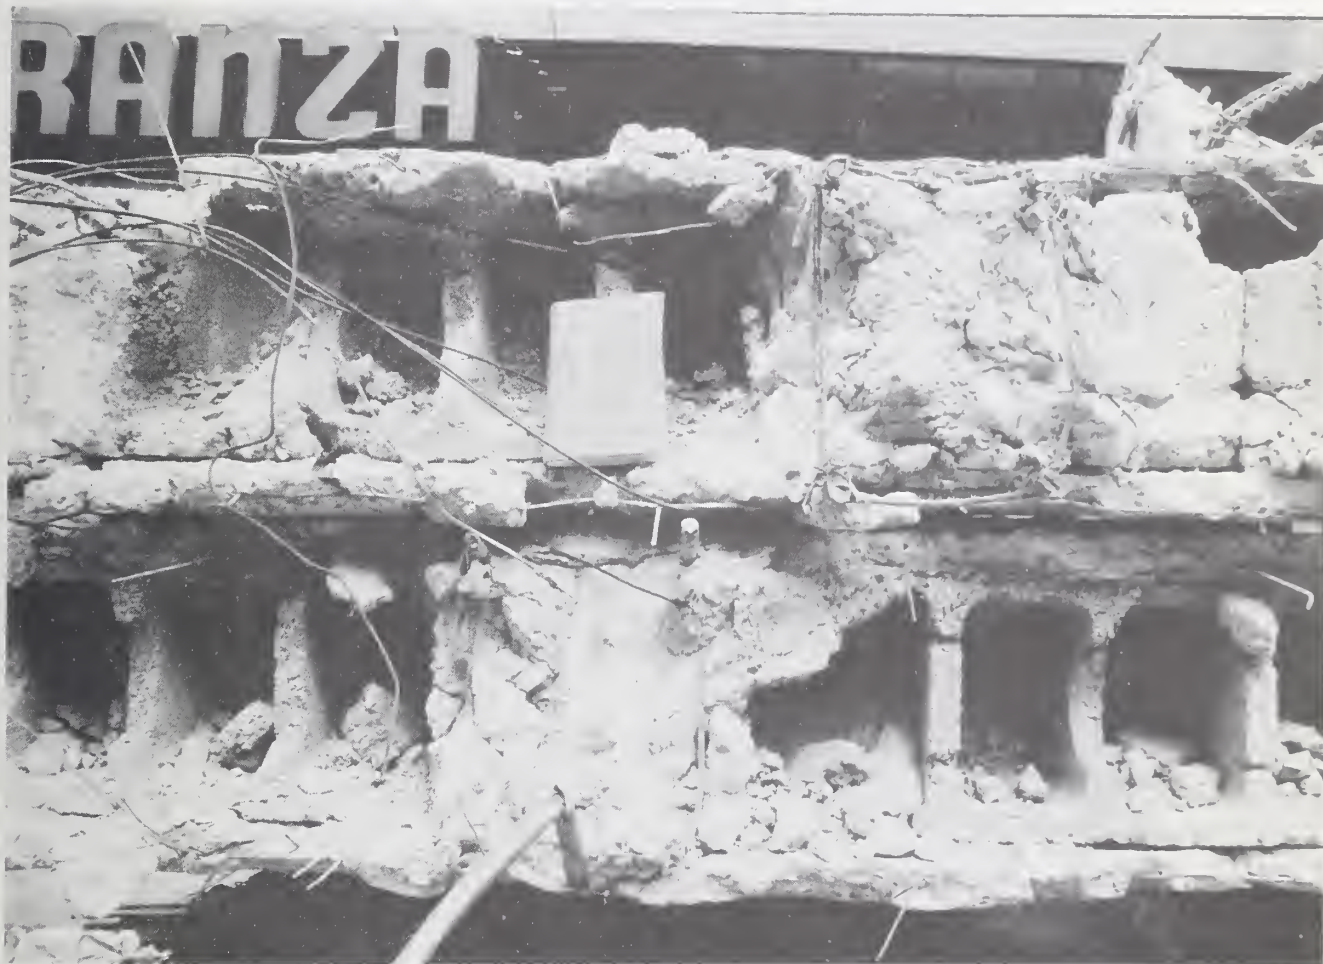
Yet another variation of this form of construction employed standard hollow cinder building block, as shown in figures 5.41. This type of slab was particularly prone to bond failure during reversed cyclic loading, leading to the "floor drop out" phenomenon shown in figures 5.42 and 5.43. In most cases, these same structures contained minimal slab reinforcement placed with

Figure 5.41. Waffle slab construction incorporating concrete block.

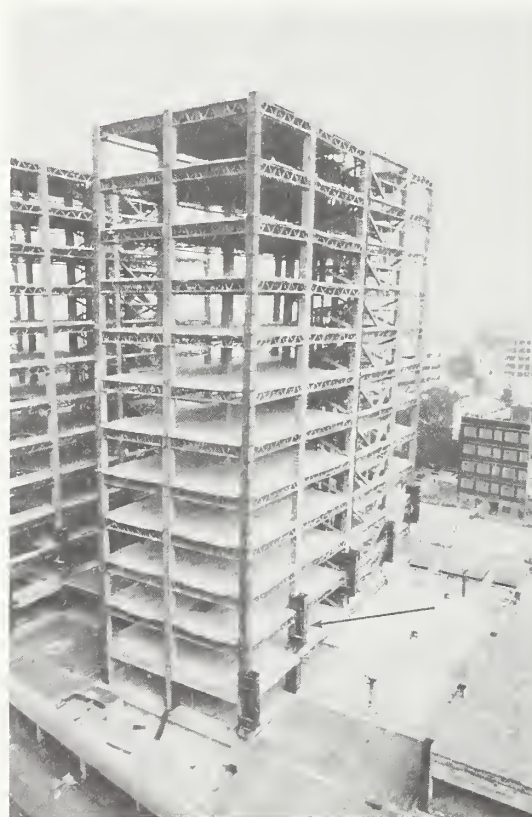
(b) Central 23-story tower (reduced to 14 stories) at Pino Suarez.
Note "C" clamps at bottom right.

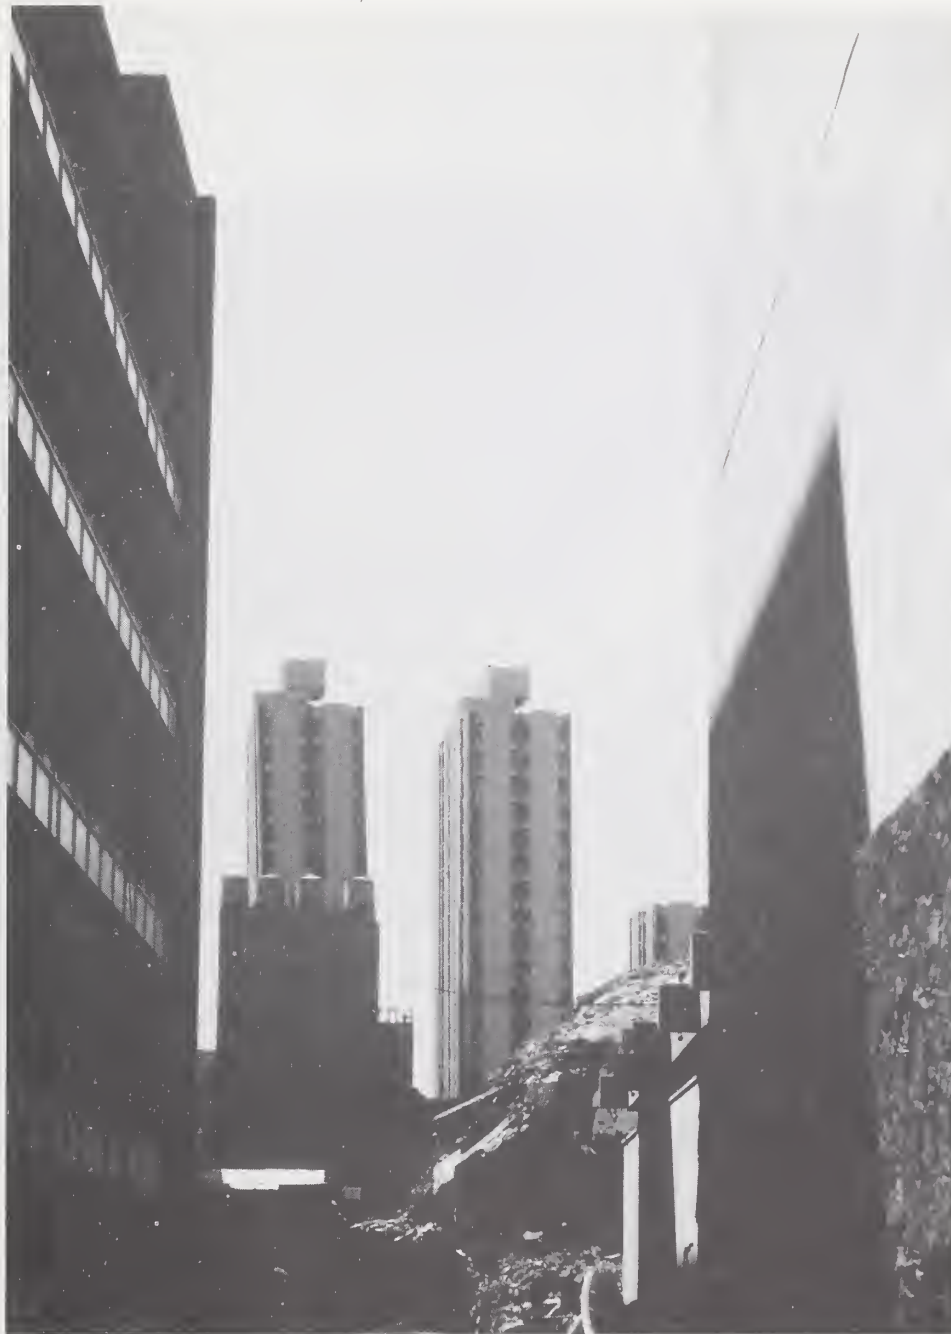
Buckling of columns, and deformations caused by other actions, induced substantial tilt towards the south, as can be seen in figure 5.52. It is highly probable that this situation existed in all three of the 23 story towers prior to the ultimate collapse of the southern-most tower. To complete the collapse mechanism, however, an additional failure was required. Figure 5.53 indicates that the final straw was likely a series of tensile fractures in the box-columns on the north side of the frame, presumably at a joint line near the second story. Lacking this crucial moment resisting element (viewing the structure as a whole) the tower was free to rotate southward, further crushing the southern column line in the process, and eventually impacting on its neighboring 14 story building. Both buildings were subsequently destroyed, leaving the two collapsed buildings in the configuration previously shown in figure 5.44.

Figure 5.52. Tilted central 23-story tower at Pino Suarez Complex. Southern side of structure is to left side.

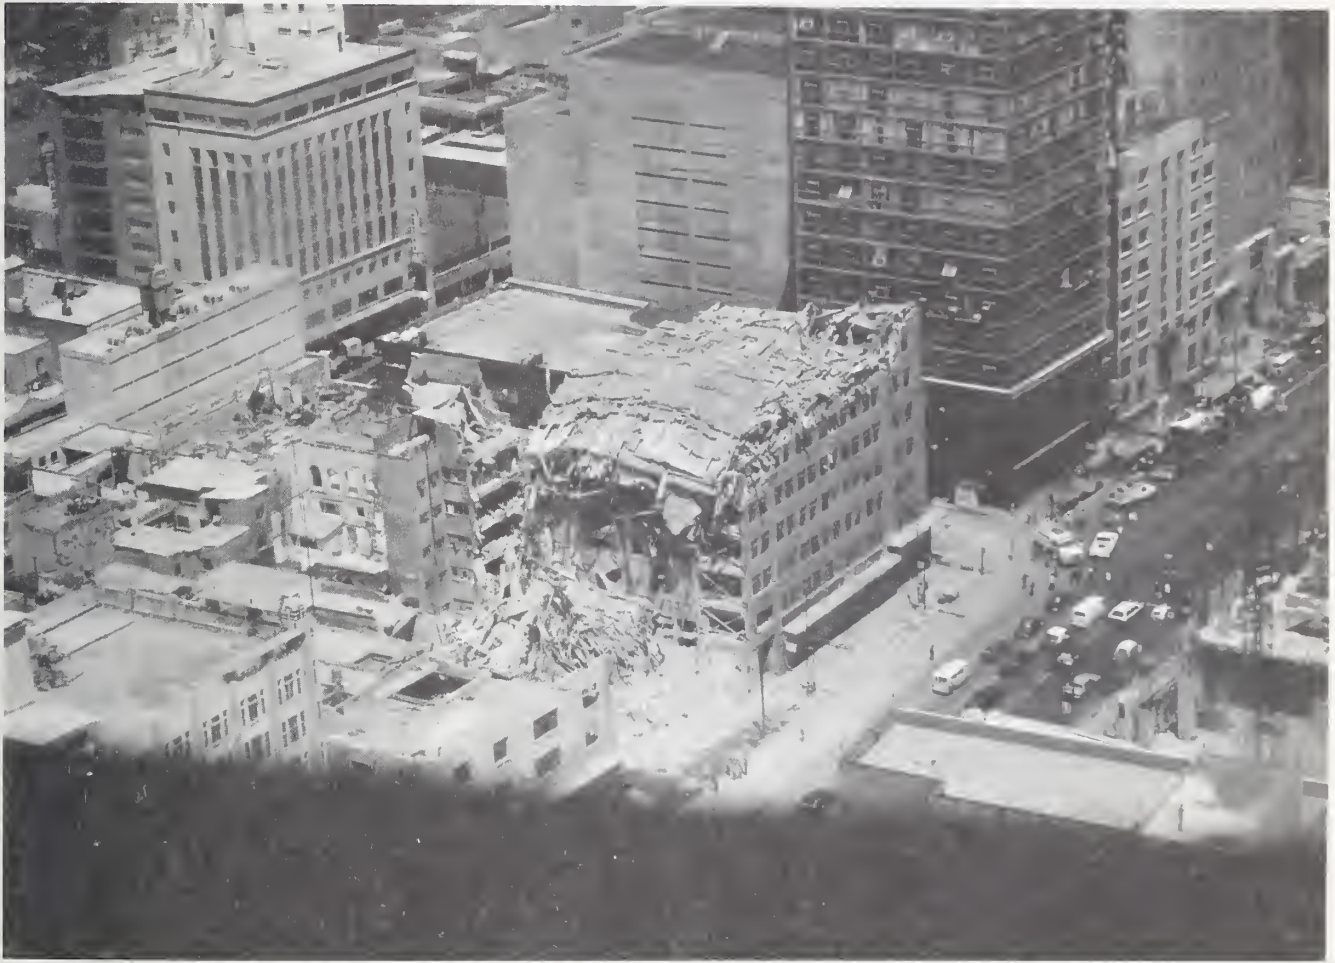
Figure 5.54. Aerial view of the Atlas Building, a typical steel frame structure constructed during the 1940's.

Other steel frame structures performed quite differently from the Pino Suarez Buildings, depending on their location, elevation, and proximity to adjacent buildings. One such example is the Atlas Building (figure 5.54), a 14-story concrete-encased steel frame structure constructed during the 1940's and located just south of Alameda Park on Avenida Lazaro Cardenas. During the 1957 quake this building suffered significant damage to moment-resisting knee braces (steel angles) and was later retrofitted with the diagonal cross bracing visible in figure 5.54.

During the 1985 earthquake the upper seven stories of the building collapsed. The front of the adjacent seven story structure was also destroyed by falling debris from the Atlas building. In the case of the Atlas Building, field evidence indicated that pounding was the principal cause of collapse of the upper floors.

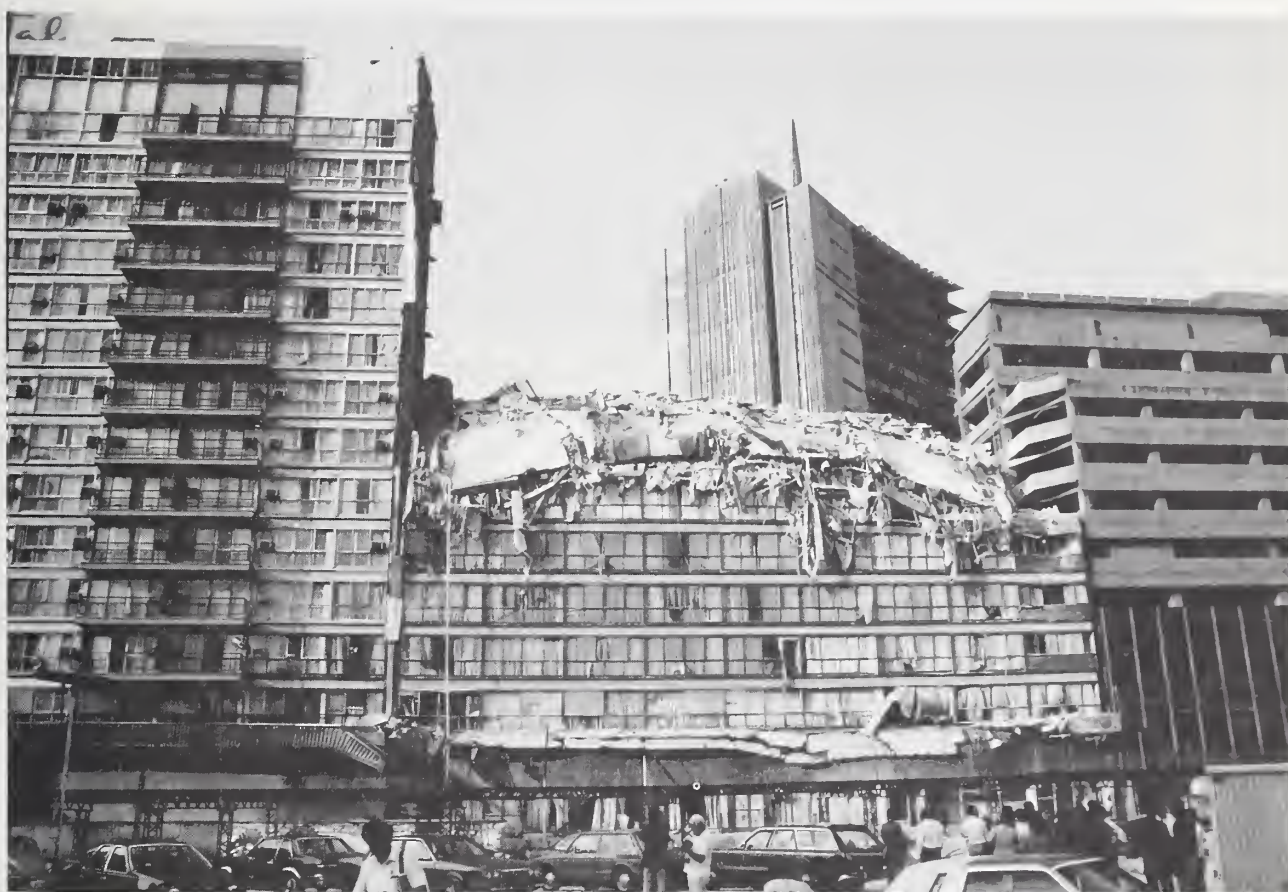
One variant on the pounding problem occurred where expansion joints existed within a structure and where it was possible for the separated substructures to vibrate independently, but where an insufficient "seismic gap" was provided to prevent pounding. An example of this type of failure was the Hotel Continental on Avenida Reforma. The building was V-shaped in plan, largely because of its street corner location, with two independent wings forming the "V" (see figure 5.60). The wing sections, each as tall as the main structure, apparently vibrated out of phase with the stiffer primary building and eventually suffered column failures due to pounding. This, in turn, led to the collapse shown in figure 5.61. Adequate separation between the wings of the building may have prevented such a failure.

Figure 5.61. View looking north of collapsed southern wing of the Continental Hotel on Paseo de la Reforma. The entire complex was subsequently dynamited.

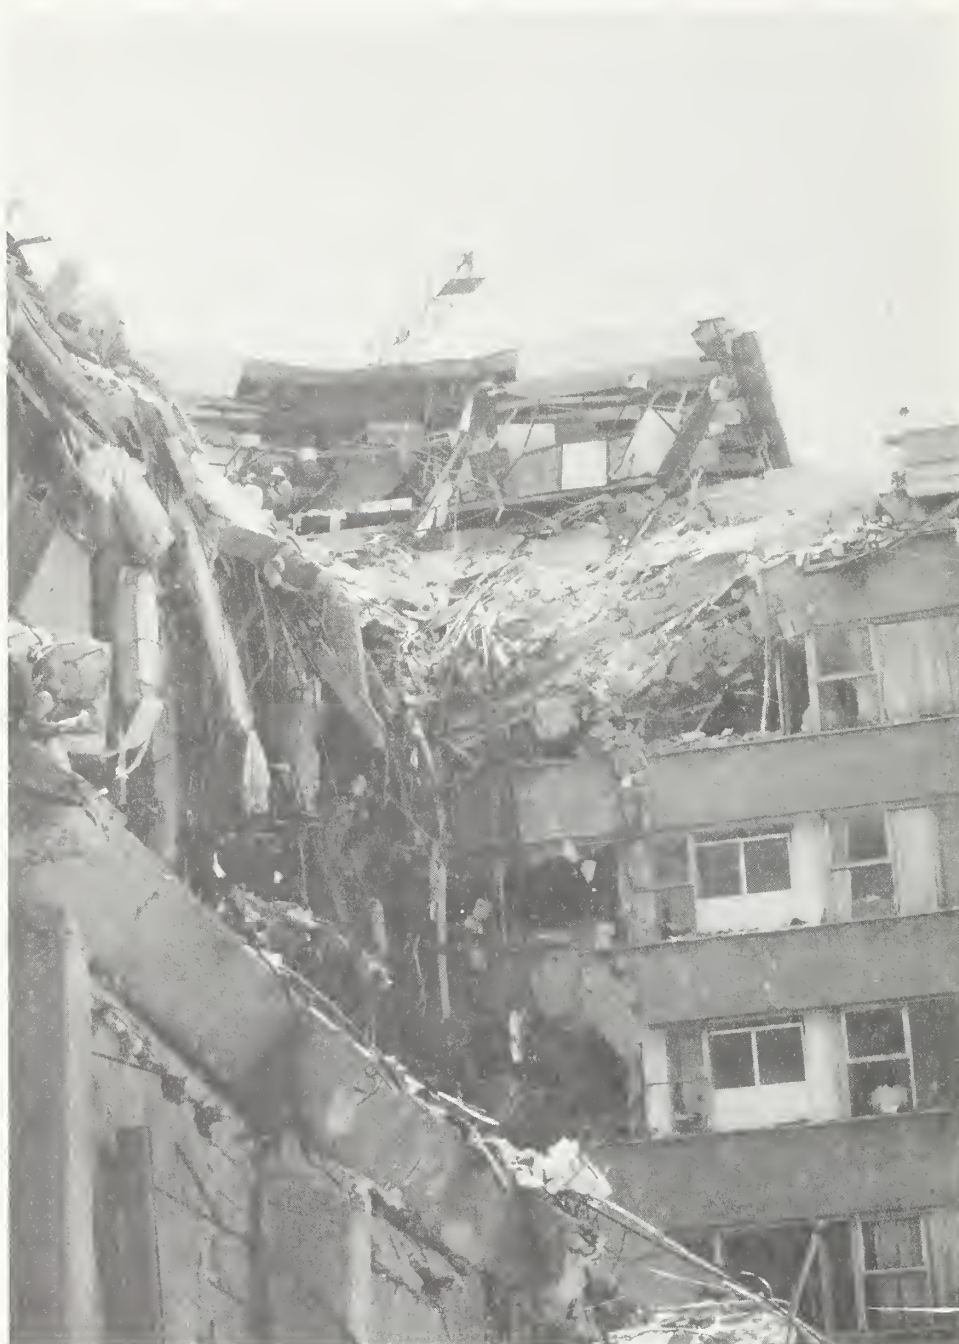
An example in which building configuration appeared to have led to torsional response during the Mexico Earthquake is illustrated by the 12-story SCT (Secretaria de Comunicaciones y Telegrafos) complex (figure 5.62) on Ave. Lazaro Cardenas, approximately two kilometers south of the central historic portion of the city. The earthquake precipitated a progressive collapse which started near the top of the building at the inside northwest (re-entrant) corner as shown in figure 5.63. The collapse was probably triggered by failure of one of the upper columns (which are often of smaller cross-section and lighter-weight concrete in Mexico City) and then propagated by means of corner column failures along the north face of the west wing and the west face of the north wing of the T as can be seen in figure 5.64. The resulting progressive slab collapse was arrested at the 8th floor, where the 7th floor columns were sufficient to resist the impact load from the collapsing upper stories.

Figure 5.63. Northwest re-entrant corner of SCT Communications Building showing likely initiation point of collapse.

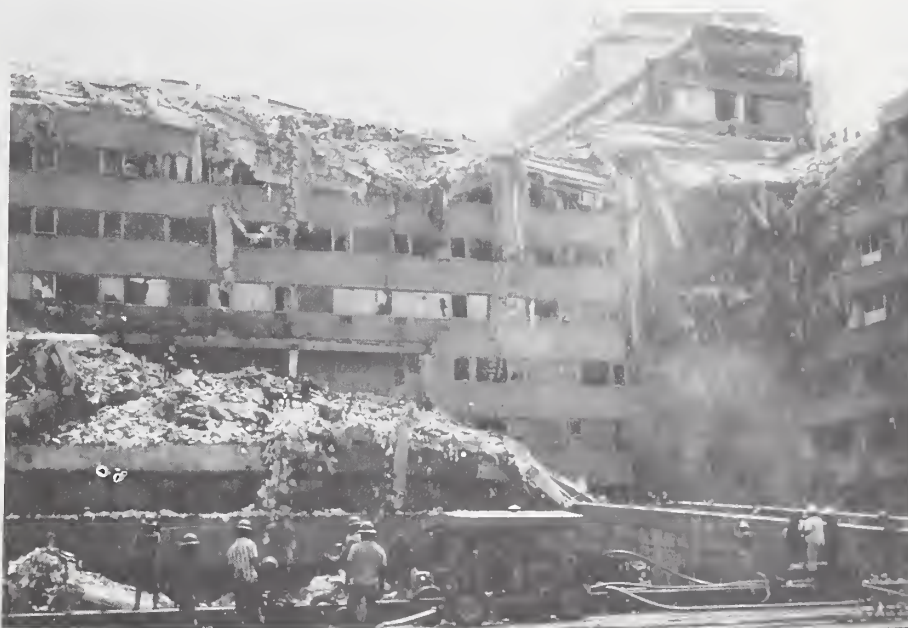
(b) West side of SCT Building.

Figure 5.64. SCT Communications Building showing extent of progressive collapse.

Later discussions with Mexican engineers [36] indicated the presence of a vertical expansion joint between each of the wings, which partly explains why the damage did not progress into the eastern wing of the structure. This would have permitted independent vibration to take place in the various sections of the building leading inevitably to collisions between the various components (i.e., pounding). In either case, T-shaped section or construction joint with insufficient separation to prevent drift interaction, the brunt of the damage would have been sustained at the same junction location. The complex is undergoing renovation and the height was reduced to a uniform 5 stories as of September 1986. The nearby SCT tower sustained negligible damage and offices were in use shortly after the earthquake.

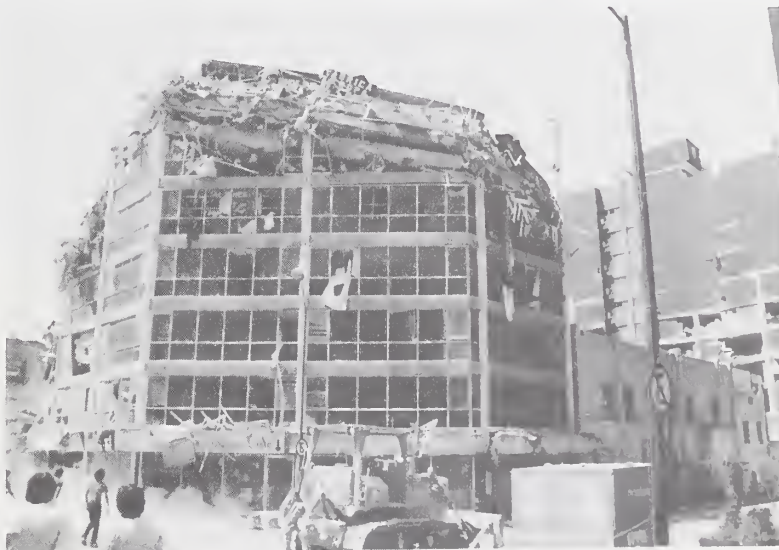
Lateral forces that a building must resist during an earthquake are greatest near the base of a structure. It is thus somewhat surprising that the third largest category of structural collapses listed in Table 4.1 was that of failures in the upper stories of buildings. In many cases observed during the field investigation (as for example the structures shown in figure 5.67), pounding was not a factor since there were no adjacent structures. This left only two likely reasons for the ubiquitous nature of this failure mode. The first is the apparently common practice of reducing column dimensions with story height in an effort to save on material costs (which in Mexico are of greater concern than labor costs). This practice is clearly demonstrated in figures 5.68 and 5.69 which show the upper story collapse initiating at the point of a general change (reduction) in column stiffness. In the case of the building shown in figure 5.68 (the eight story LACSA Building on the corner of Reforma and Marne Streets) the upper two story steel-framed penthouse was a later addition to the lower six story concrete frame. Figure 5.68 a indicates that most of the damage was confined to the penthouse.

(b) Upper story failure in clothing store.

Figure 5.67. Typical upper story failures in building where pounding did not occur.

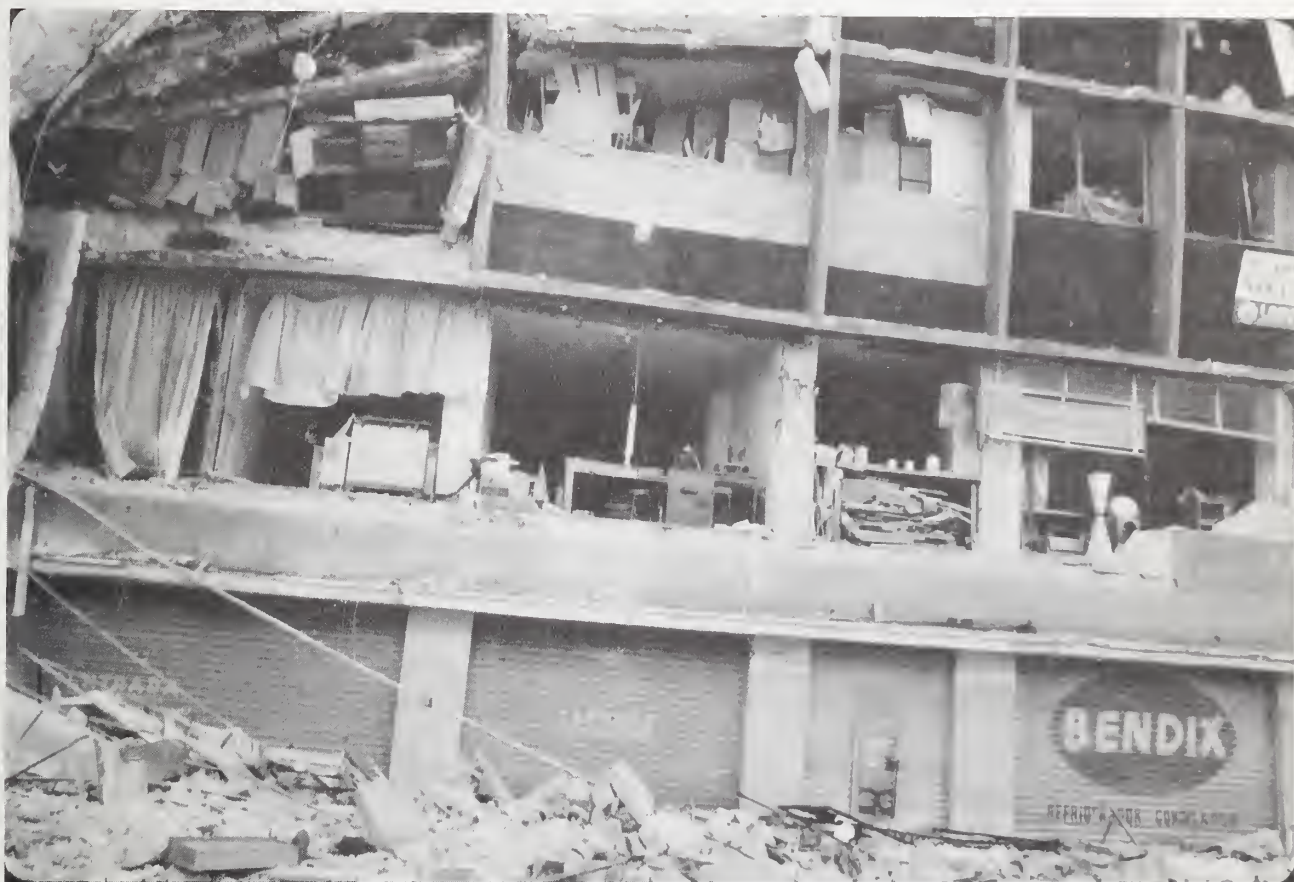
Figure 5.69. Commercial building showing large changes in column stiffness in upper stories.

The tendency to make room for additional office space by constructing "add-on" upper floors is common practice throughout Mexico, particularly where land is at a premium in urban centers. Because of the desirable nature of the lower stories for office space and living quarters, the add-on upper stories are often used to store merchandise or archival records, especially in the case of federal government buildings.

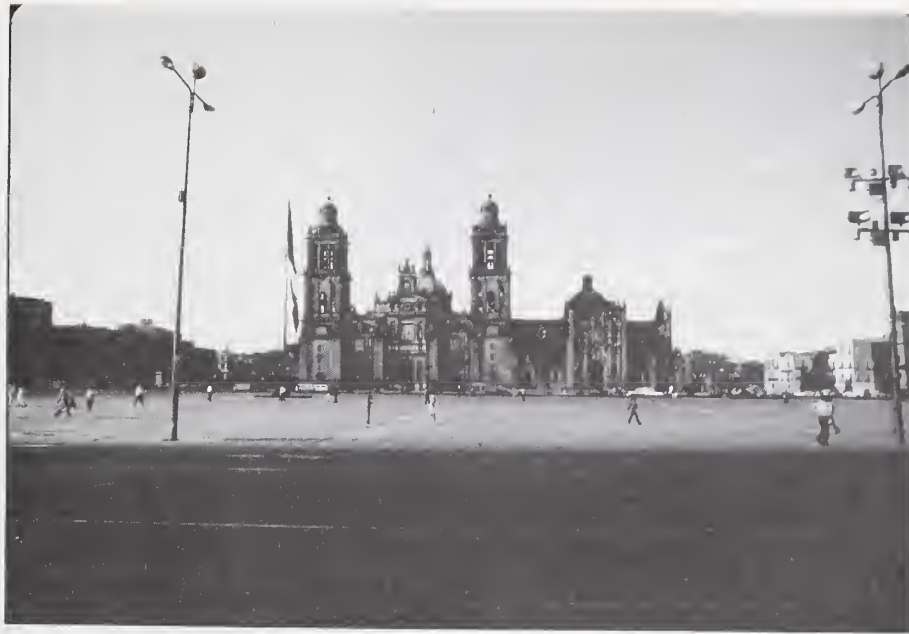
Some of the most effective "survivors" in terms of structural performance during the 1985 earthquake were the historic stone masonry churches and colonial office buildings (see figure 5.70). These buildings have withstood numerous previous earthquakes. In terms of structural behavior the endurance of these buildings may be attributable primarily to their exceptional stiffness. Since the height of these buildings is limited, these structures in general have short fundamental periods of vibration. Therefore, in the lakebed of Mexico City, these structures were out of the range of the spectral peaks of the earthquakes. Furthermore, over the years, powerful earthquakes removed the less earthquake resistant structures.

Figure 5.70. Colonial stone masonry structures (National Palace and Cathedral) have short natural periods of vibration and performed well in the earthquake.

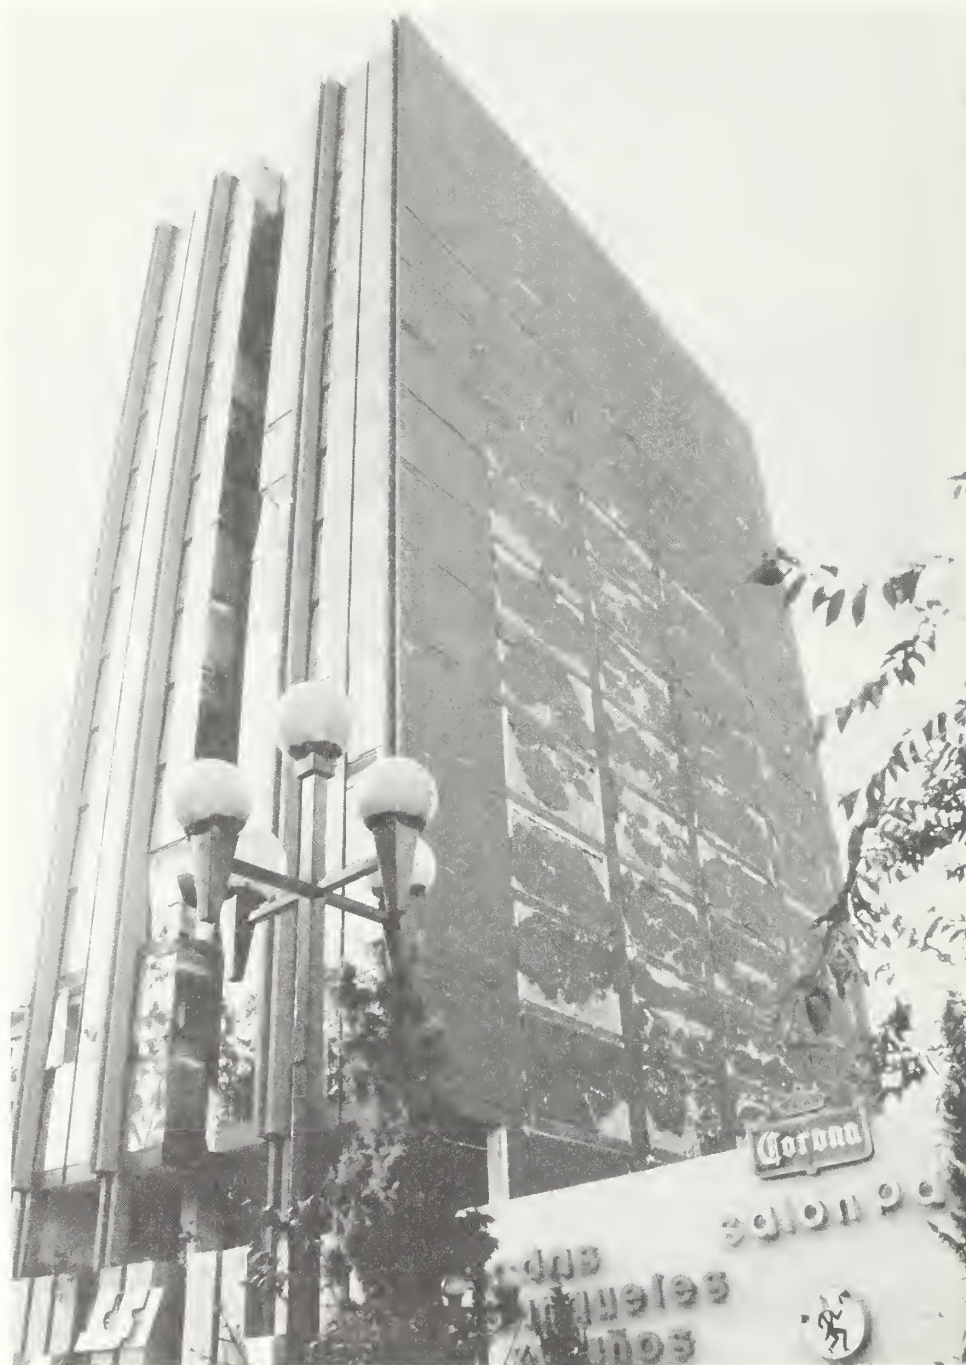
There are few modern buildings in Mexico City which employed reinforced masonry, as is commonly used in other parts of the world. Low rise, unreinforced masonry construction is very common for houses, apartments, and commercial buildings. The most general use of masonry in Mexico City, however, is for unreinforced infill walls for high rise frame structures (figure 5.71). While a number of medium and high rise buildings did suffer infill wall damage (figure 5.72), infill walls generally had a beneficial effect on structural performance [27]. This was accomplished by increasing the structure's lateral stiffness and thus reducing its fundamental period of vibration, and by providing or augmenting lateral-load resistance. Both of these

Figure 5.71. Typical high-rise reinforced concrete building with masonry infill walls.

effects served to improve performance under earthquake loading. Stiffening of structures was an advantage in Mexico City primarily due to the unusual soil conditions which produce ground motions with periods considerably longer than those experienced in most urban centers around the world. In those areas where relatively firm subsoil conditions exist, such stiffening could actually increase the lateral loads.
