NBS BUILDING SCIENCE SERIES 86

Engineering Aspects of Cyclone Tracy Darwin, Australia, 1974

Marshall, Richard D.

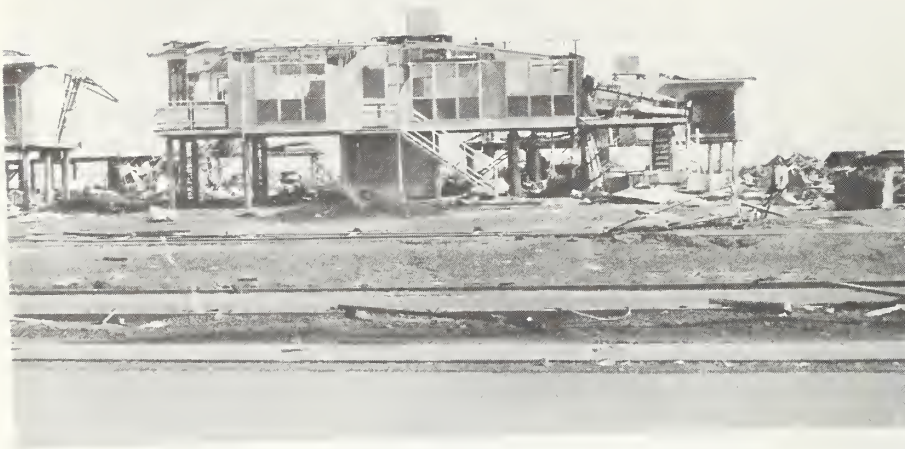
Fig. 3. Typical high-set house

By far the most popular style of house in Darwin is the so-called "high-set" house constructed for the Department of Housing and Construction. Although there are several variations the basic unit consists of an elevated platform and light timber frame with a gable roof (see Figure 3). The plan dimensions are approximately 7 x 16 meters with the platform some 2.5 meters above ground. Prior to 1968 galvanized steel pipe columns with cross-bracing were used to support the platforms (see Figure 4). These were superseded by concrete columns on simple spread footings and the cross-bracing was replaced by concrete block shear walls installed between 4 adjacent columns, the resulting enclosure serving as a laundry room or storage space.

The high-set houses performed reasonably well in the older subdivisions such as Fannie Bay and Larrakeyah where there was some protection provided by other buildings and trees and where the wood frames contained diagonal bracing. Many of these older houses were roofed with corrugated asbestos cement sheets. In the northern suburbs, however, the new high-set houses suffered extensive damage. The failure of upwind buildings created a source of missiles which undoubtedly played a major role in the widespread damage observed in the northern suburbs. This tended to be a self-sustaining effect as other structures failed downwind. The sequence of failure is believed to have been loss of roof cladding and purlins, followed by collapse of roof trusses and large unsupported walls, particularly in the living rooms. The racking strength of the walls was reduced by missiles fracturing the asbestos cement cladding and these sheets completely failed once racking deformations occurred. In many cases the entire wood frame was removed from the elevated platform (see Figure 5). The piers and platforms generally remained intact, but there were cases where the entire structure collapsed or where the piers were racked following failure of the concrete masonry shear walls due to overturning (see Figure 6). No failures of the older steel pipe columns were observed (see Figure 4). A typical connection between the concrete pier and floor beam is shown in Figure 7. Note that the floor joists are toenailed to the nailing strips which are attached to the steel beams by "Ramset" studs. Some high-set houses used metal cladding on the endwalls as seen in Figure 6 and this generally performed very well, being much more resistant to missile impact than the asbestos cement cladding. The cyclone bolts which were installed in all houses built after mid-1972 (see Figure 8) do not appear to have made any significant difference in performance since the main problem was a lack of racking strength once the asbestos cement cladding had failed. Many instances of endwall failure were observed (see Figure 9), suggesting inadequate corner connections and roof-wall connections at the gable ends. The performance of roof cladding is dealt with in a separate section of this report.

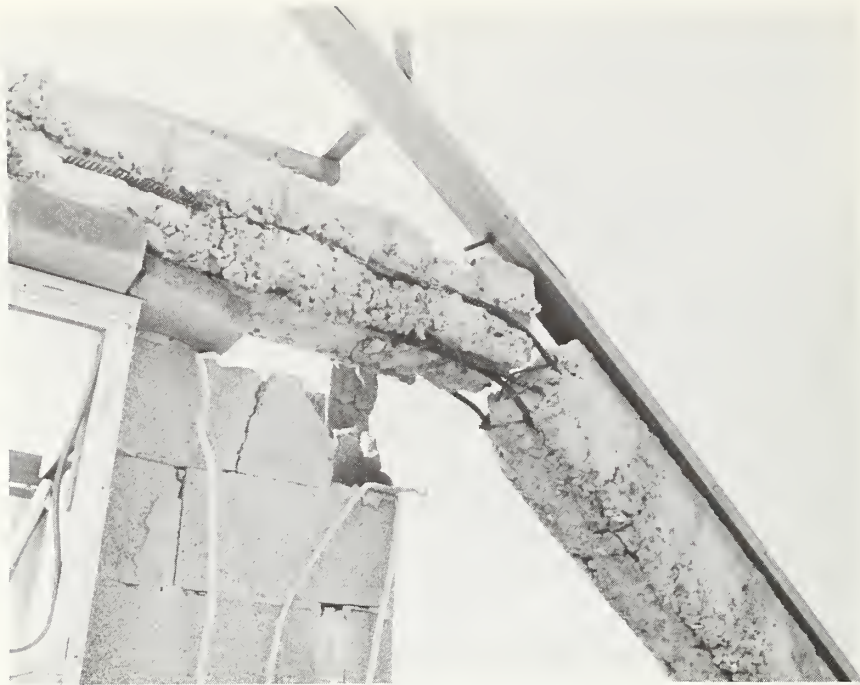
Fig. 11. Concrete bond beam and timber plate
(single-story construction)

Houses constructed for the Northern Territory Housing Commission were, for the most part, single-story slab-on-grade structures. There were several variations of this system but the cavity wall with bond beams was by far the most common. A typical cavity wall is shown in Figure 10. In several cases bond beams were provided only along the sidewalls and were inadequately tied through the walls to the footings (see Figure 11). This system generally performed very poorly with many cases observed in which the entire roof structure was removed intact and the ties between inner and outer leafs or wythes (each continuous vertical section of wall one masonry unit in thickness) of the cavity walls appeared to be inadequate. Both brick and concrete block were used for the exterior wythe. A few of the newer houses were of timber frame construction with brick veneer on the endwalls. Overall performance of this type of construction was generally poor. Some units in Wanguri and Anula, under construction at the time of Cyclone Tracy, utilized precast-tiltup concrete panels and performed exceptionally well.

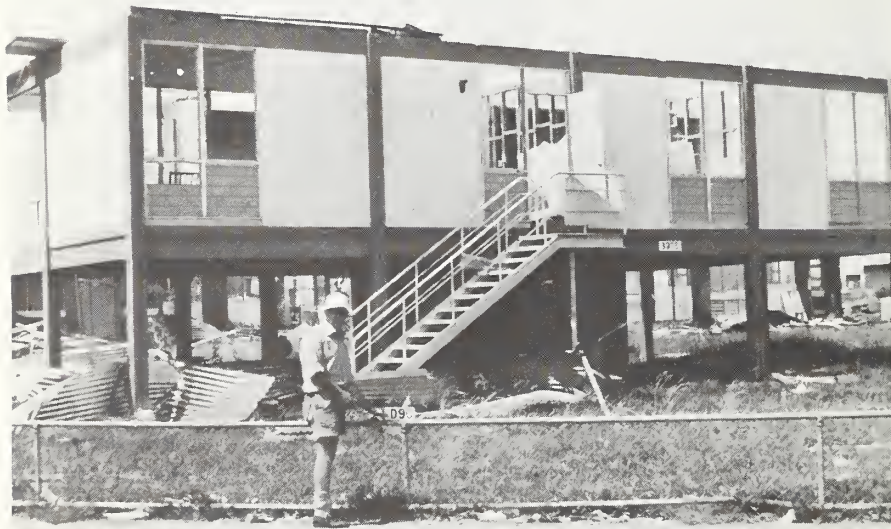
Fig. 12. High-set house with precast concrete frame and interlocking precast concrete panels.

Of the several prefabricated housing systems used in Darwin, only two were investigated in some detail and are described herein. The first is a high-set house with the same general floor plan and overall dimensions as the timber high-sets constructed for the Department of Housing and Construction (see Figure 12). All components are of precast concrete with welded and grouted beam-column connections. Columns are 200 x 200 mm in cross-section and the beams are 300 mm deep and 75 mm wide. The floor and roof panels are approximately 50 mm thick except for the edges which are 100 mm thick. A screed course is placed over the floor panels and the roof panels are bolted into sockets provided in the top edge of the beams. Wall panels lock into slots provided in the beams and columns. Conventional aluminum window frames, jalousie windows and metal louvers are also used in these houses. A conventional truss-purlin-CGI roof is placed over the ceiling panels, the timber plate being bolted down with the precast ceiling panels. This system would have performed very well had it not been for the fact that anchor bolts were installed only along the perimeter of the roof, even though the interior ceiling beams contained bolt sockets (see Figure 13). The result was that many of the panels were lifted from the interior beams, causing the perimeter anchors to fail.
