NBS BUILDING SCIENCE SERIES 94

Investigation of the Skelton House Collapse
in Fairfax County, Virginia

Investigation of the Skyline Plaza Collapse in Fairfax County, Virginia

NBS Building Research Institute, Inc. 34
Edgar V. Leyendecker and S. George Fattal

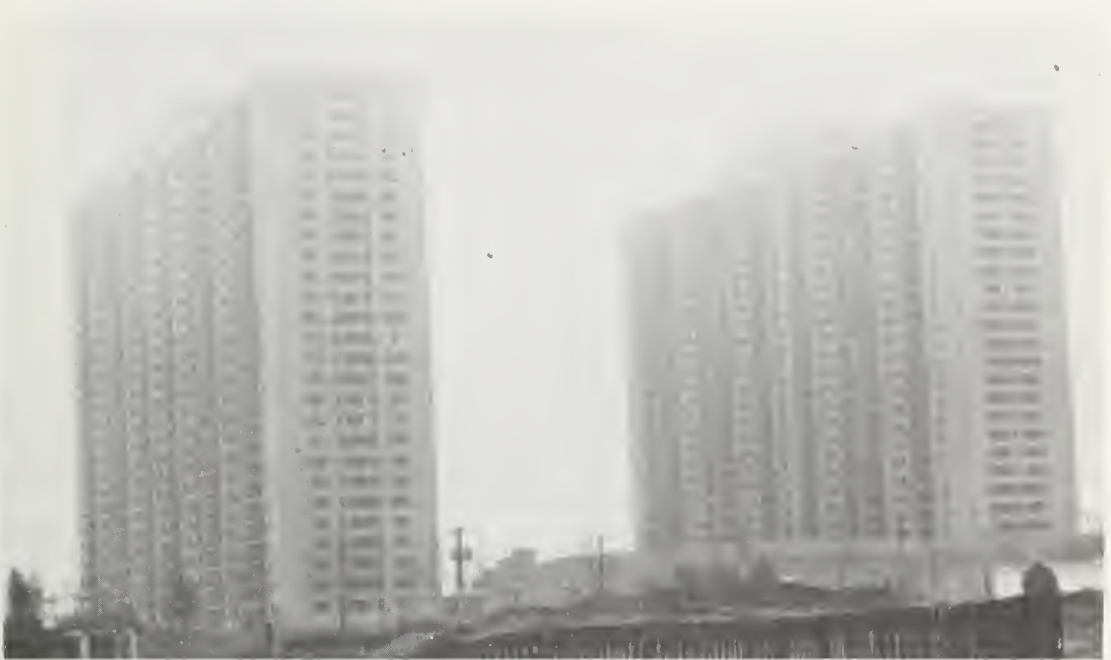
Figure 1.1 Appearance of completed apartment buildings.

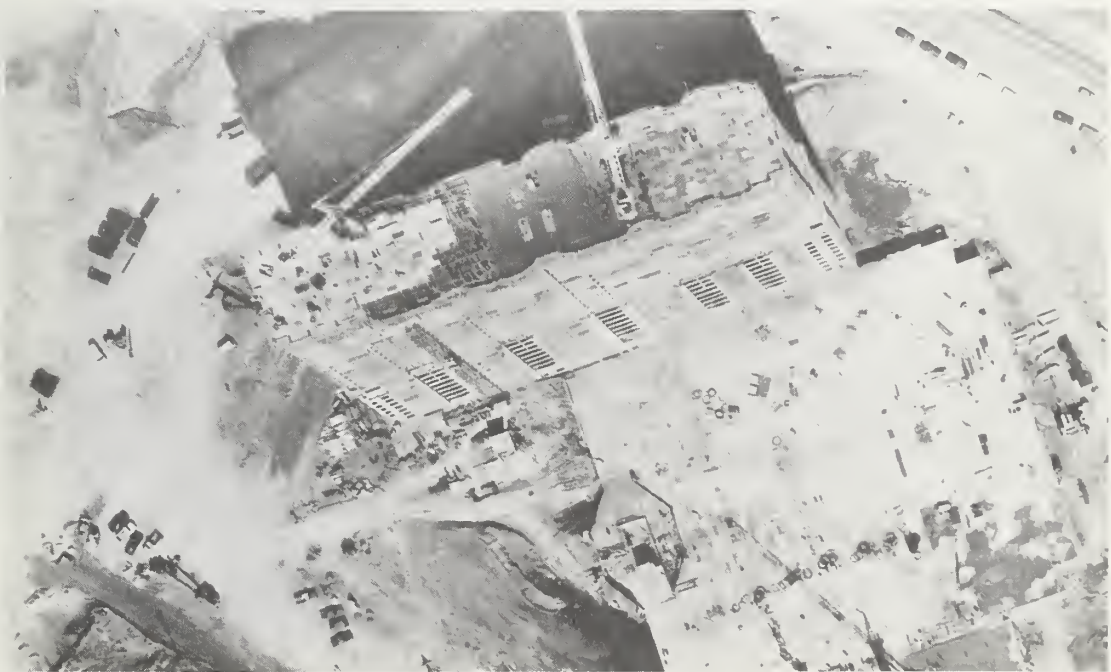
The apartment buildings under construction are shown in figure 1.2, an aerial photograph taken at about 11:00 a.m. on Friday, March 2, 1973, from an altitude of 5000 ft [18]. Several hours later, at about 2:30 p.m., a portion of the building shown in the top of figure 1.2 collapsed. The collapsed portion of the building was located approximately under the slab area being cast (in figure 1.2) and extended vertically for the full height of the building, 23 stories plus four basement stories. The collapse progressed horizontally from the tall building to include the entire parking garage area and stopped at the building shown at the bottom of figure 1.2. The full extent of the collapse is shown in figure 1.3. It has been reported by OSHA that fourteen construction workers were known to have been killed, four in the garage and ten in the tower, and another 34 injured in the incident.

*Figure 1.2 Aerial view of construction at 11:00 a.m.,
March 2, 1973 (north is to the top).*

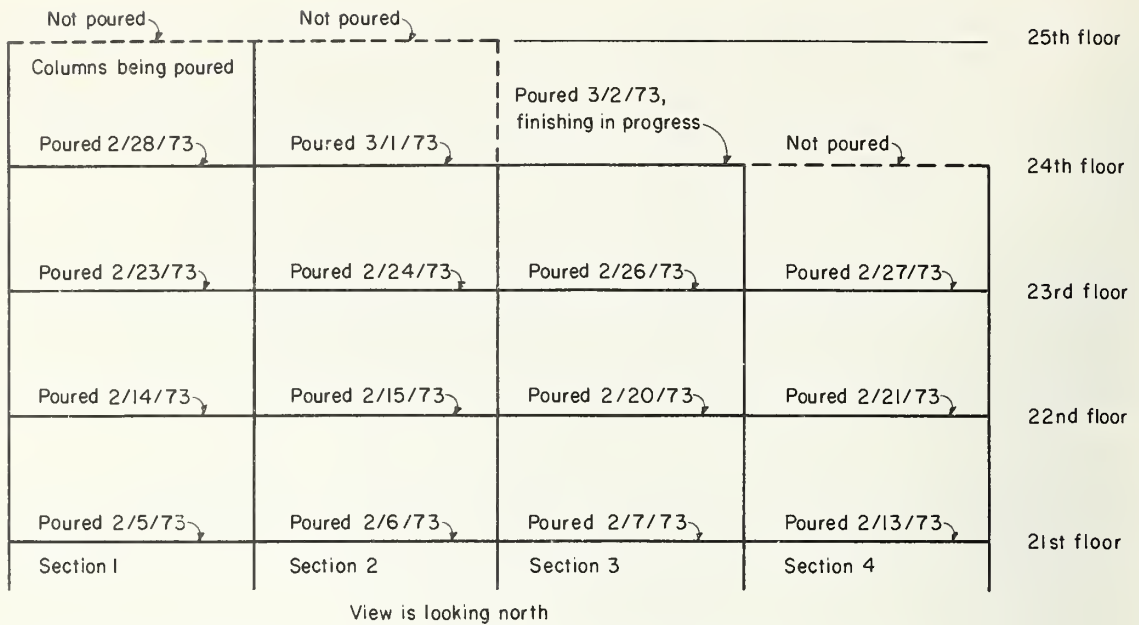
A typical floor of the building was poured in four sections; the progress of construction at the time of the collapse is shown in figure 2.2 [18]. The actual sizes of the pour sections are shown in figure 2.1. Note that the sections are not equal in size and configuration. According to statements provided to OSHA, a normal construction rate was one section a day. This rate of construction would permit the completion of one floor per week and allow an extra day for weather variation. In actual practice, this rate was not always maintained as indicated in figure 2.3.

Figure 2.2 Extent of construction at the time of collapse.

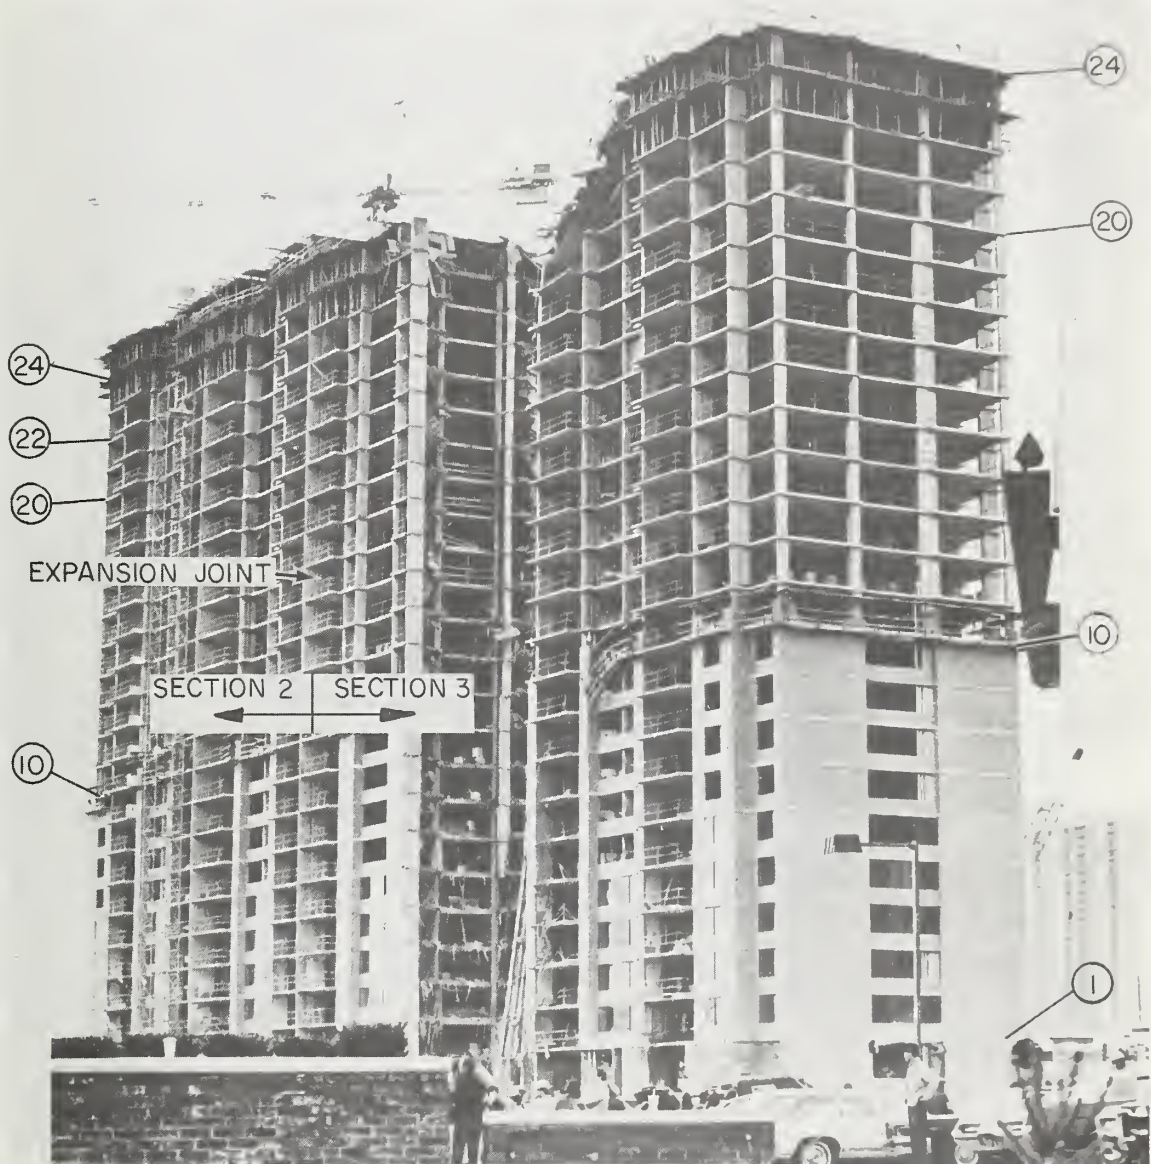
Figure 2.15 shows the locations of the formwork on March 2, shortly after the collapse. Full formwork was in place on the 24th and 23rd stories in sections 1 and 2 (refer to figure 2.1 for location). Some formwork may be seen on the 22nd story in sections 2 and 3. In section 2 this is primarily the area around the material elevator shown toward the western end of the south elevation in figure 2.15. Investigation by OSHA personnel on March 5 indicates that the only formwork not stripped on the 22nd story in section 2 was around that elevator. Employee statements indicate that this area was not stripped in order to prevent lumber from falling on bricklayers working below. Formwork may also be seen in section 3 of the 22nd story in figure 2.15. However, closer examination of the 22nd story in figure 2.10 indicates that formwork was stripped in the center portion of the 22nd story.

Full formwork was also in place under section 4 on the 22nd and 23rd stories. No reshoring can be seen under section 4 below the 22nd floor in figure 2.15 or in figures 2.4, 2.5, and 2.6. Some employee statements indicate, however, that reshoring was present below pour 4 on the 21st story. Other statements contradict this.

Figure 2.15 General appearance of building A-4 as viewed from the southeast.

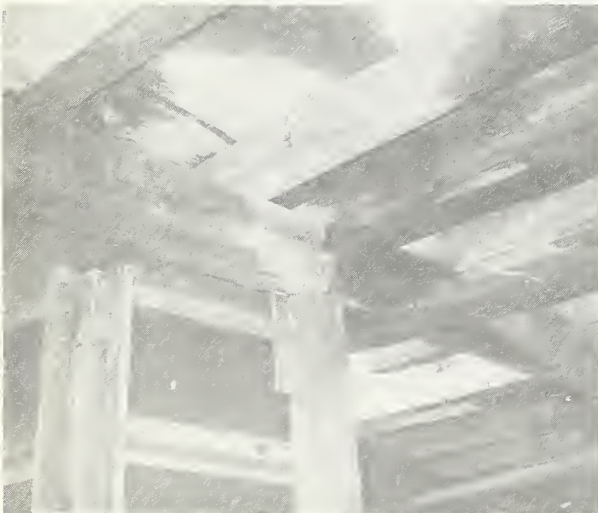
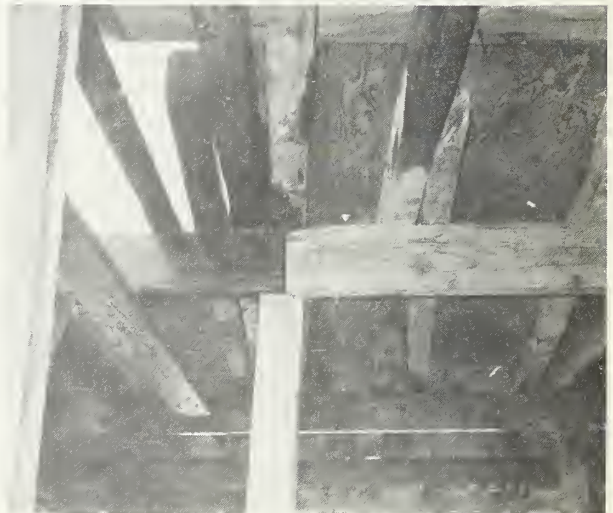
During the NBS site inspection, a considerable portion of the lumber used for the remaining forms in the 24th story was found to be in poor condition or out of plumb. For instance, the top photograph in figure 2.18 shows a stringer with a battered end directly over the shore. The second photograph illustrates a shore which is out of plumb and has a vertical crack near the top. OSHA regulations (ANSI-A10.9, sections 8.1.24 and 8.1.25) [2] require correction of both of these conditions prior to placing concrete (which was not yet placed on these forms).

Figure 2.18 Selected details of 24th story forms.

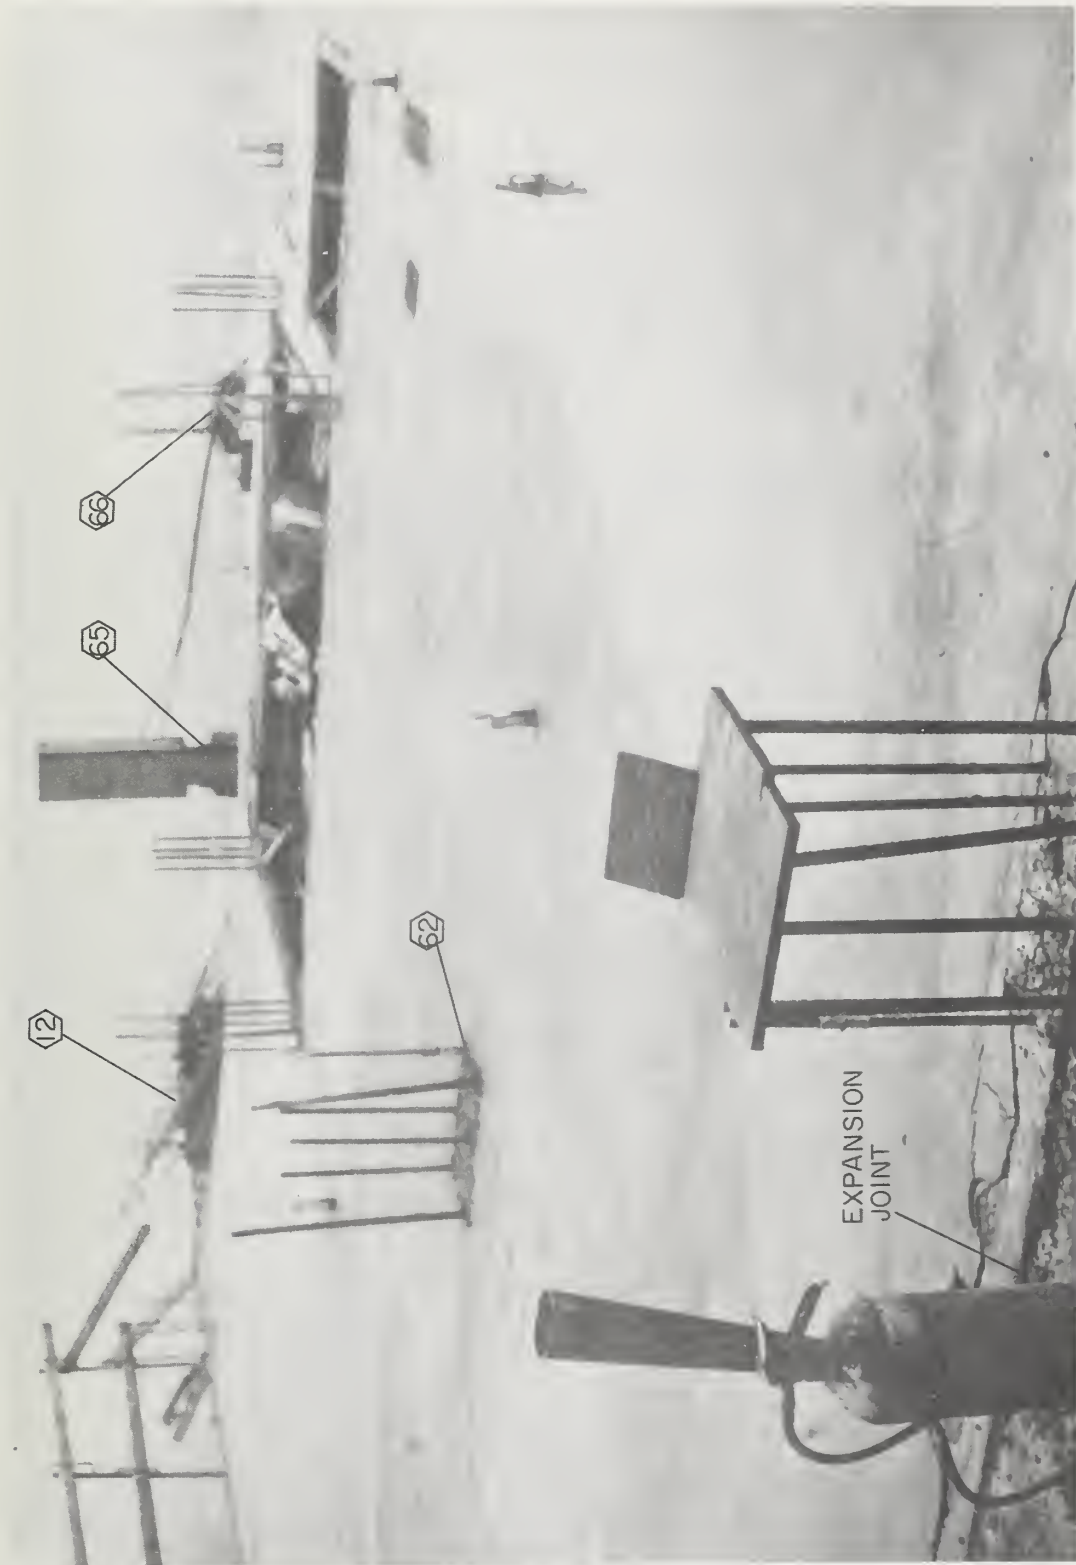
The portion of section 3 of the 24th story slab which remained standing is shown in figure 2.19. This portion of the slab was several hours old at the time of the collapse. Apparently, the only activity on the slab at the time of collapse was work being done by concrete finishers. One concrete finisher working near the stair well (around columns 65 and 66) indicated that a large deflection was seen in the middle of section 3. The statements of numerous employees agree on this point. No statements provided an exact location of the sag. However, the middle of section 3 is about midway between columns 67 and 85 (refer to figure 2.1 for location).

Figure 2.19 Twenty-fourth floor slab in section 3, looking east.

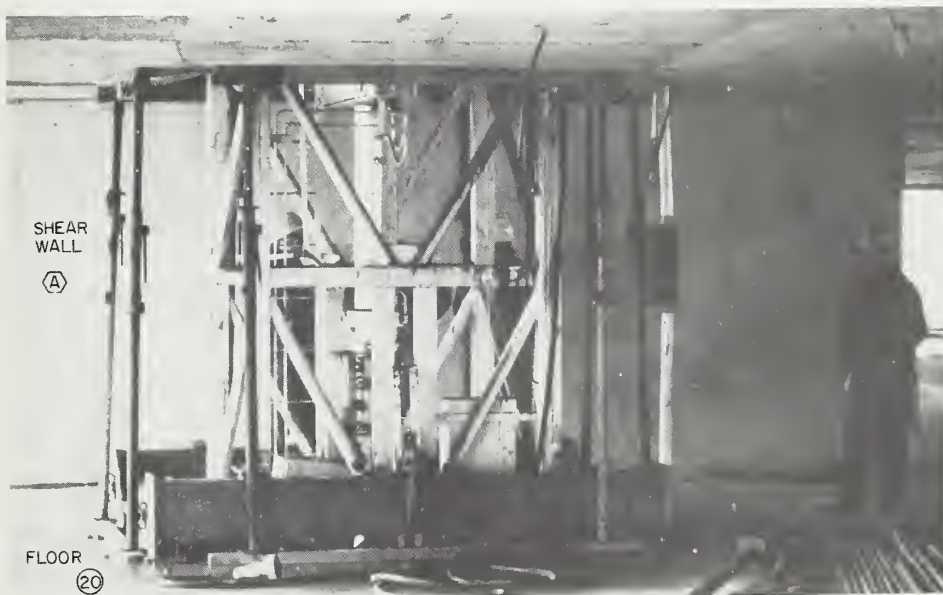
Crane no. 1 was supported by the climbing frame, the lower support, on the 20th floor as shown in figure 2.33. The upper support was provided on the 22nd floor as shown in figure 2.34. This total distance is 18 ft, slightly less than the manufacturer's specified 18 ft 4 in. A typical corner clamp detail on the 22nd floor is shown in figure 2.35. Note the cracked slab where the clamp is attached.

Figure 2.33 Climbing frame for crane no. 1.

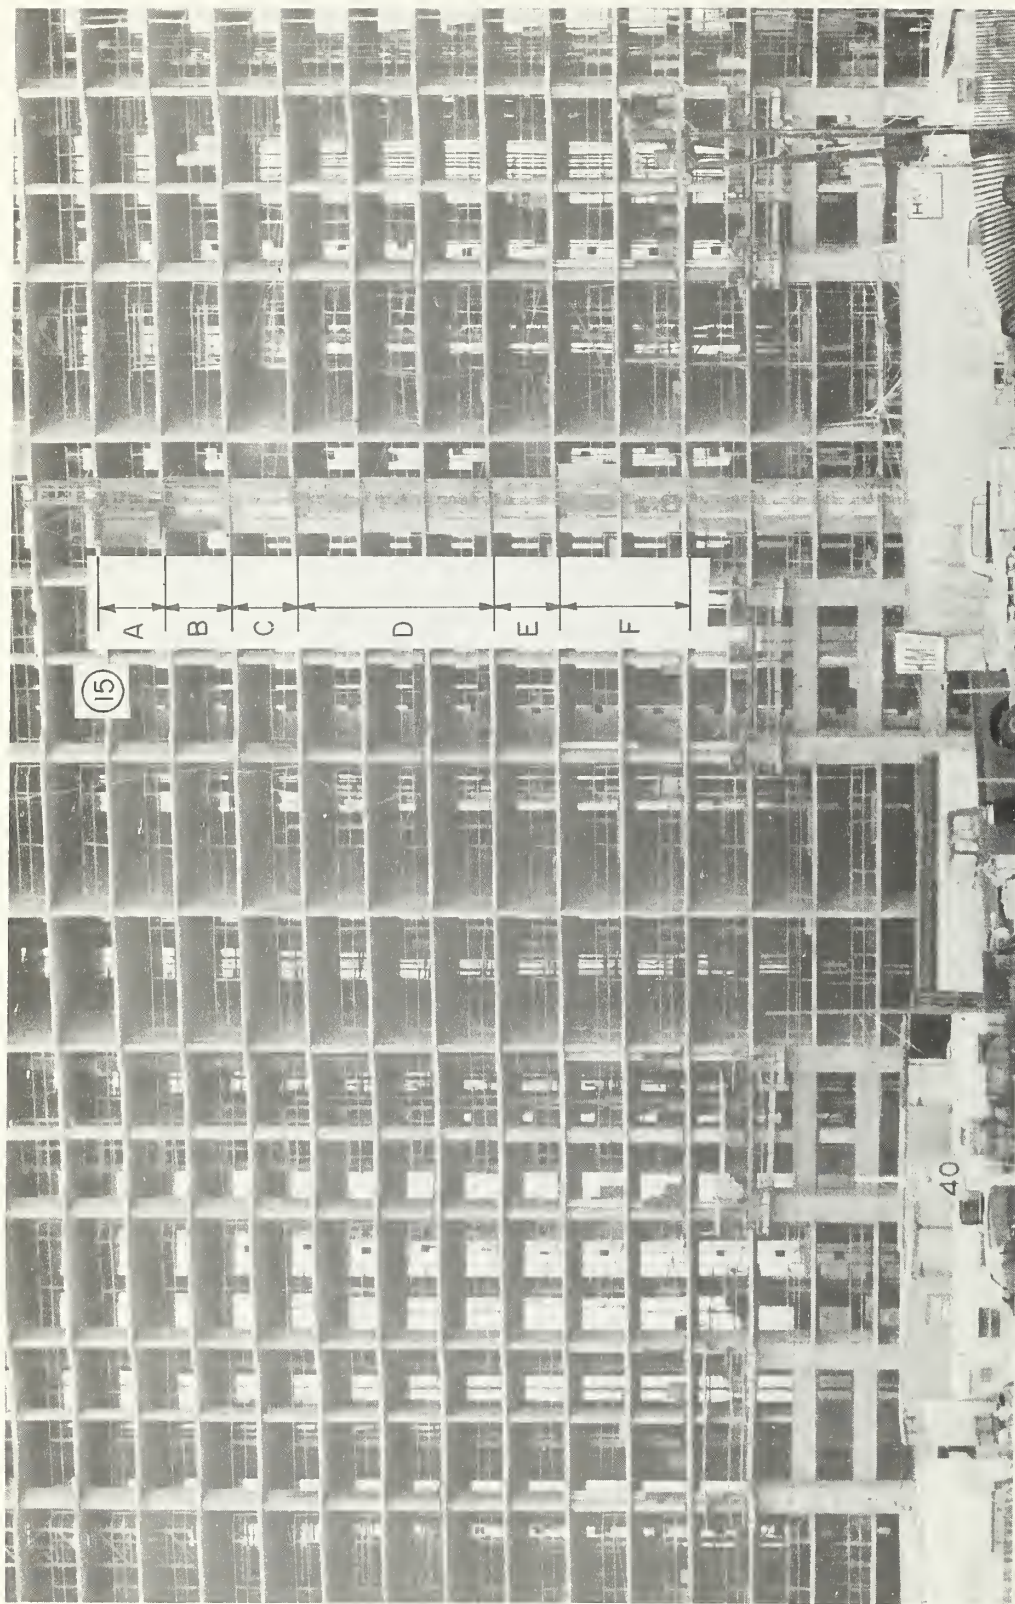
Figure 2.40 Closeup of elevator on north face.

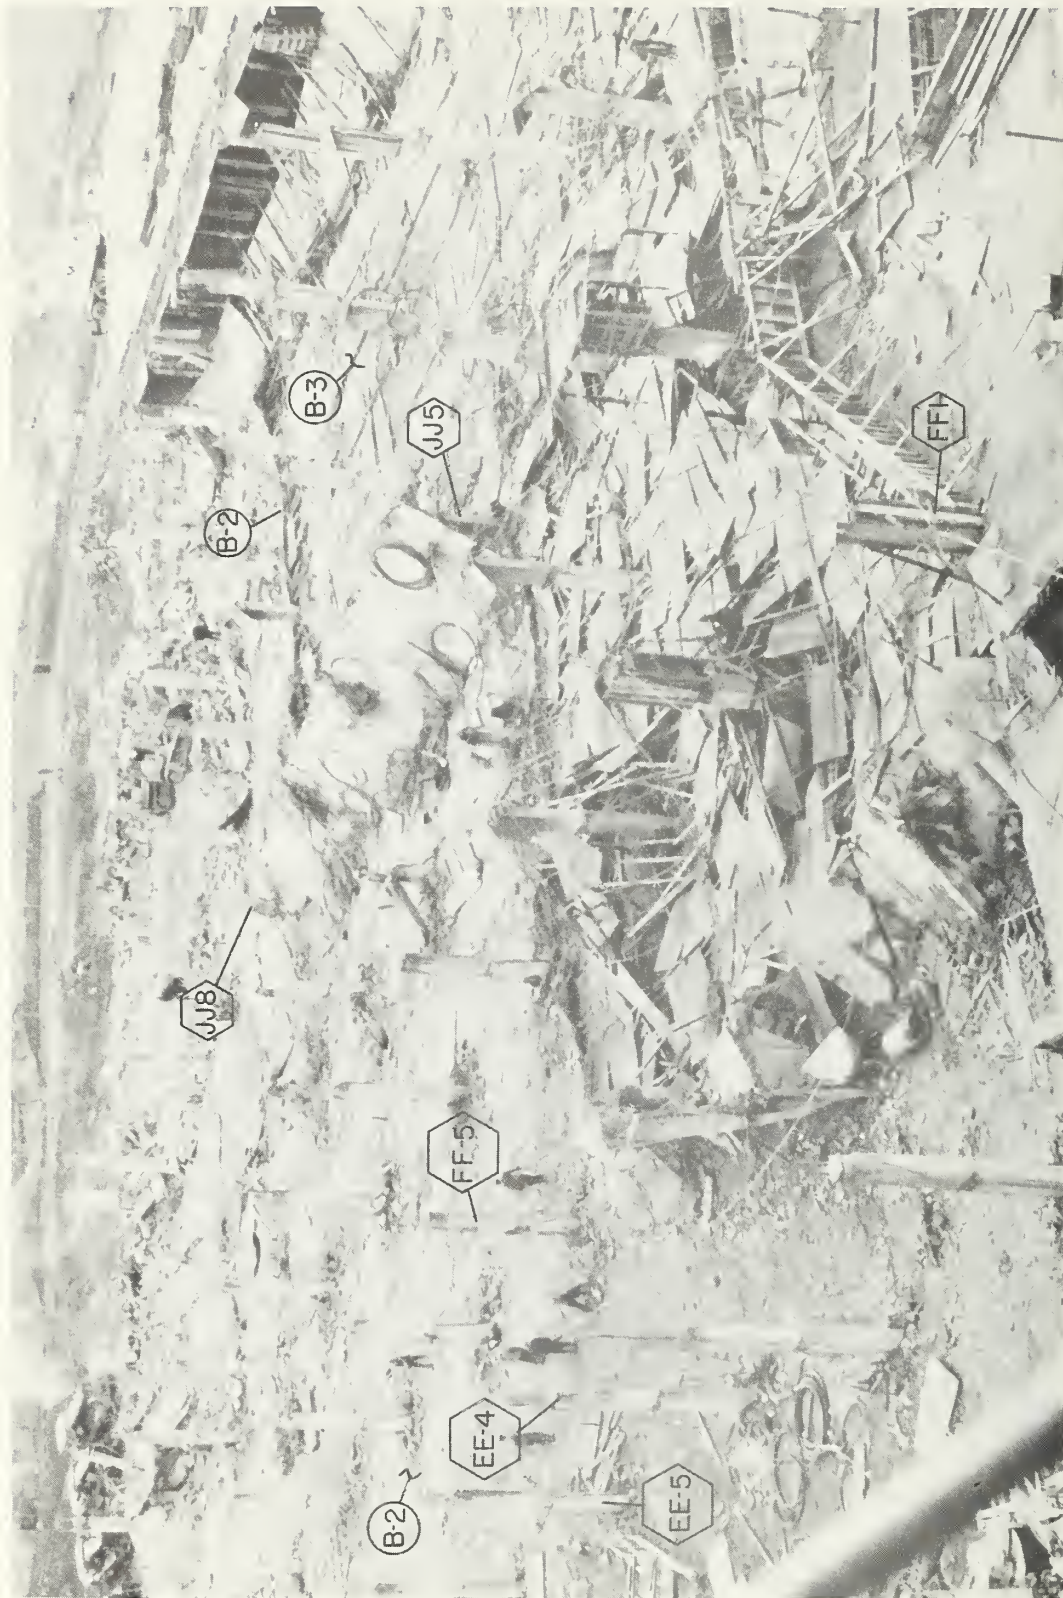
Figure 2.43 General view of parking garage from building A-4.

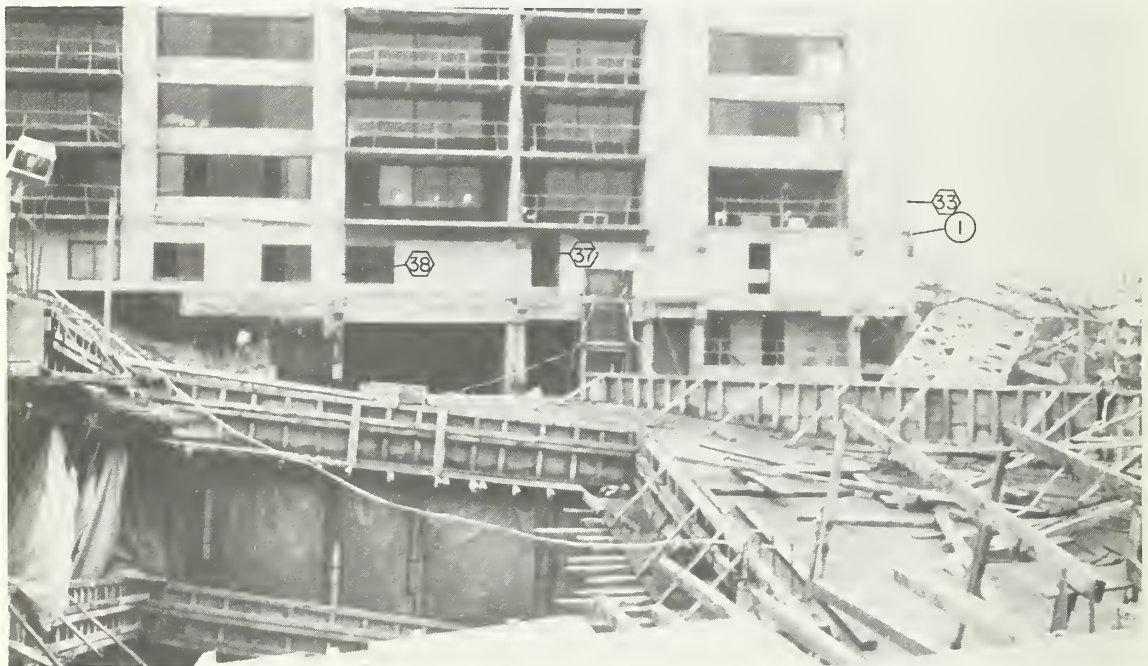
Figure 2.50 View looking north of ramp area and column corbels on building A-4.

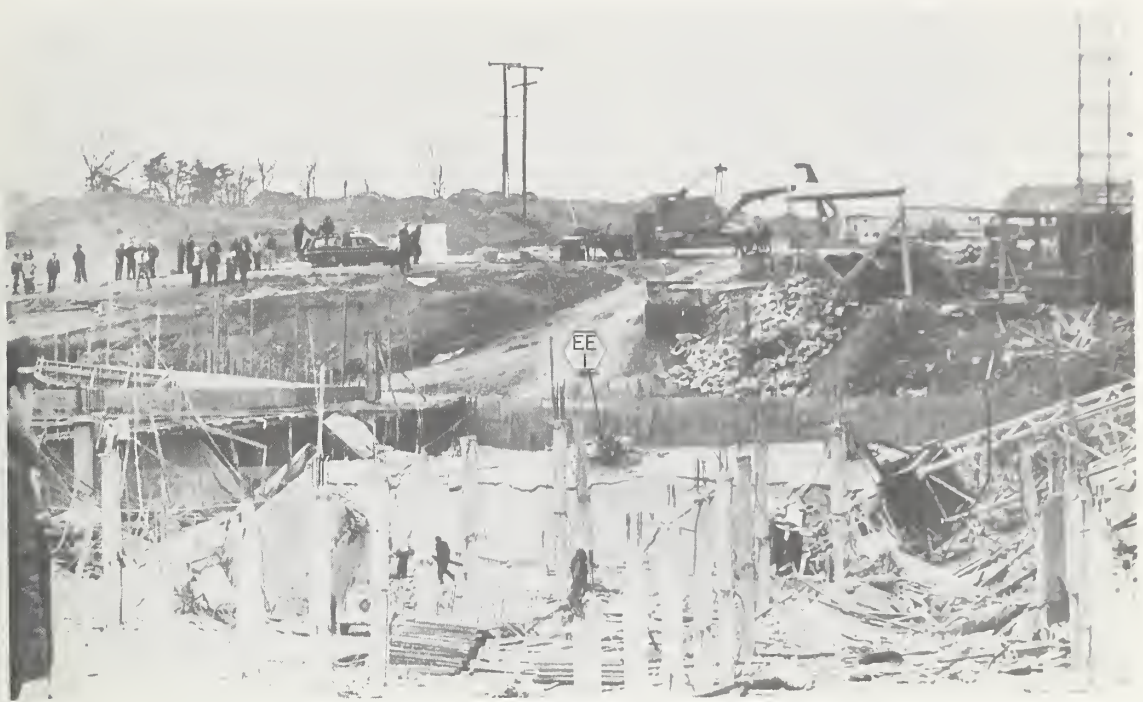
At the time of the collapse, crane No. 2 was reported idle with the jib pointed towards the garage. The exact orientation is not known. A distant view of the tower sections of the crane after the collapse may be seen in figures 2.49 and 2.51 (also 2.5). The tower top and hoist machinery (see figure 2.29) may be seen near column DD-2 in figure 2.55 (Note the partial shear cones on column DD-2). Based on an examination of the photographs it appears (refer to figure 2.1) that the crane tower lines up with the original position of the crane base (in plan view) and passes almost over columns 32 and DD-3, ending up with the top as shown in figures 2.55 and 2.56. This is a total distance of 125 to 130 ft. This distance compares to a total tower height (base section, 5 standard sections, and 1 slipring section) of about 125 ft. The implication here is that the tower fell while rotating about its original plan position. However, careful inspection of figures 2.54, 2.55, and 2.5 shows the jib is lying alongside the tower sections. The sequence of falling which would permit a jib initially pointing over the garage (as reported by employees) to assume its final position has not been determined.

Figure 2.51 View looking west of area between the ramp and building A-4.

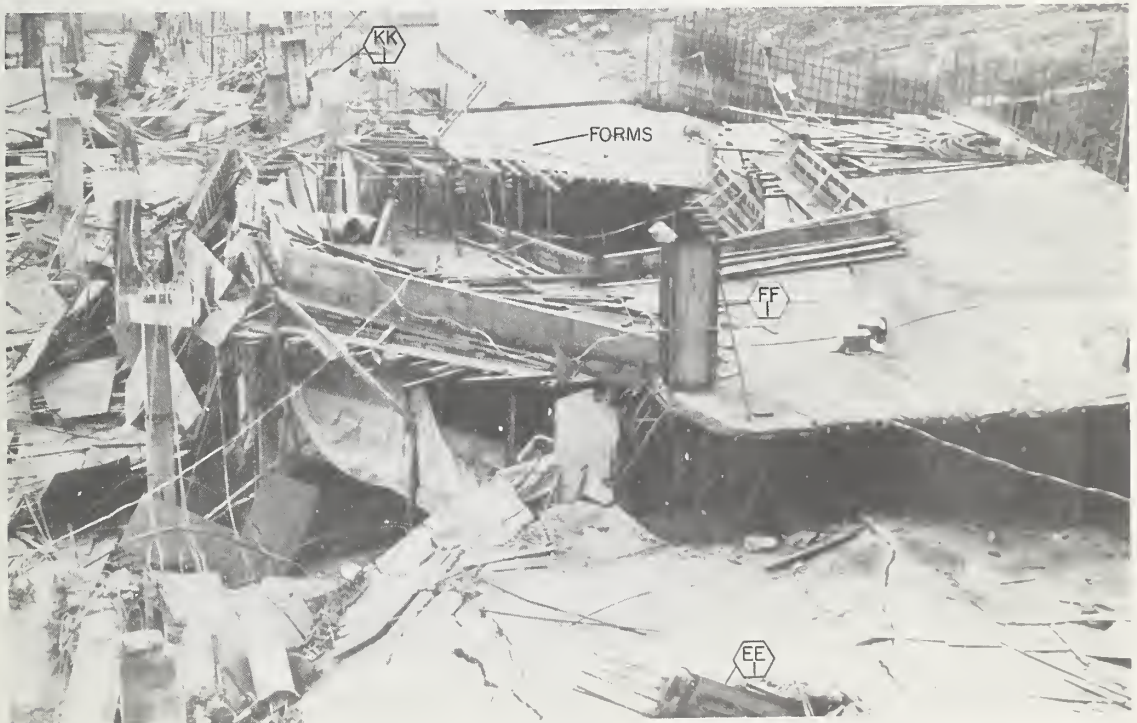
Figure 2.52 View of ramp area looking south.

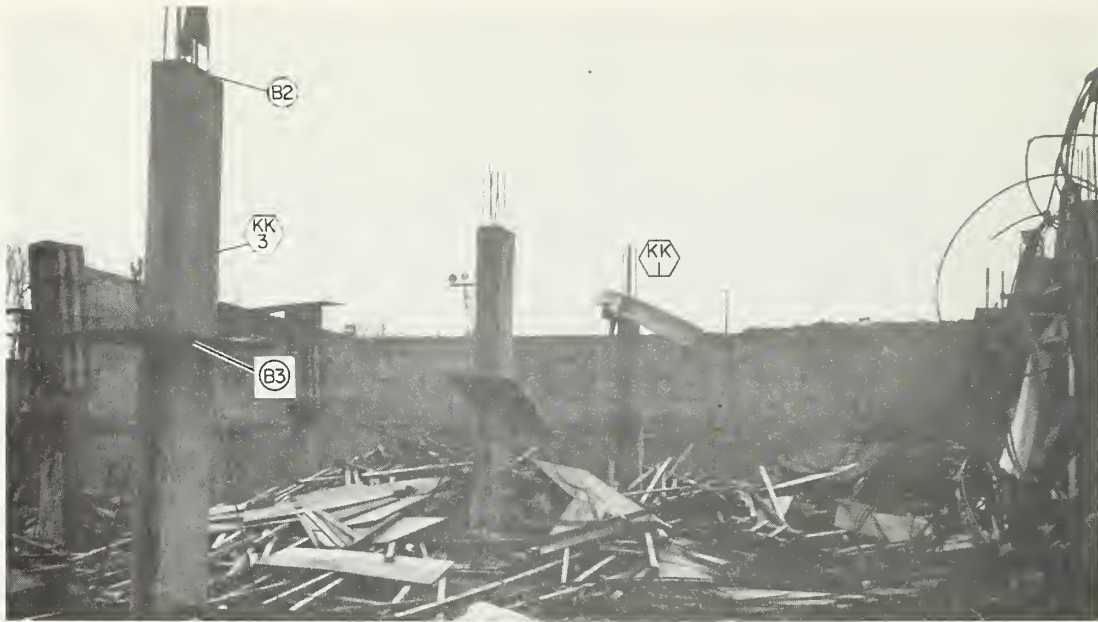
Figure 2.53 View looking west showing southwest area of parking garage.

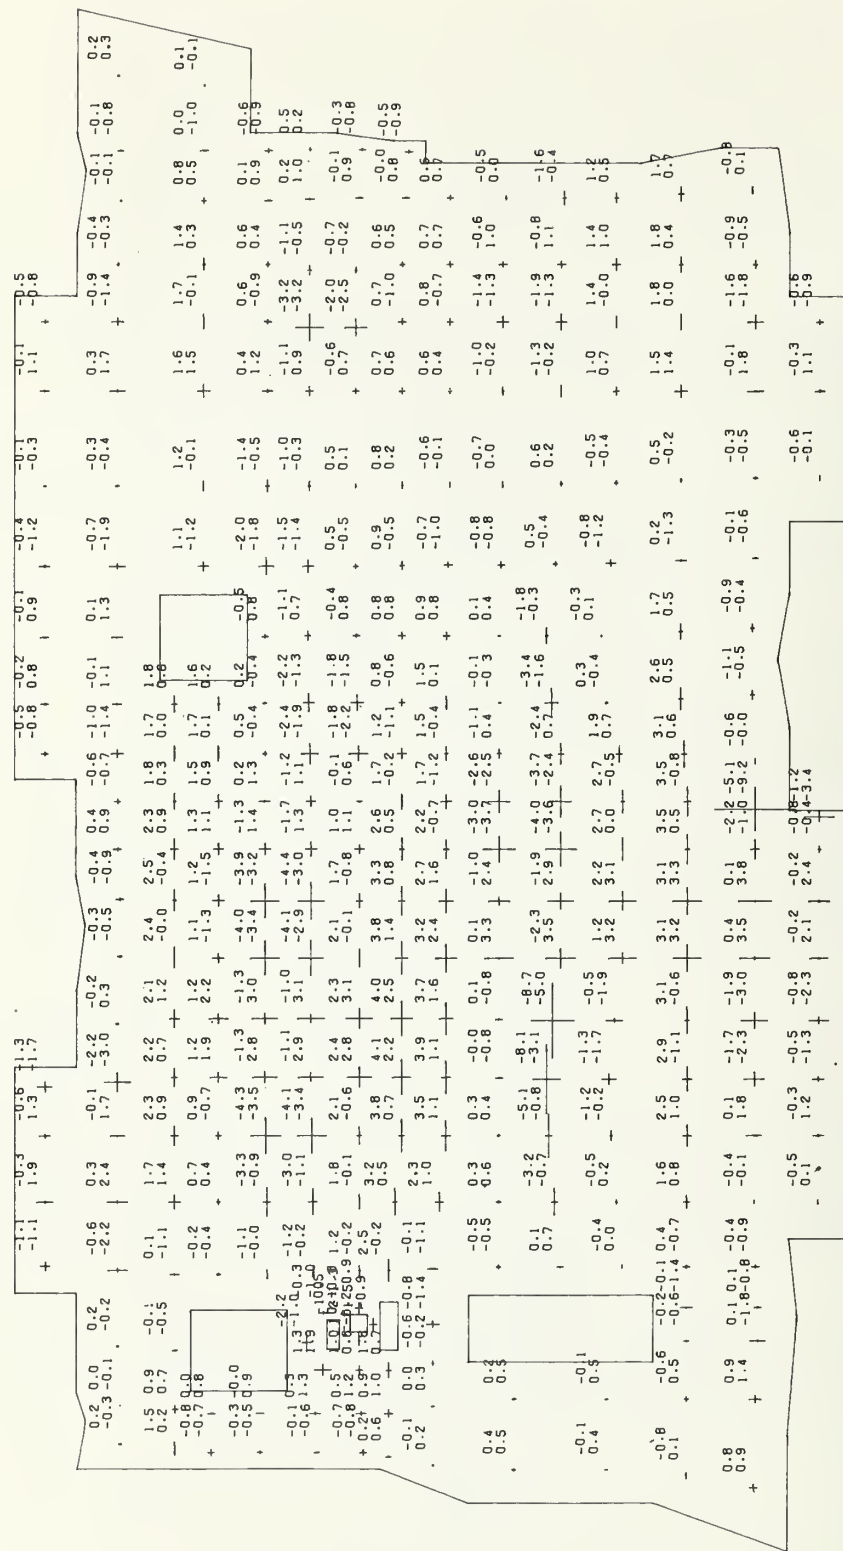
Figure 4.3 Internal moments in slab-case 1.

Figures 4.3 through 4.5 show the analytical results for cases 1 through 3. Moments M_x (rotation about x-axis) and M_y (rotation about y-axis) are designated by x horizontal and vertical lines, y respectively. They are shown plotted in pairs (and approximately to scale) at the centroids of slab elements. The numerical entries are moment magnitudes at the centroids and are expressed in units of foot-kips per linear foot of slab. Moments producing compression in the top of the slab are positive.
