NBSIR 73-140

Fire Endurance Test of Plywood-Faced Exterior Walls for Single Family Housing

March 1973

Final Report

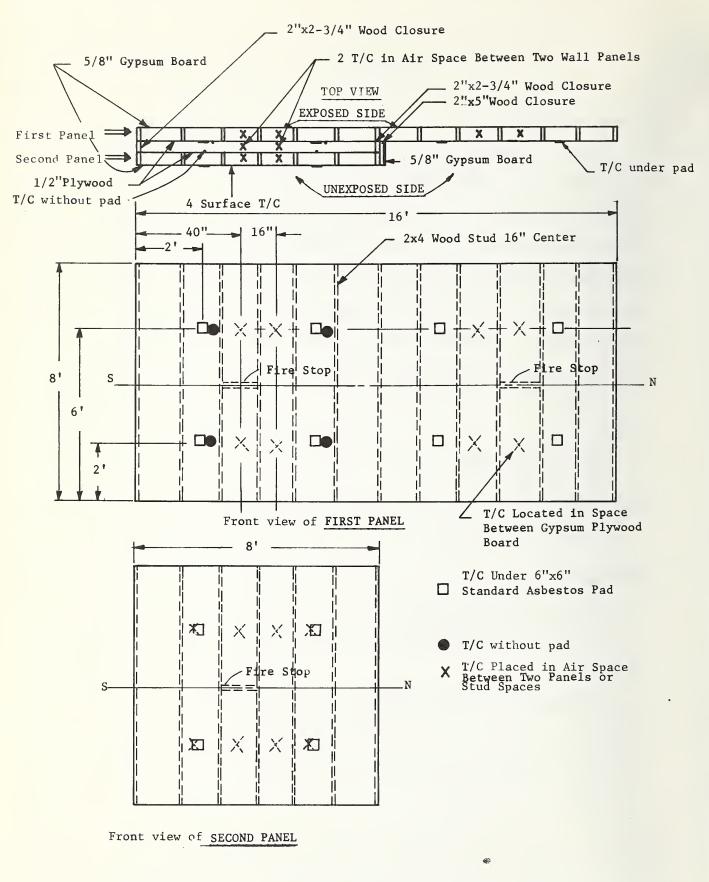
Figure 1. Details of the construction and locations of thermocouples of the specimen.

assembly consisted of a single layer of 5/8 inch Type X gypsum board as an interior (room) surface and a single layer of 1/2 inch grade A-C plywood as an exterior surface nailed to 2 x 4 inch (nominal) wood studs on 16 inch centers. On the double wall section the gypsum board sides faced the furnace and the testing room, while the plywood sides faced the air space. Nominal 2 x 4 fire stops were placed in two stud spaces of the first panel and in one stud space of the second panel at the midheight of the assembly. See Figure 1 for the details of the framing and closures between the wall panels.

thermocouples on the unexposed surface of the second wall. The surface thermocouples were placed under standard 6 x 5 in. felted asbestos pads. Figure 1 shows the locations of thermocouples. The photograph in Figure 2 shows the unexposed surface of the specimen and the connections of the thermocouples.

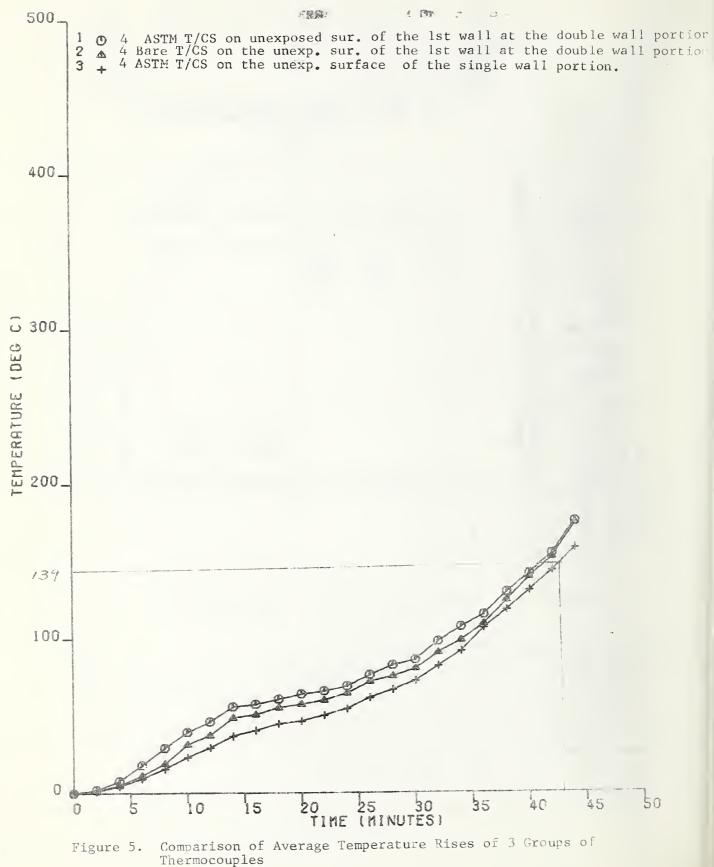
The failure of the single wall due to an average temperature rise of 139°C above its initial temperature on the unexposed surface was observed at 43 min (see Figure 5). Flame penetration was observed at the top of the vertical joint separating the single and double wall portion of the assembly at 47 min and the gas supply to the furnace was discontinued. At this time the air temperature in the stud space of the first wall was over 600°C (1112°F) and increasing rapidly. Direct flame-through of the plywood surface of the first wall occurred at 51 min. Figures 6 and 7 show the location of the flame-through just before and after the instant of the flame-through. In Figure 6, gray smoke is visible at top of the double wall portion.
