NBSIR 73-164

Fire Endurance Test of a Steel Sandwich Panel Floor Construction

Final Report

As a part of the evaluation of a housing system proposed under Operation BREAKTHROUGH, a fire endurance test was performed at the National Bureau of Standards on a floor, made up of sandwich panels consisting of a paper honeycomb core with steel and plywood surfaces, supported on steel joists.

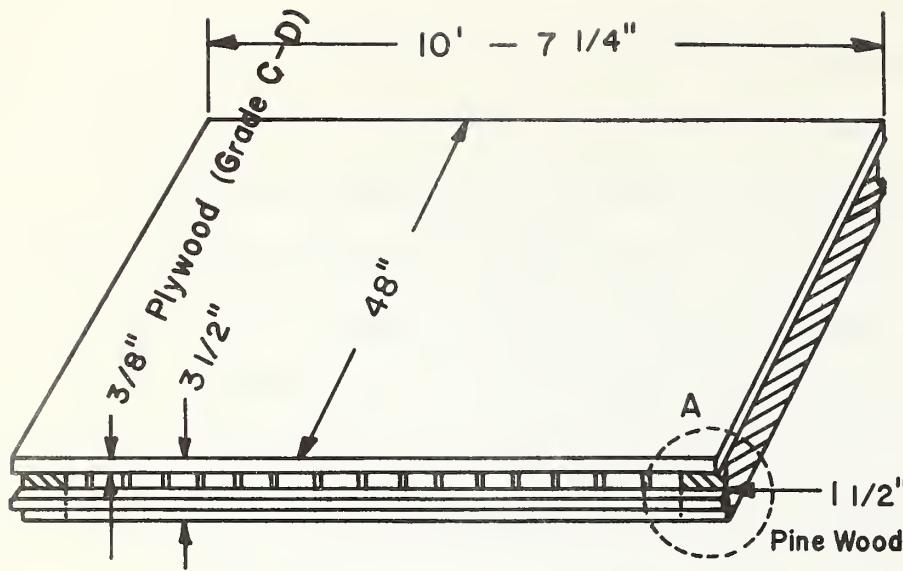
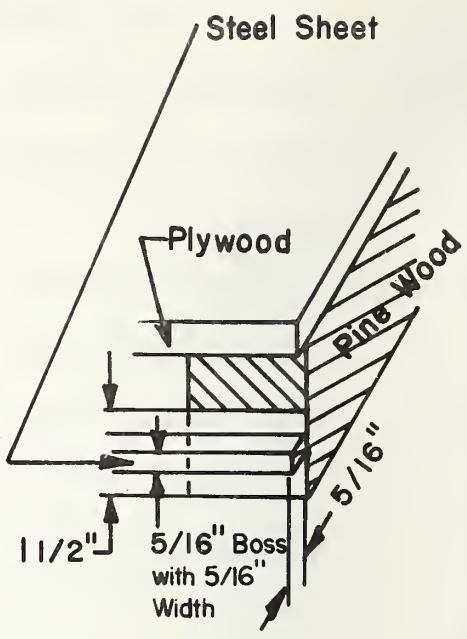
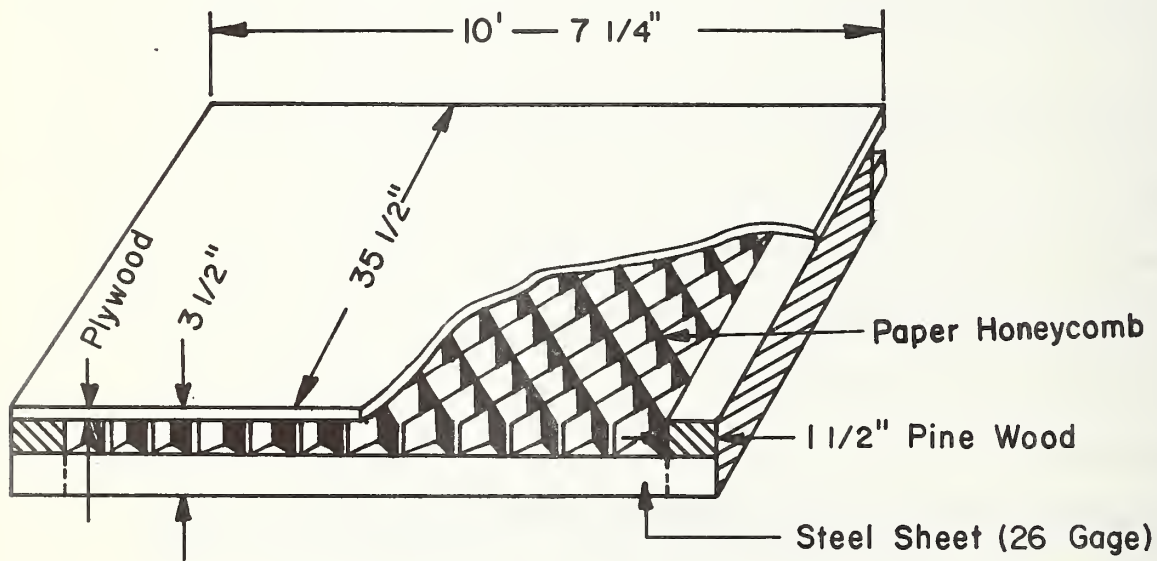
Figure 1. Details of specimen construction.

The floor consisted of five panels, each 10 ft 7-1/4 in. long. Three were 4 ft wide, the other two 2 ft 11-1/2 in. The core of a panel consisted of a 3 in. thick paper honeycomb; the top surface 3/8 in. C-D plugged interior grade (with exterior glue) plywood; the bottom, 26 gage (0.0179 in.) galvanized and phosphatized steel sheet. This sheet was bent up on the long sides to cover the bottom 1-1/2 in. of the paper core, and was shaped to contain a 5/16 in. by 5/16 in. boss which compensated for an approximate 5/16 in. setback of the paper core as shown in Figure 1. Thus, contact between panels was made at the boss and at the

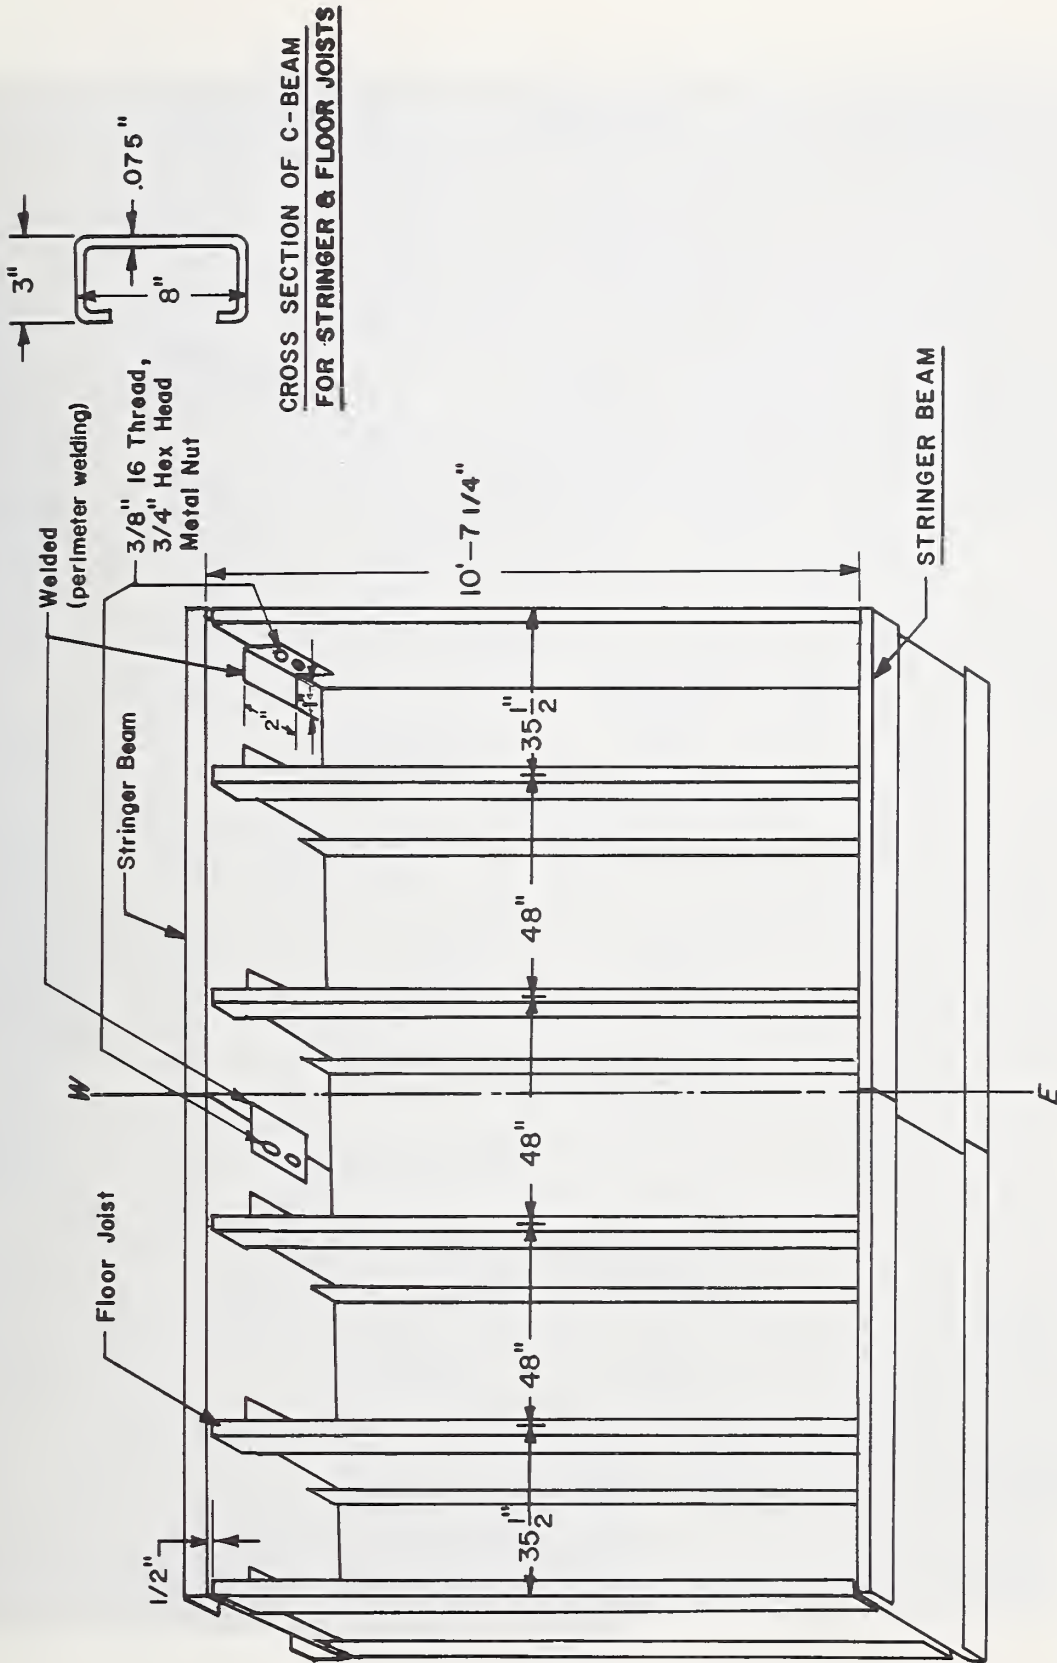
Figure 2. Structure of stringer beams and floor joists.

The panels rested on light gage steel C-shape joists and stringer beams, each 8 in. high, 3 in. wide, and 0.075 in thick. The assembly and fastenings of the floor framing members are shown in Figure 2.

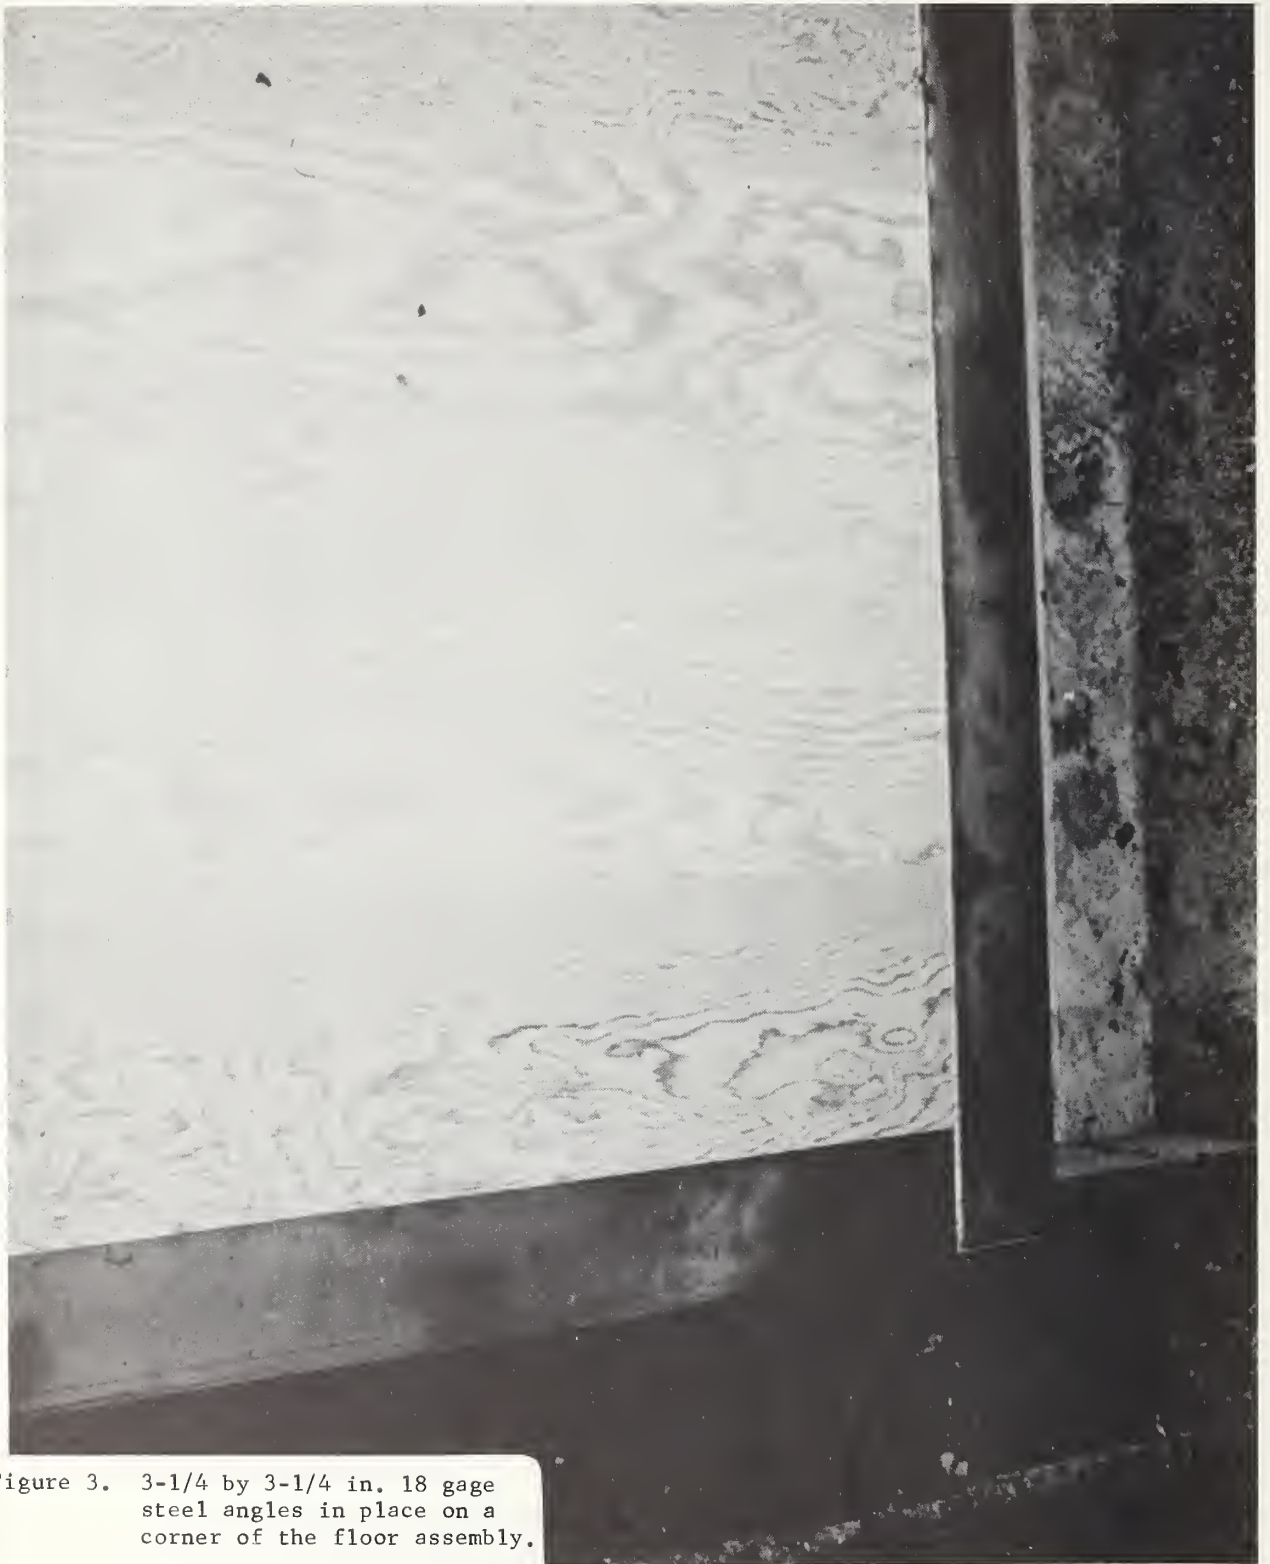
After assembly, it was noticed that the gaps between the plywood top sheets of adjacent floor panels did not exceed 1/16 in. Outer edges of the floor assembly were closed with 3-1/4 x 3-1/4 in. 18 gage (0.0495 in.) steel angles attached to the panels with 1/2 in No. 6 sheet metal screws on 16 in. centers. Figure 3 shows the angles in place on a corner of the floor assembly. The floor was finished with carpeting attached with a commercial natural latex releaseable adhesive. Figure 4 illustrates the details of the joist and stringers and the perimeter support beams. The underside (furnace exposed side) of the complete test specimen can be seen in Figure 5.

Figure 3. 3-1/4 by 3-1/4 in. 18 gage steel angles in place on a corner of the floor assembly.

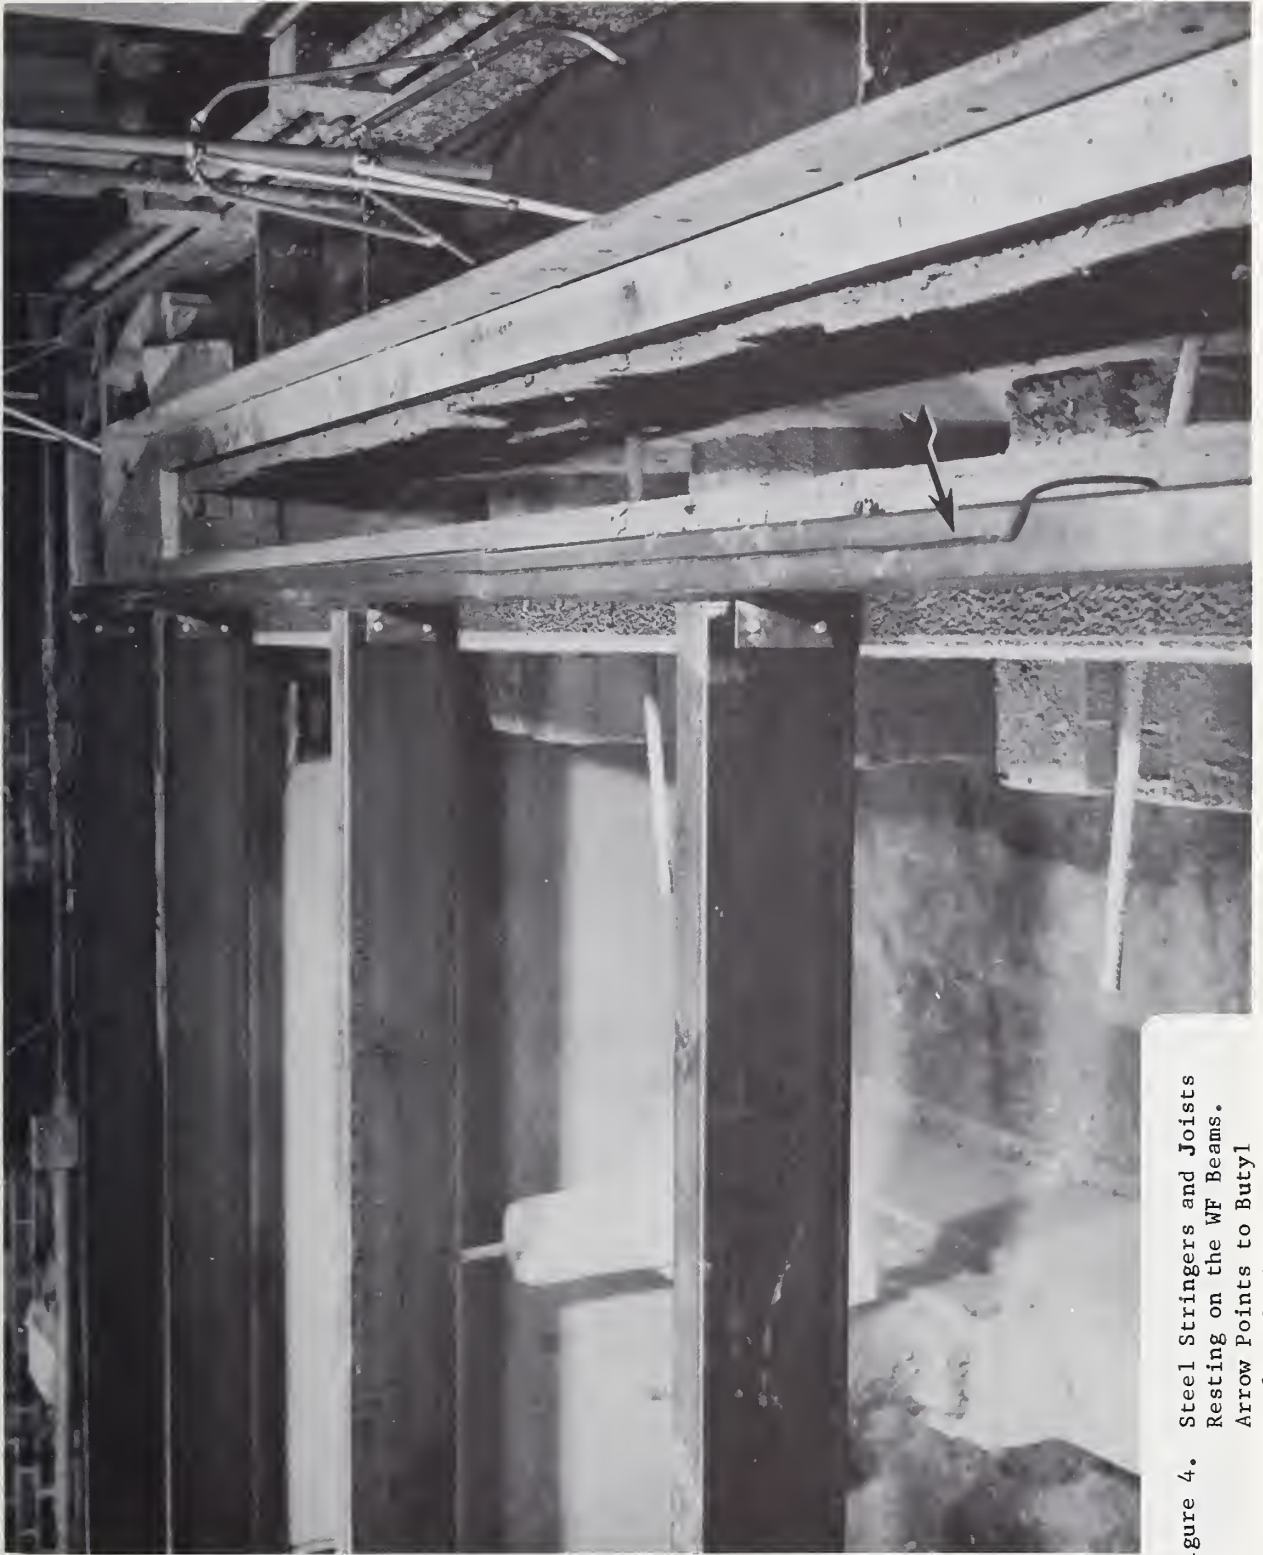
Figure 4. Steel Stringers and Joists
Resting on the WF Beams.
Arrow Points to Butyl
Sealant Strip.

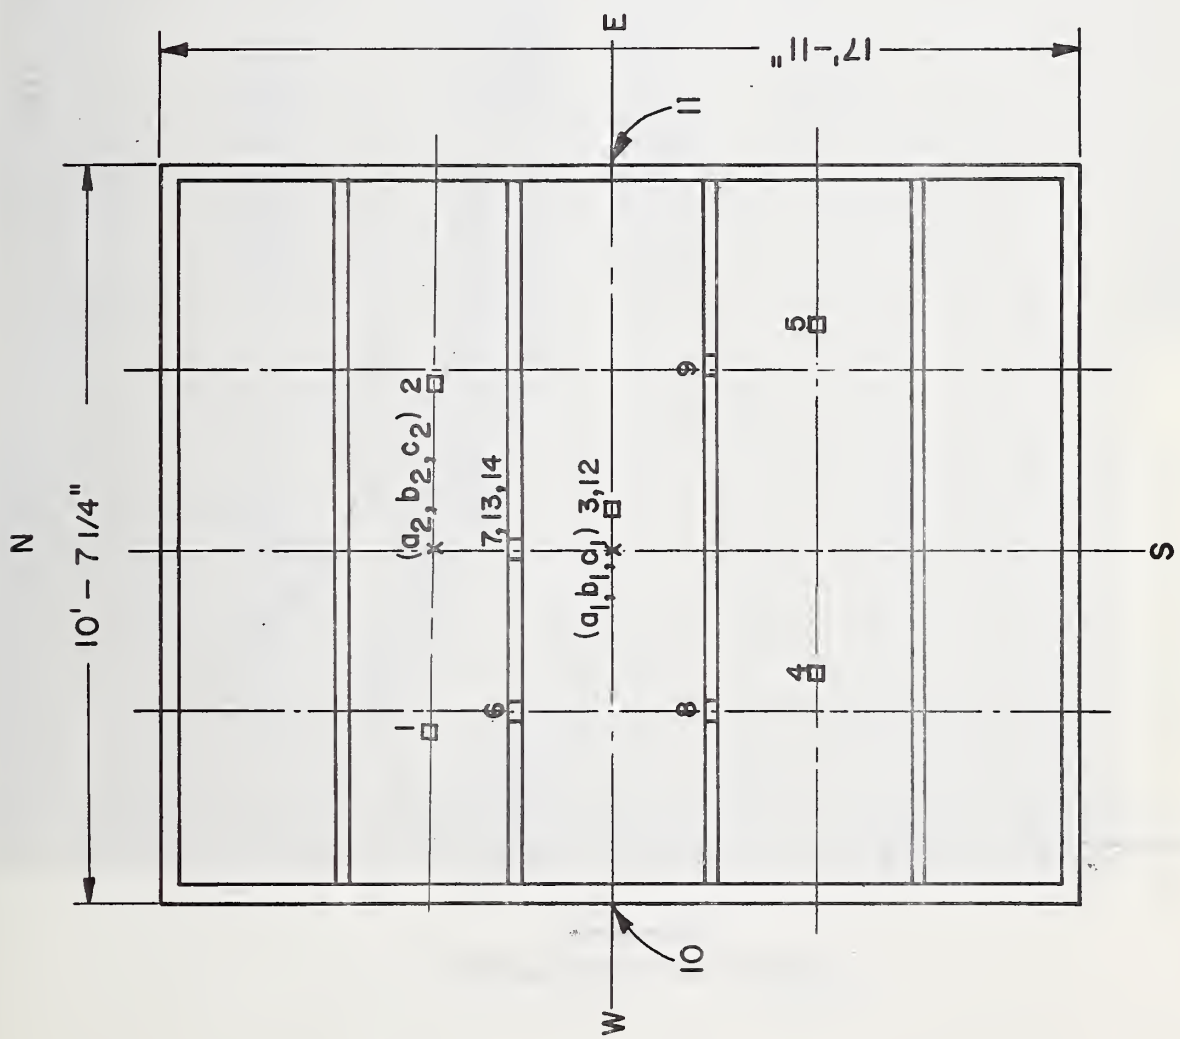
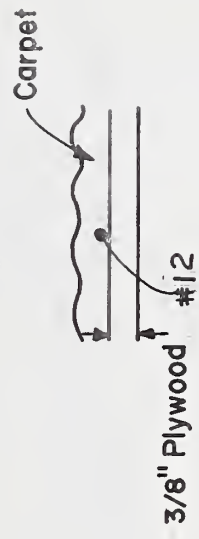
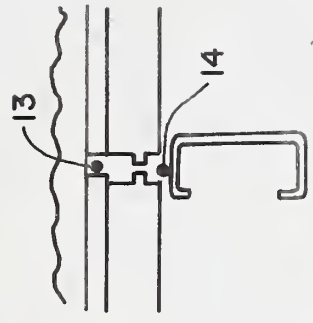
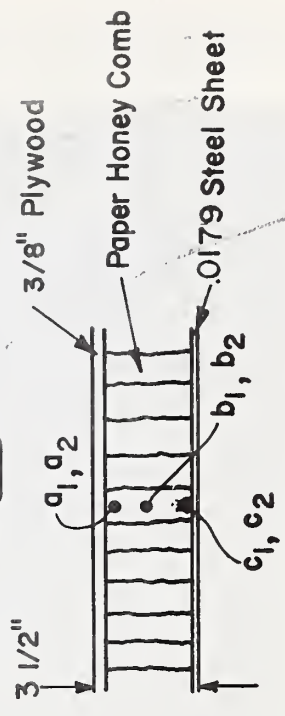
Figure 6 Locations of Thermocouples

Nine Chromel-Alumel (type K) thermocouples, each under a standard 6 in. by 6 in. by 0.4 in. thick felted asbestos pad, were applied to the exposed surface of the specimen. Five of these were positioned between joints, four were over joints. Additionally, eleven thermocouples were placed as follows: six internally in two adjacent panels, two on the supporting beams, and one each under the carpet, on a joist, and at a plywood joist. See Figure 6 for locations of thermocouples.

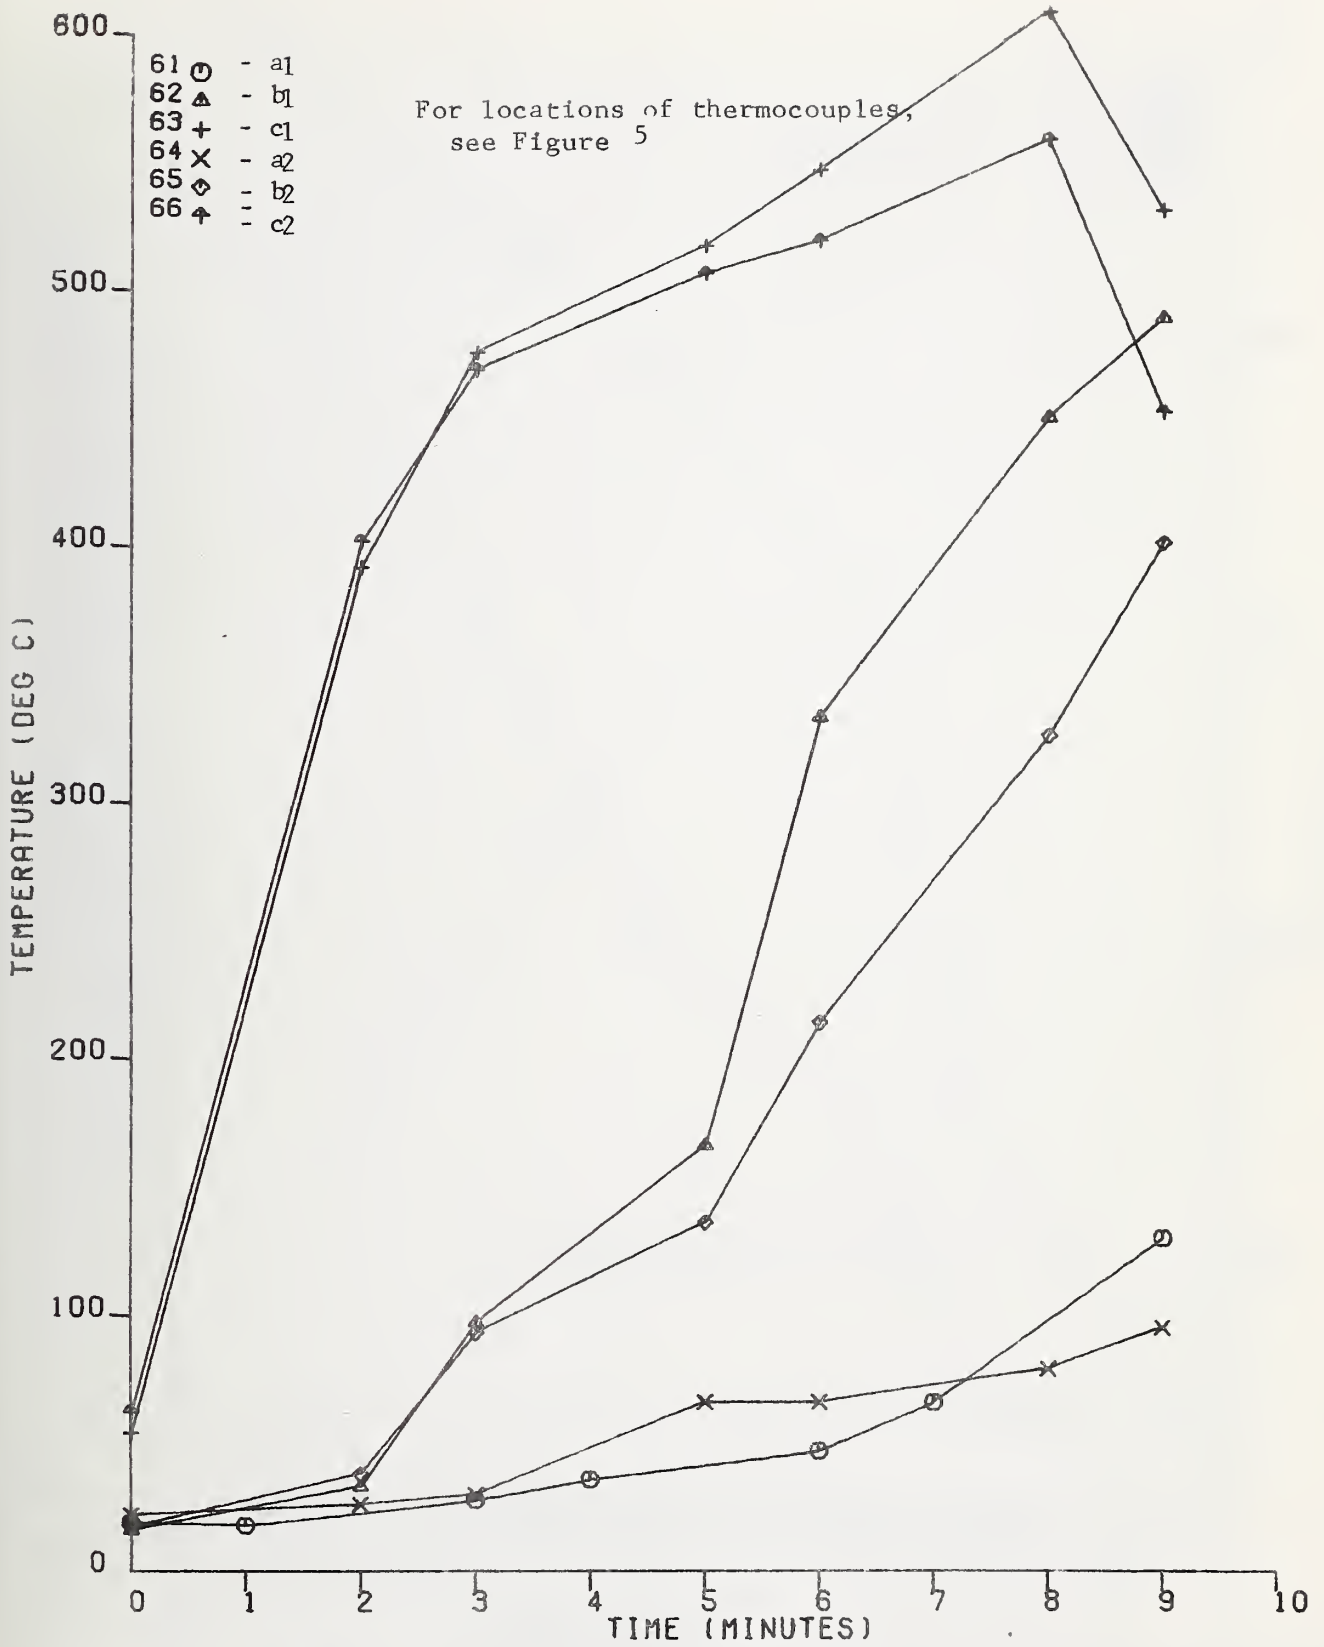
Figure 10

The average temperature rise indicated by the thermocouples on the unexposed surface away from the joints was less than 35°C (96°F) and a maximum temperature rise of over 300°C (572°F) was observed on a joint during the test, as shown in Figure 9. Temperature histories of other thermocouples in the structure are given in Figures 10 and 11.

TEMPERATURE READING OF SIX THERMOCOUPLES PLACED IN THE FLOOR

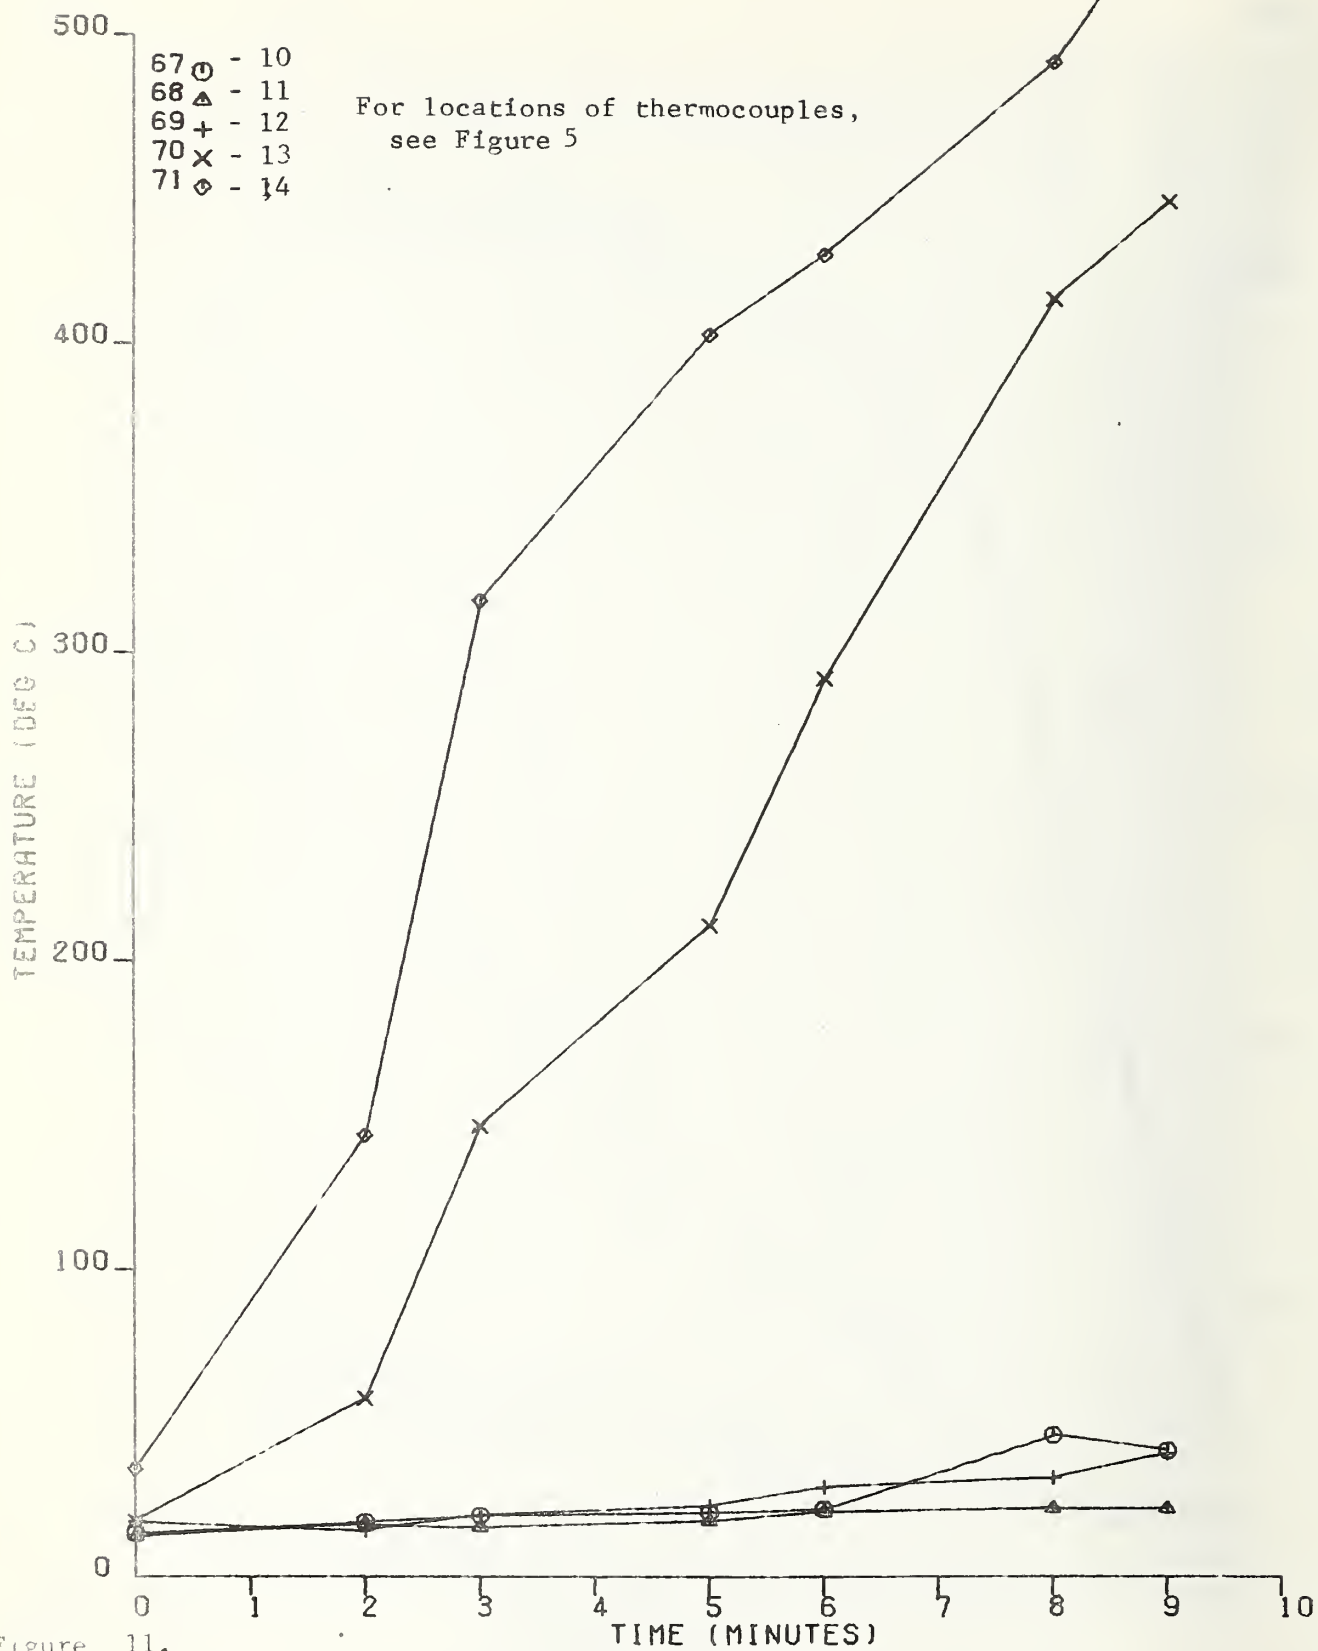
Figure 11.
 TEMPERATURE READINGS OF SPECIALLY ARRANGED THERMOCOUPLES FOR TEST 480

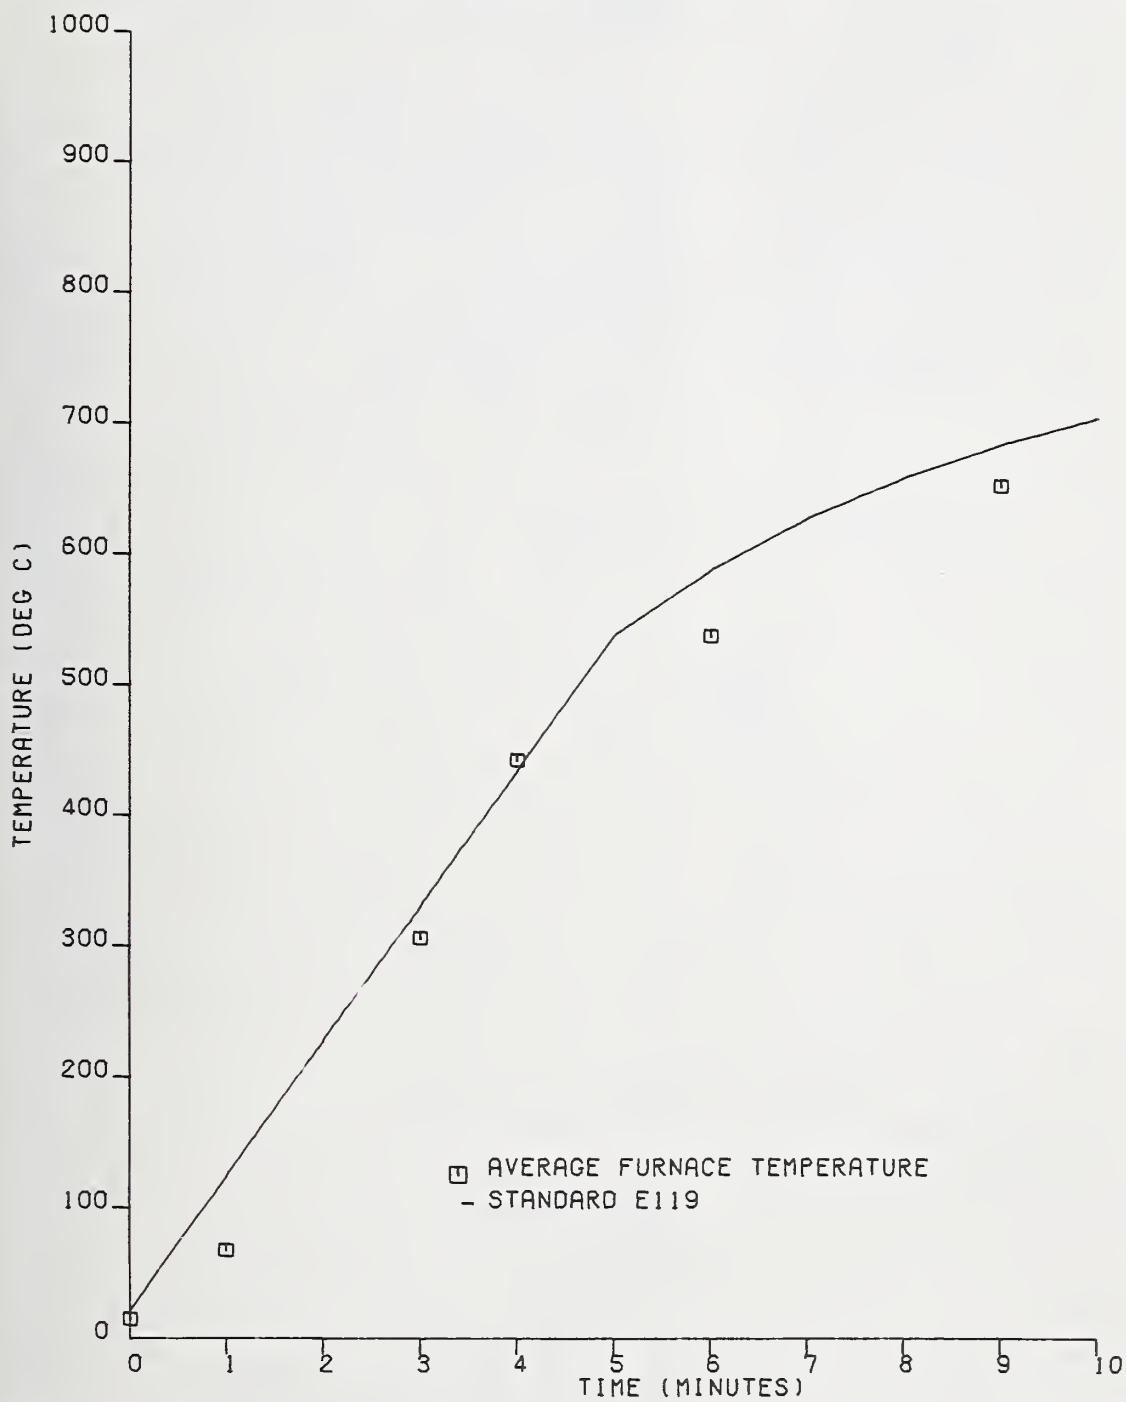
Average furnace temperatures during the test period are shown in Figure 12. The severity of the fire exposure was sufficiently close to that prescribed by the ASTM E 119 time-temperature curve as to preclude the necessity for adjusting the observed times to failure to compensate for furnace deviation.

AVERAGE FURNACE TEMPERATURE FOR TEST 480 COMPARED WITH STANDARD E119
