# NBSIR 73-167 Fire Endurance Test of a Roof/Ceiling Construction of Paper Honeycomb and Gypsum Board

Final Report

# Fire Endurance Test of a Roof/Ceiling Construction of Paper Honeycomb and Gypsum Board

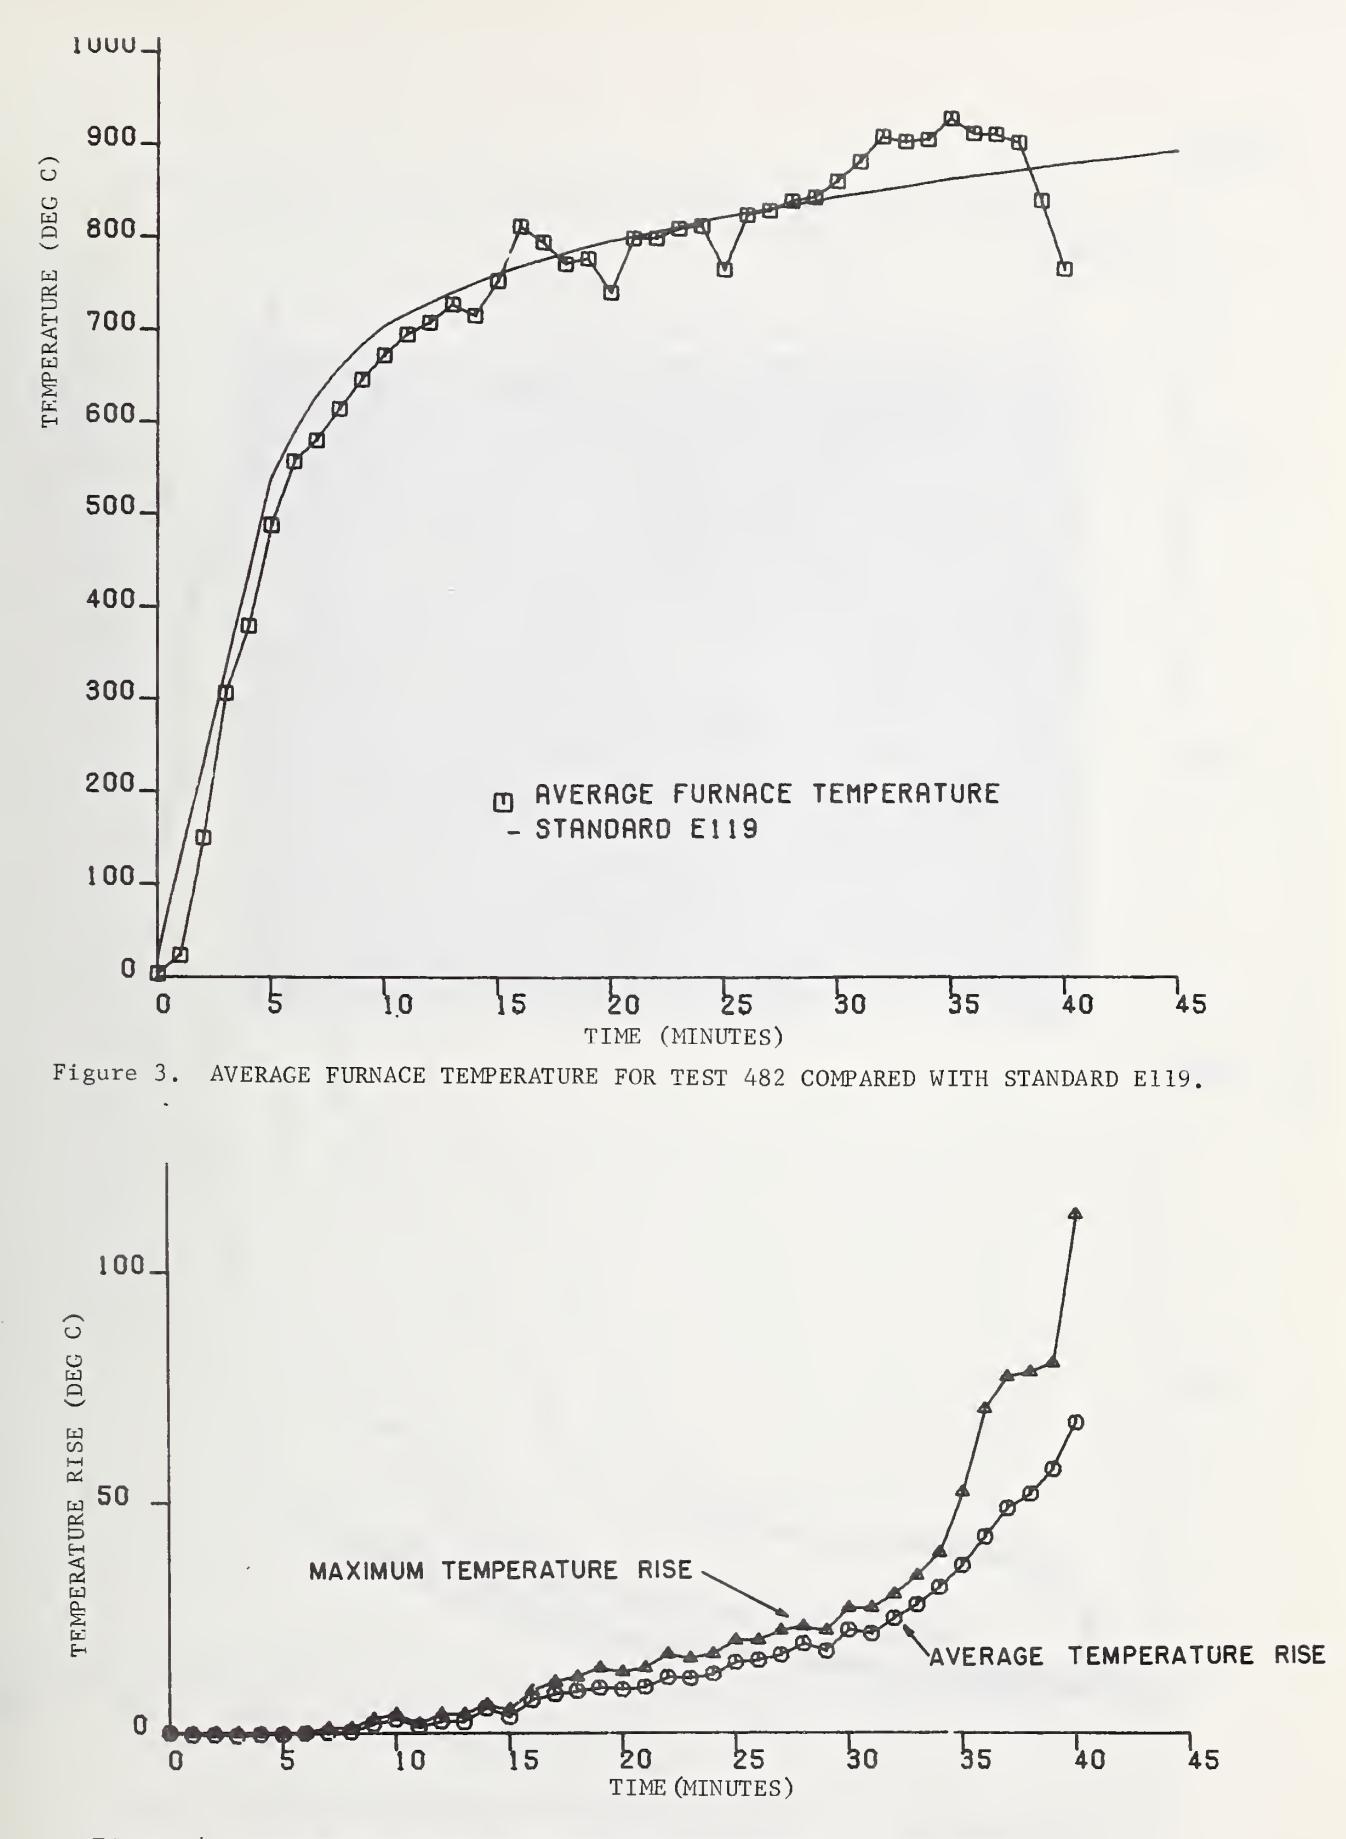
Figure 4. MAXIMUM AND AVERAGE SURFACE TEMPERATURE RISE FOR TEST 482

At the time of failure, the average temperature of the unexposed surface was 136°F (58°C), the maximum at one point 182°F(83°C), indicating that the initial flame-through did not occur in the immediate vicinity of any of the thermocouples. Temperatures at the six thermocouples inside the panel show suddenly accelerated rises at times corresponding to the falling of the ceiling gypsum boards (30 min.).

Time-temperature curves for the thermocouples on the unexposed surface are shown in figure 4; those in the paper core, in figure 5. The flamethrough failure and the inability to sustain the load at the failure point are illustrated in figure 6.
