NBSIR 73-168

Fire Endurance Test of a Fiber Glass Reinforced Polyester Double Wall Assembly

Final Report

As a part of the evaluation of a housing system proposed under Operation BREAKTHROUGH a standard fire endurance test was performed on a double wall assembly comprising a load-bearing interdwelling (party) wall for single family attached housing. The test method was in accordance with the requirements of ASTM E 119, and the applied load was 700 pounds per linear foot (plf) per wall. The test results are valid only for walls of similar construction loaded at or below the stress level developed by this loading.

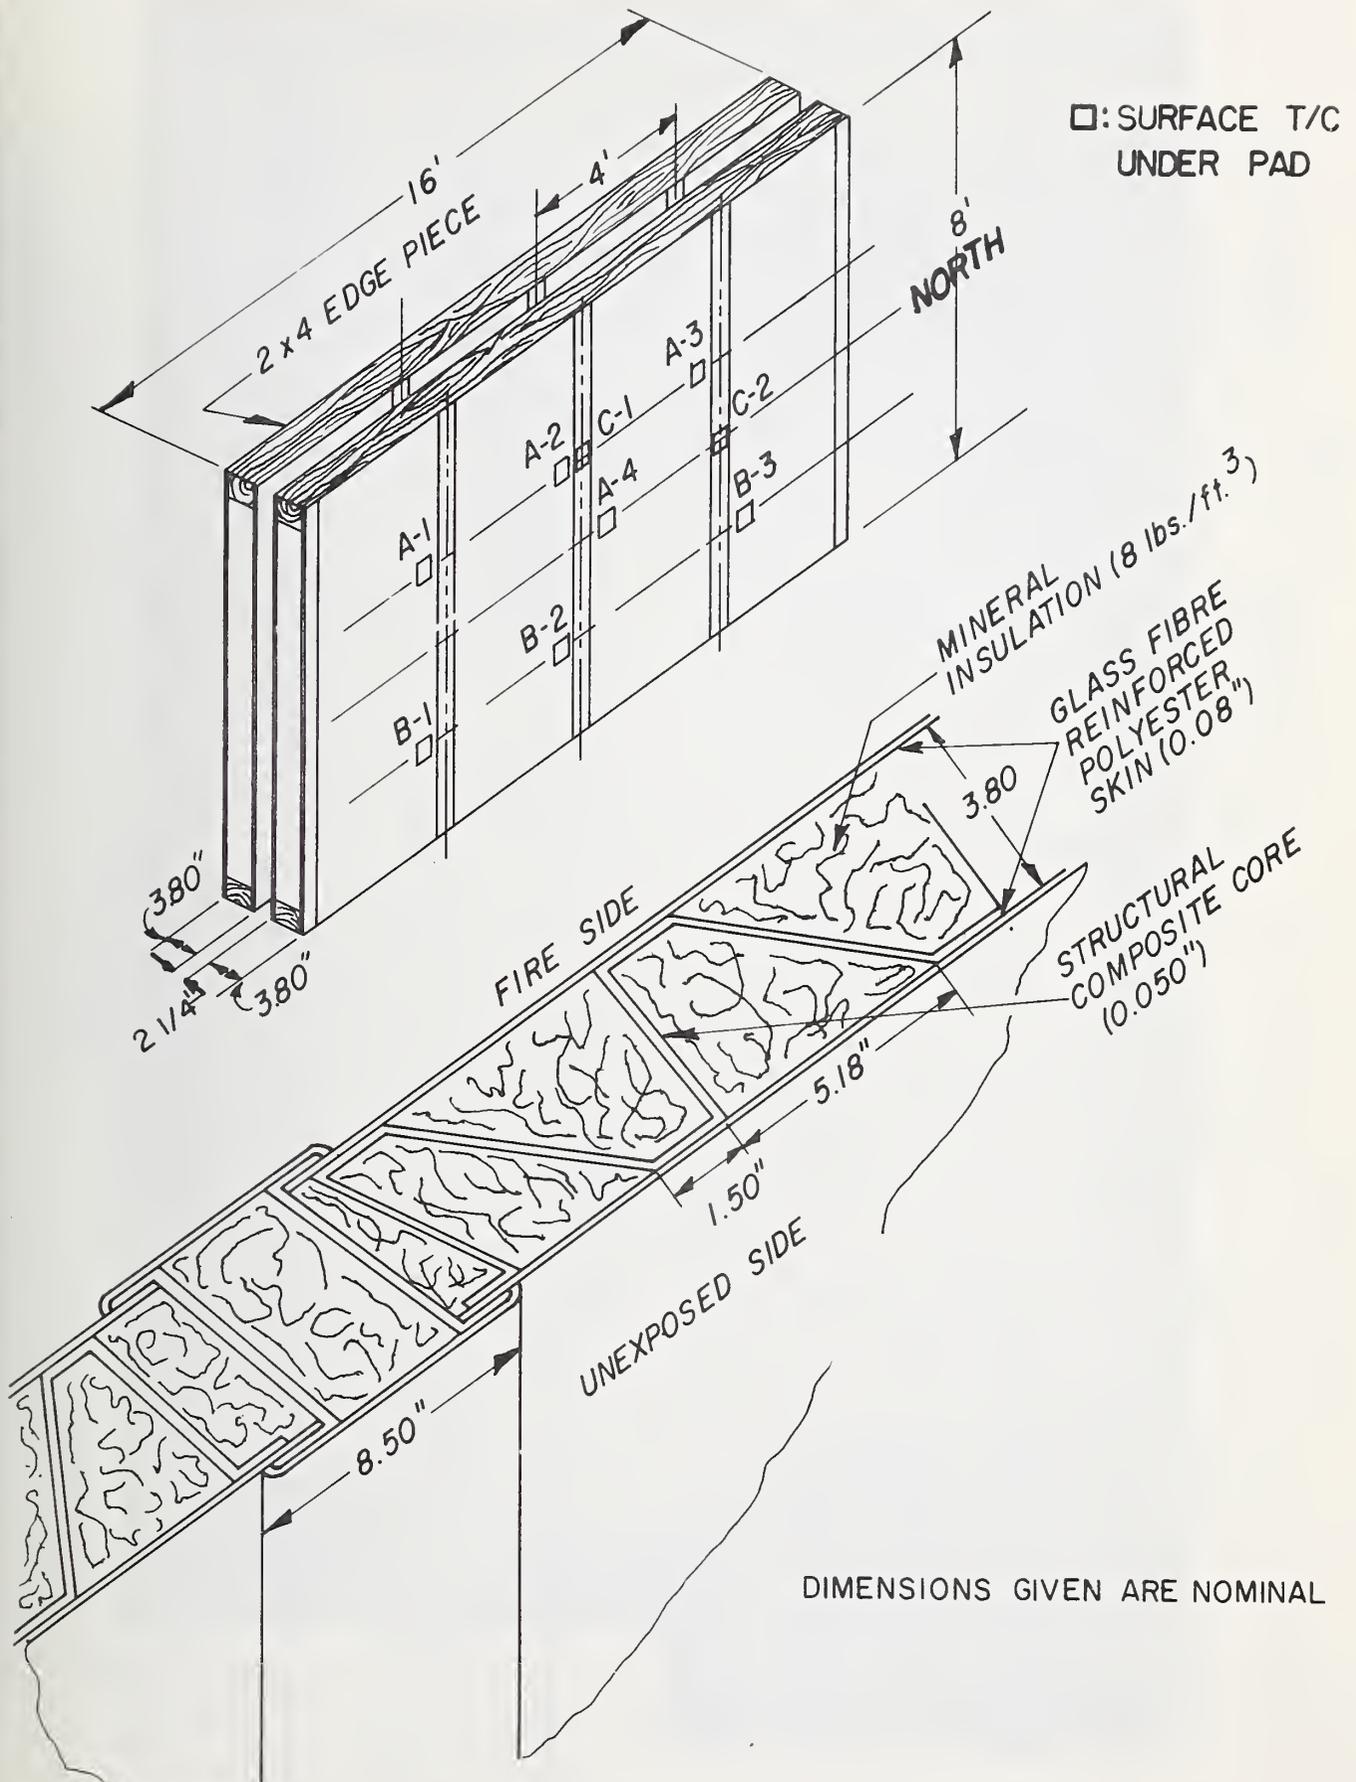
Figure 1. Construction details.

The double wall assembly consisted of two identical, 16 ft. wide x 8 ft. high walls, parallel to each other and separated by a 2-1/4 in. air space, as shown in Figure 1. The overall thickness of the double wall assembly was 9.85 in. Each wall was made up of GRP 0.05 in. thick

The construction of the specimen, as shown in Figure 1, was symmetrical so that the same fire endurance would have been achieved if the opposite side had been fire-exposed.

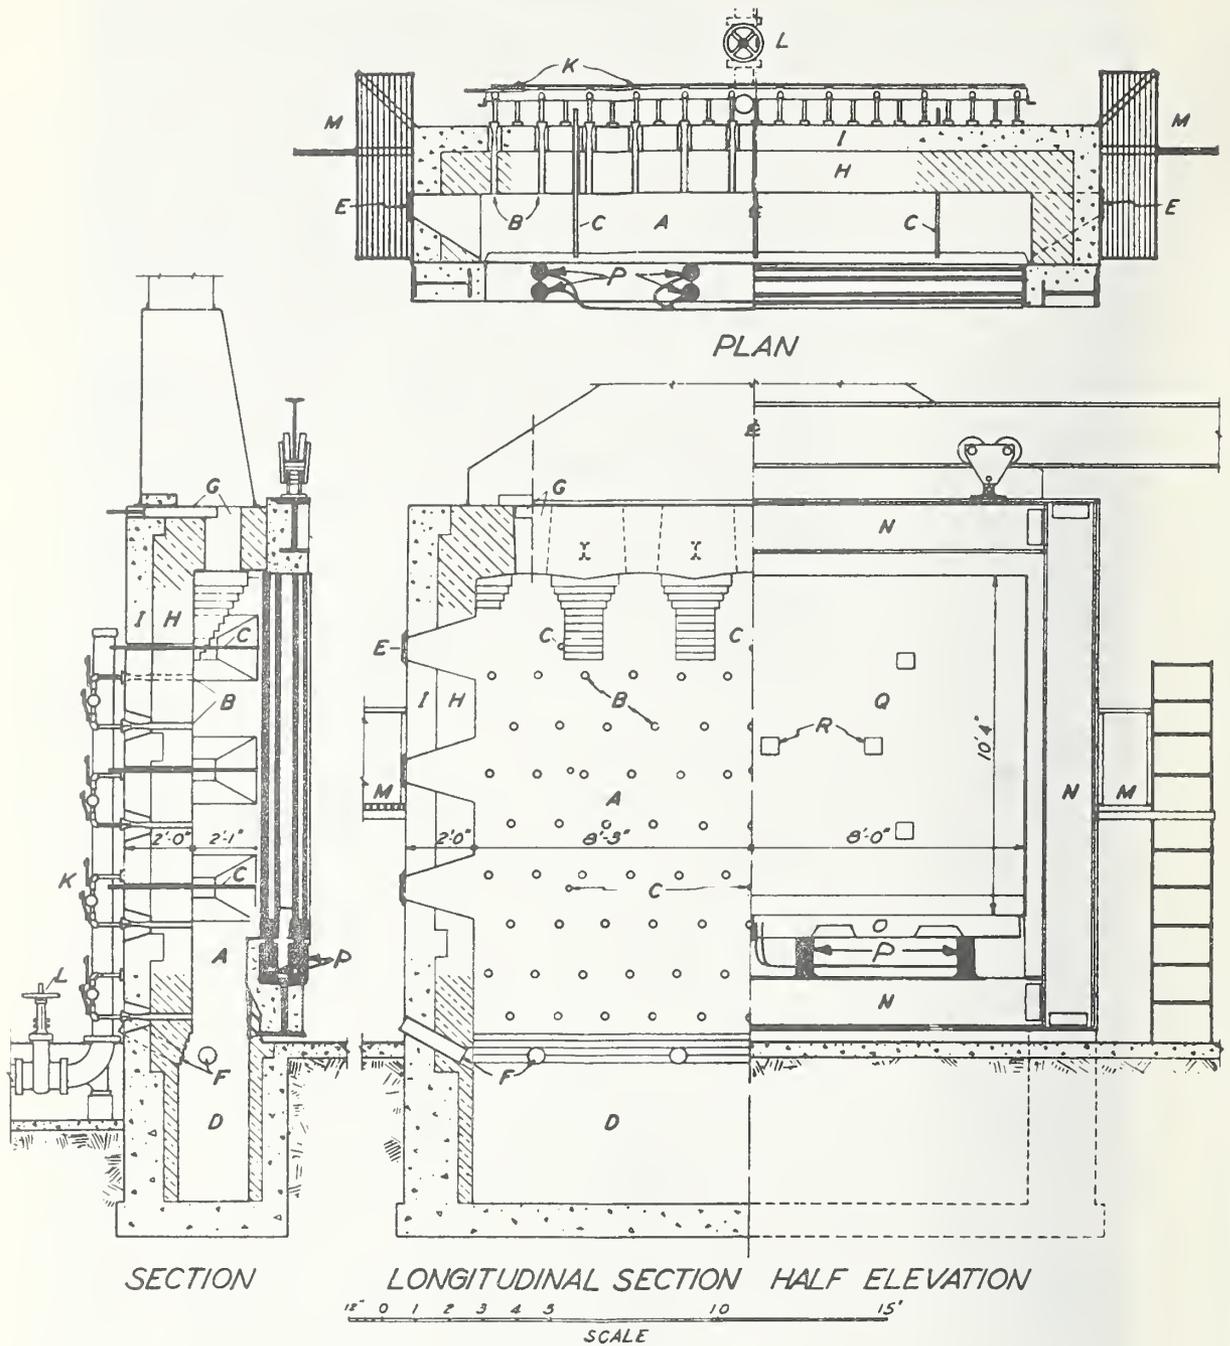
FIGURE 4. DETAILS OF WALL-TESTING FURNACE.

The test was conducted in accordance with the requirements of ASTM E 119. The double wall was mounted in a 10 x 16 foot frame of the wall test furnace at the Fire Research Section, National Bureau of Standards. Five minutes prior to the start of the test, a jacking load of 730 plf (700 plf live load + 30 plf dead load) was applied to each panel independently through four hydraulic jacks at the bottom of the specimen. The total live load per wall was 11,200 pounds throughout the test. The details of the wall furnace with typical double wall assembly in place are shown in Figure 4.

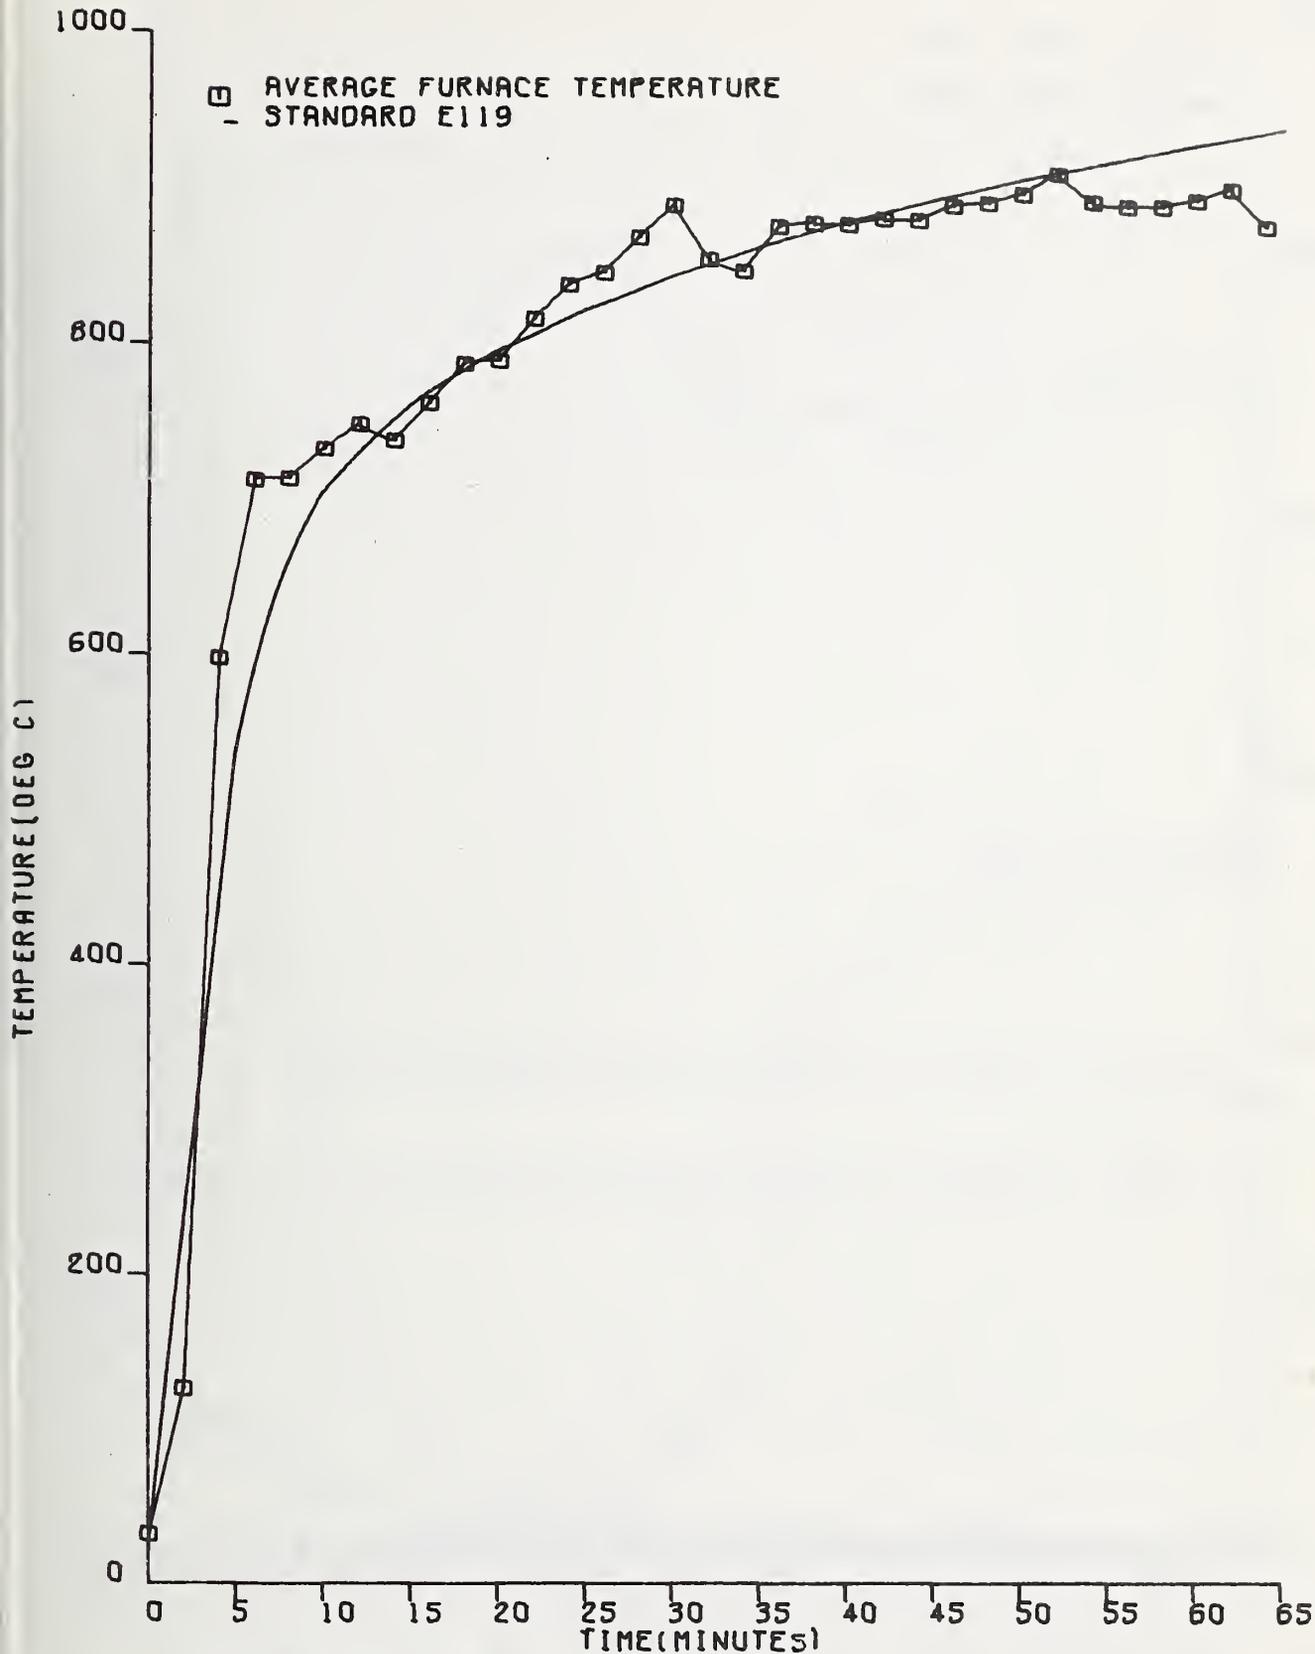
The temperature inside the furnace was measured by twelve type K thermocouples which were enclosed in sealed, standard weight, 1/2-in. diameter black iron pipe and were placed 6 in. away from the exposed surface of the assembly. The average furnace temperature, which was constrained to follow the standard ASTM E 119 temperature-time curve by manual control of the gas flow to the burner, is shown in Figure 5.

AVERAGE FURNACE TEMPERATURE COMPARED WITH STANDARD ASTM E 119 CURVE.

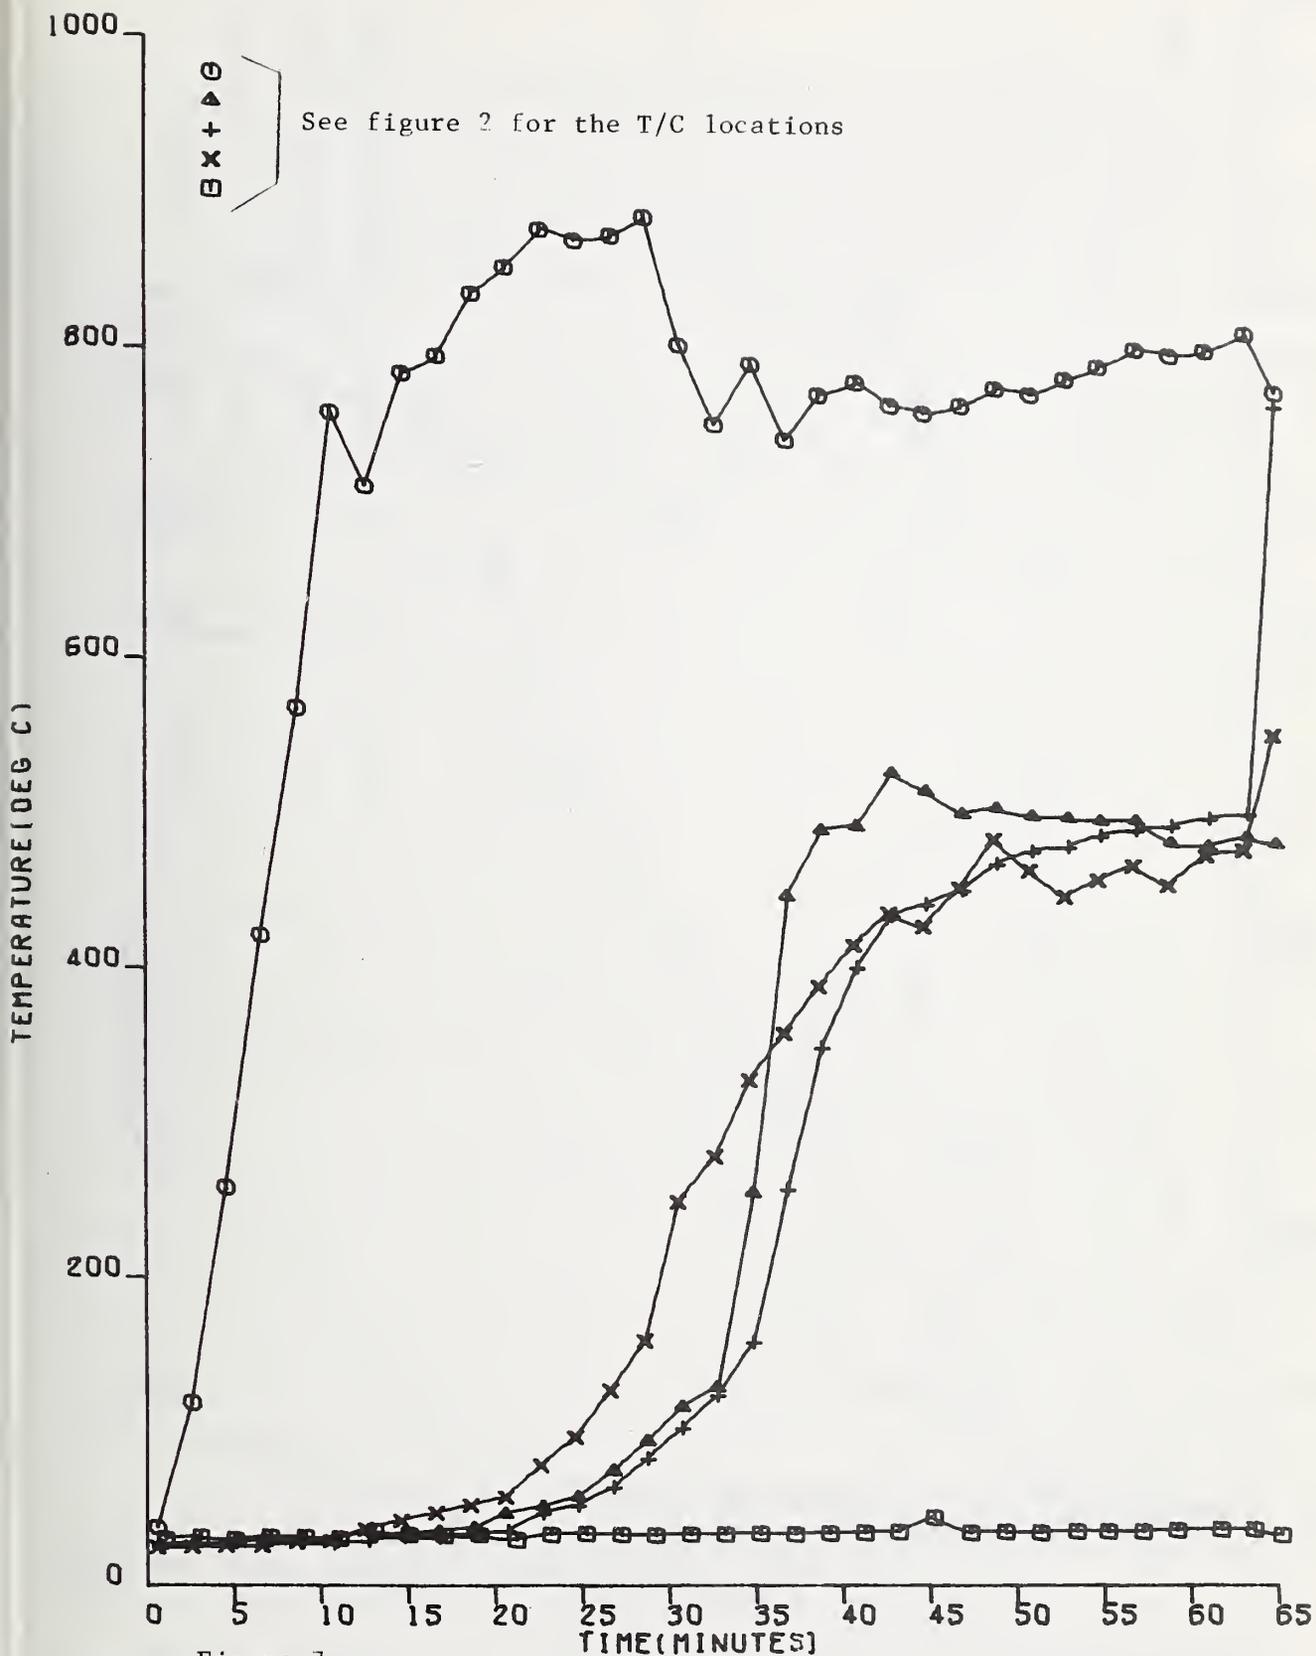
Figure 7.

A log of test observations is given in Table I. The average and maximum temperature rise of the unexposed surface during the test are shown in Figure 6. The average temperature profiles across the assembly at three different positions are shown in the Figures 7 and 8.

AVERAGE TEMPERATURE PROFILE ACROSS THE SPECIMEN OVER THE PANEL JOINT.

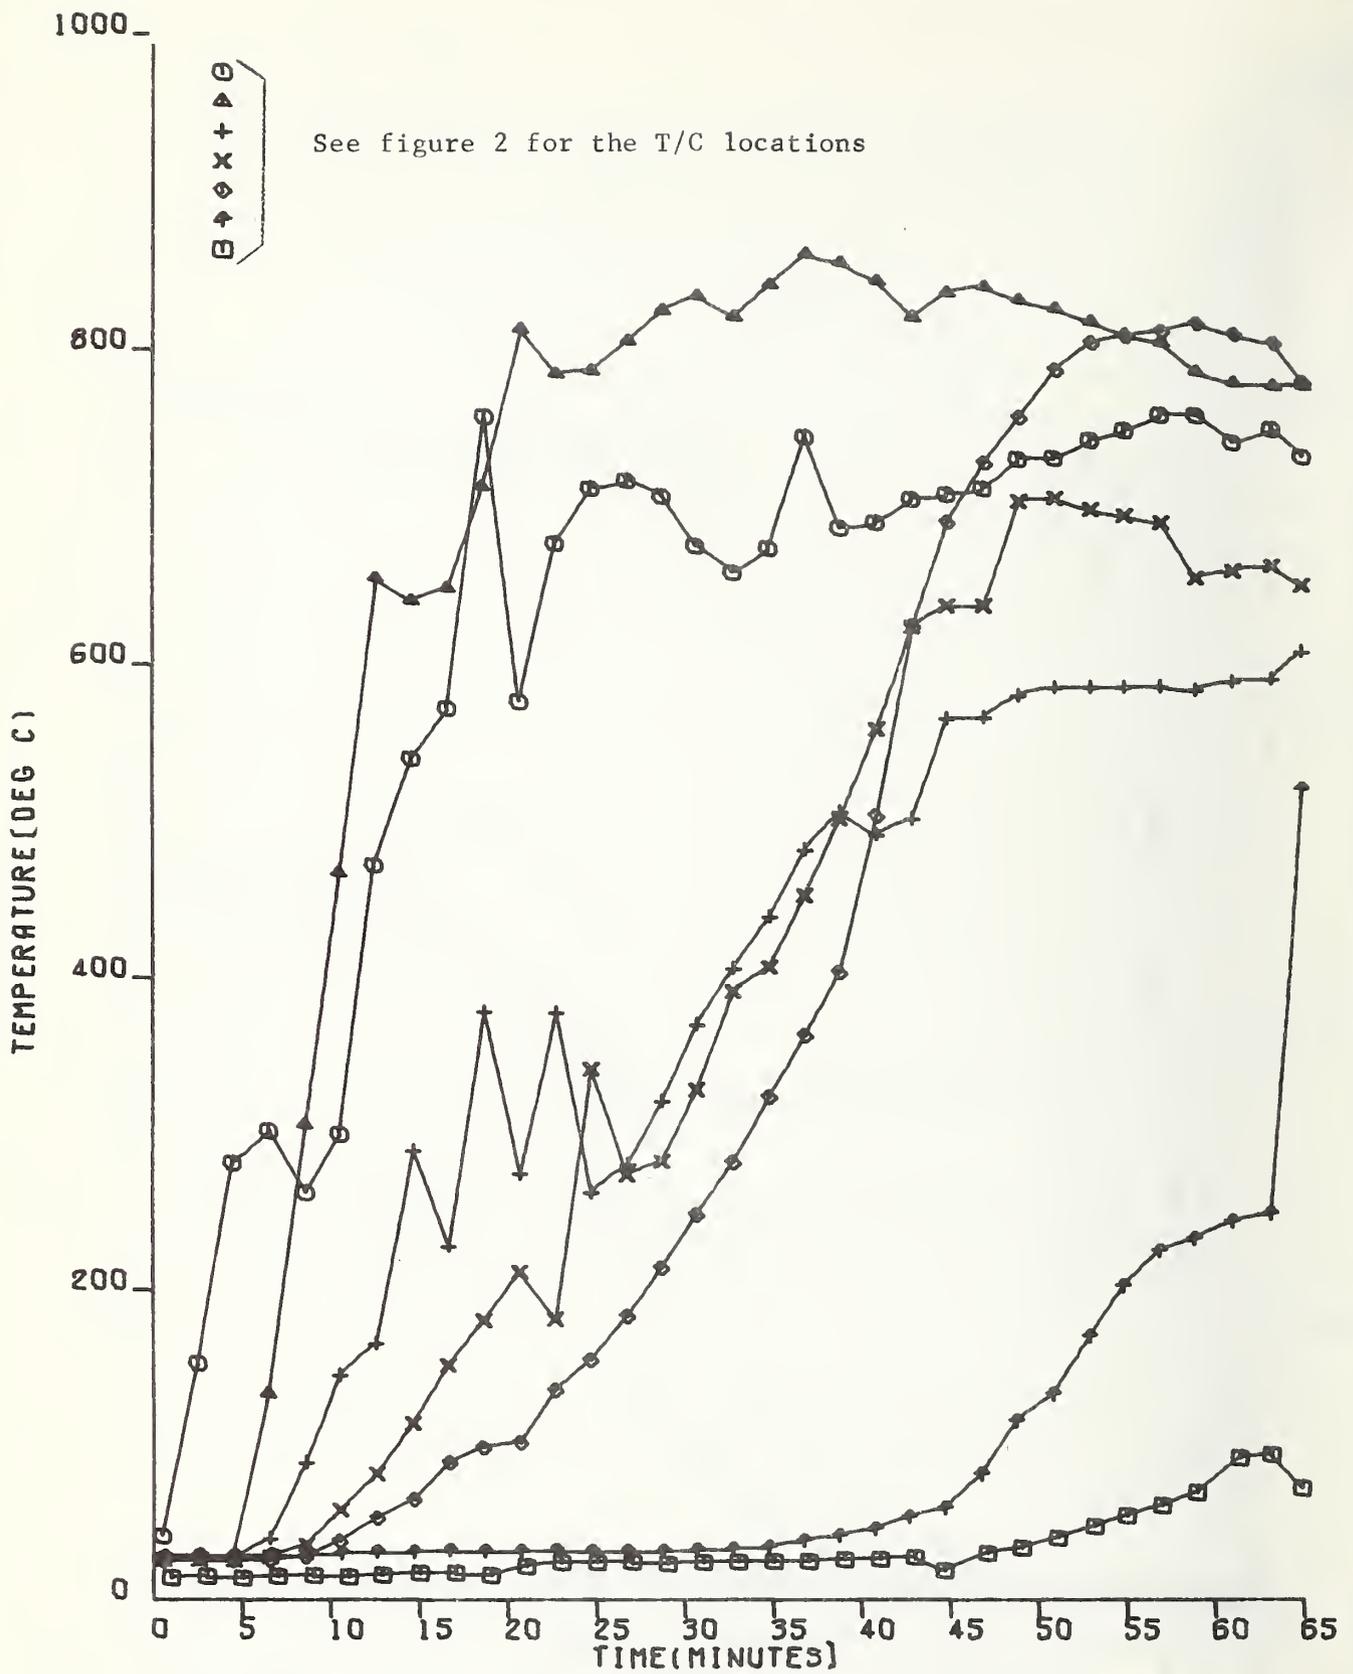
Figure 8.

AVERAGE TEMPERATURE PROFILE ACROSS THE SPECIMEN AT LOCATIONS A and B.

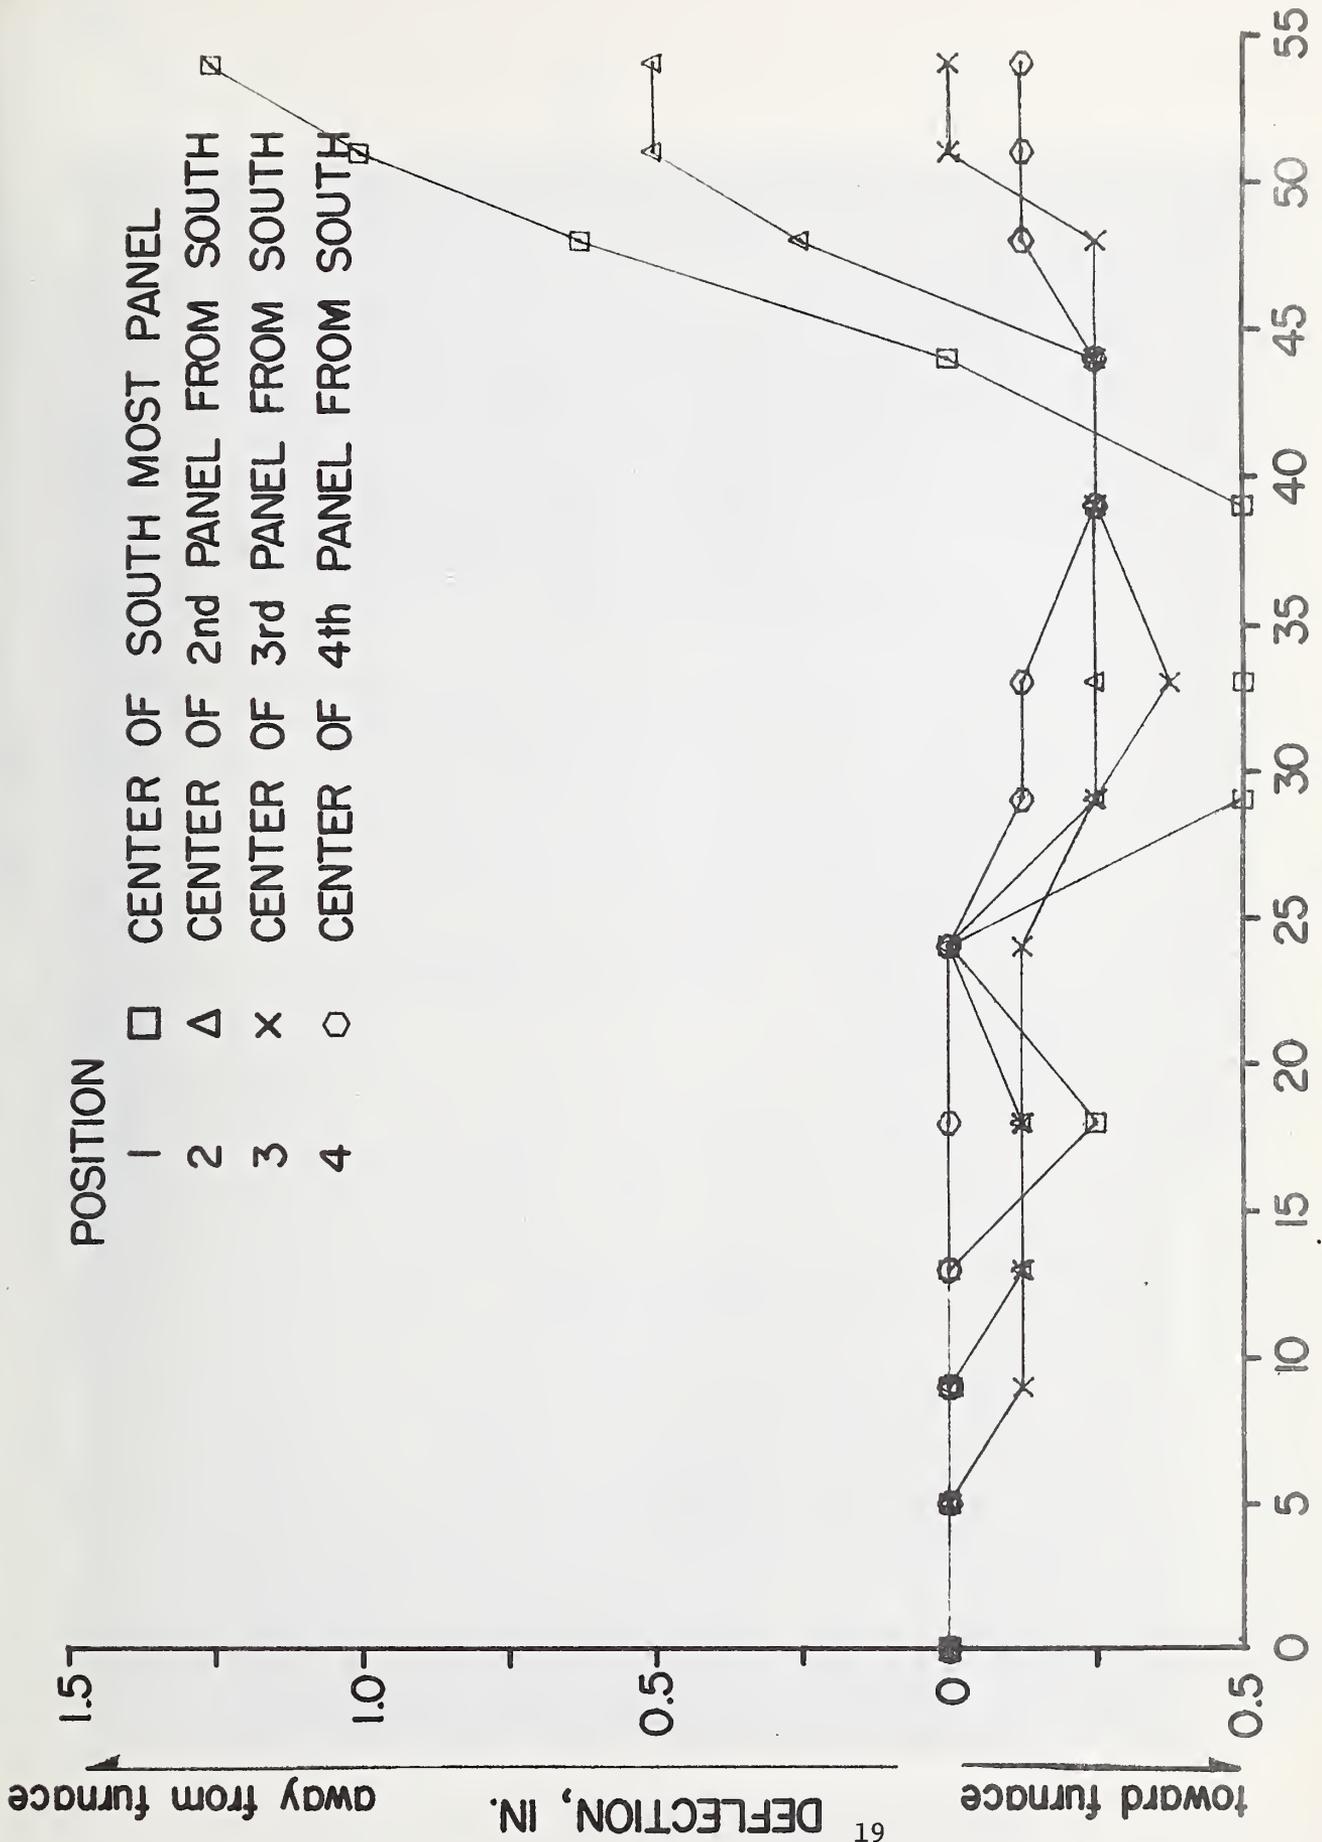
The lateral deflections at the mid-height of the second wall panel during the test and the vertical deflections of the lower edge of the panels are shown in Figures 9 and 10, respectively. Figure 11 shows the fire side of the specimen after it was removed from the furnace at the end of the test.

Figure 9. Lateral deflections at four locations of the unexposed surface.

1.06 in. AT
27 min: 25 sec.
