NBSIR 73-169

Fire Endurance Test of a Wood Stud Interdwelling Double Wall Construction

Final Report

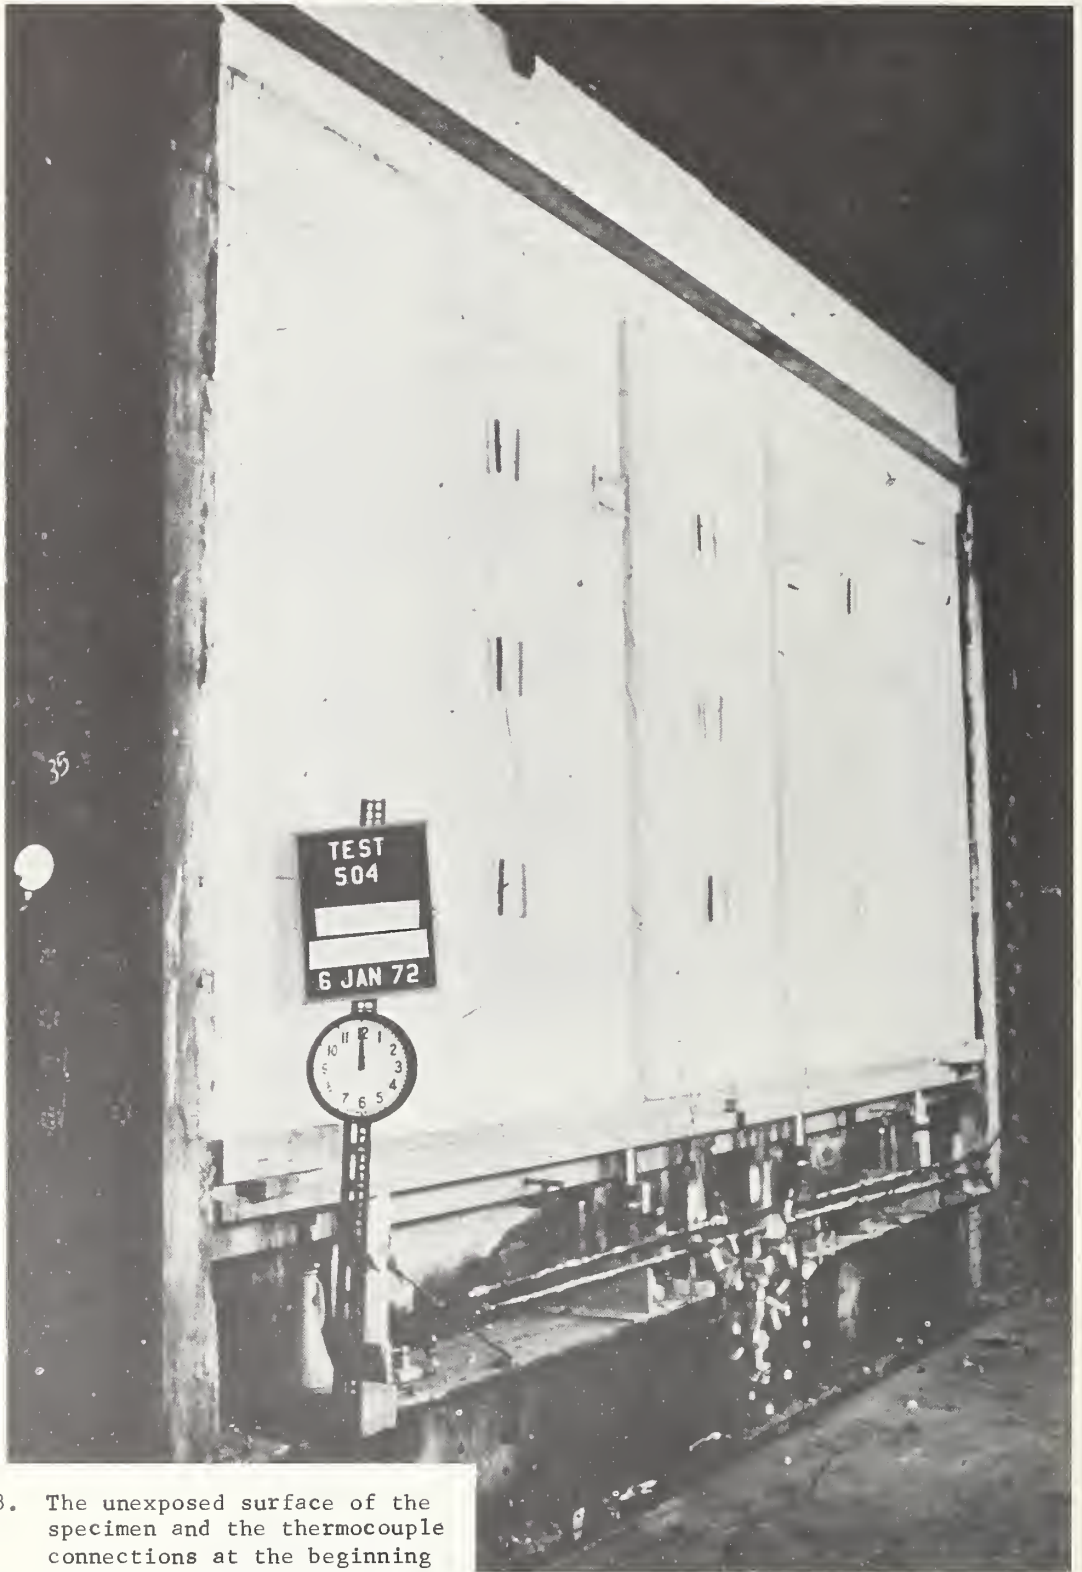
Figure 3. The unexposed surface of the specimen and the thermocouple connections at the beginning of the test. Test specimen mounted in furnace.

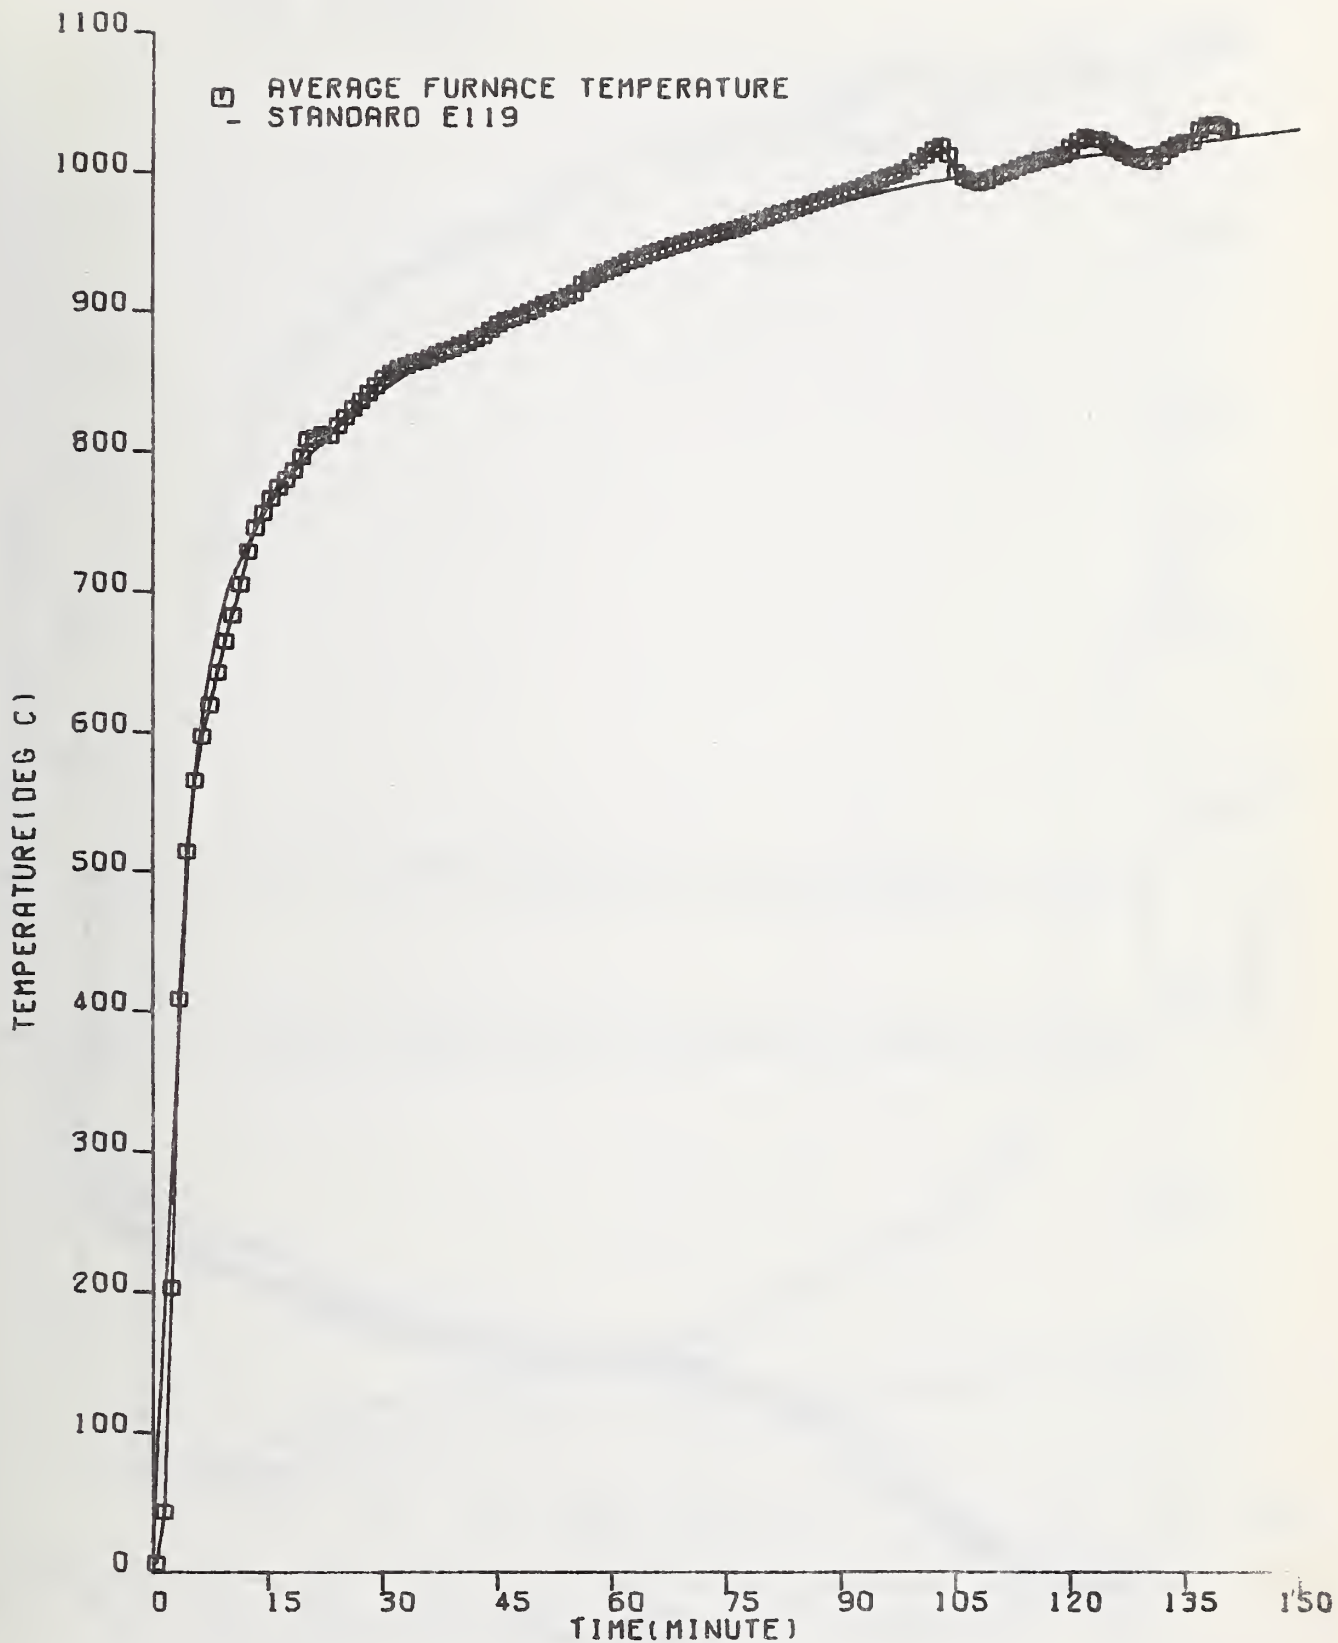
The temperature inside the furnace was measured by 12 chromel-alumel thermocouples enclosed in sealed 1/2 in. diameter wrought iron pipes placed 6 in. from the exposed face of the specimen. The furnace temperature was controlled to follow the standard ASTM E 119 temperature-time curve by manual adjustment of the gas flow to the burners. The actual furnace time-temperature curve is shown in Figure 4.

AVERAGE FURNACE TEMPERATURE FOR TEST 504 COMPARED WITH STANDARD E119 CURVE.

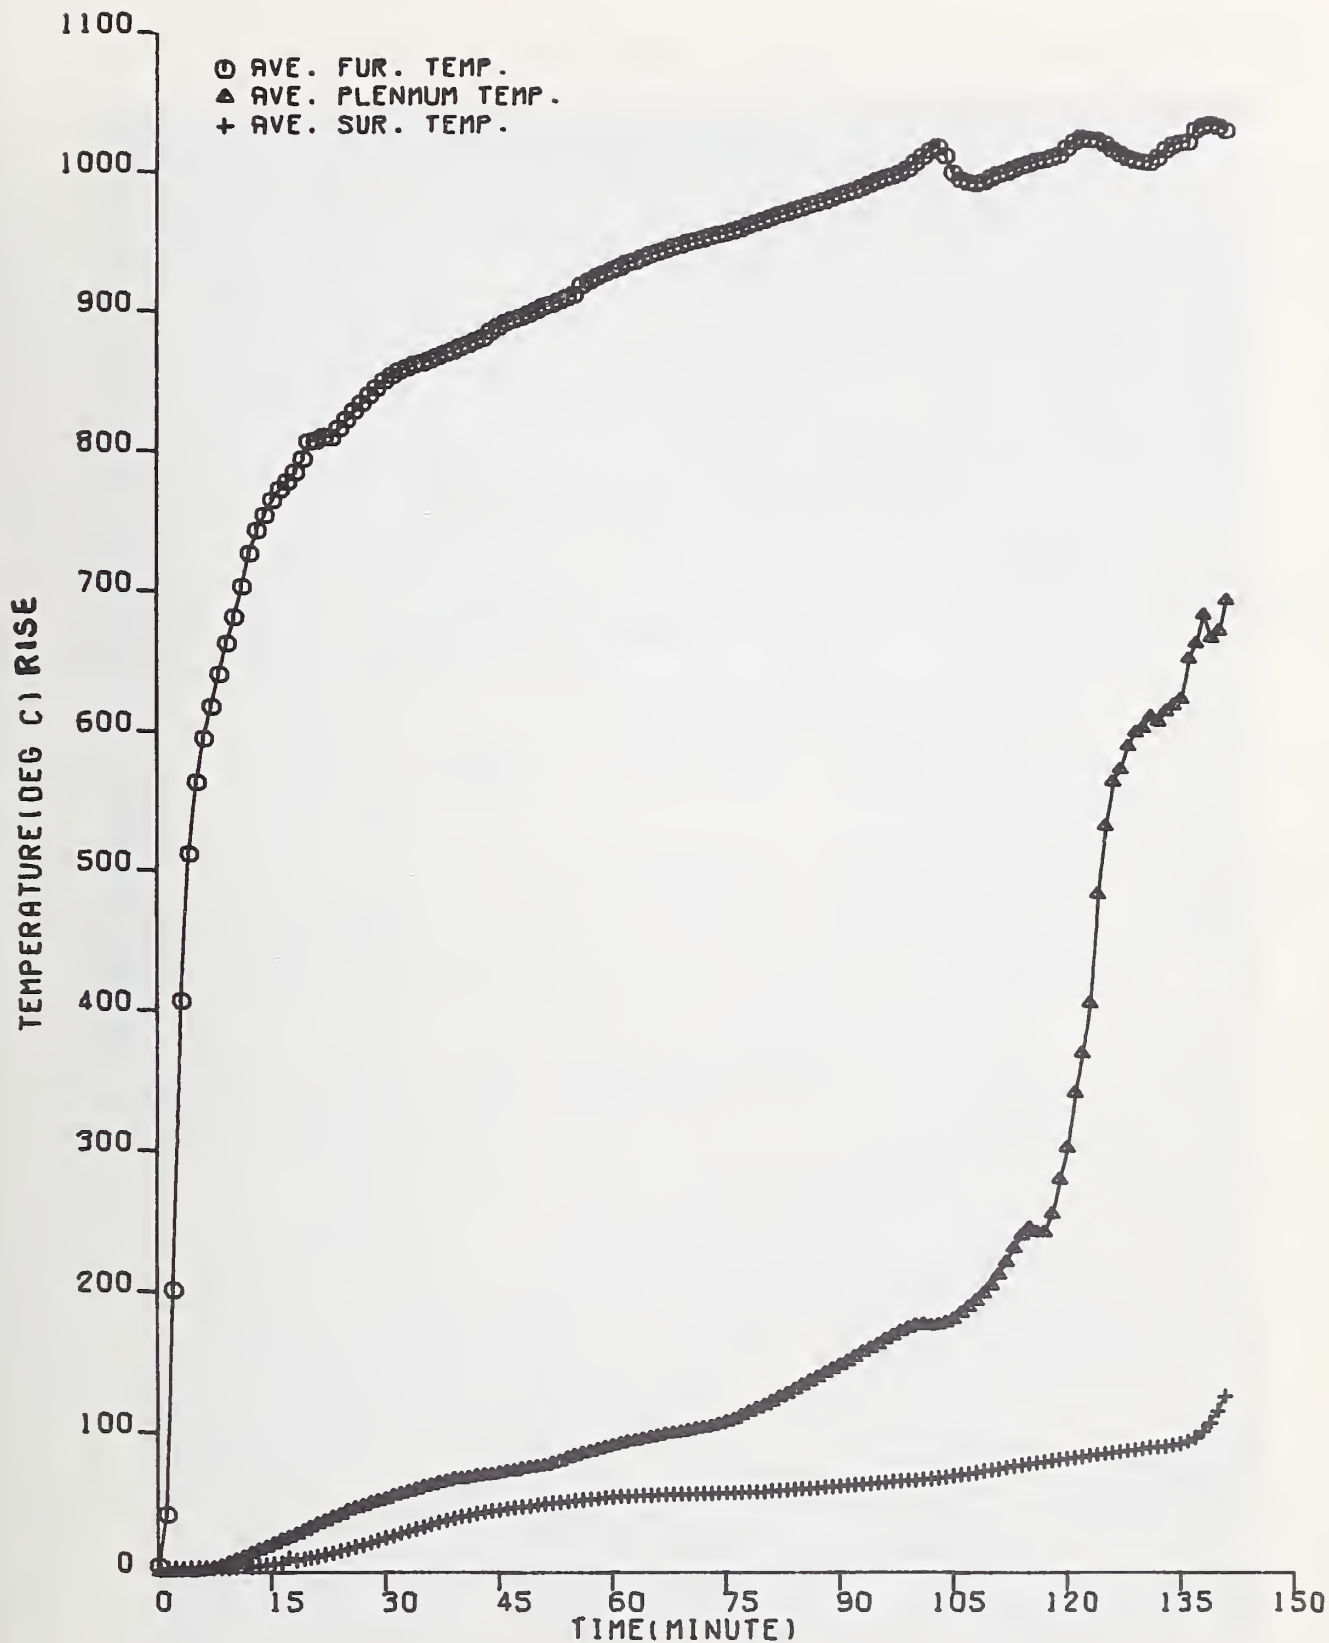
Figure 6.

AVE. AIR SPACE TEMPERATURE COMPARED WITH FURNACE TEMPERATURE AND UNEXPOSED SURFACE TEMPERATURE
