NBSIR 73-173

# Fire Endurance Tests of Double Module Walls of Gypsum Board and Steel Studs

April 1973

Final Report

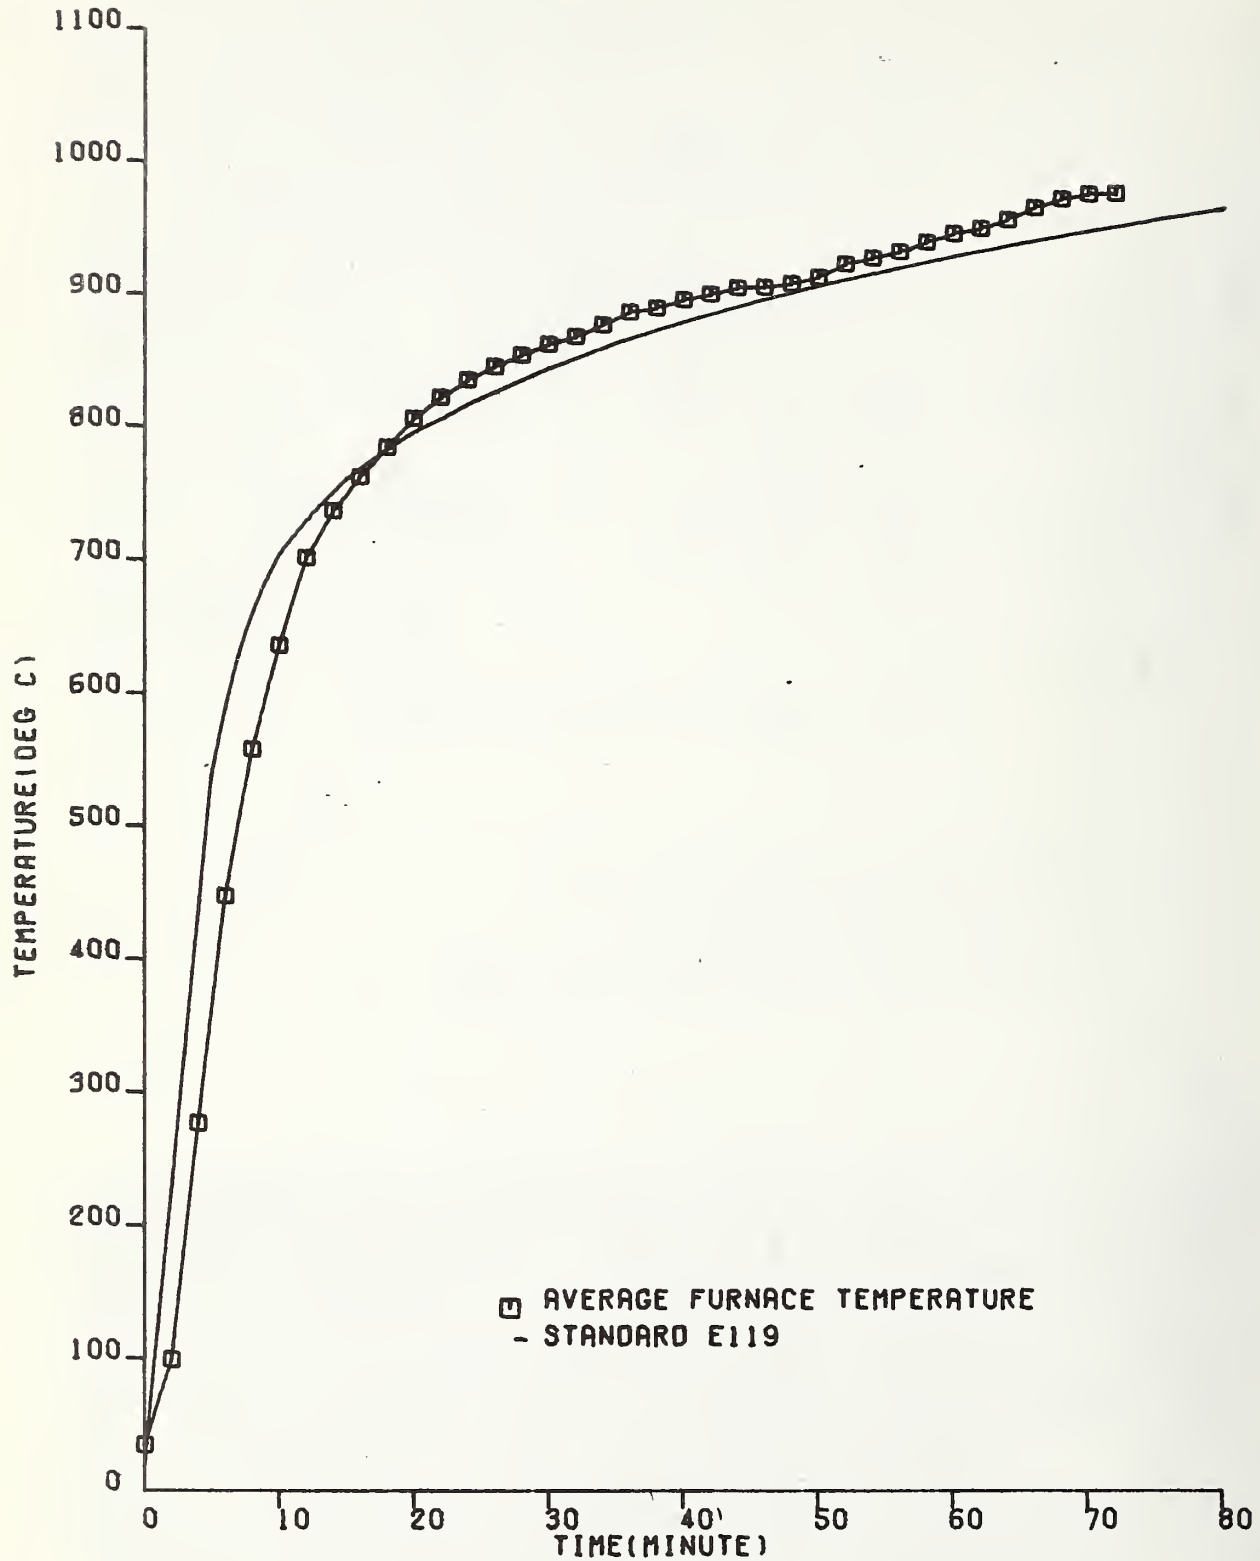
Figure 4 - Average Furnace Temperature for Wall No. 1 Compared with Standard E 119 Curve

The furnace temperatures throughout the test were in close conformance with the standard time-temperature curve and no correction was necessary to the times to failure (Figure 4).

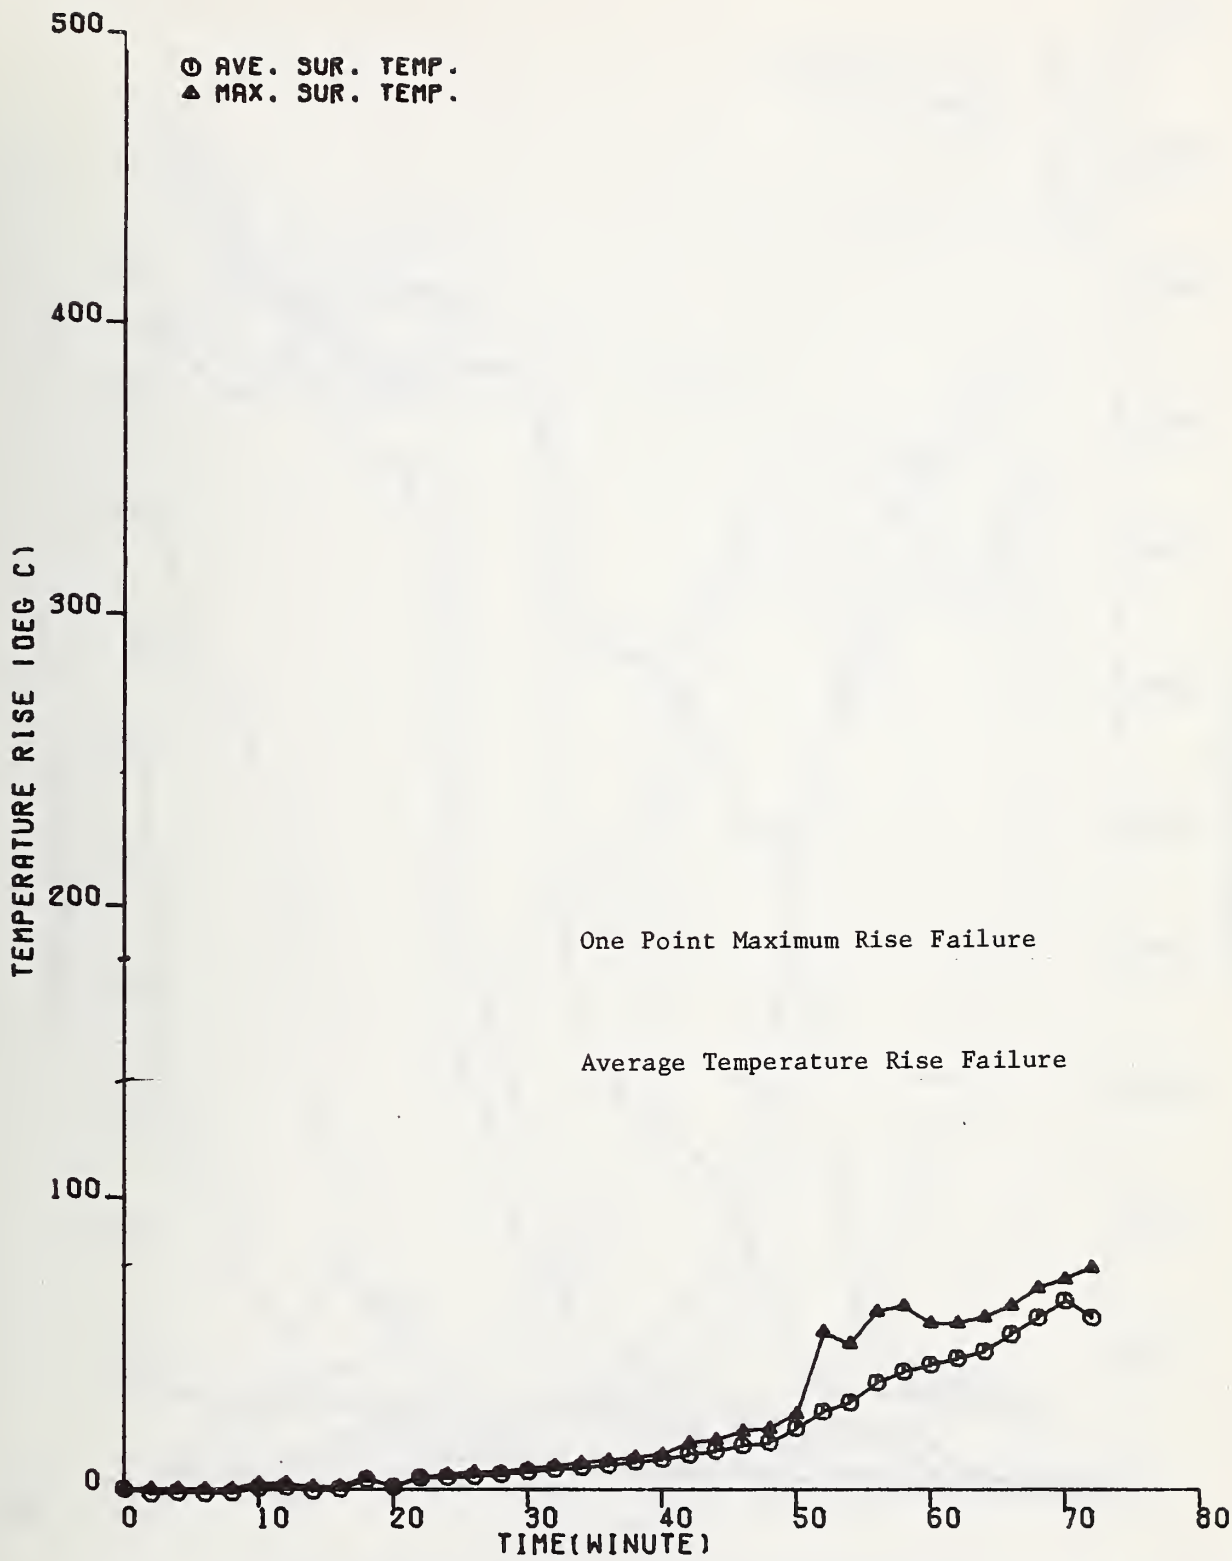
Figure 5 - Maximum and Average Temperature Rise on the Unexposed Surface Wall No. 1

As can be seen in Figure 5, temperature rise at the thermocouple locations on the unexposed surface did not approach the limiting rises established as criteria of failure in the ASTM E 119 standard. There was little temperature variation over the surface as indicated by the close correspondence of the maximum one point and average temperature curves. The temperature gradient across the wall assembly can be seen in Figure 6 (maxima) and Figure 7 (average).

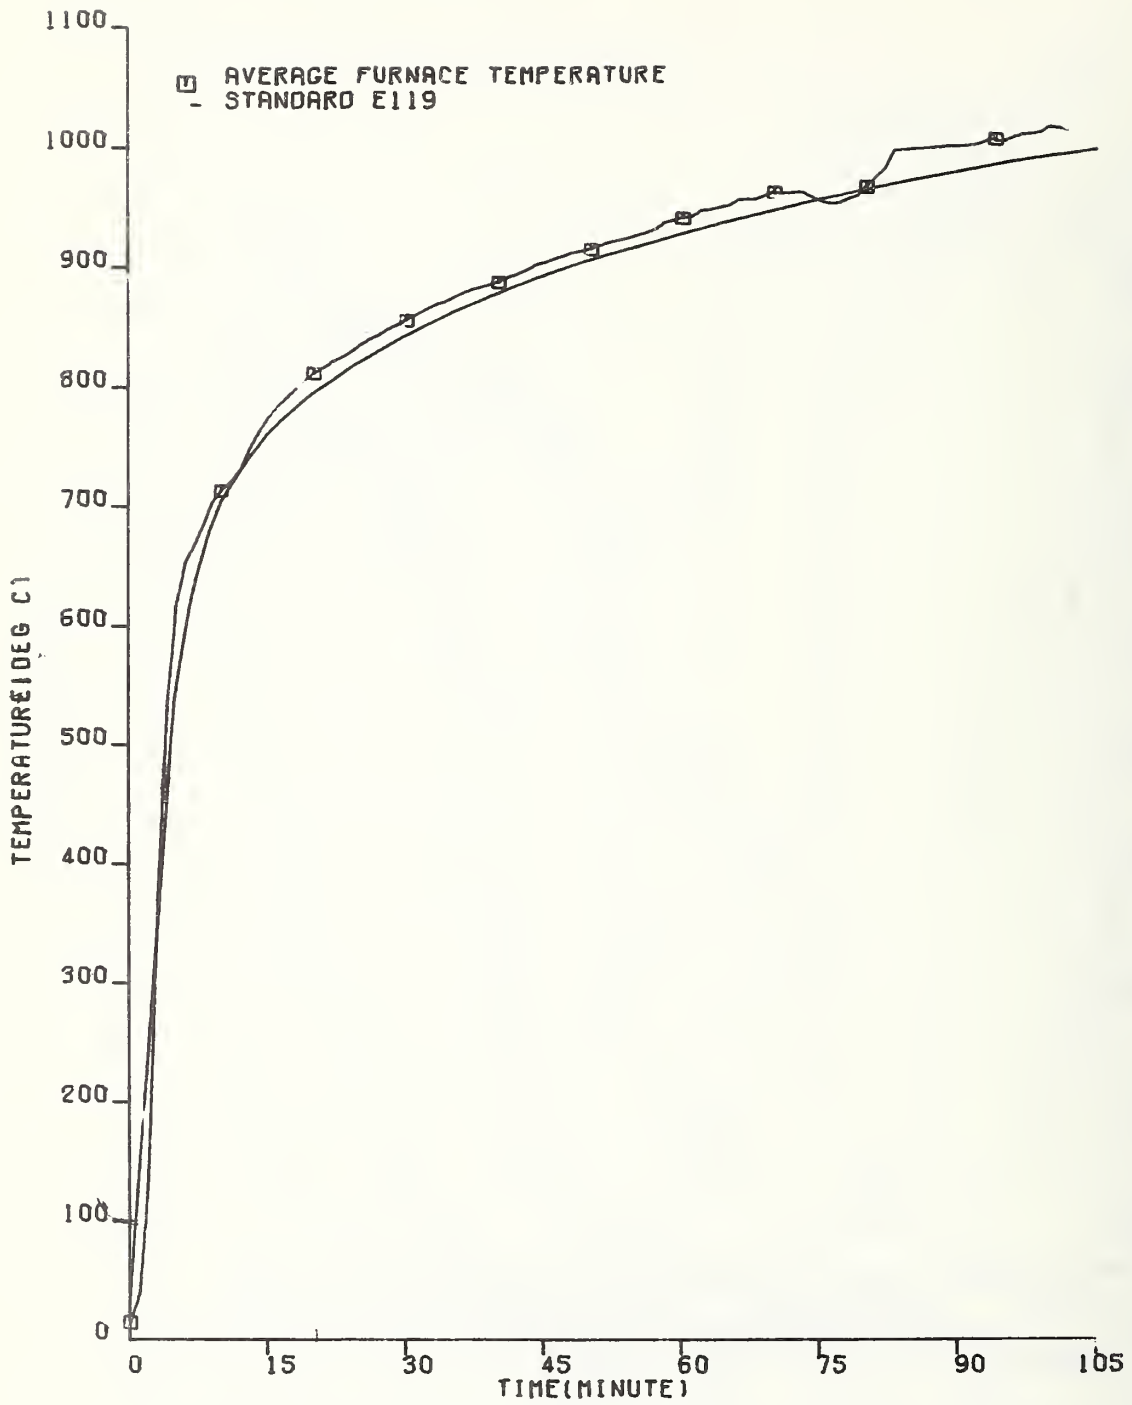
Figure 8 - Average Furnace Temperature for ... Test No. 2 Compared with Standard E 199-71 Curve.

In the fire endurance test of the second wall assembly failure (inability to sustain the applied load) occurred at 1 hour 7 minutes for the fire exposed wall and at 1 hour 43 minutes for the unexposed member. Failure by passage of hot gas through the whole assembly occurred at 1 hour 37 minutes when cotton waste held against a joint between boards on the unexposed surface was ignited. The furnace temperatures, while slightly higher than the prescribed standard, were so close to those of the standard curve that no correction was required for the indicated fire endurance times (furnace and standard curve in Figure 8).

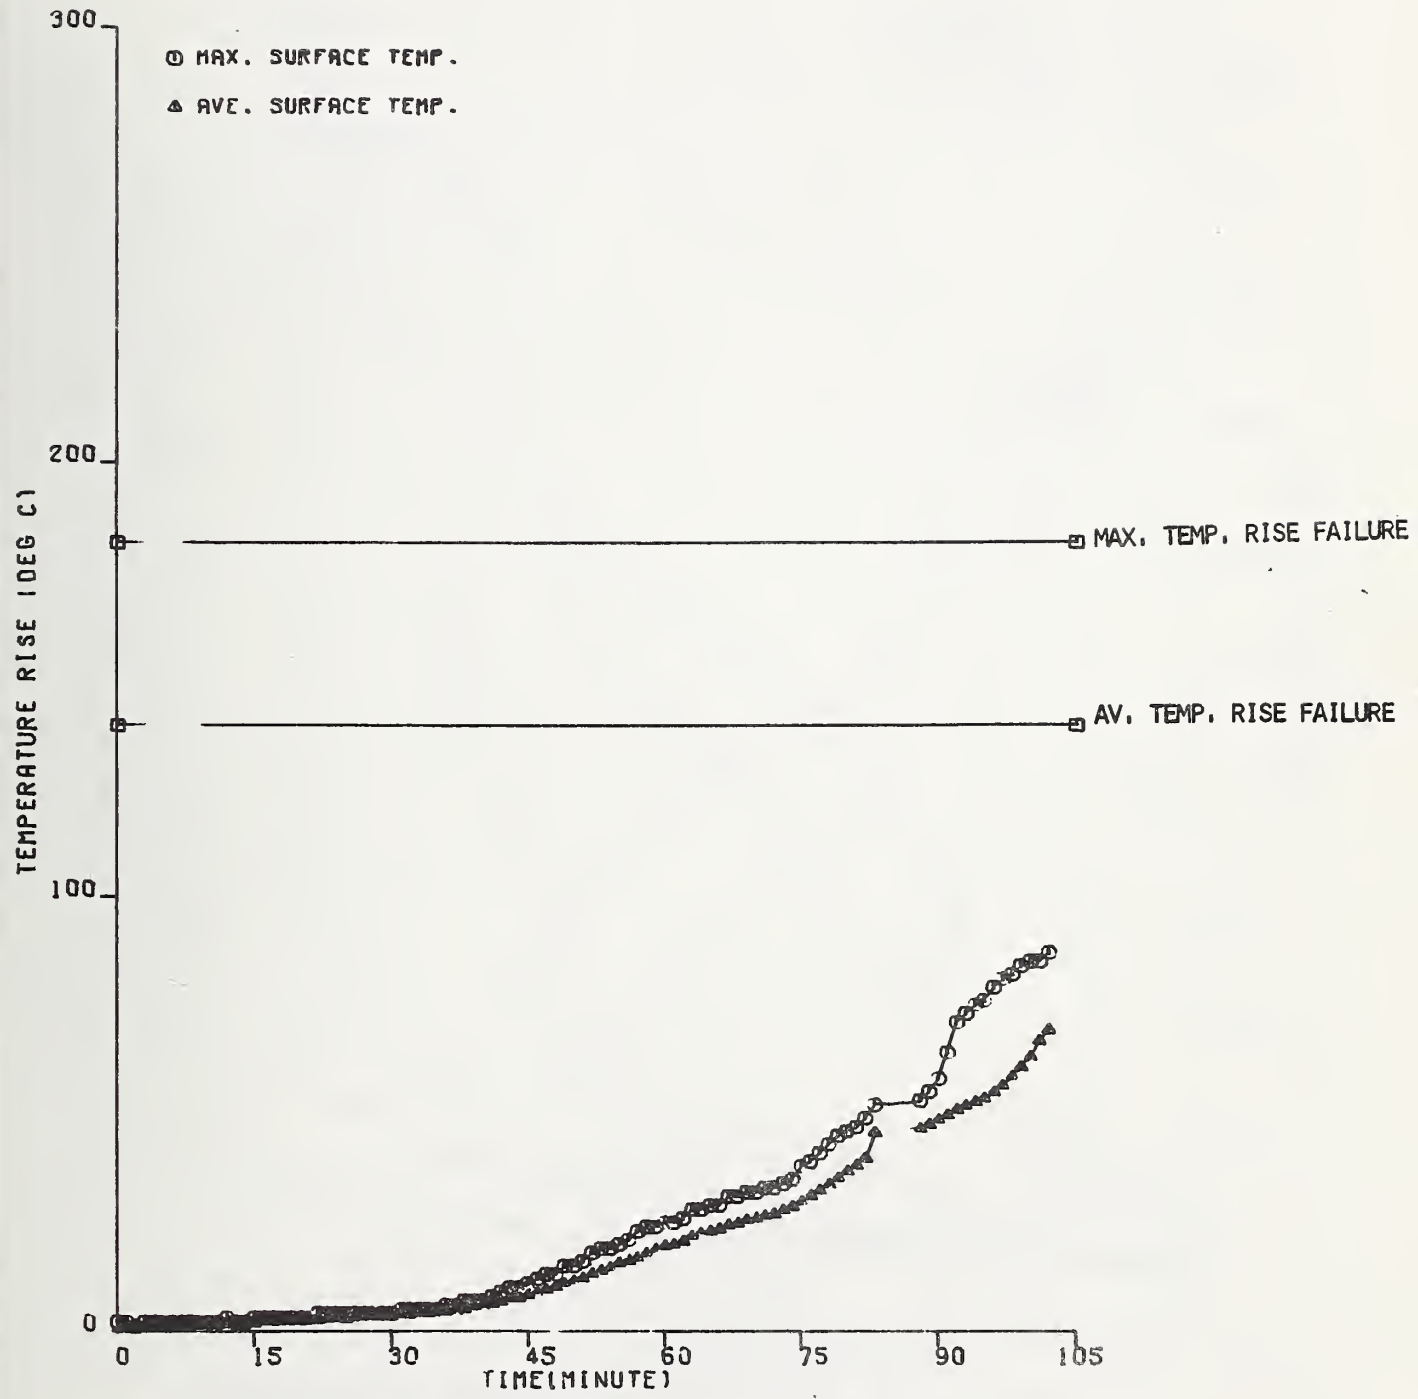
Figure 9 - Maximum and Average Temperature Rise on the Unexposed Surface 2nd Wall

As could be expected from the results of the tests on the first wall, temperature rises on the unexposed surface remained considerably below the limits established as failure points in the fire test standard (Figure 9). Here again there was little variation in temperatures over the surface, with maximum temperatures only slightly greater than averages. Temperature gradients across the wall assembly were also

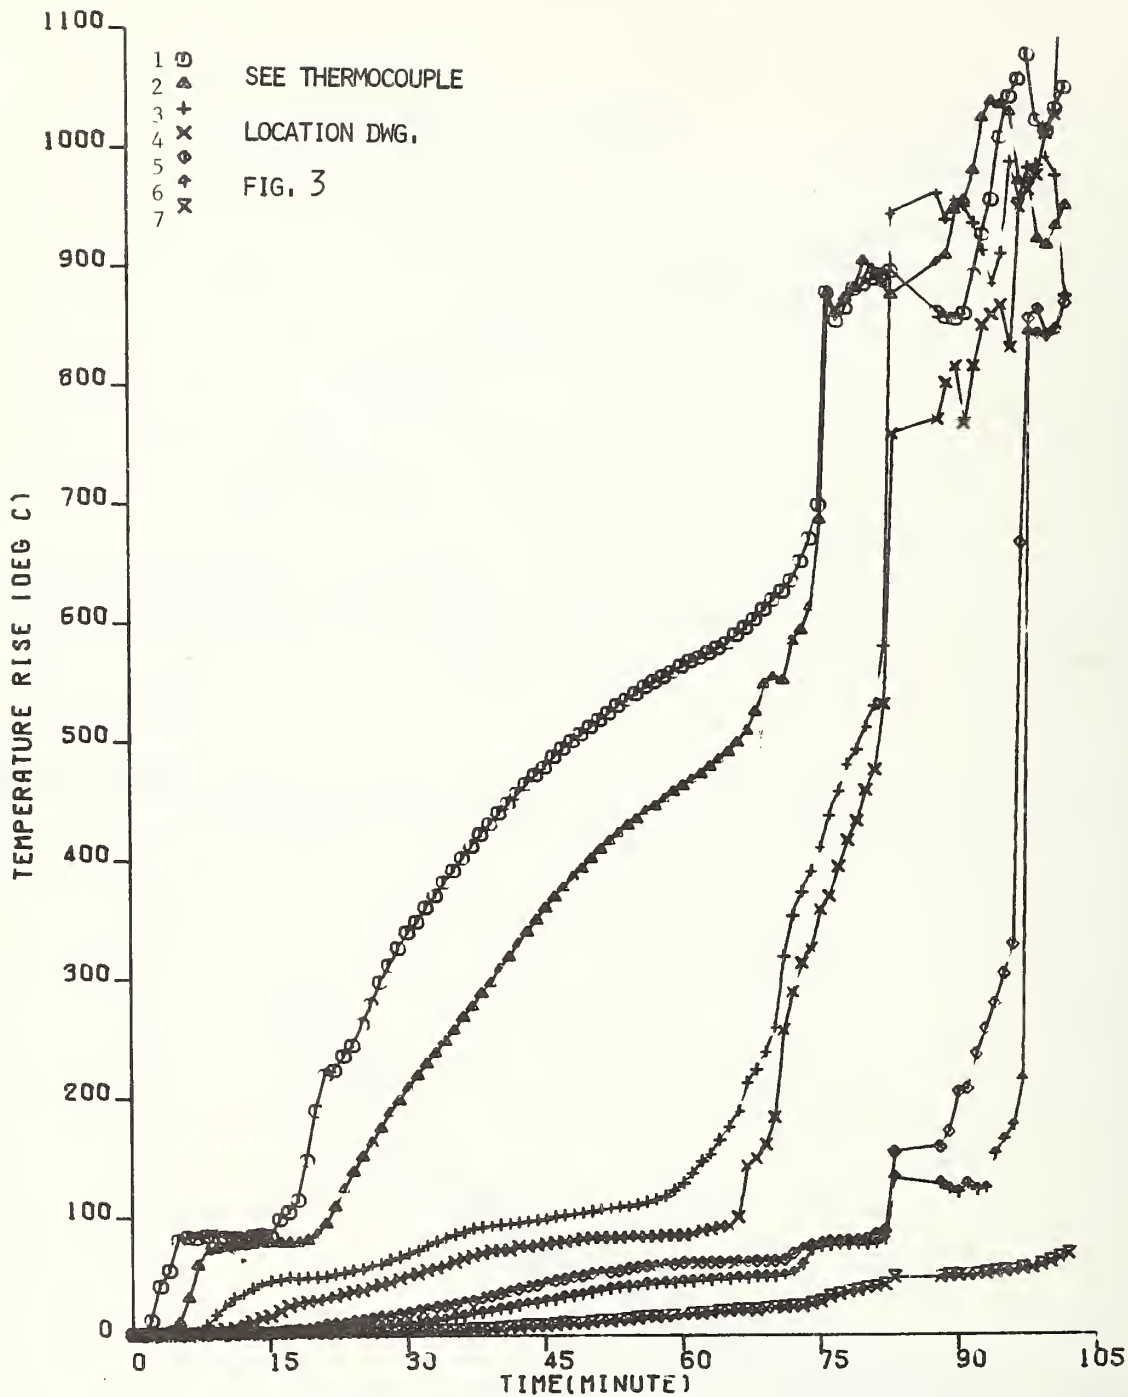
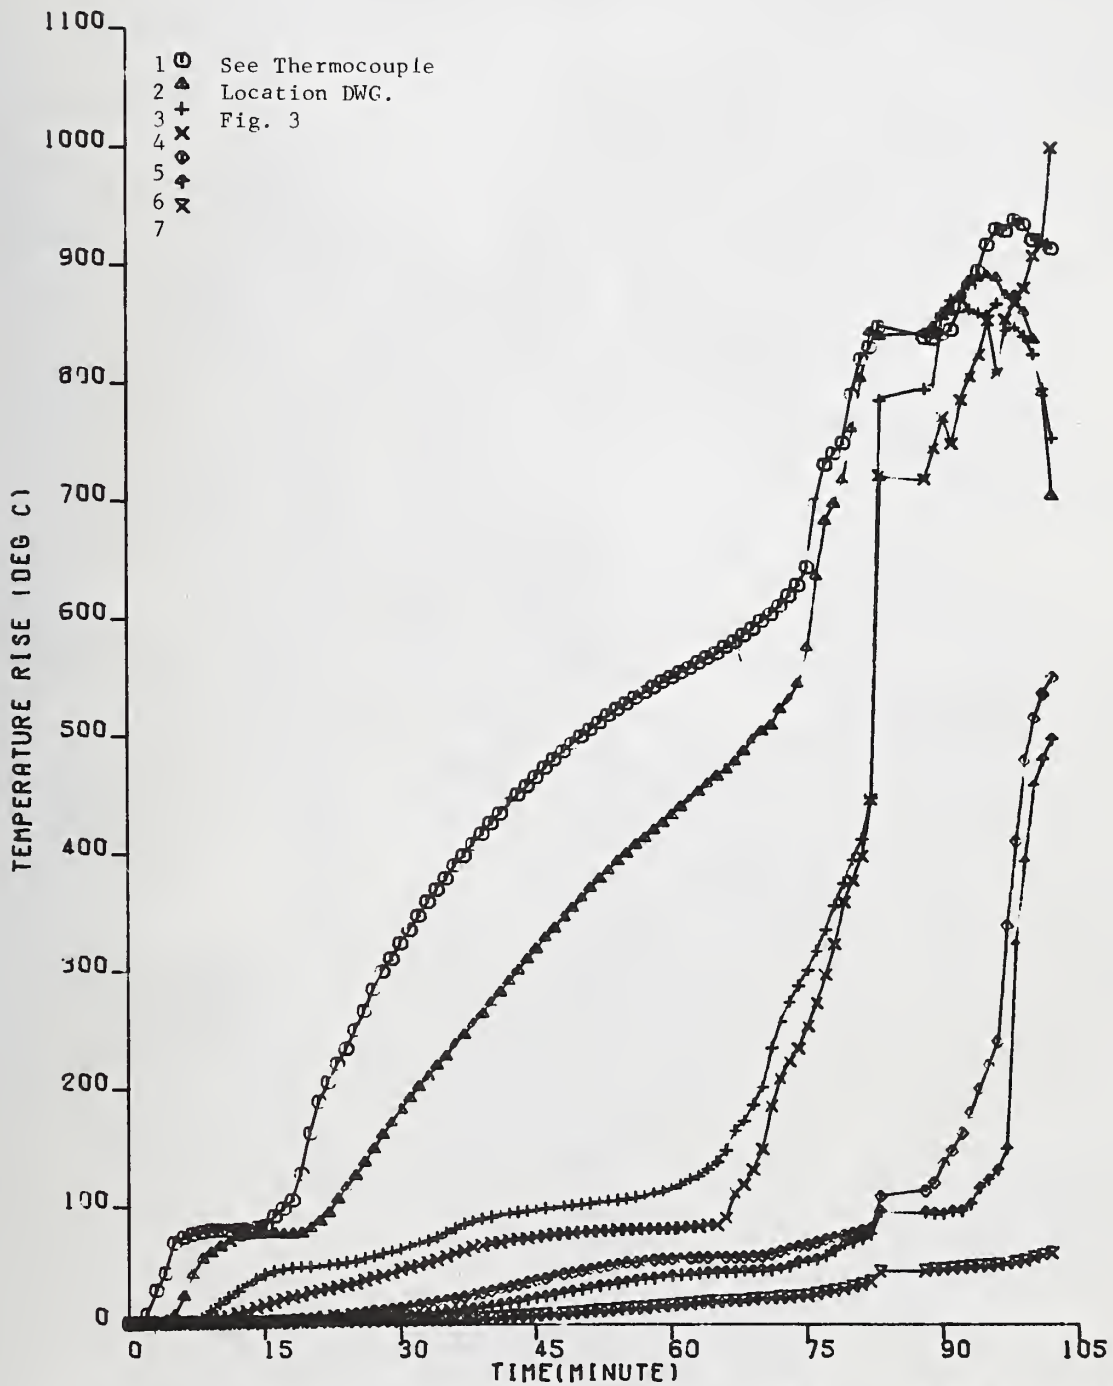
similar to those for the first test specimen, but with indication of somewhat slower heat penetration which could be attributed to the greater thickness of insulation in the second test specimen (Figures 10 and 11).
