Investigation of the Skyline Plaza Collapse in Fairfax County, Virginia

E. V. Leyendecker and S. G. Fattal

Center for Building Technology
Institute for Applied Technology
National Bureau of Standards
Washington, D. C. 20234

Final Report

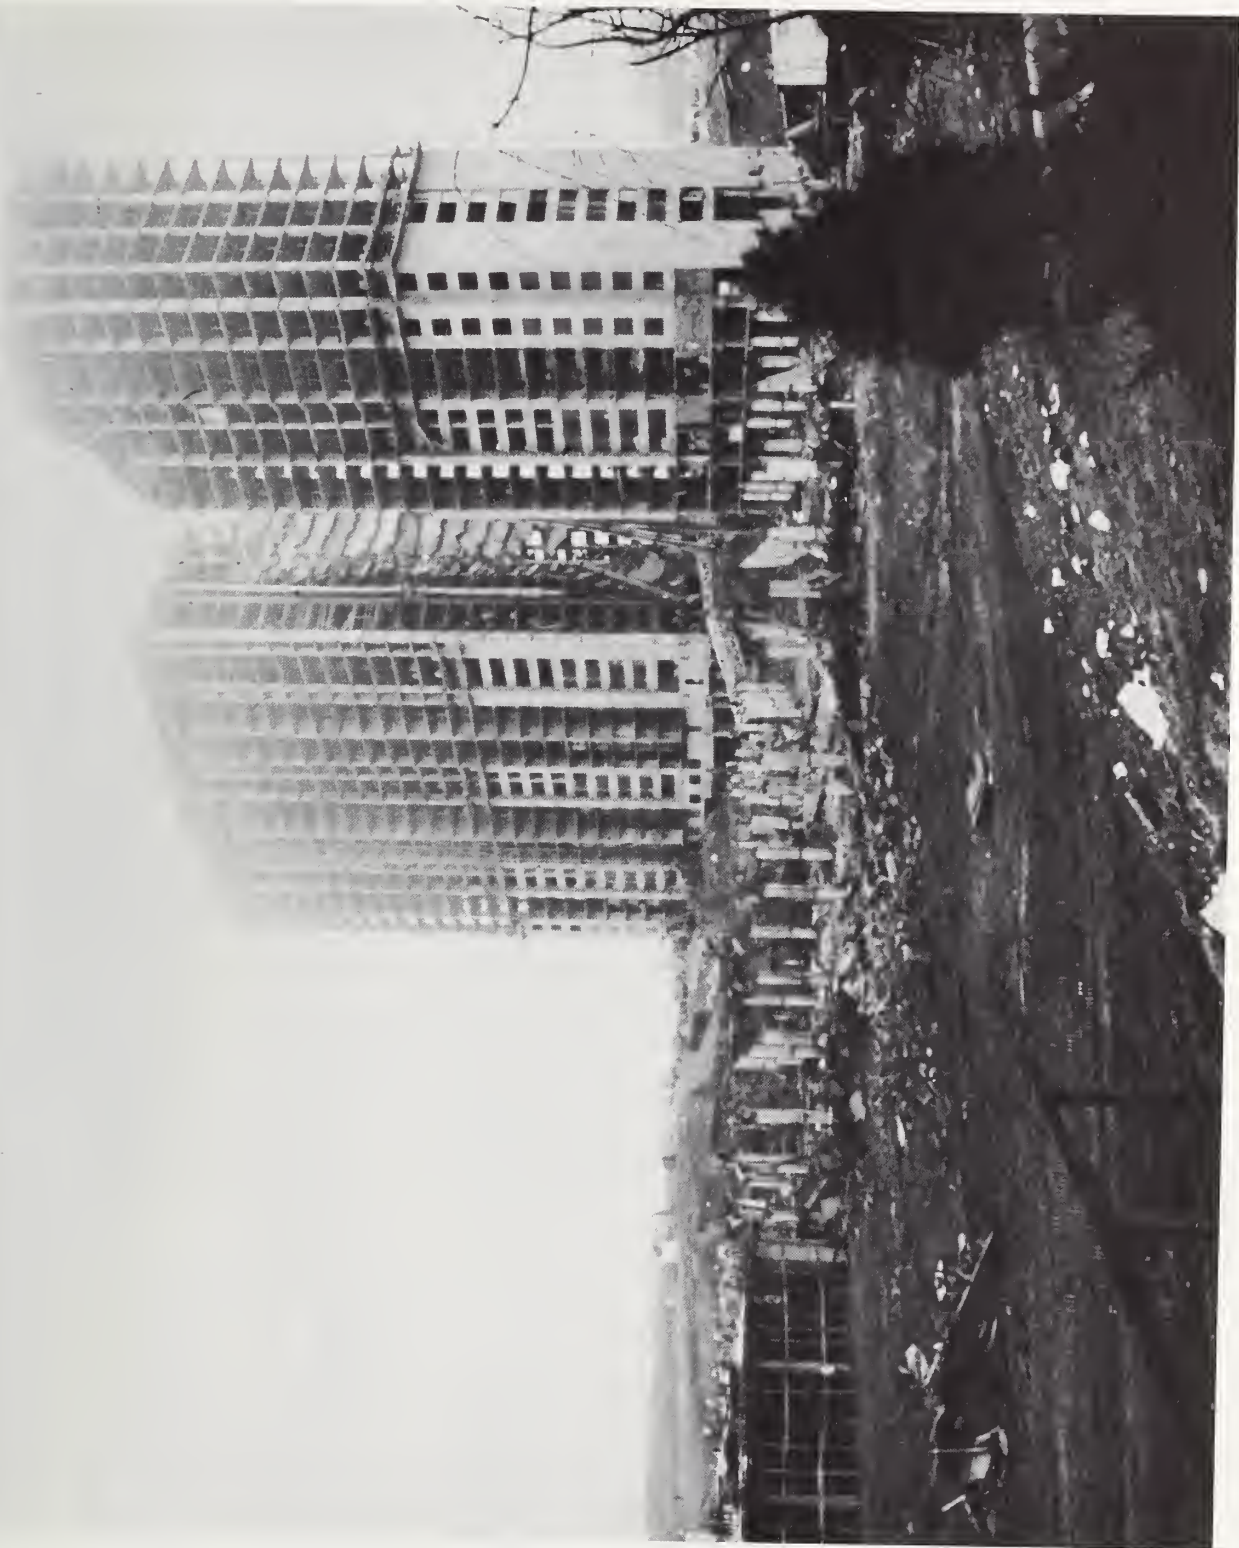
Figure 1.3 Appearance of the collapsed structures as viewed from the southeast.

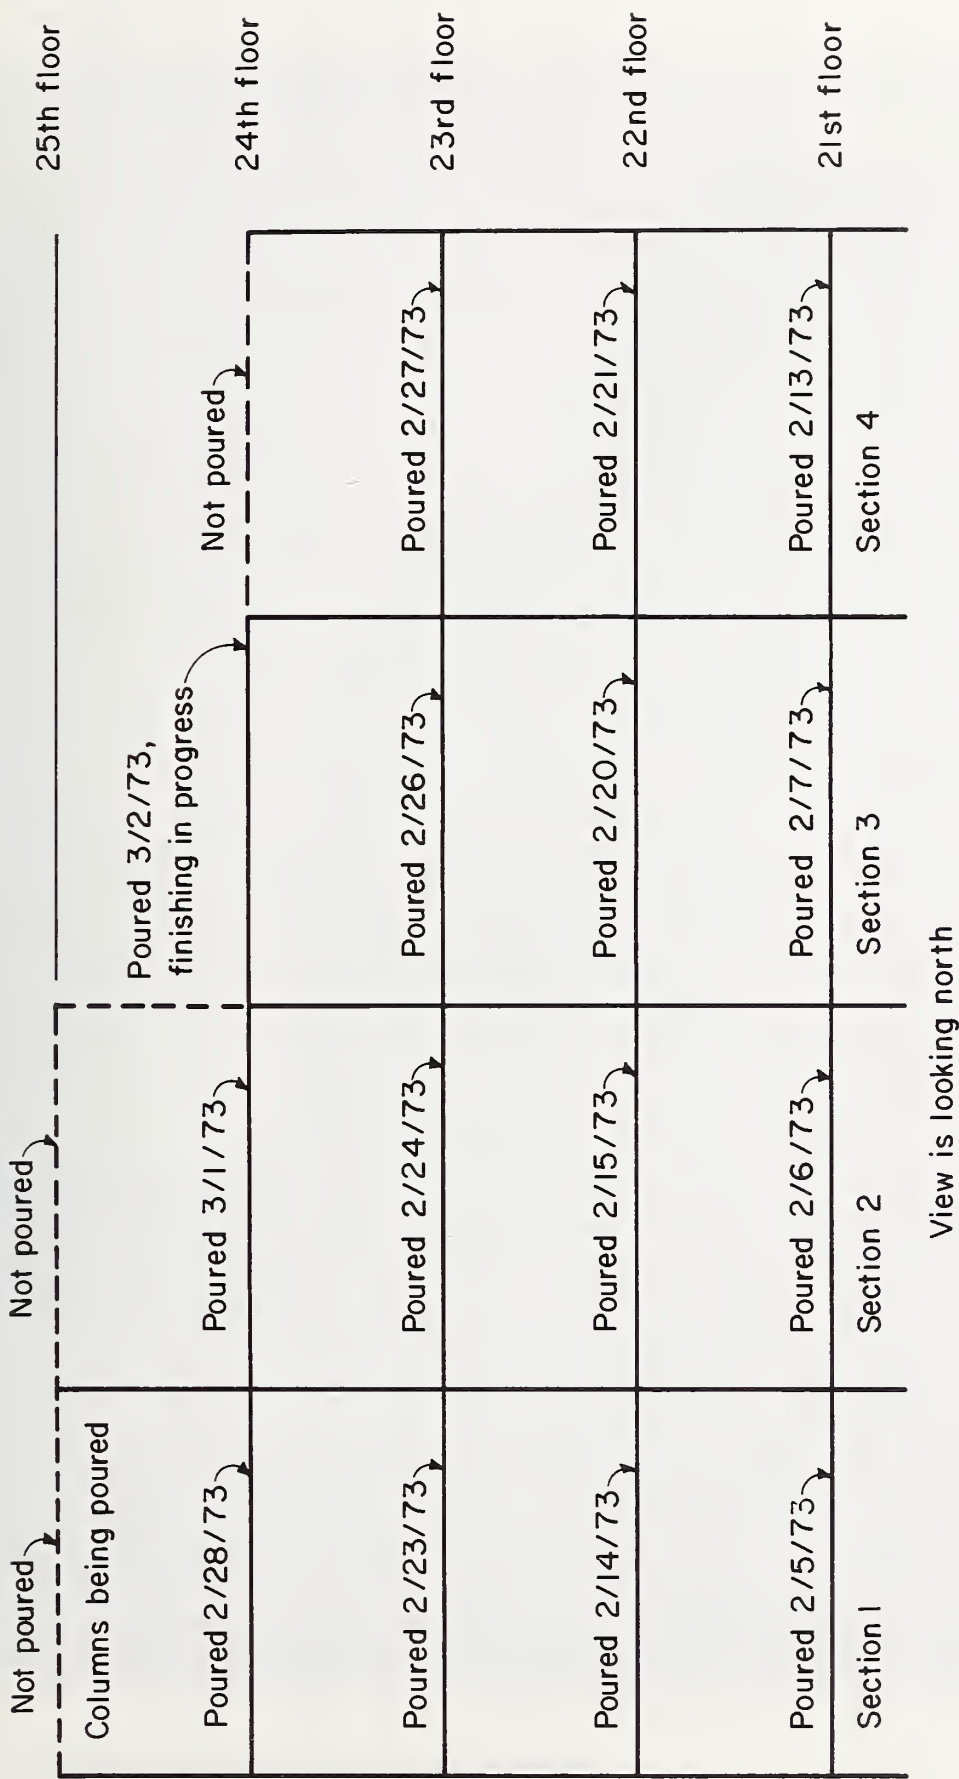
The date of the photograph (reported as February 11 or 18) can be checked by looking at figures 2.39, 2.42, and 2.2. Close examination indicates that none of the 22nd floor had been cast at the time of the photograph (openings can be seen in the slab forms). Since figure 2.2 indicates that section 1 on the 22nd floor was cast on February 14, it is established that the photograph was taken before that date. Due to the construction progress shown in the figure it can be stated that section 2 of the 21st floor which was cast February 6 (figure 2.2) was in place. Based on this evidence it appears that the photograph was taken between February 6 and February 14.

Figure 2.2 EXTENT OF CONSTRUCTION AT THE TIME OF COLLAPSE

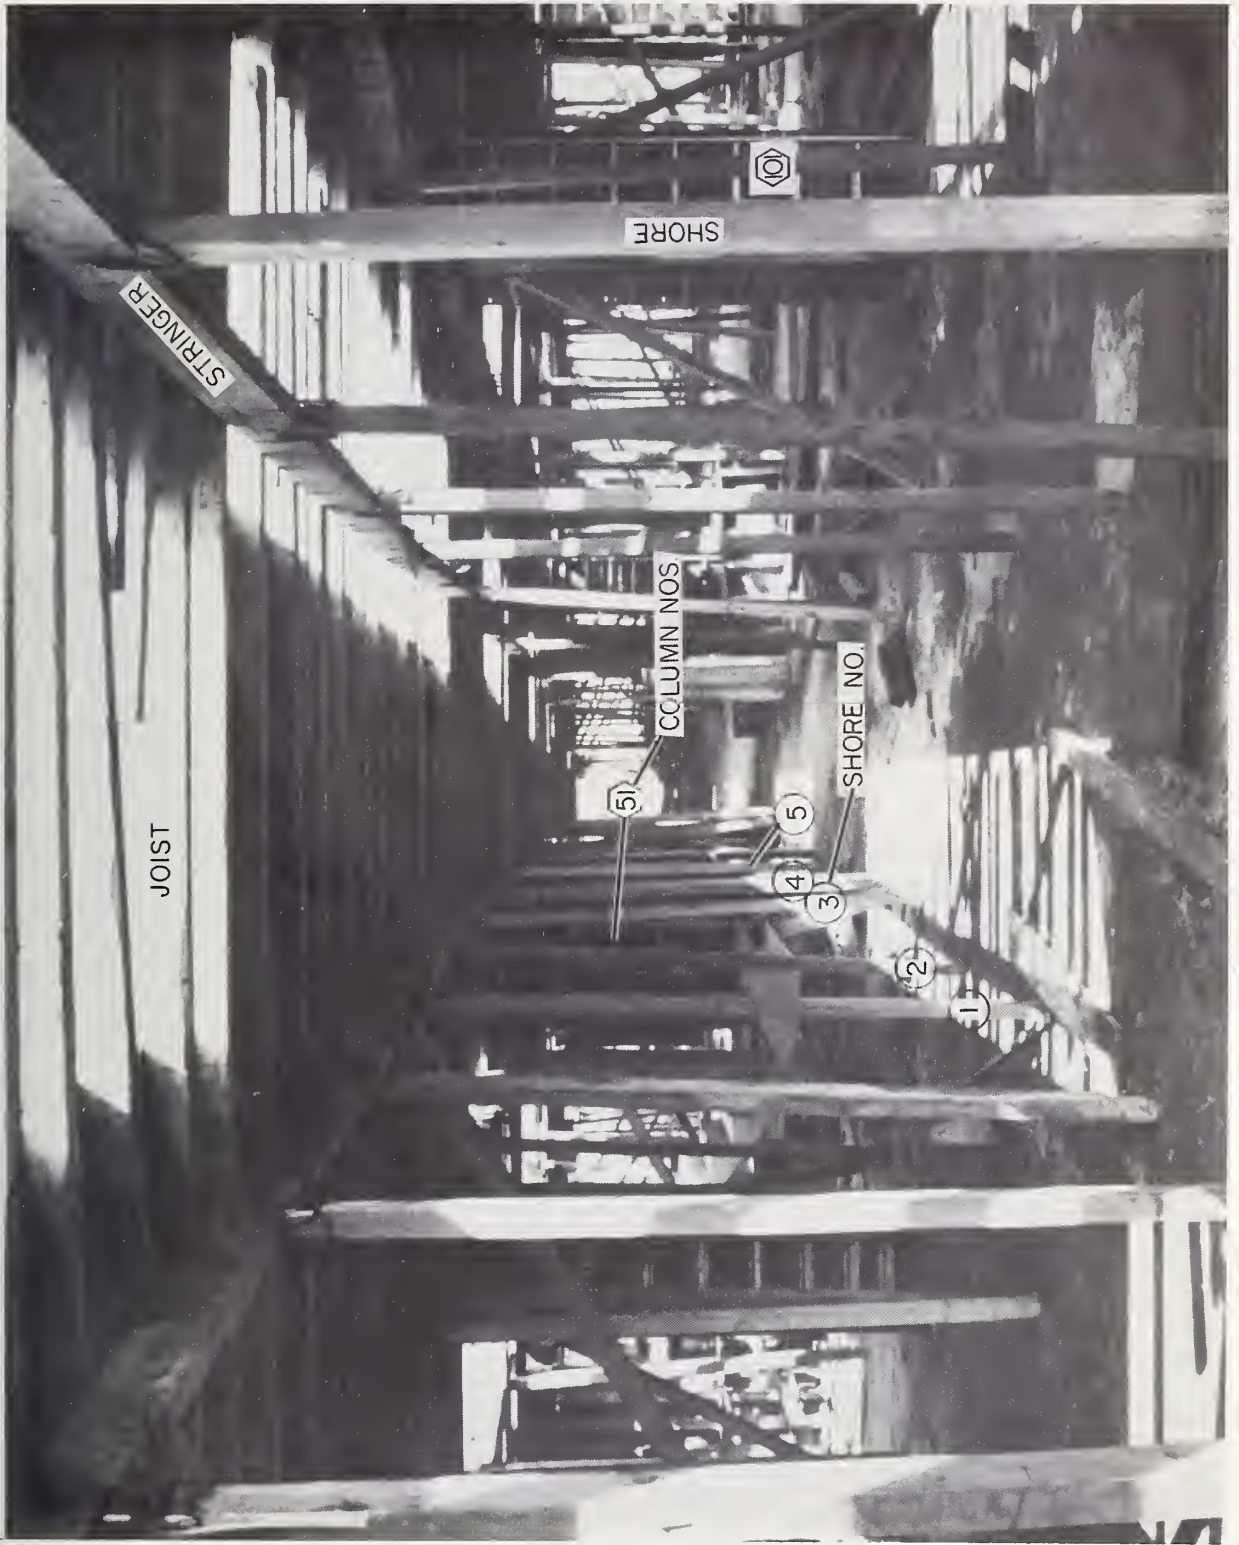
OSHA regulations (ANSI-A10.9, section 8.1.24) allow a maximum deviation of 1/8 in per 3 ft out of plumb. Deviations of shoring exceeding these limits were found on the 23rd (figure 2.20) and 24th (figure 2.16) stories.

Figure 2.16 Formwork in sections 1 and 2 of 24th story, looking east.

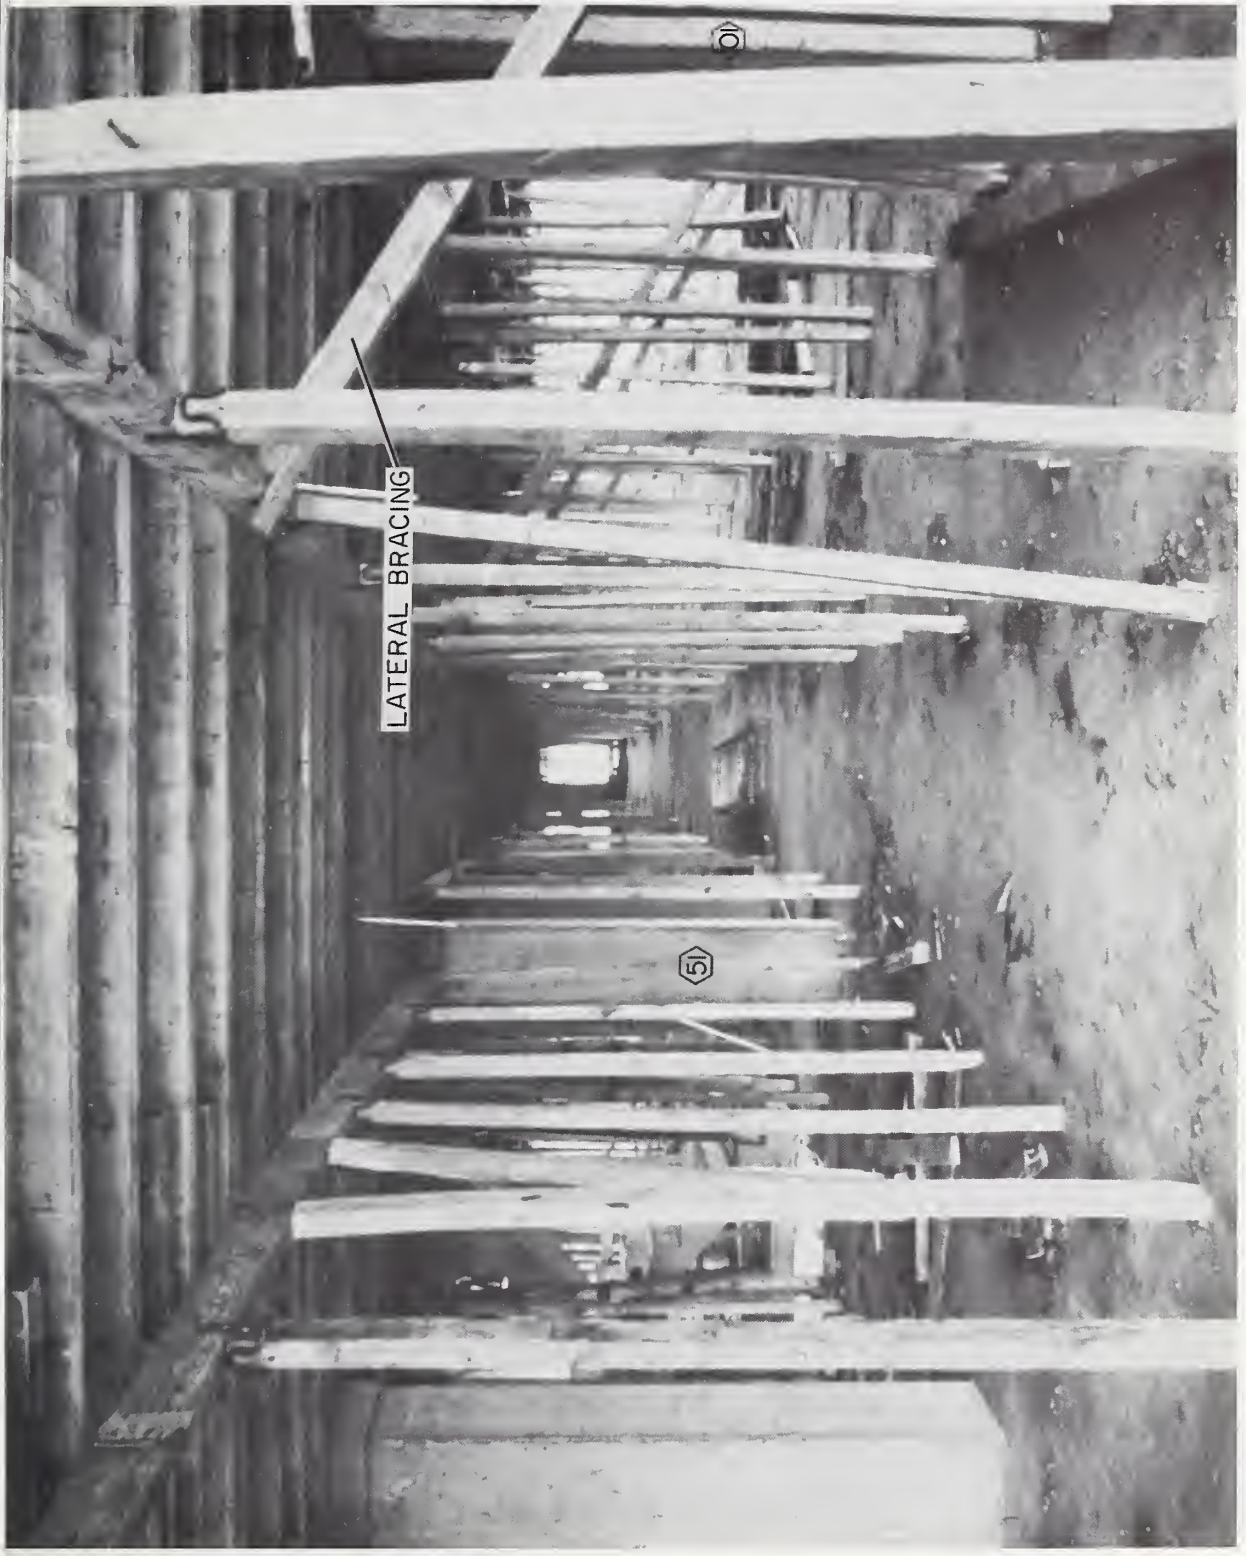
Figure 2.20 Formwork in sections 1 and 2 of 23rd story, looking east.

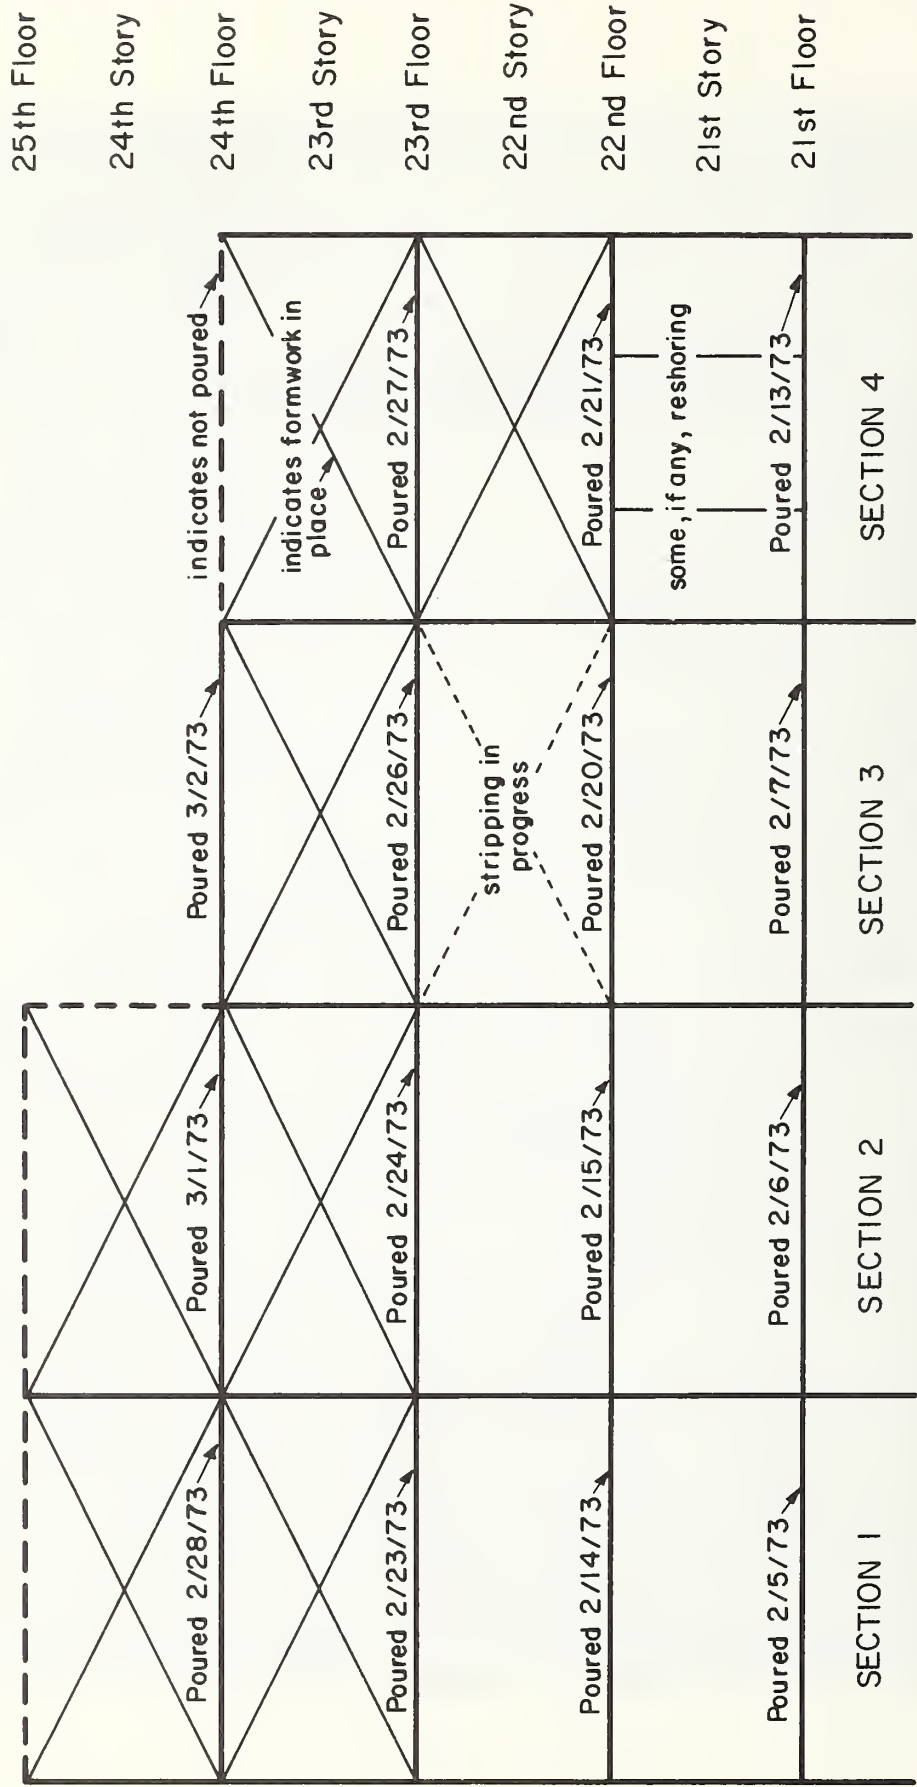
The contract documents (structural drawings) specify the following: "Slab being poured to be shored for two floors and backpropped at center of span each way and at center of bay on next floor down." Uncertainty about the effectiveness of backpropping or its presence prior to the collapse (section 2.2.2 and figure 2.27) makes it virtually impossible to make a

Figure 2.27 Estimated location of forms and reshores at the time of the accident.

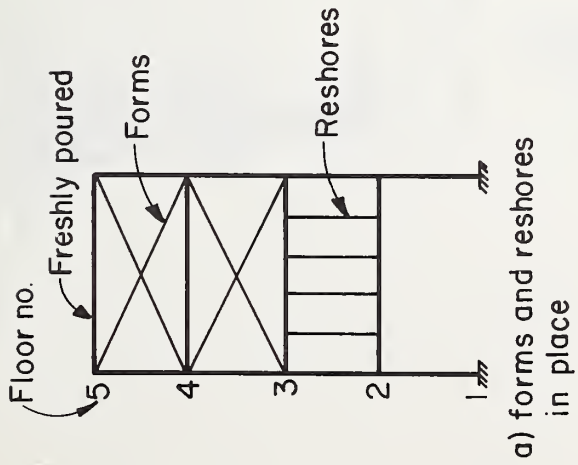
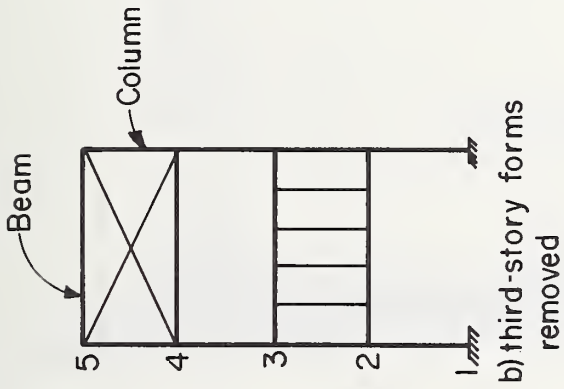
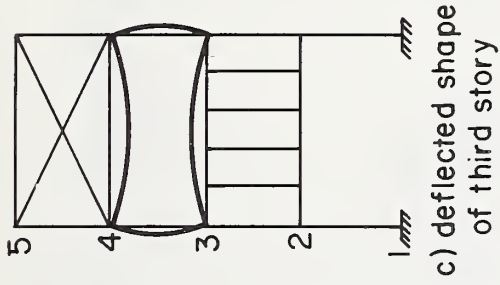
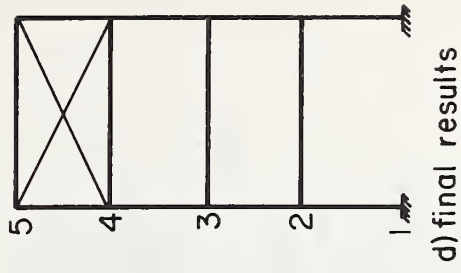
The effect of these two factors on the load distribution cannot be quantified because of insufficient information. However, the load distribution which would simultaneously mobilize both floors towards their respective shear capacities can be examined; a condition under which the combined resistance of both floors is a maximum. In this case, the total weight of three floors plus shoring in two stories would be distributed between the 22nd and 23rd floors in proportion to the square roots of their respective compressive strengths. The results indicated required compressive strengths of 1030 psi and 1115 psi for the 23rd and 22nd floors, respectively. These compare with 1200 psi and 1340 psi respective average values estimated for these floors. Consequently, failure under Case 4 loading cannot be precluded. However, the following evidence is taken as an indication that the collapse did not initiate in the 22nd floor slab: (a) employee statements did not indicate sagging of the 22nd floor slab at the time of collapse and (b) one employee statement indicating the loss of the 21st story reshores prior to the incident was interpreted as a decrease in the 22nd floor deflection (section 2.2.2 and figure 2.28).

Figure 2.28 Effect of removal of forms.

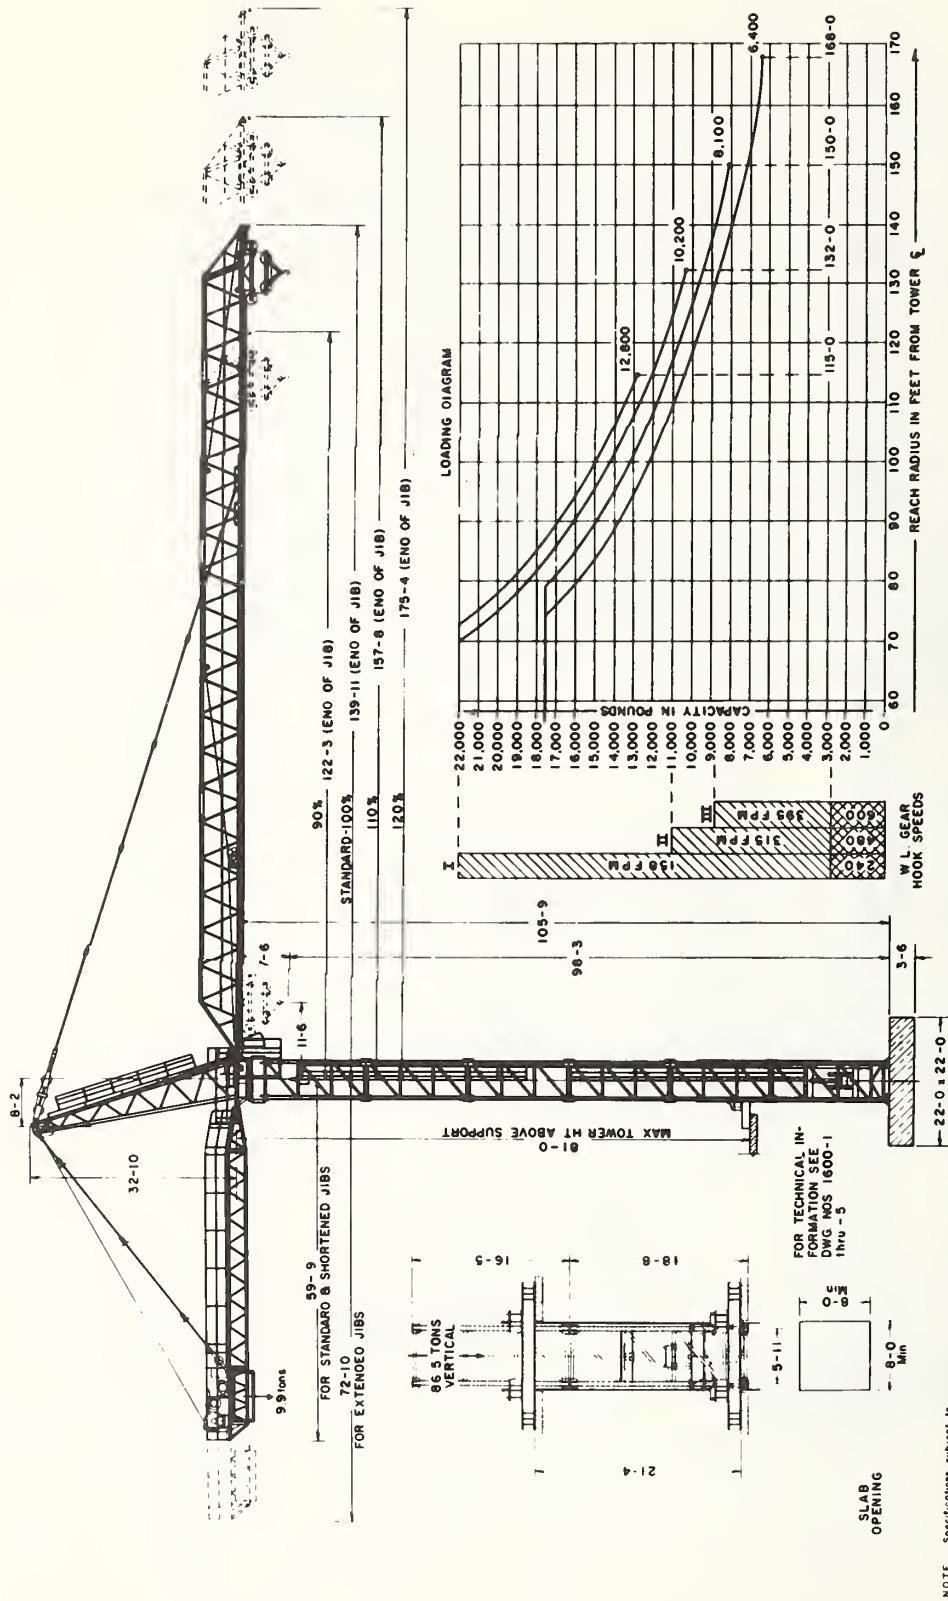
of 81 ft shown in figure 2.31. It is not known if any special precautions were taken to allow the difference between the actual and the recommended installation.

- (1) Crane no. 1 (in section 1, away from the collapse area) - distance between top and bottom supports was less than the required 18 ft 4 in (figure 2.30) (18 ft was used).
- (2) Crane no. 2 (in section 4, in the collapse area)- distance between top and bottom supports was less than the required 21 ft 4 in (18 ft was used).
- (3) Crane no. 2 (in section 4, in the collapse area) - The number of standard tower sections used was one more than the four recommended by the manufacturer (figure 2.41 and section 2.2.3).
- (4) Crane no. 2 (in section 4, in the collapse area) - The maximum tower height exceeded (by approximately one standard tower section) the 81 ft-0 in recommended (figure 2.31 and section 2.2.3).

Figure 2.31 Crane no. 2 specifications.

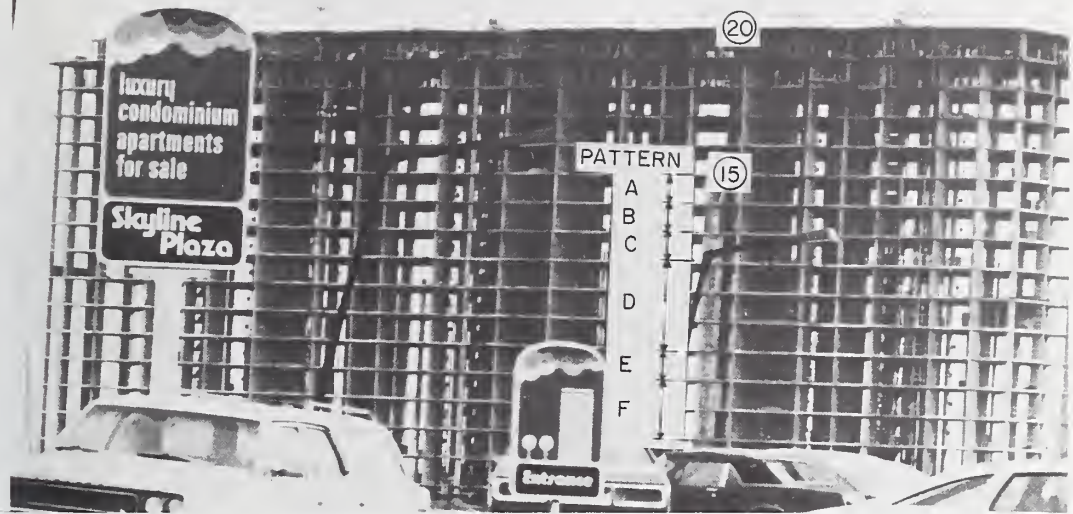
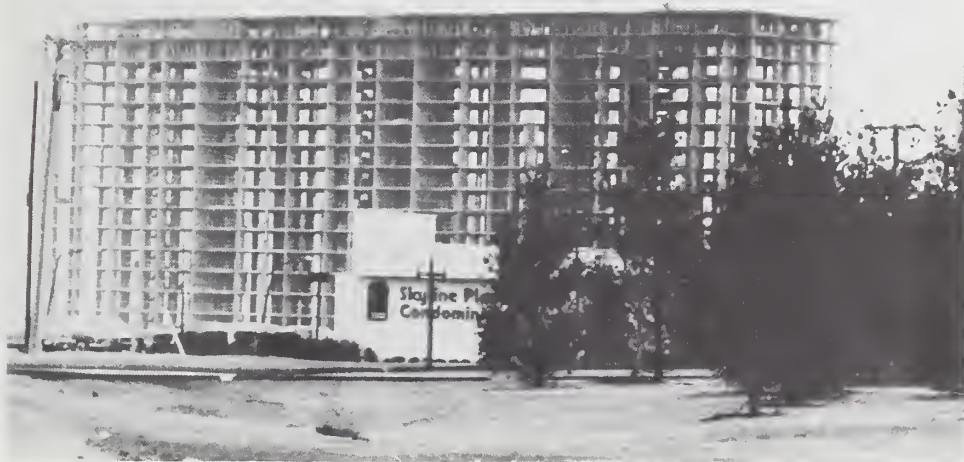
However, based on figures 2.36 and 2.38 the crane no. 2 was attached to the 10th floor between January 26 and February 1. Since this crane was raised only once after February 1, it must have been located on the 14th floor at the time of the collapse.

Figure 2.36 Appearance of construction in early February, looking south.

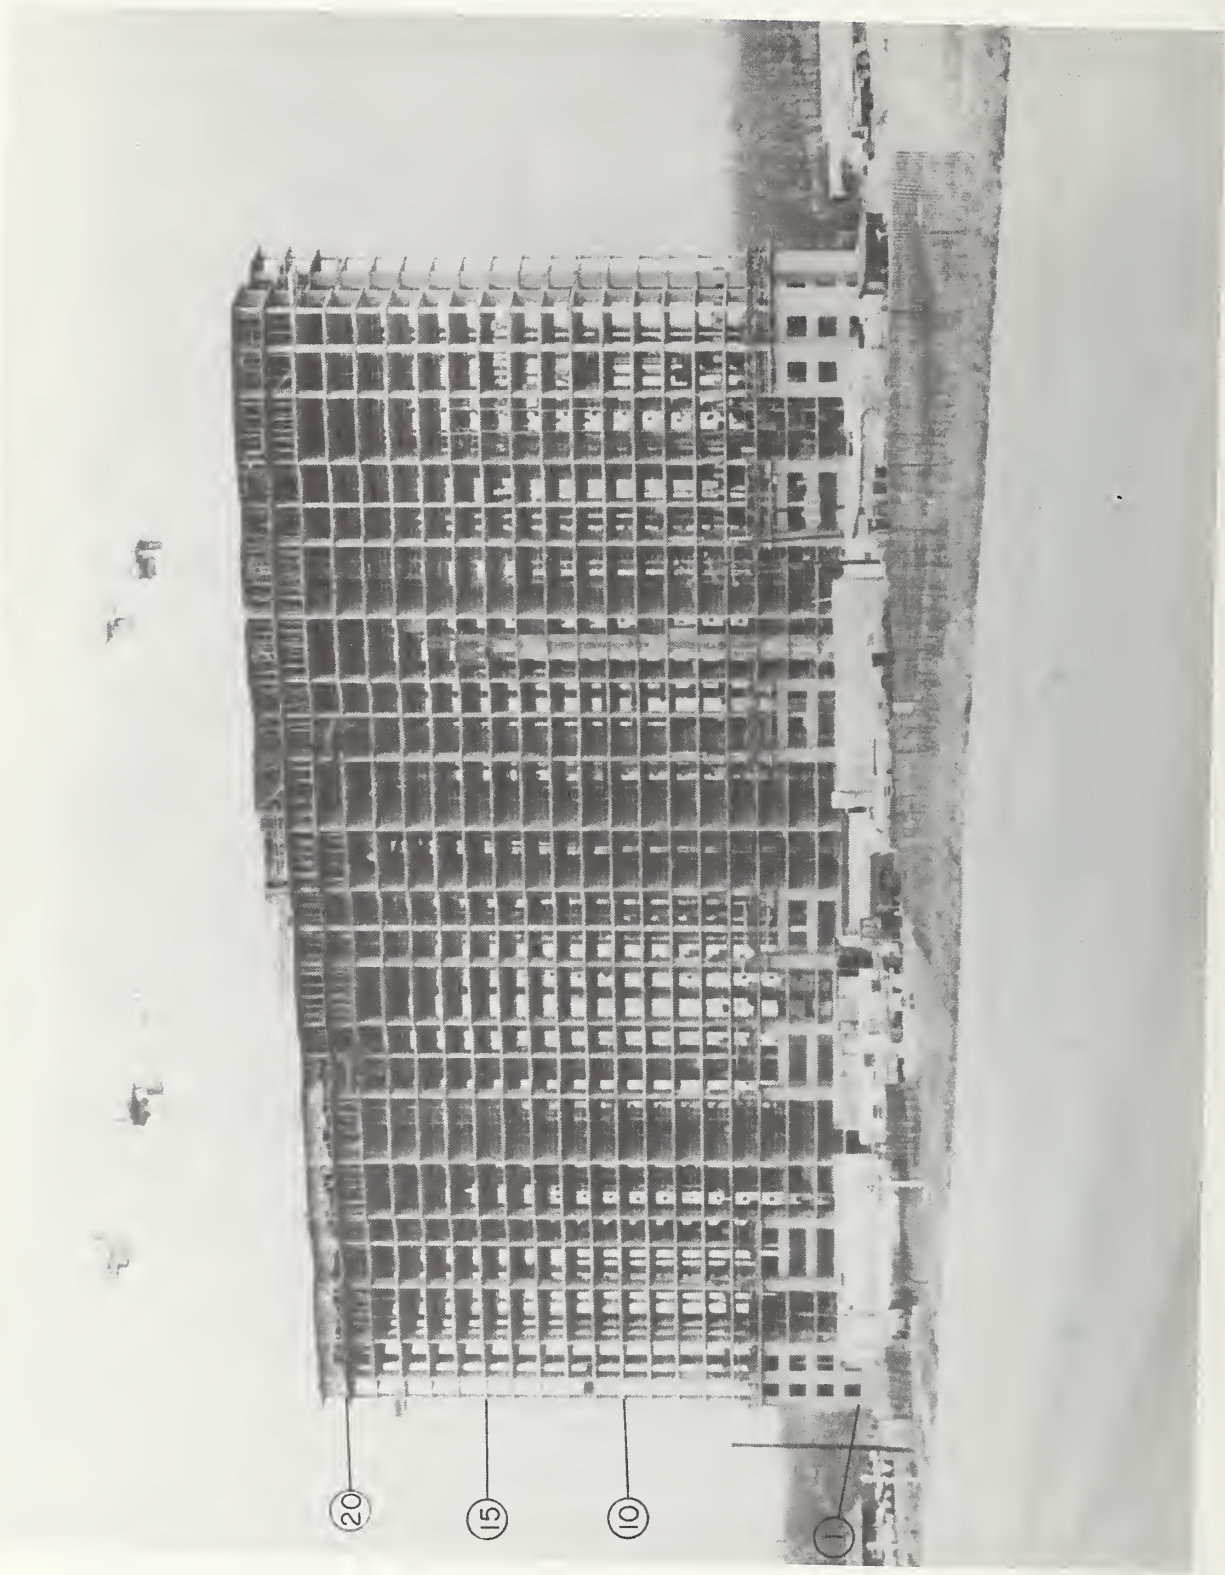
Although the forms are in place for sections 3 and 4 of the 21st floor, it cannot be positively stated that they have been cast. Therefore, on the basis of these photographs (figures 2.39 through 2.42) it cannot be conclusively stated that the crane which was raised on February 7 was based on the 14th floor.

Figure 2.39 Appearance of construction in February
some time after figure 2.36, looking south.

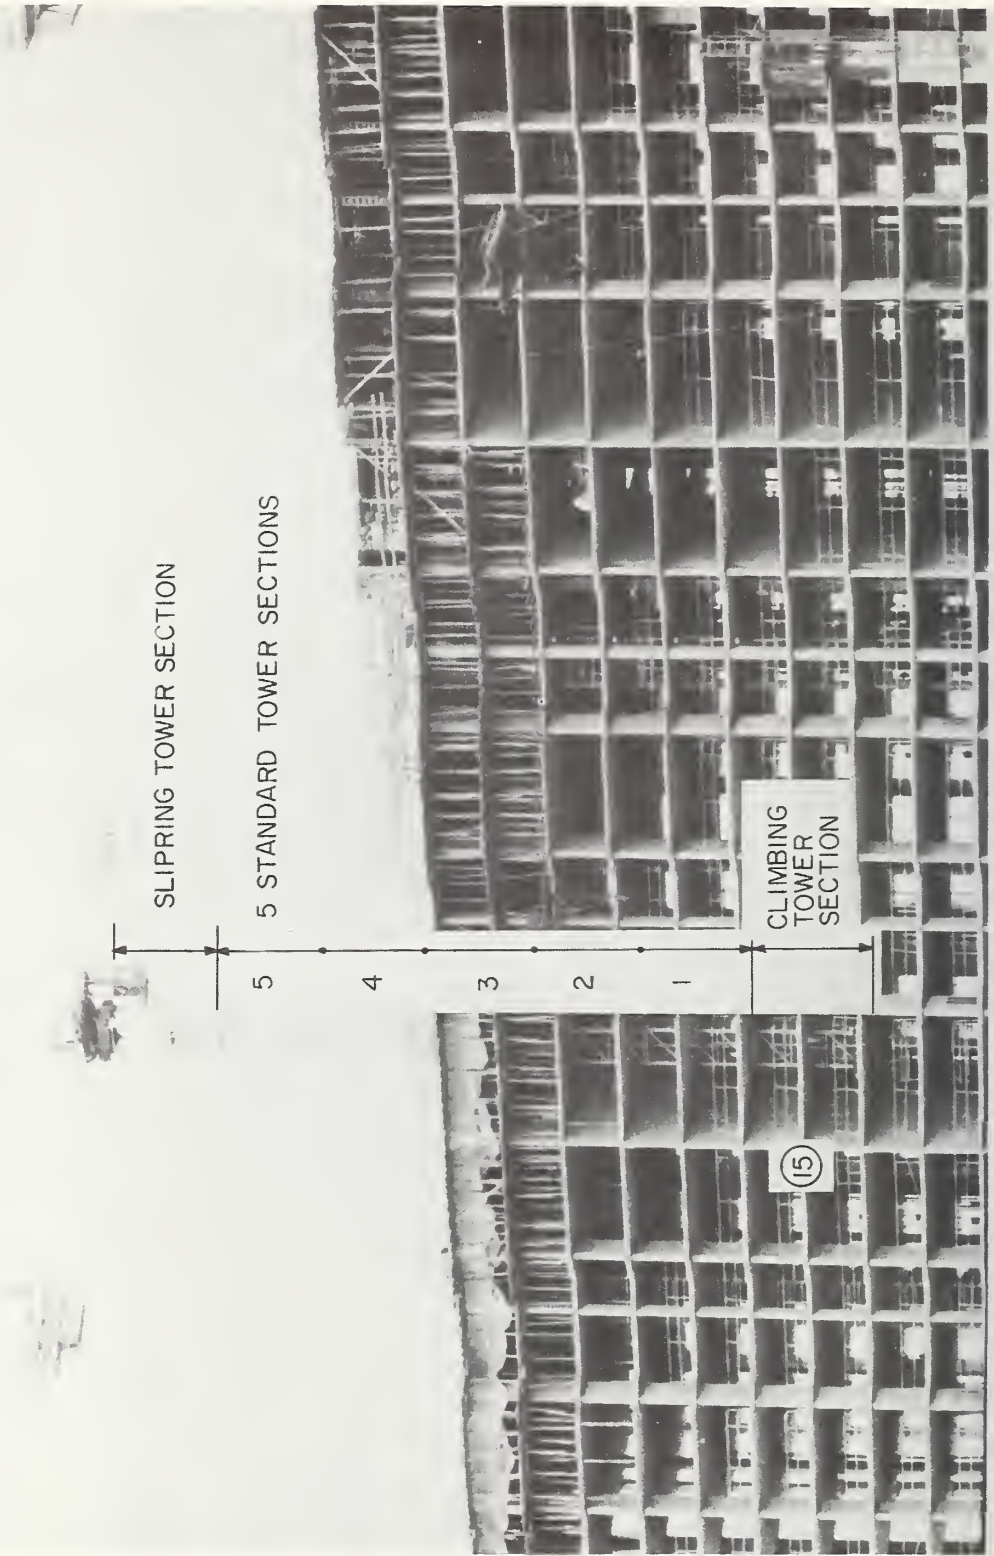
Figure 2.41 Closeup showing crane no. 2 base support.

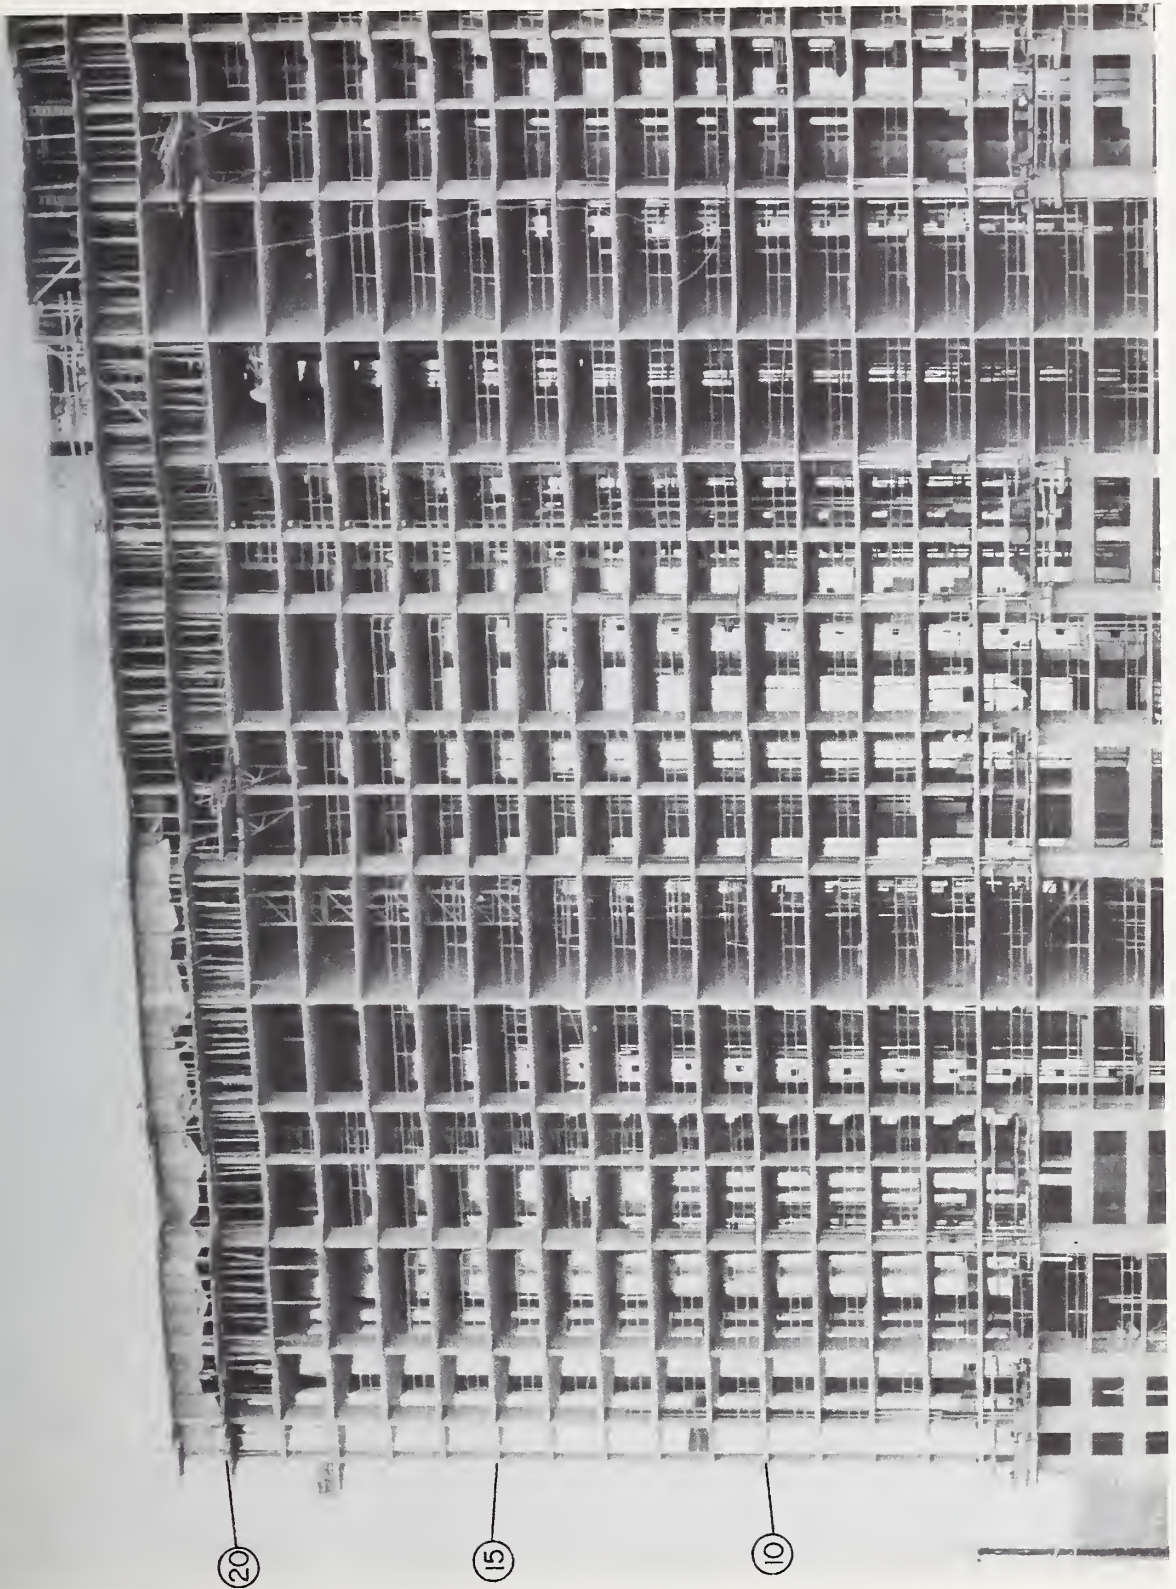
Examination of figures 2.40 and 2.42 indicates that either the crane shoring or the formwork for the concrete closure slab of the crane opening was in place in the third through thirteenth stories on the day of the photograph. Conditions below the third story are not visible in the photograph.

Figure 2.42 Closeup view showing crane no. 2 base support and shoring under crane.

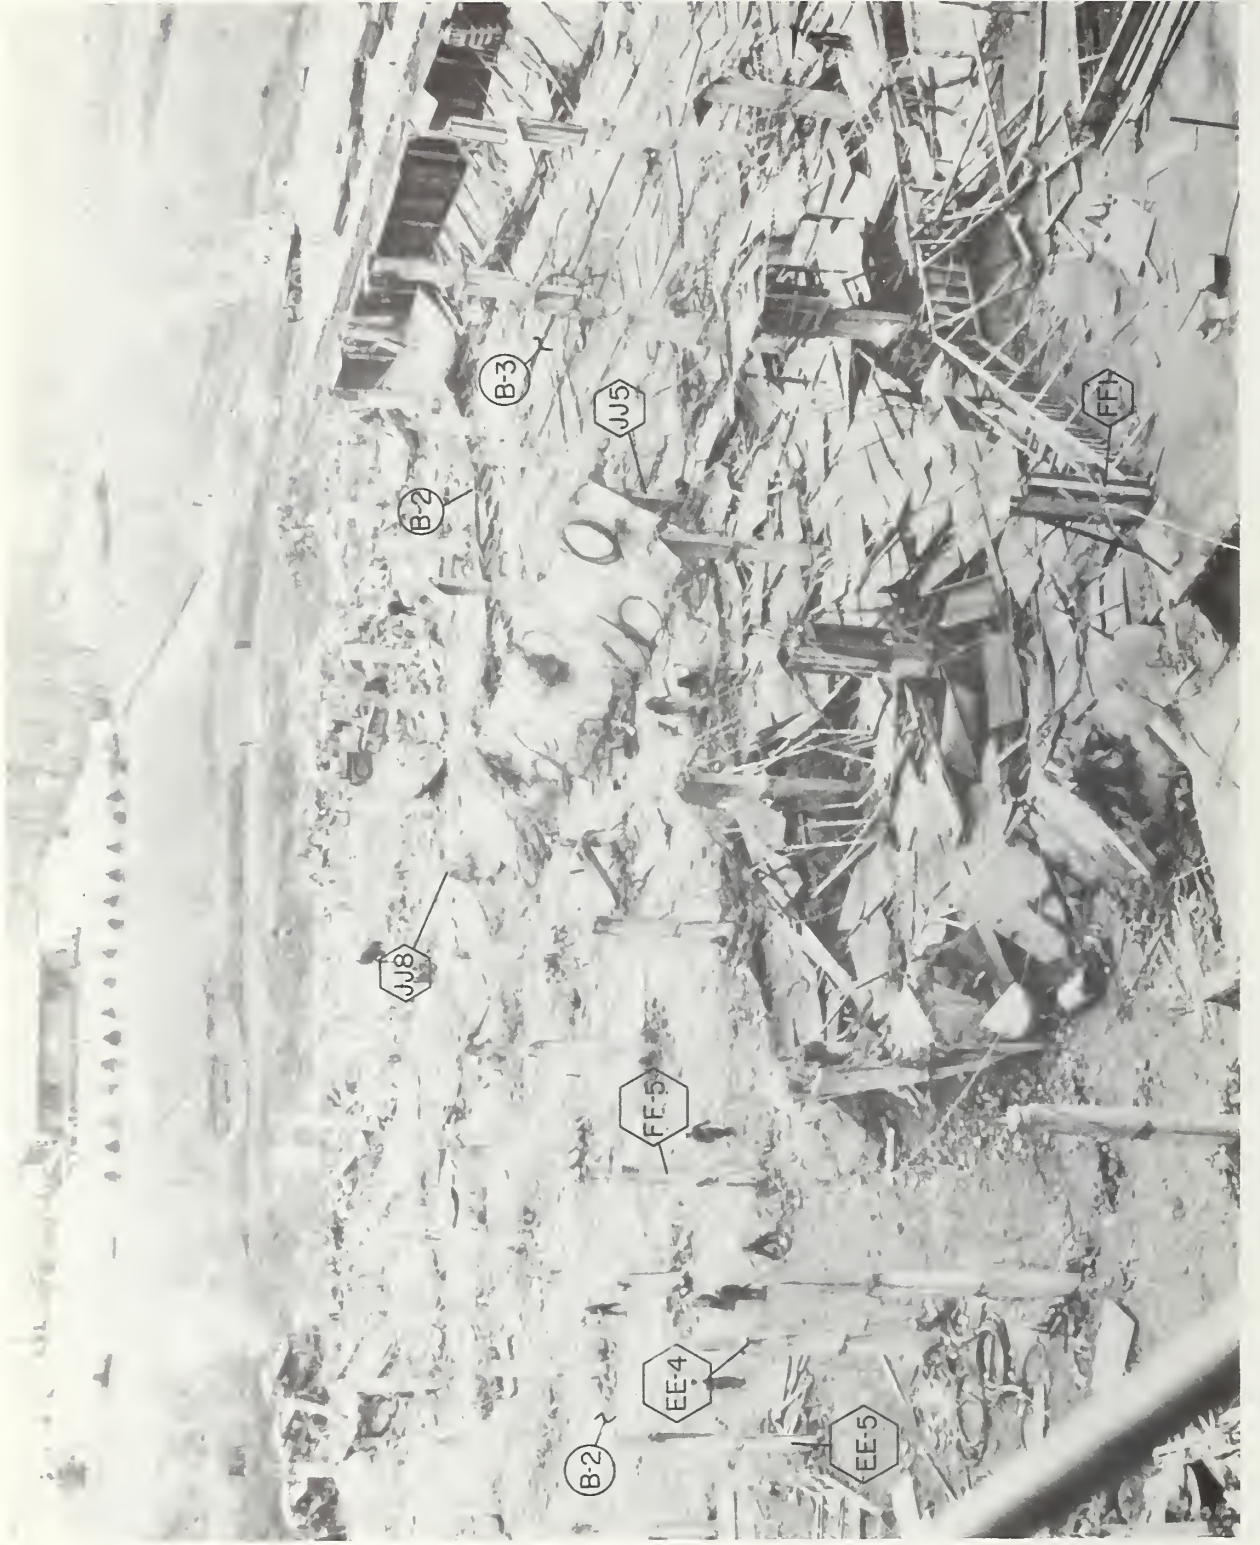
Figure 2.43 General view of parking garage from building A-4.

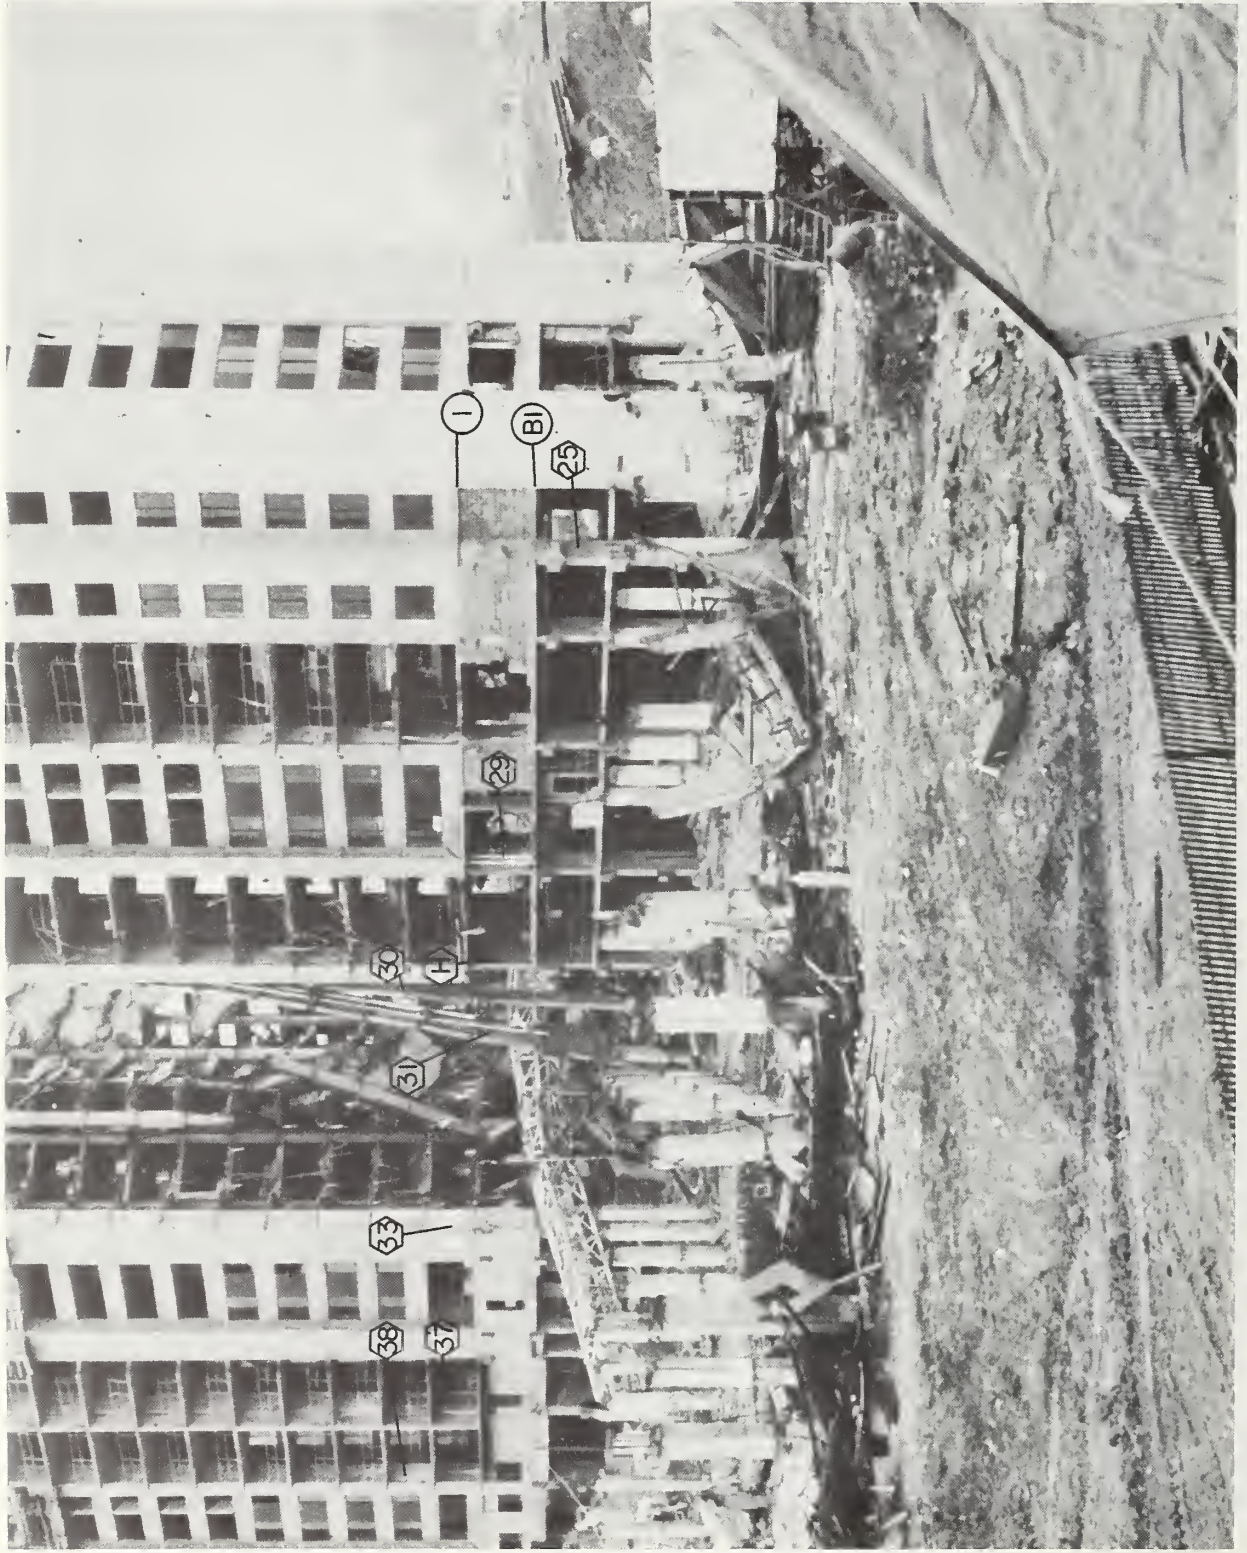
Figure 2.49 View of garage area looking northwest showing crane no. 2 and column corbels on building A-4.
