Investigation of the Skyline Plaza Collapse in Fairfax County, Virginia

E. V. Leyendecker and S. G. Fattal

Center for Building Technology
Institute for Applied Technology
National Bureau of Standards
Washington, D. C. 20234

Final Report

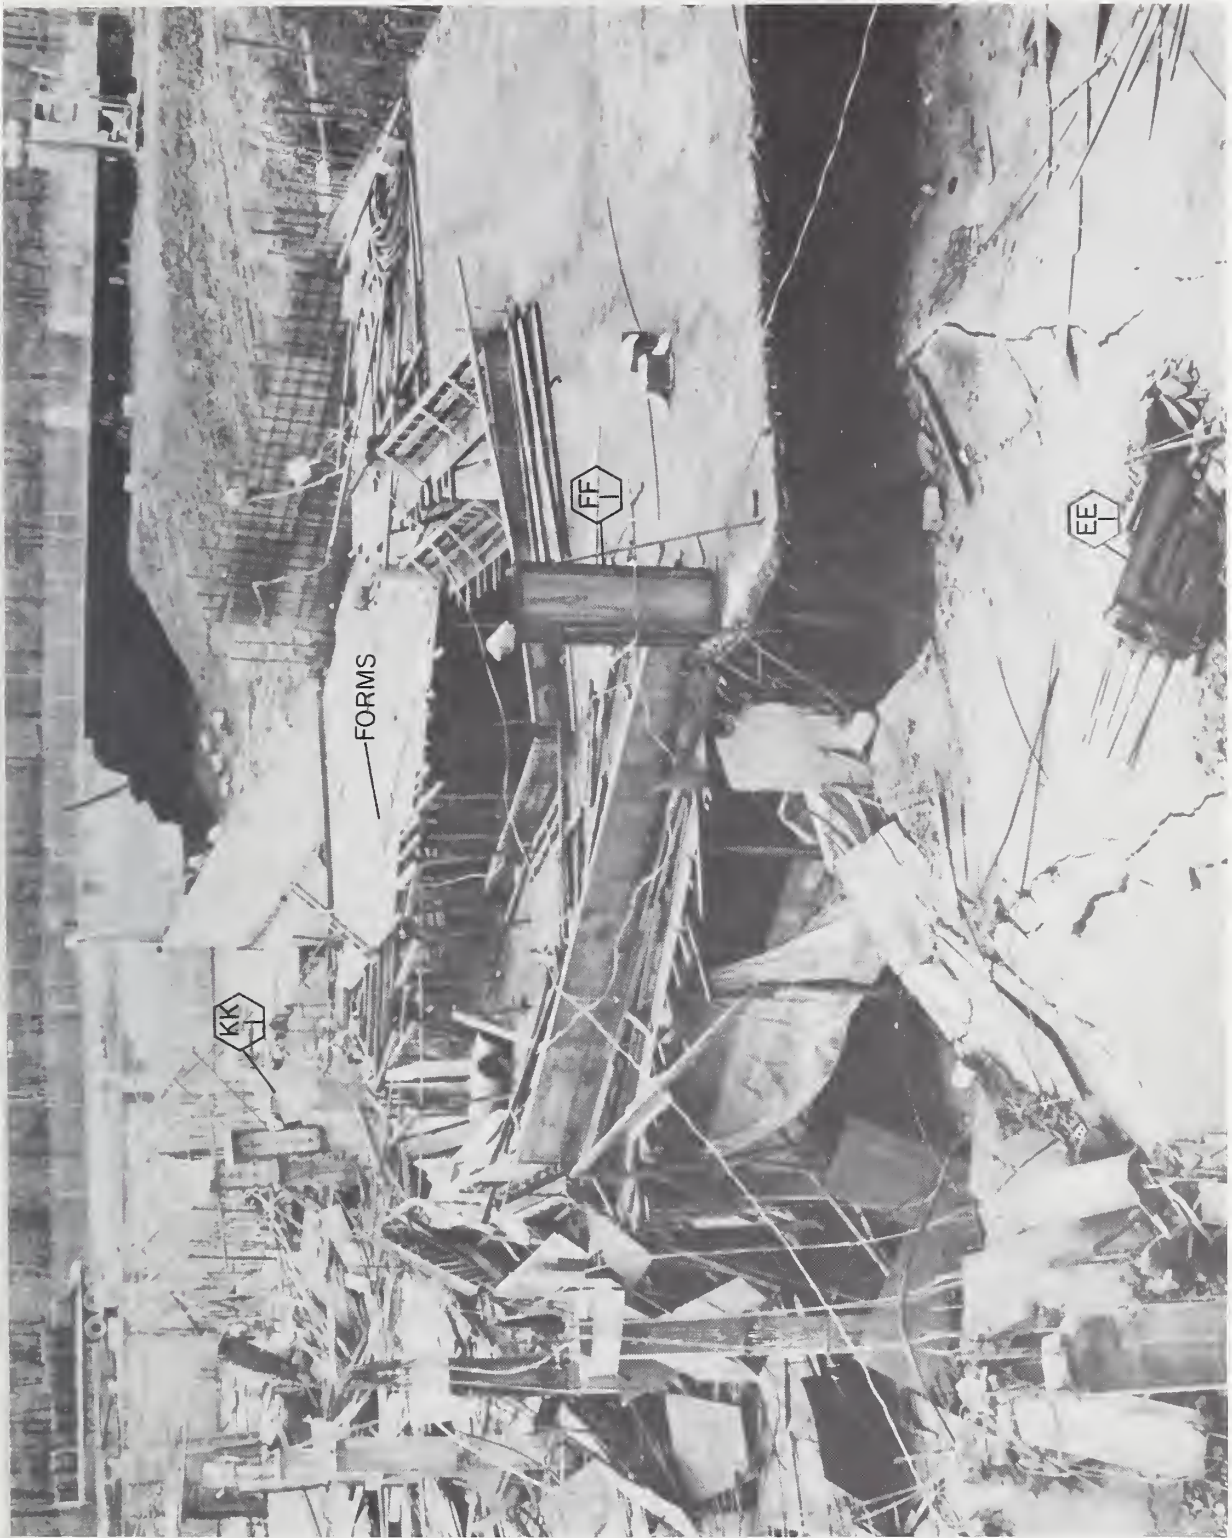
Figure 2.52 View of ramp area looking south.

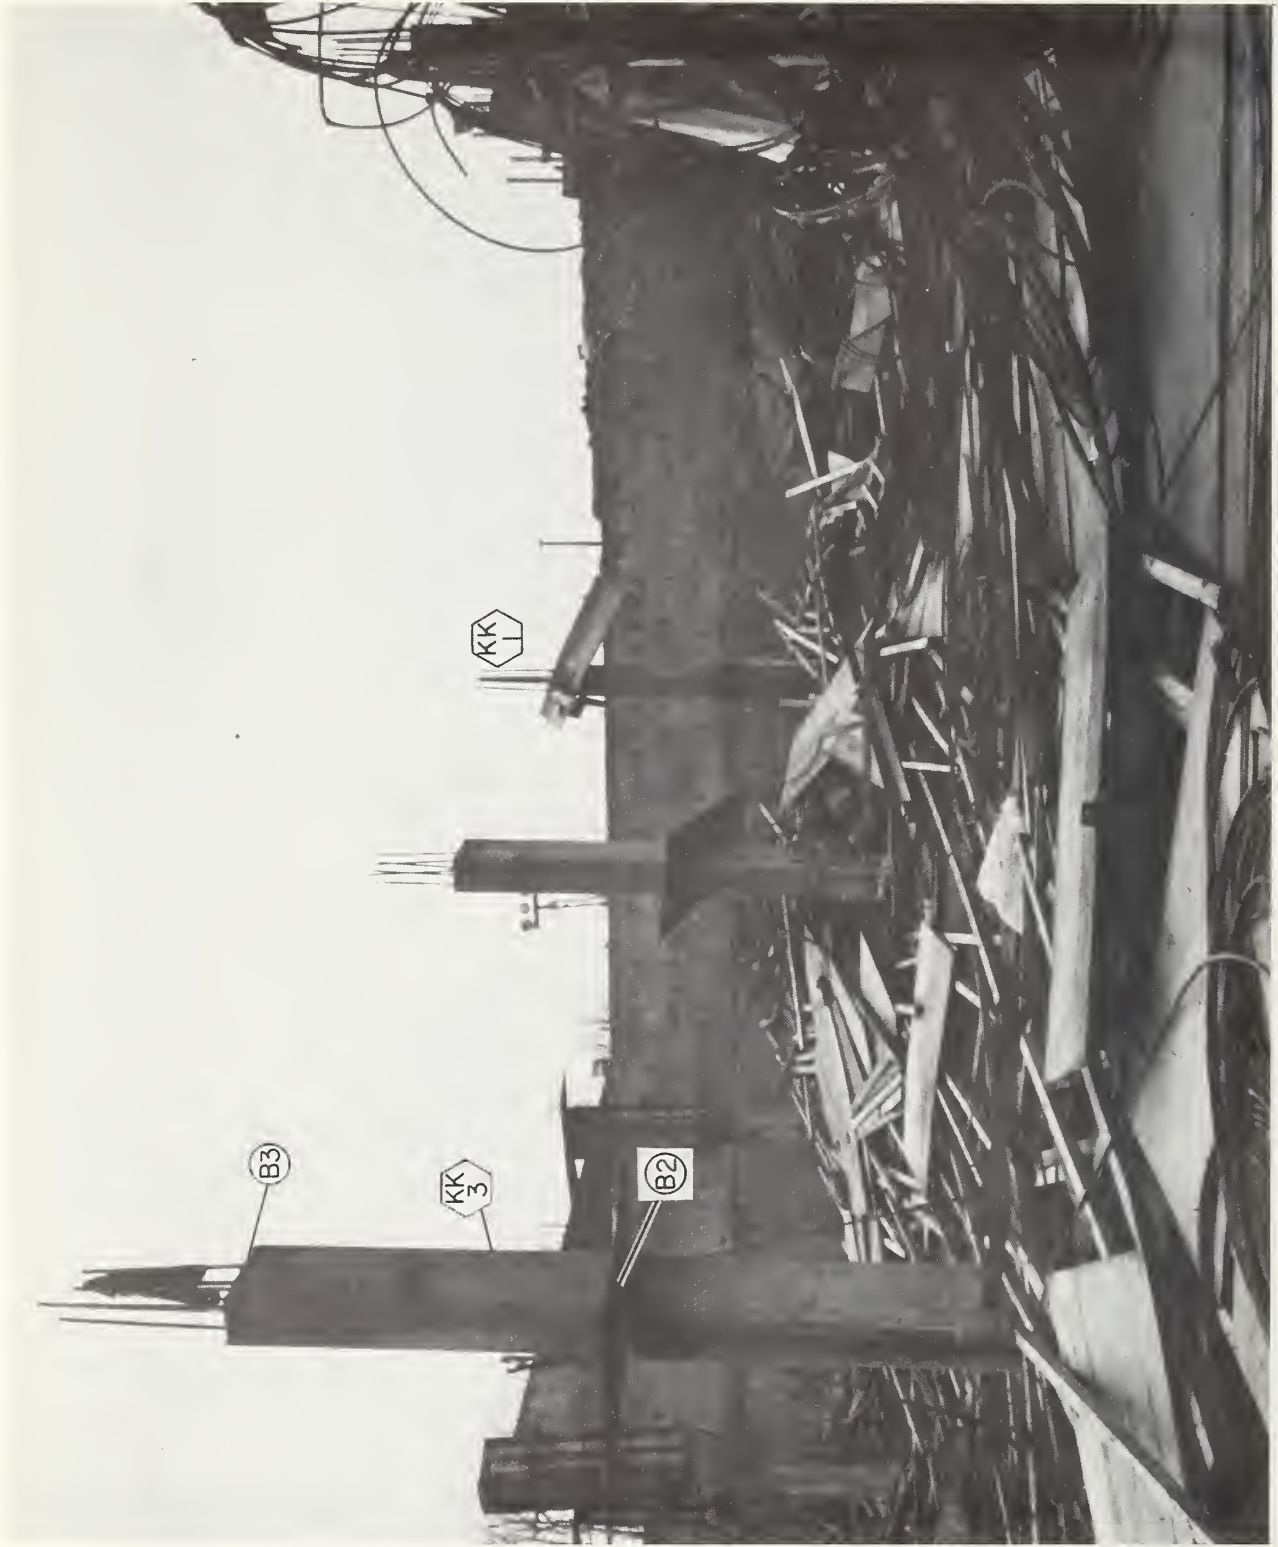
Figure 2.53 View looking west showing southwest area of parking garage.

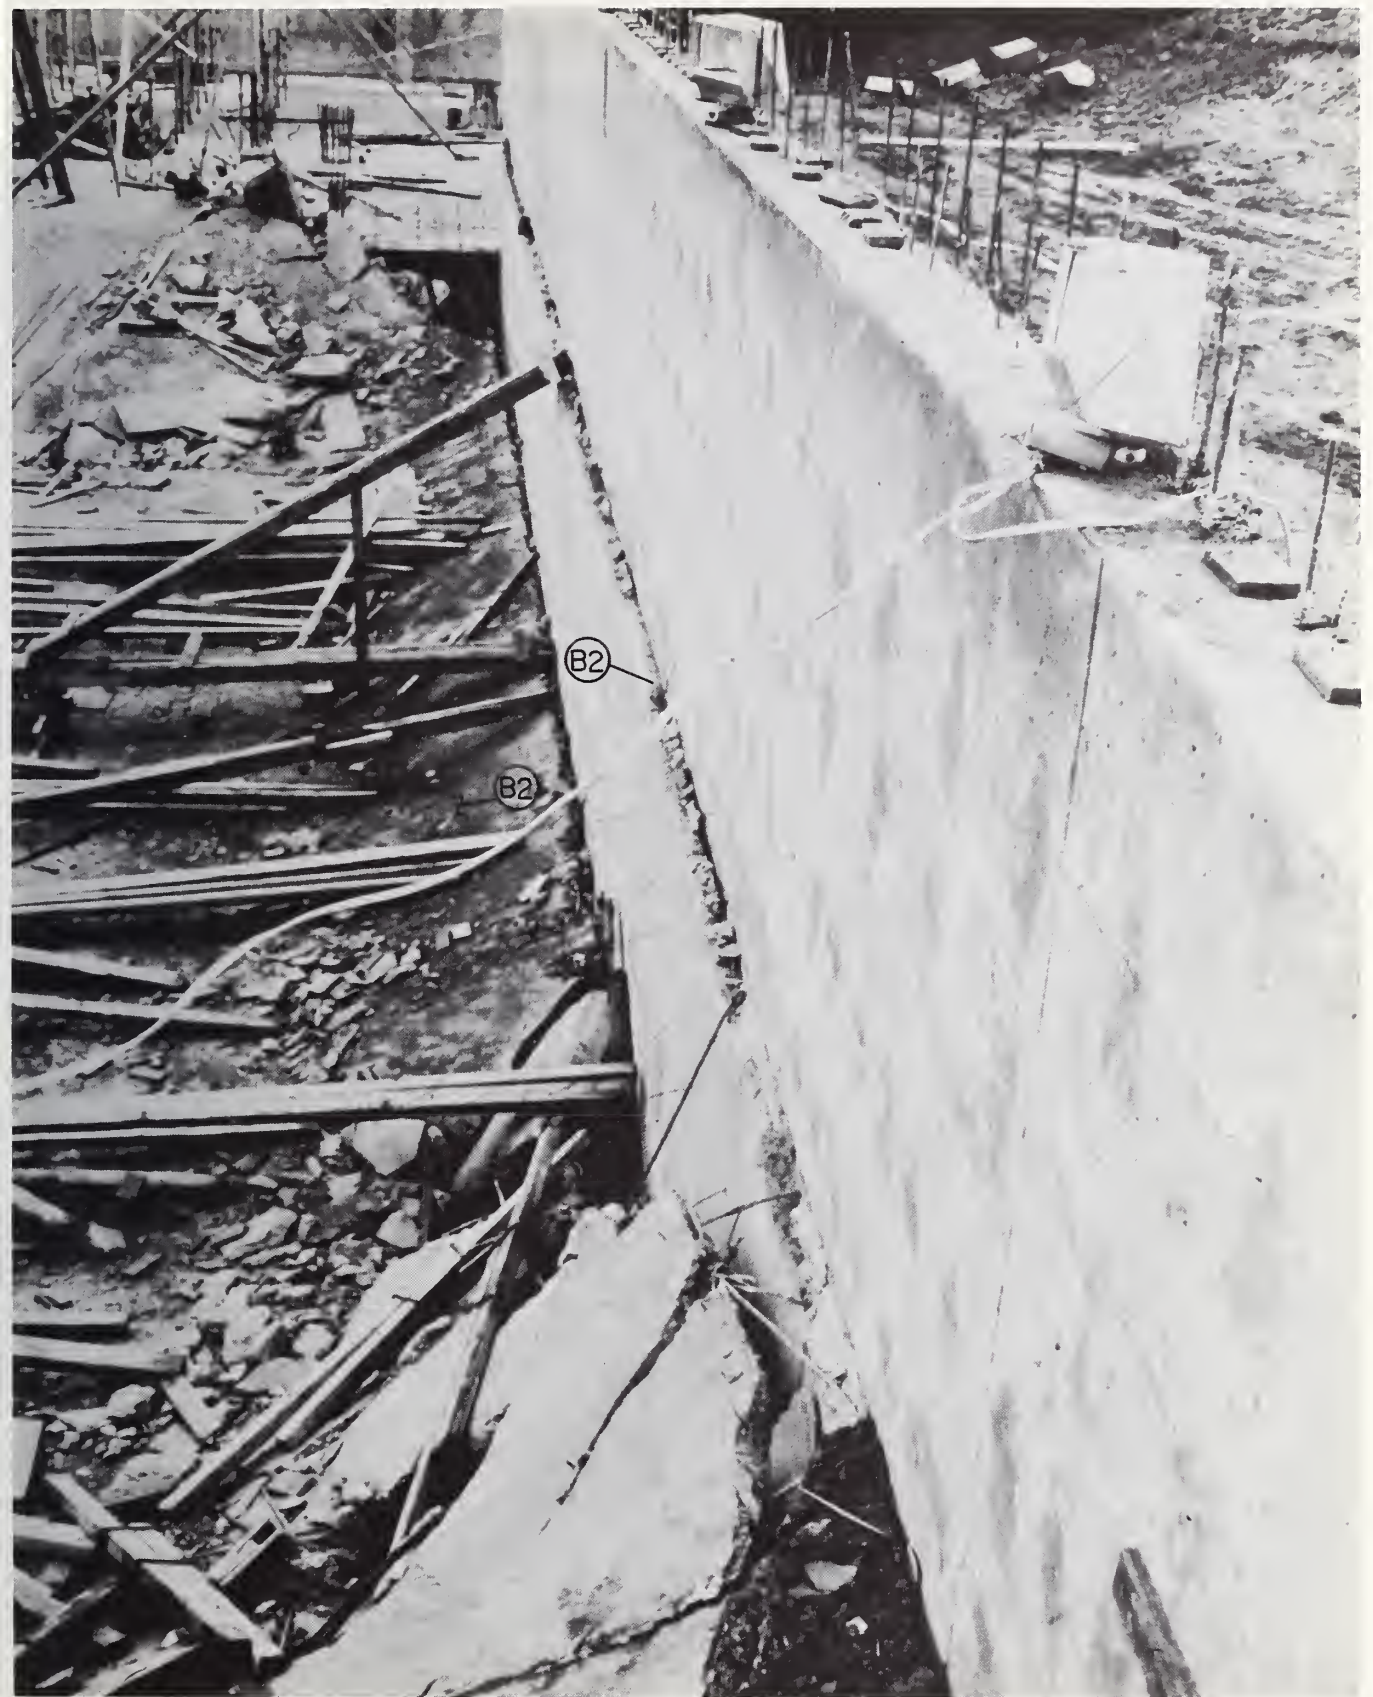
Figure 2.54 Slab support on western wall of parking garage.

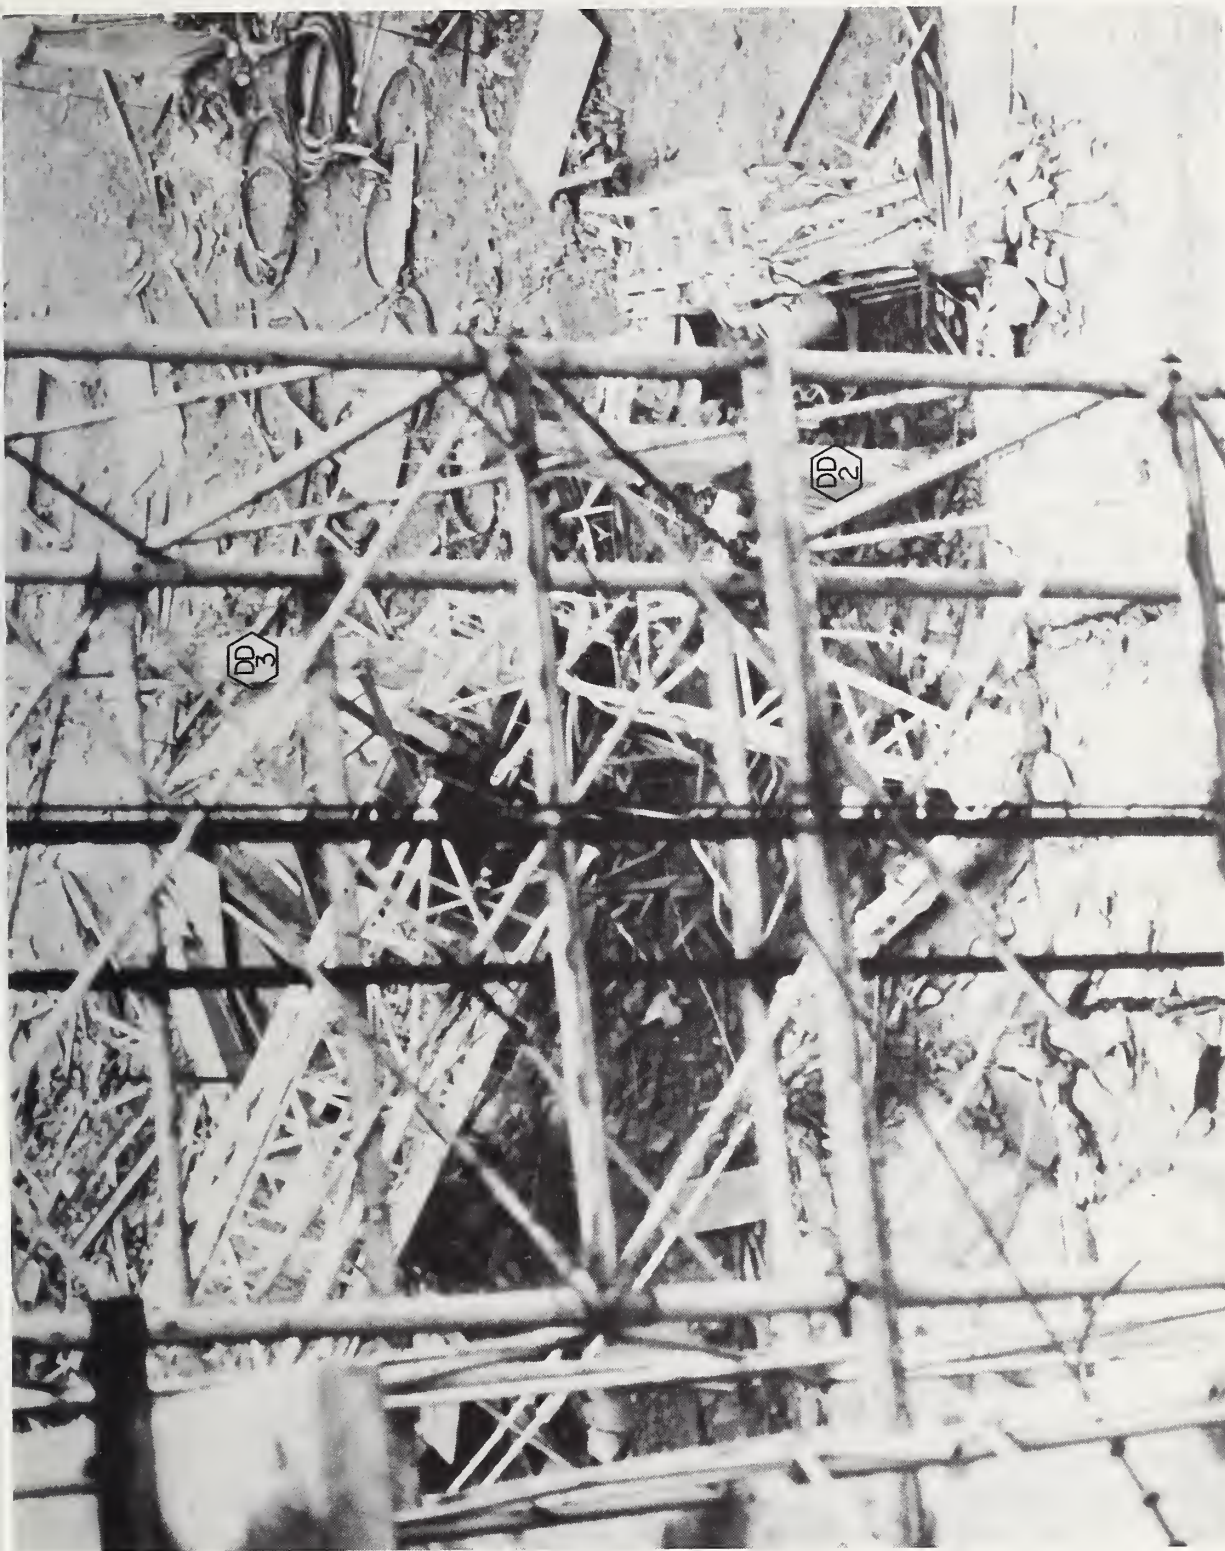
Figure 2.56 Position of fallen crane near column DD-2 looking east.

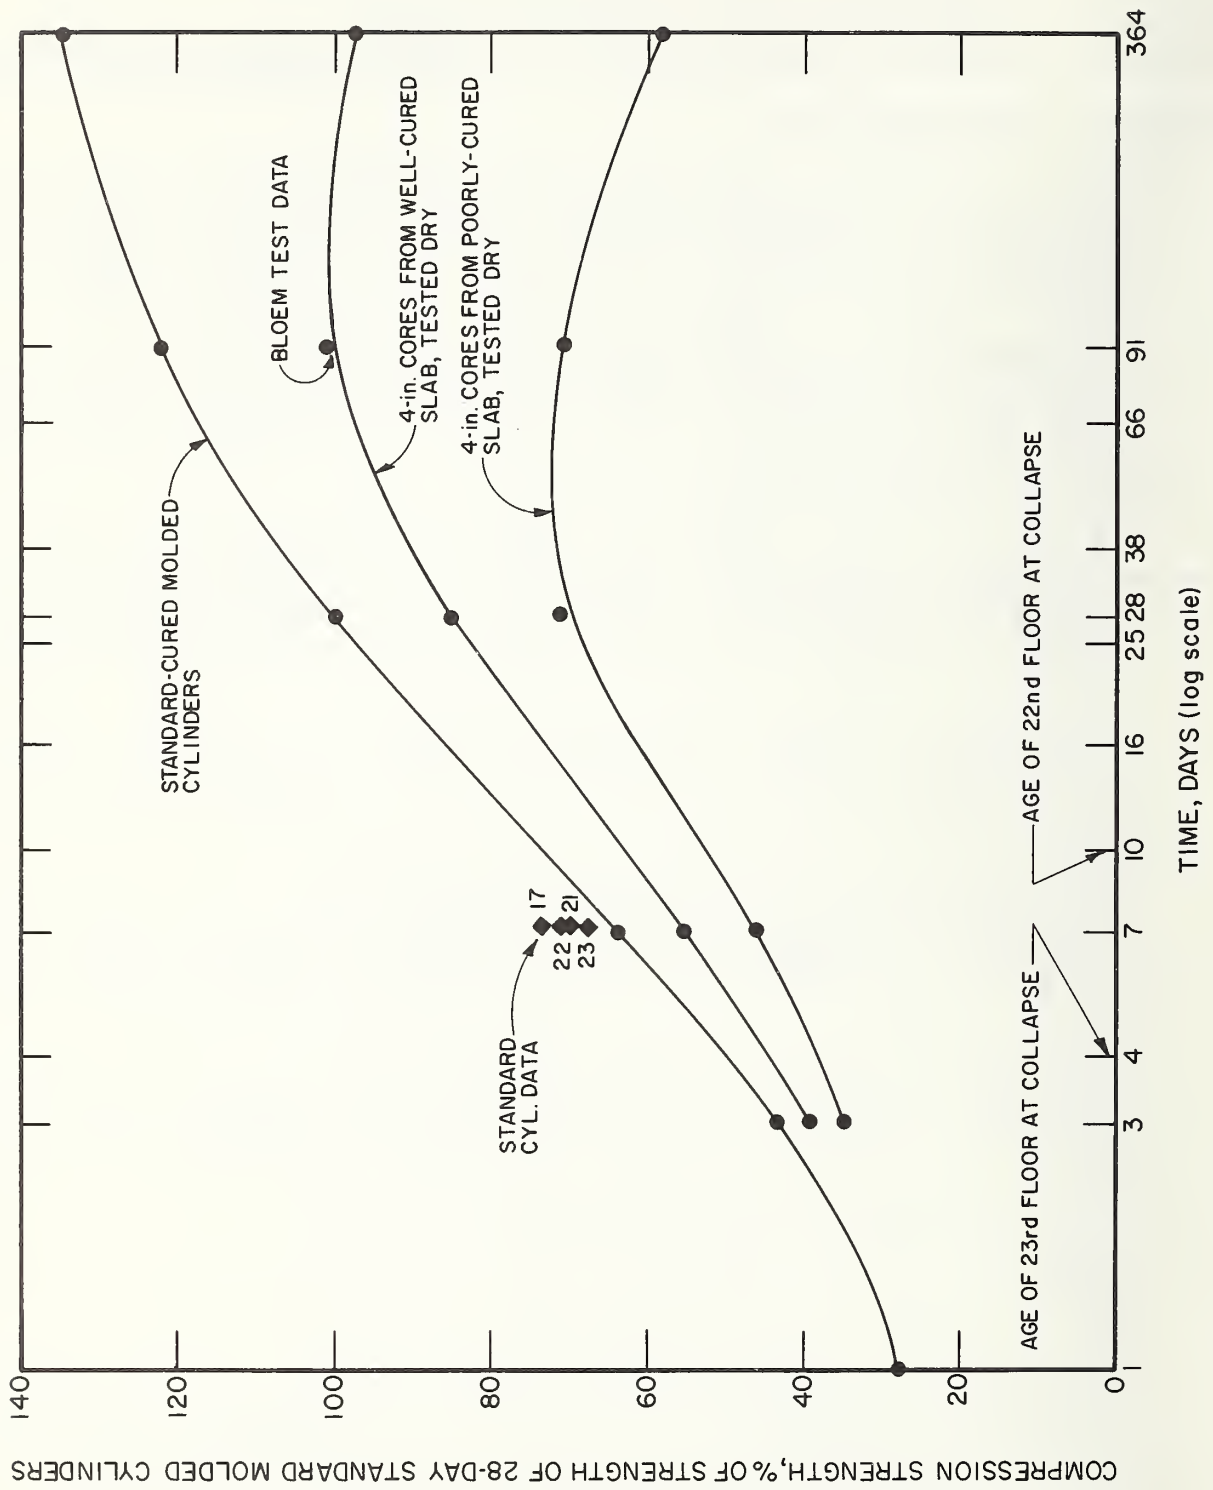
Figure 3.3 Strength measures for concrete cores and cylinders.

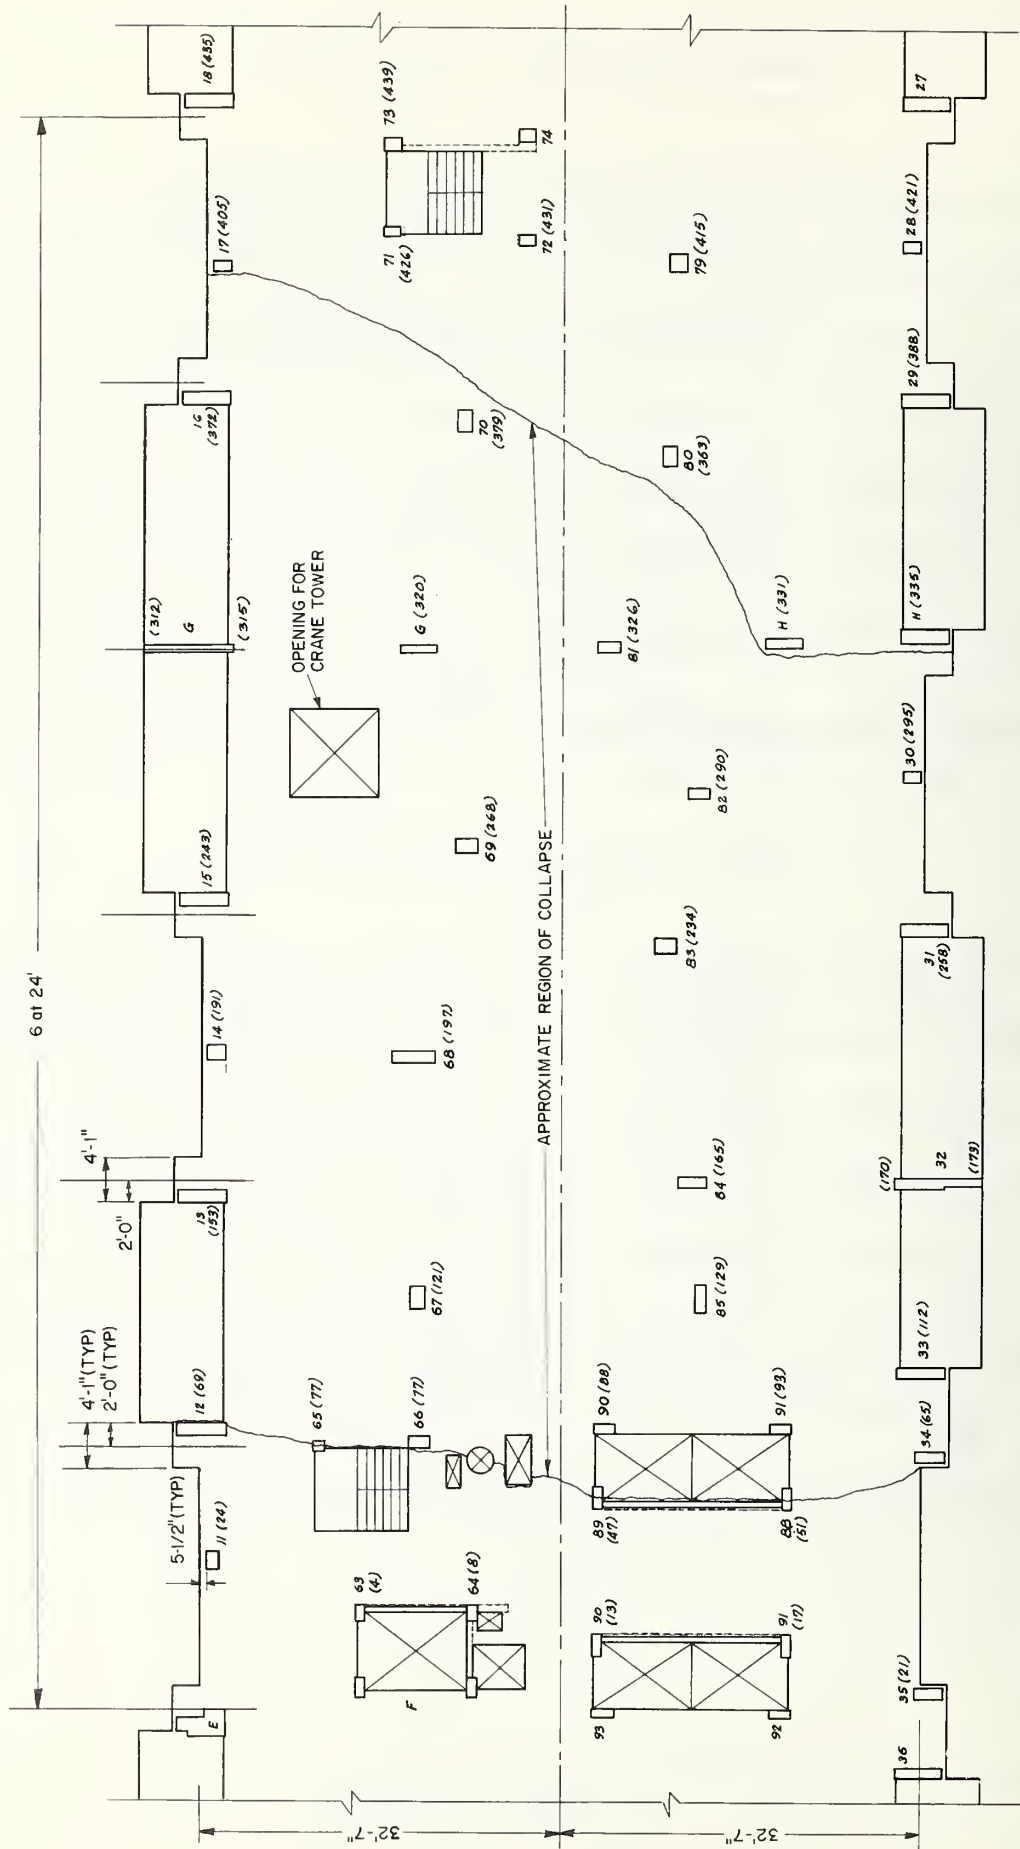
Three finite element analyses were made for the slab assembly in the region of collapse. The approximate area of collapse is shown in figure 4.1. All three analyses were based on the grid model shown in figure 4.2.

Figure 4.1 PLAN OF FLOOR SLAB AT 22nd AND 23rd FLOORS SHOWING APPROXIMATE AREA OF COLLAPSE

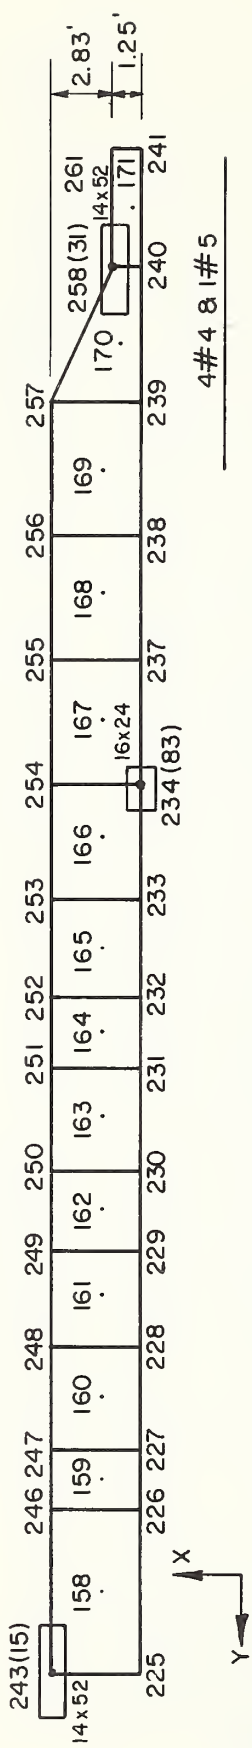
Altogether four column strips were investigated. Of these, the strip shown in figure 4.6 was found to be the one most critical in flexure. Case 1 negative moment at the critical section near column 31 (node 258) was about 9.2 ft-kips/ft. The moment capacity of the

slab at this section, determined on the basis of reinforcement details in the contract drawings, was found to be about 8.4 ft-kips/ft, indicating that the flexural capacity of the section was exceeded by about 10 percent. In this case, as in all other cases investigated, the flexural capacity of the section was found to be governed by yielding of the tensile reinforcement rather than by crushing of concrete in compression. Thus it is estimated that yielding occurred in the slab at column 31 and yielding propagated toward column 83 (see figure 4.1). However, this local yielding is not sufficient to cause a collapse mechanism of the 23rd story floor slab. In fact, a flat slab construction of the type used in Skyline Plaza building is generally recognized to have considerably greater moment capacity than the capacity at which the first local yielding occurs because of its inherent ability to redistribute peak moments to neighboring regions through the mechanism of yielding.

Figure 4.6 MOMENTS IN COLUMN STRIP 33-32-31-30

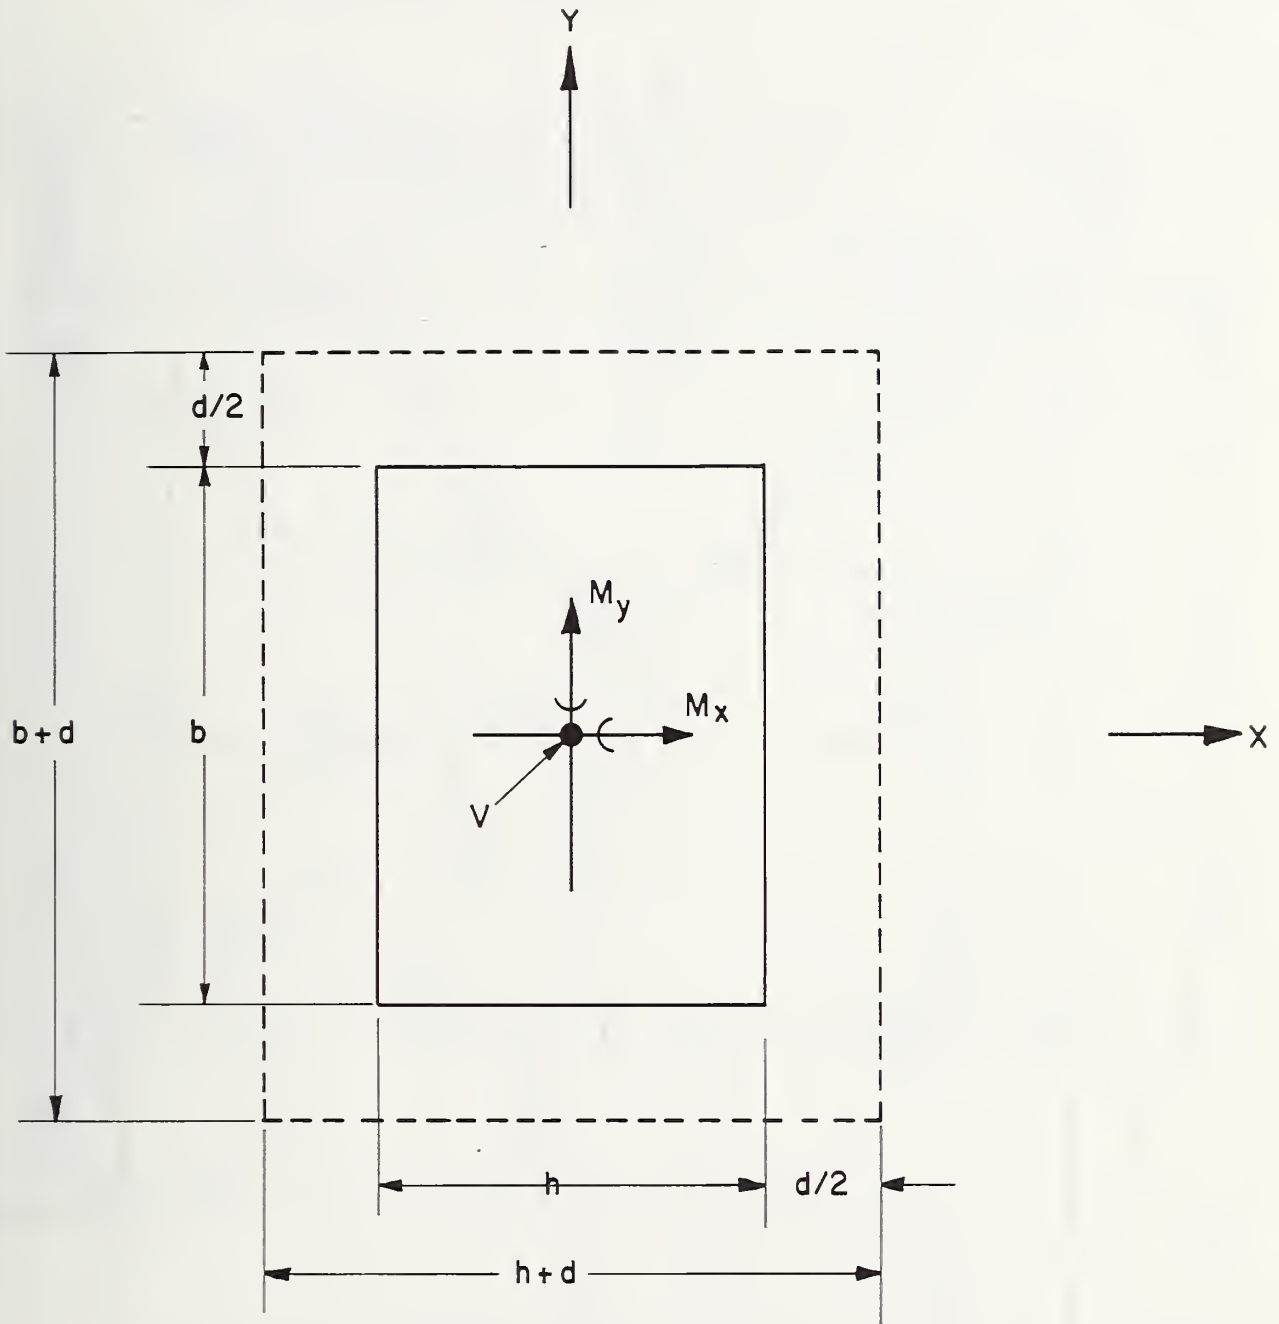
The slab was also investigated at column locations for its adequacy in shear. Shearing stresses were determined following the procedure described in section 11.13.2 of the commentary to the ACI 318-71 code. The applicable equations are given below for convenience. Figure 4.10 shows the critical section for shear around the periphery of a rectangular column and other parameters used in the following equations:

Figure 4.10 TYPICAL RECTANGULAR COLUMN SHOWING CRITICAL SECTION FOR SHEAR
