NBSIR 73-242

Pilot Demonstration of Lead Based Paint Hazard Elimination Methods

Report on Field Study No. 1

June 1973

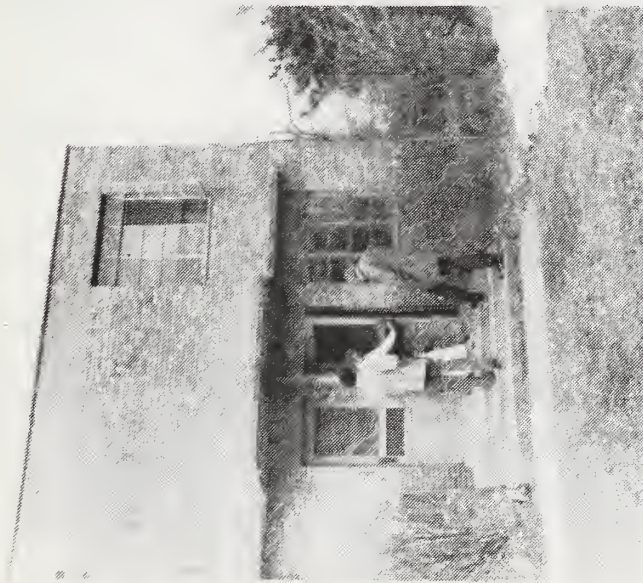
Figure 1. Pilot demonstration. One-bedroom corner apartment on first floor of a two story masonry structure at 716 Langston Terrace, N.E., Washington, D.C.
