NBSIR 73-263

Fire Endurance Tests of Unprotected Wood-Floor Constructions for Single-Family Residences

July 1973

Final Report

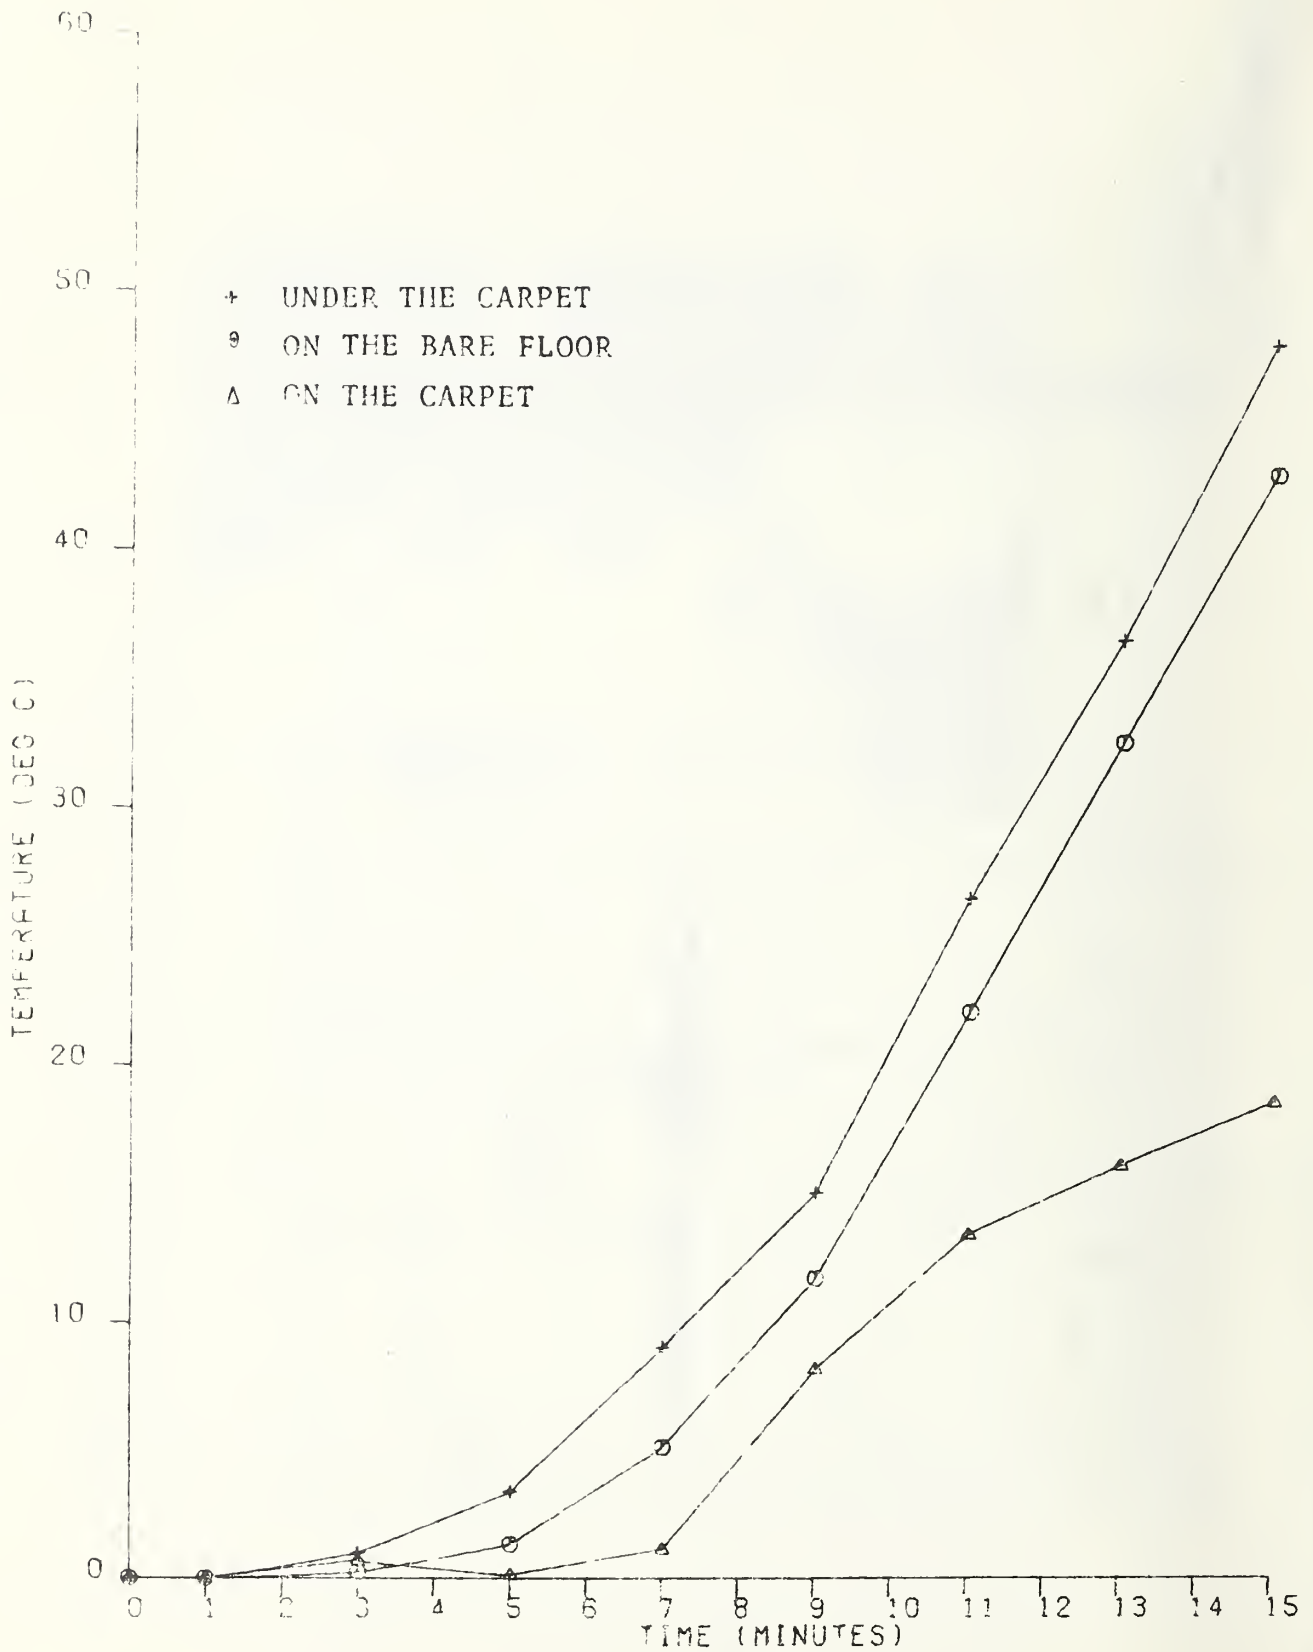
FIGURE 11. Average Surface Temperature Rises on Bare Plywood Floor, Under the Carpet, and on the Carpet (Test #L-1)

The average temperature rise of the surface thermocouples on the "bare" floor was less than 75°C when the test was terminated after 15 minutes. A single thermocouple on the carpet exceeded a 50°C rise, with a reading of 80°C indicating that it may have been directly over a nailhead. The average temperatures of the "bare" floor and the carpet-finished floor are shown along with the average temperature beneath the carpet in figure 11.

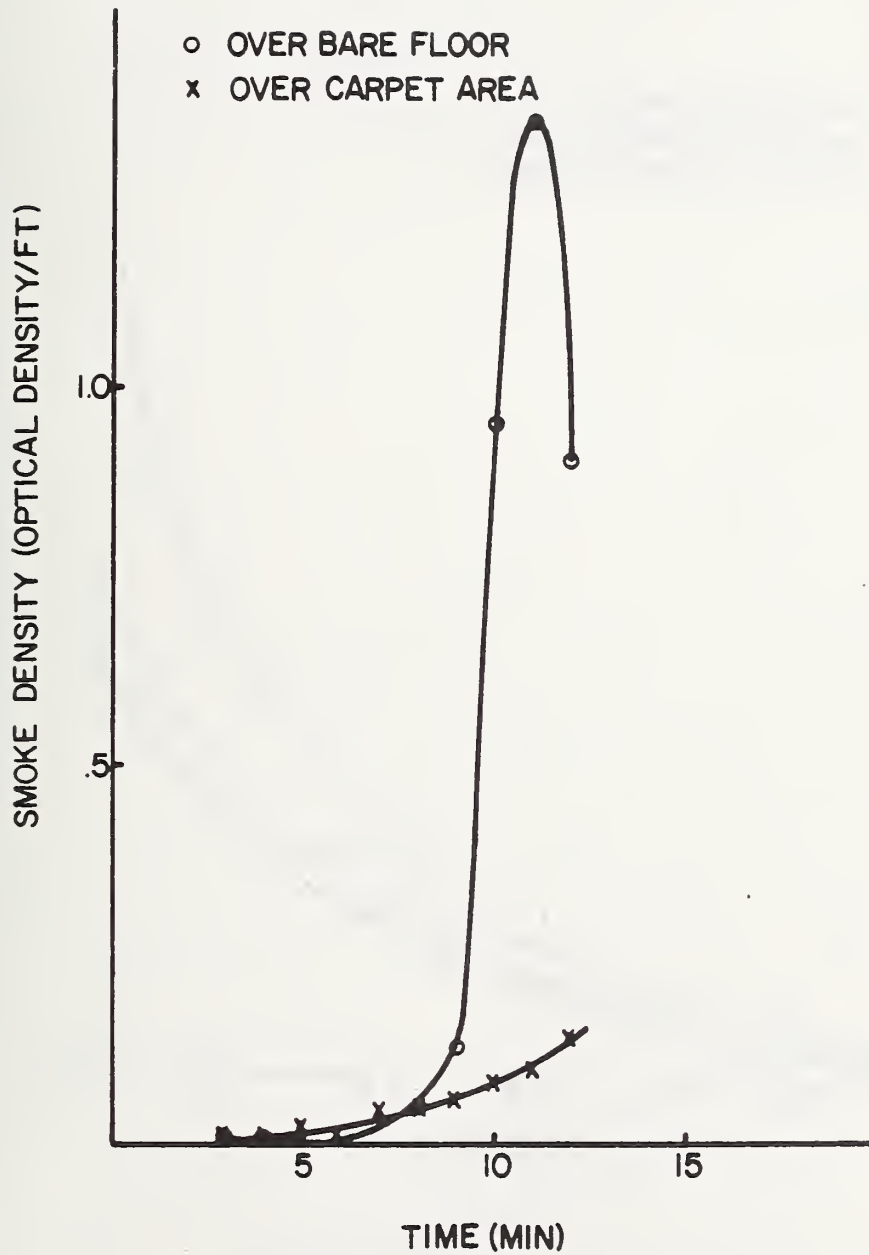
FIGURE 12. Smoke Density, Test #L-1

The smoke meter on the "bare" floor showed a sudden increase in smoke at about 9 minutes, which was more than 4 minutes before "flame through" was noticed. The smoke level indicated by the meter over the carpet-finished floor was considerably less. Smoke meter transmission is given in Table 2, Appendix I and figure 12.

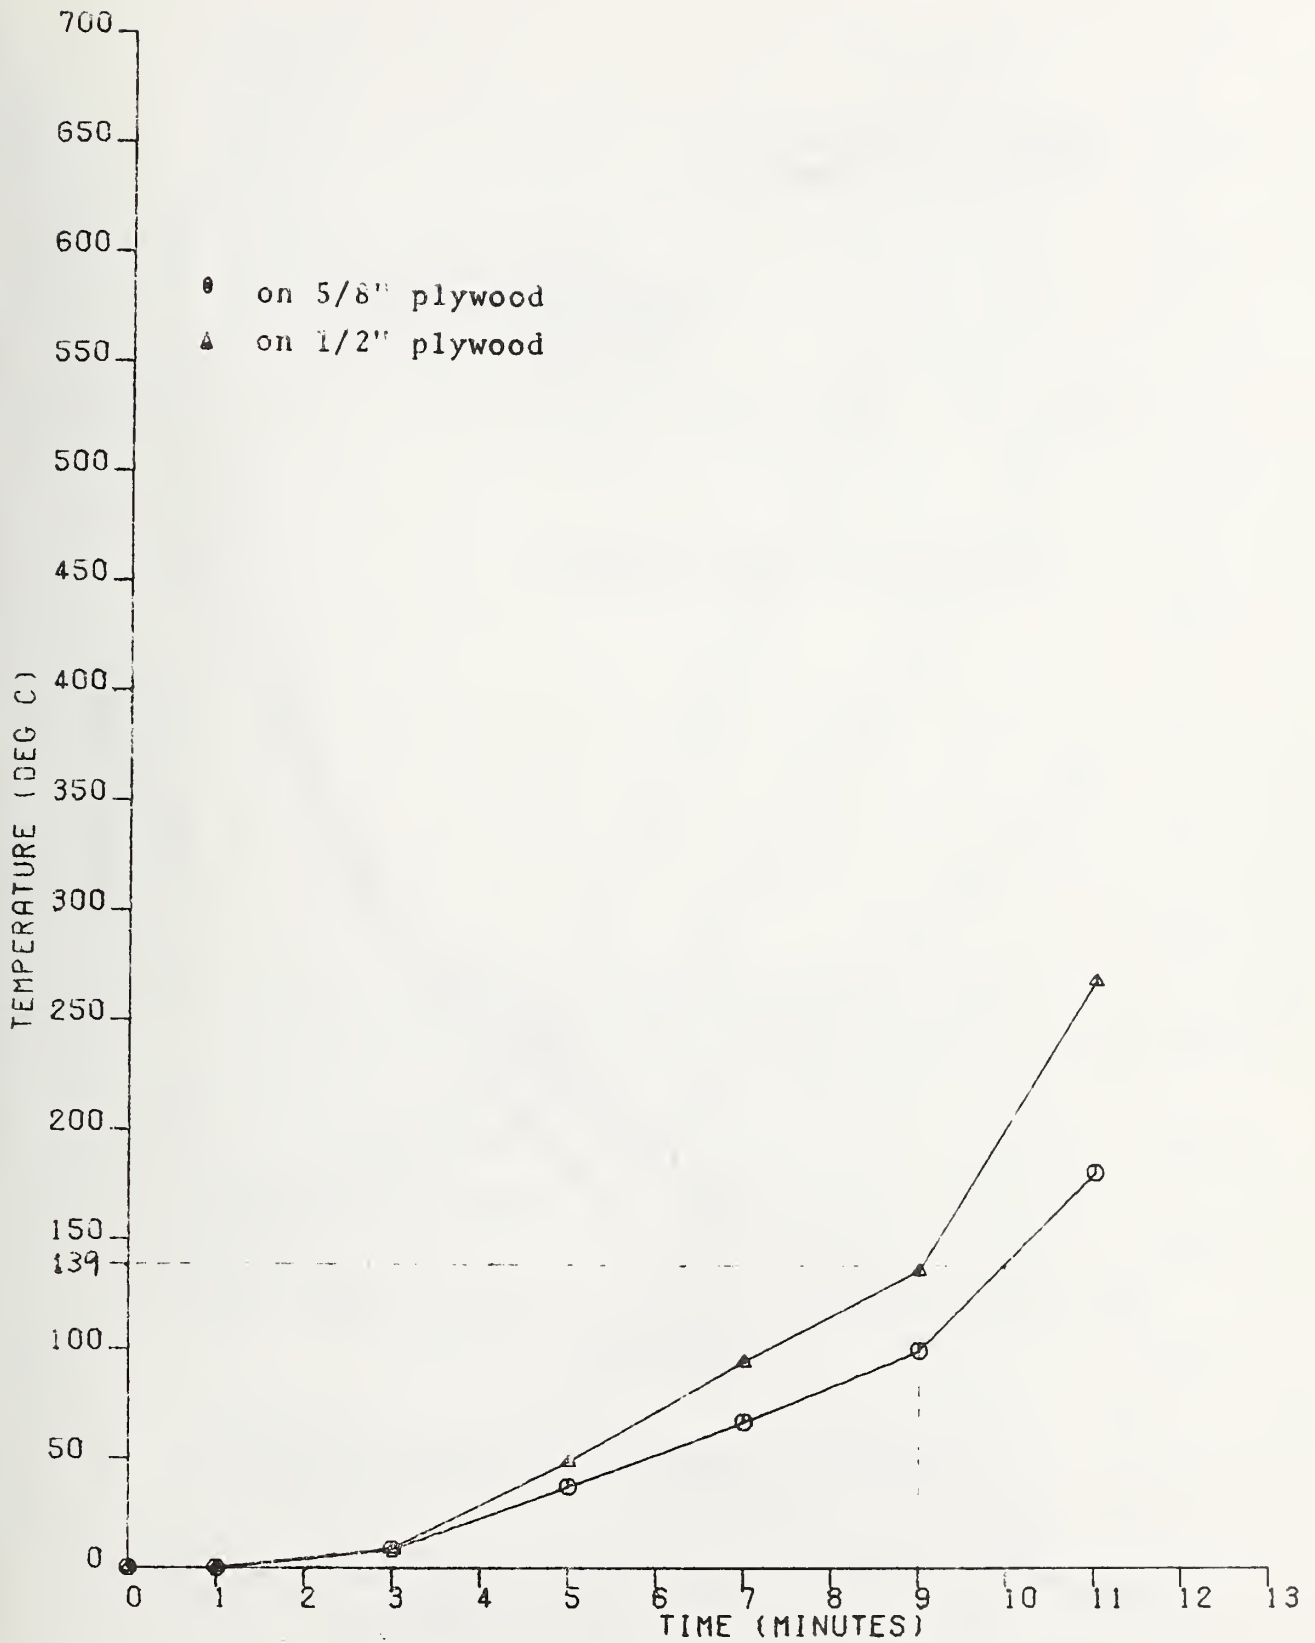
FIGURE 14. Average Temperature Rises for Test #L-2

Figure 14 illustrates average temperature rises on the unexposed surface. Temperature failure occurred at 9 min. for the 1/2 in. plywood floor and 10 min. for the 5/8 in. plywood floor.

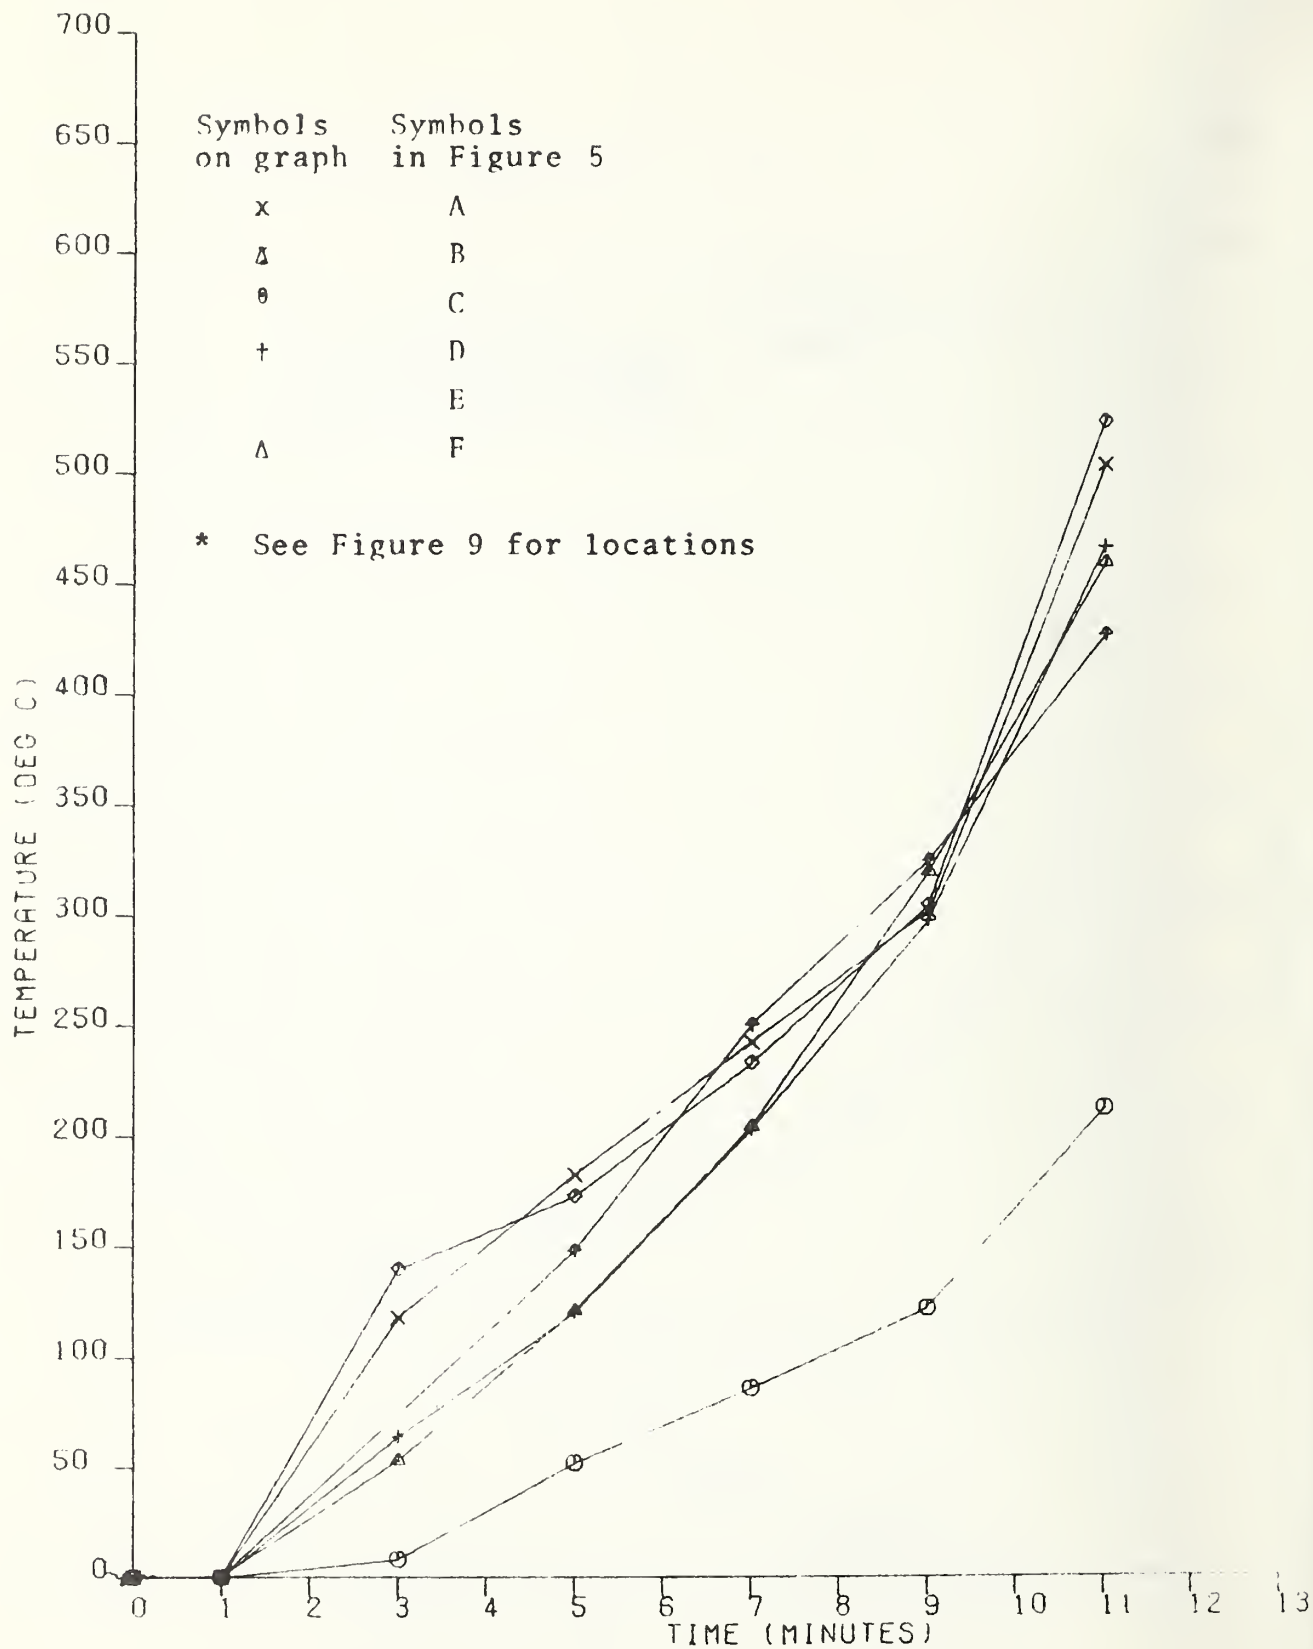
FIGURE 15. Temperature Rises of Special Thermocouples For Test #L-2

Figure 15 is the temperature history of six specially arranged thermocouples (see figure 5). The slow rise in temperature of thermocouple C illustrates the effectiveness of the blocking in protecting the joint.

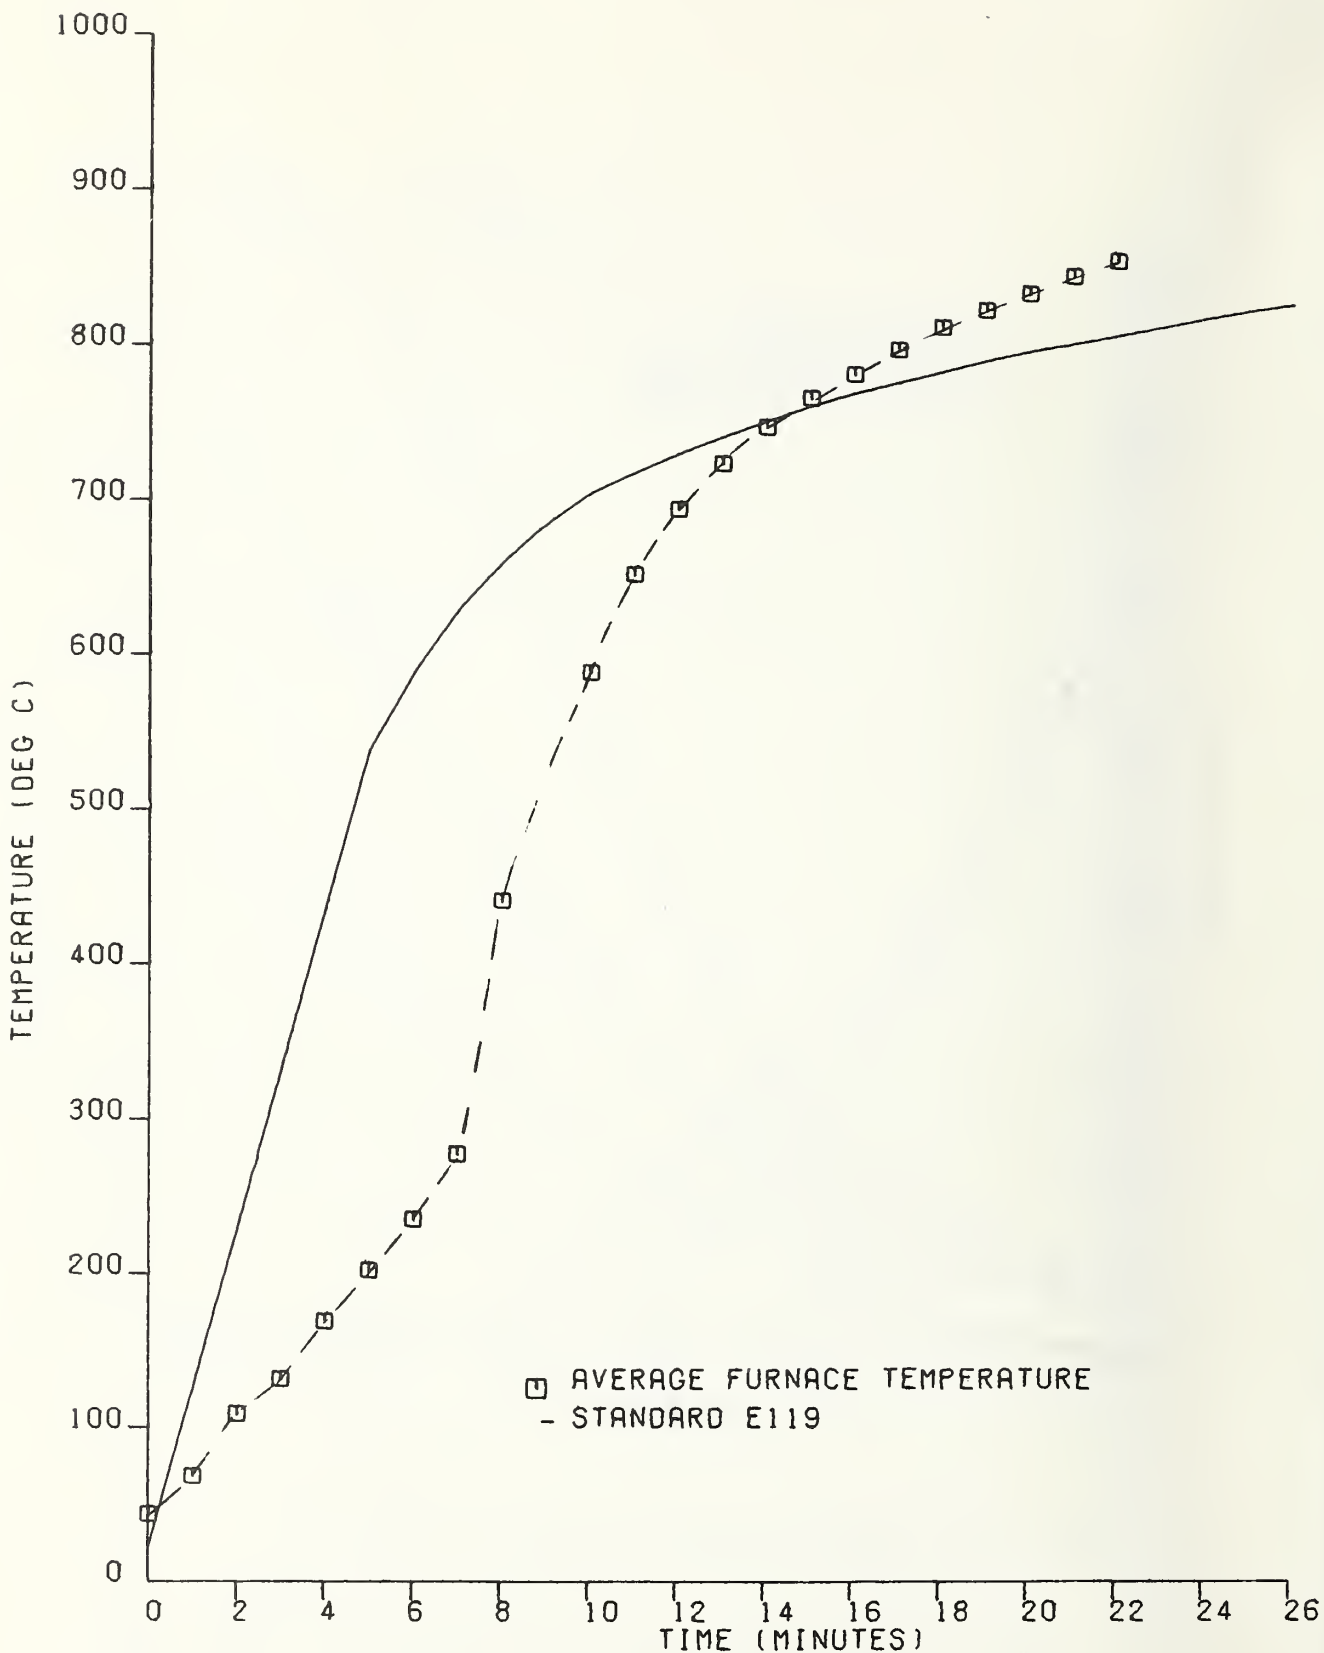
FIGURE 17. Average Furnace Temperatures for Test #S-1 Compared with Standard E 119

Some difficulty with the furnace control was experienced at the beginning of this test causing the furnace temperature-time curve to be below the standard temperature-time curve (see figure 17). Flame through occurred at 21 min:43 sec. The corrected time of flame through, according

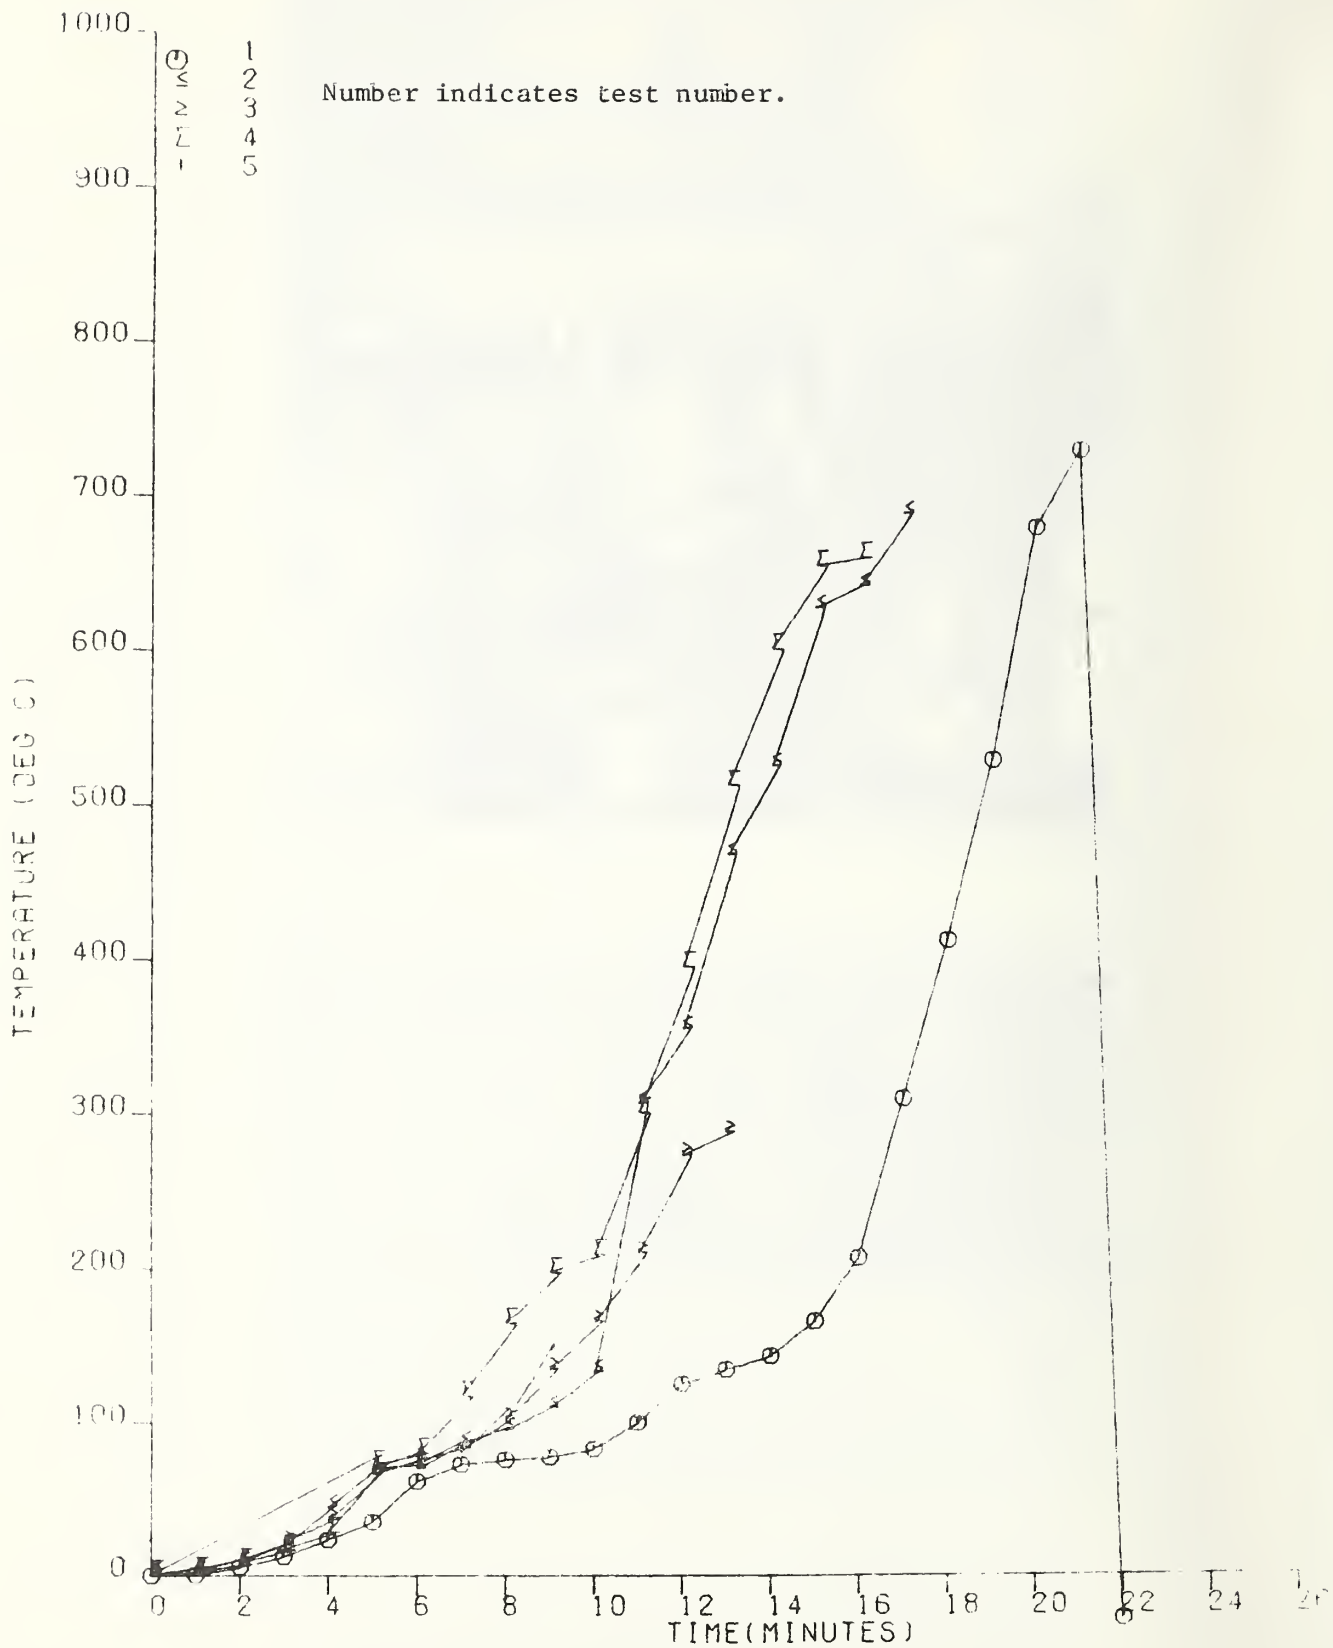
Fig. 23 Temperature Rises at Half Depth For 2X2 Tests #S-1 - 5

Figures 23 and 24 show the temperature changes at half depth for the small scale tests. In figure 24 the slope of curve 7 is flatter than the others, which is explained by the blocking under the joint protecting the joint from the fire.

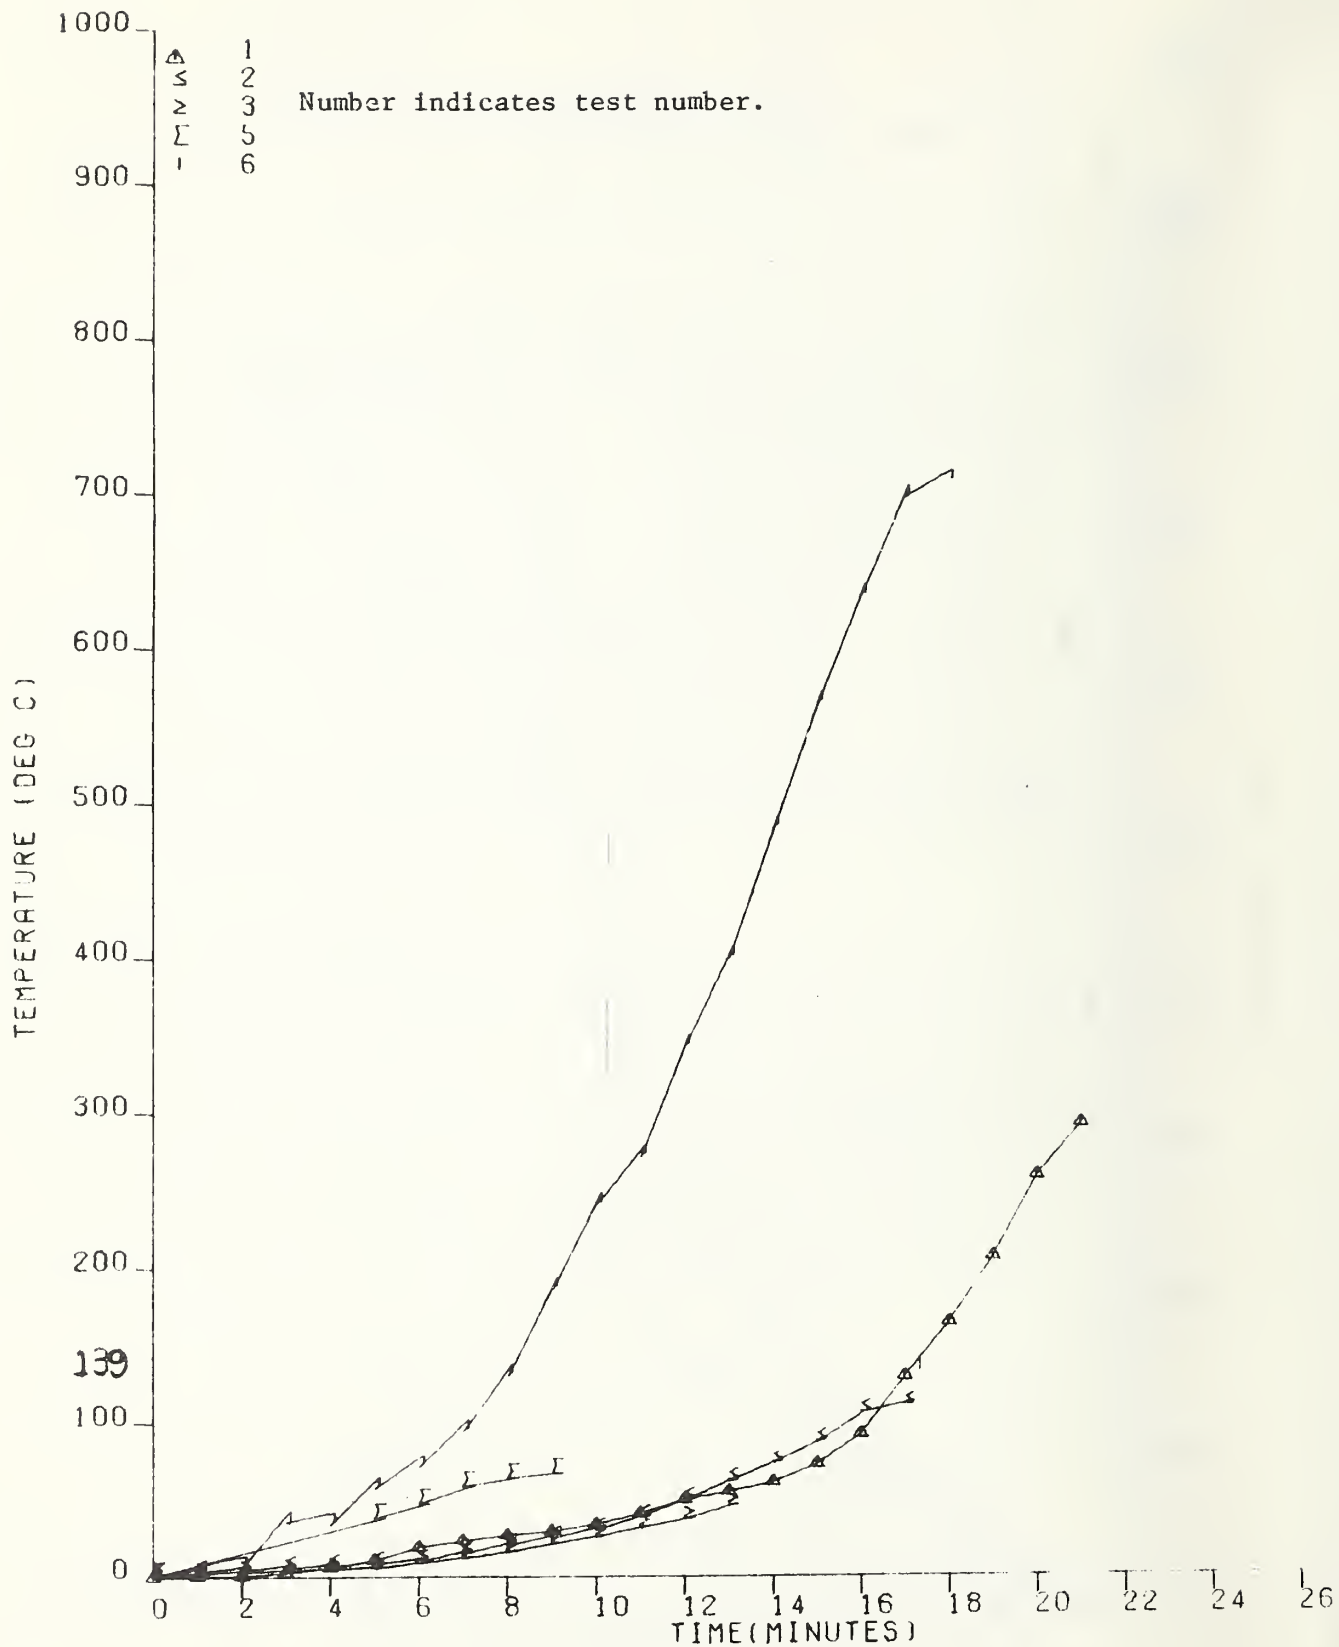
Fig. 25. Temperature Rises on the Bare Floor for Tests #S-1 - 6

The temperature changes on the bare floor and on the carpet surface are shown in Figures 25, 26 and 27. The temperature failure due to the average temperature rise of 139°C on the unexposed surface occurred a few minutes (1-7 minutes) earlier than the failure by flame through. These are shown in Table 1 of Appendix I.

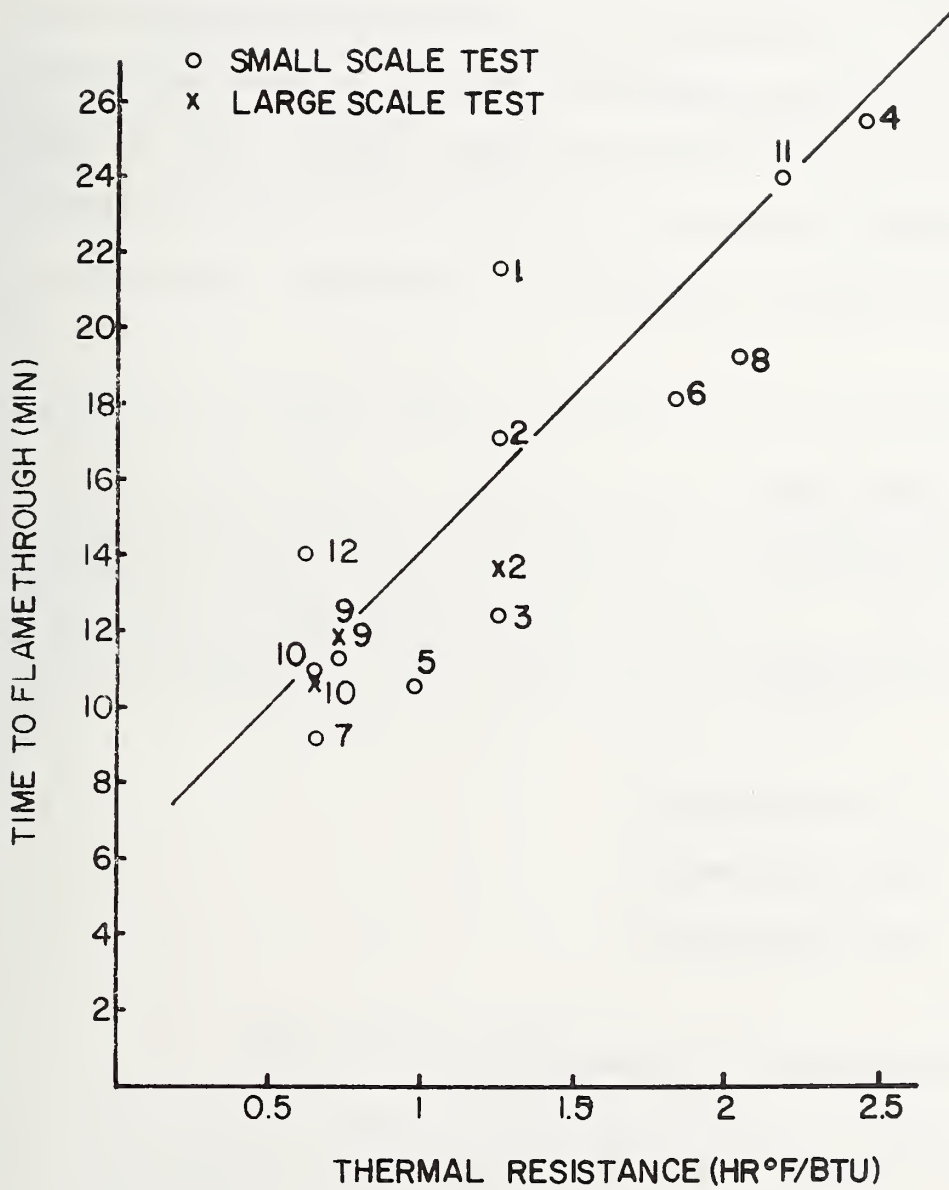
Fig 28 Thermal RESISTANCE of Floor Construction Vs Flamethrough Time

Figure 28 illustrates the influence of the thermal conductivity of various materials on the time of "flame through" under free convection conditions and at room temperature. It is apparent that construction #S-4 (1/2 in. plywood + 1/2 in. plywood + 1/8 in. gap + carpet) has the largest value of thermal resistance and requires the longest time for the flame to penetrate through the floor. It can be also seen in figure 28, that empirically there is a linear relation between the thermal resistance and the "flame through" time. The developed slope K is 0.133 (BTU/°F).
