# Investigation of a 1-Ton Tank-Car Tank That Leaked Phosgene in Easton, Pennsylvania on April 24, 1973

C. G. Interrante

Failure Analysis Report

Prepared for  
**Federal Railroad Administration**  
**Department of Transportation**  
Washington, D. C. 20590

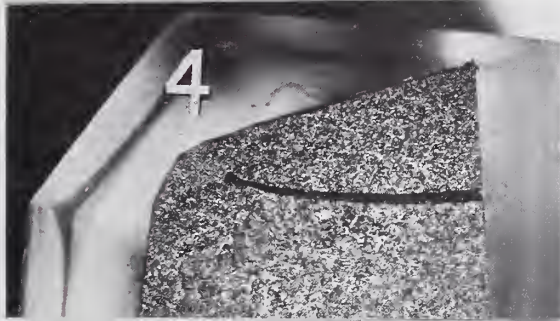
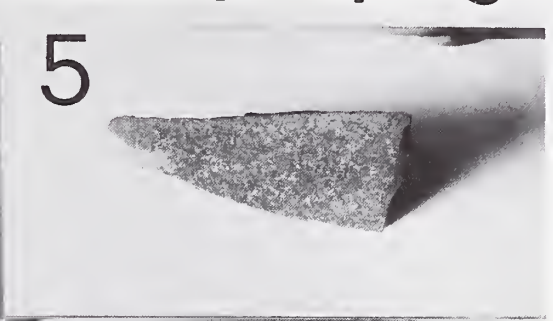
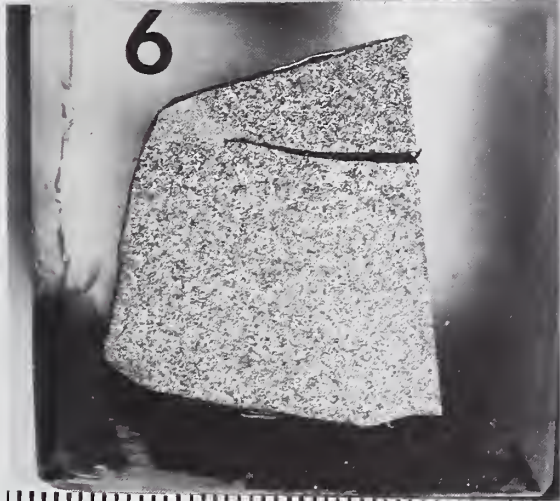
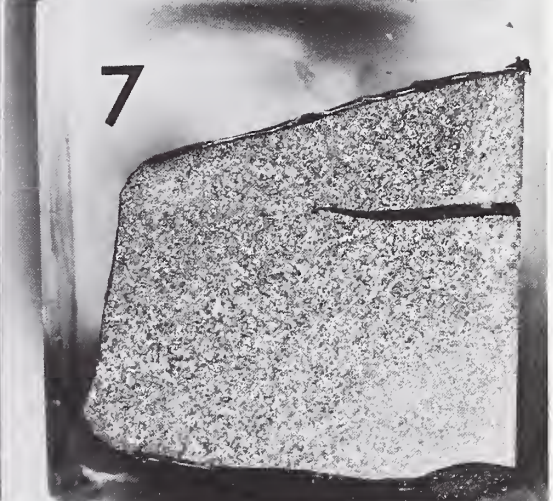
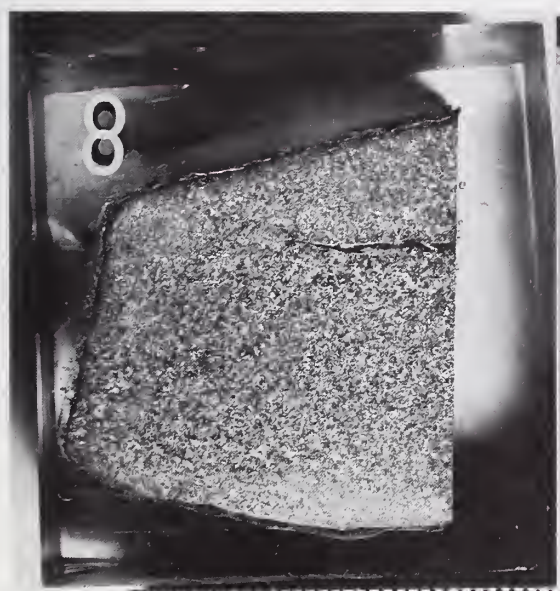
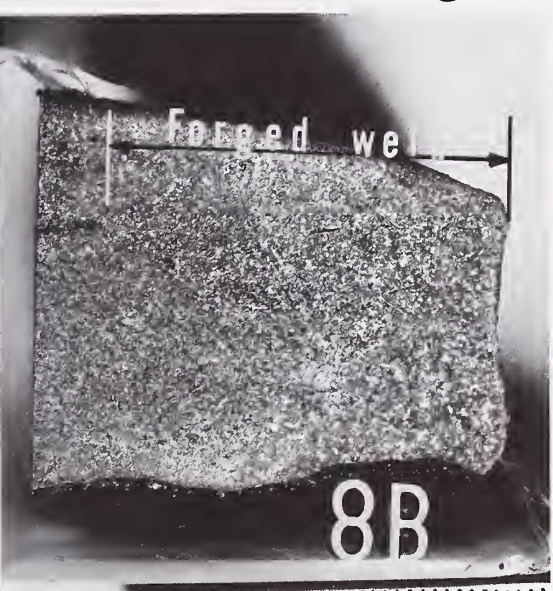
Both the rough-ground segments of Figure 4 and the polished segments of Figure 5 show that the bonded region extends for less than 0.4 inches (1.0 cm), in segments numbered 1 through 7, and for about 0.6 inches (1.5 cm), in segment number 8. The shortness of these lengths of the bond line are somewhat surprising, especially for segments 2, 4, and 5 which have bond line lengths of less than 0.2 inches (0.5 cm).

In the polished and etched condition (Figure 5), segments numbered 2, 4, and 5 were observed to have no fusion from lap welding, i.e. no forged weld region. The bonded metal shown here for these three segments is that of a tac weld at the end of the vessel. The other segments examined had at least some small length of forged weld metal along their bond lines. Segments 1B and 8B were taken from the ends of the original flame-cut section at distances somewhat remote from the leak, as marked on the photograph of Figure 2. In Figure 5, the polished and etched faces of these two segments clearly show forged weld metal in lengths of 1.3 inches (3.3 cm) for 8B and 0.6 inches (1.5 cm) for 1B. Segment 8B is more distant from the tac weld than any of the other segments examined, and 8B has the longest forged weld region.

Figure 5. Eight 1-inch segments from near the leak and two end segments taken from the section that contained the leak, in the cropped, polished, and etched condition.
