# **Safety Evaluation of Soda-Acid Fire Extinguishers**

**Bruce W. Christ and John H. Smith**

**Failure Analysis Report**

**Prepared for  
Bureau of Engineering Safety  
Consumer Product Safety Commission  
Washington, D. C. 20207**

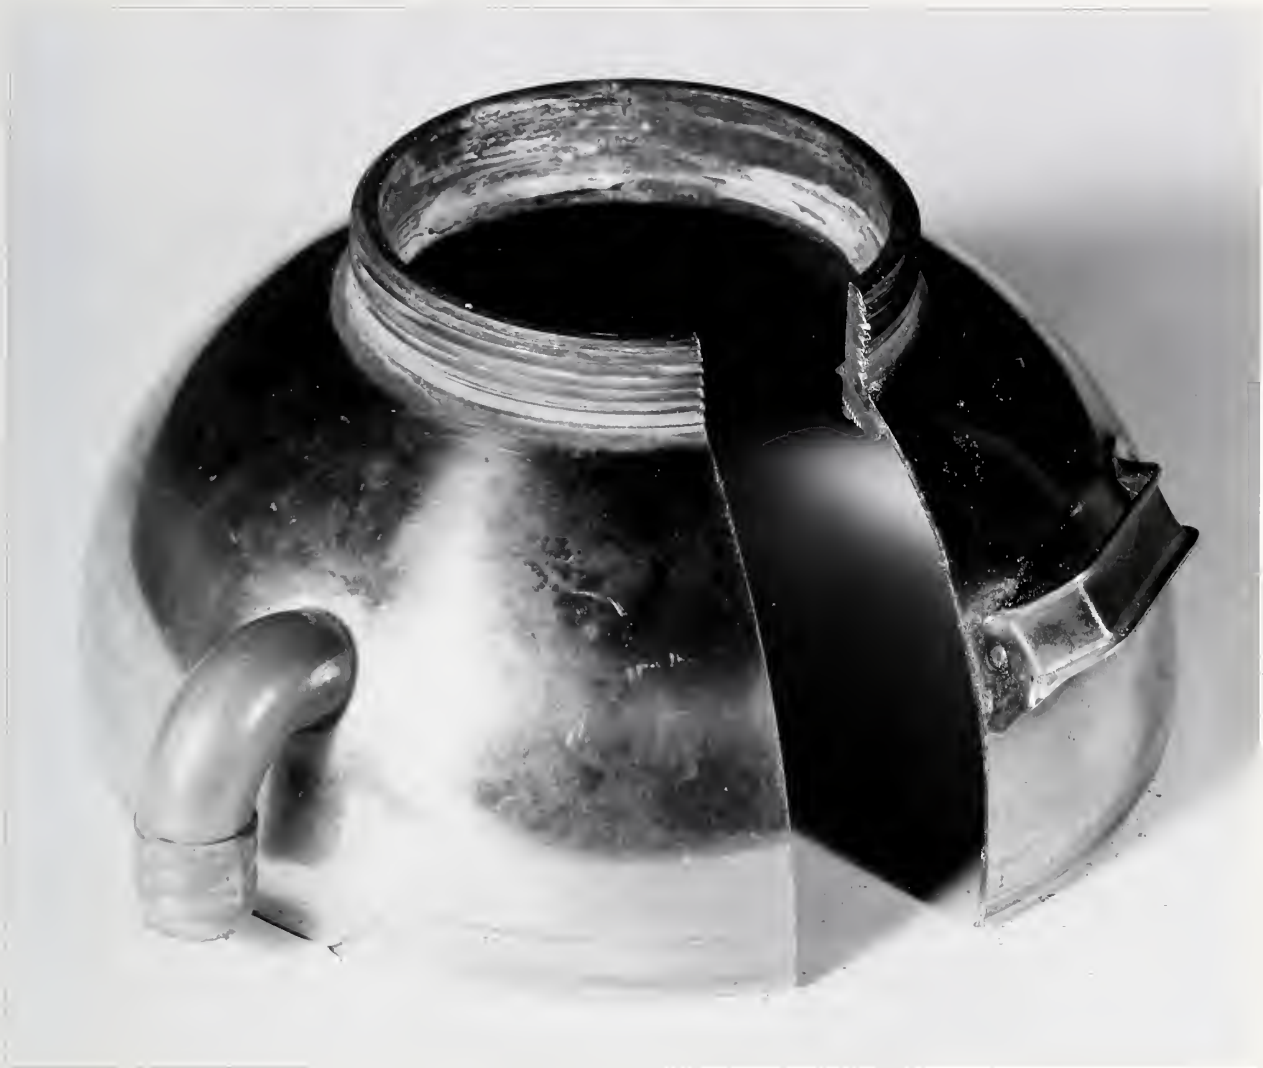
Figure 5a. Dome removed from fire extinguisher  
number F 700745. X 3/4

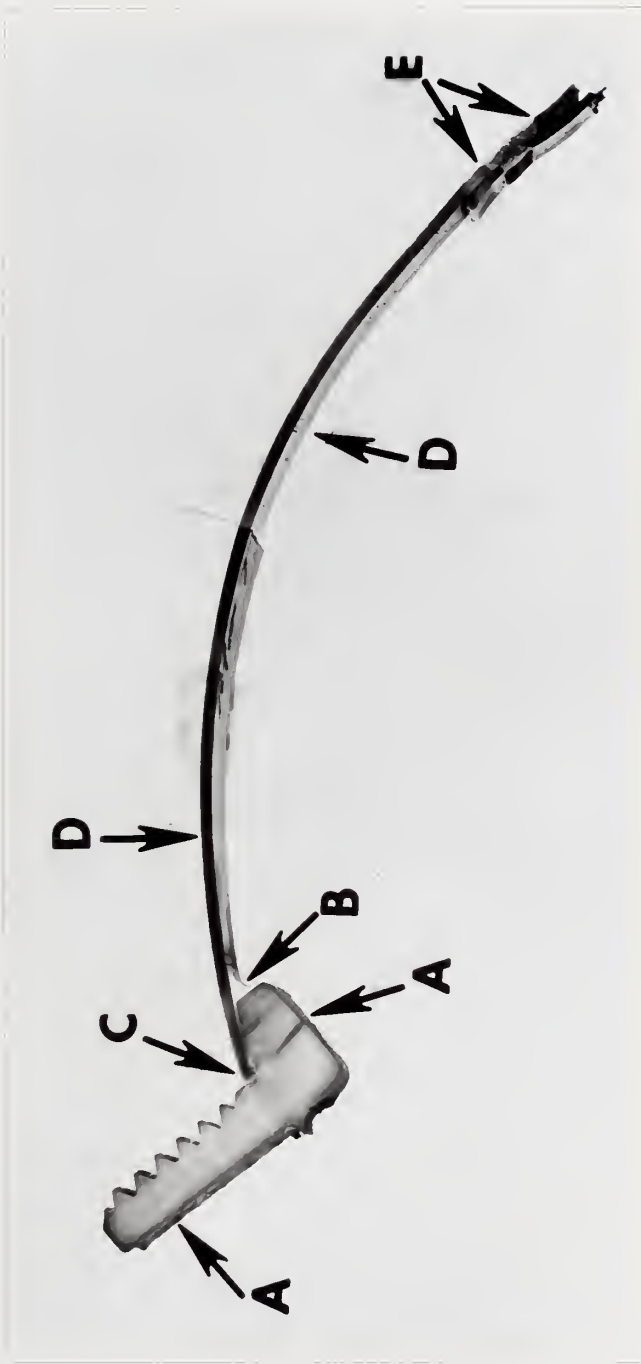
Figure 5b. Longitudinal section through dome wall showing collar (A), joining metal (B and C), dome wall (D) and joint between dome wall and shell wall (E).  
X 1 1/2

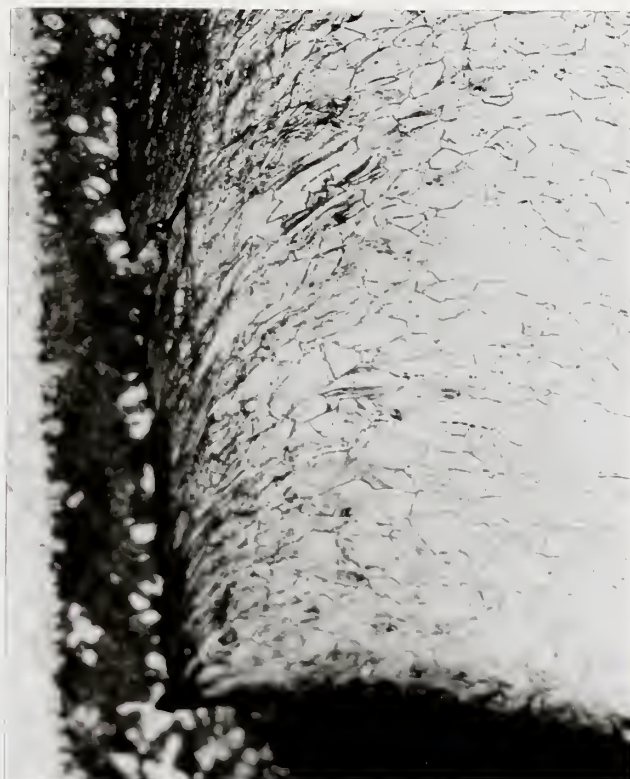
Figure 9a. End of the dome metal under the outside fillet of joining metal. Note severely distorted grains at end indicating localized distortion.
