NBSIR 76-1181

**METALLURGICAL EVALUATION AND
FRACTURE ANALYSIS OF A
PNEUMATICALLY-BURST SEAMLESS
STEEL COMPRESSED GAS
CYLINDER**

Failure Analysis Report

April, 1977

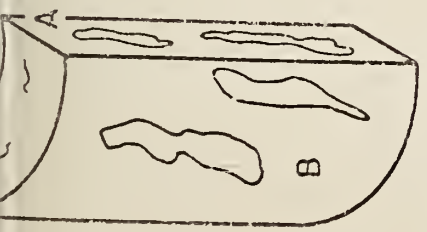
The average tensile and yield strengths in Table VII compare favorably with the average tensile and yield strengths in Table III. However, reduction in area and elongation show decreases of about 30 and 40%, respectively. Hence, there seems to be no orientation dependence for strength, but a substantial dependence for ductility. This reduction in ductility is attributable in part to the inclusions elongated in the longitudinal direction, Figure 15.

A - Longitudinal Section - Circumferential Direction

B - Longitudinal Section - Radial Direction
