NBSIR 78-1415

Fire Endurance Tests of Residential Walls Containing Branch Circuit Wiring - Preliminary Findings

Lionel A. Issen

February 1978

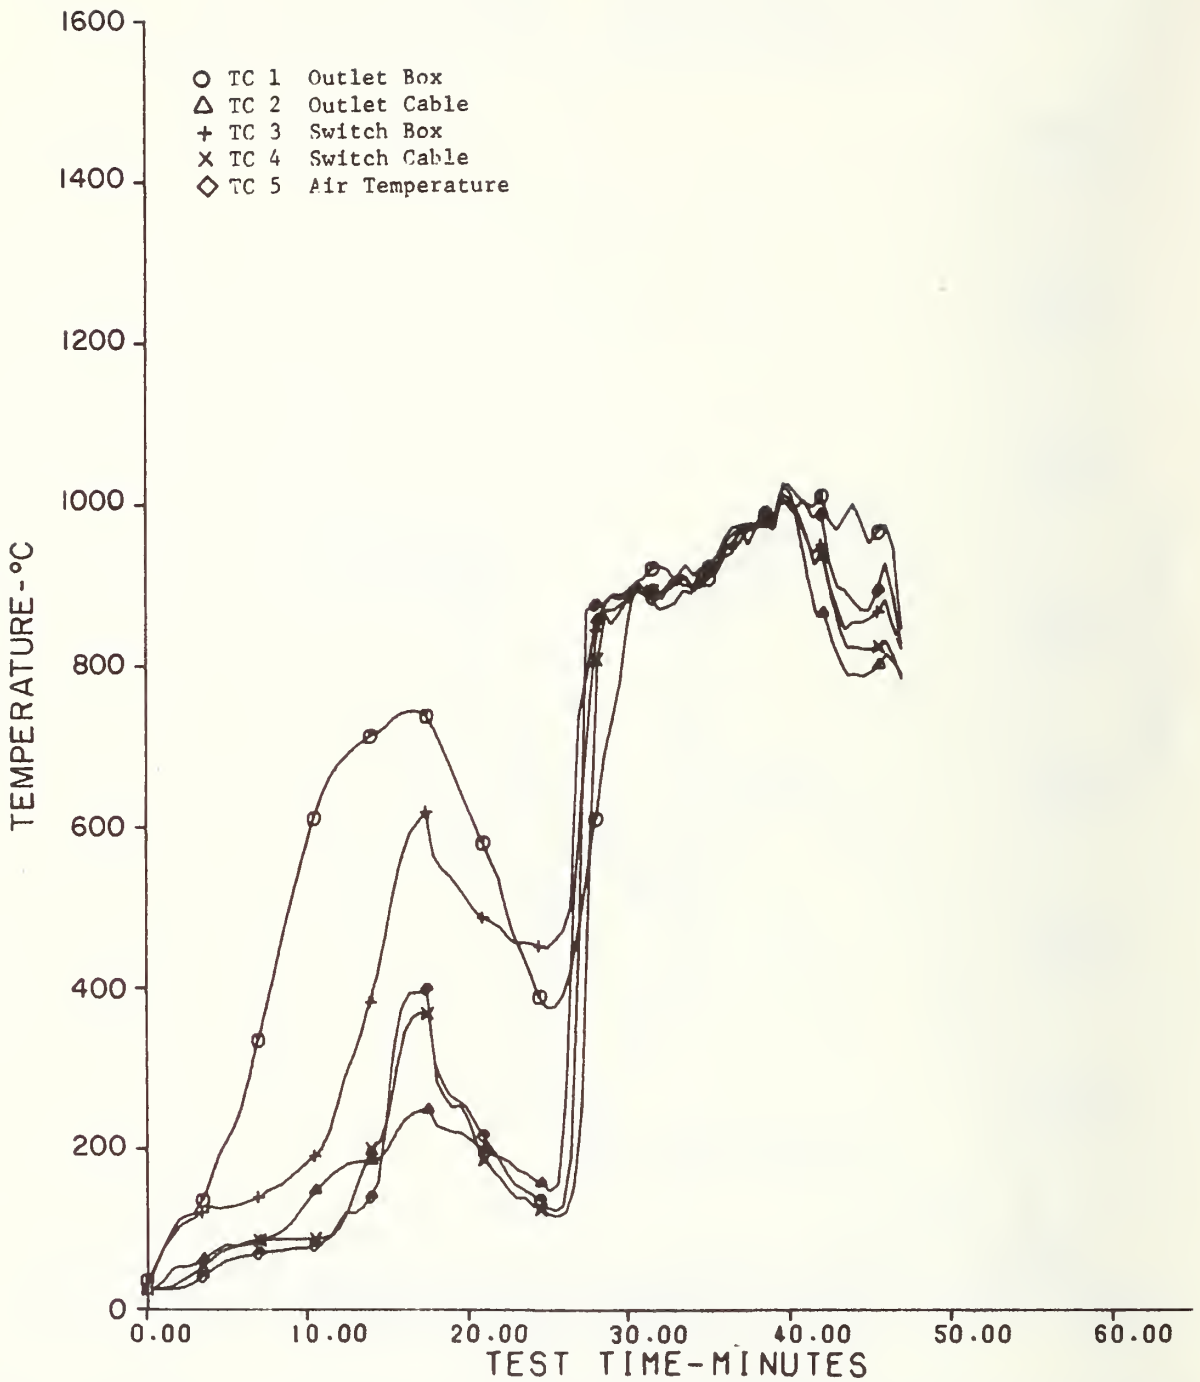
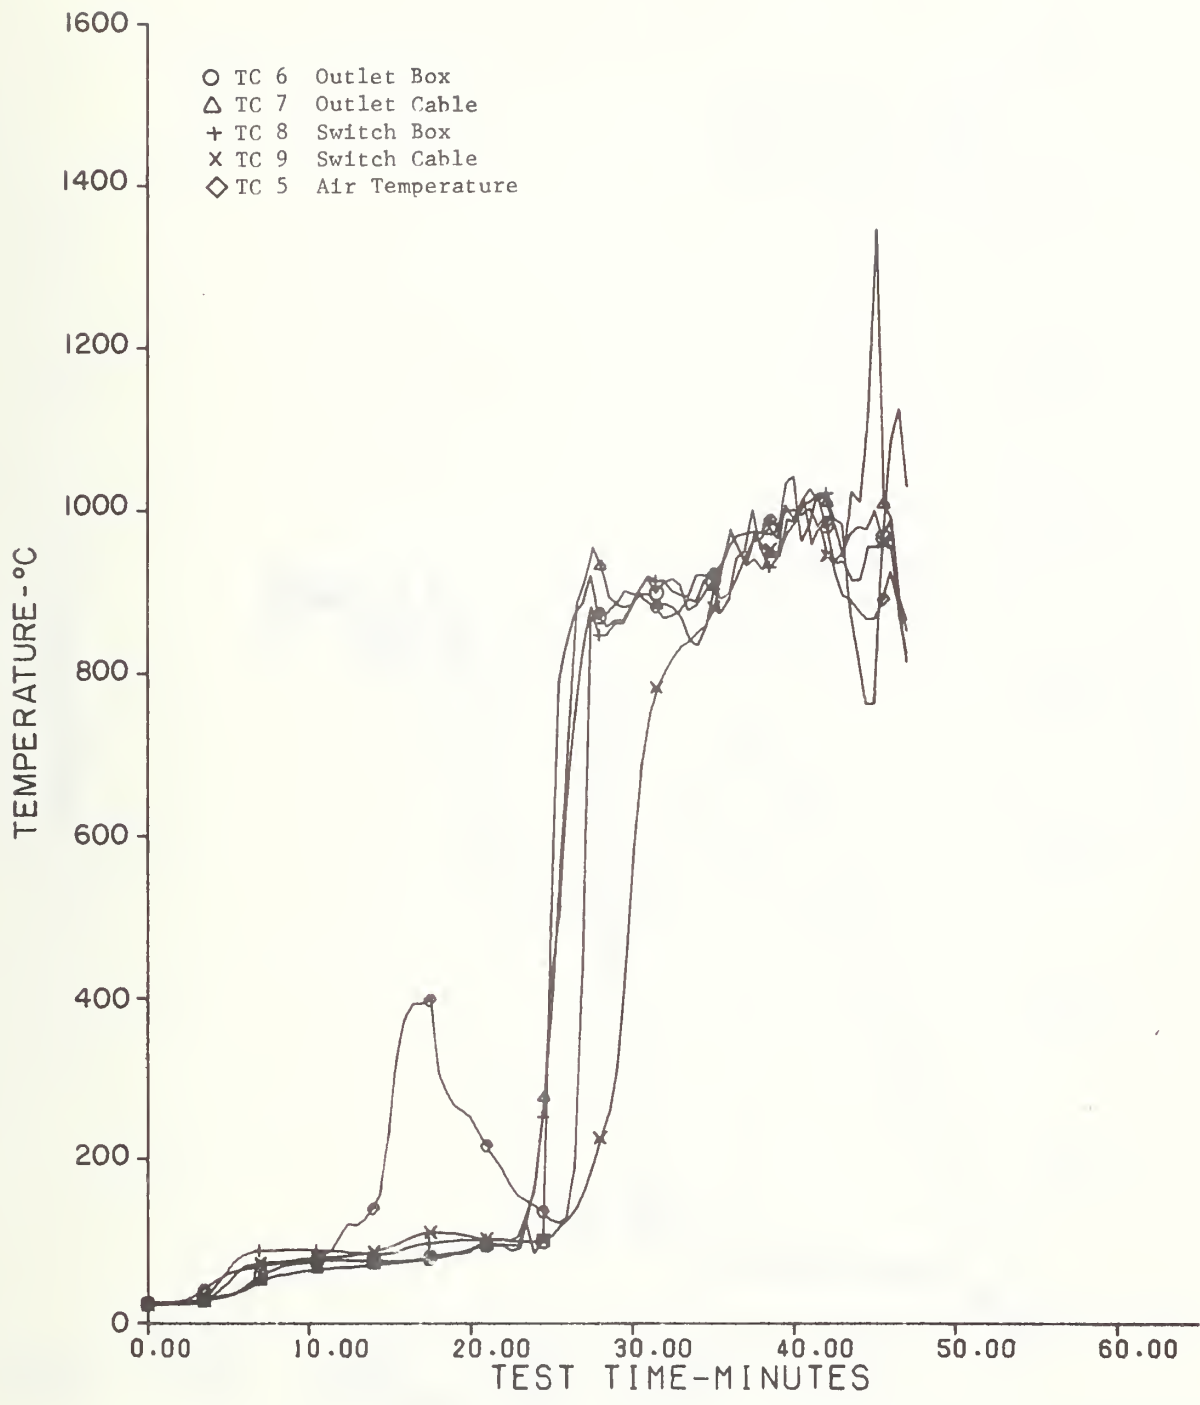
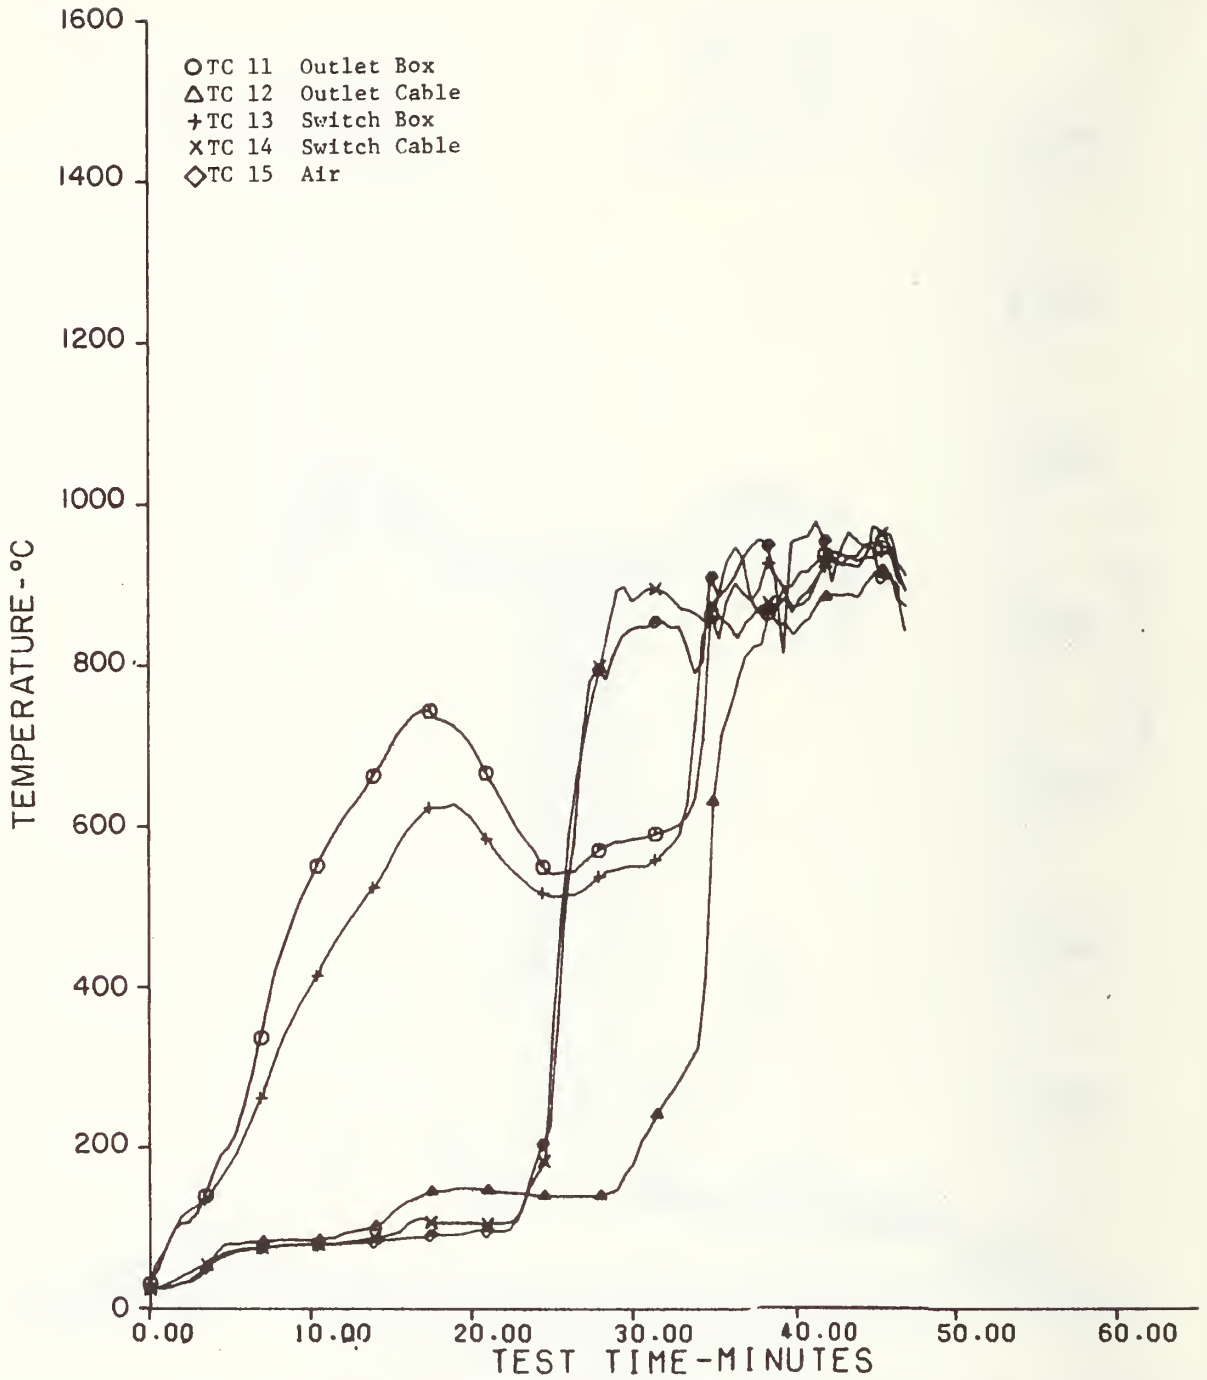
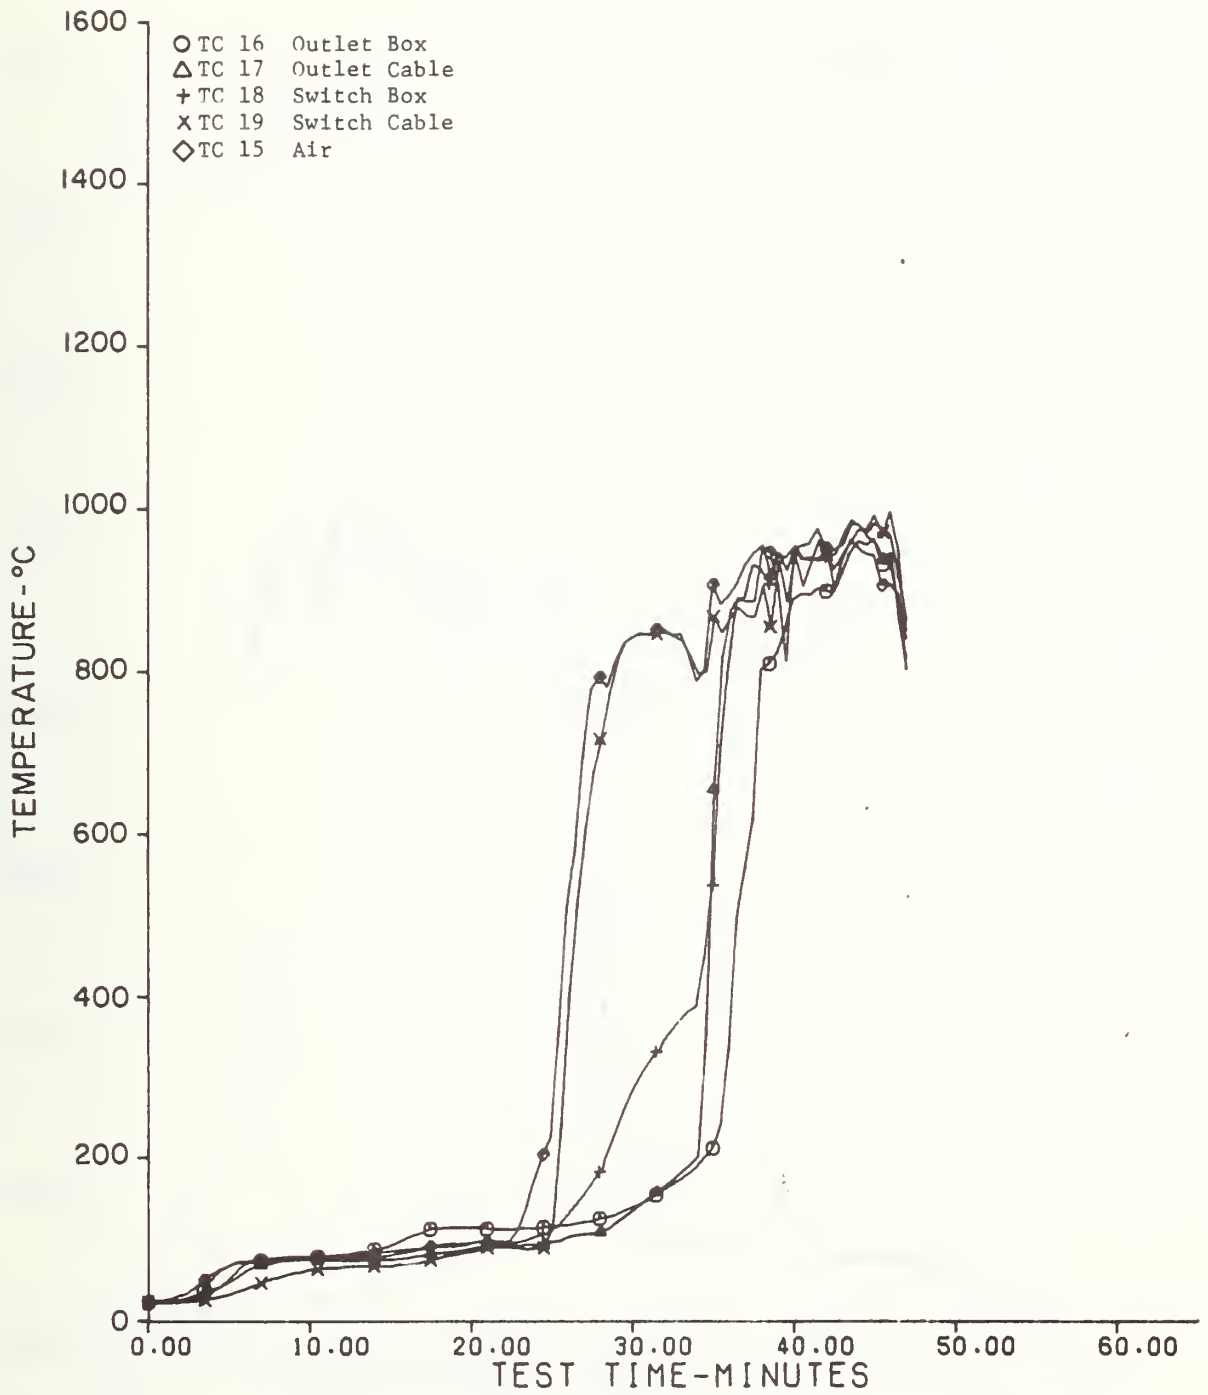
Figure 16. Test FE 1 - Insulated wall NM fire side temperatures

With minor exceptions, the temperatures on both the fire side and the room side of the insulated half of the wall showed no significant difference between the type NM and type AC assemblies. The temperatures are shown in figures 16, 17, 18, and 19.

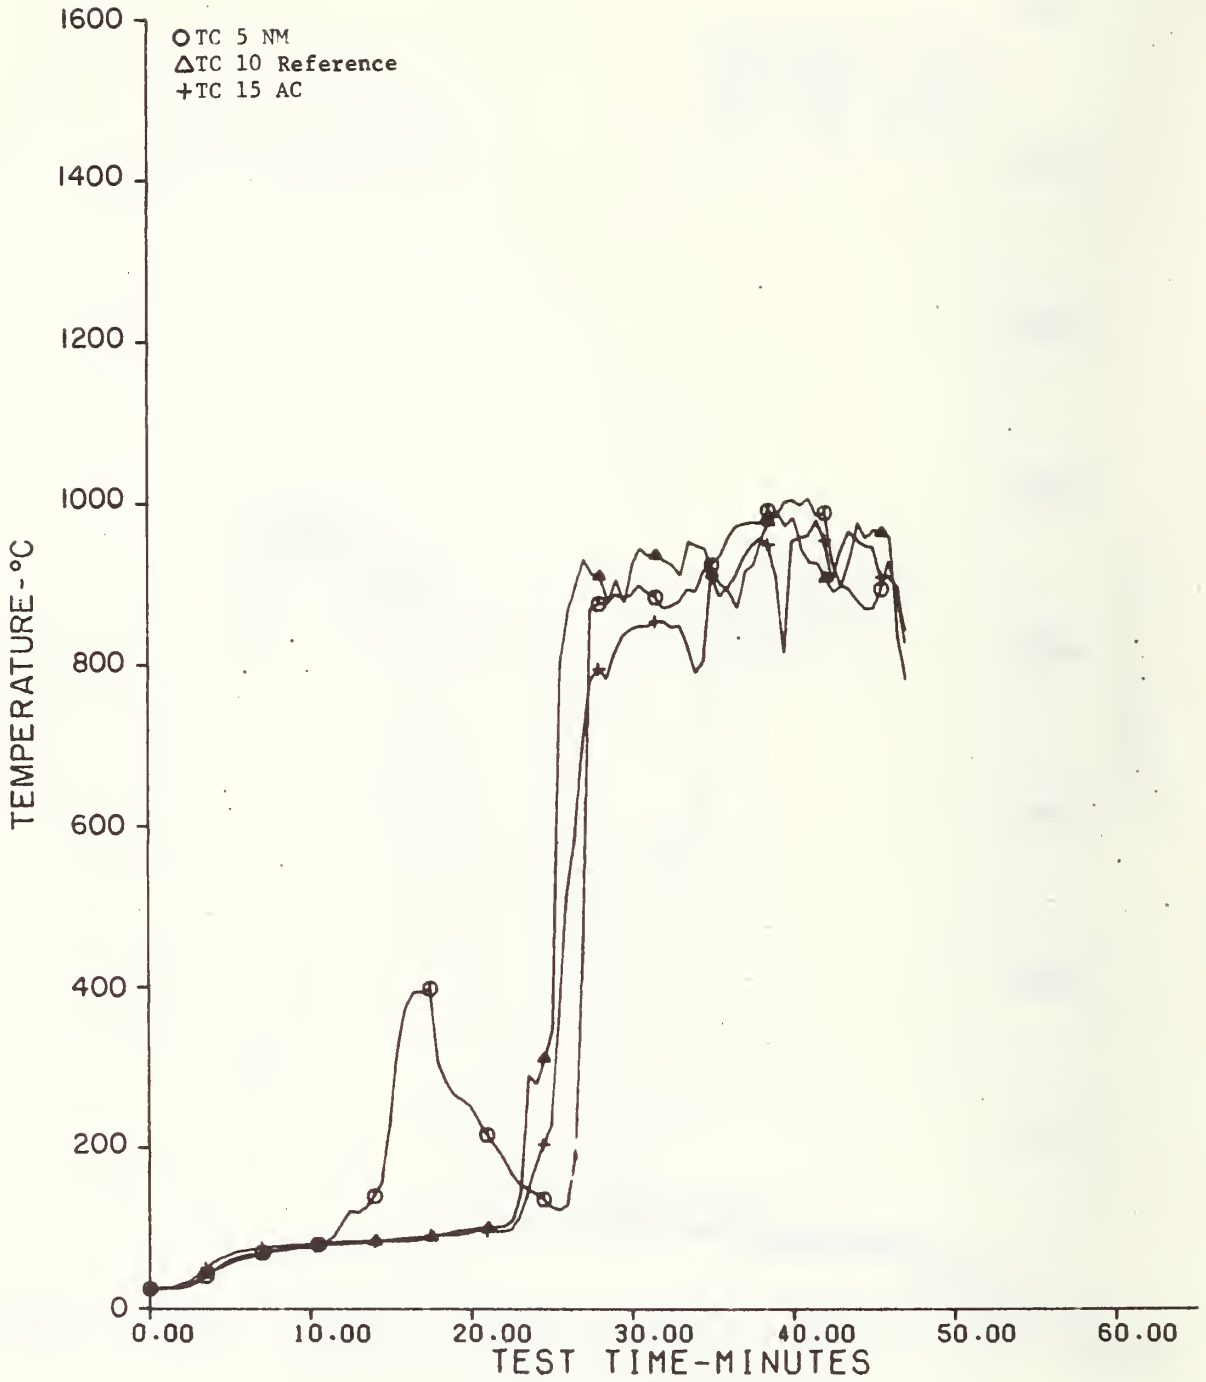
Figure 20. Test FE 1 - Air temperatures insulated wall

The air space temperatures shown in figure 20 for three insulated stud spaces showed that there was no significant difference between the air space temperatures for the type NM and AC assemblies. The NM air space appears to have been influenced by the high furnace pressures for several minutes prior to the damper control change at 16 minutes. This t/c may have been inadvertently located toward the fire. With this qualification, the air temperatures remained relatively low until the wall deteriorated exposing the stud spaces to the direct furnace heat after about 25 minutes.

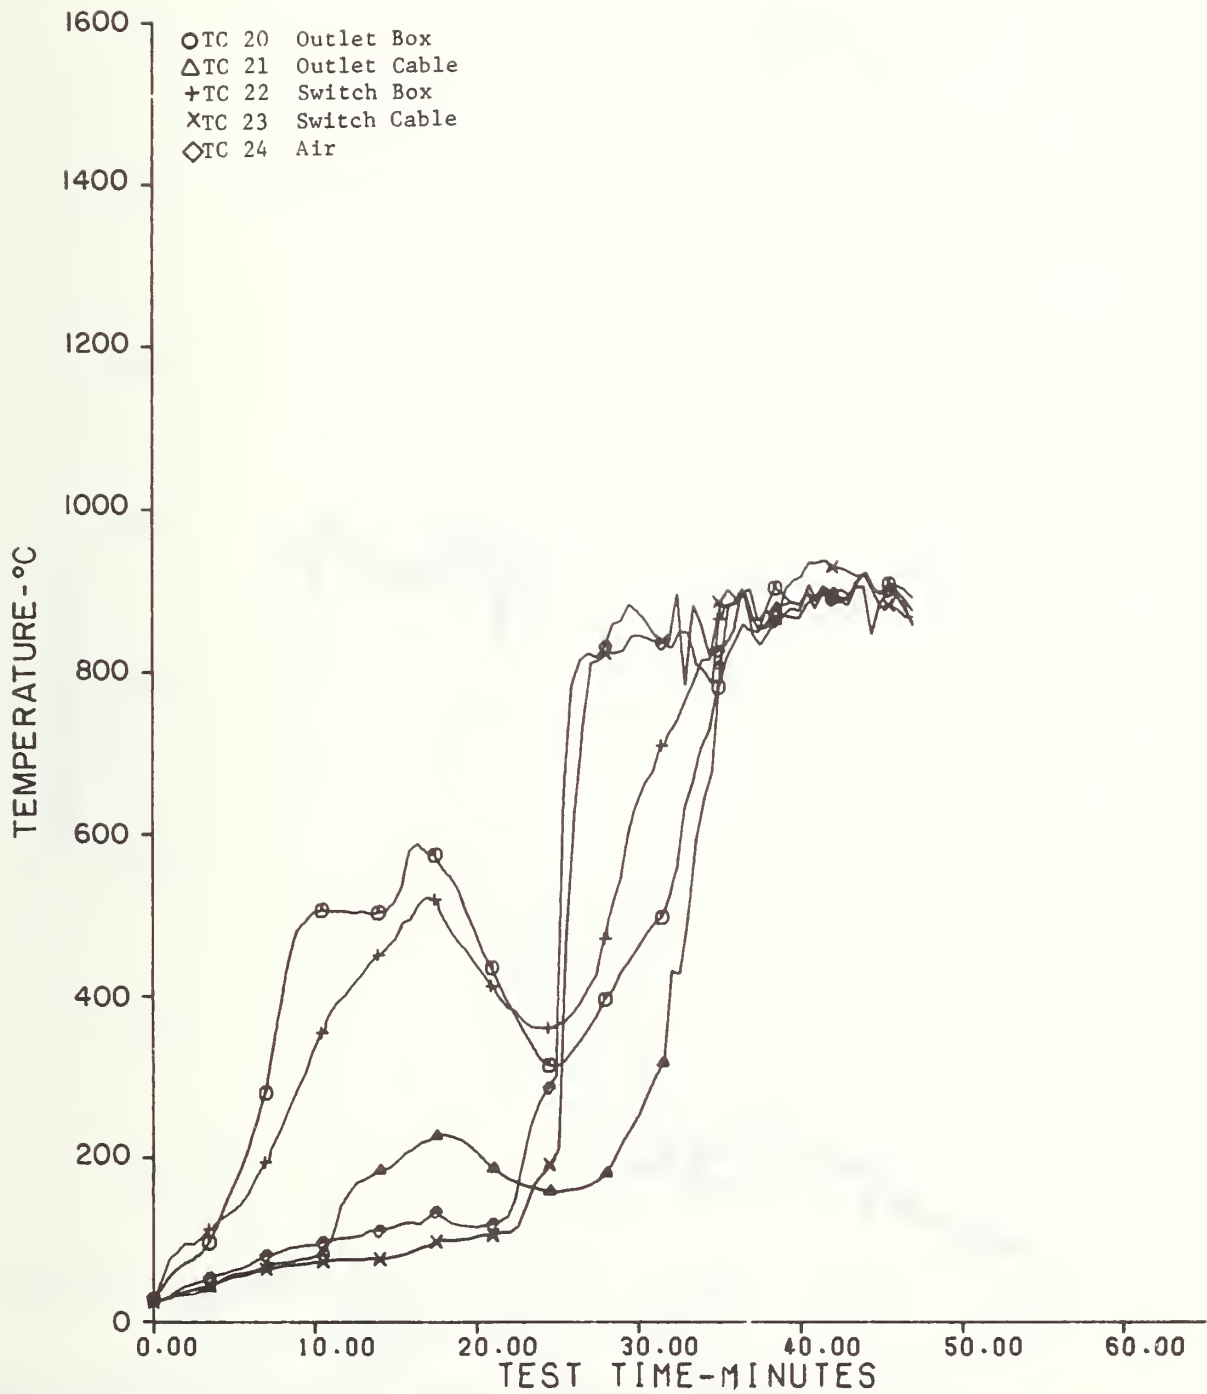
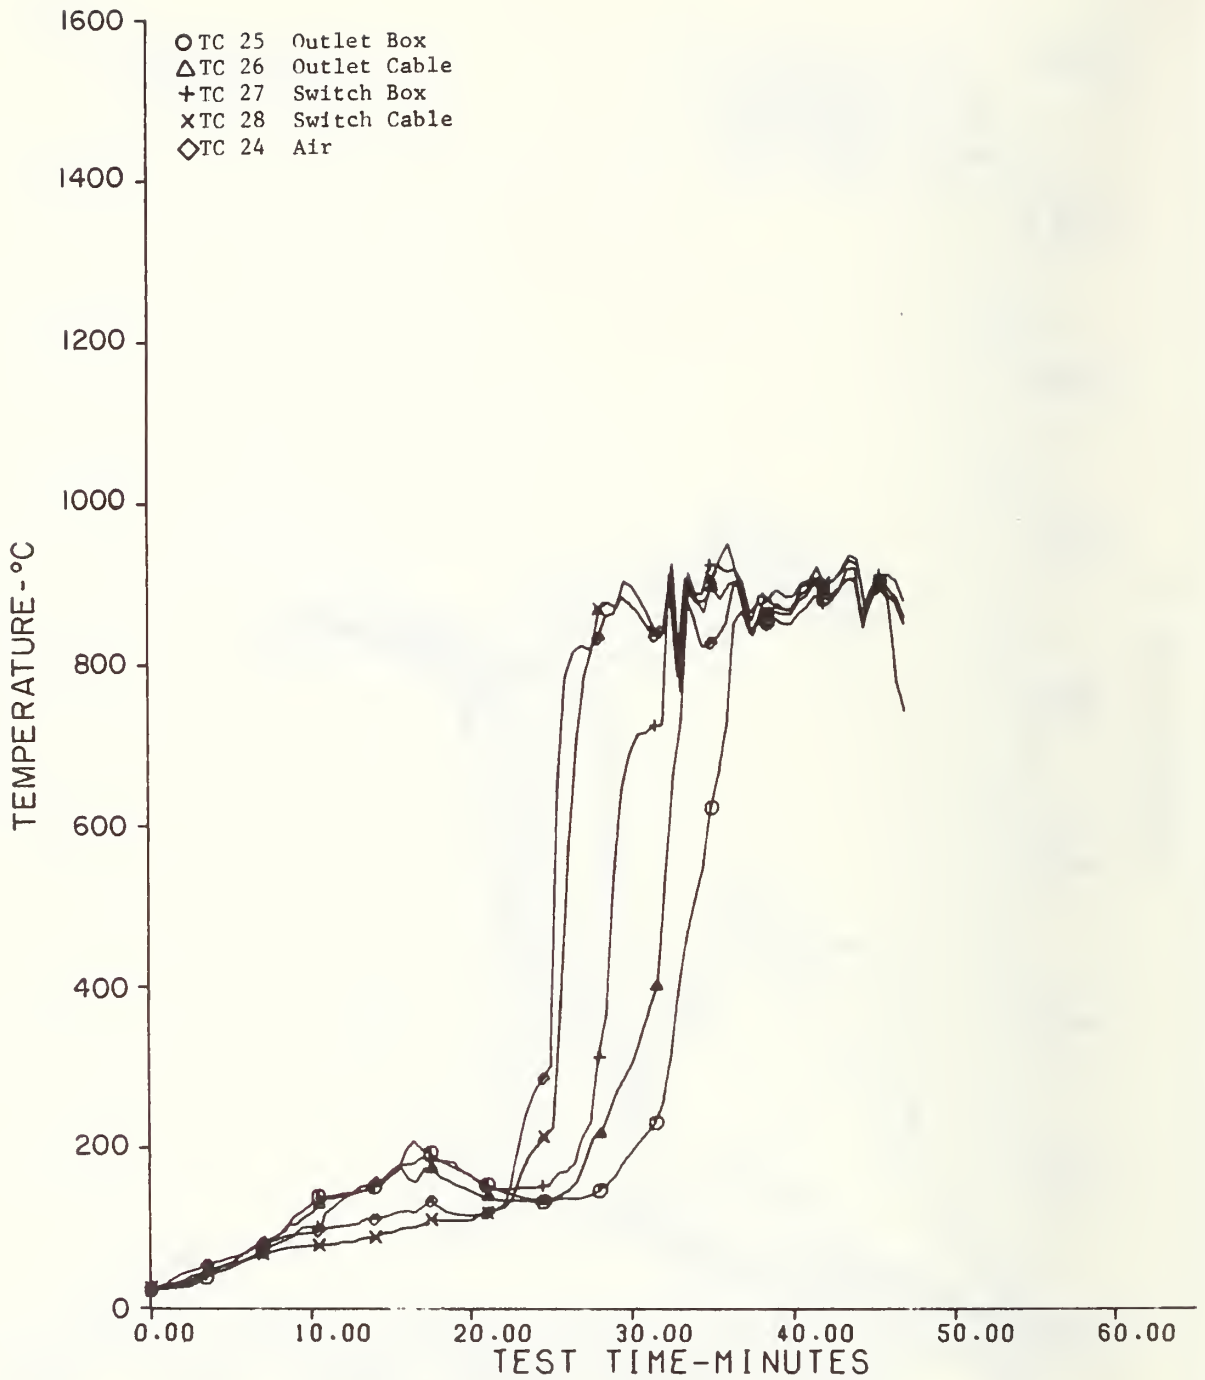
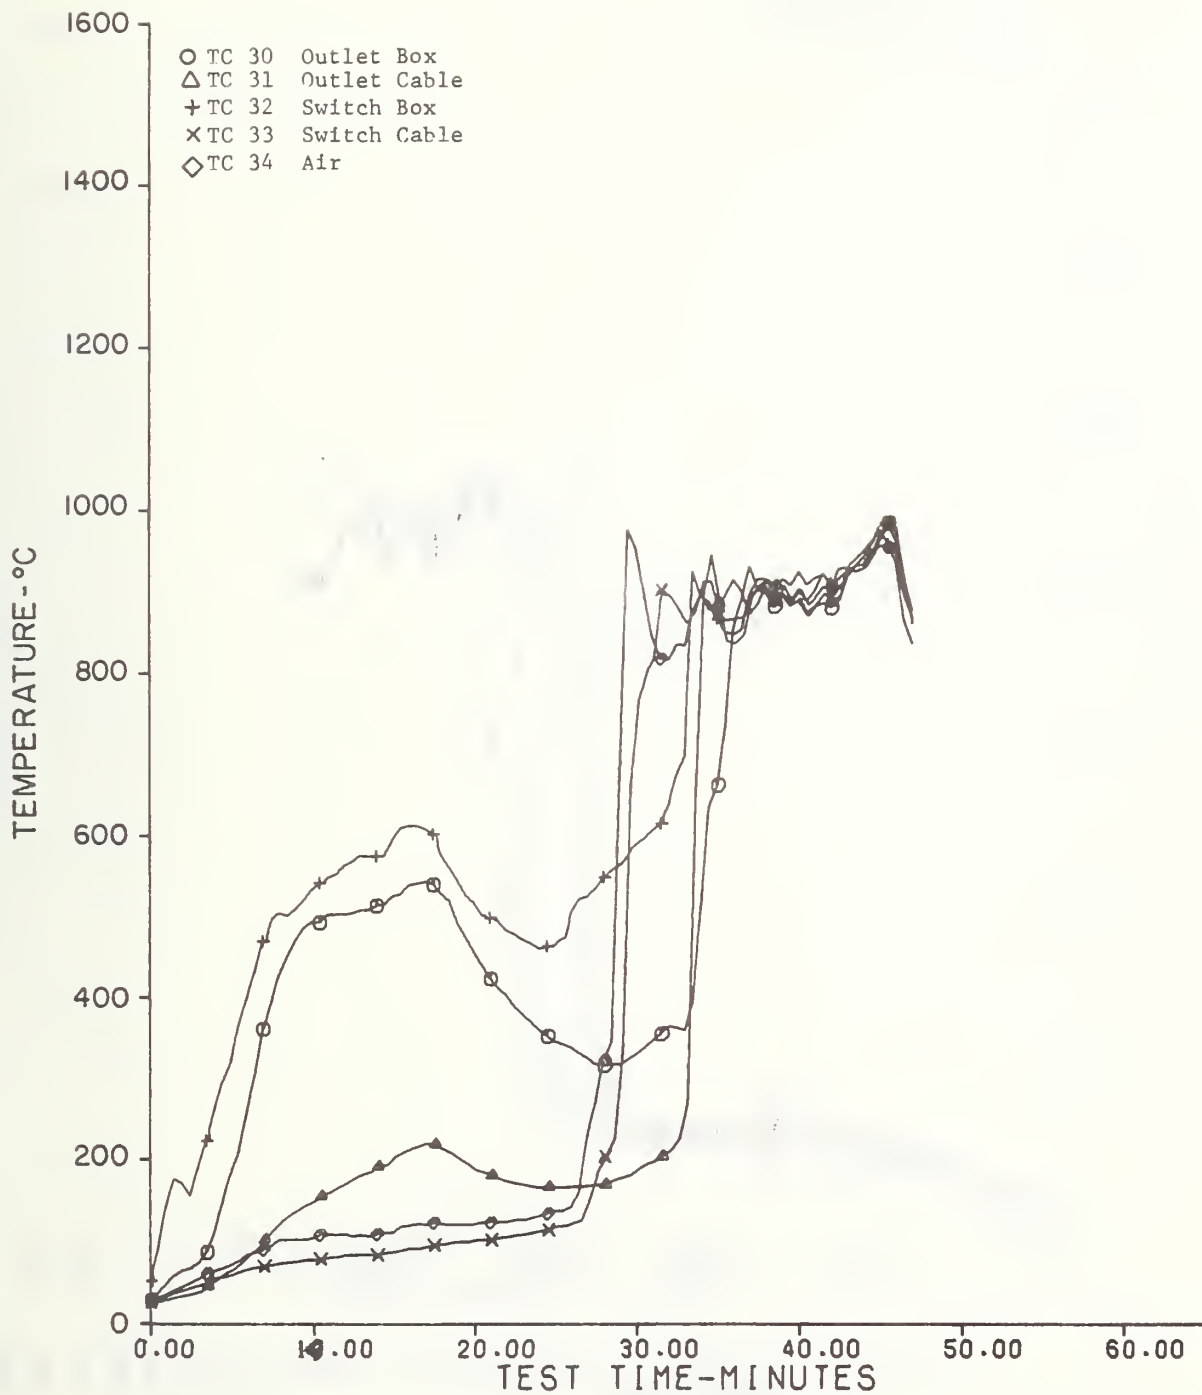
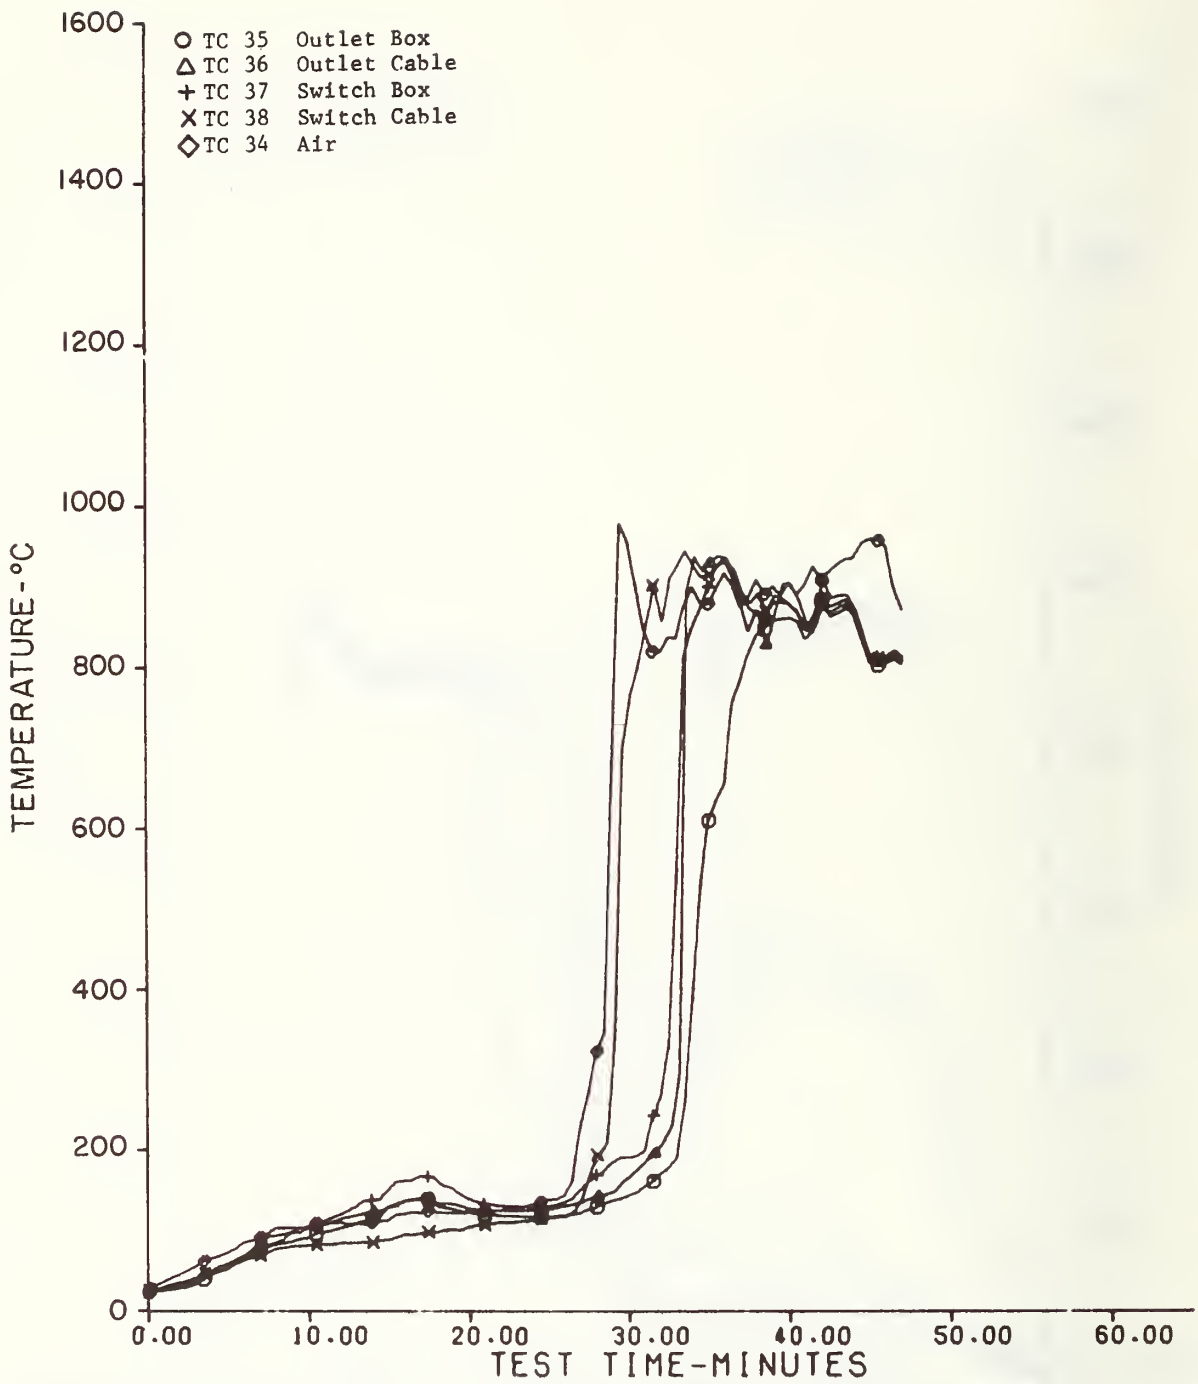
Figure 21. Test FE 1 - Uninsulated wall NM fire side temperatures

The temperatures on both the fire side and room side of the uninsulated half of the wall showed no significant differences between the type NM and the type AC assemblies. The temperatures are shown in figures 21, 22, 23, and 24.

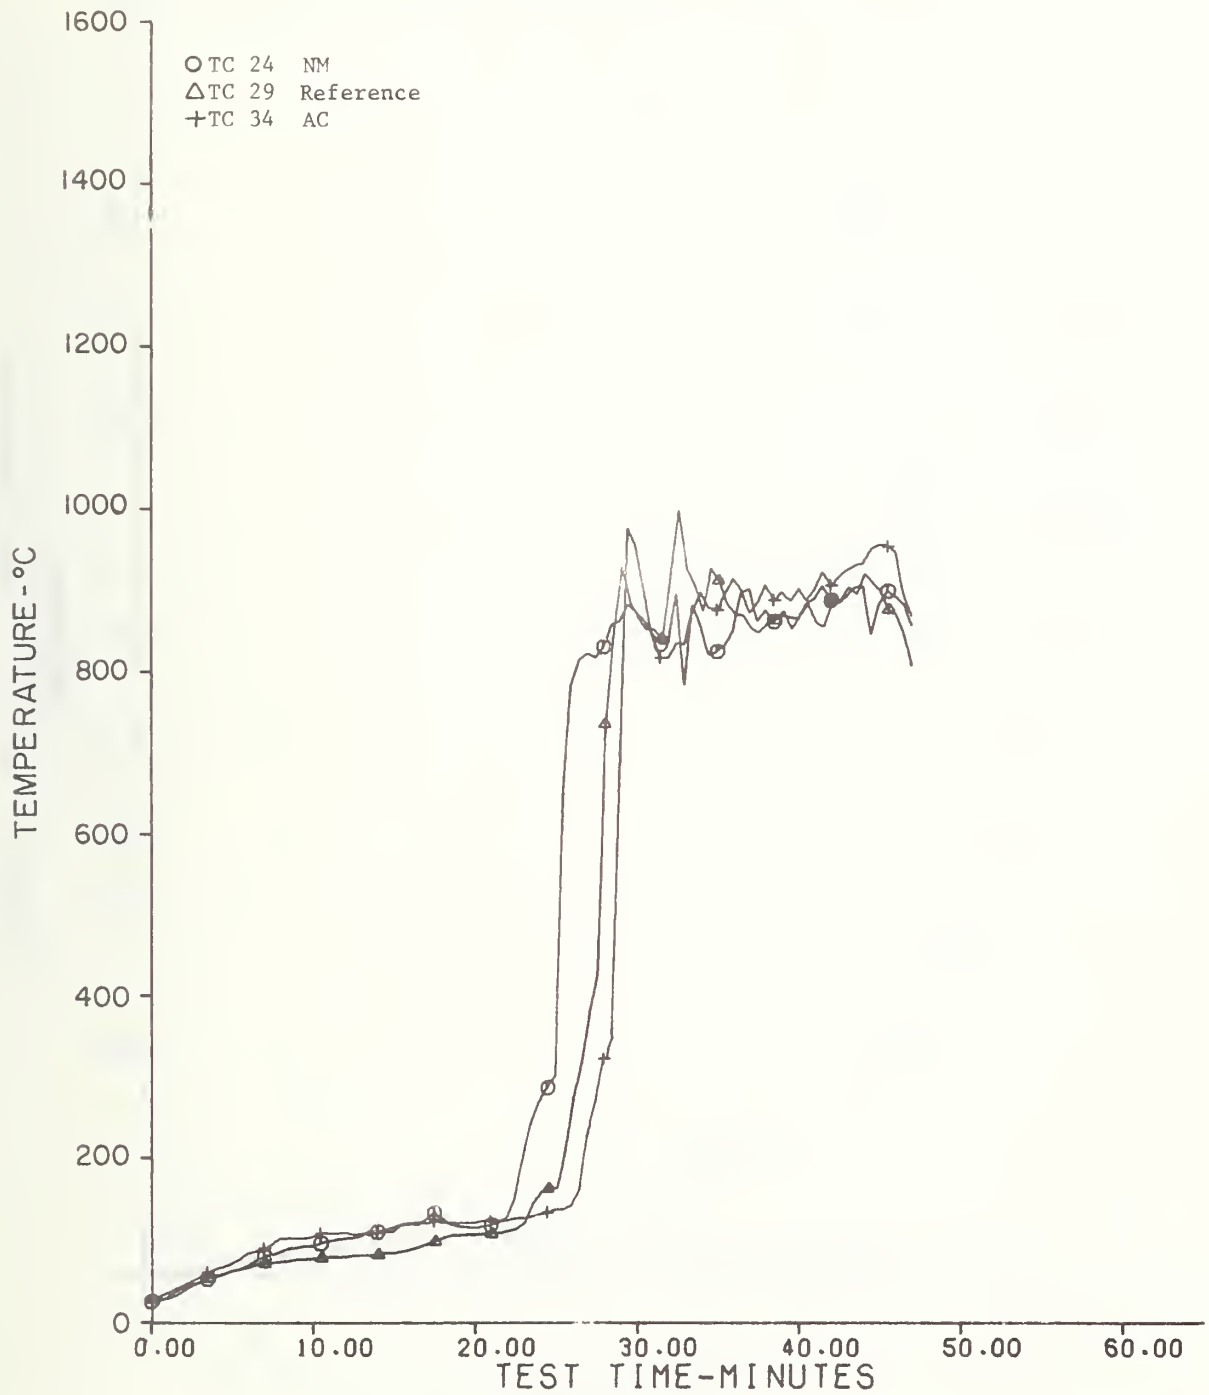
Figure 25. Test FE 1 - Uninsulated wall air space temperatures

The air space temperatures, shown in figure 25, also showed no significant differences between the three stud spaces.

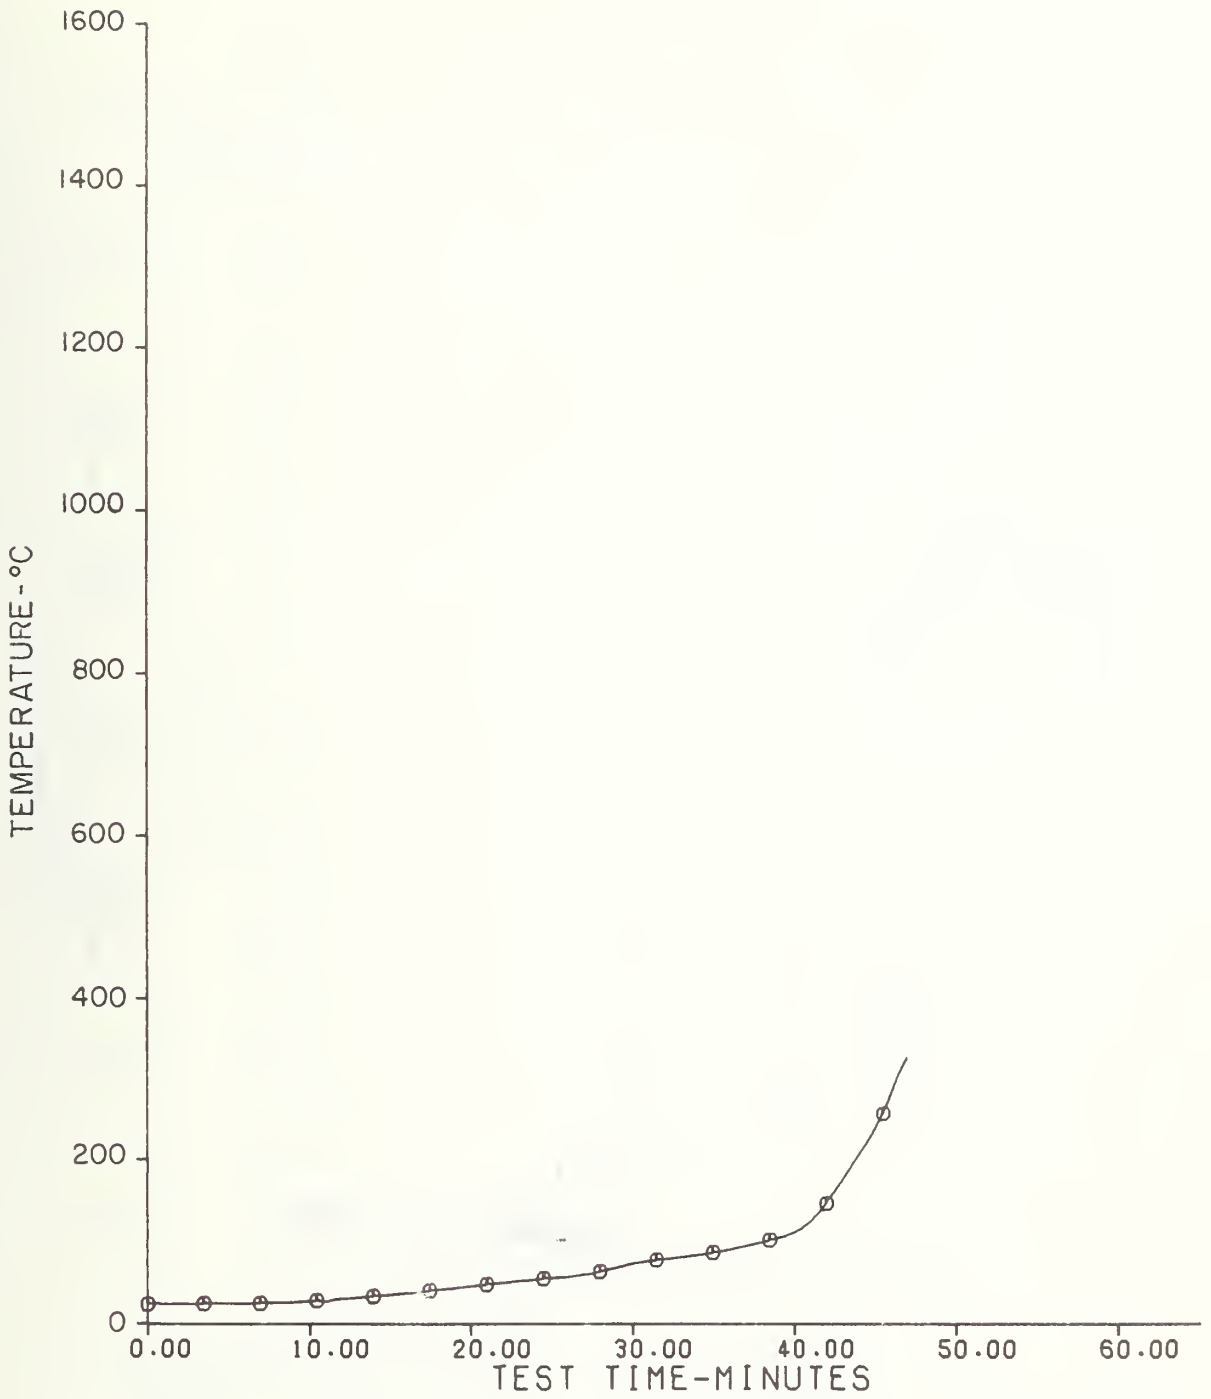
Figure 27. Test FE 1 - Average unexposed surface temperature away from electric fittings

The furnace temperatures, which were controlled to follow the standard ASTM E-119 curve [2], are shown in figure 26. The correction to the fire endurance based on the method given in ASTM E-119 was + 0.7 minute. The average unexposed surface temperature measured by t/cs 39 to 50, away from the switch and outlet boxes, is shown in figure 27.

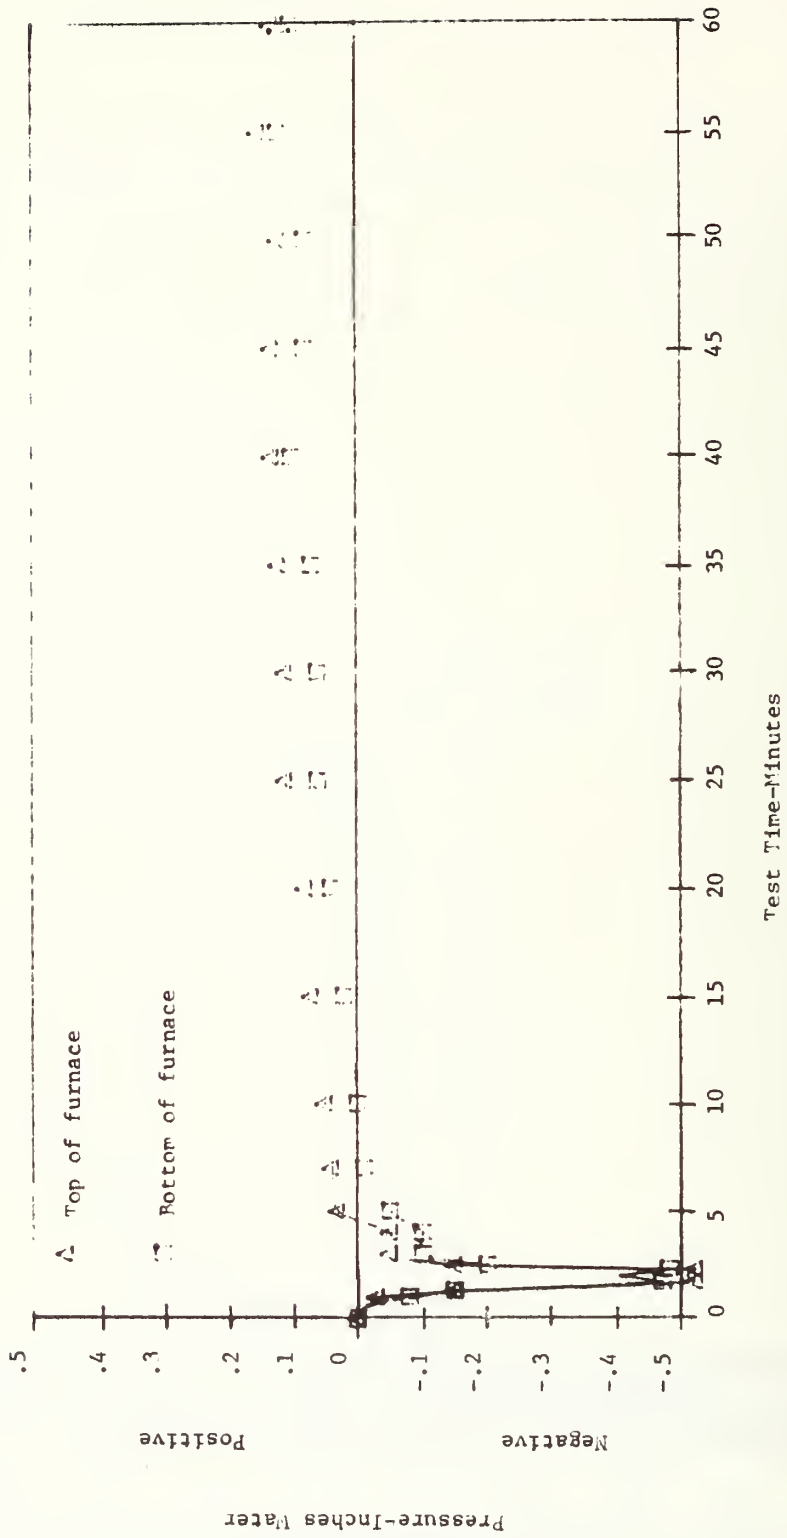
Figure 28. Test FE 2 - Furnace pressure

Prior to this test, the furnace damper control was changed to allow for better control of the furnace pressure than occurred during the first test. The furnace pressures, shown in figure 28, were under better control than in the first test except for the initial 2-1/2 minutes when furnace pressures were unstable. After 10 minutes of test time the average furnace pressure was + 0.09 inch water column.
