NBSIR 78-1415

Fire Endurance Tests of Residential Walls Containing Branch Circuit Wiring - Preliminary Findings

Lionel A. Issen

February 1978

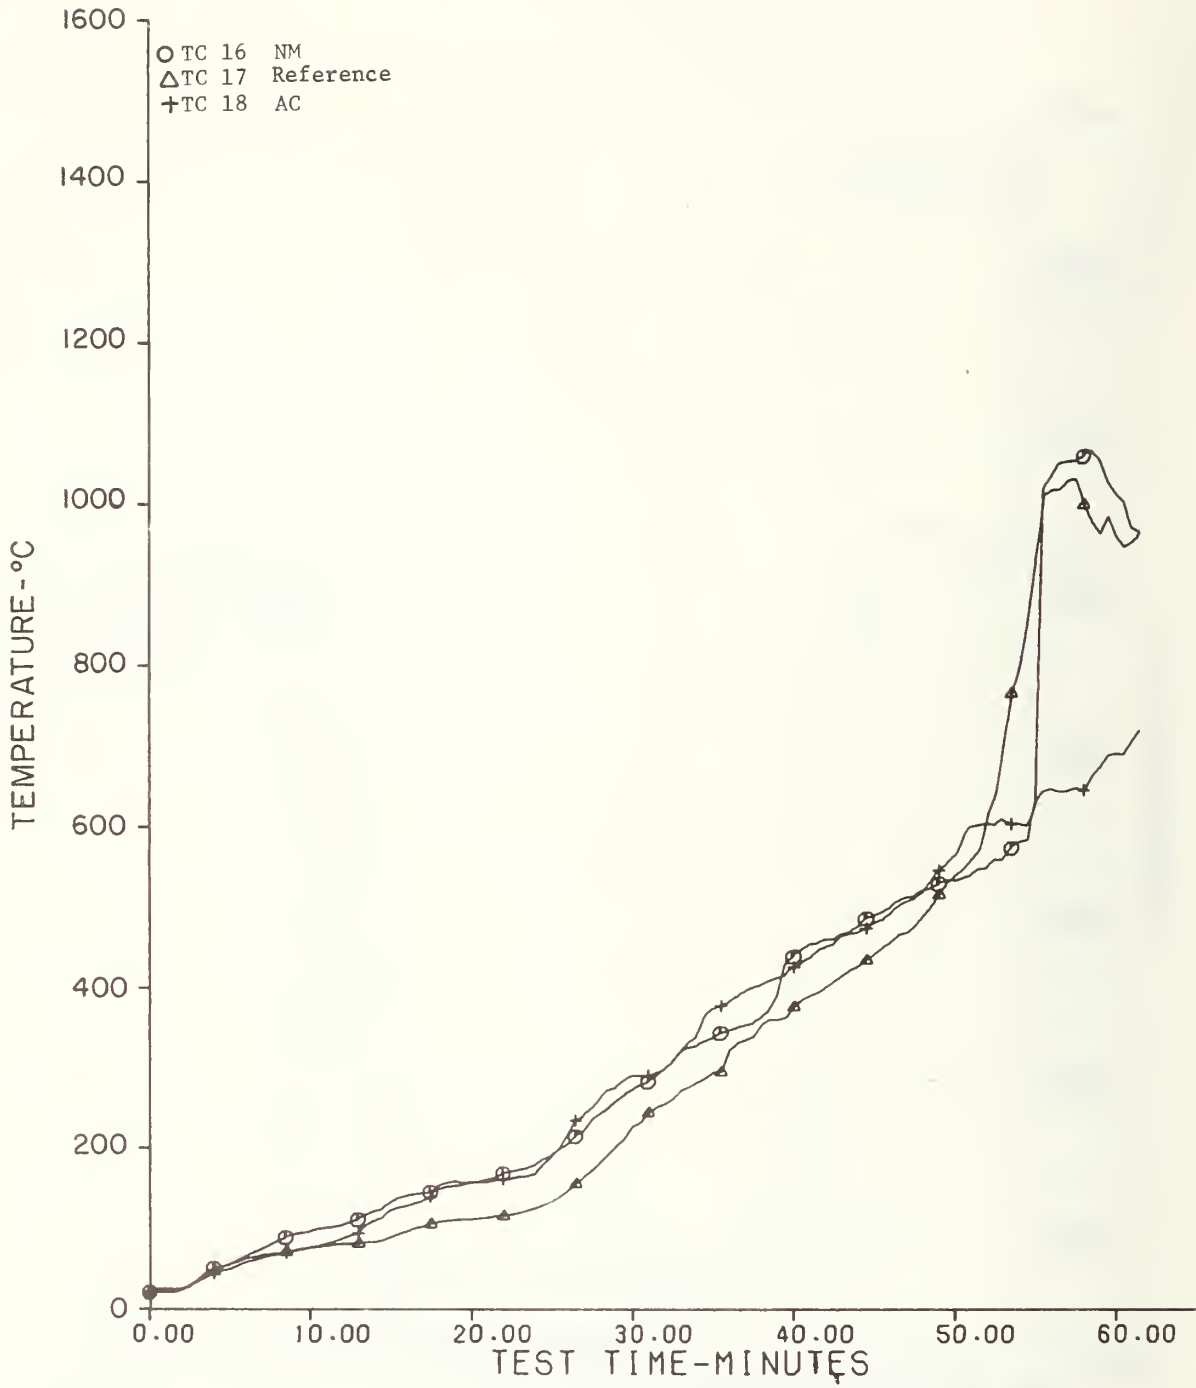
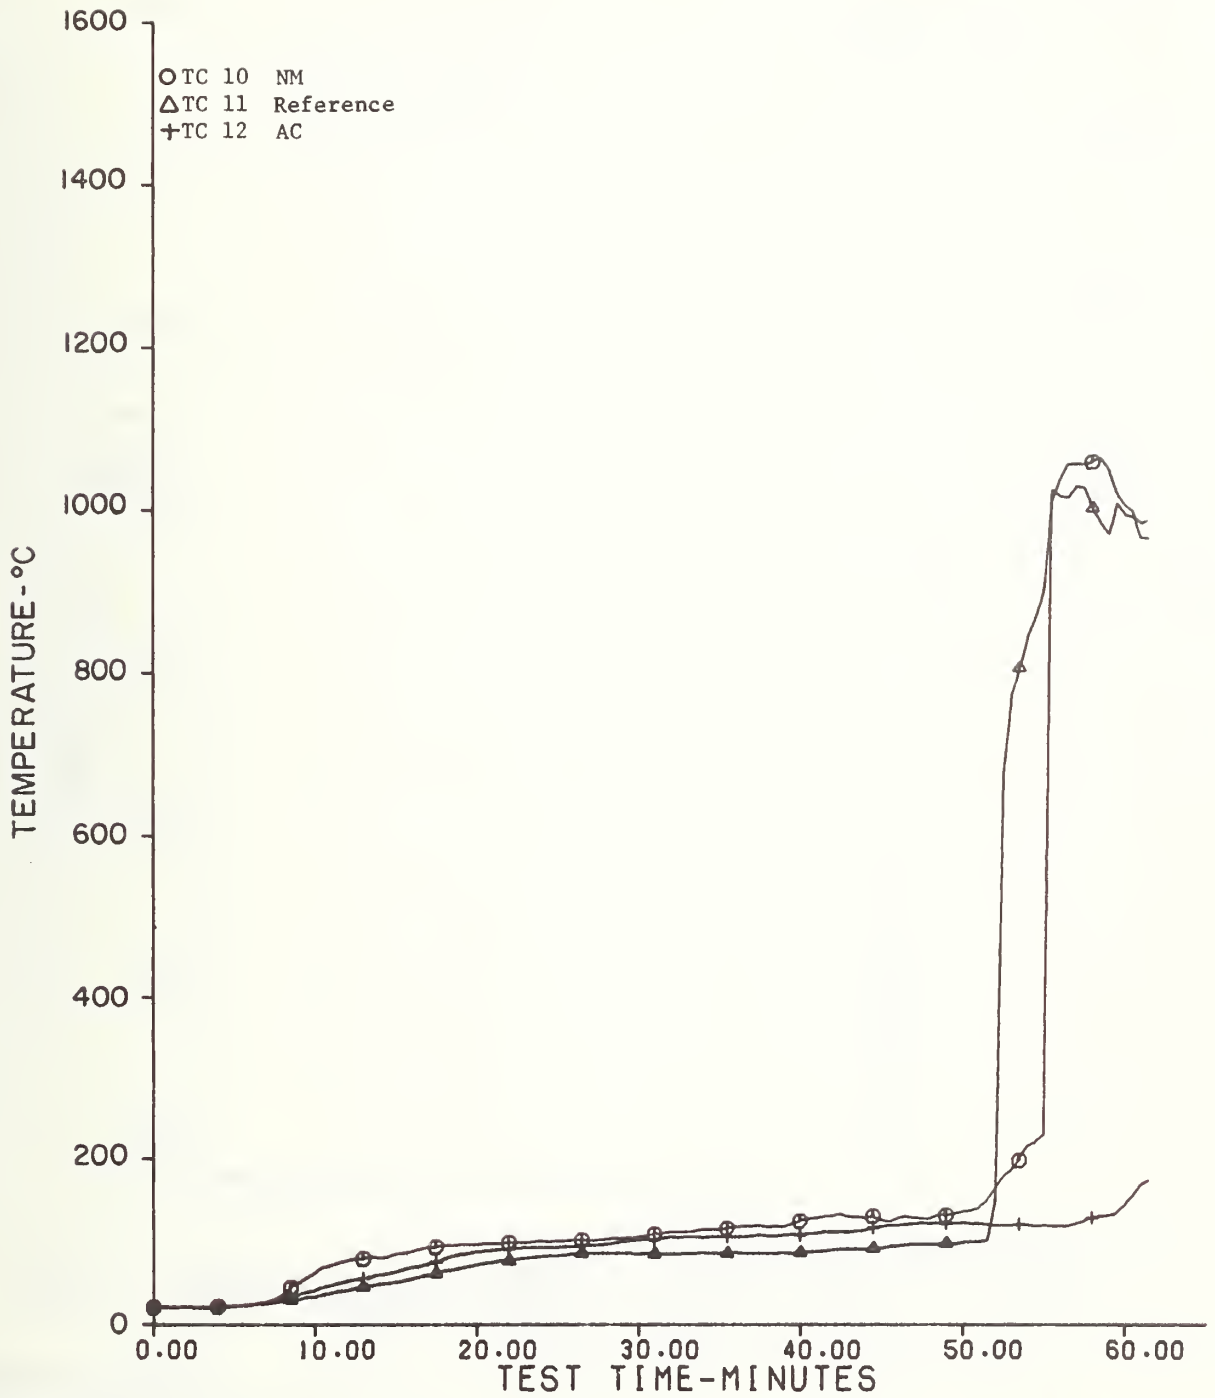
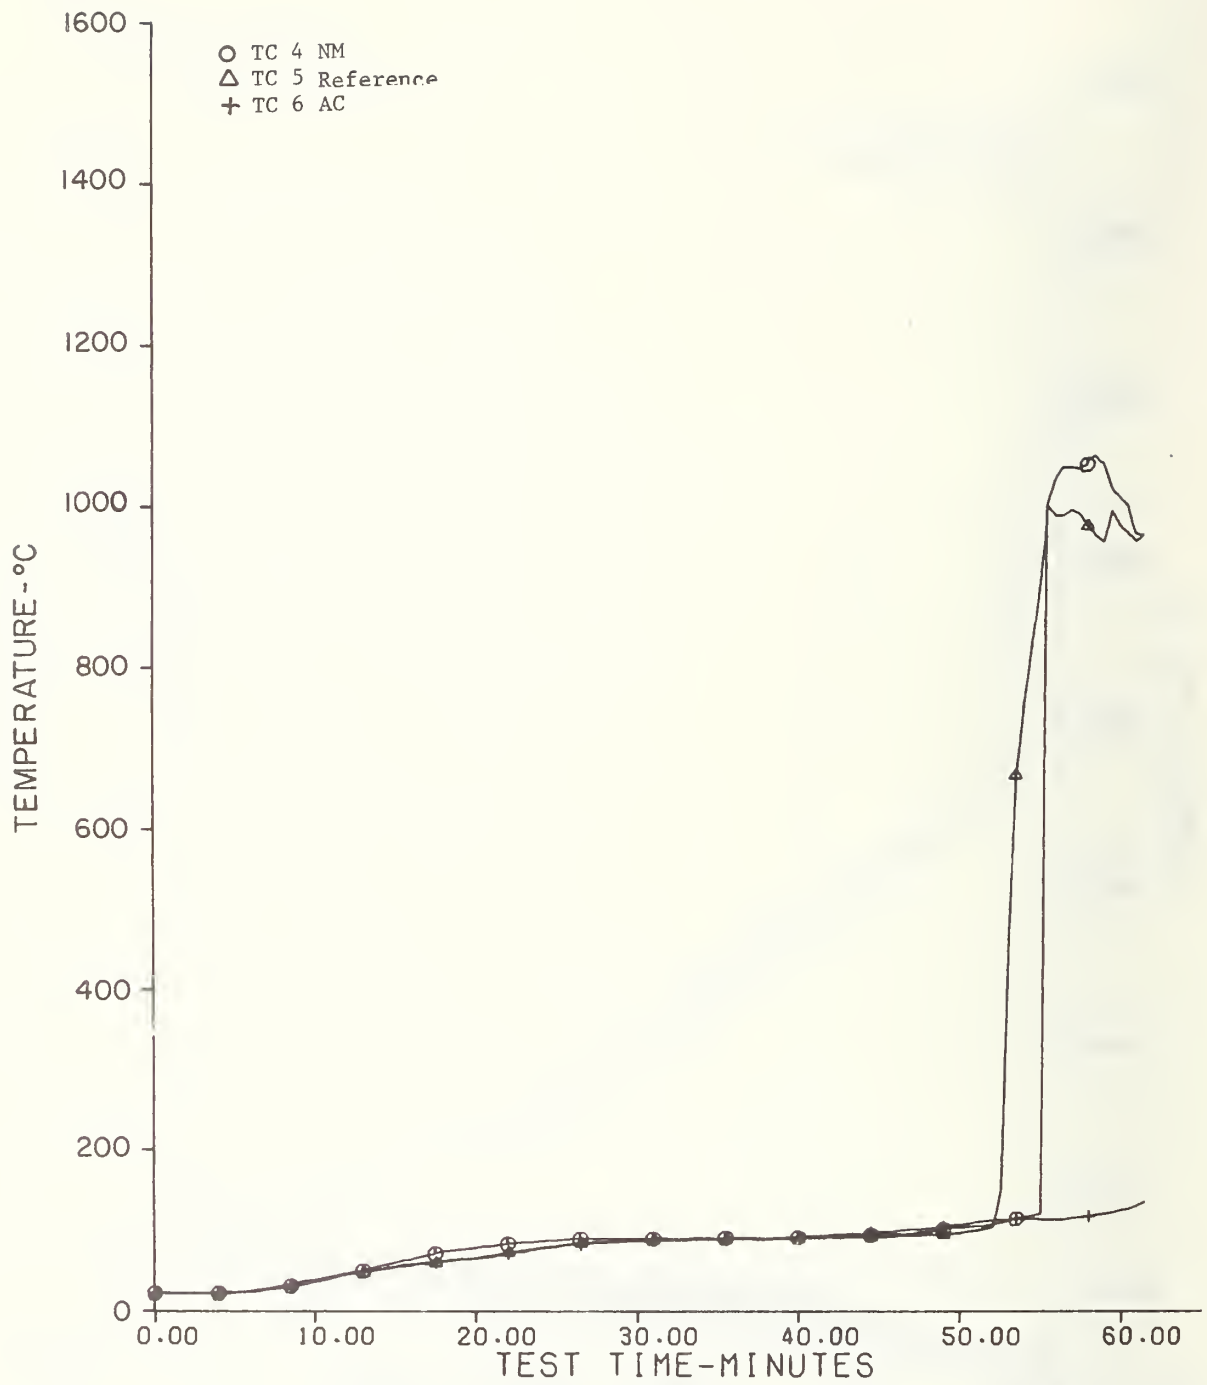
Figure 32. Test FE 2 - Air temperatures lower uninsulated wall

In a general way the air temperatures which are shown in figures 32, 33, and 34 in the uninsulated wall were similar to those in the insulated wall, except that the fire side appeared to fail after about 52 minutes of test. The temperatures in the AC space rose only moderately. This may be due in part to local conditions in the furnace during the test and to the manner in which the wall failed.

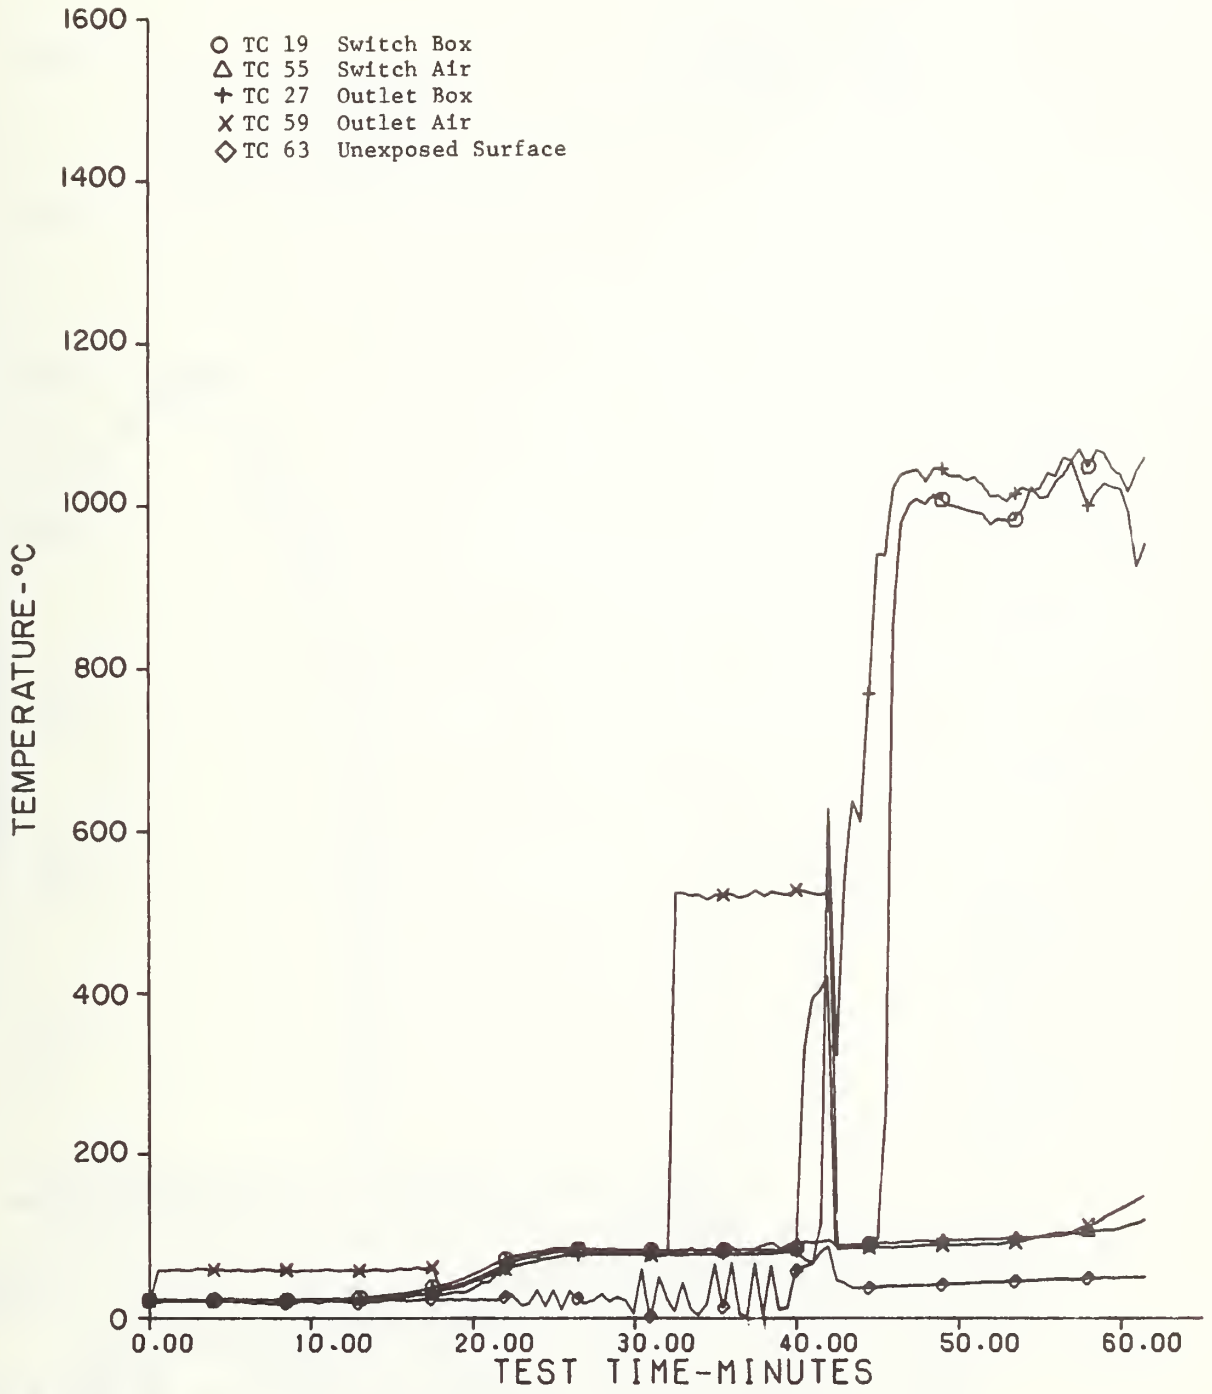
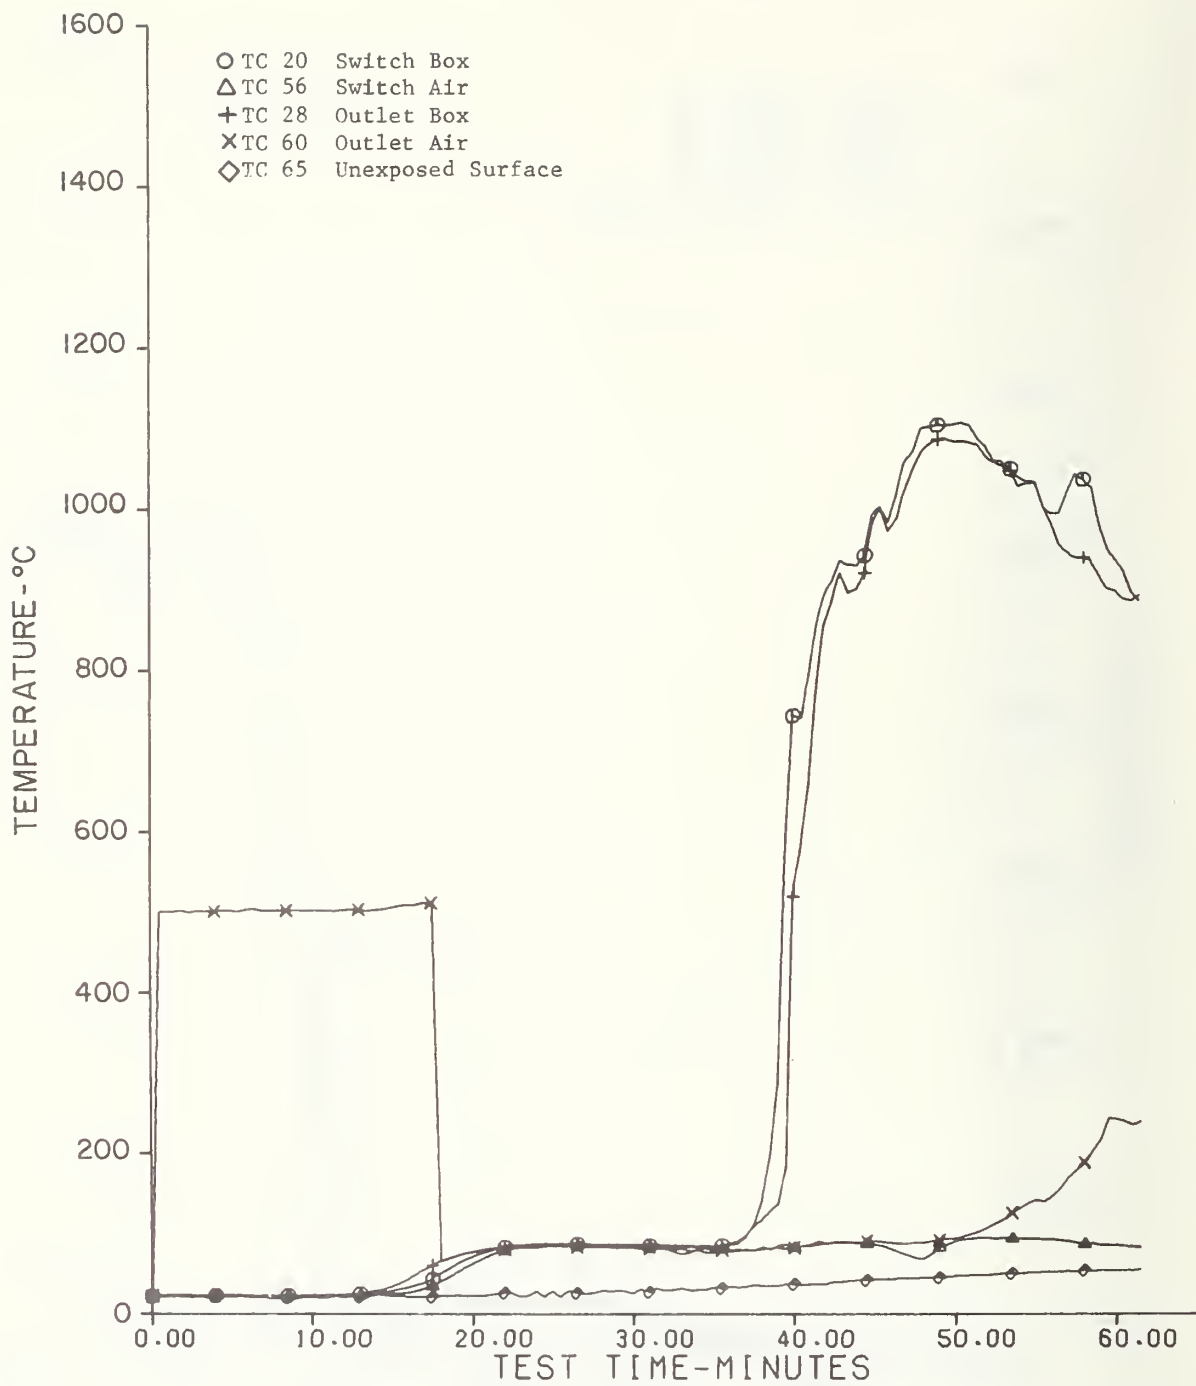
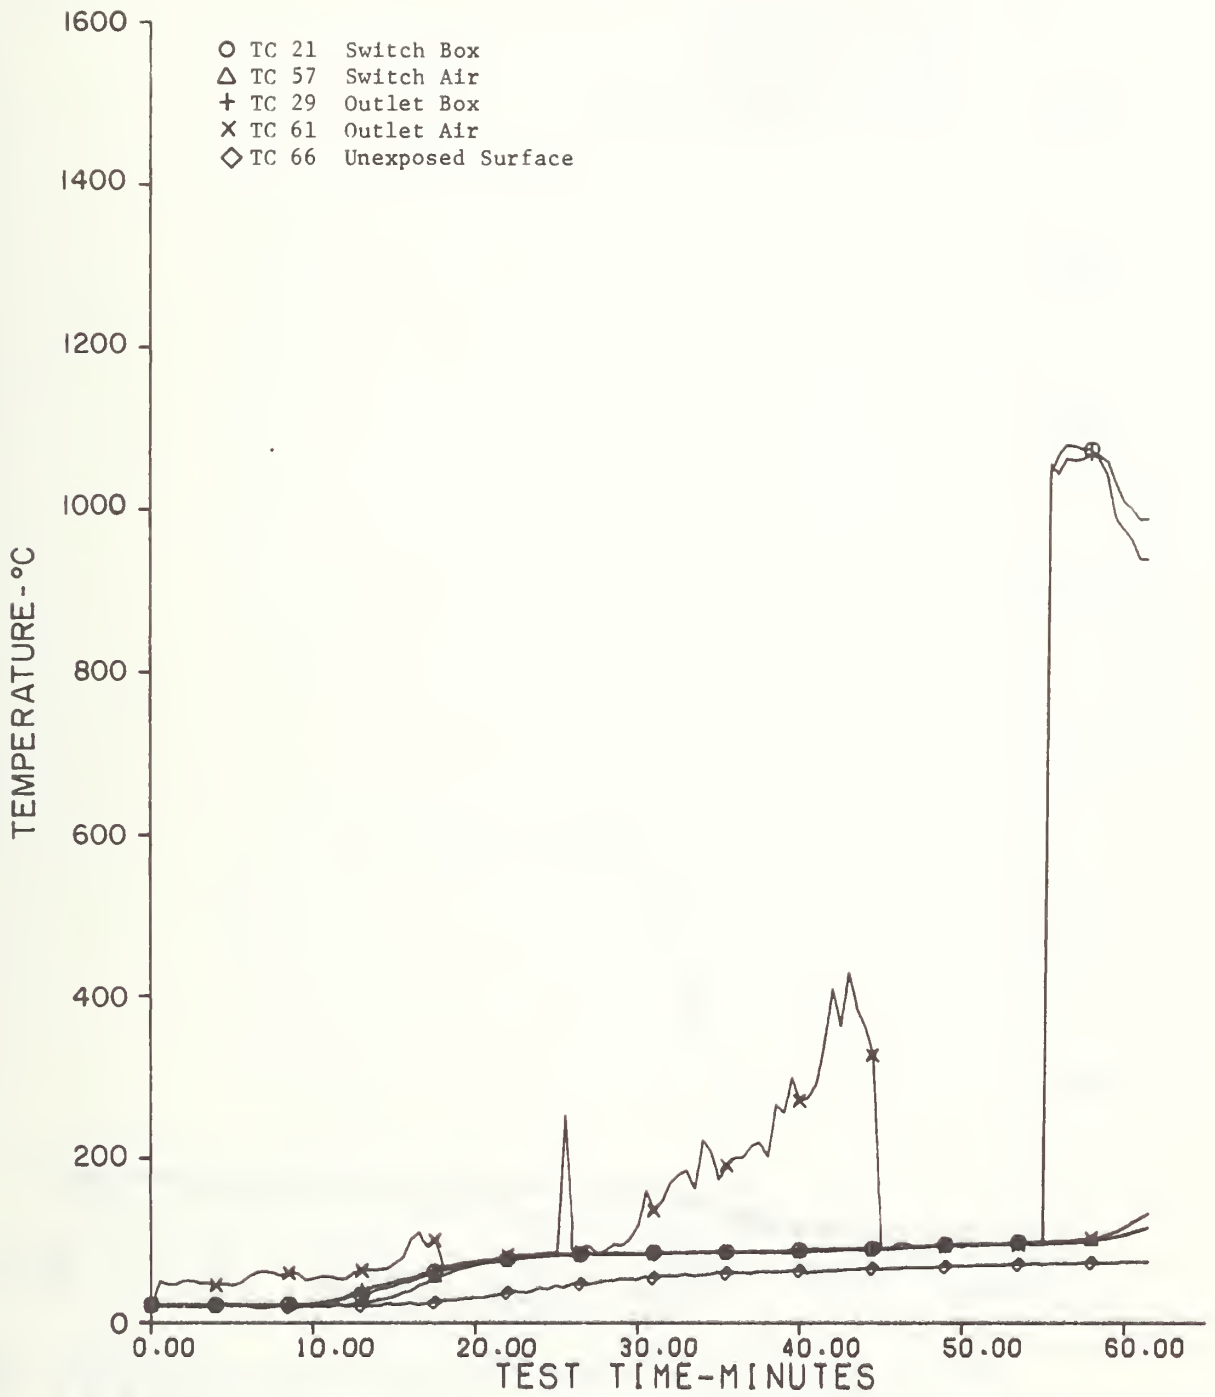
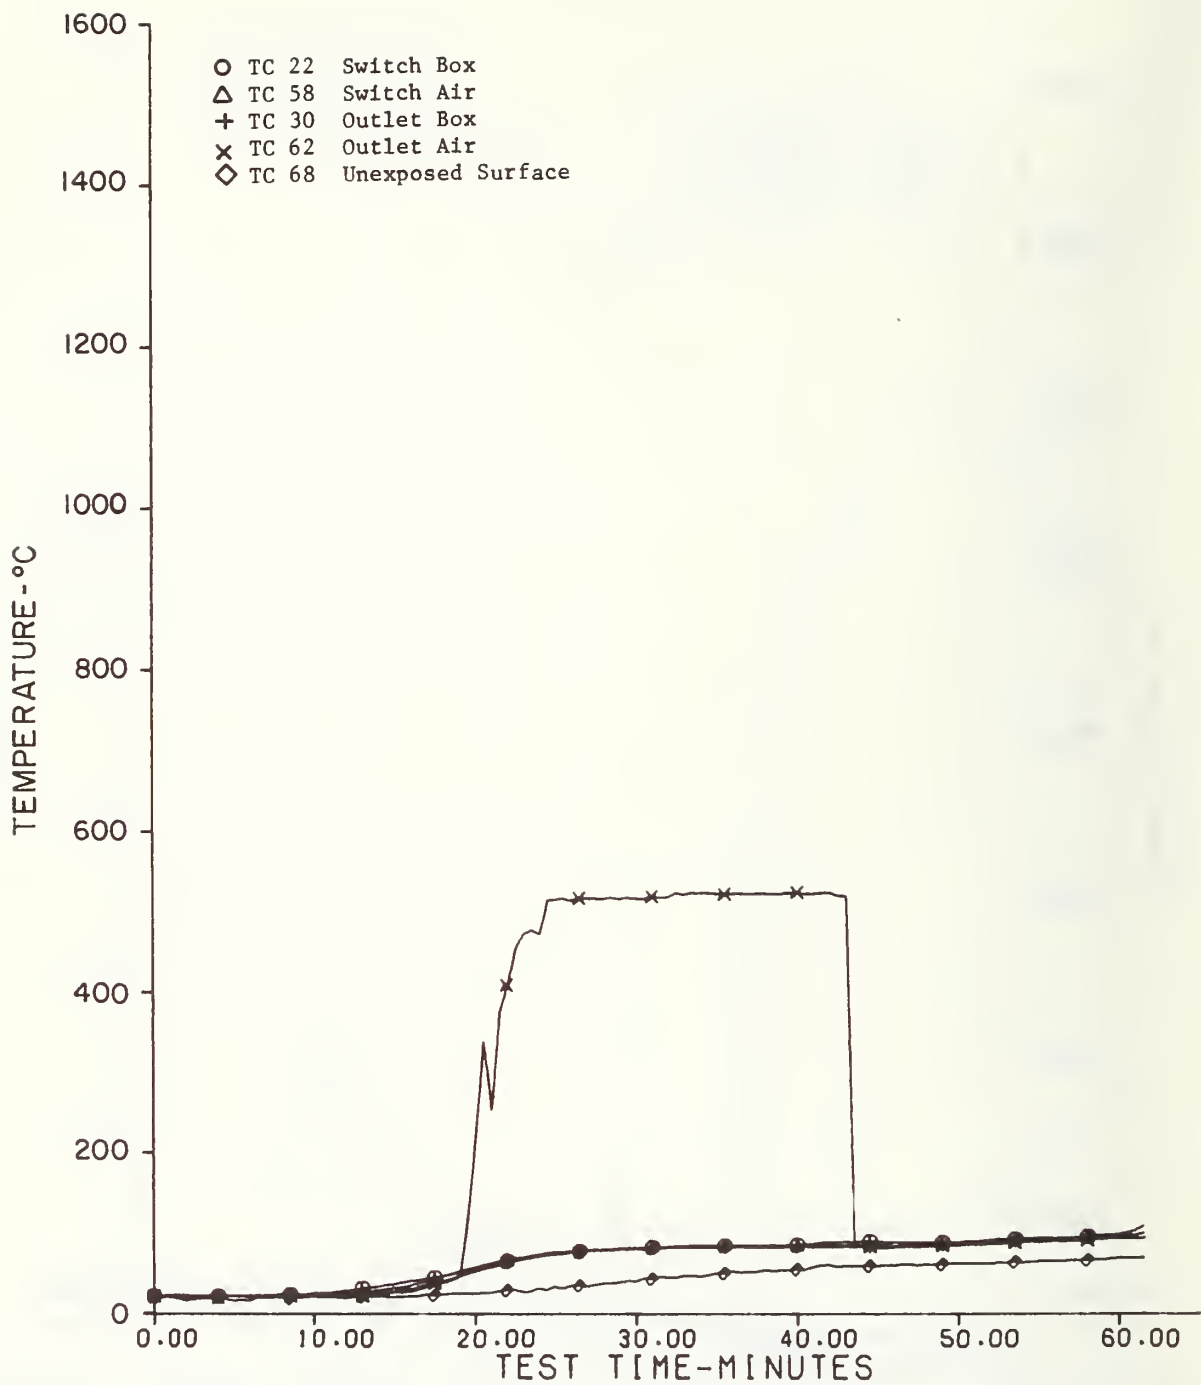
Figure 35. Test FE 2 - NM insulated upper wall room side temperatures

For both the insulated and uninsulated halves of the wall, the temperatures marked "outlet air" (t/cs 59, 60, 61, and 62 on figures 35, 36, 37, and 38 respectively) were erratic and should be ignored.

The outlet box temperatures, outlet box air temperatures and neighborhood ASTM surface temperatures on the room side of the upper wall are shown in figures 35, 36, 37 and 38. In general, the temperatures of the floor space and upper space air and cables were related to the deterioration of the wall during the test.

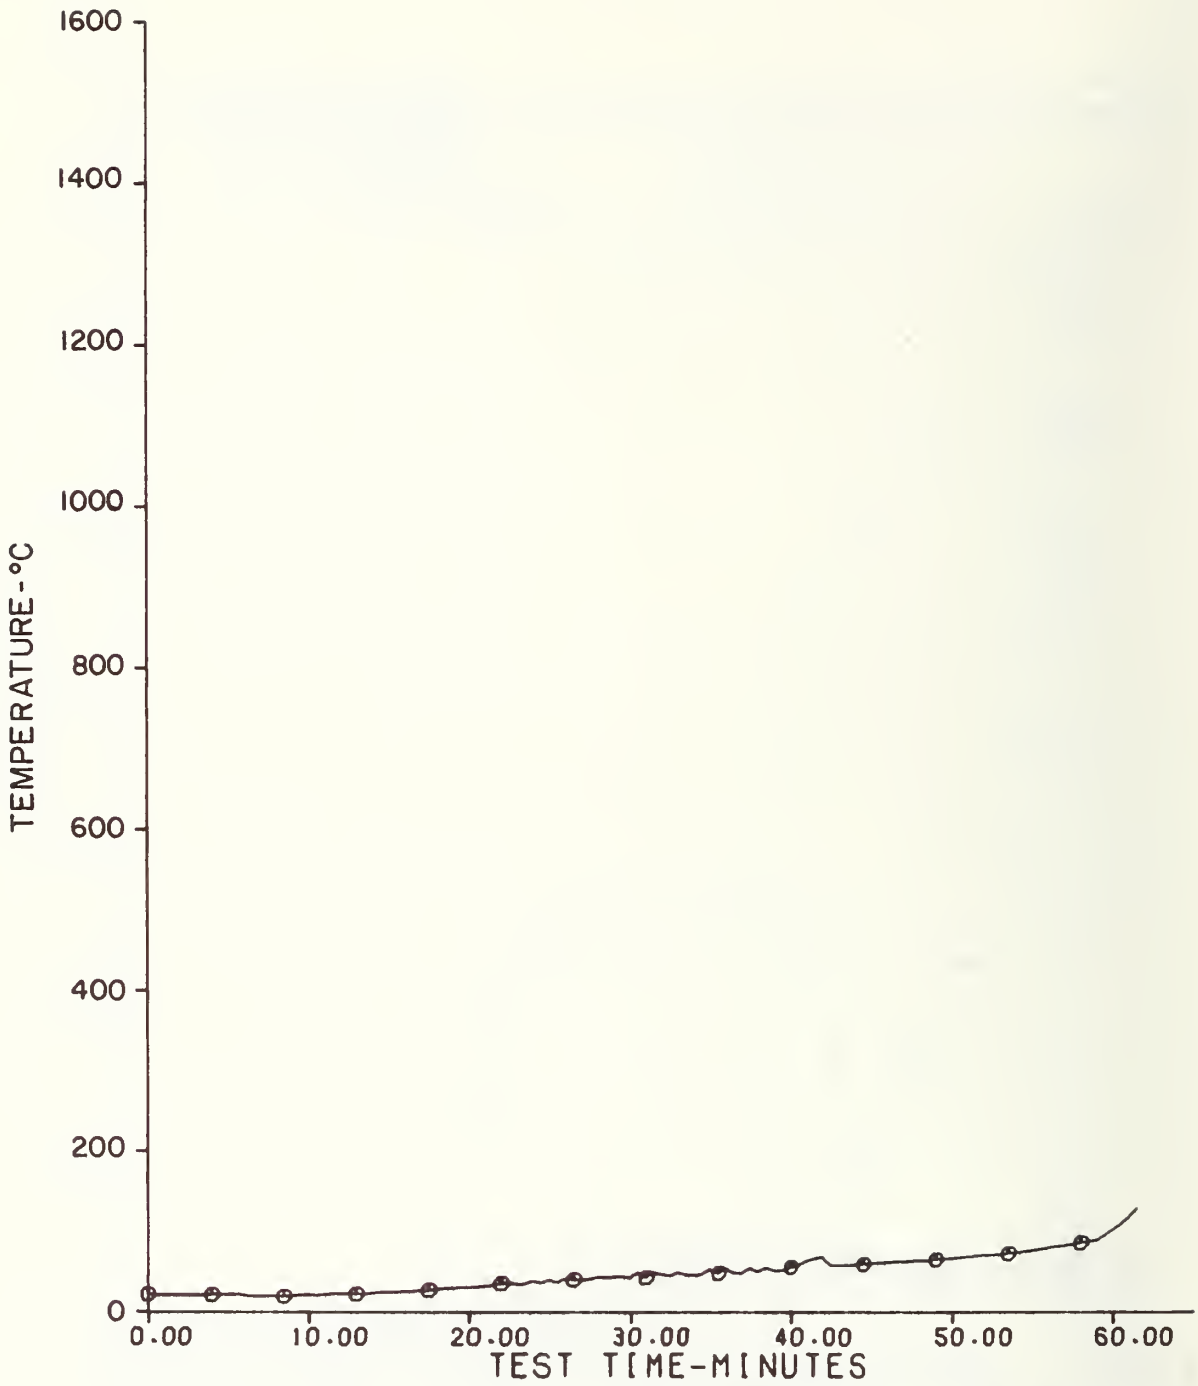
Figure 40. Test FE 2 - Average unexposed surface temperatures

The average surface temperatures (t/cs 63 to 74) away from the electric boxes are shown in figure 40.

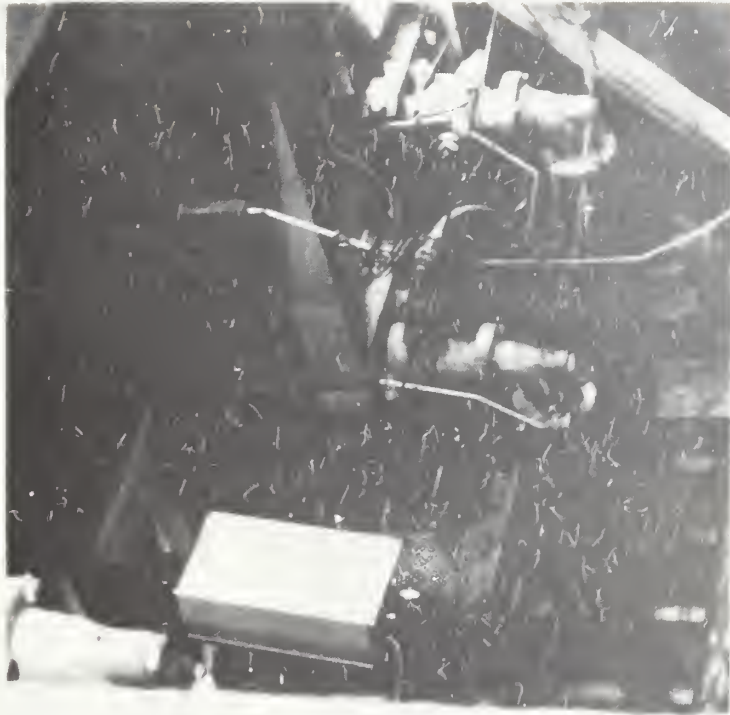
Figure 41. Test FE 2 - Mounted TV camera

In this test, a TV camera was installed to make a video tape of the exposed wall surface during the test. However, because of the high thermal flux radiated through the observation window it was necessary to remove the camera at 24 minutes. A simple compact technique of protecting the TV camera from the furnace heat needs to be developed before it can be used effectively to monitor the furnace conditions during a fire test. A picture of the mounted TV camera is shown in figure 41.
