# **Analysis of the Pneumatic Burst of a Large Seamless Steel Pressure Vessel in Natural Gas Service**

**U.S. DEPARTMENT OF TRANSPORTATION  
MATERIALS TRANSPORTATION BUREAU  
Office of Hazardous Materials Regulations  
Washington, D.C. 20590**

NBSIR 78-1589

Failure Analysis Report

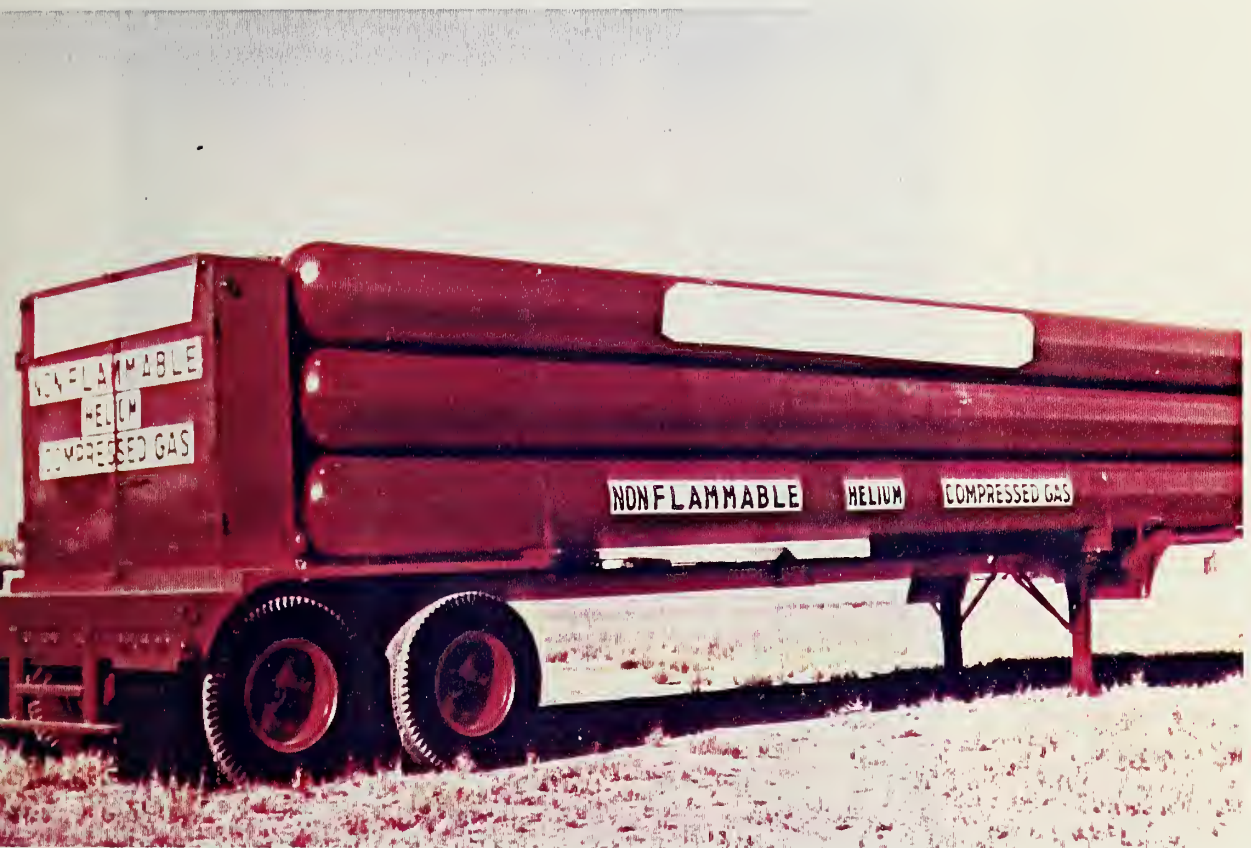
Figure 4. Intact tube trailer composed of specification DOT 3T cylinders. The array of cylinders on the trailer is 3-high by 4-wide. (Photo courtesy of Mr. W. Piehl, Western Sales and Testing, Inc., Amarillo, Texas.)

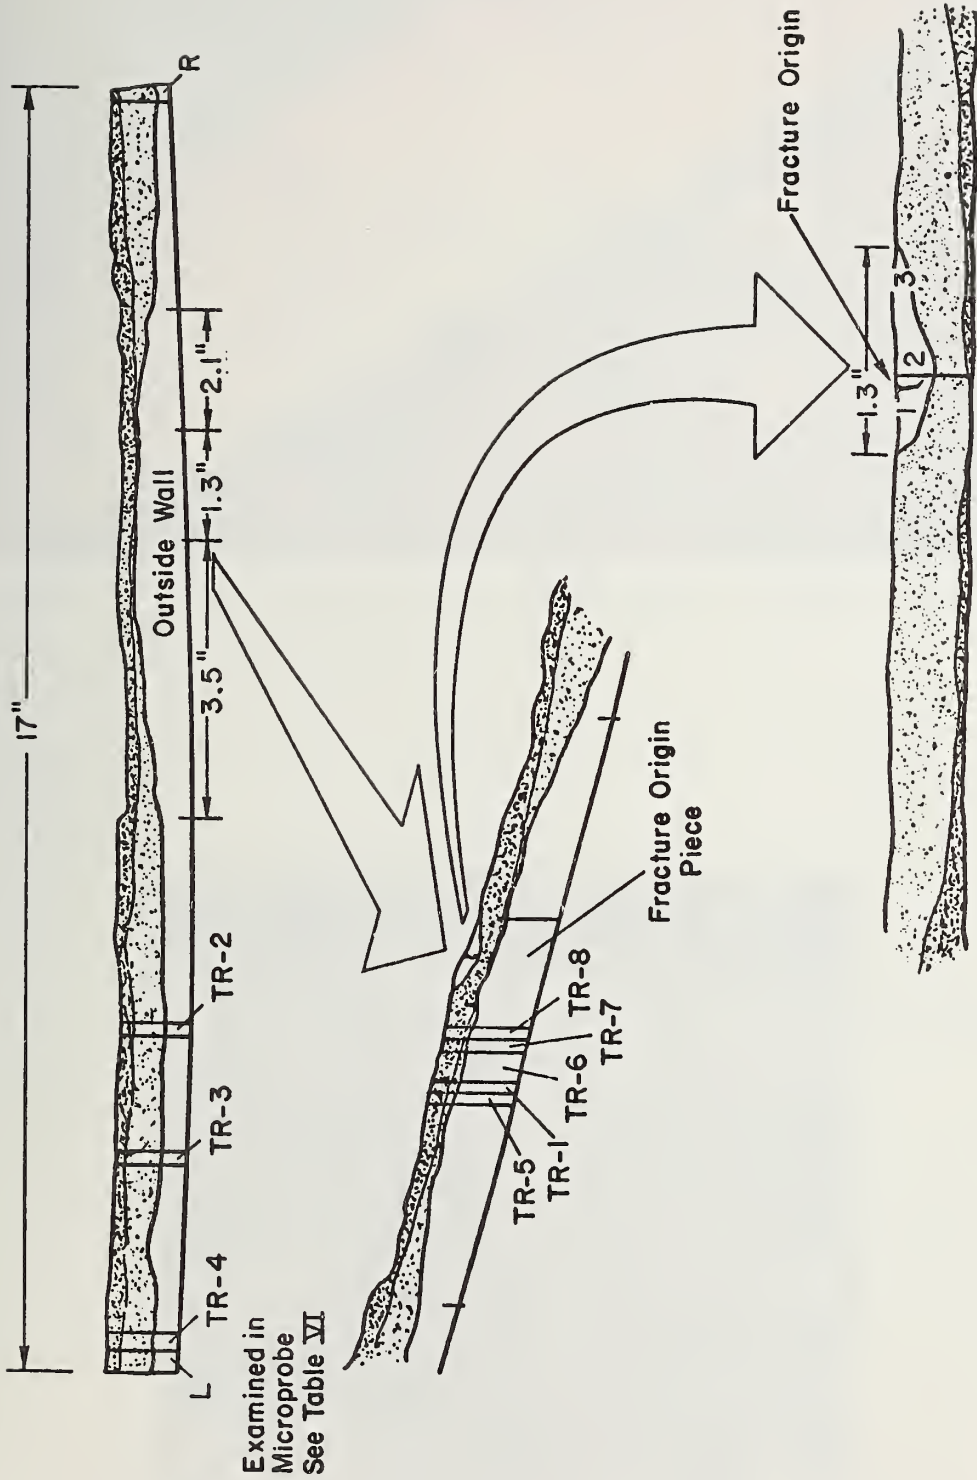
Examined in  
Microprobe  
See Table VI

Figure 7c. Artist's drawing of the segment containing the fracture origin. Transverse sections cut from this segment are labeled "TR-1" through "TR-8".

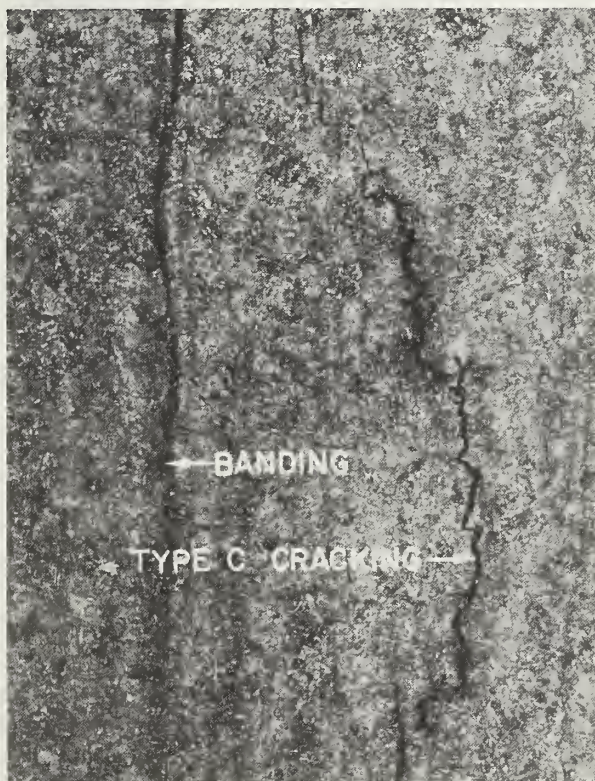
Figure 14. Banding near inside wall detected in transverse section taken from a ring cut near the front head of cylinder 10041.

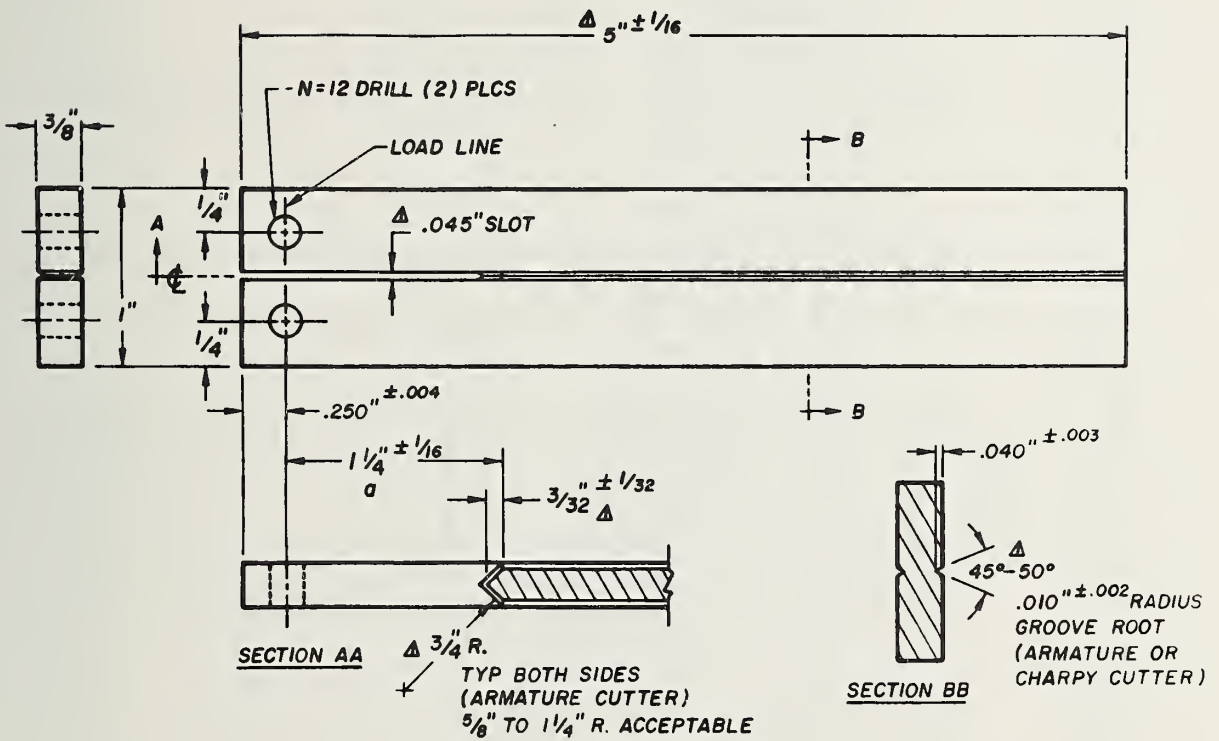
A wedge-loaded double cantilever beam test specimen was used, Fig. 26. Specimen thickness was 0.375-inches, which fulfills the requirement in ASTM E399-75<sup>15a</sup> for a valid plane strain test for stress intensities up to 50 ksi $\sqrt{\text{in.}}$ . The specimens were cut from the ring section such that the long axis of the specimen was parallel to the longitudinal axis of the cylinder. The axis of the crack was perpendicular to the wall thickness, so that the crack grew longitudinally. This orientation was selected to approximate the growth of the type L cracks discussed in Section 4.3.

Figure 26. Diagram of the double cantilever beam test specimen used for  $K_{ISCC}$  testing.

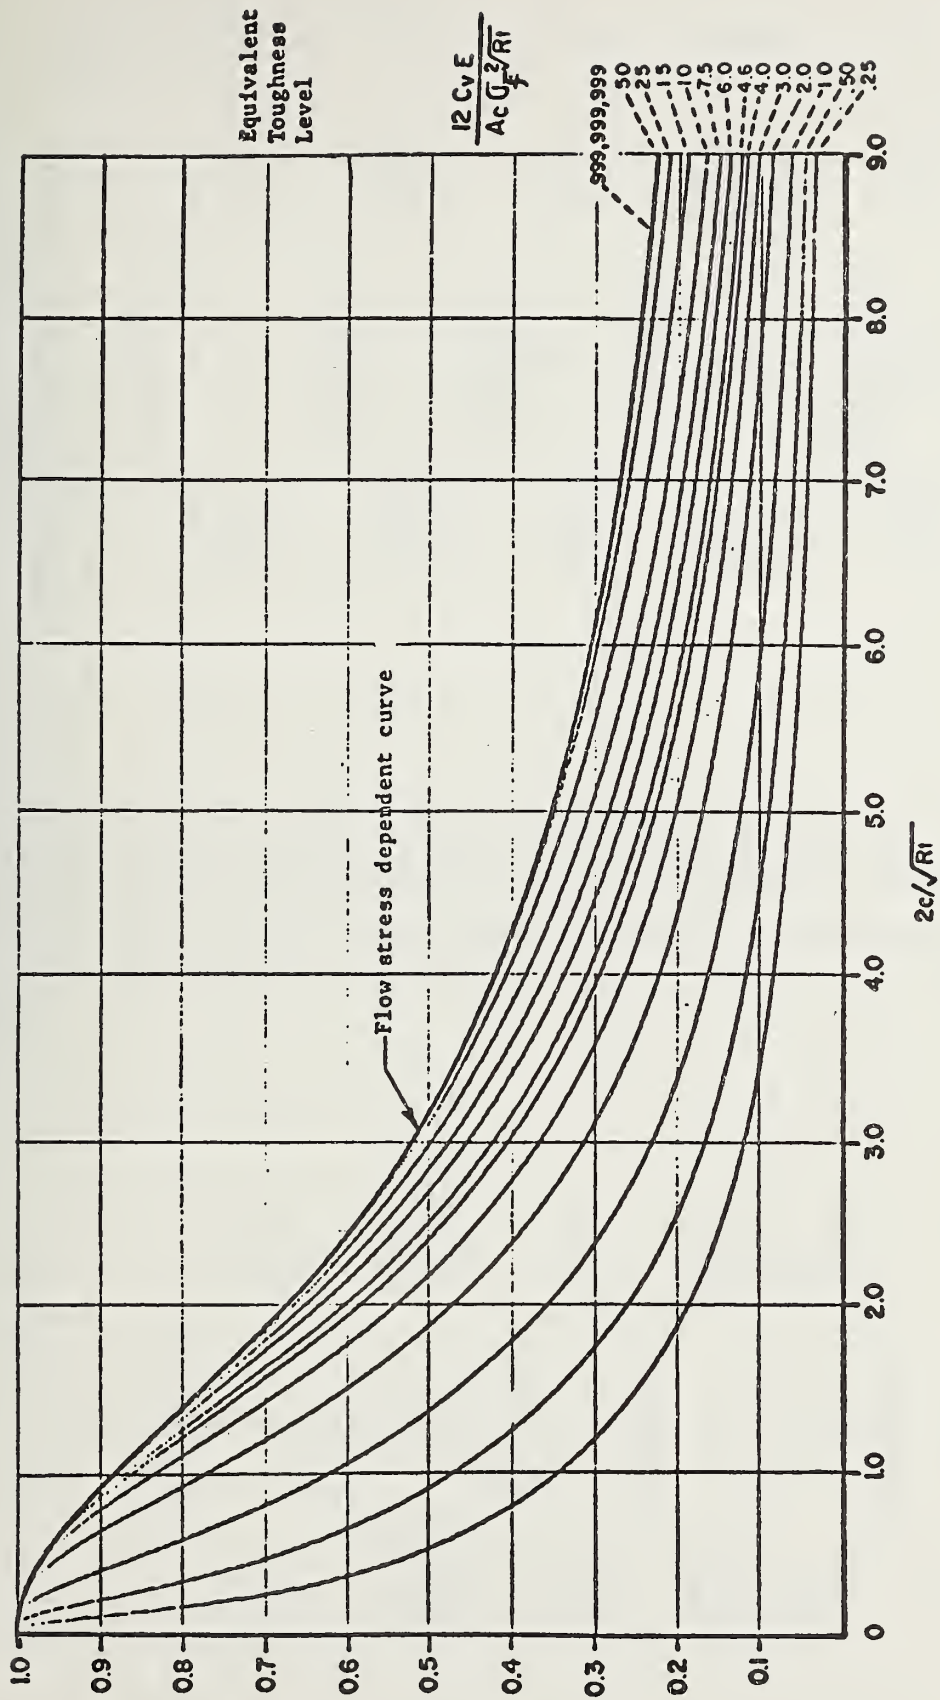
Suitable analysis of equations 4 and 5 leads to the family of parametric curves plotted in Figure 27. Taking the energy for a full-size transverse Charpy specimen from near the fracture origin as 10 foot-pounds

from Table IV, and the yield strength for a transverse tensile specimen from near the fracture origin as 128 ksi from Table III gives a value for the toughness parameter on the right hand side of Figure 27 of

From these two parameters, 0.68 and 0.40, a point can be located on Figure 27 as shown, thus leading to an estimate of  $\frac{2c}{\sqrt{RT}} = 1.4$ . This gives a value for the critical crack length of  $2c = 1.4 \sqrt{(11)(1/2)} = 3.3$ -inches. Reference to Figure 7a indicates that the transition from flat fracture to slant fracture began when the flat region was about 3-inches long. Hence, the empirical analysis formulated by Maxey and co-workers<sup>26-28</sup> predicts a result which is consistent with the observations. It may be concluded that the sidewall opened up via a flat fracture which became slant fracture after a short extension. The time frame for the extension of the flat fracture is uncertain. It may have been a few milliseconds or even a few seconds.

Figure 27. Through wall flaw size-toughness relationship for cylindrical pressure vessels. (Diagram courtesy of W. Maxey of Battelle Memorial Institute, Columbus, Ohio.)
