NBSIR 81-2326

Investigation of Solar Collector Fire Incident

August 1981

William D. Walton

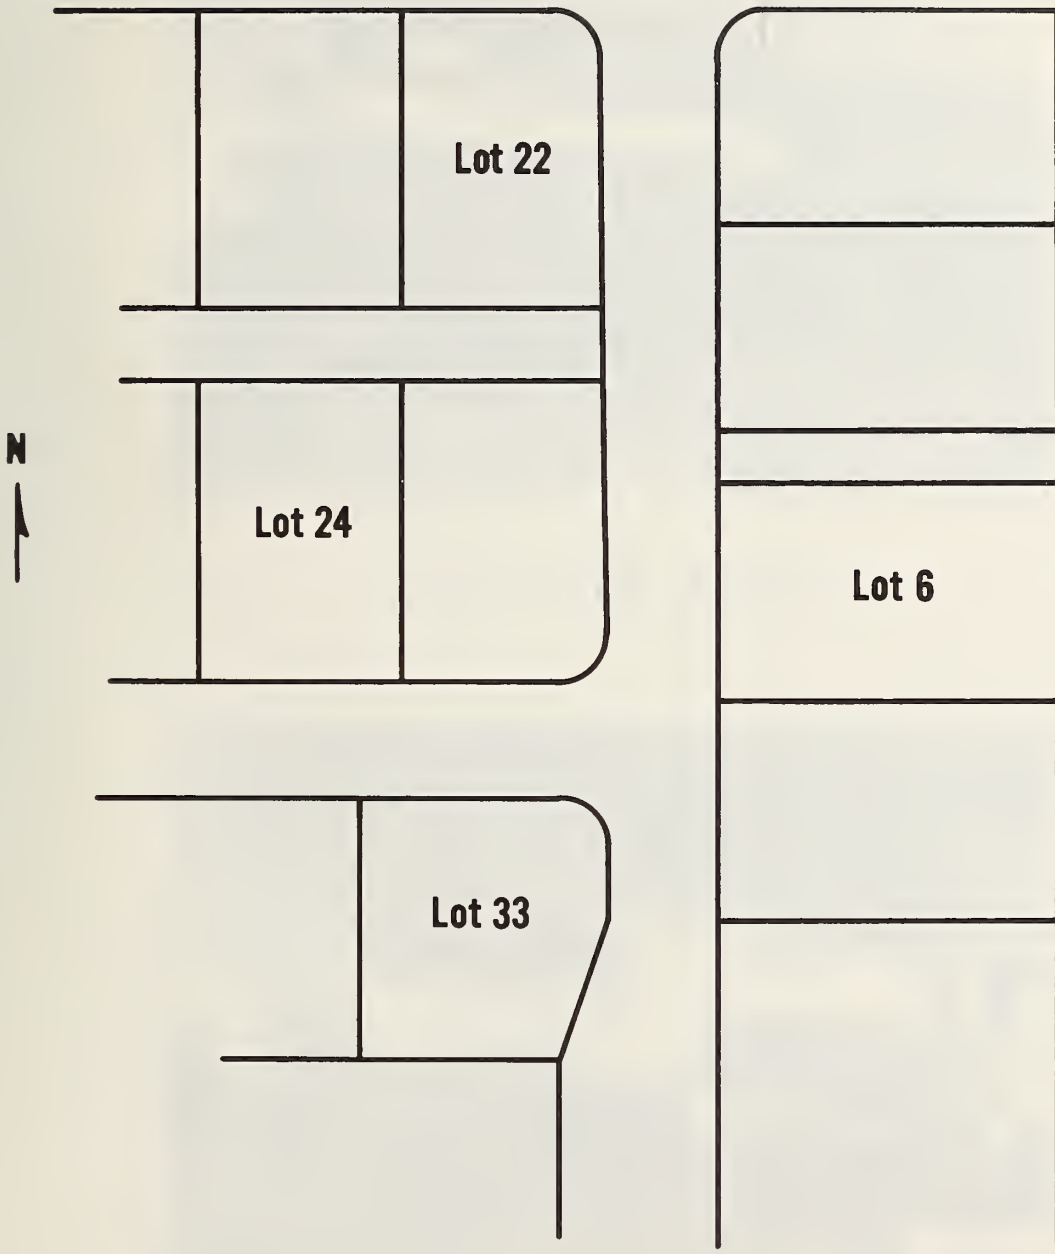
Figure 1. Site Plan

Four houses utilizing identical solar collectors from the same manufacturer are located in a housing development in Boulder, Colorado. The houses are of new (1979-1980) construction, each of a different design, all located within approximately one block of each other. Figure 1 shows the layout of the site. The houses on which the collectors were mounted are located on lots 6, 22, 24, and 33. Figures 2 - 5 show the location of the collectors on the houses on lots 6, 22, 24, and 33, respectively, as of early July 1980. (Note: the glazing on the collectors was painted white after the fire to reduce solar heat gain.) Since that time, all of the original collectors have been replaced with collectors of a different design. All collectors face due south and it can be seen from the figures that the houses on lots 6 and 24 each have 9 collectors and the houses on lots 22 and 33 have 10 collectors each. The house on lot 33 was the site of the fire and the 10 collectors on the house were mounted in two rows of 5. The collectors had been removed and the fire damage to the roof repaired prior to the photograph.

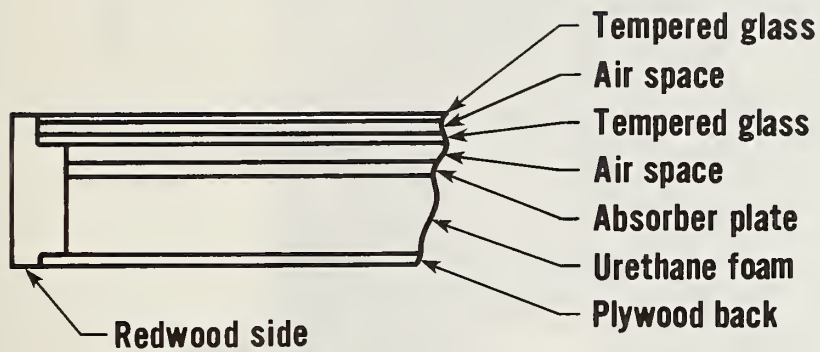
Figure 7. Collector section

The collector is of the flat plate type with overall dimensions of approximately 36 inches (91 cm) wide by 94 inches (239 cm) long by 3-1/2 inches (8.9 cm) thick. The glazing consists of two sheets of tempered glass separated by an air space and the absorber is pressure-bonded copper with a black chrome selective surface. The insulation directly behind the absorber plate consists of approximately 1-5/8 inches (4.4 cm) of factory-applied spray-in-place urethane foam. The back of the collector is 3/8-inch (0.95-cm) exterior grade plywood; the framing is clear heart redwood. A cross section of the collector is shown in figure 7.

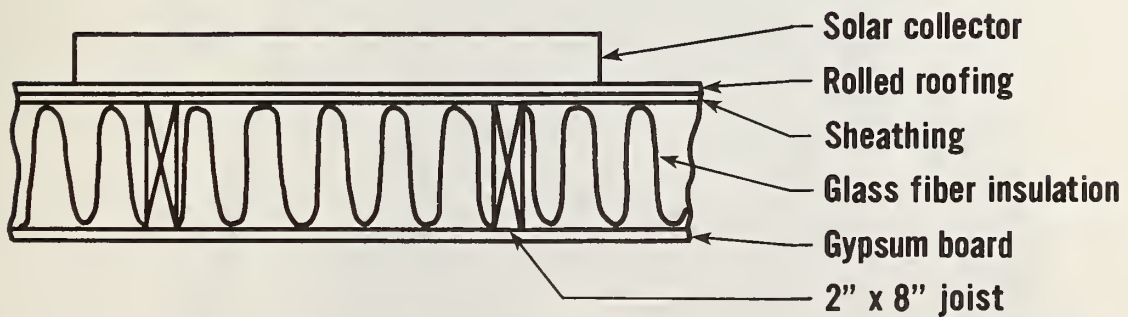
Figure 8. Roof section

Because each house is of a different design, the roof construction and collector mounting varies with each house. All of the collectors on the houses on lots 6 and 33 are mounted on roof decks insulated with 6 inches (15 cm) of kraft paper-faced glass fiber insulation between 2 x 8 inch joists which are 24 inches (61 cm) on center. A layer of gypsum board underneath forms the interior finish of a cathedral type ceiling. A cross section of this assembly is shown in figure 8. Collectors 1 and 6 on lot 22 appear to be mounted over uninsulated roof decks and the remaining collectors on this house over the same type of insulated deck shown in figure 8. All collectors on the house on lot 24 appear to be mounted on an uninsulated roof deck.

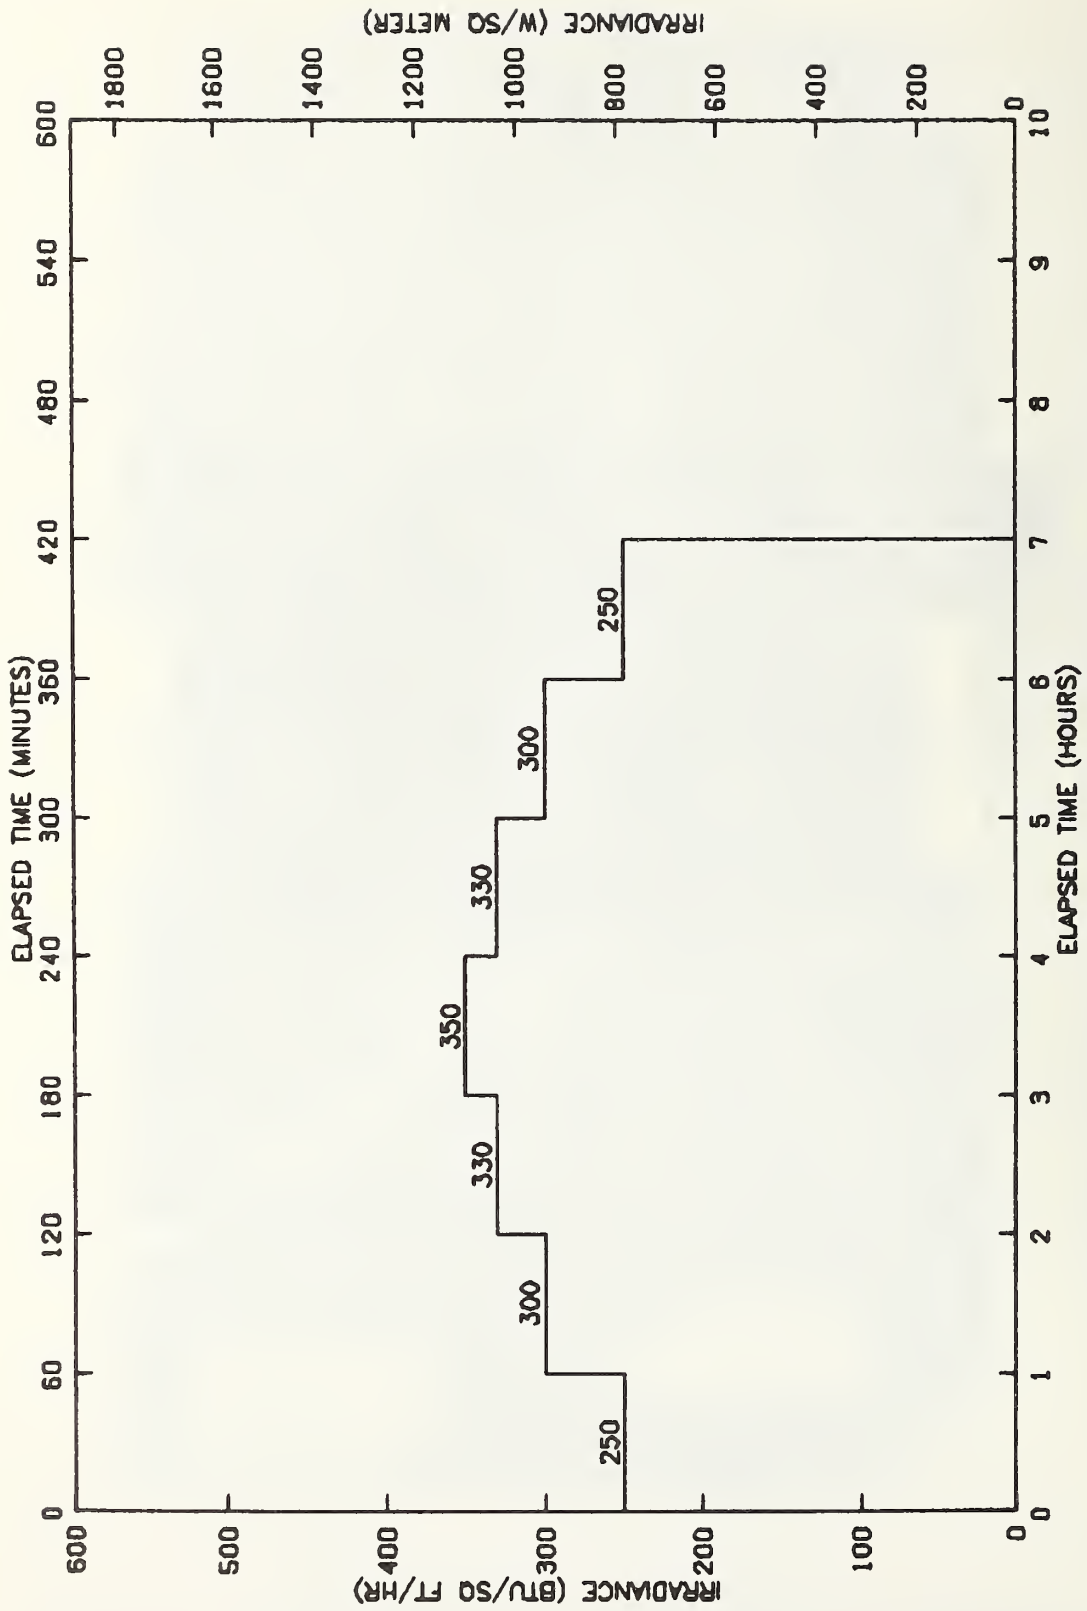
FIGURE 16. SIMULATOR SOLAR IRRADIANCE PROFILE.

Both configurations were tested at a tilt angle of 60 degrees with the radiation normal to the collector surface. The radiation was provided from xenon arc lamps with spectral filters [8]. The solar irradiance profile is shown in figure 16 and the ambient temperature was a constant 85°F (29°C). This profile was selected to represent a typical good solar day.

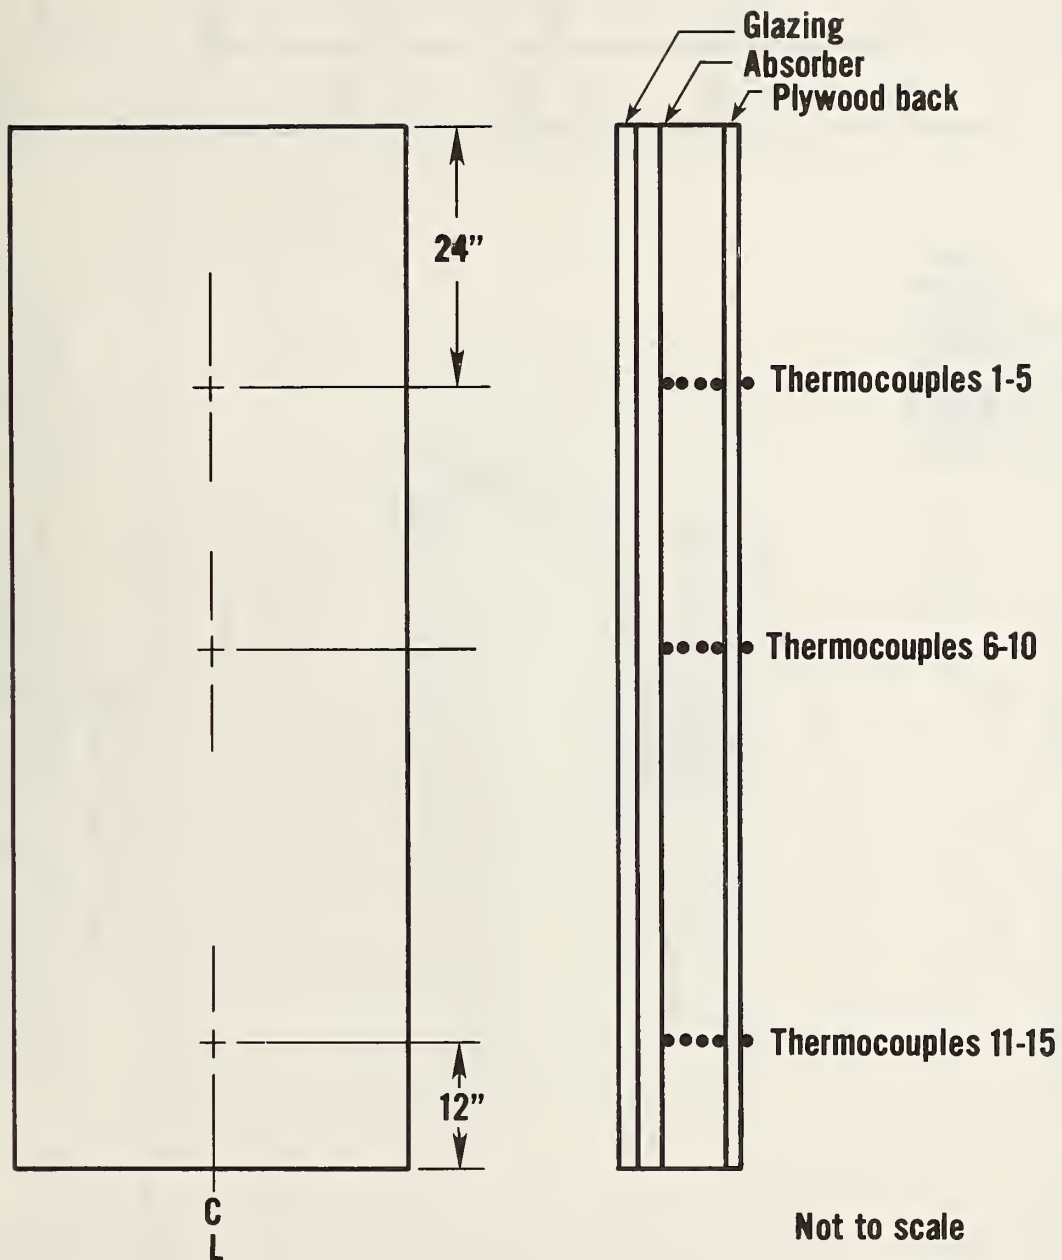
Figure 17. Location of thermocouples in collector

Thermocouples were placed at three locations in the collector, each of them along the center line, as shown in figure 17. The first was 24 inches (61 cm) from the top end of the collector, the second in the center, and the third 12 inches (30 cm) from the bottom end. At each of these locations a 3-inch (7.6-cm) diameter core was removed from the back of the collectors and thermocouples placed on the absorber, 1/2 inch (1.3 cm) into the foam from the absorber, 1 inch (2.5 cm) into the foam from the absorber, and at the foam and plywood backing interface. The core was then replaced and a fifth thermocouple placed on the back side of the plywood backing.

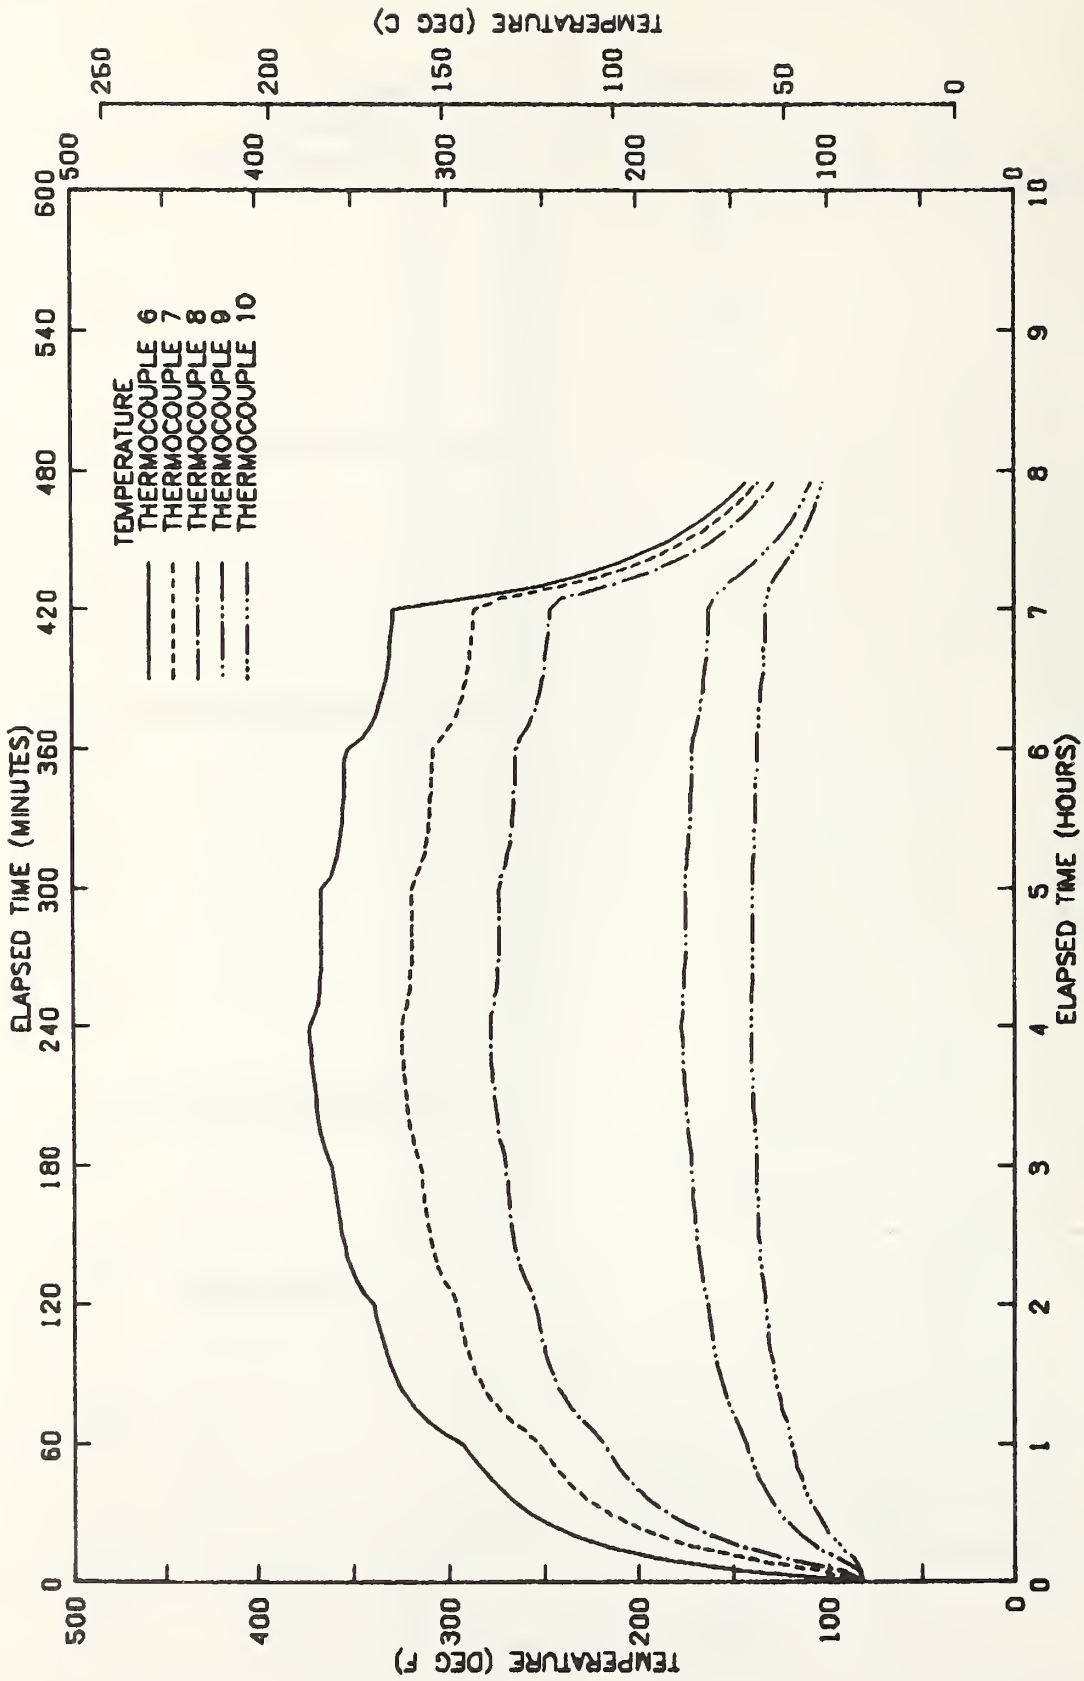
FIGURE 18. TEMPERATURE DISTRIBUTION IN COLLECTOR MOUNTED ON TEST FRAME.

The test results show some variation in temperature between the three locations within the collector probably as a result of the condition of the insulation and the mounting of the thermocouples. The temperature profiles at the center of the collector are presented as typical of those at the three locations. Figure 18 shows temperature profiles for the collectors with no deck and figure 19 shows the profile for the collectors mounted over the simulated insulated roof deck.

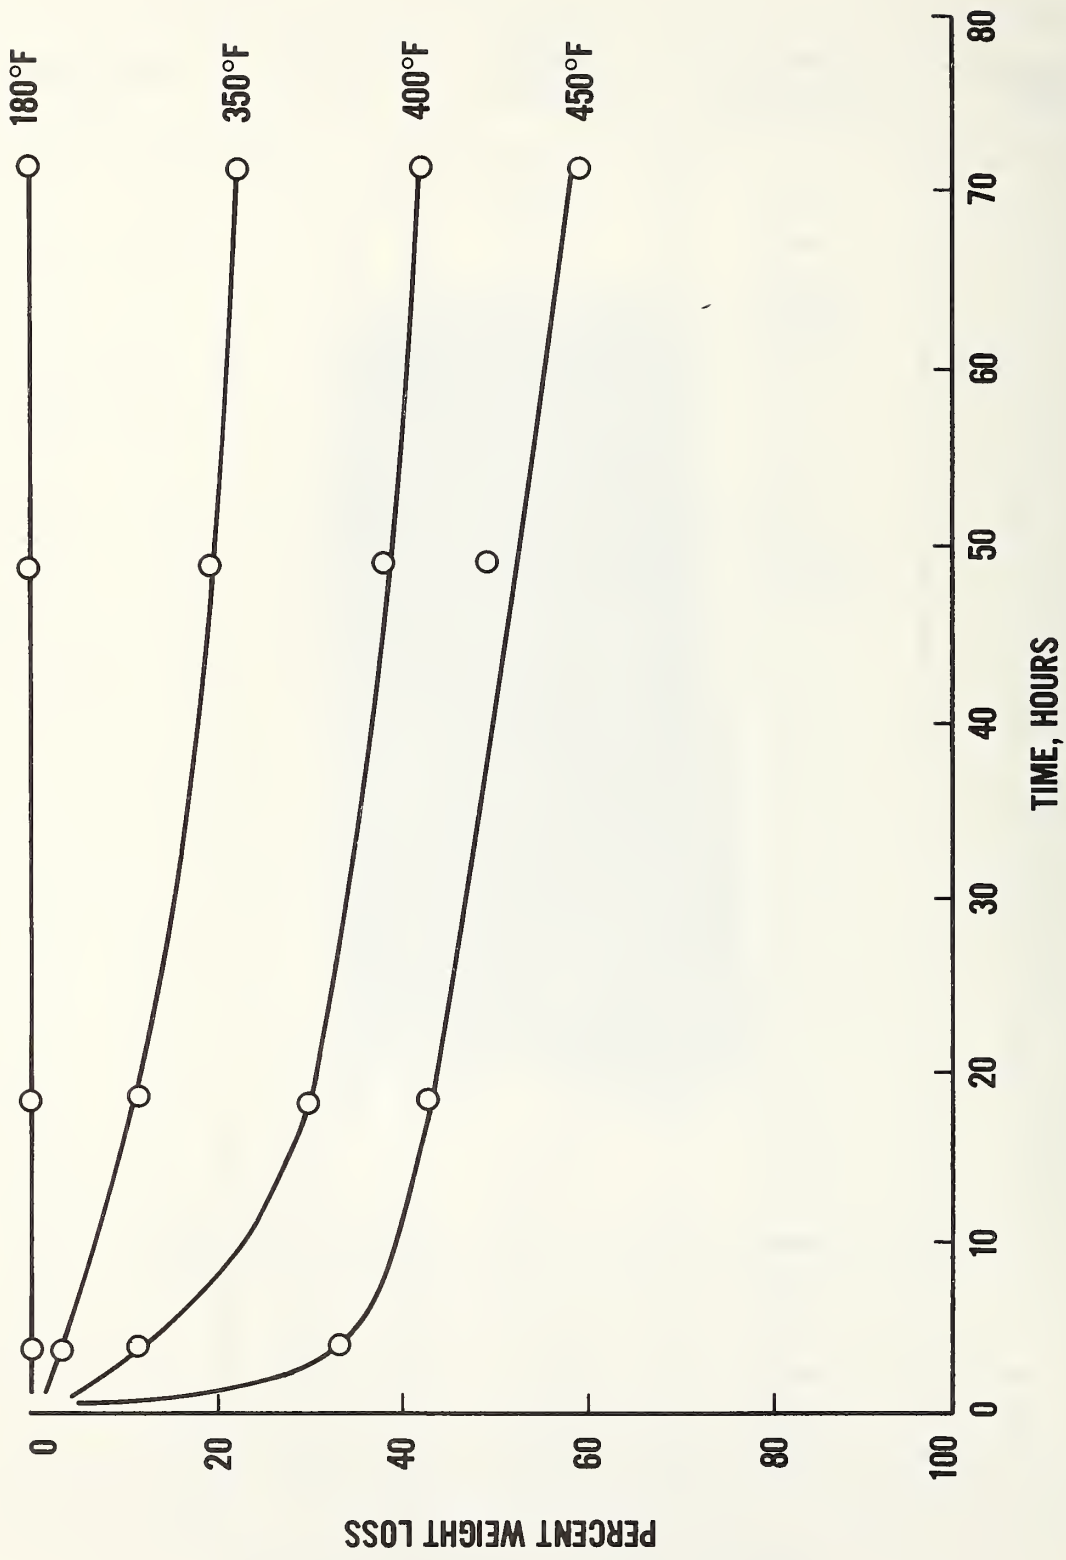
Figure 22. Isothermal weight loss of polyurethane foam

would generally be considered safe. The maximum permissible temperature for polyurethane from insulation is given in the standard as 327°F (164°C). Unpublished test results from the Boeing Company shown in figure 22 indicate that the polyurethane tested experienced approximately a 20% weight loss when exposed to 350°F (177°C) for 72 hours. The urethane tested had noticeably darkened after the exposure. These results indicate that 327°F (164°C) is not a safe maximum permissible temperature for urethane. This example is an indication of the inadequacy of the current knowledge on exposure of materials like urethane to elevated temperatures. This is further complicated by the fact that urethane foam describes a family of materials with varying properties. Therefore, it is recommended that research be conducted with an emphasis on developing a test method by which the effect of long term exposure of materials at elevated temperatures can be determined.
