NBSIR 81-2374

Investigation of Construction Failure of Harbour Cay Condominium in Cocoa Beach, Florida

September 1981

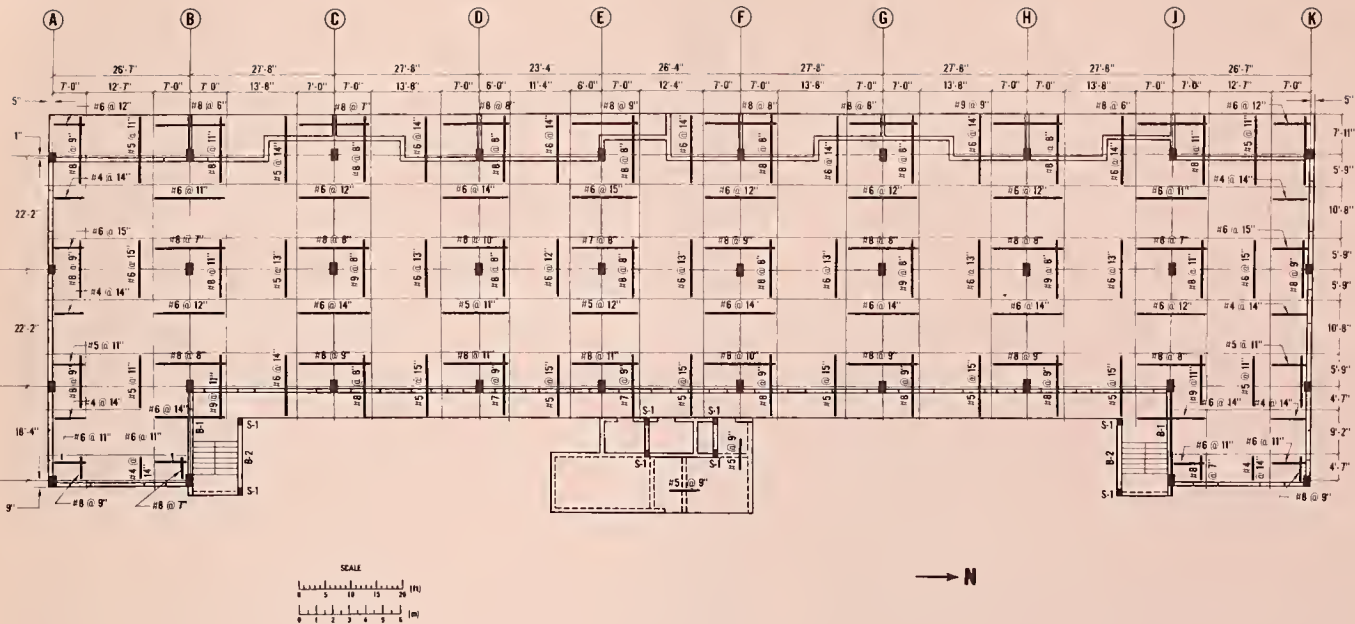
Figure 2.1 Top reinforcement layout in typical floor slab

It is shown that high punching shear stresses resulted from use of reduced height individual high chairs to support the top reinforcing bars in the column strip, thereby reducing the effective depth of the slab. The omission of a check for punching shear capacity in the design calculations resulted in a slab thickness of 8 in (203 mm). The ACI Code would have required a thickness of 11 in (279 mm) to provide adequate safety against punching shear under design loads. It is shown that this design deficiency resulted in a reduction of the margin of safety such that the slab had insufficient reserve strength to accommodate construction errors.

Reinforcing steel for the slabs and columns was specified as deformed bars ASTM Grade 60. The framing plans in figures 2.1 and 2.2 show the top and bottom reinforcement in the slab, respectively. Table 2.1 shows the reinforcing schedule for the columns. The structural drawings called for 4000 psi (27.60 MPa) strength for concrete in the above-grade portion of the structure. The specified live loads were 20, 40, 60 and 100 psf (960, 1920, 2870 and 4790 Pa) for the roof, floor, public balcony and stairways, respectively. The wind design was specified to conform with the SBCC Standard Building Code, 110 mph (49 m/s) wind with a 100-year return period [2.2]. Concrete block masonry strength was specified as $f_m = 1500$ psi (10.35 MPa). Non-load bearing concrete masonry construction was used for the exterior walls of the building.

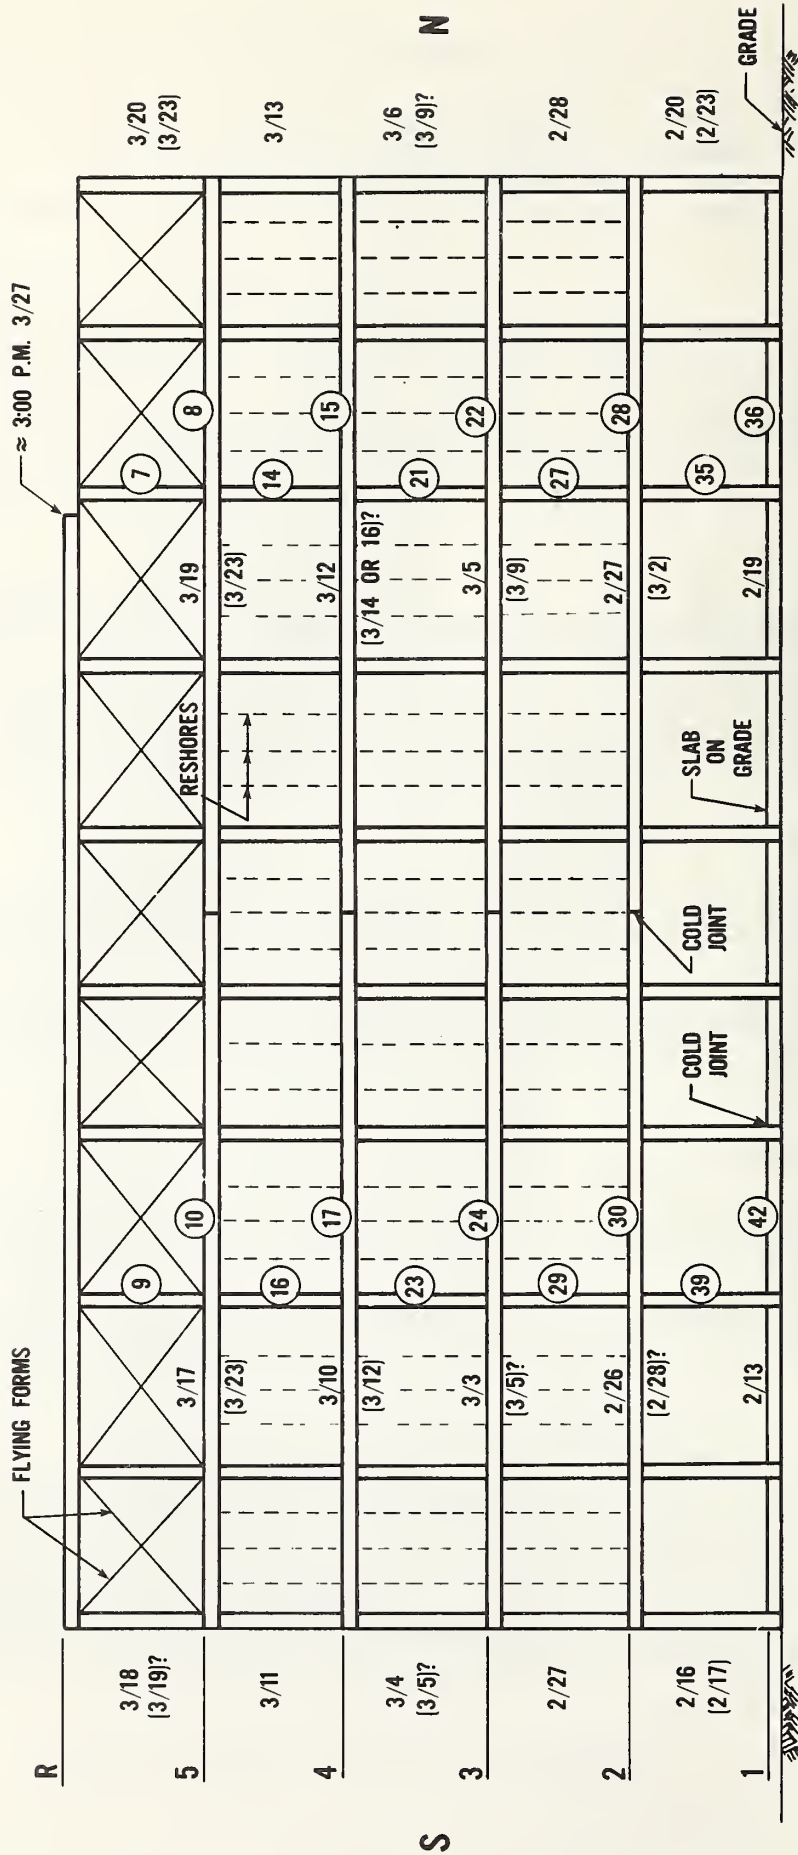
Figure 2.11 Assumed state of construction at time of the collapse

Figure 2.11 shows the various casting and stripping dates and the ages of the columns and floor slabs relative to the time of the collapse. In the case of incomplete information or conflicting witness statements regarding the date of a particular event, a question mark appears next to the specified date in the figure. Note that, unlike the lower story slabs, the roof slab was scheduled to be cast in one day. At the time of the collapse, all but the two north bays of the roof slab had been cast.

Figure 2.11 shows full reshores in the second through fourth stories. A fully reshored story conforms with the reshoring layout shown in figure 2.9. There is sufficient indication from worker statements to assume that the fourth story was fully reshored at the time of the collapse. Likewise, it is known that there were no reshores in the first story with the exception of some peripheral reshores under the balconies and walkways (see sec. 3.3 and fig. 2.11). Although there is a question as to when the first story reshores were removed, they would have been recovered for reuse when the fourth story forms were flown. Note that the removal of reshores from the first story marks the first time when the forces in the total shoring system will no longer have a direct path independent of the columns to the foundation (slab on grade, in this case).

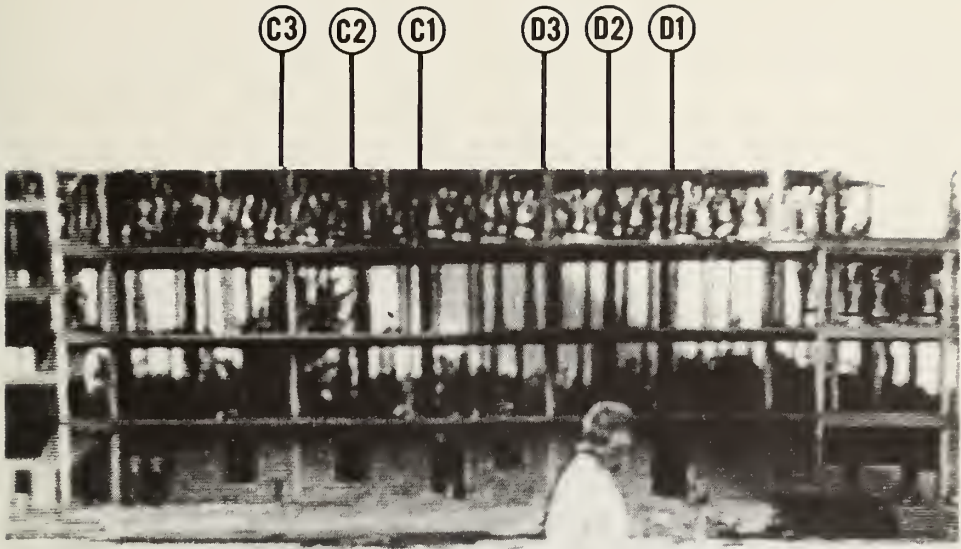
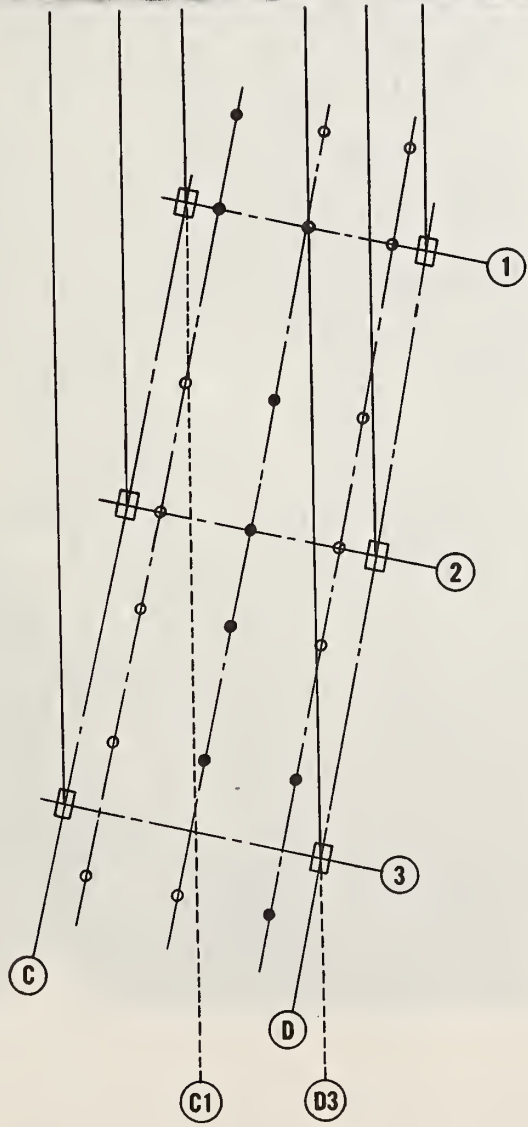
Figure 2.12 Schematics for determining amount of reshores using partial view of east side of building

Figure 2.12 is a partial view of the east facade of the building between the south stairwell and the elevator tower. Because the building was viewed from the northeast side, it is possible to identify all the columns on column lines C

and D, as indicated in the figure. Within the third story, it is shown, by means of the superimposed graphics in the figure, that the projected space between columns C1 and D3 (the distance between C1 and D3 in the figure) should be occupied only by eight reshores within bay CD, assuming that story is fully reshored. From figure 2.12 and the closer view shown in figure 2.13, the third story appears to be fully reshored at the time these photographs were taken. It also appears that the number of second story reshores is comparable to that in the third story, although their locations appear to be different. Noting that the flying forms within the south four bays of the fourth story are in place, the date of the photographs is placed between March 12 to March 15, or 12 to 15 days before the collapse (see figs. 2.10 and 2.11). It is not known whether or not any of these reshores were removed in the interim.

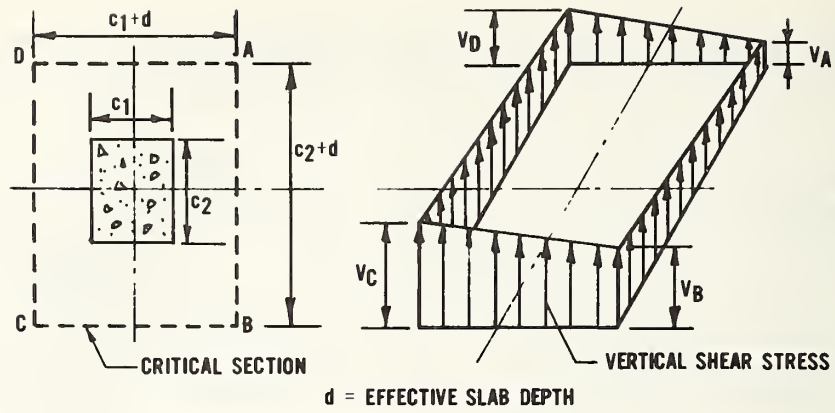
Figure 6.1 Shear stress distribution at interior column

To verify that such a failure had occurred, punching shear stresses resulting from direct shear forces and unbalanced moments were computed at slab-column connections using the shear and moment values for construction loads given in figure 5.13. These shear stress values were compared with the shear capacity of the slab based on the predicted in-place strength of concrete at the time of collapse. Because the punching shear stress values are maximum at the fifth floor level (see figures 5.12 and 5.13), the shear stresses are evaluated only for this level. The guidelines given in the ACI Code [2.1] are followed in computing the punching shear stress. Figure 6.1(a) shows the critical section in the slab around an interior column. The critical section where shear stresses are evaluated is taken perpendicular to the plane of the slab and a distance a half of the effective depth away from the periphery of the column. The assumed distribution of shear stresses at the critical section is shown in figure 6.1(b). The critical sections for edge and corner columns and corresponding assumed shear stress distributions at these critical sections are shown in figure 6.2(a) and (b) and figure 6.3(a) and (b), respectively.

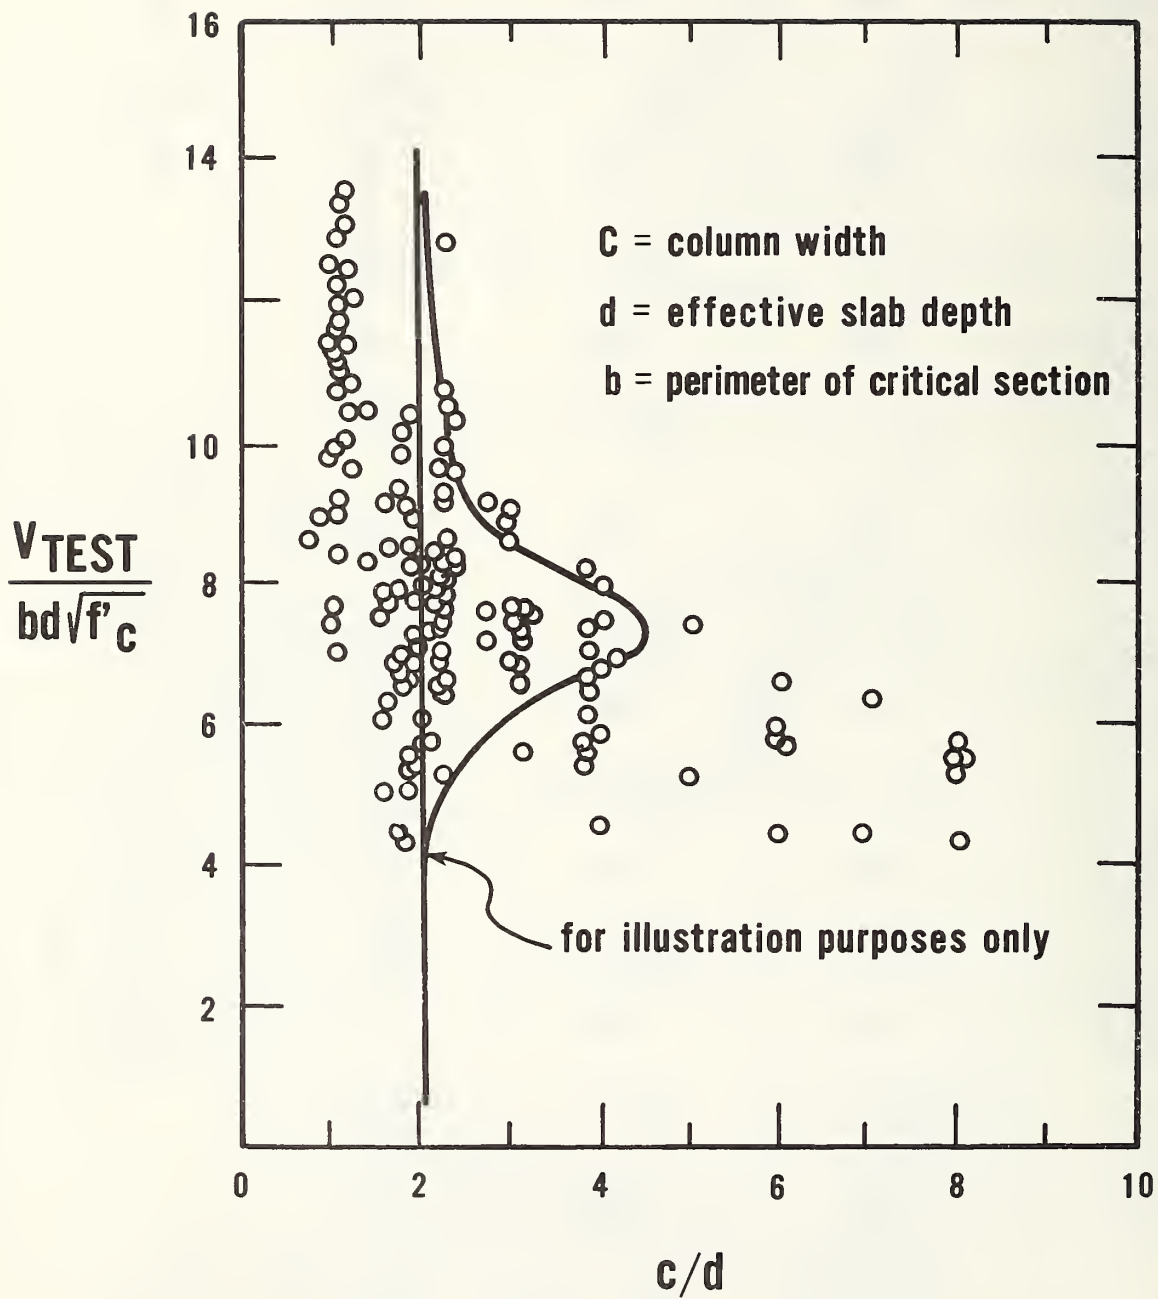
Figure 6.5 Results of punching shear tests of slab-column connections (ref. 6.1)

If, for the sake of illustration, the probability of failure at any given location where a stress of $4 \sqrt{f'_c}$ occurs is assumed to be two percent ($P_1 = .02$), which is quite plausible in light of the data shown in figure 6.5, the probability of failure, P_2 , of an element in a system consisting of 30 such locations would be (assuming independence)

It should be pointed out that the data shown in figure 6.5 was obtained from laboratory experiments where, in general, much better quality control can be exercised than in the field. Therefore, it is reasonable to expect that if actual field conditions were simulated, the data would have shown greater scatter and a lower expected value than indicated in figure 6.5. Both factors imply a greater probability of strength below $4 \sqrt{f'_c}$. There is evidence, as discussed in chapter 4, that the concrete used in the structure had high variability in terms of composition and strength.
