NBSIR 82-2465

Investigation of the Kansas City Hyatt Regency Walkways Collapse

February 1982

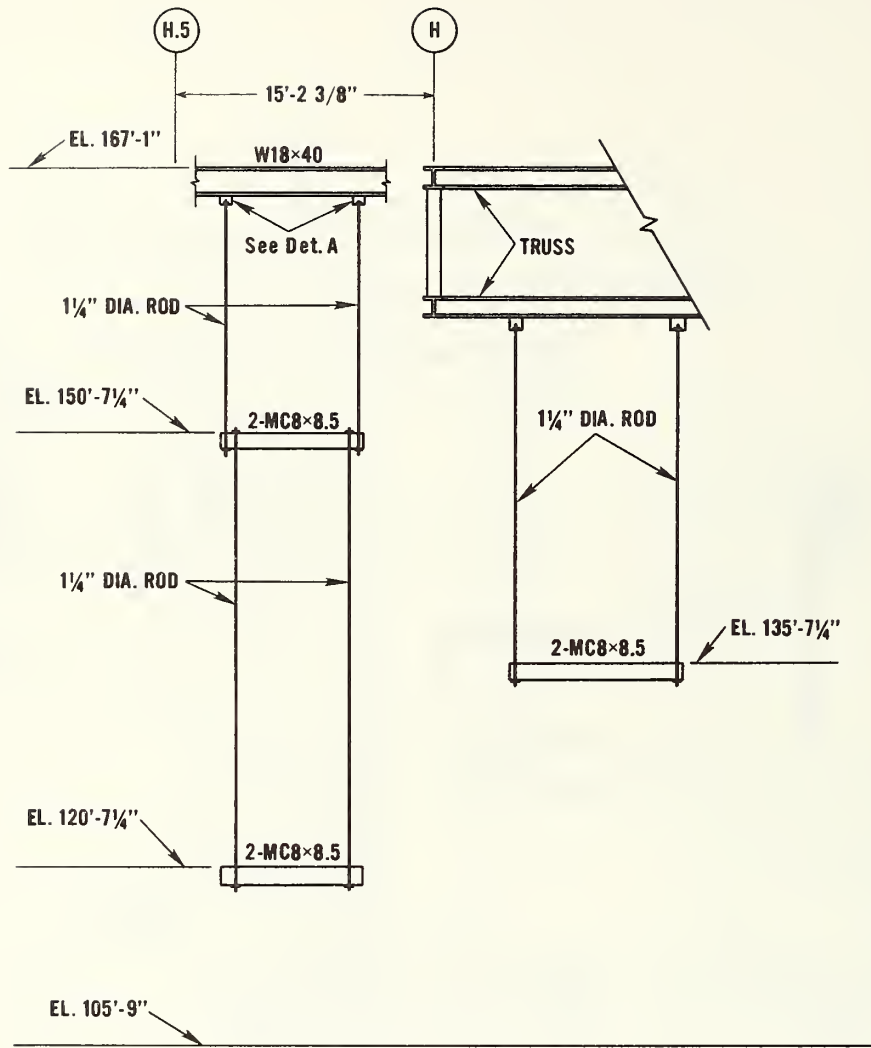
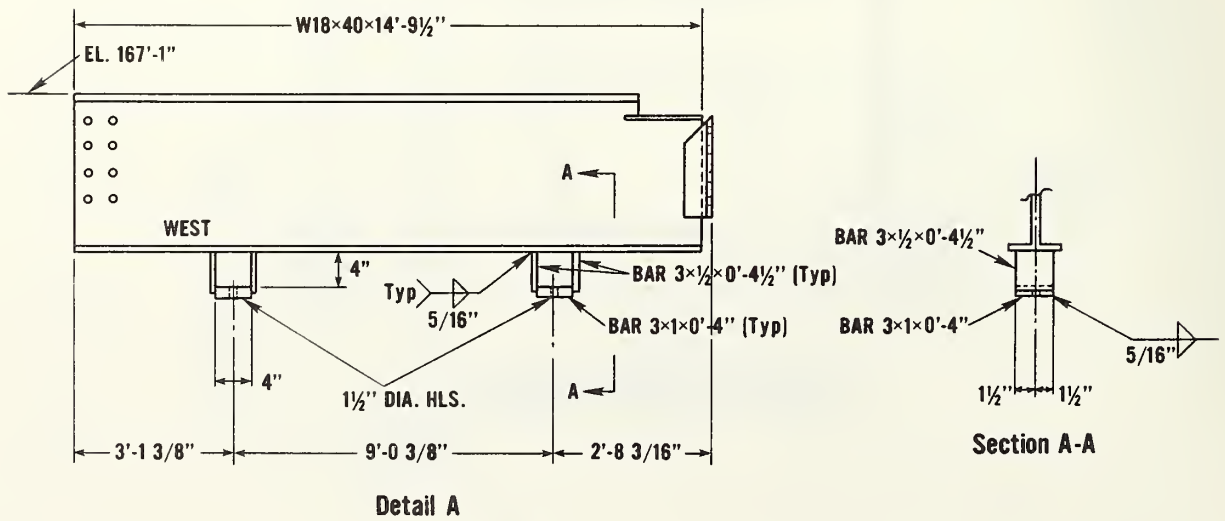
Figure 3.11 Elevation of typical box beam-hanger rod assembly.

REFLECT THE SECOND AND FOURTH FLOOR HANGER ROD DETAIL ACTUALLY USED IN THE CONSTRUCTION OF THE WALKWAYS. The hanger rod detail actually used will be explained in the discussion of figures 3.9-3.11.

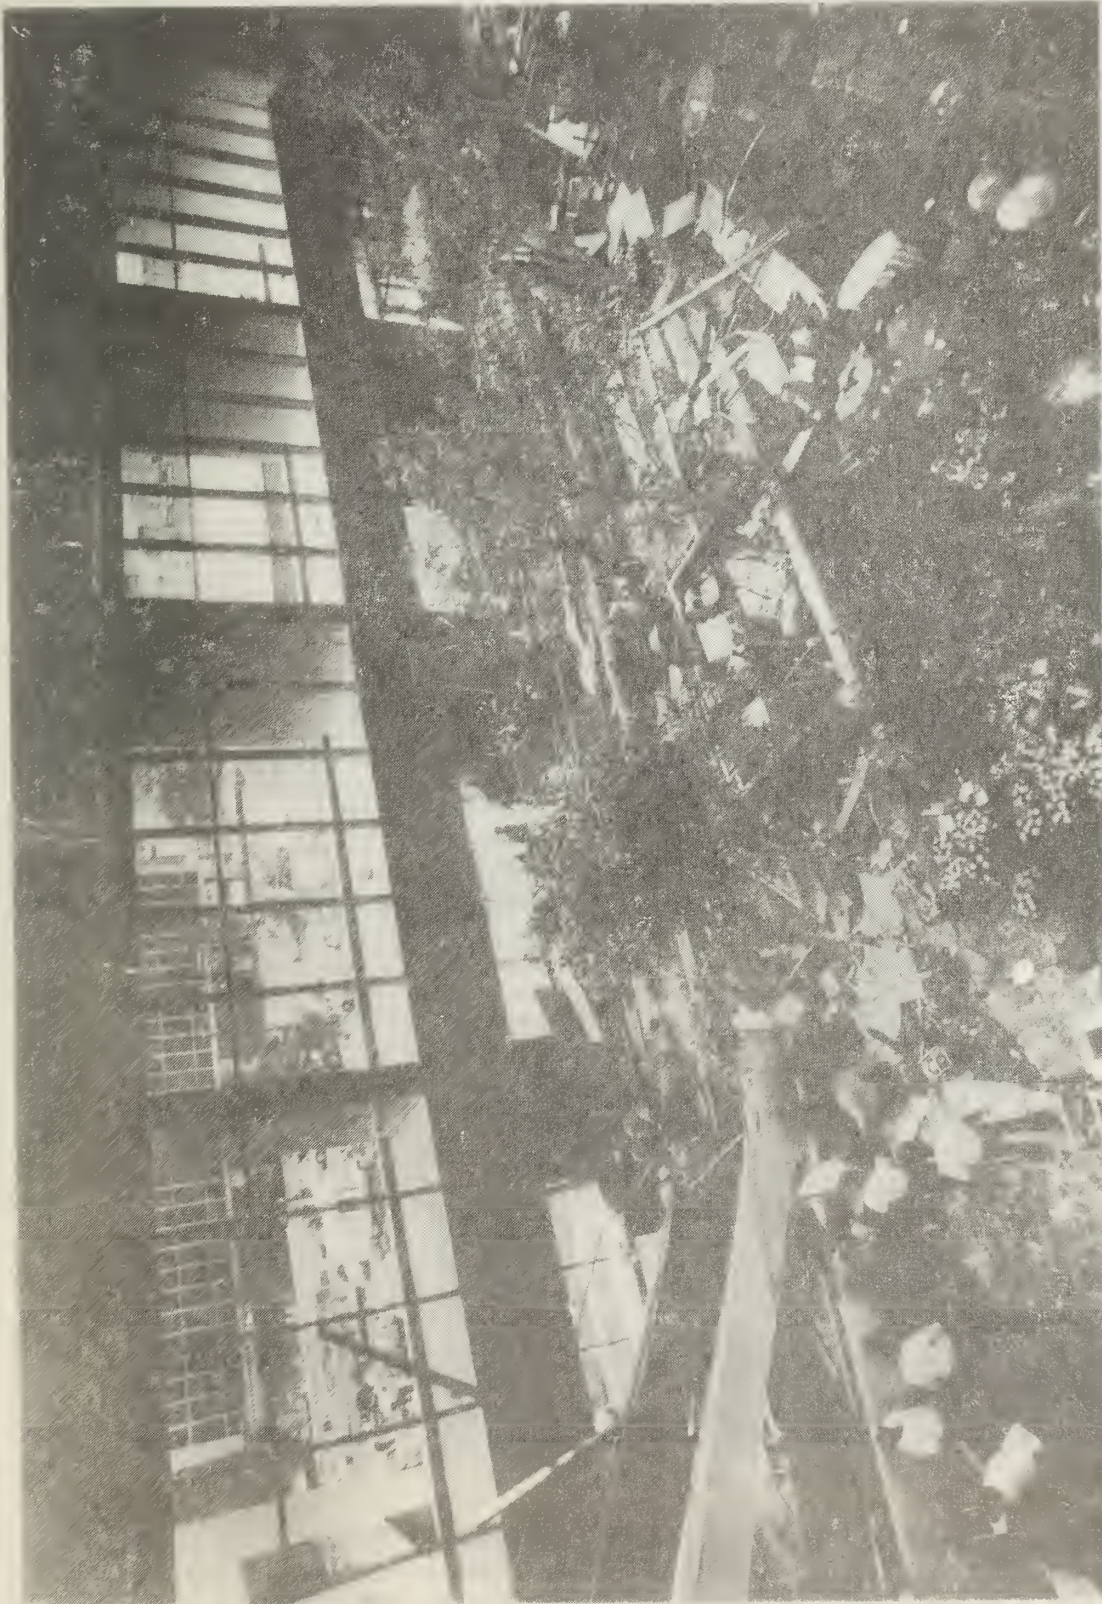
Figures 4.1 and 4.2 show the walkways shortly after the collapse, just as the rescue operation was getting under way. The photograph in figure 4.1 appears to have been taken from the stairway landing at the south side of the atrium between the second and third floors. The view is to the west-northwest and shows part of span U7-8 which lodged in the second-floor portal originally occupied by span L7-8. Spans U8-9 and U9-10 can be seen behind the trees in the middle of the picture. The photograph in figure 4.2 was taken from the third floor with the view directly to the north along the axis of the walkways. Span U7-8 is in the foreground and the third floor walkway can be seen to the upper right. Span U10-11 is visible at the far (north) side of the atrium. The north end of this span appears to have experienced an appreciable displacement to the west during the collapse. Water is coming from walkway sprinkler pipes severed when the north walkway spans were pulled off of their bearing seats.

Figure 4.1 Walkways shortly after the collapse. View is to the west-northwest with span U7-8 sloping down and to the right. Spans U8-9 and U9-10 are visible behind the trees. Photo by Greg Smith, reprinted by permission of The Kansas City Times, © 1981, The Kansas City Star Company.

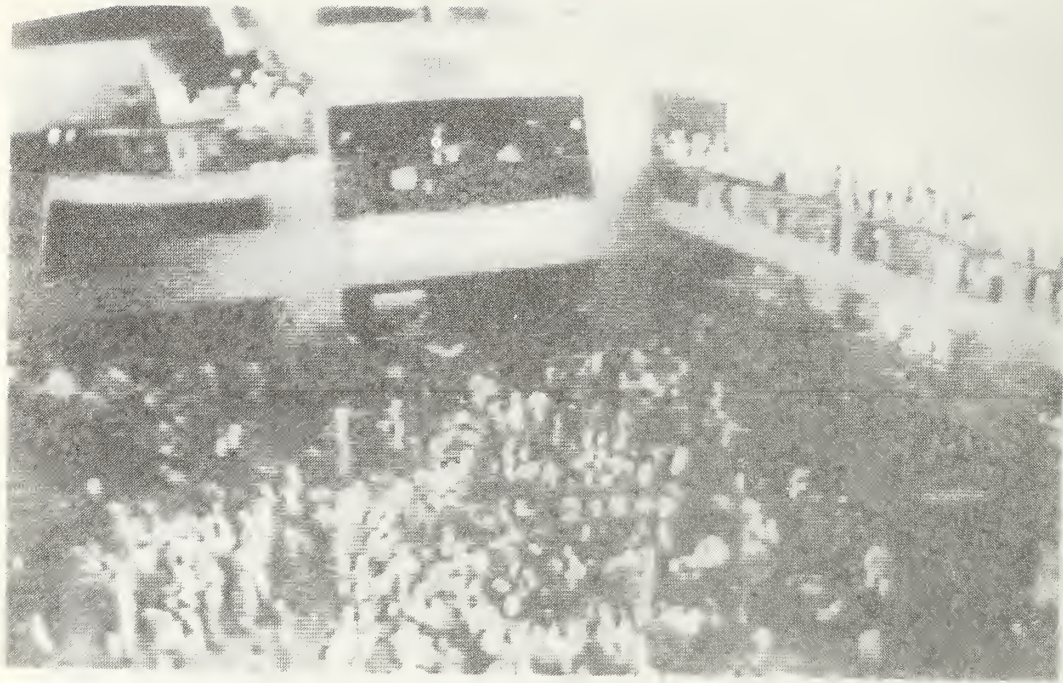
Three segments of the tape provided by KMBC TV were suitable for analysis. The scene in figure 4.4 is from the third floor balcony on the north side of the atrium with the view to the southwest. All of span L7-8 and most of span

Figure 4.4 Scene from third floor balcony on north side of atrium. View to the southwest showing spans L7-8 and L8-9 of second floor walkway. Videotape courtesy of KMBC TV.

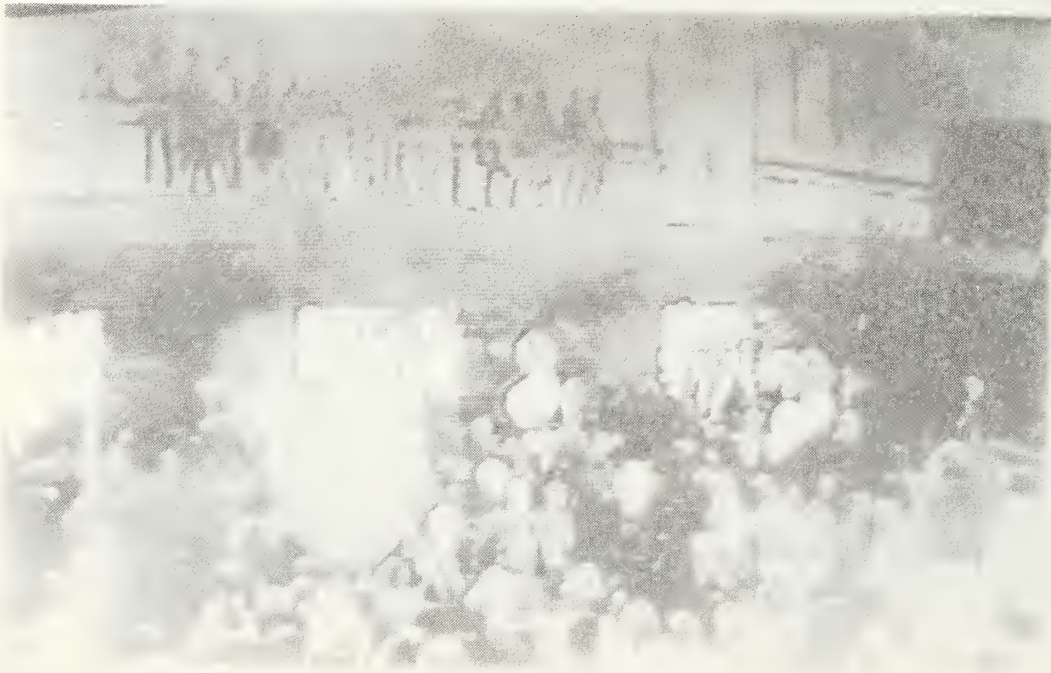
The scene in figure 4.5, believed to have been taken a few minutes after the frame shown in figure 4.4, appears to be from the landing of the main stairway in the southeast corner of the atrium, looking northwest. Part of span L8-9 and all of spans L9-10 and L10-11 of the second floor walkway are visible. Eight or nine people are occupying the south portion of span L9-10 along the handrail and span L10-11 is not occupied.

Figure 4.5 Scene from landing of main stairway in southeast corner of atrium. View to northwest shows part of span L8-9 and all of spans L9-10 and L10-11 of second floor walkway. Videotape courtesy of KMBC TV.

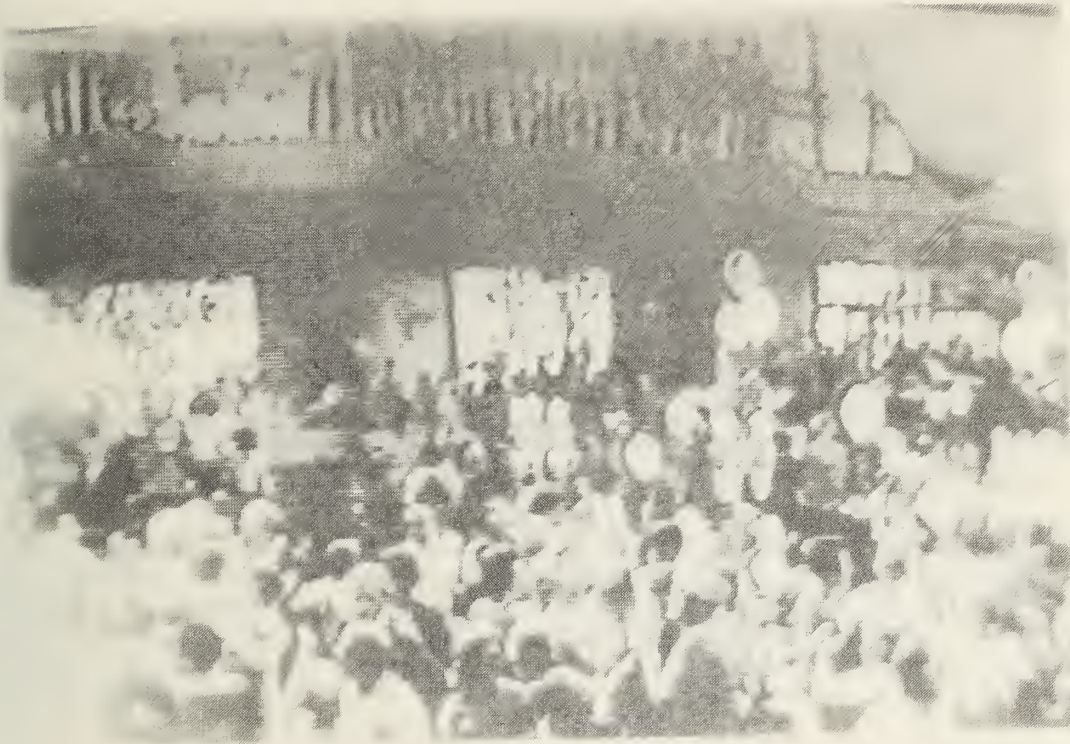
The scene in figure 4.6, taken a few frames later, appears to be from the same location as that in figure 4.5, but shows more of span L8-9. Judging from their relative heights, the people on span L9-10 have not moved from their positions shown in figure 4.5. It appears that the count on span L9-10 is now 11, but blurring makes an accurate count difficult.

Figure 4.6 Same view as figure 4.5, but a few frames later. Videotape courtesy of KMBC TV.

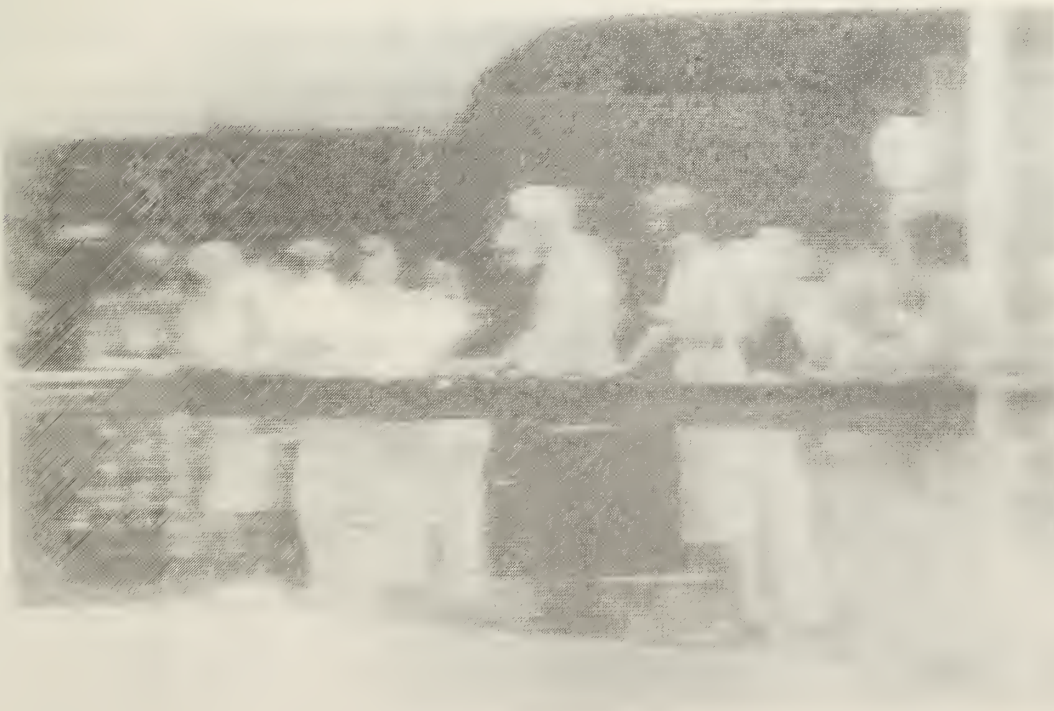
Figure 4.7 is a close-up of the southernmost span (span M7-8) in the third floor walkway. The view is from the same location as figure 4.4. Again, it is difficult to make an accurate count, but at least 11 persons can be observed.

Figure 4.7 View from third floor balcony on north side of atrium. View to southwest showing southernmost span (span M7-8) of third floor walkway. Videotape courtesy of KMBC TV.

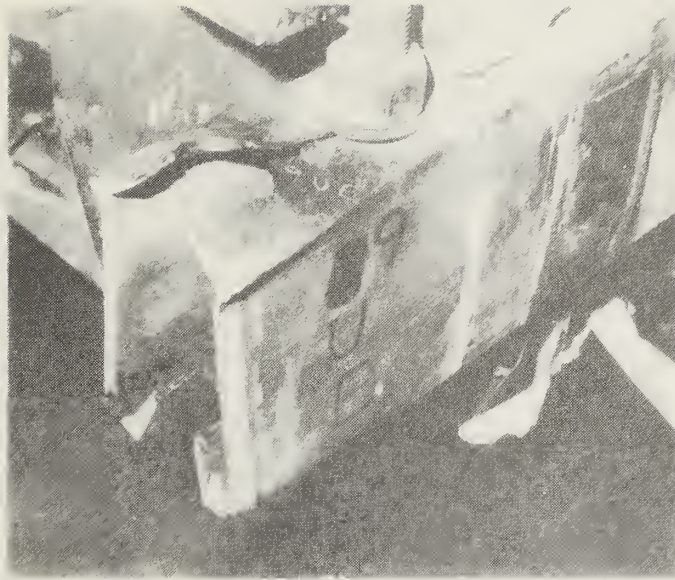
Figure 5.7 Hanger rod pull-through at location 9UE.

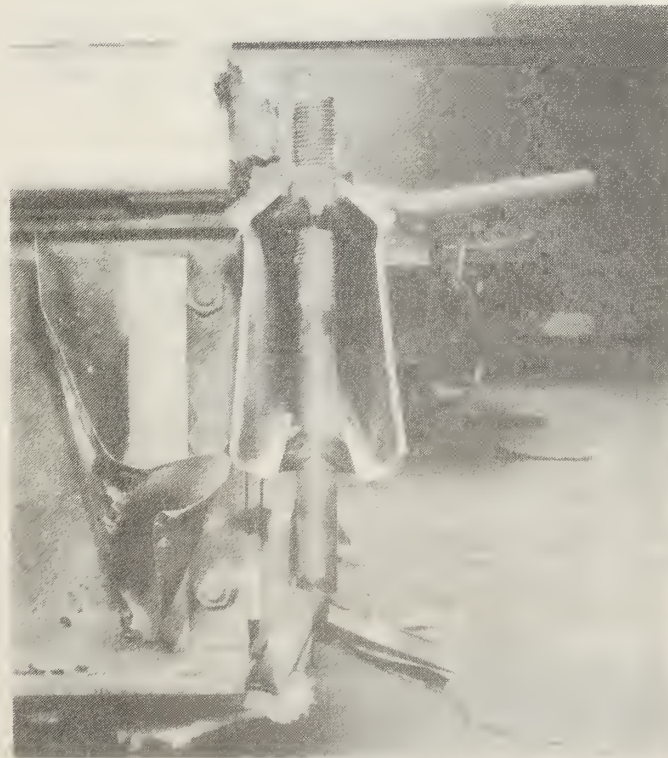
Figure 5.8 End view of box beam at location 9UE.

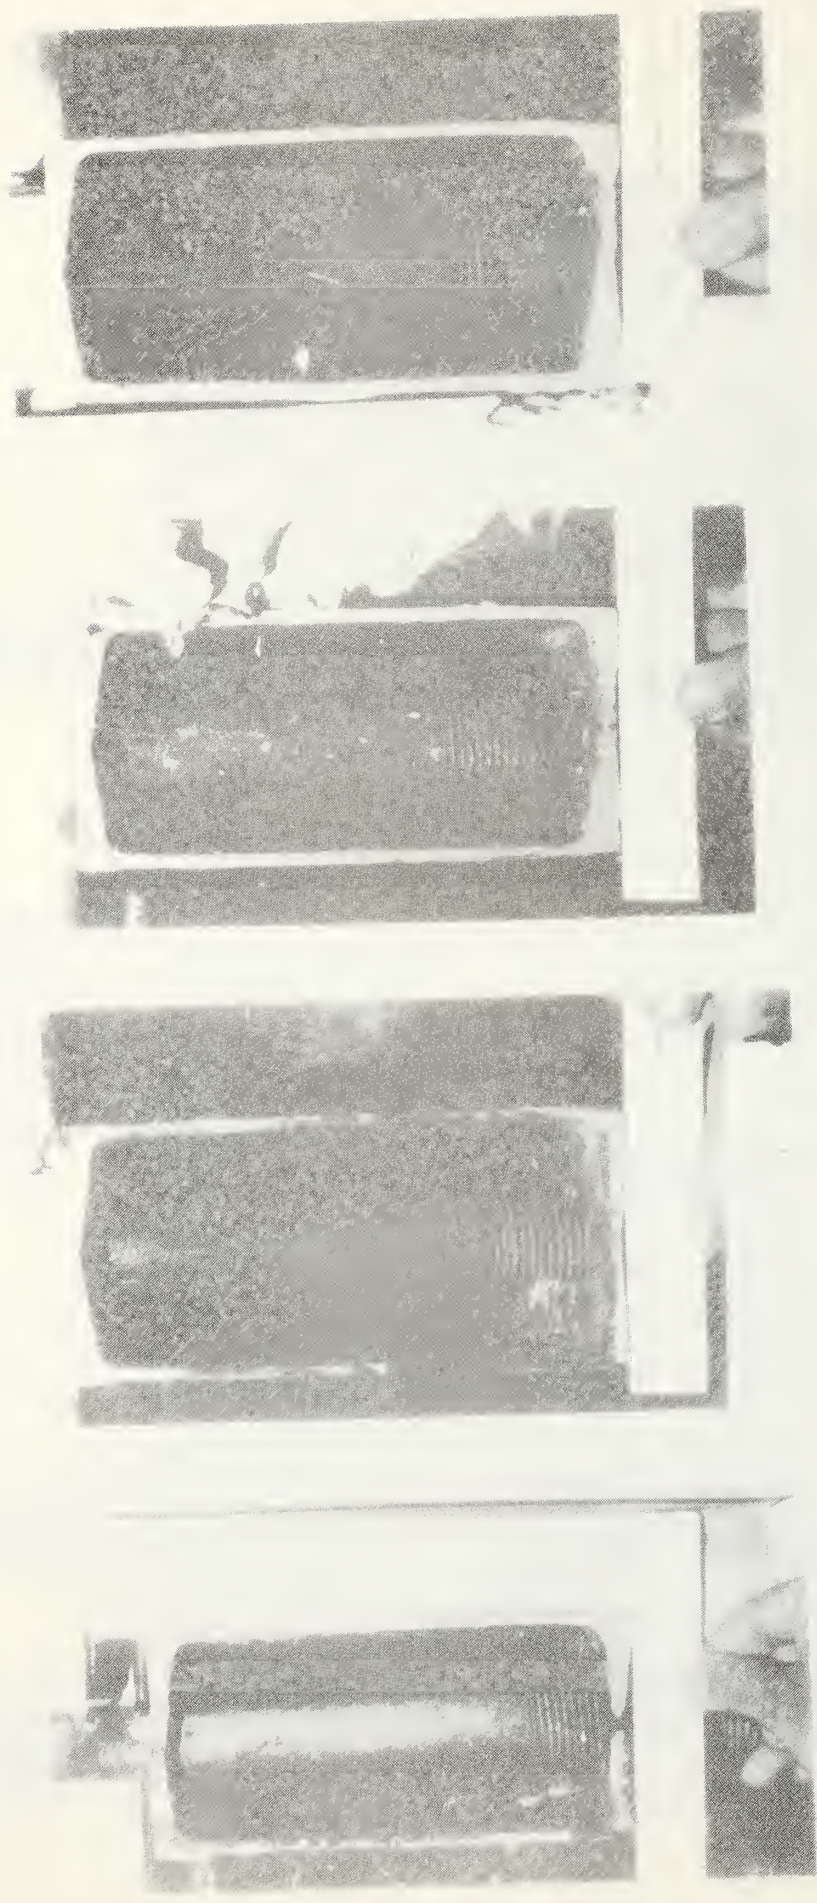
a) Location 8MW. b) Location 8ME. c) Location 9MW. d) Location 10MW.

Figure 5.9 Evidence of permanent distortion in box beam ends of third floor walkway.

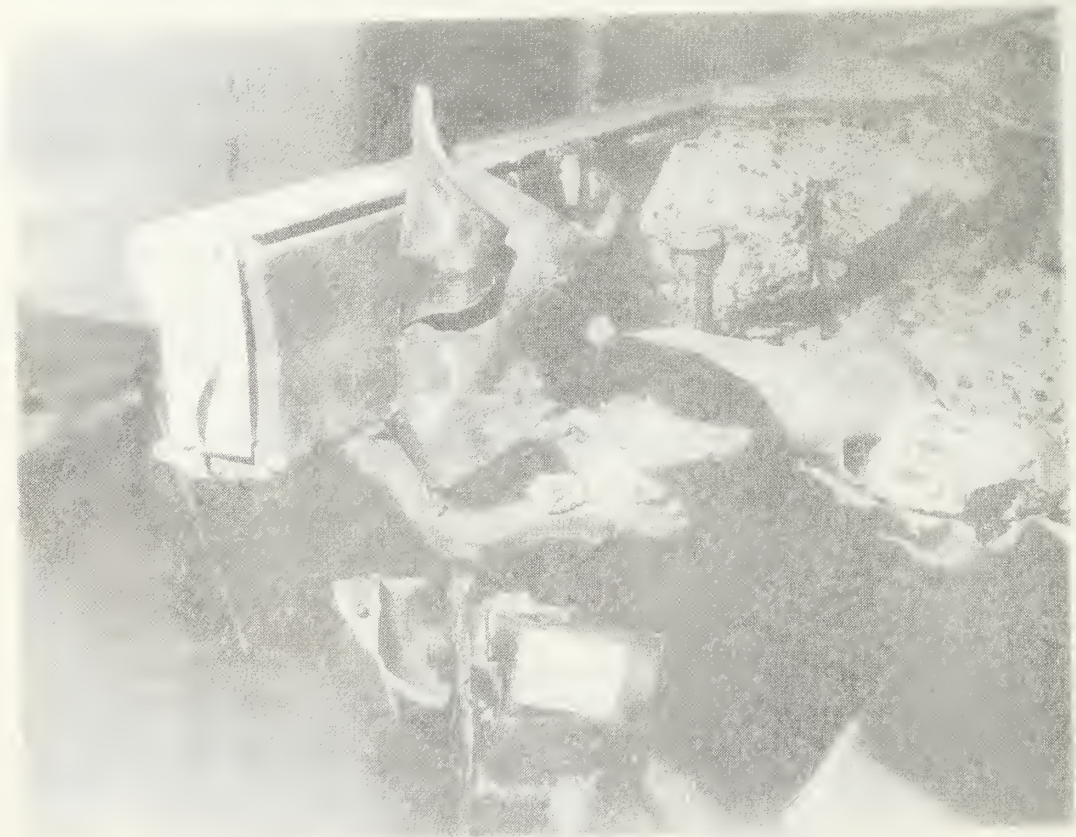
Figure 5.12 End view of 1/4" x 6" edging plate at location 10UW (Span U10-11).

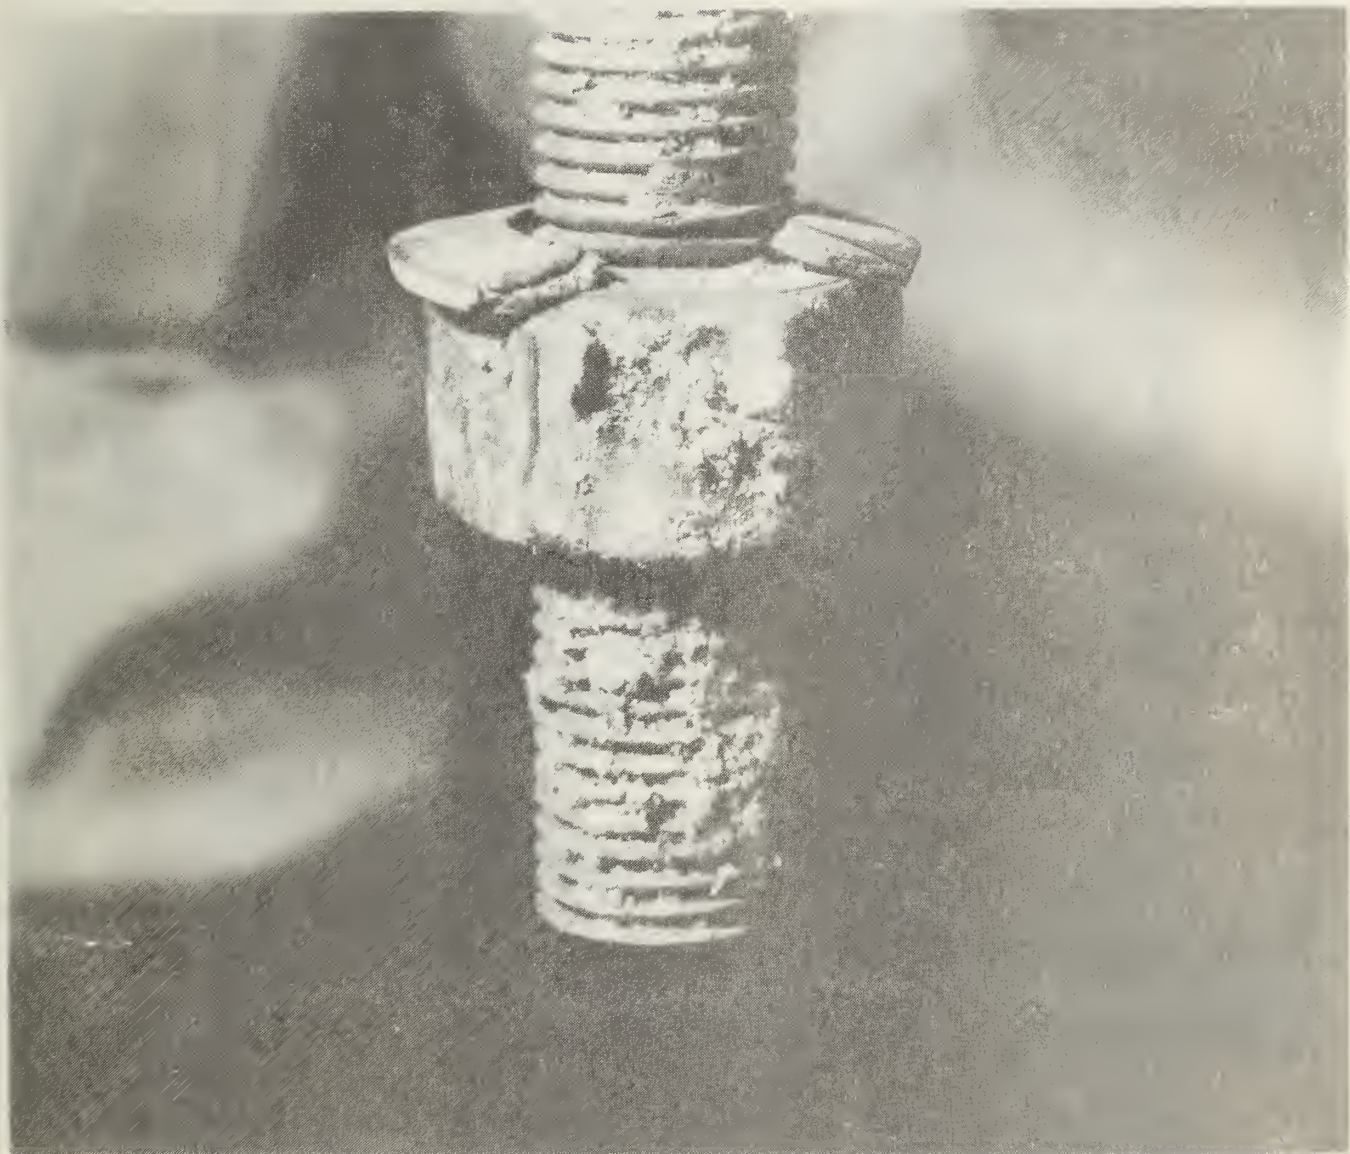
Figure 5.13 Washer at bottom end of fourth floor to ceiling hanger rod 9UW.

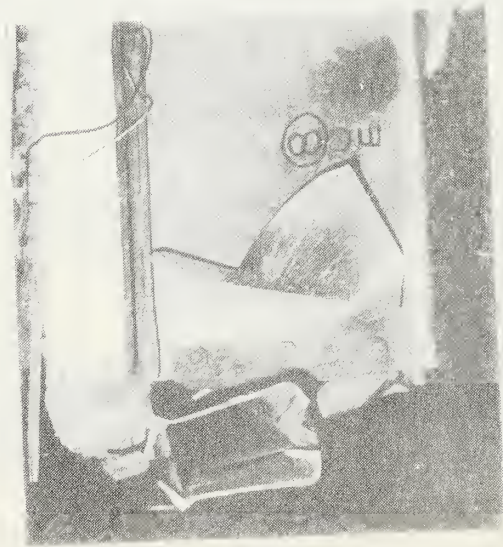
d) Location 8UE.

Figure 5.14 Observed symmetry of distortion of box beams at locations 8U and 10U relative to the box beam at location 9U.

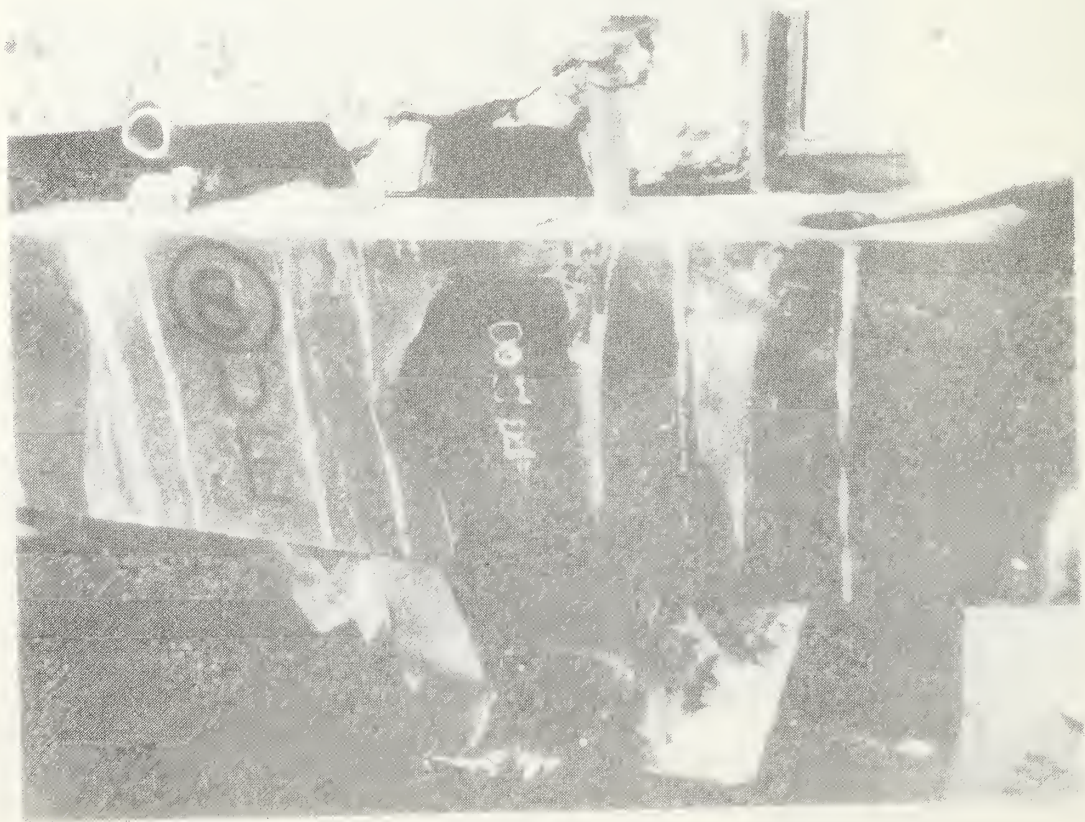
Figure 5.24 Tear in box beam web at location 8UE.

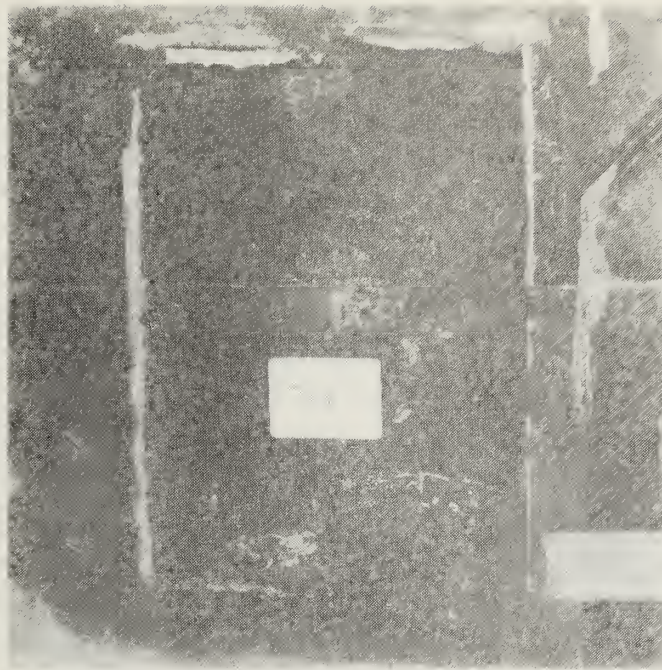
Figure 5.25 Embedded plate at connection 7UE.

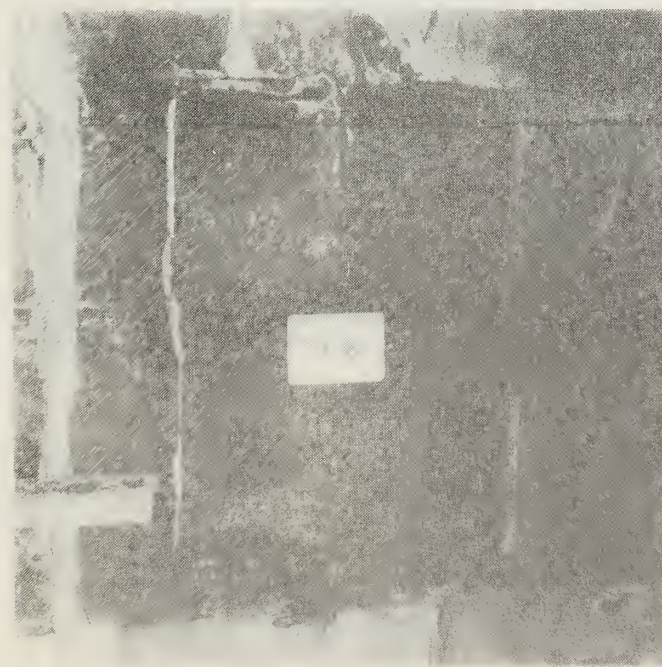
Figure 5.26 Embedded plate at connection 7UW.

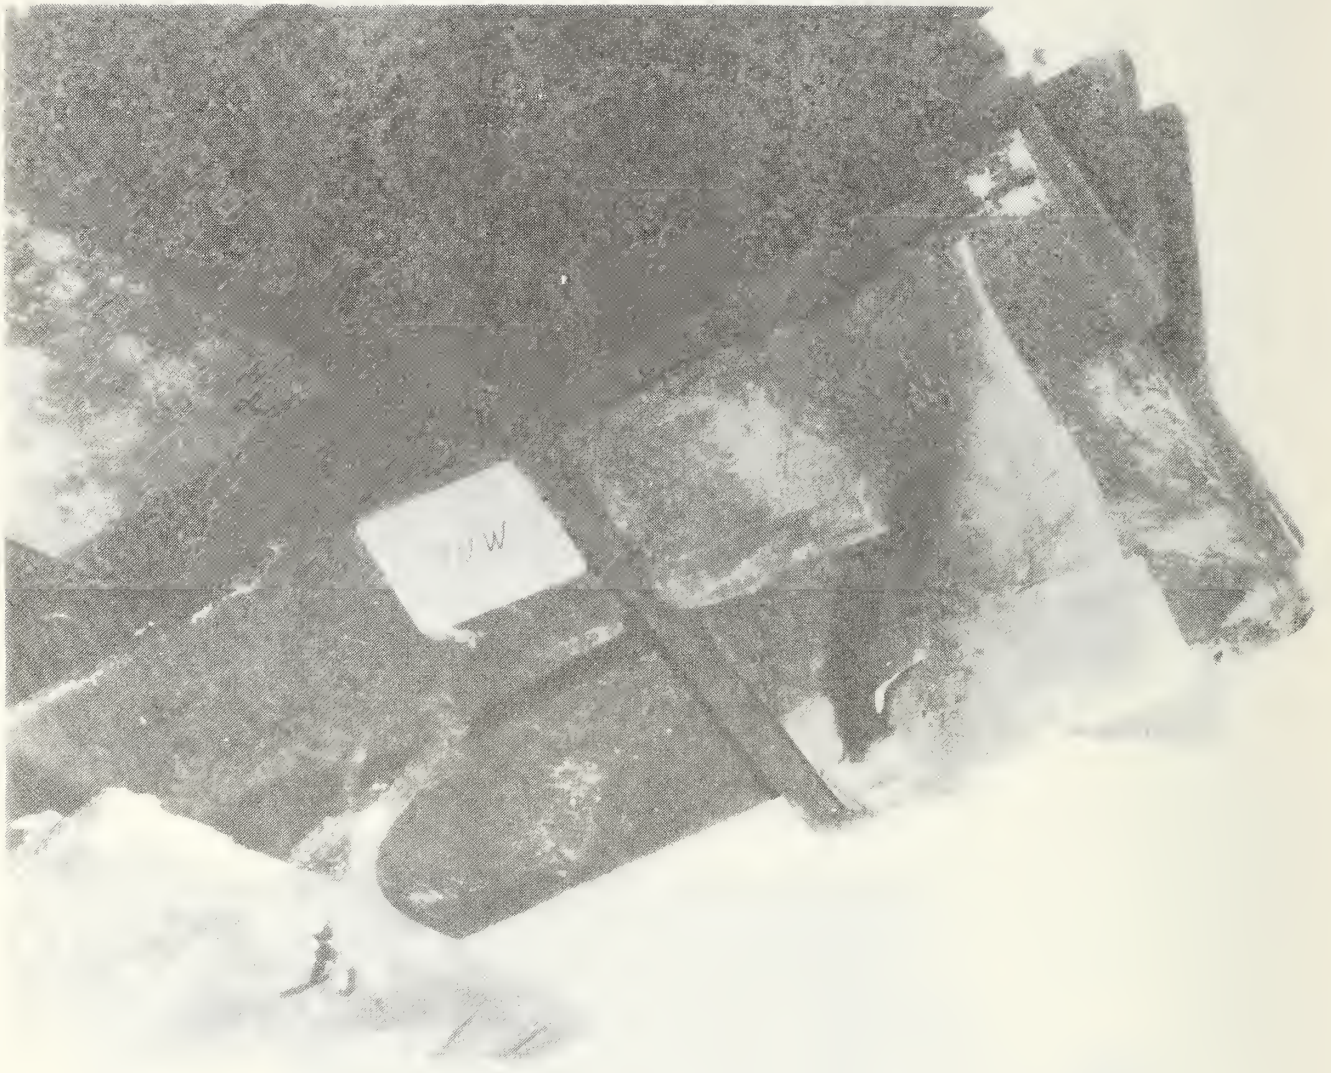
Figure 5.27 Modified bearing pad at location 11UW.

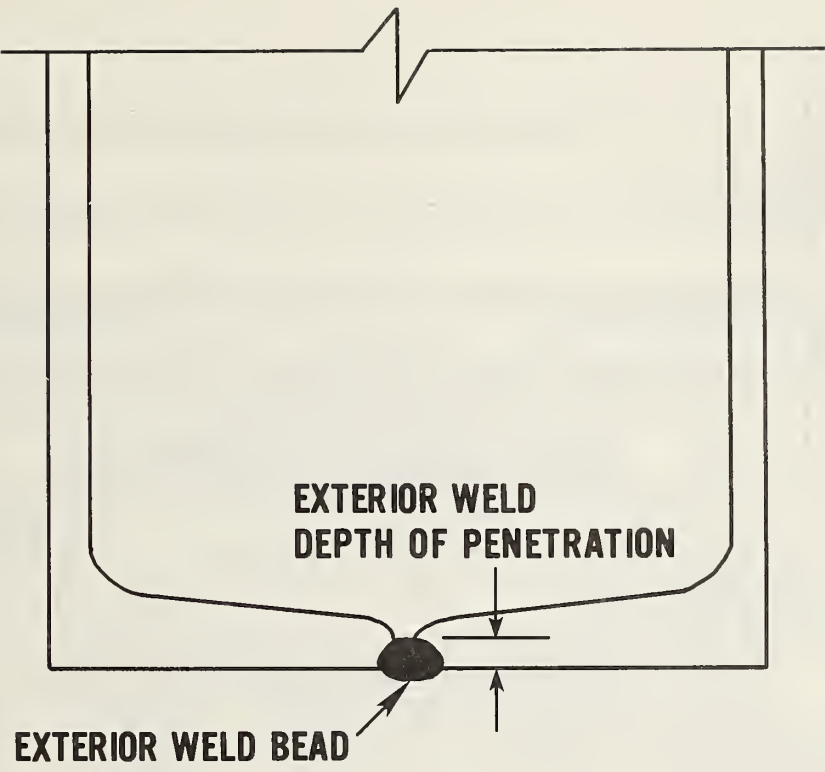
Figure 6.2 Exterior weld penetration.

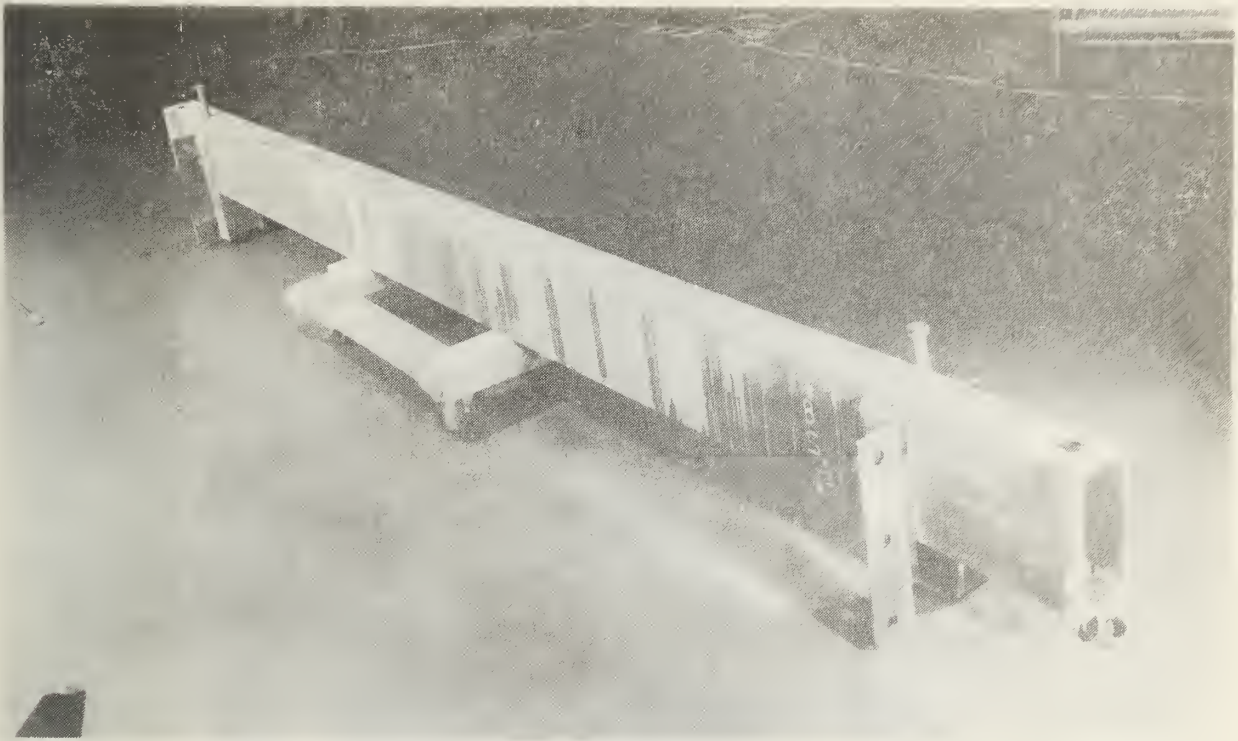
One full-length box beam was obtained from column line 9 of the third floor walkway (figure 6.7). One full-length box beam test and four short box beam tests were conducted on this beam. Specimen characteristics are shown in table 6.5.

Figure 6.7 Full length box beam showing stringer-box beam clip angles.

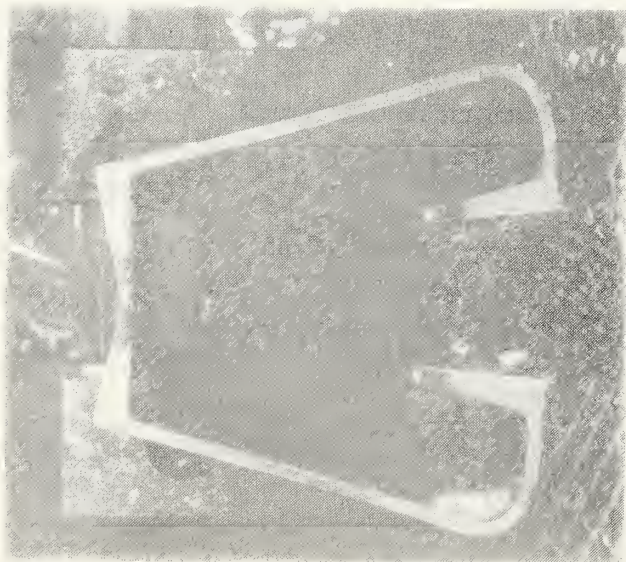
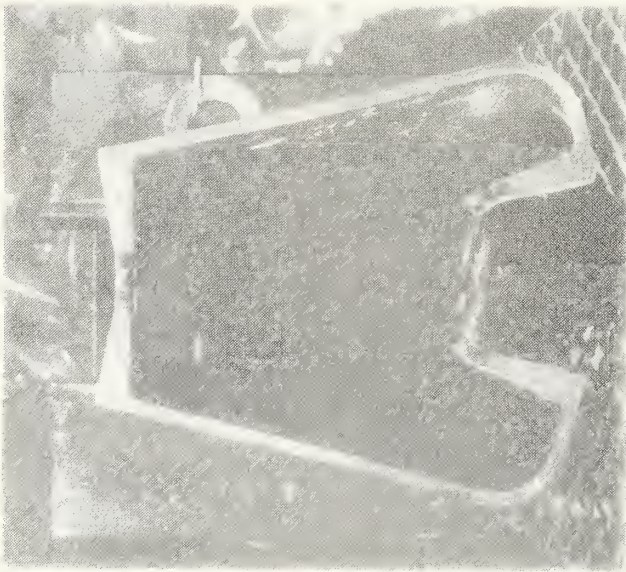
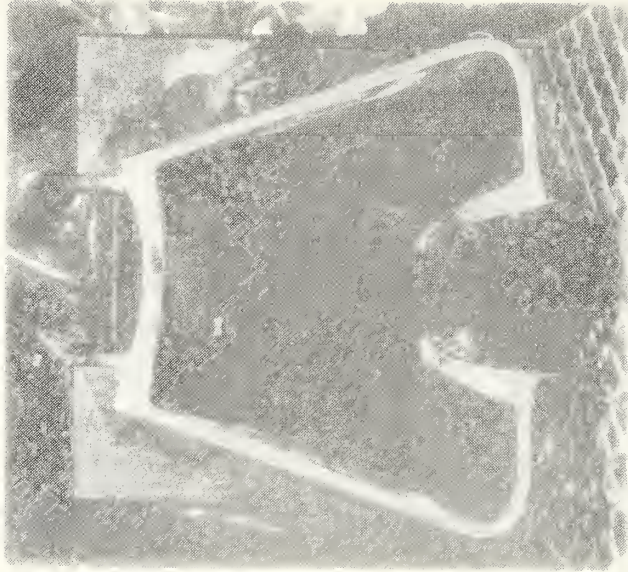
Figure 6.14 Deformed shapes.

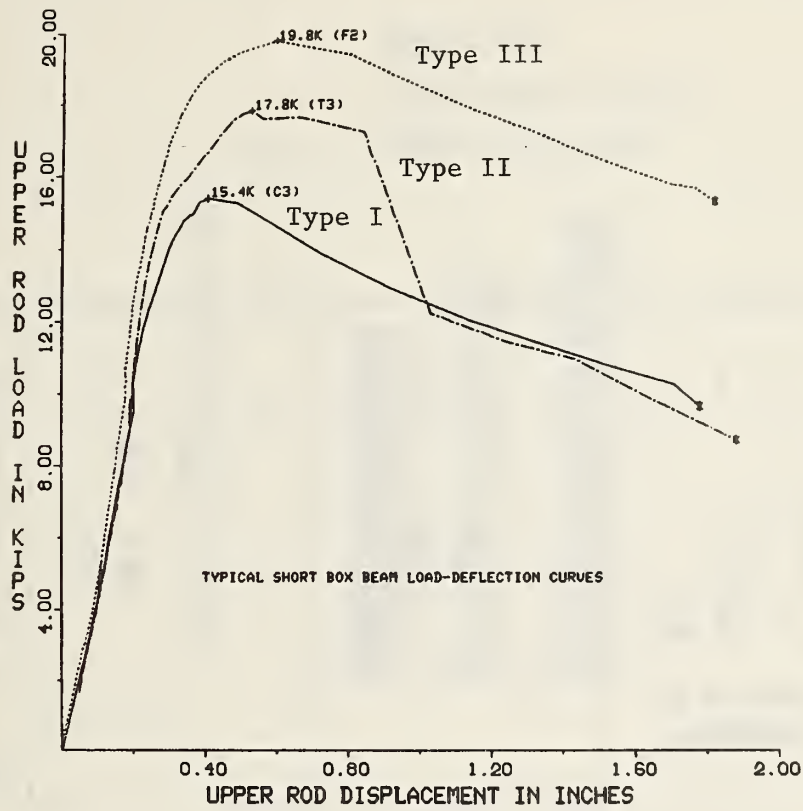
Figure 6.15 In-plane load deflection curves for specimens C-3, F-2, and T-3.

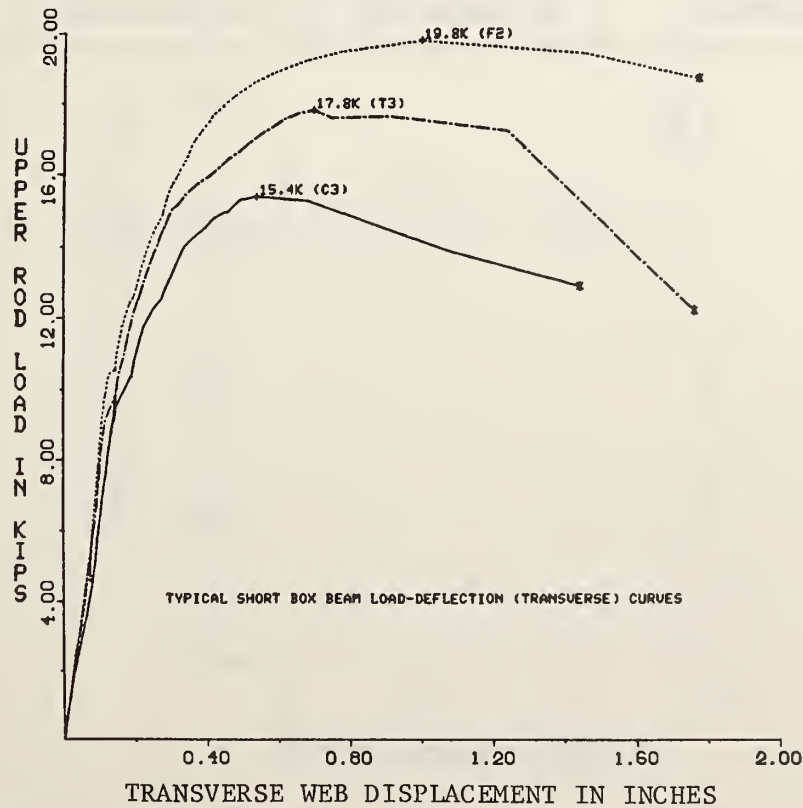
The out-of-plane load-deflection curves show the same trends as exhibited by the in-plane load-deflection curves. The out-of-plane load-deflection curves for the above described specimens are shown in figure 6.16. Each curve is a plot of the same load described for figure 6.15 versus the displacement measured by the middle transverse LVDT (figure 6.13). These data show that the web is beginning to deform outward shortly after the application of dead load from the second floor is started.

Figure 6.16 Out-of-plane web load displacement curves for specimens C-3, F-2, and T-3.

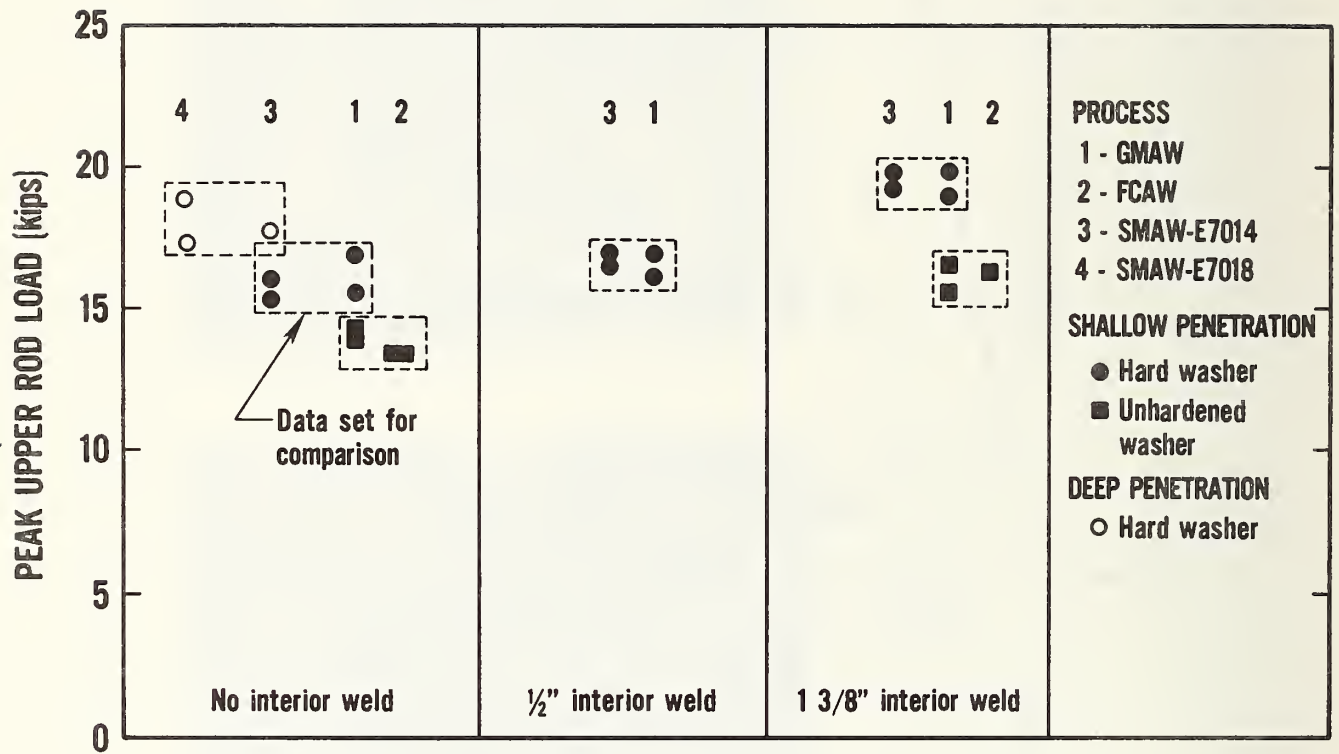
Comparisons between specimens in which the only intentional difference is the welding process appear in figure 6.17. Six sets of data, each consisting of comparable specimens, are shown enclosed in the figure. Hardened washer data are used where possible since it was found (section 6.10.5) that hardened washers were used in the actual walkway construction. The specimens compared for a particular process were fabricated at the same time. This selection of data was done to maintain as much similarity as possible since there was variation in the amount of weld material deposited and, as discussed in section 6.10.4, the peak upper rod load was later found to vary in proportion to weld area.

Figure 6.17 Effect of weld process.

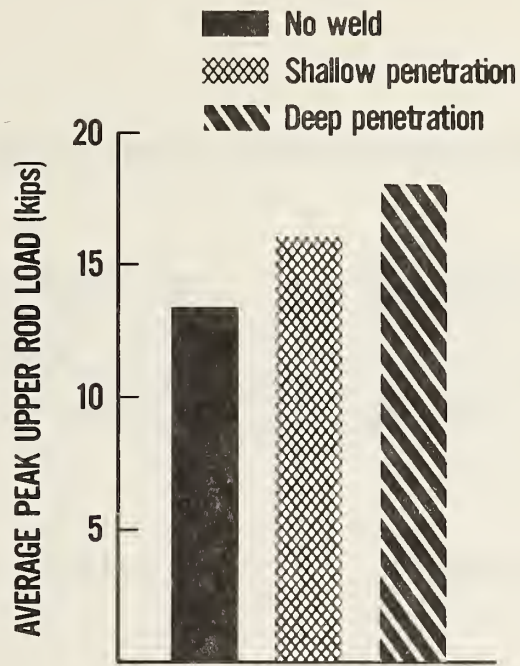
Figure 6.18 Effect of exterior weld penetration.

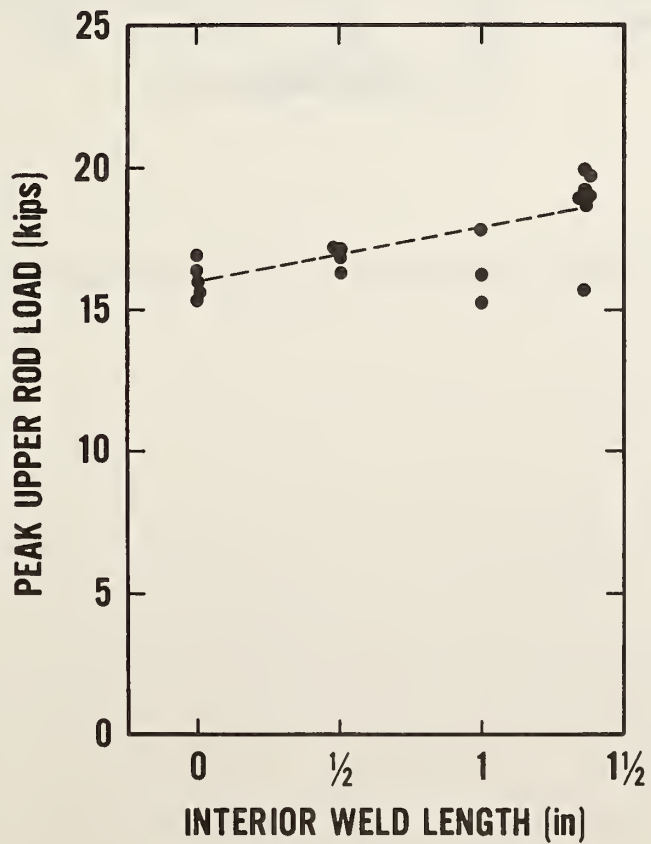
Interior Weld Length. The length of interior weld has a significant effect on load resistance of the short box beams. A limited comparison of test results is shown in figure 6.19 to illustrate this point. Data shown include shallow penetration weld specimens shown in table 6.1 except for variations due to weld position, washer thickness, nut shape, nut orientation, clip angle presence, initial rod load, and number of rods. Although a regression analysis was not done it is apparent that increasing the interior weld length increases the load resistance. The increase in load resistance is roughly linearly proportional to the increase in interior weld length. However length of interior weld alone is insufficient to account for load variation since it does not consider penetration of either the interior or exterior welds.

Figure 6.19 Effect of interior weld length on peak load.
