NBSIR 82-2465

Investigation of the Kansas City Hyatt Regency Walkways Collapse

February 1982

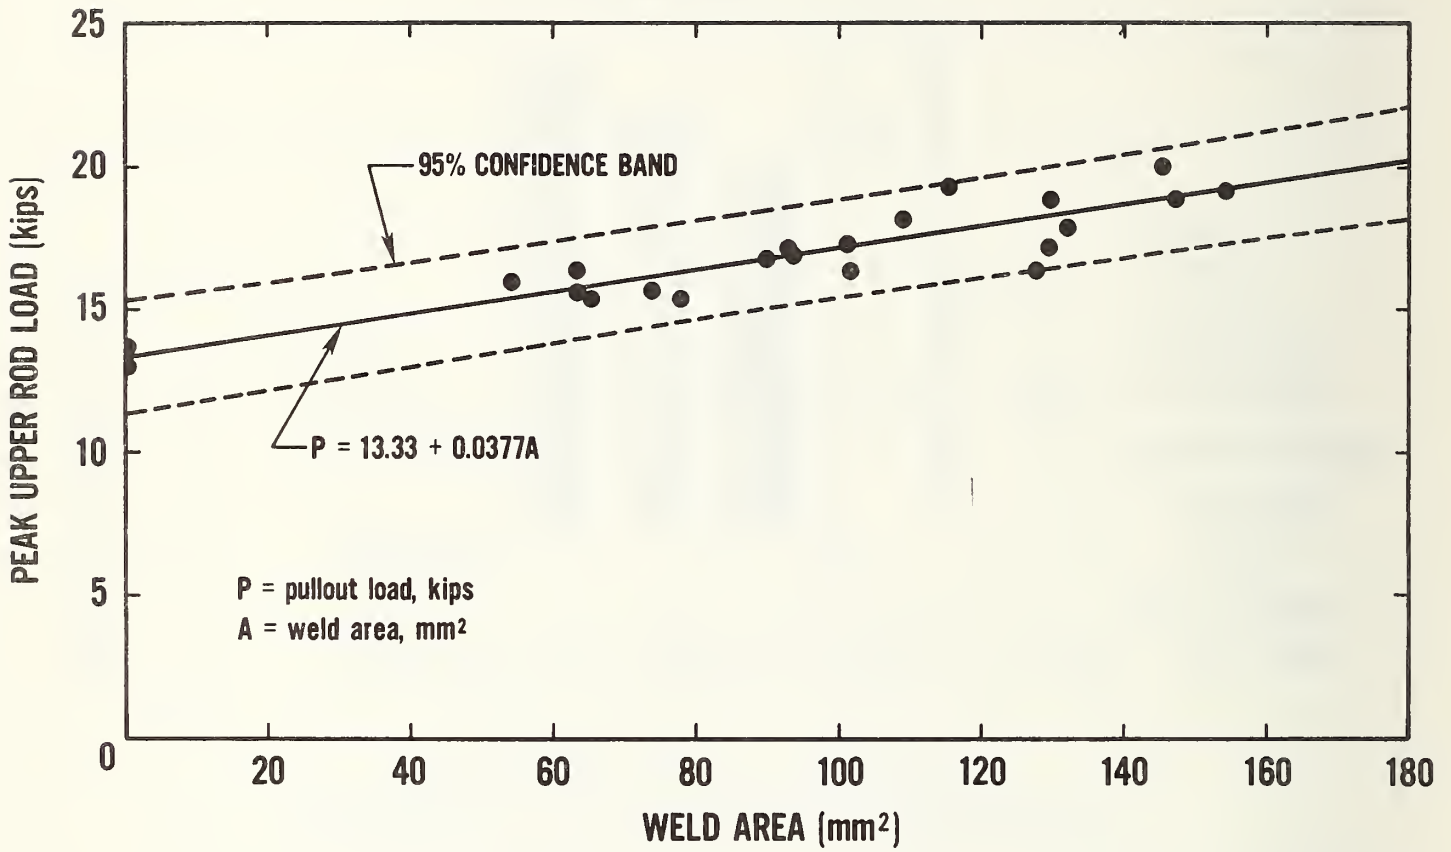
Weld Area. The effect of weld length and depth of penetration of the exterior and interior weld was examined by determining the interior and exterior weld areas between the beam end and the hole for the fourth floor rod. Fracture surfaces between the exterior hole and beam end were examined under magnification for all short box beam specimens. Lengths and depths were measured. Depths were measured at five locations and averaged. These average measurements are summarized in tables 6.1, 6.2, and 6.3, and 6.4 for the NBS tests. Weld area was determined as the sum of the products of the average depth and length for the exterior and interior welds. The peak upper rod load is plotted in figure 6.20 against the weld area. Weld area is used as a measure or index

The data shown in figure 6.20 include all tests on short box beams with hardened washers as listed in table 6.1 except for round nut bevel, initial rod load, single rod and clip angle presence. These latter parameters are discussed in section 6.10.5.

The correlation coefficient, r , is 0.90 for the equation for the mean peak upper rod load [6.2]. An r value of 1.0 indicates perfect correlation. The r^2 value is 0.80, indicating that 80 percent of the total variation in the peak upper rod load is accounted for by the regression line. The other 20 percent is unaccounted for by the weld area alone. Thus the equation for the mean based on the weld area is a reasonable representation of the load resistance within the range of the test data. A 95 percent confidence band for the data is also shown in figure 6.20. Ninety five percent of the test results for individual specimens are expected to be within the limits of the band.

Figure 6.20 Effect of weld area on peak load, hardened washers.

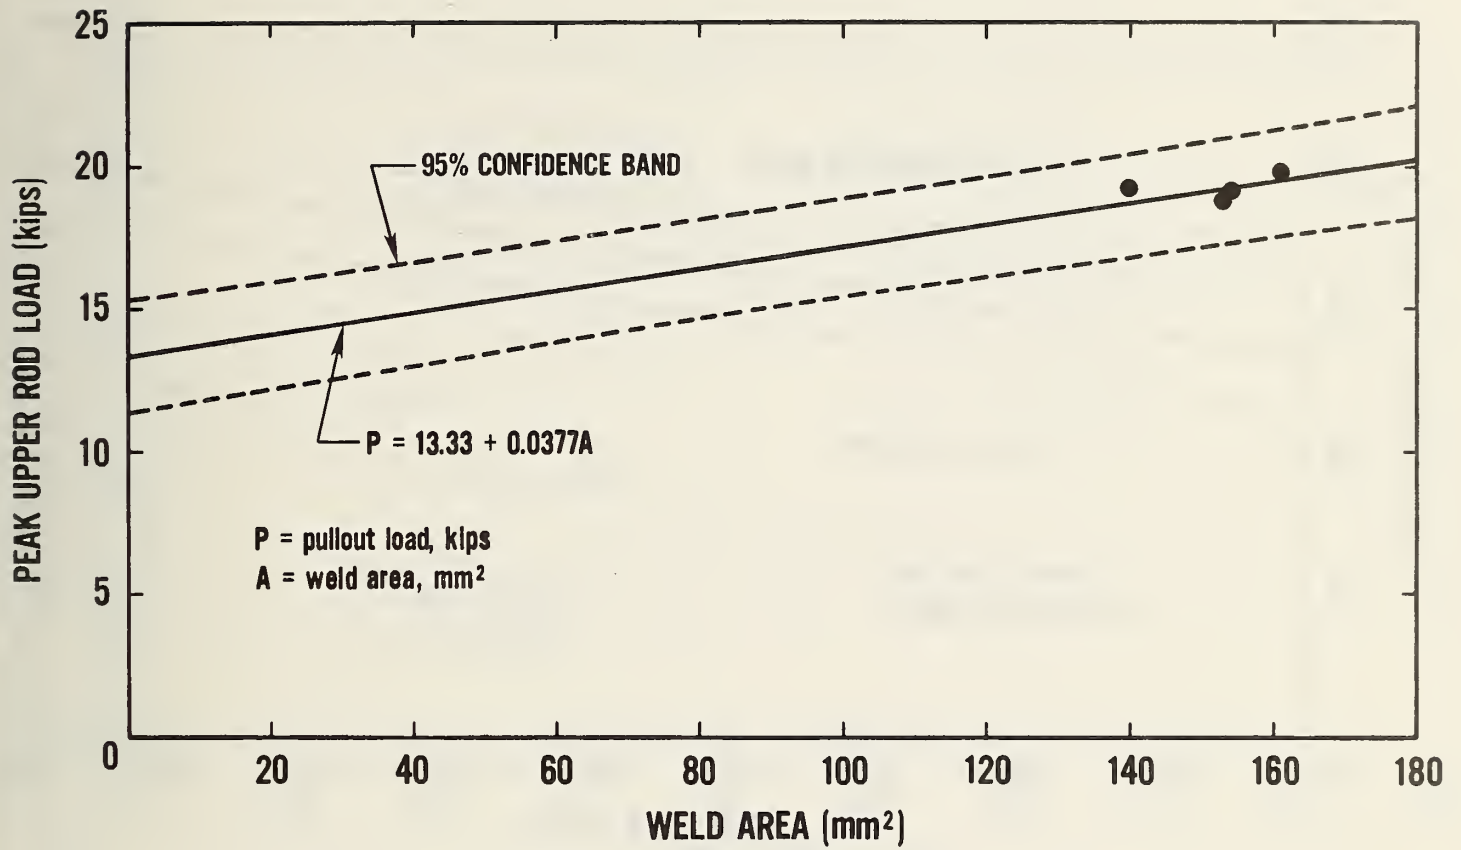
The presence of clip angles does not significantly affect the peak upper rod load capacities of the short box beams as is apparent from the data for specimens S1-S4 shown in figure 6.21 compared to the mean peak upper rod load and the 95 percent confidence band. This observation was expected based on the zone of distress observed on the white-washed box beams since the zone of distress did not extend to the location of the stringer-box beam clip angle.

Figure 6.21 Effect of clip angles.

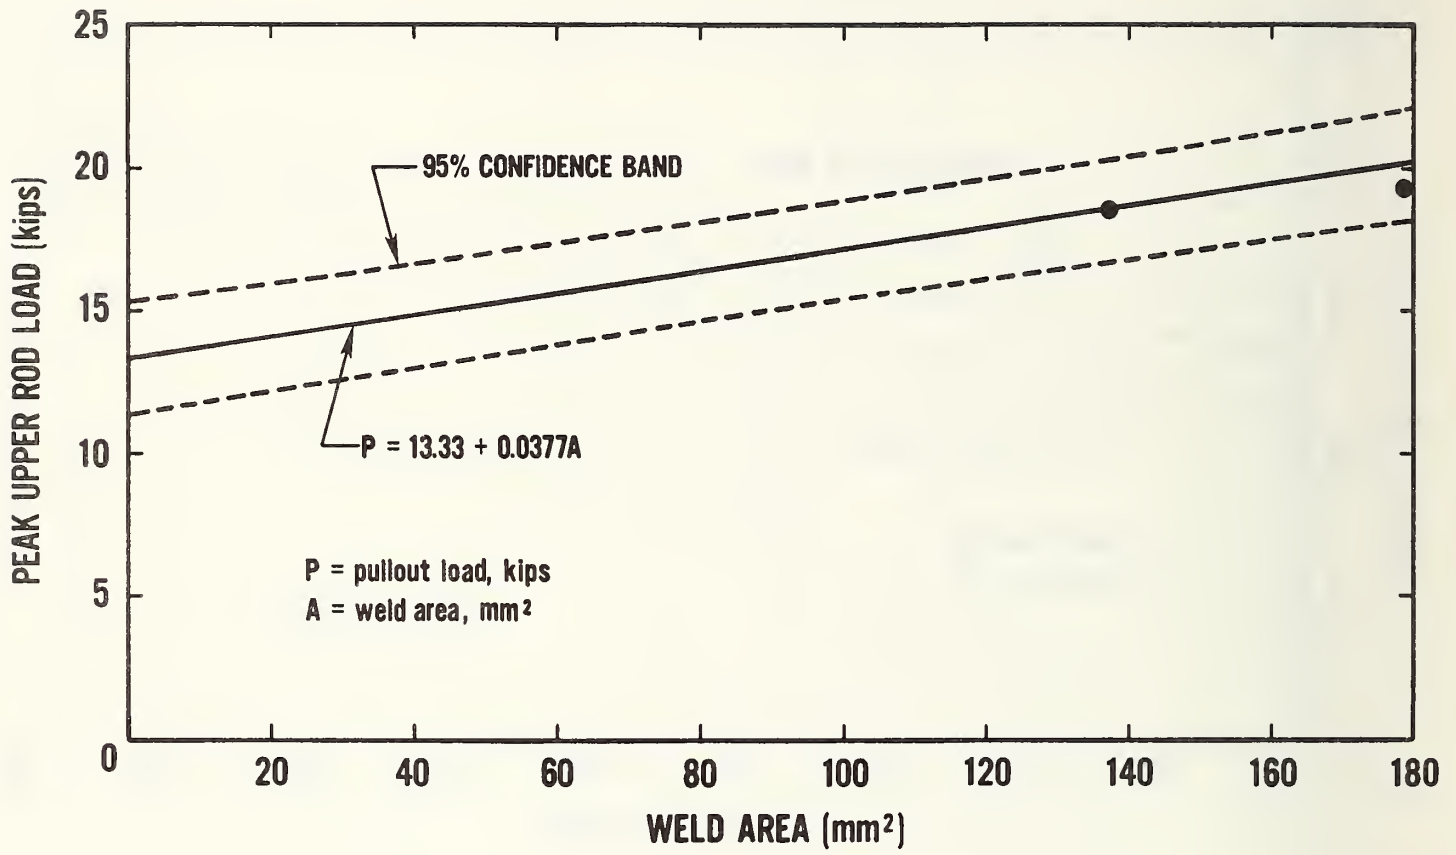
Initial Upper Rod Load. The short box beam tests began prior to the weighing of the walkway spans. The nominal upper walkway dead load was calculated on the basis of the contract drawings and thus for this part of the laboratory test program the dead load contribution to the upper hanger rod was set at 7500 pounds (33 kN) in all but three of the short box beam tests. The two remaining specimens were tested using an initial upper rod load of 9000 pounds (40 kN) to examine the effect of the initial rod load on the load resistance of the box beam-hanger rod connection. As evidenced by a comparison of these two tests (figure 6.22) with the regression analysis from figure 6.20, the influence of initial upper rod load on peak load capacity is insignificant for the range of 7500 pounds (33 kN) to 9000 pounds (40 kN).

Figure 6.22 Effect of initial upper rod load.

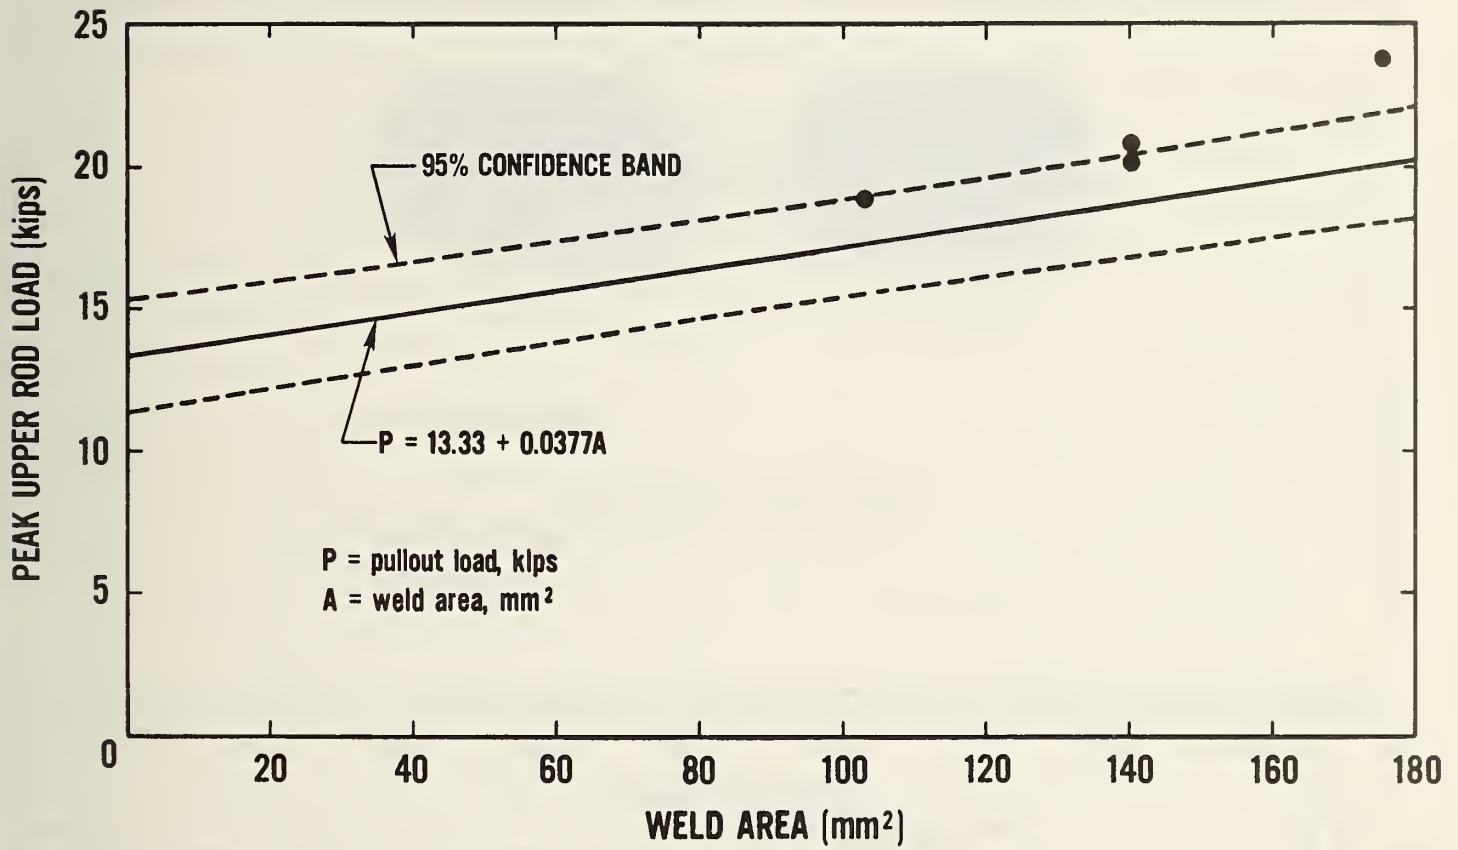
A comparison of the single rod data for B2, H1, X1 and X2 listed in table 6.1 is presented in figure 6.23. These data are consistently about 2.0 kips (9 kN) higher than the mean for double rods for a given weld area. Thus the single rod tests are considered to be outside the range of the regression analysis and were not used as part of the data base in estimating load resistance of connections loaded by two hanger rods.

Figure 6.23 Effect of loading configuration.

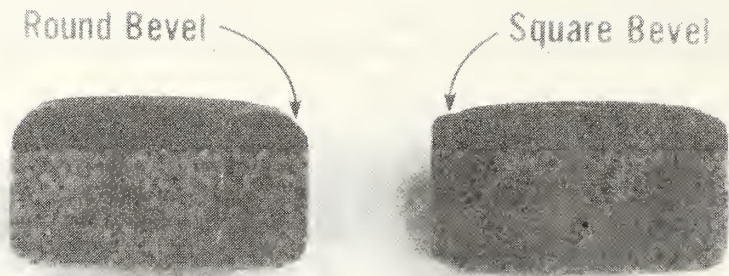
Nut Shape. Based on the observed dimensions of the walkway hanger rod nuts it was determined that they were 1 1/4 in (32 mm) heavy hex nuts. Such nuts were procured locally and their dimensions were similar to the walkway hanger rod nuts. However, the amount of bevel at the intersection of corners and bearing surface was greater on the actual walkway hanger rod nuts (figure 6.24). The effect of nut shape was explored by testing two specimens with nuts which were altered to a geometry similar to the walkway hanger rod nuts. This is referred to as a "round" nut bevel while the nut used on most tests has a "square" bevel.

Figure 6.24 Nut shape.

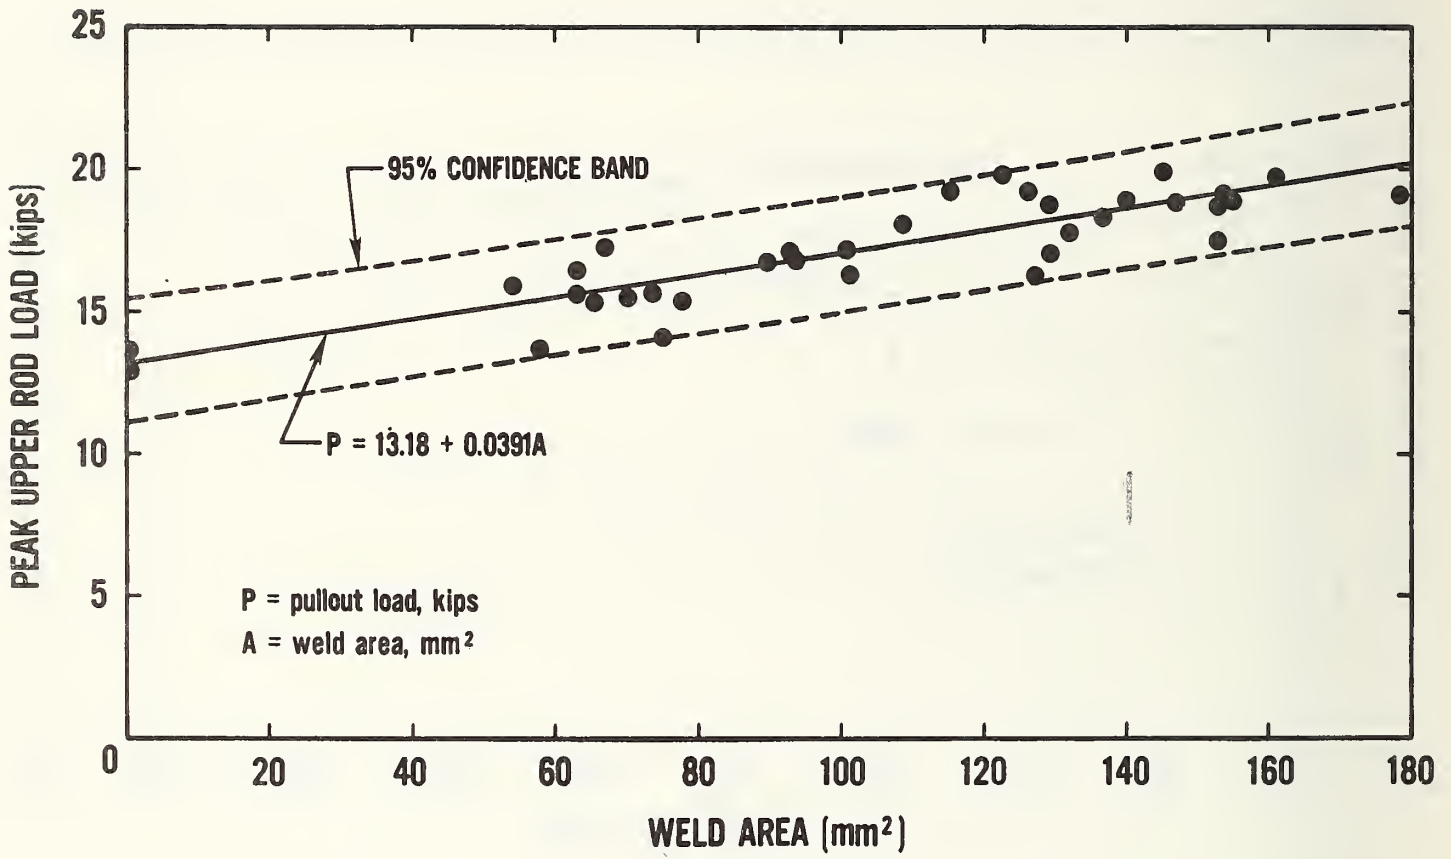
Although these comparisons indicate that the regression analysis based on the data shown in figure 6.31 reflects the trend of the walkway data, the walkway section is slightly heavier than the section used in the NBS tests, as shown in table 6.6. Thus, somewhat greater ultimate strength might be anticipated for the walkway cross-sections. This heavier cross-sectional area may explain why the test data fall essentially between the average and the upper portion of the confidence band with none below (recall that KC4 was tested with an unhardened washer).

Figure 6.31 Effect of weld area on pullout load for NBS tests.

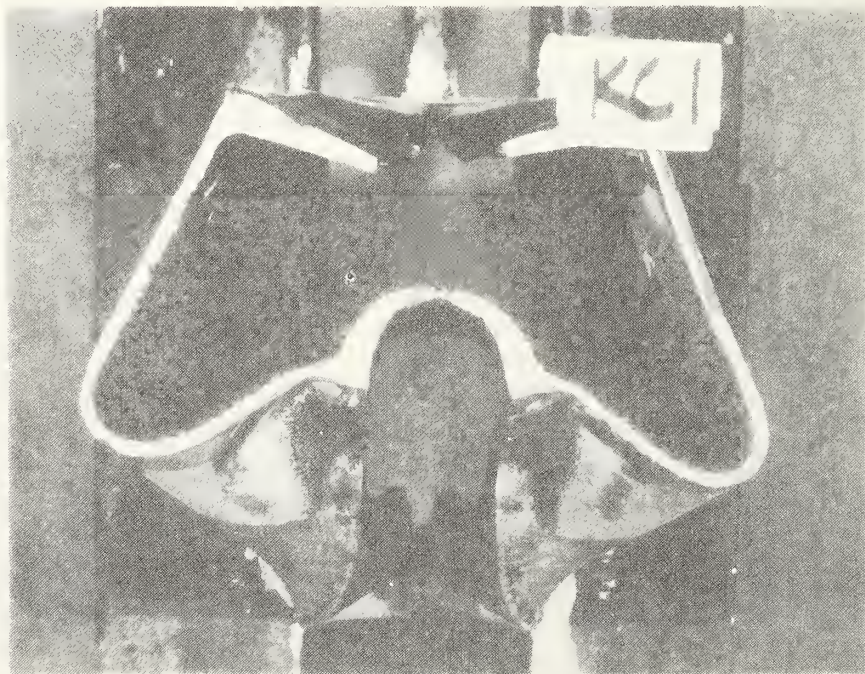
Figure 6.35 Deformed shape of walkway specimen KC1.

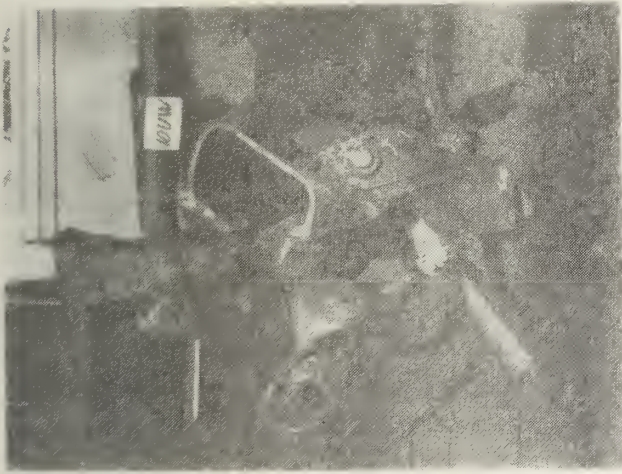
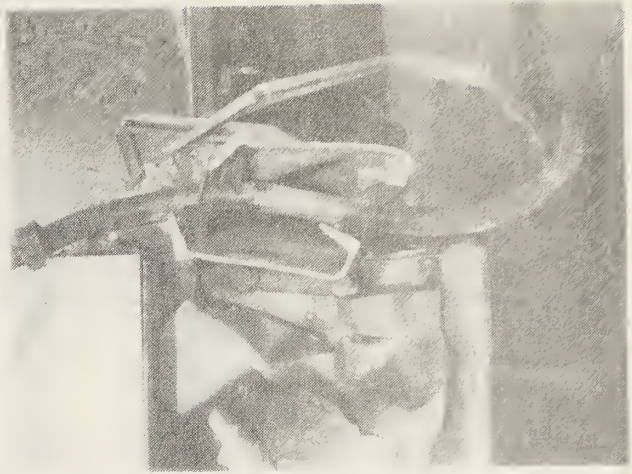
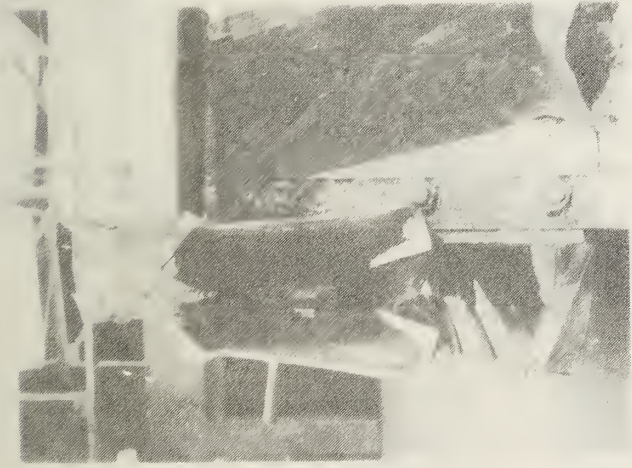
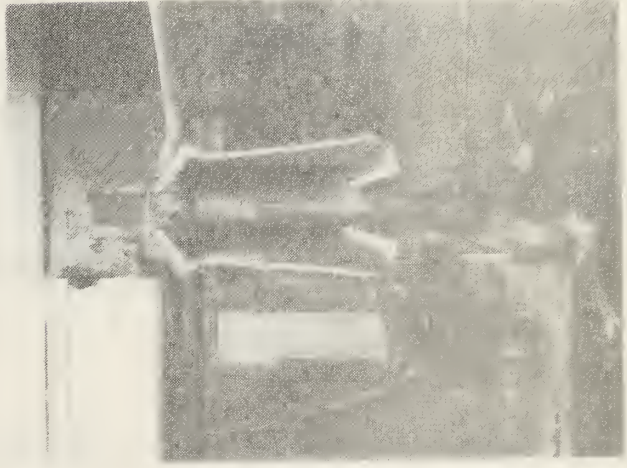
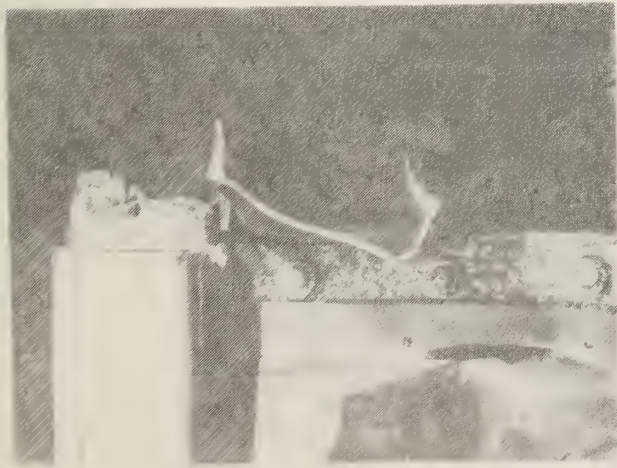
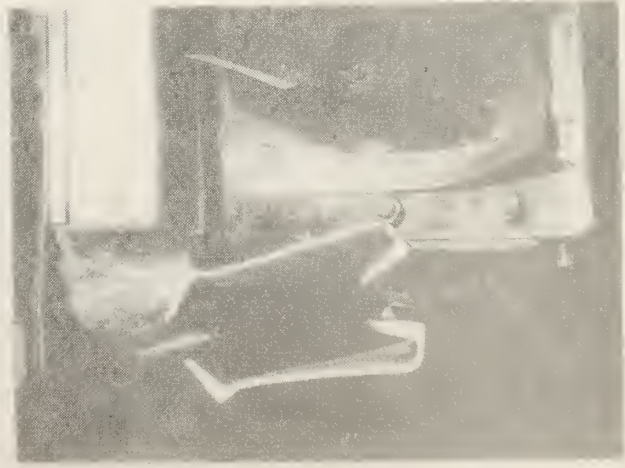
Figure 6.36 Walkway deformed shapes.

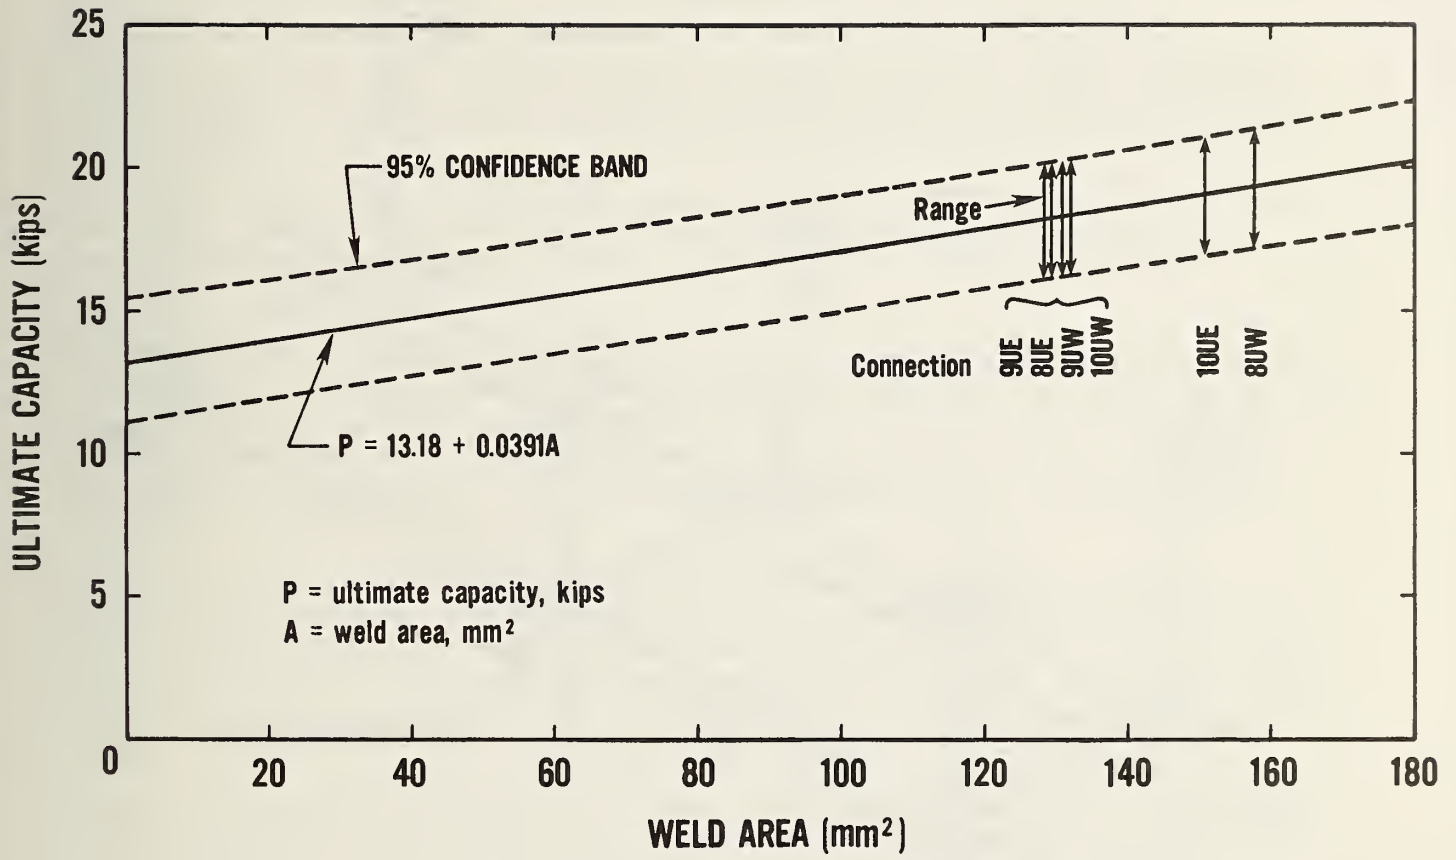
The meaning of figure 6.38 is amplified by discussing box beam-hanger rod connection 9UE as an example. Simply described, if many specimens like 9UE were tested, their average should fall close to the regression line. However, for a single test one can be 95 percent confident that the test result would fall within the 95 percent confidence band. Thus each connection should be thought of in terms of the range of ultimate strength as well as the average.

Figure 6.38 Estimated ultimate capacity for walkway box beam-hanger rod connections.

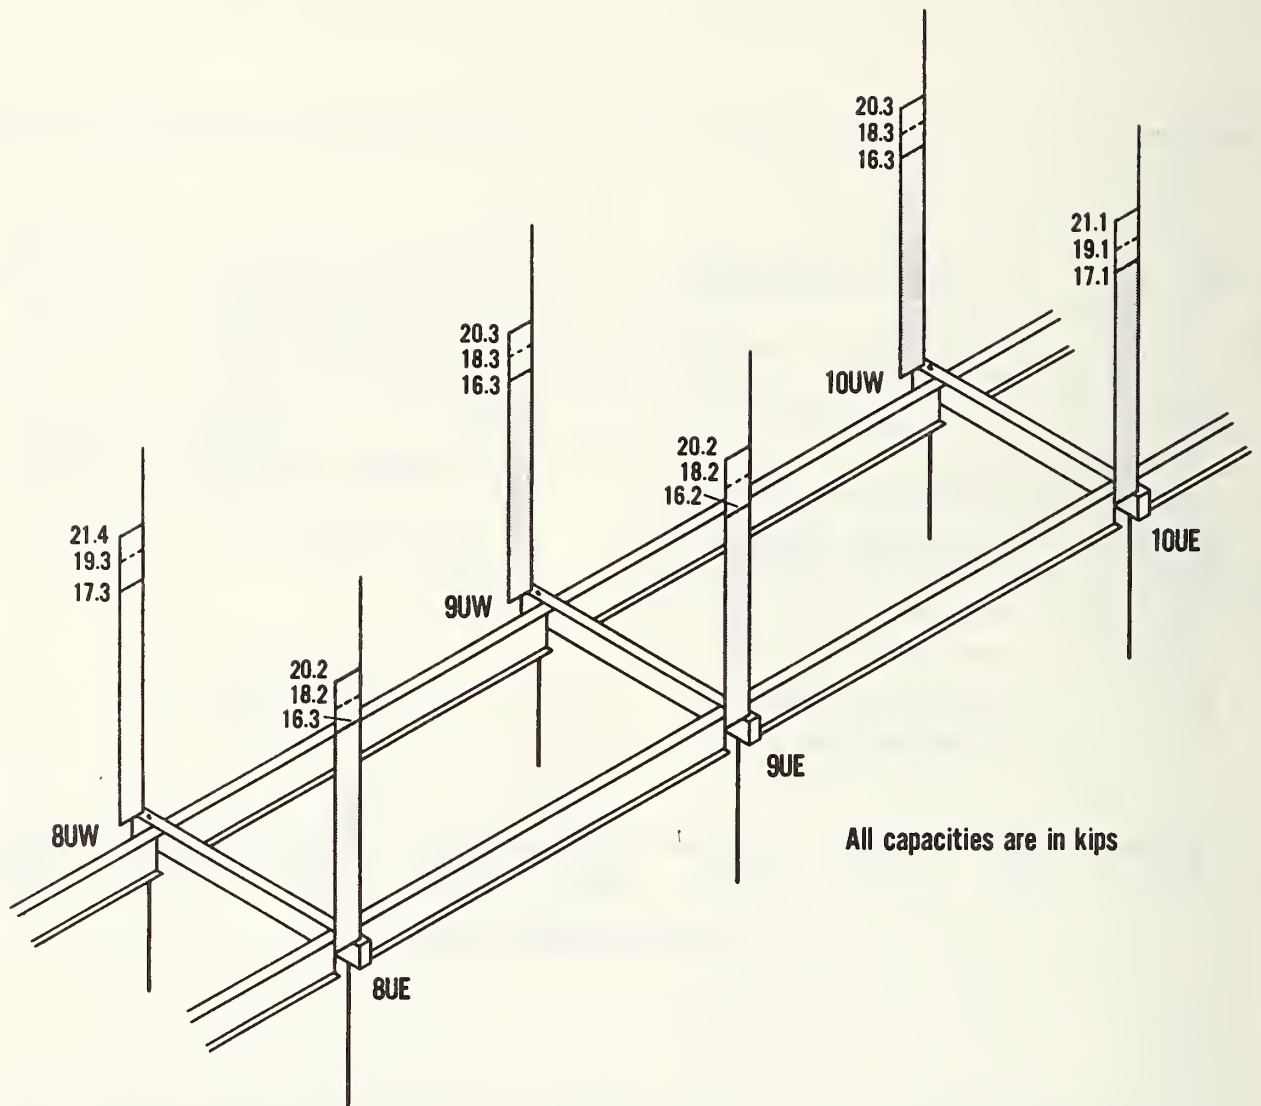
These ultimate capacities are summarized in figure 6.39 on a layout of the six box beam-hanger rod connections. A bar diagram is shown adjacent to each hanger rod. Location 8UE is described to denote the meaning. The range from 16.3 to 20.2 kips (73 to 90 kN) is the 95 percent confidence interval estimate

Figure 6.39 Summary of ultimate capacities.

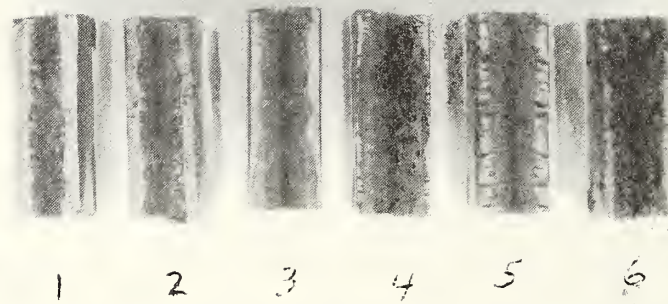
Variation in the transverse strength of the walkway box beam longitudinal welds was determined by testing 1.0 in (25.4 mm) wide tensile coupons to failure. Weld caps were machined flush to simulate conditions near the beam ends. The results, summarized in table 7.5, show a substantial variation in breaking load among specimens taken from the same beam. The observed variability is not unusual for the type of weldment tested considering the small weldment area sampled by each specimen. Figure 7.9 shows the variability in the amount of weld metal from specimen to specimen at the fracture. This variability correlates reasonably well with the specimen breaking loads (table 7.5). Differences in the amount of porosity found on the fracture surfaces of the specimens also contribute to the ultimate strength variation.

Figure 7.9 Fracture surfaces of walkway weldment tensile specimens. Both halves of each fracture are shown. The bright regions represent fracture and indicate the depth of weld penetration. Specimen key is as follows. X1

1. 1BX3W2
2. 1BX3W4
3. 2BX3W2
4. 2BX3W4
5. 3BW4
6. 3BW1

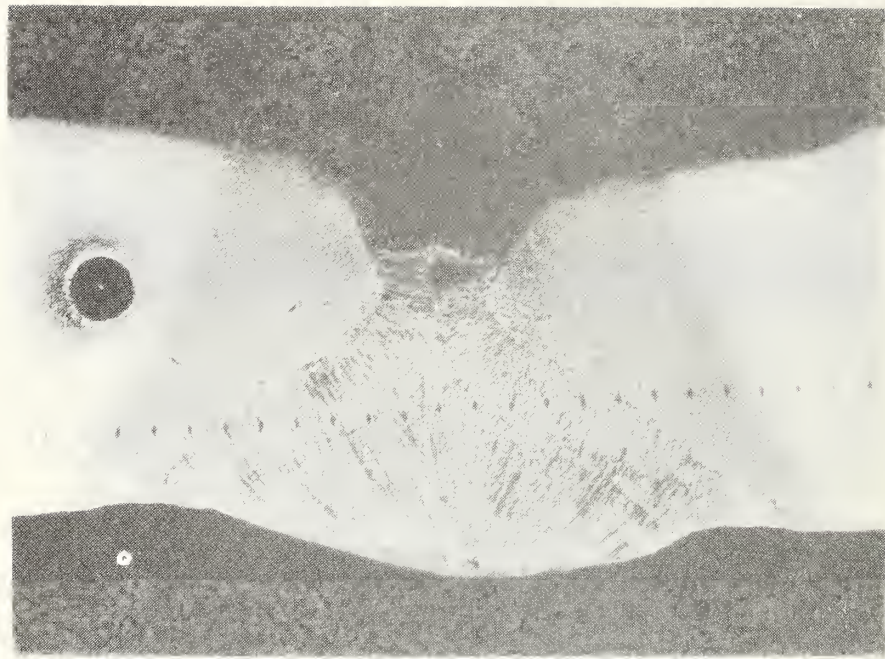
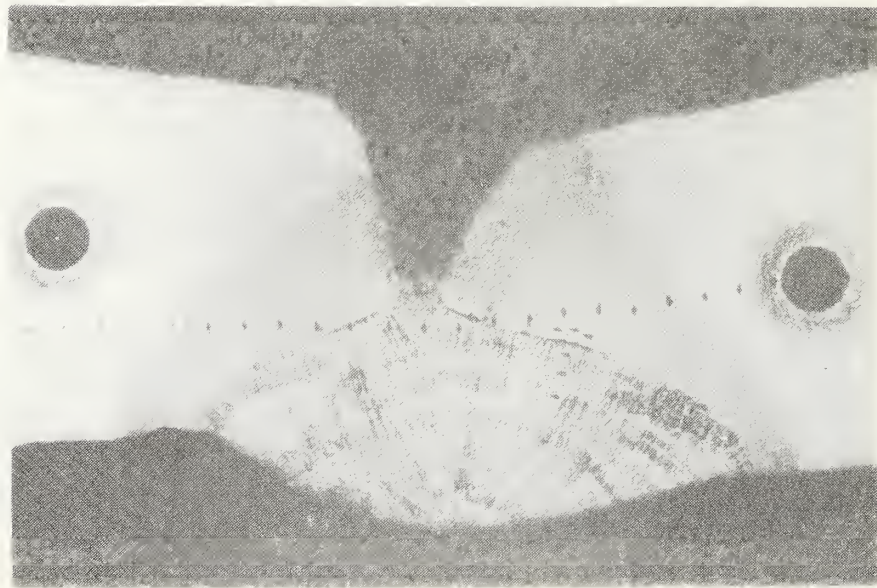
Figure 7.10 illustrates the appearance of an NBS weldment made by the GMAW process, while figures 7.11-7.13 illustrate the appearance of weld regions in box beams 9U, 8L and 9M, respectively. Basic walkway weldment hardnesses were normal. Maximum hardnesses were 92-95 Rockwell B (HRB) for the weld regions, 85-93 HRB for the heat-affected zones and 70-79 HRB for the unaffected parent metal. Small zones of increased hardness (28-33 HRC) were noted in the heat-affected zones of one section taken from location 9U and one section taken from location 8L. The structure of the hard zones appeared to be tempered martensite.

Figures 7.10 to 7.13 illustrate a substantial variability in the contour of the mating flange ends forming the faying surfaces for welding. The effect, coupled with differences in weld penetration, creates regions of varying notch acuity in the weld region. However, no cracks were observed to have initiated from such notches in any of the sections studied.

Figure 7.11 Cross sections through weld regions of box beam 9U (NBS 1). Sections were separated about 7 in (180 mm) along the beam length. Microhardness indentations traverse the surfaces. X 8 1/2

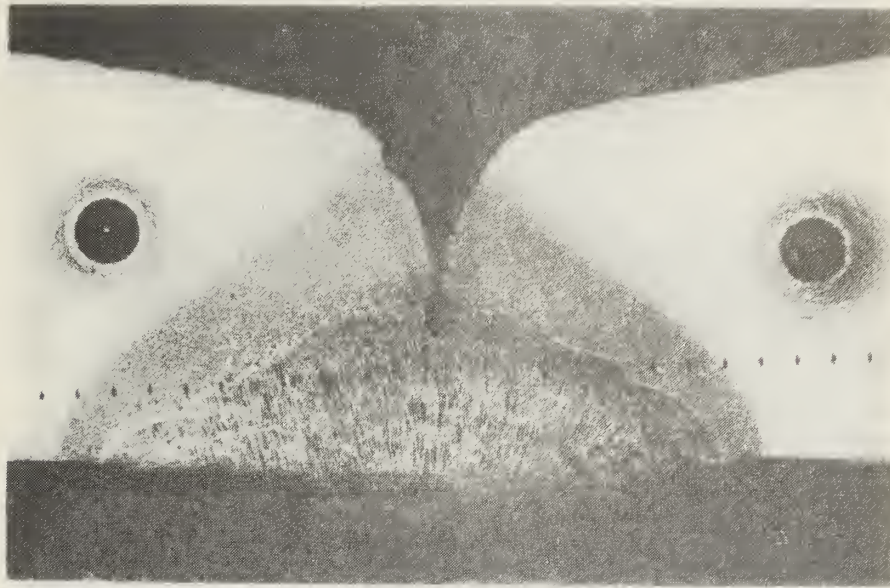
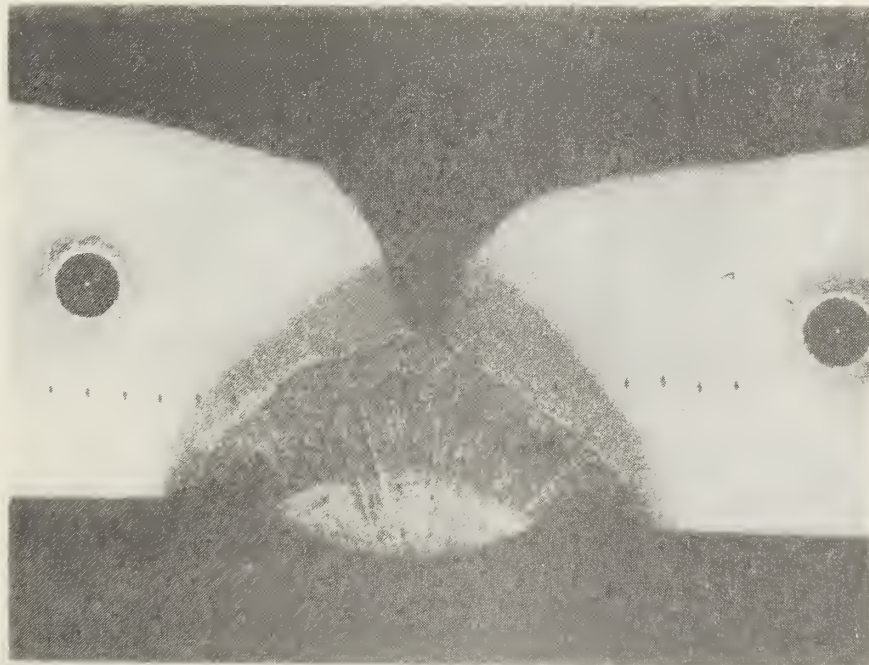
Figure 7.12 Cross sections through weld regions of box beam 8L. Sections were separated about 7.5 in (190 mm) along the beam length. Microhardness indentations traverse the surfaces. X8 1/2

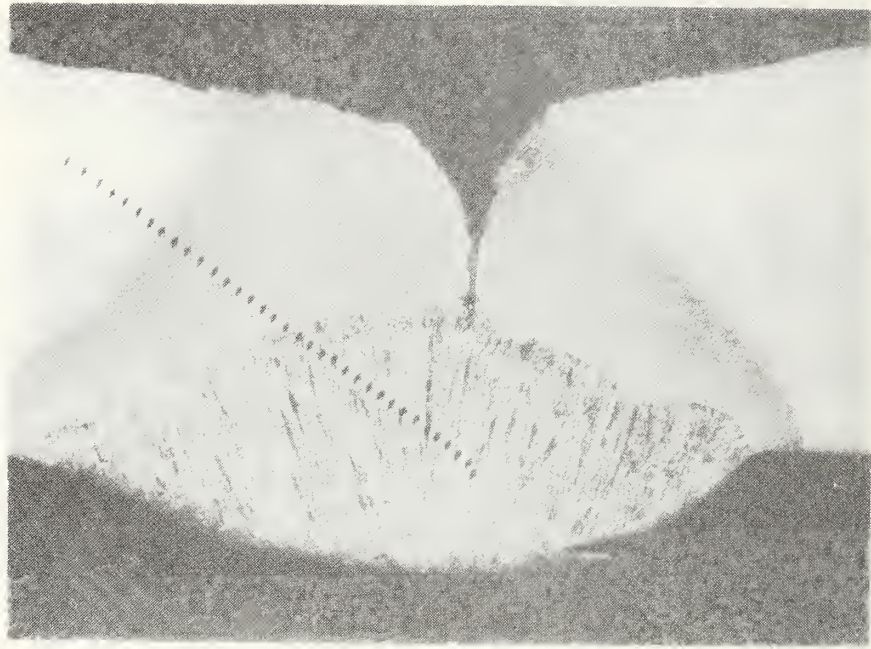
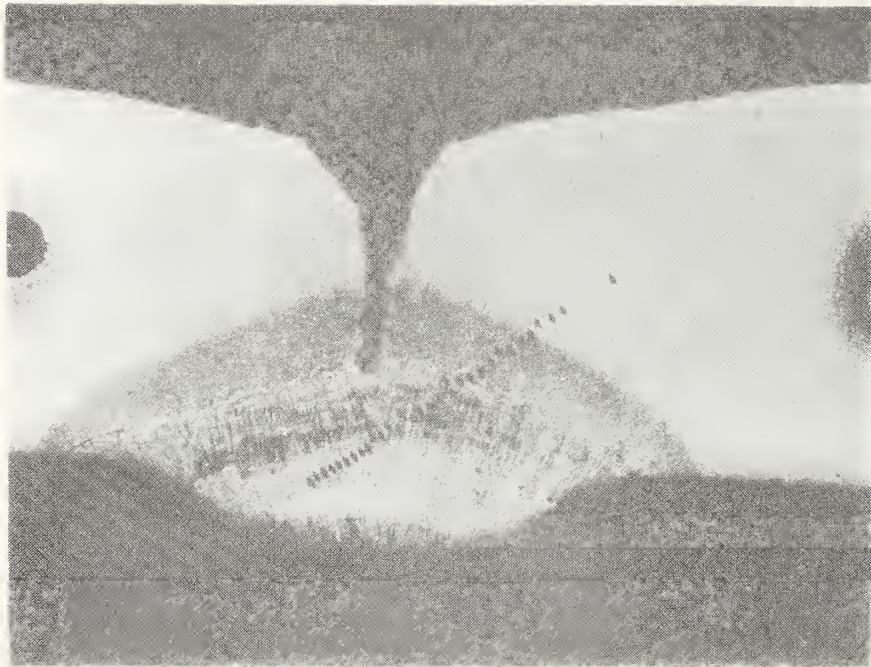
Figure 7.13 Cross sections through weld regions of box beam 9M. Sections were separated about 7.5 in (190 mm) along the beam length. Microhardness indentations traverse the surfaces. X8 1/2

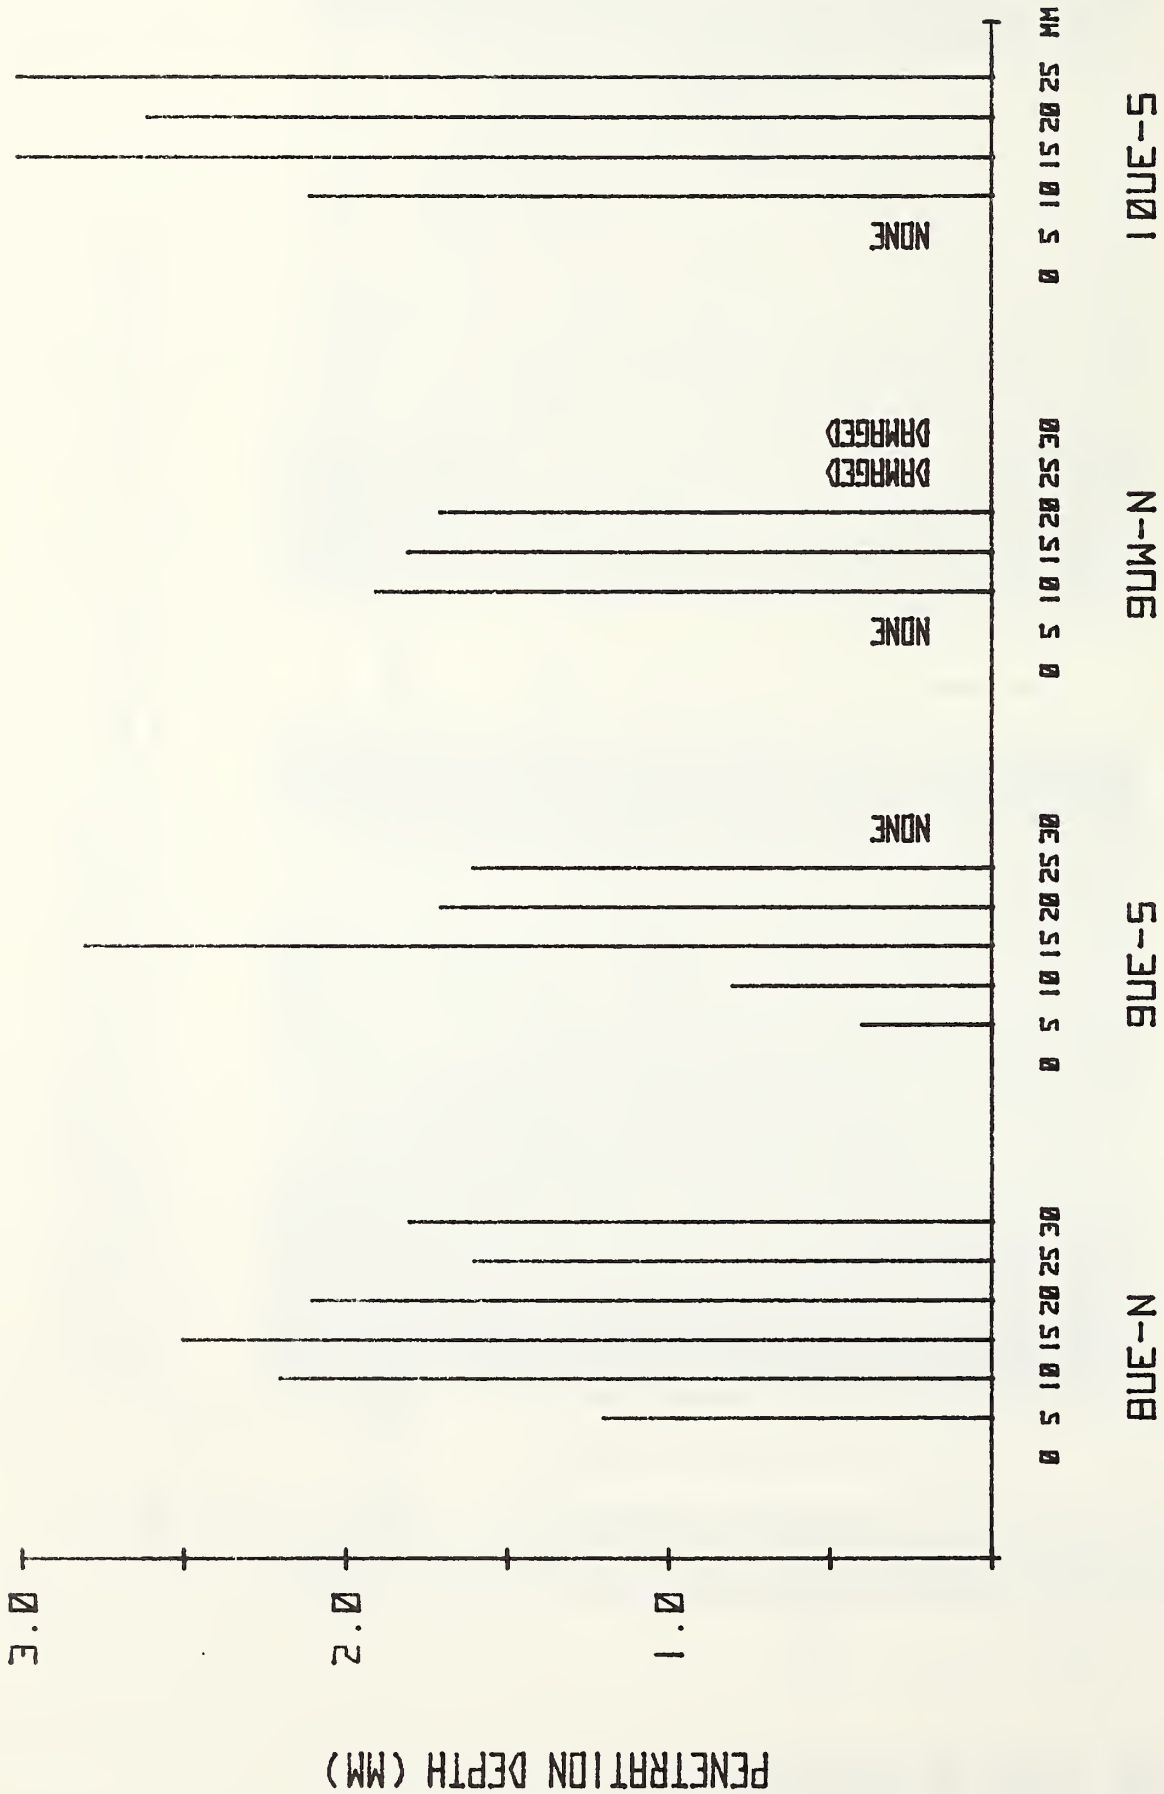
Interior tack welds were present at the bottom flanges of all beam ends examined. The location of these welds relative to the beam ends and their approximate overall depth as measured from photographs of the fractures are shown in figure 7.15. Estimates were made of the total area of interior tack weld plus the longitudinal weld in the box beam length between the outer hanger rod hole and the box beam end. The data in table 7.6 were compiled by measuring the penetration depth of the longitudinal and tack welds along the fractures at

Figure 7.15 Overall depth of interior tack welds measured from fractures with data points reflecting equally spaced measurements from beam end (left) to hanger rod hole (right). NONE indicates no tack weld at that location.

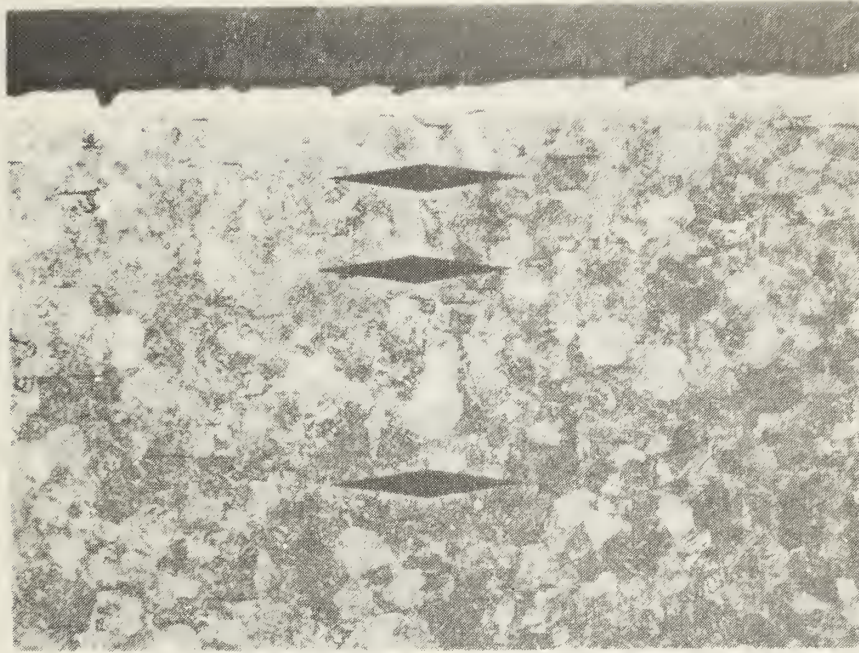
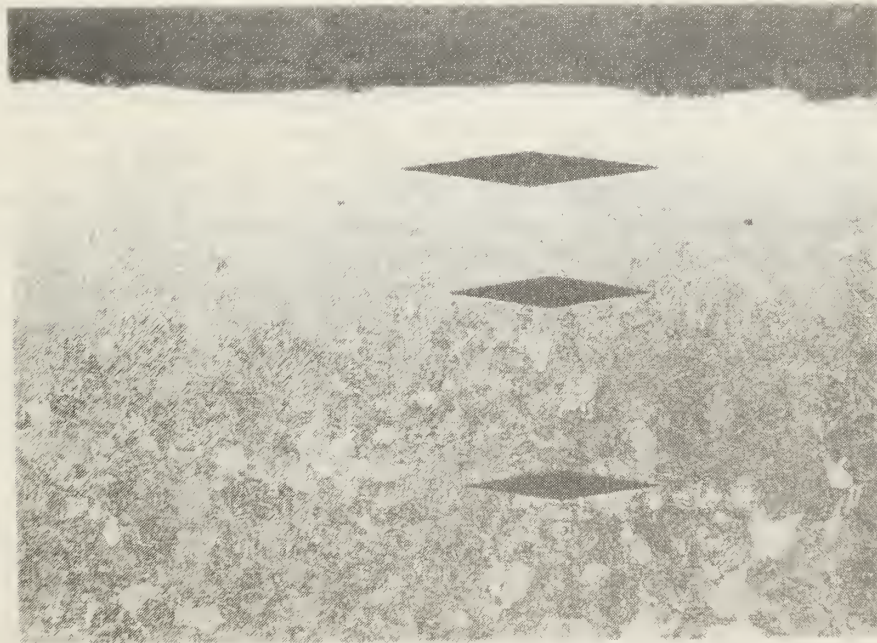
Figure 7.16 Microstructures of washers from 9MW (NBS specimen 3), (a), and of hardened washer used in NBS tests, (b). Whiter layer near surface (top of illustrations) is decarburized layer. Interior structure is tempered martensite. Etchant: Picral. X200

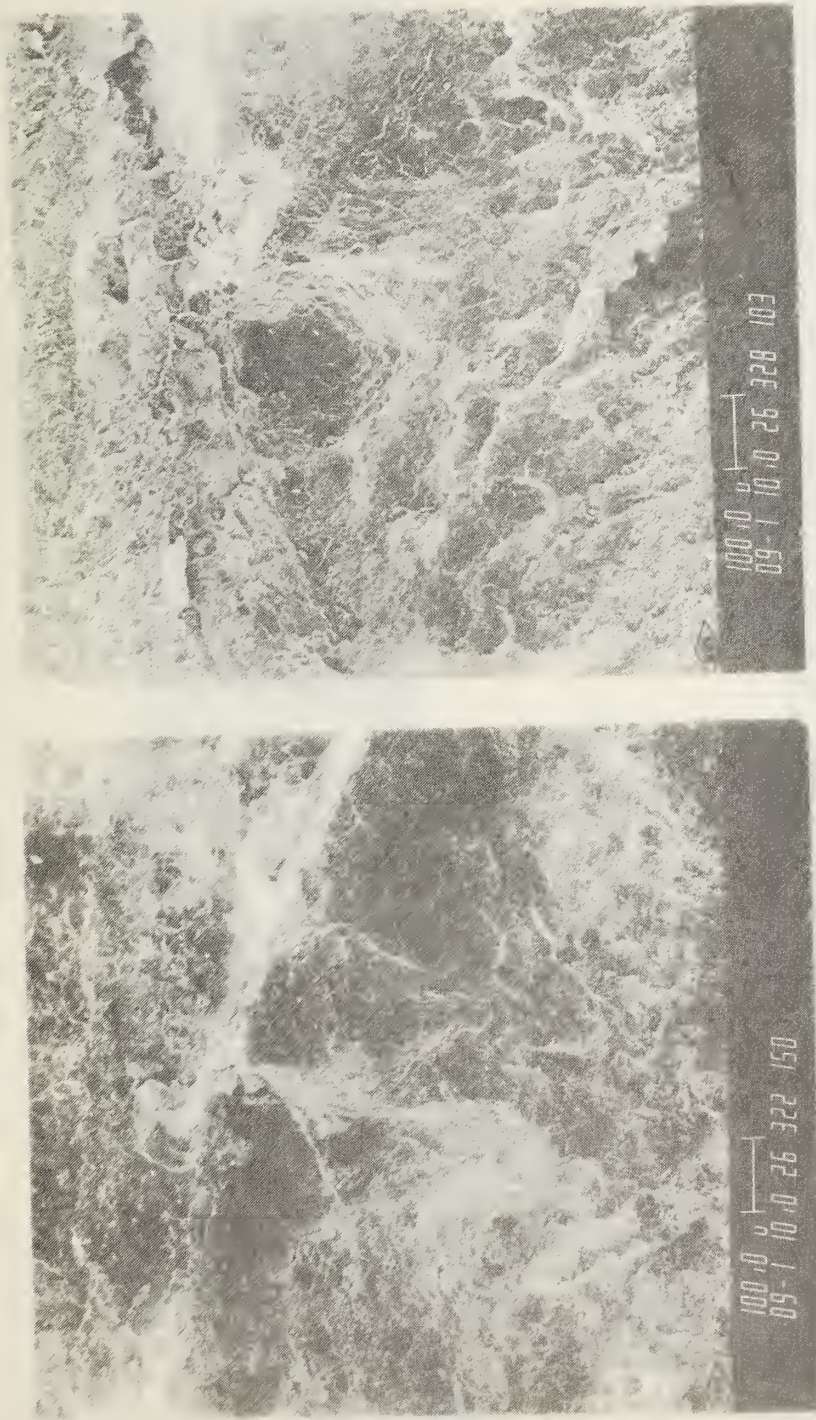
Figure 8.1 Comparison of quality of image by direct SEM (a) and by replication (b) where replica contact is ideal. Fracture surface is located at root of upper exterior longitudinal weld of walkway box beam at location 8UW (north). Magnification X100.
