NBSIR 82-2465

Investigation of the Kansas City Hyatt Regency Walkways Collapse

February 1982

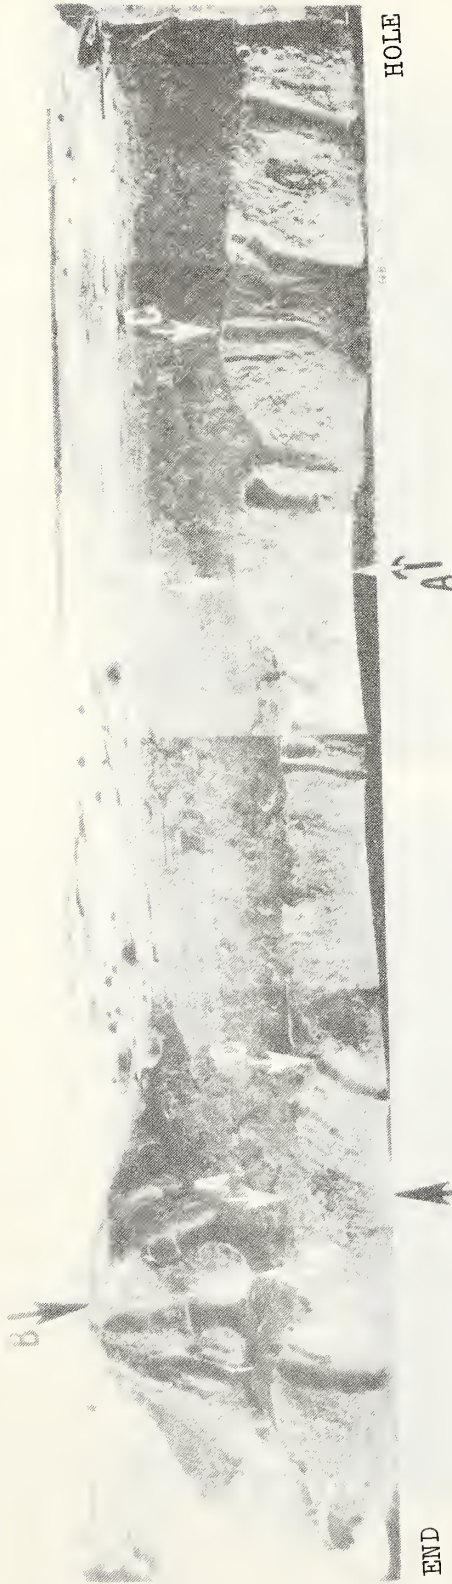
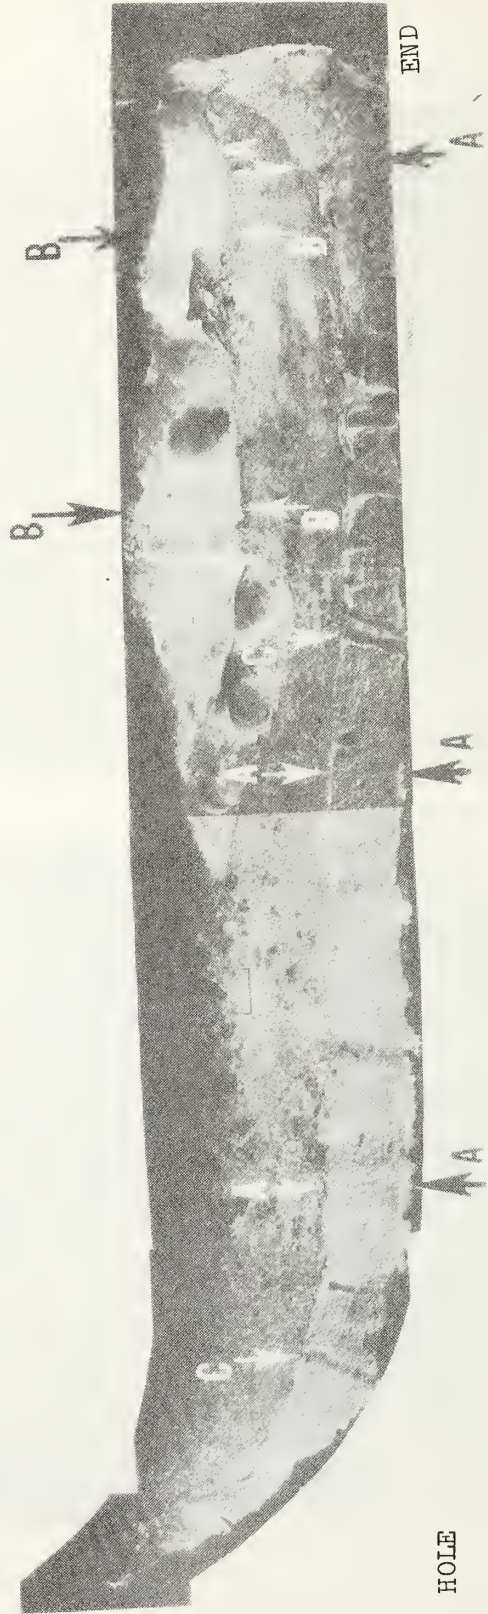
Figure 8.2 illustrates that the gross features of the fracture in the lower longitudinal weld between the outer hanger rod hole and beam end of box beams tested to failure were similar, regardless of whether the beam had been fabricated at NBS or had been obtained from the walkway debris. Rounded and piping porosity are evident in both fractures. The sharply delineated weld region in these figures indicates the absence of rust on the freshly fractured surfaces.

Figure 8.2 One half of box beam fracture surface between beam end and outer hanger rod hole for NBS fabricated box beam K2 (a) and for walkway box beam 9M tested at NBS (b). Exterior longitudinal weld indicated by arrows A, interior tack weld indicated by arrows B, examples of piping porosity indicated by arrows C. Magnification X6.

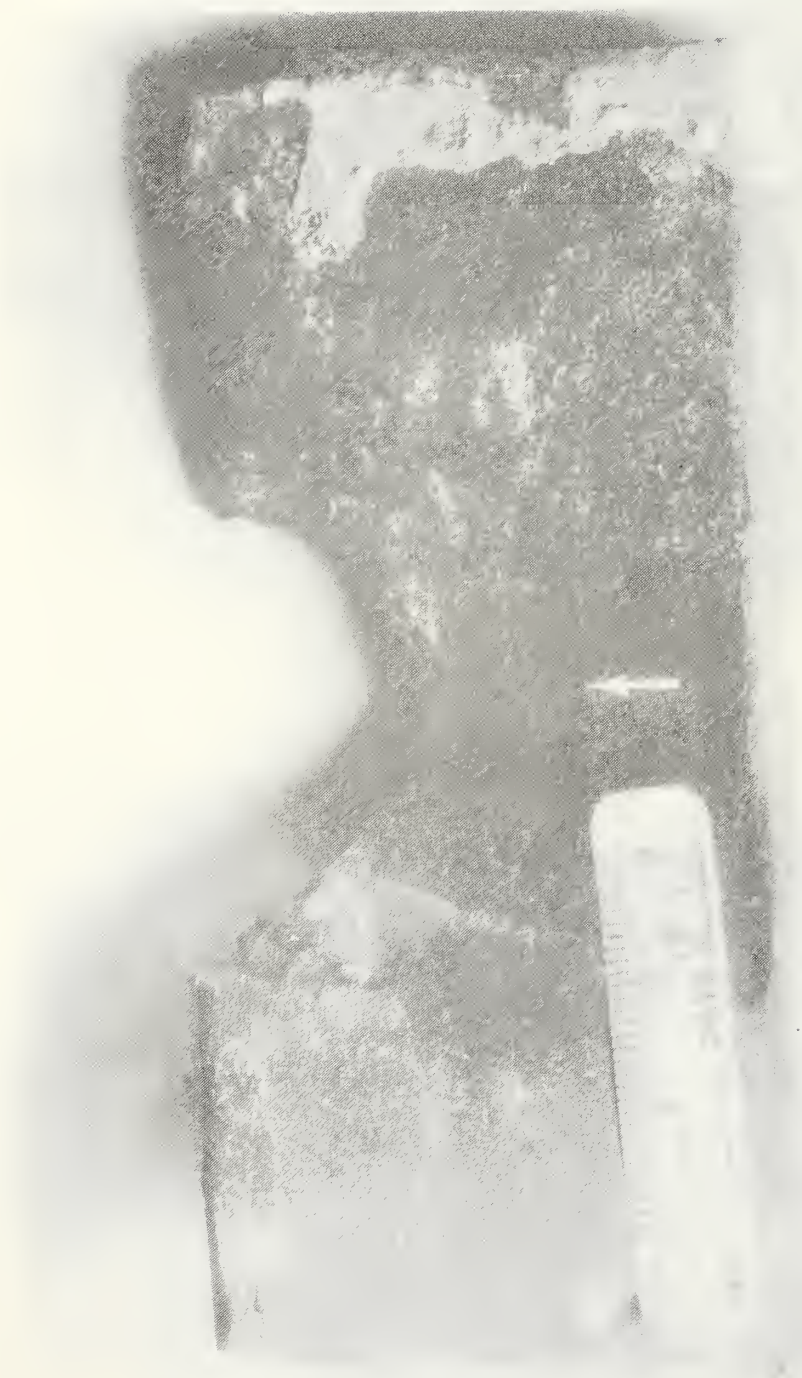
Figure 8.10 Washer contact region on bottom flange at location 8UE (north).
Arrow denotes initial washer position. Magnification X1.5.

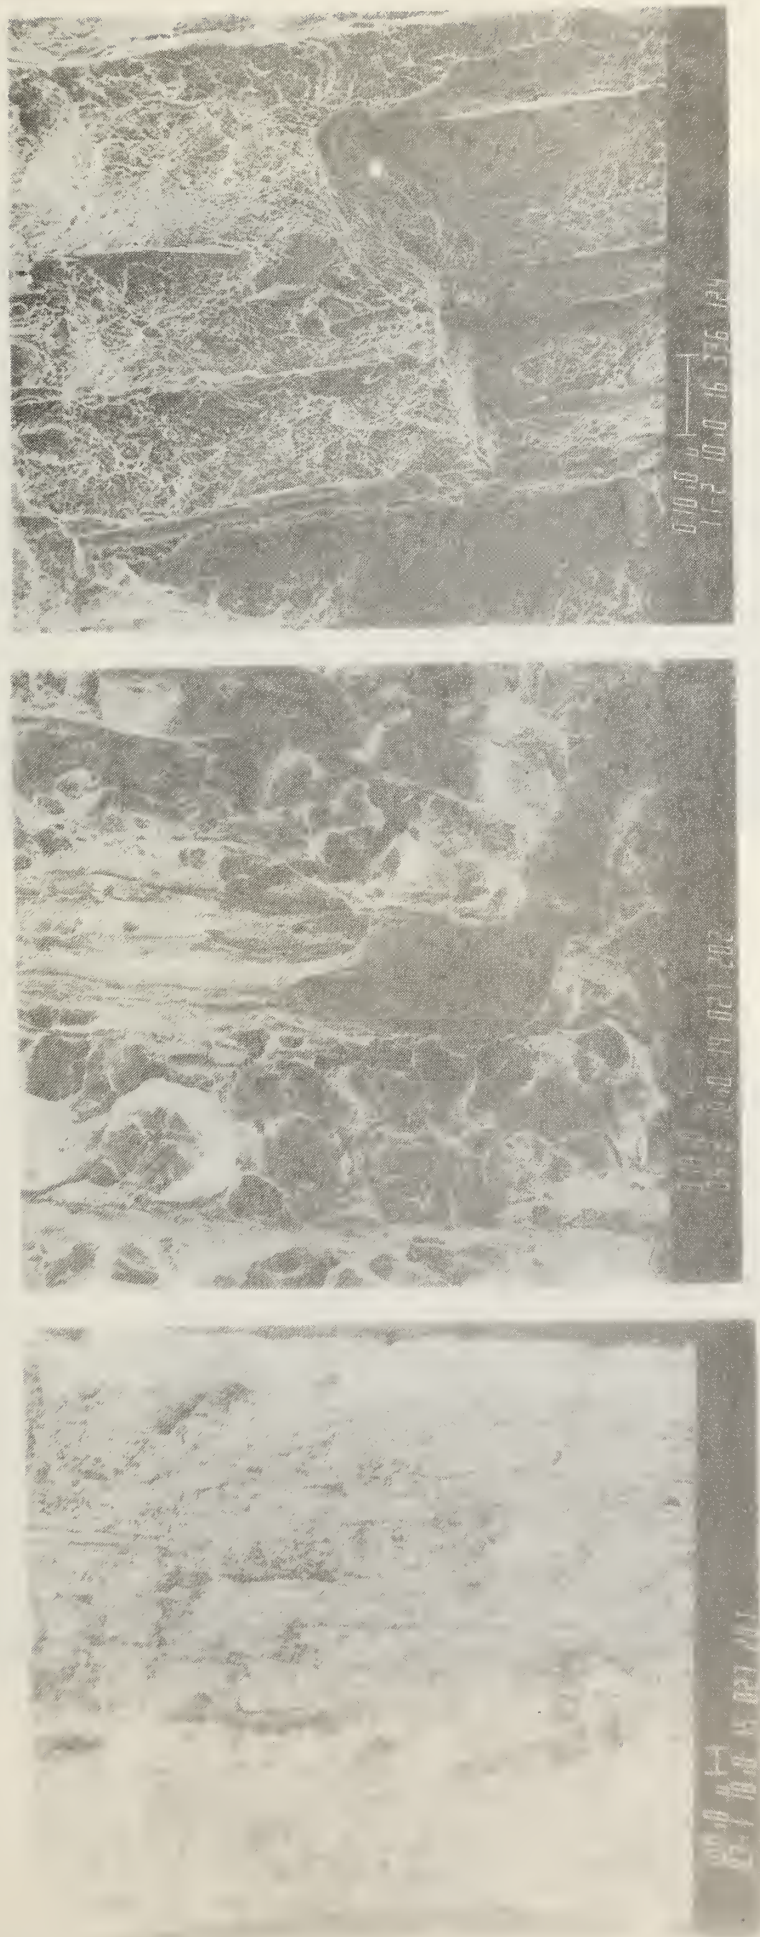
As noted in chapter 6, some washers obtained from the walkway debris fractured in the course of NBS beam tests while hardened washers purchased by NBS did not fracture under similar test conditions. Examination of the fracture surface of a walkway washer at location 9MW that failed during an NBS test conducted on walkway box beam 9M revealed that the washer had failed in a predominantly brittle manner. This is evidenced by the dominant intergranular and cleavage modes of failure illustrated in figure 8.11b. This is a magnified photomicrograph of the central region of the fracture surface shown in figure 8.11a. By contrast, figure 8.11c shows predominantly ductile failure at the surface decarburized layer of the washer.

Figure 8.11 Fractographic appearance of hardened washer fractured in NBS test of walkway box beam 9M, washer installed at location 9MW (a). Center portion, area (b), reveals a mixture of brittle (intergranular and cleavage) and ductile fracture. Area (c) reveals ductile rupture through a decarburized surface layer. Elongated features are indicative of MnS stringers. Magnifications (a) X35, (b) X550, (c) X1050.

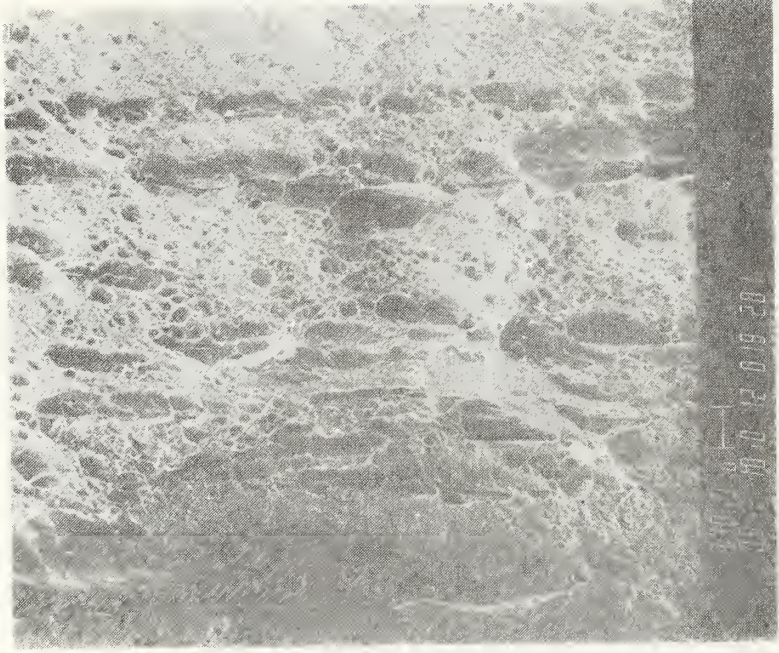
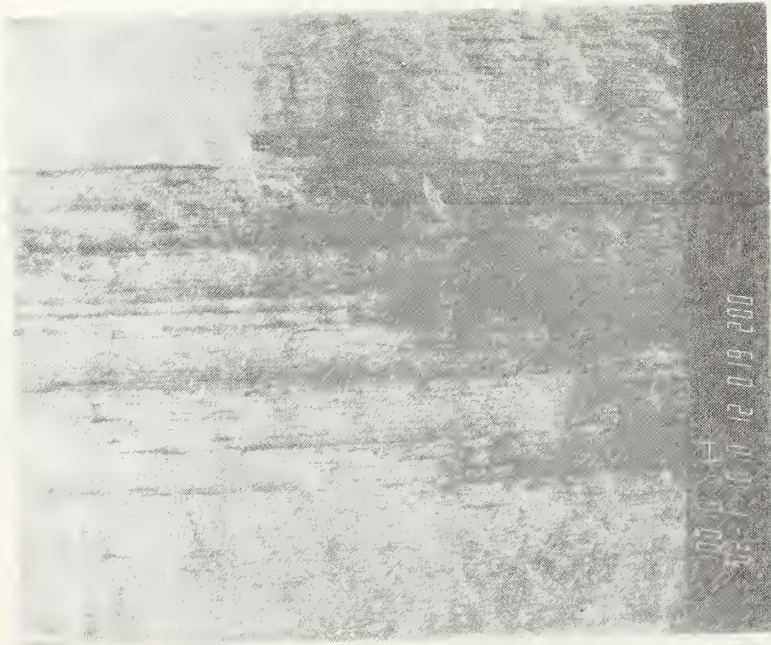
These figures show that the fracture characteristics of the walkway and NBS washers were basically similar. Both contained elongated stringers of MnS (figures 8.12a and 8.14a). Fracture characteristics of the walkway and NBS washers varied from predominantly ductile (figures 8.12 and 8.14) to predominantly intergranular (figures 8.13 and 8.15). However, the walkway washers displayed a higher percentage of intergranular fracture.

Figure 8.12 Fractographic appearance of walkway washer fractured in NBS test of box beam 9M (specimen KCl). Lower magnification view (a) shows high density of MnS stringers oriented parallel to the bend axis. Higher magnification view of center portion (b) shows mostly ductile rupture. Magnification (a) X25, (b) X550.

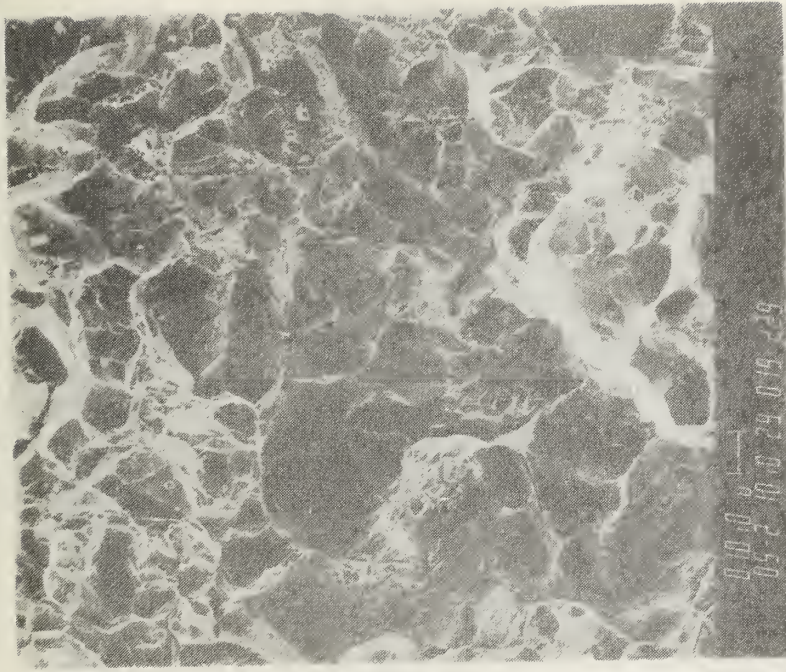
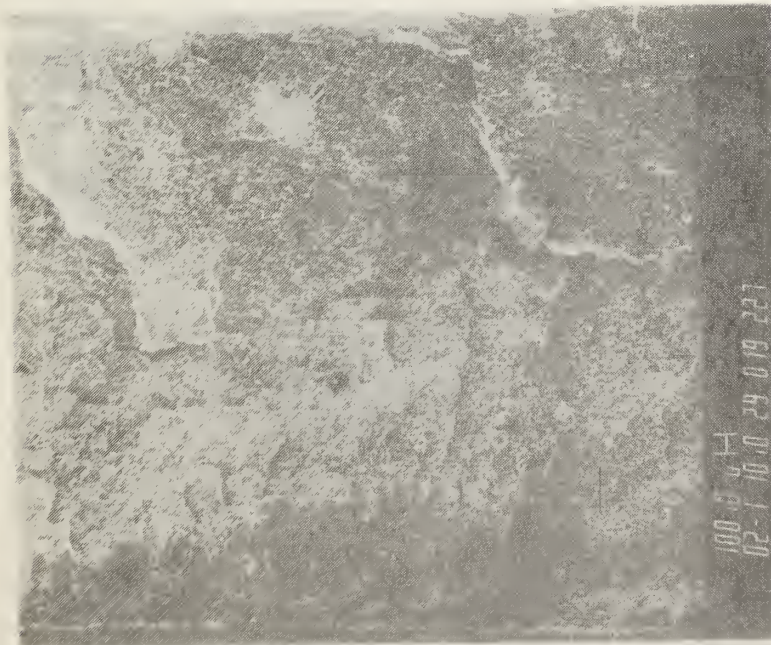
Figure 8.13 Fractographic appearance of walkway washer from upper end of hanger rod at location 9UE (NBS 11B) broken at NBS. Lower magnification view (a) shows no prominent MnS inclusions. Higher magnification view of center portion (b) shows essentially brittle intergranular fracture with a small amount of ductile rupture. Magnification (a) X25, (b) X550.

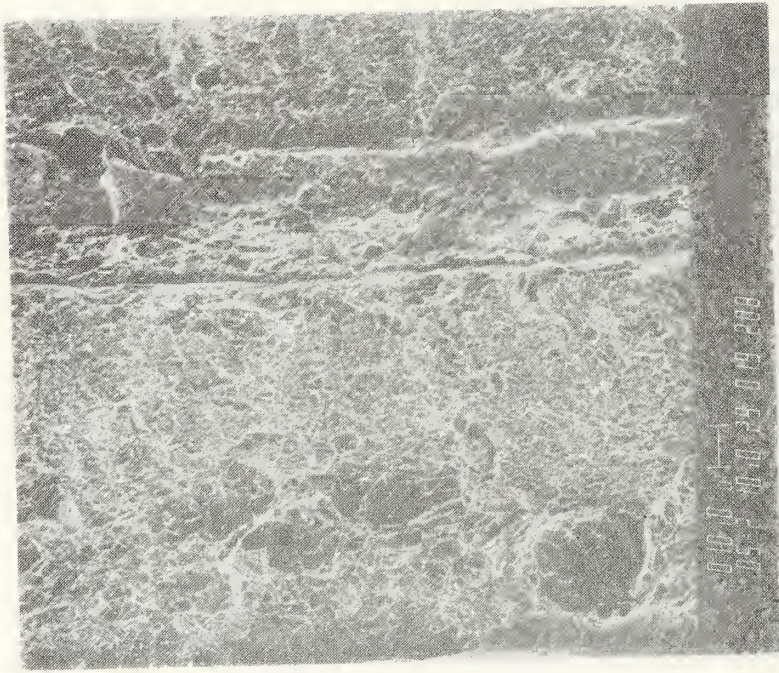
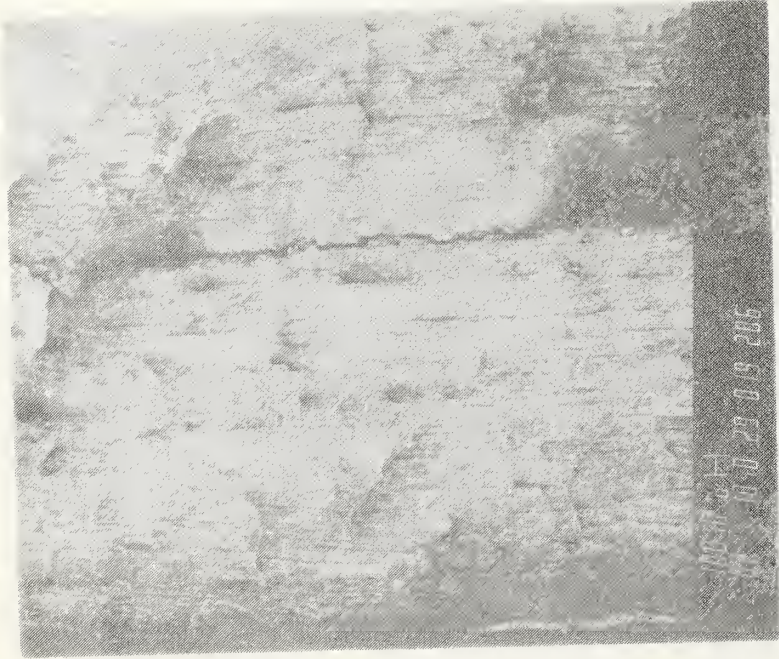
Figure 8.14 Fractographic appearance of NBS washer No. 3 broken at NBS. Low magnification view (a) shows elongated MnS inclusions. Higher magnification view of center portion (b) shows essentially ductile rupture. Magnification (a) X25, (b) X550.

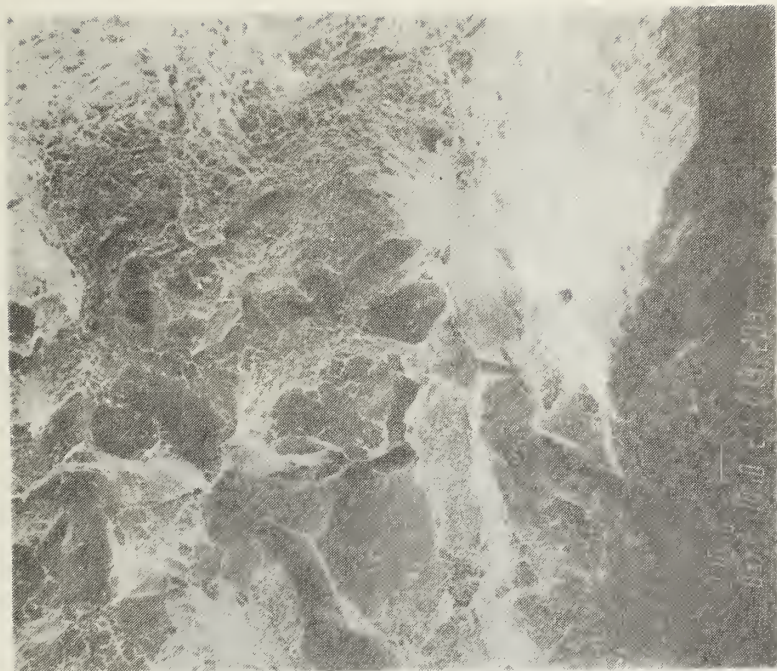
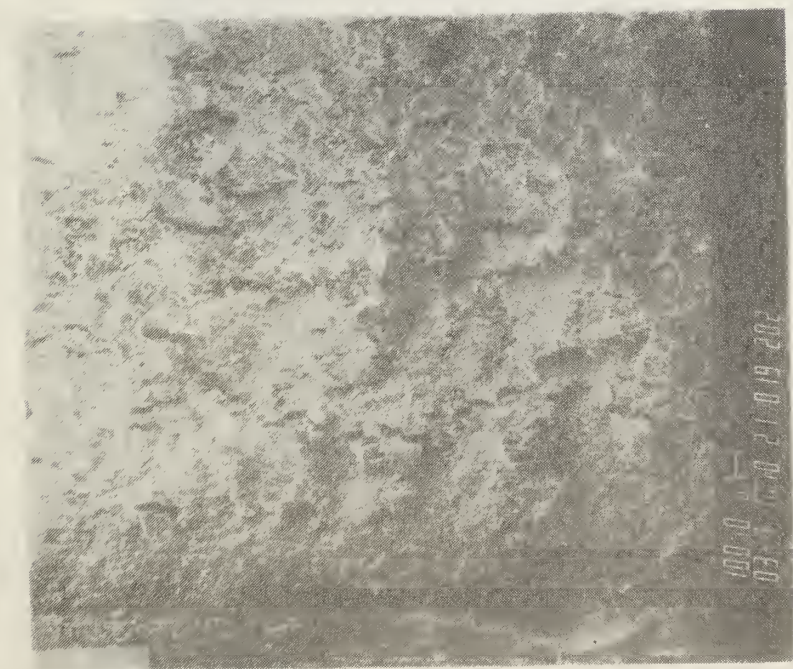
Figure 8.15 Fractographic appearance of NBS washer No. 2 broken at NBS. Low magnification view (a) shows no prominent MnS inclusions. Higher magnification view of center portion (b) shows 15-20 percent brittle intergranular fracture along with ductile rupture. Magnification (a) X35, (b) X550.

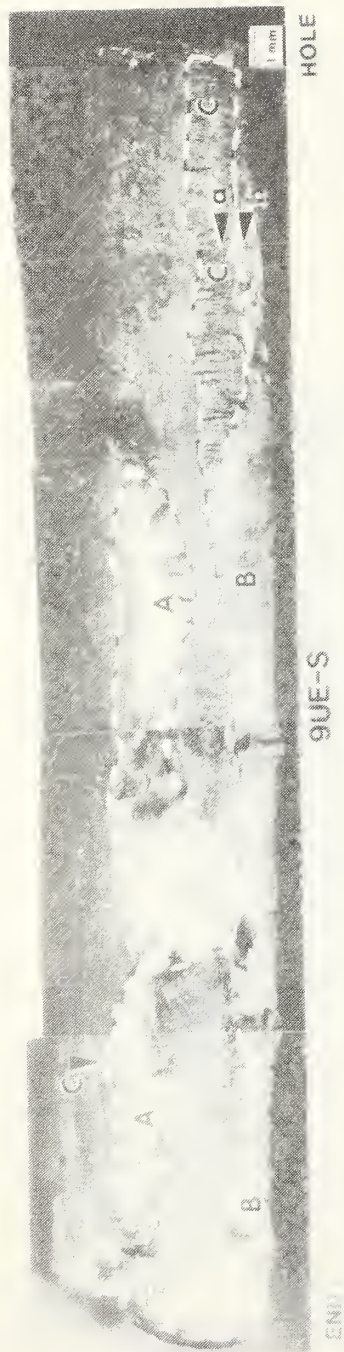
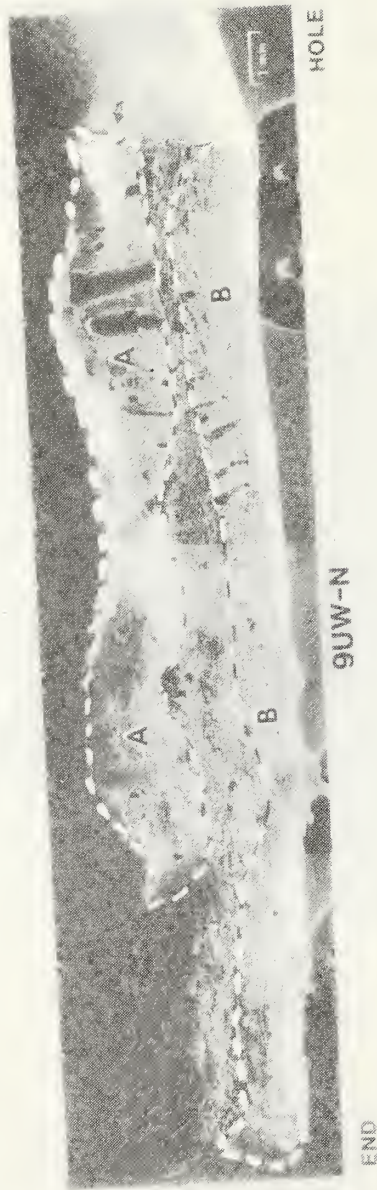
Figure 8.18 One half of box beam lower fracture surface between beam end and outer hanger rod hole.

(a) location 9UE - S (optical, magnification X4.5)

(b) location 9UW - N (SEM, magnification X6.5)

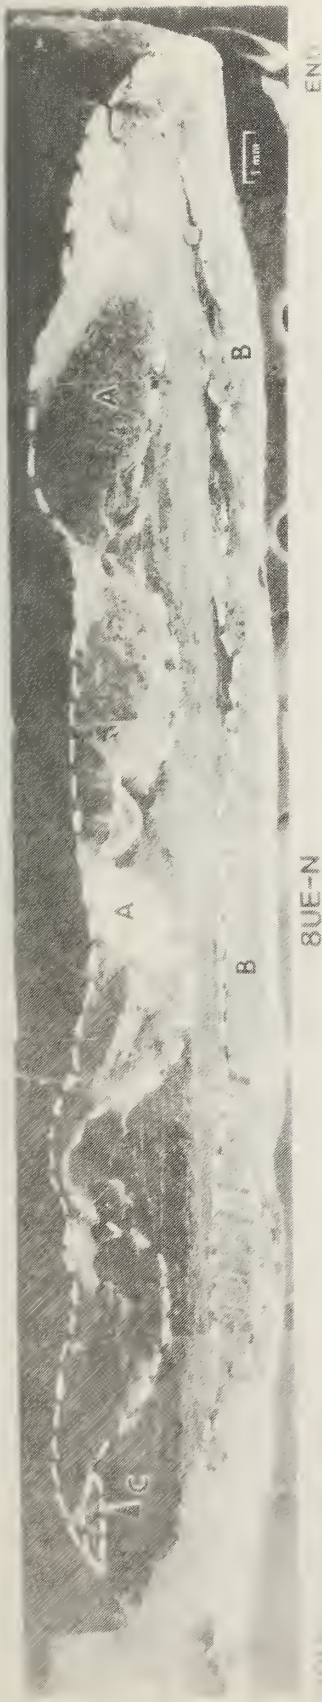
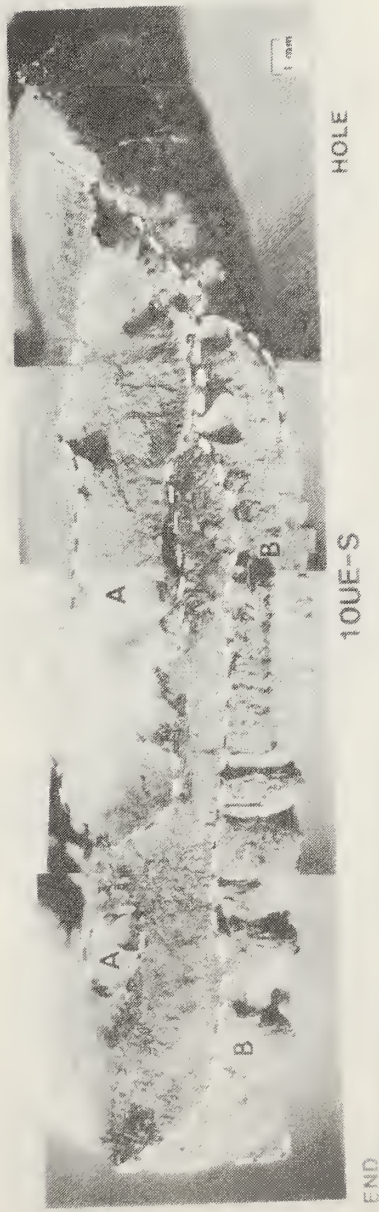
Figure 8.19 One half of box beam lower fracture surface between beam end and outer hanger rod hole.
 (a) location 8UE - N (SEM, magnification X6.5)
 (b) location 10UE - S (optical, magnification X4.5)

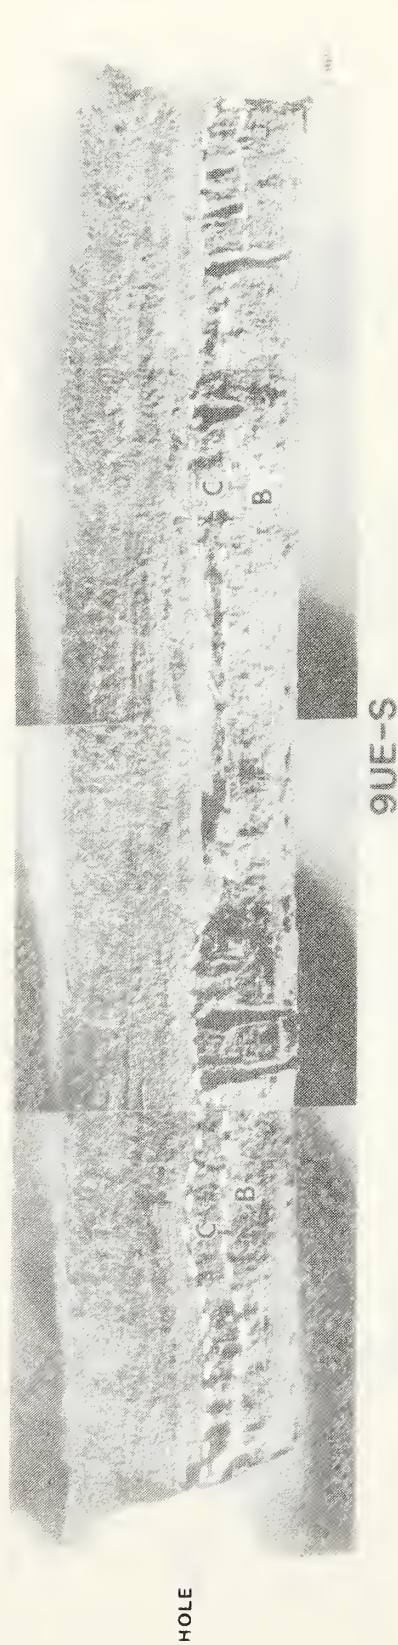
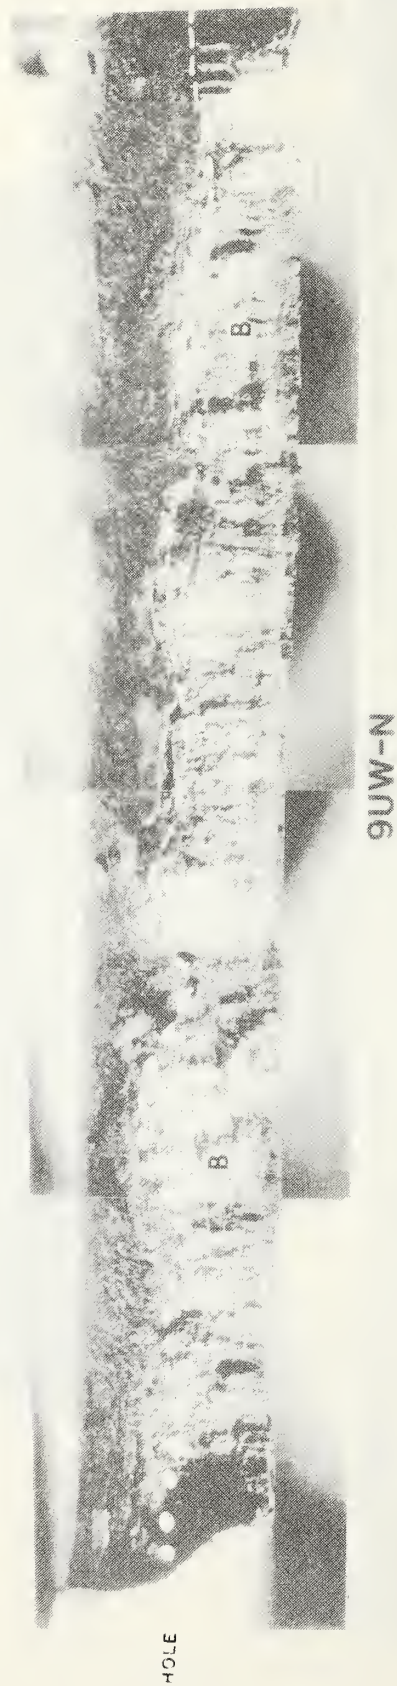
Figure 8.20 One half of box beam lower fracture surface between outer and inner hanger rod holes.

(a) location 9UE - S (optical, magnification X5.5)

(b) location 9UW - N (optical, magnification X5.5)

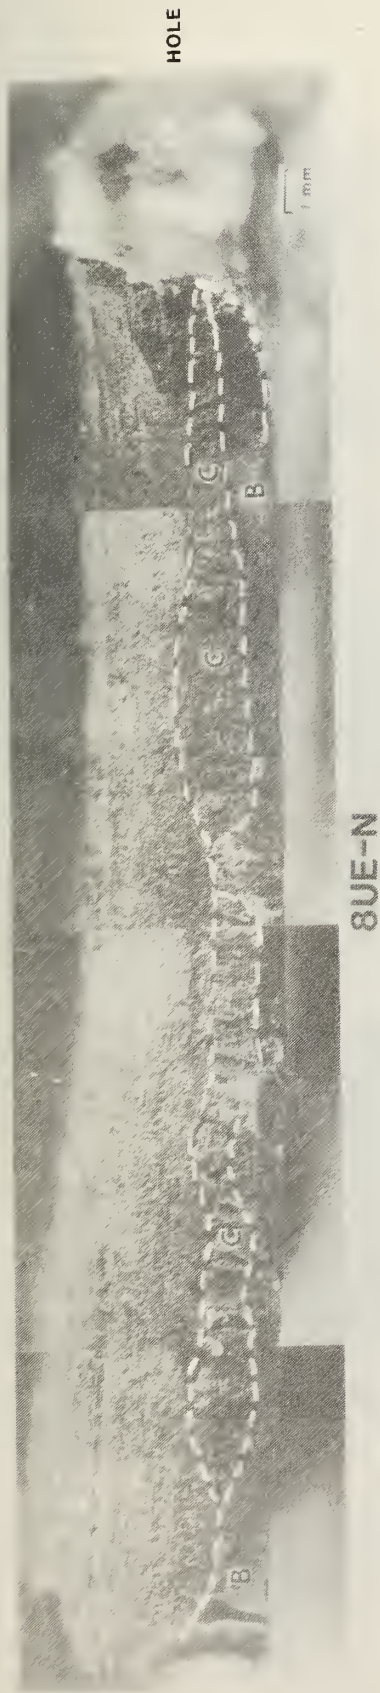
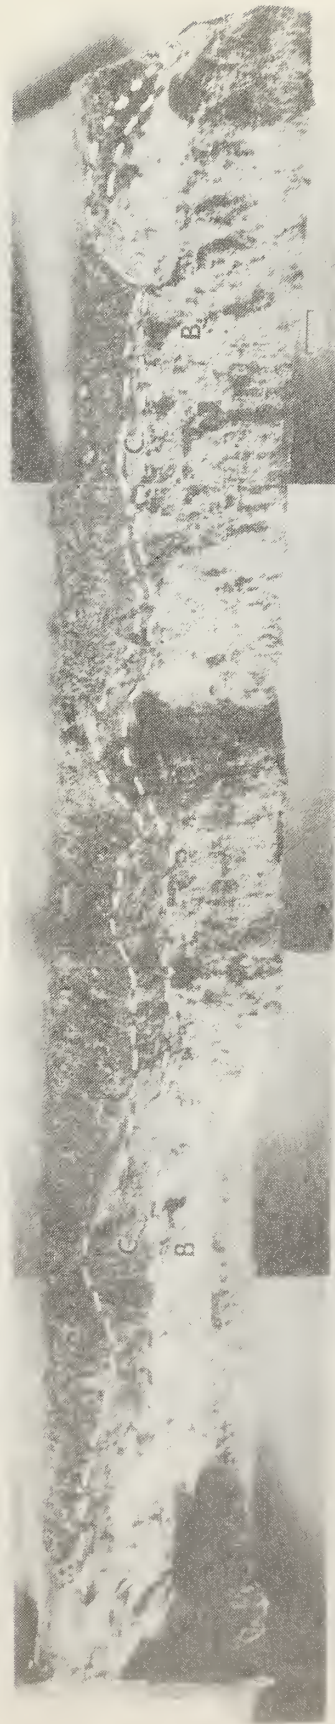
(a) location 8UE - N (optical, magnification X5.5)

(b) location 10UE - S (optical, magnification X5.5)

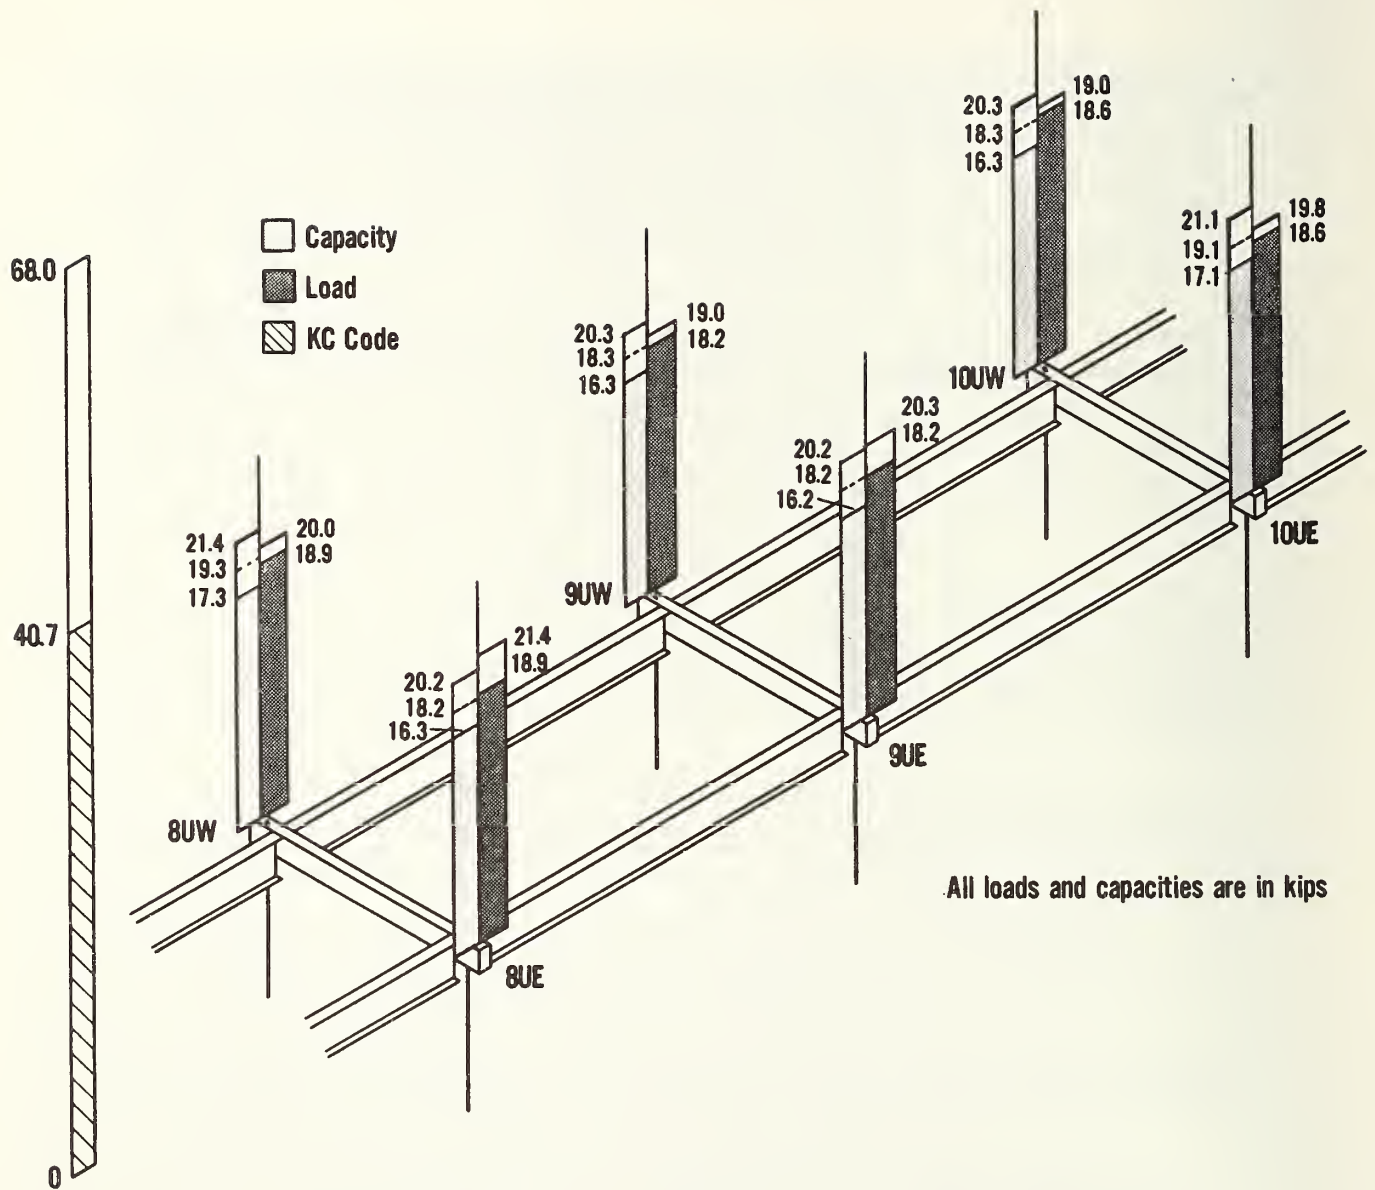
It is important to point out that the load capacities described in figure 10.1 are ultimate values. As noted in section 9.3.3, the design load (estimated nominal dead load plus code-specified design live load) for a fourth floor to ceiling hanger rod is 40.7 kips (181 kN). This is the load that should be used in a working stress approach to design in which the nominal strengths of materials are reduced by an appropriate factor of safety.

the AISC Specification is the basis for the steel design provisions of the Kansas City Building Code, this same ultimate load capacity would be expected of a connection designed under the Kansas City Building Code. The hanger rod load to be applied in working stress design under the Kansas City Building Code and the expected ultimate load capacity are shown in the bar diagram on the left in figure 10.1.

Figure 10.1 Comparison of fourth floor walkway box beam-hanger rod connection capacities with loads believed to have been acting at time of collapse.

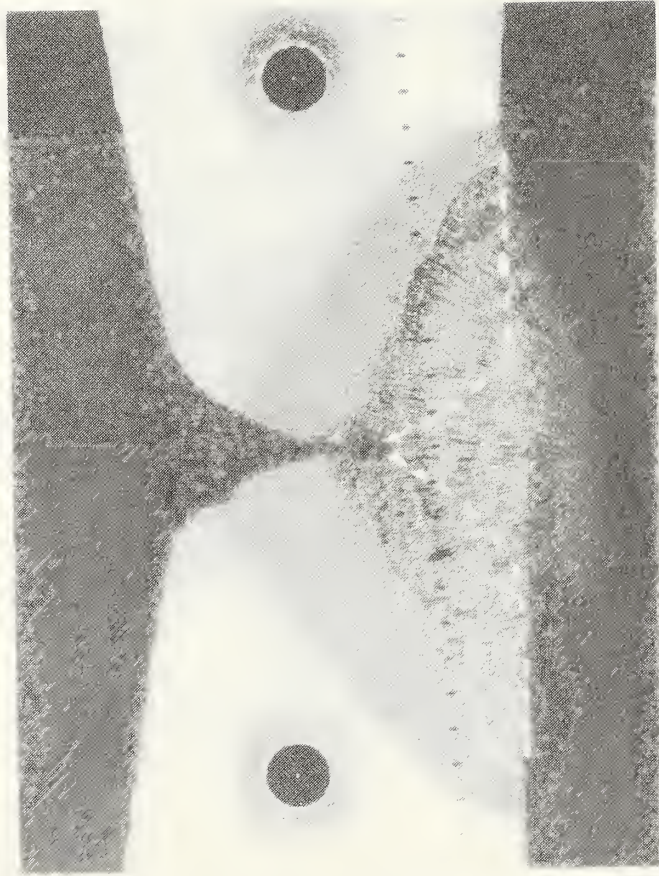
The welding symbol and field observations relevant to the box beam longitudinal welds have been discussed in sections 3.3 and 5.3.3, respectively. As noted in section 3.3, the welding symbol used on the shop drawings is interpreted to require a prequalified partial joint penetration groove weld. However, the geometry of the mating surfaces as discussed in section 5.3.3 and as illustrated in figure 10.3 does not satisfy the dimensional tolerances for a prequalified partial joint penetration groove weld as stated in section 2.10 of AWS D1.1-79; the root face is less than 3 mm (Item 2.10.2.4), and the required minimum root opening was not provided.

Figure 10.3 Cross section through weld region of walkway box beam 8L showing the exterior longitudinal weld joint at the bottom flange. Dotted lines indicate approximate original geometry of the flange toes. X8 1/2
