NBSIR 82-2593

# Investigation of Construction Failure of the Riley Road Interchange Ramp, East Chicago, Indiana

October 1982

N. J. Carino  
H. S. Lew  
W. C. Stone  
R. M. Chung

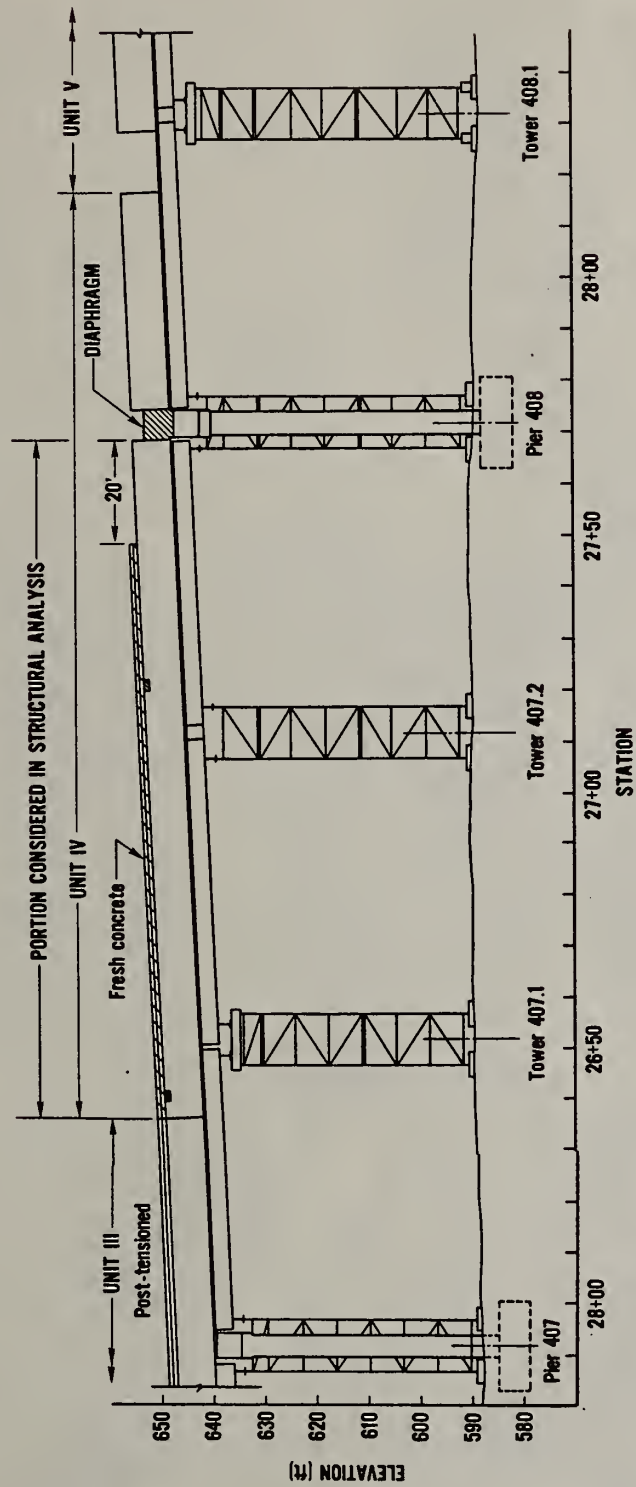
Figure 2.13 State of construction at the time of the collapse

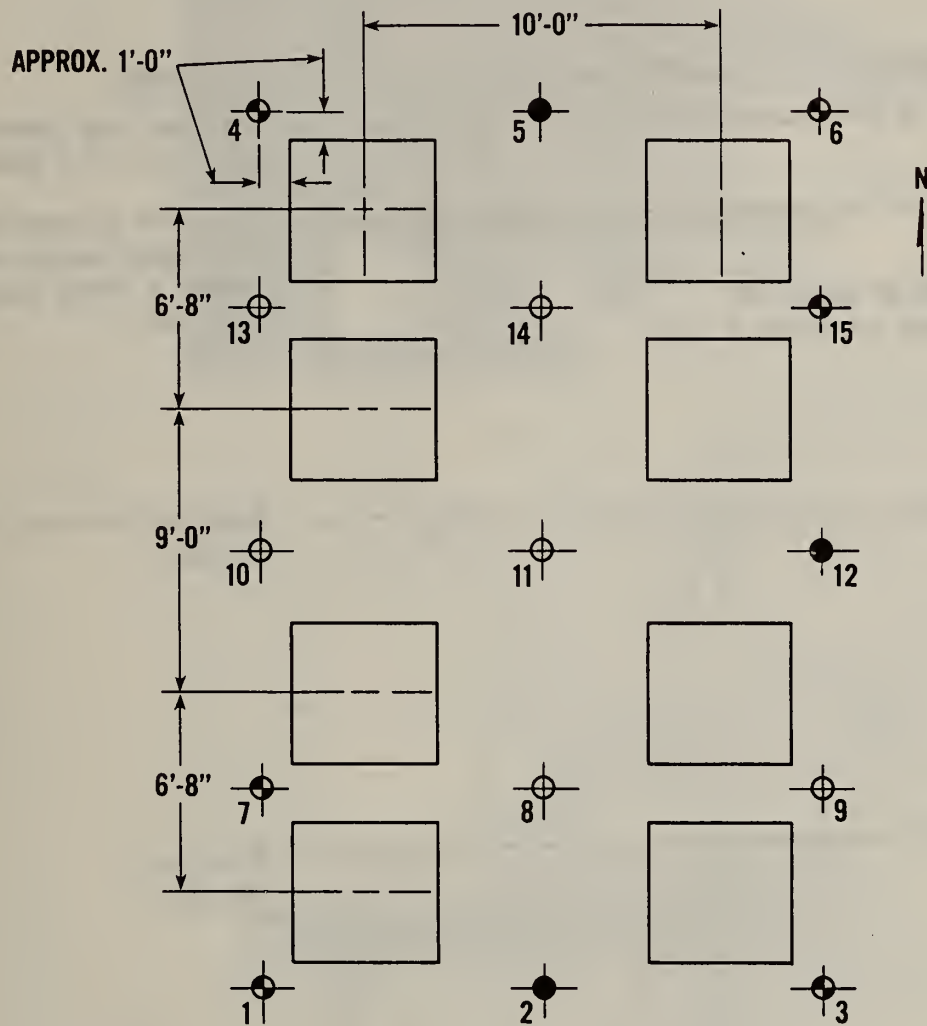
Soil test borings were made along Ramp C after some of the collapse debris had been removed, and the IOSHA provided NBS with the boring data. Soil borings were taken at each tower location from 403.2 to 409.2 as indicated in figure 3.2. In most instances, the soil test borings were 15 ft (4.6 m) deep and samples were taken at 2 ft (0.6 m) intervals using a 2-in (51-mm) outside diameter split spoon sampler. Blow counts from the Standard Penetration Test (ASTM D 1586-67 (1974)) were obtained. Other holes were bored to a depth of 25 ft (7.6 m) or 35 ft (10.7 m) with the samples taken in the same manner. The samples were placed in sealed jars and stored at the project site.

Figure 3.2 Position of soil borings at each tower location

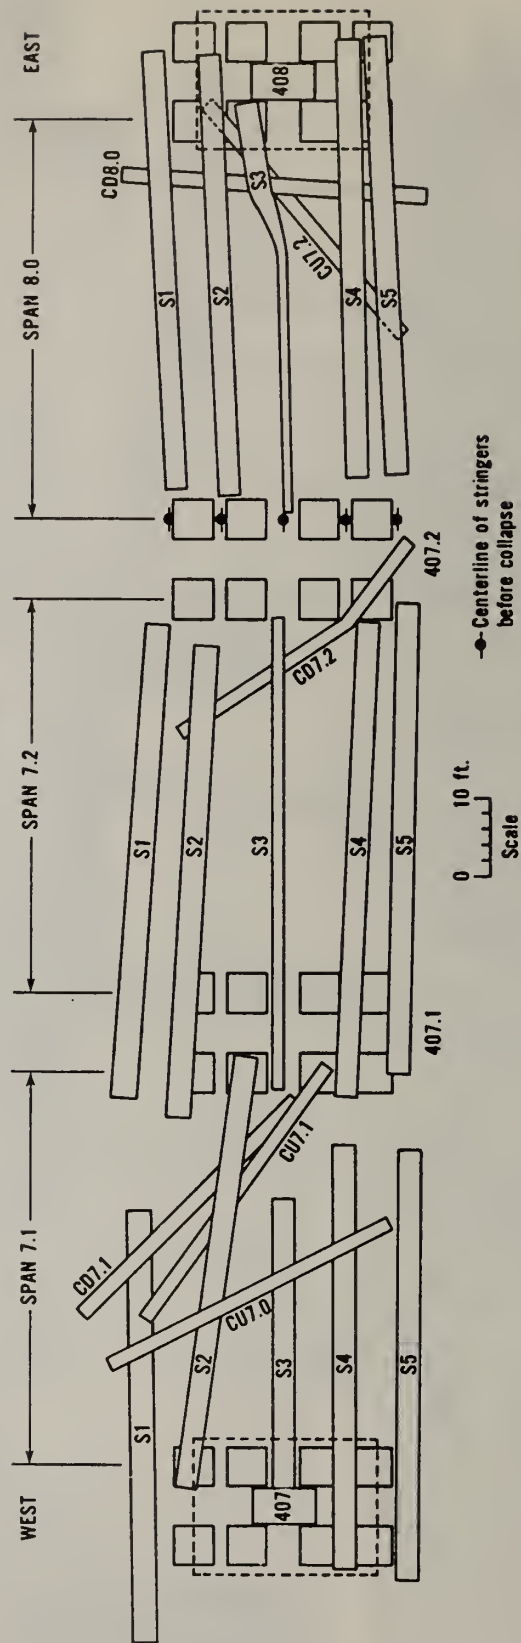
Figure 3.17 Location of crossbeams and stringers after the collapse

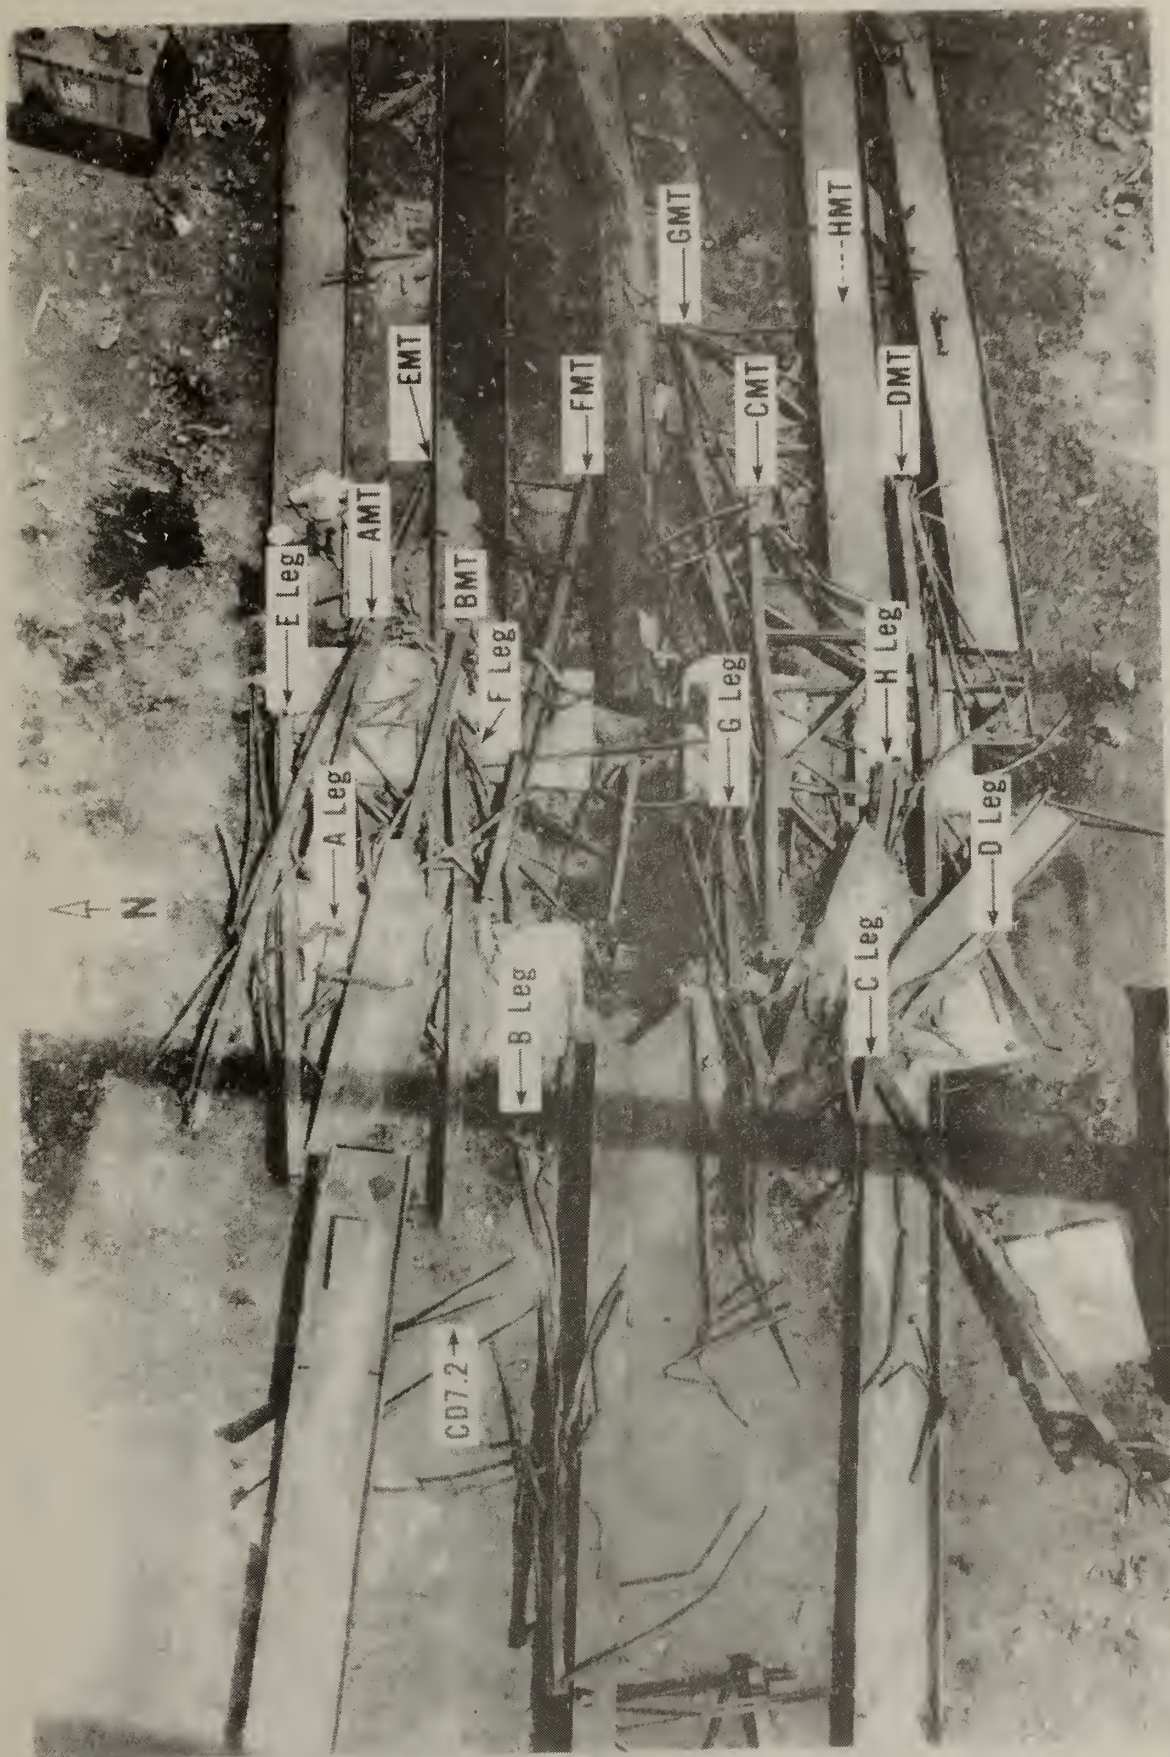
Figure 3.18 Location of various parts of the shoring towers at 407.2

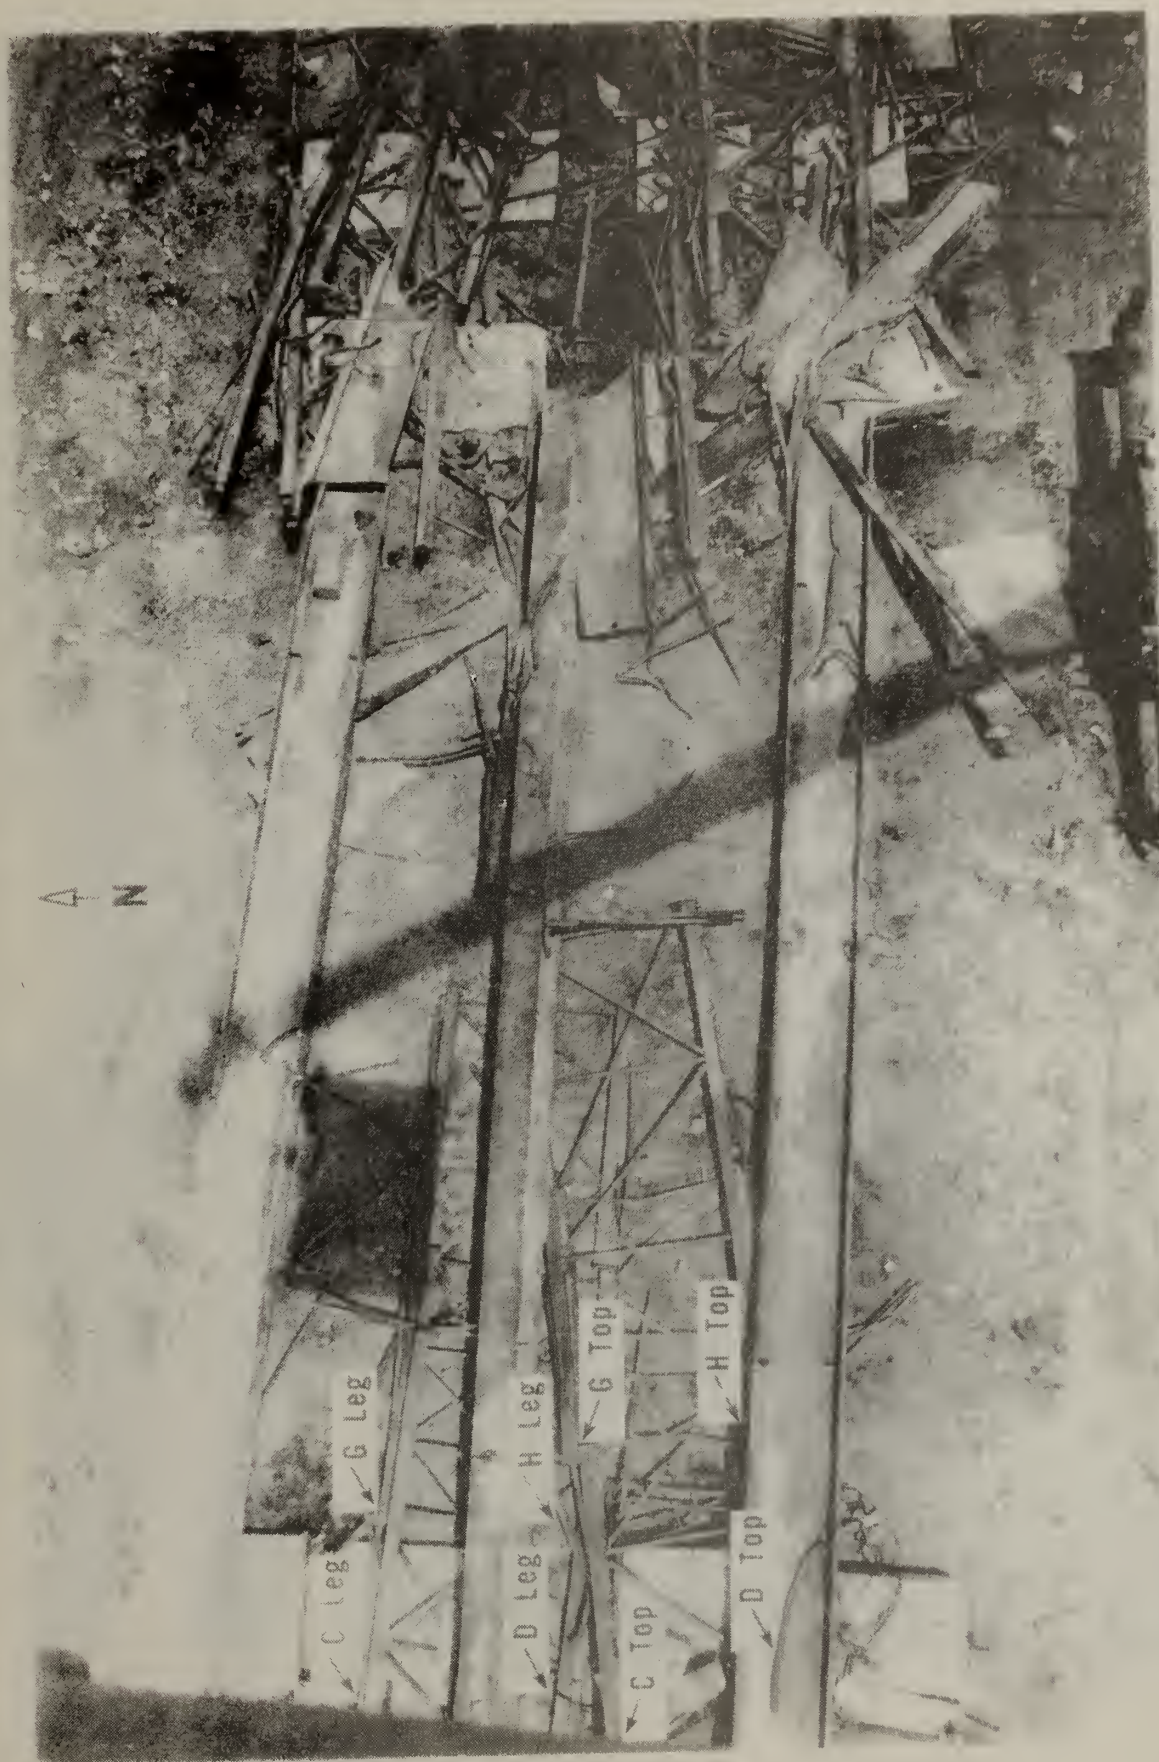
Figure 3.20 Location of parts of the south tower at 407.1

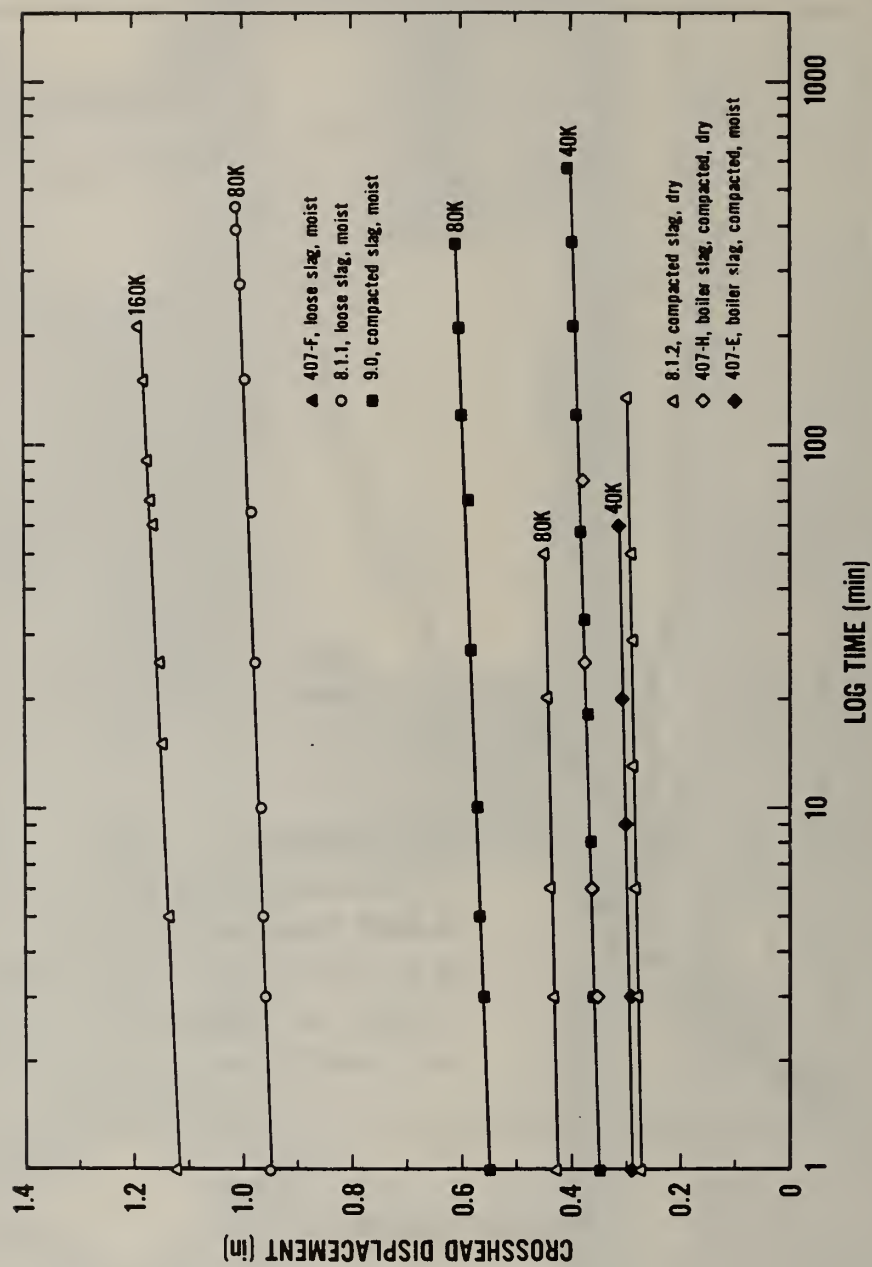
Finally, figure 4.11 shows the results of the sustained load tests. The crosshead displacements are plotted as a function of the logarithm of time. The behavior was similar for all tests.

Figure 4.11 Crosshead displacement versus logarithm of time for sand boxes under sustained load

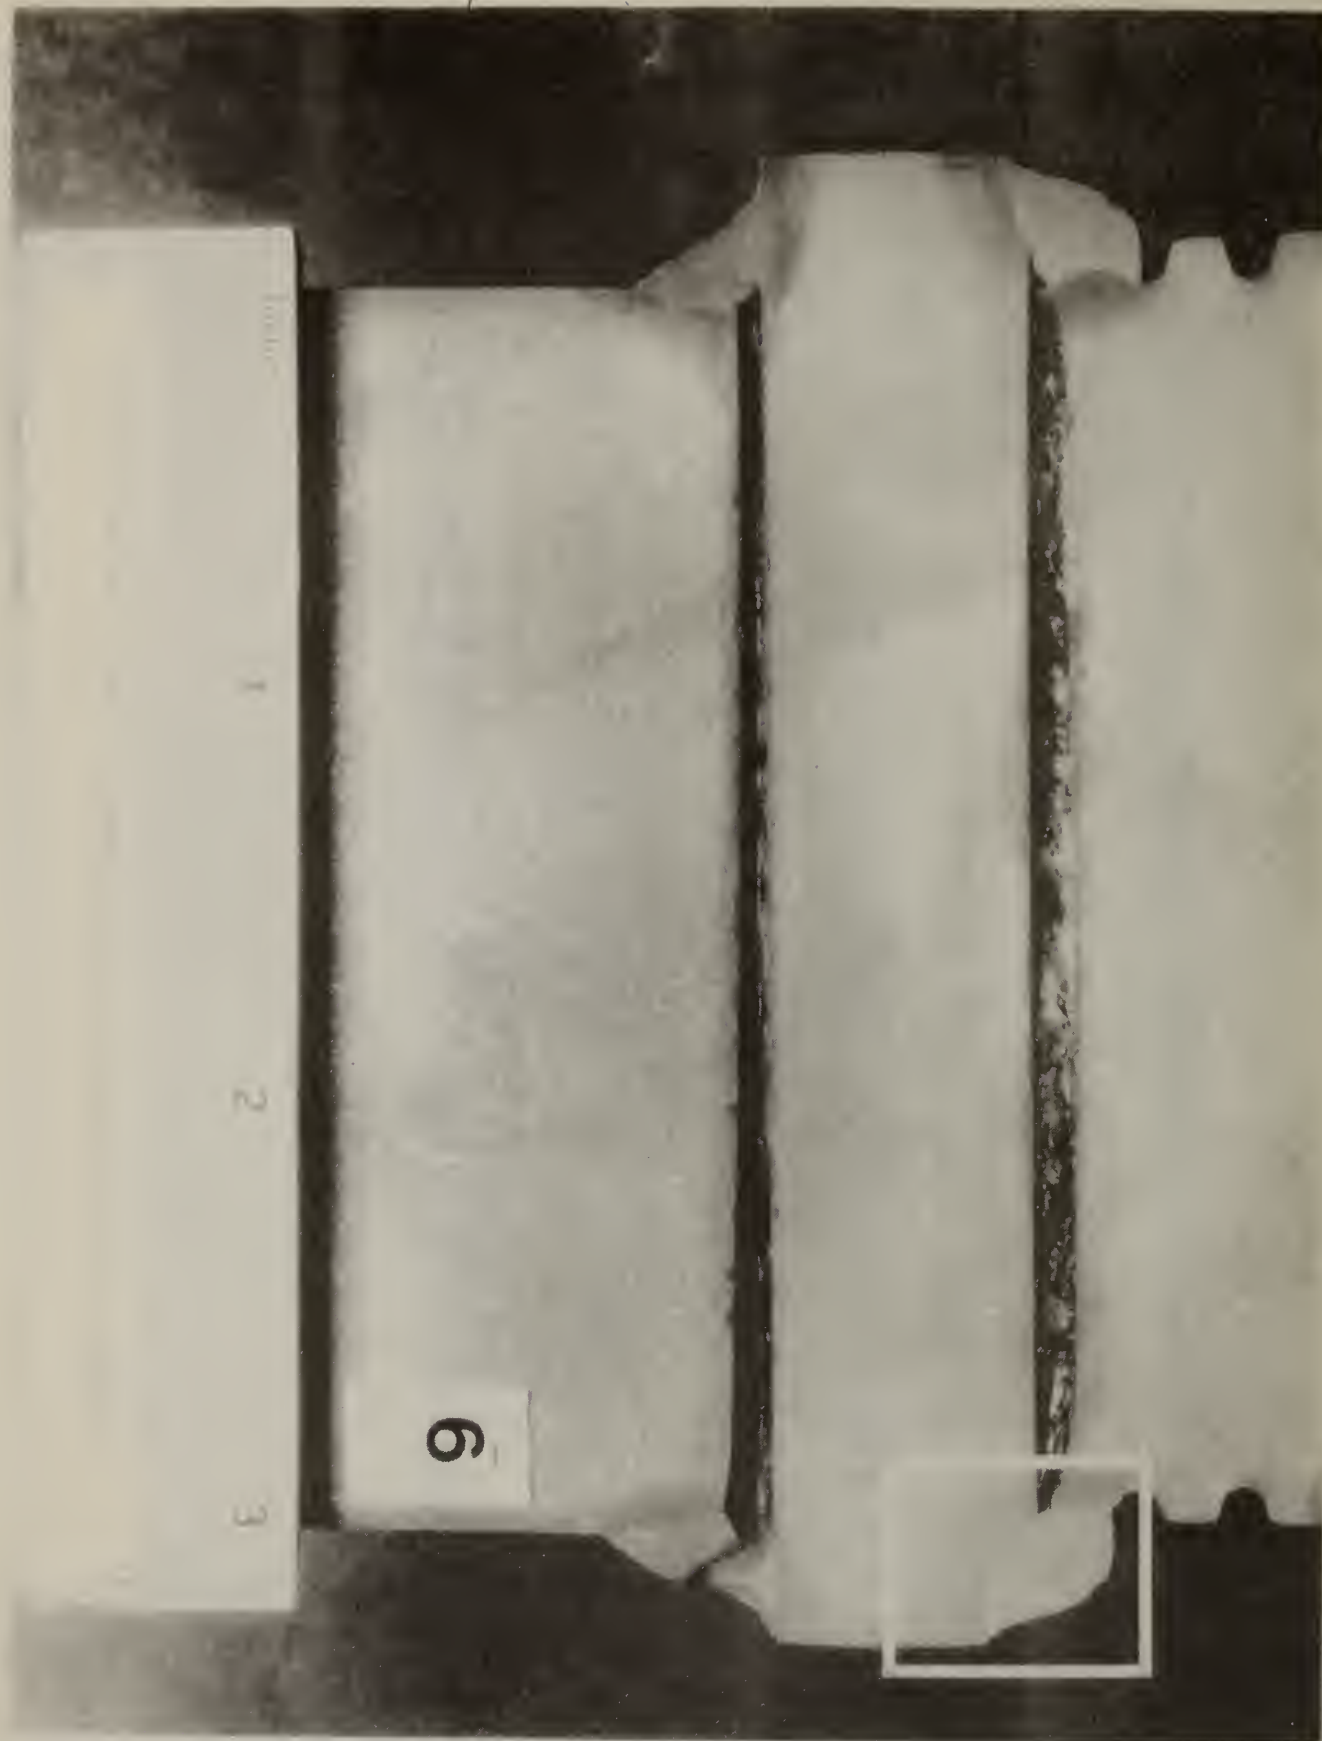
Figure 4.17 Cross-section along width of post of screw jack #9

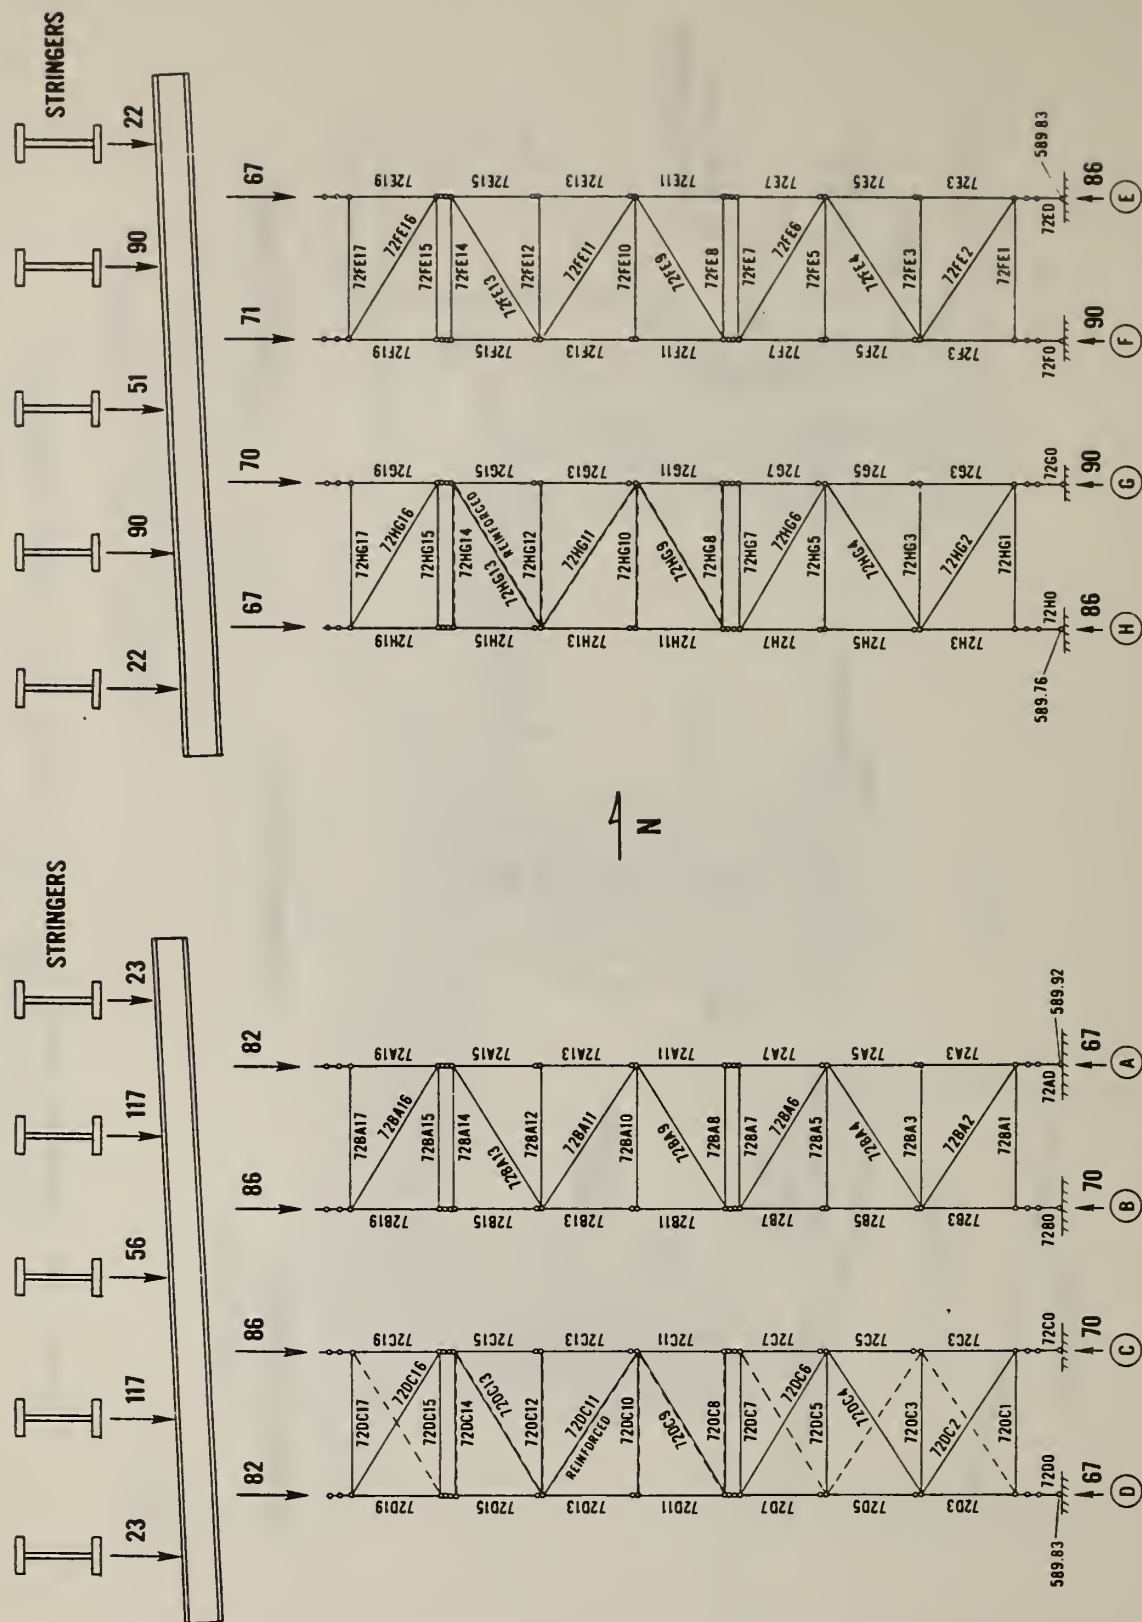
Figure 5.11 Stringers, crossbeam, and support reactions for towers at 407.2, for Case I plus Case II loadings (kips)

W36 x 194 section and 117 kips (521 kN) for the W36 x 260 section (see fig. 5.11). These two different reactions result from the continuity of the concrete box girder over the two supports provided by the shoring towers. When these moment and reaction values due to construction loads are compared with the AISC allowable values of the two stringer cross sections, it is found that the allowable strength values exceed the maximum applied moment and reactions by large margins. The shear capacities of the webs were also computed and they were found to be far in excess of the shear resulting from the applied loads.

Using a nominal yield strength of 36 ksi (350 MPa), the AISC allowable shear capacity of a W24 x 68 section is 135 kips (600 kN). This value is substantially greater than maximum shear of 59 kips (260 kN) occurring between stringer S2 of span 8.0 and the U-head reaction at leg A as shown in figure 5.11.

In accordance with the AISC Specification, the maximum concentrated load that a W24 x 68 section can support without crippling of the web due to a localized force is 276 kips (1230 kN). This capacity is about 2.34 times the maximum stringer reaction of 117 kips (521 kN) (see figure 5.11).

The maximum loads in the falsework assembly tests are greater than the maximum computed load of 86 kips (383 kN) on the U-heads at legs B and C (see figure 5.11). The failure of the falsework assembly was governed by the strength of the crossbeam rather than by the strength of the U-head. This observation suggests that U-heads would not have failed under the applied loads. Thus, it is unlikely that a U-head failure initiated the collapse of unit IV.

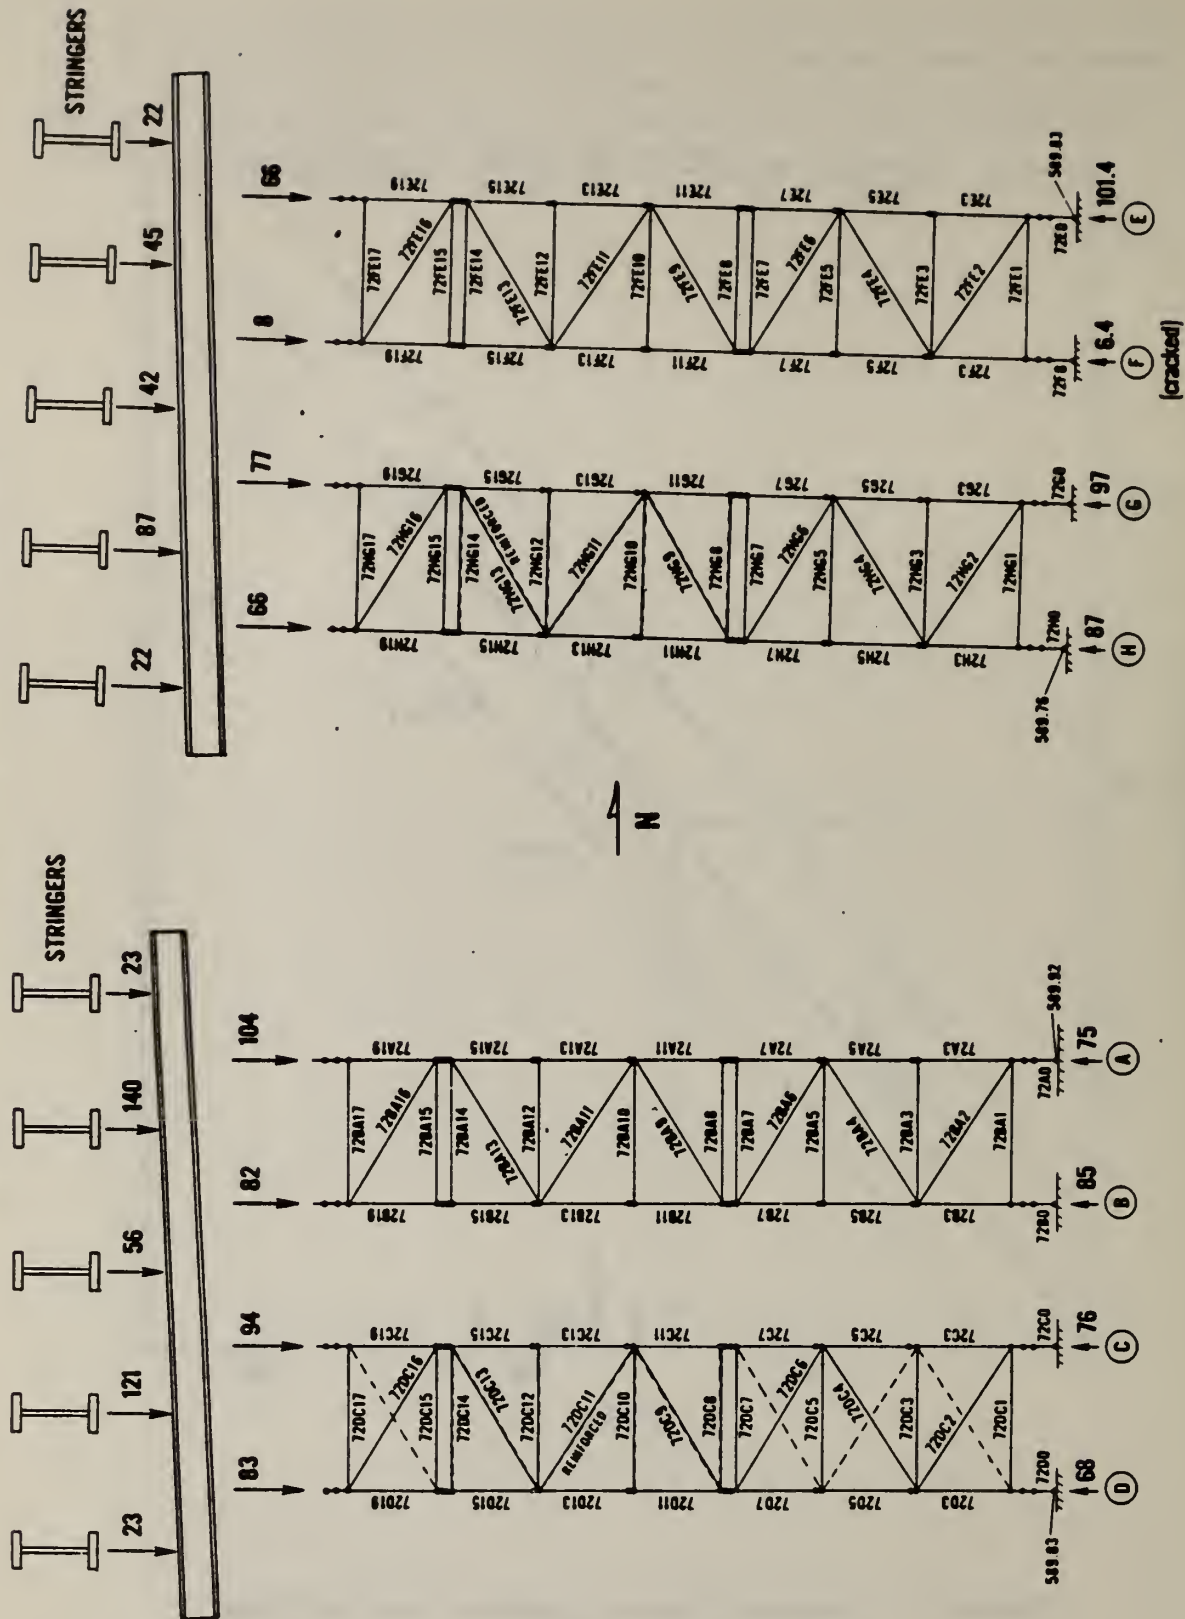
The load-settlement measurements observed during the field tests showed that when the pads failed, the bottom screw jack dropped instantly an average value of about 0.4 in (10 mm). The actual settlements of eight tests ranged from 0.14 in (10 mm) to 0.72 in (18.3 mm) (see table 4.4). The structure-falsework system was reanalyzed with 0.4-in settlement applied at leg F. The results are shown in figures 6.2 and 6.3. As a result of the 0.4-in settlement of leg F, the reaction at leg E increased from 86 kips (383 kN) to 101 kips (450 kN) and the reaction at leg G increased from 90 kips (400 kN) to 97 kips (432 kN). These increases in reactions placed pads E and G as the next likely candidates for cracking. In addition, the settlement of leg F caused the force in the diagonal 72EA4 to increase from 4.86 kips (21.6 kN) to 9.09 (40.5 kN) which is greater than the average experimental buckling load of 6.3 kips (28.0 kN).

Figure 6.2 Stringer, crossbeam, and support reactions for towers at 407.2 with support settlement of 0.4 in at pad F

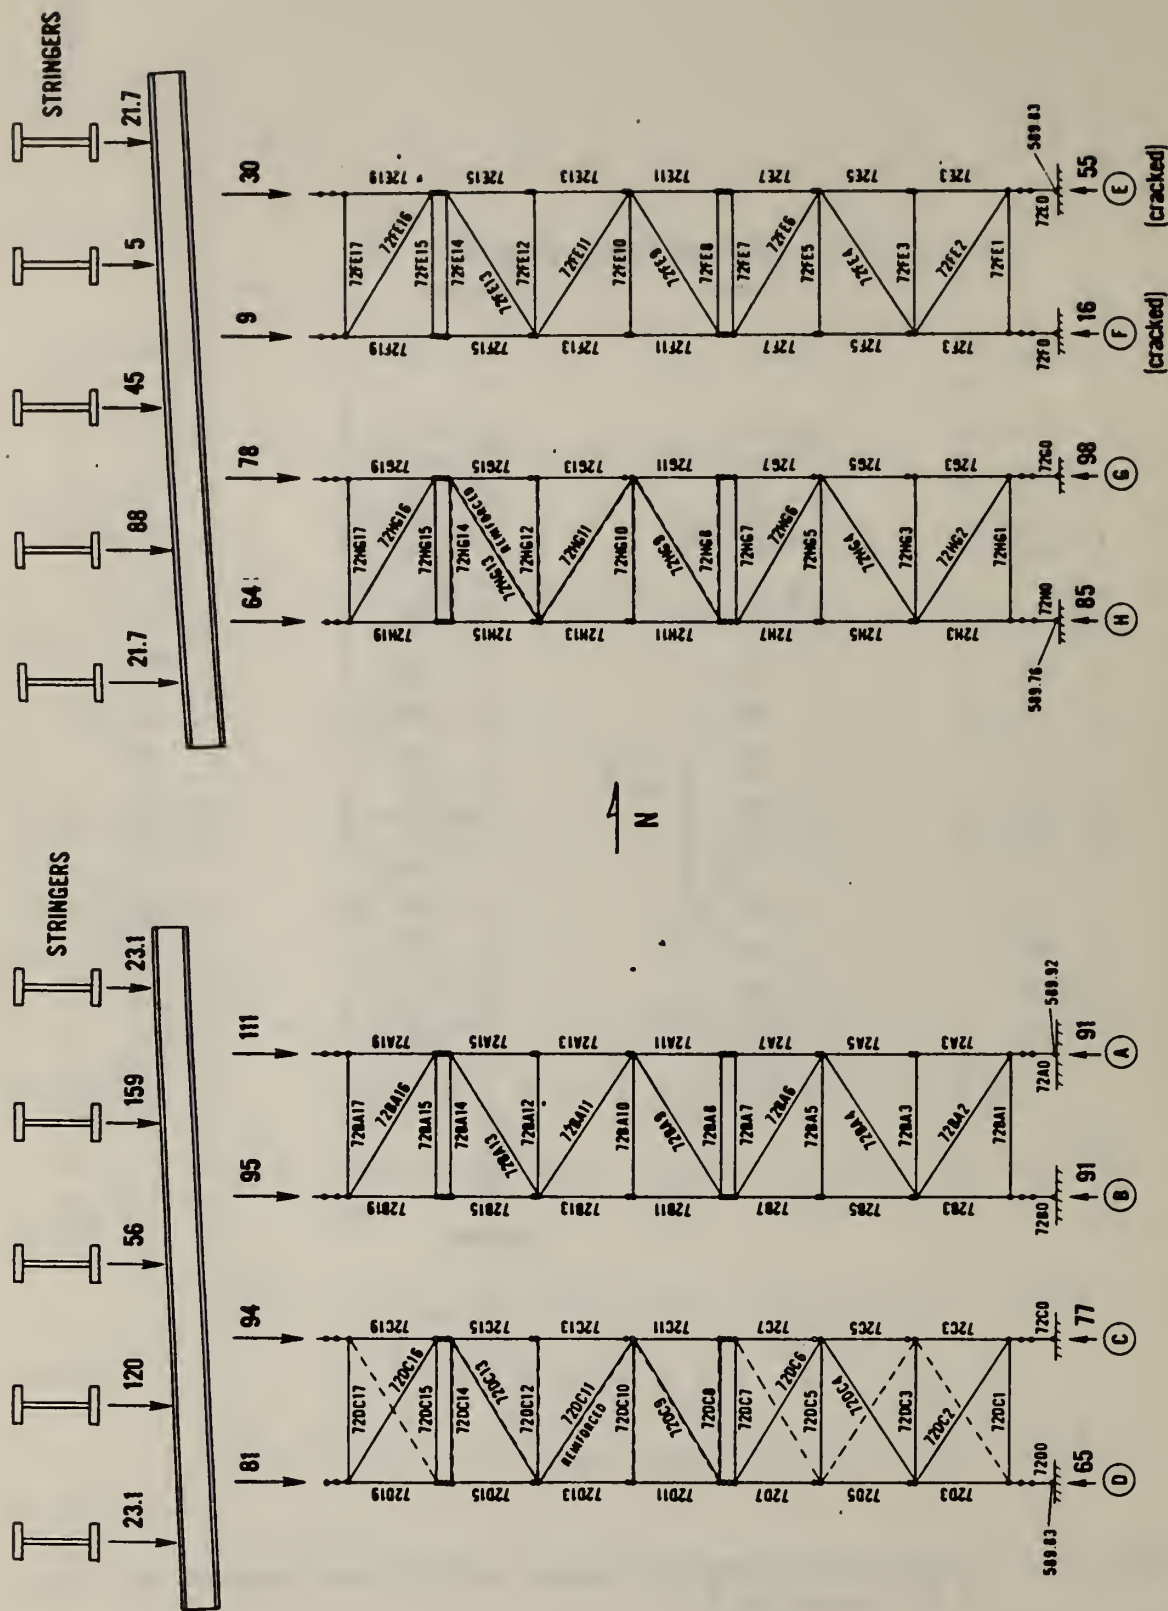
An additional analysis of the structure-falsework system was performed with the following two modifications to the computer model. First, the linear-elastic diagonal member 72EA4 was replaced with an elasto-plastic member with its maximum load remaining constant at a value of 6.3 kips, the assumed buckling load based on the NBS tests.\* Second, a 0.4 in drop of leg E was introduced to represent the settlement of the leg due to the cracking of pad E. The results of the analysis are shown in figures 6.4 and 6.5. It is seen from these figures that only the reaction of pad A changed substantially, from 75 kips (334 kN) to 91 kips (405 kN). Other reactions as well as the forces in the bracing members did not change significantly. The main reason for this is that the total load supported by the towers at 407.2 decreased as a result of the pad failures, and the load on the towers at 407.1 increased. The load transfer results from the continuity of the U-section over the supports at 407.2.

Figure 6.4 Stringer, crossbeam, and support reactions for towers at 407.2 with support settlement of 0.4 in at pads E and F and buckled diagonal 72EA4

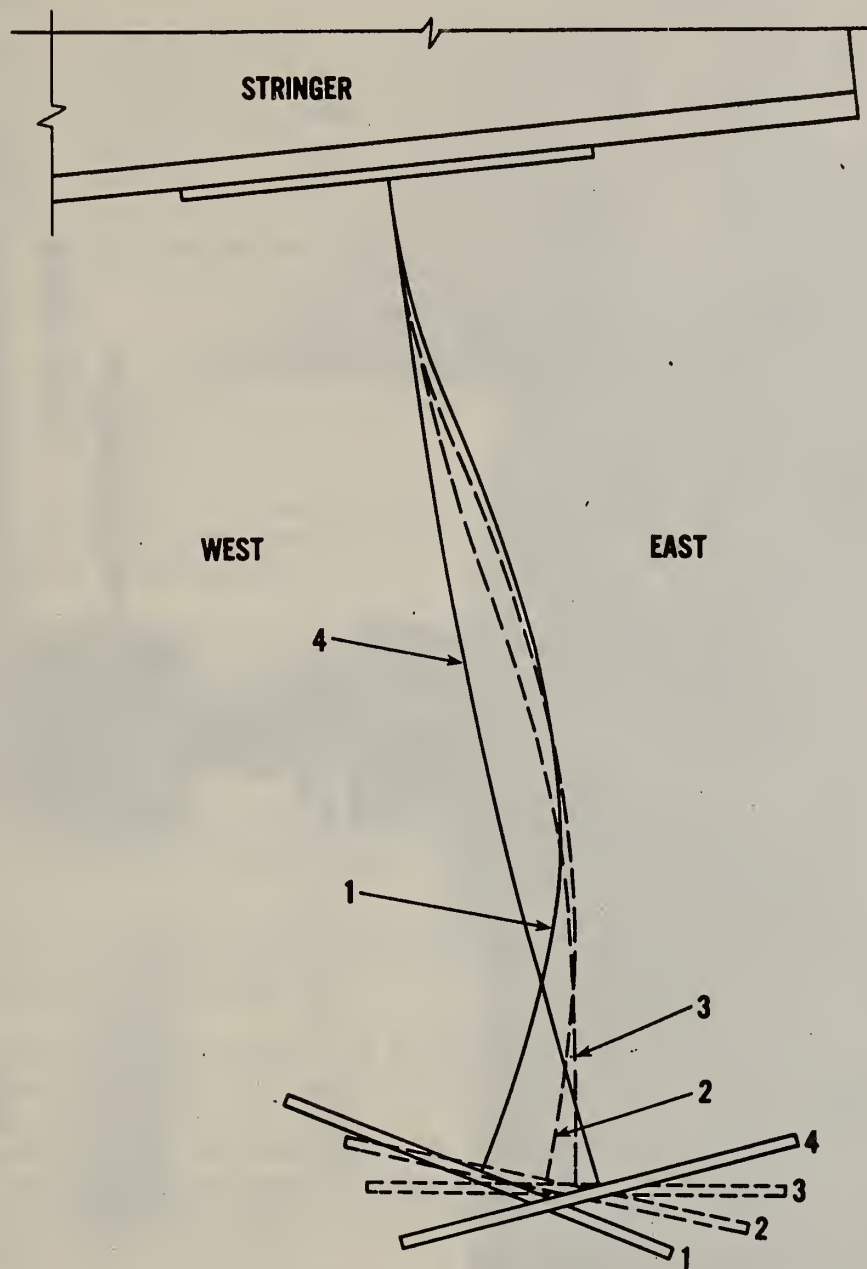
Figure 6.7 Schematic representation of the change in the deformed shape of the crossbeam web as the bottom flange translates eastward

A second analysis was performed in which the U-heads were assumed to provide no rotational restraint to the lower flange of the crossbeam. All other boundary conditions and applied loads were the same as in the first analysis. The resulting deflected shape is shown in figure C.3. This change in curvature of the crossbeam web agrees with the changes described in figure 6.7.

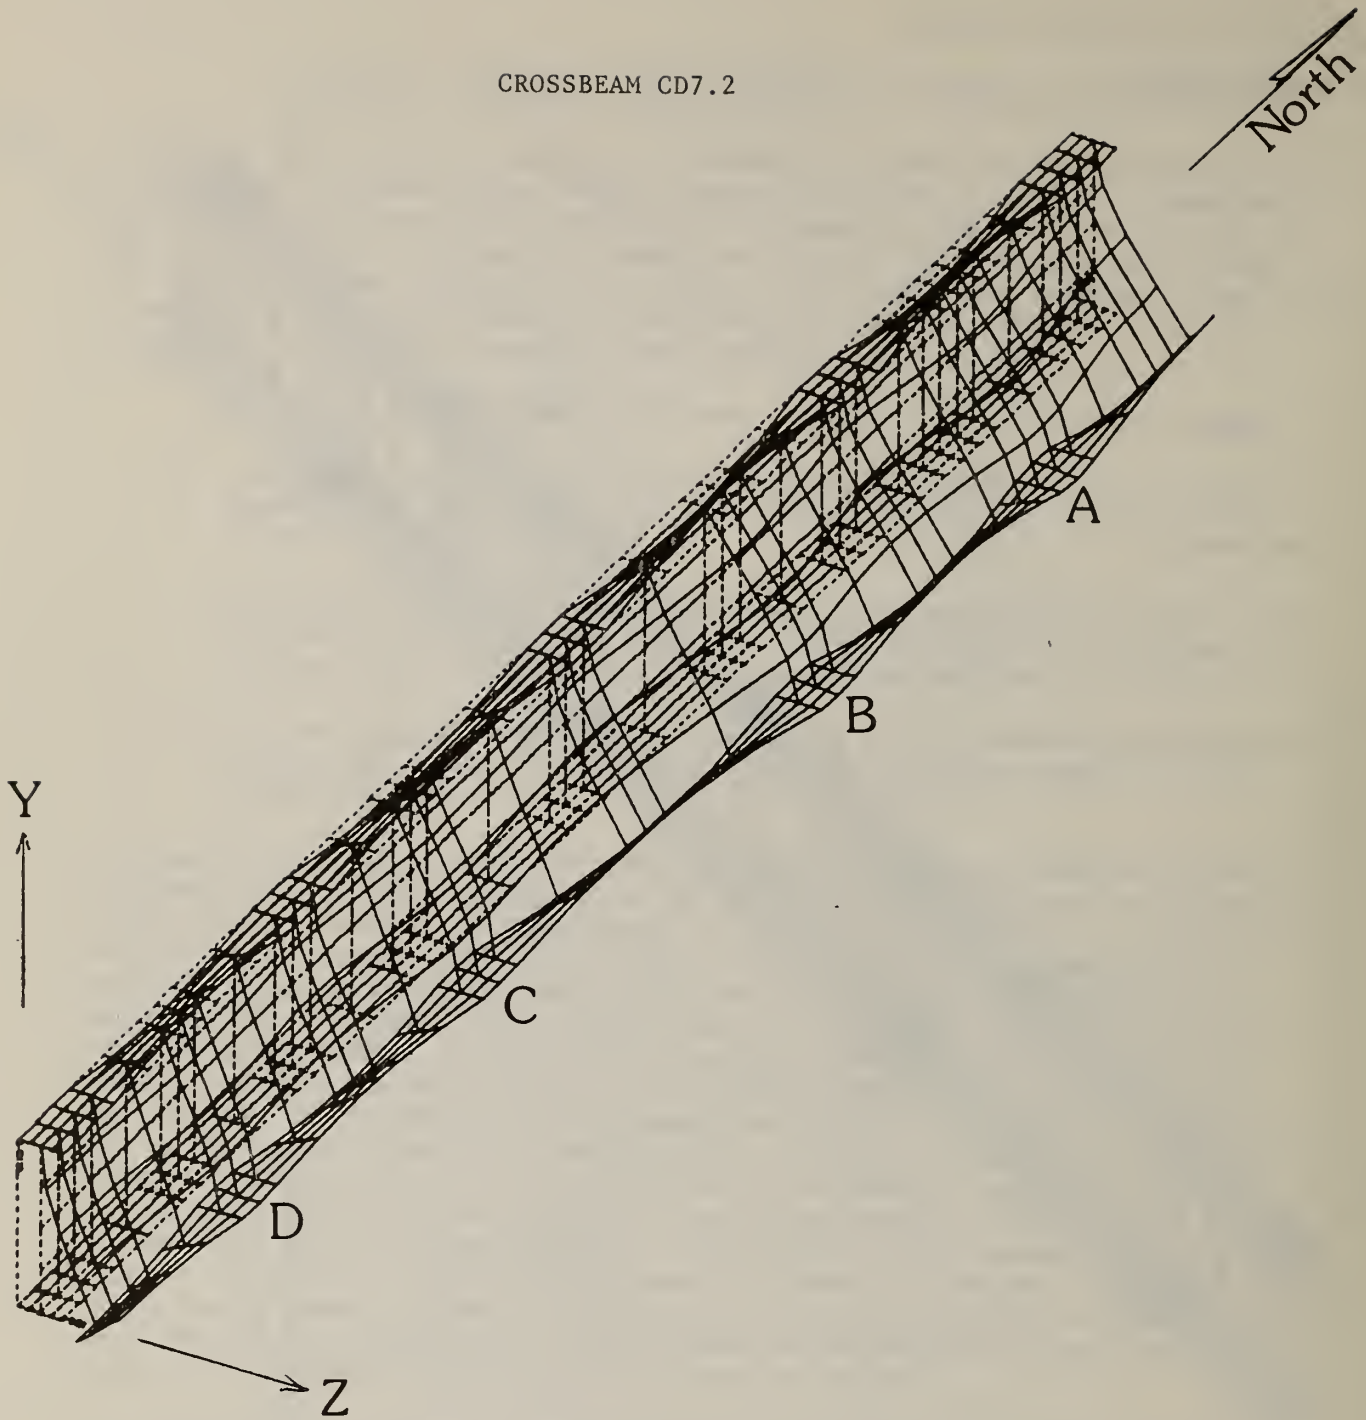
As part of the structural analysis to examine the behavior of crossbeam CD7.2 subjected to the translation of the tops of the towers at 407.2, a separate analysis was performed. This crossbeam was supported by the four U-heads at legs A, B, C and D. Figure C.1 shows the finite element mesh used to model the crossbeam. Overlapping plate bending (type 'BPR') and membrane (type 'PSR') elements were used to account for the three dimensional response of the structure. The applied boundary conditions were as follows:

Figure C.2 Deflected shape of crossbeam for analysis #1. U-head supports are assumed to provide rotational resistance to bottom flange of crossbeam. Dotted lines indicate original position of undeformed beam.
