ASBESTOS SURVEY OF THE FEDERAL BUILDING AND COURT HOUSE AT 450 GOLDEN GATE AVENUE, SAN FRANCISCO, CALIFORNIA

NBSIR 83-2650

James H. Pielert

February 1983

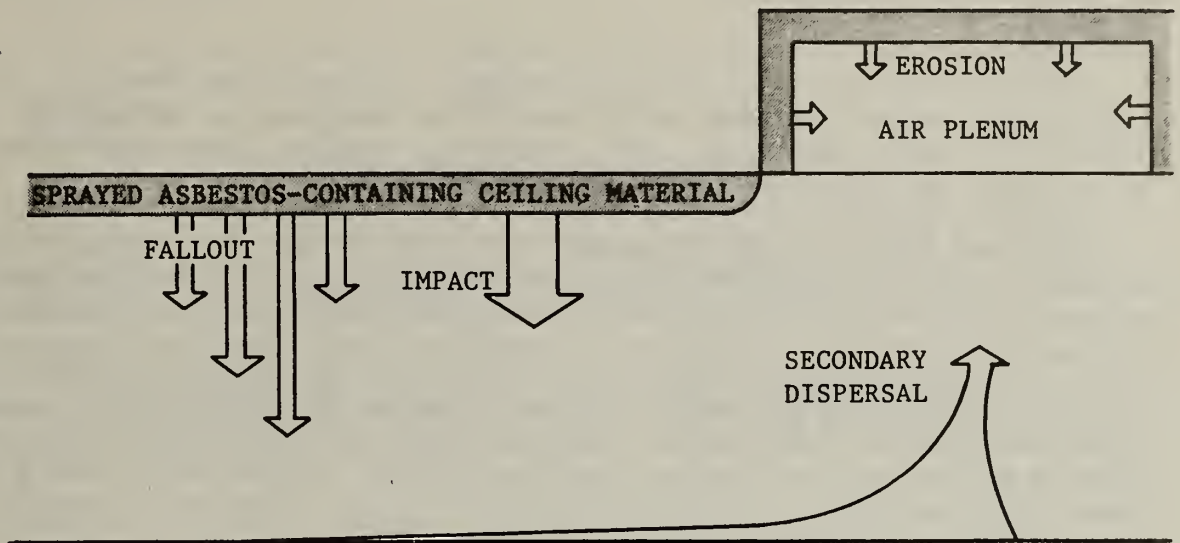
Figure 1. Mechanisms for generating airborne asbestos levels^{1/}

"Circumstances that result in asbestiform fibers becoming airborne include fallout, impact, and reentrainment. Fallout is considered to be a result of aging and degradation of the bonding agents in an asbestos-containing material. Fallout is usually low level, continuous, and may increase with the age of the structure. It represents a source of fallen fibers which may accumulate over periods of time. Impact with asbestos-containing material may be intentional, accidental, capricious, or destructive. Specific actions include striking, cutting, or penetration of the material. Such contact disturbs the integrity of the matrix and results in fiber dissemination. Most friable forms of asbestos-containing material are readily susceptible to such damage or disturbance. Even spraying friable surfaces with sealants or paints causes fiber release. Reentrainment of fallen debris and asbestos dust by custodial activities such as dusting or sweeping will resuspend accumulated fibers in the atmosphere. Generally, the reentrainment effect is proportional to the level of activity in the facility."

MODE	CAUSES	FREQUENCY	FIBER RELEASE RATE
FALLOUT/ EROSION	AIR MOVEMENT, VIBRATION, DETERIORATION	CONSTANT	LOW
IMPACT	MAINTENANCE, ACCIDENTAL IMPACT	OCCASIONAL	HIGH
SECONDARY DISPERSAL	USUAL ACTIVITY CUSTODIAL SERVICE	FREQUENT	LOW TO HIGH

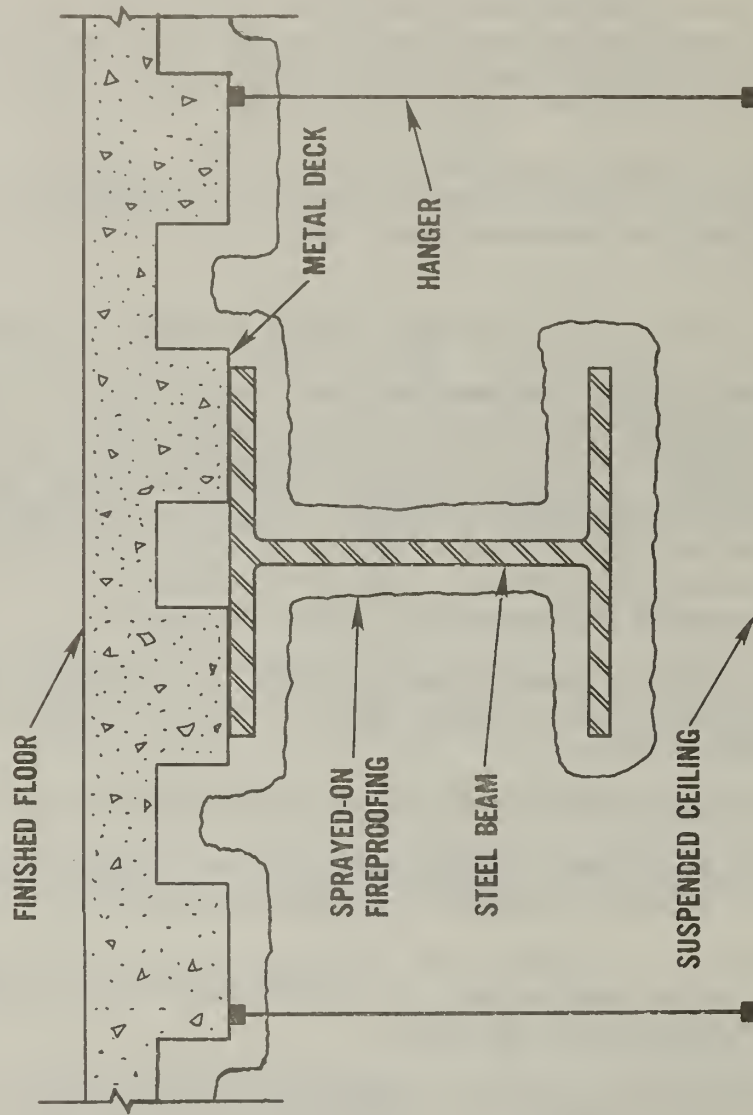
Figure 2. Schematic of typical composite steel/concrete floor construction

The building is a steel frame structure with composite floors constructed of light gage steel deck and cast-in-place concrete. The deck used was a standard structural deck with built-in wireways but no air movement cells. A schematic cross-section drawing of typical floor construction is shown in figure 2.

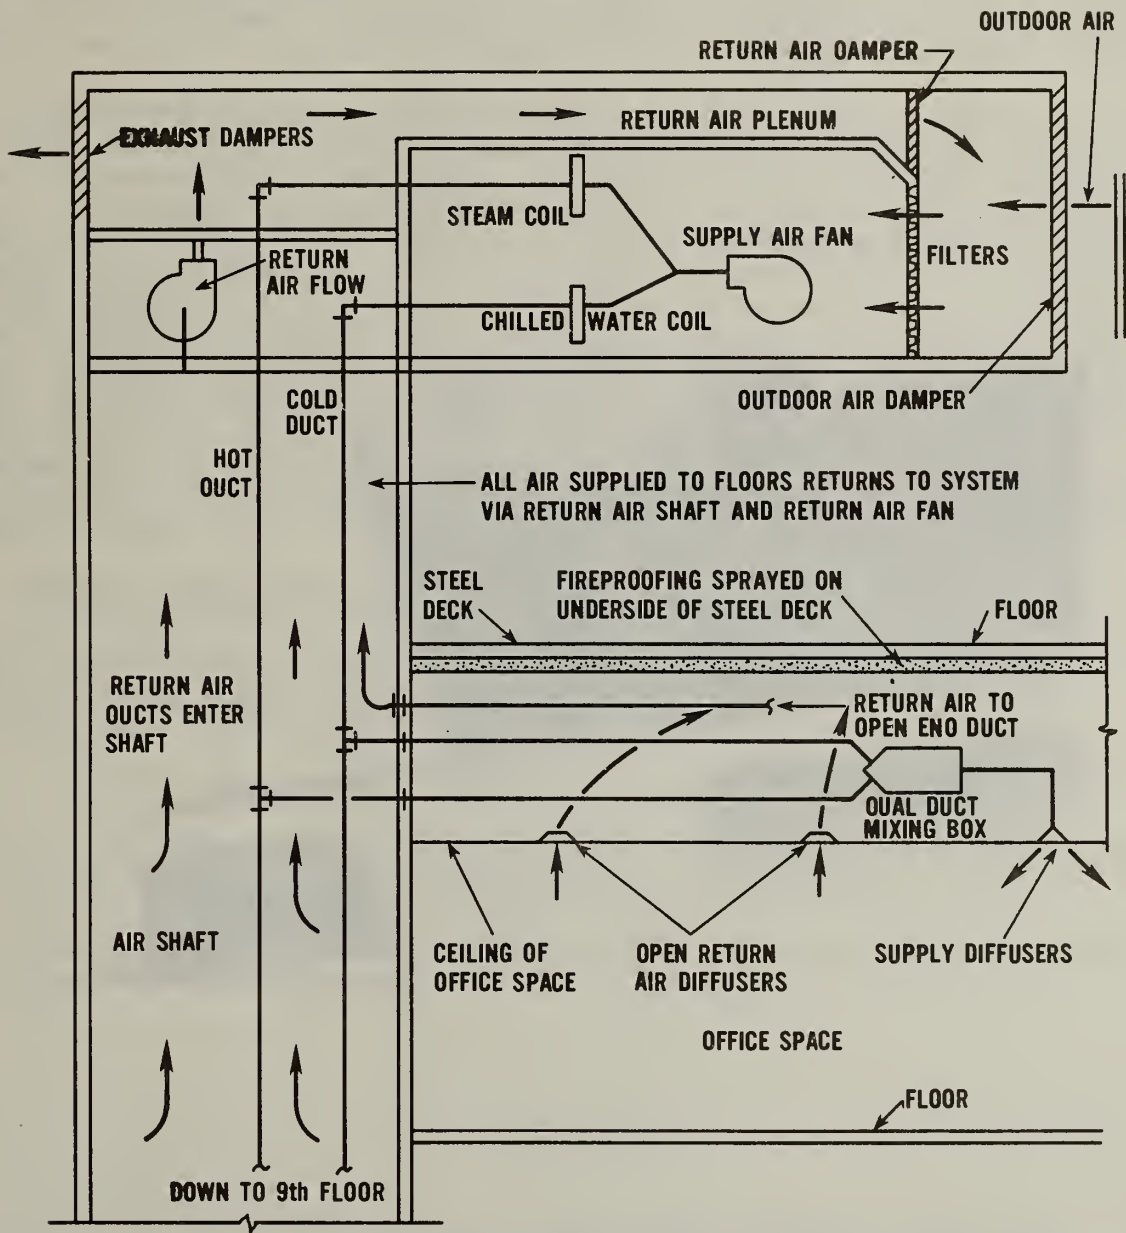
Figure 3. Schematic of typical air handling system

The HVAC system is a four-pipe system consisting of six separate air handling systems providing air flow to all spaces in the building. The air handling systems are such that four of these systems feed down from the twentieth floor to the ninth and two systems feed up from the basement areas through the eighth floor. These systems are dual duct systems with separate steam heating coils and chilled water cooling coils in each system with duct mixing boxes as the terminal units. The system has the ability to cool or heat at any time that the air handling units are running. The portions of the HVAC system observed were consistent with the building drawings. A schematic drawing of a typical air handling system for occupied office areas is shown in figure 3.

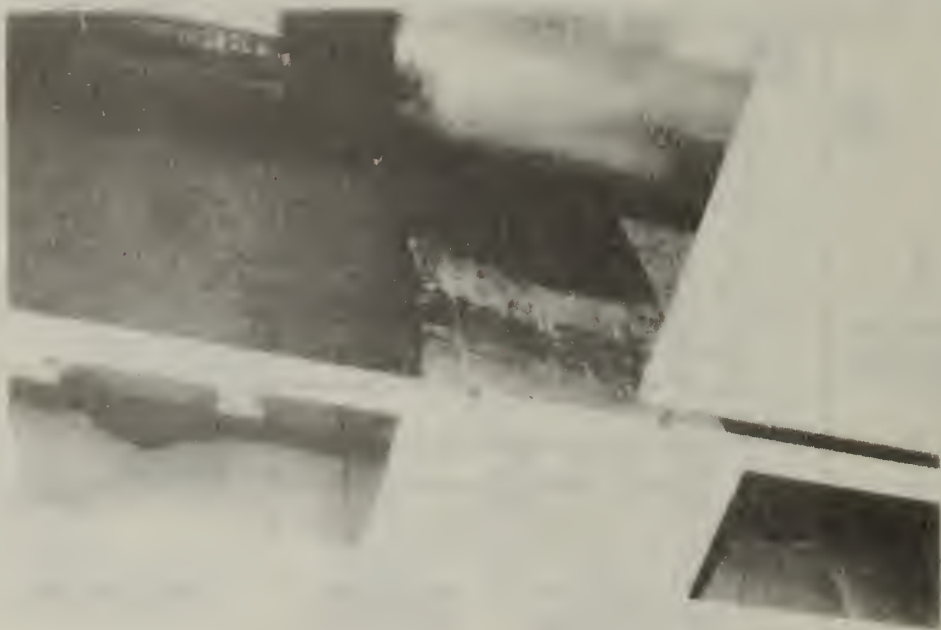
The return air systems consist of a series of ceiling diffusers placed on a modular basis throughout office spaces and are open to the plenum above through a small sound attenuation chamber. Air that is supplied to the room through supply type diffusers goes back up into the plenum through these return air diffusers (figure 4). Return air is not ducted through the plenums where fire-proofing coats the structural steel and the underside of the floor deck. There are also small slots at each window to take the downdraft from the glass and feed back into the return system. The latter portion of the system is duct connected and this air does not return through the open plenum.

Figure 4. Air return diffusers with sound attenuation collar in ceiling above typical occupied space

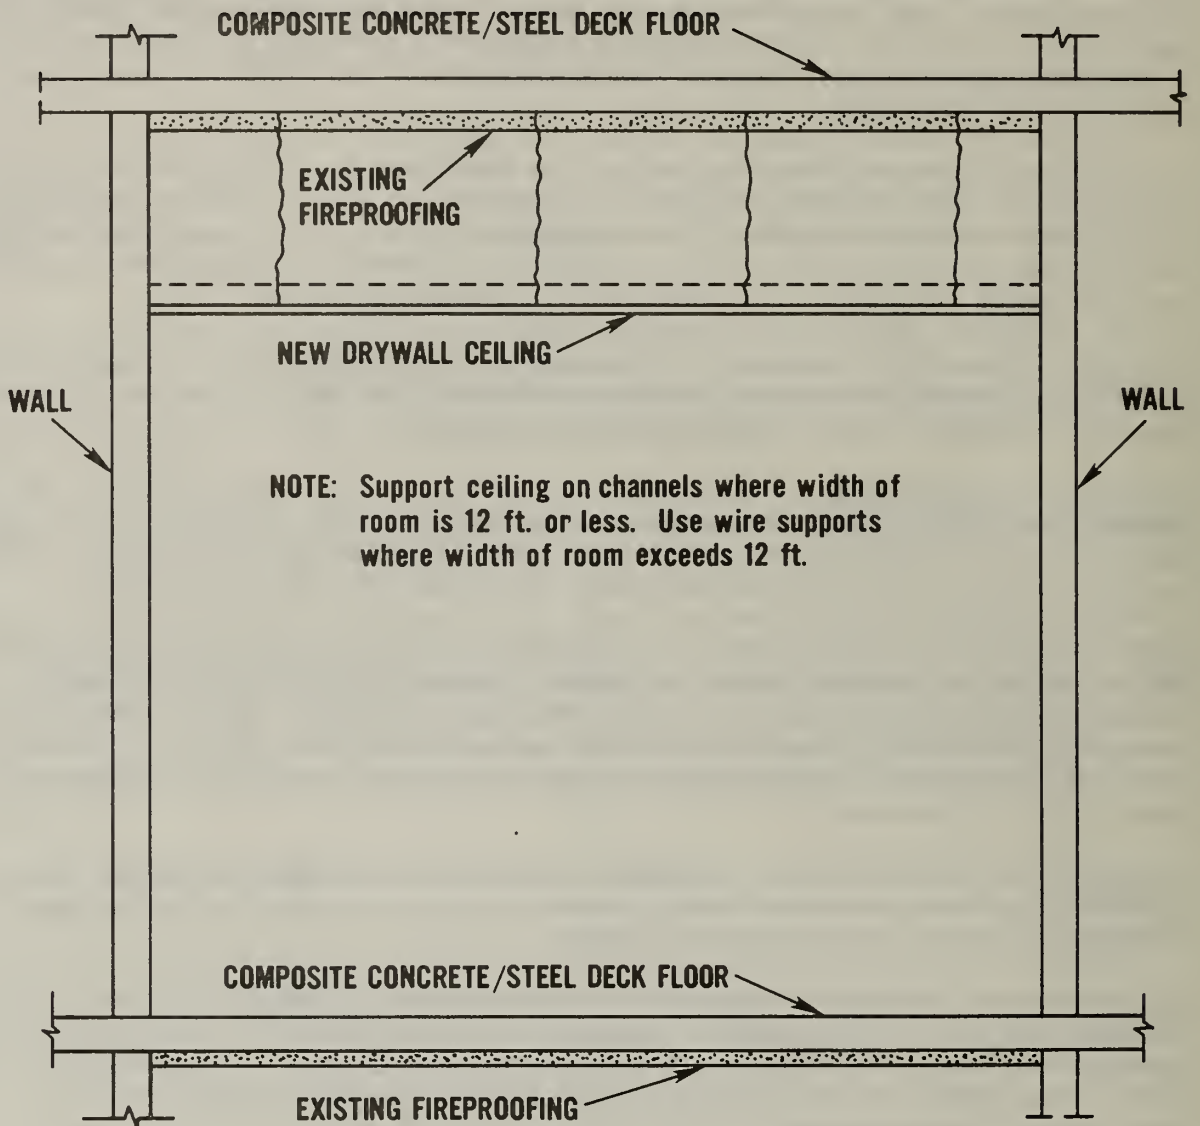
Figure 14. Method of installing ceiling where exposed fireproofing is present

Discussion and Approach - Certain rooms throughout the building do not have ceilings and the fireproofing is exposed to the occupants of these rooms. Any material dislodged in these rooms may fall on the floor or directly on the occupants. Installation of a ceiling in these rooms as shown in figure 14 is considered to be feasible.

Approach and Cost - The cost of installing ceilings is estimated to be \$10.00 per square foot average, and there is approximately 9,000 square feet for an estimated cost of \$90,000.

Section thru room showing method of installing ceiling where fireproofing is exposed to room (electrical closets, telephone closets and elevator rooms)
