NBSIR 85-3158

Fire Performance of Interstitial Space Construction System

J. Randall Lawson

May 1985

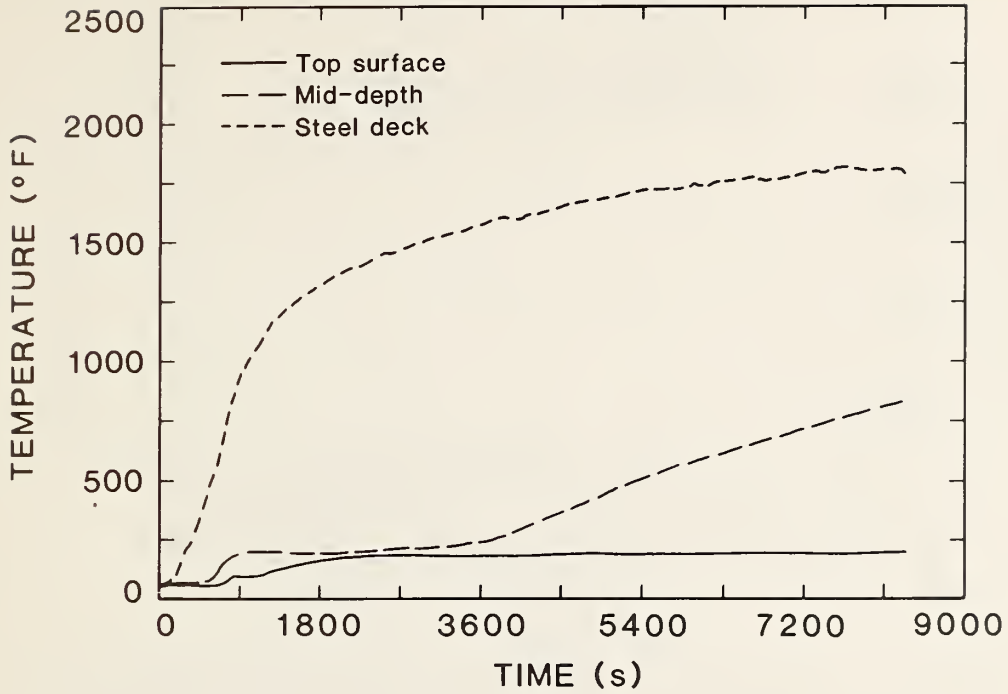
Figure 43. Walk-on deck temperatures thick section quadrant I, test 1

Figures 43 to 46 shows a comparison of walk-on deck temperatures. The high temperatures noted in figure 44 resulted from a crack developing in the walk-on deck near the measurement location. Temperatures were high enough to easily ignite cotton waste, as referenced in NFPA 251. Figures 45 and 46 show temperature rise data for a floor area that did not exhibit major cracking. In this case the surface temperatures stayed below 250°F.

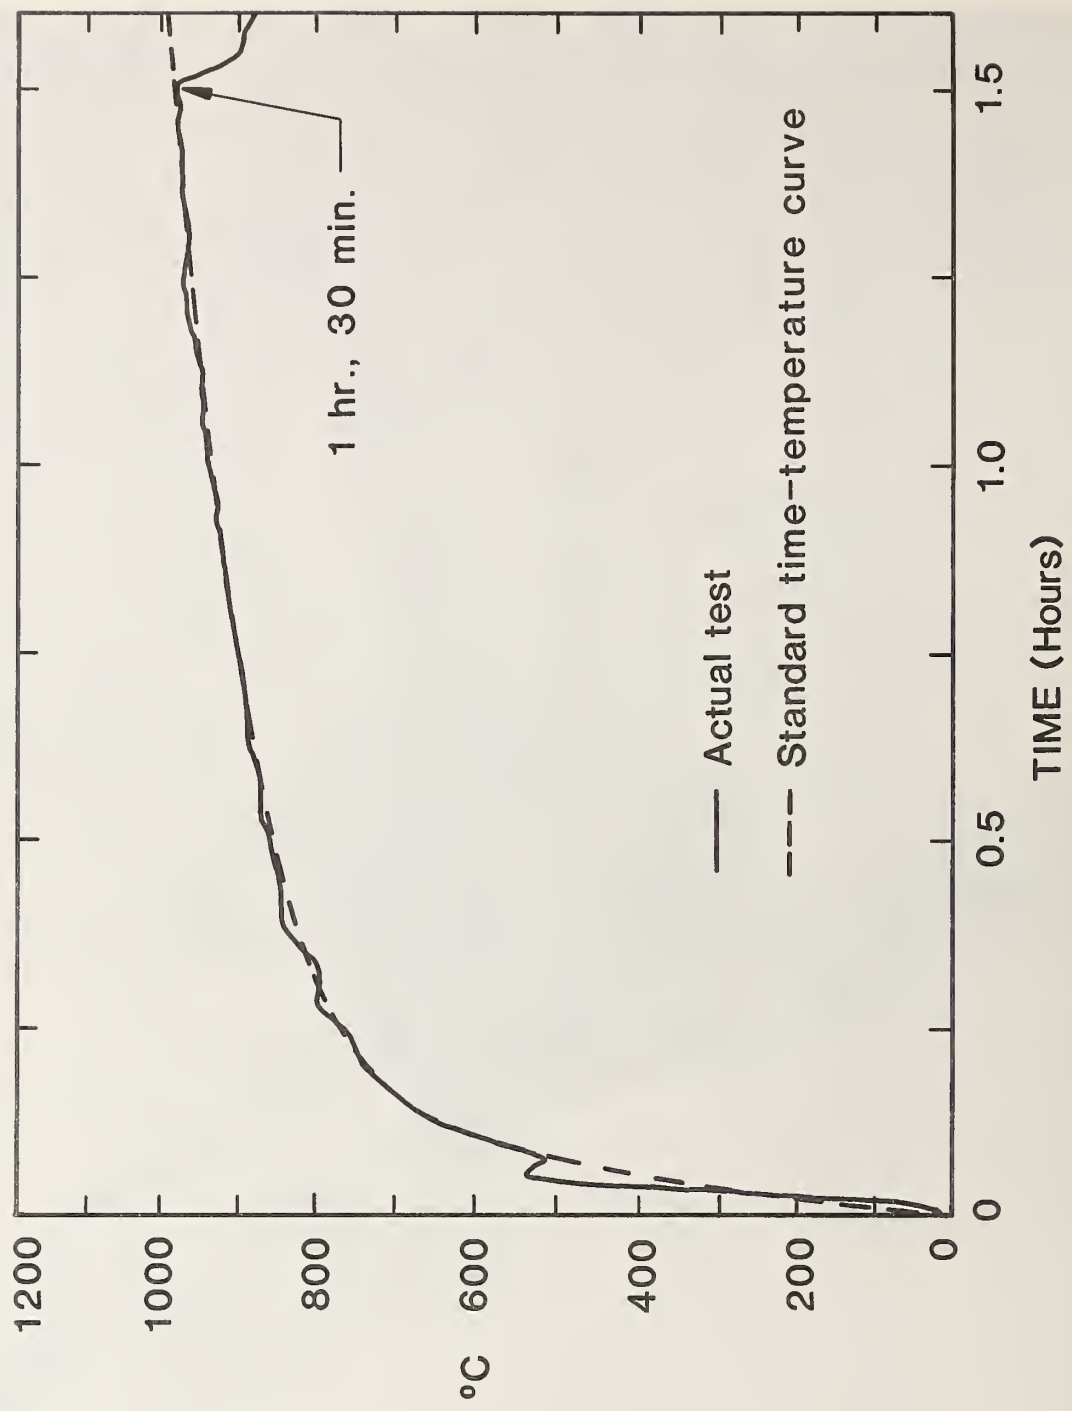
Figure 52. Chart record of average furnace temperature, test 2

A record of the average furnace temperature is presented in figure 52. This test was terminated at 1 hour 30 minutes into the test. This termination was not related to any failure of the construction assemblies under test. It resulted from the excessive heat losses from the fire compartment described in section 4.

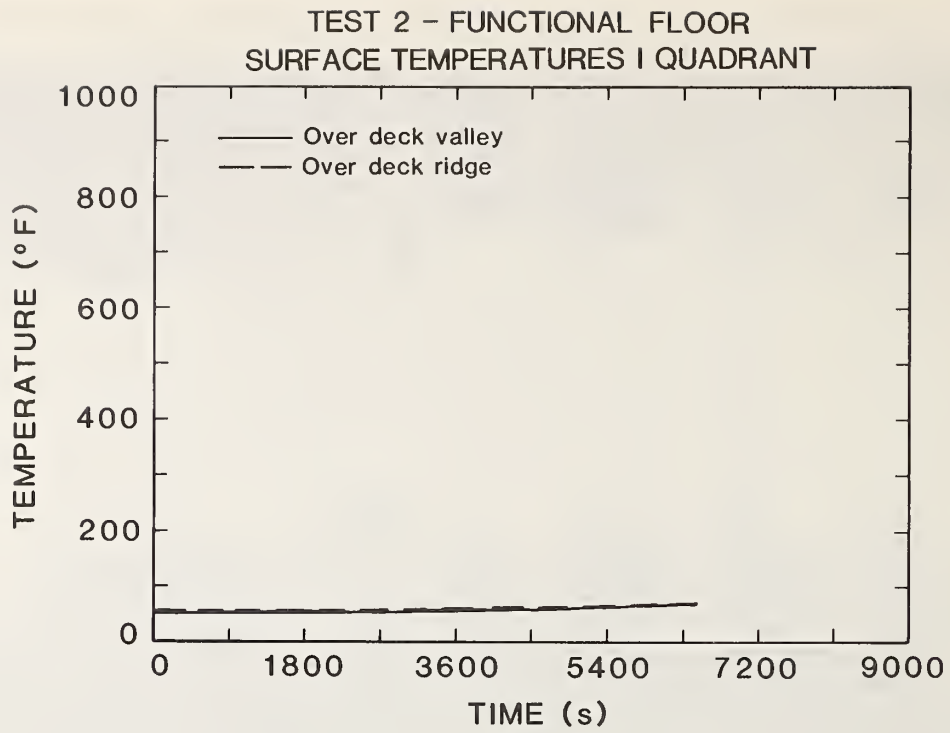
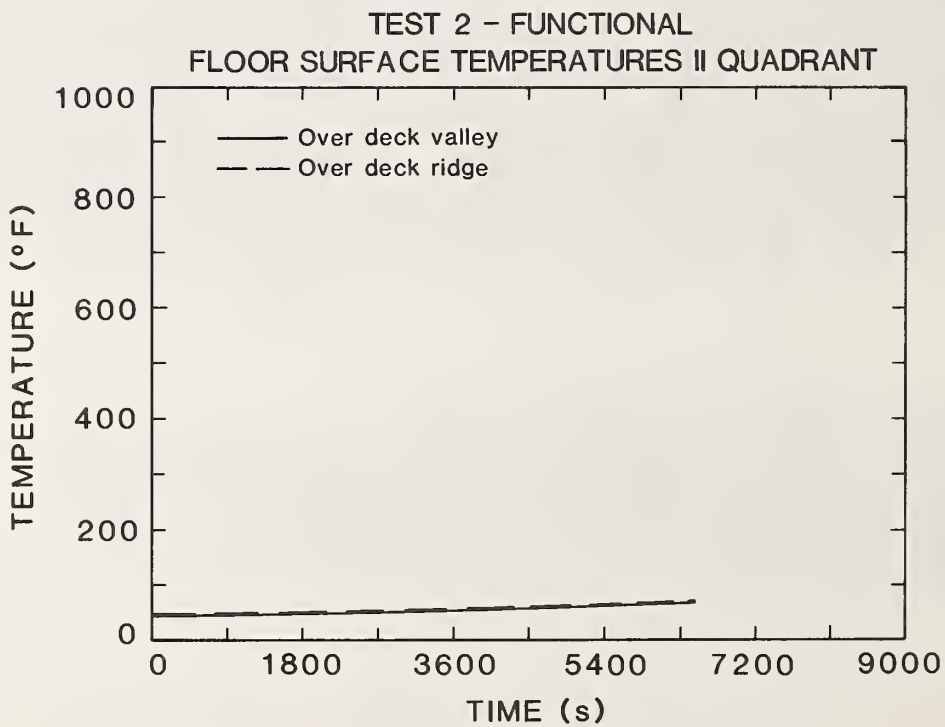
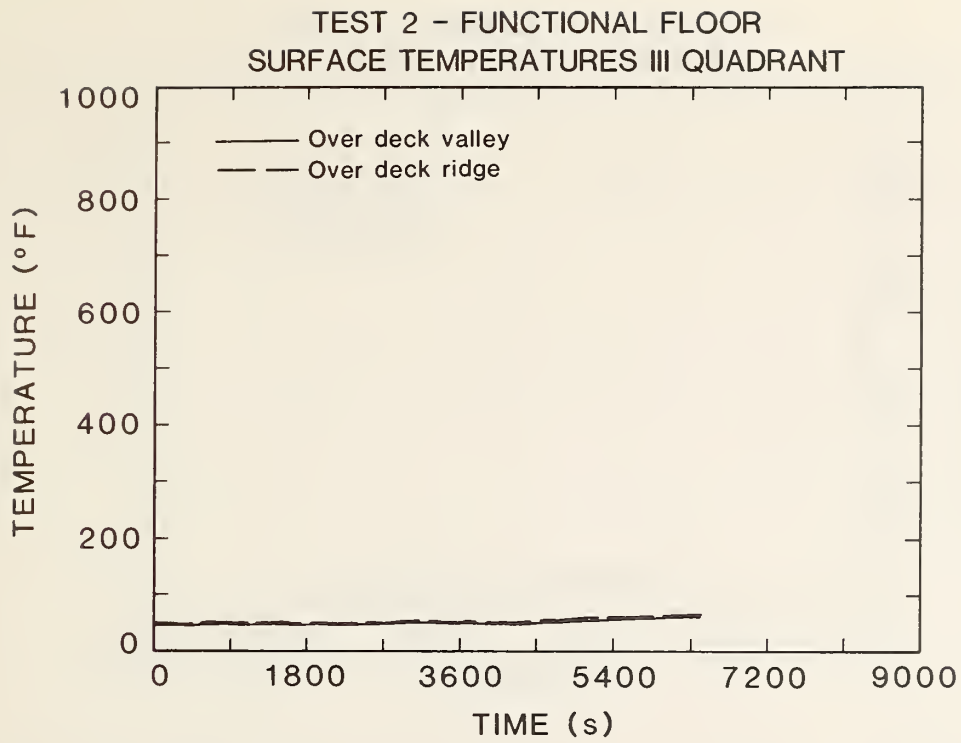
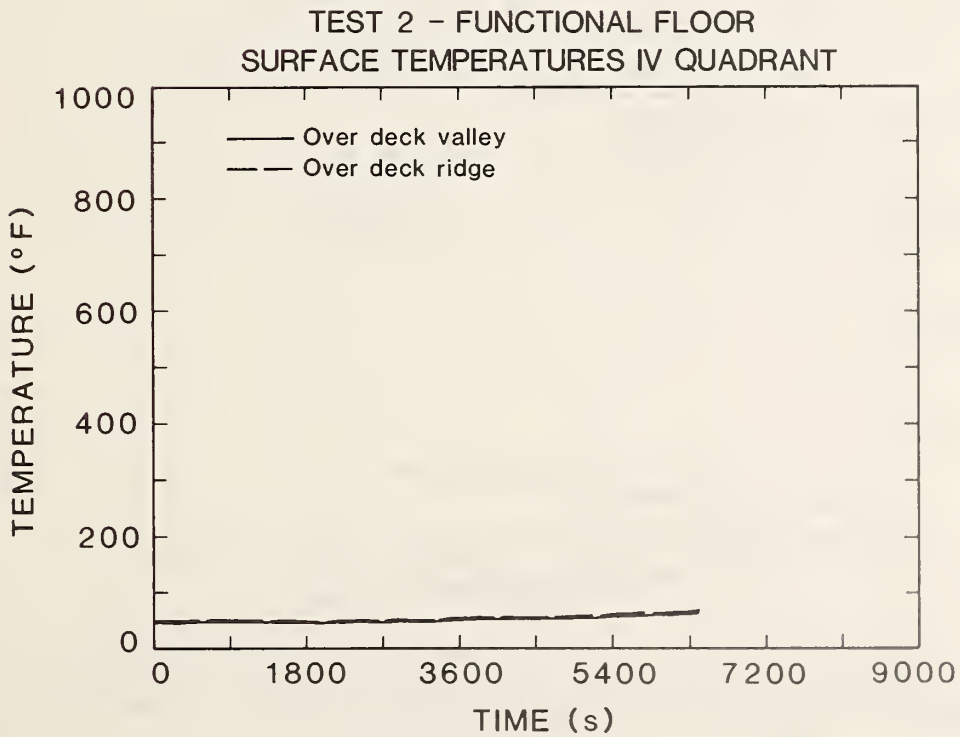
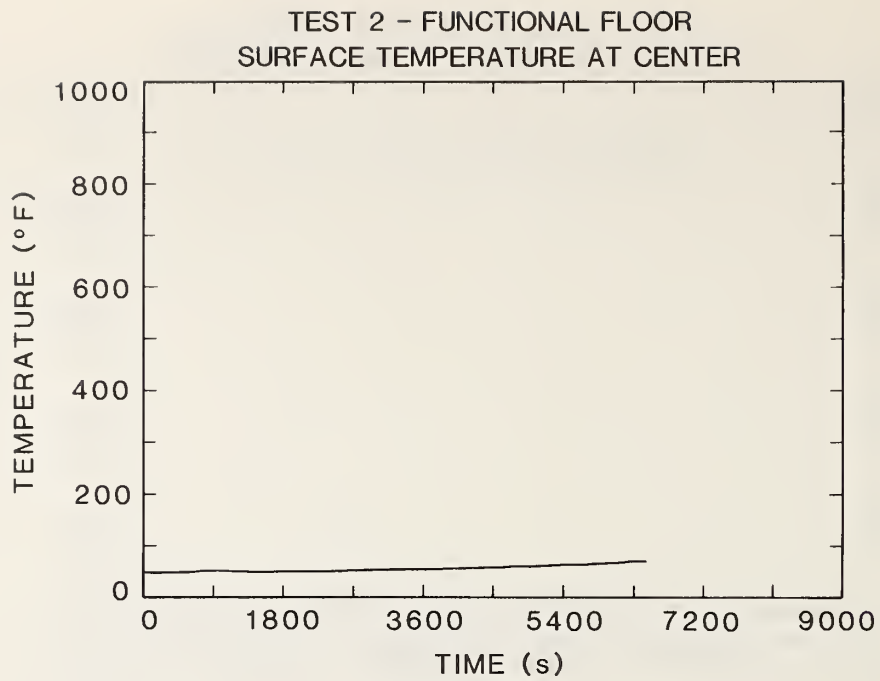
Data representative of the functional floor surface temperatures recorded during test 2 are shown in figures 54 to 58. The surface temperature from this test never exceeded 77°F. This was also well below the failure point of 250°F. The cooler surface temperatures in this test reflected the cooler weather experienced during test 1, see table 2. The steel deck temperature reached a peak of 138°F by the test's end, figure 59. The center beam supporting the function floor reached a peak temperature of 153°F, figures 60 and 61. The maximum temperature reached by the unprotected portion of the center column in the interstitial space was 165°F, figures 62 and 63. Figures 64 to 67 present plots of temperatures for the protected center column

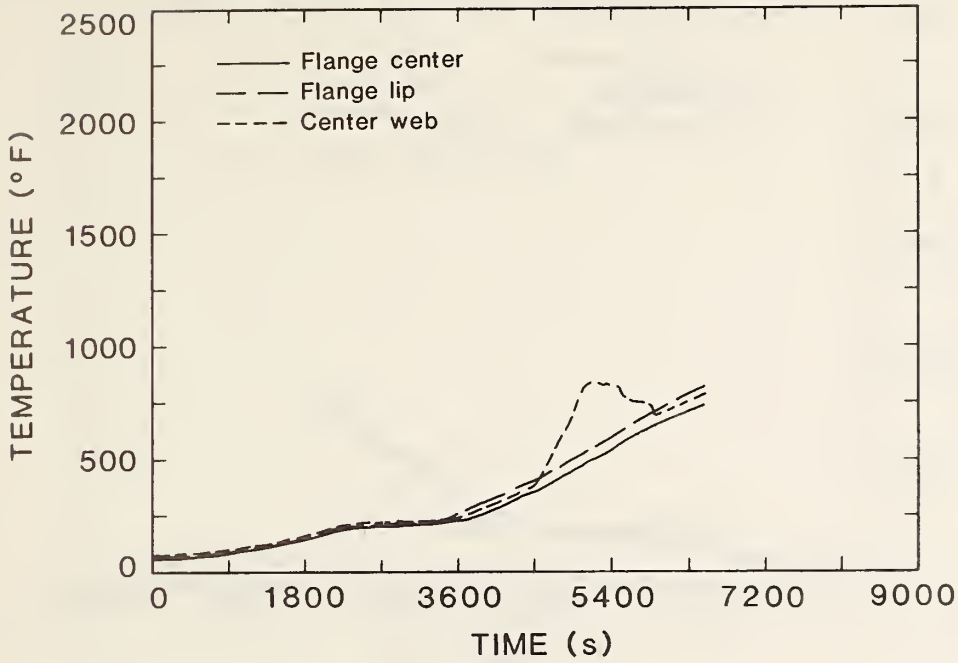
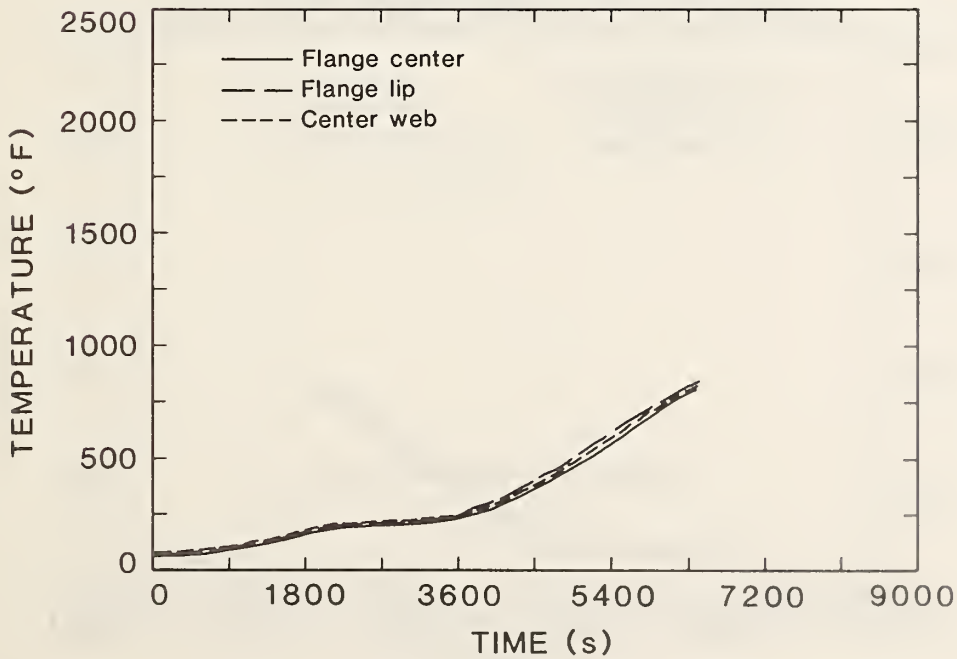
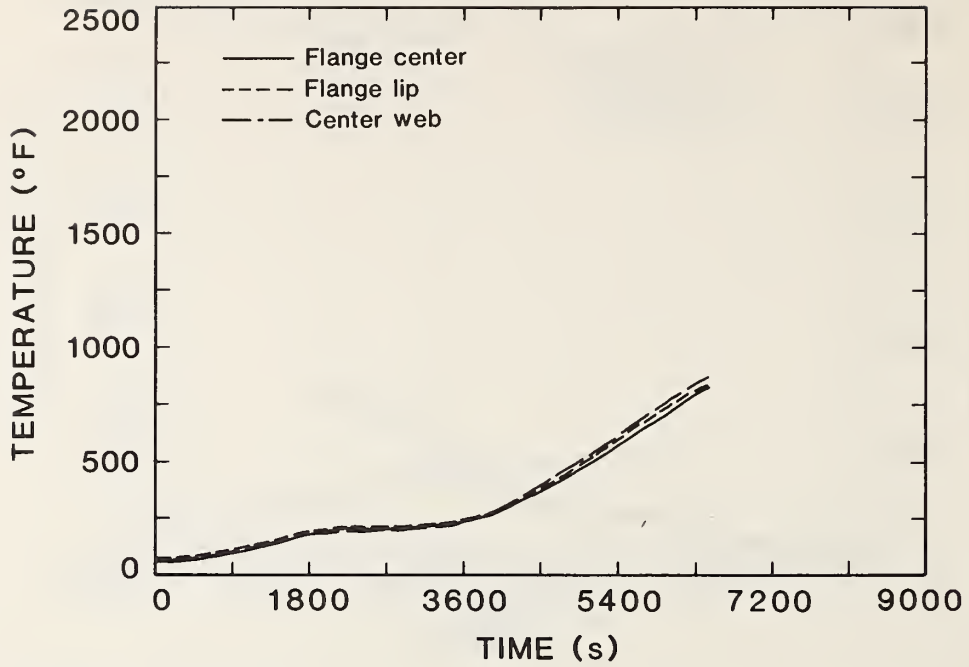
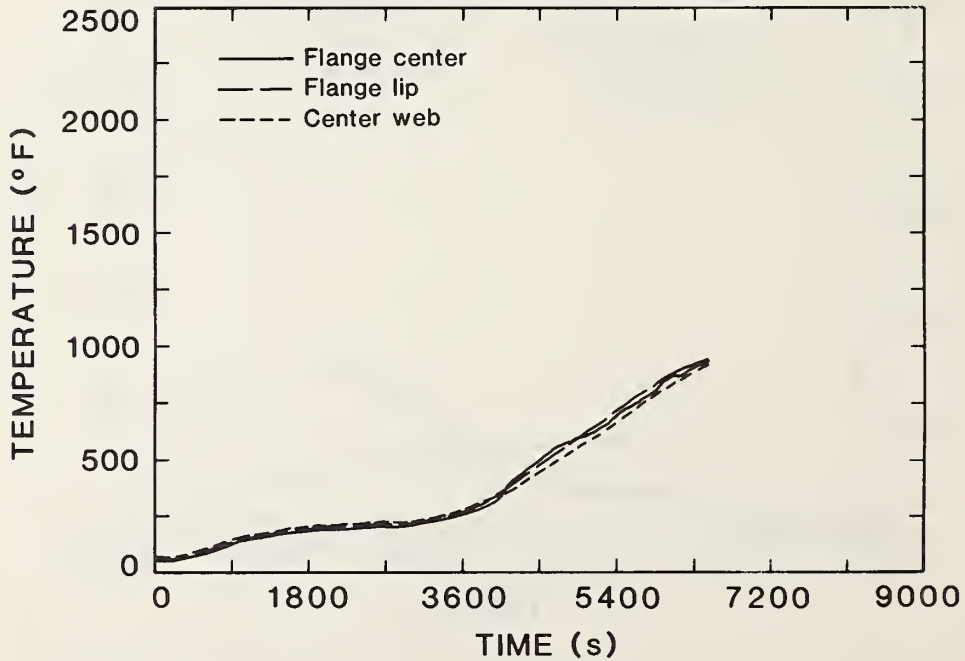
section that was exposed to the fire compartment. The maximum test temperature for the column was 937°F, and it occurred 18 minutes after the furnace burner was turned off. The fireproofed purlins supporting the walk-on deck performed well, figures 68 to 71. As stated in section 5.2.2, all fireproofing stayed on the purlins. This resulted in a maximum purlin temperature for this short test of only 354°F, figure 71. The walk-on deck temperatures are shown in figures 72 to 75. These temperature plots show similarity with the data obtained in test 1. The maximum surface temperature measured was 205°F. This again occurred after the burner was turned off, but the overall floor performance is much like that seen in test 1. Temperature plots for the walk-on deck suspension rods and steel tube bracket are shown in figure 76. Heat transfer through the purlins and the suspension system was clearly reduced as a result of the fireproofing remaining in place. The temperature of these structural elements remained significantly low throughout the test exposure. Figures 77 and 78 provide information on duct temperatures and air temperatures in the interstitial space. Again, these temperature plots show similar performance to that experienced with the first test. However, a major difference is seen in figure 79 when compared with figure 49 of test 1. Test 2 shows very little movement in purlin deflection measurements. Since the purlins and walk-on deck system of test 2 appeared to maintain much of their initial strength after this aborted test, it was decided to conduct another full two hour test on the same assembly in an attempt to obtain additional information. Only the fire protection on the column and pier was replaced.

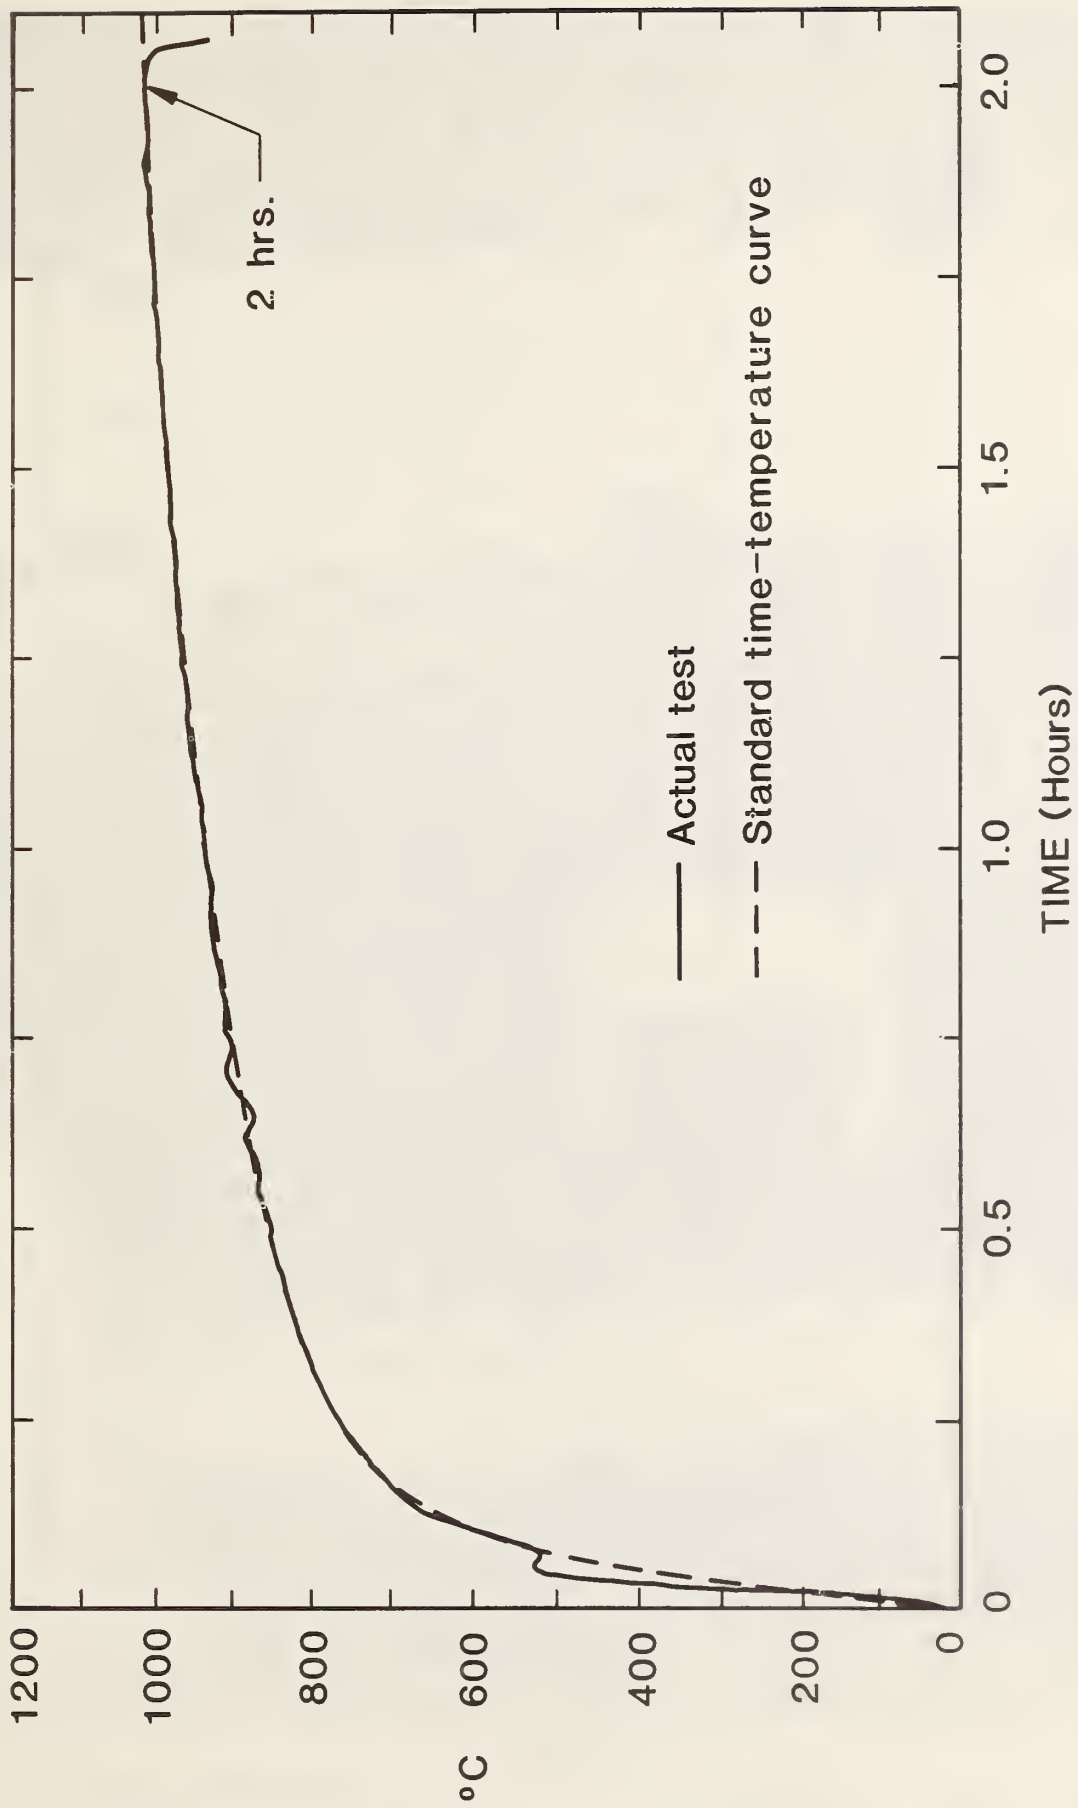
Figure 80. Chart record of average furnace temperature, test 2A

The record showing the average furnace temperature throughout the two hour test is presented in figure 80. It should be noted that the assembly exposed to this standard fire test was the same assembly tested for 1.5 hours the day before. This should be kept in mind when comparing test results. The gypsum board protection on the column and pier was replaced for test 2A.

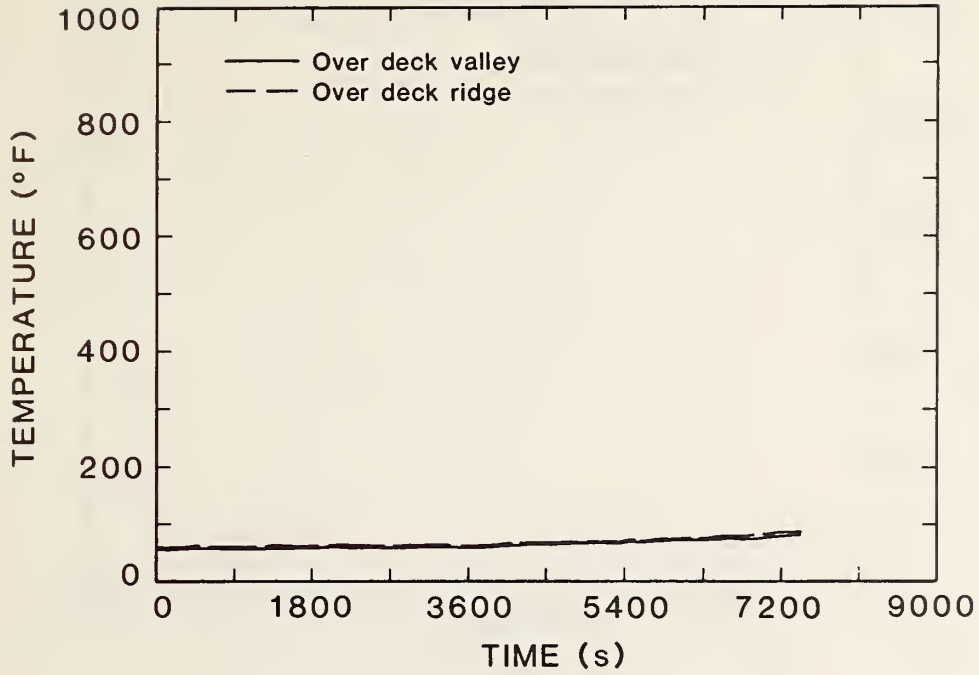
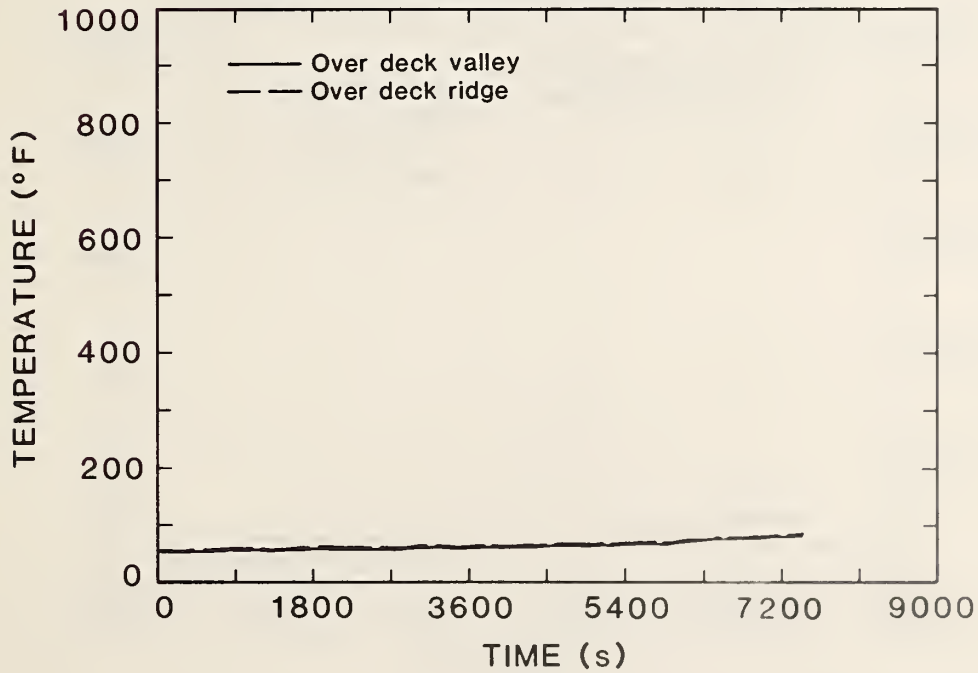
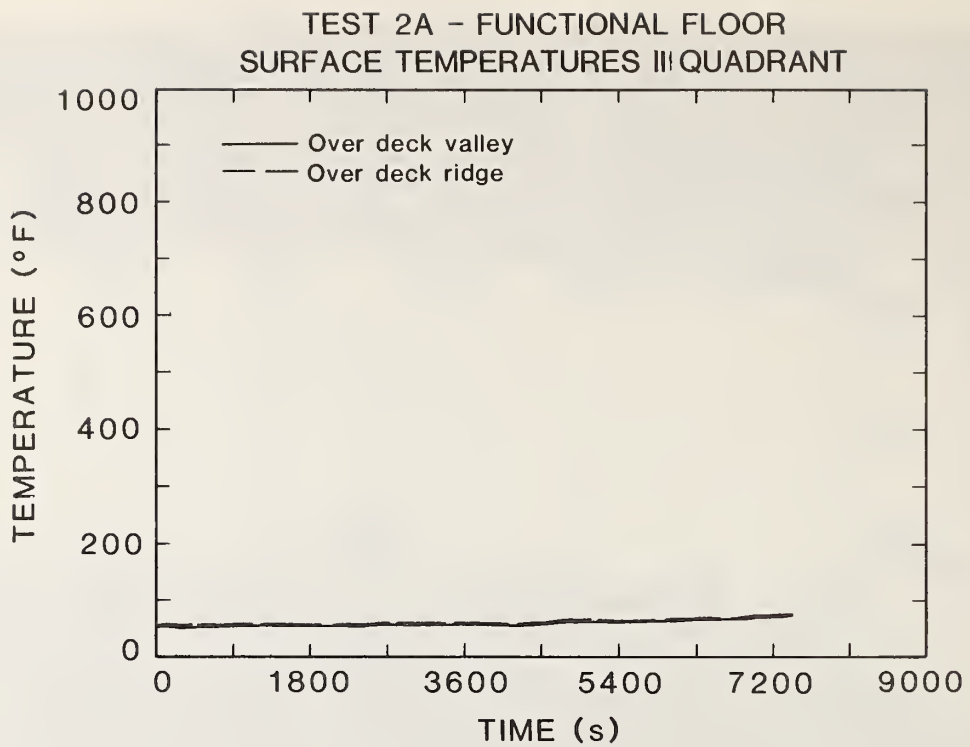
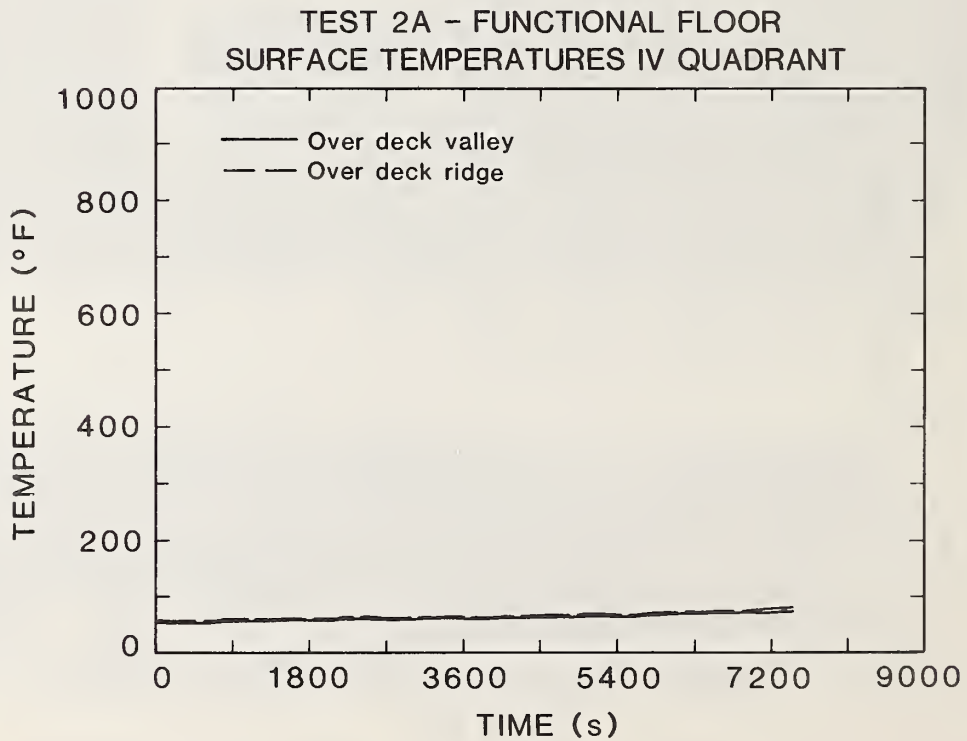
Heat transmission through the functional floor during the second exposure of the test assembly was limited, figures 82 to 86. The maximum temperature on the unexposed surface of the functional floor was 88°F. The steel deck supporting the floor experienced a maximum temperature of 156°F which was 18°F more than that during test 2, figure 87. In addition, the center beam supporting the walk-on deck also showed higher temperatures than recorded in tests 1 or 2, figures 88 and 89. The maximum temperature in this test for the beams was 201°F. The center column in the interstitial space also performed well during this second exposure, figures 90 and 91. It should be remembered that the gypsum board system protecting the center column in the fire compartment was completely rebuilt for test 2A. As seen in figures 92 to 95, the column did not remain adequately protected in the fire compartment. A

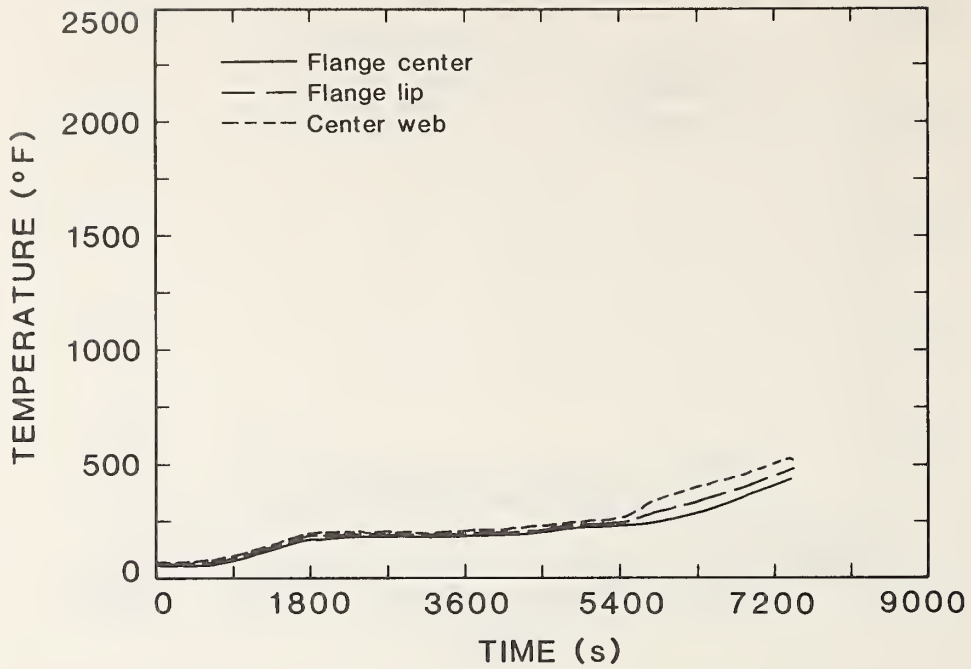
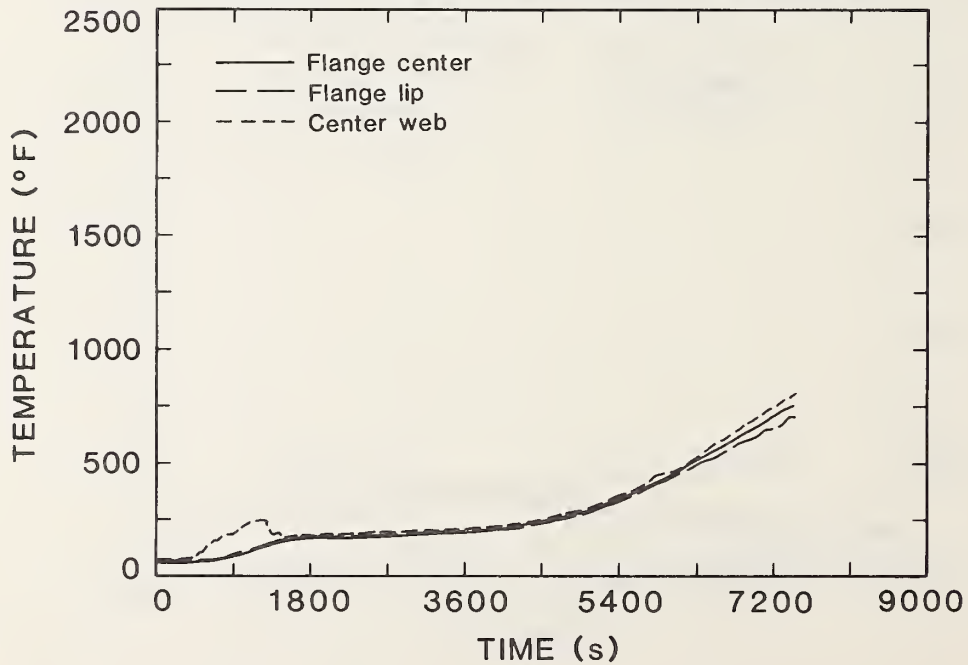
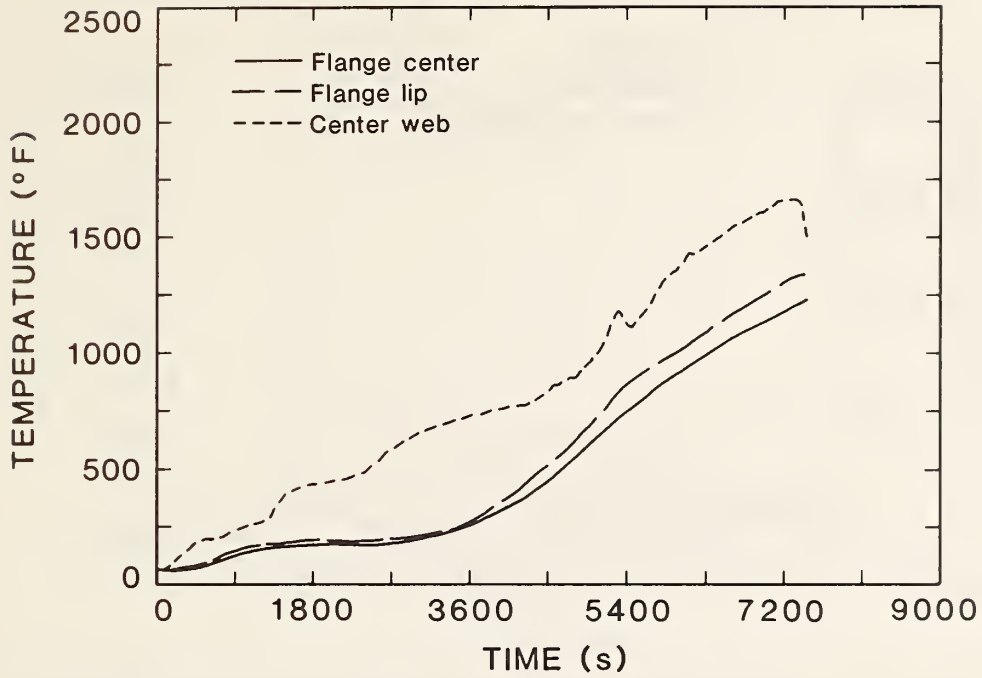
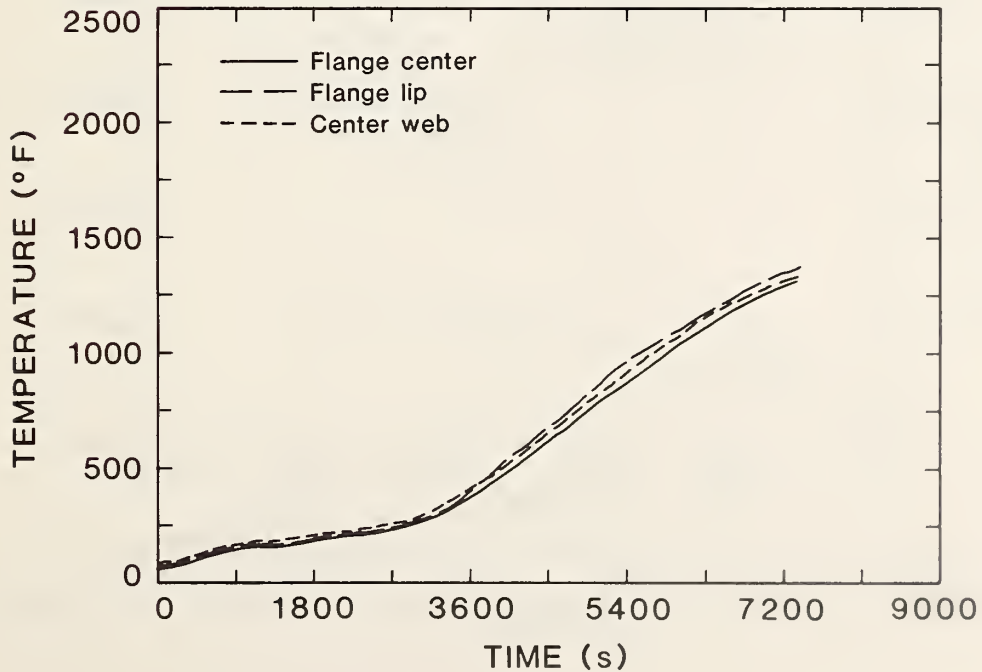
single point temperature failure occurred at 1 hr. 35 min. into the test. This occurred at the six foot high point. The temperature limits were exceeded at four other locations some 15 to 20 minutes later. The single point failure temperature for the column is 1200°F. Even though this failure occurred in the fire compartment, the heat transfer through the column did not result in failure condition in the interstitial space. The fireproofing protecting the purlins remained in place on all purlins during most of the second exposure, figures 96 to 99. This fireproofing gave protection for a cumulative exposure time of 3.5 hours between the two different fire test exposures. The maximum single point temperature on a purlin was 546°F, well below the temperature limit for beams. The woven wire mesh on purlins "A" and "B" helped to hold some of the fireproofing on the purlins resulting in clearly improved performance as compared to test 1.

Figure 92. Column temperatures in furnace compartment two feet up from floor, test 2A

Figure 93. Column temperatures in furnace compartment four feet up from floor, test 2A

Figure 94. Column temperatures in furnace compartment six feet up from floor, test 2A

Figure 95. Column temperatures in furnace compartment eight feet up from floor, test 2A

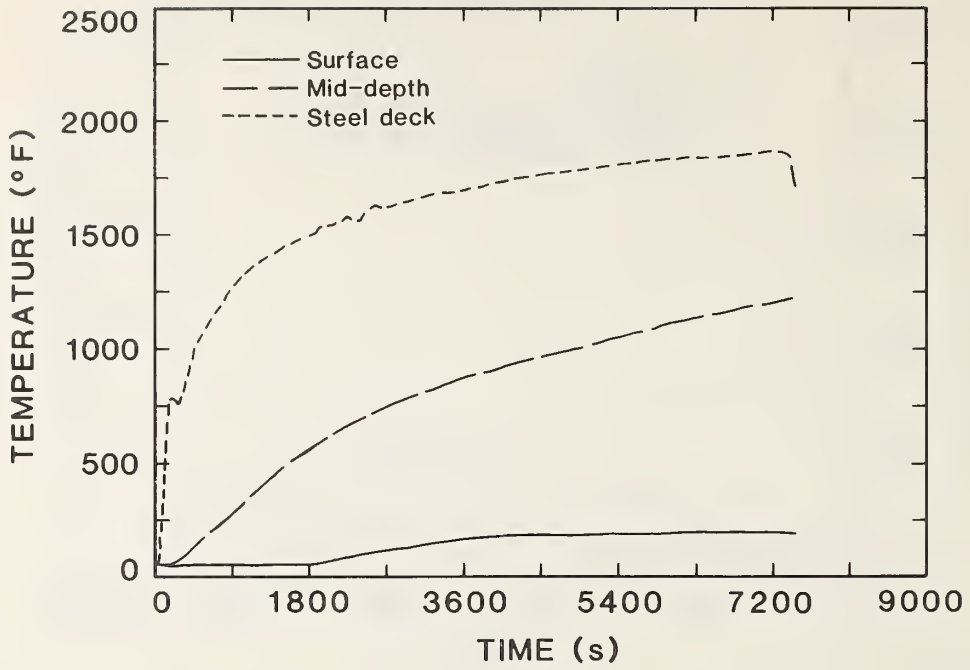
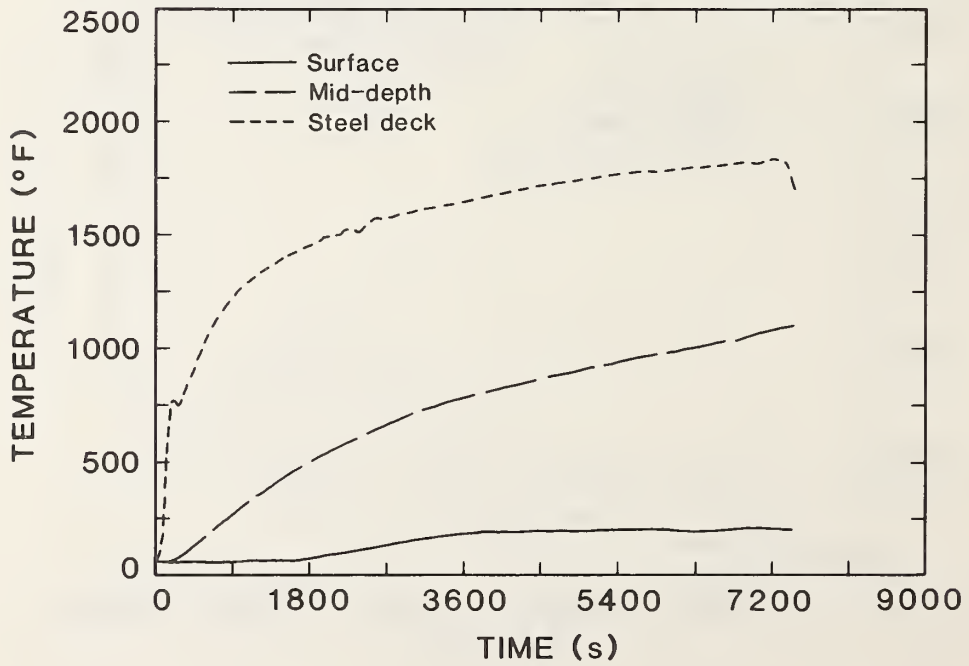
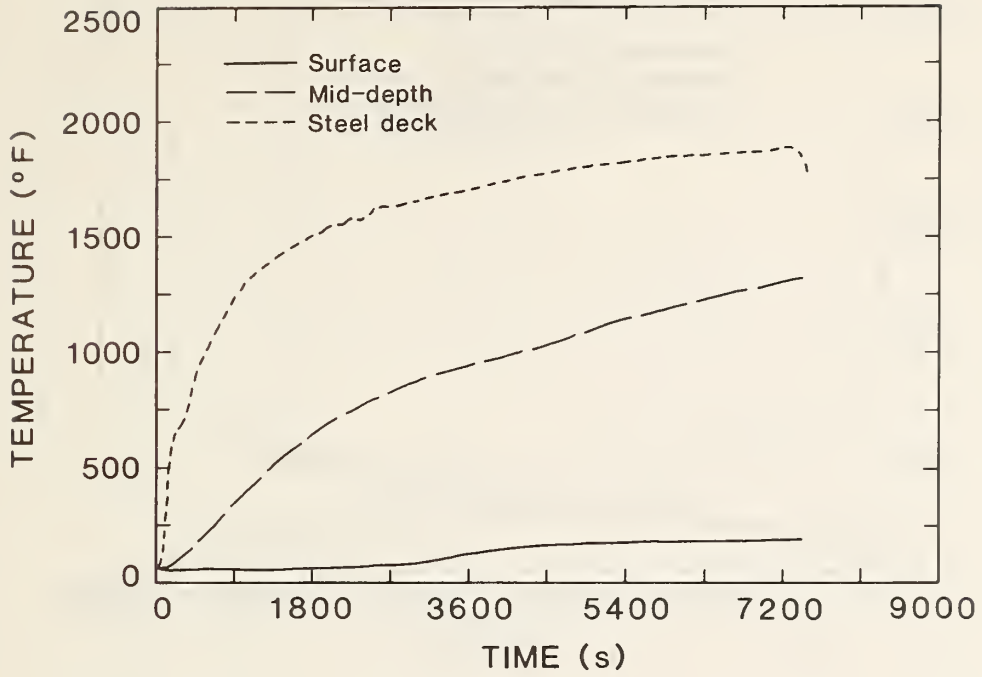
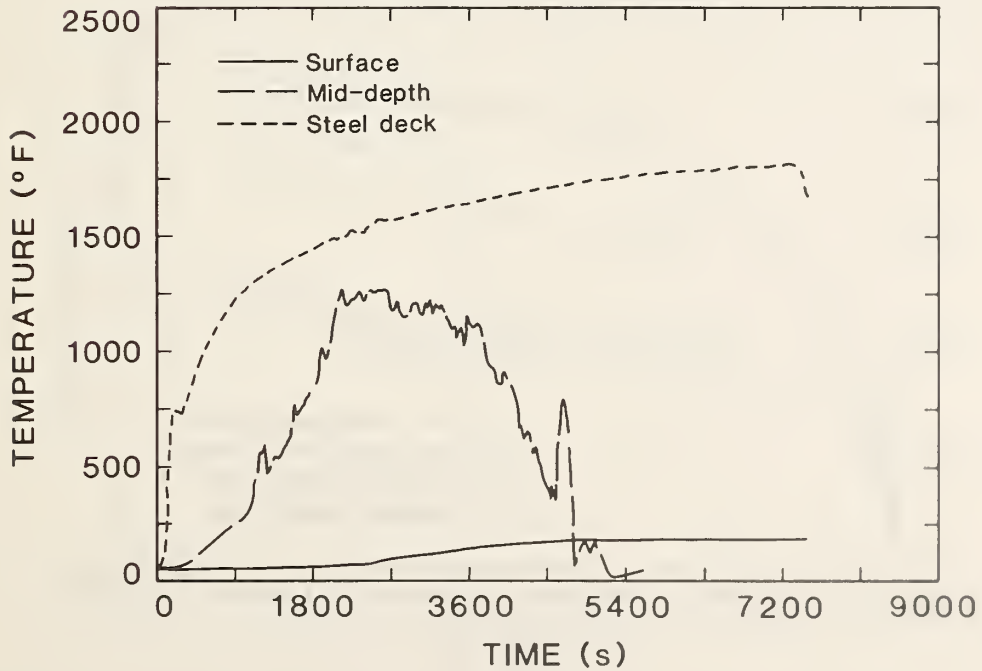
The walk-on deck during this test generally performed better than the walk-on deck in test 1, figures 100 to 103. This deck did not show the amount of cracking noted at the end of test 1. The suspension rod and steel tube bracket temperatures are presented in figure 104. Temperatures recorded for the dummy air conditioning ducts, figure 105, are similar to results obtained during tests 1 and 2. Air temperature in the interstitial space reached a maximum of 331°F. This is only 36 degrees higher than that experienced in test 1. Particular attention was paid to the purlin deflections recorded during this test, figure 107. In test 1, the deflections were random, and in test 2 the purlins moved very little. During this test the purlins showed a gradual movement in the downward direction. This movement was attributed in part to the gradual degradation of the fireproofing combined with the

Figure 100. Walk-on deck temperatures thick section quadrant I, test 2A

Figure 101. Walk-on deck temperatures thin section quadrant I, test 2A

Figure 102. Walk-on deck temperatures thick section quadrant III, test 2A

Figure 103. Walk-on deck temperatures thin section quadrant III, test 2A
