NBSIR 85-3158

Fire Performance of Interstitial Space Construction System

J. Randall Lawson

May 1985

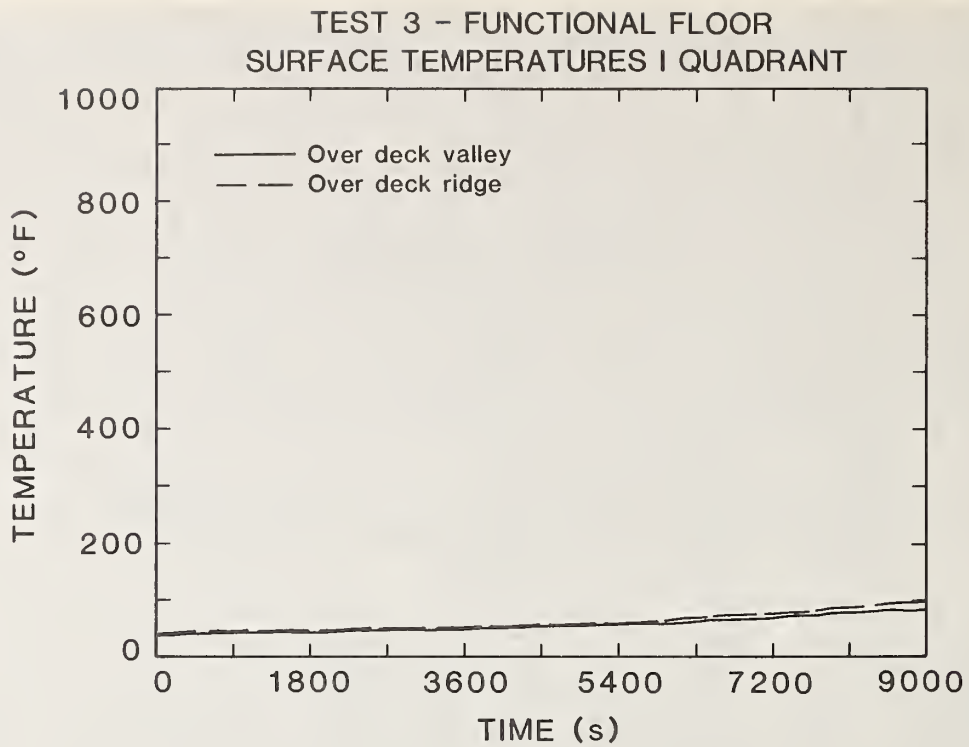
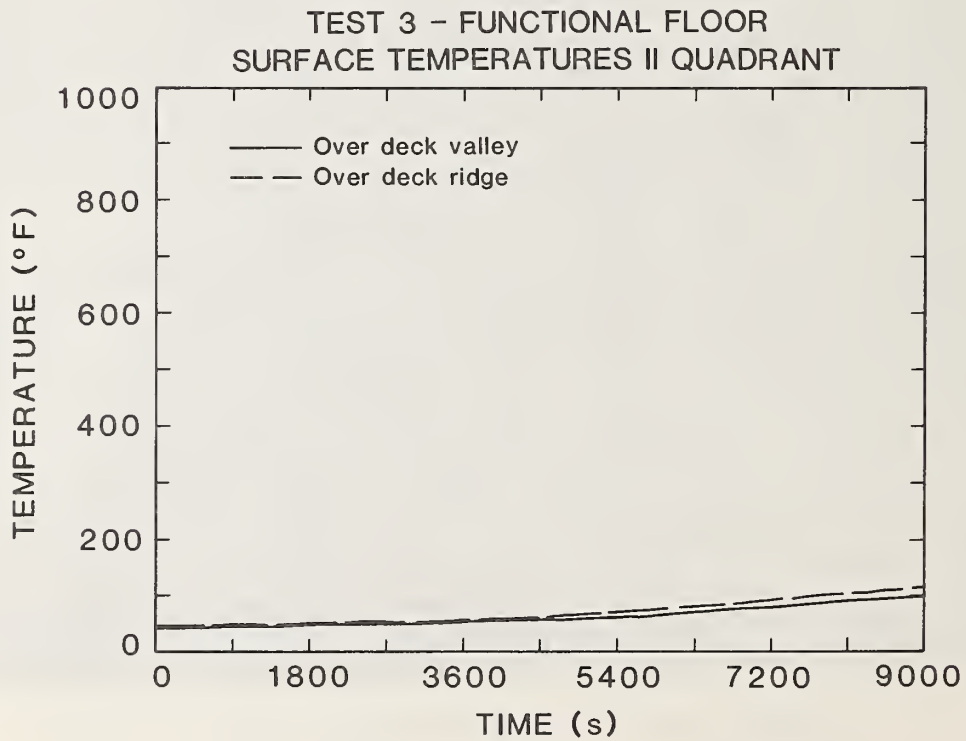
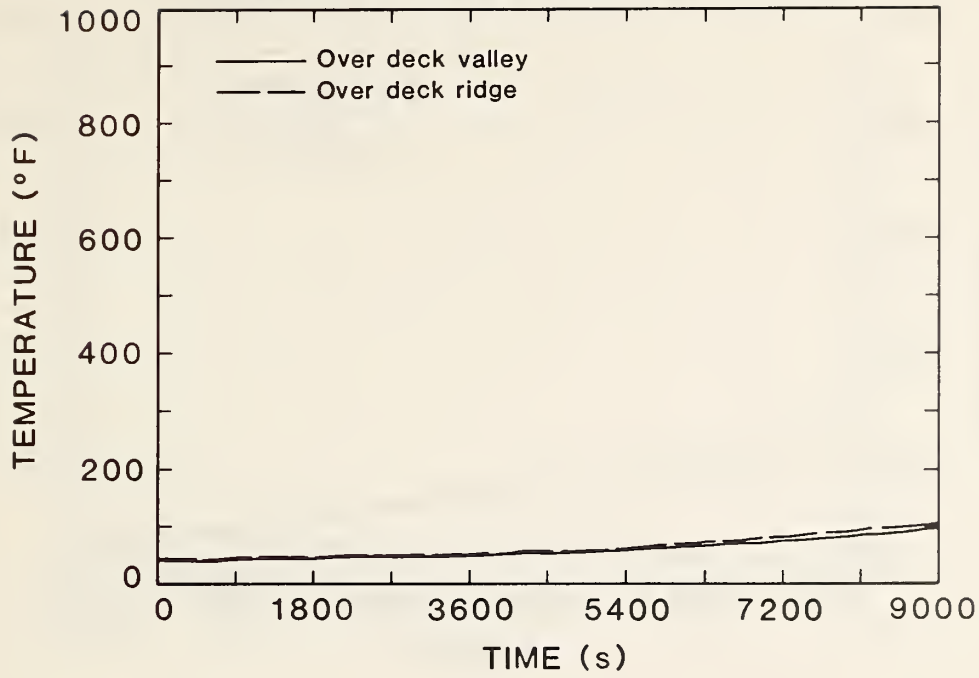
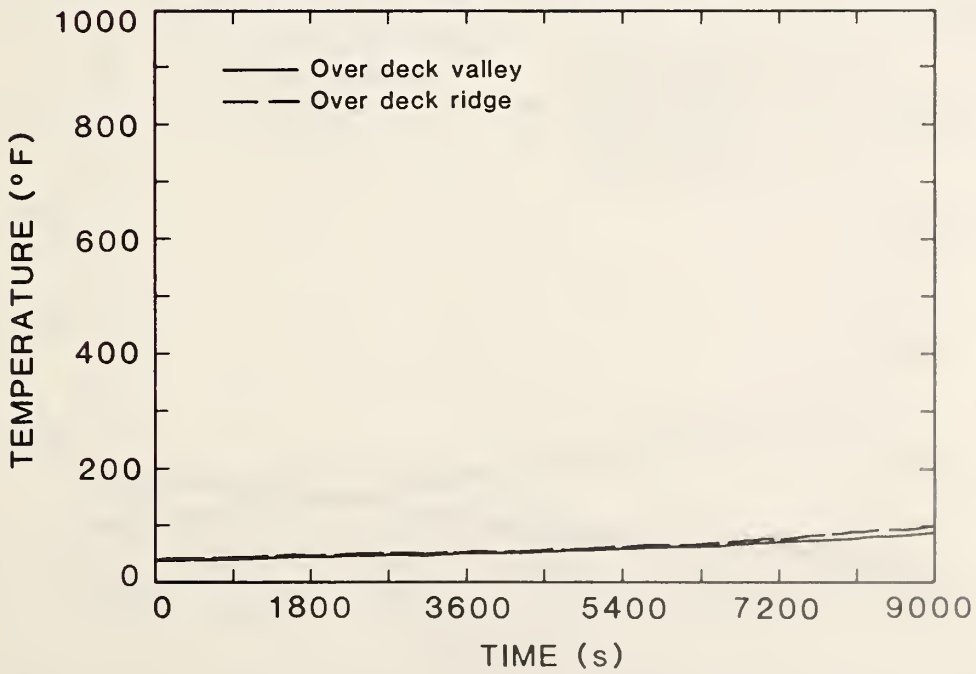
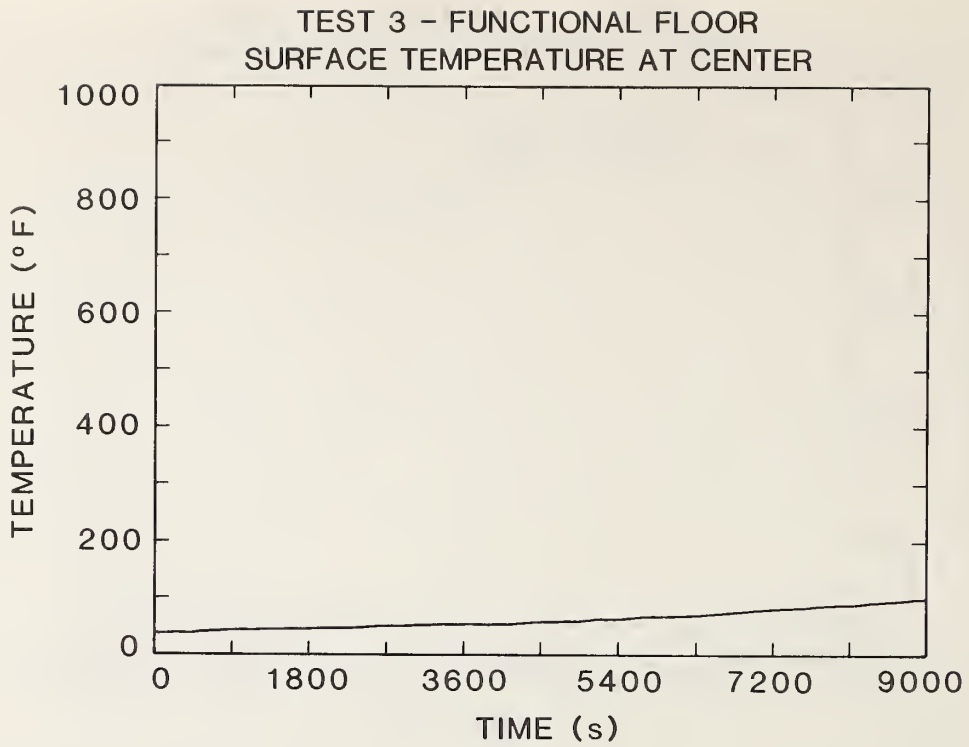
In test 3, the functional floor temperatures showed that the walk-on deck provided significant resistance to heat flow. Figures 114 through 118 show that the maximum temperature on the top functional floor surface never exceeded 115°F during the 2.5 hour exposure. The temperature of the steel deck supporting the functional floor had a maximum temperature of 176°F, figure 119. This temperature was less than that measured in test 1, but was more than 35°F higher than the maximum steel deck temperatures measured in tests 2 and 2A. These maximum deck temperatures are still well below any critical temperatures specified by the test procedure. Temperatures for the central beam supporting the functional floor are shown in figures 120 and 121. The highest temperature measured was 304°F which is substantially below the critical temperature for that structural element. This temperature was measured after 2.5 hours of test exposure. The unprotected column in the

Figure 114. Functional floor surface temperatures quadrant I, test 3

Figure 115. Functional floor surface temperatures quadrant II, test 3

Figure 116. Functional floor surface temperatures quadrant III, test 3

Figure 117. Functional floor surface temperatures quadrant IV, test 3

Figure 118. Functional floor surface temperature center of test bay, test 3

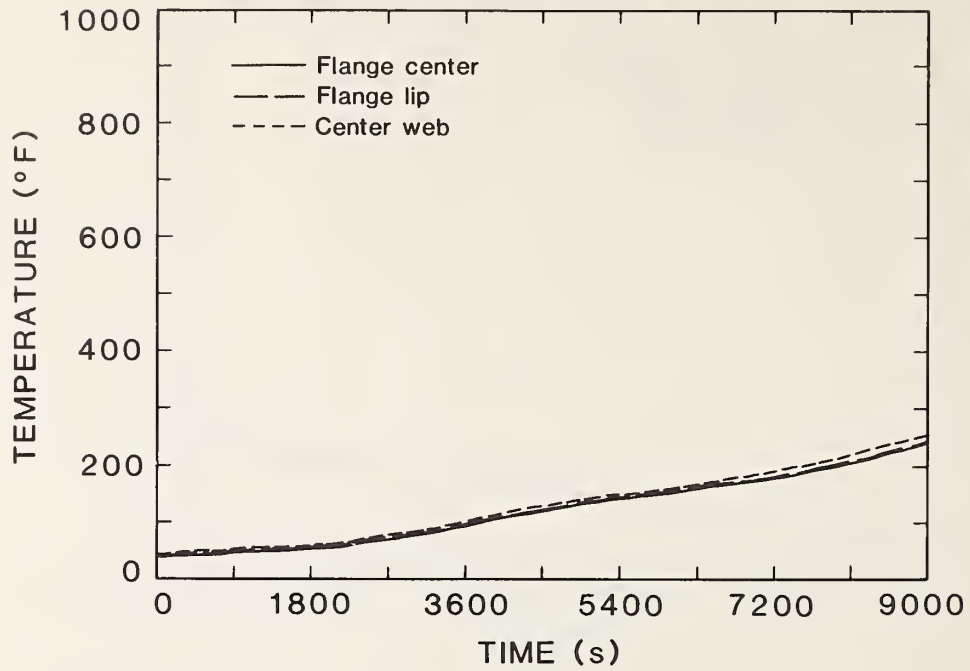
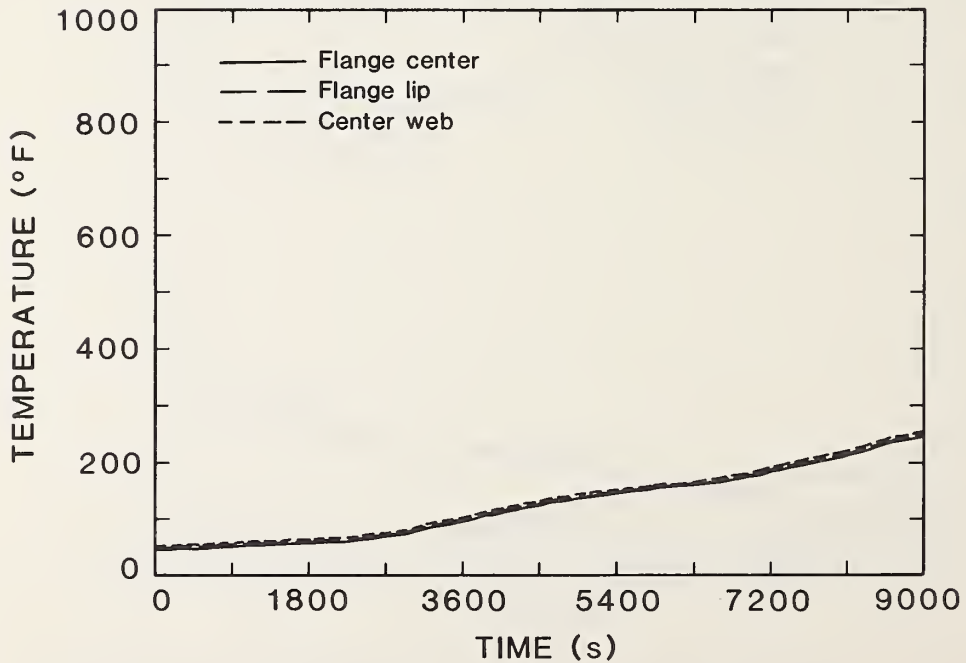
interstitial space also showed relatively low maximum temperatures, figures 122 and 123. In figure 123, the measurement made at the column flange lip was discarded because of a thermocouple failure. The flange and web temperatures show similar results with measurements well below the critical 1200°F value. The protected part of the center column also performed well in this test, figures 124 to 127. After the initial two hours, the maximum temperature was still more than 60°F below the failure point.

Figure 122. Center column temperatures in interstitial space at measurement point two feet above walk-on deck, test 3

Figure 123. Center column temperatures in interstitial space at measurement point four feet above walk-on deck, test 3
