EXAMINATION OF A PRESSURE VESSEL THAT RUPTURED AT THE CHICAGO REFINERY OF THE UNION OIL COMPANY ON JULY 23, 1984

National Bureau of Standards
U.S. Department of Commerce
Boulder, Colorado 80303

March 1986

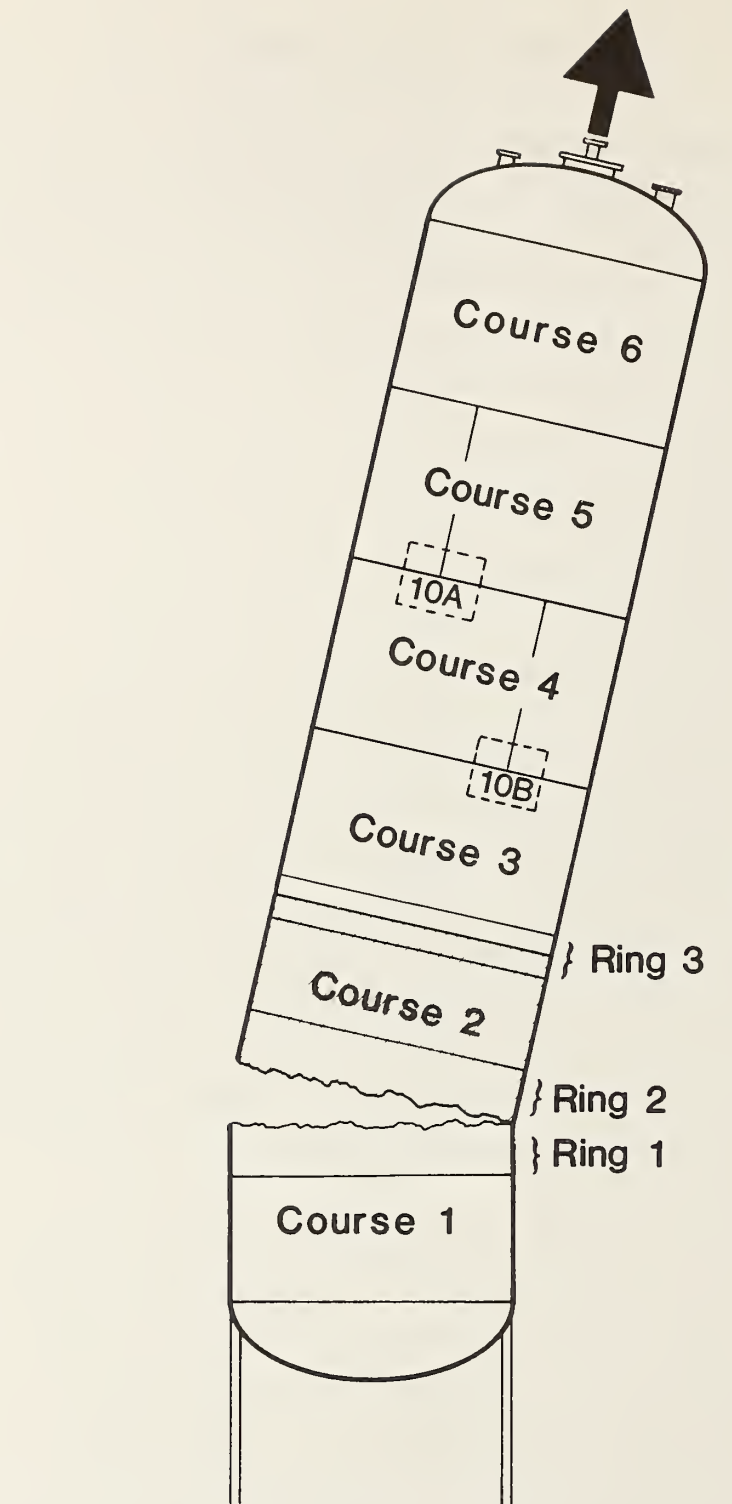
Figure 2. Locations of the pieces of pressure vessel 12D701 investigated by NBS: Rings 1, 2, and 3 and Plates 10A and 10B.

The fracture path was primarily in Course 1, adjacent to the field weld joining Course 1 to Course 2 (the replaced section), as shown in Figure 2. The failure investigation was conducted on segments removed from the upper and lower pieces of the vessel as part of the FMI. These consisted of Rings 1, 2, and 3 (three cylindrical sections) and Plates 10A and 10B (two square plates) cut from the vessel at the locations shown in Figure 2. Samples were removed from each segment and retained as part of the FMI. The remainder of the main segments were shipped to NBS (Boulder, Colorado) for this investigation. In addition, some of the pieces removed in the FMI were sent to NBS and included in this investigation. These are shown as speckled areas in Figure 3. The locations of the samples not received by NBS are shown as blank areas in Figure 3.

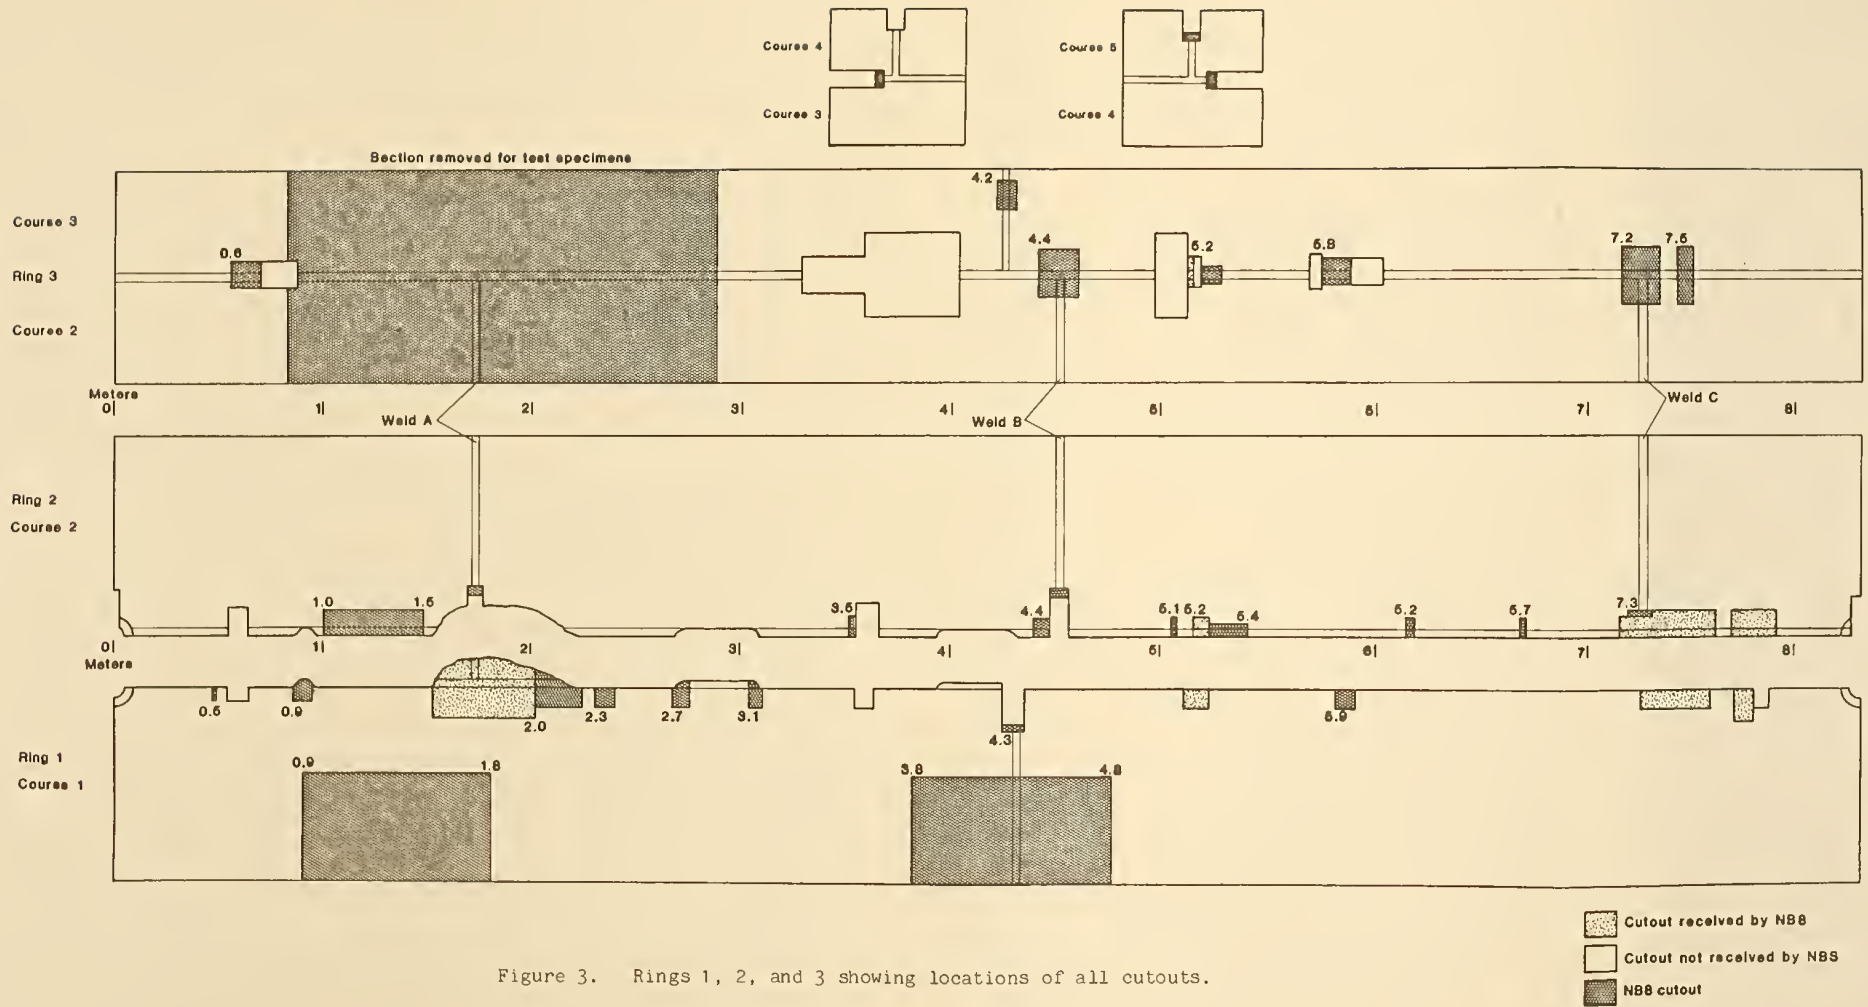
Figure 3. Rings 1, 2, and 3 showing locations of all cutouts.

The circumferential coordinates (CC) given in Figure 3 are used throughout the report. The zero position is the centerline of the hydrocarbon inlet piping. When the vessel is viewed from above, the circumferential coordinates are numbered clockwise with zero at 12 o'clock. A particular position along the circumference is identified by CC # m, where # m is the coordinate in meters. The reference piece for marking the coordinates was Ring 1, which remained nearly circular despite the failure. Position marks were scribed on the outside surface at 305 mm (1 ft.)

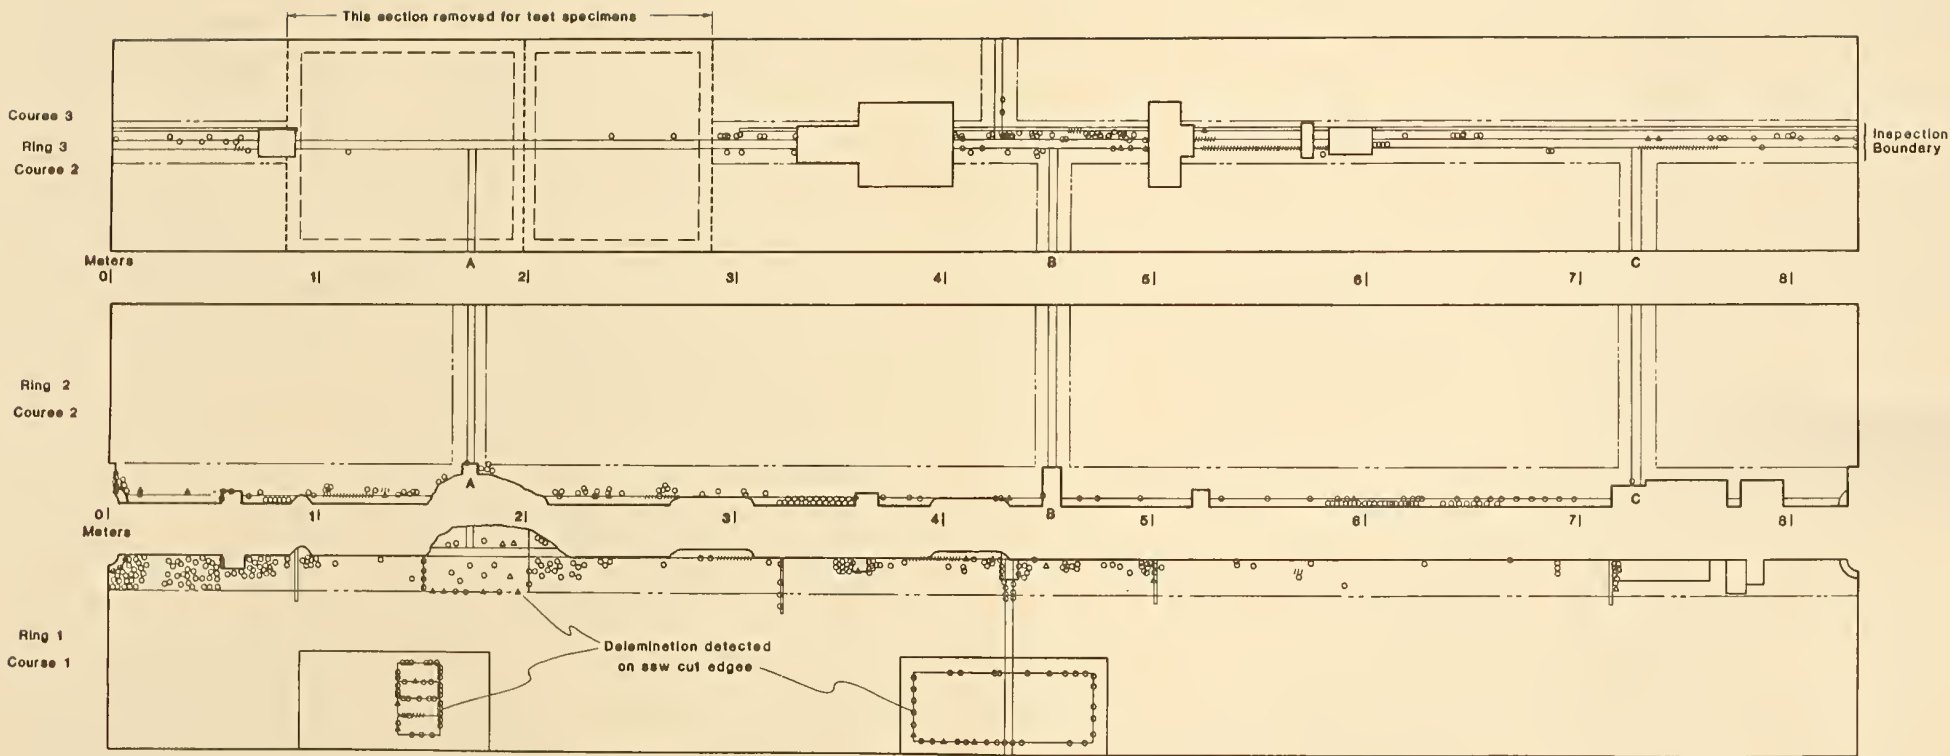
Figure 6. Summary of magnetic particle inspection results.

The results of the MPI are summarized in Figure 6 and Appendix B. The indications observed were of the linear type associated with cracks open to the surface. There were numerous small indications in the base metal and in the HAZ of Welds 1/2 and 2/3. The three vertical welds (A, B, and C) joining the replacement segments of Course 2 were inspected, and only two small indications were detected. Several small (<10 mm long, 0.4 in.) indications were observed in the vertical weld in Course 1, and two isolated indications were found in the vertical weld in Course 3. No indications were observed in Plates 10A and 10B. The results listed in Appendix B generally agree with the inspection results of the FMI [1].

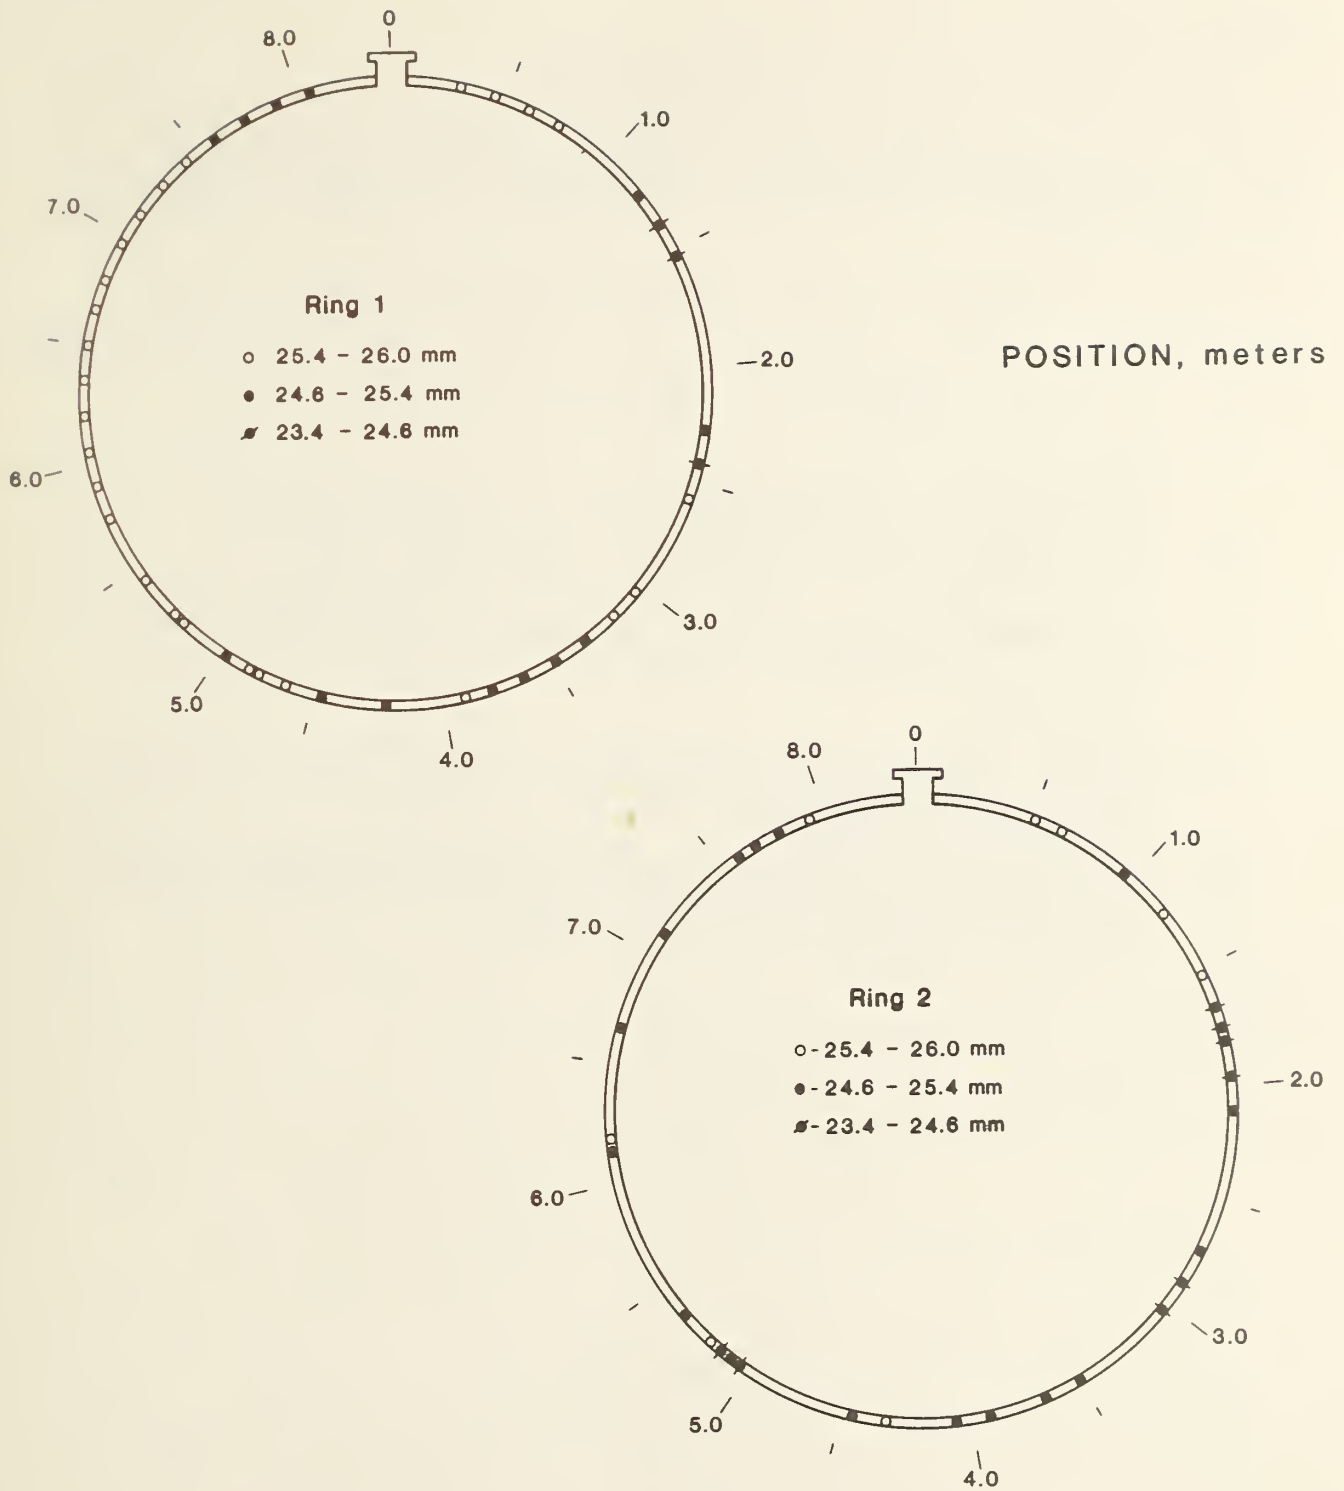
Figure 7. Wall thickness measurements near the fracture surface.

The thickness of Courses 1 and 2 in the vicinity of Weld 1/2 was spot-checked with a micrometer. The results, summarized in Figure 7, indicate that the thickness was typically equal to or greater than the nominal wall thickness of 25.4 mm (1.0 in.). The minimum thickness measured was 23.4 mm (0.92 in.), which was well within the corrosion allowance for the pressure vessel.

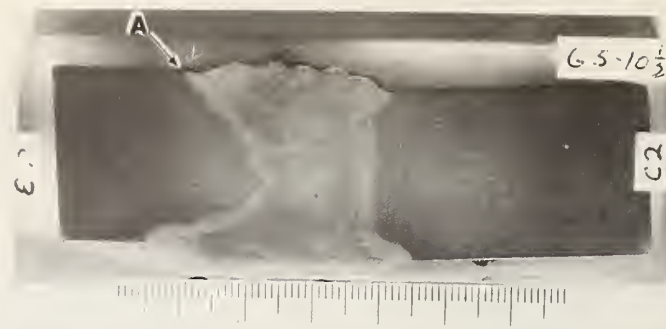
a. Macrostructure of Weld 2/3 at CC 1.8 m

Weld 2/3: A specimen was removed from the part of Ring 3 (CC 1.8 m) where vertical Weld A in Course 2 intersected Weld 2/3. The macrostructure of Weld 2/3, shown in Figure 13a, reveals the expected shape for a weld done in the horizontal position, i.e., a square lower edge (Course 2) and a V-shaped upper edge (Course 3). The sequence was to weld from the outside first and then complete the weld from the inside.

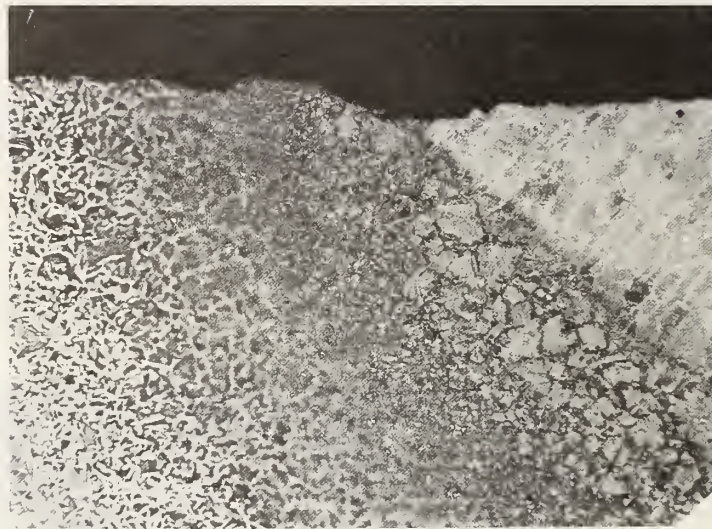
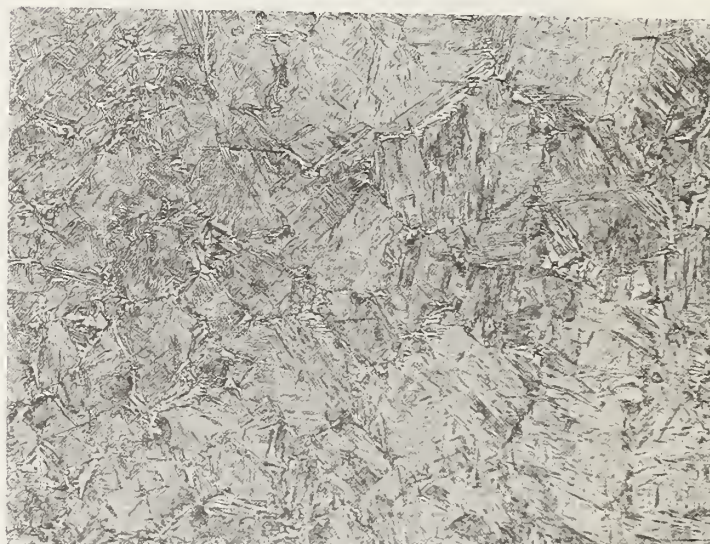
In the photograph of the HAZ 3 microstructure near the inside surface, Figure 13b, Weld 2/3 is in the upper right, and the base metal of Course 3 is in the lower left. Within the HAZ, there is a coarse-grain region nearest the weld, then a fine-grain region, and finally, a partially transformed zone next to the base metal. The microstructure of the coarse-grain region, shown at higher magnification in Figure 13c, has the acicular appearance of martensite or martensite-bainite. The presence of martensite was also indicated by microhardness measurements taken near the inner surface in both HAZ 2 and HAZ 3. In both cases, the peak hardness values were in excess of 400 on the

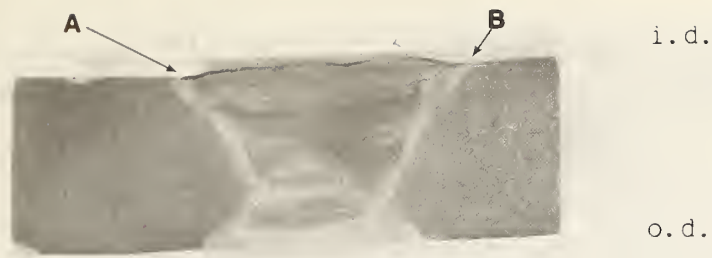
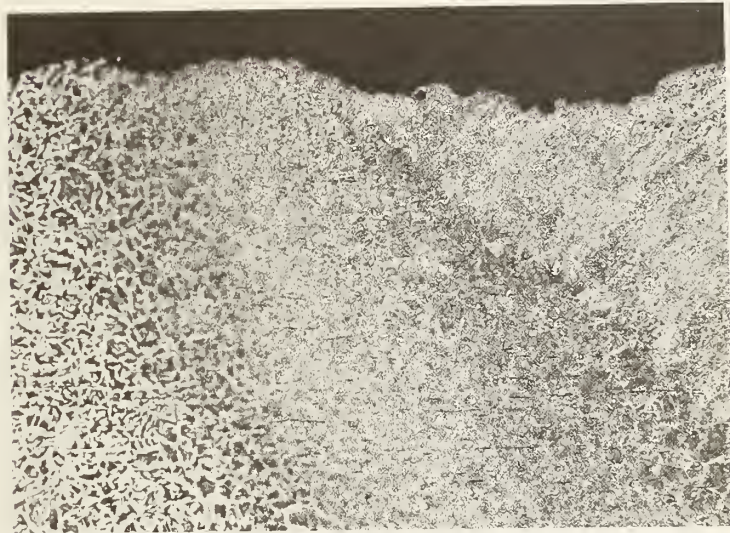
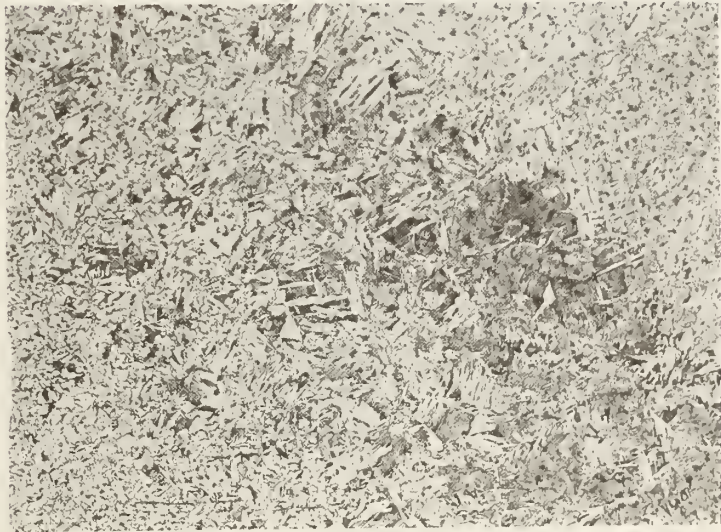
Figure 15. Macrostructure and microstructure of vertical weld A in Course 2.
Etchant: 2% nital

Vertical Weld A, Course 2: The metallography of vertical Weld A in Course 2 is shown in Figure 15. This is a field weld made at the time Course 2 was replaced. The weld was done in the vertical position, and as shown in Figure 15a, the joint preparation was symmetrical, and fewer weld passes were used to fill the joint than those used for the horizontal repair welds. The microstructure of the HAZ at the inside surface, shown in Figure 15b, does not show the coarse-grain region that can be seen in the horizontal repair weld in Figure 13b. This is because the microstructure in the coarse-grain region is ferrite and pearlite, as shown in Figure 15c, i.e., the same phases that exist in the other parts of the weldment. A microstructure of ferrite and pearlite is softer and more resistant to cracking than the martensite seen in the horizontal repair welds. Microhardness values in the HAZ ranged from 206 to 240 HK, as shown in Figure 16.

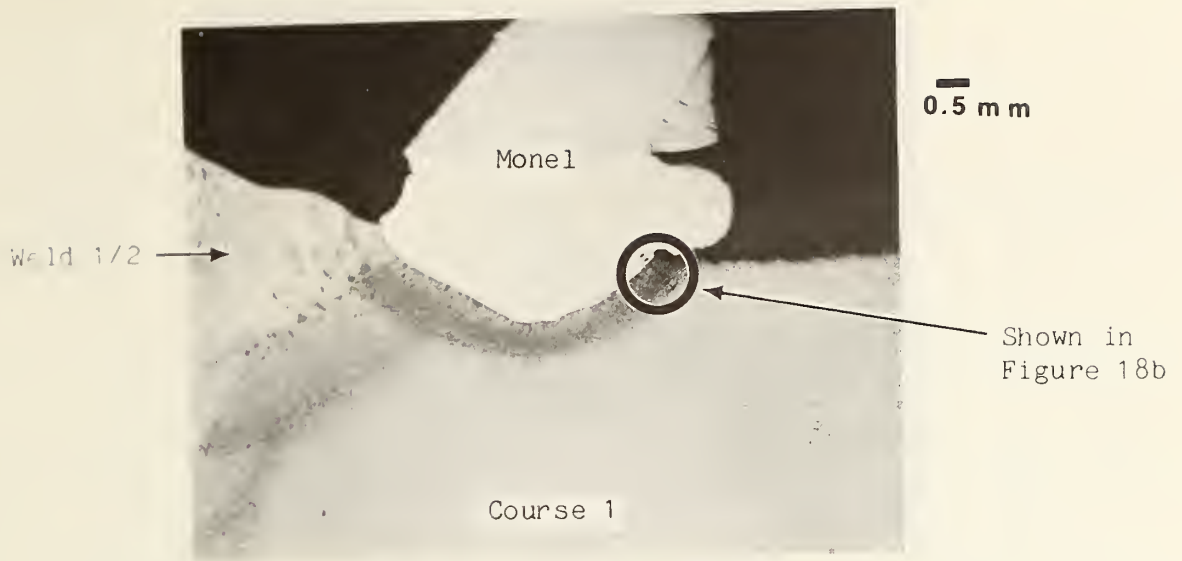
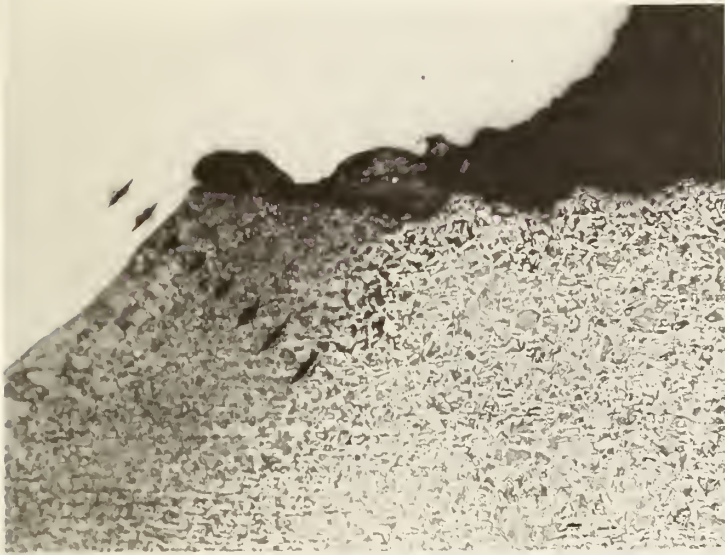
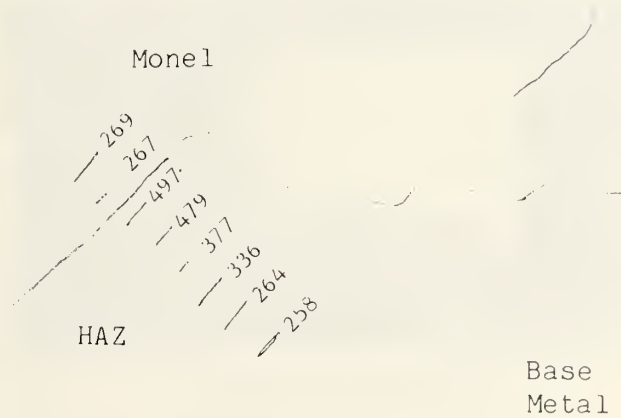
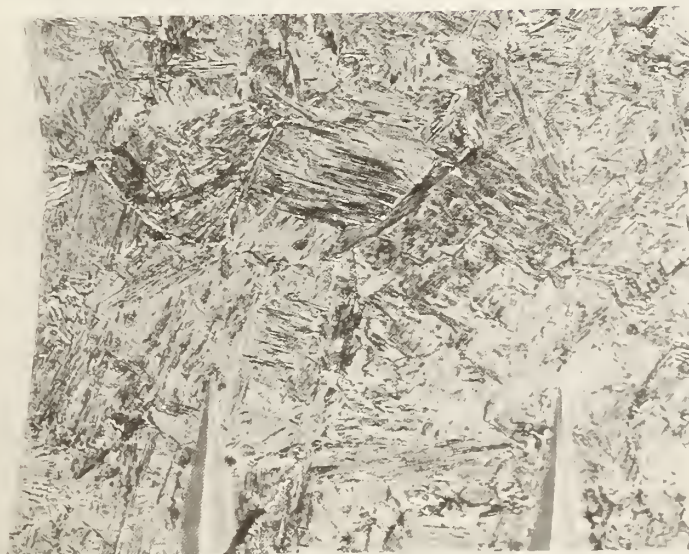
Figure 18. Microhardness of the HAZ of the Monel-to-steel weld at the location shown in Figure 17a. Etchant: 2% nital

The microstructure on the steel side of the Monel-to-steel joint is shown in Figure 18. Monel that laps over onto Course 1 has apparently been eaten away by crevice corrosion, as shown in Figures 18a and 18b. This suggests that the Monel was locally anodic to the steel. This is contrary to what is expected on the basis of the position of these metals in the electromotive series. The microhardness indentations, Figures 18b and 18c, indicate hardness values of 479 and 497 HK adjacent to the Monel. The microstructure at higher magnification, Figure 18d, shows that the high hardness values are due to the presence of martensite.

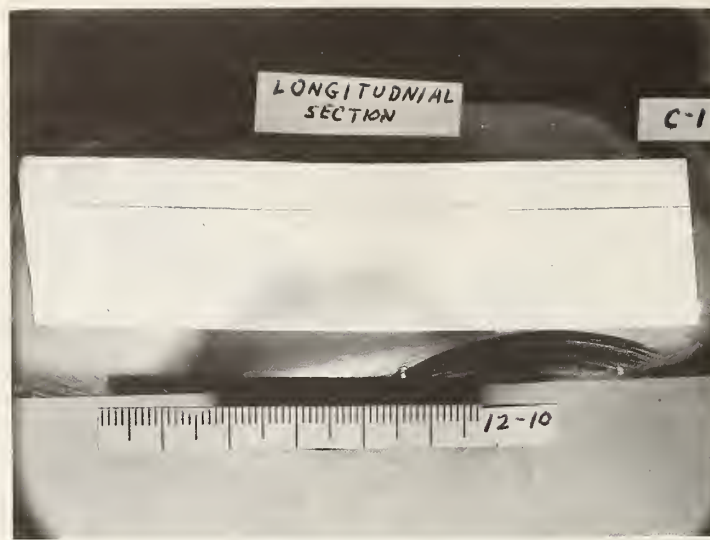
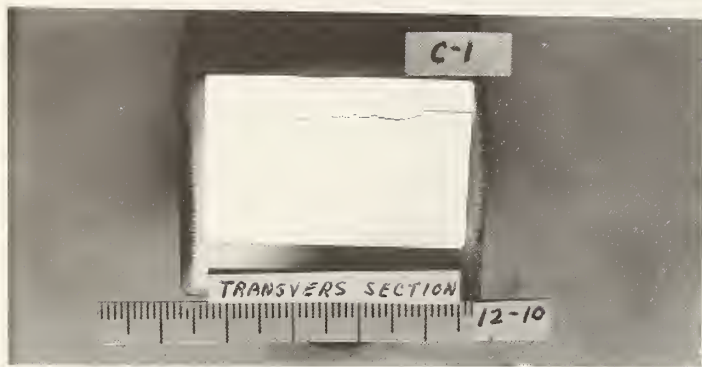
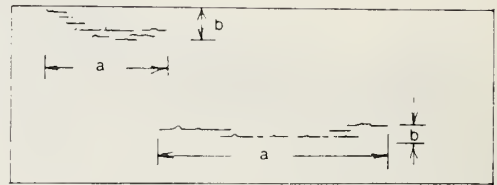
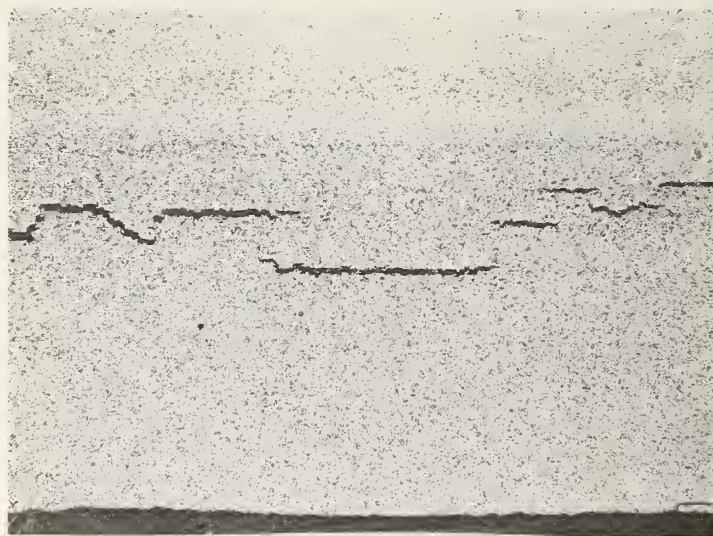
Figure 19. Hydrogen pressure cracking in Course 1 at CC 3.9 m.
Etchant: 2% nital

Delamination in Course 1: A sample was cut from Course 1 in an area where ultrasonic and magnetic particle inspection indicated delamination of the plate. Longitudinal and transverse sections through the sample are shown in Figures 19a and 19b, respectively. The transverse section is the view that would be observed in a section through a circumferential weld. At a higher magnification (Figure 19d), its appearance is similar to that observed on several metallographic samples and to a sketch (shown here as Figure 19c) of what is called "hydrogen-induced stepwise cracking" in NACE Standard TM-02-84 [7].

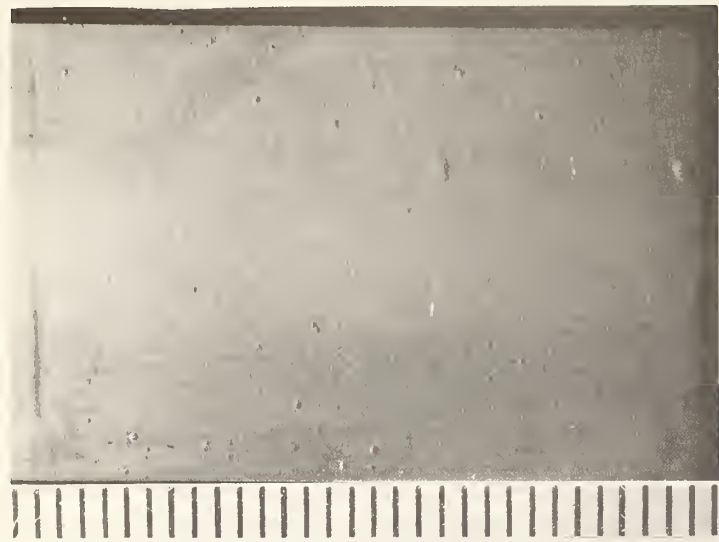
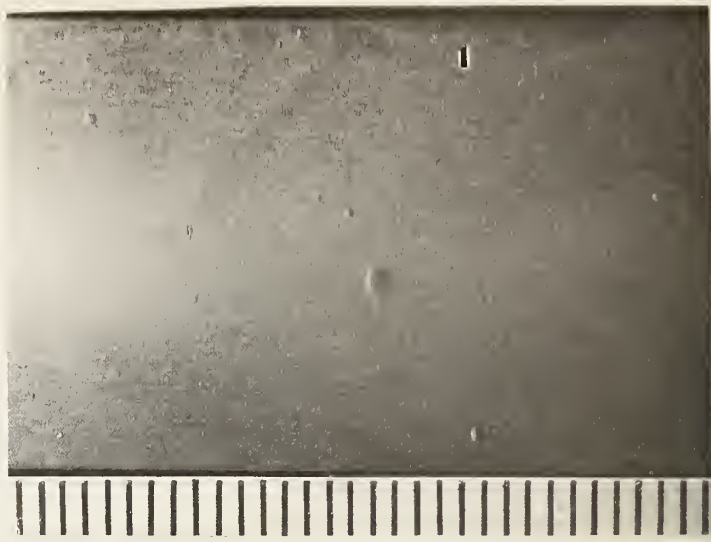
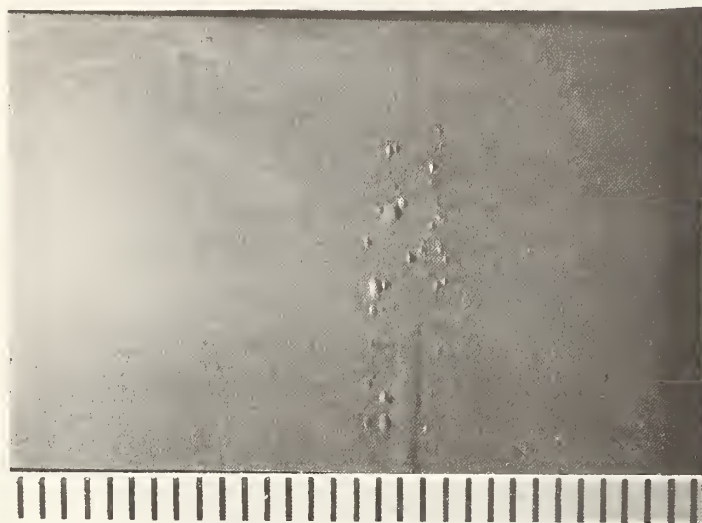
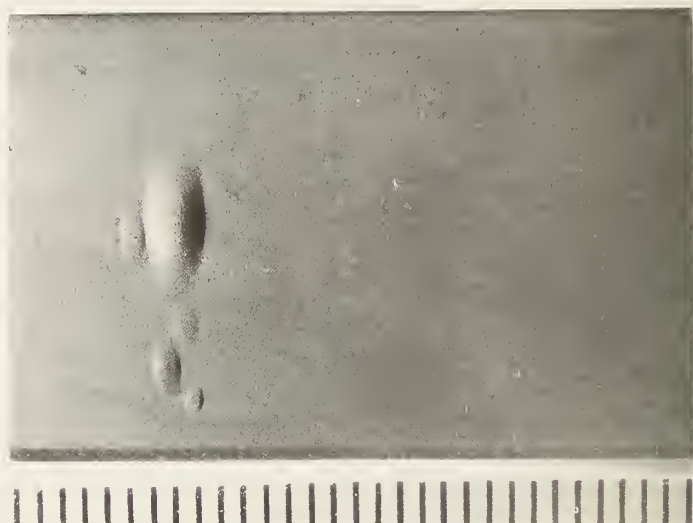
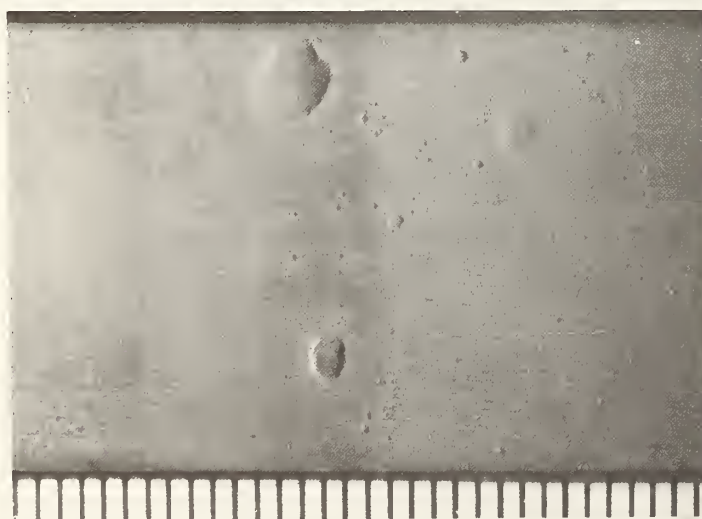
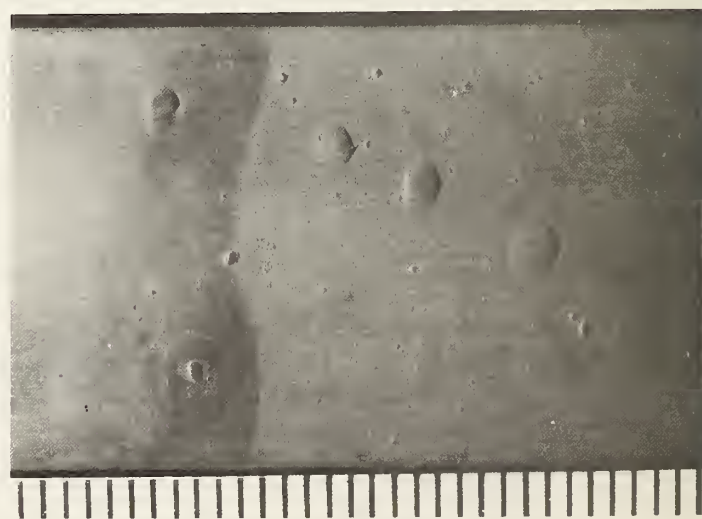
a. Specimen B4 from Course 1

b. Specimen C4 from Course 1

c. Specimen X from Course 2

d. Specimen Y from Course 2

e. Specimen I2 from Weld 2/3;
blisters are in Course 3

f. Specimen J2 from Weld 2/3;
blisters are in Course 2

Figure 21. Blistering on surface of specimens after hydrogen pressure cracking tests.

The results, summarized in Table V, indicate that the A516 Grade 70 steel from both Courses 1 and 2 is susceptible to hydrogen pressure cracking in the NACE solution [8].

The results also show that Course 1 steel is more susceptible to hydrogen pressure cracking than the Course 2 steel. This is consistent with the lower levels of inclusion formers, sulfur and aluminum, in the Course 2 steel. No cracking was observed in the welds, but cracks did form in the HAZ. Metallographic sections of typical cracks are shown in Figure 22. The linkage of several hydrogen pressure cracks into a surface-breaking crack is shown in Figure 22a. The size and orientation of the hydrogen pressure cracks is not simply related to the microstructure, as shown in Figure 22b. The cracks that developed in HAZ 3 of Weld 2/3 are shown in Figure 22c.

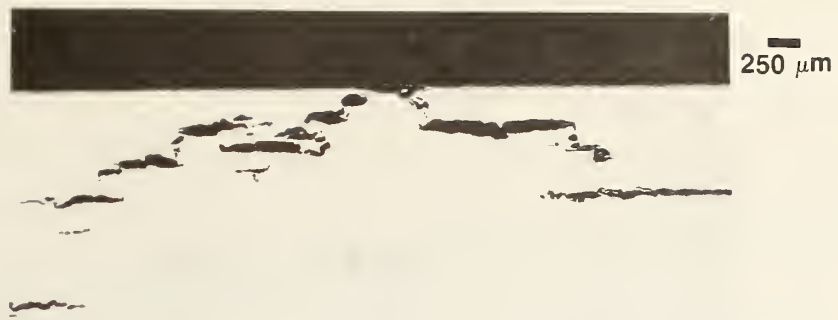
a. Specimen C4 from Course 1 (as polished)

Figure 22. Metallography of cracking in specimens after hydrogen pressure cracking tests.

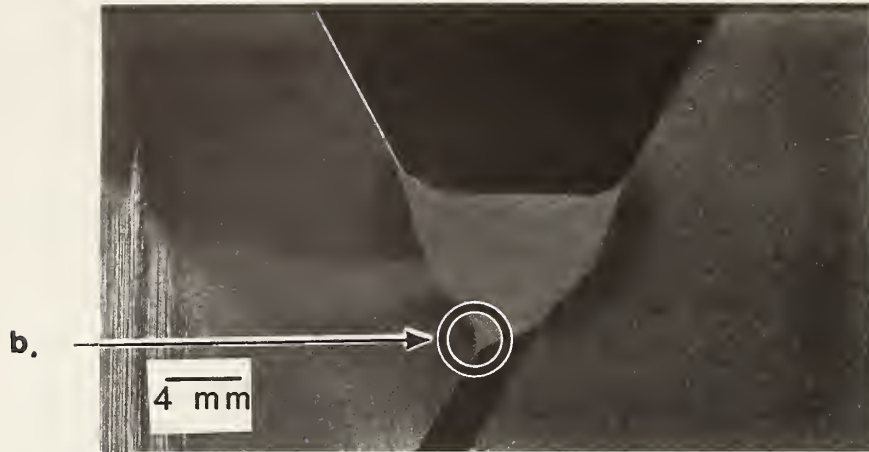
a. Macrostructure of y-groove test

Next, a specimen was prepared that simulated two conditions that may have existed at the time of the repair: 1) the Course 1 steel may have been hydrogen charged at the time of repair welding because of the prior service, and 2) welding may have been done on a cool day (-1°C , 34°F) without preheat. The test was conducted on a duplex specimen consisting of Course 1 steel on one side and Course 2 steel on the other. The Course 1 side of the specimen was charged with hydrogen by soaking it in the NACE solution (NACE Standard TM-01-77) [10] for 80 h. The NACE solution is an acidic ($\text{pH} = 3$) saltwater saturated with H_2S . The duplex specimen was cooled to 1°C (34°F) and welded using the standard procedures [8]. It cracked at the root of the weld on Course 1 (hydrogen-charged) side. A cross section of the specimen is presented in Figure 24a. The root cracking, shown in Figure 24b, occurred in the coarse-grain part of the HAZ. The microhardness in the vicinity of the crack was typically 350 on the Vickers scale indicating the presence of martensite.

The results indicate that Course 1 was susceptible to cold cracking if charged with hydrogen and welded without preheat. Thus, cold cracking could have occurred at the time Course 2 was replaced. However, the numerous cracks observed by MPI in Course 2 cannot be attributed to cold cracking on the basis of these tests. Also, if cold cracking was prevalent in Course 1, it may have occurred on either the inside or the outside surface of the vessel. The HAZ of Weld 1 on the outside surface of Ring 1 was checked for cracking by MPI in the limited regions where the fracture did not occur along HAZ 1; no cracks were found.

Figure 24. Cross section of y-groove test specimen of Course 1 steel welded to Course 2 steel showing cracking in HAZ 1.

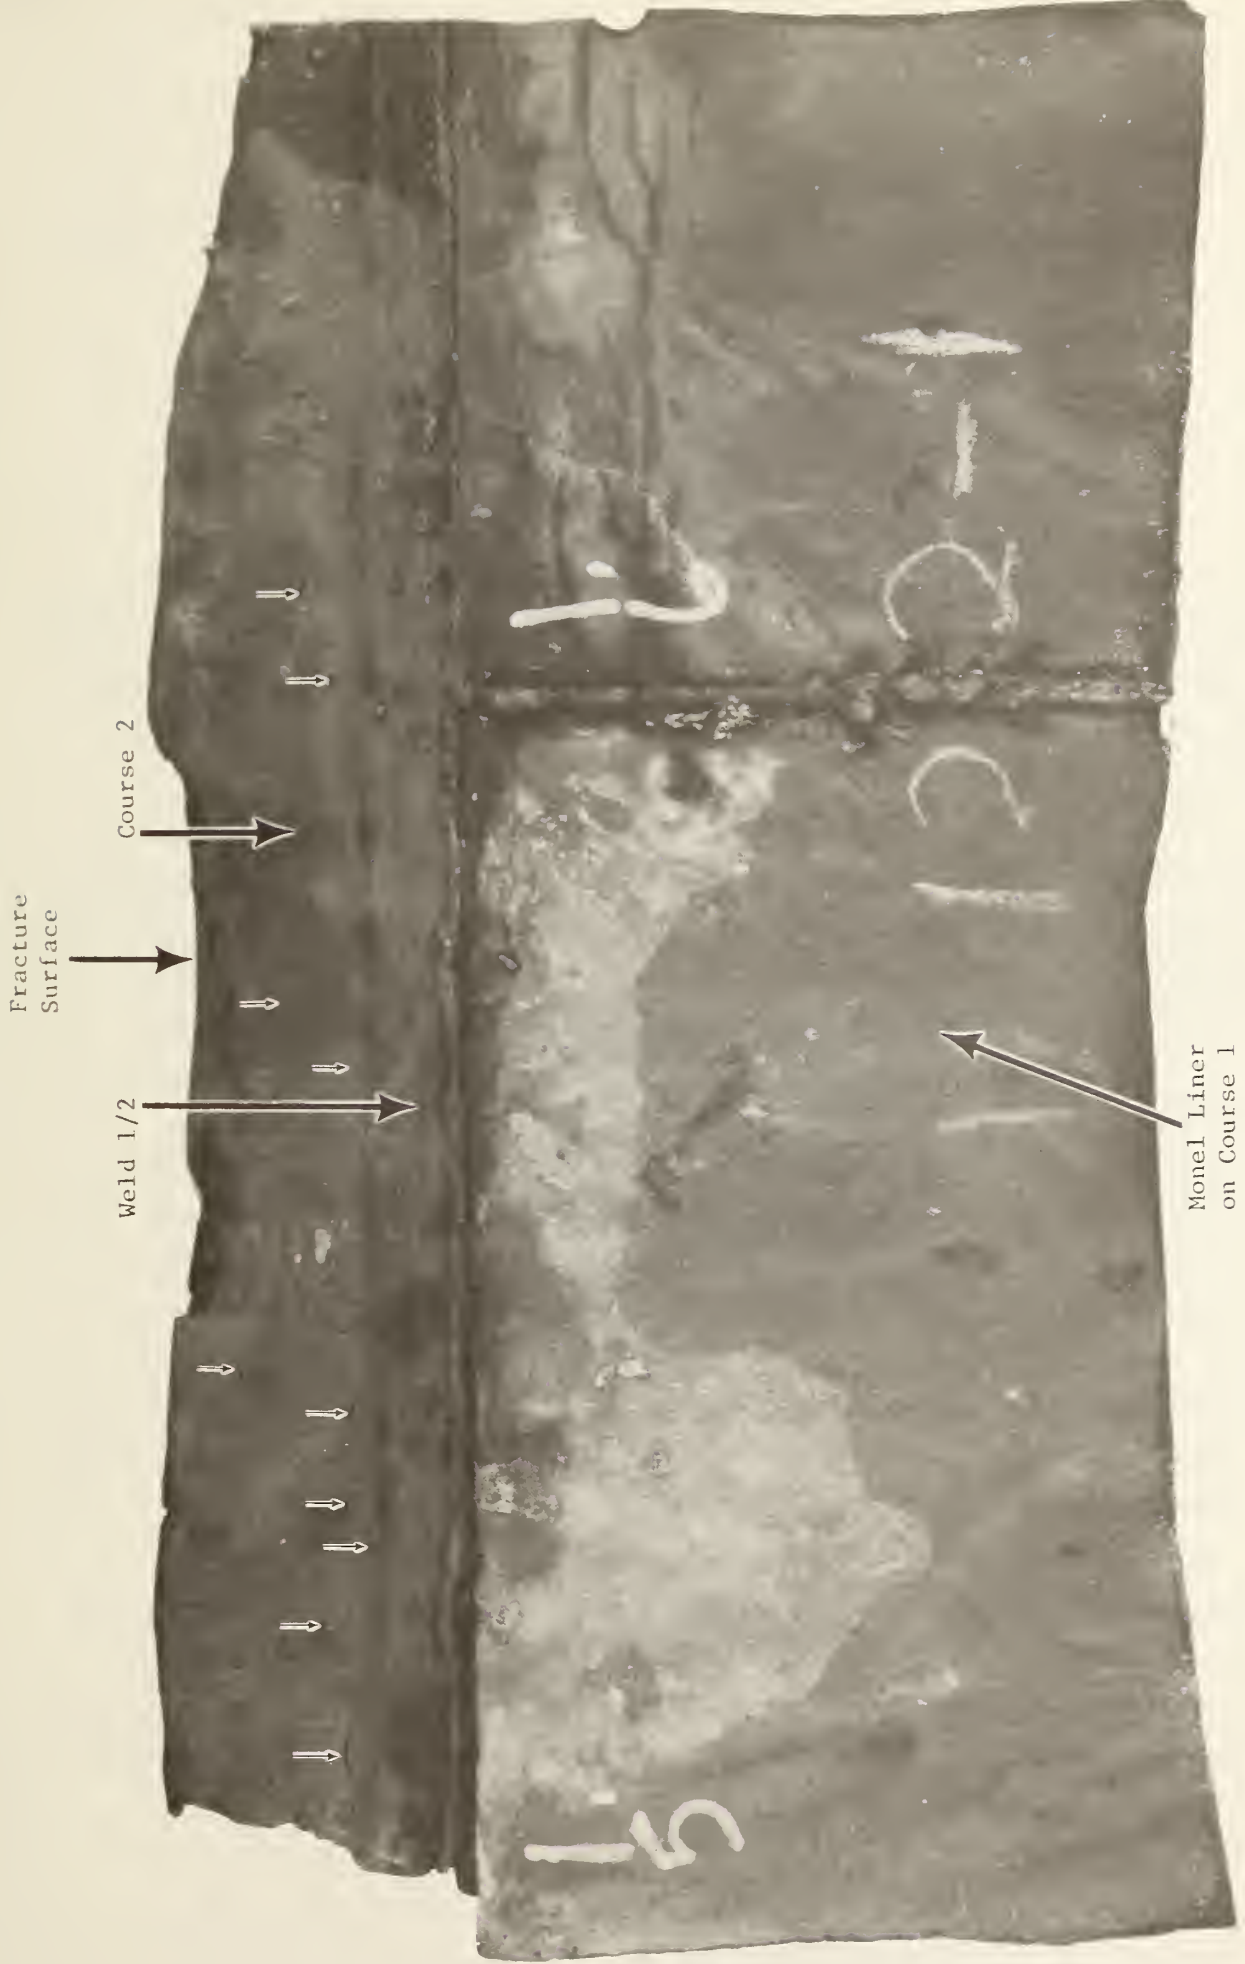
Figure 30. Piece cut from Ring 1 where the fracture passed through Course 2.

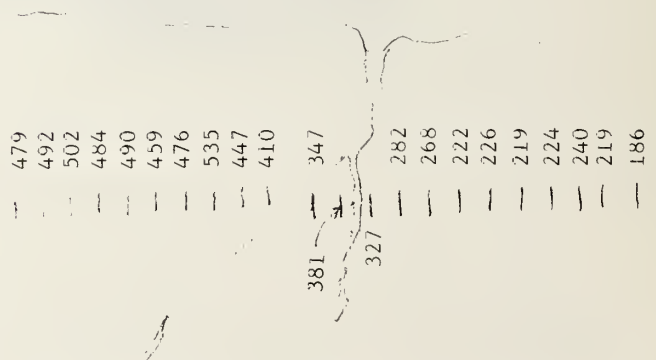
d. Knoop hardness values (HK 300) (tracing of Fig. 32c)

Figure 32. Microstructure of Weld 2/3 at CC 7.6 m, metallography of cracks in HAZ 2 and HAZ 3, and microhardness of HAZ 3.

The crack in HAZ 2 of Weld 2/3 at CC 7.6 m (Figure 32b) had the same features observed in sections taken through regions of black deposit on the fracture surface. The crack intersects the surface at the fusion line, runs in a straight line through the HAZ, and then zigzags through the base metal to about the midthickness level, where it stops in the HAZ.

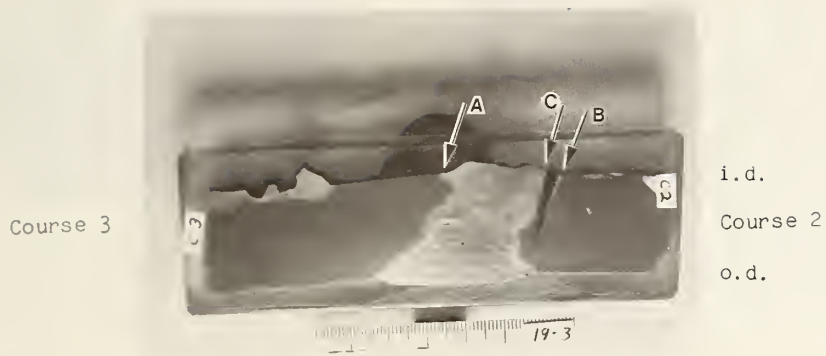
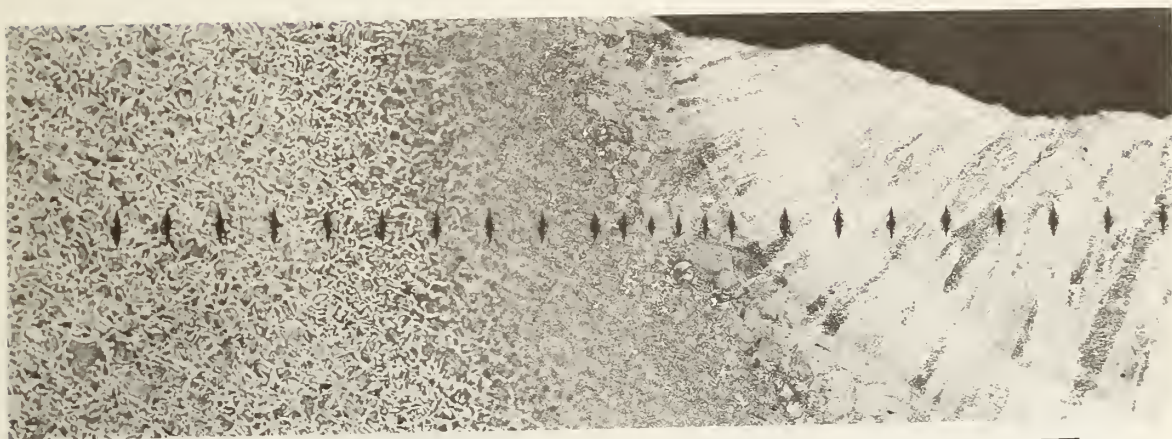
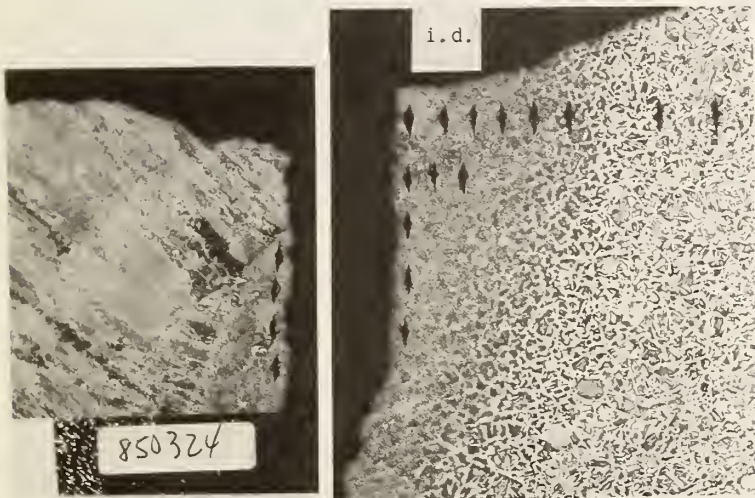
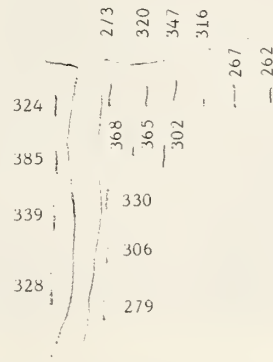
a. Macrostructure of Weld 2/3 at CC 5.9 m

b. Knoop microhardness values of HAZ 3 at location A in Fig. 33a 200 μm

c. Knoop hardness indentation of HAZ 2 at locations B and C in Figure 33a 200 μm

d. Knoop hardness values (HK300) at locations B and C (tracing of Fig. 33c)

Figure 33. Macrostructure of Weld 2/3 at CC 5.9 m and microhardness values of HAZ 2 and HAZ 3.

The crack in HAZ 2 of Weld 2/3 at CC 5.9 m, propagated through the HAZ for nearly 10 mm (0.4 in.), yet it had the same key features observed in the other specimens. The crack intersected the surface near the fusion line and had straight edges while located in the hardened part of the HAZ. Microhardness indentations along this straight edge are shown in Figure 33c. When it propagated through the HAZ that had been tempered by a subsequent pass, it changed to the zigzag mode and continued in this mode into the base metal.

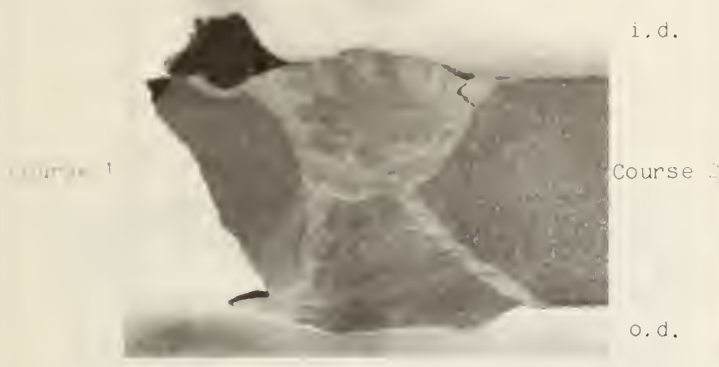
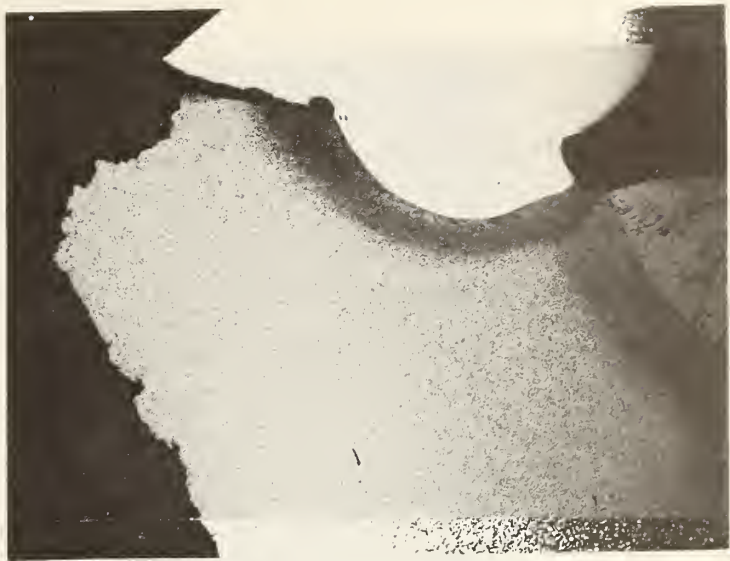
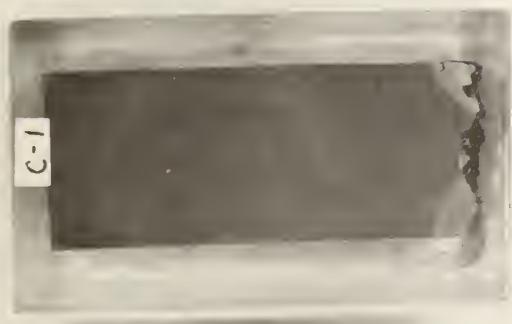
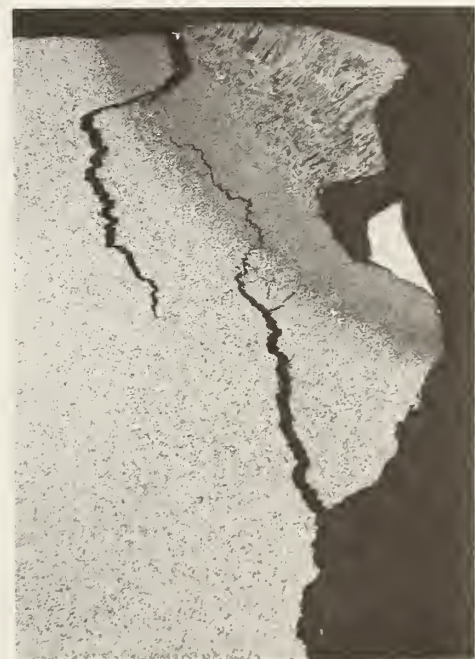
Several sections were taken through the fracture surface to determine the path of the fracture in locations that were not marked by a black deposit, i.e., whether the crack was located in the HAZ or in the base metal near the HAZ. In general, the crack path included some HAZ near the surface, but most of the crack front passed through the base metal. This can be seen from the sections taken from Weld 1/2 at CC 1.0 m shown in Figure 15 and from Weld 1/2 at CC 1.3 m and Course 1 at CC 5.7 m shown in Figure 34. Thus, the path of the catastrophic fracture is more correctly described as being near the HAZ rather than through the HAZ.

a. Macrostructure of Weld 1/2 at CC 1.3 m

b. Enlargement of Figure 34a at inner surface 1mm

c. Macrostructure of Course 1 at CC 5.7 m

d. Enlargement of Figure 34c at inner surface

Figure 34. Macrostructures at two locations where a black deposit was not found on the fracture surface.
