EXAMINATION OF A PRESSURE VESSEL THAT RUPTURED AT THE CHICAGO REFINERY OF THE UNION OIL COMPANY ON JULY 23, 1984

National Bureau of Standards
U.S. Department of Commerce
Boulder, Colorado 80303

March 1986

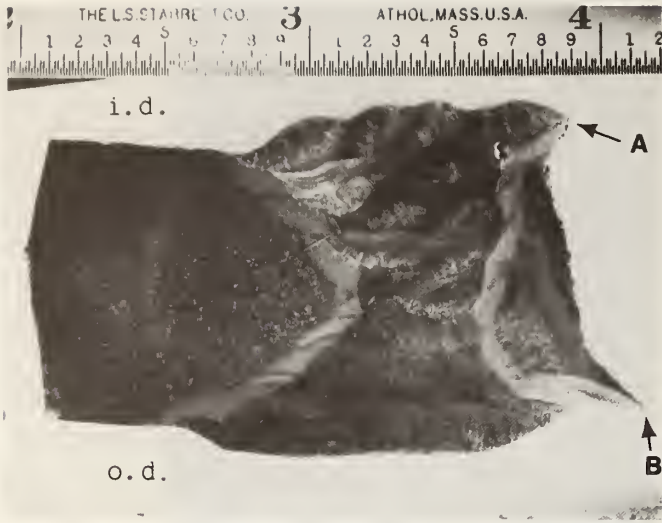
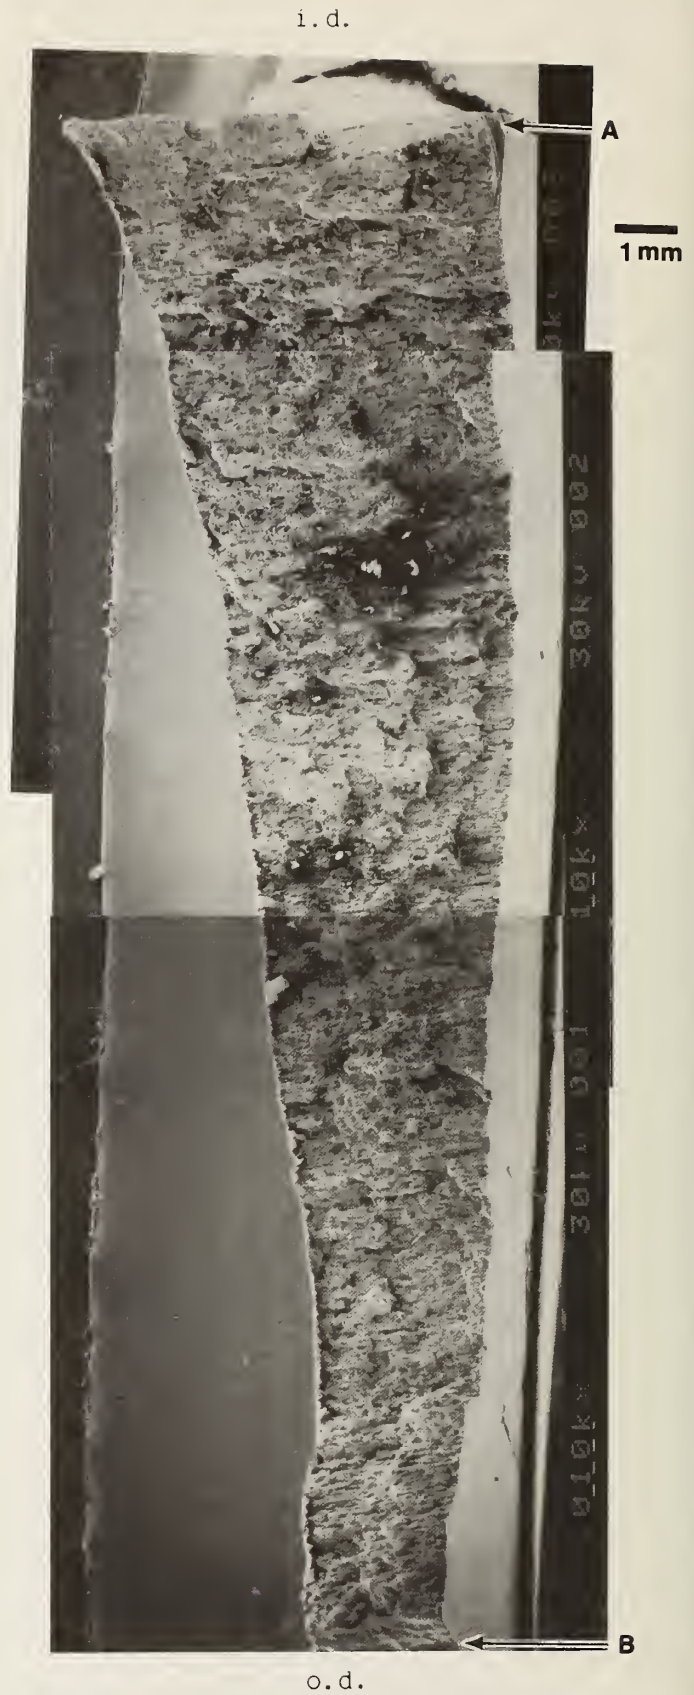
The metallographic section and corresponding fractograph of specimen PE 114 are shown in Figure 36. This specimen was taken at CC 7.3 m in a region free of the black deposit. The metallographic section shows that the fracture passed through the HAZ and base metal. The fracture intersects the inside surface in the HAZ near the fusion line and the fibrous texture is somewhat finer near the surface. Yet, the distinct change in texture noted in specimen PE 103 was not apparent.

a. Macrostructure of Weld 1/2 at CC 7.3 m

b. SEM fractograph of the fracture surface at the location shown in Figure 36a

Figure 36. FMI [1] photographs of the macrostructure of Weld 1/2 and fractograph at CC 7.3 m. The letters show corresponding areas.

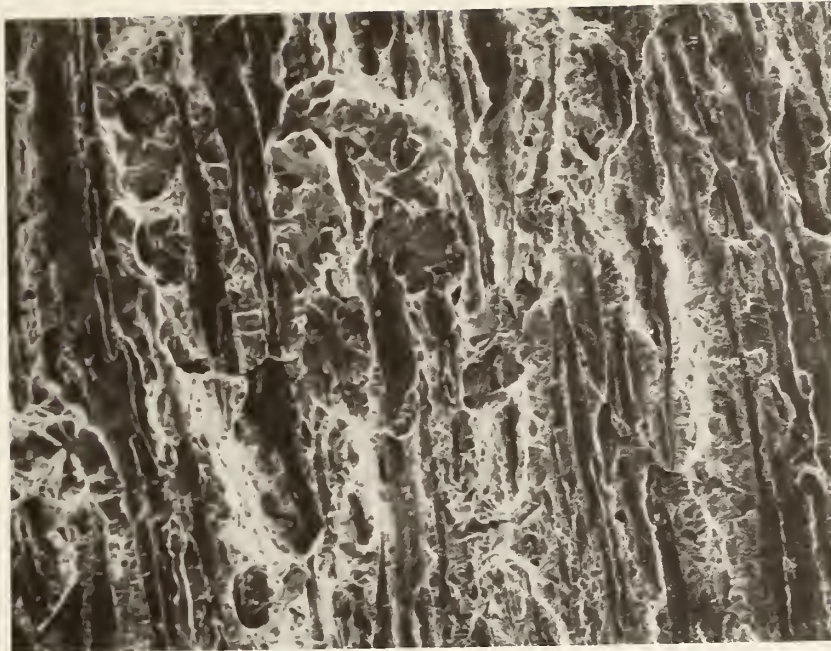
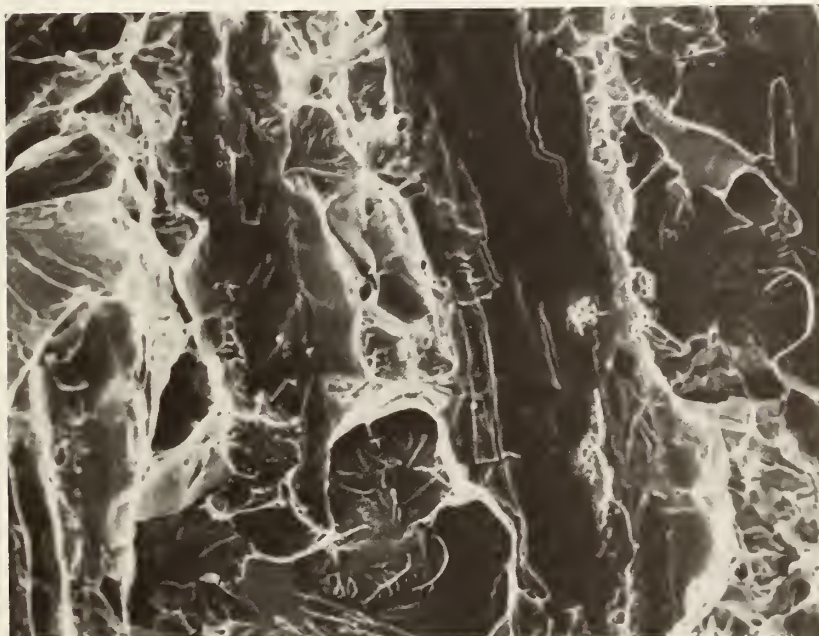
Figure 38. SEM fractographs of hydrogen pressure cracks in Course 1.

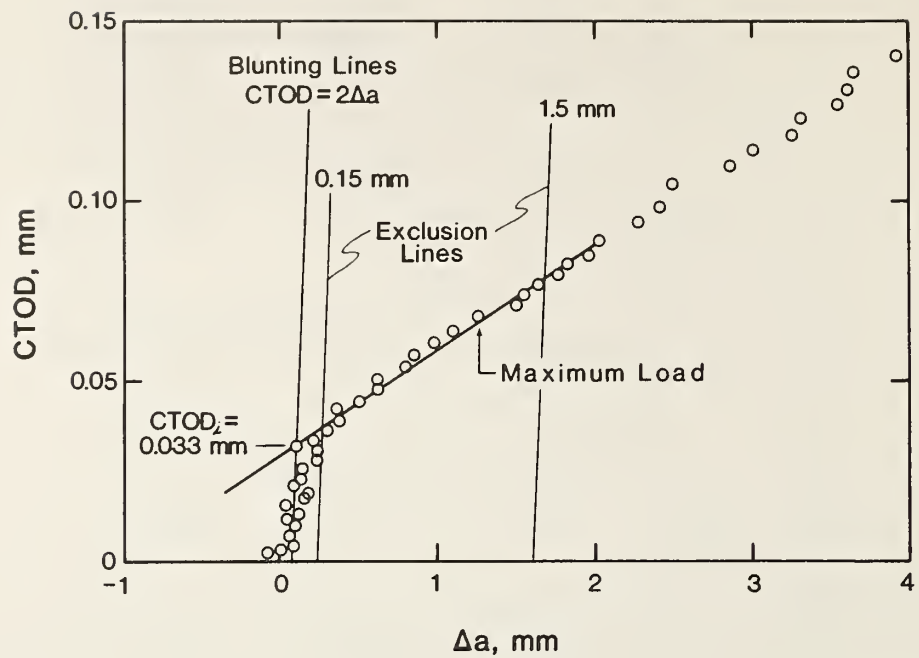
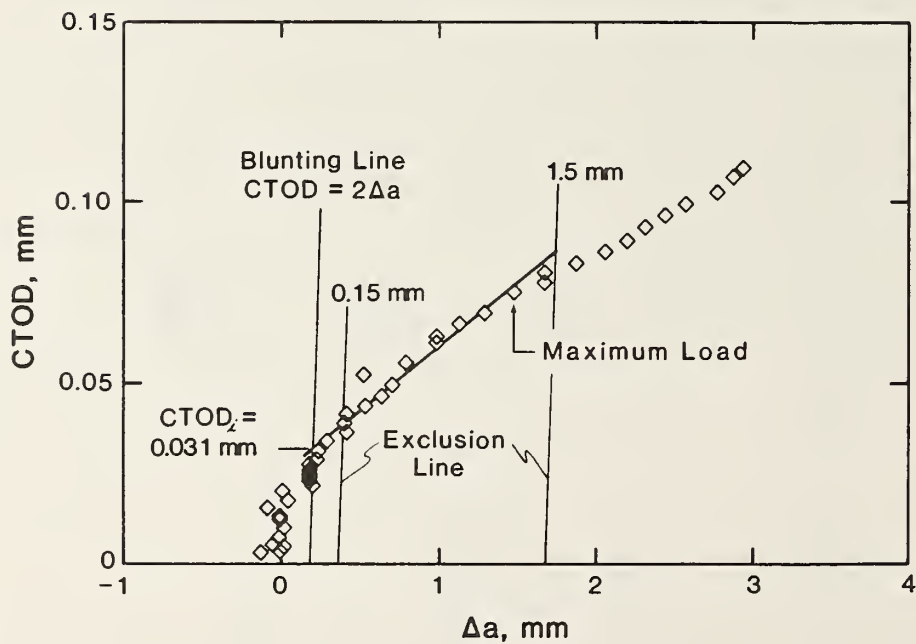
In addition to measuring CTOD in the compact specimens, crack extension was measured as a function of load using the unloading compliance method of ASTM E 813 [16]. The results are presented in the form of CTOD versus crack extension (Δa) curves in Figure 39. From these curves, the CTOD at the initiation of tearing was found to be 0.032 mm (0.0013 in.) by the procedures of the Draft ASTM Test Method for CTOD Testing (November 1985). This extremely low value of CTOD indicates low tearing resistance and means that cracks that are shorter than the critical size can grow at the stress levels that occur in the pressure vessel.

a. Specimen 66

b. Specimen 531

Figure 39. CTOD vs. crack extension, Δa , curves for the Course 1 side of Weld 1/2 after hydrogen charging. Tested at 38°C (100°F). Fracture analysis was conducted using the CTOD value at maximum load.

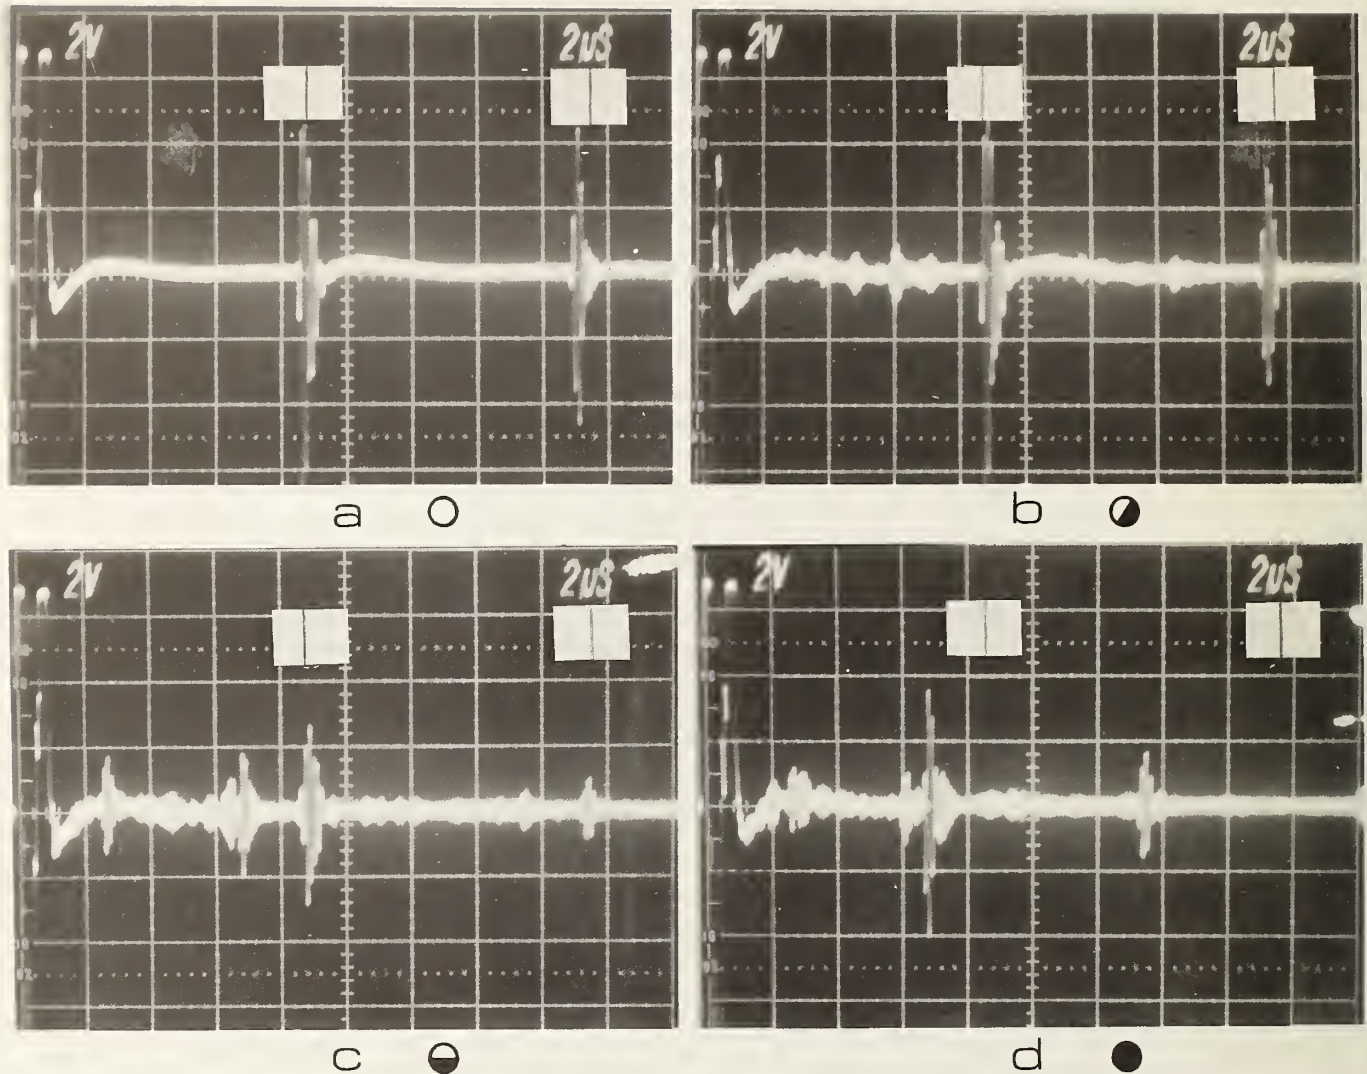
Figure C3. Samples of typical oscilloscope traces. Markers near top of each photo indicate position of first two echoes from outer surfaces. Refer to Table CI. x-axis: 2 V/division; y-axis: 2 μ s/division.

- a) Degree 1. Specimen 2 [2.11 m on circumference, 0.05 m (2 in.) below weld].
- b) Degree 2. Specimen 2 [2.11 m on circumference, 0.20 m (7.9 in.) above weld].
- c) Degree 4. Specimen 1 [4.24 m on circumference, 0.20 m (7.9 in.) above bottom of plate].
- d) Degree 5. Specimen 1 [4.29 m on circumference, 0.20 m (7.9 in.) above bottom of plate].

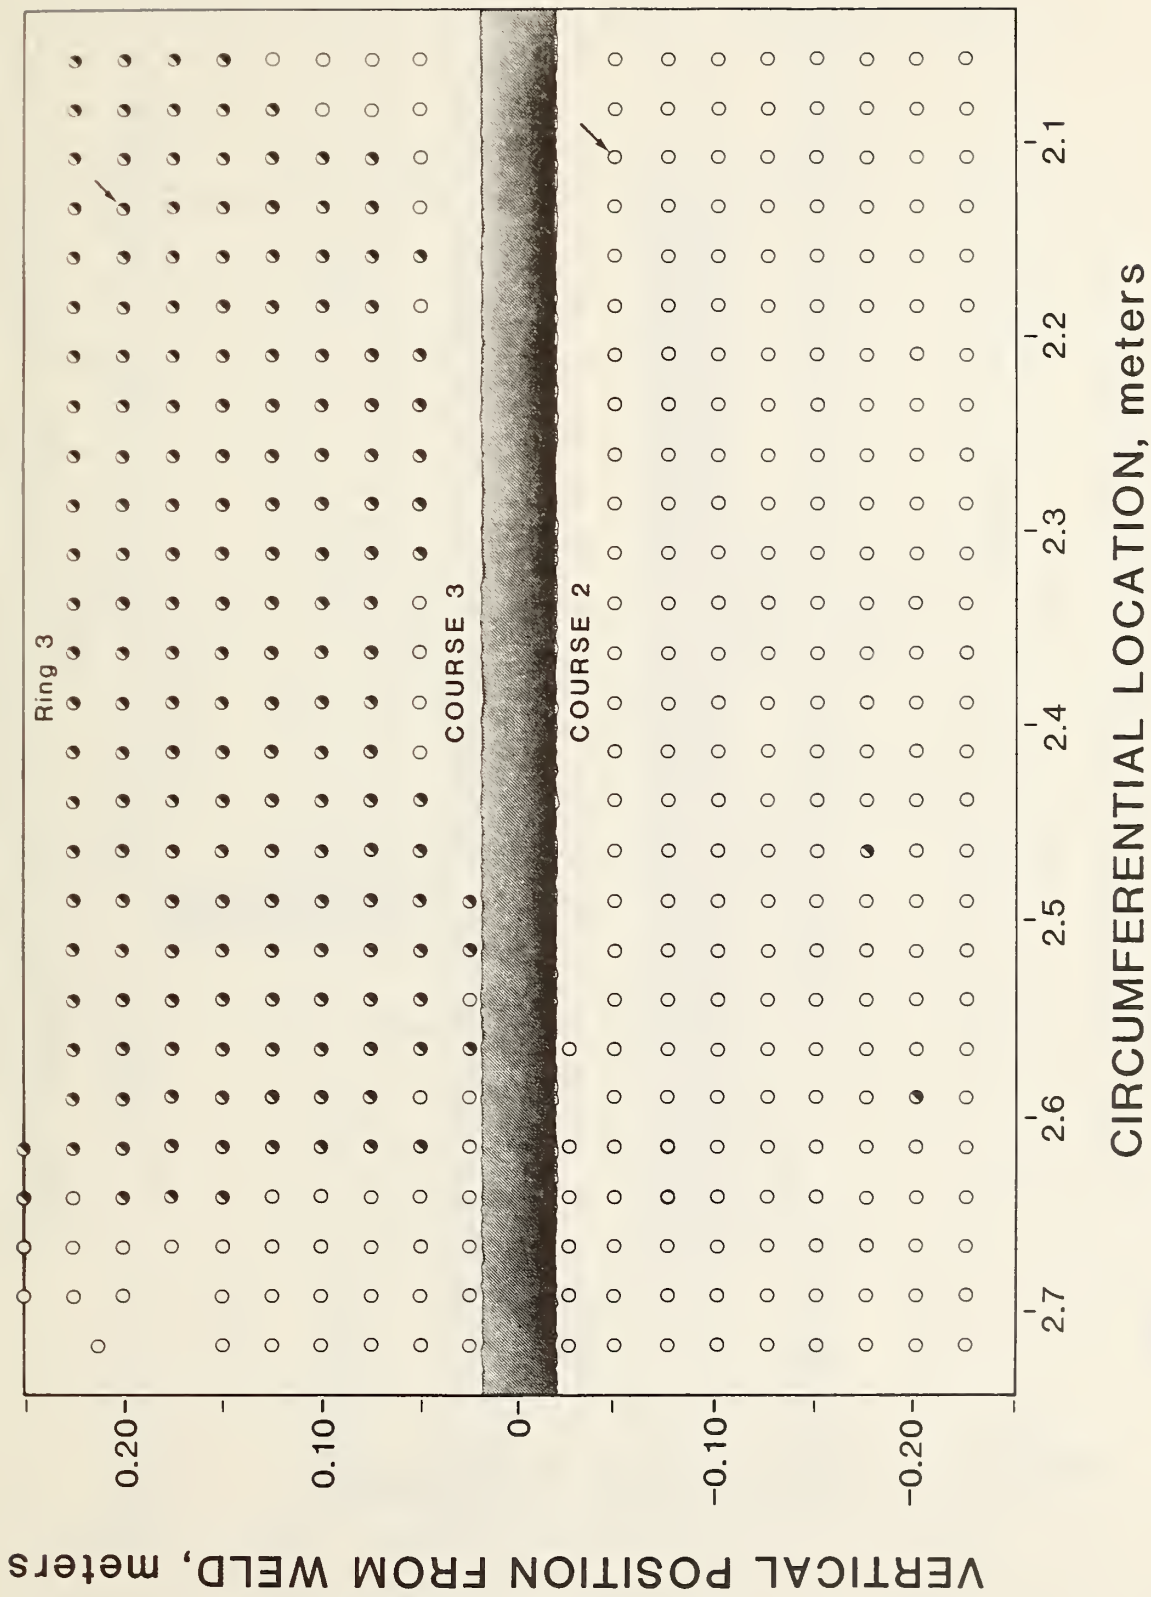
Figure C5. Scan of Specimen 2 (Ring 3, Courses 2 and 3). (✓ location for oscilloscope traces in Figure C3a and b).

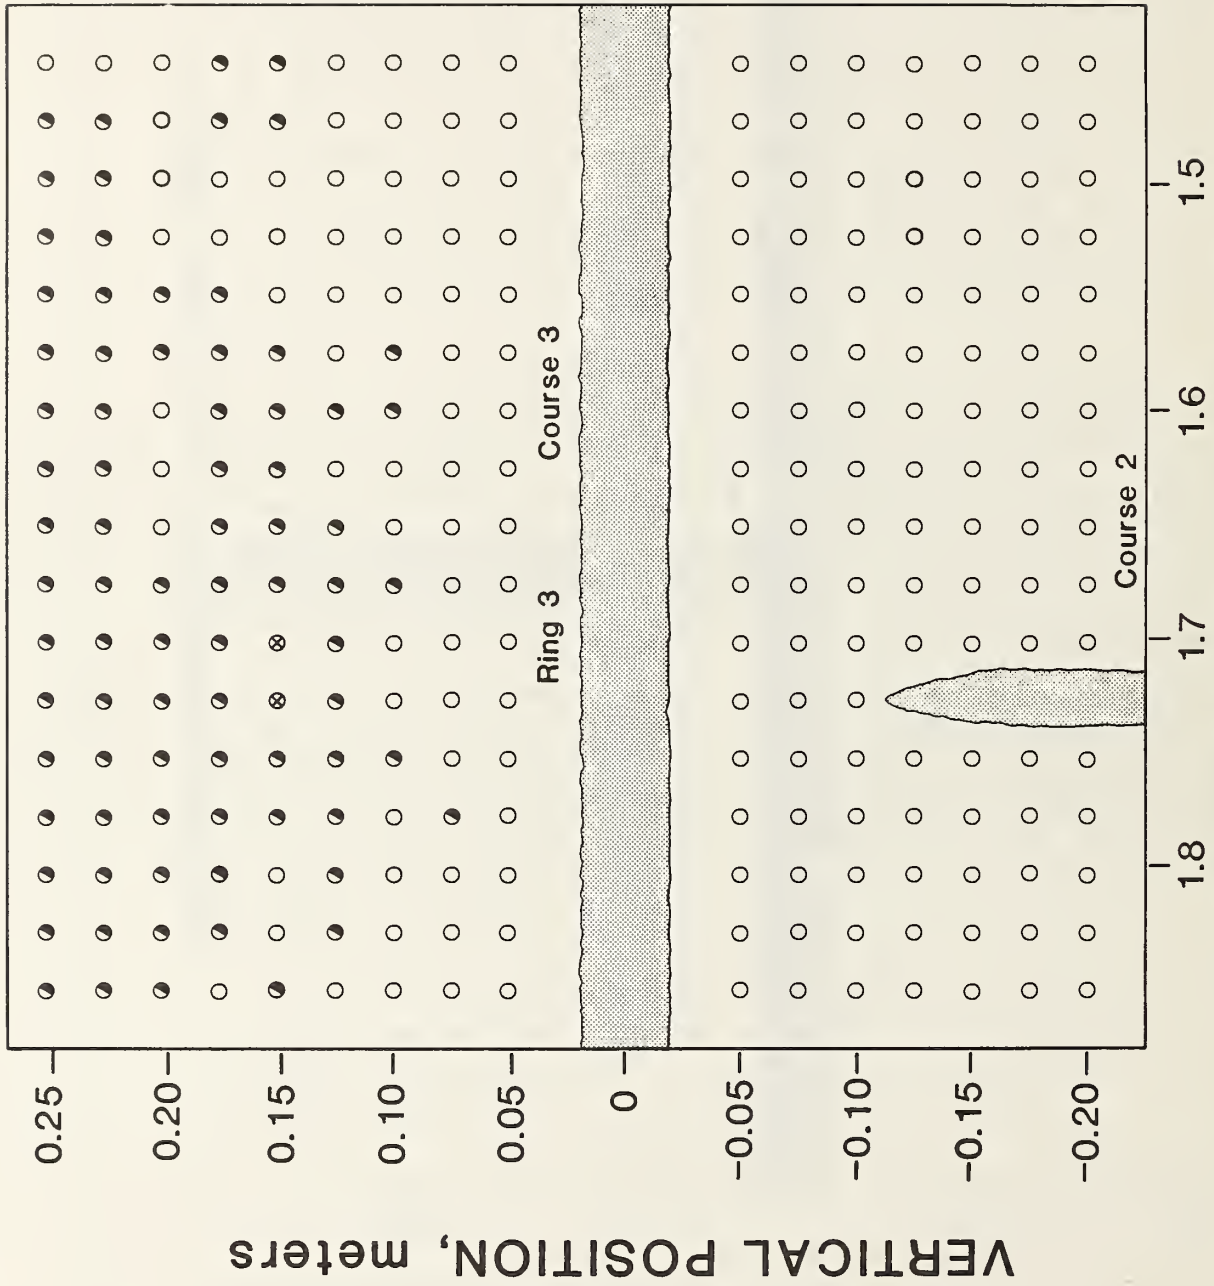
Figure C6. Scan of Specimen 3 (Ring 3, Courses 2 and 3).

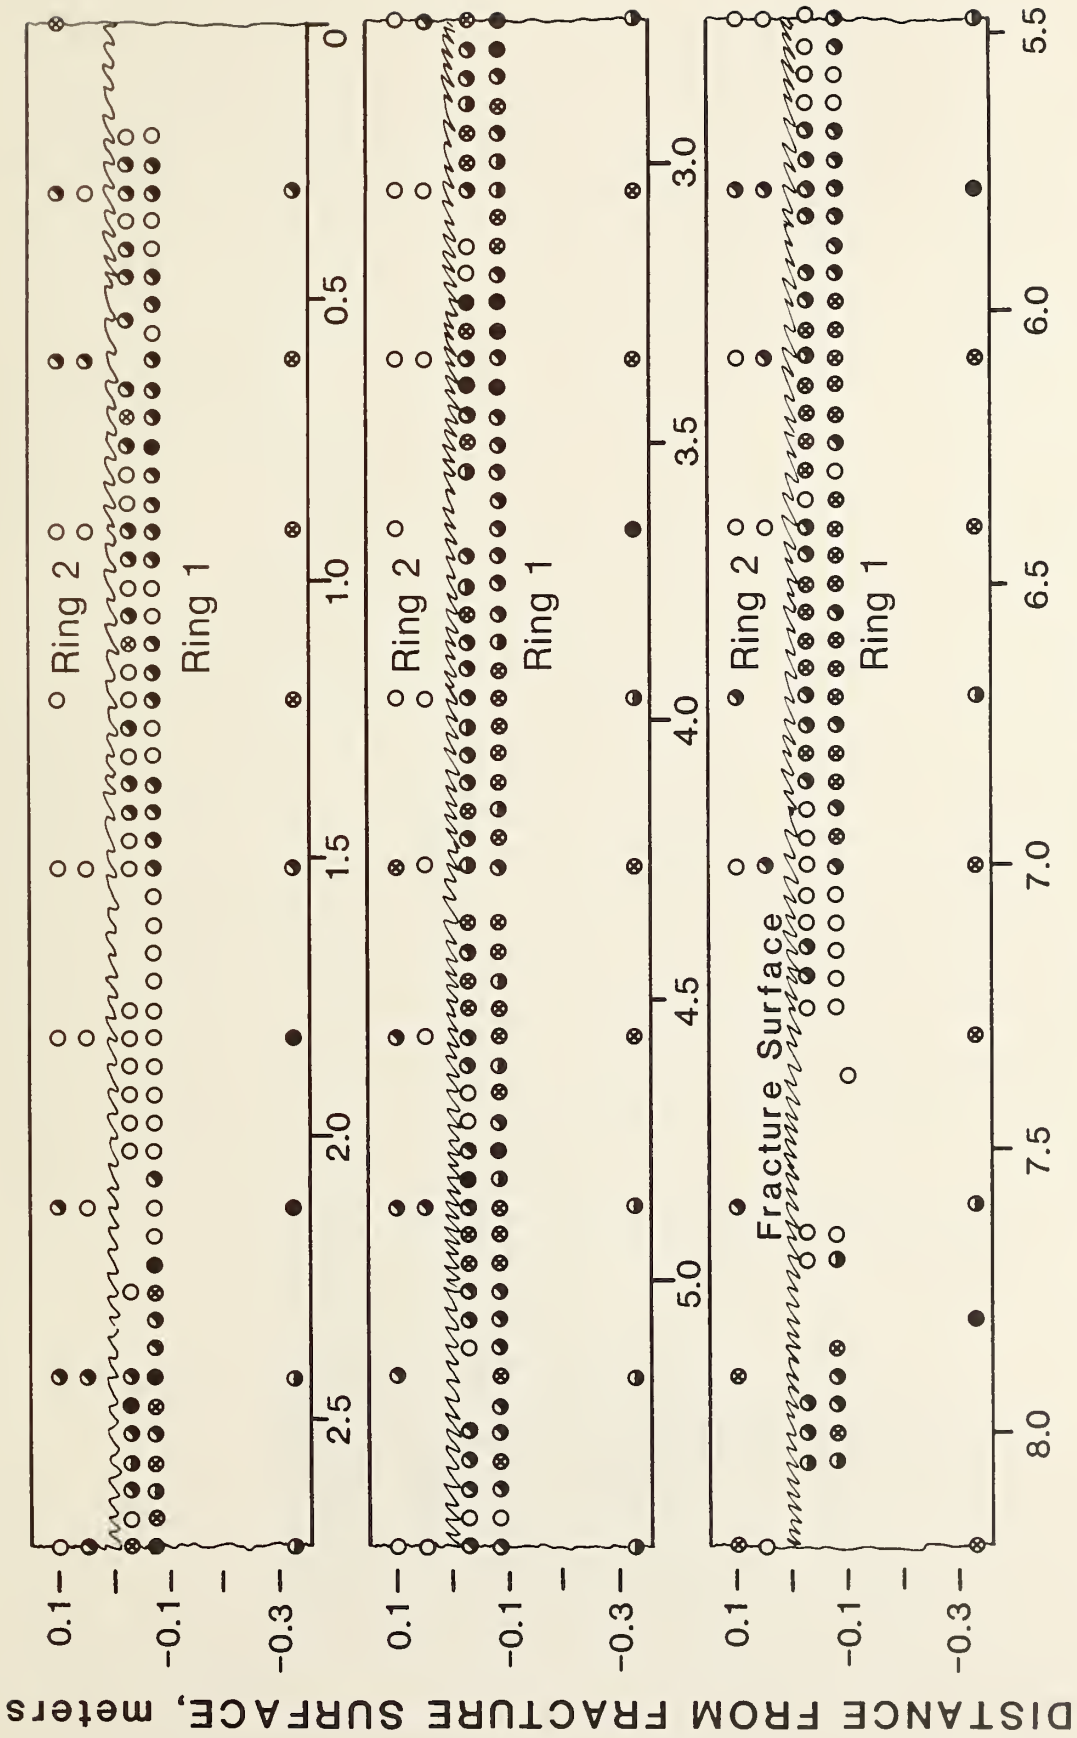
Figure C7. Results of the ultrasonic inspection for delaminations near the fracture surfaces in Rings 1 (lower) and 2 (upper).

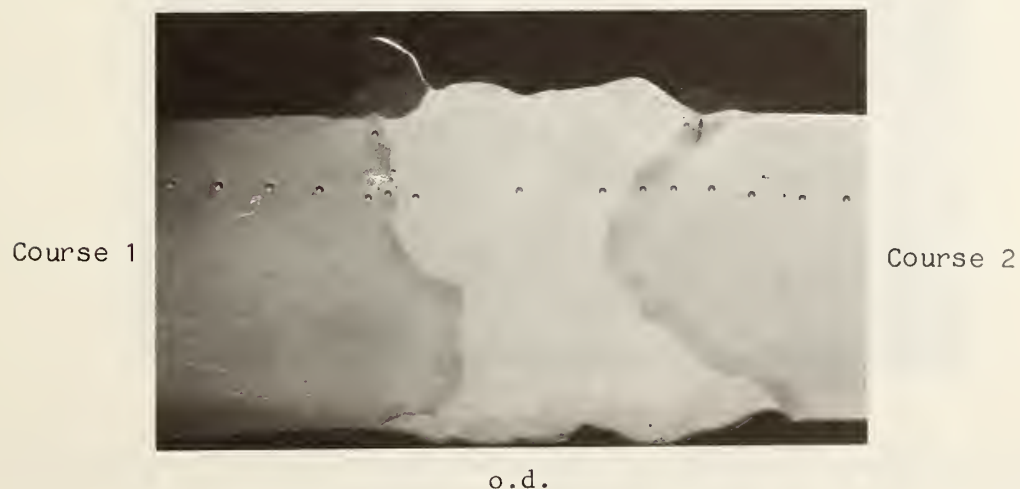
Figure D1. Hardness traverses of the weld between Course 1 and Course 2.

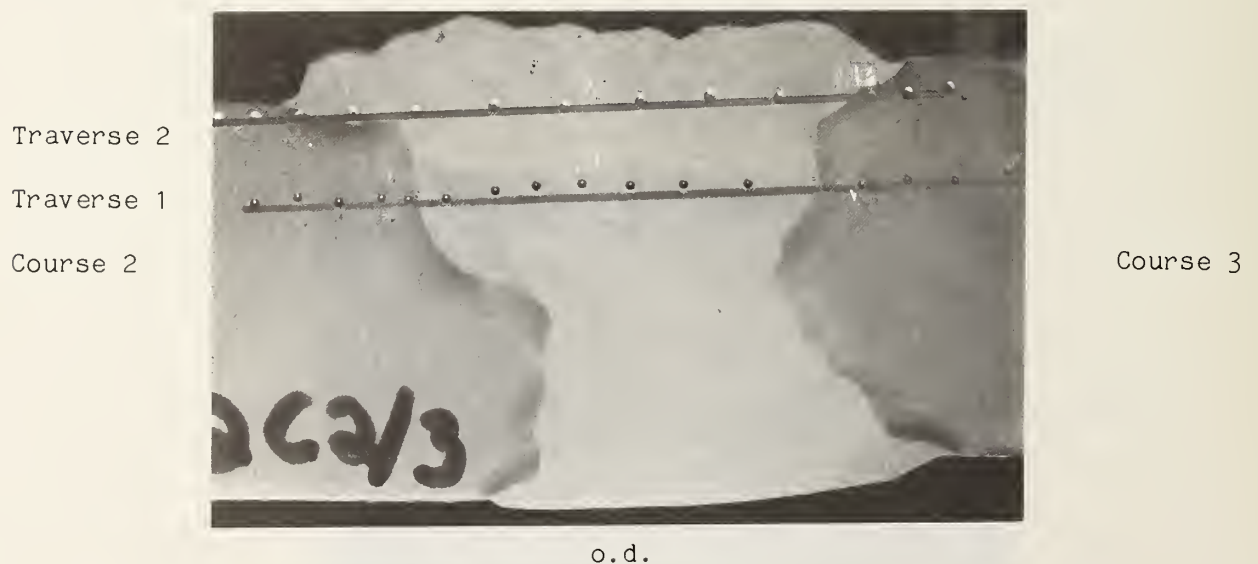
Figure D2. Hardness traverses of the weld between Course 2 and Course 3.

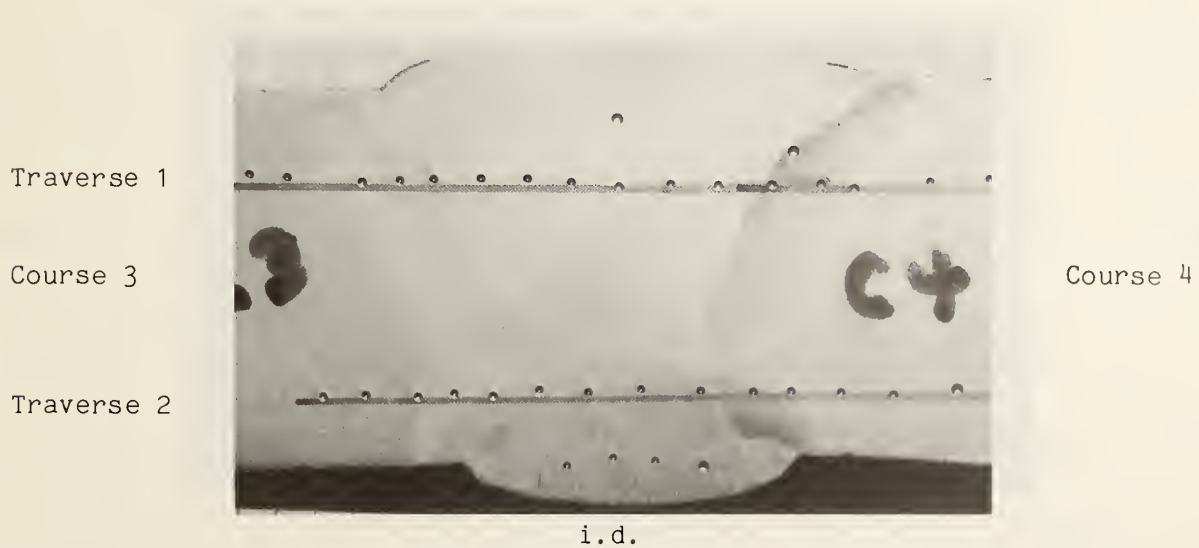
Figure D3. Hardness traverses of the weld between Course 3 and Course 4.

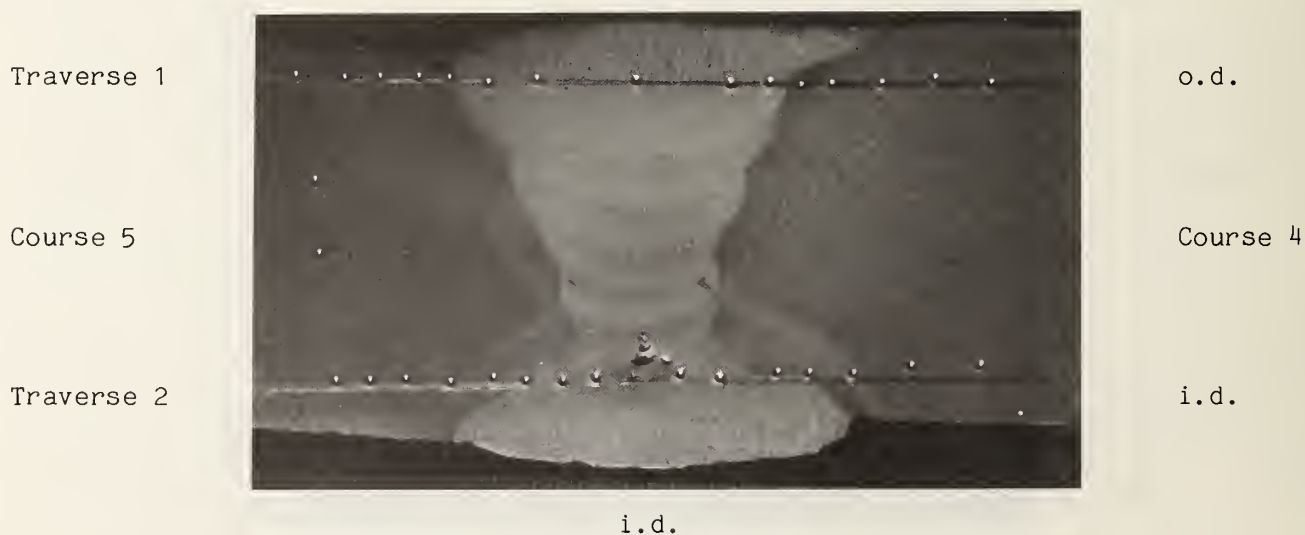
Figure D4. Hardness traverses of the weld between Course 4 and Course 5.

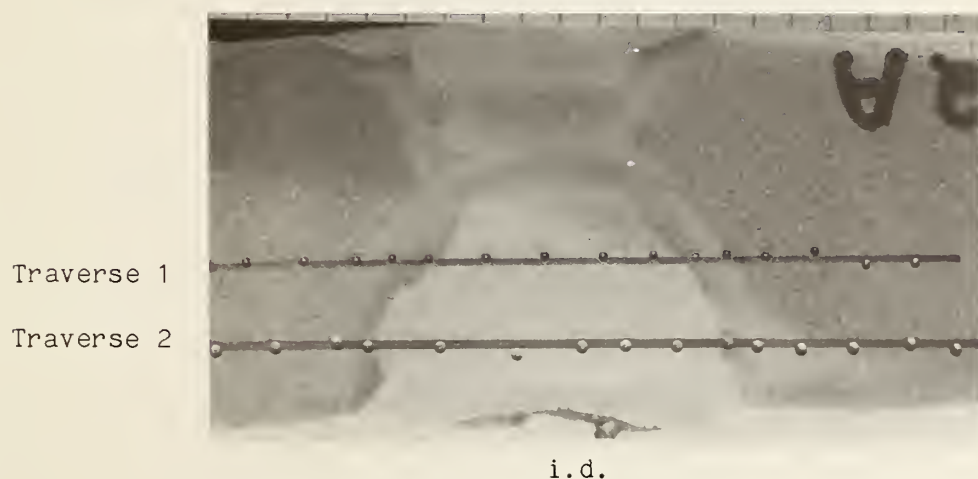
Figure D5. Hardness traverses across vertical weld A in Course 2.

Traverse 1		Traverse 2	
	Identification Number	Hardness, HRA	Identification Number	Hardness, HRA
Base Metal	1	51.5	1	52
	2	52	2	52
	3	51.5	3	52.5
			4	51.5
			5	50.5
HAZ	4	50.5	6	51
	5	50.5	7	52
	6	53	8	53
	7	53		
Weld Metal	8	51.5	9	51
	9	51.5	10	52
	10	51.5	11	51.5
HAZ	11	52	12	53
	12	52	13	52.5
	13	51	14	50.5
Base Metal	14	51.5	15	51
	15	51.5	16	51
			17	51

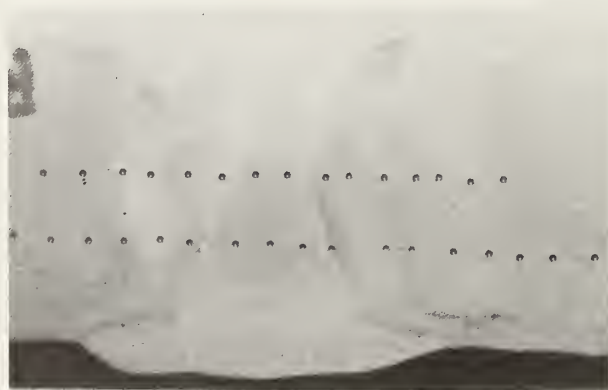
Figure D6. Hardness traverses across vertical weld B in Course 2.

Traverse 1		Traverse 2	
	Identification Number	Hardness, HRA	Identification Number	Hardness, HRA
Base Metal	1	49.5	1	86.5
	2	49.5	2	86.5
	3	49.5		
HAZ	4	51.5	3	86.5
	5	53.5	4	89.5
Weld Metal	6	50.5	5	88
	7	50.5	6	90
	8	50.5	7	89.5
	9	51.5	8	90
	9	91.5		
HAZ	10	53	10	89
	11	53	11	86
Base Metal	12	50.5	12	87
	13	50.5	13	87
	14	51

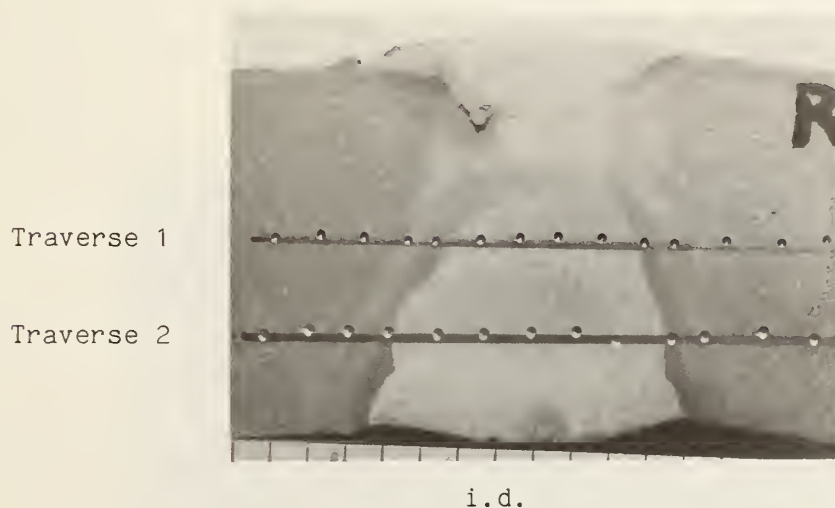
Figure D7. Hardness traverses across vertical weld C in Course 2.

Traverse 1		Traverse 2		Traverse 3	
	Identification Number	Hardness, HRA	Identification Number	Hardness, HRA	Identification Number	Hardness, HRA
Base Metal	1	50.5	1	48	1	52
	2	51.5	2	50.5	2	52
			3	50.5		
			4	50		
HAZ	3	52	5	50.5	3	52
	4	53.5	6	53	4	54
	5	54.5	7	53	5	54
					6	54
Weld Metal	6	54	8	52	7	53.5
	7	54	9	52	8	53.5
	8	54	10	51	9	53.5
	9	53.5	11	51	10	53
	10	54				
	11	53				
	12	52				
HAZ	13	53	12	51	11	53
	14	53	13	50	12	53.5
	15	52			13	52.5
Base Metal	16	51	14	49	14	52.5
			15	49.5

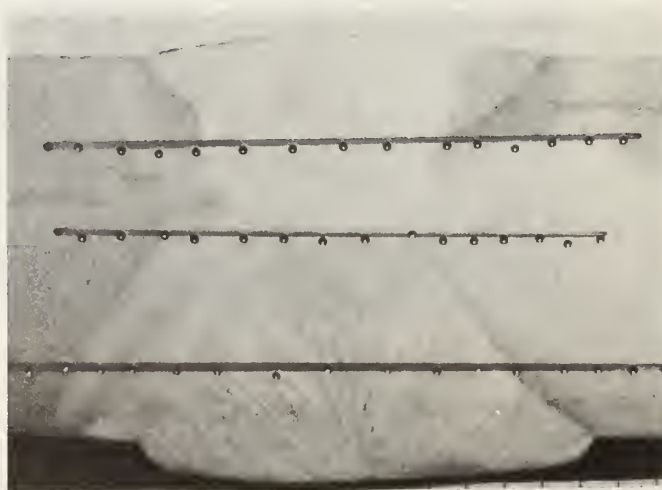
Figure D8. Hardness traverses across the vertical weld in Course 1.

Traverse 1		Traverse 2	
	Identification Number	Hardness, HRA	Identification Number	Hardness, HRA
Base Metal	1	53.5	1	52
	2	53.5	2	52.5
			3	52.5
			4	52.5
HAZ	3	53	5	51.5
	4	53.5	6	52.5
	5	53	7	53
	6	53		
Weld Metal	7	52	8	52.5
	8	52	9	53.5
	9	52	10	54.5
	10	51.5	11	54
			12	54
			13	54
			14	53.5
HAZ	11	51	15	54.5
	12	51	16	53
	13	50	17	52
Base Metal	14	50.5	18	51
	15	51	19	52
	16	50.5	20	51.5

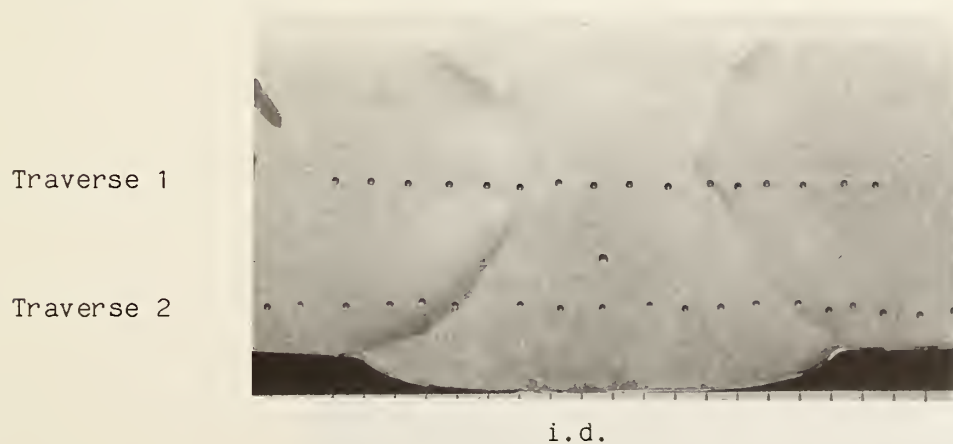
Figure D9. Hardness traverses across the vertical weld in Course 3.

Traverse 1		Traverse 2	
	Identification Number	Hardness, HRA	Identification Number	Hardness, HRA
Base Metal	1	50	1	51.5
	2	52.5	2	52
	3	53	3	51.5
	4	52	4	51.5
HAZ	5	52	5	52
	6	52		
	7	53.5		
	8	54		
Weld Metal	9	53.5	6	52.5
	10	54	7	52
	11	53.5	8	52.5
	12	53.5	9	52
	13	54	10	52
	14	53.5		
HAZ	15	54	11	53
	16	53.5	12	53
	17	53		
Base Metal	18	52.5	13	52
	19	53	14	52.5

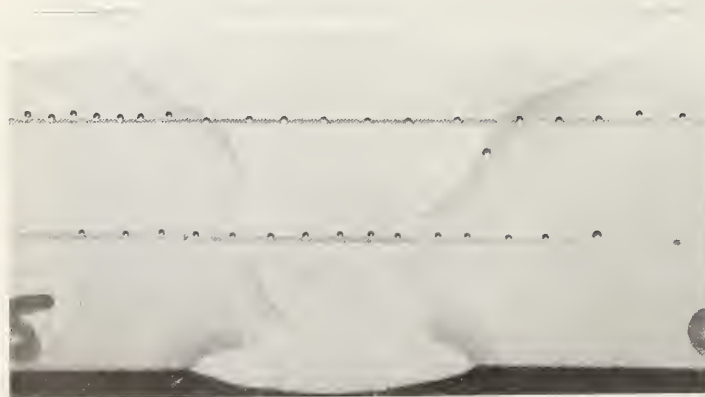
Figure D10. Hardness traverses across the vertical weld in Course 5.

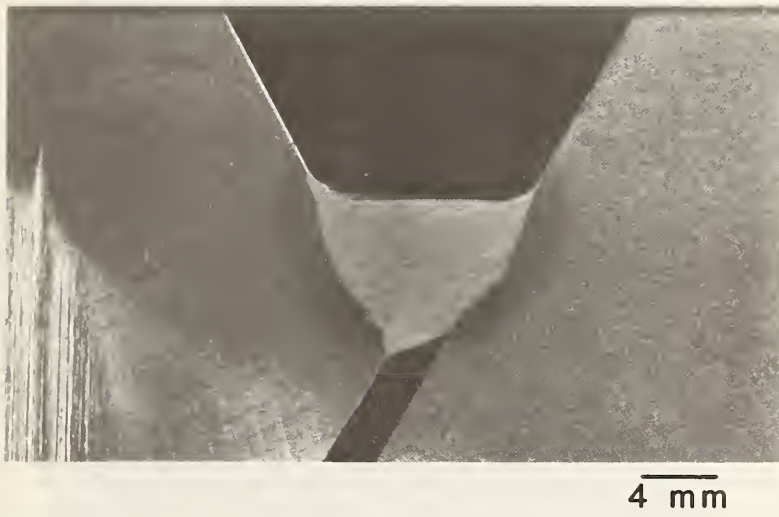
No cracking was found in Test 3 during the nondestructive examination of the weld bead surface. However, cracking was found in the examination of the weld cross section. A typical section through the weld, Figure E3, reveals a rounded bead with good penetration into the sides. The crack is visible in a higher magnification view, Figure E4, extending from the root along the Plate 1 (hydrogen-charged) side of the groove. The crack was always in the HAZ on the Plate 1 side of the groove and was consistently near 20% of the leg length (distance from the toe to the root of the weld).

Figure E3. Typical cross section of the weld at the center (test) section of Specimen 3.

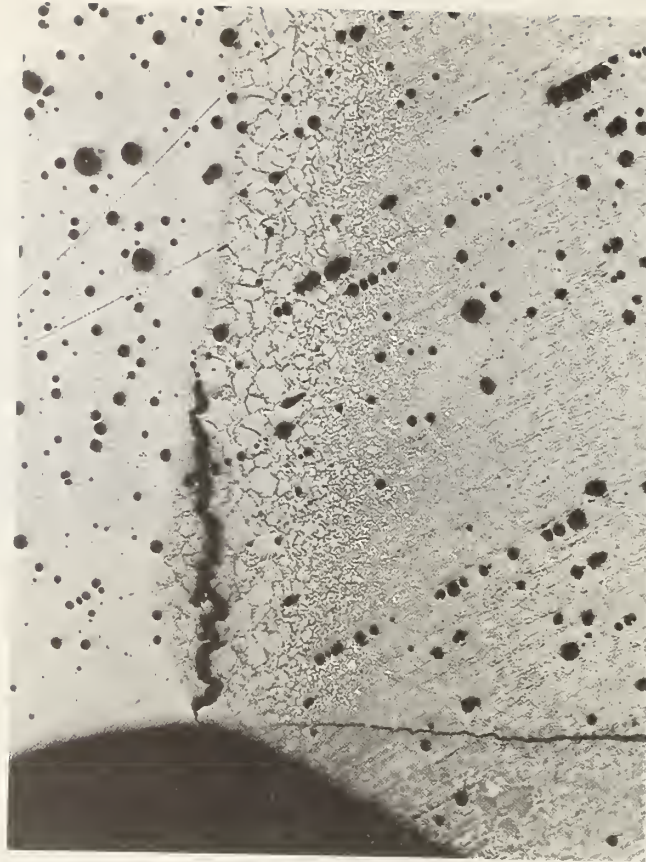
* Cracking confined to HAZ on the Course 1 side of the specimen.

Figure E4. Typical crack along the HAZ in the Plate 1 side of the groove, extending 20% of the leg length from the weld root.

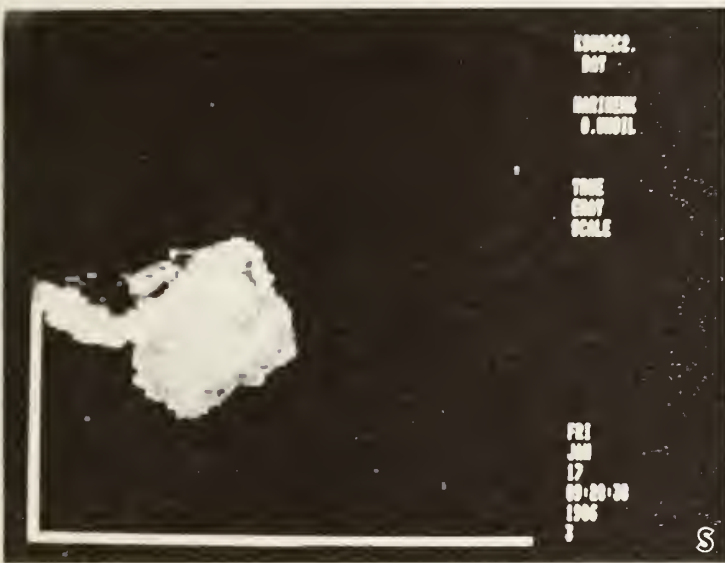
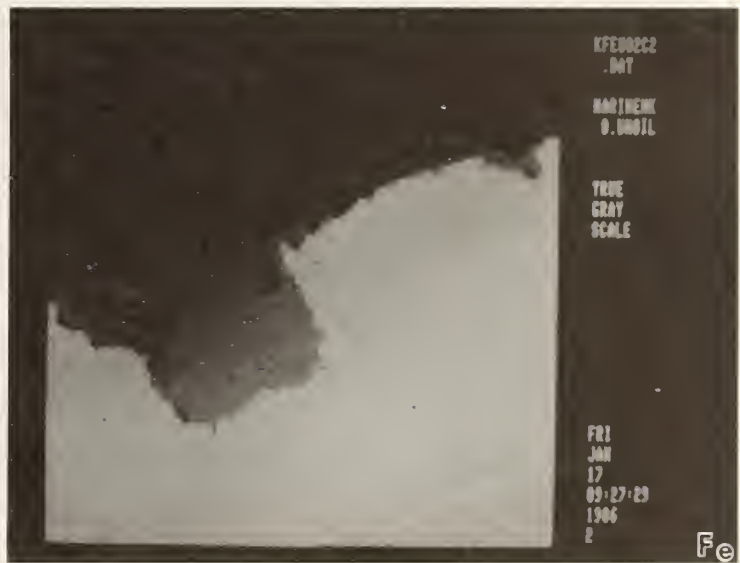
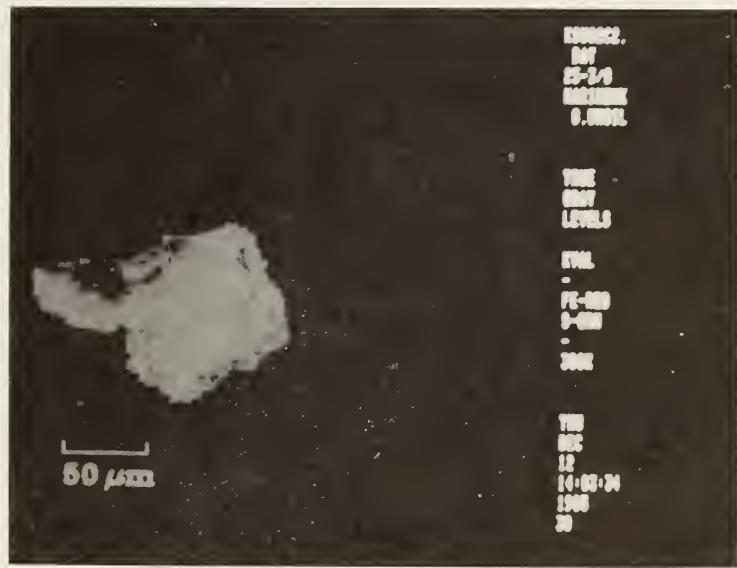
Figure F2. WDS maps of specimen 25-3/8C2.

These maps can be displayed on an image analysis system in black and white or in color. In each of Figures F2-F4 are shown the individual black and white maps for each element and the composite color maps for each of the three pitted areas. The areas in Figures F2 and F3 were from the large specimen denoted 25-3/8C2, while the area in Figure F4 was from the small specimen labeled "out" and denoted 25-3/8C20 in our notation. The color maps were prepared by overlaying the iron, sulfur, and silicon ratio maps. Iron is red, sulfur is green, and silicon is blue. Silicon was not included in Figure F2 because there was so little observed in the silicon map of this area. There is also little silicon in the area of Figure F3. In both of these maps, sulfur and iron are the major components of the pitted region. In Figure F4 there is a lot of silicon in the pitted region and sulfur is located primarily along the interface between the iron metal and the silicon-rich pit. Since other elements were observed in the EDS spectra of this region, an EDS map was prepared of this pit in order to include more elements

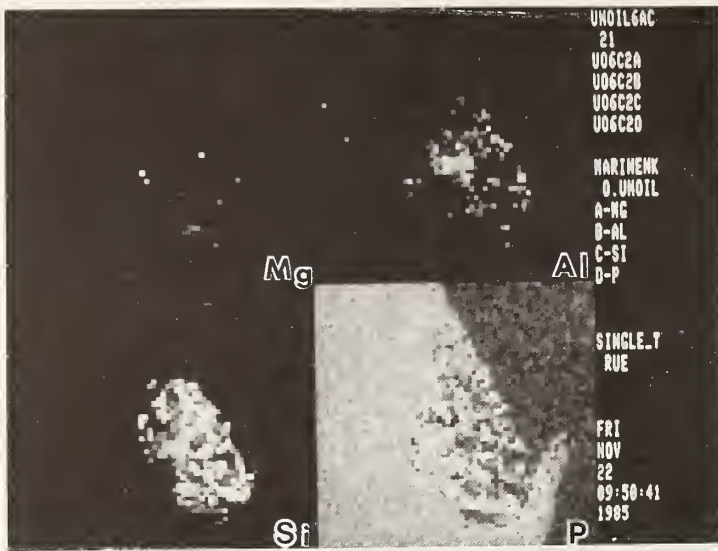
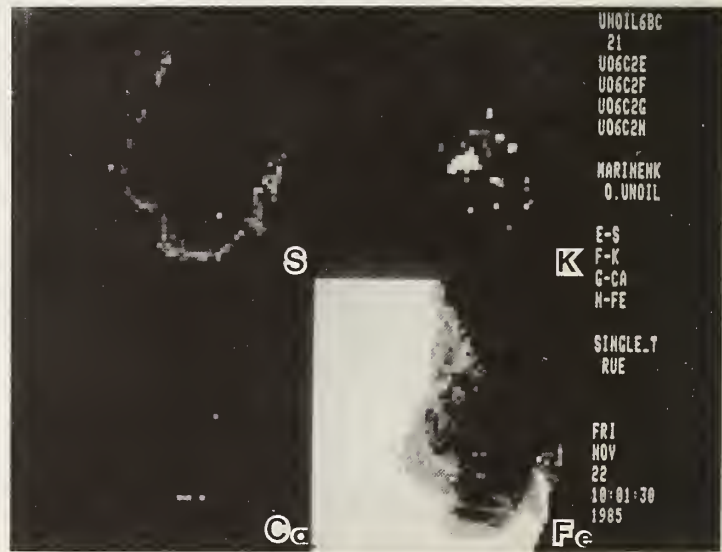
Figure F5. Energy dispersive spectra of the pitted area of specimen 25-3/8C20.

in a single-mapped region. (Only three elements can be observed at the same time with WDS since there are only three wavelength spectrometers on our instrument.) These EDS maps are displayed in black-and-white in Figure F5. Some elements such as aluminum, potassium, and phosphorus are present with silicon in the pitted region. Other elements found frequently in other EDS spectra of the fracture surface, calcium and magnesium, are not present to any noticeable extent in this region.
