Investigation into the Ashland Oil Storage Tank Collapse on January 2, 1988

NBSIR 88-3792

Issued June 1988

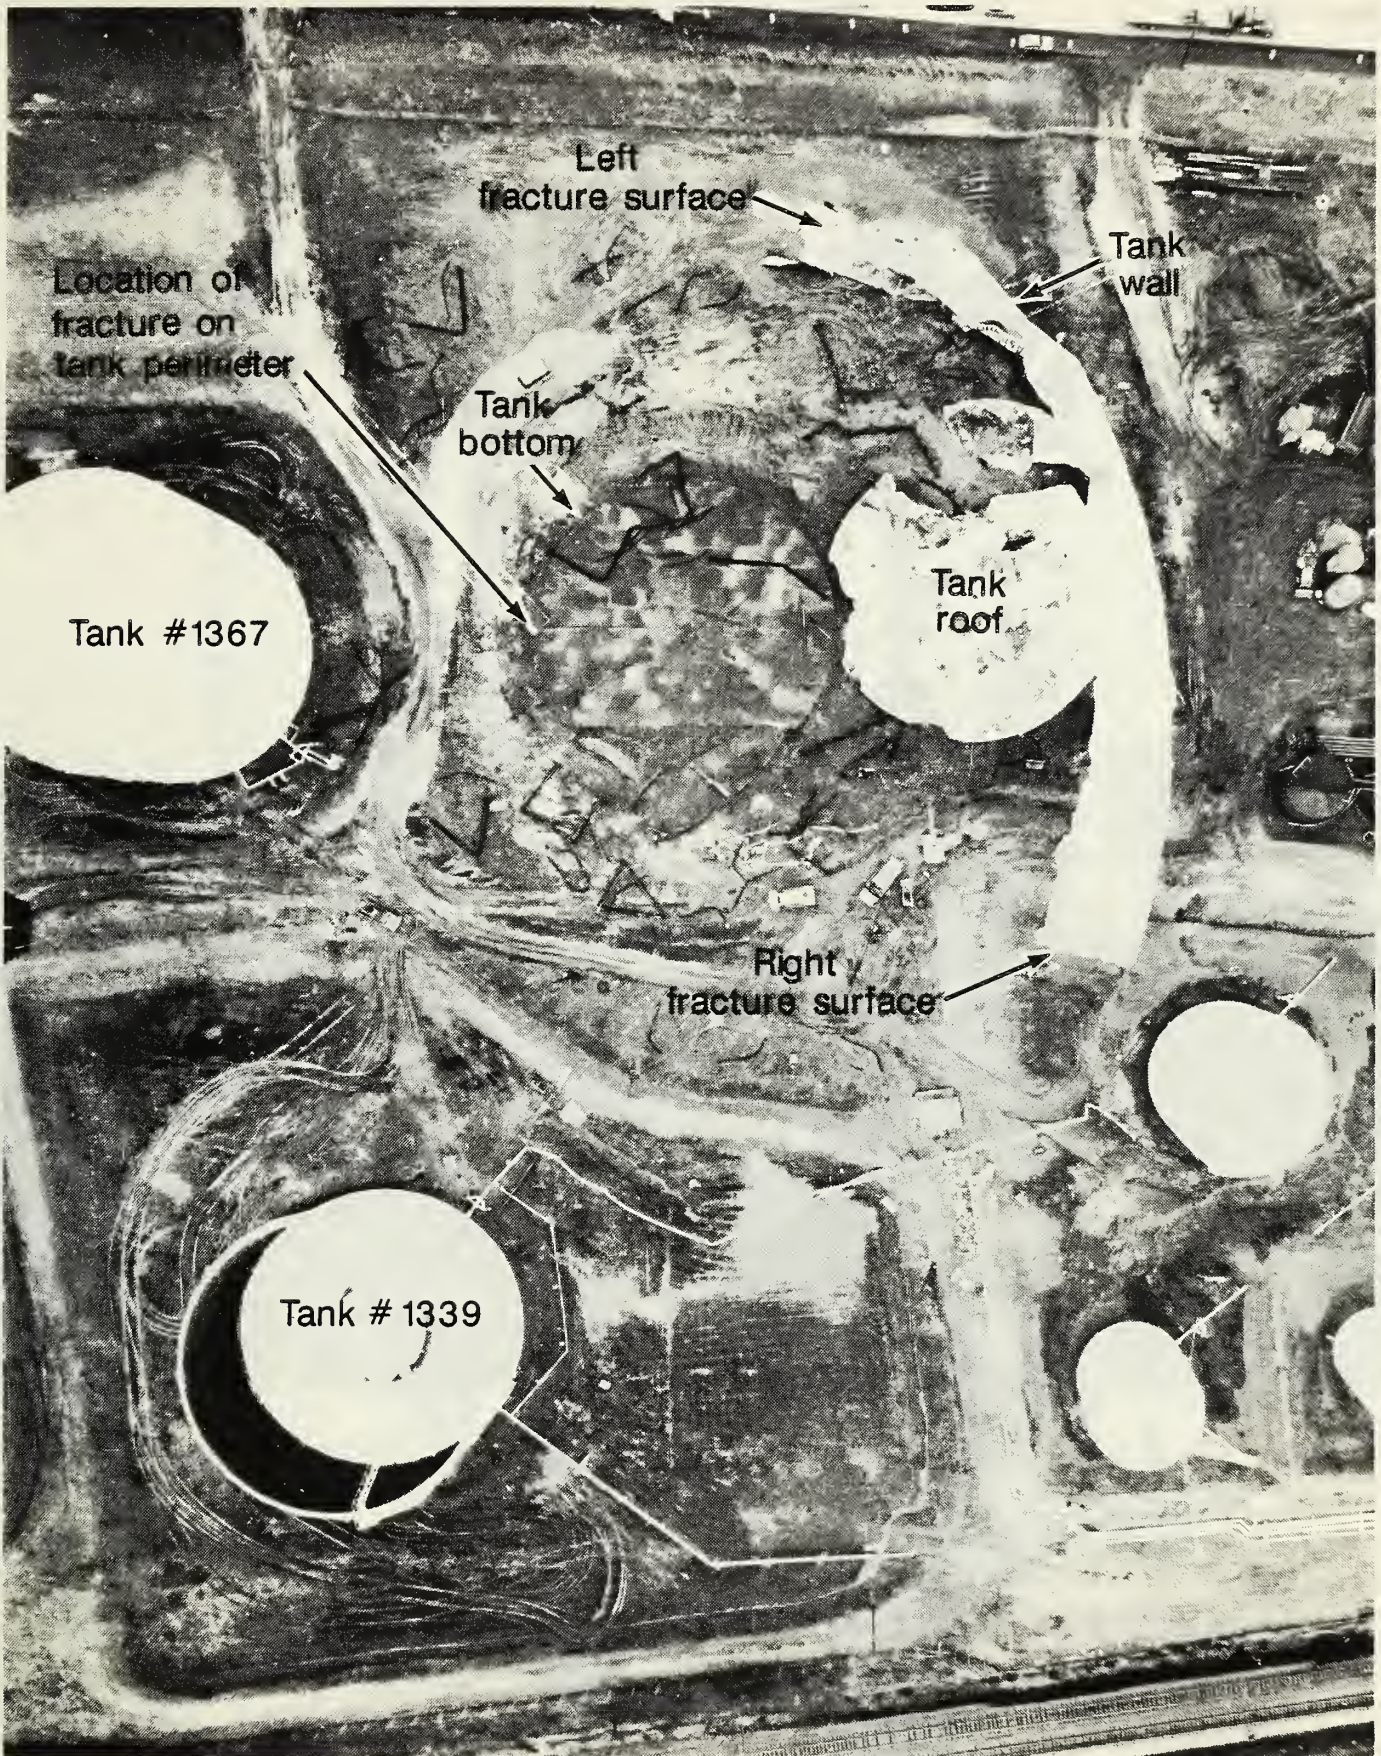
Figure 3.3 - Aerial View of the Collapse Site
(Photo by Pennsylvania Task Force)

As can be seen from the aerial view of the collapse site shown in Figure 3.3 (3.3), the tank wall had split completely open and the once-cylindrical shell had unwrapped until it was nearly straight. The tank shell came to rest on top of a dike approximately 120 ft and generally north of its original location. A description of the fractured tank wall is given in the next section. A composite photograph of the collapsed tank from within the dike area is shown in Figure 3.4.

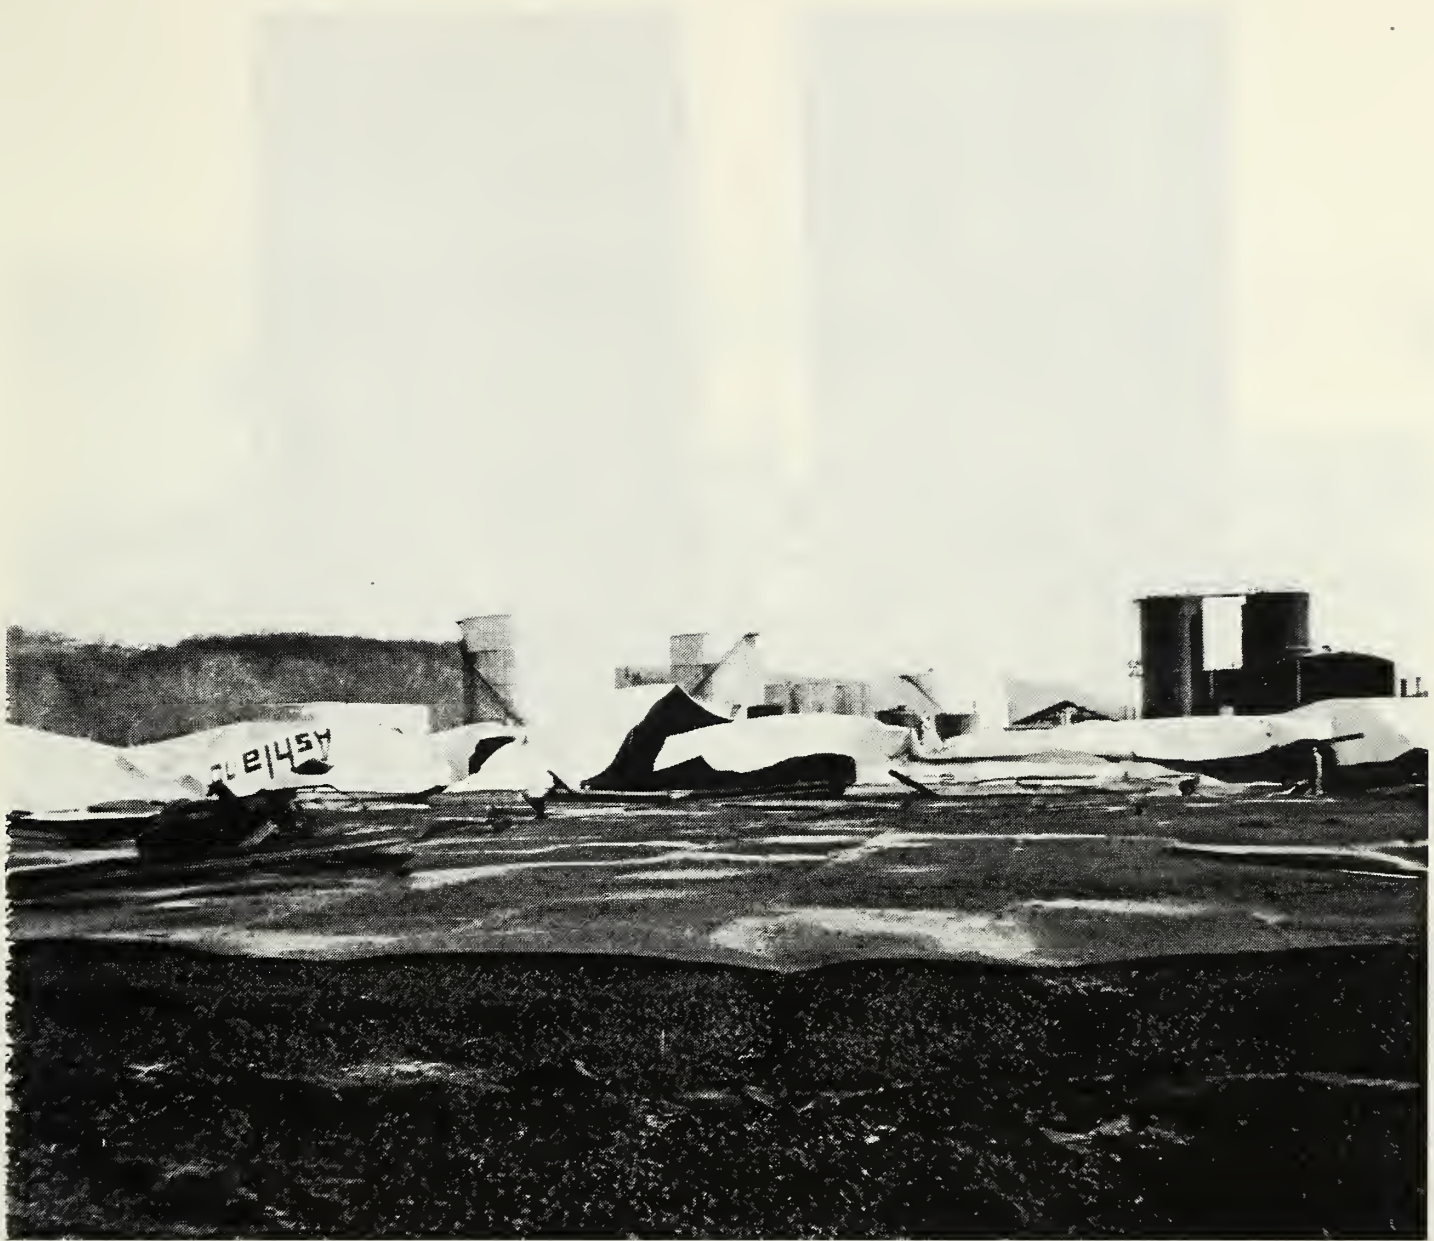
Figure 3.5 - View of Tank Bottom with Tank Wall and Roof in Background

The wall was completely separated from the tank bottom. Figure 3.5 shows the tank bottom in the foreground and the tank wall and portions of the roof in the background. The bottom tore at the toe of the inside fillet weld attaching the first shell course to the bottom plate leaving a 3-inch "lip" attached to the tank wall (see Figure 3.6). This tear was ductile as evidenced by the approximately 45° failure plane. The tank bottom remained relatively intact except for two large tears in the lap welded seams. The edge of the bottom plate where the tank wall tore away had a "scalloped" appearance as shown in Figure 3.5.

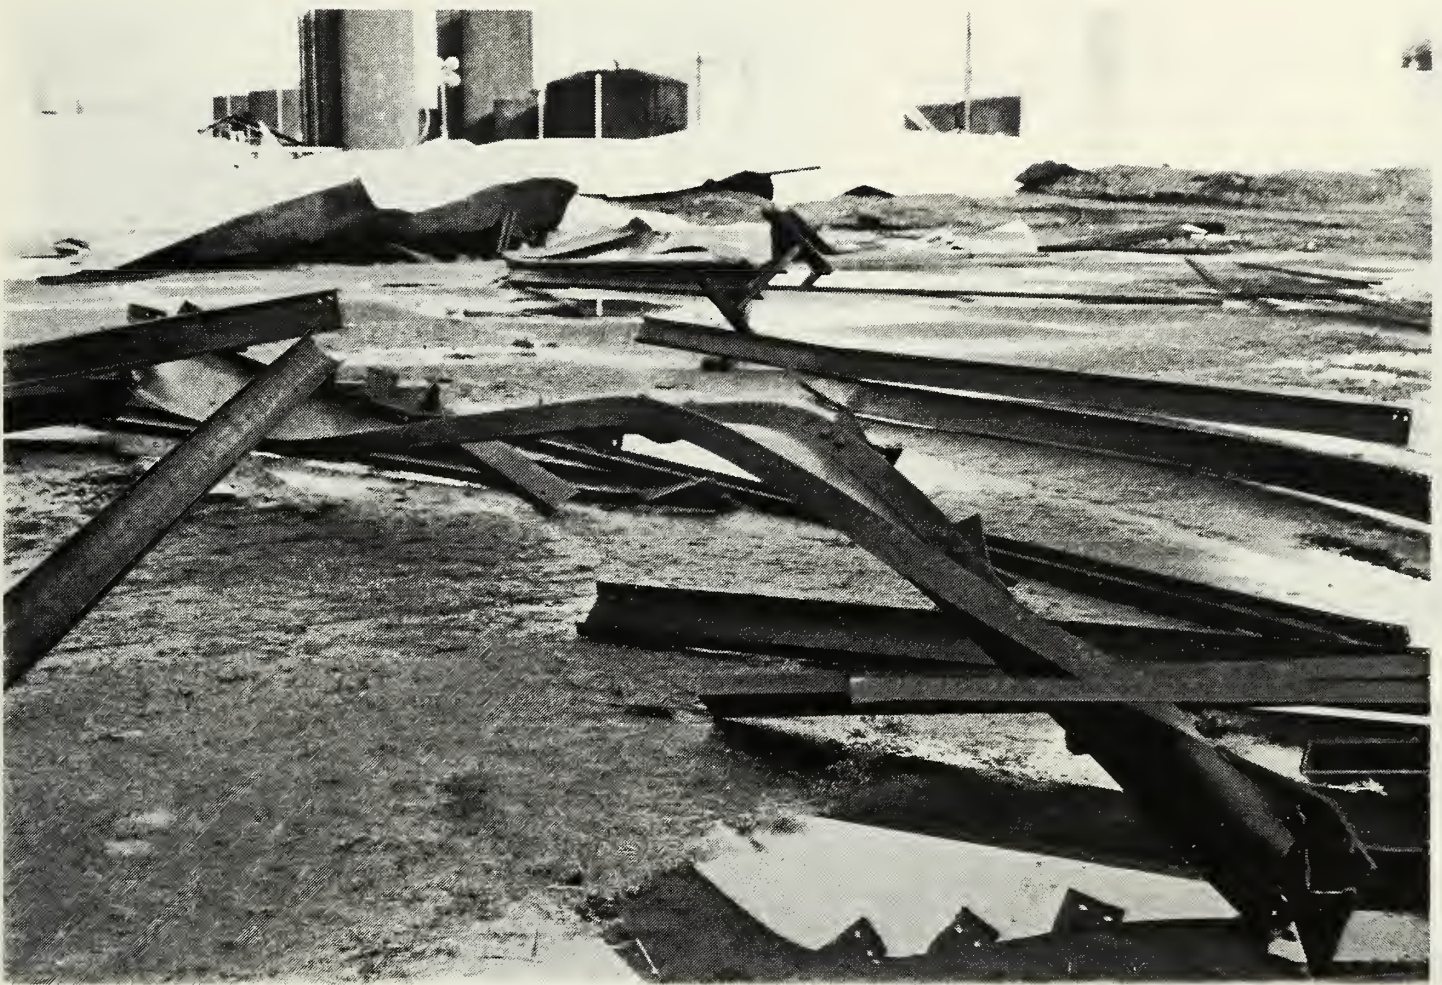
Figure 3.7 - Roof Framing Debris Scattered on Tank Bottom

Debris from the roof support system lay scattered mostly within the dike area as can be seen in Figure 3.3. A closer view of some of the debris on the tank bottom is shown in Figure 3.7. The roof framing members were severely twisted

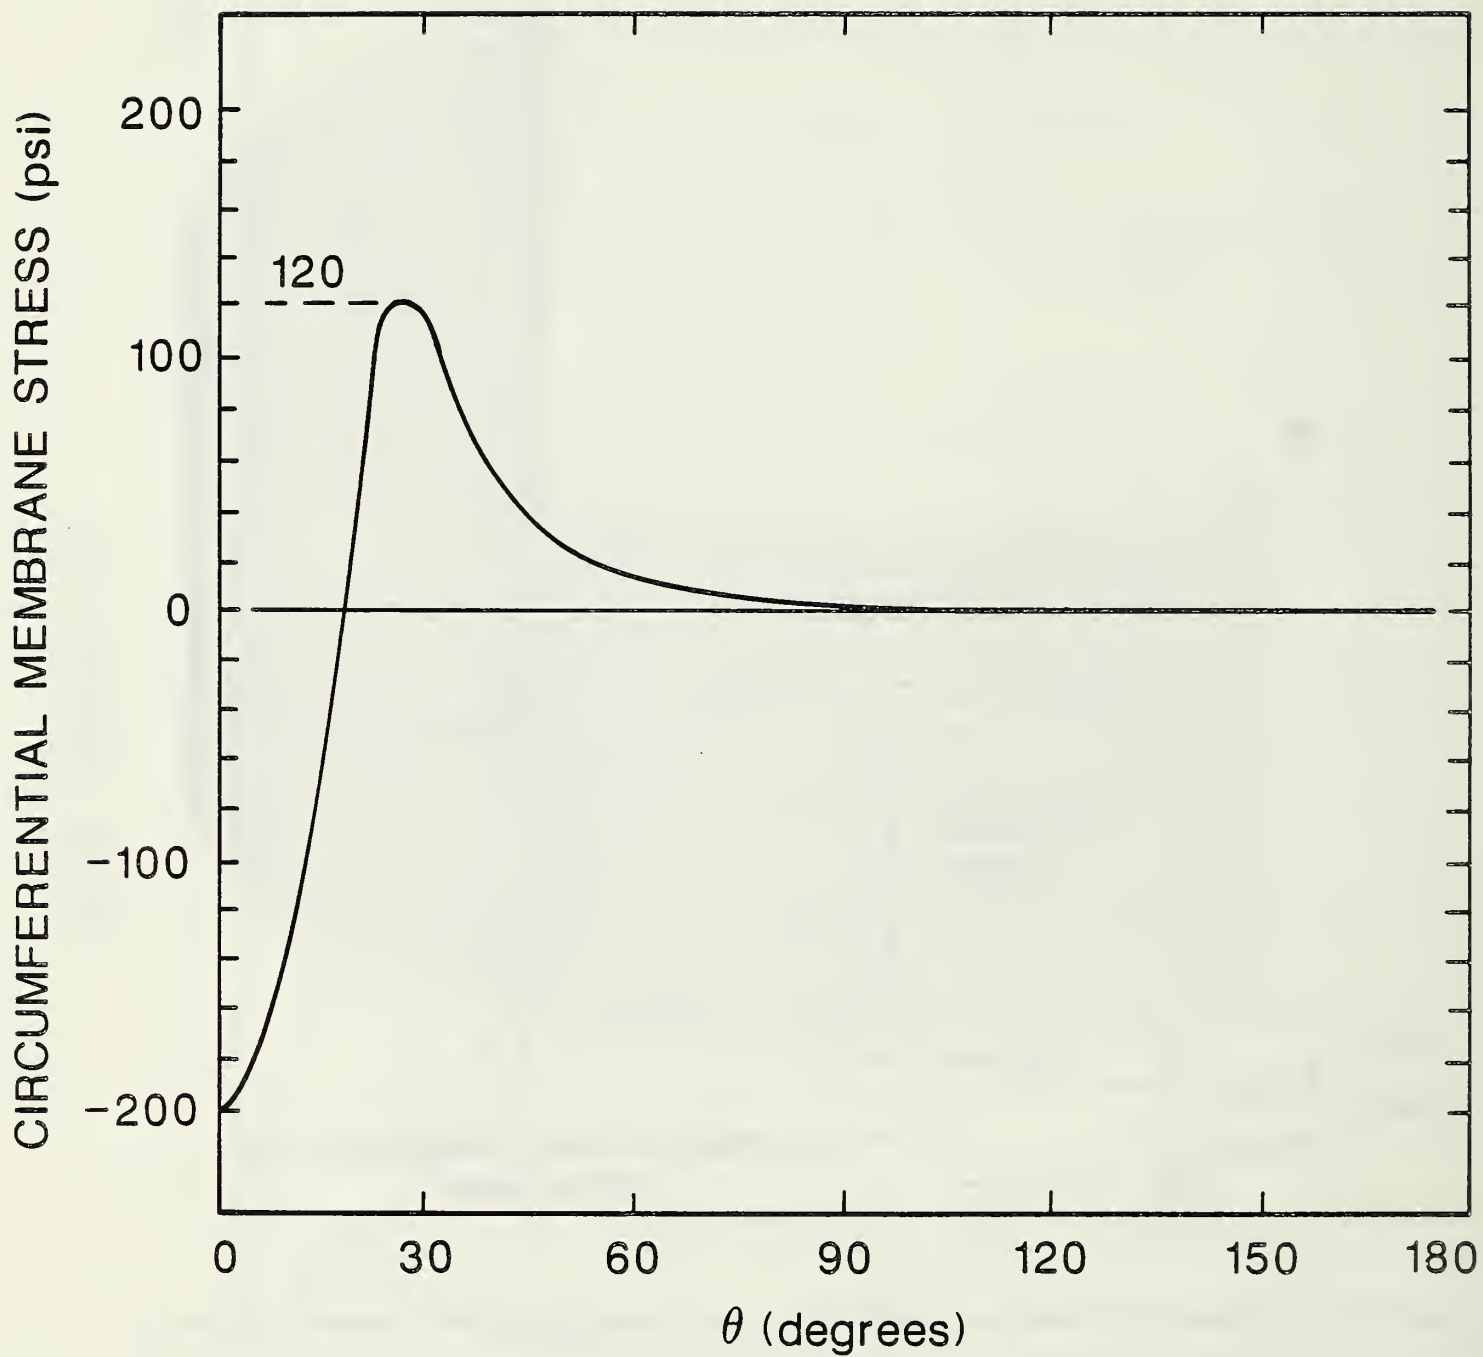
Figure 5.5 - Circumferential Stresses in the Tank Wall at a Height of 8 ft due to an Assumed Differential Settlement of 0.01 ft

The maximum meridional membrane stress was approximately 3 ksi. Of more interest is the circumferential stress at the juncture of the first and second shell courses (height above tank bottom of the flaw). The membrane circumferential stress, plotted as a function of θ , is shown in Figure 5.5. As can be seen, the maximum tensile stress is approximately 120 psi and the maximum compressive stress is approximately 200 psi. The stresses are seen to decay to zero within 90° . From this analysis, it is seen that localized differential settlements on the order of 0.04 ft (approximately 0.5 in) would produce tensile membrane stresses in the vicinity of the flaw of only 500 psi. Thus, it is unlikely that any differential foundation settlements contributed significantly to the tensile stress normal to the flaw.

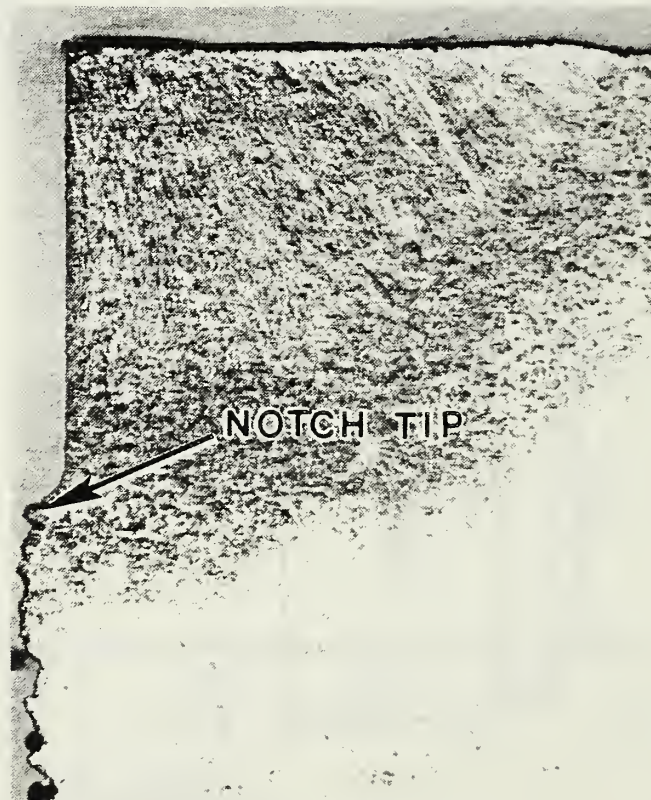
Figure 7.12b - Hardness of Embrittled Zone in Single-Edge Notched Bend Specimens

<u>Depth (in)</u>	<u>Hardness</u>
0.020	HRC 35
0.040	HRC 36
0.060	HRC 37
0.080	HRC 43
0.100	HRC 31
0.120	HRC 27
0.140	HRB 85
0.160	HRB 80

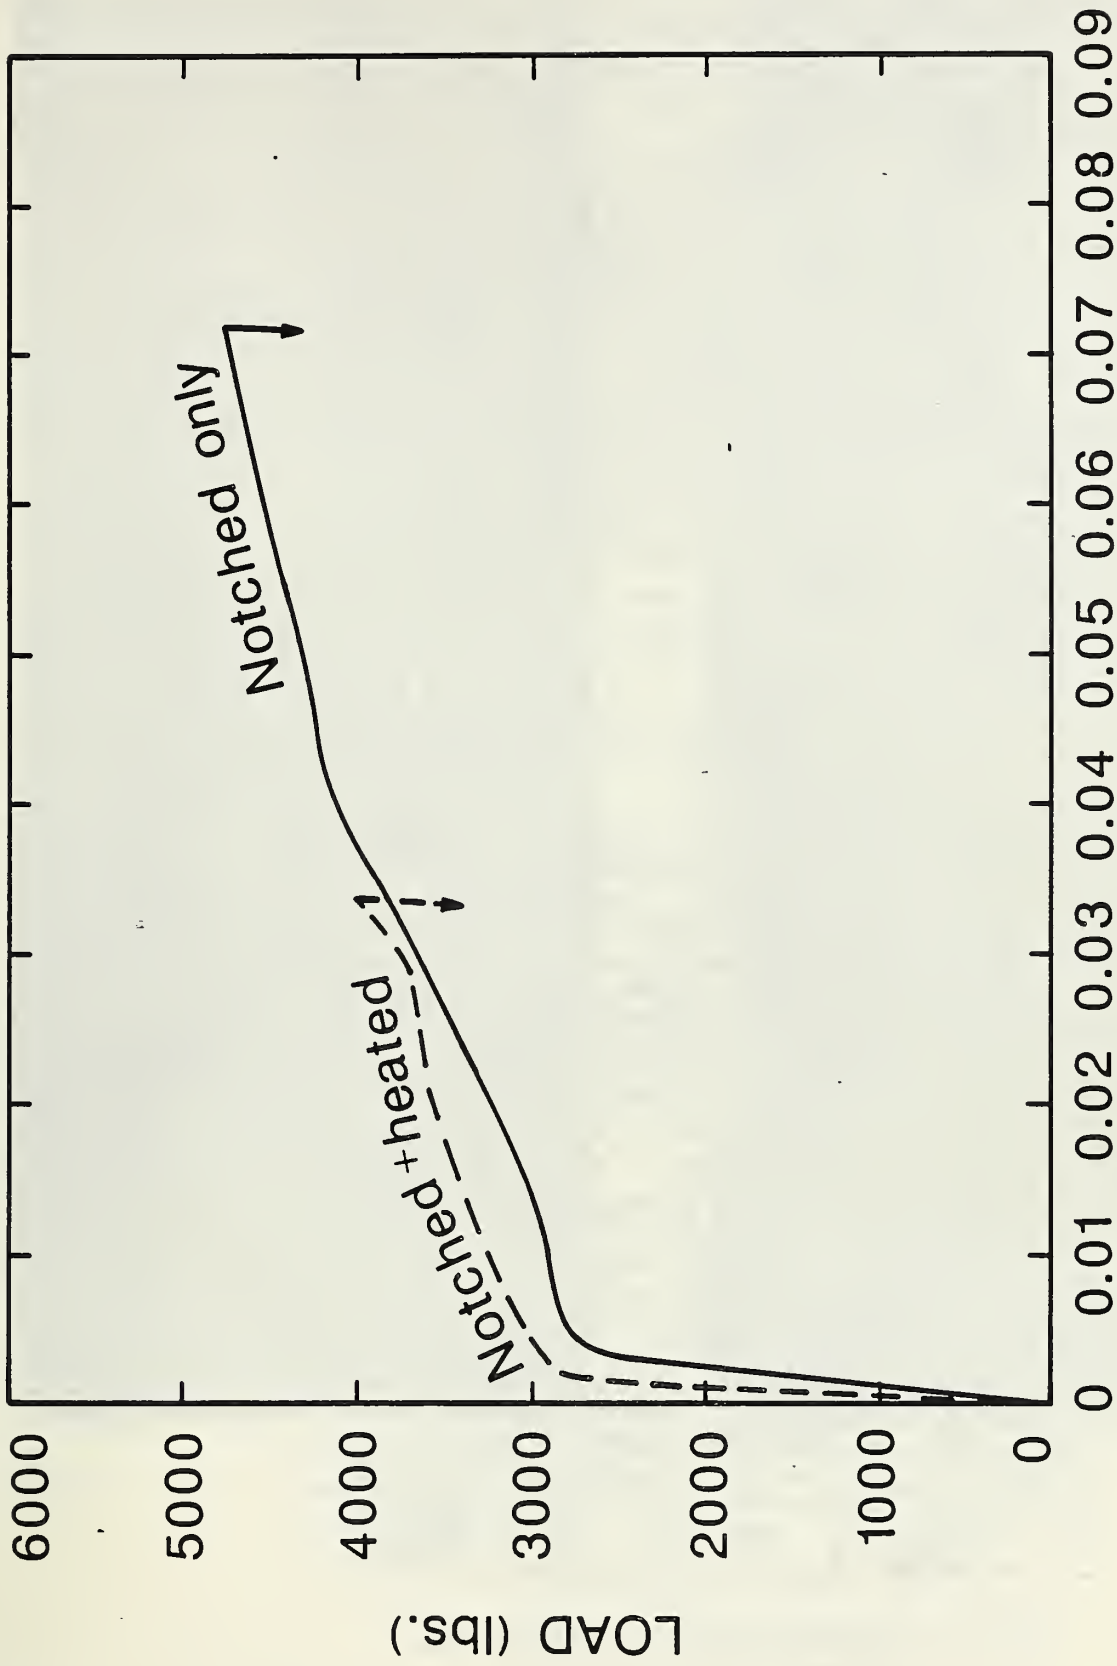
Figure 7.13 - Results of Notched-Bend Test

In this investigation, the effect of the heat-affected zone on the steel is determined from the load/displacement curve. It is seen in Figure 7.13 that the notch mouth-opening displacement at the maximum load (point of fracture initiation) for the heat affected (embrittled) specimen was 0.032-inch compared with a value of 0.072-inch for the notch mouth-opening displacement for the normal steel plate. The area under the load-displacement curve, (Figure 7.13) which can be expressed in terms of energy, can also be taken as a measure of the tendency to fracture. For example, two specimens that were tested at 40° F with just a notch in the base metal had energy values at maximum load equal to 21.4 and 21.7 foot-pounds. A similar specimen tested at 40° F, in which the metal had been embrittled by heating before cutting the notch had an energy at maximum load of 9.0 foot-pounds and a specimen that was heated after cutting the notch had an energy at maximum load of 9.7 foot-pounds. It was found that the energy to initiate fracture in the notched and heat embrittled specimens at 40° F was less than one half the energy to initiate fracture in the steel base metal that had not been embrittled by heating.

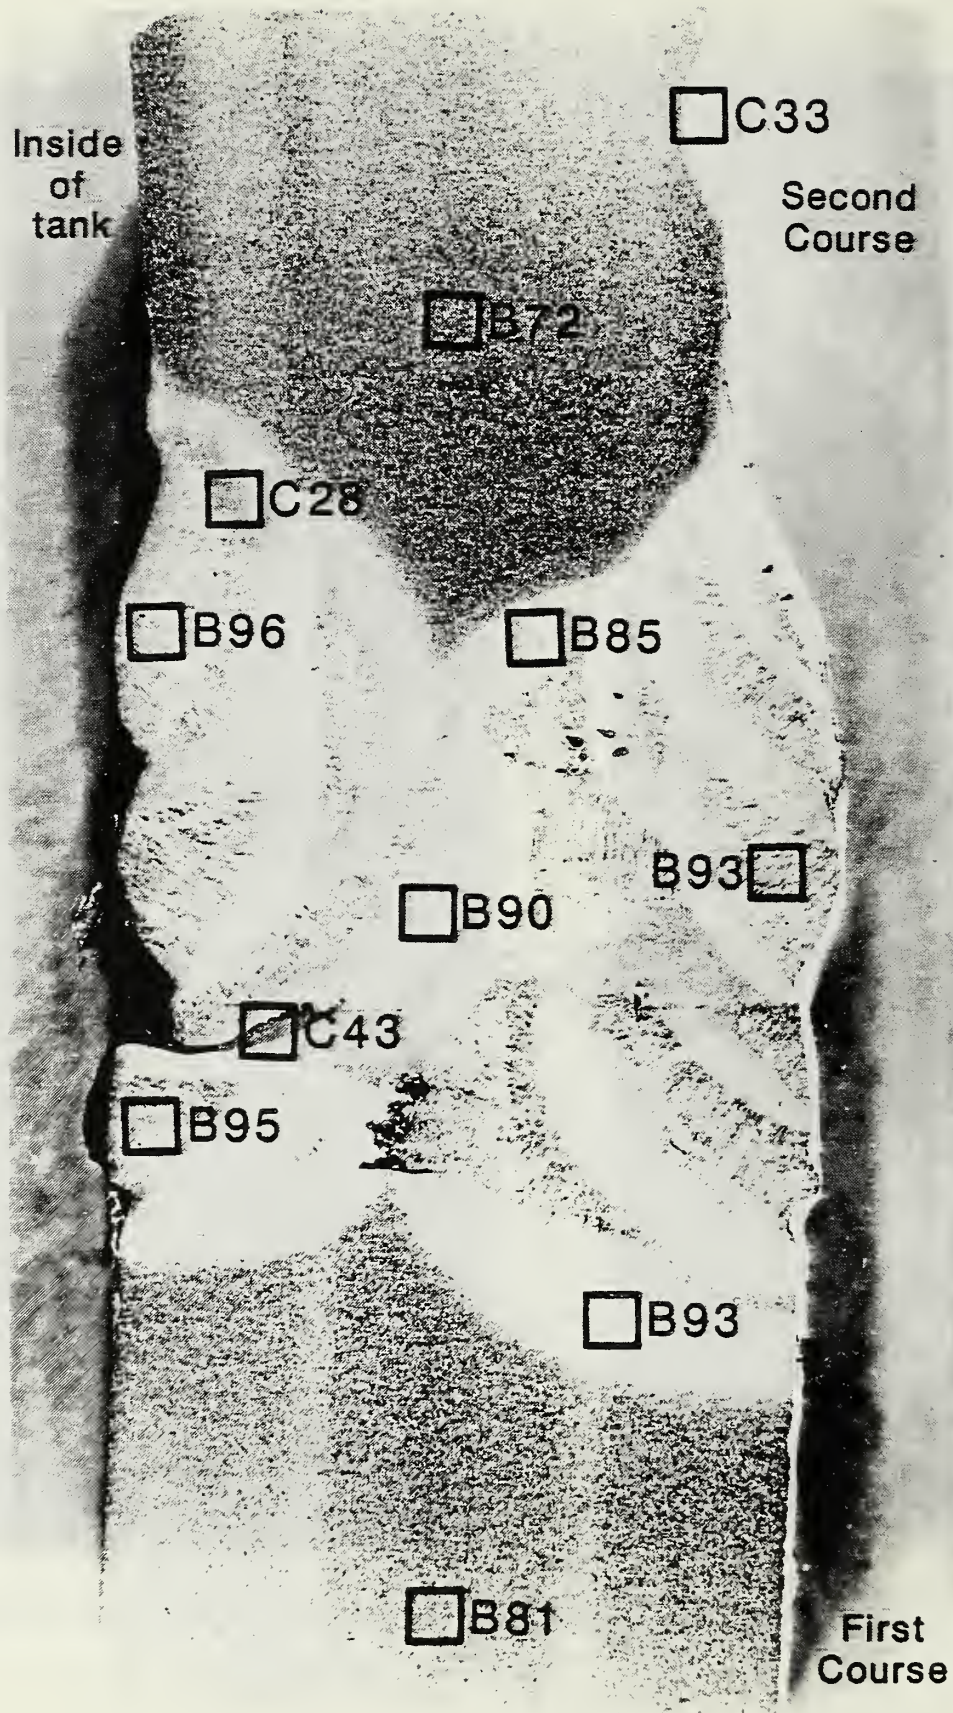
Figure 7.16 - Microstructure and Hardness of Horizontal Weld Metal

Rockwell B and C Scale Hardness Values are given for various Locations.

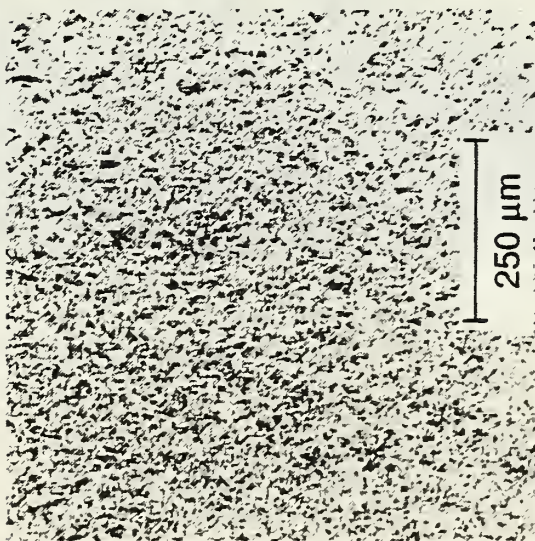
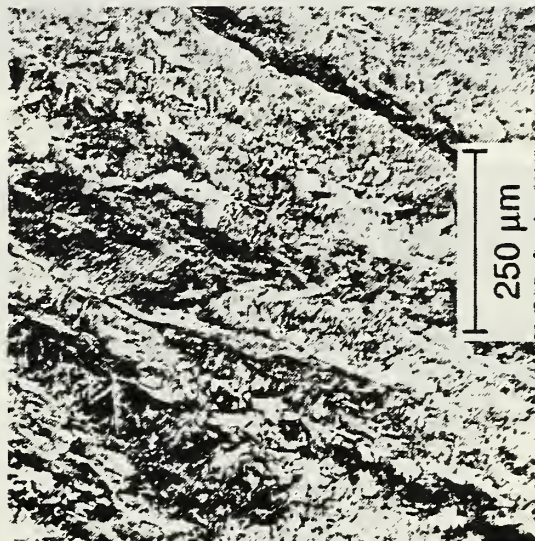
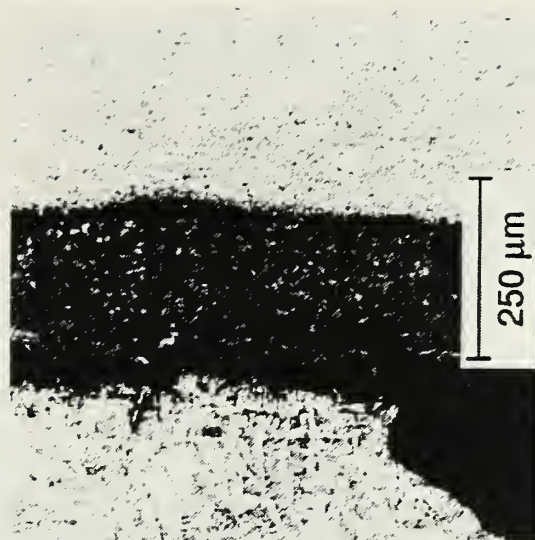
Figure 7.17 - Microstructure of Horizontal Weld Metal

1 - HAZ

2 - Weld Metal

3 - Hard Spot

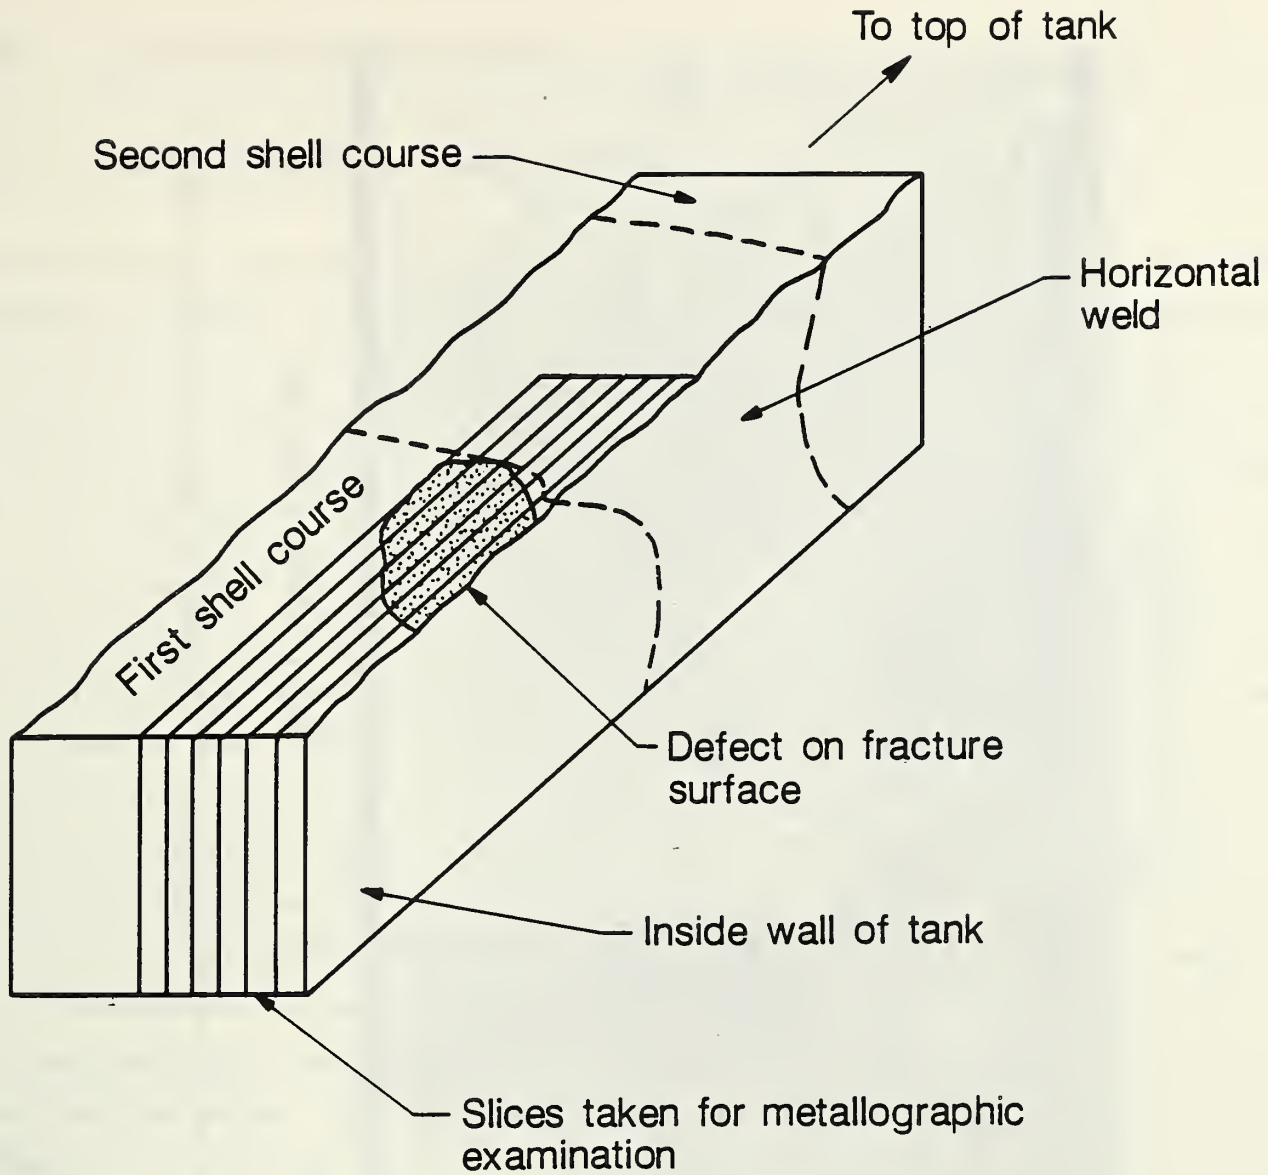
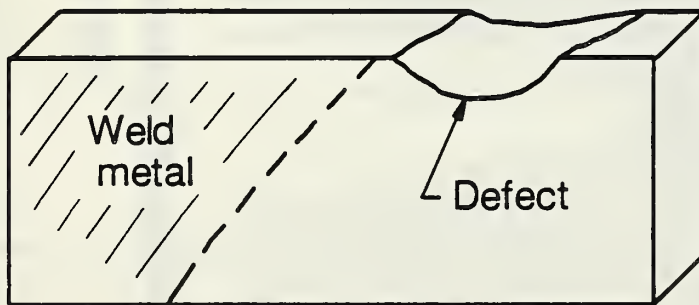
Figure 7.25 - Details of Sectioning to Determine Location of Defect

To determine the exact location of the defect with respect to the new weld metal, old weld metal, and first shell course plate, the sample shown in Figure 7.24 was sectioned as shown in Figure 7.25. The sections were cut using a fine wire electrodischarge machine. Eight specimens were cut at intervals of 0.080 in starting from the inner surface of the tank. These specimens were then examined metallographically to permit a 3-dimensional reconstruction of the defect to be made and to determine the exact location of the defect. An example of one of these sections is shown in Figure 7.26. This figure shows that the defect was located entirely in base metal from the first shell course. The edge of the defect extended just to the edge of the heat affected zone of the old weld metal.

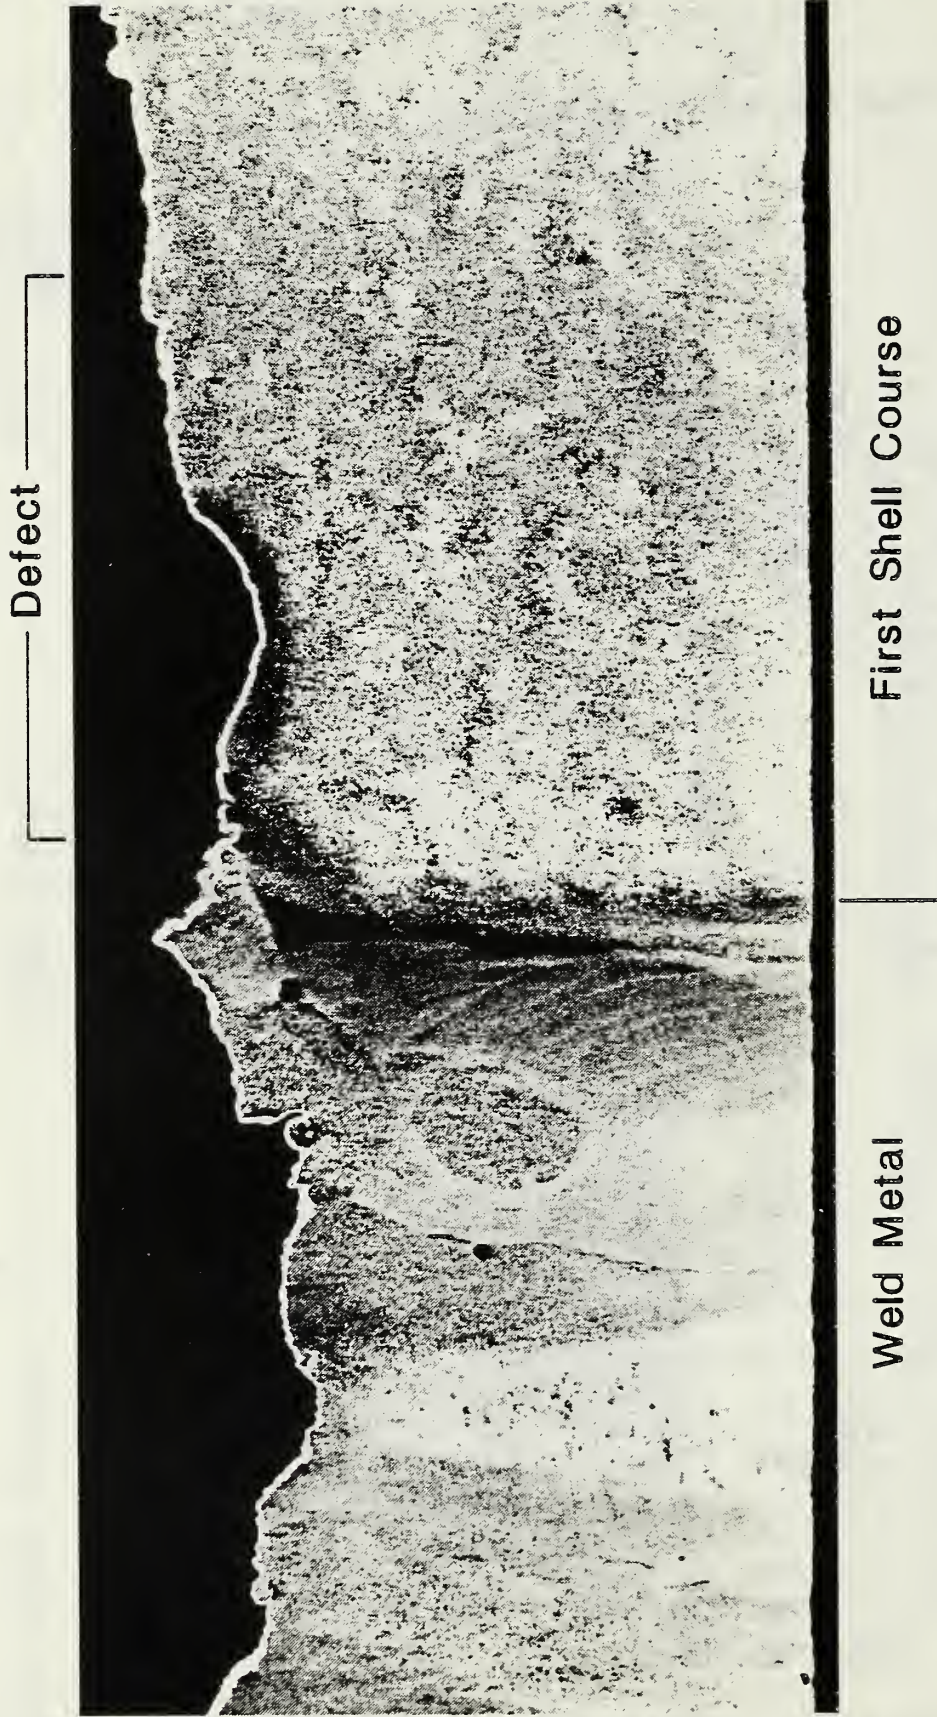
Figure 7.26 - Transverse Section of Fracture Surface Defect Showing Exact Location of Defect

As seen in Figure 7.26, a dark etching region is present surrounding the defect below the fracture surface. This dark etching region is believed to represent a region of heat-affected zone caused by heating of the metal, probably at the time the defect was formed. Hardness measurements made by Battelle showed that this heat-affected zone had a maximum hardness of slightly in excess of 400 Knoop (HKN) (equivalent to a Rockwell hardness of HRC 40) at the edge of the defect and that the hardness decreased with distance below the defect until a hardness of about HRB 85 was reached at a distance of about 0.050 in below the edge of the defect. The hardness of HRB 85 is representative of the hardness of the base metal plate. Chemical analyses using the electron microprobe and secondary electron emission imaging were conducted on the surface of the defect and in the heat-affected zone below the defect. A heavily carburized layer was found near the surface of the defect at the location showing the maximum hardness. Formation of such a carburized layer can only occur from a combination of high temperature and excess carbon in the atmosphere. This is the primary evidence for concluding that the defect was formed by a cutting torch.

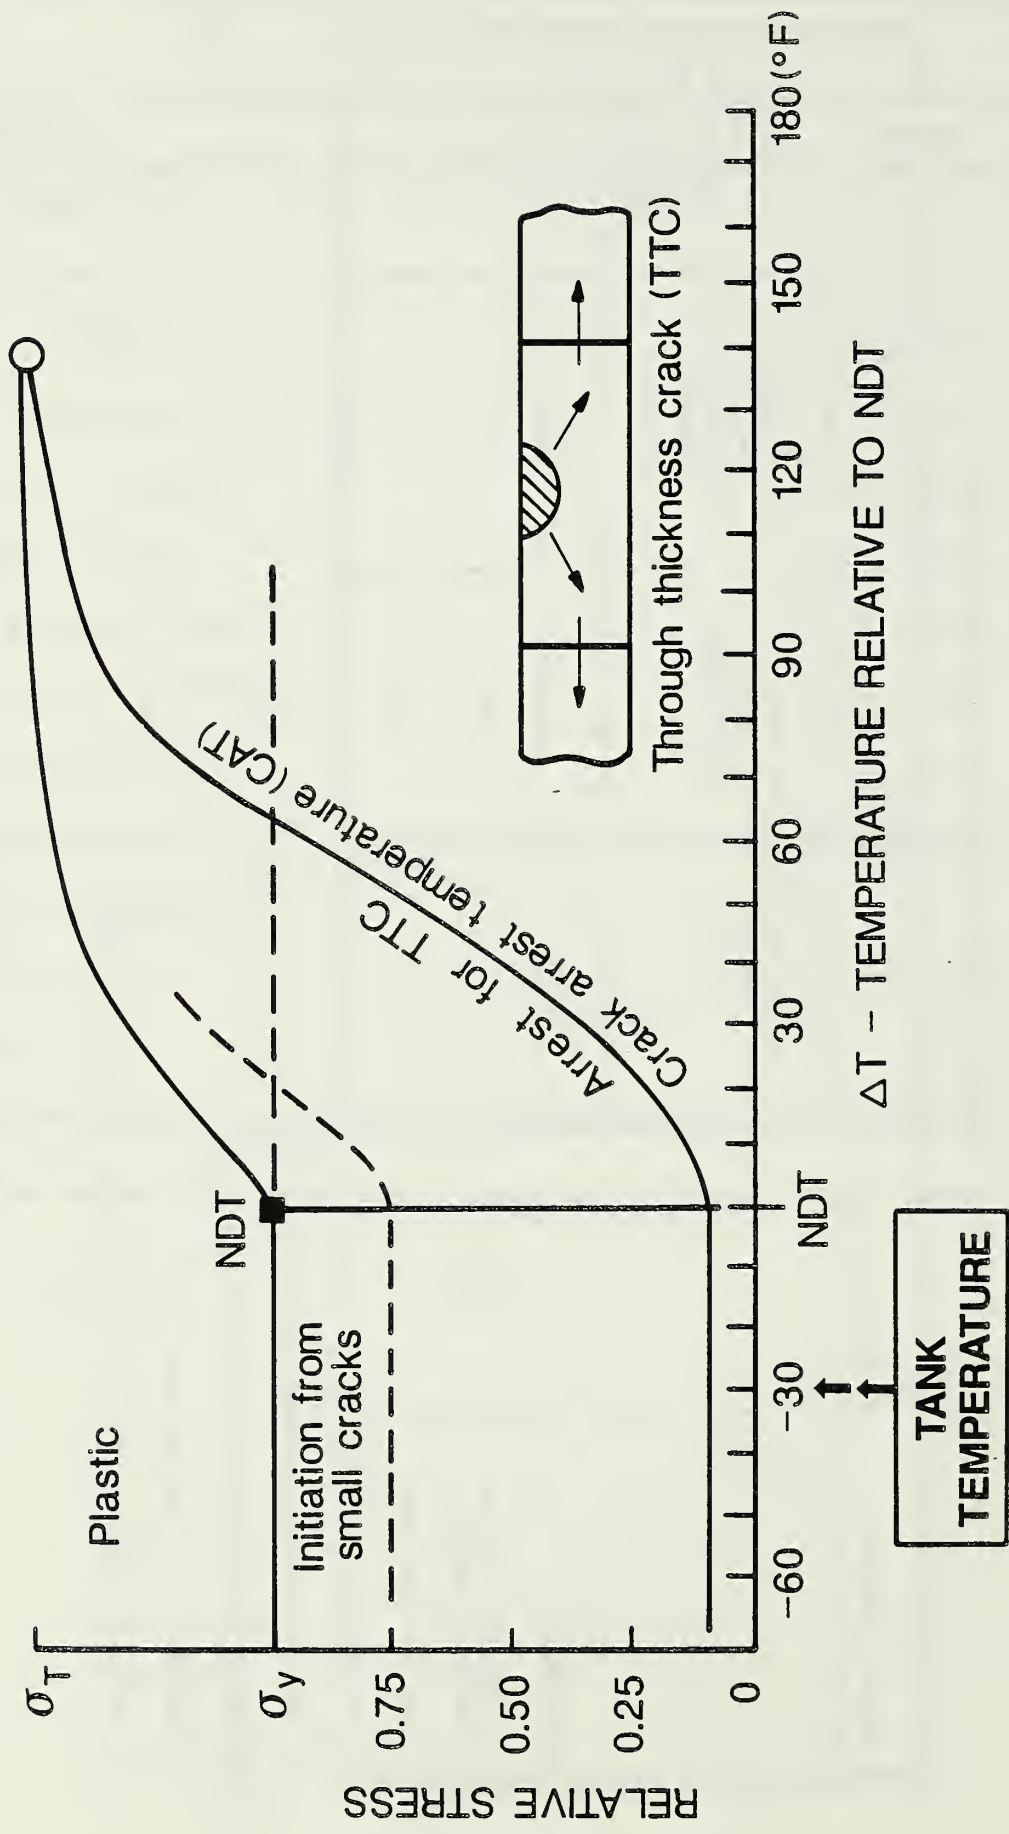
Figure 8.1 - Fracture Analysis Diagram (FAD)

A more exact, but still empirically based, procedure to assess the probability of fracture initiation and arrest is the determination of the drop-weight nil-ductility transition (NDT) temperature. This NDT temperature is used in conjunction with the generic Fracture Analysis Diagram (FAD), shown in Figure 8.1, to make an assessment of the probability of fracture initiation and arrest [8.4]. The Fracture Analysis Diagram provides a generalized description of the relationships between the crack size, relative stress, and operating temperature relative to the NDT. At temperatures below the NDT, the Fracture Analysis Diagram predicts that fracture will initiate from small defects (typically less than 1-inch in length) at stress levels below the yield strength of the steel and that the fracture will be brittle in nature. As seen in Table 7.8, the NDT for the first and second shell course steel plates was 20° F to 40° F above the operating temperature of the tank at the time of the failure. Based on the measured NDT and the Fracture Analysis Diagram, fracture initiation is predicted to be likely to occur in this tank at the operating temperature of 32° F.

The NDT temperature also can be used to make a qualitative assessment of the probability of fracture propagation or arrest once fracture has been initiated. A crack arrest temperature (CAT) curve is defined by the Fracture Analysis Diagram and shows that fracture propagation is expected to occur at and below the NDT temperature even when the stress levels present are very low (<10 per cent of the yield strength). Fracture propagation is predicted at stress levels of approximately one half the yield strength level at temperatures about 30° F above the NDT temperature. Fracture arrest is not expected at stress levels equal to the yield strength of the steel until a temperature of approximately 50° F above the NDT temperature is reached.

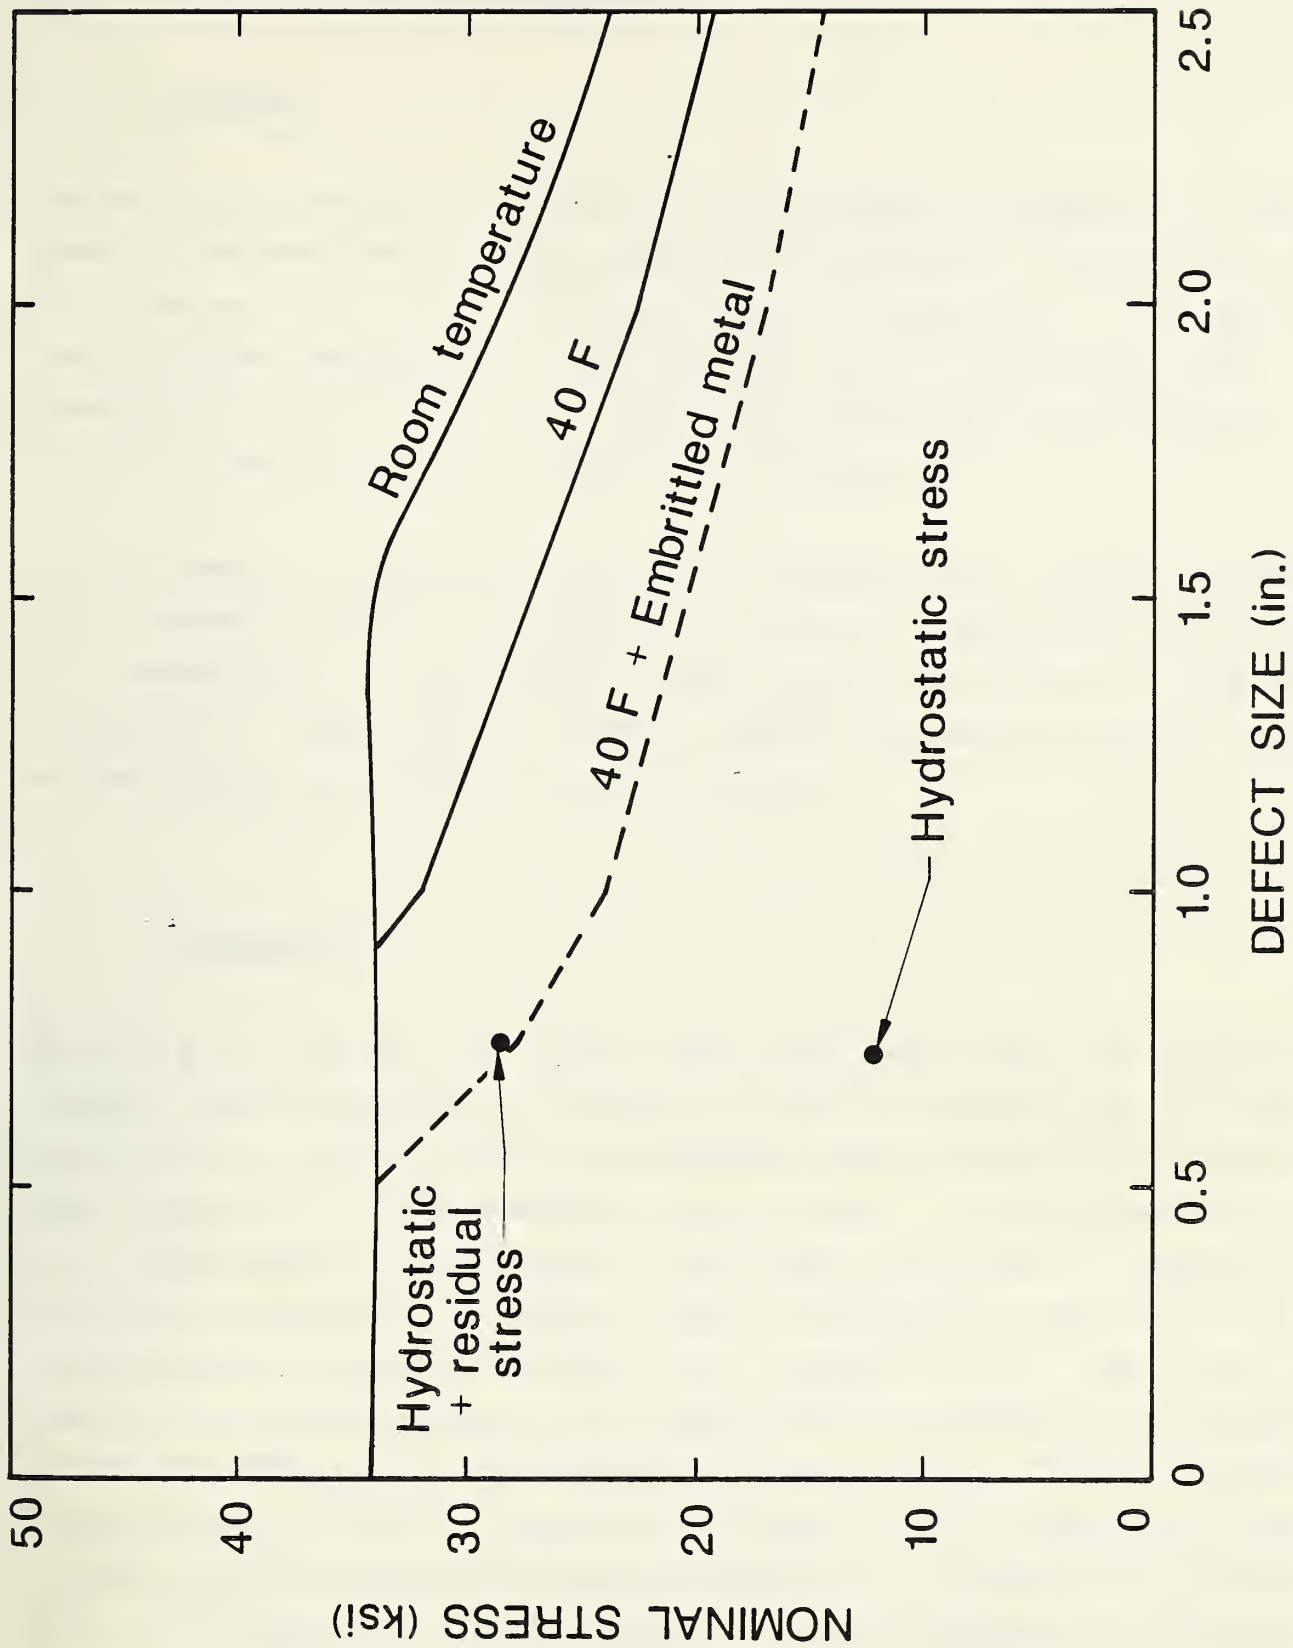
Figure 8.2 - Calculated Stress - Defect Size Relationship for Through-Wall Defect

For all cases considered in the fracture analysis, the calculated applied stress intensity for the defect identified as the fracture origin was substantially below the stress intensity required to initiate fracture and cause rupture of the tank. This can readily be shown by the stress-flaw size curve shown in Figure 8.2. For the measured toughness (47.7 ksi√in) the

relationship between the nominal applied stress and the length of a through-thickness defect is calculated. Combinations of nominal stress and defect size that lie above the line shown in Figure 8.1 are predicted to cause fracture initiation and any combination of defect size and nominal stress that lies below the curve is not expected to result in fracture initiation. As can be seen from the points plotted in Figure 8.1, fracture is not expected to be initiated from a through-thickness defect of the length of the defect found on the fracture surface (0.742 inch.) even if the stresses in the vicinity of the defect are equal to the yield strength of the steel plates. Therefore, additional causes must be identified to determine why the tank ruptured. For the fracture analysis to predict rupture of the tank, either the defect must be significantly larger than the size identified on the fracture surface or the fracture toughness of the steel plate must be lower than that measured in this investigation.
