NBSIR 88-3820

July 1988

**COLLAPSE OF MASONRY WALL UNDER
CONSTRUCTION IN PAWTUCKET, RI,
OCTOBER 28, 1985**

Felix Y. Yokel

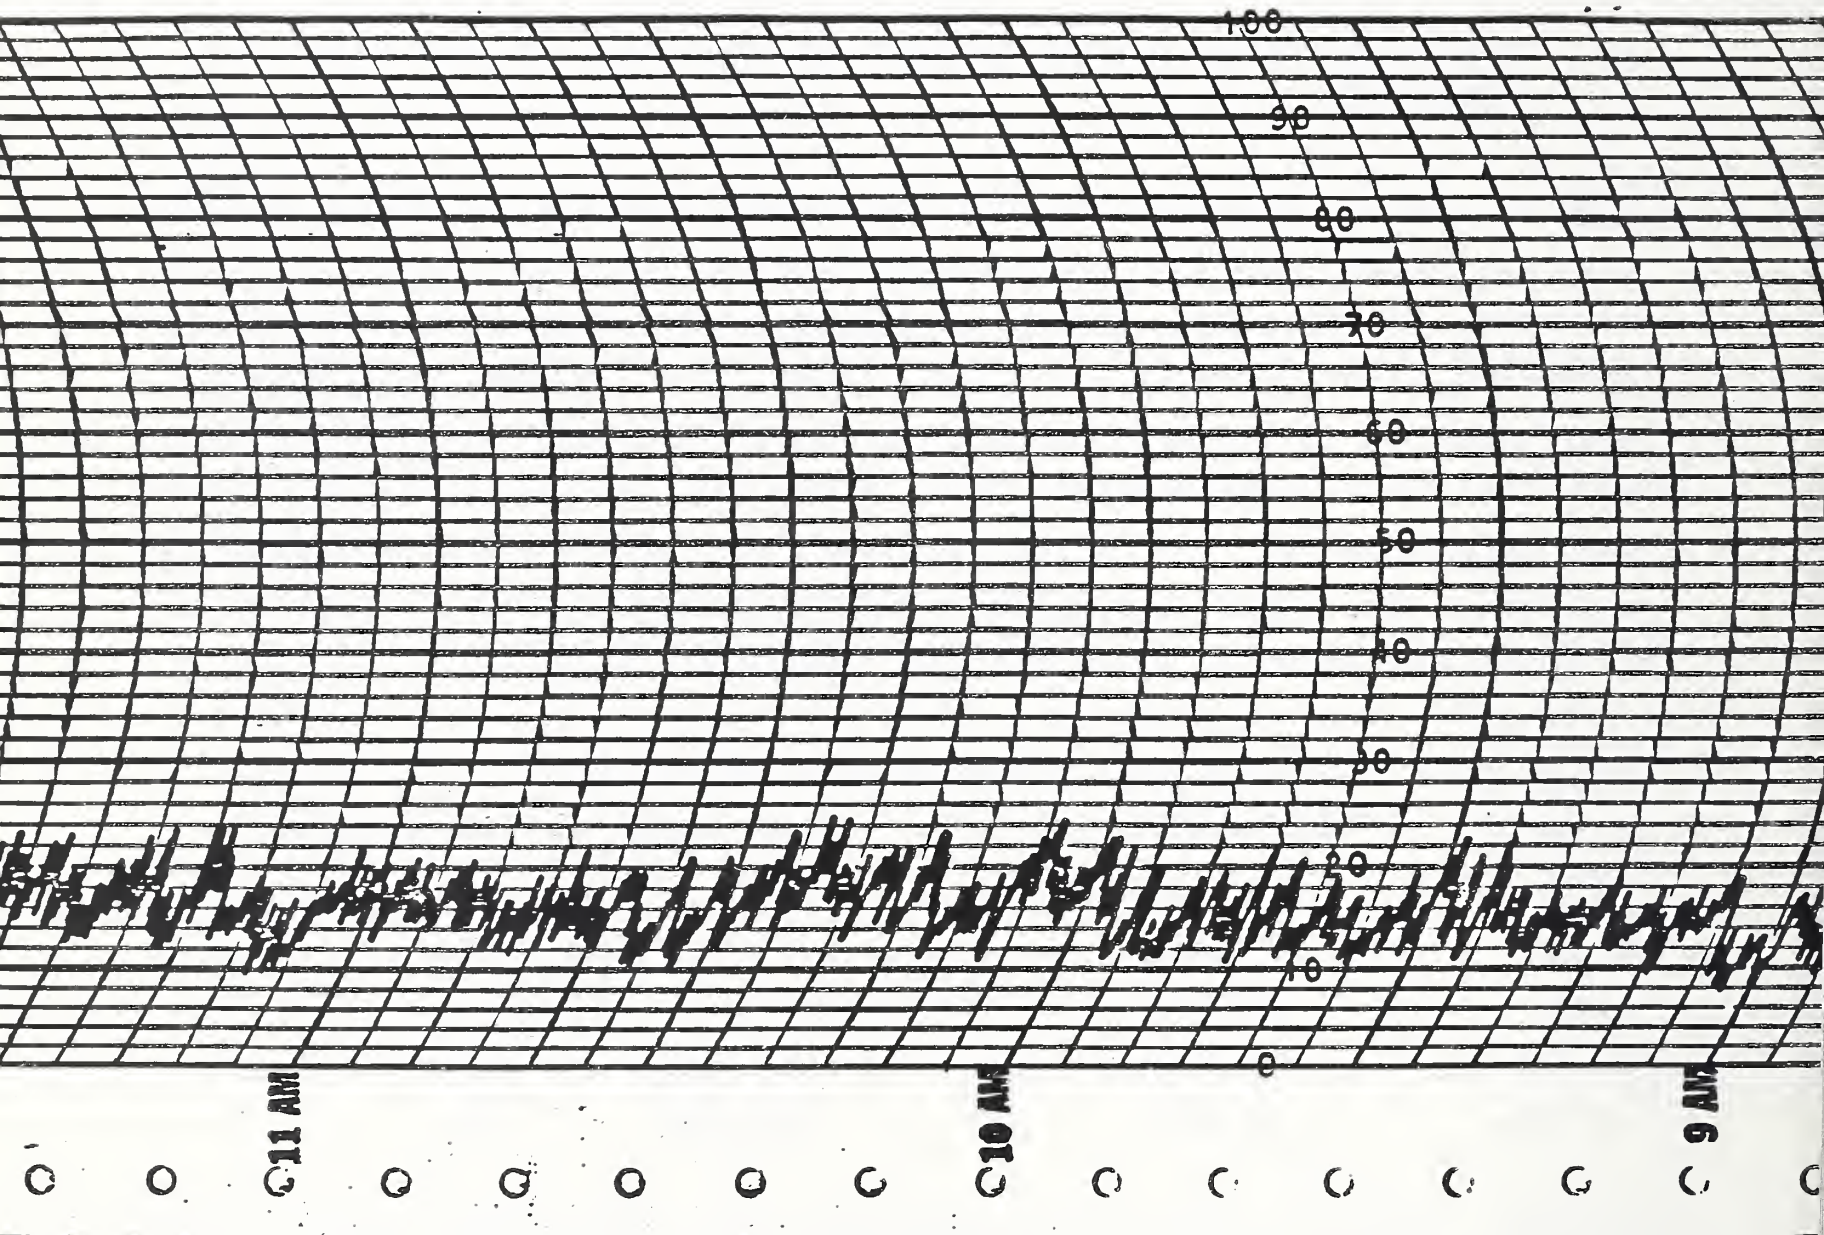
Figure 2 shows a stripchart recording of wind speeds taken at the same NWS station. The wind speed in the chart is recorded in knots (1 knot = 1.151 mph). Note that the wind speed increased somewhat between 9:55 AM LST and 10:30 LST. At the accident site, this increase in wind speed probably occurred somewhat earlier, since the wind came from a northerly direction. From an

Figure 2. Stripchart Recording of Wind Speeds in Knots, Taken on August 28, 1985 at an Elevation of 20 ft. Above Ground at the NWS Station at the Warwick RI Airport.

examination of the recording, the fastest mile wind speed is estimated to have been 20 knots or approximately 23 mph.

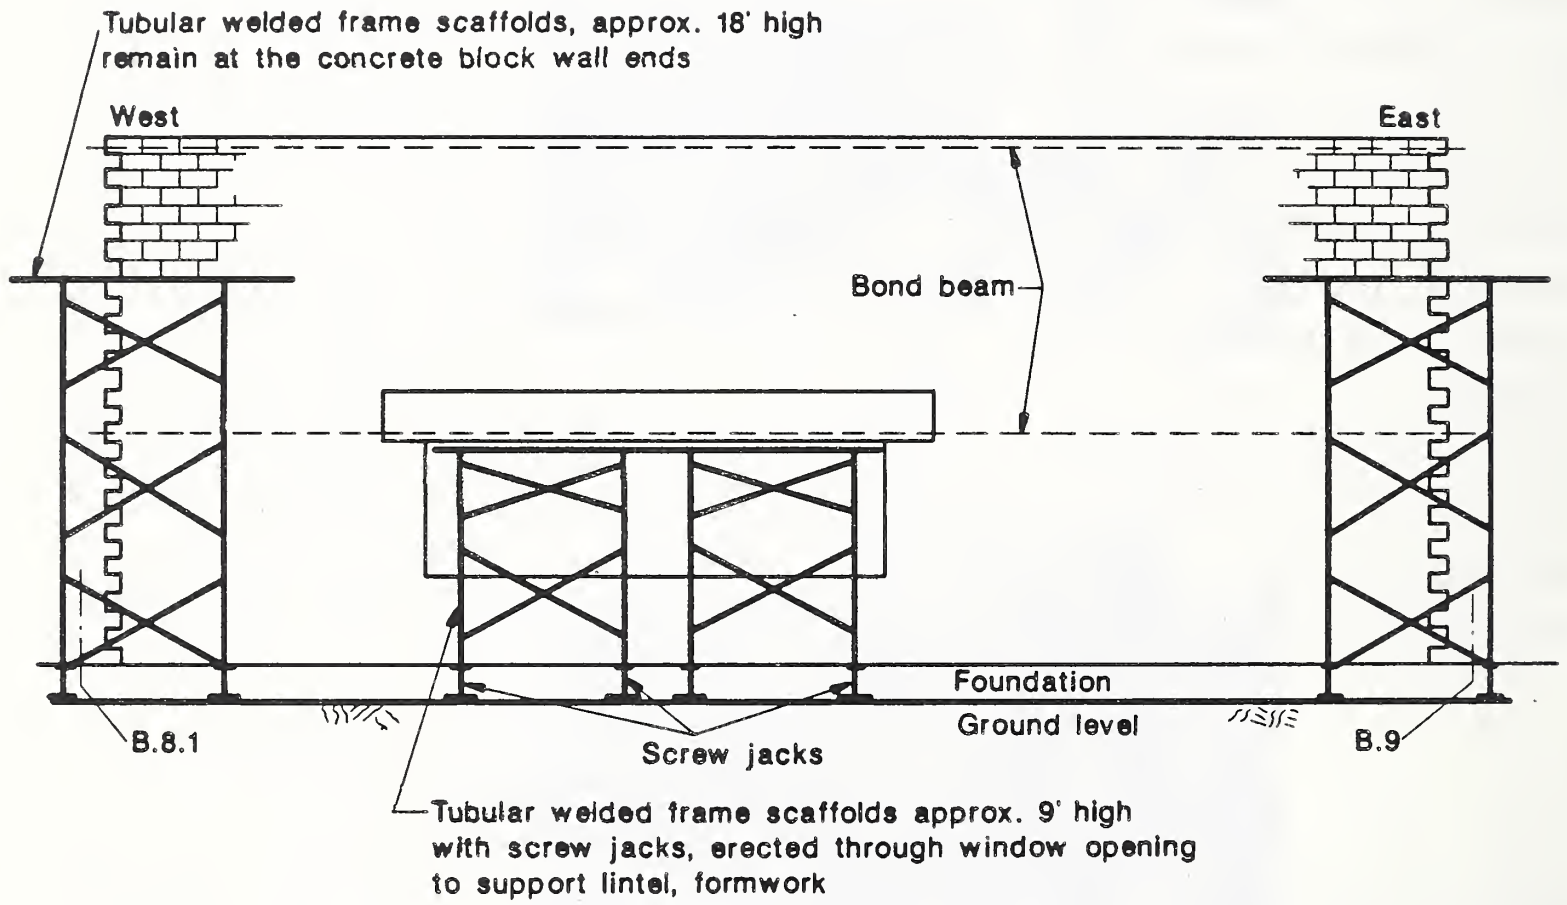
Evidence from photographs and reports by OSHA inspectors from the collapse site indicates that in addition to the braces described above there were scaffolds adjacent to the wall. These consisted of scaffolds under the window opening and scaffolds on the leeward side at the two ends of the wall. The scaffolds under the window opening were originally used to provide support to the concrete forms for the lintel. The scaffolds were adjusted by screw jacks at the bottom. After the lintel was poured, the screw jacks were relaxed to remove the forms. Evidence provided by the OSHA inspectors indicates that after removal of the forms these screw jacks were tightened lightly, but no upward thrust was exerted against the wall. The scaffolds at the two ends of the wall were left in place for future use to finish the connection of the ends of the wall to the columns which were to be erected at both ends of the wall. These scaffolds did not bear against the wall. The remains of the scaffold that supported the lintel form are shown in figure 9(a). Figure 9(b) shows a scaffold recovered from the wall (on side) and an undamaged scaffold. The probable position and configuration of the scaffolds prior to the collapse is shown in figures 10 and 11. There is no indication that these scaffolds could provide significant lateral support to the wall.

Figure 10: Front View of Scaffolds Looking From South.

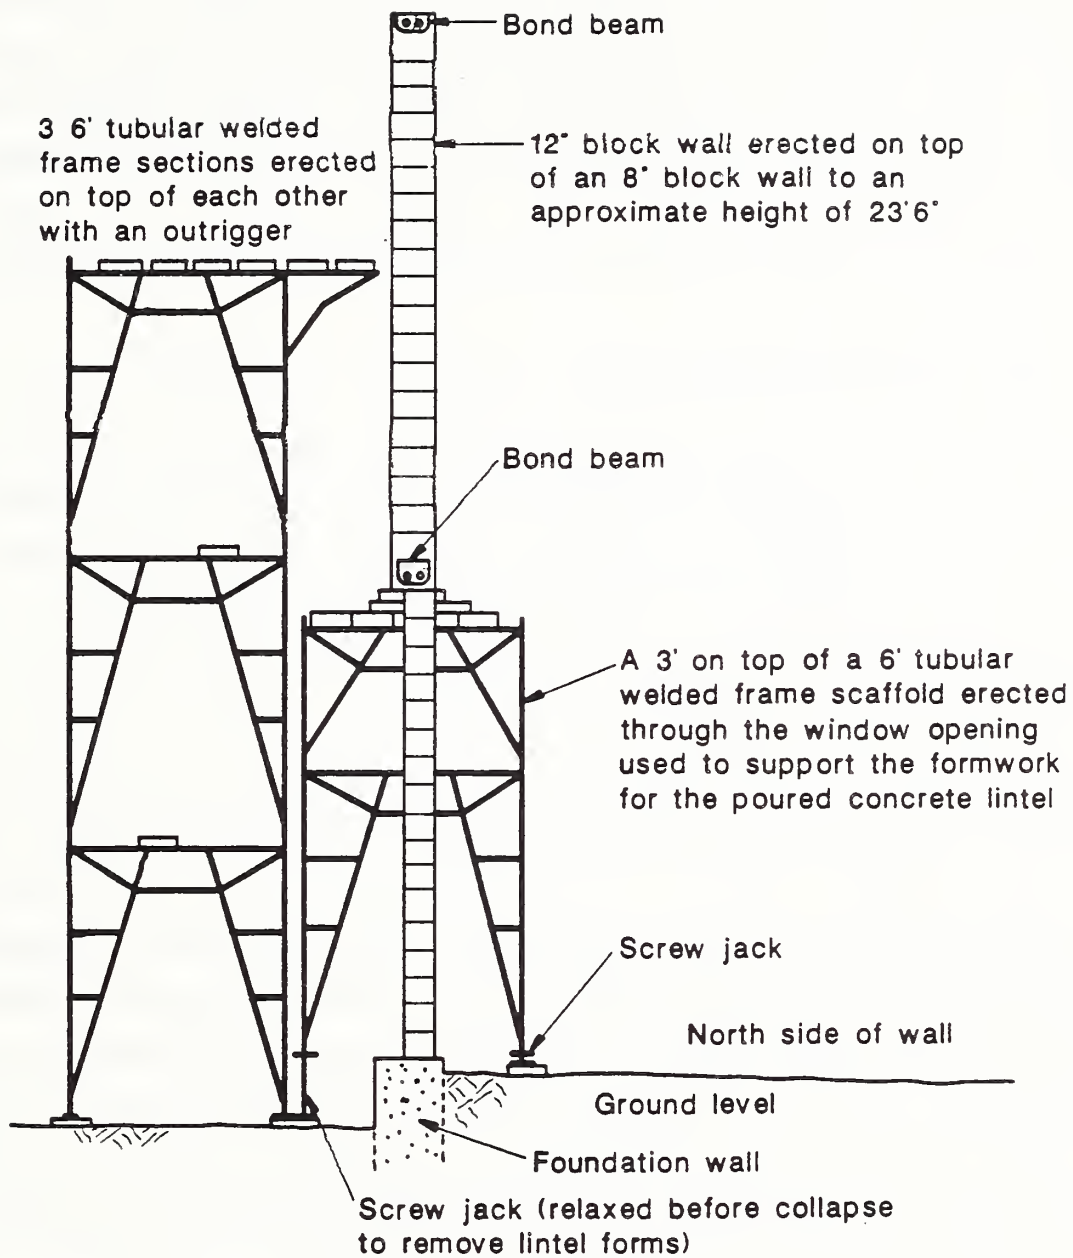
Figure 11. Side View of Position of Scaffolds
