NISTIR 4972

Observations From a Field Study of the Performance of Polymer-Modified Bitumen Roofing

Walter J. Rossiter, Jr.
Randy D. Denchfield*

Building and Fire Research Laboratory
Gaithersburg, Maryland 20899

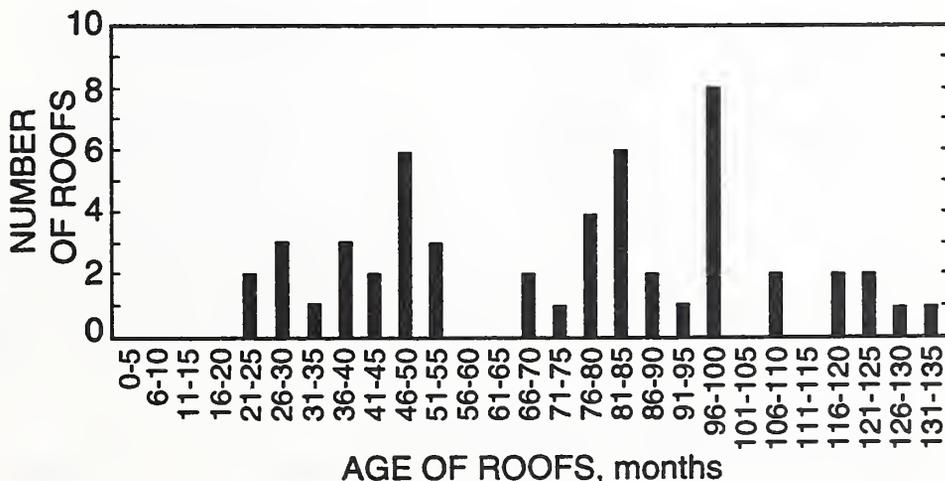
The type of modified bitumen was equally split between APP and SBS. Re-roofing predominated the type of construction, although this was divided somewhat evenly between tear-off and re-covering (i.e., without tear-off). In the latter case, all re-covered membranes were the conventional built-up bituminous type. The ages of the roofs varied from 24 to 131 months. Fig. 1 is a frequency plot (in 5-month increments) of the roof ages. All roofs were considered relatively young, which reflected the fact that modified bitumen roofing in the United States was quite limited a decade ago. As evident in Fig. 1, about 40 percent of the roofs were less than five years old, which is quite young for a roof.

Figure 1. Number and age of the roofs inspected
