NISTIR 5353

Source of Phenol Emissions Affecting the Indoor Air of an Office Building

February 1994 Building and Fire Research Laboratory National Institute of Standards and Technology Gaithersburg, MD 20899

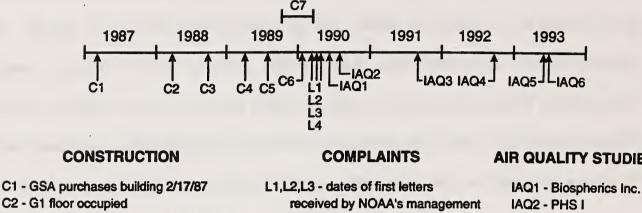
- C3 floors 5 through 9 occupied 10/28/88 C4 - excessive feflections in 4th floor slab
- noted 3/25/89
- C5 structural loading of 4th floor 7/7-10/89
- C6 2nd through 4th floors occupied 1/15/90
- C7 epoxy-based leveling compound installed 10/89 - 1/90
- complaining about poor IAQ 1/30/90 - 2/16/90 L4 - petition signed by occupants
 - of 3rd floor complaining about poor IAQ - 2/21/90

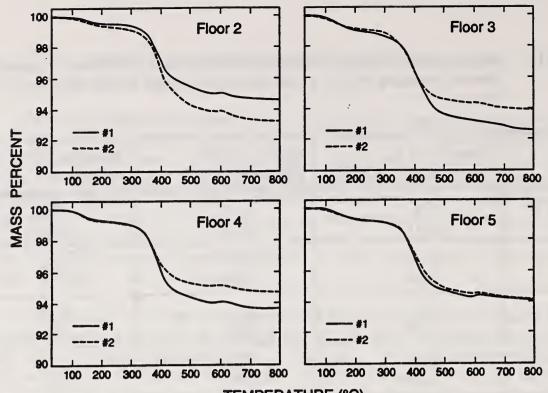
materials. (Refer to Table 5 and Appendix A for data on the other samples taken from Floors 2 through 5). At temperatures between 200° C and 800° C, the epoxy binder undergoes thermal degradation causing the epoxy resin to break down into small molecular units by pyrolysis or oxidation which are volatilized along with the high boiling organic compounds, like amines. From the TG curve, the epoxy binder comprised approximately 5.7 % of the total mass of the leveling material (Figure 3). The remaining 0.8 % of the volatile material (100 % - 93.5 % - 5.7 % = 0.8 %) was volatilized between room temperature and 200° C. This would include volatile organic compounds like phenol which might contribute to the indoor air quality complaints in SSMC-1. Of this 0.8 %, between 0.1 and 0.2 % was water².

Figure A1. Thermogravimetric curves heated to 800 °C for composite samples made from core samples taken from Floors 2 through 5.

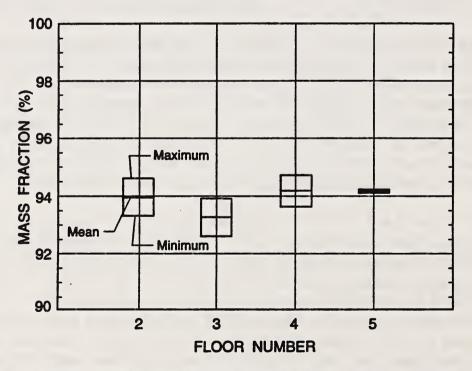
Figure A2. Box-and-whisker diagram for mass fraction of low volatile organic material volatilizing between 200 and 800 °C from the composite samples made from core samples taken from floors 2 through 5.

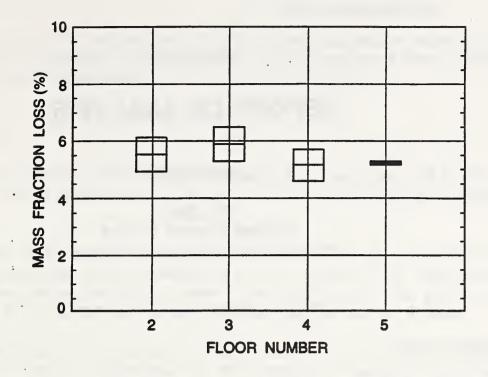
Figure A3. Box-and-whisker diagram for mass fraction of low volatile organic material volatilizing between 200 and 800 °C from composite sample made from cores taken from Floors 2 through 5.

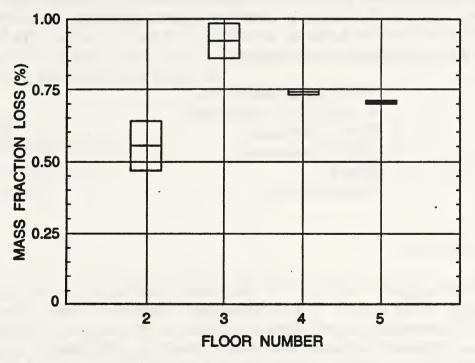
Figure A4. Box-and-whisker diagram for the mass fraction of volatile organic materials volatilizing between room temperature and 200 °C for composite samples made from core samples taken from Floors 2 through 5.

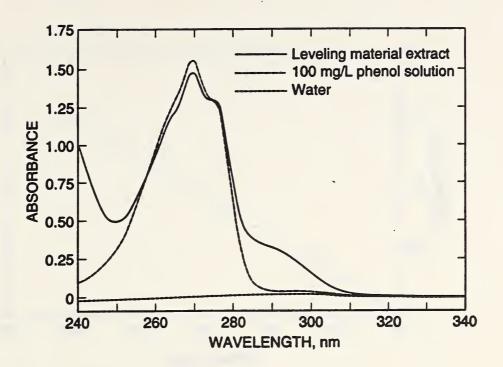
Figure D1. UV-spectra of water, a 100 mg/L aqueous phenol solution, and the Soxhlet water extract from the floor leveling material.
