1994 Northridge Earthquake

Performance of Structures, Lifelines and Fire Protection Systems

NISTIR 5396

March 1994
Building and Fire Research Laboratory
National Institute of Standards and Technology
Gaithersburg, MD 20899

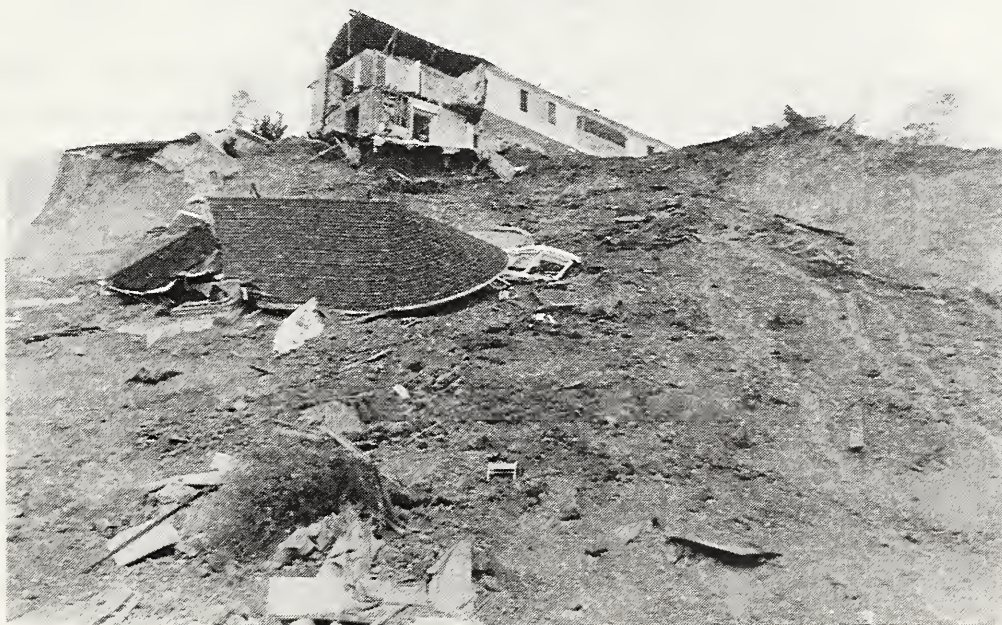
Figure 2.8 A landslide along the Pacific Coast Highway north of Santa Monica undermined the foundation of a house at the crest of the slope, bringing a portion of the house down.

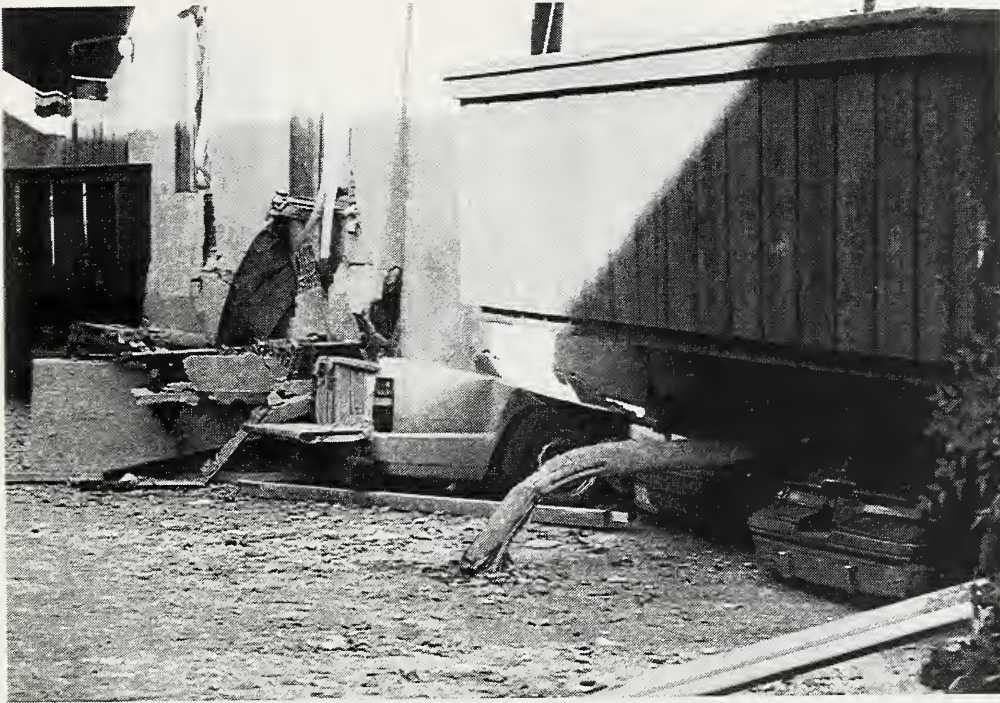
The upper stories of the collapsed buildings were displaced laterally and in some cases came to rest offset by as much as three meters from their original locations. The steel pipe columns, which hinged at their bases, apparently controlled the distance of the offset as they bent to the ground under the load of the building above (Figure 3.6). Collapses occurred in buildings aligned longitudinally east-west as well as those aligned north-south. At the southeast end of the complex, some building portions collapsed to the north, and other portions collapsed to the south, which indicates that no one extreme pulse of energy brought all the buildings down.

Figure 3.6 At Northridge Meadows, the first story steel pipe columns generally hinged near their bases but retained their length, controlling the displacement of the upper stories.

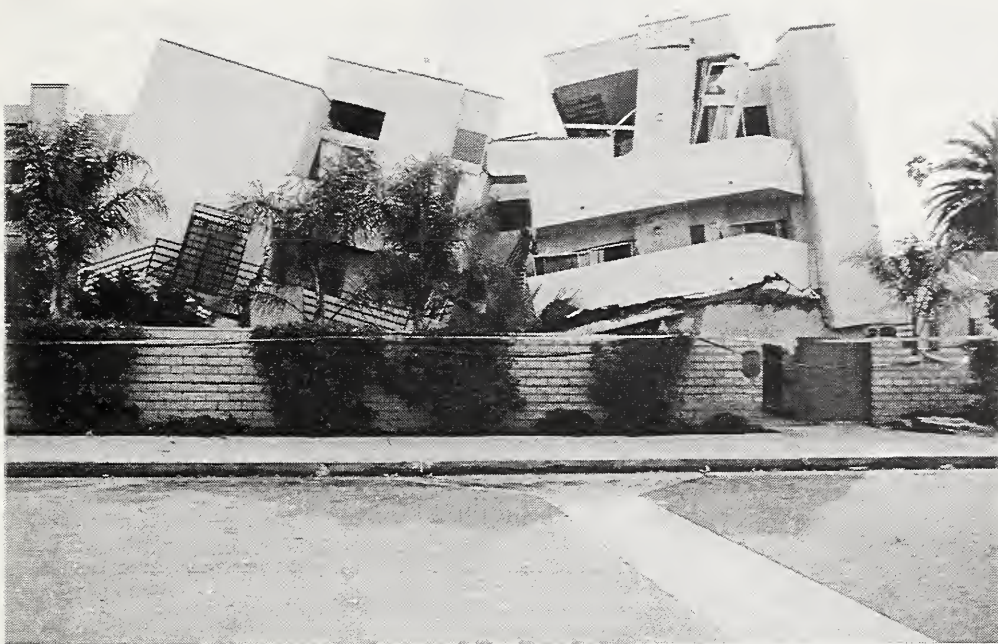
A more unusual collapse occurred in an apartment building of more recent vintage with the entire first story used for parking, located on Sherman Way in Sepulveda. In this building, the first story parking area was open only on the transverse ends. Concrete block walls formed the longitudinal walls at the first story and a row of concrete columns supported the mid-span of the flat plate concrete floor slab above. The two stories of living space over the parking level were wood-framed with a stucco facade. The entire line of mid-span concrete columns failed. The two halves of the upper stories settled in towards the middle (Figures 3.10 and 3.11), essentially destroying the structure.

Figure 3.10 The central row of concrete first-story columns in a three story apartment building on Sherman Way in Sepulveda collapsed, causing the wood-framed upper stories to settle inward.

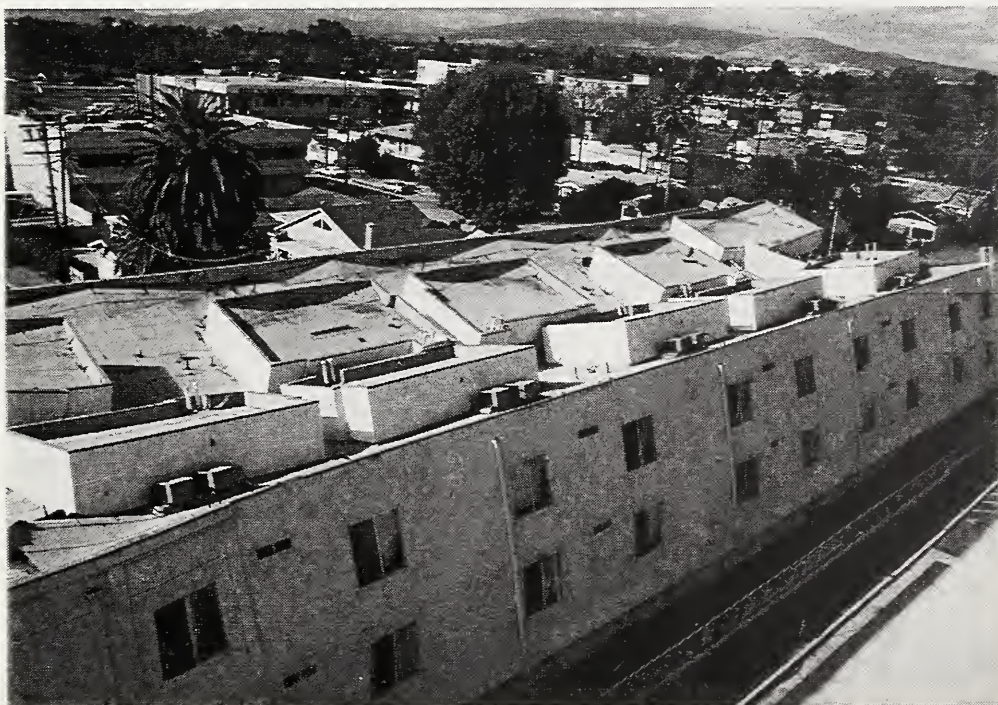
Figure 3.11 This overhead view of the partially-collapsed apartment building on Sherman Way shows the solid concrete masonry block perimeter walls along the longitudinal axis of the building. Access to the first story parking was limited to the transverse ends of the building. When the row of interior columns failed, both sides of the building settled in towards the middle.

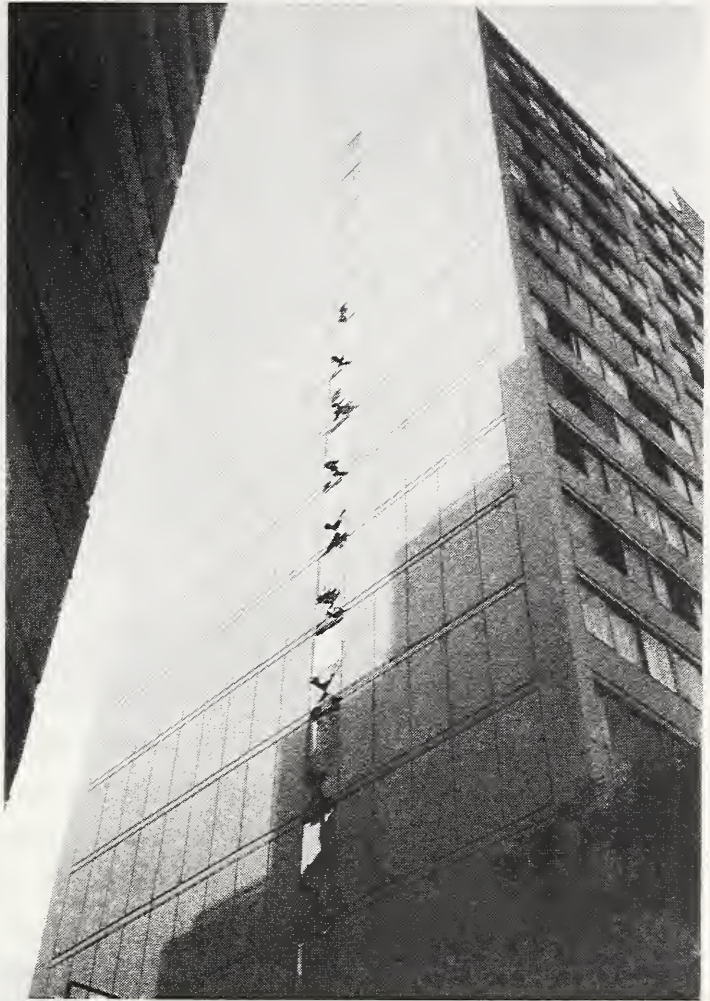
The transverse end walls are pierced by a single vertical row of window openings. The wall segments between the windows act as coupling beams linking the wall segments on either side. These coupling beams suffered serious diagonal cracking, increasing in severity from top to bottom of the building (Figure 3.12).

Figure 3.12 Champagne Towers apartment building in Santa Monica suffered a classic form of earthquake damage: shear failure of the coupling beams between linked shear walls at the transverse end of the building.

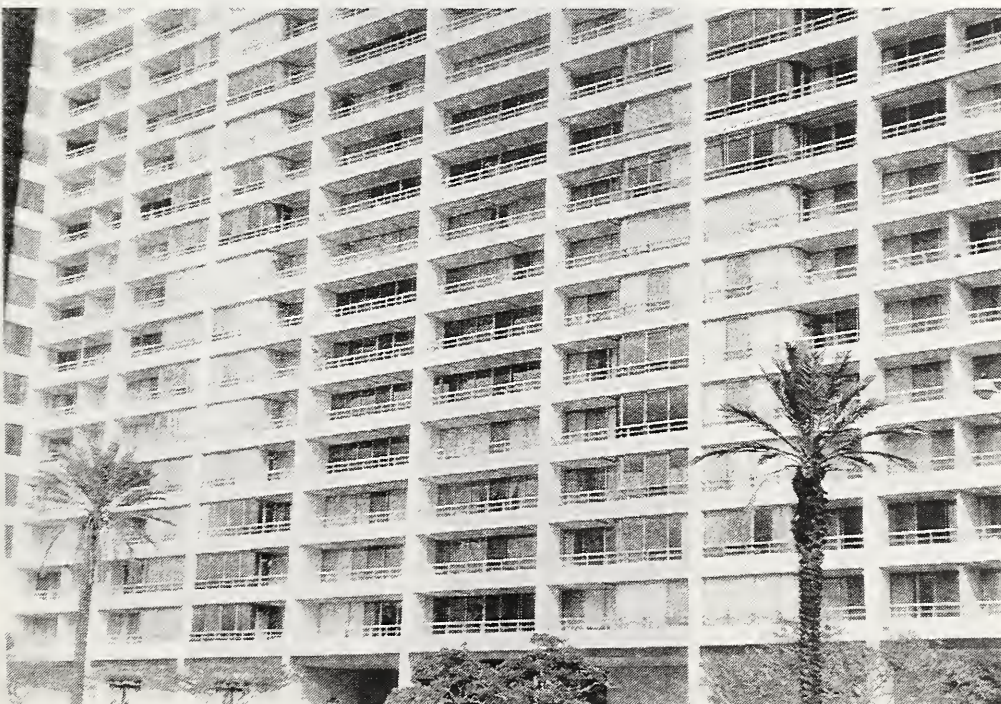
Figure 3.13 The front of the 16-story Champagne Towers building had no apparent damage. Note the steel pipe railings at the balconies.

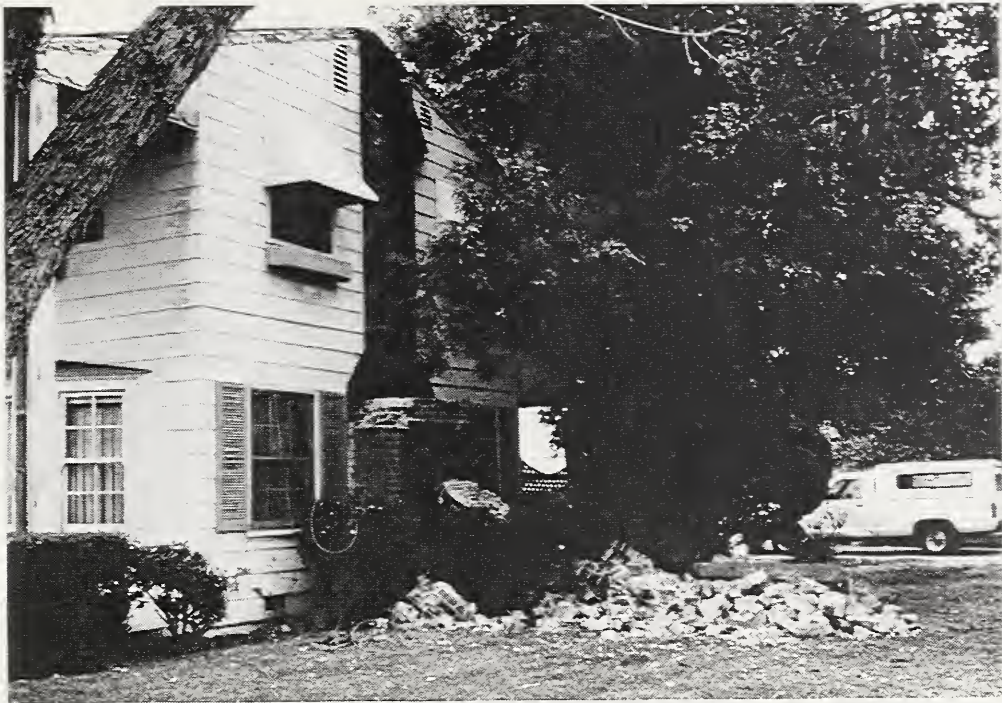
The most common and easily visible damage to single family homes was damaged and collapsed masonry chimneys (Figure 3.17). In some cases, the chimney fell onto and through the roof. Cracked stucco, fallen roof tiles, and racked garage door openings were visible throughout the affected area. Some houses shifted on their foundations. In the epicentral area, damage to concrete masonry fences at the edges of lots was almost universal (Figure 3.18). Piles of debris outside many homes attested to widespread interior nonstructural and contents damage.

Figure 3.17 Failure of masonry chimneys was common.

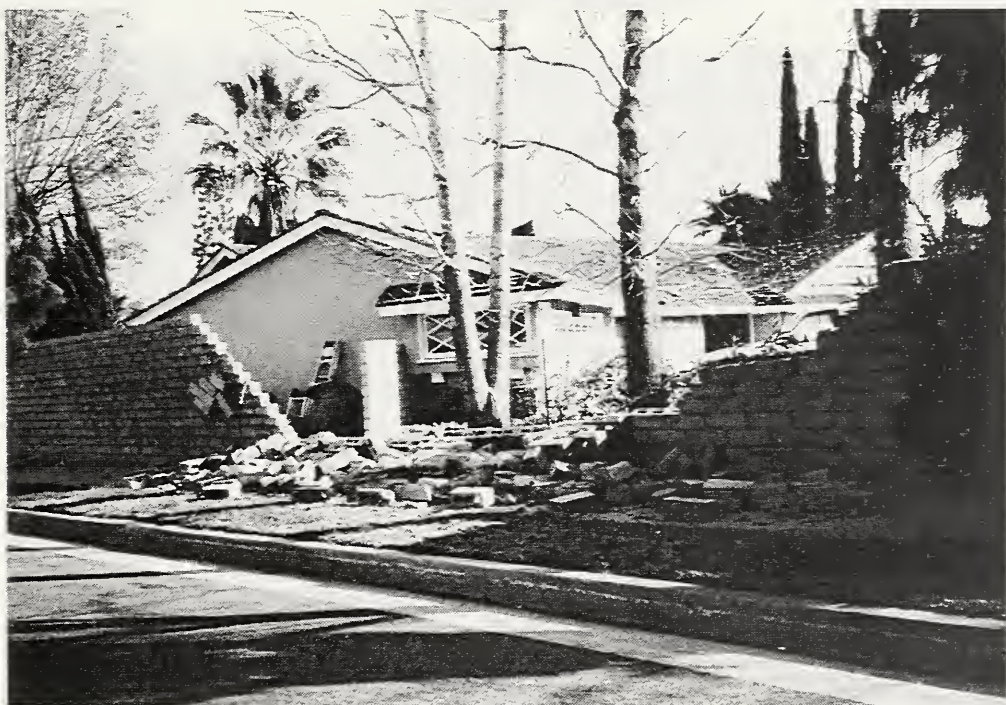
Figure 3.18 Damage to masonry privacy fences was ubiquitous. Many of these fences were tall enough to have been a serious threat to passersby when they failed. Luckily, due to the early morning hour of the quake, yards and sidewalks were essentially deserted.

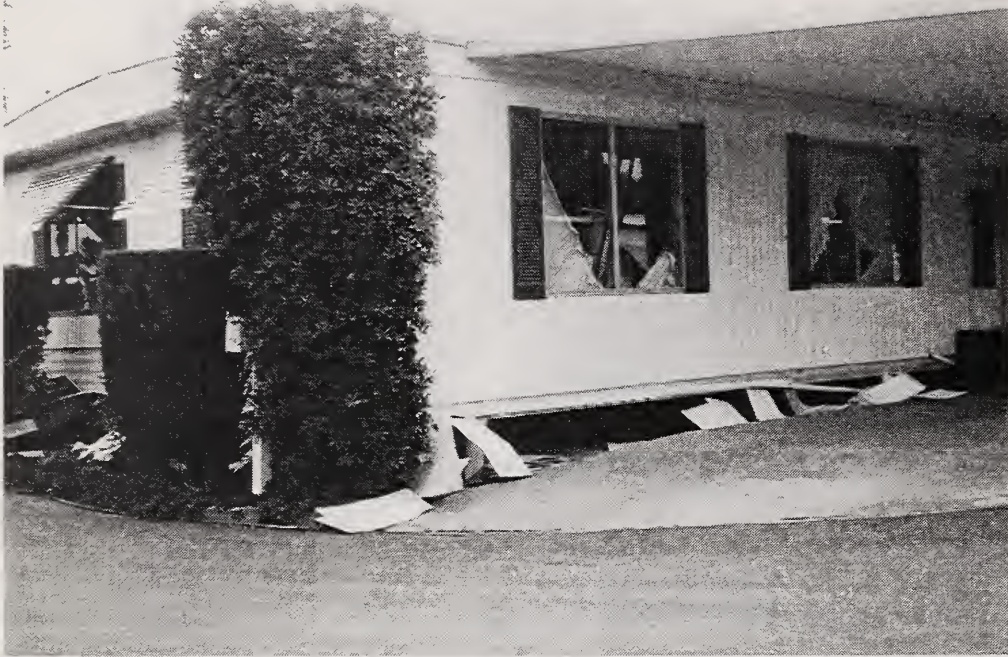
The vulnerability of mobile homes to earthquake ground shaking was demonstrated once again by the Northridge earthquake. For example, in a trailer park near the epicenter, at the intersection of Nordhoff Street and Tampa Avenue, nearly every home had moved on its supports. These types of homes are usually supported on small concrete and metal base supports (Figures 3.19, 3.20, and 3.21). These supports provide little resistance to lateral movements, and toppled during the quake (Figure 3.22). The identical failure was observed in the 1971 San Fernando earthquake. It is clear that no improvements in the practice of supporting manufactured homes adequately against lateral loads have been made during the past twenty-three years.

Figure 3.19
Damage to
manufactured
homes caused by
collapsed supports
was common.

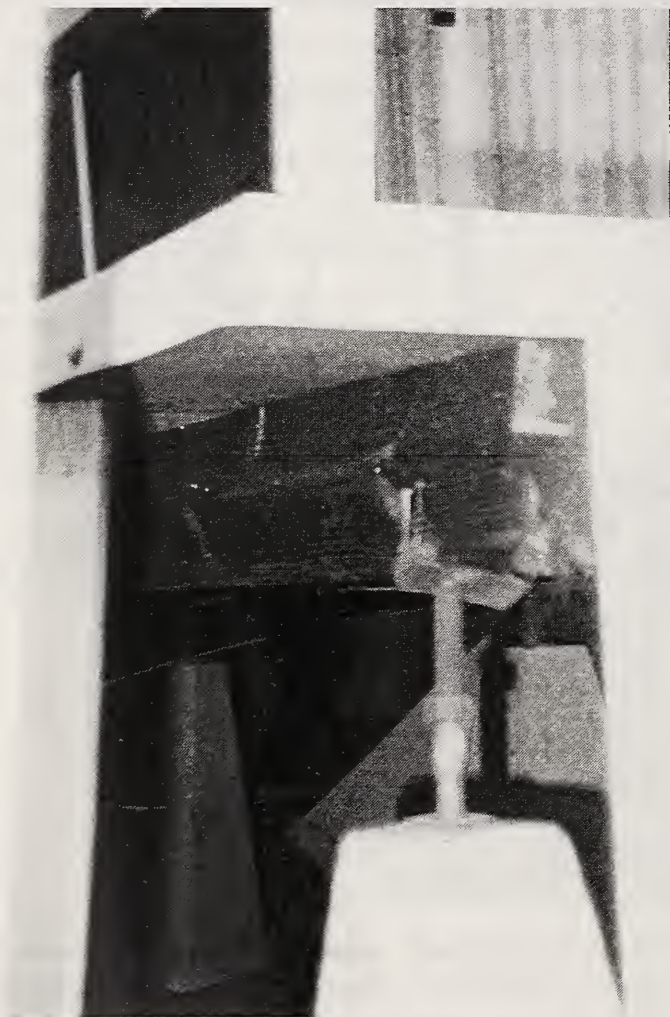
Figure 3.20 Small concrete base supports
are a common foundation system used to
support manufactured housing. This type
of system provided little resistance to
lateral forces.

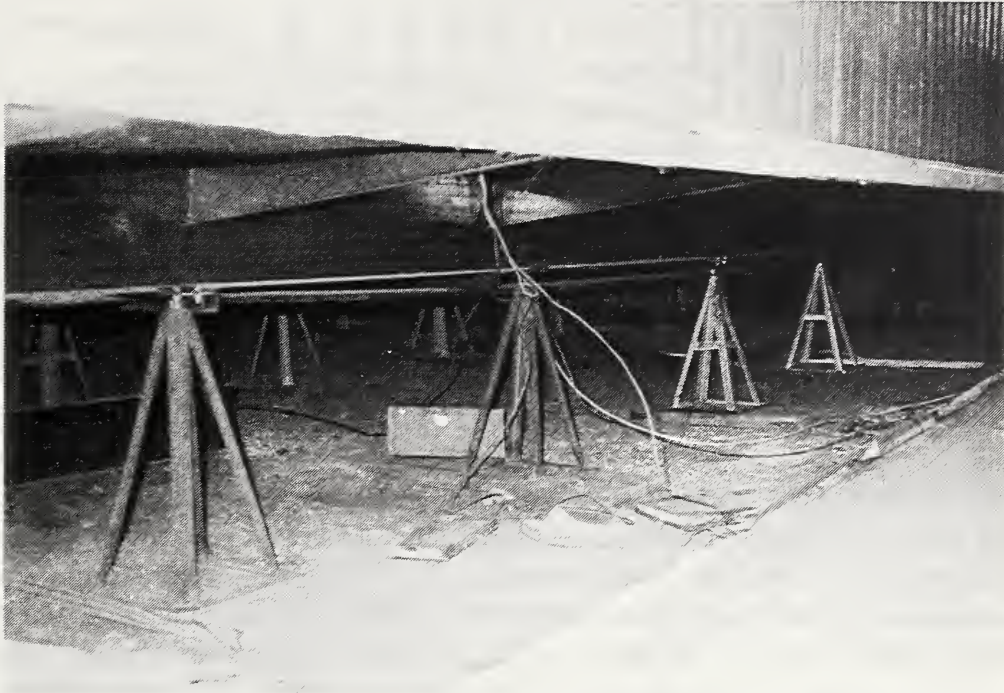
In some cases, the metal base supports were braced with small steel angle members. However, they were not adequately fastened to the supports and did not prevent the supports from rocking.

Figure 3.21 Another foundation system used for manufactured housing consists of supports constructed of small metal angles.

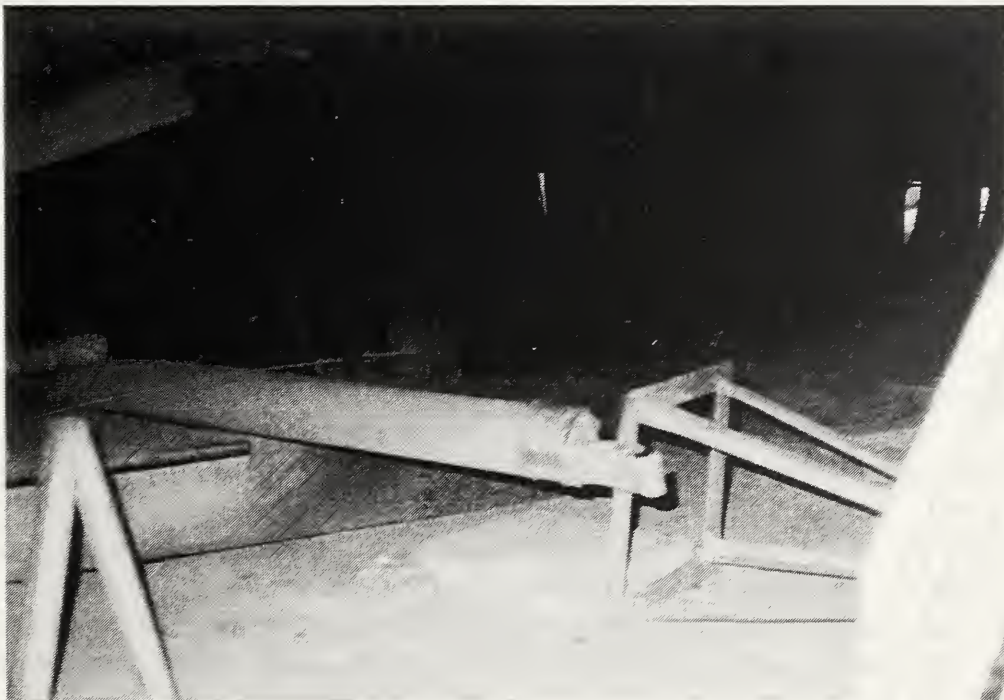
Figure 3.22 The metal supports under many homes tipped over, bringing down the houses above.

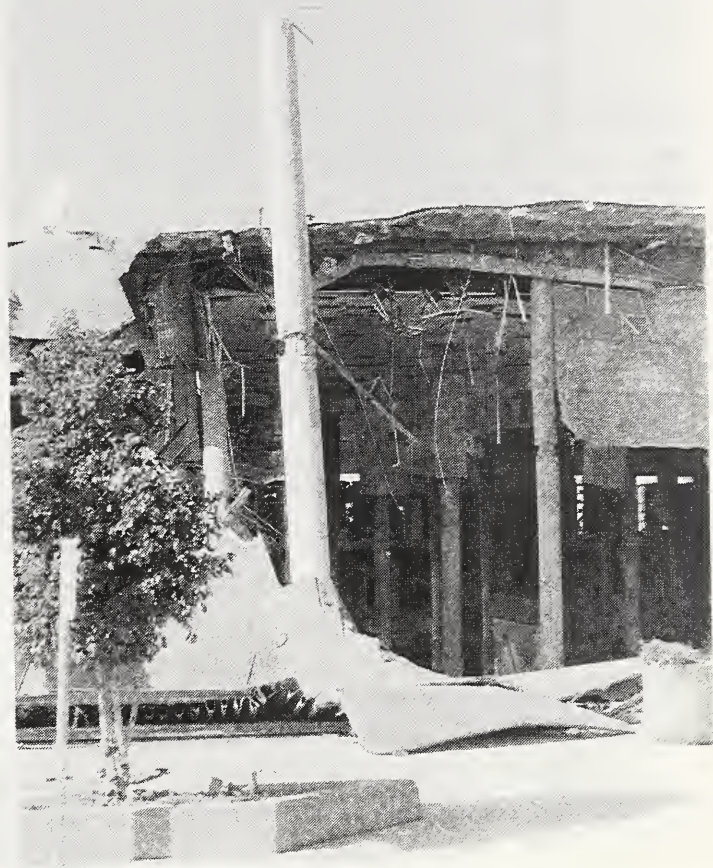
Figure 3.30 The Bullock's department store had an extremely irregular vertical geometry. At the northeast end it was shaped like a truncated pyramid.

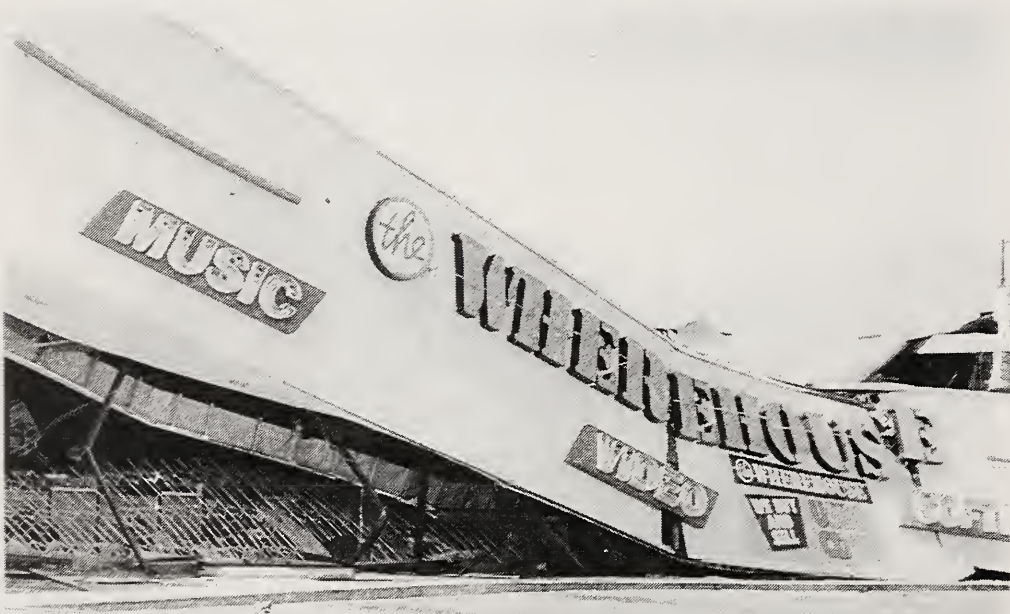
The area around the Northridge Fashion Center showed evidence of having been severely shaken. Significant damage of many types occurred. South of the Northridge Fashion Center, several single story retail structures were damaged; at least one, the Warehouse, collapsed (Figure 3.32).

Figure 3.32 Many commercial buildings were damaged in the blocks south of the Northridge Fashion Center. The single-story Warehouse collapsed completely.

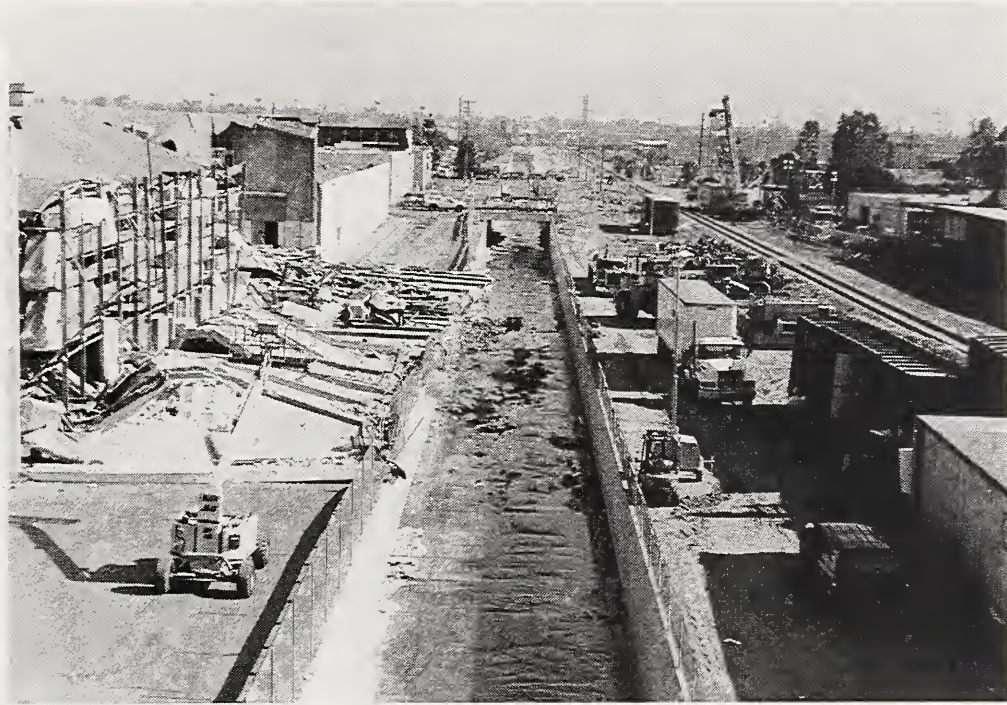
Figure 3.33 The south wall of the concrete tilt-up Levitz furniture store/warehouse south of the Northridge Fashion Center fell away from the building into the alley and stream channel. The damaged roof was being supported by the racks of furniture. On the south side of the stream channel a freight train derailed during the earthquake. That clean-up effort was still underway three days after the quake.

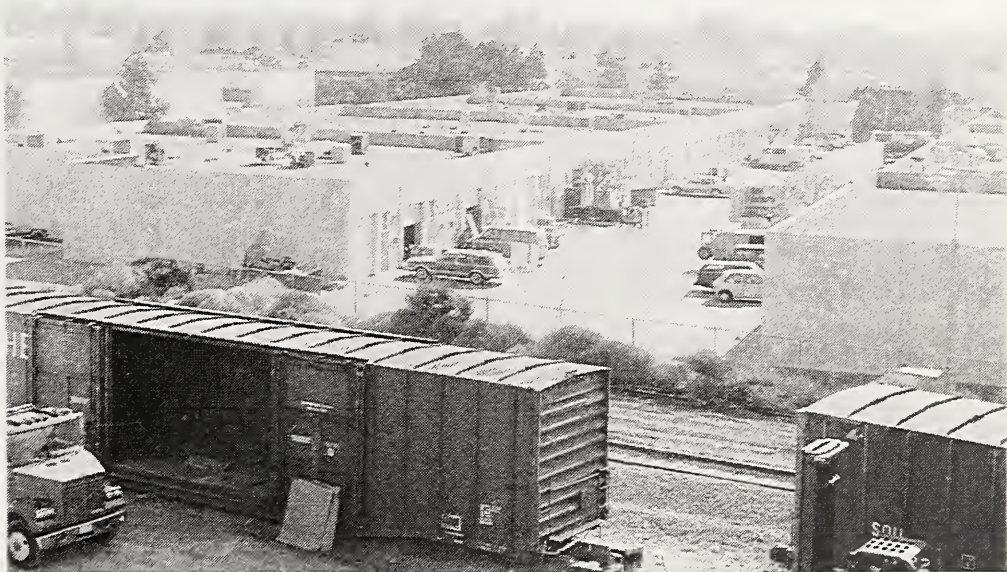
Figure 3.34 The single-story modern masonry commercial buildings directly south of the damaged Levitz furniture store and train derailment were apparently undamaged. All parapets and piers between garage openings appeared intact.

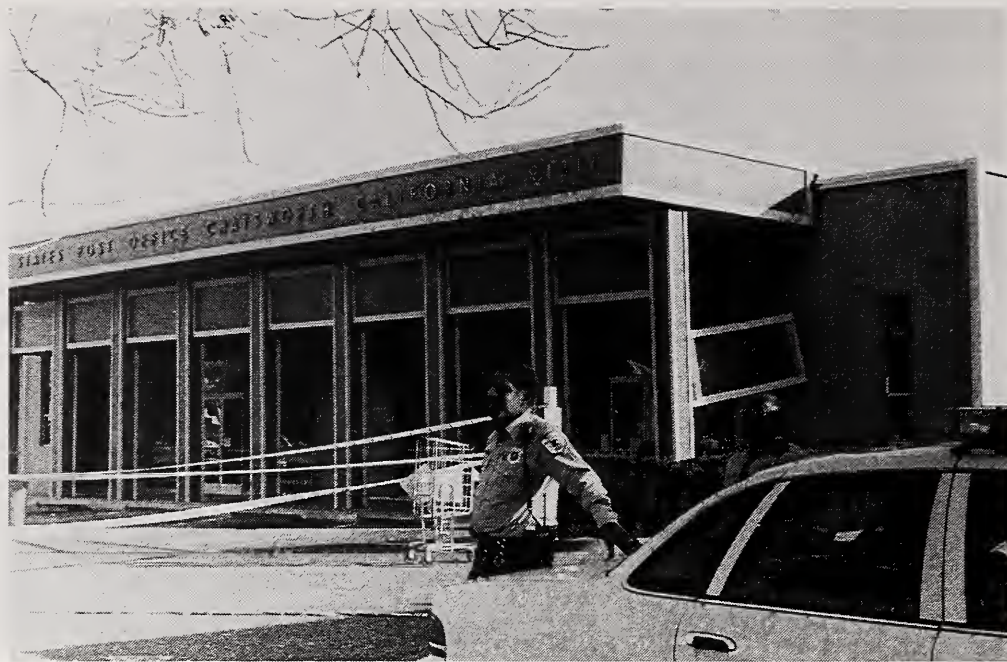
facade panel had become detached and interior ceiling panels had fallen (Figure 3.35). Mail was being collected in the parking lot.

Figure 3.35 The Chatsworth Post Office was closed due to damage. Mail was being collected in the parking lot.

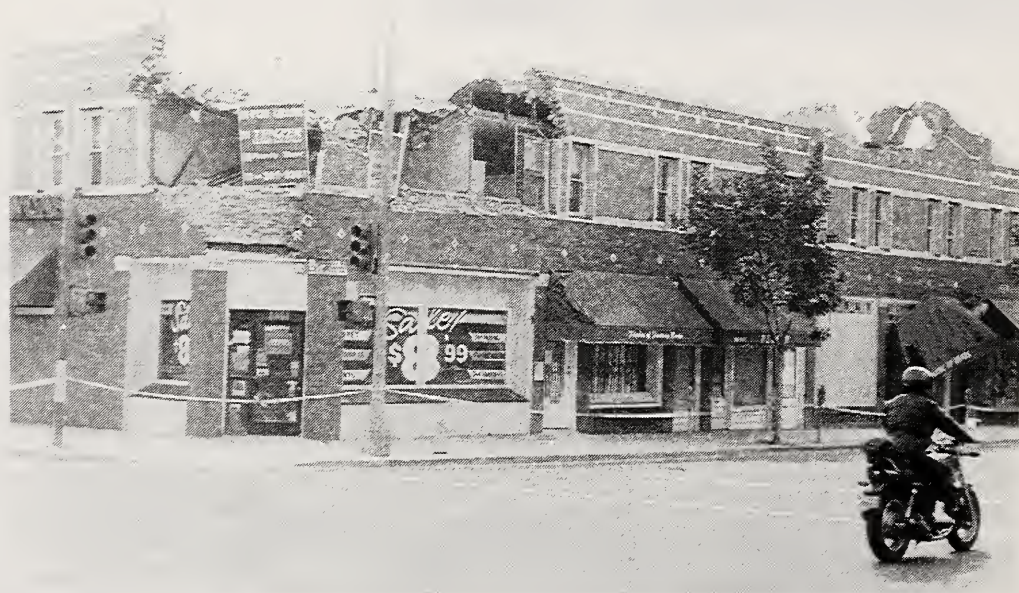
Figure 3.36 Damage to unreinforced masonry buildings, even those that had been rehabilitated, was common. Upper stories and corners were particularly vulnerable to damage. The rows of light-colored diamonds on the face of this building are the end plates of through-bolts used to connect the wall to the floor joists, a typical rehabilitation technique. The remains of parapet braces can be seen on the roof.

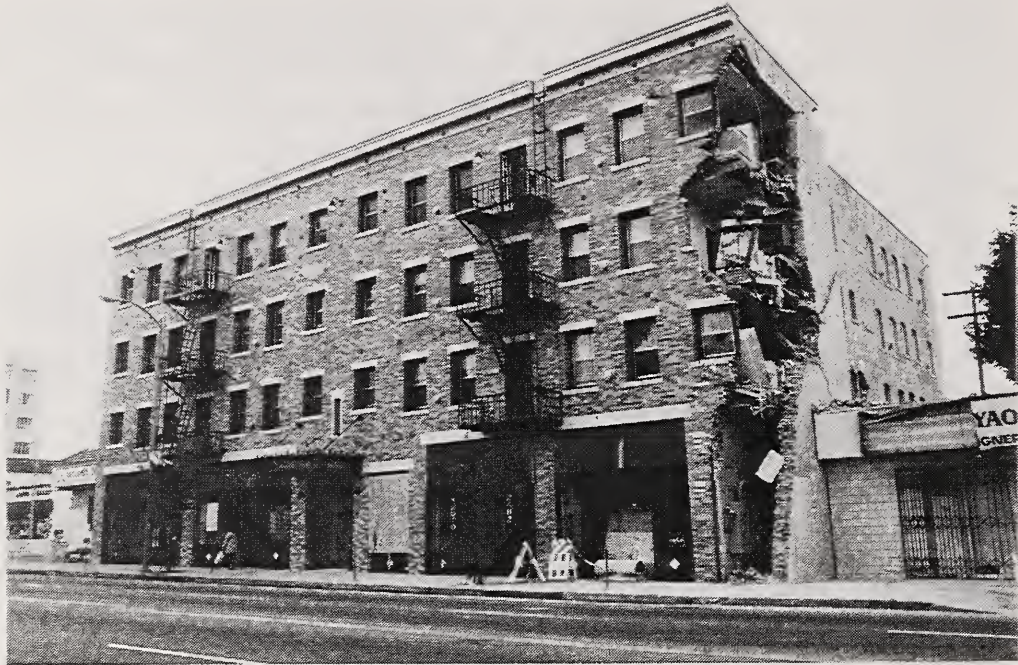
Figure 3.37 The corner of this rehabilitated unreinforced masonry apartment building in East Hollywood crumbled on all four stories.

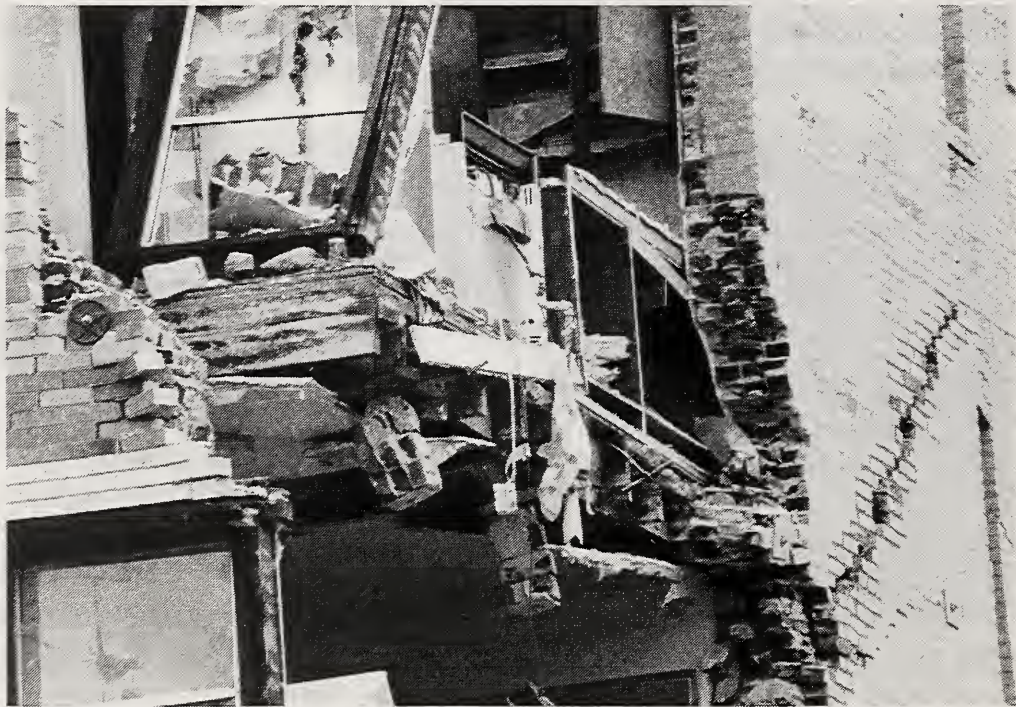
Figure 3.38 A close-up view of the third-story floor diaphragm of the building picture above shows (lower right) a rehabilitation bolt still holding a few bricks to the floor joists, after all the walls on three out of four sides of the bolts had disintegrated.

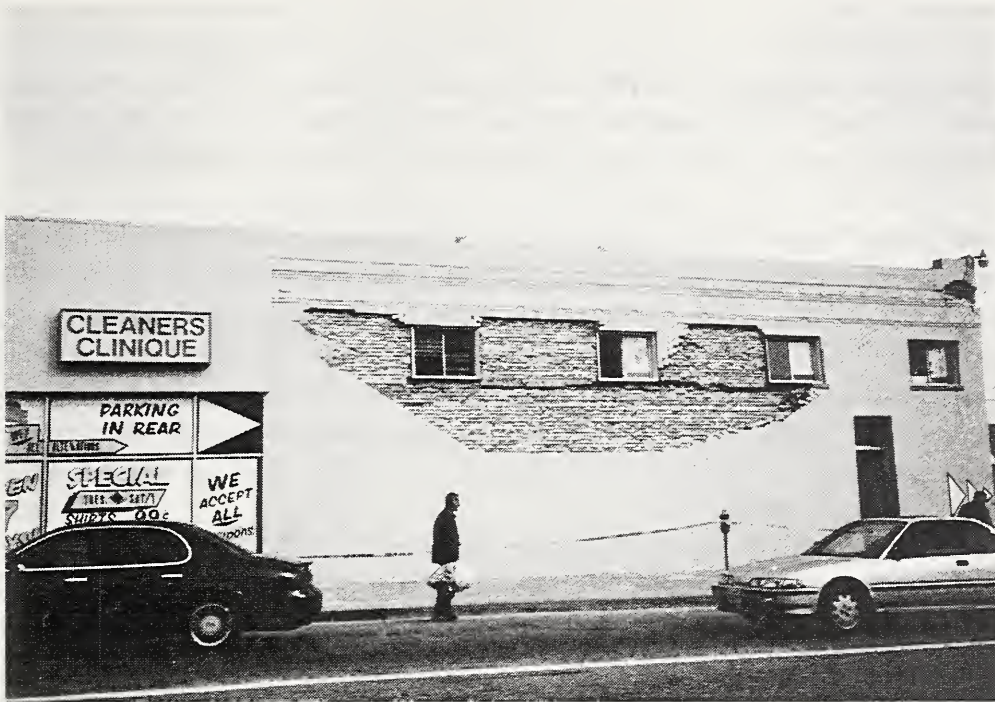
Figure 3.39 Only the exterior wythe of brick peeled off of this rehabilitated unreinforced masonry building in Santa Monica.

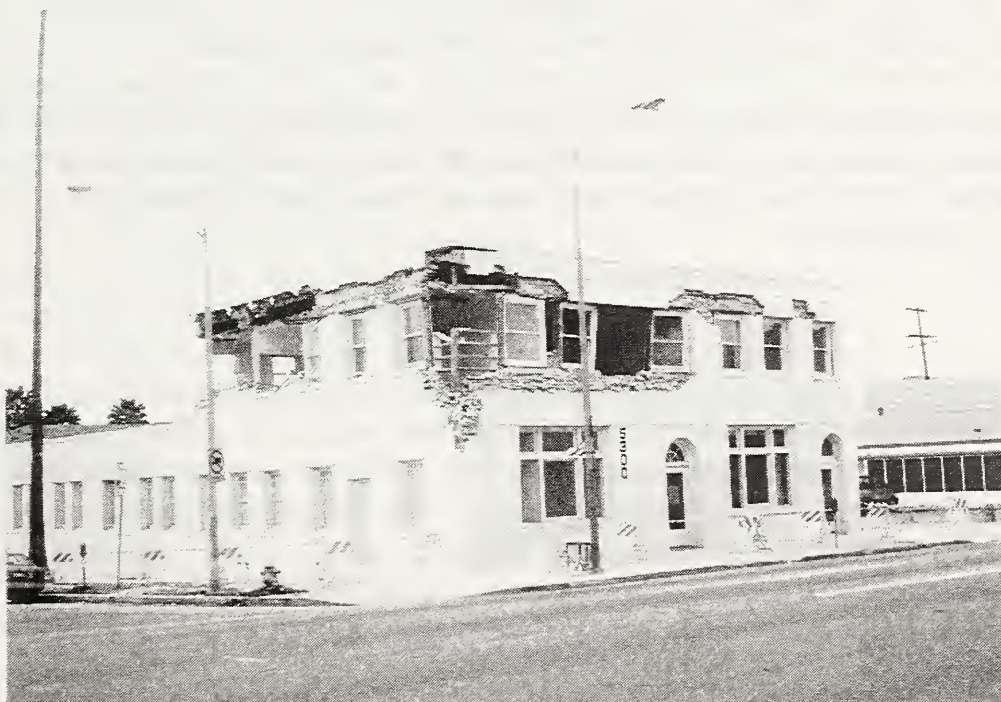
Figure 3.40 In other rehabilitated unreinforced masonry buildings, such as this two story structure in Hollywood, entire wall thicknesses were lost between rows of through-bolts.

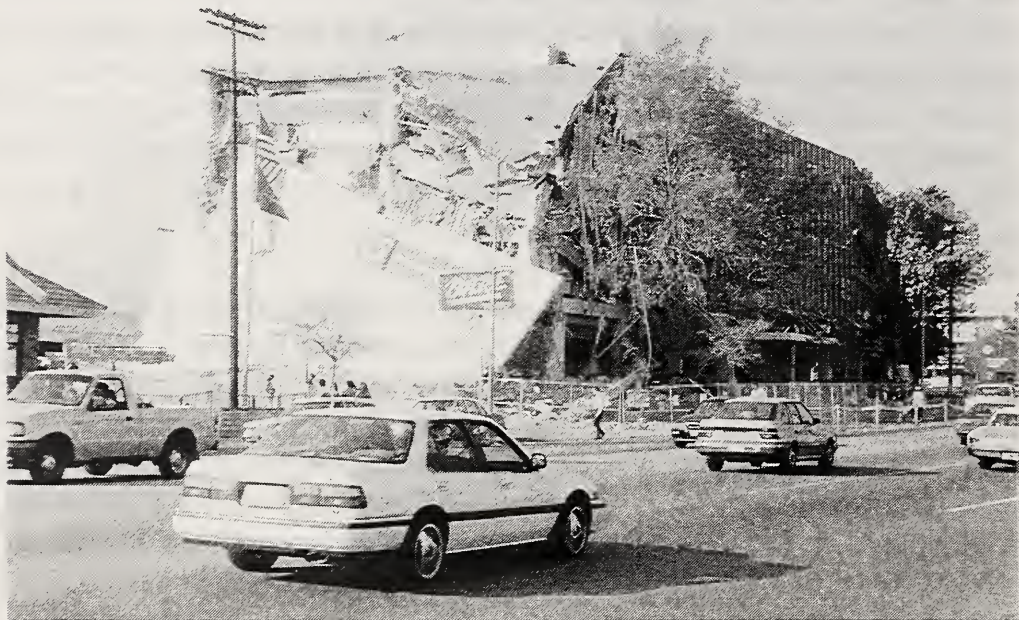
The concrete frame Kaiser Permanente office building on Balboa Boulevard in Northridge was badly damaged. The second story columns disintegrated, causing the upper stories to collapse onto the first story, which remained intact (Figure 3.41). At the ends of the building, damage to the frame caused partial collapses, but the mid-section of the building remained intact. The apparently nonstructural end walls became detached at both ends of the building and slid to the ground (Figures 3.42 and 3.43). The failure of these end walls may have contributed to the damage to the frame at the ends of the building.

Figure 3.42 Both end walls of the Kaiser Permanente building slid, partially intact, to the ground. The south wall is pictured here. Both ends of the building suffered damage to the concrete frame at all story levels, while the middle half of the building, except for the second story, remained intact.

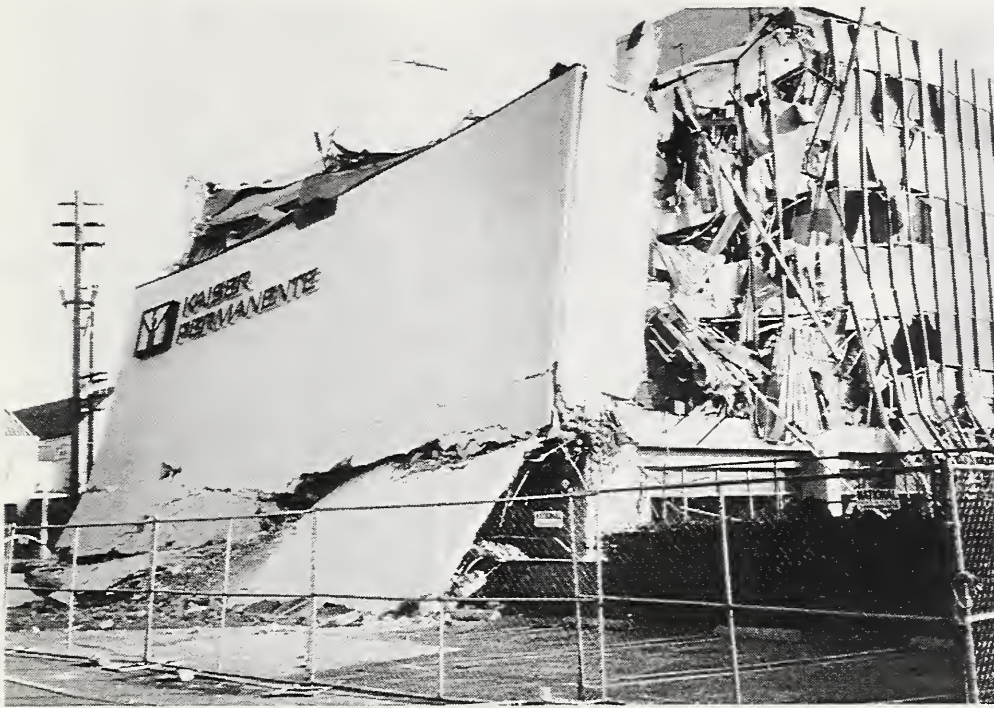
Figure 3.43
Damage at the
north end of the
building was similar
to damage at the
south.

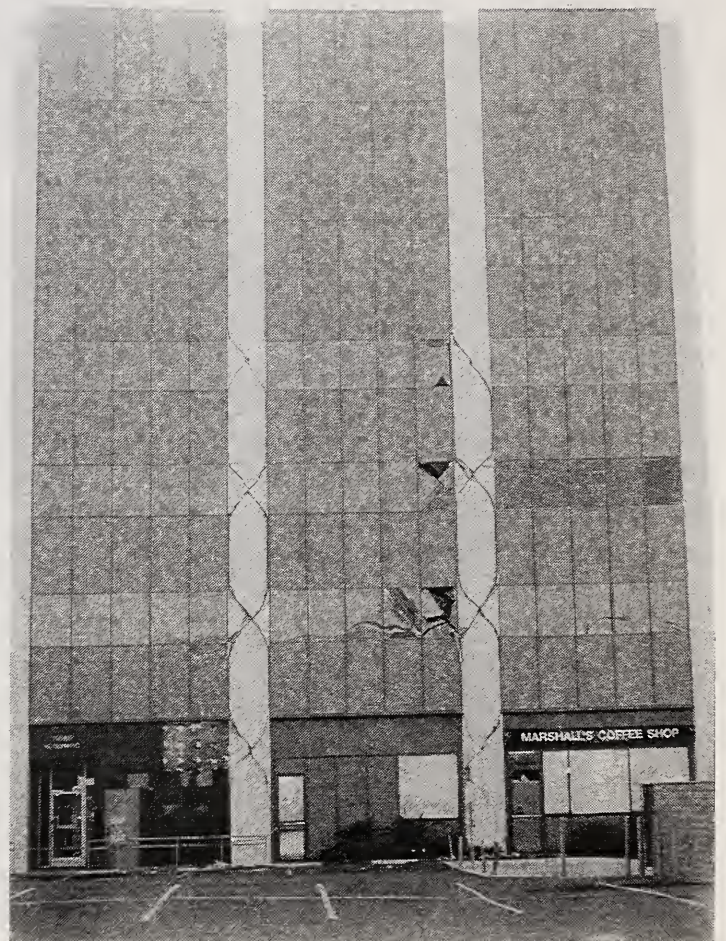
The L-shaped concrete frame Barrington Building in West Los Angeles also had damage concentrated in the second story columns (Figure 3.45). In this building, the horizontal architectural panels stiffened the lower half of the columns at each story, creating a short-column effect. The effectively shortened columns failed in shear between the windows, creating a pattern of X-cracking in the columns that diminished in severity towards the top (Figure 3.46). At the second story, the cracking was severe enough to cause a loss of vertical-load-carrying capacity; the bulging window frames indicate about a 50 to 100 mm reduction in height (Figure 3.47). The building was demolished within a few days of the quake.

Figure 3.46 The stiff infill panels of the Barrington Building effectively shortened the concrete columns, forcing all the displacement into the column sections bounded by windows. Diagonal X-cracking decreased in severity towards the top of the building.

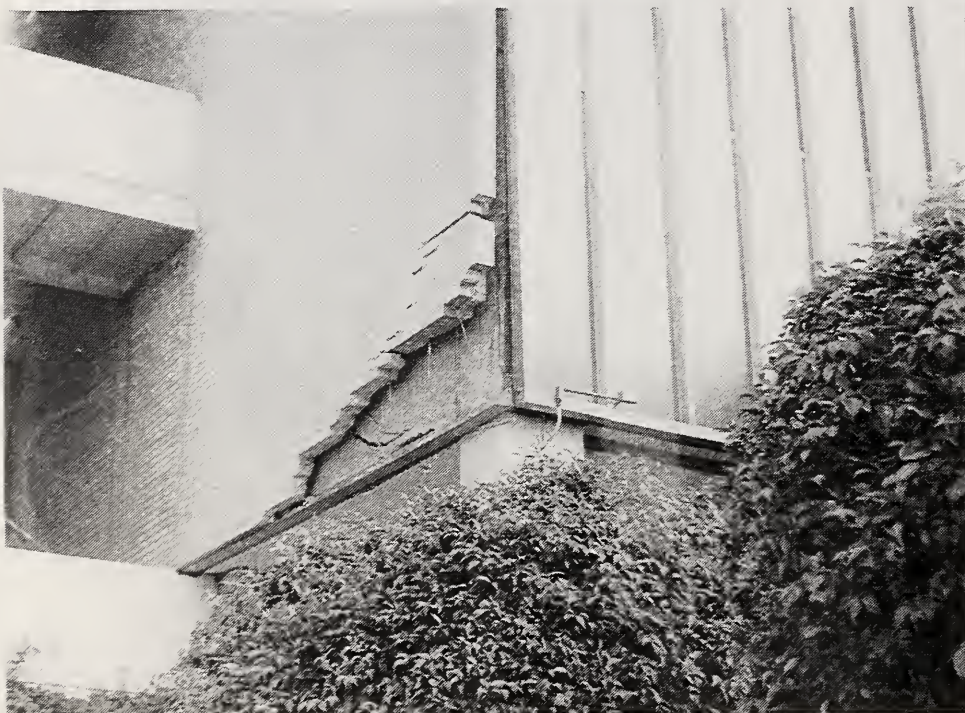
Figure 3.50 The similar west wall of was damaged, but did not peel away from the structure. This close up of the interface between the first and second stories shows that the masonry facade is supported on a steel angle. At the west end of the building, the facade was crushed at the toe where it is supported by the angle.

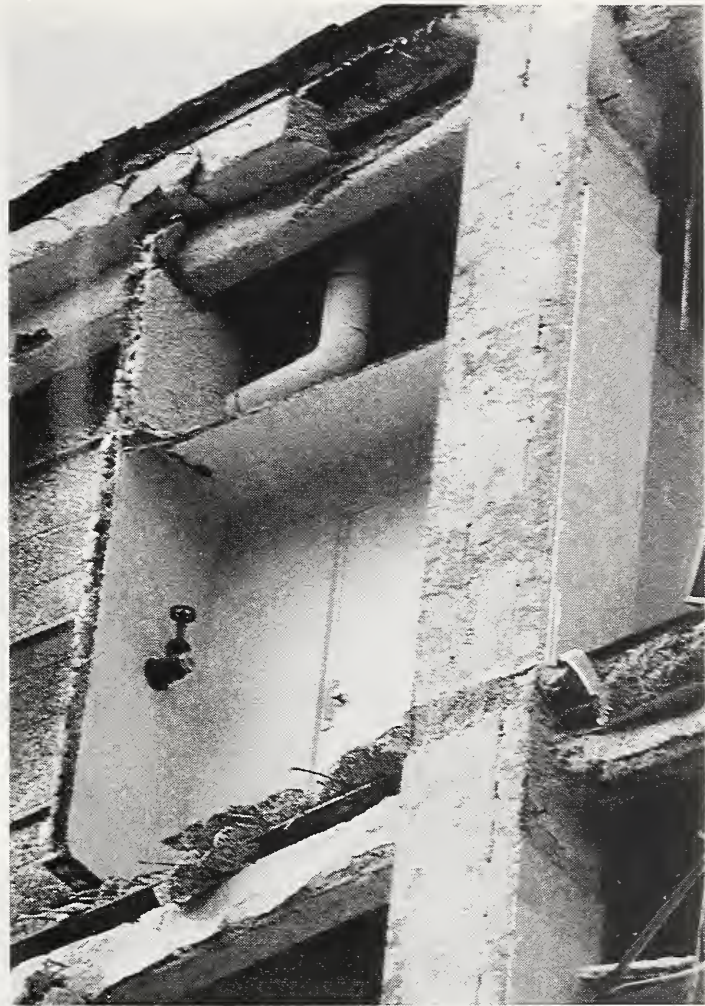
A steel-frame office building on the west side of Topanga Canyon Boulevard in Canoga Park, housing the American Savings Bank, experienced significant movement in its first story columns, apparently swaying in a north-south direction during the quake. It did not return to its original position, but suffered a permanent offset to the north (Figure 3.52). A nearly identical building on the same site, oriented at right angles to the first, had only minor damage to glass at the first

Figure 3.52 The first-story columns of the steel-framed building housing the American Savings Bank on Topanga Canyon Road in Canoga Park flexed during the quake and ended up slightly displaced from their original positions.

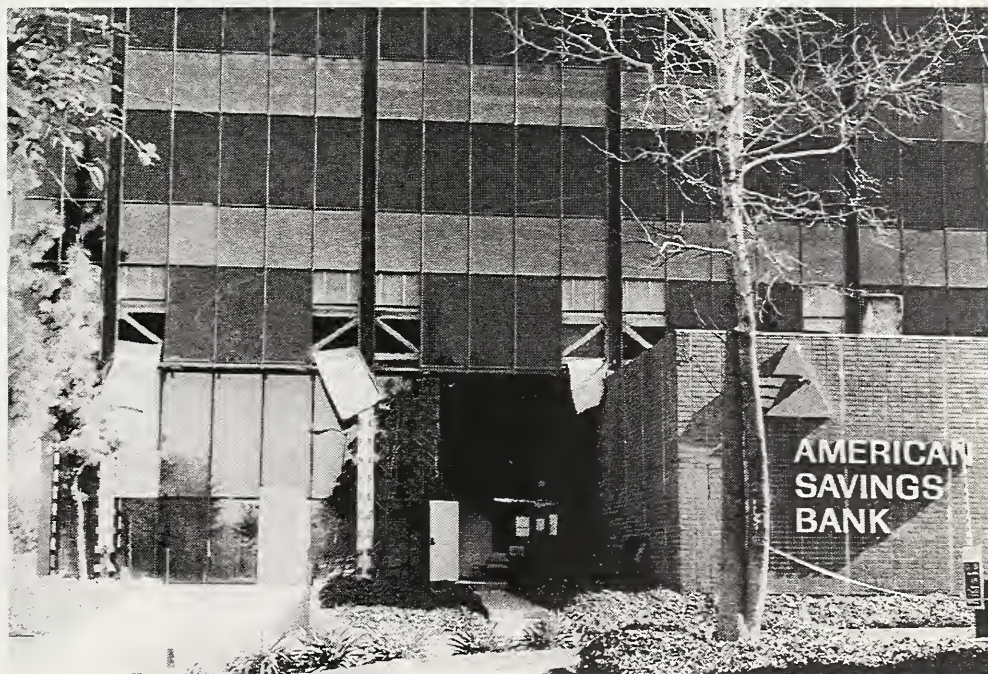
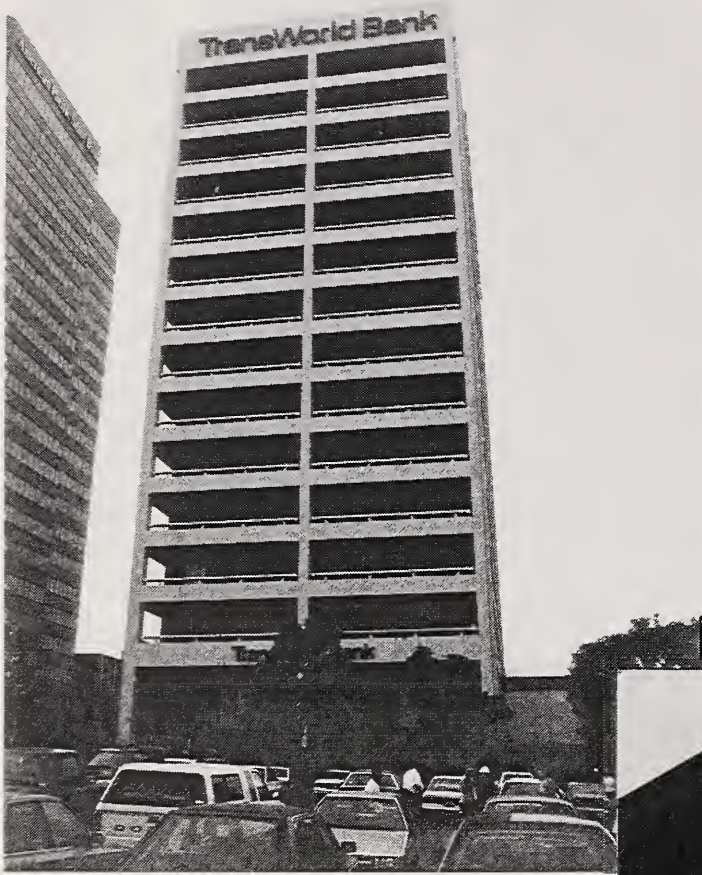
The business district along Ventura Boulevard in Sherman Oaks was another area with significant numbers of badly damaged buildings. The thirteen-story Trans World Bank Building is located at 15233 Ventura Boulevard (Figure 3.53). There is a two-level underground garage below the building and a mechanical penthouse on the roof. This reinforced concrete frame building was designed under the 1964 Los Angeles City code. Structural damage was in the first-story columns, primarily at the second-floor beam-column joints. Identical failures occurred during the 1971 San Fernando earthquake. The damaged joints were repaired with epoxy shortly after the 1994 earthquake (Figure 3.54).

Figure 3.53 The Trans World Bank building, in Sherman Oaks, was damaged in both the 1971 San Fernando and 1994 Northridge earthquakes.

Figure 3.54 The cracked beam-column joints between the first and second stories of the Trans World Bank building were repaired using epoxy injection.
