1994 Northridge Earthquake

Performance of Structures, Lifelines and Fire Protection Systems

NISTIR 5396

March 1994
Building and Fire Research Laboratory
National Institute of Standards and Technology
Gaithersburg, MD 20899

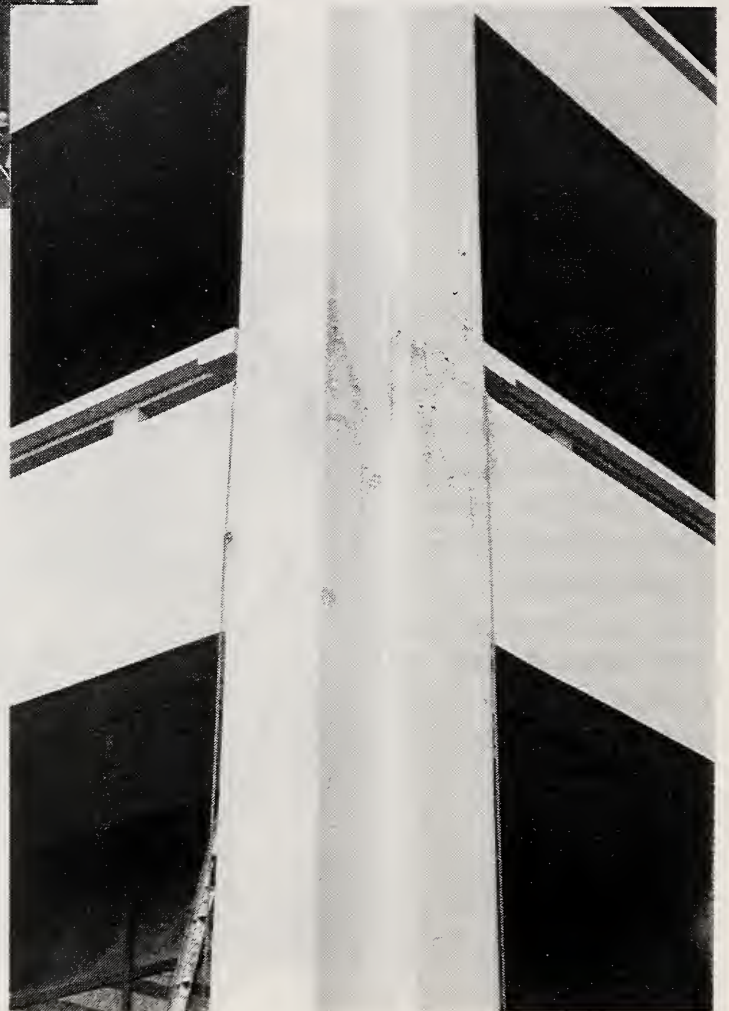
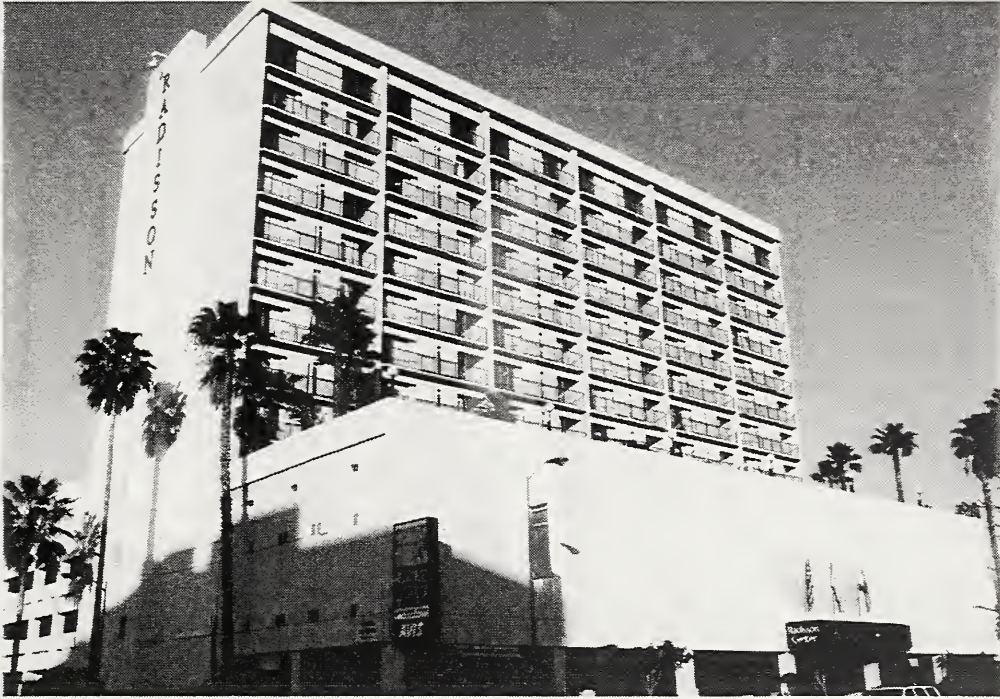
The Radisson Valley Center Hotel is located at 15433 Ventura Boulevard in Sherman Oaks (Figure 3.55). This thirteen-story concrete structure sustained serious damage to columns located at the first and fifth stories. Exterior columns which support the three-story appendage at the front of the hotel were also damaged (Figure 3.56)

Figure 3.55 The concrete Radisson Valley Center Hotel in Sherman Oaks had serious damage to the columns at the first and fifth stories.

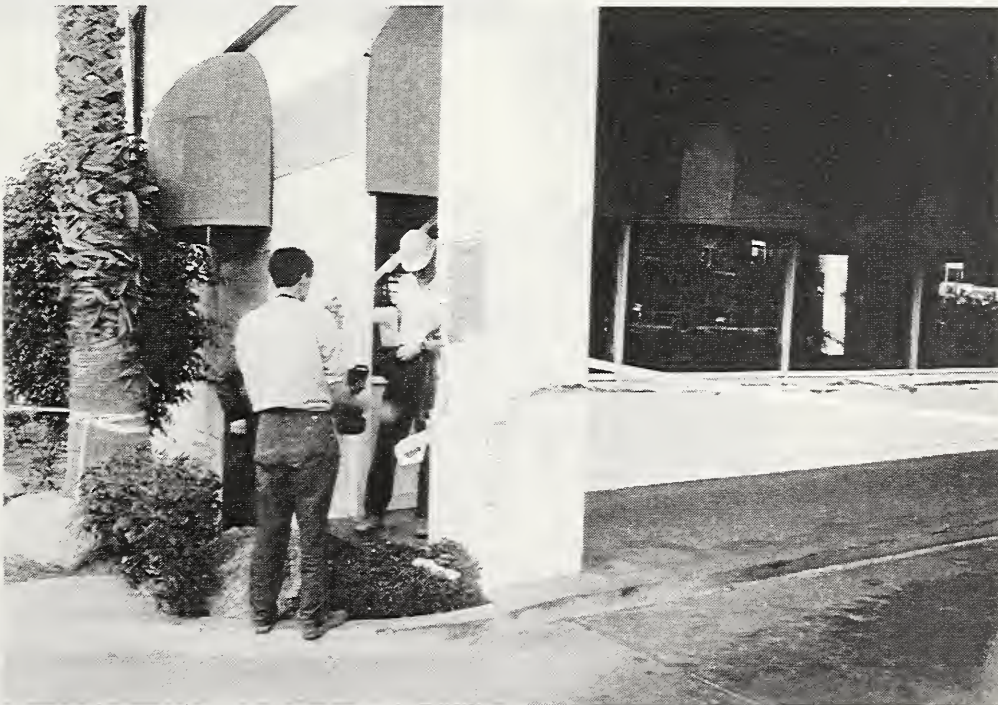
Figure 3.56 The columns supporting the three-story appendage at the front of the Radisson Hotel had serious shear cracks and related spalling.

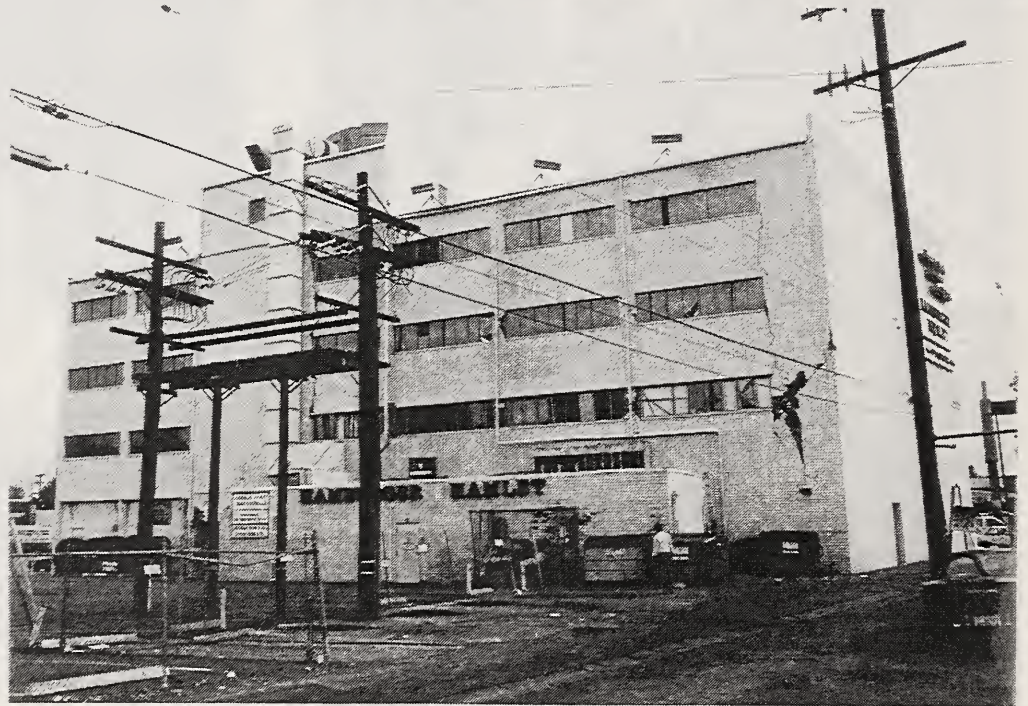
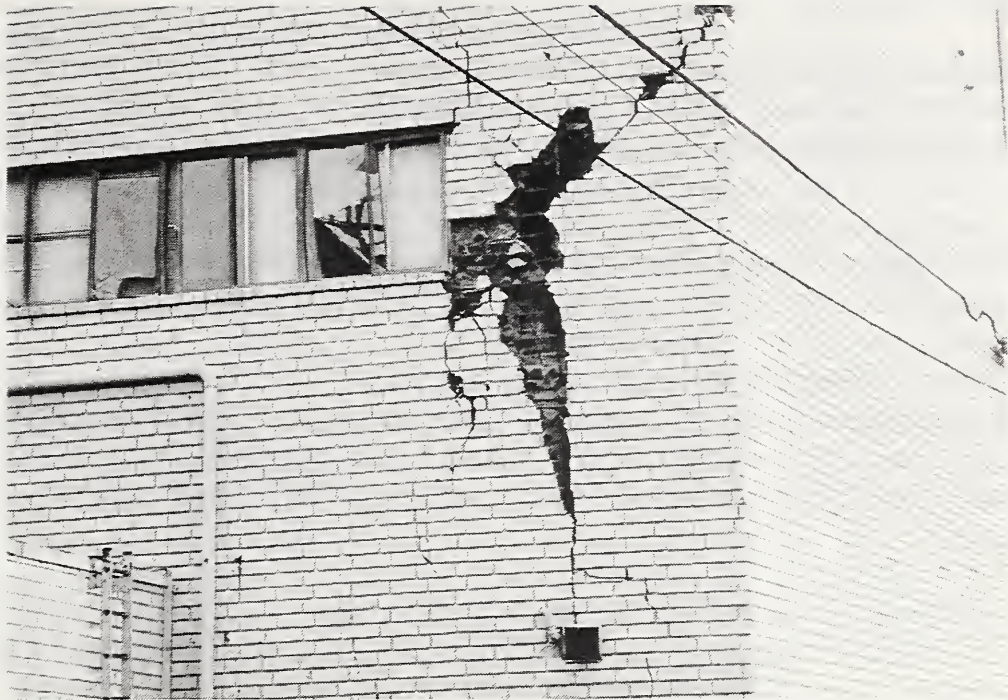
A four-story steel frame structure located at the intersection of Moorpark Street and Cedros Avenue was shaken seriously during the earthquake (Figure 3.58). The exterior reinforced masonry wall was cracked in many places, particularly at the second floor level (Figure 3.59). The evidence of large ground shaking in the Sherman Oaks area was also seen by serious lateral displacements of single family houses and three-story apartment buildings from their foundation. In fact, a strong-motion instrument station in Tarzana located only a few kilometers away from this general area recorded the largest acceleration in this earthquake (1.82g horizontal, 1.18g vertical).

Figure 3.59 A close-up view of the damage shows the pattern of reinforcing used in the masonry facade.

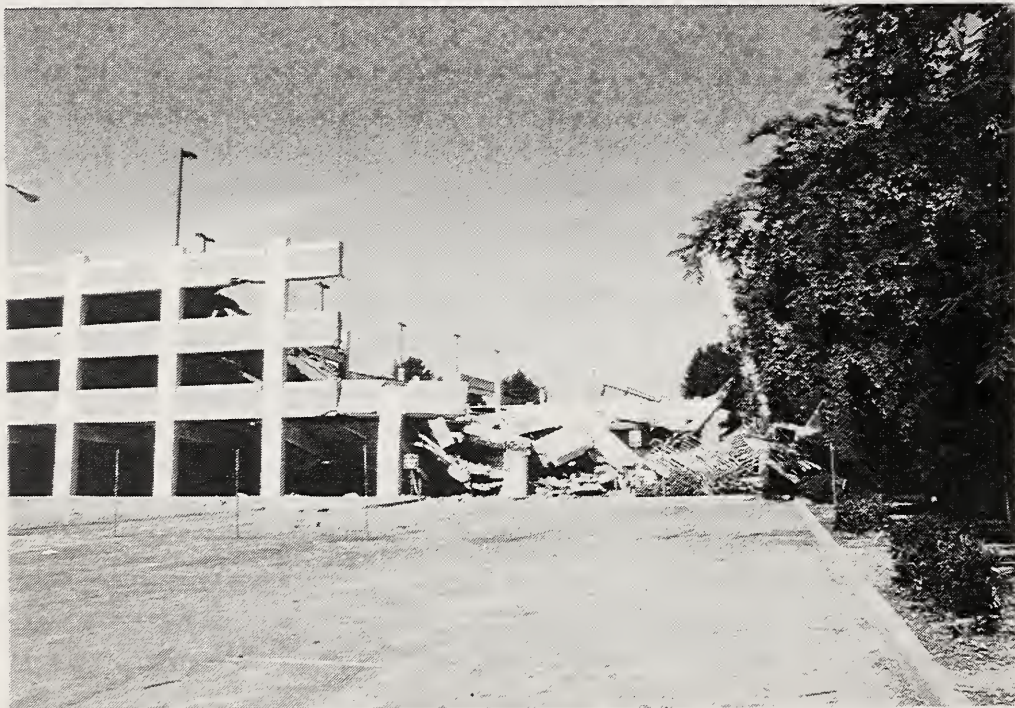
The collapse apparently started at the interior of the building. The exterior perimeter frame was pulled over towards the center of the structure (Figure 3.60), suggesting that interior beams had lost their vertical support, causing the floor plates to collapse and pull the exterior walls in with them. While some interior columns had collapsed, others were left intact, jutting up above the fallen floor slabs (Figure 3.61).

Figure 3.61 Some interior columns of the Northridge campus parking garage remained standing.

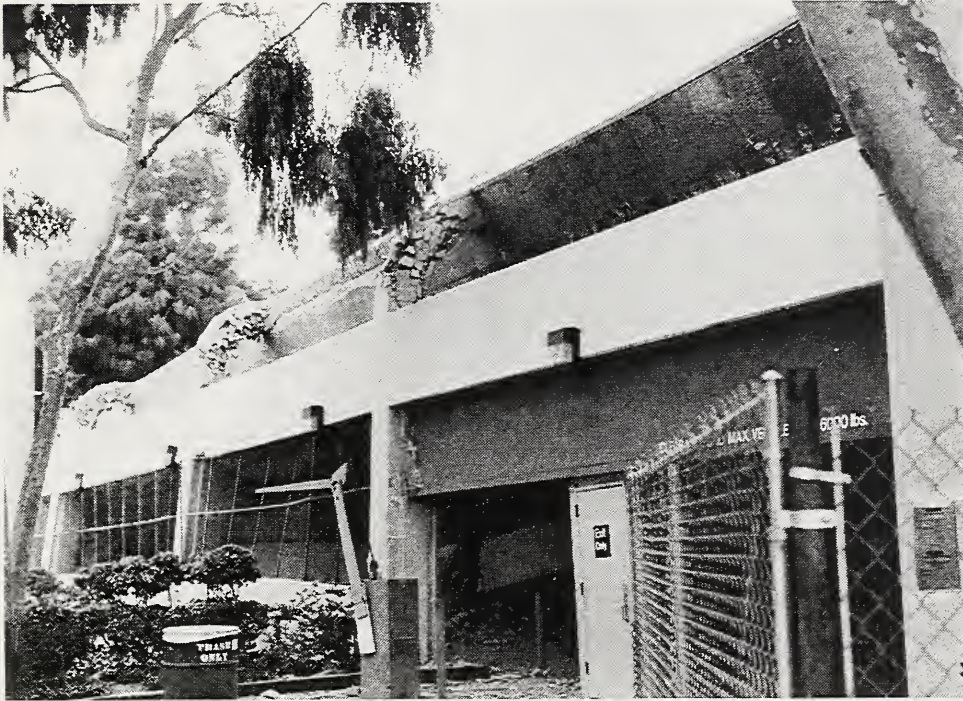
The five-level parking garage at the Kaiser Permanente medical complex on Cadillac Avenue in West Los Angeles experienced a similar collapse. All four facades were pulled inward, suggesting that an interior failure precipitated the damage (Figure 3.62). This garage was a post-tensioned cast-in-place concrete structure with shear walls providing the lateral-force resisting system at the east and west ends, and moment frames at the north and south perimeter. The shear walls were cracked horizontally throughout their height due to the out-of-plane bending (Figure 3.63). There was minor diagonal cracking, suggesting that the lateral load was not fully transmitted to the shear walls. The stair towers remained standing. Typically, these towers are structurally isolated from the post-tensioned slab to minimize potential deformations in the towers due to creep and shrinkage in the post-tensioned slabs.

Figure 3.62 The cast-in-place concrete parking garage at the Kaiser Permanente Hospital complex in West Los Angeles collapsed in on itself. The moment frame that provided lateral resistance on the south face of the structure could not resist the out-of-plane forces apparently caused by the collapse of interior elements.

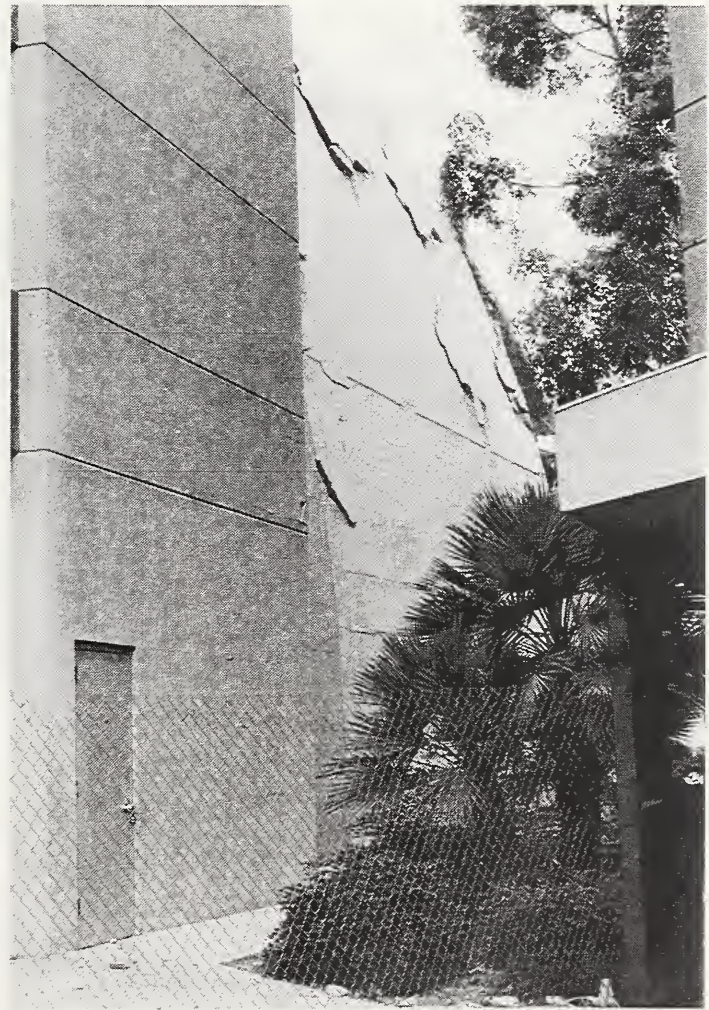
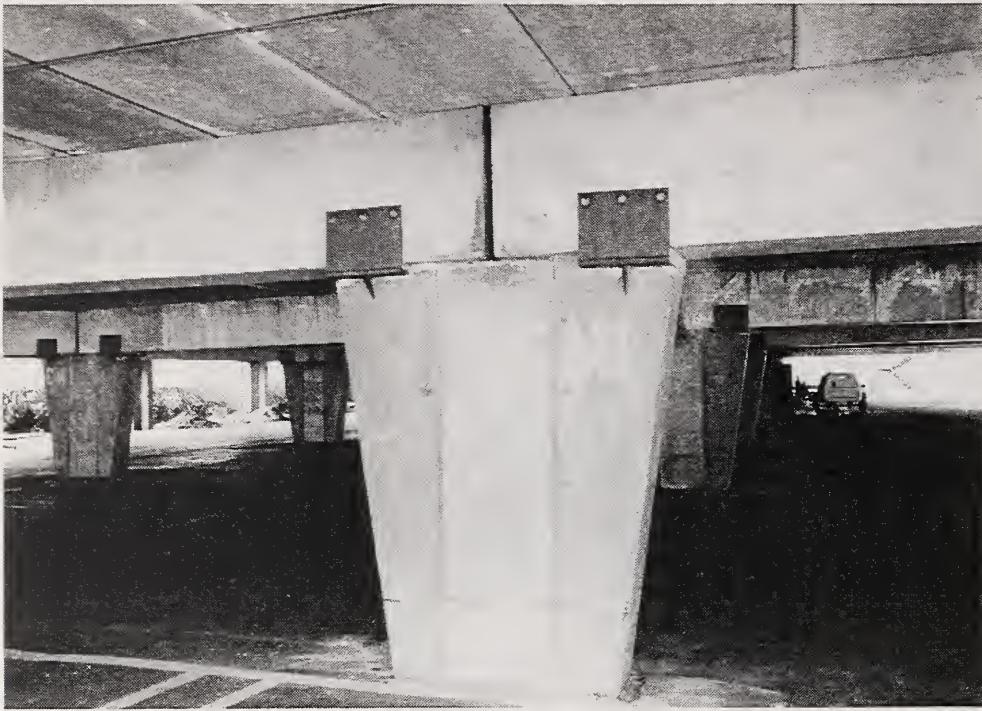
Figure 3.63 - At the east and west faces of the Kaiser Permanente Hospital parking garage, shear walls made up the lateral force resisting system. Both walls had horizontal cracks caused by the out-of-plane bending when the walls were pulled inward. Neither wall had major diagonal cracking, suggesting that the lateral load was never fully delivered to the walls. The stair towers remained erect. The east wall and stair tower are shown here.

Figure 3.64 The interior columns of the two-level parking garage at the Trans World Bank in Sherman Oaks had been seismically strengthened after it suffered damage in the 1971 San Fernando quake. The interior columns fared well in the 1994 Northridge quake.

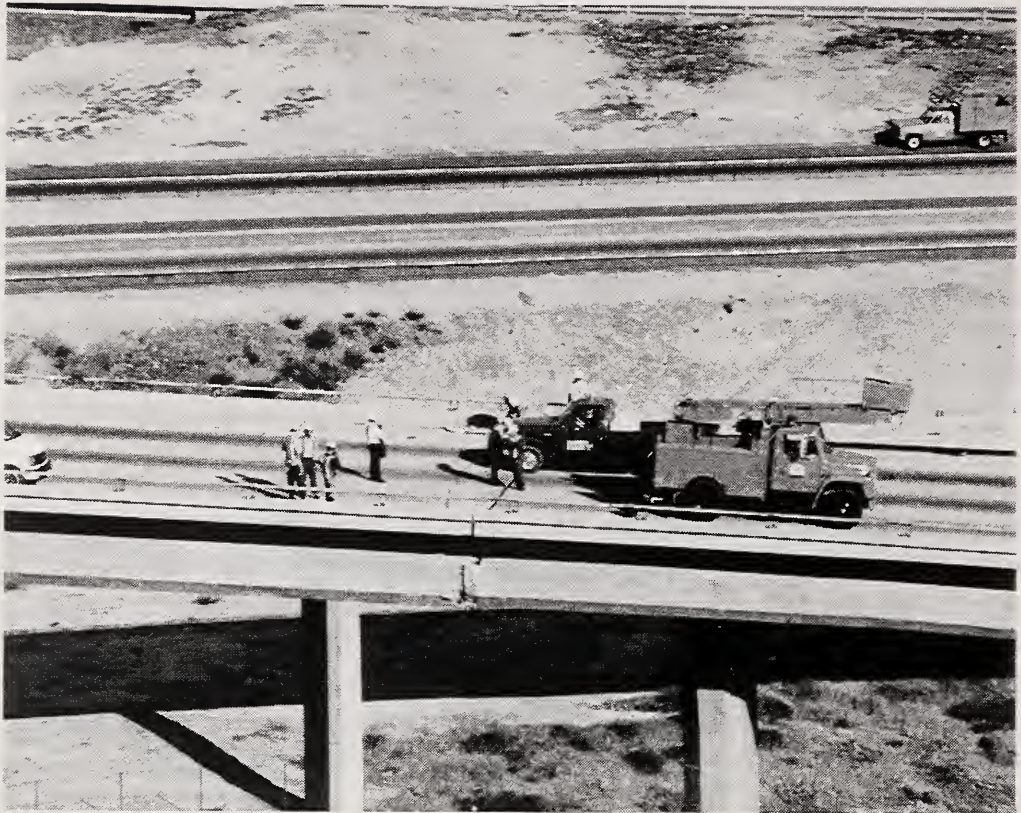
Figure 4.7 Example of pounding and offset at a hinge in the SR14/I5 interchange

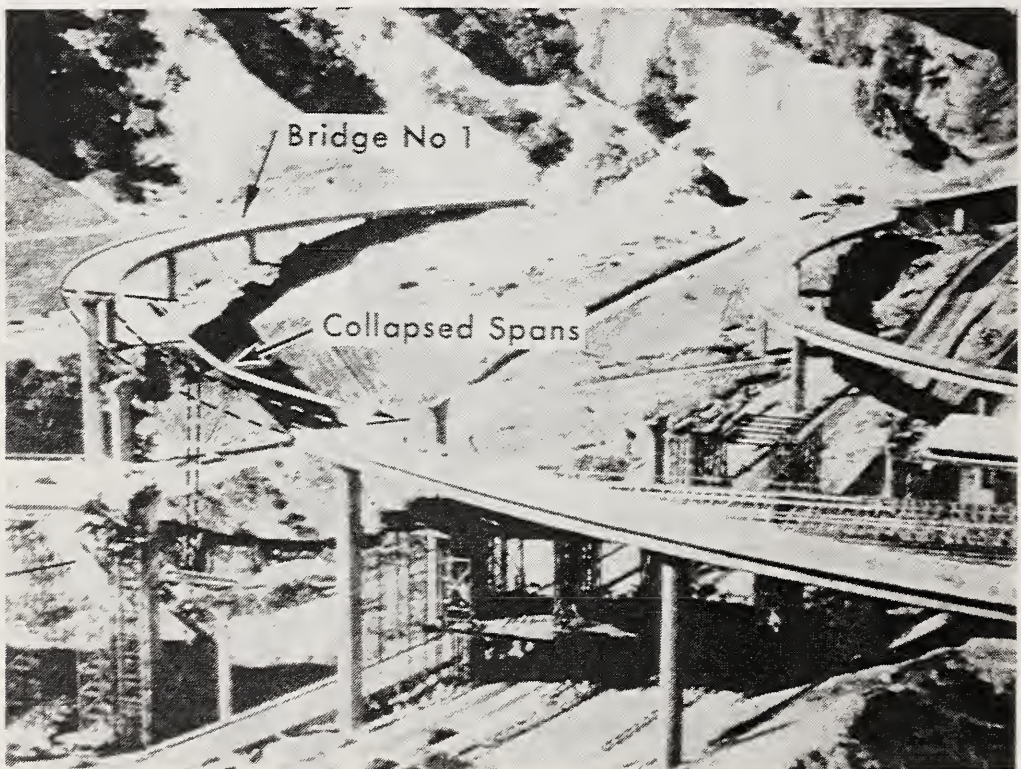
This interchange was designed in 1968 and was under construction in 1971 when portions were damaged by the San Fernando earthquake. At that time, one of the completed ramps in the interchange collapsed, and two ramps which were under construction were damaged. The portion which collapsed in 1971 was the South Connector Overcrossing, connecting southbound I5 with eastbound SR14. A photograph of the collapsed ramp, taken in 1971, is shown in Figure 4.8. This ramp was later rebuilt, with improved pier reinforcement, and it suffered no significant damage in the Northridge earthquake. The damaged portions of the other two ramps under construction in 1971 were repaired in place, but not strengthened; the portions not yet constructed were completed with limited seismic upgrading. Both of the ramps which partially collapsed in the Northridge earthquake were under construction at the time of the 1971 earthquake.

Figure 4.8 SR14/I5 interchange after the 1971 San Fernando earthquake. View looking to the west, showing collapsed South Connector Overcrossing

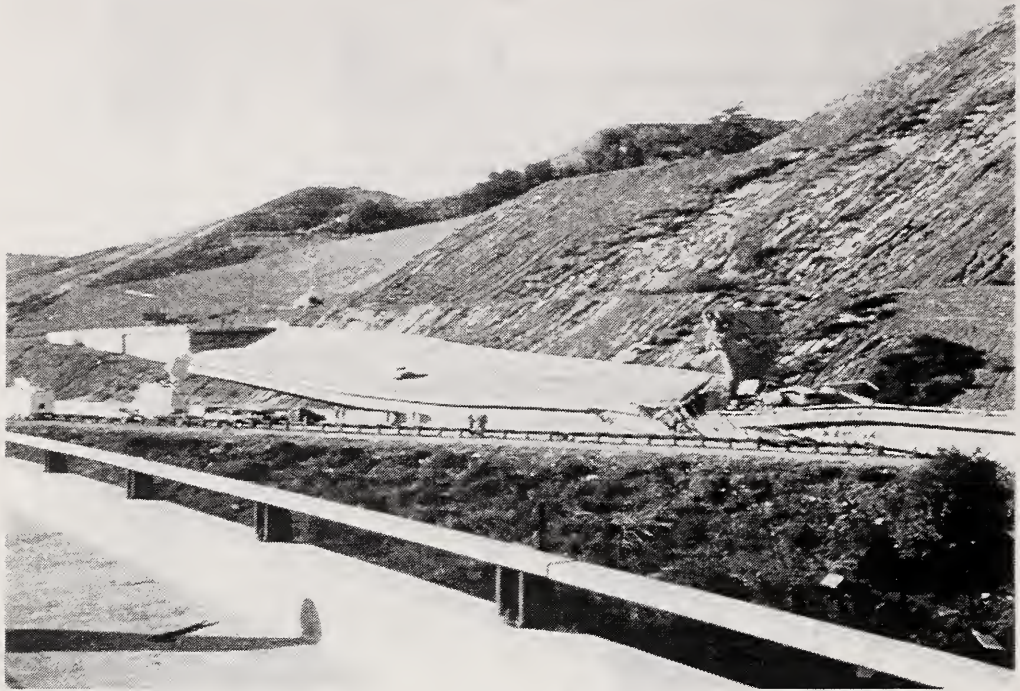
* It has been suggested that the superstructure was first pulled off the abutment seat, transferring excessive loads to Pier 2, causing it to fail. However, this appears unlikely as the bearing seat length at Abutment 1 was rather long: 24 inches (610 mm).

Figure 4.11 Overview of the collapse of the SR14/I5 Separation and Overhead, Ramp C, looking to the south at Abutment 1. Pier 3 can be seen at the right of the photograph (Courtesy of EERC)

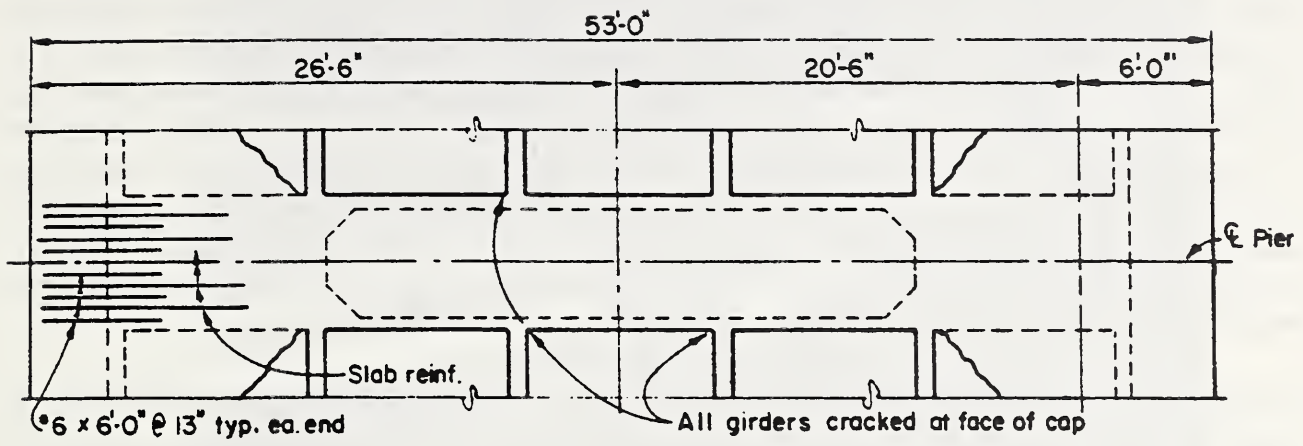
Figure 4.13 Cracking reported at Piers 2 and 3 following the 1971 San Fernando earthquake (Reproduced from State of California, 1971)

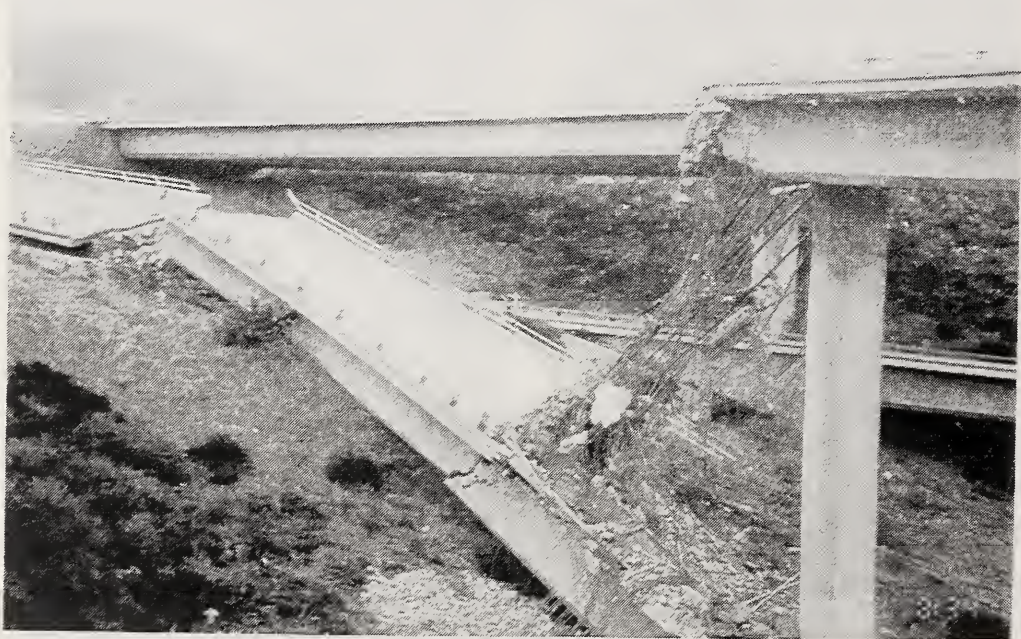
The collapse in the Northridge earthquake appears to have been initiated by the failure of Pier 2. After Pier 2 failed, the simply supported span between Abutment 1 and the hinge near Pier 2 collapsed, and, as shown in Figure 4.15, the superstructure failed in bending near Pier 3 due to a large negative moment. Pier 2 completely disintegrated, as shown in Figure 4.16. This is the shortest pier in the structure, so it is likely that it attracted a high level of lateral force, was damaged in shear, and finally collapsed in compression. Pier 10 is similar in height to Pier 1, but the quantities of lateral reinforcement in Pier 10 are greater than those in Pier 1, as illustrated in Figure 4.18. This is because Pier 2 had already been completed, but Pier 10 had not yet been constructed, when the 1971 earthquake occurred. Following the 1971 earthquake the plans for Pier 10 were revised to provide increased lateral reinforcement, as shown in Figure 4.18.

Figure 4.14 Collapsed portion of the SR14/I5 North Connector Overcrossing, looking east.. Pier 2 was at the left, near the broken hinge on the ground (Courtesy of EERC)

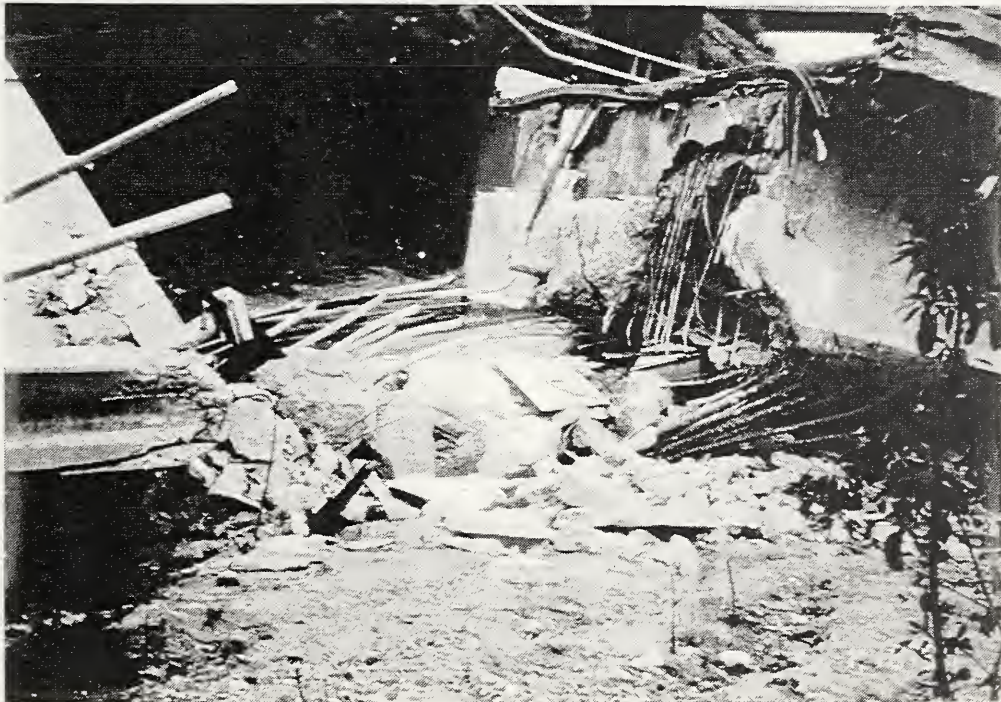
Figure 4.16 View of crushed Pier 2 and the hinge near Pier 2 (Courtesy EERC)

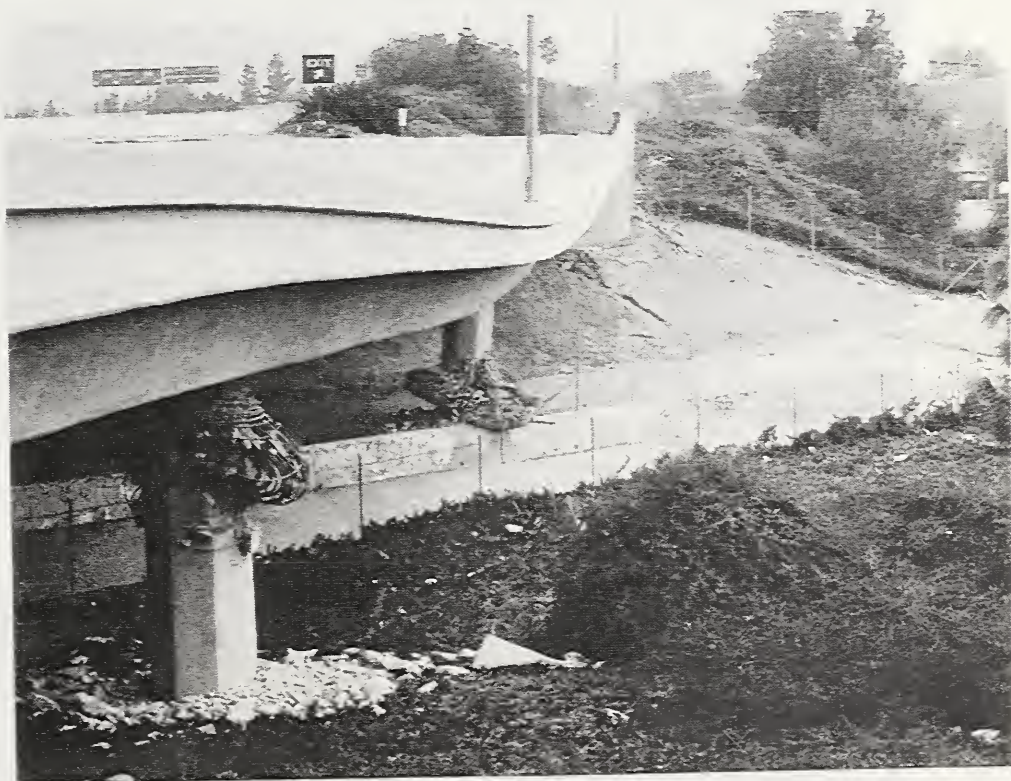
Figure 4.26 Ground-level view of State Route 118 at Bull Creek Canyon Channel, looking along the south edge, towards the east

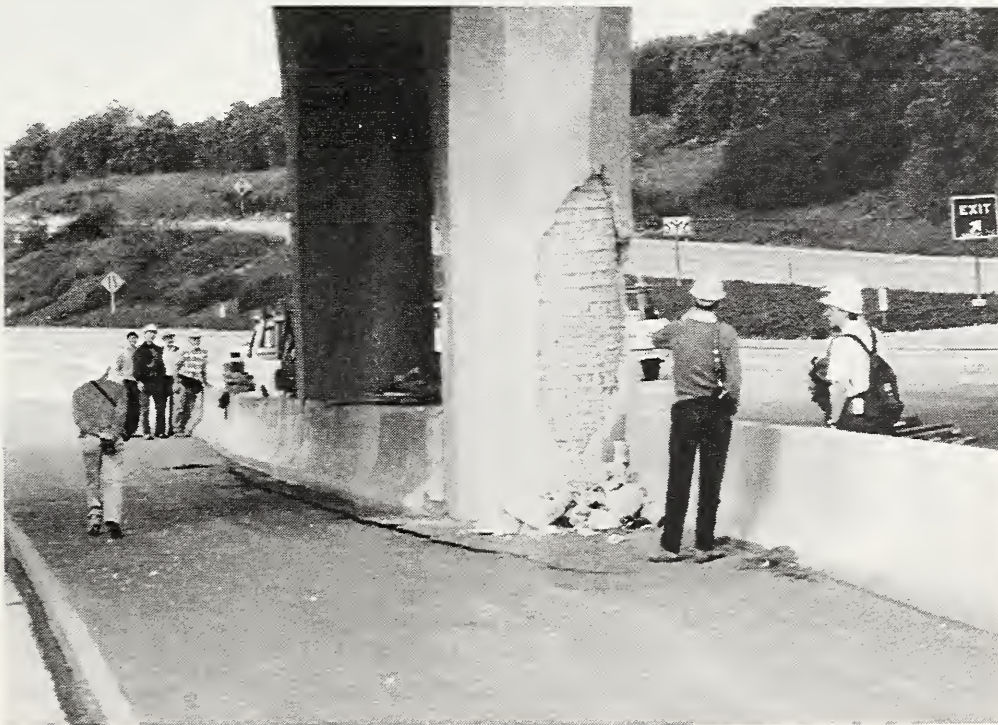
This bridge was designed in 1971, after the San Fernando earthquake. It was not damaged seriously in the Northridge earthquake. The bridge has a fairly simple configuration: a two-span prestressed concrete box girder superstructure (spans of 50.3 m and 52.4 m [165 and 172 ft.]), continuous over a central two-pier bent, with the superstructure resting on seats at each abutment. The seat lengths were generous: approximately 1500 mm (5 ft.). The bridge alignment is skewed about 21 degrees. The only significant damage suffered by the bridge was extensive spalling at one of the central piers, as shown in Figure 4.31. The pier damage appeared to be limited to the cover concrete. This pier could be repaired relatively easily, and the bridge returned to full service. The spiral hoop reinforcement in the piers was #5 (16 mm) spirals spaced 89 mm (3.5 in.), which is similar to the level of confining reinforcement required by current design codes. It is interesting to note that these piers have similar geometry and reinforcement content as the piers at the nearby Mission-Gothic Undercrossing, which were severely damaged. However, these piers are more flexible because they are taller and have a somewhat smaller diameter than the piers at the Mission-Gothic Undercrossing.

The good seismic performance of this bridge can probably be attributed to two factors. First, the central piers performed well because they contained adequate confining reinforcement and they were slender enough that they were not prone to a shear-dominated failure mode. Second, the overall geometry of the bridge is fairly compact, so that much of the lateral forces were carried by the abutments rather than the central piers. It is not common to see extensive seismic damage to short-span overpasses of this type.

Figure 4.31 SR118 Ruffner Ave. Overcrossing, easternmost central pier, looking to the west

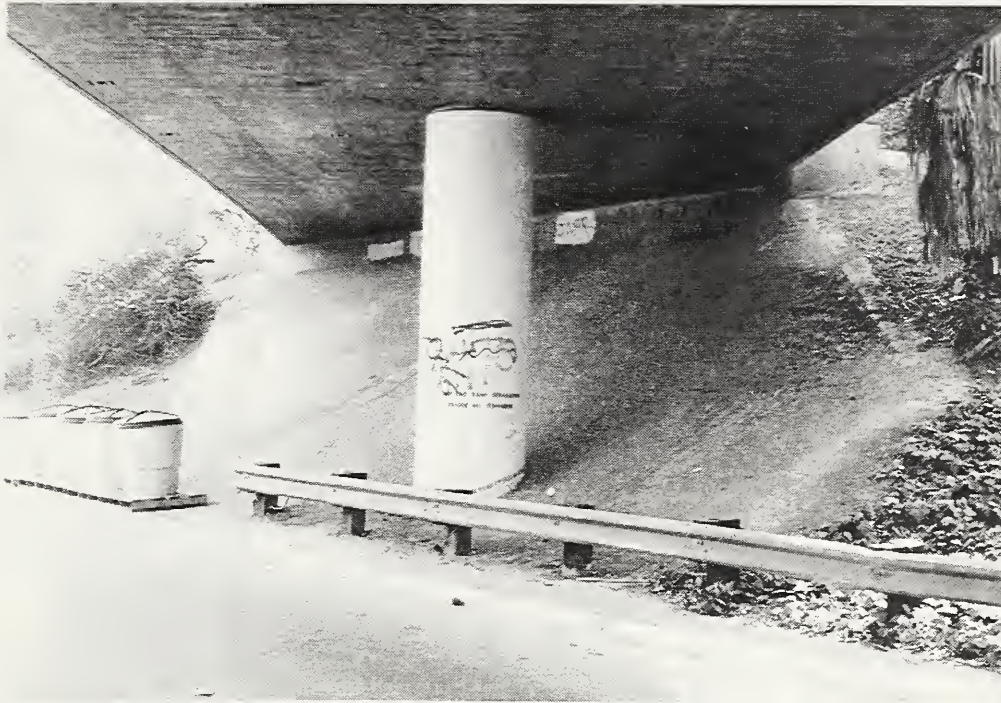
Figure 4.34 Cadillac Ave. ramp; view to east showing jacketed pier

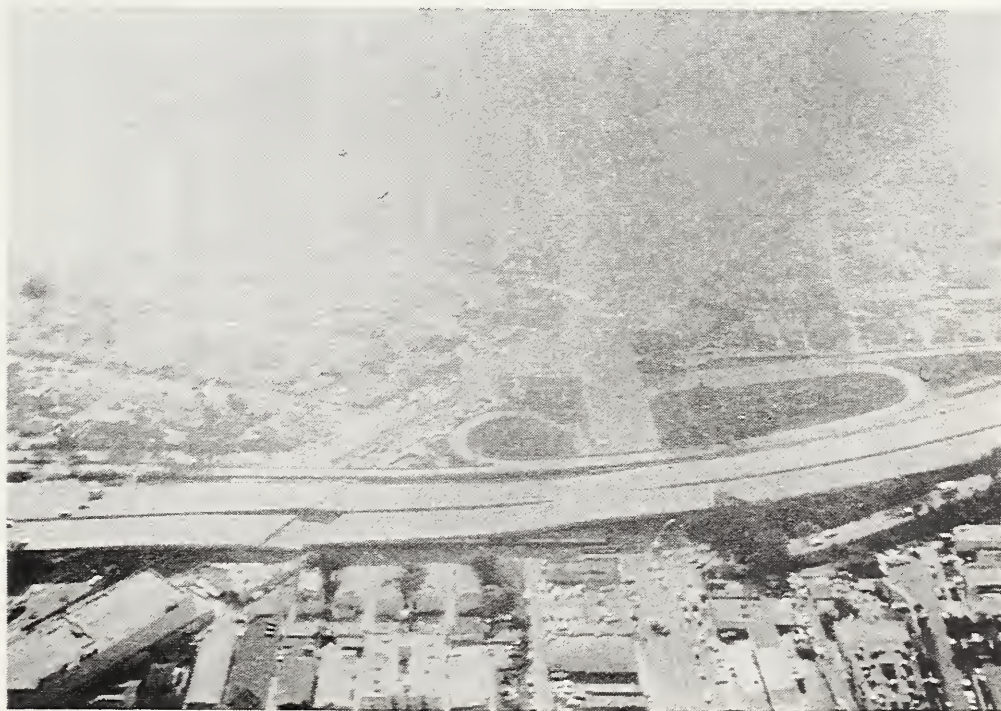
Figure 4.35 is an aerial view of I10 where it passes over La Cienega Blvd. and Venice Blvd. The view is toward the south, and Venice Blvd. is the diagonal street on the left side of the photograph. The portion of the westbound lane which collapsed to ground level can be seen. However, there was extensive damage to most of the supporting piers of the eastbound and westbound lanes.

Figure 4.35 Aerial view (looking south) of I10 Separation at La Cienega Blvd. and Venice Blvd., (Courtesy of FHWA)

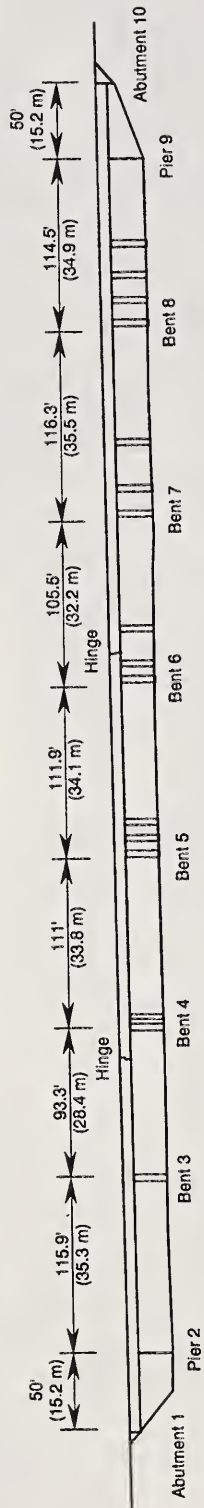
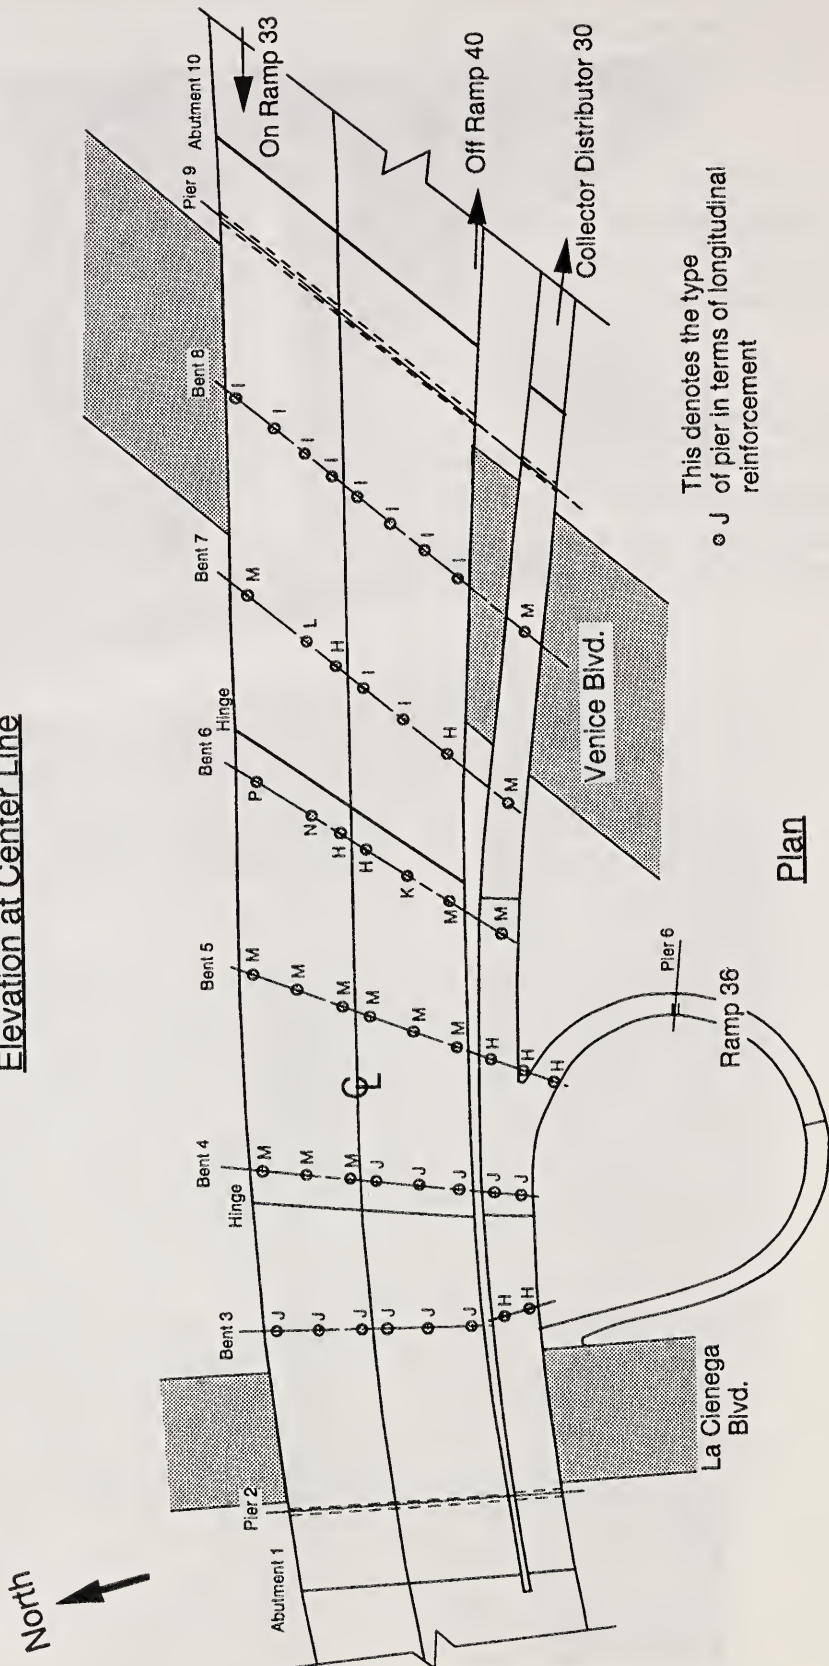
Figure 4.36 Elevation and plan of I10 Separation at La Cienega Blvd. and Venice Blvd.

Figure 4.36 shows elevation and plan views of the nine-span bridge structure. Solid wall piers provided support adjacent to the abutments, and the remainder of the supports were multiple-pier bents. Two expansion joints (hinges) were provided as shown. Bents 3 to 7 included three supporting piers for each lane, while Bent 8 had four piers per lane. The exit ramp to La Cienega Blvd. and the eastbound collector-distributor did not collapse. Figure 4.37 shows the pier details. The piers had circular cross sections with a diameter of 1220 mm (4 ft.), and the longitudinal reinforcement consisted of #11 (35 mm) or #18 (57 mm) deformed bars. The different pier reinforcement configurations were identified by pier "types" as shown in Figure 4.37. These pier types are indicated in the plan shown in Figure 4.36. The lateral reinforcement consisted of #4 bars (13 mm) at 305 mm (12 in.) vertical spacing.

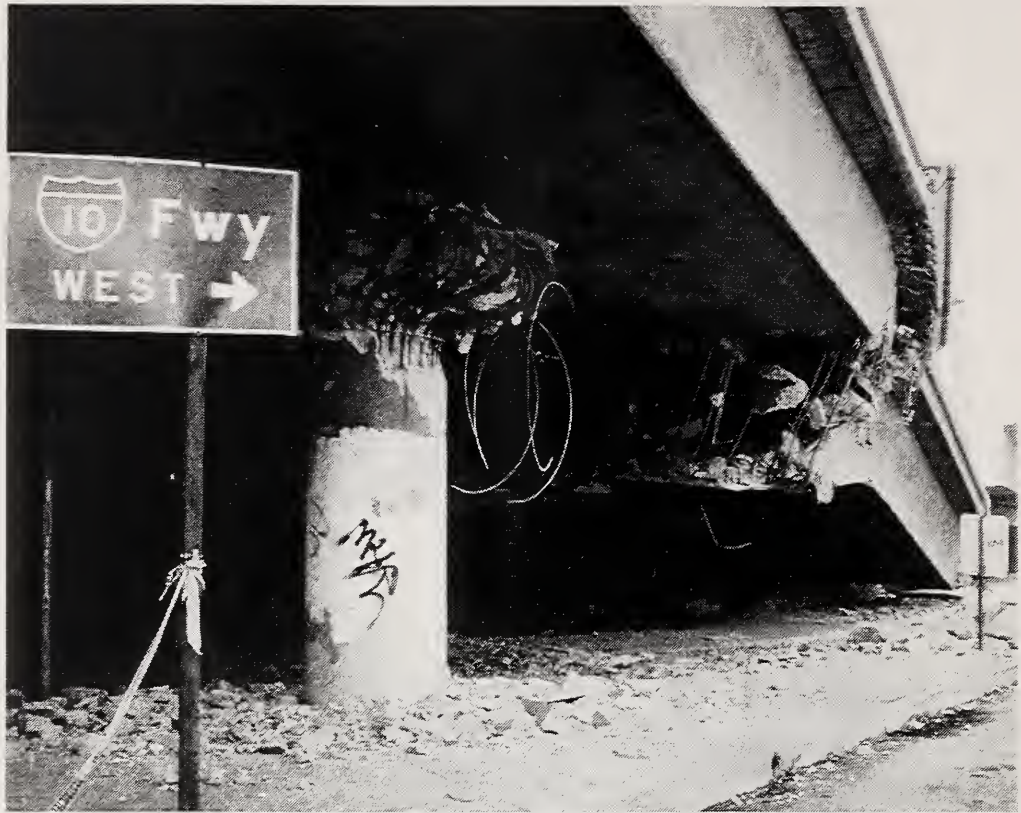
Figure 4.38 is a ground-level view of the portion of the westbound lane that collapsed to the ground at the hinge located between Bents 7 and 6. The pier in the foreground is the northernmost pier of Bent 7. It is seen that there was extensive column shortening due to the failure of the lateral reinforcement to provide adequate confinement of the core concrete. Fractured lateral reinforcement can be seen to the right of the failed portion of the pier. Figure 4.39 shows the other two piers of Bent 7 which supported the westbound lane. Extensive failure and column shortening is evident. The concrete block wall behind the piers is part of a storage

building that was constructed beneath the bridge structure. The storage building extended from Venice Blvd. to La Cienega Blvd. The piers of Bent 7 which supported the eastbound lane suffered relatively minor damage, and the roadway to the east of Bent 7 remained largely at its original elevation.

In summary, the bridge structure spanning La Cienega Blvd. and Venice Blvd. was extensively damaged. The failure is attributed to the small amount of lateral pier reinforcement. As the piers cracked due to the lateral loading, the lack of adequate confinement resulted in a reduction of the vertical load capacity because of core concrete loss and buckling of the longitudinal bars. Had it not been for the storage building located beneath the bridge, it is likely that more spans would have collapsed to the ground.

Figure 4.38 Collapsed westbound lane of I10 at Venice Blvd.; pier of Bent 7 in foreground

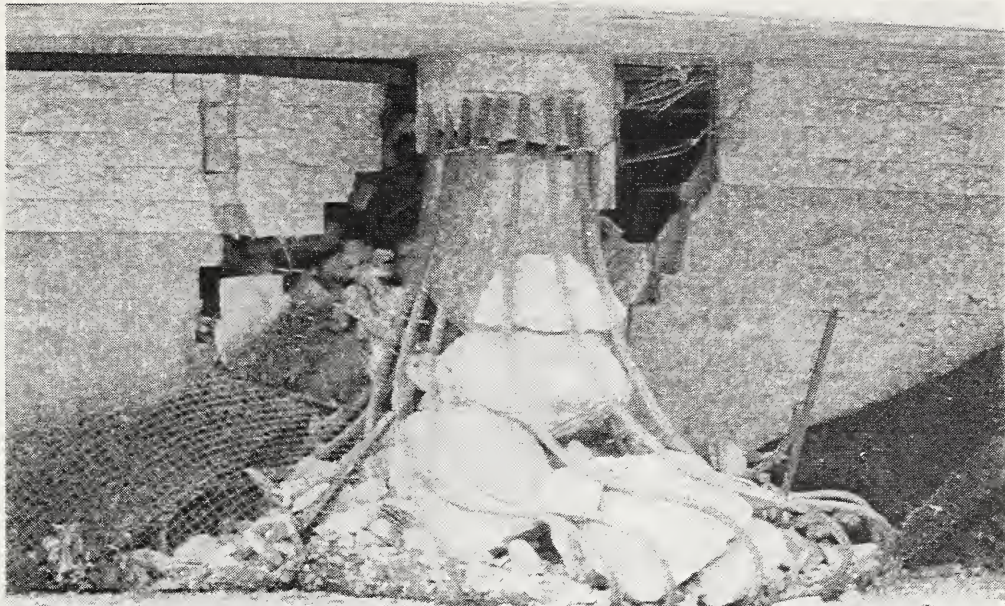
Figure 4.40 shows the northernmost pier of Bent 6, located just to the west of the hinge. This pier totally disintegrated, but the storage building prevented the roadway from collapsing to the ground. Figure 4.41 shows the southernmost pier supporting the eastbound lane at Bent 3. The top of the pier is severely damaged and it is likely that the storage building prevented the total collapse of the roadway.

Figure 4.40 Northernmost pier of Bent 6 supporting westbound lane of I10 (west of Venice Blvd.)

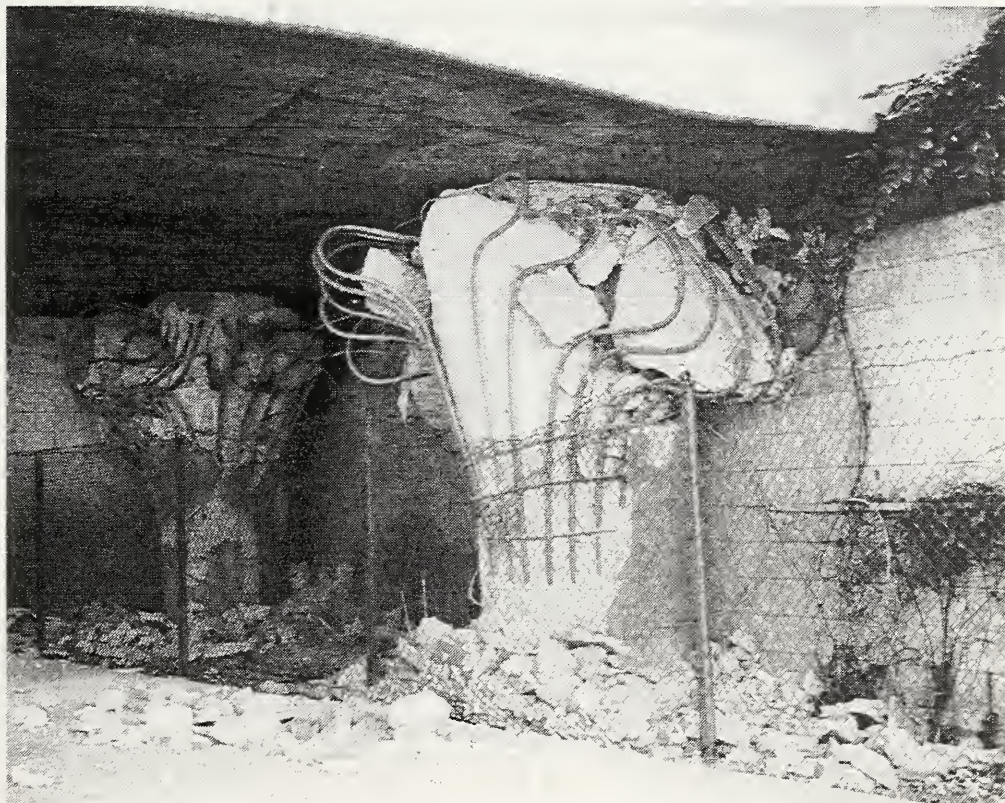
Figure 4.41 Piers of Bent 3 supporting eastbound lane of I10 at La Cienega Blvd.
