1994 Northridge Earthquake

Performance of Structures, Lifelines and Fire Protection Systems

NISTIR 5396

March 1994
Building and Fire Research Laboratory
National Institute of Standards and Technology
Gaithersburg, MD 20899

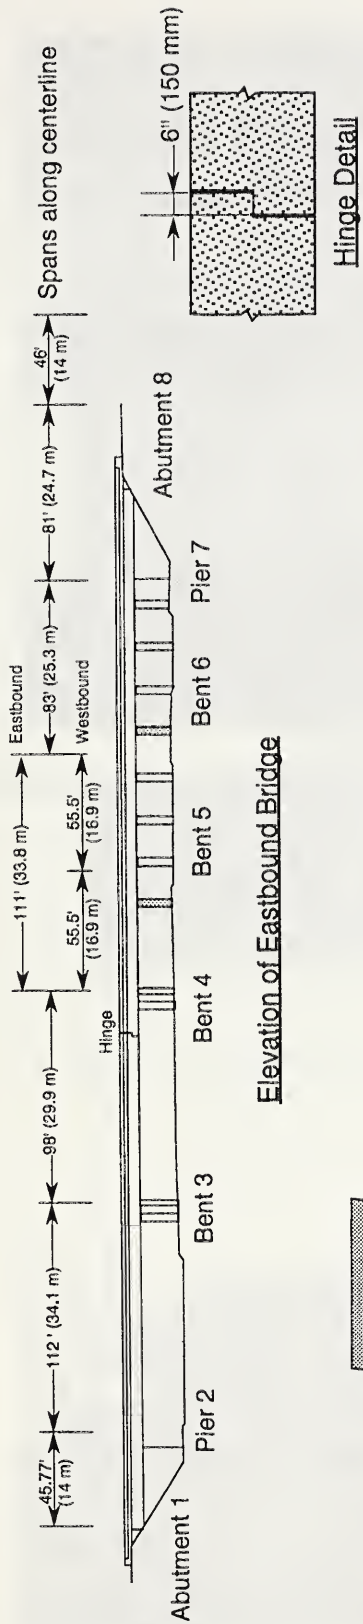
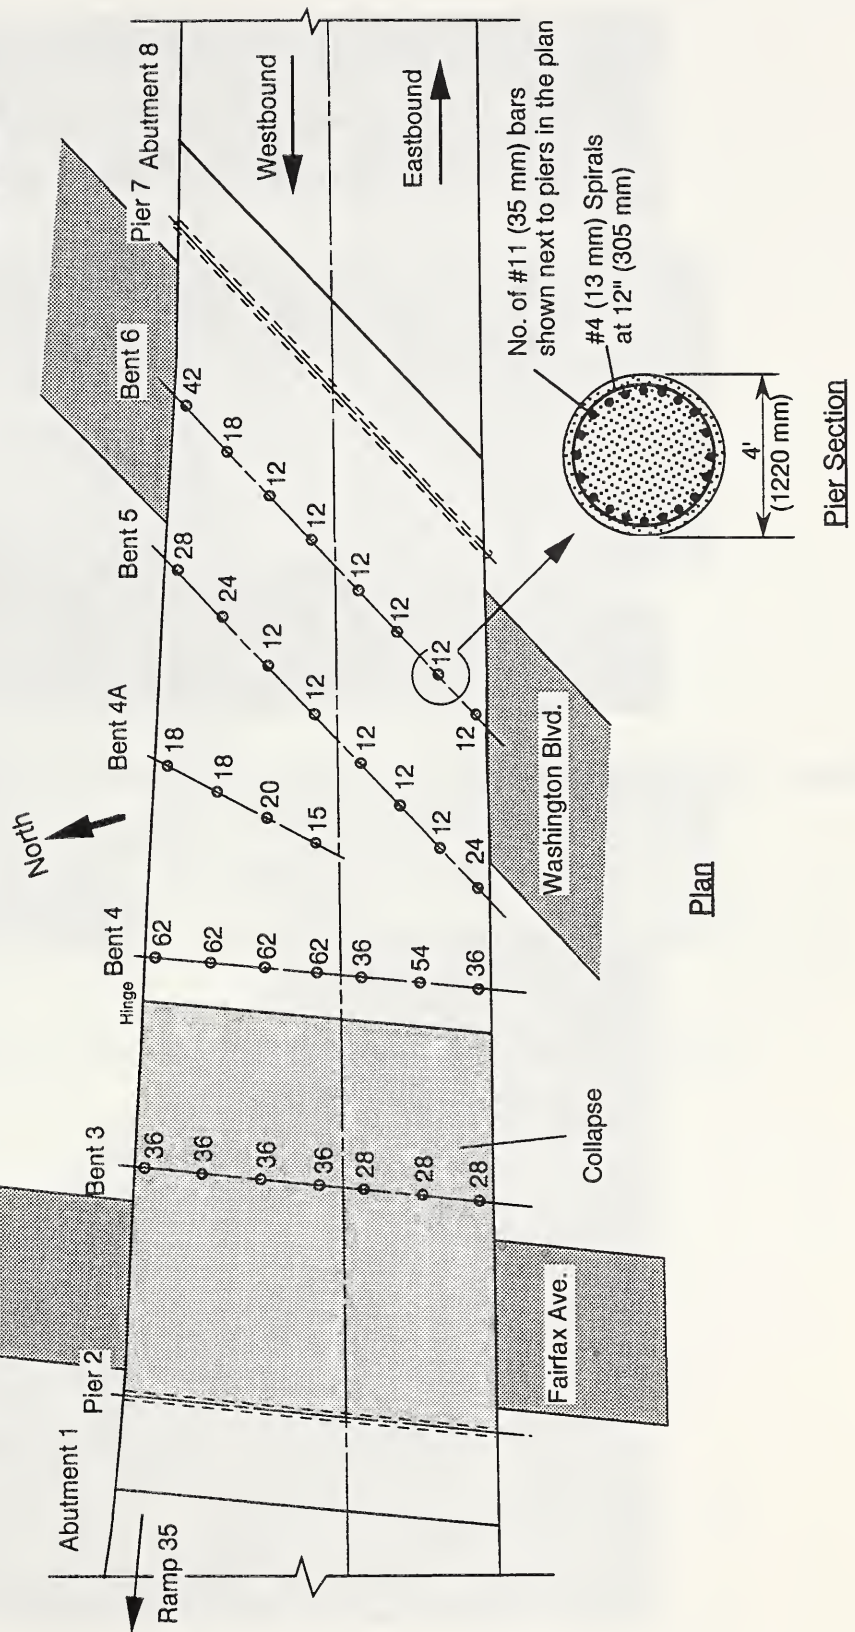
Figure 4.42 Elevation and plan of I10 at the Fairfax Ave./Washington Blvd. Under Crossing

The earthquake caused partial collapse of two spans of the eastbound and westbound lanes on either side of Bent 3 (Figure 4.42). When the reconnaissance team arrived at the site, the collapsed spans had been completely removed and workmen were preparing to open up traffic on Fairfax Ave. Hence it was not possible to examine the collapsed structure. Conversations with Caltrans engineers at the site revealed that the piers in Bent 3 had failed and caused the girders to sag at this location. However, cable restrainers at the hinge west of Bent 4 prevented the girders from falling off of the hinge seats (Figure 4.43). Figure 4.44 is a photograph provided by EERC which shows the westbound lane of I10 over Fairfax Ave. It can be seen that the piers in Bent 3 shortened and caused the girder to sag. It can also be seen that the span to the west of Pier 2 lifted off of the abutment. Figure 4.45 is a close up view of one of the piers in Bent 3. The failure mode is similar to that observed at Venice Blvd. and La Cienega Blvd. When the piers were subjected to lateral ground motions, the lateral reinforcement was not able to adequately confine the core concrete. As a result of lateral load damage, there was a loss of axial load capacity and the piers shortened under the action of the vertical loads. As mentioned, the piers at Bent 4 had considerably more longitudinal reinforcement than the other piers. Examination of the piers in Bent 4 revealed varying degrees of diagonal cracking and spalling of the concrete cover. At the time of the site visit, these piers were surrounded with wooden shoring as a precautionary measure during the demolition of the collapsed spans.

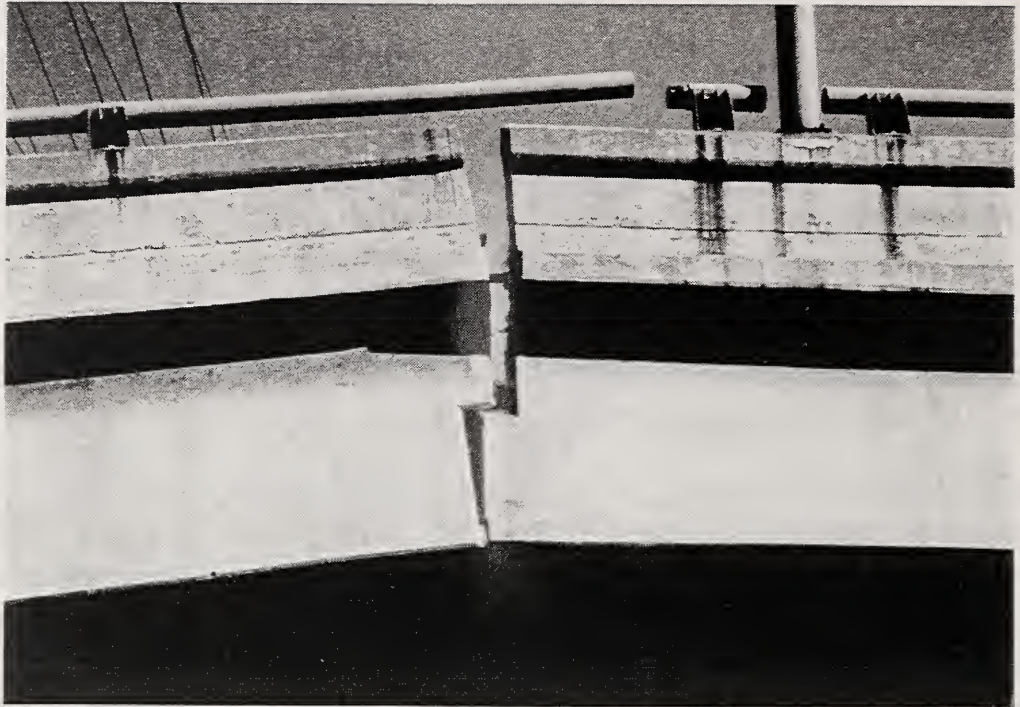
Figure 4.43 Hinge adjacent to Bent 4 of I 10 at Fairfax Ave.; cable restrainers prevented loss of support (Courtesy of EERC)

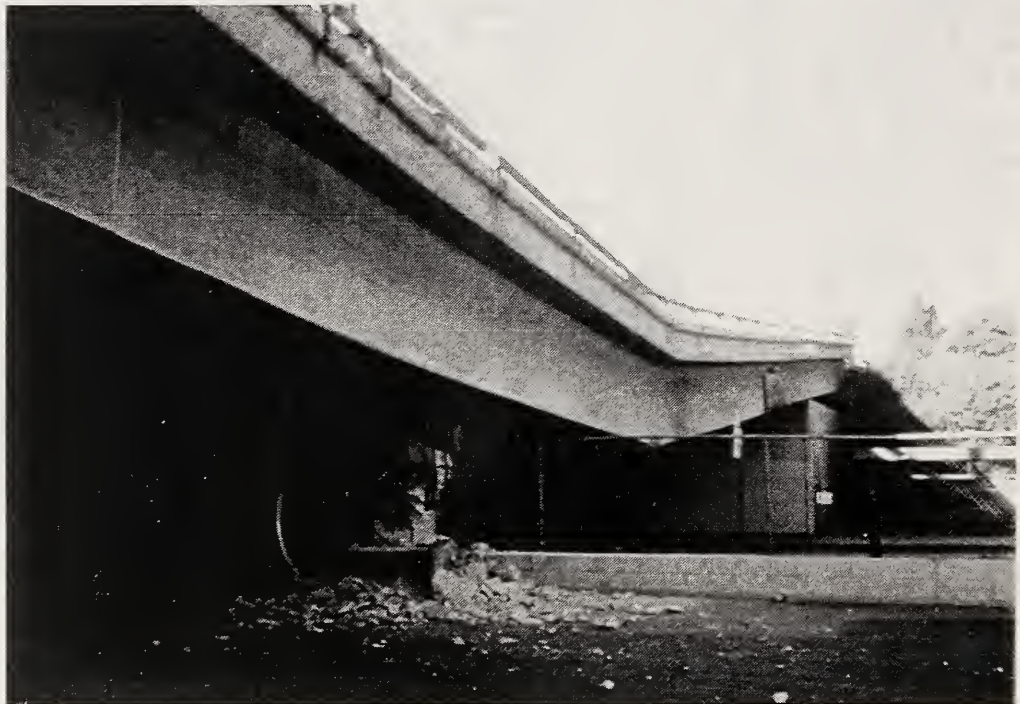
Figure 4.44 View of collapsed span of I10 over Fairfax Ave.; note rotation of girder over Pier 2 (Courtesy of EERC)

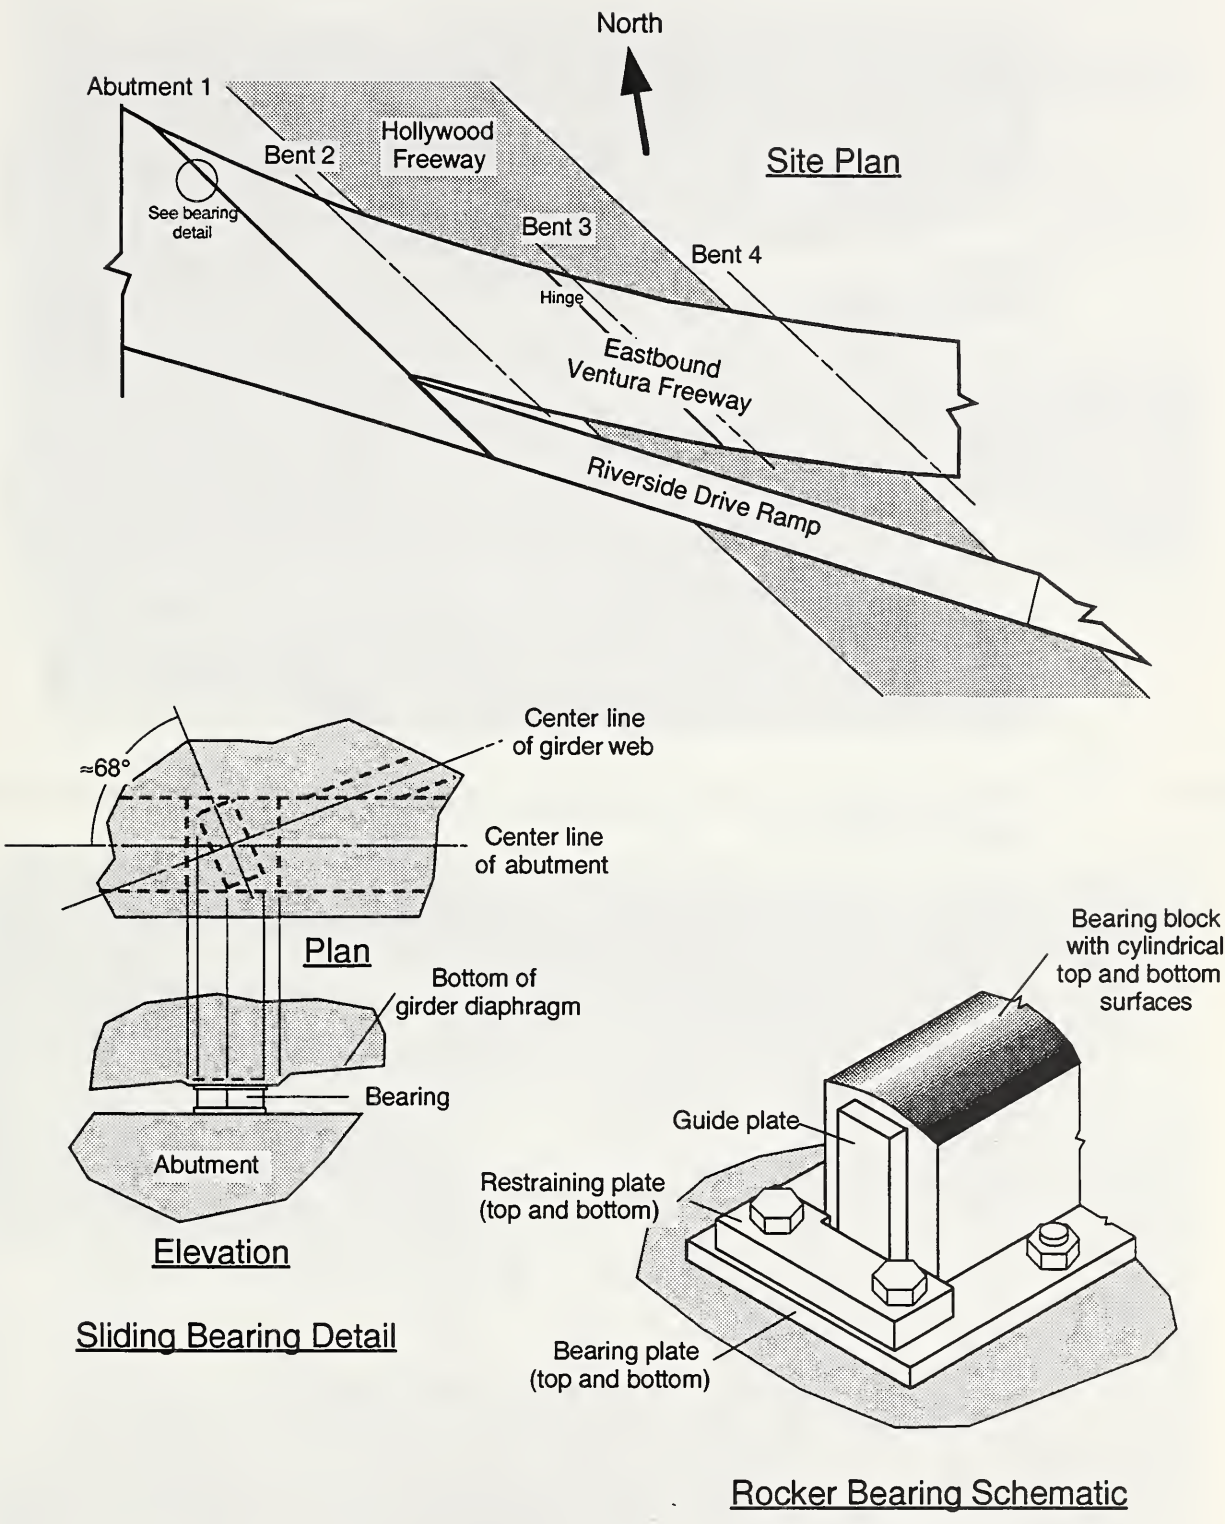
Figure 4.46 shows a simplified plan of the eastbound lane of the Ventura Freeway and the Riverside Drive ramp. Figure 4.47 is a ground level view of the eastbound lane as seen from the northbound lane of the Hollywood Freeway. At Abutment 1 (Figure 4.46), bearing supports are provided at the locations of the webs in the box girder. As shown in Fig, 4.46, the longitudinal axes of the bearings are aligned at right angles to the longitudinal axes of the girder webs. The four bearings on the north side of the eastbound lane of Ventura Freeway are of the sliding-type. Figure 4.48 shows the type of damage that was observed at these locations. Apparently, the dynamic frictional resistance of the bearing resulted in forces sufficient to spall off the shell of the abutment. The remainder of the bearings supporting the eastbound lane and the Riverside Drive ramp are of the rocker type. Figure 4.46 shows a schematic of this type of bearing. A steel bearing block with cylindrical surfaces is located between steel plates set into the abutment and girder end diaphragm. The blocks are kept in position with a system of guide plates and restraining plates as shown in Figure 4.46. All of the rocker bearings showed some type of earthquake damage. The bolts for the restraining plates were sheared off at many locations, and the sheared bolt heads were found at distances of up to several meters from their original position. Some of the bearing blocks were skewed from their original positions (Figure 4.49). In one case, the bearing block had tipped over resulting in a complete loss of support at that location (Figure 4.50).

Figure 4.46 Eastbound lane of Ventura Freeway crossing over Hollywood Freeway; site plan and bearing details

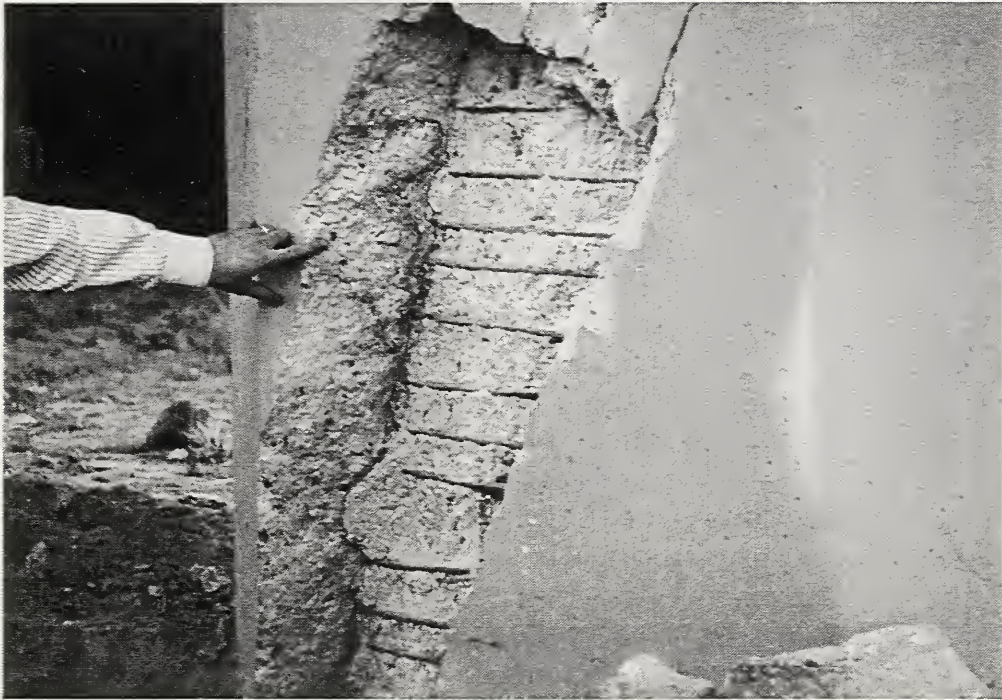
This is a long, curved ramp structure with piers of varying height. The last pier before the west abutment, adjacent to Sharp Avenue, exhibited severe shear cracking. This was one of the shortest and stiffest piers in the structure, so it probably attracted large lateral forces. Damage to the pier is shown in Figures 4.51 and 4.52. Note that when the photos in Figures 4.51 and 4.52 were taken the loose cover concrete had been removed by Caltrans workers to inspect damage to the core. It appeared that cracks extended into the core of the pier. The pier is octagonal in cross section, measuring 2440 mm (8 ft.) across, and has a flared section at the top. Longitudinal reinforcement consists of 64 #11 (36 mm) bars (EERC 1994). This pier contains high levels of shear reinforcement: #4 (13 mm) spirals spaced at 89 mm (3.5 in.). Damage to the abutment just to the west of this pier was also observed. This damage was apparently due to pounding between the superstructure and the abutment.

Figure 4.52 Close-up view of the westernmost pier at the Interstate 5, State Route 118, Southwest Connector, looking to the southeast. Loose cover concrete has been removed by Caltrans.

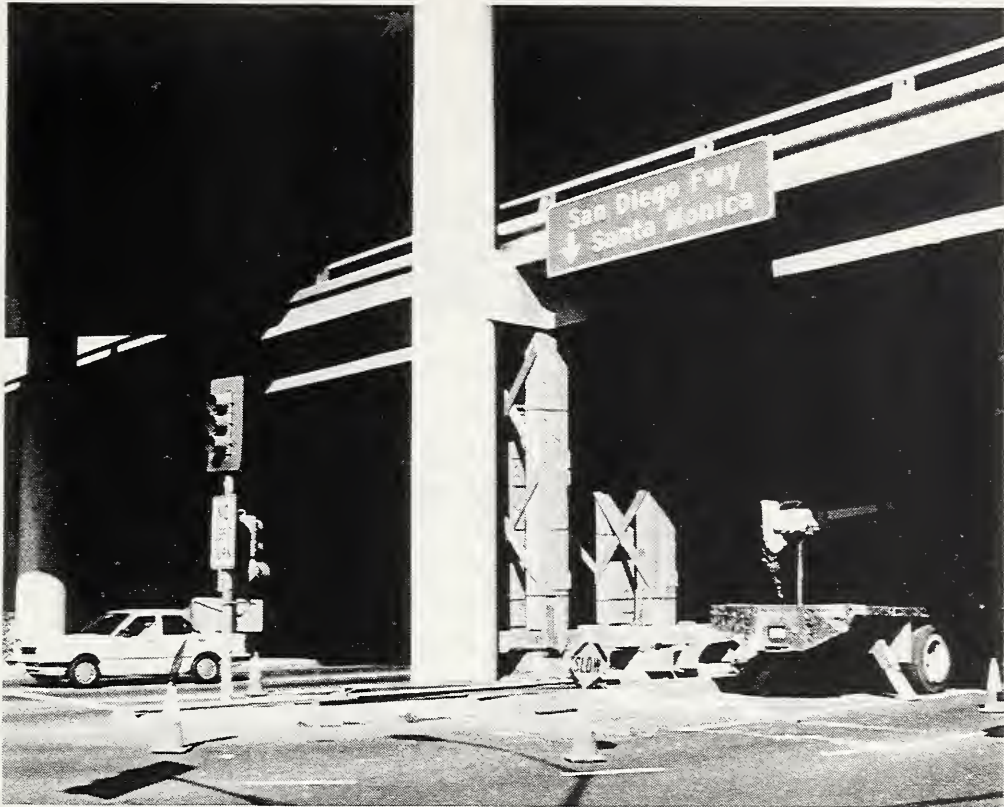
The damage observed in the Northridge earthquake possibly arose from three factors. First, the joint regions where cracking occurred are not as heavily reinforced as they would be under current design standards. Second, the structural hinges at the bases of most outrigger piers tended to increase the moments imposed on the outrigger joints. Third, the Jefferson Blvd. Undercrossing shares piers with the SR90 ramp above, as shown schematically in Figure 4.55. The upper SR90 structure is more flexible than the lower Jefferson Blvd. Undercrossing, possibly resulting in further concentrations of moments at the outrigger joints.

Figure 4.53 Overview of the outrigger joint at the SR90/I405 interchange, Jefferson Boulevard Undercrossing, center bent, west side, looking to the north

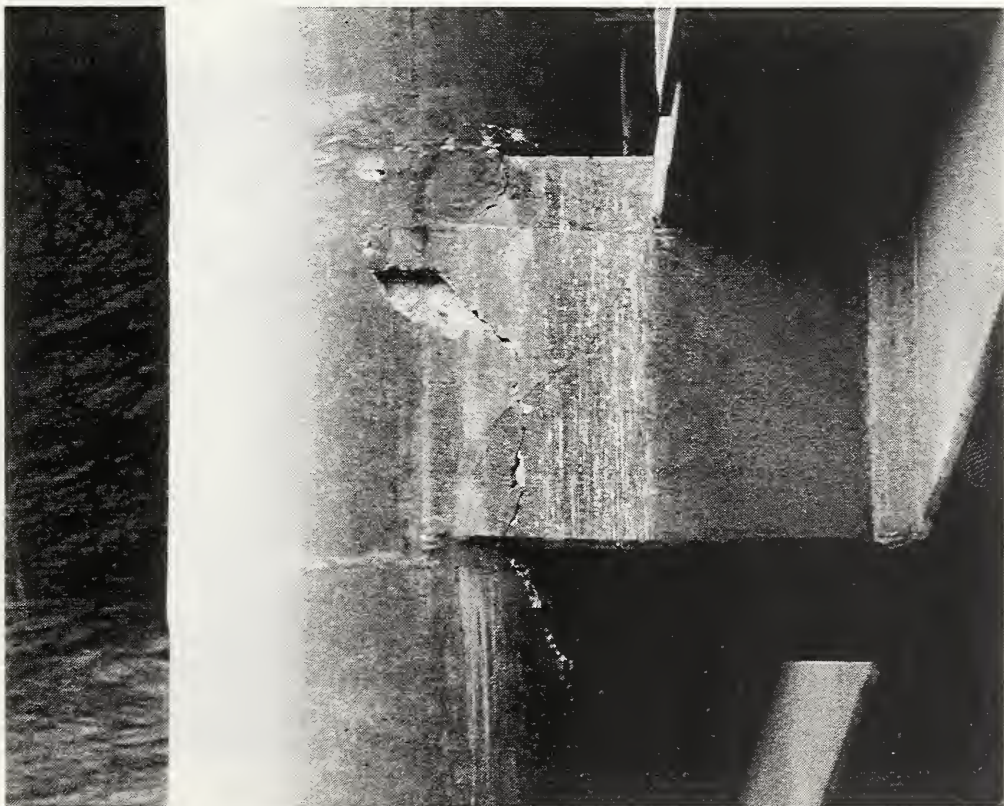
Figure 4.54 Close-up of the outrigger joint at the SR90/I405 interchange, Jefferson Boulevard Undercrossing, center bent, east side, looking to the south

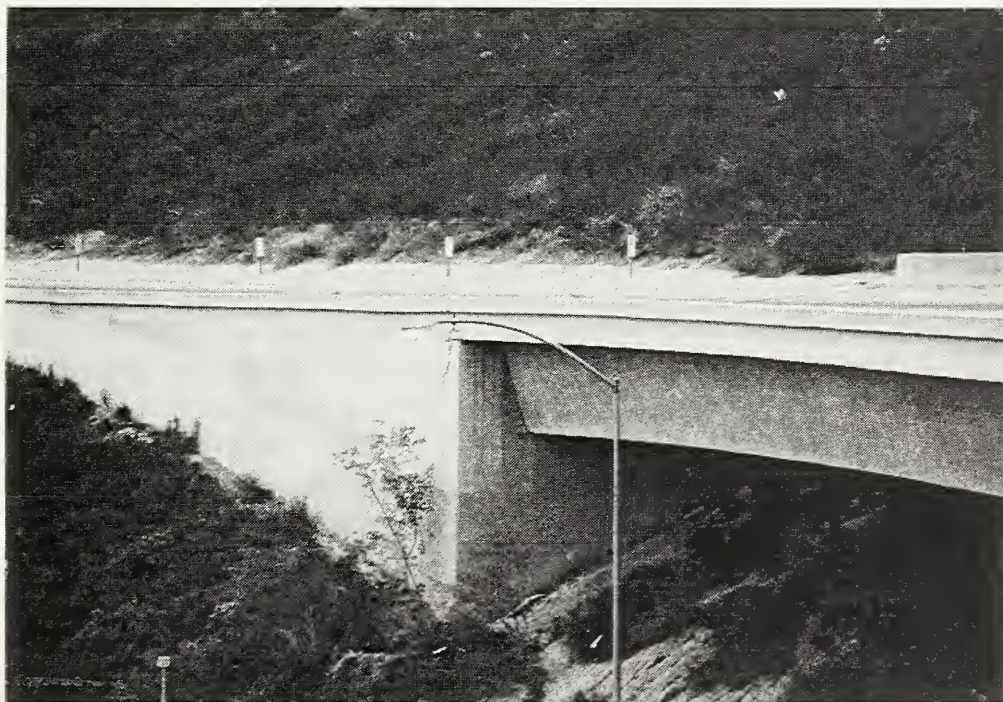
In the Northridge earthquake, bridge abutment damage ranged from minor settlement of backfill soil at the approaches, to cracking of wing walls, to permanent displacement of the entire abutment. For example, at the intersection of State Route 118 and Interstate 210, there was damage to the abutment at the east end of the long elevated structure connecting eastbound SR118 with northbound I210. An overview of the abutment is shown in Figure 4.56, and a close-up of some of the abutment sidewall cracking is shown in Figure 4.57. At the interchange of US101, SR134 and SR170, at the Riverside Drive Offramp Overcrossing (Caltrans bridge No. 53-1493S, described above) the abutments at both ends of the offramp exhibited severe cracking in the wing walls. Damage to concrete abutment piles was reported (EERC, 1994) at the Las Virgenes Overcrossing on US101 (Caltrans bridge No. 53-1442). There were many other cases of bridge abutment damage observed by the reconnaissance team, and reported by other investigators, which are too numerous to list here.

Figure 4.56 Overview of abutment at the east end of the ramp connecting eastbound SR118 with northbound I210

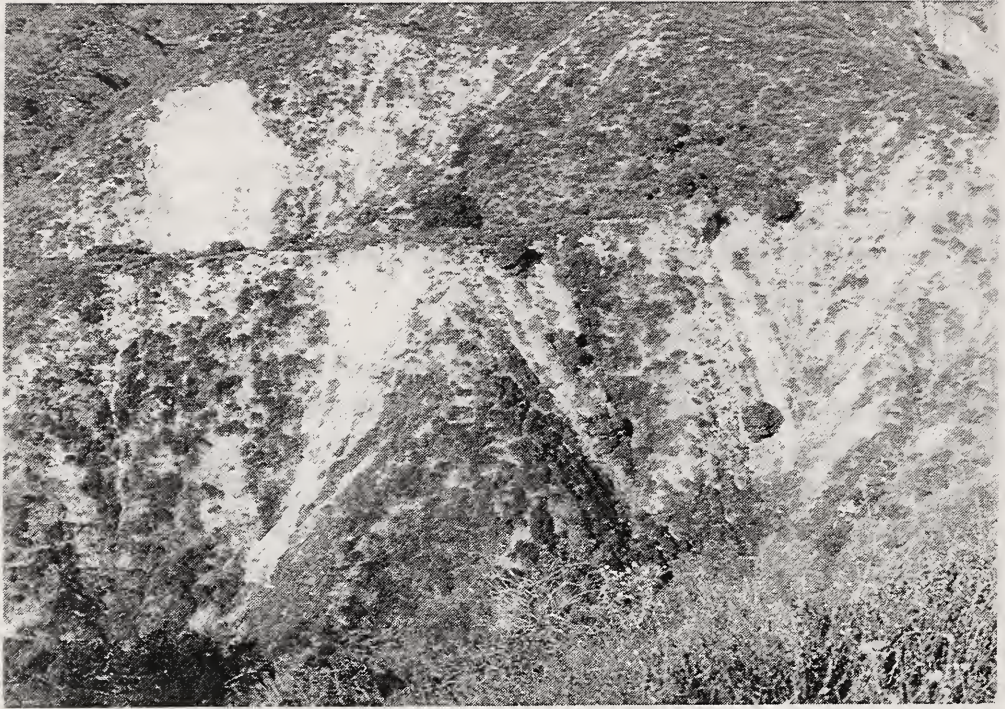
Among the numerous situations that contributed to the disruption of the water supply system was damage to one of the four damaged pipelines, Los Angeles Aqueduct No. 2 at Terminal Hill. Aqueduct No. 2 is made of 2.1-m (77 in.) diameter steel pipes. (Pipeline diameters range from 1.4 to 3 m (54 to 120 in.)) Terminal Hill is located about 20 km (12.5 miles) north-northwest of the epicenter, southwest of the intersection of I-5 and SR14. There is no strong motion record available for the site. However, two stations maintained by the California Division of Mines and Geology (CDMG) and the U.S. Geological Survey (USGS) about 5 km (3 miles) south of the site showed peak ground accelerations over 0.9g, indicating that the site probably was strongly shaken by the earthquake. Another indication of strong shaking can be seen from the numerous landslides along the mountainside to the north of the site (Figure 5.1).

Figure 5.1 Strong shaking at Aqueduct No. 2 at Terminal Hill can be inferred from the numerous landslides along the mountain slopes to the north of the site.

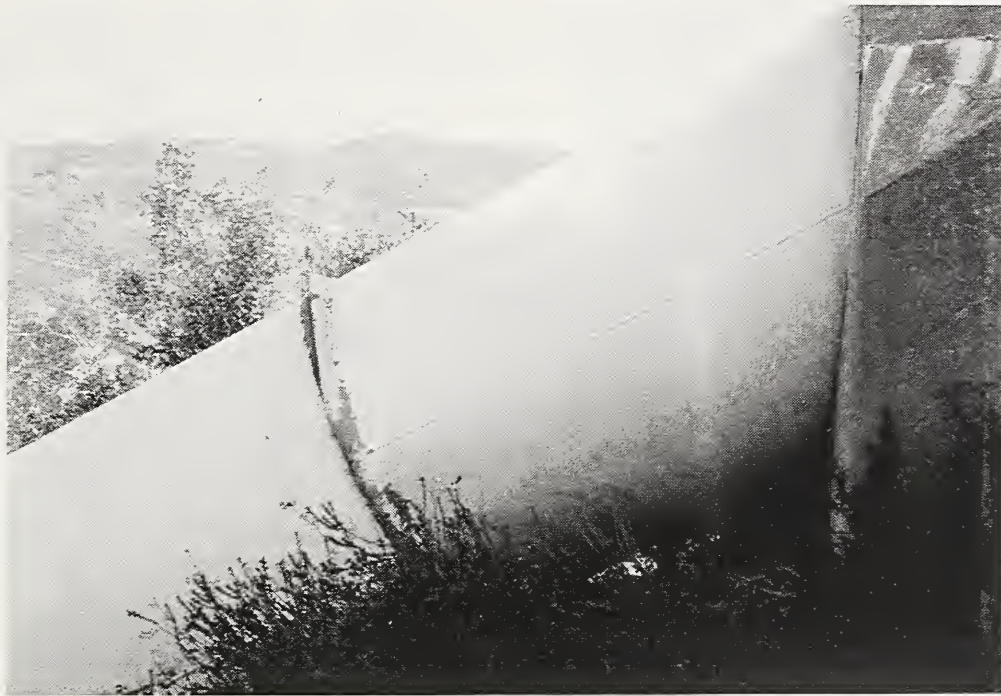
The reinforced concrete relief tank (surge chamber) on top of the hill appeared to perform well through the earthquake--no damage was observed (Figure 5.2). A steel pipe brings water up from the canyon below (Figure 5.3). The pipe is supported on concrete saddles built along the mountain slope. In a few places, the pipe separated from the saddles creating 50 to 80 mm (2 to 3 in.) gaps. In at least one location, the pipe crashed into the saddle. In two other locations, the pipe sections bulged 80 mm and 150 mm (3 and 6 in.) respectively. However, no rupture or leakage was noticed. The ruptured section of the 2.1-m pipe is located near top of the hill. The two sections where the rupture occurred were connected together using a mechanical coupling system (Figure 5.4). To restrain the relative movement between the two pipe sections during strong shaking, the sections were connected by eight pairs of restrainer rods 35 mm (1-3/8 in.) in diameter and 2.2 m (7 ft) long. The rods were attached to brackets, which were welded to the pipes. These welds broke due to strong shaking (Figure 5.5) and resulted in the separation of the two pipe sections.

Figure 5.3 The steel pipeline at Terminal Hill separated from its supporting saddle at several places and pipe sections bulged at other locations along the alignment.

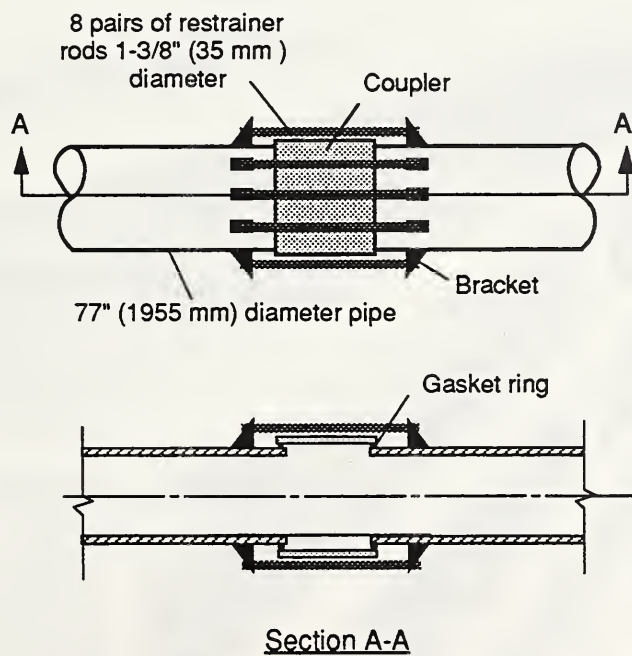
Figure 5.4 Schematic drawing of connection of the two steel pipe sections which were pulled apart during the earthquake.

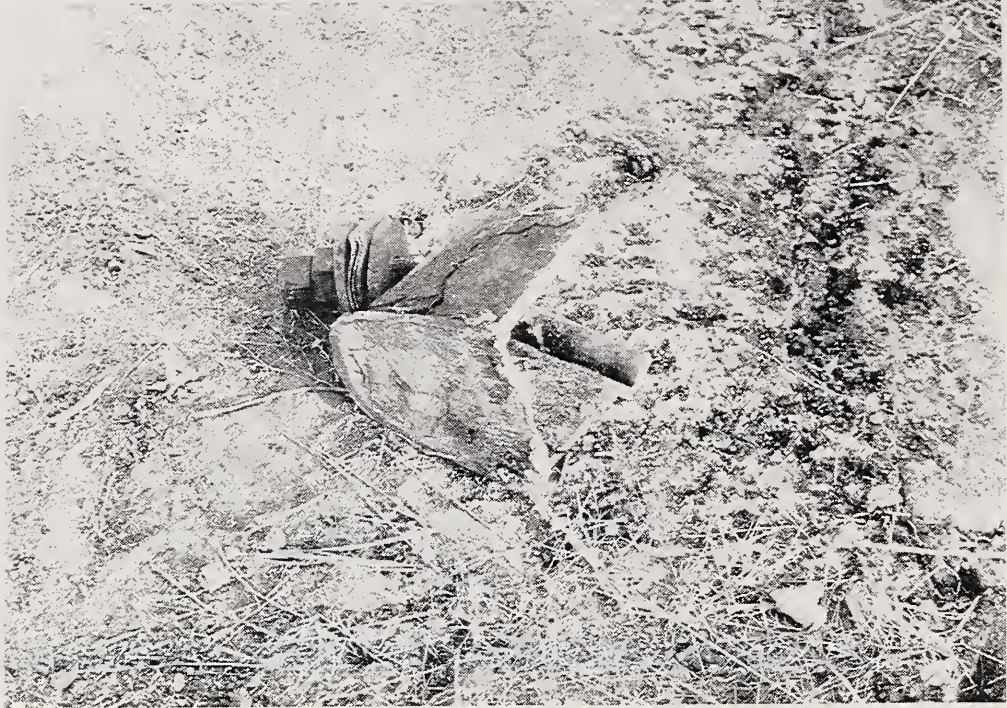
Figure 5.5 Welds of the restrainers broke as the result of strong shaking.

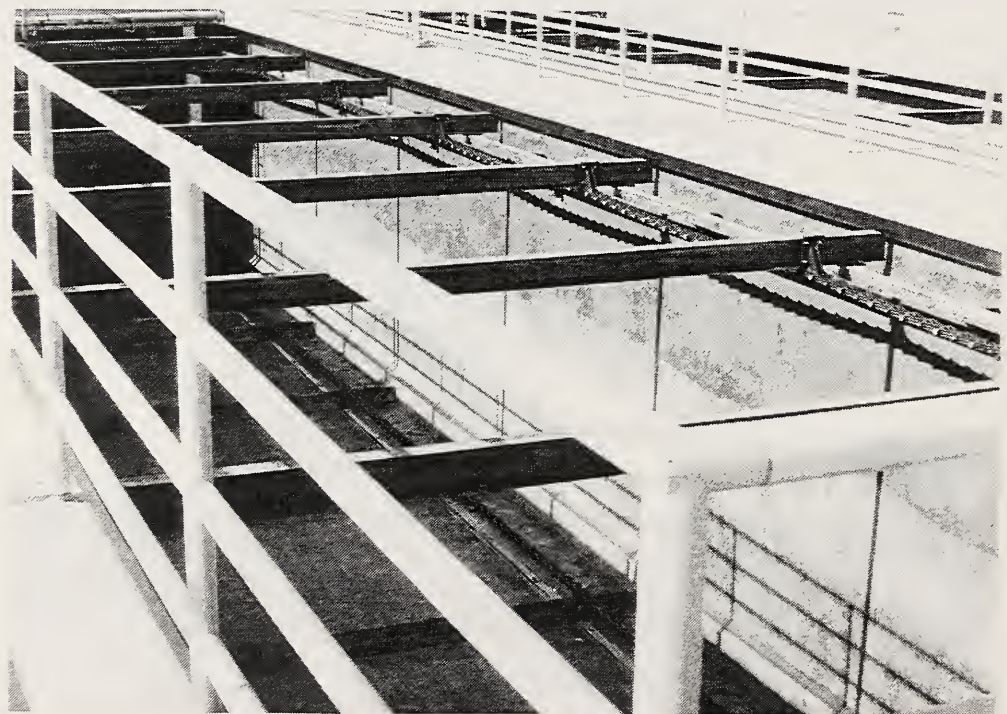
Figure 5.6 Undamaged clarifier tank at the Tillman Water Reclamation Plant.

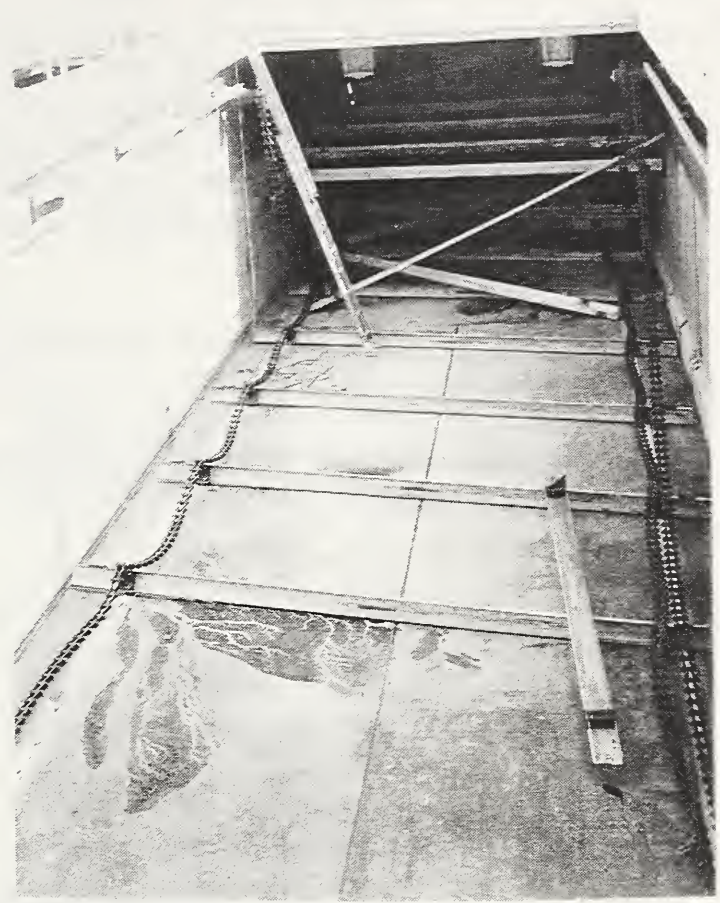
The earthquake resulted in damage to five out of twenty-two final clarifier tanks built in 1991 as the Phase II expansion. Twenty-two Phase I tanks built in 1983 survived the earthquake without damage. Figure 5.6 shows a typical undamaged final clarifier tank. The scrapers are supported by railings attached to the walls with brackets. Chains are used to move the scrapers. All these components were made of plastics in the Phase II construction, whereas the brackets were made of metal and railings and scrapers were made of redwood in Phase I. Pins about 10 mm (3/8 in.) in diameter and 19 mm (3/4 in.) long connected the brackets to the railings. In the tanks where the system failed, it is suspected that the pins dislodged as the result of wave action in the tank and displaced the railing, therefore jamming the movement of the chain, which disabled the system (Figure 5.7).

Figure 5.7 A damaged sludge scraper in a clarifier tank at the Tillman Water Reclamation Plant.

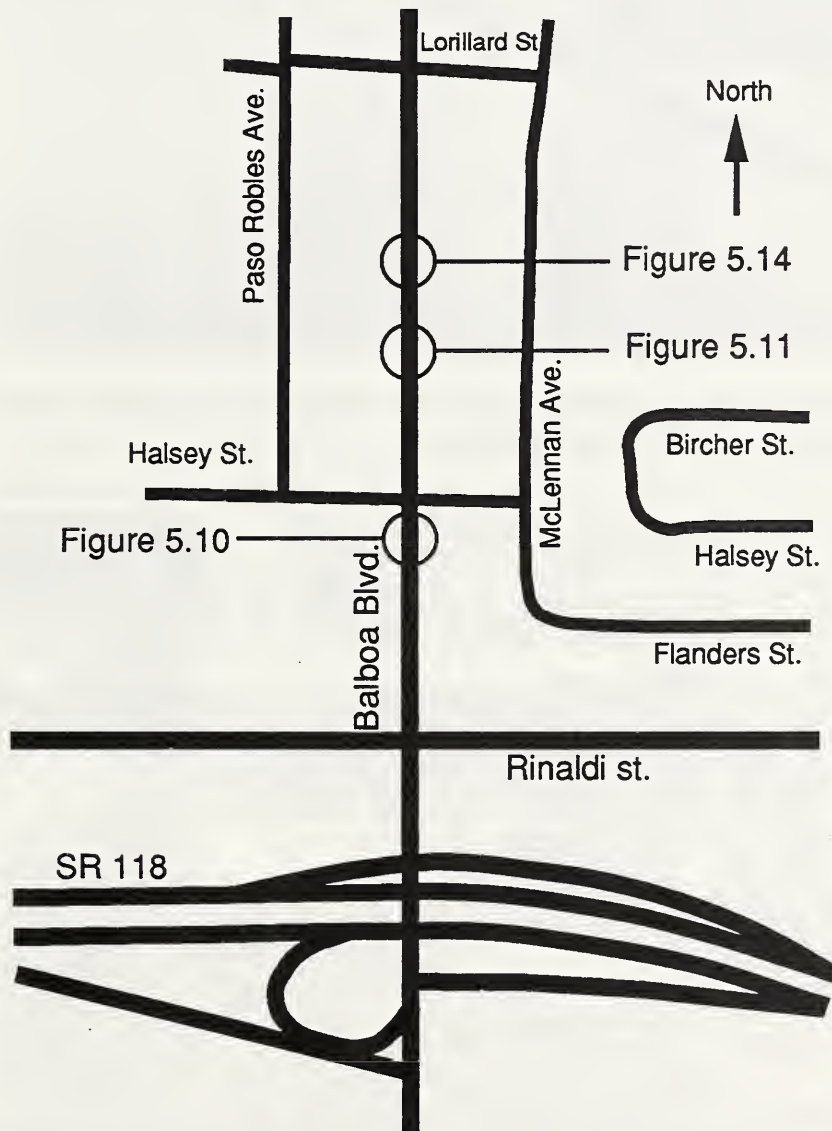
The rupture of a 0.6-m (22-in.) gas main occurred along Balboa Boulevard between Rinaldi Street to the south and Lorillard Street to the north, about 0.5 km (0.3 miles) north of the intersection of Balboa Boulevard and SR118 (Figure 5.8). Along this stretch, compressional ground failures occurred between Rinaldi Street and Halsey Street, and extensional ground failures occurred between Bircher Street and Halsey Street. Ground extension at this location is prominently exhibited by the transverse cracks in the pavement as shown in Figure 5.9. Further, lateral spreading of 25 to 100 mm (1 to 4 in.) toward the west was observed along the sidewalk on the west side of Balboa Boulevard north of Halsey Street, whereas no lateral spreading was observed on the east side of Balboa Boulevard.

Figure 5.8 Location of the 0.6-m gas main rupture on Balboa Boulevard.

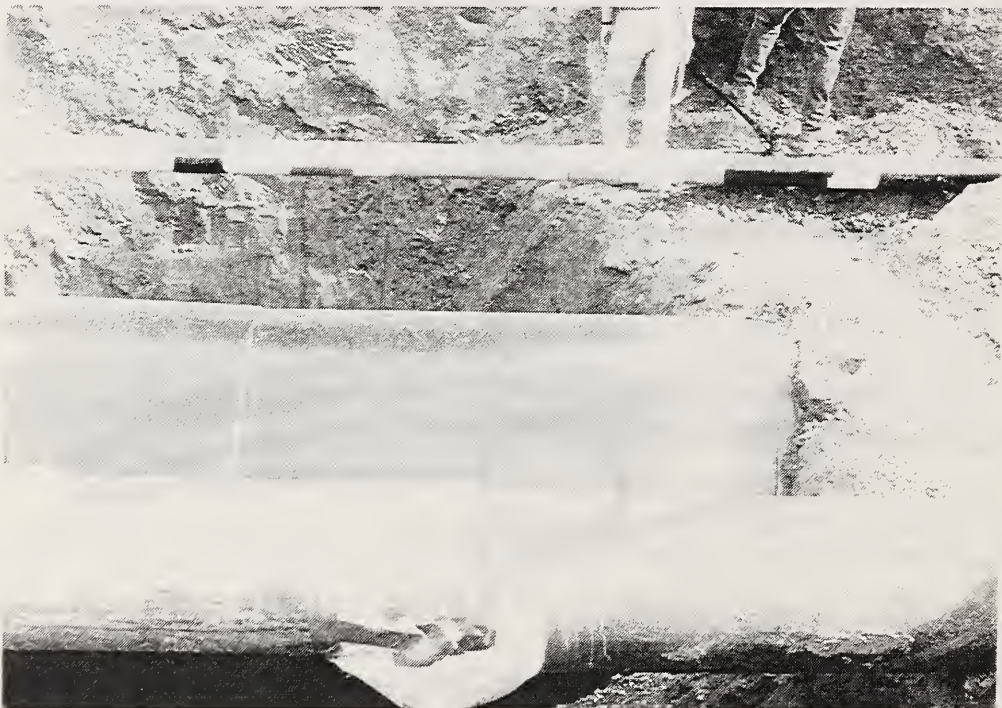
Three pipelines ruptured as the result of ground contraction; a 150-mm (6-in.) gas distribution line, the 1.8-m (68-in.) Rinaldi trunk water line, and a 0.6-m (22-in.) gas main (Figure 5.10). The Rinaldi trunk line was of post-1971 construction and the gas main was of 1930 vintage. These pipes showed a shortening of 125 to 150 mm (5 to 6 in.).

Figure 5.10 Ground contraction along Balboa Boulevard caused the rupture of a gas distribution line, the Rinaldi trunk water main, and a gas main.

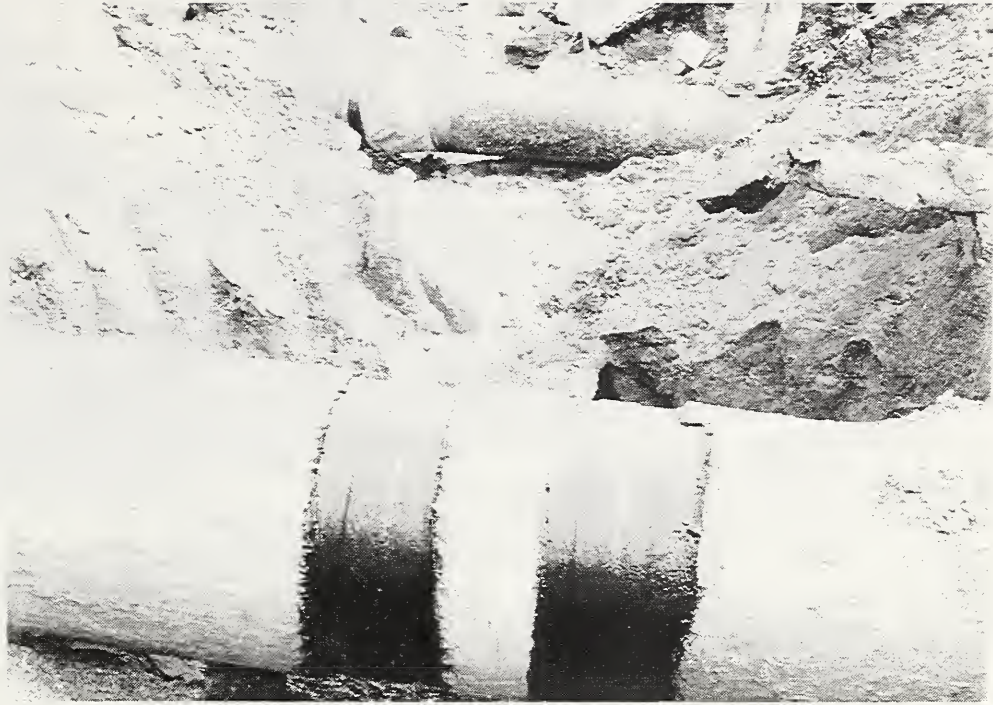
About one block north, the ground extension caused rupture of the same 0.6-m (22-in.) gas main and a 1.2-m (48-in.) water main (Figure 5.11). These pipes were pulled apart as the result of the ground extension. The rupture of the gas main caused a major fire at the site that destroyed five houses (Figures 5.12 and 5.13). The loss of both water mains at this location and the difficult access to the site due to the fire and flooding in the street made fire fighting difficult.

Figure 5.11 Ground extension along Balboa Boulevard resulted in the rupture of the same gas main and water main shown in Figure 5.10. The rupture of the gas main here caused a major fire that engulfed five houses.

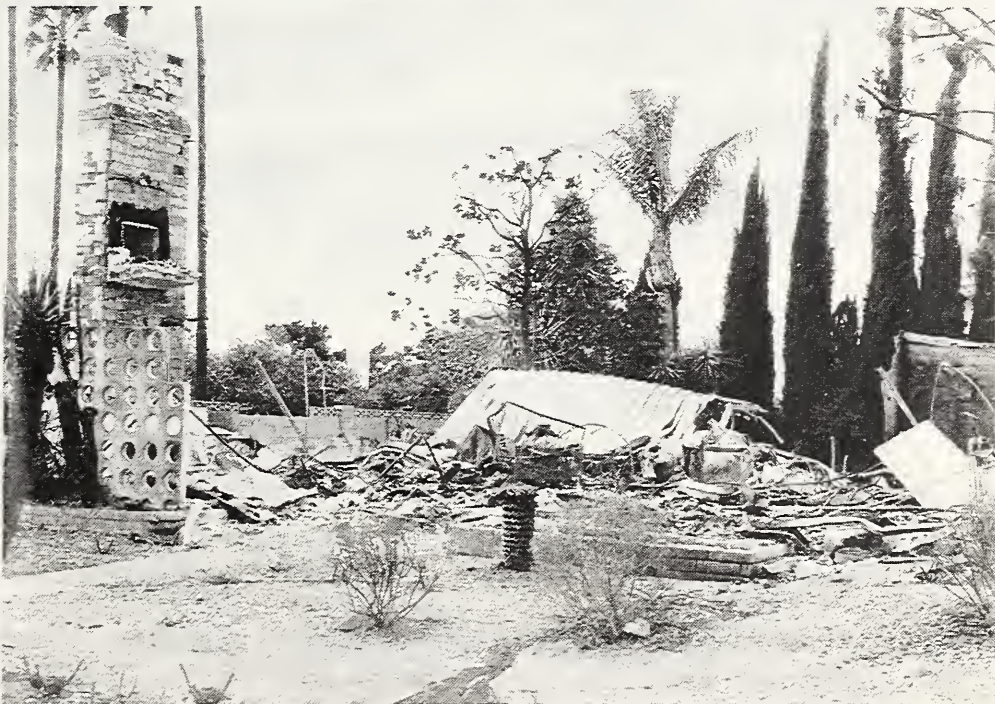
Figure 5.12 Houses destroyed by a fire resulting from the rupture of the 0.6-m gas main along Balboa Boulevard.

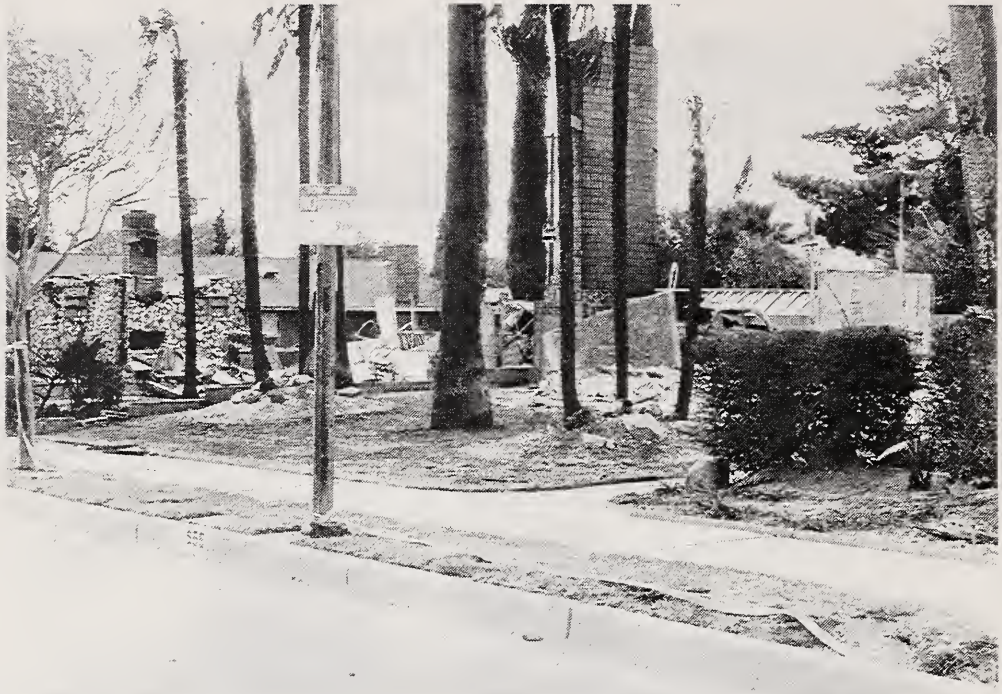
Figure 5.13 Houses destroyed by a fire resulting from the rupture of the 0.6-m gas main along Balboa Boulevard.

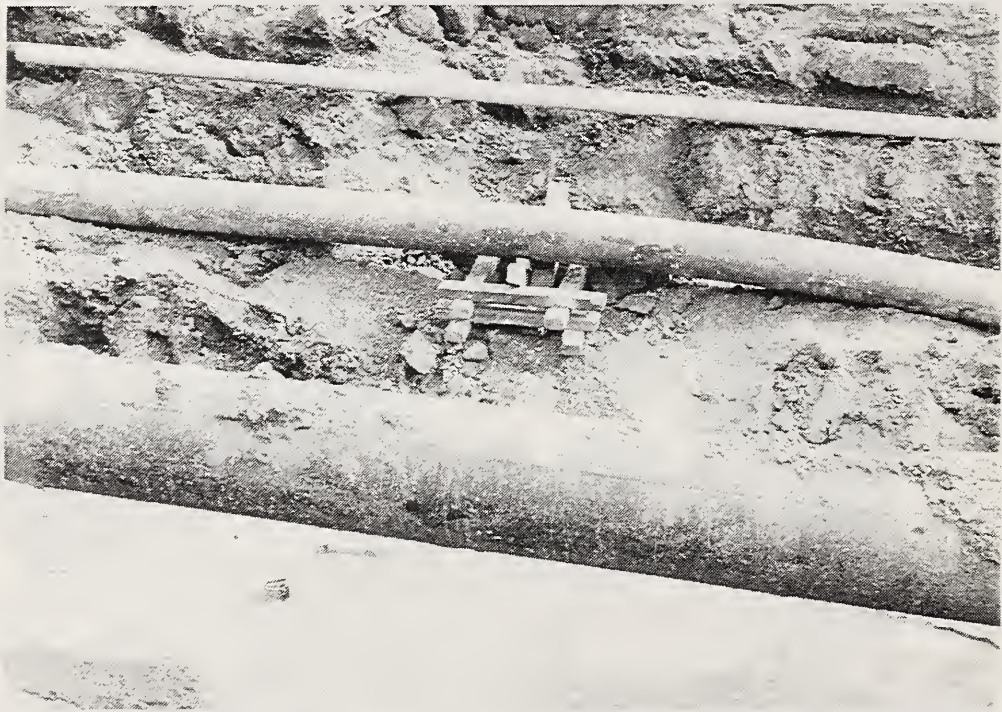
Figure 5.14 Some of the buried pipelines located near the intersection of Balboa Boulevard and Bircher Street--the potential hazard of co-location of lifeline systems. At this site are three water lines (two of them main lines); three gas lines; two sewers; one crude oil line; overhead power, telephone, and cable TV lines; the street lighting system; and the street itself.

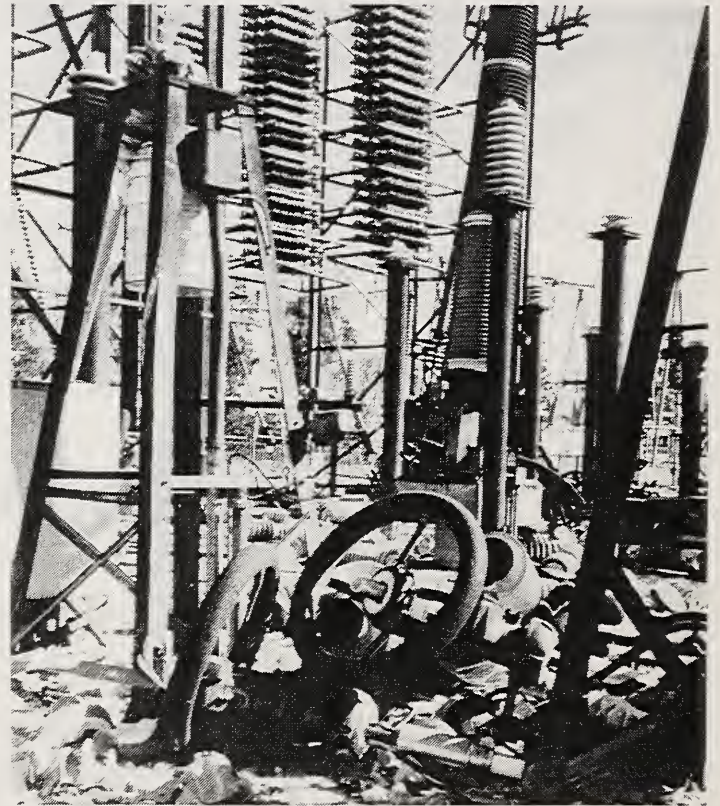
Figure 5.16 Porcelain is an integral part of high voltage electrical equipment due to insulation requirements and is also the most vulnerable to damage during strong earthquake shaking. (Photo courtesy of Edward Matsuda, Pacific Gas and Electric Company.)

- Improved methods for avoiding damage to high voltage substations should be supported. New materials should be developed to replace the brittle porcelain insulators. Better switch systems should be developed and installed to prevent blackouts in areas serviced by the system. Failures of foundations for transmission towers should be more thoroughly investigated.

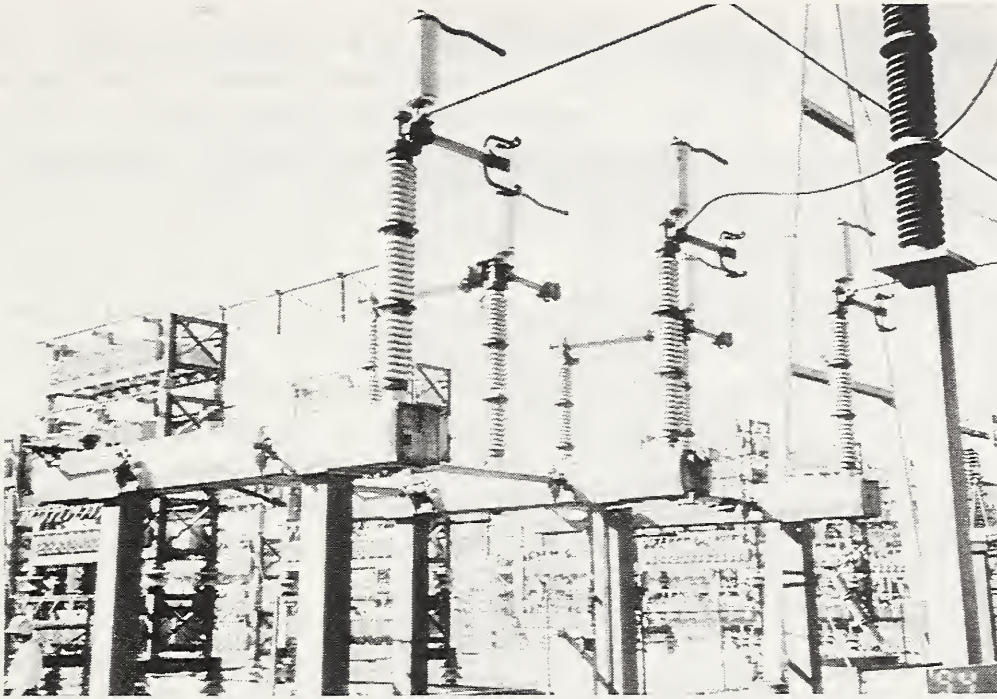
Figure 5.17 Most of the 230 kV circuit switchers (in the forefront) at the Sylmar substation were damaged. Most of the capacitor banks (in the background) performed well in this earthquake, whereas most collapsed during the 1971 quake. (Photo courtesy to Edward Matsuda of Pacific Gas and Electric Company.)

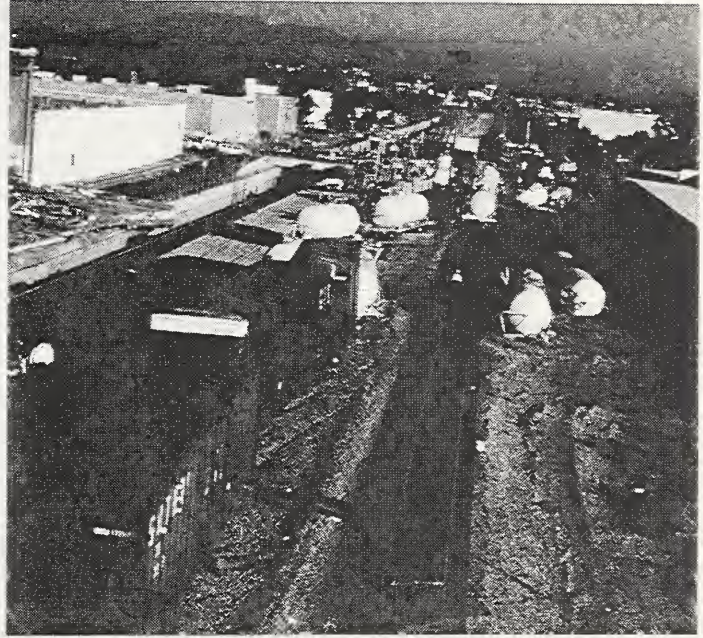
There was a freight train derailment in Northridge during the earthquake (Figure 5.18). The 64-car freight train belonged to Southern Pacific and was on its way from Houston to Sacramento. Twenty-five cars derailed, sixteen of which carried sulfuric acid or diesel fuel. The derailment resulted in the spill of 30,000 liters (8,000 gallons) of sulfuric acid and 7,500 liters (2,000 gallons) of diesel fuel. There were no casualties in this incident. About 200 m (650 ft) of railroad tracks were replaced immediately following the earthquake and rail service was restored at 2:00 a.m., January 19. Removal of damaged cars and cleanup of debris were completed on January 21.

Figure 5.18 Derailment of a 64-car freight train in Northridge. The incident resulted in the spill of 30,000 liters of sulfuric acid and 7,500 liters of diesel fuel.

- The spill of sulfuric acid and diesel fuel caused by the railroad derailment in Northridge was brought under control within two days after the quake. Nevertheless, it demonstrated the potential hazard to an urban environment caused by spills of toxic materials.
