1994 Northridge Earthquake

Performance of Structures, Lifelines and Fire Protection Systems

NISTIR 5396

March 1994
Building and Fire Research Laboratory
National Institute of Standards and Technology
Gaithersburg, MD 20899

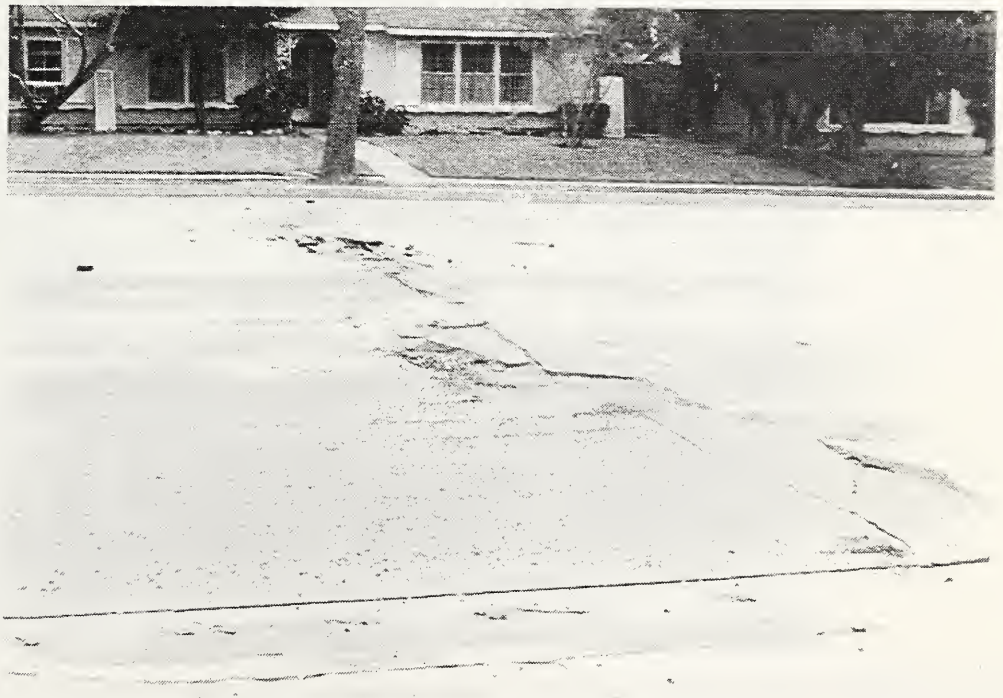
Strong ground shaking and lateral movement of subgrade materials resulted in numerous ruptures of asphalt pavement and concrete sidewalks in the epicentral area (Figures 5.19 and 5.20). In some instances, local traffic was interrupted temporarily waiting for the repair of these cracks. In most cases, the damage was minor and local traffic was not interrupted. The south approach of Balboa Boulevard at SR118 caved in because of loss of abutment fill due to a water main break (Figure 5.21). This bridge was closed for traffic due to some structural damage to the piers and the loss of the south abutment fill.

Figure 5.19
Transverse cracks
in pavement along
Balboa Boulevard
in Northridge area.

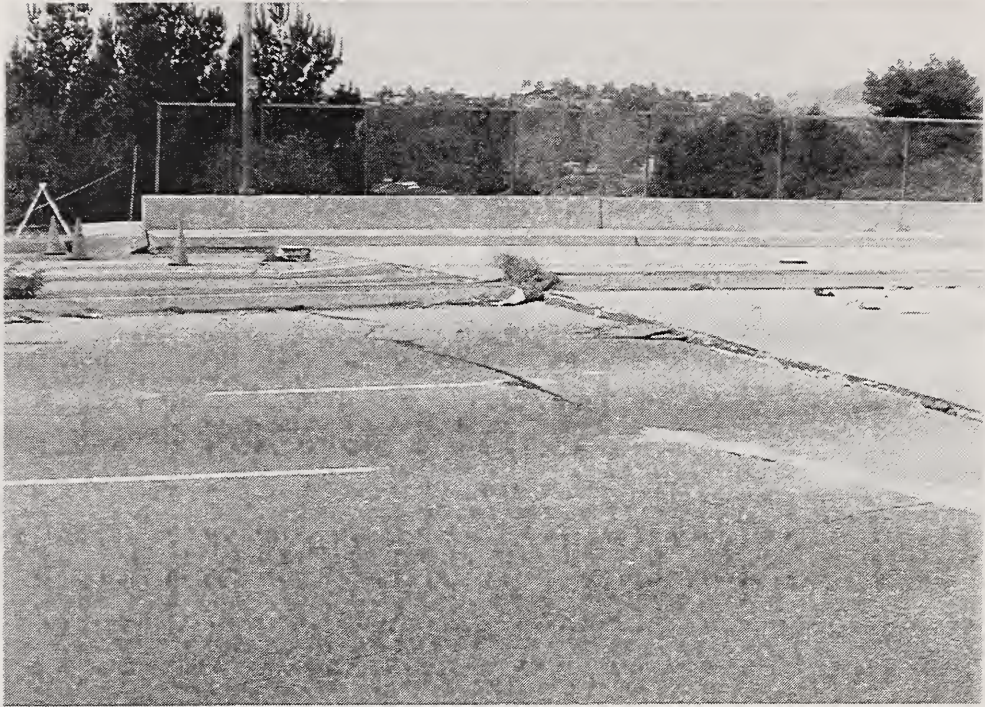
Figure 5.20 Transverse cracks in pavement near the intersection of Balboa Boulevard and SR118.

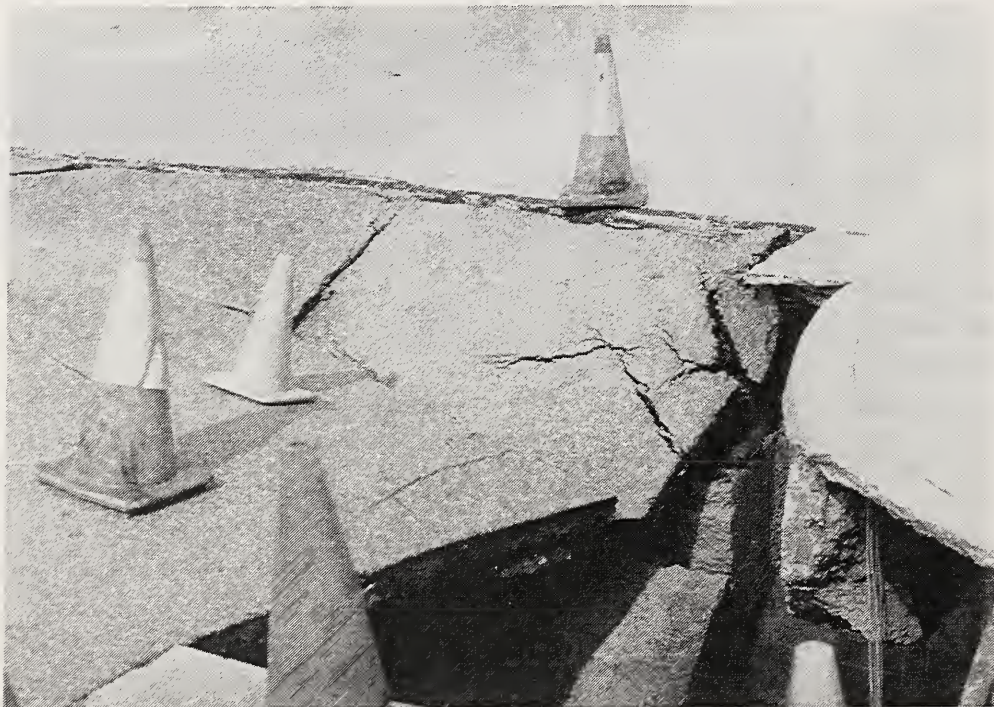
Figure 5.21 The approach of Balboa Boulevard at SR118 caved in due to the loss of the abutment fill because of a water main break.

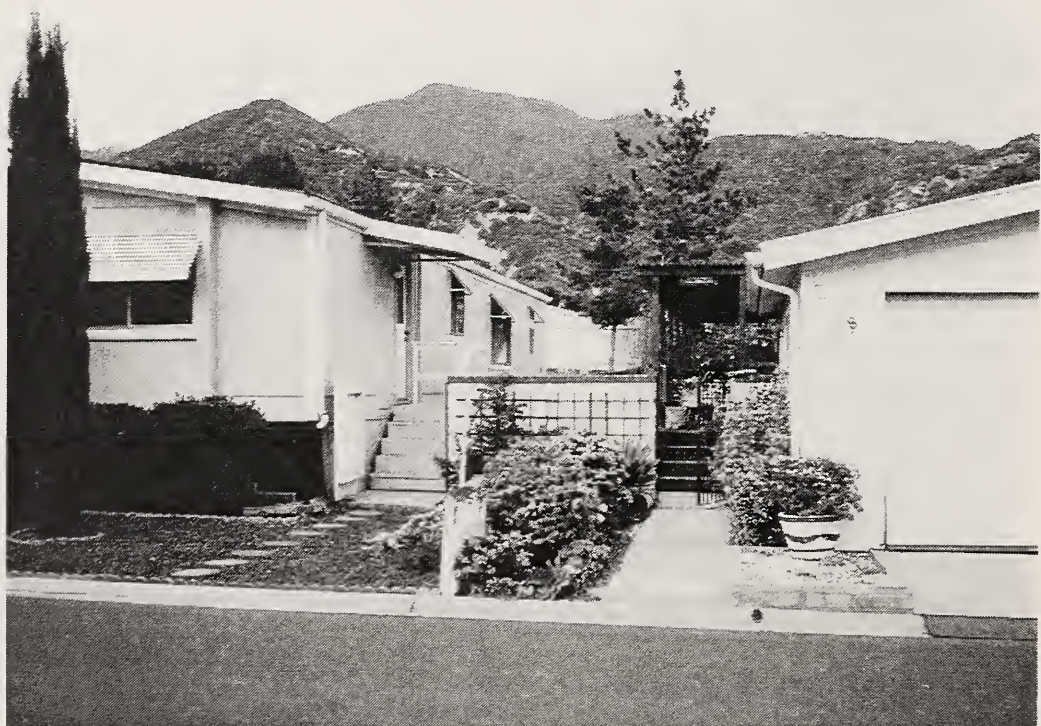
Building-to-building fire spread was limited to three manufactured housing developments (mobile home parks). Figure 6.8 shows the typical spacing between units in one of these developments. Figure 6.9 shows an area of the development destroyed by fire. Observations made at this development after the fires indicates the method of unit-to-unit fire spread was primarily through windows. Once a unit became completely involved in fire, the thermal radiation was sufficient to either cause the breakage of windows in an adjacent unit or ignite combustibles within the unit directly through the windows. The fire department reported low water pressure in the area which combined with multiple independent fires and limited resources hindered fire fighting operations. The fire spread was stopped either by separation such as roads and open areas or by fire department operations.

Figure 6.8 Typical unit spacing in a manufactured housing development.

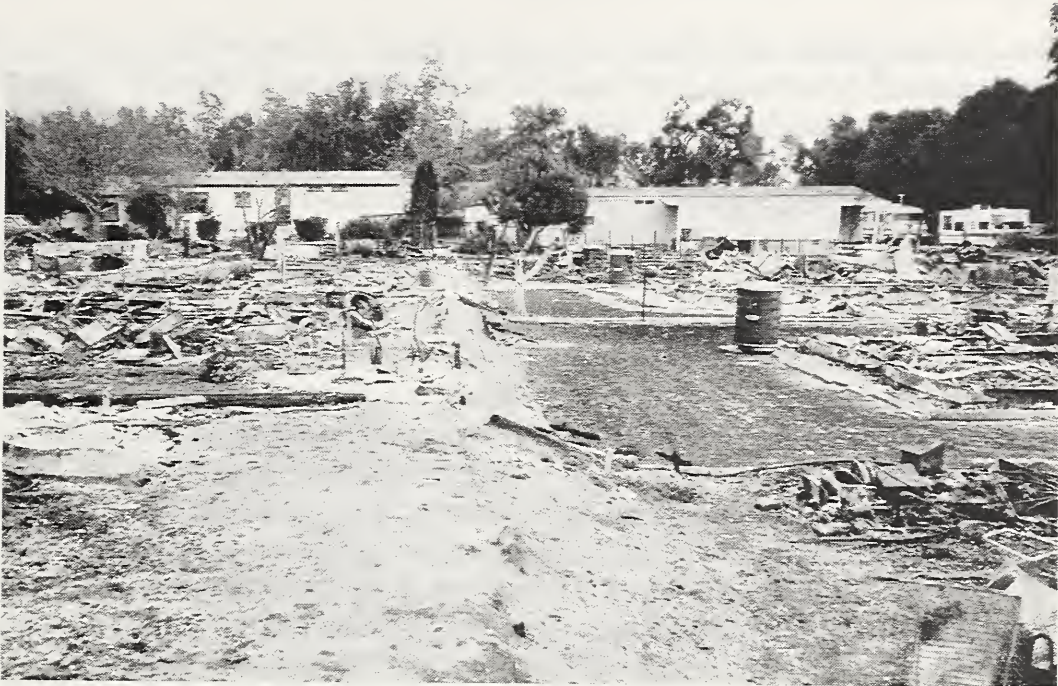
Figure 6.9 Impact of a multiple unit fire in a manufactured housing development.

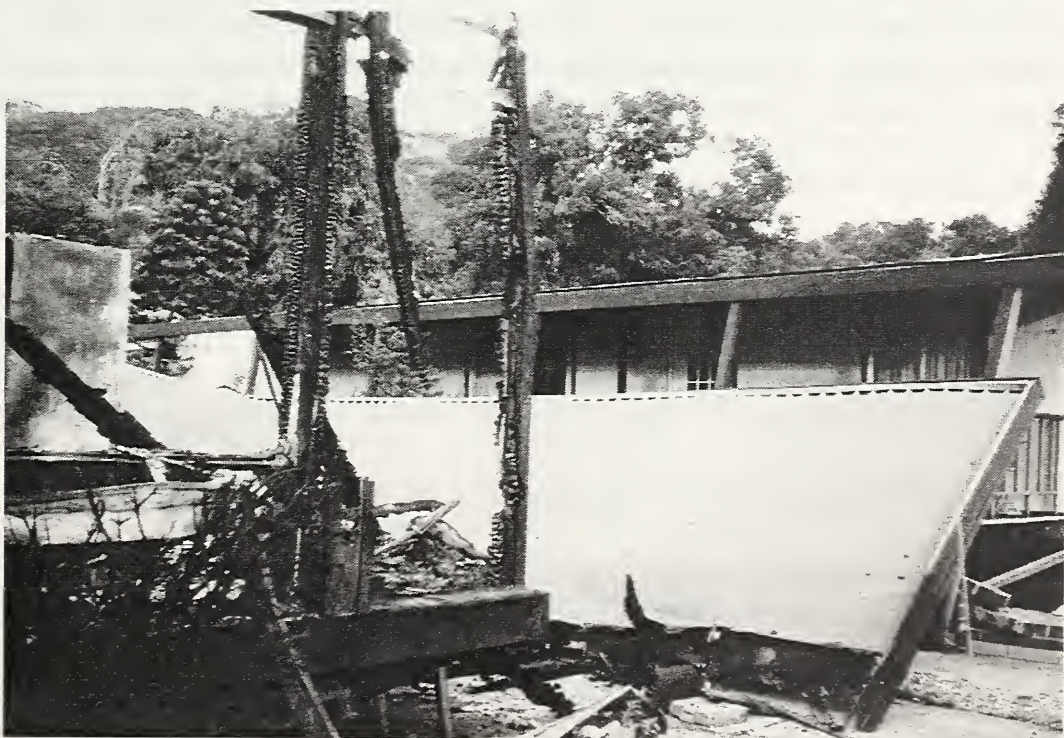
A unique aspect of the construction of these manufactured units played a role in limiting the spread and assisting fire department actions. As the units burned from the inside, the carport roofs collapsed from the building side, coming to rest on the outside supporting columns. In this way the carport roofs formed fire breaks as shown in Figure 6.10. Although these roofs would not necessarily have survived the fire by themselves, they reduced the fire exposure on adjacent units and thus enhanced fire fighting operations.

Figure 6.10 Collapsed roof which acted as a fire break in a manufactured housing development.
