NISTIR 5488

Performance of HUD-Affiliated Properties During the January 17, 1994 Northridge Earthquake

Prepared for:
U.S. Department of
Housing and Urban
Development

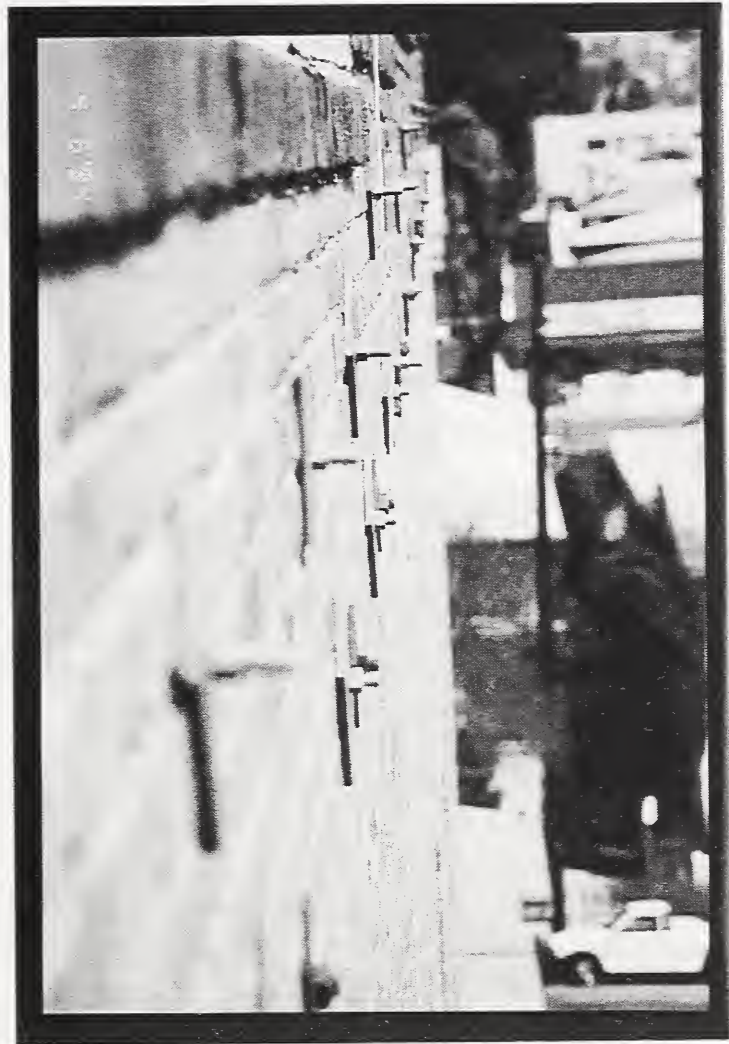
Figure 8 Pre-earthquake seismic rehabilitation of unreinforced masonry buildings typically included face plates and through-bolts anchoring the walls to the floor and roof joists.

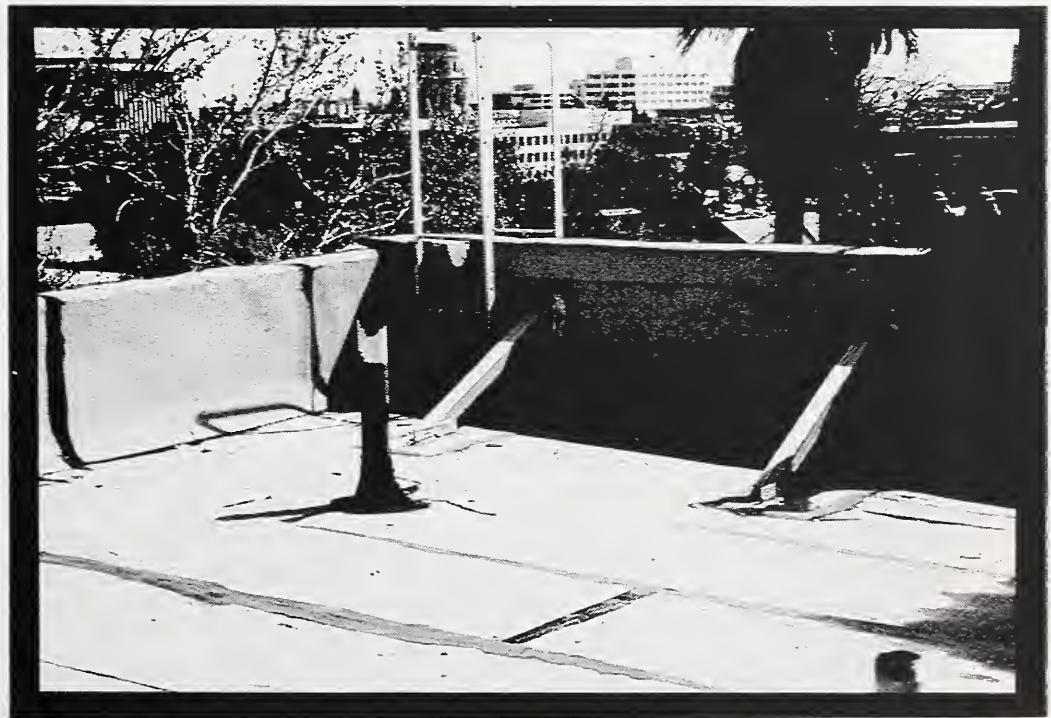
Figure 9 Unreinforced masonry buildings that had been rehabilitated prior to the earthquake typically had had their parapets braced.

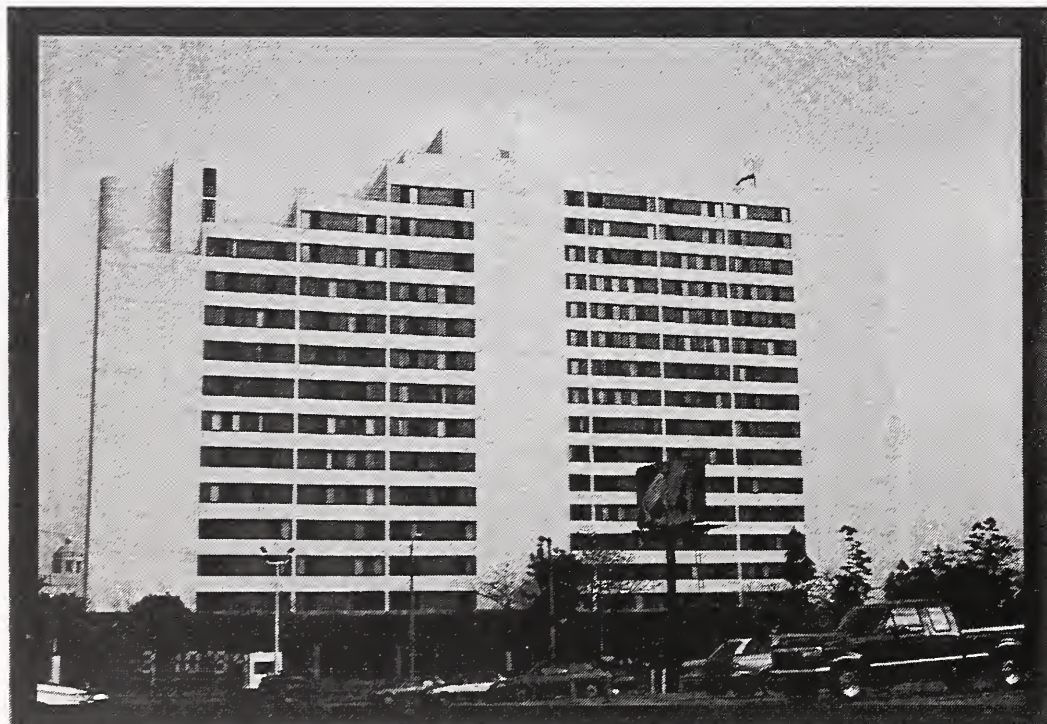
There were no steel frame buildings in the candidate group of damaged buildings. One of the buildings in the inventory was originally misidentified as a steel frame structure. The building manager had stated that Cathay Manor, a 16-story building about 33 km from the epicenter, had a steel frame. When the BFRL investigators arrived at the site, the plans of the structural system were not available. The investigators found no evidence to suggest that the building was a steel frame building. Their observations led them to conclude that the building was a concrete shear wall building, and it has been classified as such in this study (fig. 10). The building suffered cracks in the shear walls and nonstructural walls similar to those observed in concrete buildings.

Figure 10 Cathay Manor, a 16-story building about 33 km from the epicenter, was determined to be a concrete shear wall building.

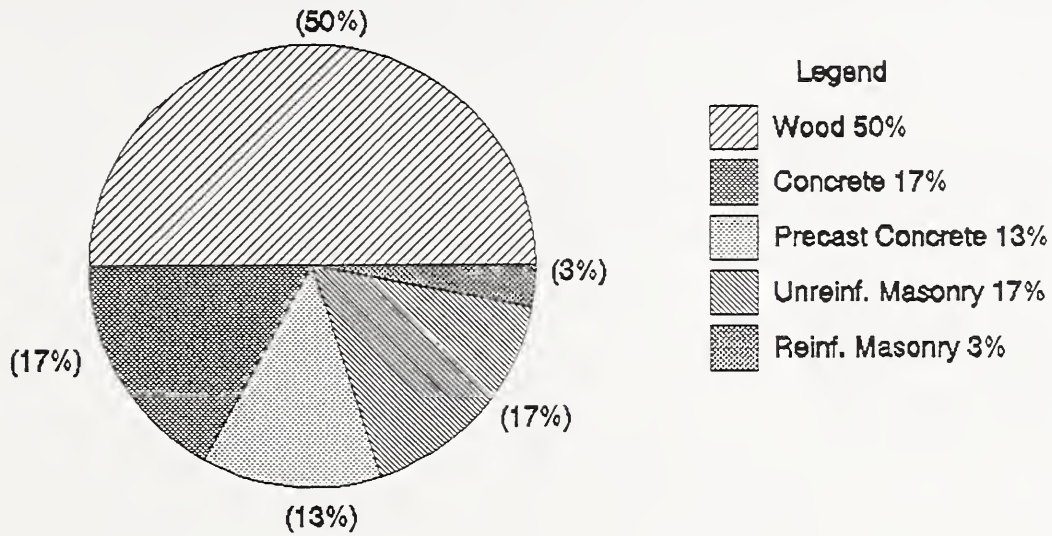
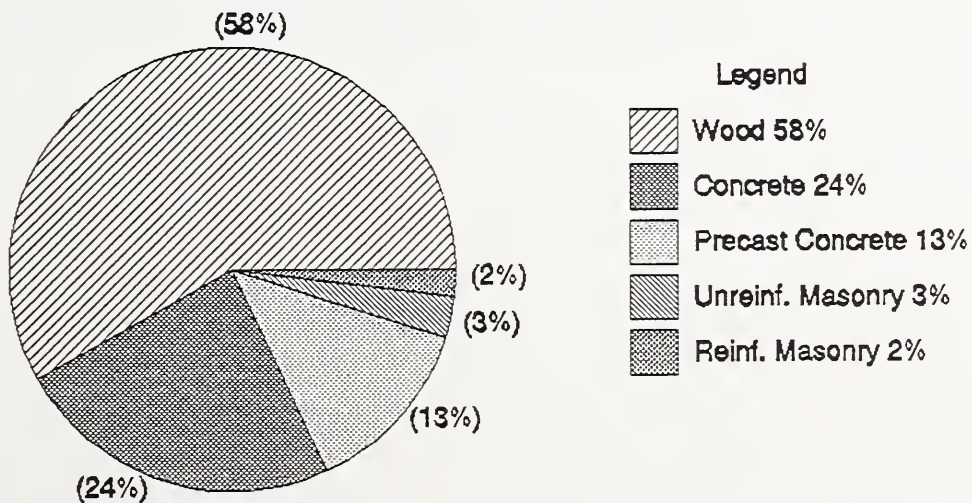
Figure 11 Above, distribution of structural types in the buildings in the sample when tabulated by site; below, distribution of structural types by number of living units.

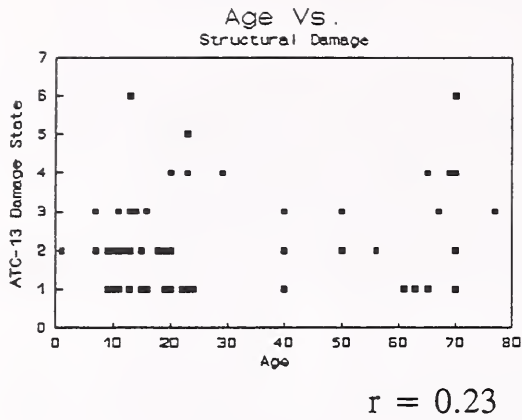
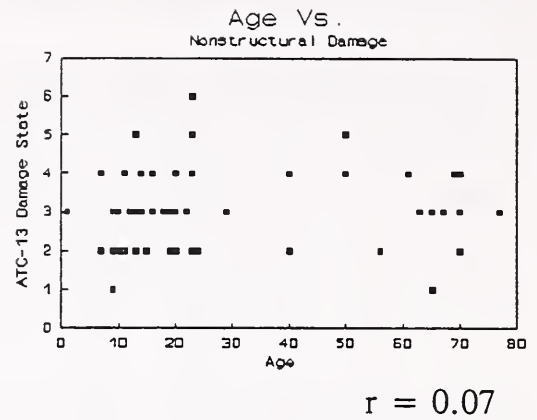
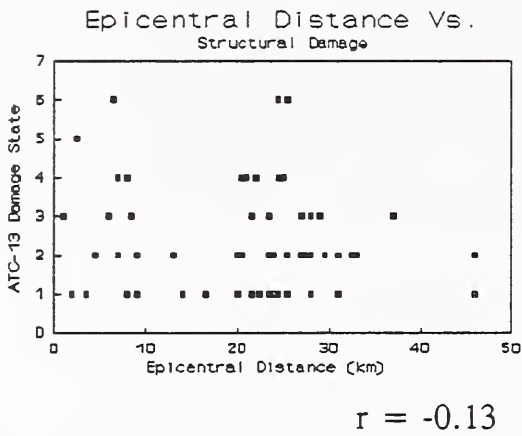
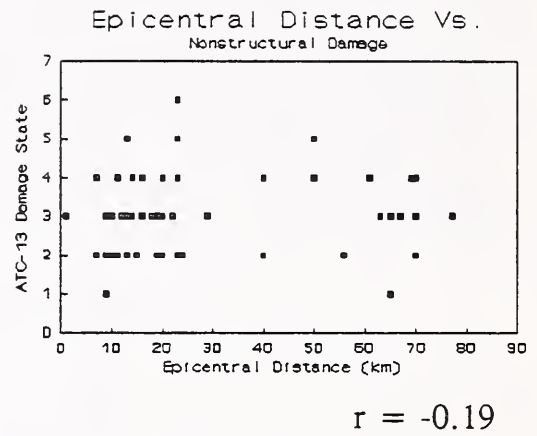
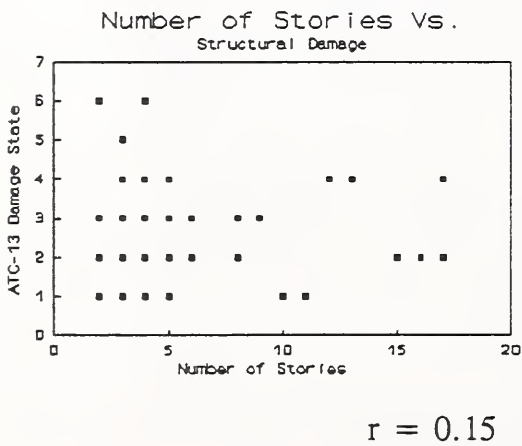
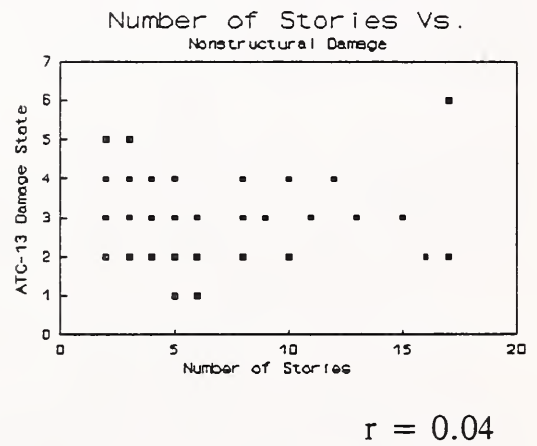
Figure 29
Scatter Plots and Coefficients of Correlation
Age, Epicentral Distance and Number of Stories
Compared to Structural and Nonstructural Damage States

Scatter plots were produced, evaluating each site as one data point. The scatter plots showed a wide distribution of damage states for each of the variables considered (fig. 29). Note that, as can be seen from the data in Table C, each of the dots shown in figure 29 may represent more than one data point. Regression analysis confirmed that no statistically valid trends existed in the data for age, number of stories, or epicentral distance (considered individually and ignoring the influence of the other parameters) when measured against structural and nonstructural damage states. The correlation coefficient, r , was greatest for the correlation between age and structural damage, but, with a value of only 0.23, the correlation cannot be considered significant. The correlation coefficient r always has a value between -1 and 1; these values imply perfect correlation. A value of zero indicates no correlation whatsoever.

It is possible that strong trends do exist in more narrowly defined groupings of data which consider the combined effects of multiple variables, for example, age-to-damage state correlations for each different structural system, rather than for all systems considered together. However, the relatively limited number of data points available from this study does not justify more finely partitioned analyses. Given a larger set of data points, trends may well become apparent.

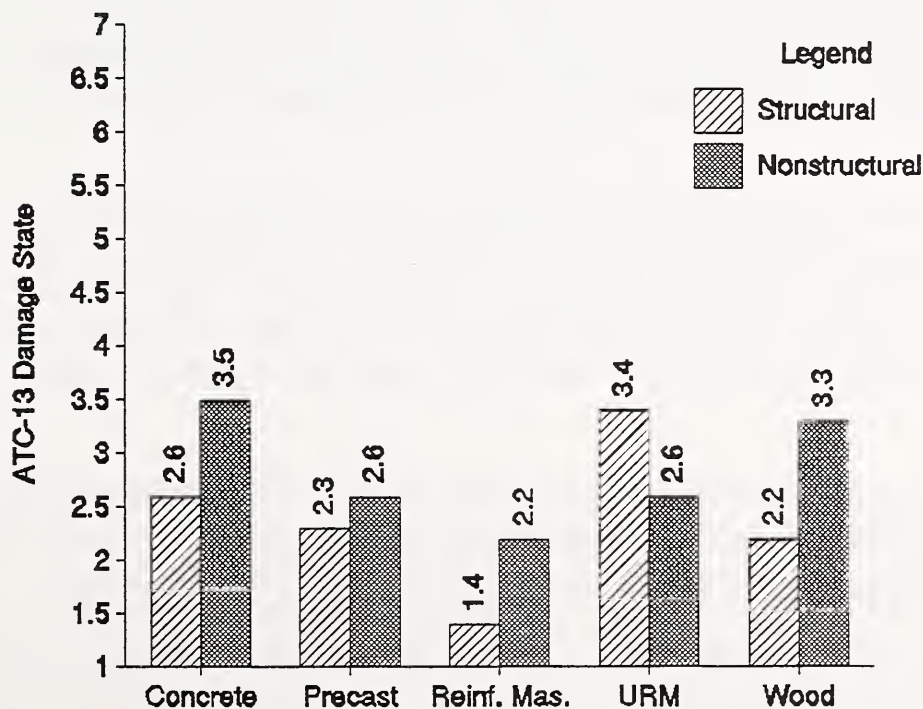
Figure 30 Bar graph showing weighted averages of ATC-13 structural and nonstructural damage states by structural system.

The highest average damage state was 3.5, for non-structural damage in concrete buildings, which is between "light" (1%-10%) and "moderate" (10%-30%) damage. The lowest average value, 1.4, for structural damage in reinforced masonry buildings, is between damage rated as "none" (0%) and "slight" (0%-1%).
