Deterioration of Iowa Highway Concrete Pavements: A Petrographic Study

Paul E. Stutzman

December, 1999

Building and Fire Research Laboratory
National Institute of Standards and Technology
Gaithersburg, MD 20899

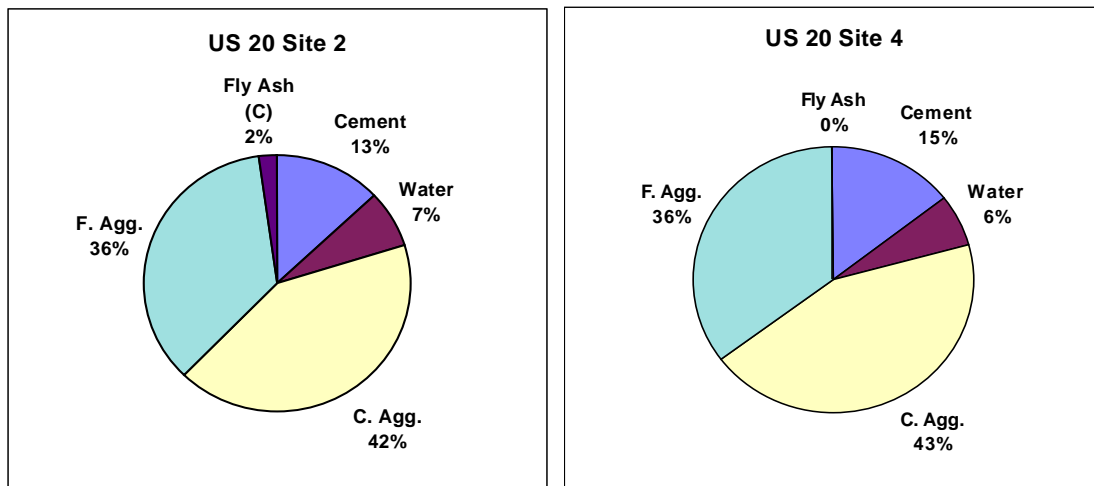
Figure 4 gives the concrete materials proportions from US 20 for mixes with and without fly ash while Figure 5 indicates the gap grading of the aggregates. Evaluation of the mix design by two separate internationally recognized engineers [18,19] found agreement in that the high sand content and gap-grading probably led to difficulties in workability and consolidation, and may have resulted in drying shrinkage problems. The aggregate distributions plotted on a Shilstone Coarseness Factor Chart [20] fall in a region reflecting gap-graded concrete and where workability difficulties may be present (Figure 6). The parallel blue lines on this chart define a region of optimum grading for low water demand and optimum response to vibration. While the potential difficulty in workability were not unexpected to the Iowa Department of Transportation staff [21], it is significant in that it may also affect the development of the entrained air void system during mixing. Failure to develop an adequate entrained air void system appears to be contributory to the deterioration of these pavements.

Figure 4. Concrete materials proportions, by mass, for selected sections of Iowa US 20.

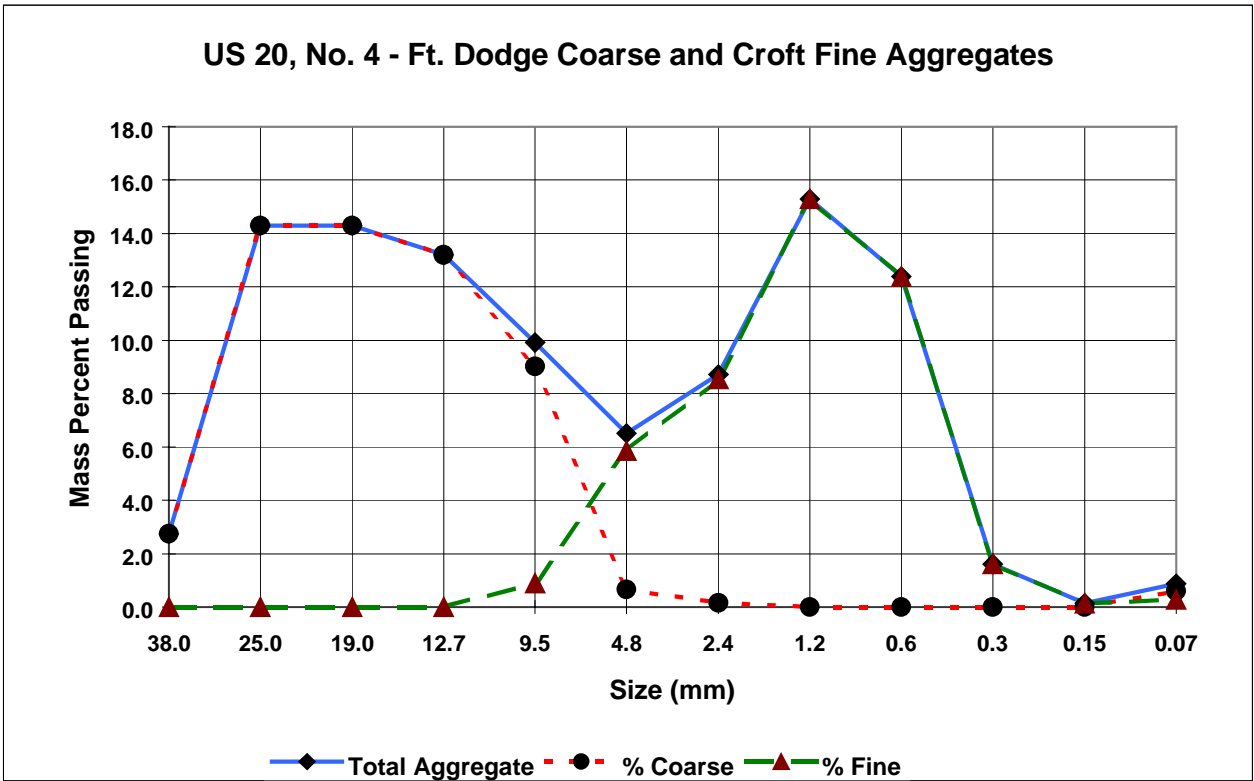
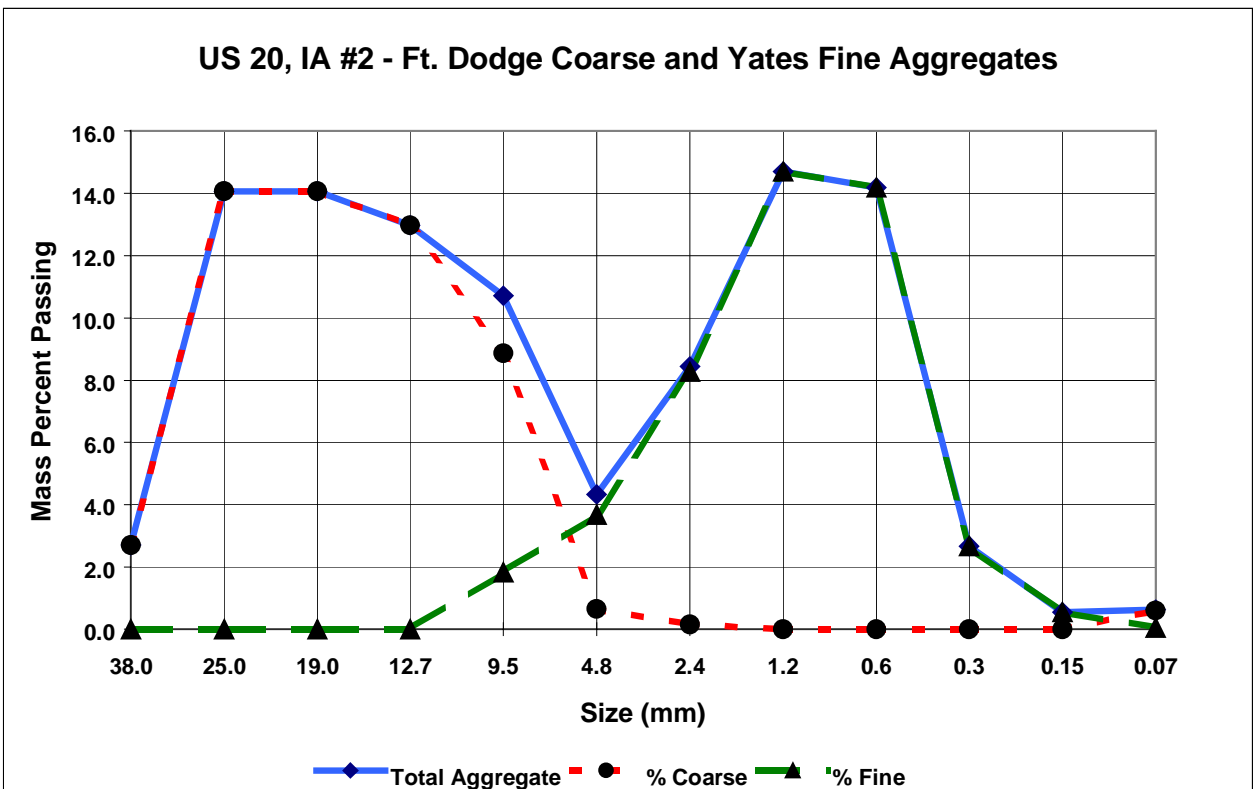
Figure 5. Aggregate gradation plots showing coarse, fine, and combined aggregate gradation and the lack of particles in the intermediate size range.

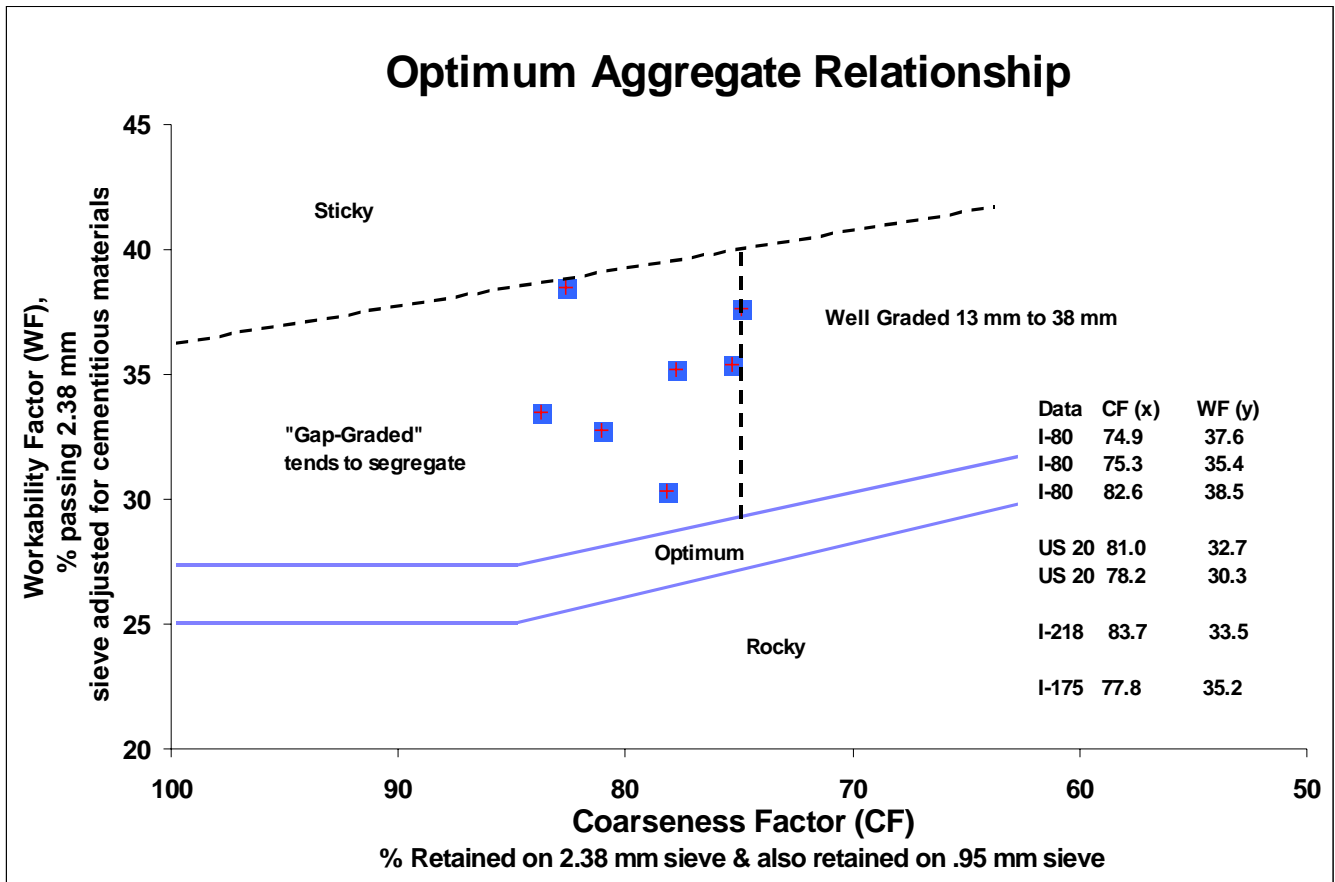
Figure 6. Optimum aggregate chart plots of Iowa pavement mix designs fall into the gap-graded region and indicate likely difficulties in workability [20].

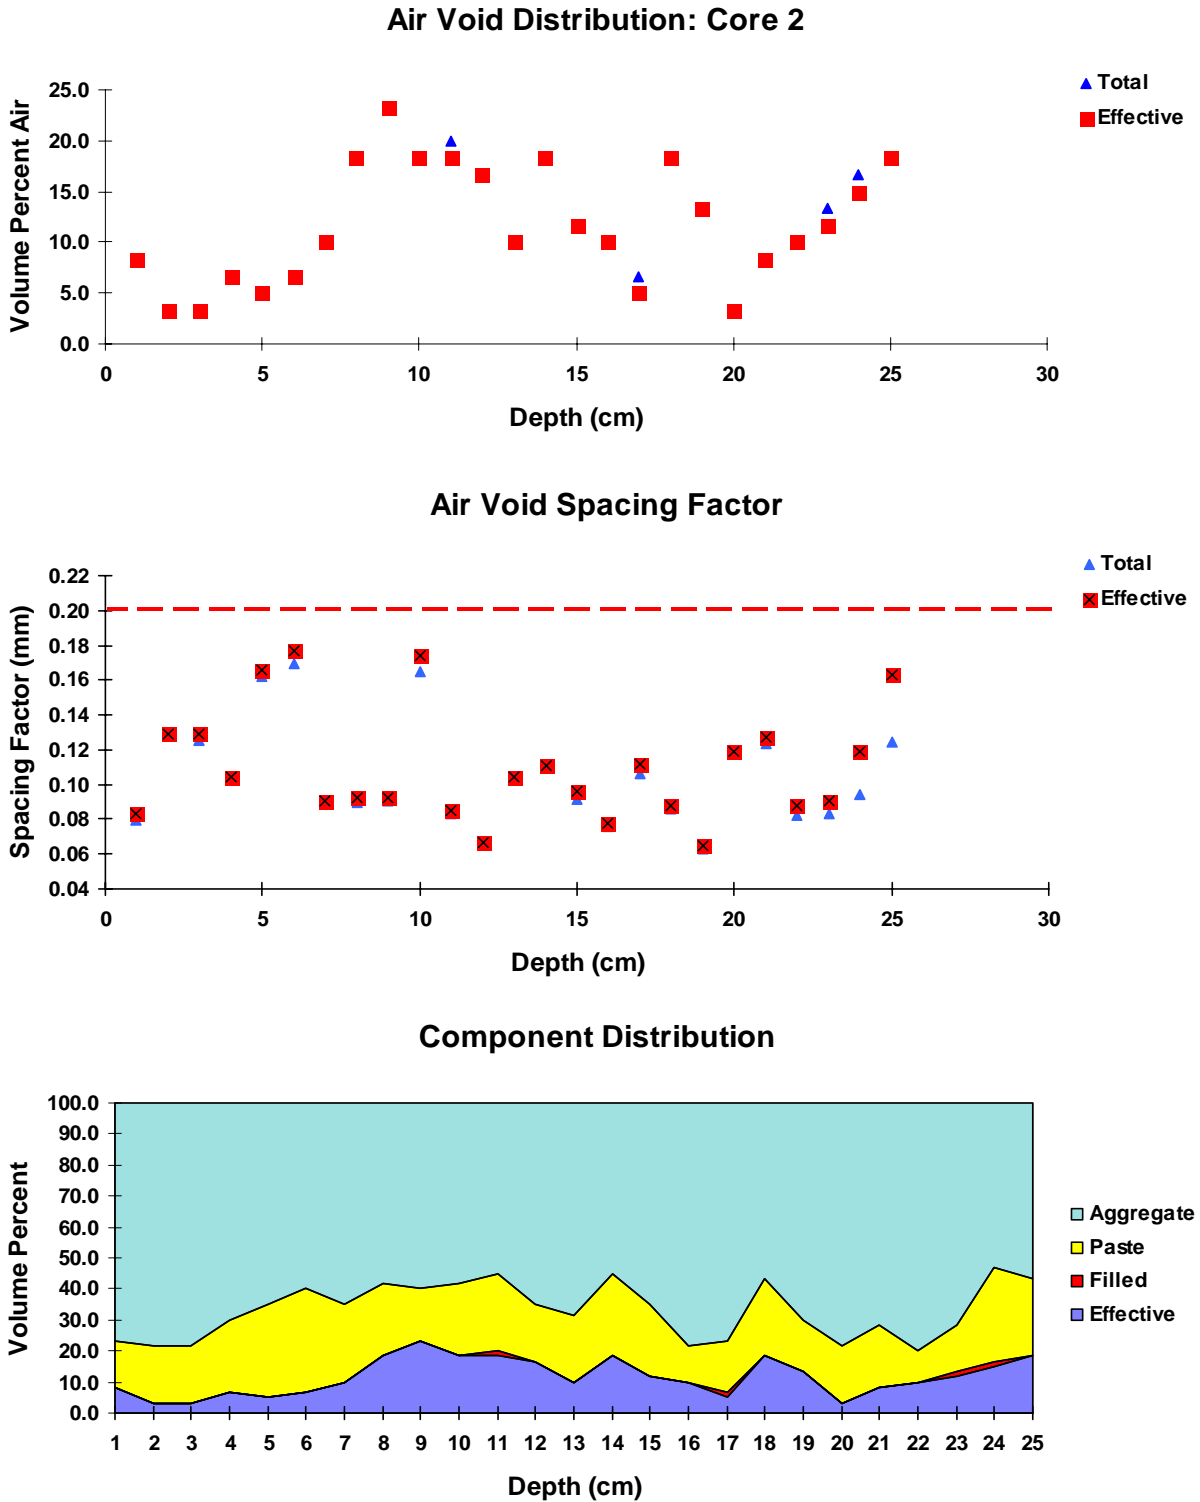
Figure 13. Iowa 175 Core 2 air void and materials distribution plots. A decrease in air near the surface may reflect the loss of entrapped air. The blue triangles represent an air void parameter estimate for the original concrete; the red box represents that value as affected by void filling, if present.

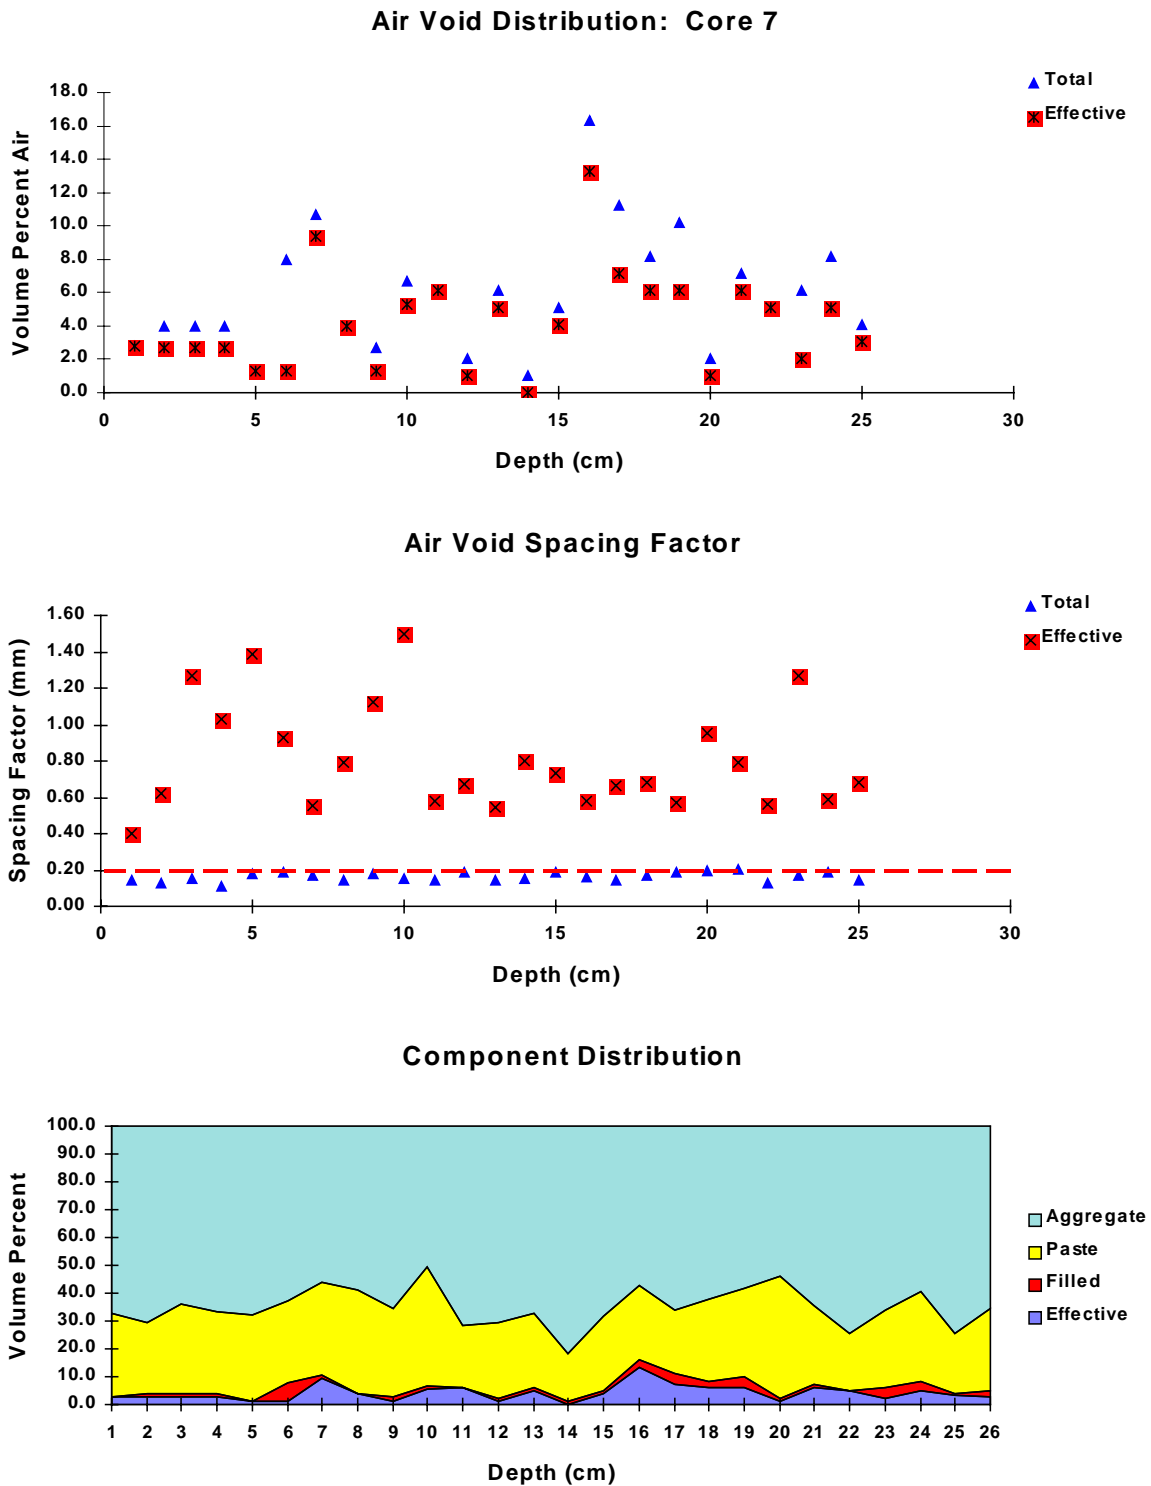
Graphical representation of the total air, spacing factors, and component distribution (Figure 18, Figure 19) illustrates the alteration of the air void system resulting from the ettringite filling. Air distribution, as measured by total air volume, appears uniform from the core top to base. Core 7 may show a slight decrease in air in the upper 50 mm, possibly reflecting the elimination of entrapped air in the upper-most portion of the concrete. This also indicates that, outside the immediate regions of the immersion vibrators, the air void spacing factors do not appear to be adversely affected. The decrease in ettringite precipitation near the surface (upper 5 mm) may reflect the influence of surface drying. At greater depths, filling of voids appears uniform from both a total air void volume and loss of spacing factor. Component distribution appears uniform indicating no apparent vertical segregation of materials due to vibration.

Figure 18: Air void distribution, spacing factors, and concrete component distribution versus depth for Core 7. The red boxes represent the current value, the blue triangle, the original value, and the red line in the spacing factor plot denotes the ASTM C 457 recommended limit for freeze-thaw protection.

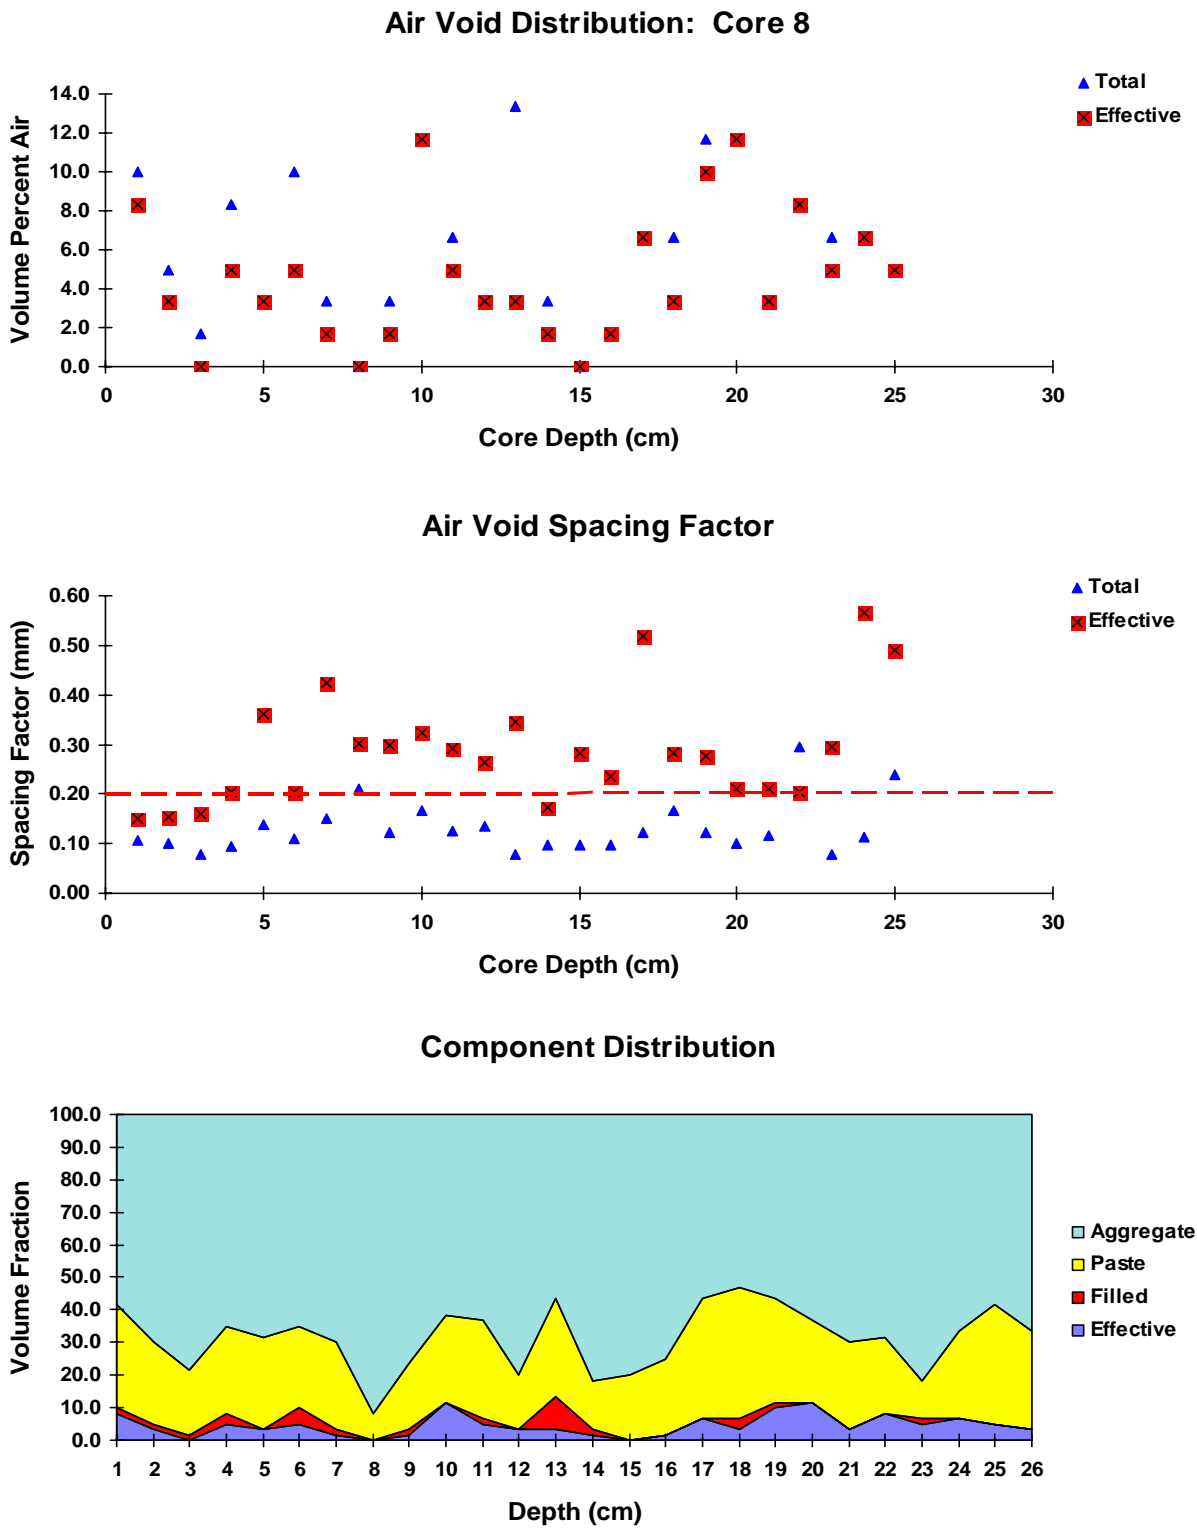
Figure 19: Air void distribution and spacing factors versus depth, and concrete component distribution for Core 8, mid-panel.

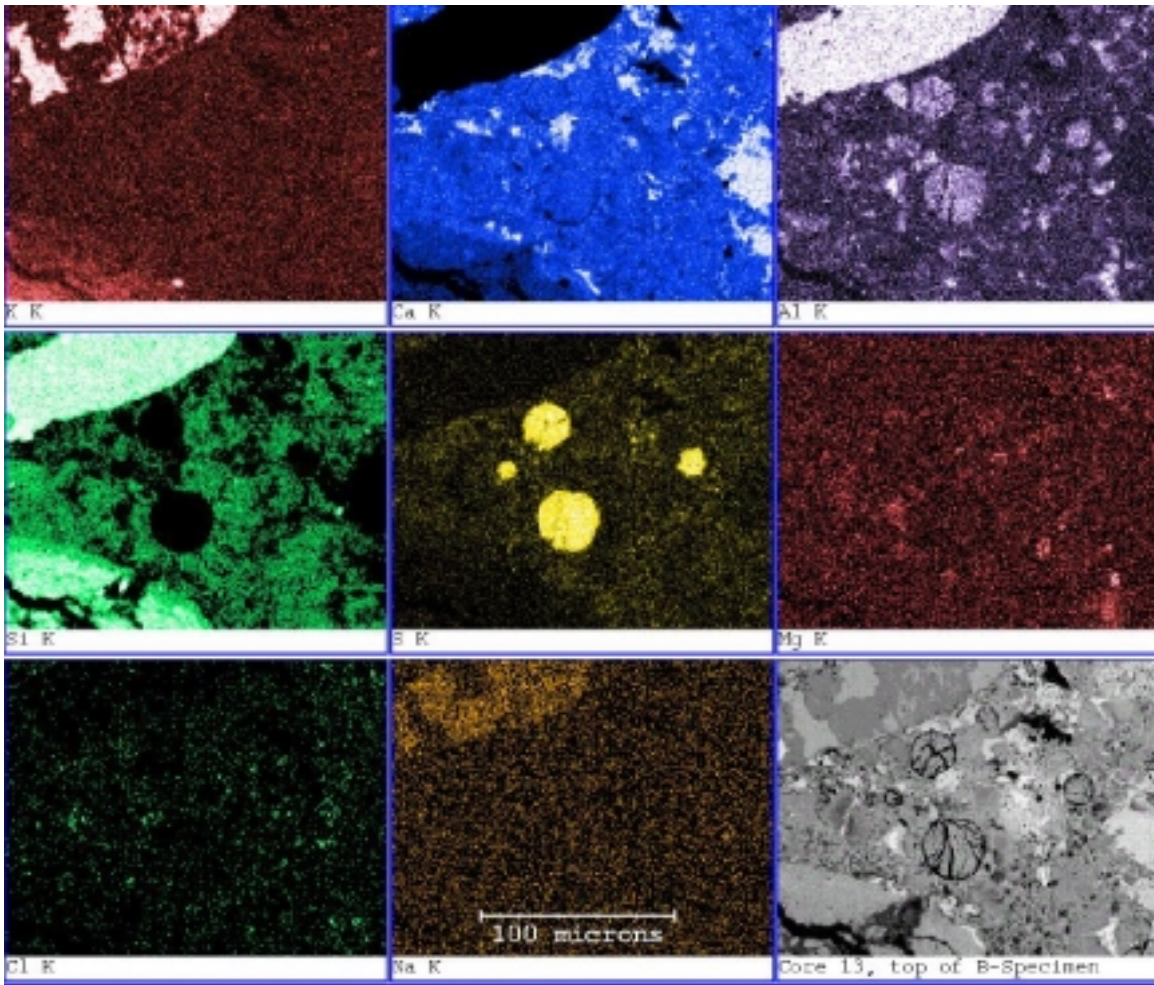
Figure 24. X-ray images corresponding to image in Figure 23. While the shale has undergone alkali-silica reaction, no cracking is apparent within the paste. Common locations of aluminum, sulfur and calcium in the X-ray images delineate ettringite.

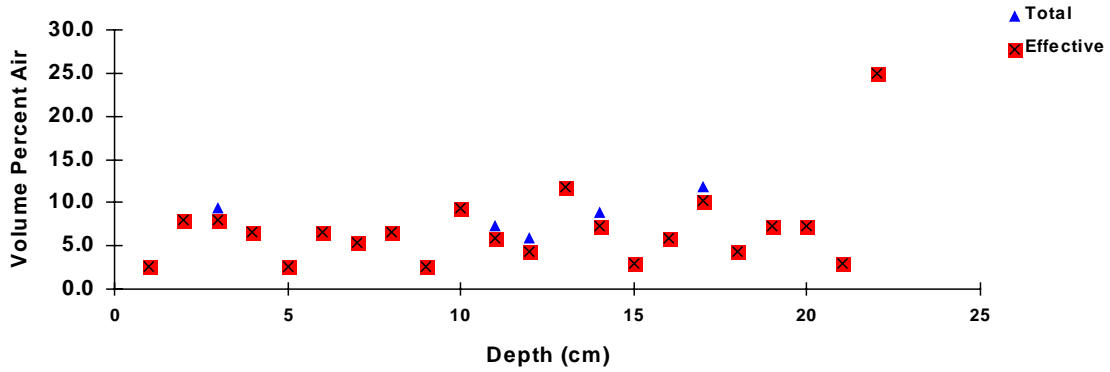
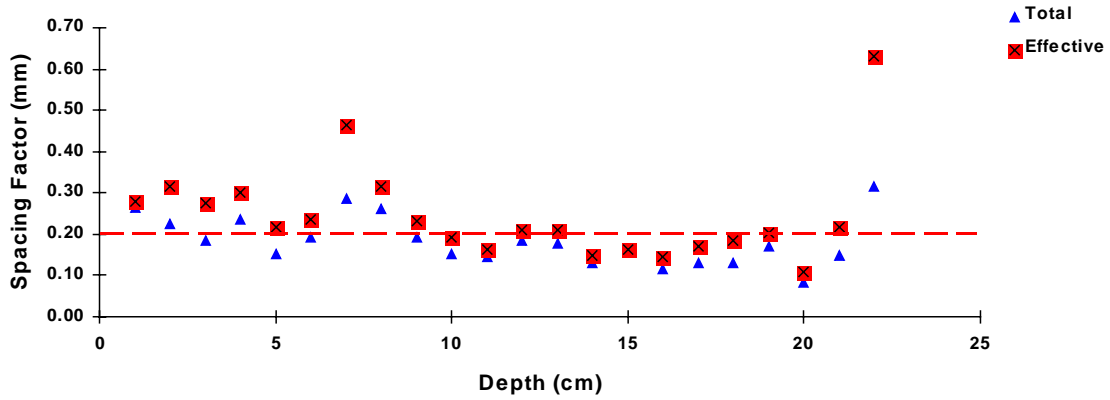
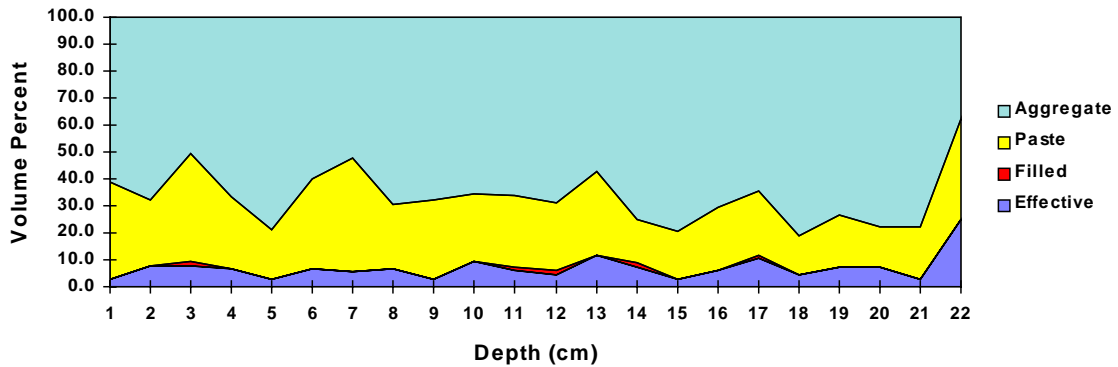
Figure 25. Air void distribution and spacing factors versus depth, and concrete component distribution for Core 13. The air volume appears uniform with depth while the spacing factor appears substandard in the upper 100 mm. Filling has resulted in a slight increase in the spacing factor.

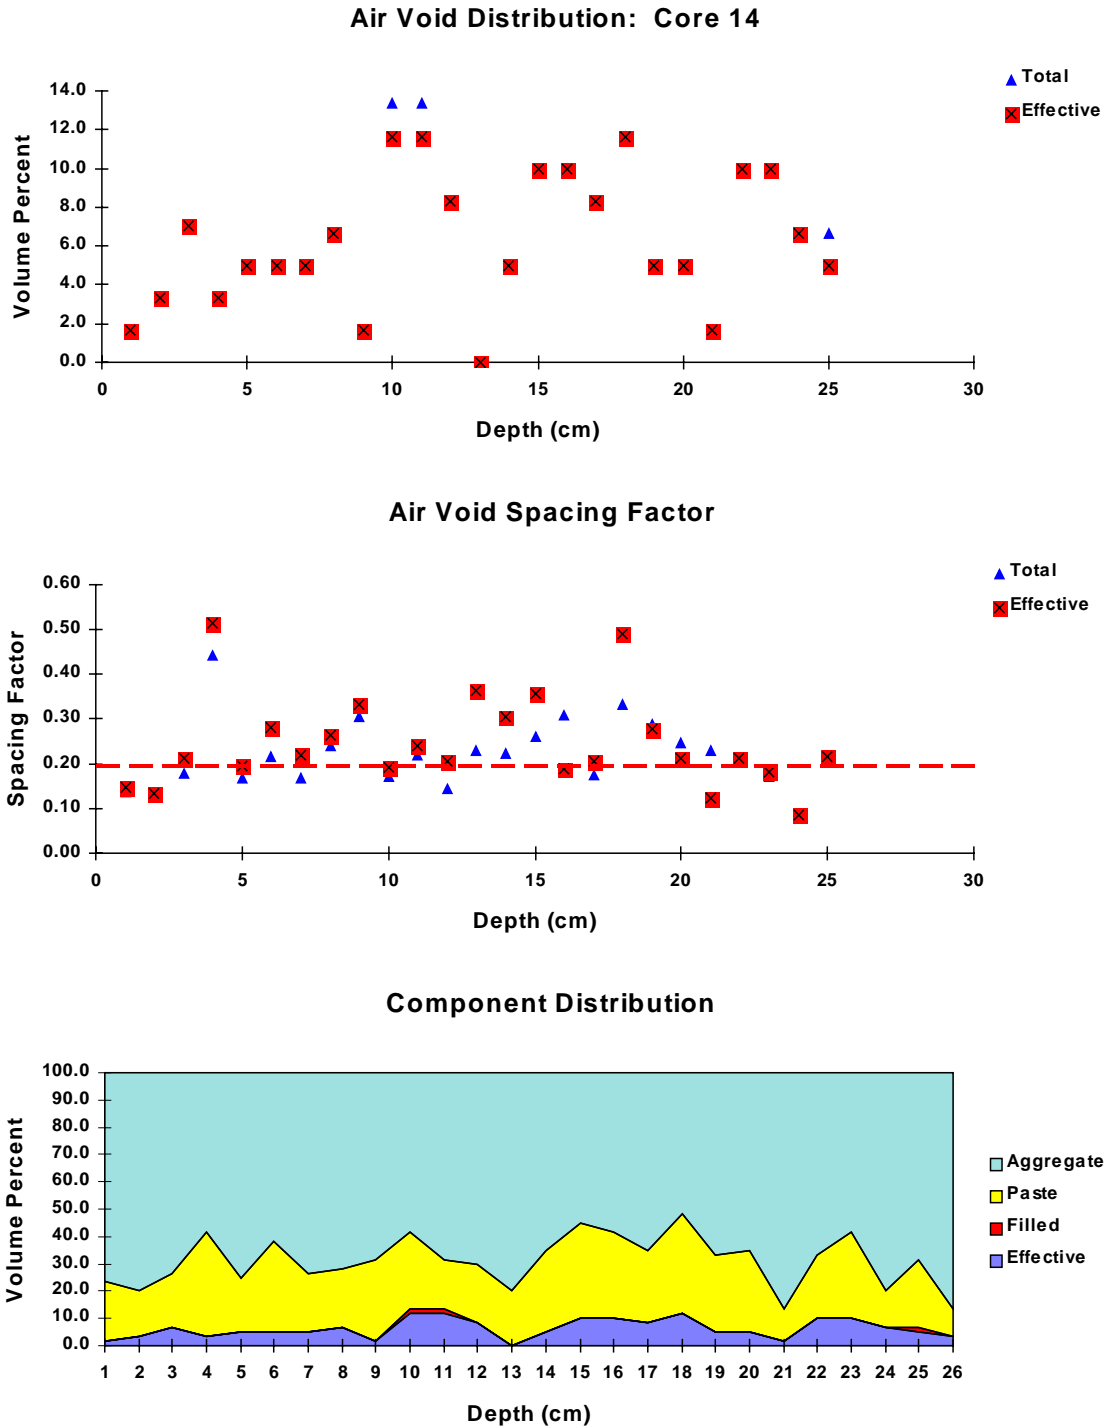
Figure 26. Air void distribution and spacing factors versus depth, and concrete component distribution for Core 14. The total air volume appears similar to that of Core 13 from the joint and appears uniform with depth (deviations from the median probably reflect entrapped air voids). The spacing factor appears marginal to sub-standard at depths below 6 cm, and filling of the smaller entrained air voids has resulted in an increase in void spacing factor.

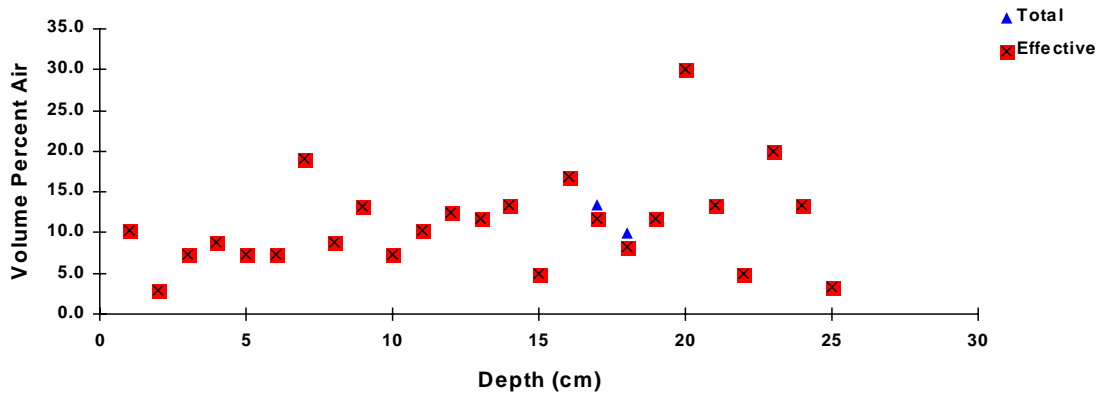
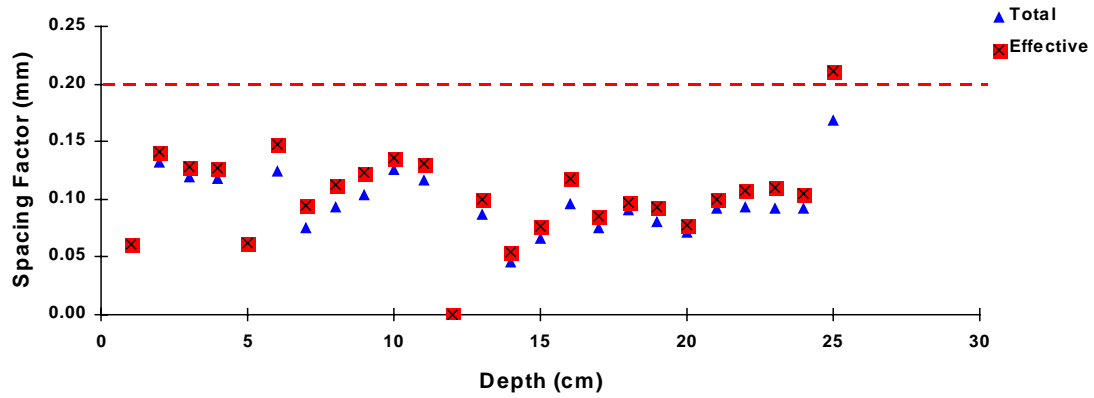
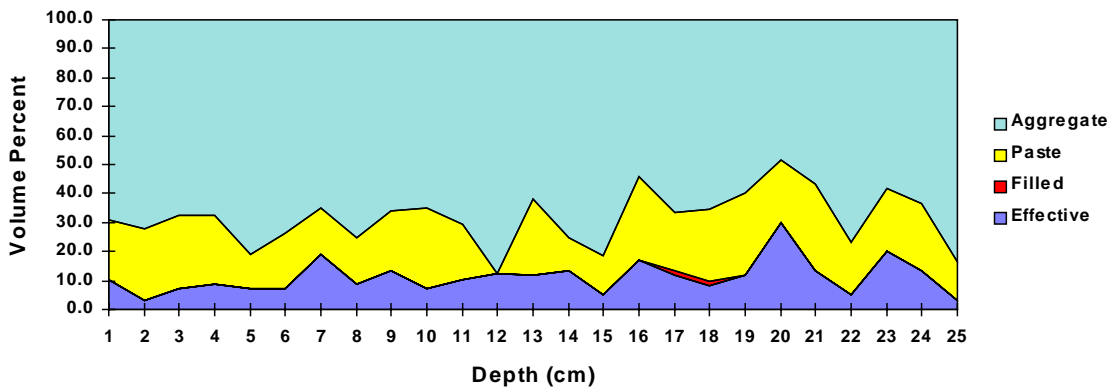
Figure 28. Air void and component distribution plots for core 18. Little loss of air void volume is evident with only a slight, uniform loss of air void spacing factor. Component distribution appears uniform from top to bottom.

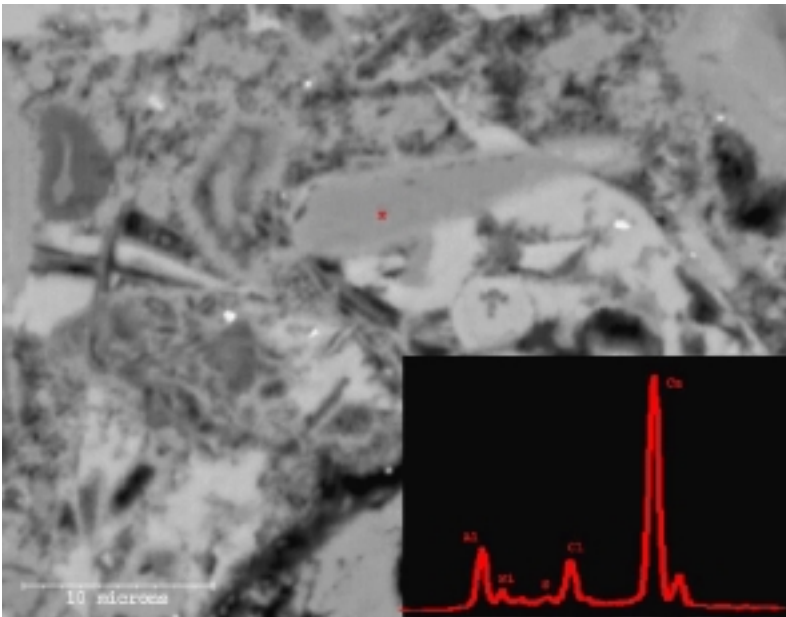
Figure 30. Friedel's salt in hardened paste is identified here using X-ray microanalysis. It appears to be a primary hydration product in the paste throughout the cores, suggesting that it may be a result of the presence of chlorides in the original mix as opposed to the infiltration of road salts.

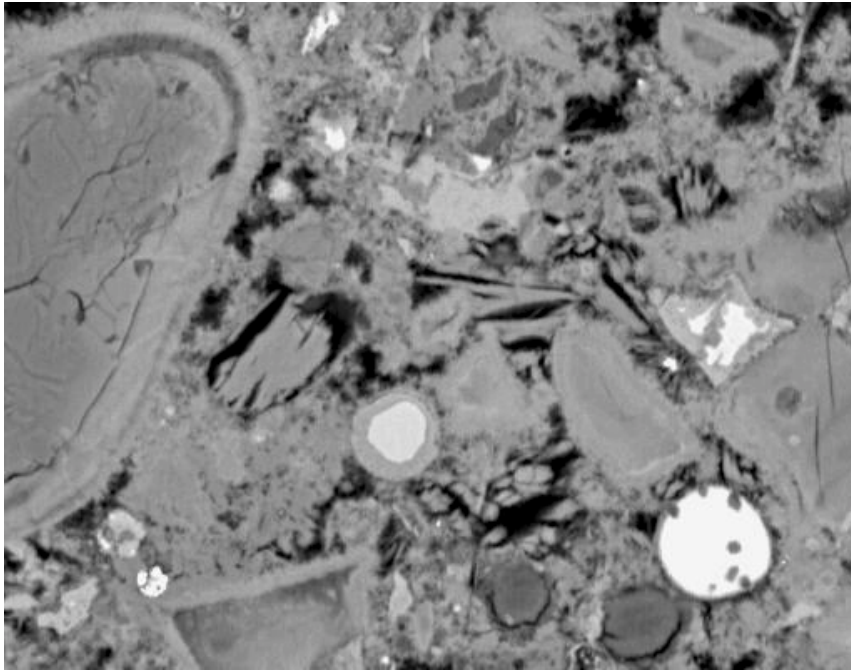
Figure 34. Back scattered electron image of Core 19 paste microstructure showing ASR-affected shale (left) and fly ash (circular). X-ray image regions of high sulfur (yellow) and intermediate aluminum (purple) mark locations of ettringite while regions of high chlorine (lower left image) denote locations of chloroaluminate.

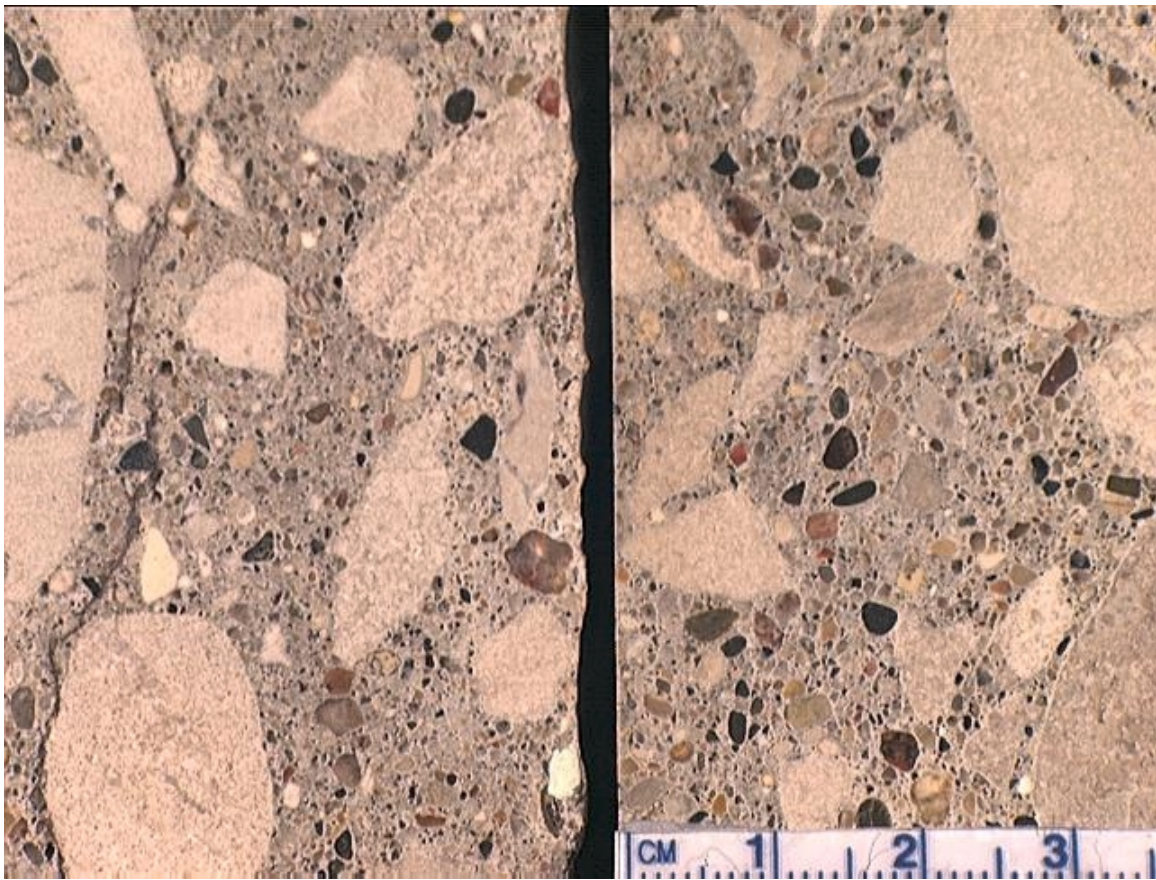
Visual examination of Cores 18 and 19 found a likely difference in aggregate grading (Figure 35) with Core 18 appearing to have a more uniform, and perhaps smaller, aggregate gradation. The apparent change in aggregate gradation may have affected the development of the higher-volume entrained air void system in Core 18. However, specific surface values indicate a coarse air void size distribution.

Figure 35. Core 19 (left) appears to have a finer-sized sand and possibly a larger maximum coarse aggregate size when compared to Core 18 (right).

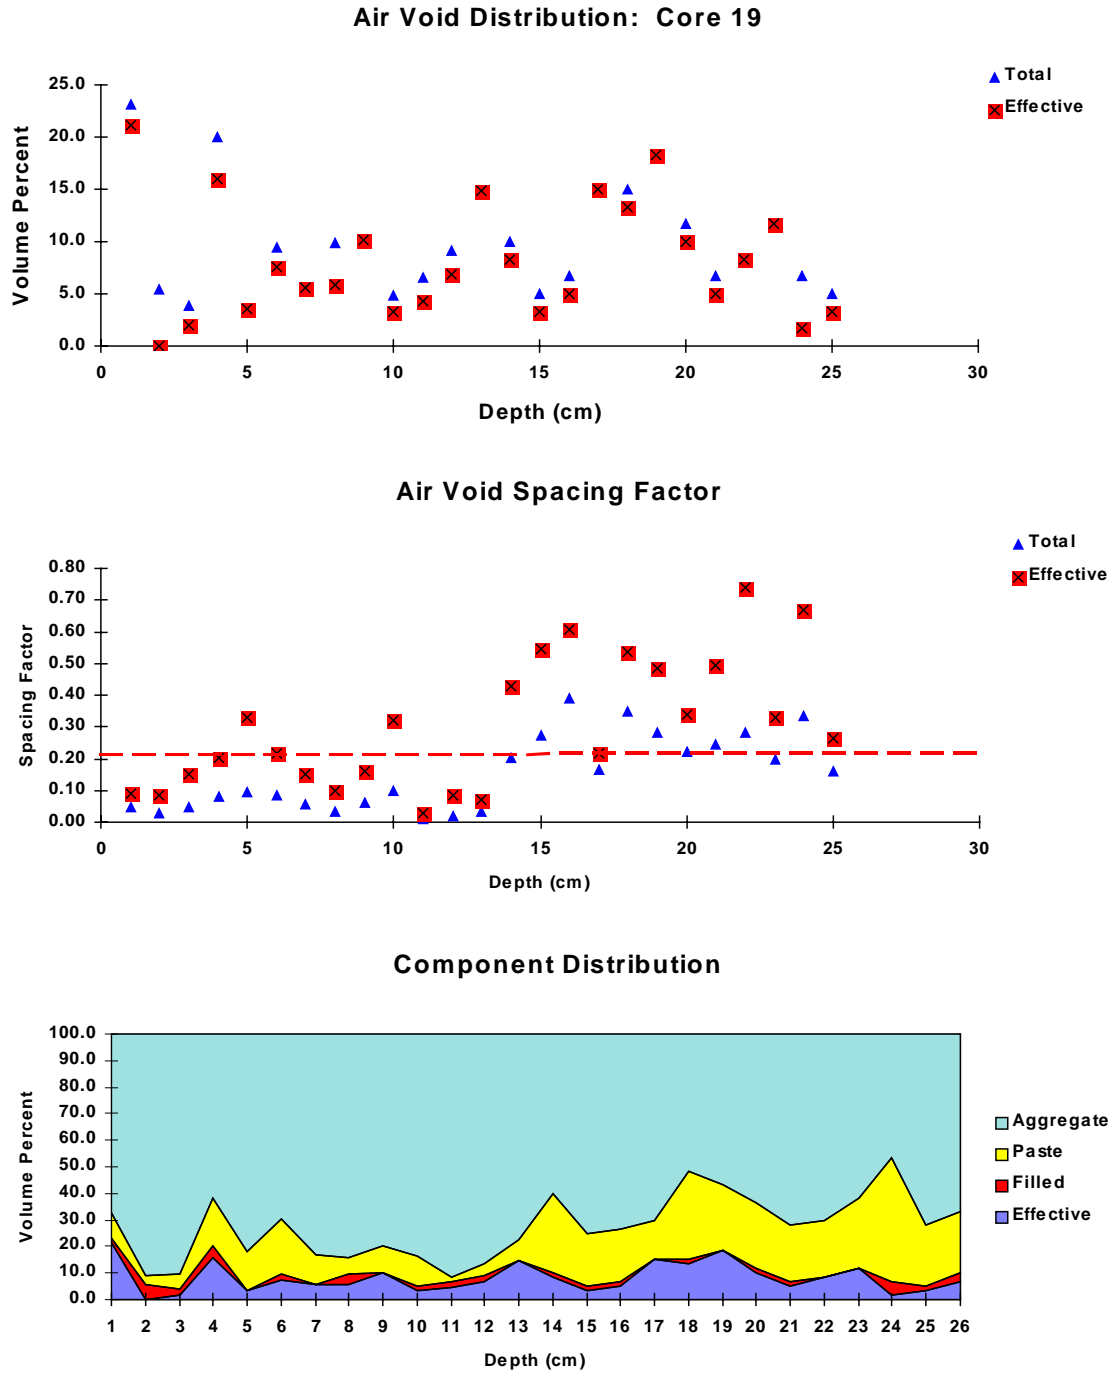
Graphical representation of the air void and component distributions indicates a decrease in spacing factor and an increase in cement paste content with depth (Figure 36). The spacing factors for both the total (original) and effective systems fall beyond that necessary for frost protection at depths greater than 150 mm.

Figure 36. Core 19 data show a decrease in spacing factor with depth and possibly a trend to an increased loss of spacing factor with depth. The component distribution plot shows a possible increase in aggregate and decrease in paste in the upper half of the core.

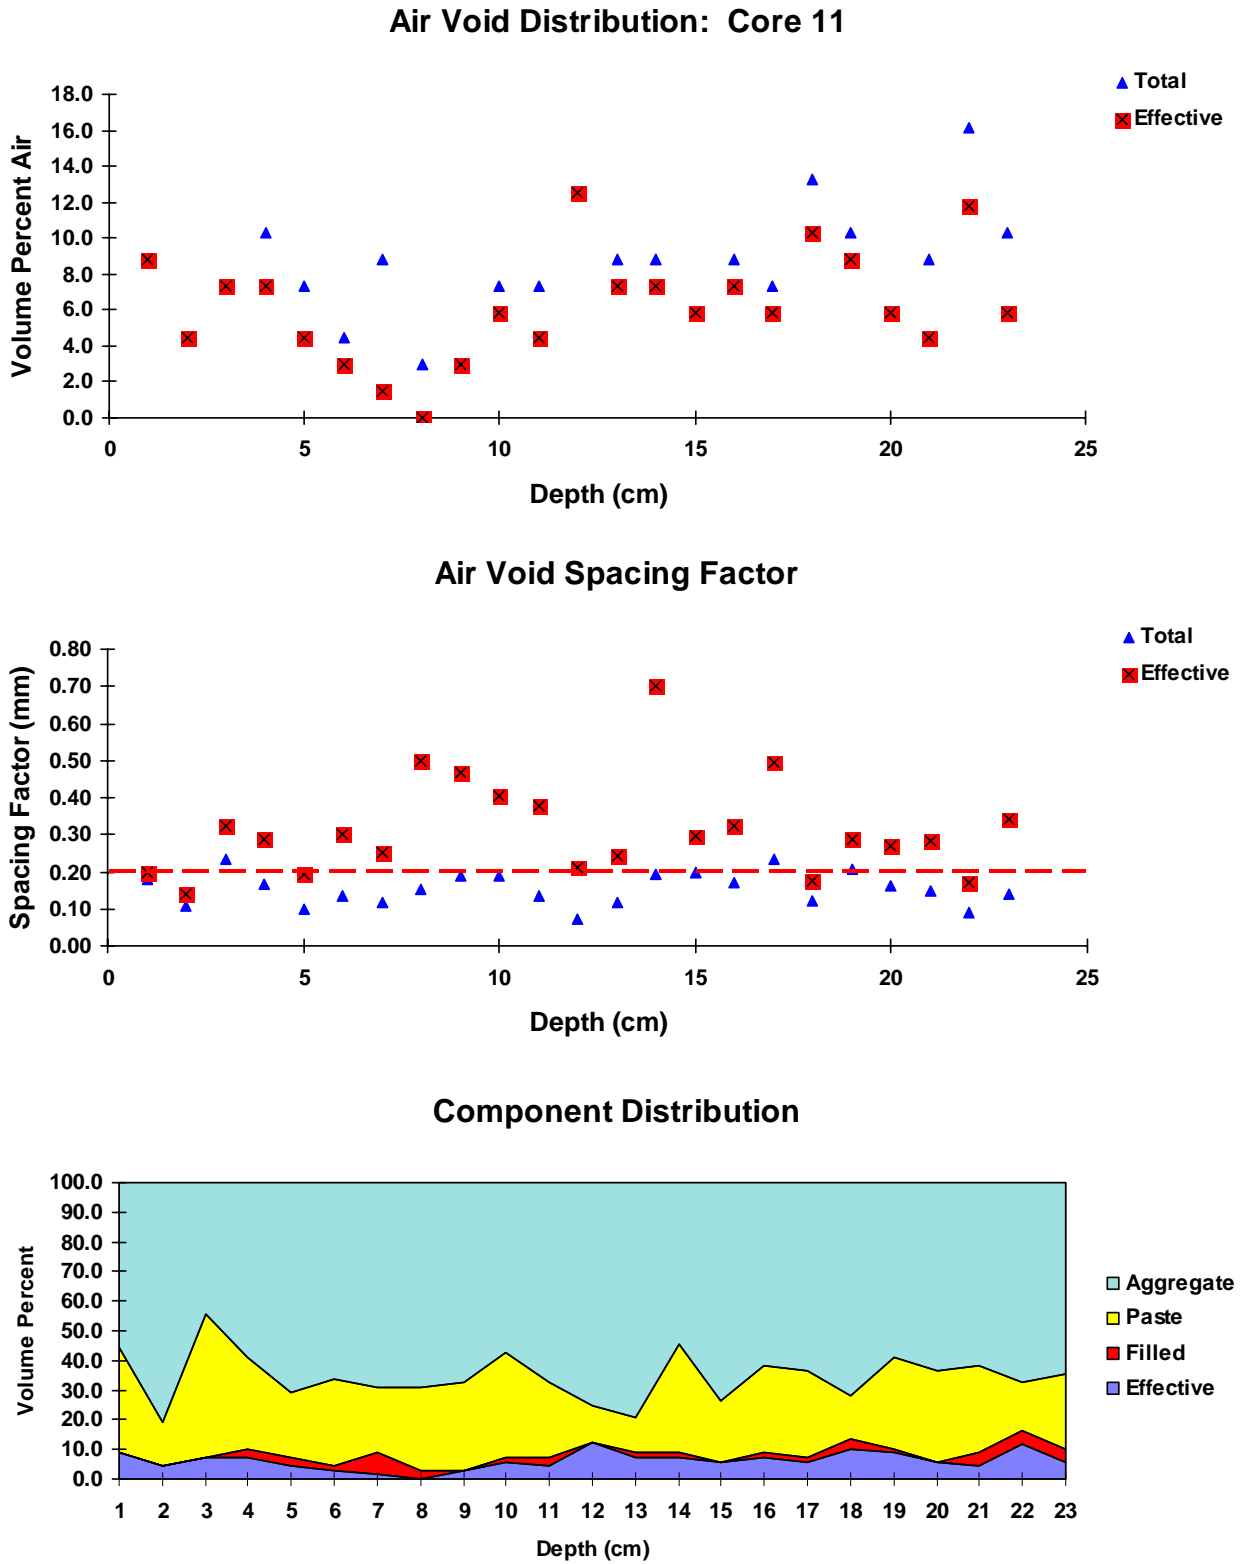
Figure 41: Core 11 air void parameters and component distribution show a loss of air void spacing yet relatively uniform air void volume and materials distribution.
